Building and Timber Pest Inspection Report

Inspection Date: Fri, 27 Feb 2026

Property Address: 1040 Barooga St, North Albury NSW 2640, Australia

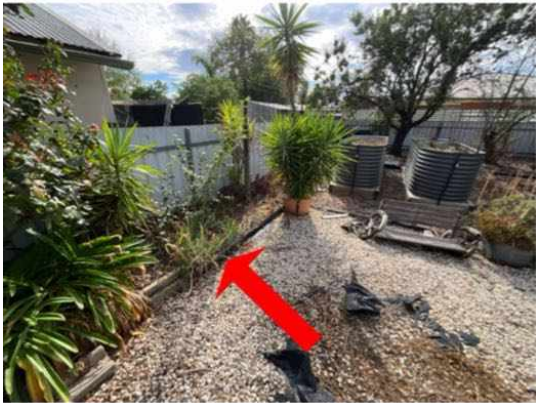
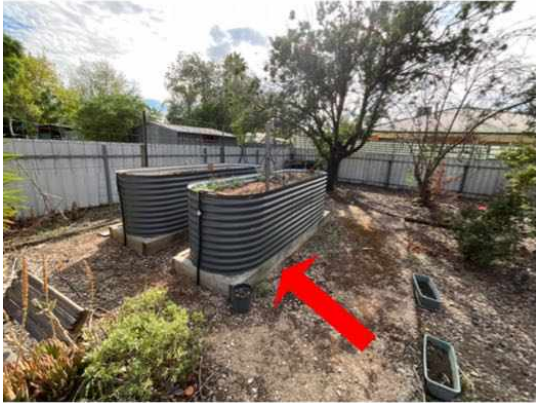
Finding 6.02

Building: Building 1
Location: Yard - Back
Finding: Guttering Missing
Information: The Guttering in this area was missing at the time of inspection. Guttering, Downpipes and Stormwater drainage are vital to protect the integrity of the structure and to prevent an environment conducive to Timber Pest attack.
