# Building and Timber Pest Inspection Report

Inspection Date: Thu, 19 Mar 2026

Property Address: 10 Shaun St, Redbank Plains QLD 4301,  
Australia

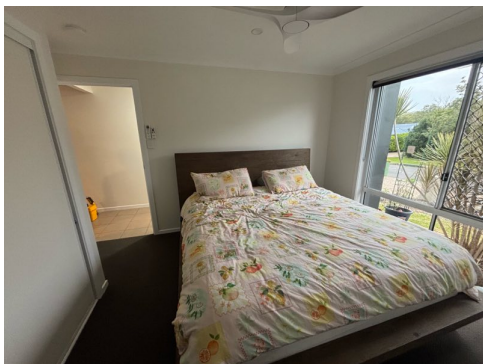
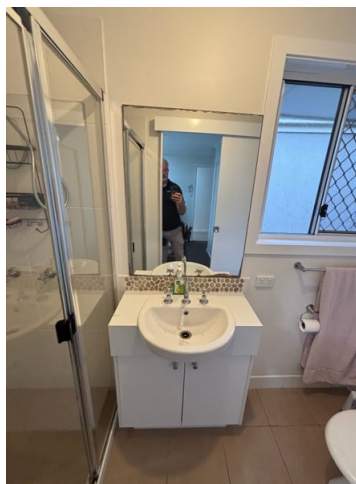
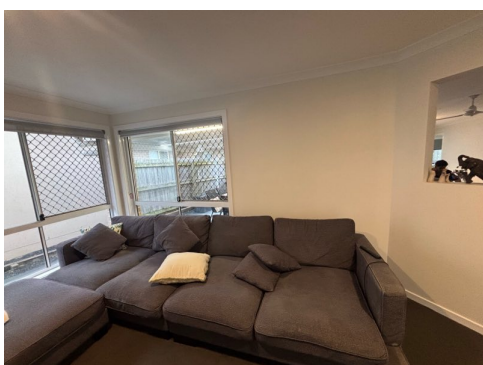
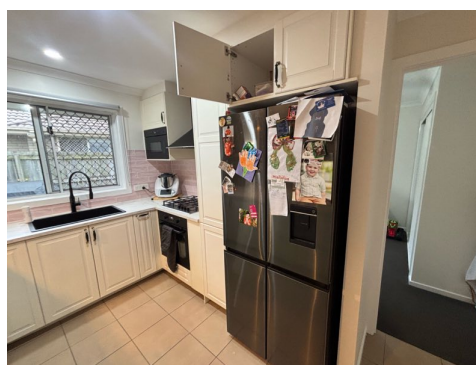
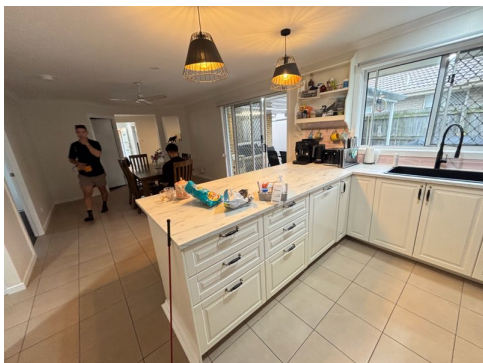
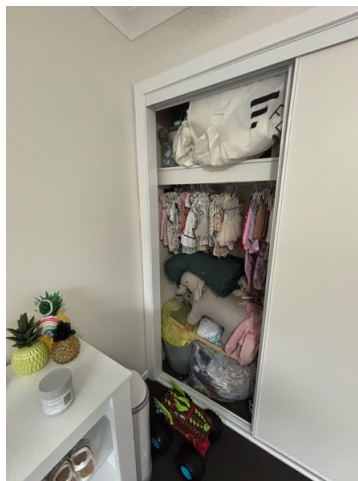
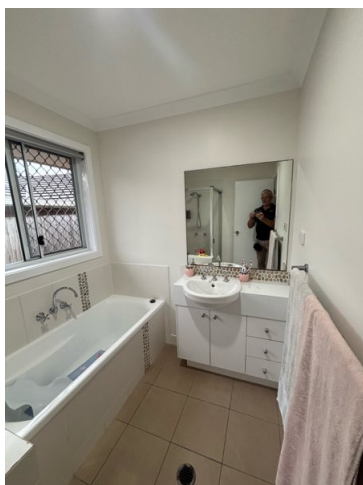
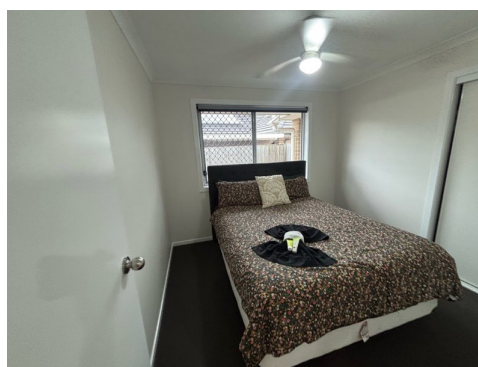
Finding: Obstructions and Limitations - Internal areas

Information: These photographs are an indication of the obstructions and limitations which impeded full inspection of the property of the internal areas at the time of inspection. These obstructions can hide an array of defects and should be removed to allow full inspection to be carried out. A re-inspection is recommended once the areas are made accessible.

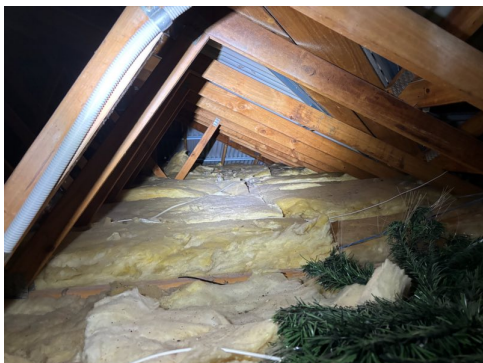
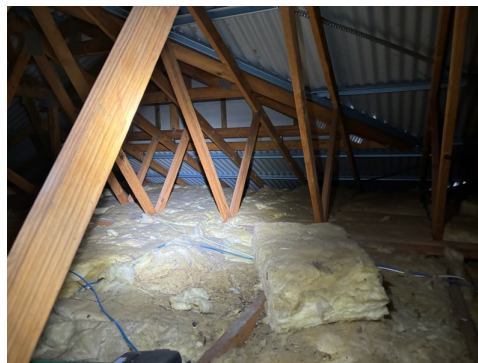
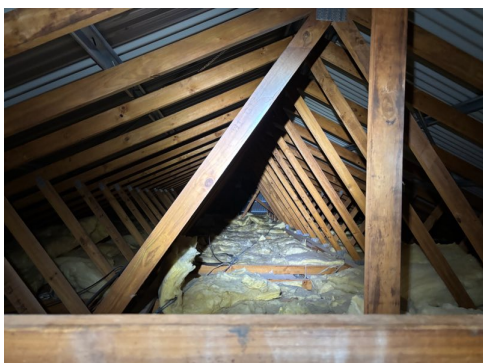
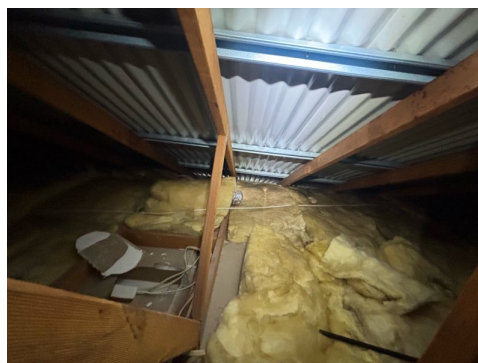
Finding: Obstructions and Limitations - Roof cavity

Information: These photographs are an indication of the obstructions and limitations which impeded full inspection of the property of the roof cavity at the time of inspection. These obstructions can hide an array of defects and should be removed to allow full inspection to be carried out. A re-inspection is recommended once the areas are made accessible.

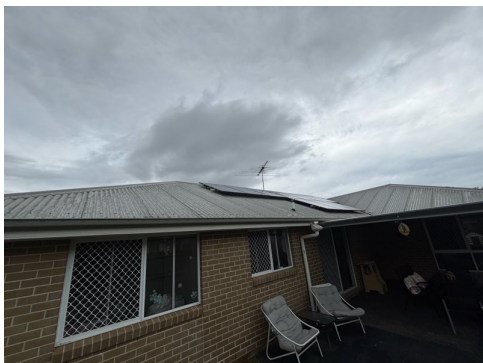
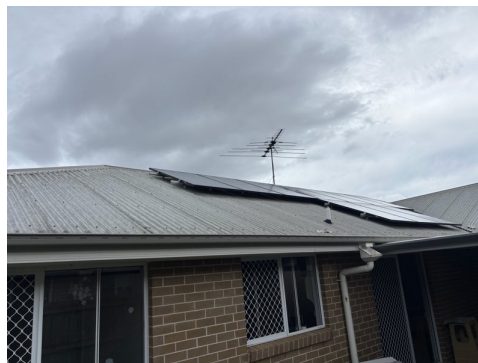
Finding: Obstructions and Limitations - Roof exterior

Information: These photographs are an indication of the obstructions and limitations which impeded full inspection of the property of the roof exterior at the time of inspection. These obstructions can hide an array of defects and should be removed to allow full inspection to be carried out. A re-inspection is recommended once the areas are made accessible.

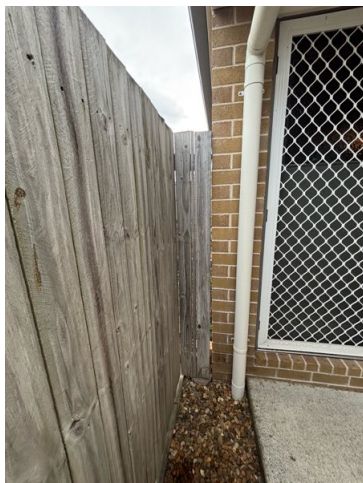
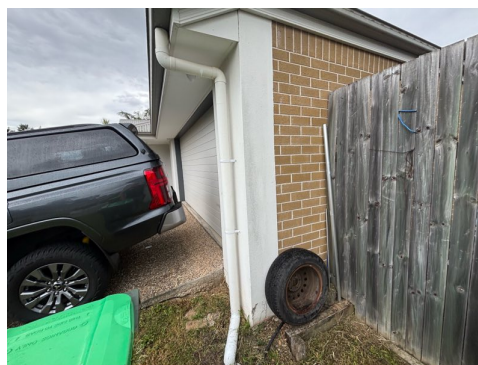
Finding: Obstructions and Limitations - External areas

Information: These photographs are an indication of the obstructions and limitations which impeded full inspection of the property of the external areas at the time of inspection. These obstructions can hide an array of defects and should be removed to allow full inspection to be carried out. A re-inspection is recommended once the areas are made accessible.
