Building and Timber Pest Inspection Report

Inspection Date: Mon, 16 Feb 2026

Property Address: 2/204 Great Western Highway, St Marys
NSW 2760

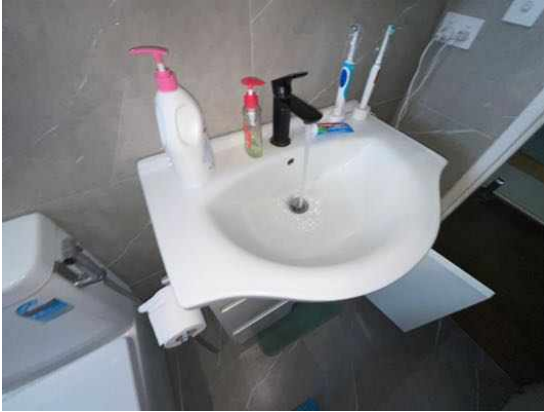
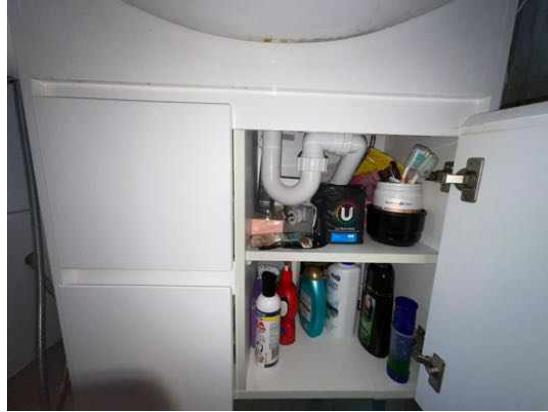
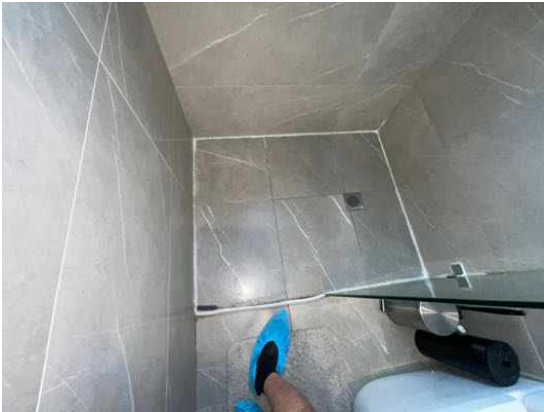
Building: Main Building
Location: Ensuite
Finding: Wet Areas - Bathroom(s) - Overall Condition & Recommendations.
Information: Overall Condition & Recommendations

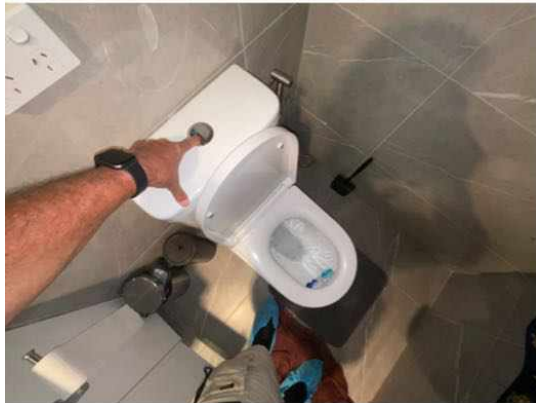
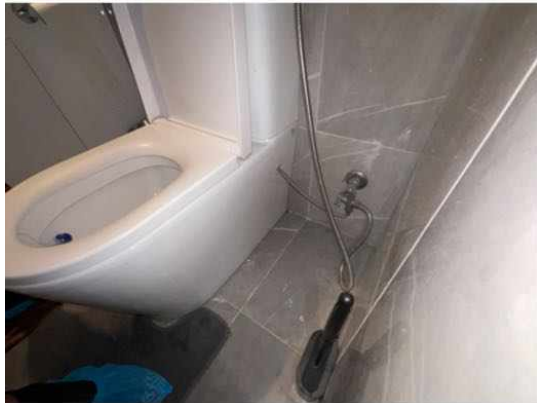
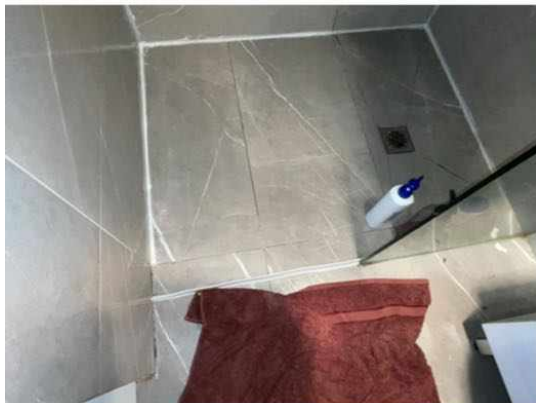
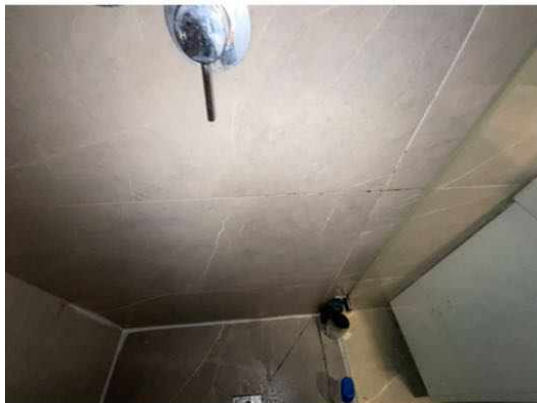
Building: Main Building
Location: Toilet (WC)
Finding: Overall Condition: Toilet & Basin.
Information: TOILET & BASIN ASSESSMENT
