Building and Timber Pest Inspection Report

Inspection Date: Tue, 3 Mar 2026

Property Address: 100 Woorarra Ave, North Narrabeen NSW
2101, Australia

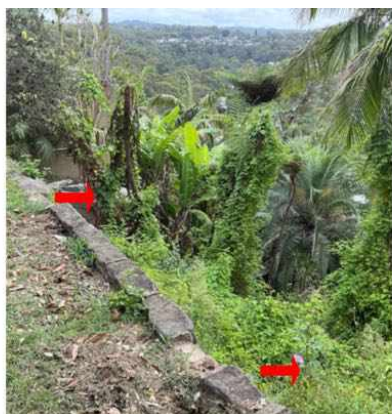
Building:	Main Building
Location:	All External Areas
Finding:	Sloping site - No edge protection and further assessment required
Information:	The rear boundary area is located on a steeply sloping site with dense vegetation and limited fall protection. A low masonry/stone edging is present, however, it does not function as an effective retaining structure or safety barrier given the significant drop beyond. The soil appears loosely compacted with organic ground cover and root systems, which may be susceptible to erosion and localised instability during heavy rainfall. Dense vegetation and trees in close proximity increase moisture retention and termite habitat risk. The absence of a compliant balustrade or barrier along the upper edge presents a potential fall hazard.

Further assessment of slope stability, drainage management and edge protection is recommended.

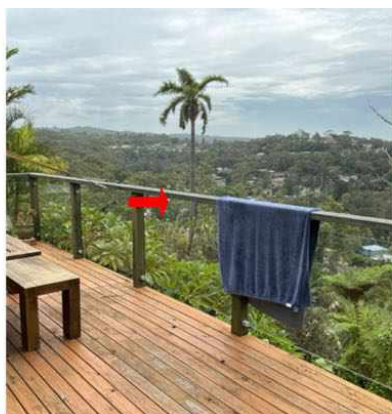
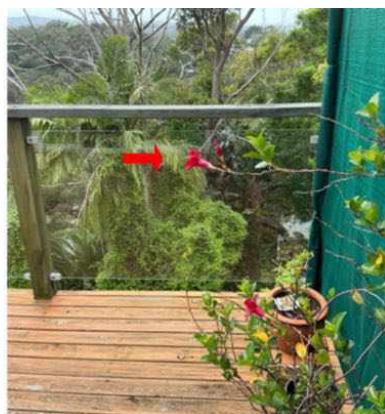
Finding 1.02

Building:	Main Building
Location:	All External Areas
Finding:	Balcony Handrail Movement
Information:	The balcony handrail was physically tested and was found to move when shaken, indicating it may not be adequately secured. This represents a potential safety hazard, as handrails are required to be structurally sound and comply with the National Construction Code (NCC) performance requirements. Immediate further assessment and rectification by a licensed carpenter or builder is recommended to ensure the handrail is safe and compliant.

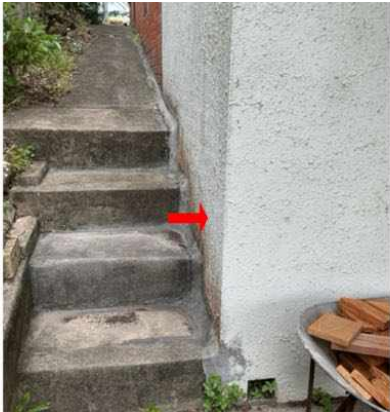
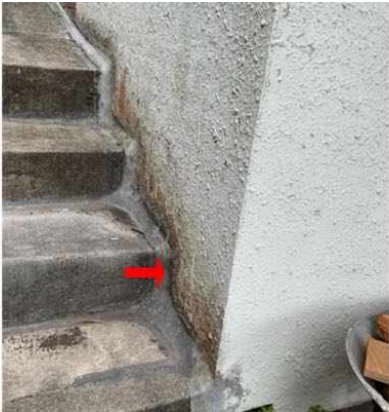
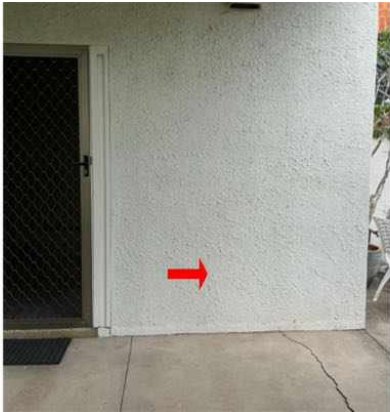
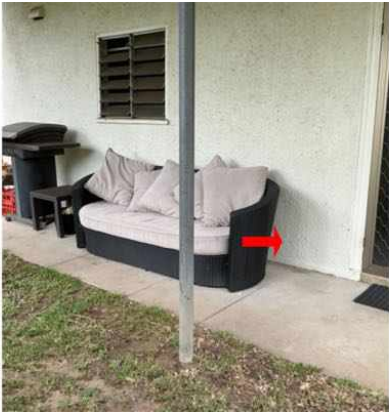
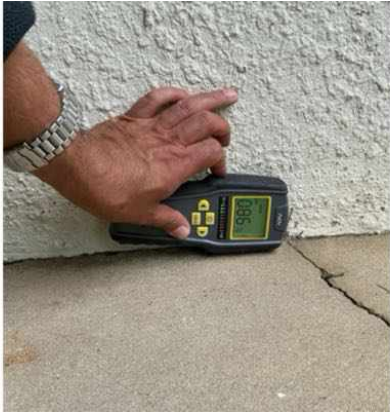
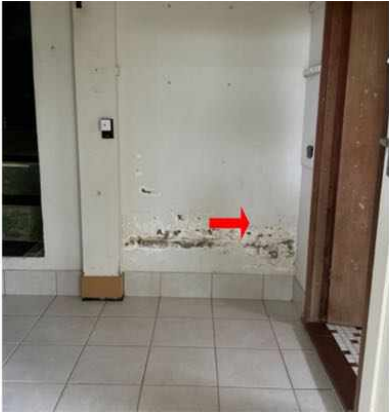
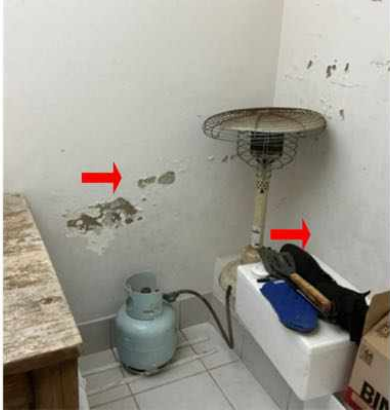
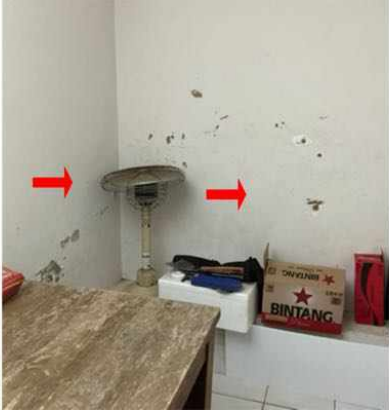
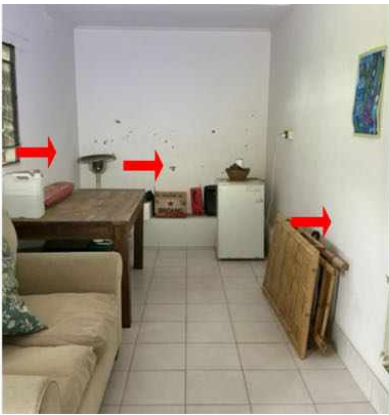
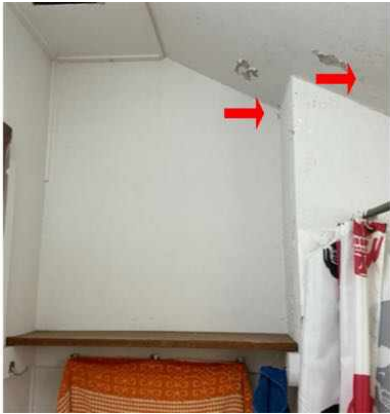
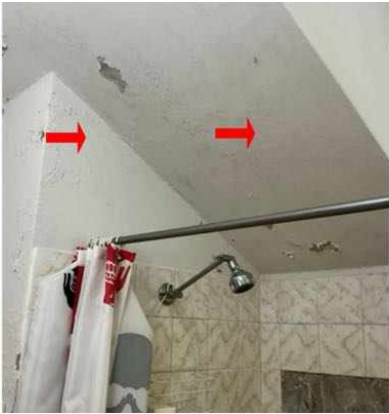
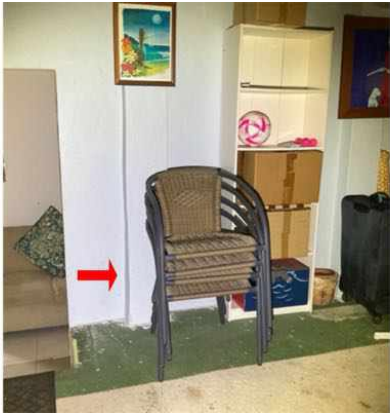
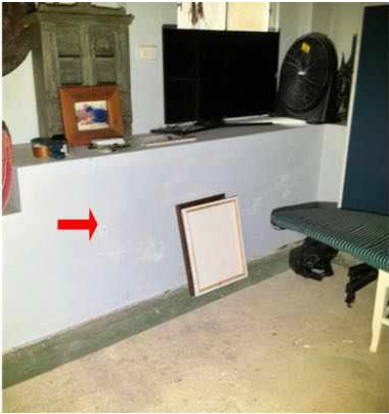
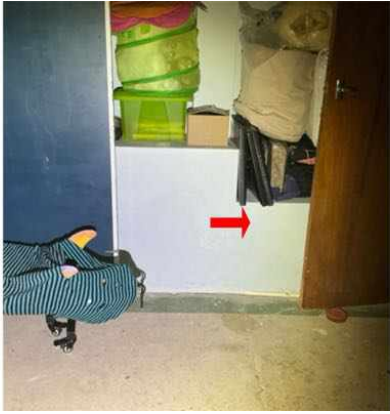
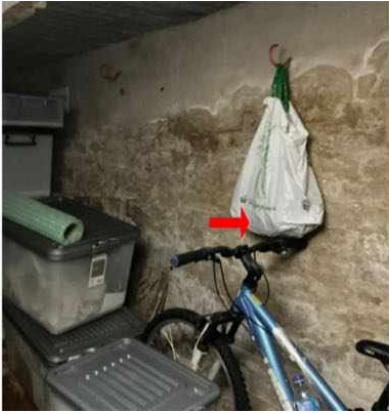
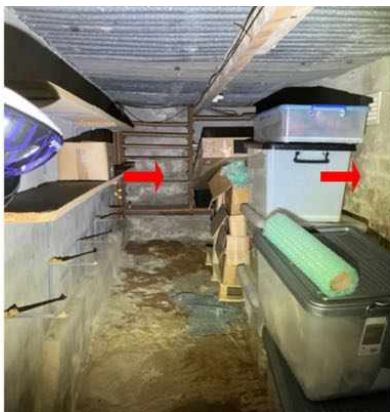
Finding 2.01

Building:	Main Building
Location:	All External Areas - Subfloor area
Finding:	Damp
Information:	Damp (or structural damp) refers to the presence of unwanted moisture in the structure of a building, either as the result of intrusion from outside, or condensation from within the structure. Generally, structural damp is caused by rain penetration, rising damp, and leaks from plumbing pipes.

Unmanaged damp facilitates the formation and development of mould, fungi growth and wood rot, decaying associated building materials and compromising their structural integrity. Damage to finishes is also likely to occur, including lifting, bubbling, peeling and staining of paint, plaster and wallpaper.

It is important to address damp conditions, as the World Health Organisation notes that excess moisture leads - on almost all indoor materials - to growth of microbes such as moulds, fungi and bacteria, which subsequently emit spores and other matter into the indoor air. Exposure to these contaminants is associated with a wide range of respiratory and other health-related problems. Additionally, the development of damp in timber building elements also provides an environment that is conducive to termite / timber pest attack.

The first step in addressing damp is to diagnose the cause. The identified cause should be addressed first prior to repairing the appearance and other defects which have resulted from the rising damp. If the original cause is not resolved, further cases of damp are likely to ensue, resulting in secondary defects.

Consultation with a qualified plumber is advised immediately to identify the cause of damp and perform remedial works as required. Where excessive mould growth is present, further inspection by a specialist environmental health inspector should also be considered.

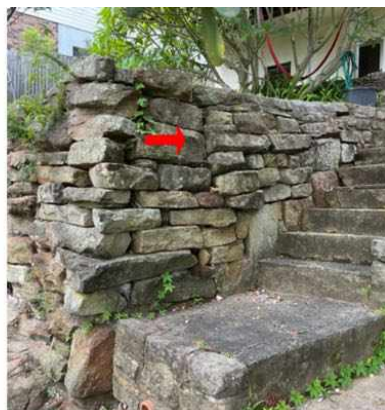
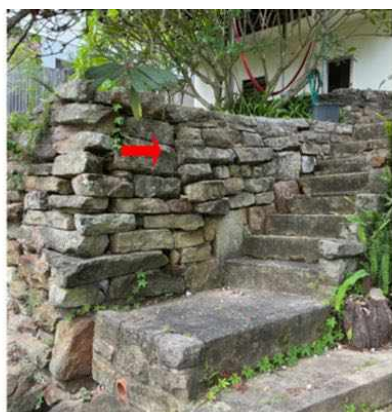
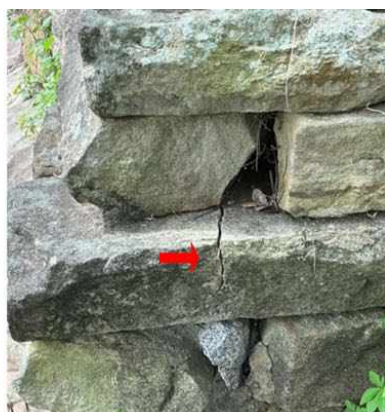
Finding 2.02

Building:	Main Building
Location:	All External Areas - Rear & Side
Finding:	Retaining wall - Defective (Rear and side) Bulging rear and collapsed side wall
Information:	The retaining wall in this area was found to be defective at the time of inspection. Generally, defective retaining walls are caused by poor original design or material use. However, deteriorated retaining walls may also be a result of substandard construction, poor site drainage or unmanaged stormwater flows.

Significant repair and replacement should be expected. Where retaining walls are considered structural walls, a structural engineer / surveyor should be consulted regarding required remedial works. Otherwise, a landscaper or retaining wall installer may be appointed to repair or replace the wall, at the discretion of the client.

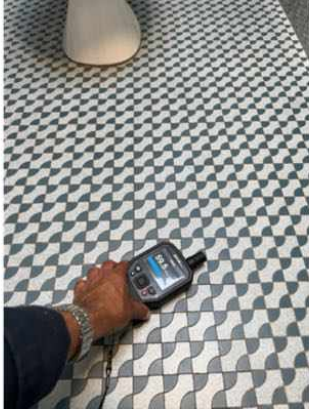
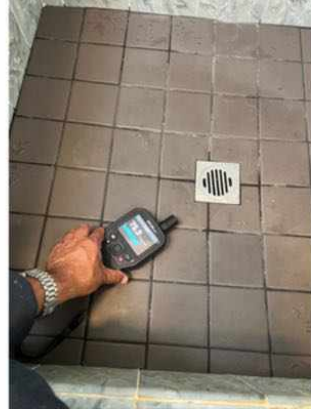
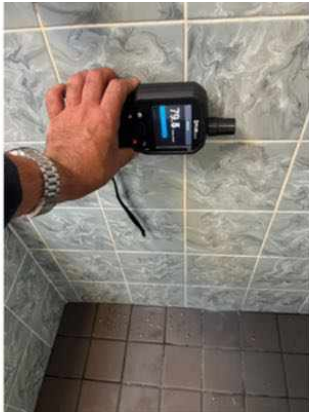
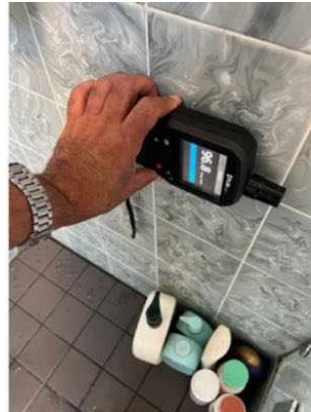
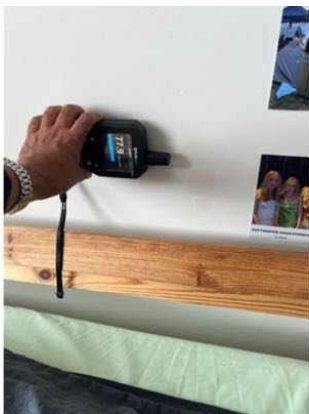
Finding 2.03

Building:	Main Building
Location:	Bathroom
Finding:	Elevated Moisture Bathroom & Back of shower (Possible waterproofing requires further investigation)
Information:	Elevated moisture levels were detected to tiled surfaces in bathroom/shower areas. This may be due to porous or missing grout, cracked tiles or recent use, however the possibility of waterproofing membrane failure or plumbing leaks cannot be excluded. Persistent moisture ingress can lead to concealed damage, including timber rot and mould growth. Further investigation by a licensed plumber and/or waterproofing contractor is recommended as soon as possible. The back of shower area also

showed elevated moisture but no visible deterioration was evident at the time of inspection.

A further invasive inspection by a licensed timber pest technician is also recommended to check for concealed timber pest activity

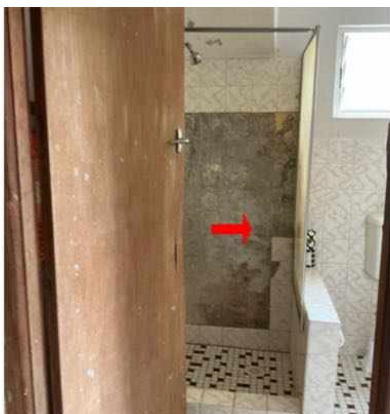
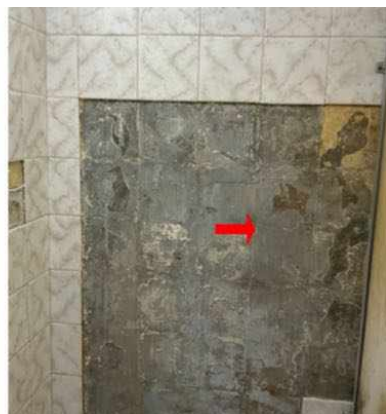
Finding 2.04

Building:	Main Building
Location:	Bathroom
Finding:	Building element - Damaged - Tiles missing and Possible Waterproofing
Information:	The absence of tiles in a wet area likely compromises the waterproofing membrane and increases the risk of water penetration into the wall structure. The surrounding original tiles appear aged, and junction detailing around penetrations and edges may no longer provide effective moisture sealing. Further assessment and reinstatement of compliant waterproofing and wall finishes to the shower area is recommended.

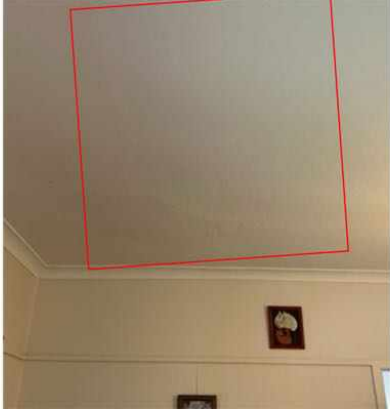
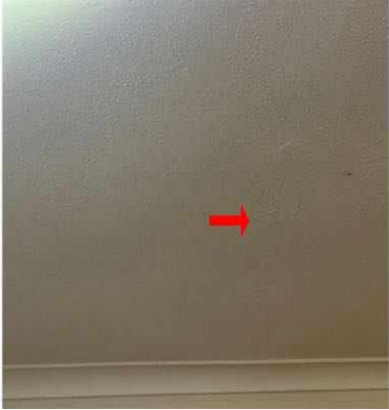
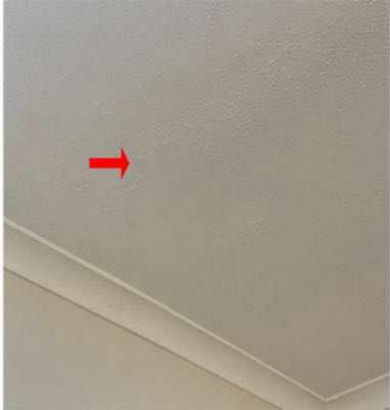
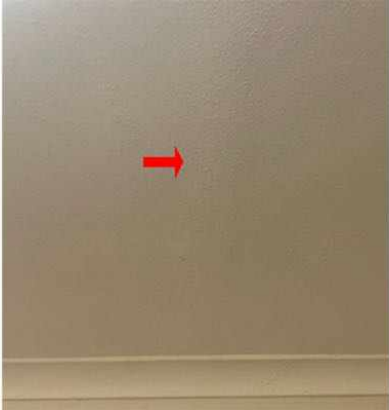
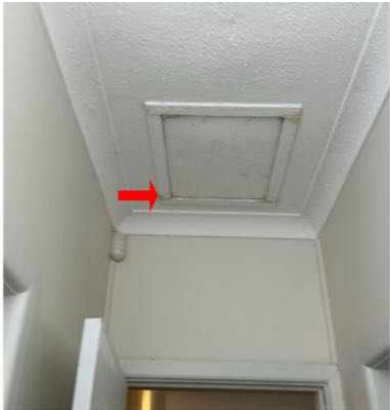
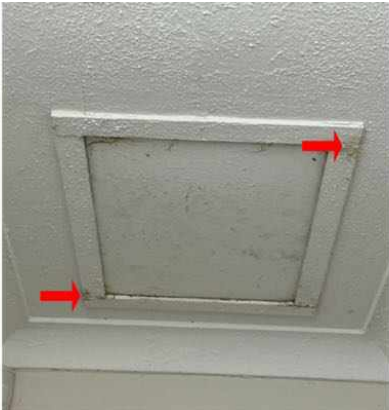
Finding 2.05

Building:	Main Building
Location:	All Internal Areas - Lounge , hallway , bedrooms , sitting
Finding:	Painted surface - Bubbling
Information:	Sections of paint in this area was found to have bubbled and deteriorated. Paint bubbling is generally an indication of excessive moisture in the area, that is currently hidden by the painted surface.

It is highly advised that the affected paint be cleaned to allow a further, more invasive inspection by a licensed plumber. Failure to act on this defect may necessitate major works in the future.

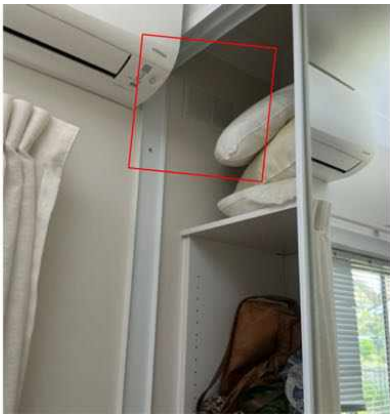
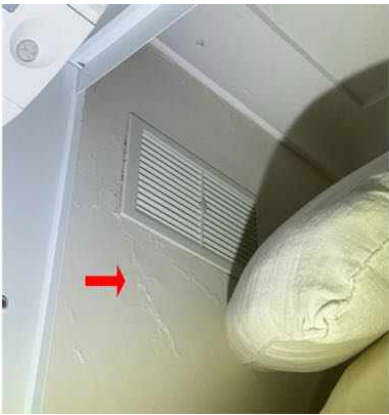
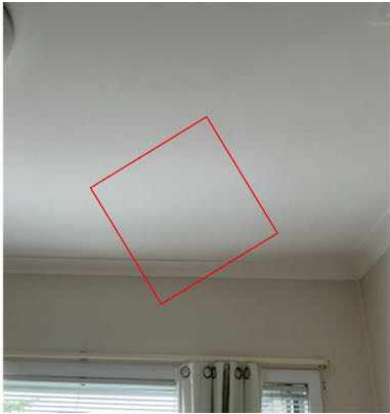
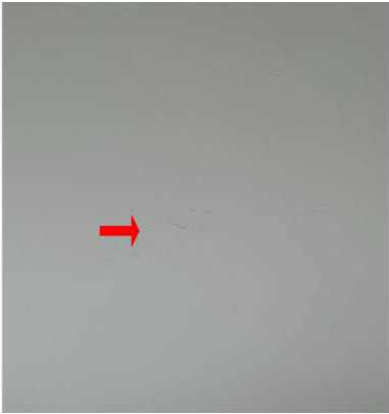
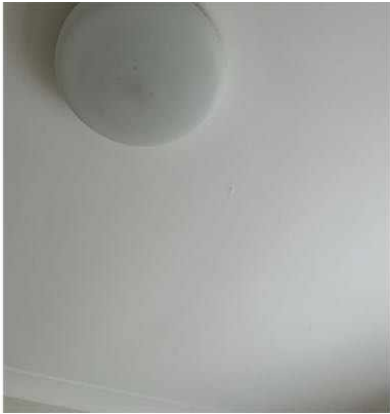
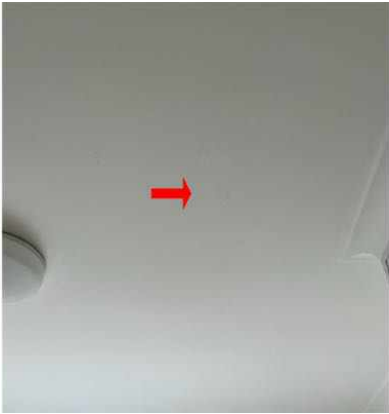
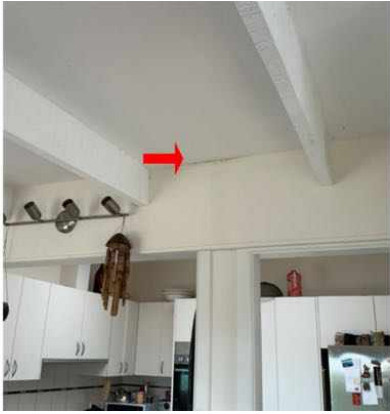
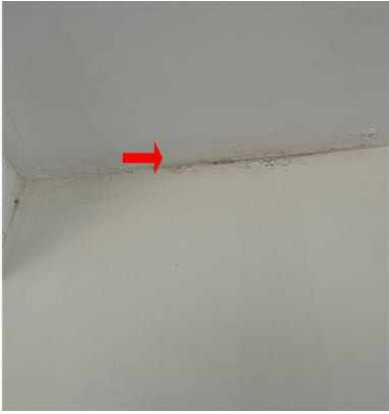
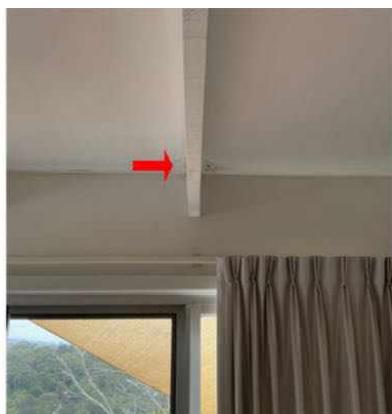
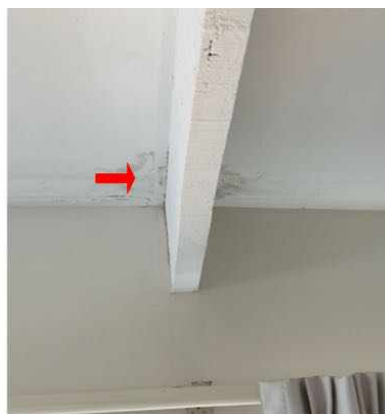
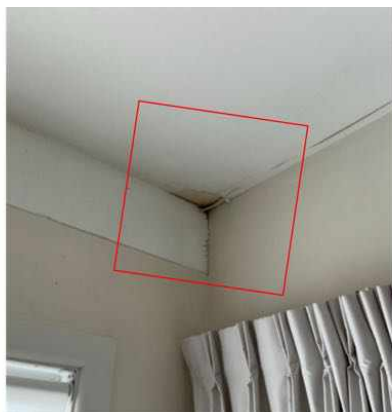
The presence of excessive moisture can have major implications on associated building elements if left unattended. While only seemingly minor at this stage, the damage cannot be determined due to the paint obstructing any further inspection of

the damage.

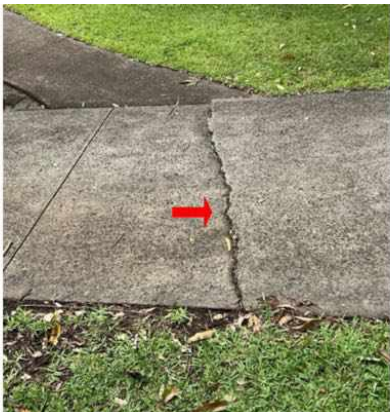
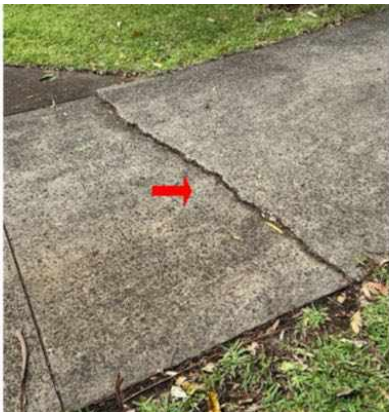
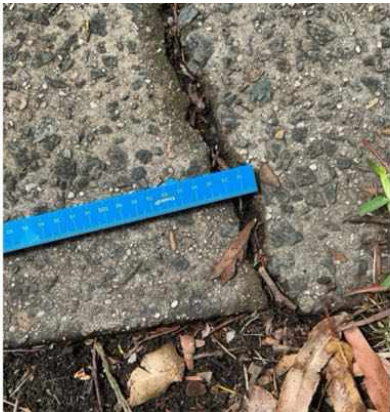
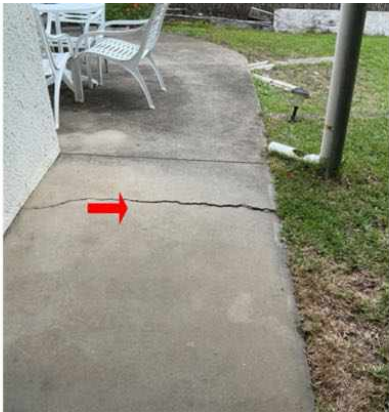
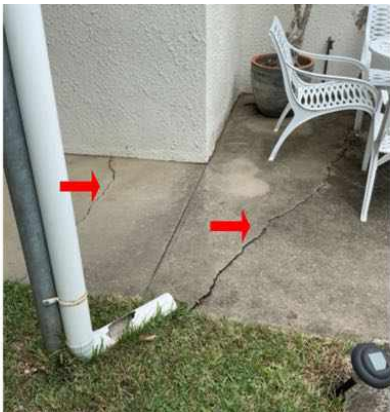
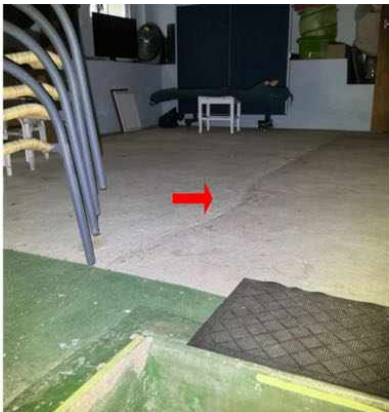
Finding 3.01

Building:	Main Building
Location:	All External Areas
Finding:	Cracking - External Concrete Paving Damage Category 4 - Gaps in Slab (4mm - 10mm +)
Information:	Gaps in the slab were identified in external concrete paving. Gaps in the slab are significant and are likely to lead to the development of safety hazards and secondary defects if left unmanaged, such as the creation of a trip hazard.

General age and expected deterioration of the paved areas is a common cause of this type of cracking. However, expansion and contraction of the slab may also have occurred due to environmental factors. Such factors include variable moisture and weather conditions, the presence of trees and their roots having a settling or lifting affect on the soil, or the effect of load bearing, e.g. heavy vehicles over a sustained period of time.

Cracking to this degree may also be due to poor original installation of the concrete. Factors such as poor compaction of the sub surface and/or inadequate reinforcing of the slab may create cracking and other secondary defects. Gaps in the concrete paving may also have a more significant structural cause, such as subsidence of soils.

Where gaps in the concrete paving are adjacent to structural elements of the building, the advice of a Structural Engineer is advisable before undertaking repairs. Significant repair and likely replacement of the concrete paving is probable.

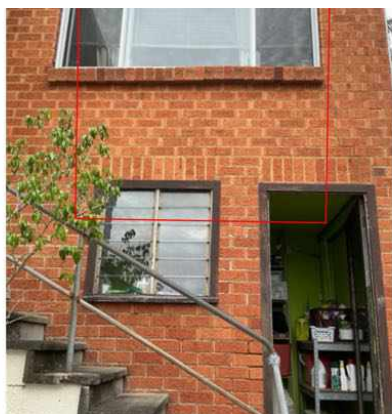
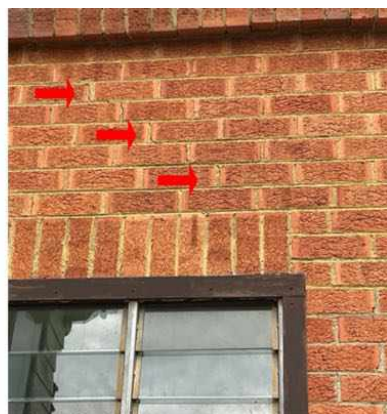
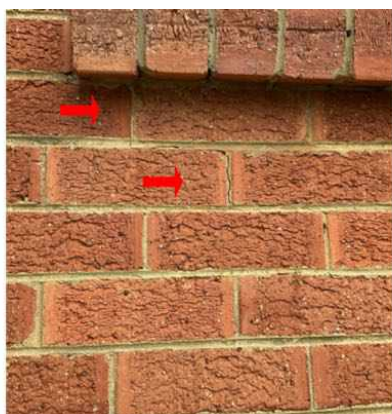
Finding 3.05

Building: Main Building
 Location: All External Areas - Rear
 Finding: Brickwork - Cracking noticeable
 Information: There were several cracks and or crack repairs evident to external brickwork.

Noticeable cracks are a common occurrence in external brickwork and are a likely result of age expected building movement, general expansion, and/or contraction of building materials in different weather conditions. Noticeable cracks in brickwork may develop if left unattended, with potential for necessitating major remedial works or replacement of the brickwork.

It is highly advised that a qualified bricklayer be appointed to provide necessary works to cracked brickwork to prevent any further damage. Such works should be conducted as soon as possible.

Always monitor these cracks and contact a building inspector should cracks widen, lengthen, or become more numerous.

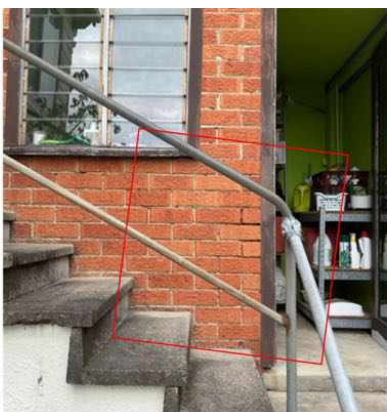
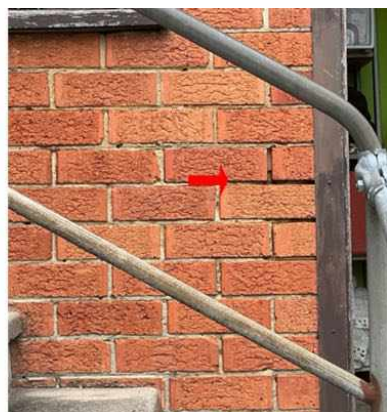
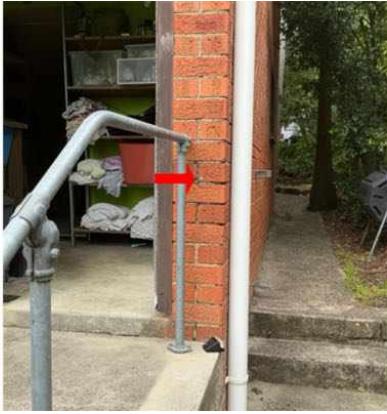
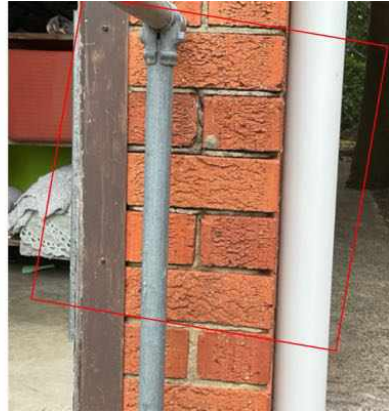
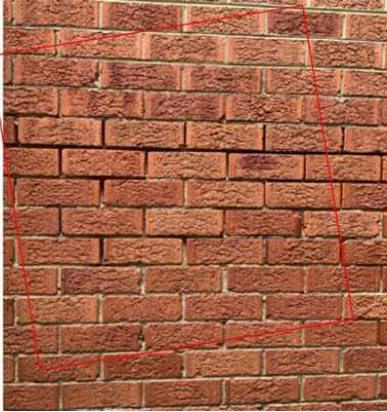
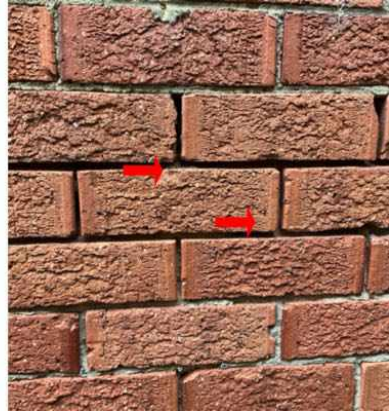
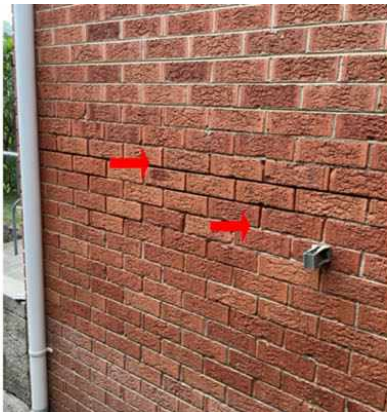
Finding 3.07

Building:	Main Building
Location:	All External Areas
Finding:	Brickwork - Deteriorated mortar to some areas
Information:	Mortar, or 'bedding', is the material which fills joints and intersections between bricks in masonry walls and structures. Sections of mortar in this brickwork were identified as having deteriorated, which is generally expected for a property of this age and condition.

Mortar may deteriorate as a result of age of building materials, minor movement of bricks, or frequent exposure to weathering. Mortar should be replaced to ensure that bricks remain in their intended location and to prevent gaps, which would allow water or moisture ingress and secondary damage as a result.

Mortar deterioration can be addressed by a bricklayer where areas of deterioration are localised and easily accessible. Alternatively, appointment of a registered builder is advised, to repoint large areas of decaying mortar. Where secondary structural defects have become evident, consultation with a structural engineer may be required.

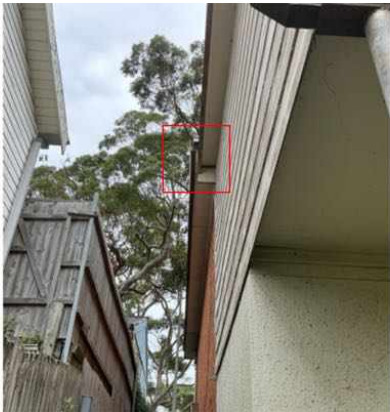
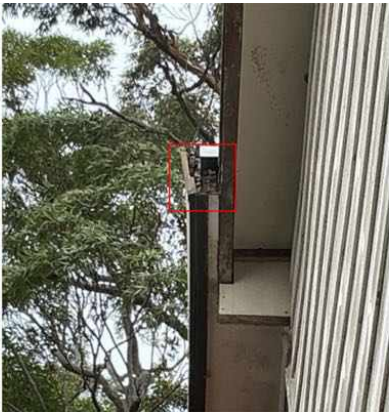
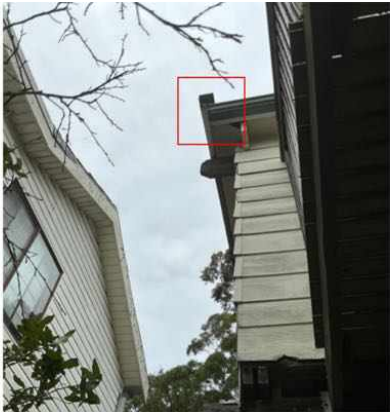
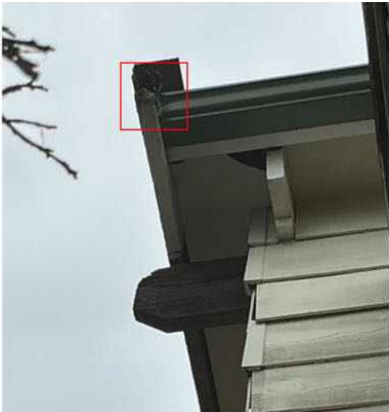
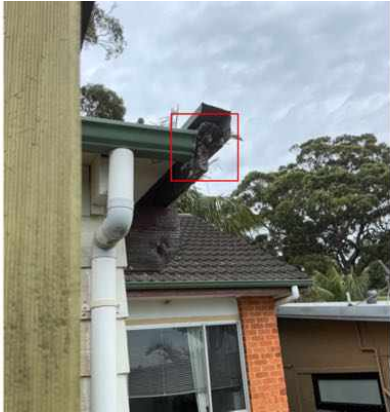
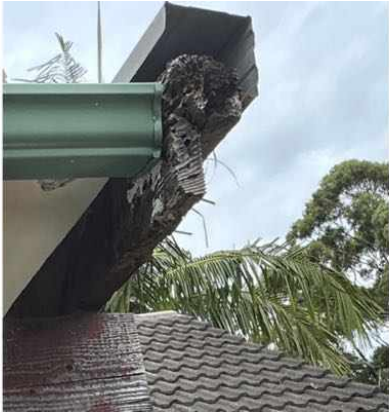
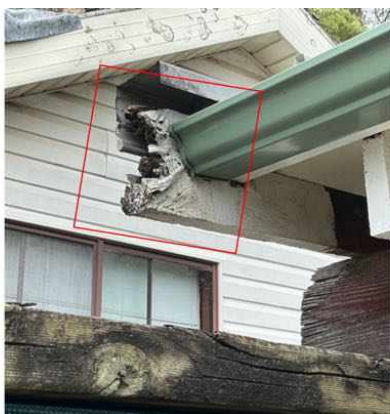
Building:	Main Building
Location:	All External Areas
Finding:	Fascias - Wood rot (Also refer to defect - Fungal decay)
Information:	Wood rot was found to be affecting fascias and barges in this area, evidenced by the presence of mould on the surface in some areas. Wood rot, also known as Fungal Decay, occurs when timbers and other cellulose building materials are exposed to damp conditions on an ongoing basis.

It is likely that this wood rot has developed as a result of faults in the roof plumbing, creating excessive moisture in this areas. Frequent exposure to rain and other weather conditions also make fascias and barges susceptible to accelerated deterioration.

Early intervention and regular maintenance will prolong the useful life of these building elements. Prior to any works being performed, the cause of the moisture that has created the visible wood rot should be identified and addressed in a suitable manner.

It is advised that a roof plumber be appointed to inspect all roof plumbing and subsequently identify the cause of the wood rot. Replacement of affected fascias and barges may then be a necessary step in protecting surrounding building elements from such deterioration.

A qualified plumber may be appointed to assess the cause of excessive moisture and to provide advice on any remedial works as required. A qualified carpenter or registered builder may also be required to replace affected building materials.

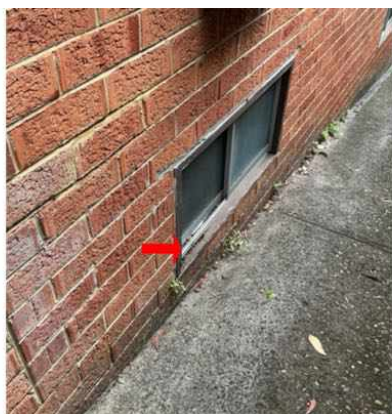
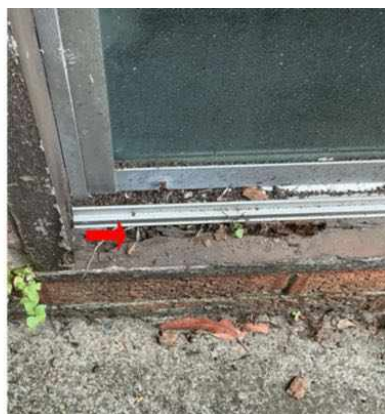
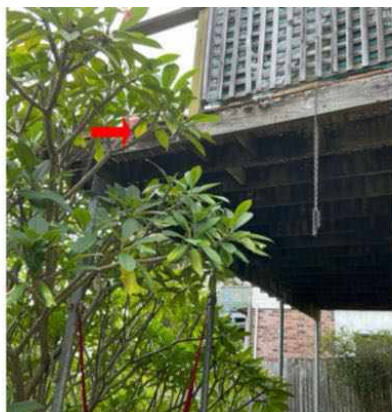
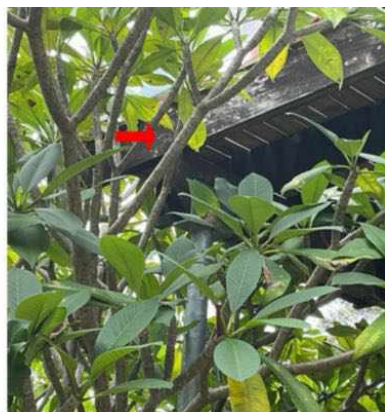
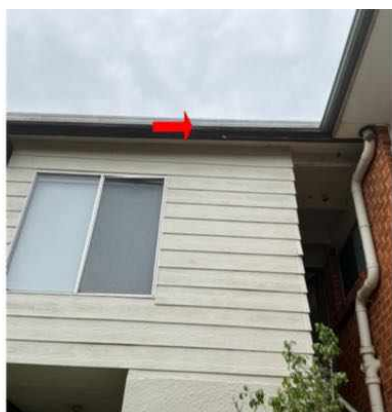
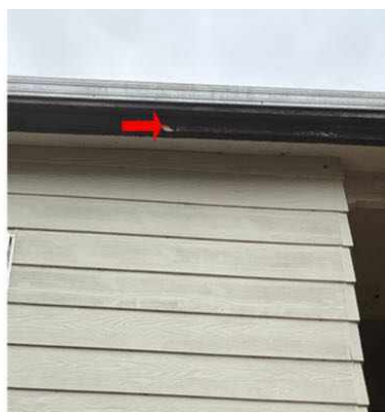
Finding 3.10

Building:	Main Building
Location:	All External Areas
Finding:	Wood rot to some areas
Information:	This building element shows evidence of wood rot. Wood rot, also known as Fungal Decay, occurs when timbers and other cellulose building materials are exposed to damp conditions on an ongoing basis. This could be the result of exposure to weathering over a prolonged period of time, or the attraction of excessive moisture from other abutting building materials. Contributing factors also include poor air ventilation in the area.

Wood rot is often associated with general damp problems and is evidenced by a 'musty' smell or mould and mildew occurring on surfaces. If left unmanaged, damp conditions can lead to further health problems and the decay of timbers will continue.

Early intervention and regular maintenance, particularly of exterior timbers, will prolong the useful life of these building elements. Prior to any works being performed, the cause of the moisture that has created the visible wood rot should be identified and addressed in a suitable manner. Replacement of affected timbers may then be a necessary step in protecting surrounding building elements from such deterioration.

A qualified plumber may be appointed to assess the cause of excessive moisture and to provide advice on any remedial works as required. A qualified carpenter or registered builder may also be required to replace affected building materials.

Even though Liverpool termite activity was not visible. A further invasive inspection by a licensed termite technician its also highly recommended to eliminate possibility of potential termite activity.

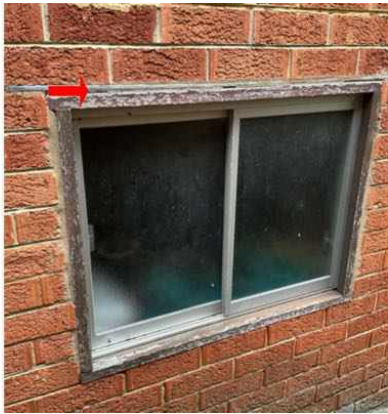
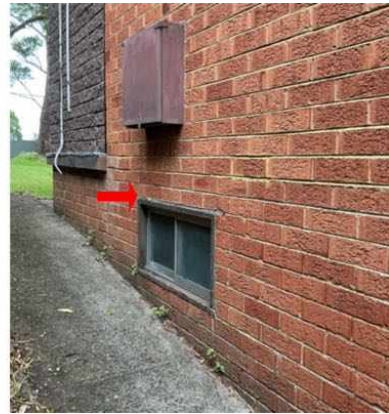
Finding 3.11

Building:	Main Building
Location:	All External Areas
Finding:	External painting deteriorated
Information:	Whilst incomplete or missing paint finish is generally an appearance defect, it can also lead to the development of secondary building defects over time. Incomplete areas of paint finish expose the area to moisture, potentially accelerating the deterioration of underlying building materials.

Degraded paint finishes should be sanded back, filled, leveled and painted, as applicable. Where inadequate or missing paint protection has led to the deterioration of the associated building element, repair and/or replacement of this building element

may be required.

A painting contractor should be appointed as soon as possible to perform necessary works to aid the appearance of the affected area and to ensure the area is protected against further deterioration. Alternatively, the homeowner following manufacturer instructions may perform these works.

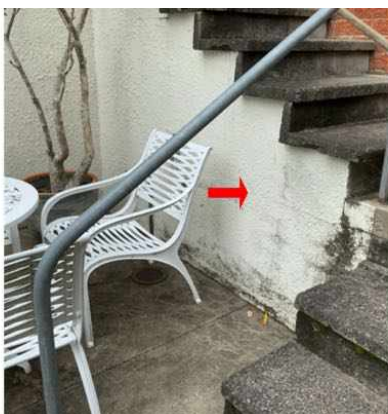
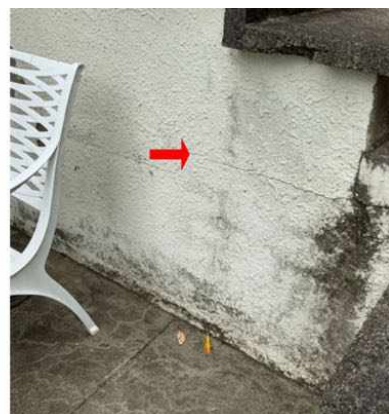
Finding 3.12

Building:	Main Building
Location:	All External Areas
Finding:	Cracks to render - Category 1 to some areas
Information:	It has been observed that cracking to rendered surfaces has occurred. The degree of damage falls within Category 1, described as fine cracks that do not need repair and which are less than 1.0mm in width limit.

Damage of this category is not considered a defect for rectification. Always contact your building inspector should cracks widen, lengthen, or become more numerous.

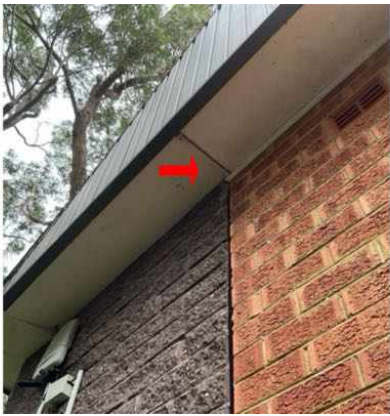
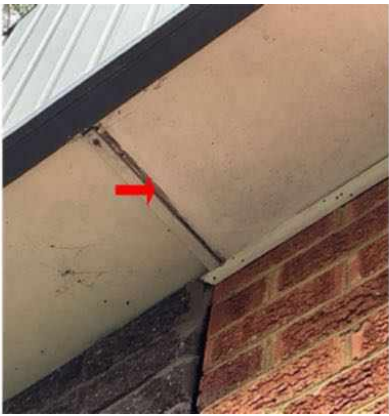
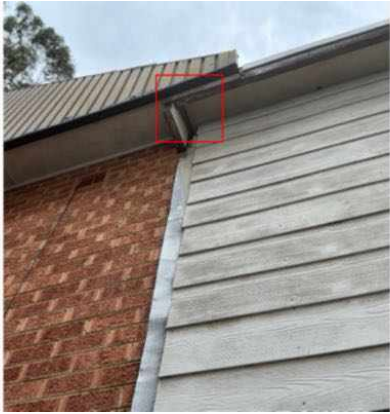
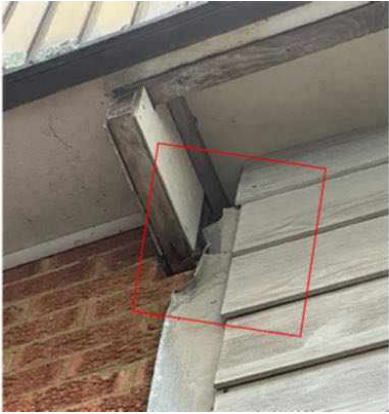
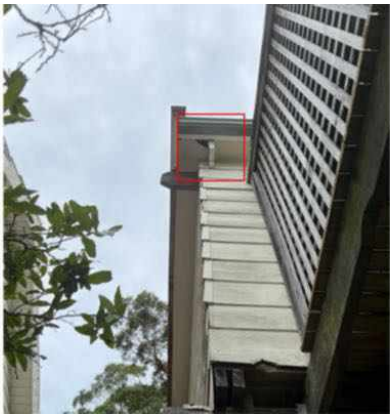
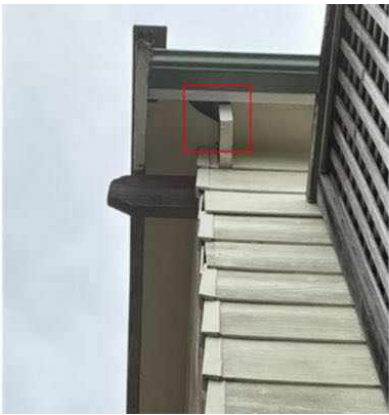
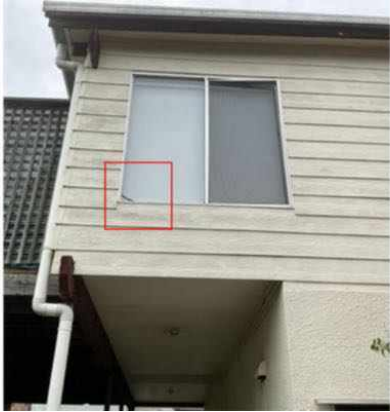
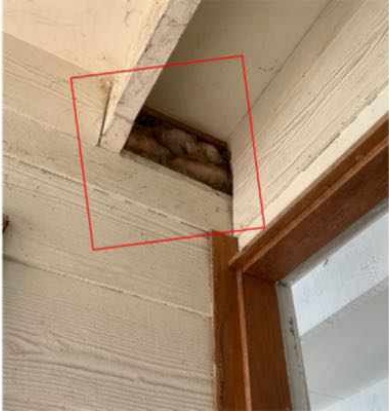
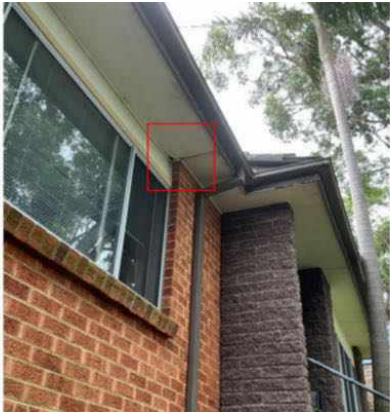
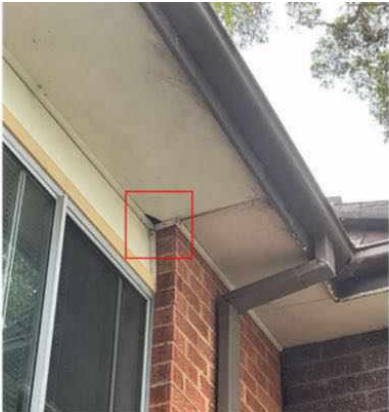
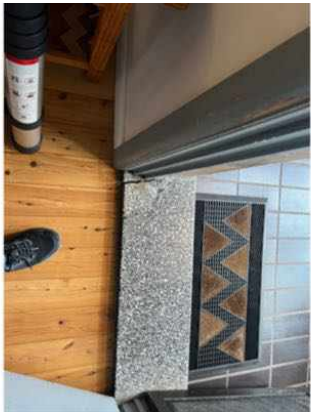
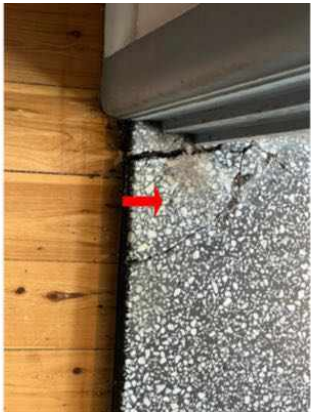
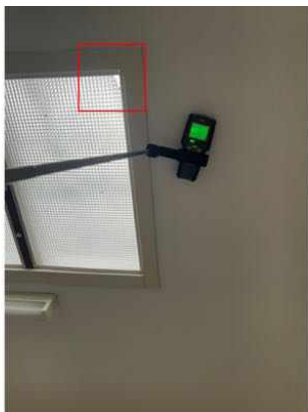
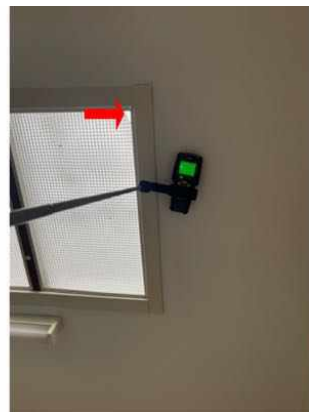
Finding 3.15

Building: Main Building
 Location: All External Areas

Finding: Building element - Damaged - Eave loose right , Gap not sealed possible water ingress , window seals damaged , missing flashing , concrete paving damaged front , cracked skylight Perspex

Information: Breakage occurs generally when the building materials have either aged and decayed, or as a result of damage (accidental or deliberate).

Repair and/or replacement of broken elements is advised to ensure that additional secondary defects do not arise as a consequence. Such works are necessary, as all building elements play a key role in the operation and function of the overall structure and its performance.

A relevant tradesperson should be appointed to repair or replace the affected building element prior to any subsequent damage being caused.

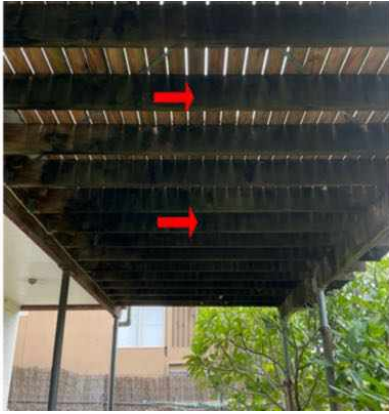
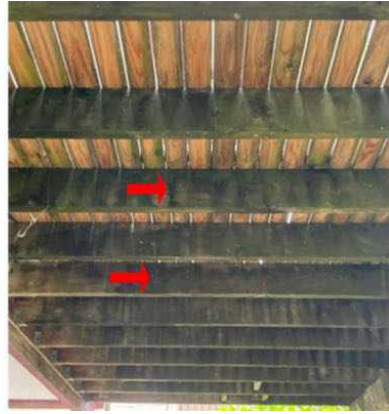
Finding 3.16

Building:	Main Building
Location:	All External Areas
Finding:	Water staining - Timber deck and moisture damaged underside of deck (Requires further investigation)
Information:	Water staining was evident in this area at the time of inspection. Water staining indicates that surfaces have been exposed to excessive moisture over time. The minerals and other elements in the water lead to staining, which may graduate to corrosion and deterioration if left unmanaged.

While mostly an appearance defect, water staining can be indicative of more serious defects, which may be currently concealed by other building elements.

Where water staining is active, a licensed plumber must be consulted to identify the cause of the staining and to provide advice on any reparation works that may be required. Replacement of any broken or damaged structures is advised.

Conversely, where water staining is old and inactive, affected building materials may be repaired or replaced at client discretion. A qualified carpenter or registered builder may be appointed to perform these works.

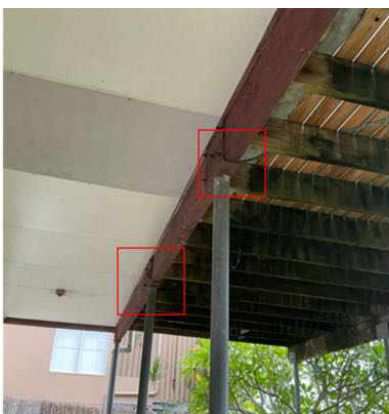
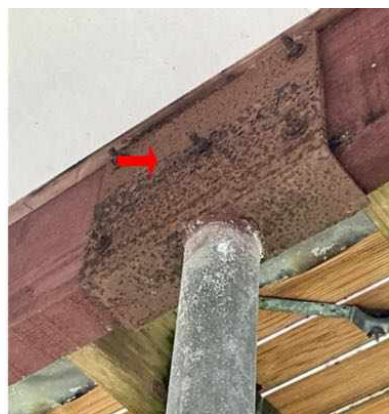
Finding 3.17

Building:	Main Building
Location:	All External Areas - Rear deck
Finding:	Building element - Rusted or corroded
Information:	This building element shows evidence of rusting and corrosion, which is likely to have developed as a result of excessive exposure to moisture and or inadequate coatings.

As surface rust provides no protection to the underlying iron, the deteriorating condition is likely to worsen if not addressed in the short-term future.

Where possible, the use of galvanized (treated) metals or aluminium coated metals aid in rust prevention, as does regular general maintenance. Rust formation can be controlled with coatings, such as paint, that isolate the iron from the environment.

Rusting and corrosion should be managed by ideally removing or limiting the affected surface from exposure to moisture. A registered builder may be appointed to replace any building elements that have been severely affected by rust or water damage.

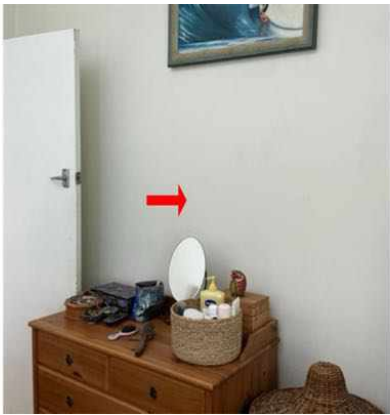
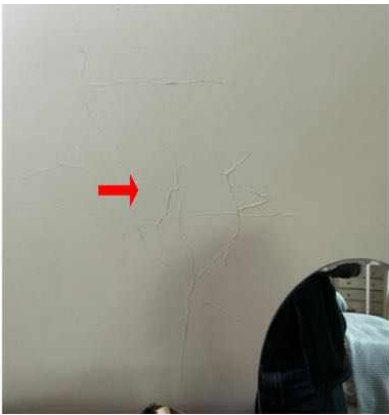
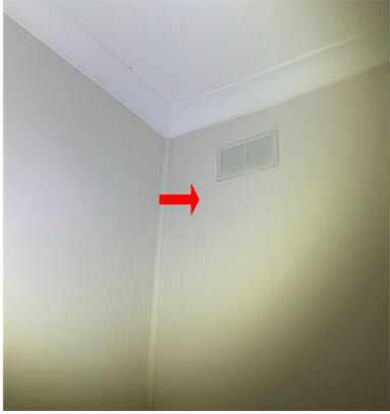
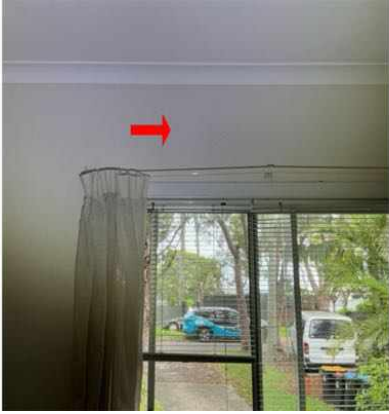
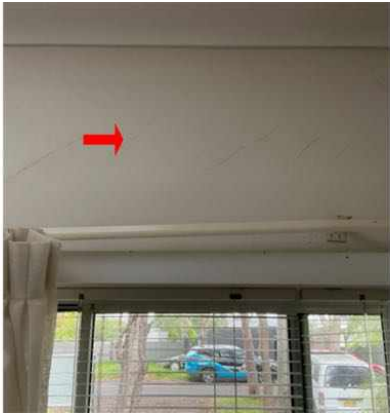
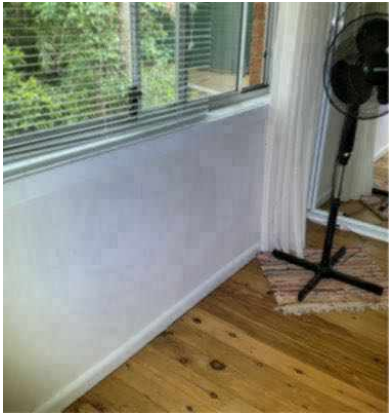
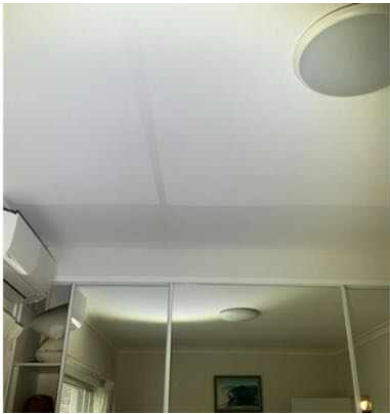
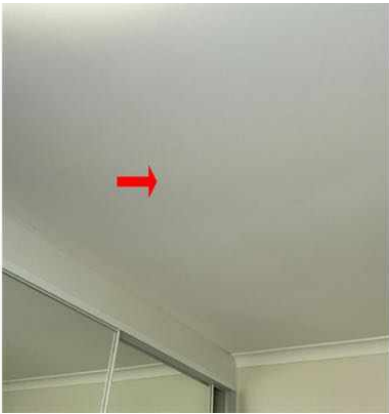
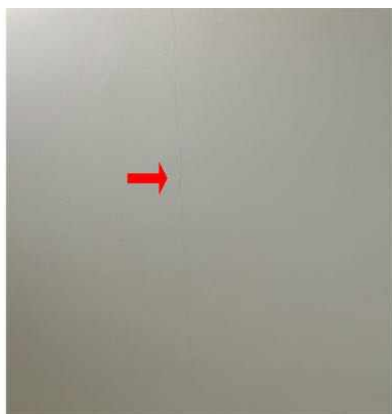
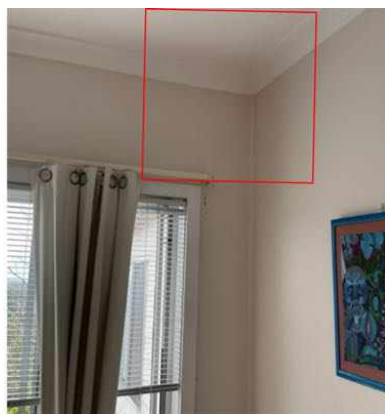
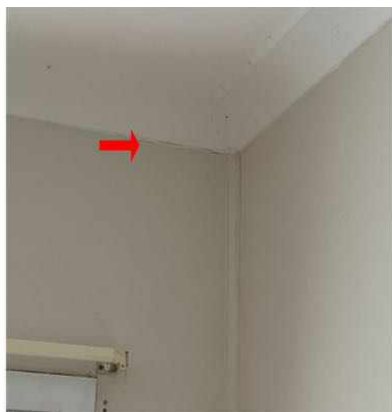
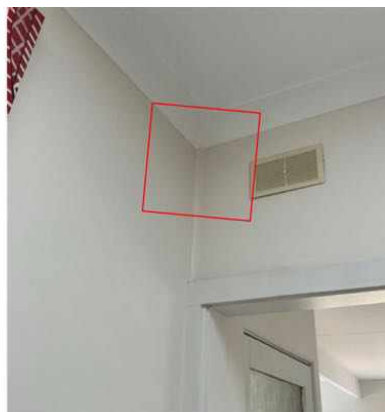
Building:	Main Building
Location:	All Internal Areas
Finding:	Paint Finish & Hairline Cracking - To some areas
Information:	The paint finish in this area was identified as being incomplete or substandard at the time of inspection including some hairline minor cracking/separation. Monitoring is recommended where cracking and separation is evident.

Whilst incomplete or missing paint finish is generally an appearance defect, it can also lead to the development of secondary building defects over time. Incomplete areas of paint finish expose the area to moisture, potentially accelerating the deterioration of underlying building materials.

Incomplete paint finishes should be sanded back, filled, leveled and painted, as applicable. Where inadequate or missing paint protection has led to the deterioration of the associated building element, repair and/or replacement of this building element may be required.

A painting contractor should be appointed as soon as possible to perform necessary works to aid the appearance of the affected area and to ensure the area is protected against further deterioration. Alternatively, the homeowner following manufacturer instructions may perform these works.
