Building and Timber Pest Inspection Report

Inspection Date: Tue, 3 Mar 2026

Property Address: 100 Woorarra Ave, North Narrabeen NSW
2101, Australia

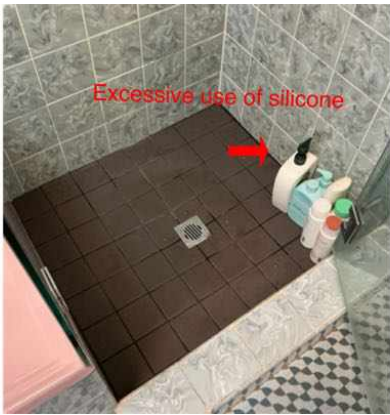
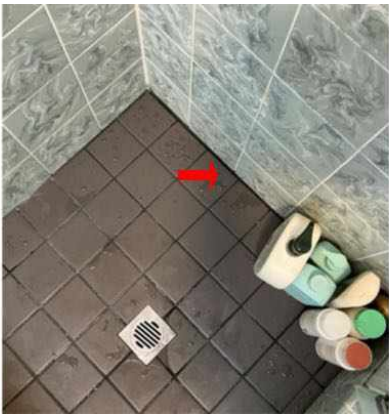
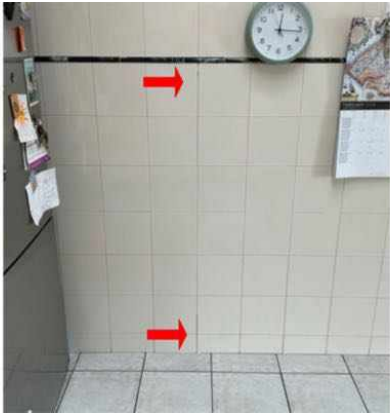
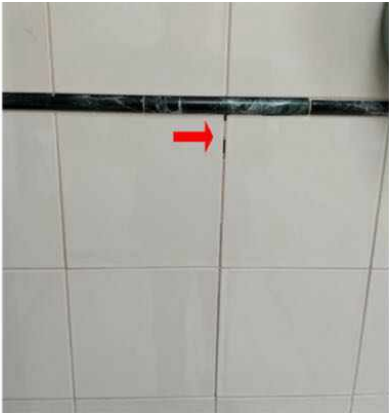
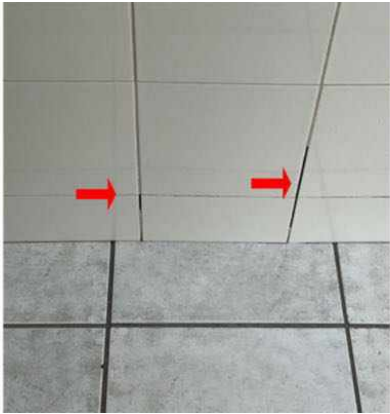
Finding 3.24

Building:	Main Building
Location:	All Internal Areas
Finding:	Sealant and grouting - Missing or degraded to some areas
Information:	It was noted on inspection that sealant or grout is degraded.

Different materials and floor areas move at different rates, generally causing cracking to grout or sealant at this point. A flexible sealant is required to allow for expected expansion and contraction, while keeping the joint water tight and protective of all associated building materials.

Excessive mould to the sealant and grout may require scraping out and replacement.

Flexible and mould resistant materials should be applied to affected areas to prevent any subsequent water damage that is likely to occur. Regular maintenance and replacement of damage or missing or damaged sealant and grout is highly recommended to the wet areas, as this is a regular wear and tear defect. Sealant and grouting in areas that come into regular contact with water should be maintained for the long term care of your property.

A sealant specialist or tiling contractor should be appointed to complete these works as soon as possible

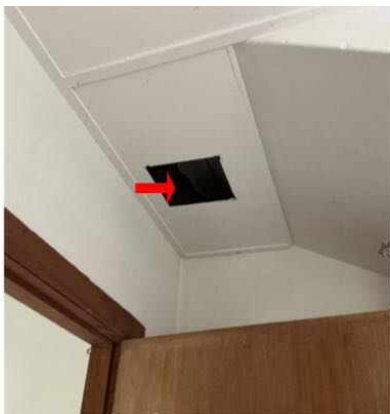
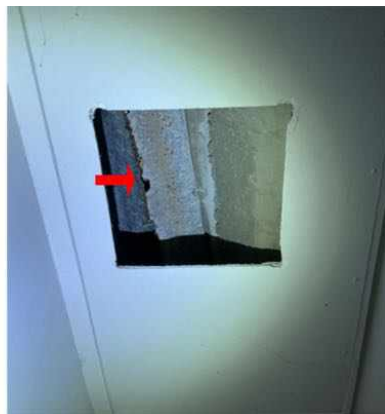
Finding 3.25

Building: Main Building
Location: All Internal Areas - Subfloor area
Finding: Building element - Damaged - Hole not sealed and rust bathroom
Information: Breakage occurs generally when the building materials have either aged and decayed, or as a result of damage (accidental or deliberate).

Repair and/or replacement of broken elements is advised to ensure that additional secondary defects do not arise as a consequence. Such works are necessary, as all building elements play a key role in the operation and function of the overall structure and its performance.

A relevant tradesperson should be appointed to repair or replace the affected building element prior to any subsequent damage being caused.

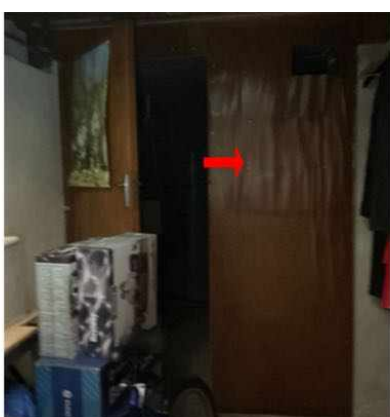
Finding 3.26

Building:	Main Building
Location:	Subfloor
Finding:	Building element - Damaged - Door moisture damaged
Information:	Breakage occurs generally when the building materials have either aged and decayed, or as a result of damage (accidental or deliberate).

Repair and/or replacement of broken elements is advised to ensure that additional secondary defects do not arise as a consequence. Such works are necessary, as all building elements play a key role in the operation and function of the overall structure and its performance.

A relevant tradesperson should be appointed to repair or replace the affected building element prior to any subsequent damage being caused.

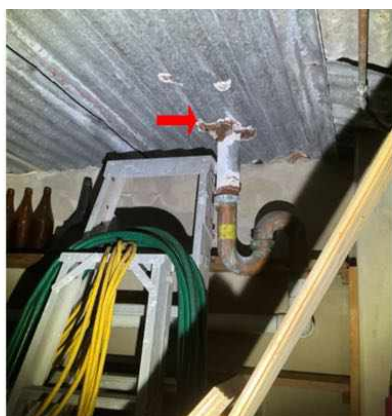
Finding 3.27

Building:	Main Building
Location:	Subfloor

Finding: Building element - Rusted or corroded
 Information: This building element shows evidence of rusting and corrosion, which is likely to have developed as a result of excessive exposure to moisture and or inadequate coatings.

As surface rust provides no protection to the underlying iron, the deteriorating condition is likely to worsen if not addressed in the short-term future.

Where possible, the use of galvanized (treated) metals or aluminium coated metals aid in rust prevention, as does regular general maintenance. Rust formation can be controlled with coatings, such as paint, that isolate the iron from the environment.

Rusting and corrosion should be managed by ideally removing or limiting the affected surface from exposure to moisture. A registered builder may be appointed to replace any building elements that have been severely affected by rust or water damage.

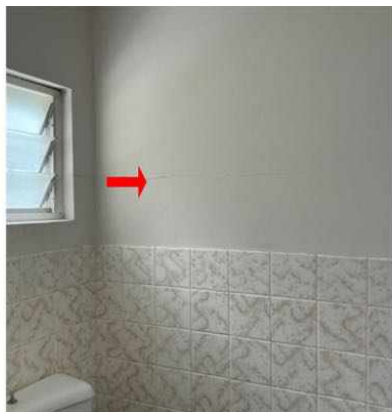
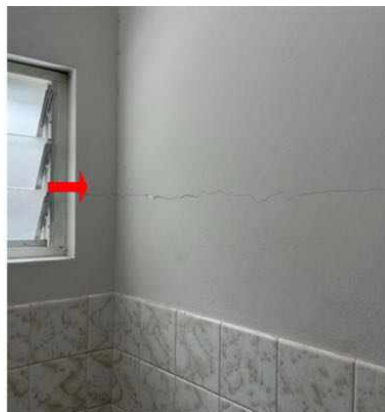
Finding 3.28

Building: Main Building
 Location: Bathroom subfloor
 Finding: Cracks to internal render - Category 1
 Information: It has been observed that cracking to internal rendered surfaces has occurred. The degree of damage falls within Category 1, described as fine cracks that do not need repair and which are less than 1.0mm in width limit.

Damage of this category is not considered a defect for rectification. Always contact your building inspector should cracks widen, lengthen, or become more numerous.

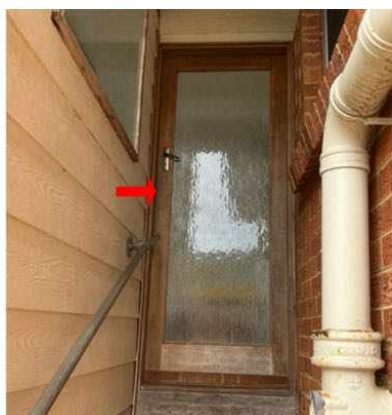
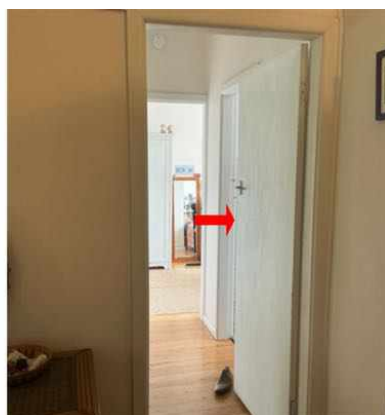
Finding 3.29

Building:	Main Building
Location:	All Internal Areas - Lounge , hallway to bedrooms
Finding:	Doors - Binding/Jamming
Information:	Binding and/or jamming of several doors throughout the property were evident during standard operation. This defect inhibits the functionality of affected doors as well as creating potential for secondary defects to associated building elements, such as damage to the floor covering.

A door that binds to flooring or to the associated door frame may have several causes, ranging from minor defects, such as poor installation of the door or deteriorated hinges, through to major structural issues, such as damage to subfloor structures.

Where door binding/jamming appears to indicate major structural issues, a registered builder specialising in re-stumping should be appointed to provide an estimate on the cost of rectification.

For minor causes, a qualified carpenter or general handyperson should be appointed to perform minor rectification works at client discretion.

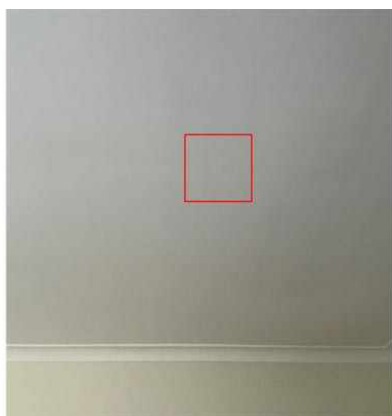
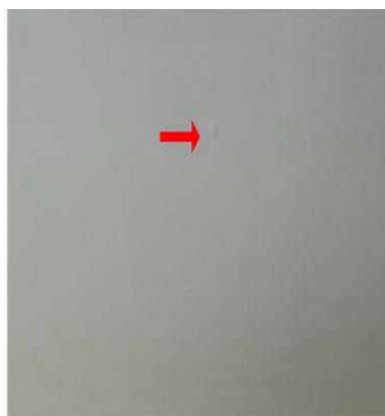
Finding 3.30

Building:	Main Building
Location:	All Internal Areas
Finding:	Ceiling nails - Popping To some areas
Information:	Numerous popped nails were identified in the internal ceiling at the time of inspection. Nails and screws hold simply by the friction between them and the surface they are applied to. Over time, the nails and screws can back out, which is often a result of general ageing and deterioration of the building structure.

If left unmanaged, the ceiling sheets may become loose and unstable, increasing the rate of deterioration of the internal ceiling and creating potential for the development of secondary defects.

Re-fastening of popped nails will help to maintain the stability of the internal ceiling and associated building elements. Such minor works will also help to improve the appearance of the affected area and secure the ceiling sheets, so as to prevent the onset of ceiling sagging. These works should be performed by a qualified carpenter or plasterer at client discretion.

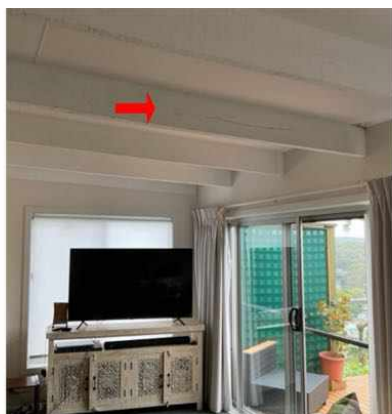
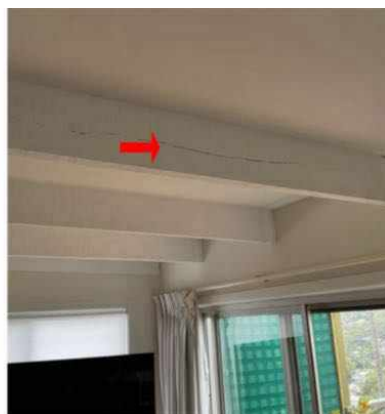
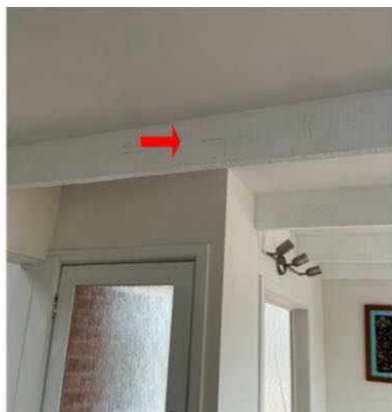
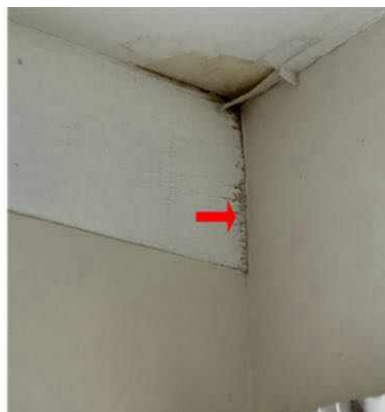
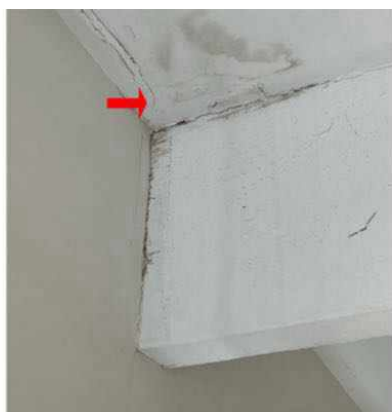
Finding 3.31

Building:	Main Building
Location:	Lounge Room
Finding:	Timber Decay and surface splitting
Information:	The timber shows signs of surface splitting, water staining and possible early fungal decay. While no active termite activity was identified, further investigation is recommended to rule out concealed damage.

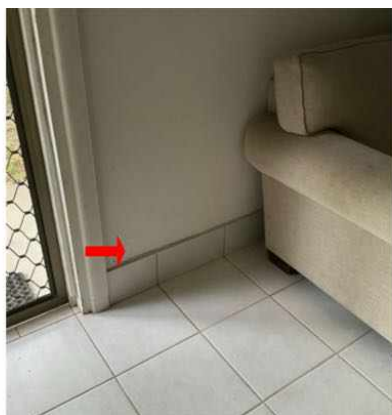
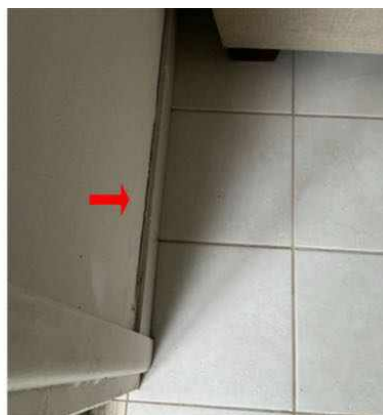
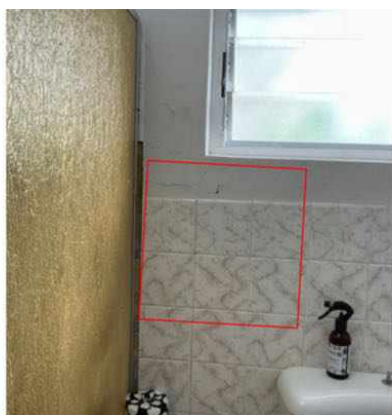
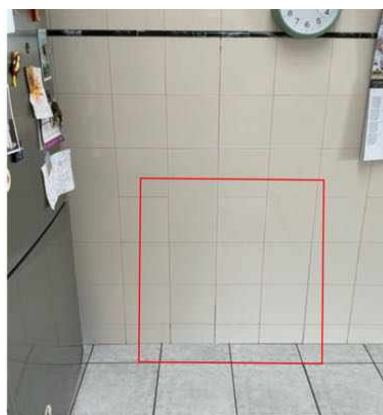
Finding 3.32

Building:	Main Building
Location:	All Internal Areas - Kitchen.. lower level,
Finding:	Tiles - drummy to some areas
Information:	Drummy tiled areas were identified at the time of inspection. The term 'drummy' refers to tiles that have become detached from their fixing, despite otherwise being in relatively good condition. Such defects are generally caused by physical or moisture damage to the area. Drummy tiled areas may also be a direct result of poor workmanship during the construction process.

Tiled areas may swell and shrink with changes in air humidity if the area has sustained moisture damage. Any exposure to moisture is capable of causing tiled areas to

become drummy and/or cracked over a prolonged period of time. Drummy tiled areas generally require removal and replacement of affected tiles, with adequate sealant and grouting.

Specialist trades are available for these types of services. A registered builder may be required to undertake works if damage is extensive or if secondary building defects have resulted. Otherwise, it is advised that a tiling contractor be appointed to perform works as necessary. Immediate action is recommended to ensure that no further damage is sustained in the affected area.

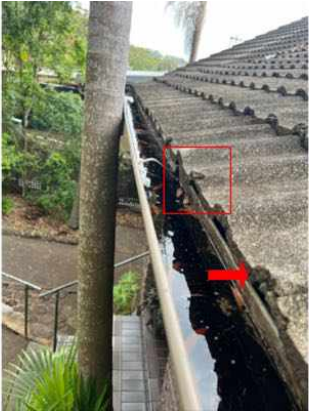
Finding 3.33

Building:	Main Building
Location:	Roof Exterior
Finding:	Roof tiles condition
Information:	The roof tiles display general surface weathering, minor edge erosion, consistent with age and environmental exposure. Some tiles appear slightly uneven, likely due to minor settlement or past foot traffic. Routine maintenance including cleaning of biological growth, clearing of valleys and checking that tiles are properly seated is recommended to maintain effective drainage and long-term weatherproof performance.

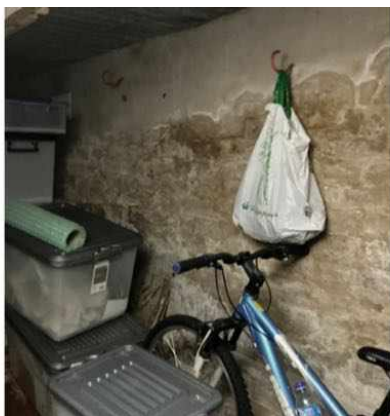
Building:	Main Building
Location:	Subfloor
Finding:	Subfloor ventilation - Inadequate
Information:	Adequate subfloor ventilation aids in preventing excessive moisture wood rot and termite activity by ensuring a dry subfloor environment.

Where ventilation is substandard it is usually caused by factors such as failure to install adequate vents during construction subsequent building works or earth and vegetation covering over vents low subfloor clearance and items or debris in the subfloor restricting airflow.

Subfloor ventilation can be improved in most cases by addressing the causes such as exposing subfloor vents installing additional new vents installing mechanical (forced airflow) ventilation and removing debris from the subfloor.

A registered builder should be appointed as soon as possible to perform these works as necessary.

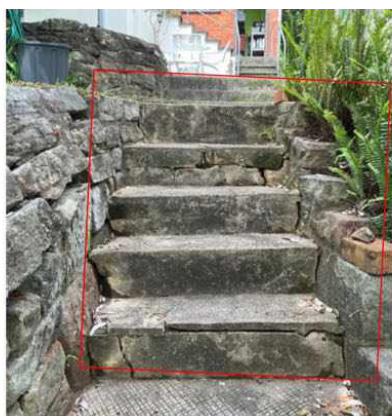
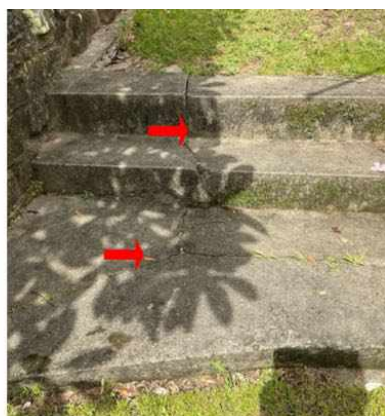
Finding 3.38

Building:	Main Building
Location:	All External Areas

Finding: Building element - Damaged (Cracked and damaged stairs rear)
 Information: Breakage occurs generally when the building materials have either aged and decayed, or as a result of damage (accidental or deliberate).

Repair and/or replacement of broken elements is advised to ensure that additional secondary defects do not arise as a consequence. Such works are necessary, as all building elements play a key role in the operation and function of the overall structure and its performance.

A relevant tradesperson should be appointed to repair or replace the affected building element prior to any subsequent damage being caused.

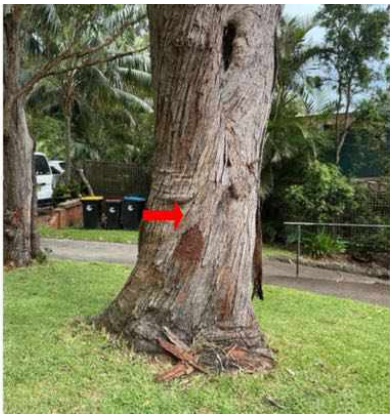
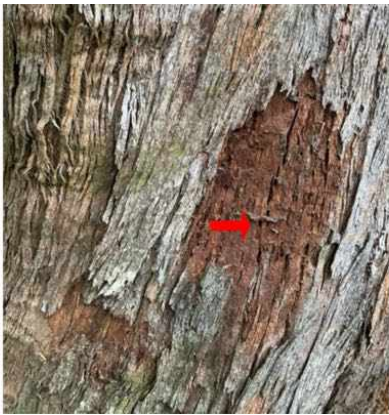
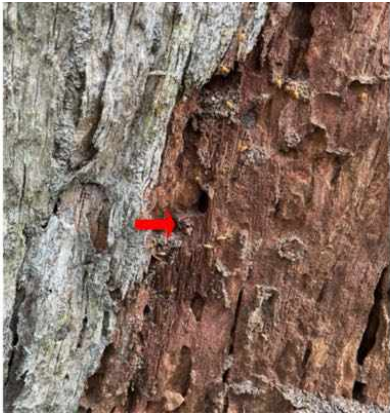
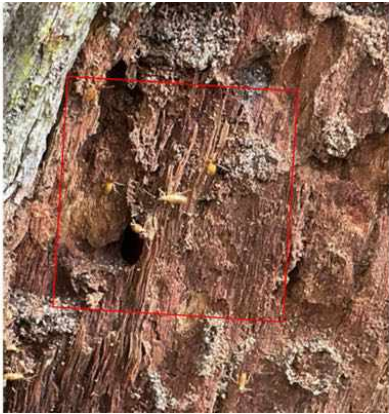
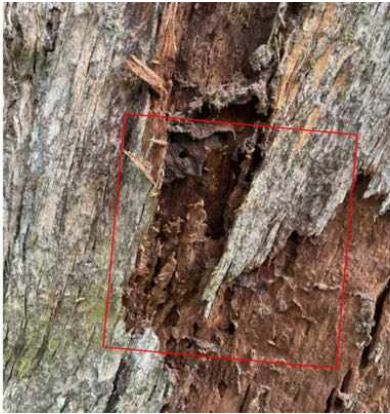
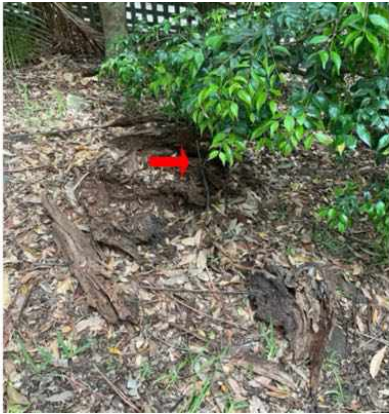
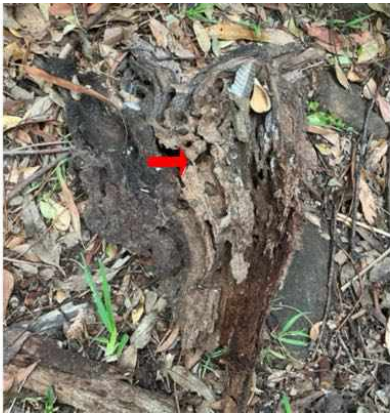
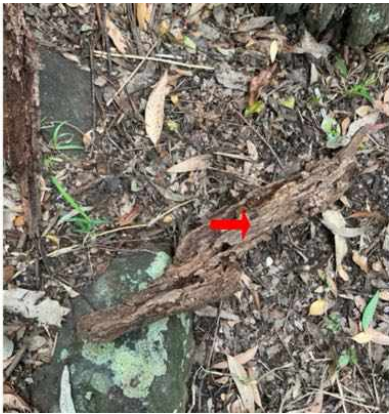
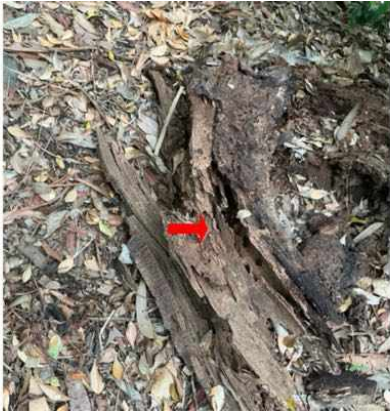
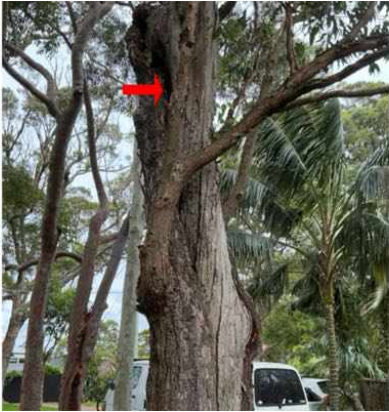
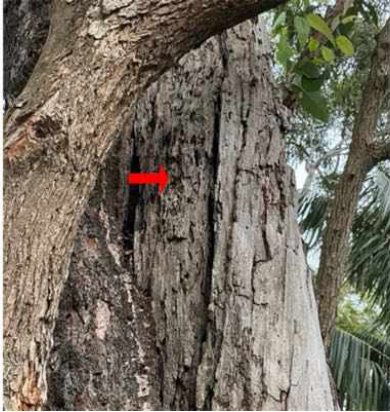
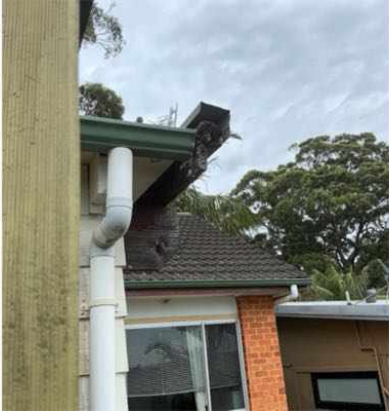
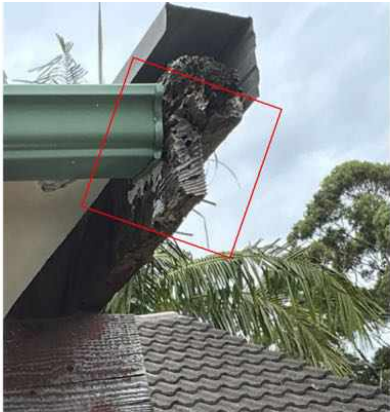
Building: Main Building
 Location: All External Areas
 Finding: Evidence of live termite activity was identified
 Information: Live termite activity was found on the property in the tree at the front. This may be in the form of mud trails the identification of a live termite nest or termites found to be attacking timber building elements. The species of the termites could not be identified at the time of inspection which may impact on the mode of eradication. Works to eradicate live termites should be undertaken immediately to prevent any further damage that will inevitably ensue.

A second tree at the front , a piece of large timber at the front of house and rear fascia also showed damage consistent with possible previous termite activity. A further invasive inspection is highly recommend to check for concealed activity

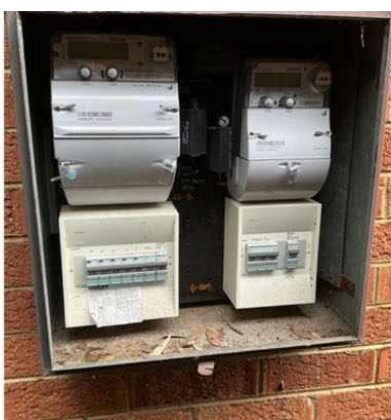
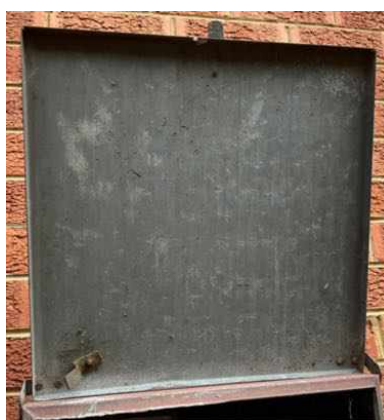
Information: The application of a post-construction chemical termite barrier is highly recommended for all properties, particularly if live termite activity has been found on the site previously. Such barriers are highly effective in preventing termite attack on any timber building elements throughout the property.

A durable notice should be placed in the switchboard unit to indicate current termite barriers. At the time of inspection, it appeared as though no termite management system has been installed, with no evidence to suggest preventative works taking place.

The client may consider gaining further advice from a pest controller as to the costs and procedures involved with this application. It is recommended that obtaining such advice be a short-term priority.

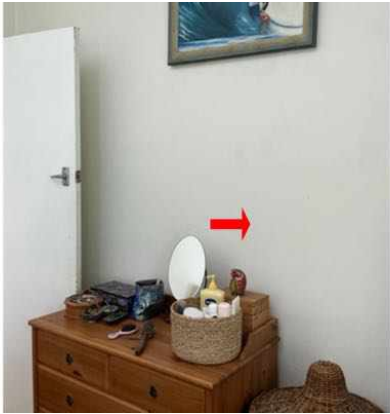
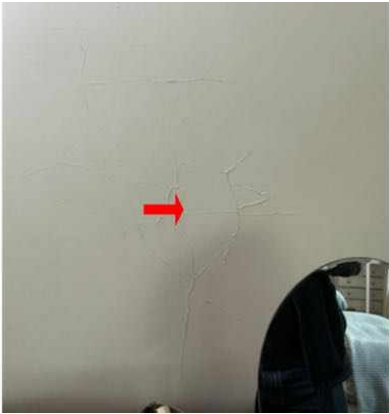
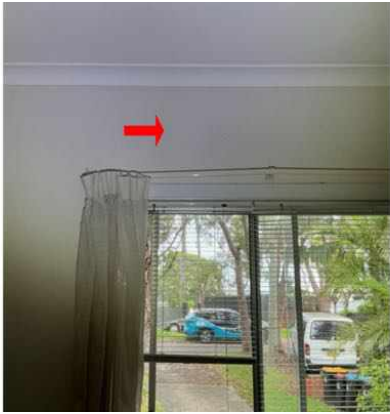
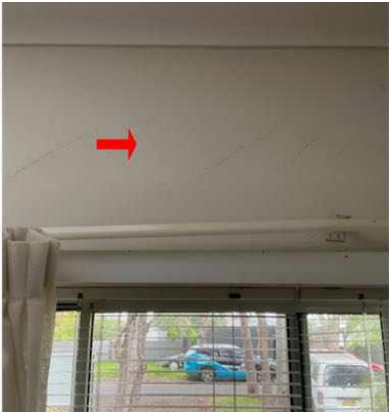
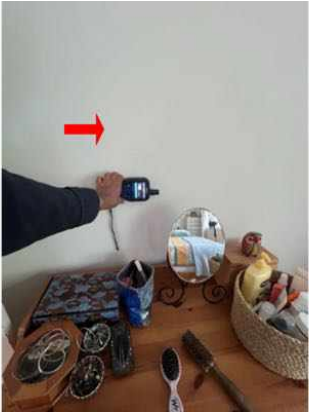
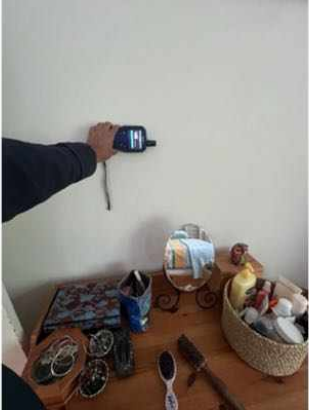
Finding 6.02

Building: Main Building
Location: Bedroom
Finding: Elevated moisture - identified (Possible timber pest activity requires invasive inspection)
Information: Elevated moisture can attract termites and produce conditions that promote fungal growth and wood decay.

Elevated moisture is generally caused by deteriorated, inadequate or missing roof drainage, leaking plumbing pipes or fixtures, poorly plumbed HWS overflows or condenser units and poor site drainage.

Prior to any remedial works being performed a qualified plumber should be appointed to further inspect the property and to identify the cause of the excessive moisture. Works to remove affected building elements may then be necessary and should be performed by an appropriate tradesperson.

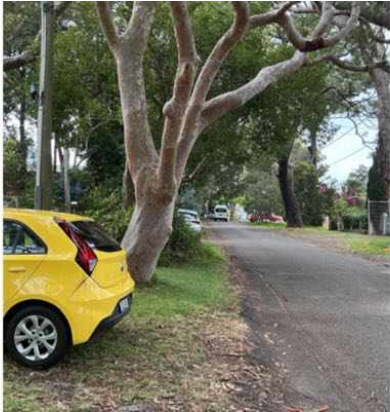
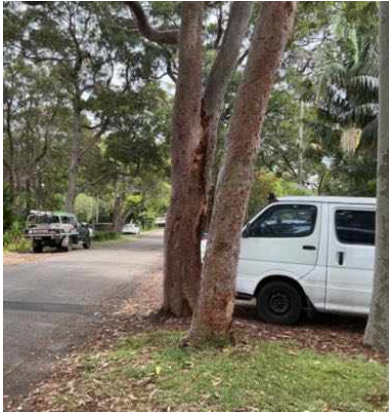
Finding 6.03

Building: Main Building
Location: All External Areas
Finding: Trees within 50m
Information: Trees within 50m of the property can be conducive to termite activity. It is recommended an invasive inspection of all trees with 50m to the property be carried out by a qualified pest control expert.

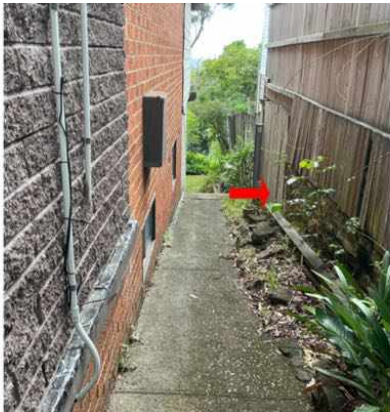
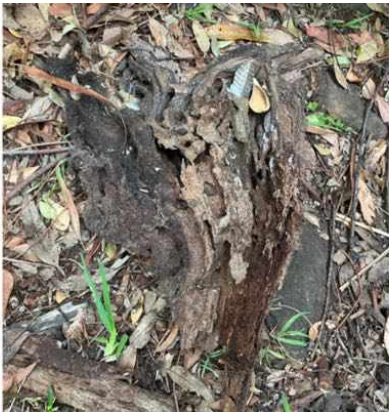
Finding 6.04

Building: Main Building
Location: All External Areas
Finding: In ground contact - Timber to some areas
Information: Any timbers in direct ground contact provide opportunity for concealed termite entry and are likely to be subject to premature rot and decay as the soil retains moisture or damp conditions against the timbers.

Remove untreated timber that is in direct contact with external grounds. Consider replacement with more durable materials i.e. treated timber or non timber elements. Frequent pest inspections are advised to readily identify any termite activity in these areas.

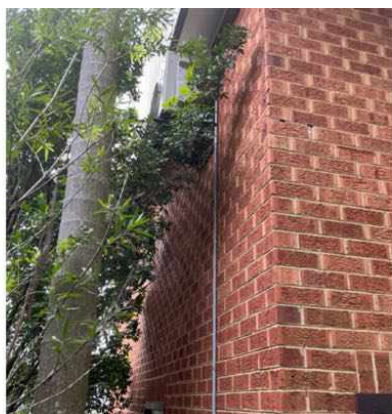
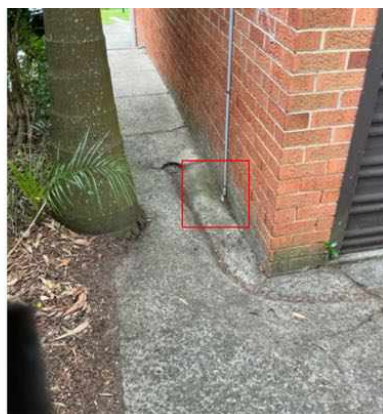
Finding 6.05

Building:	Main Building
Location:	All External Areas
Finding:	Air conditioner - Disconnected overflow
Information:	The Air Conditioner (A/C) overflow was found to be disconnected from storm water drainage and is creating excessive moisture in the surrounding area.

Such leaking creates an environment which is conducive to an array of defects, including water damage to associated building elements and the attraction of termite or timber pest infestation.

It is highly recommended that a licensed plumber be appointed to connect the A/C overflow in order to prevent such an environment from being created. These minor works should be carried out as soon as possible.

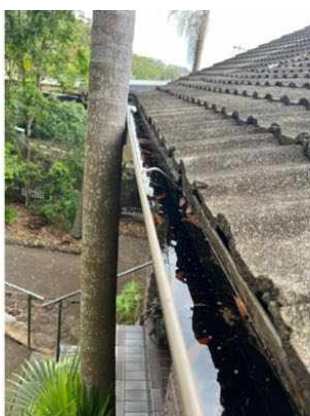
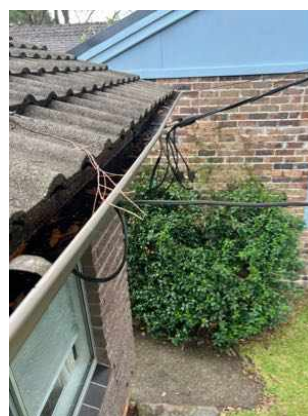
Blocked gutters are likely to lead to high levels of moisture in the affected areas. Such moisture will not only cause rust and decay of the associated building materials, but can also provide conditions that are conducive to termite and timber pest activity. Blockages in gutters should therefore be removed immediately to ensure dry conditions are maintained.

Consult a Licensed Plumber for further specific advice on remedial works that may be required. In the interim, it is highly advised that blocked gutters be removed by the homeowner or a general handyperson as a matter of urgency.

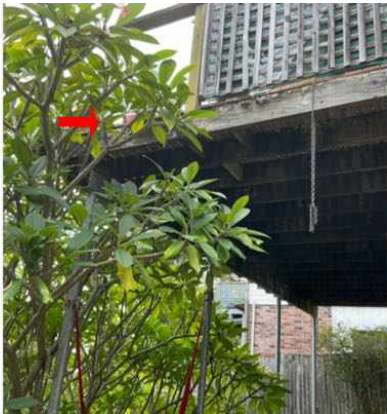
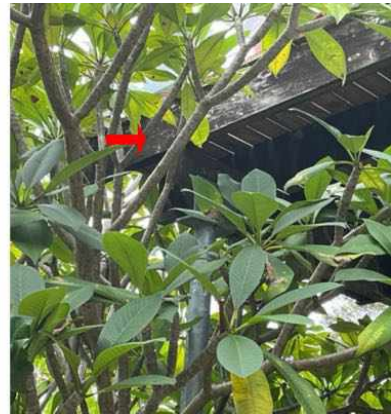
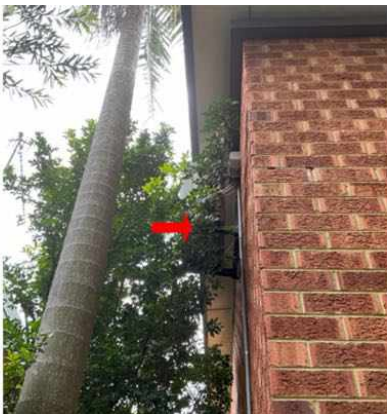
Finding 6.08

Building:	Main Building
Location:	All External Areas
Finding:	Bridging - Vegetation
Information:	Where vegetation obstructs inspection of building elements, also known as bridging as it provides a bridging point for the access of termites, full inspection can not be achieved. Consequently moisture or dampness may be present and the areas becomes conducive to termite activity. Plants against or very close to buildings provide cover, shade and can provide an environment that is attractive to termite

The removal and replanting of species that do not provide "cover" or cutting back of existing vegetation will assist greatly in preventing Bridging from occurring.

The removal of any such materials that may be conducive to termite activity should be carried out as soon as possible and arrange re inspection to minimize the risk of termite attack.

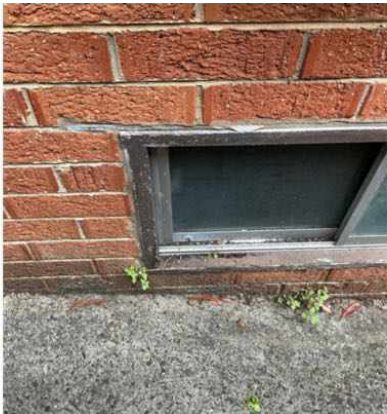
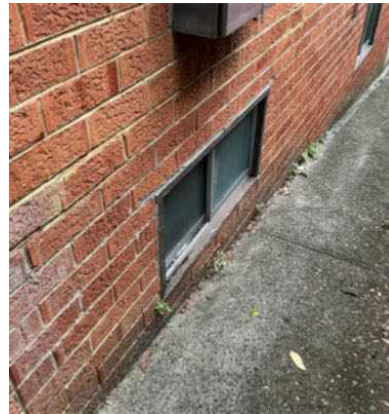
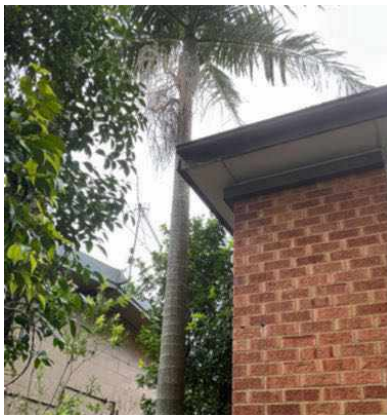
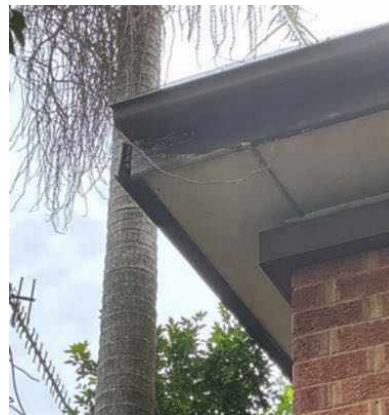
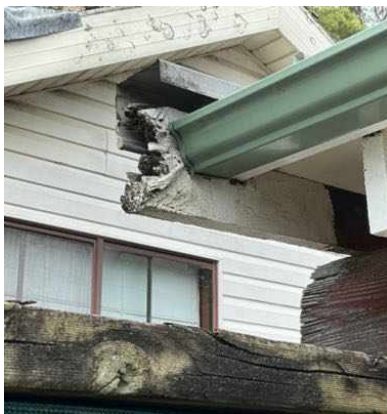
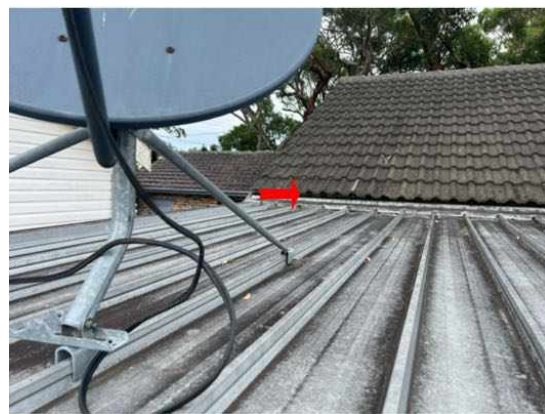
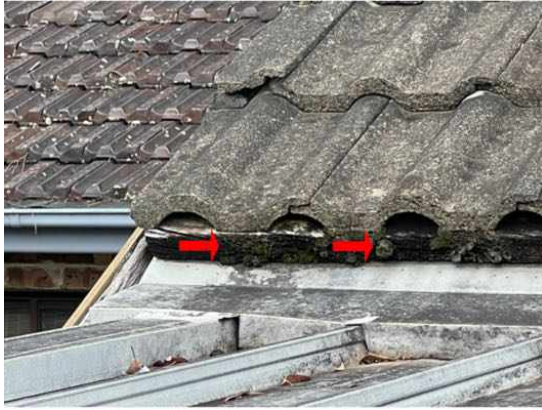
Finding 7.01

Building:	Main Building
Location:	All External Areas
Finding:	Fungal decay - present to some areas
Information:	Fungal decay also known as wood decay or wood rot generally refers to the deterioration of timber elements when in contact with excessive levels of moisture for a prolonged period of time.

In this case although the affected timber element is in a decaying state the extent of any visible damage appears to be localised to a specific area and is yet to spread to other parts of the building element or affect adjoining structures. The fungal decay is therefore likely to be of a relatively superficial nature with minimal impact on the structural integrity or tensile strength of the timber element.

A further invasive inspection by a licensed timber pest technician is highly recommended to check for concealed activity.

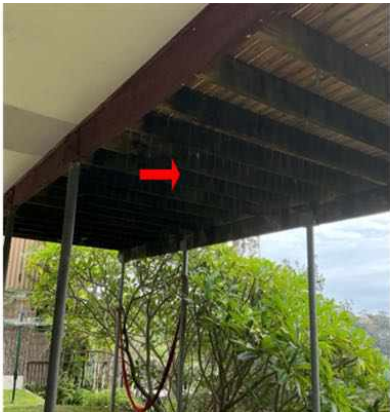
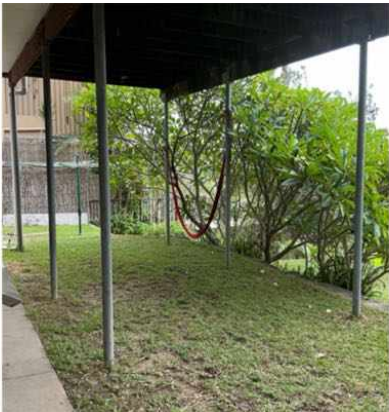
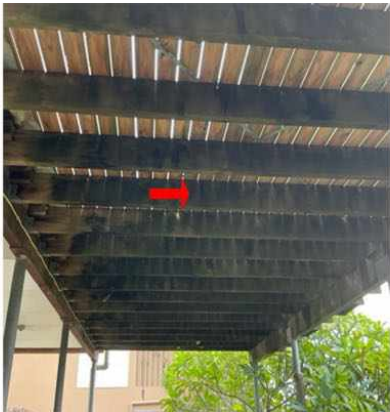
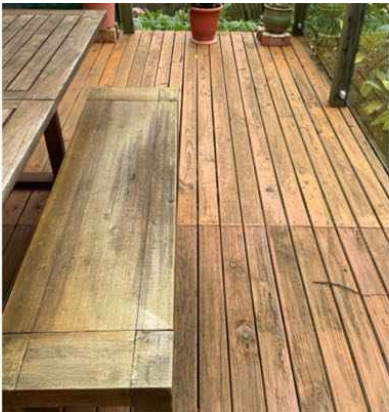
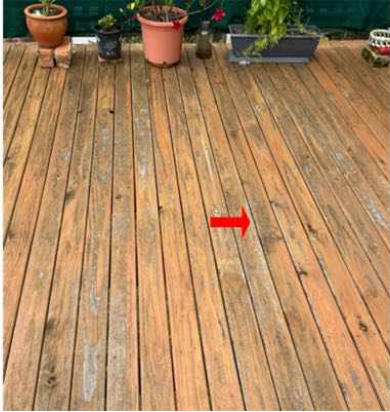
External timber structures are also constantly exposed to weather elements and can deteriorate in an accelerated manner, ongoing assessments are required.

It is highly recommended that a Structural Engineer further assess the external timber balcony or deck to inform the client of its load capacity. Regular maintenance

inspections by competent practitioners is needed.

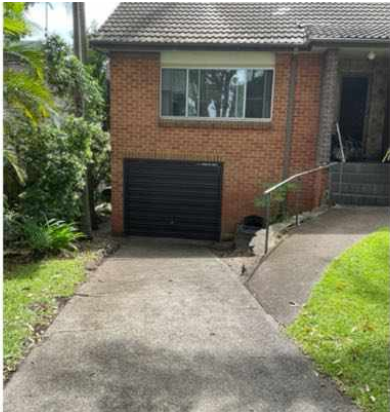
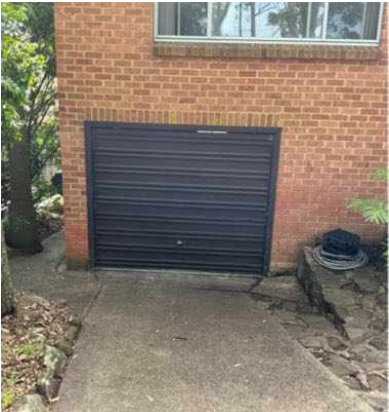
Building: Main Building
Location: All External Areas
Finding: Drainage Performance Risk
Information: The driveway and entry path to the property present a potential risk of water sheeting toward the garage during periods of heavy rainfall. While the area was dry at the time of inspection and no pooling was evident, it is recommended that drainage performance be monitored during large rain events to confirm effective surface runoff capture. This condition does not currently present as a defect, but proactive

maintenance of drainage inlets and consideration of fall adequacy is advised to ensure long-term compliance with NCC FP1.4 and AS/NZS 3500.3 stormwater drainage provisions.

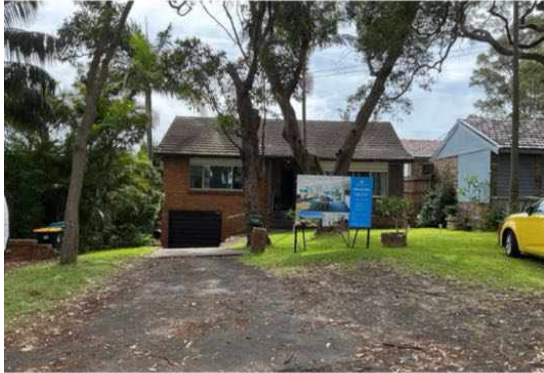
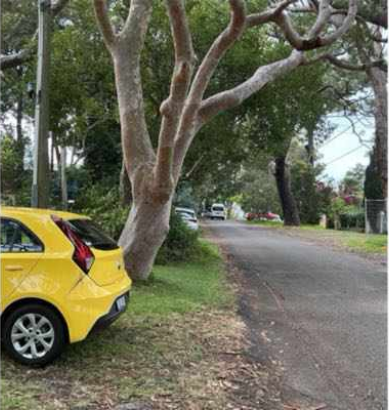
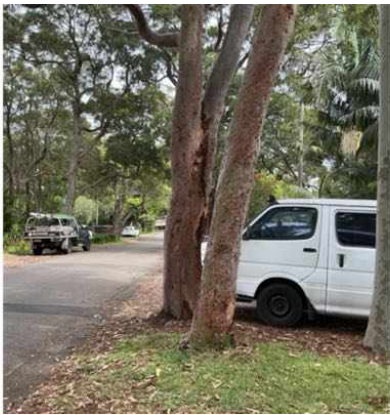
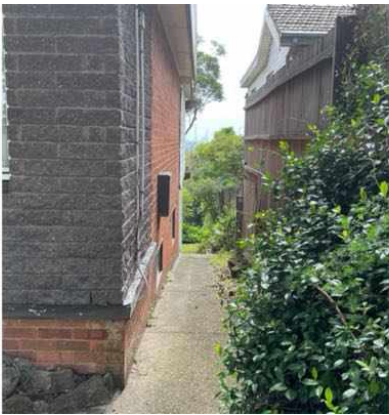
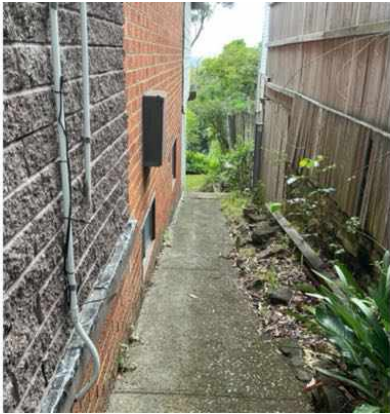
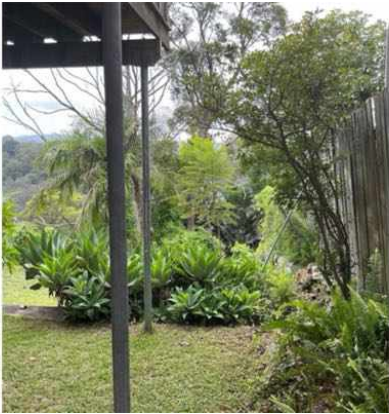
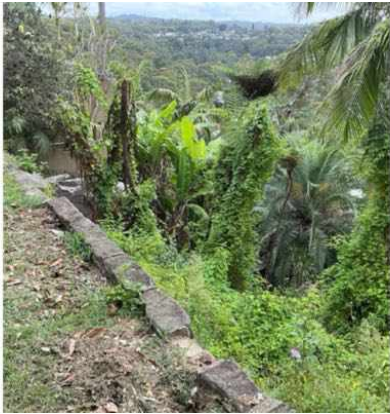
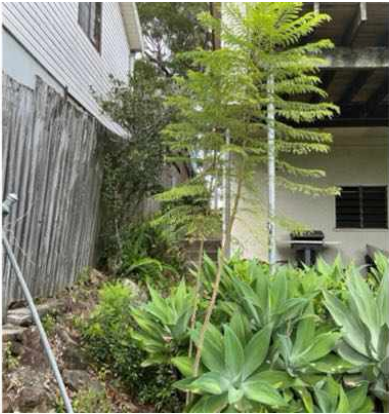
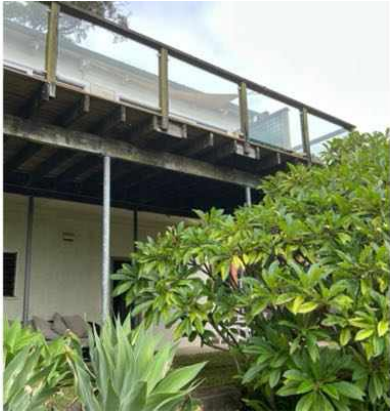
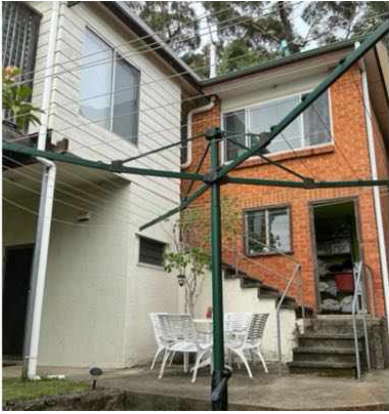
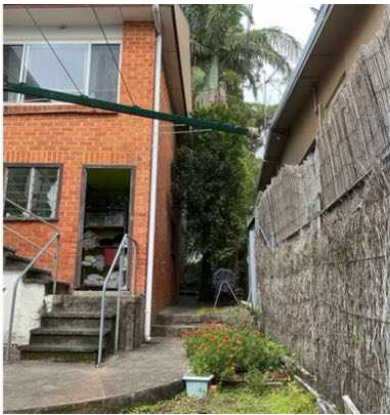
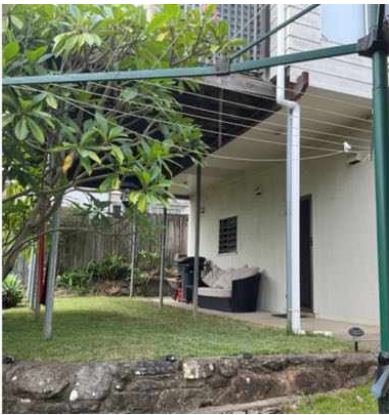
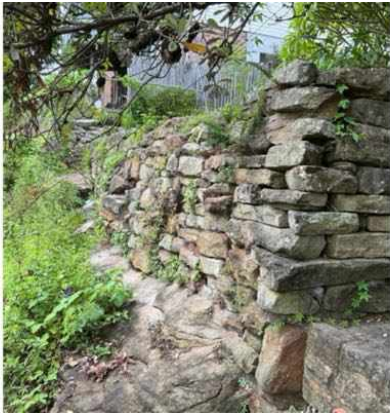
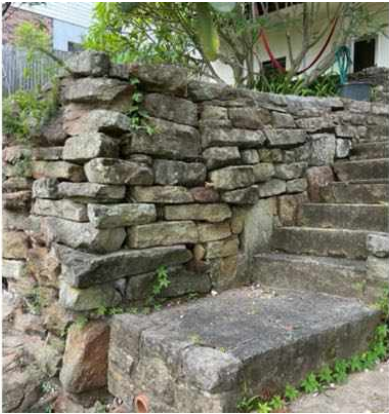
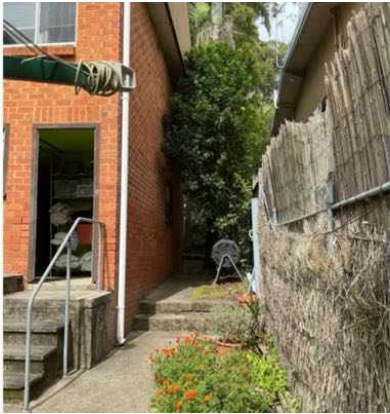
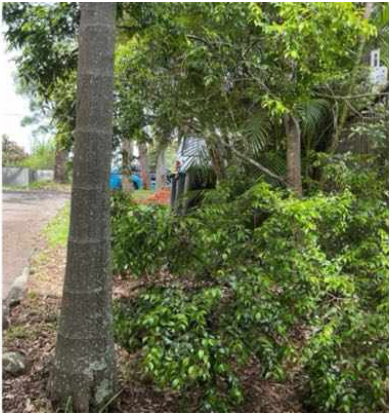
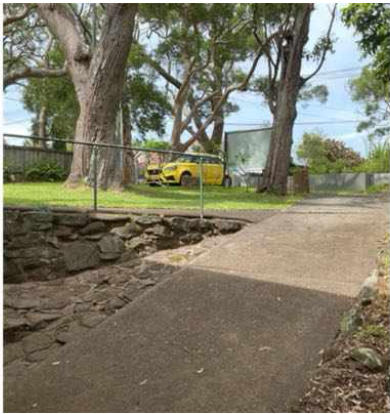
Building: Main Building
Location: All External Areas
Finding: Additional Photos - Obstructions and Limitations
Information: These photographs are an indication of the obstructions and limitations which impeded full inspection of the property at the time of inspection. These obstructions can hide an array of defects and should be removed to allow full inspection to be carried out. A re-inspection is recommended once the areas are made accessible.

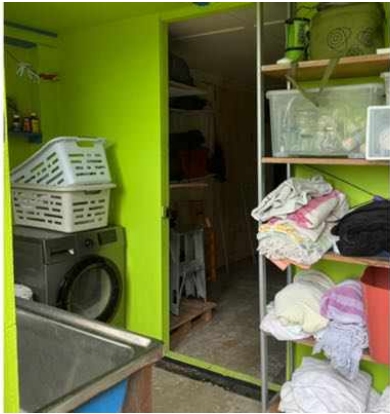
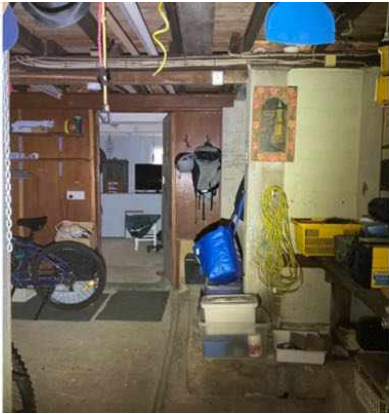
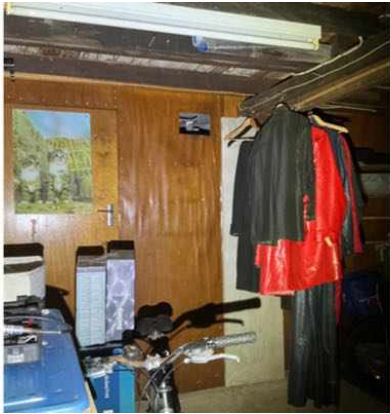
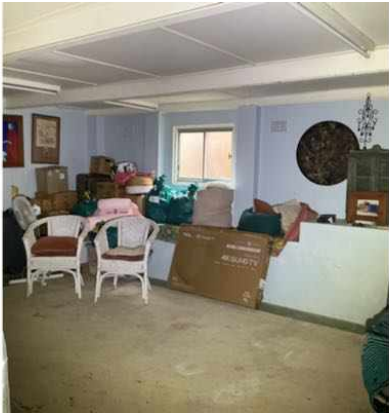
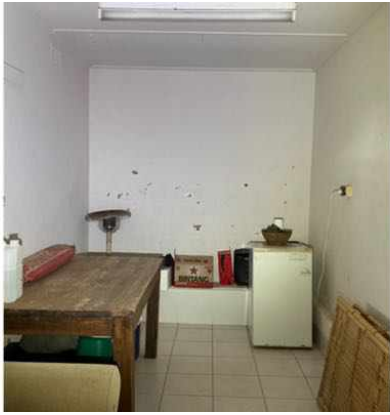
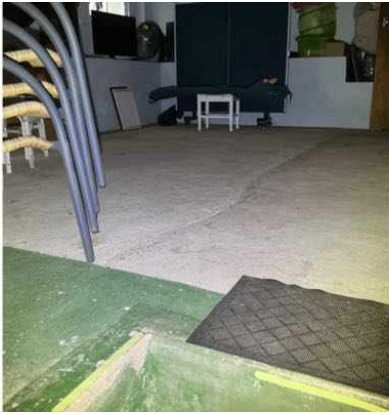
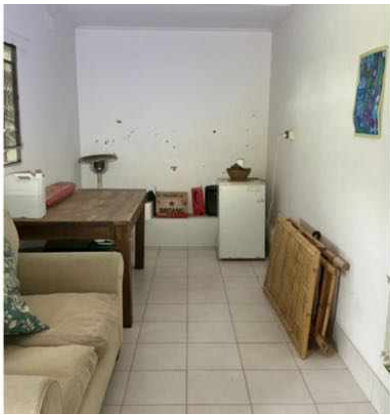
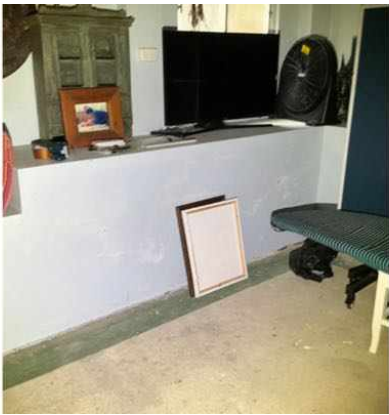
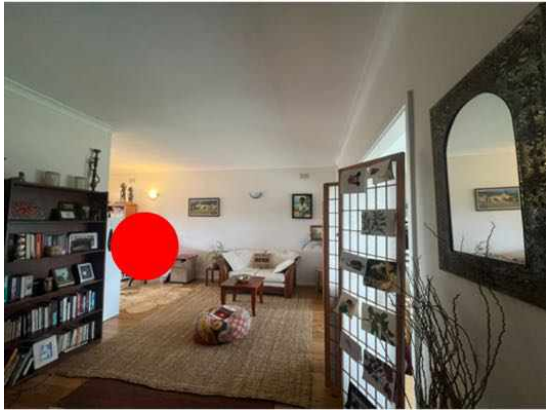
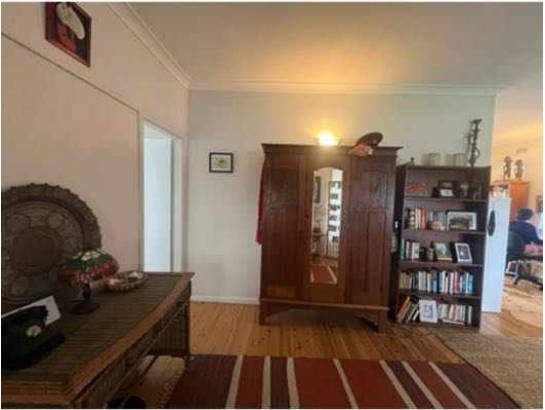
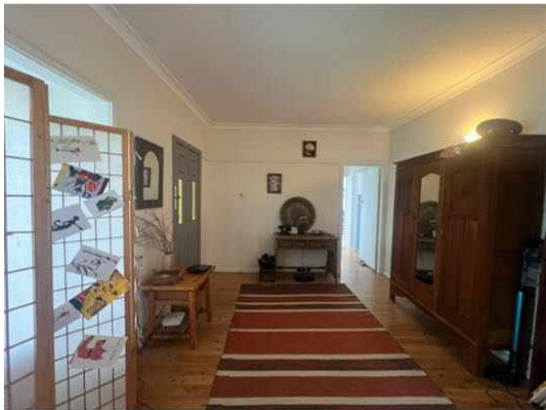
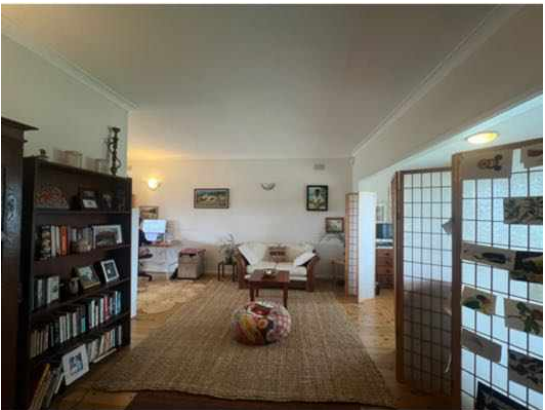
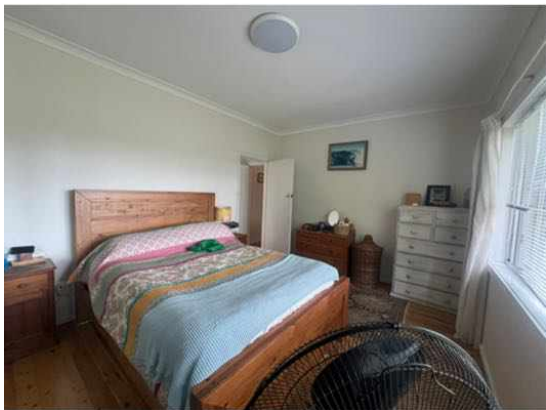
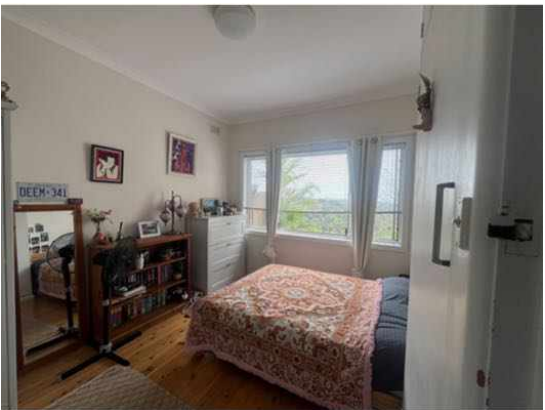
Building: Main Building
Location: All Internal Areas
Finding: Additional Photos - Obstructions and Limitations
Information: These photographs are an indication of the obstructions and limitations which impeded full inspection of the property at the time of inspection. These obstructions can hide an array of defects and should be removed to allow full inspection to be carried out. A re-inspection is recommended once the areas are made accessible.
