Building and Timber Pest Inspection Report

Inspection Date: Tue, 3 Mar 2026

Property Address: 100 Woorarra Ave, North Narrabeen NSW
2101, Australia

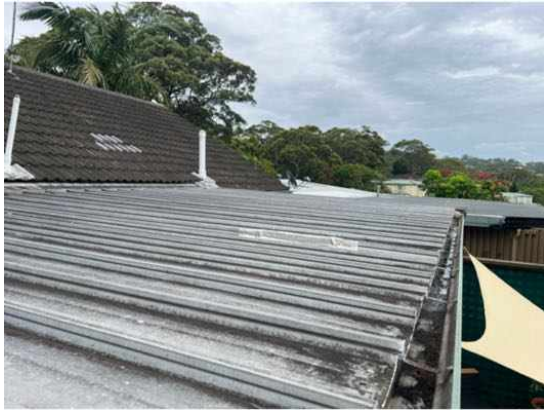
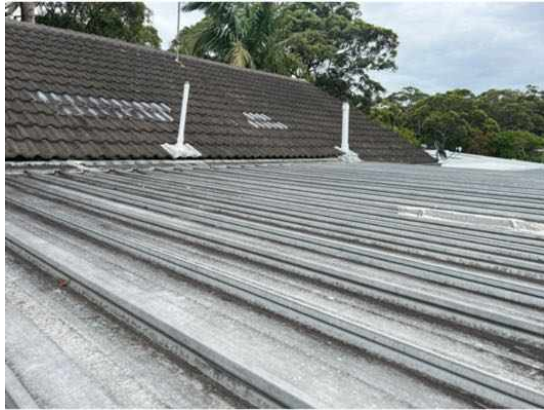
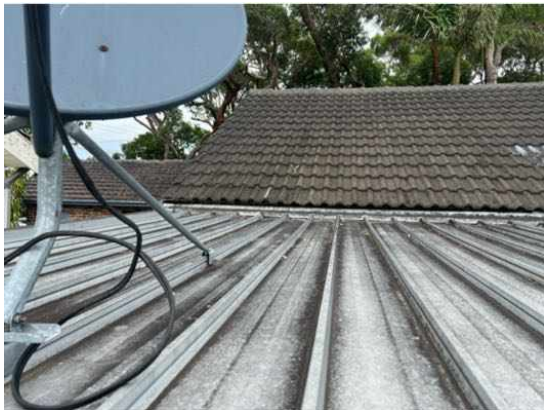
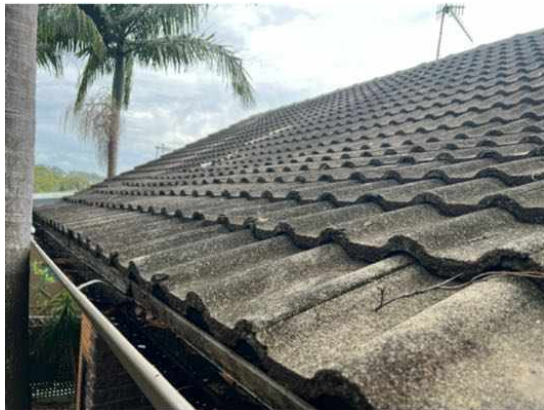
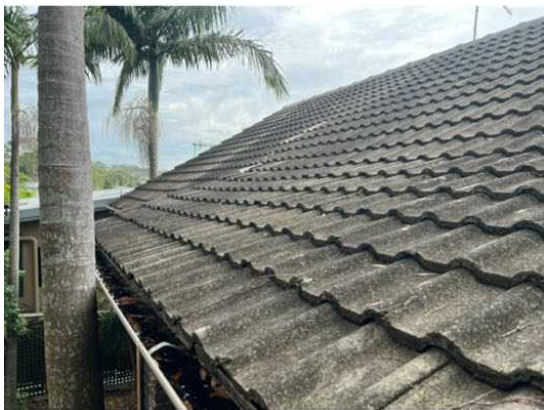
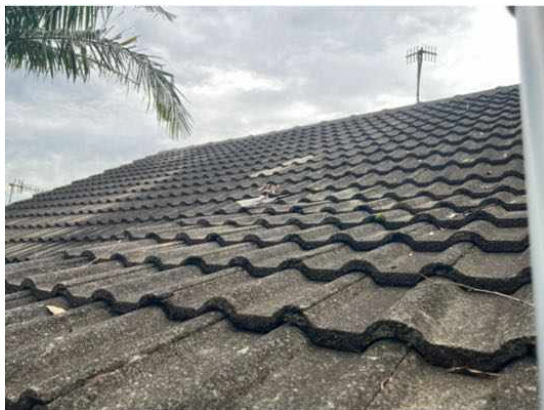
Building: Main Building
Location: Roof Exterior
Finding: Additional Photos - Obstructions and Limitations
Information: These photographs are an indication of the obstructions and limitations which impeded full inspection of the property at the time of inspection. These obstructions can hide an array of defects and should be removed to allow full inspection to be carried out. A re-inspection is recommended once the areas are made accessible.

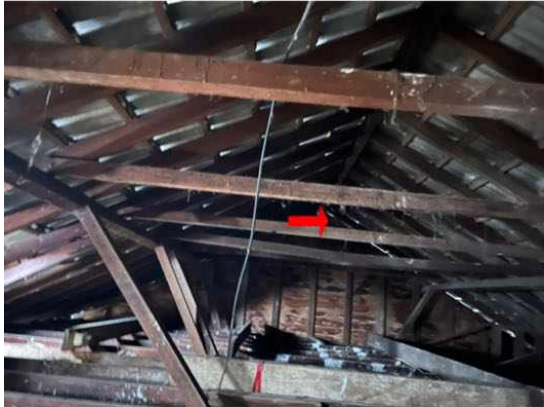
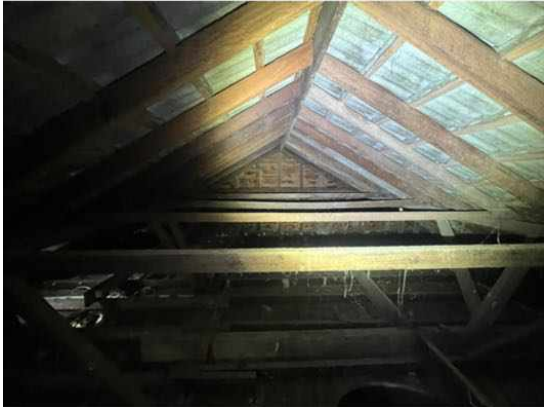
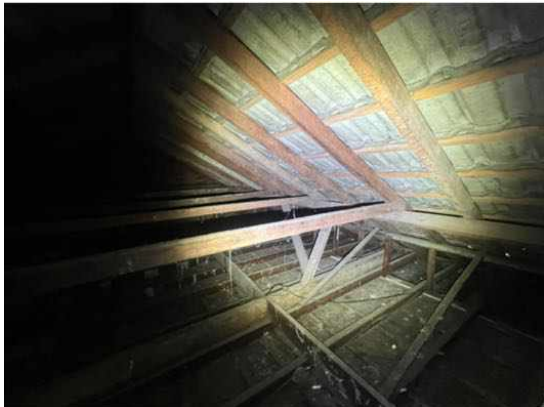
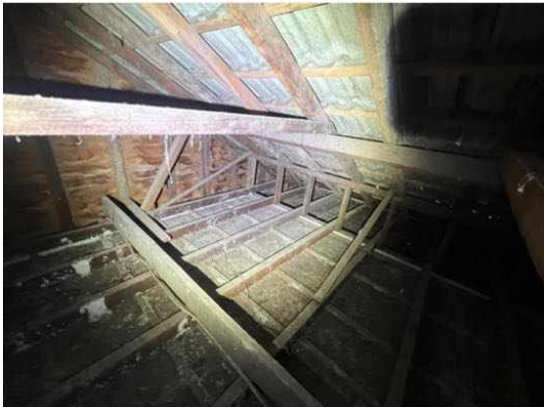
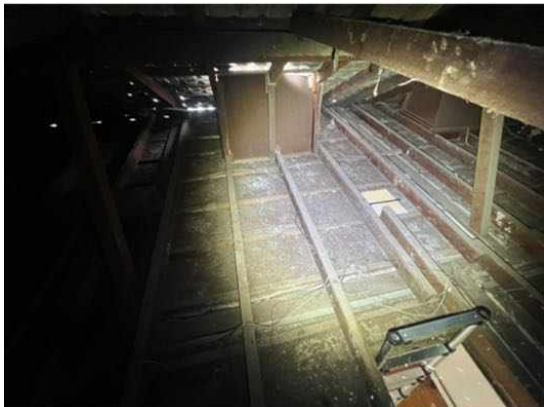
Building: Main Building
Location: Roof Void

Finding: Additional Photos - Obstructions and Limitations
 Information: These photographs are an indication of the obstructions and limitations which impeded full inspection of the property at the time of inspection. These obstructions can hide an array of defects and should be removed to allow full inspection to be carried out. A re-inspection is recommended once the areas are made accessible.

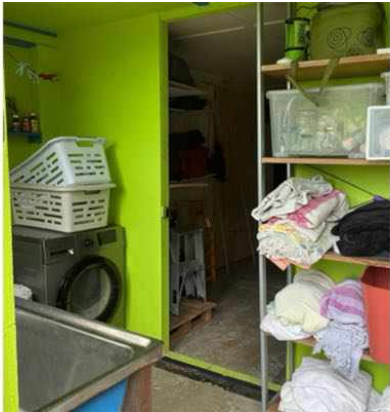
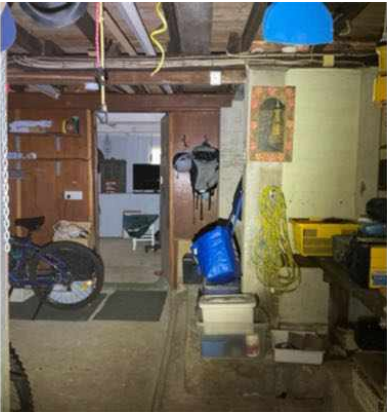
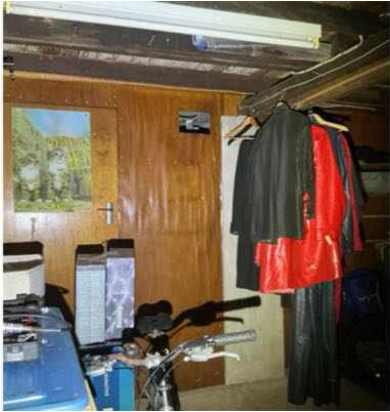
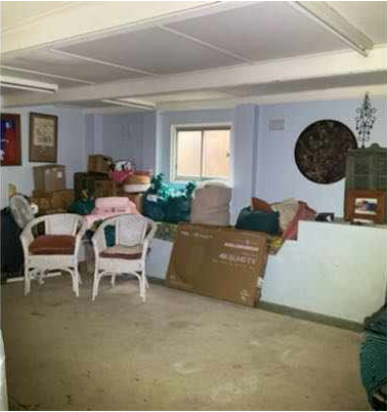
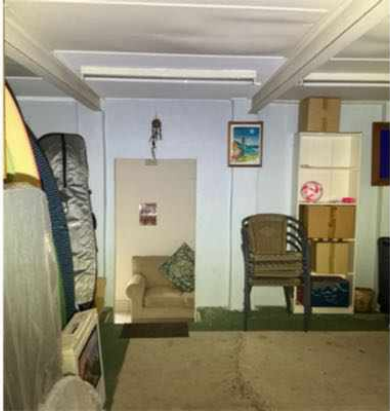
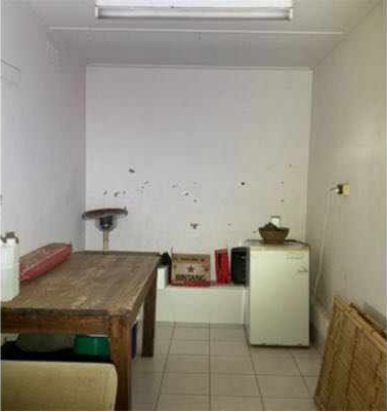
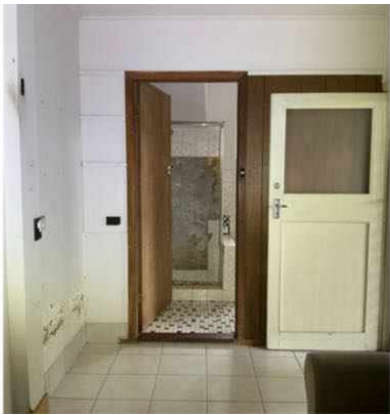
Building: Main Building
 Location: Subfloor
 Finding: Additional Photos - Obstructions and Limitations
 Information: These photographs are an indication of the obstructions and limitations which

impeded full inspection of the property at the time of inspection. These obstructions can hide an array of defects and should be removed to allow full inspection to be carried out. A re-inspection is recommended once the areas are made accessible.
