Building and Timber Pest Inspection Report

Inspection Date: Thu, 19 Mar 2026

Property Address: 173 Shellharbour Rd, Port Kembla NSW
2505, Australia

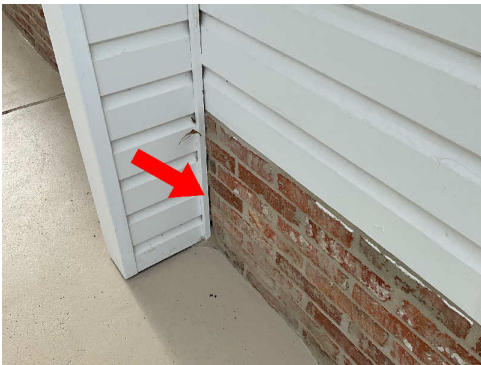
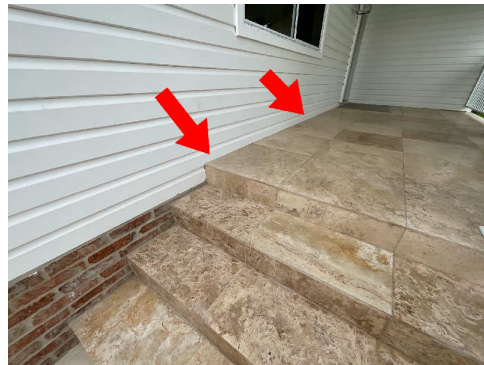
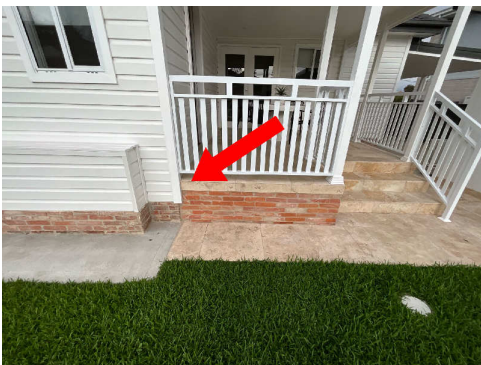
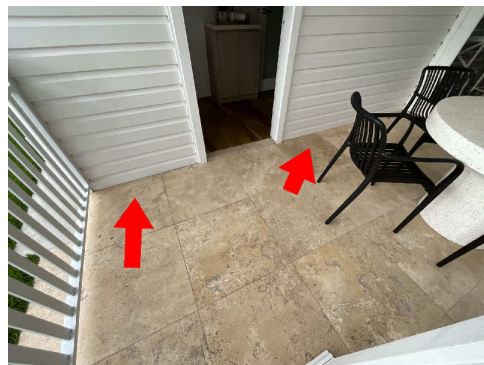
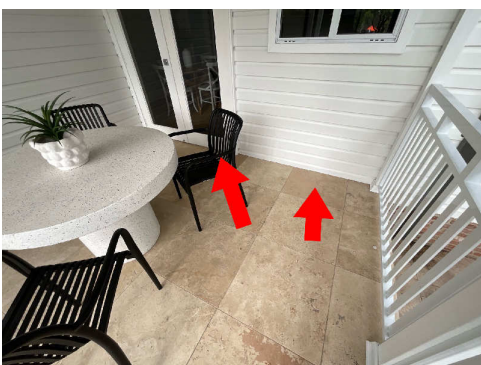
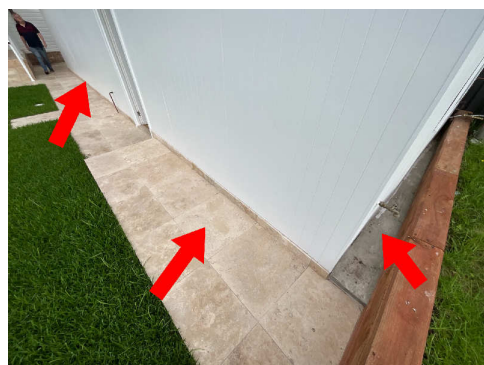
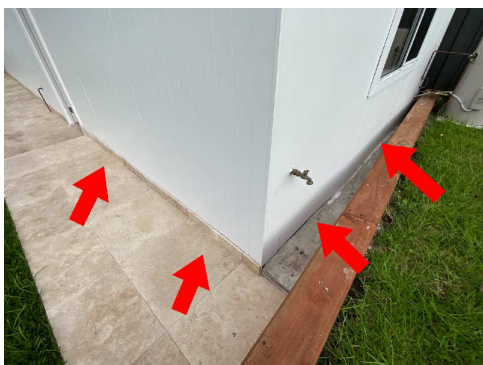
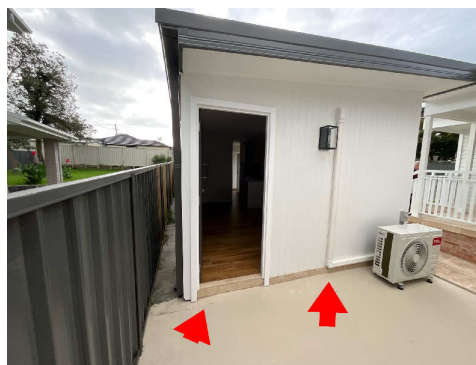
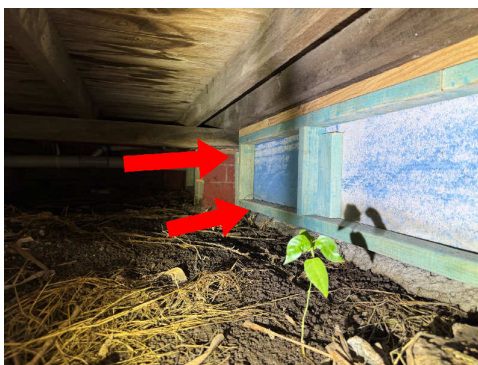
Generally this takes the form of finished ground levels external paving or concrete being retrospectively installed above the damp course level the adjacent internal floor level or weep and ventilation holes.

Where bridging has occurred full inspection is prevented and termites may enter a property in a concealed or undetectable manner.

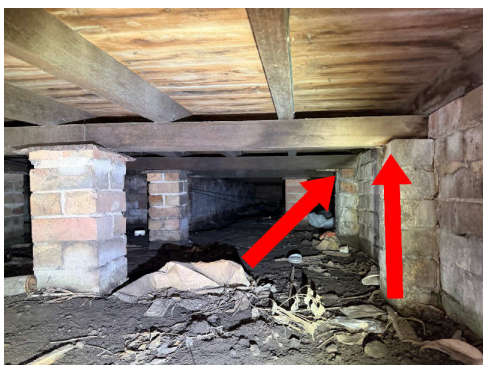
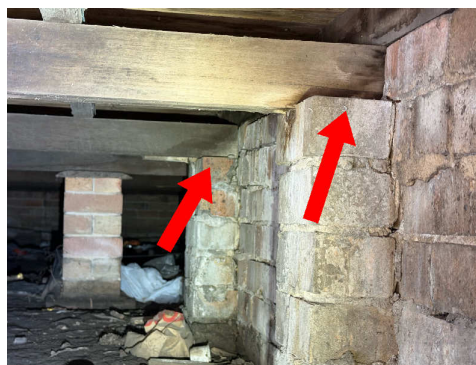
Installed during the construction process, ant caps are designed to easily identify termite or pest ingress from stumps to the adjoining bearers.

Where ant caps have not been installed, frequent monitoring of these areas should be carried out in order to identify any signs of termite or timber pest workings.

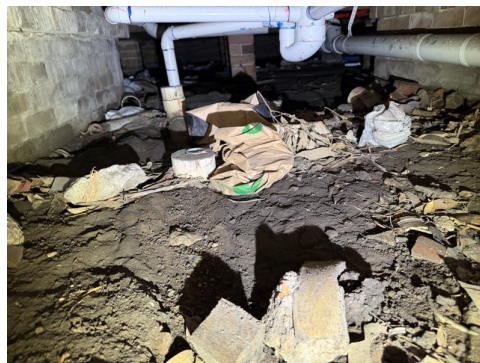
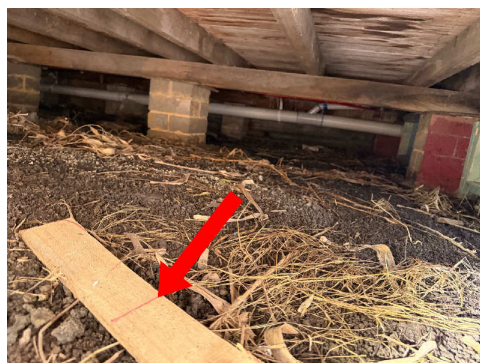
Finding 6.06

Information: An array of debris was found in the subfloor area at the time of inspection. Debris in this area restricts subfloor ventilation and creates potential for concealed pest entry. Stored timbers and other materials may also make the area susceptible to termite activity and wood rot.

A clear and empty subfloor will be better ventilated and easier to maintain in a dry condition. The removal of any timber debris is vital in minimising the risk of termite or wood borer activity.

Debris in the subfloor should be removed as soon as possible. Depending on the location and amount of debris and stored items, the homeowner may elect to undertake this task. Alternatively there are a large number of rubbish removal subcontractors that could undertake these works.

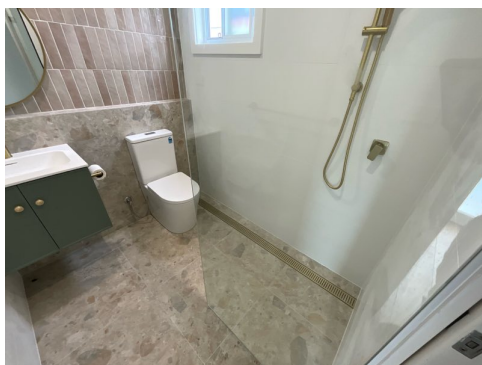
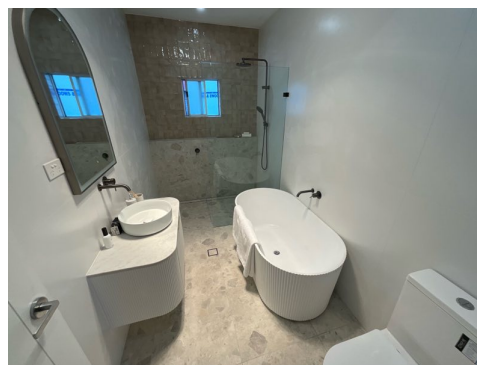
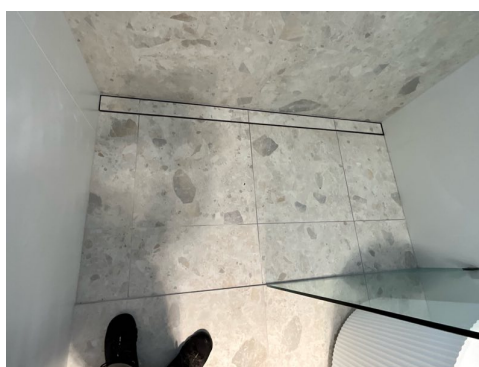
Finding: Waterproof membrane maintenance

Information: Regular maintenance of the waterproof membrane is essential to ensure its long-term effectiveness. Inspections should be conducted periodically to check for any signs of wear, damage, or deterioration, particularly around seams, joints, and high-traffic areas. Prompt repair of grout or silicone is essential and will help prevent water ingress and maintain the integrity of the structure.

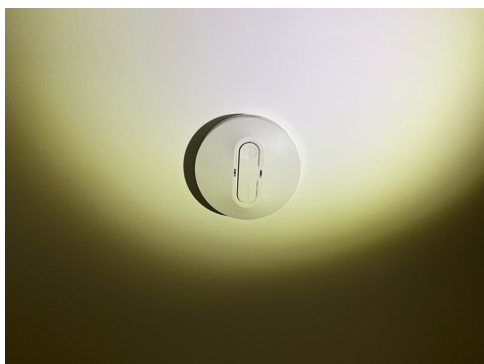
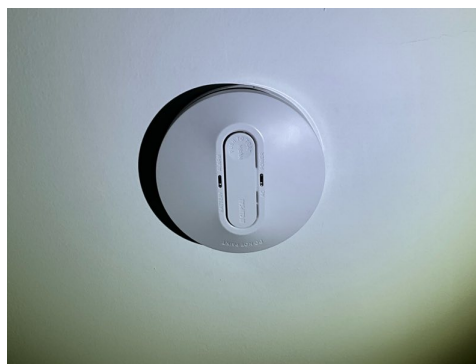
Always ensure sufficient working and suitable smoke detectors are installed prior to occupying any building. Additionally, it is advised that all smoke detectors be tested by the homeowner on a monthly basis.

Please refer to AS3786 and state based legislation, which may also apply.

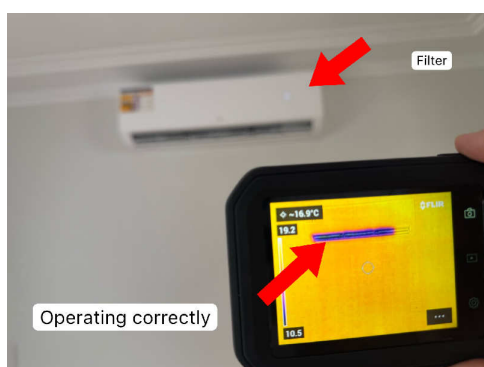
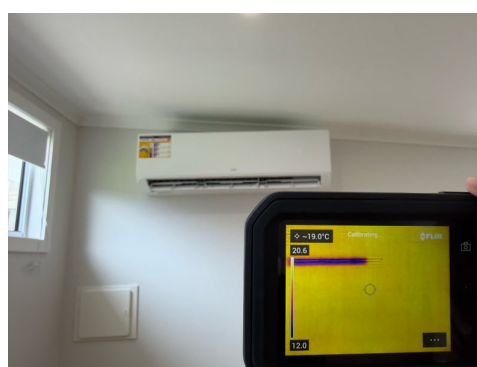
Finding: Air Conditioning Return Air Filter

Information: Maintaining return air filters is crucial for indoor air quality air conditioning system efficiency. Here's a basic maintenance routine:

1. Regular Inspection: Check the filter monthly to assess its condition.
2. Cleaning or Replacement: Clean or replace the filter as needed. Disposable filters should typically be replaced every 1-3 months, while reusable filters can be cleaned according to manufacturer instructions.
3. Cleaning Procedure: For reusable filters, vacuum or wash them with mild detergent and water. Ensure they are completely dry before reinstalling.
4. Proper Installation: Install the filter properly, following the manufacturer's instructions and ensuring it fits snugly.
5. Schedule Maintenance: Set reminders to check and replace filters regularly to maintain optimal performance and air quality.
6. Professional Inspection: Periodically, have a professional inspect your HVAC system, including the filters, to ensure everything is functioning correctly.

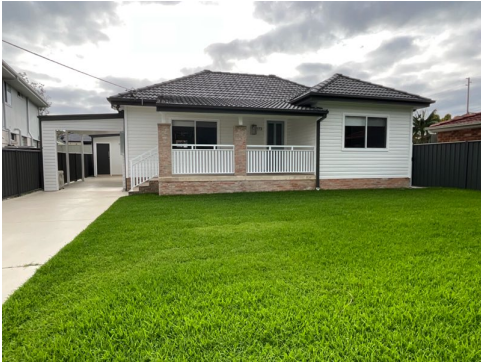
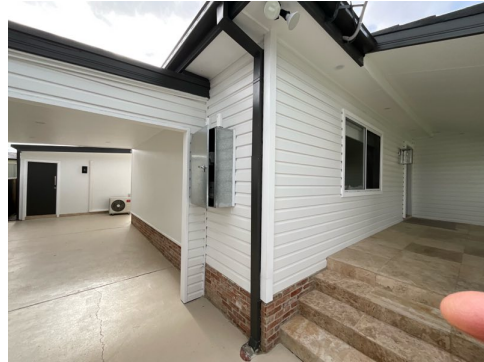
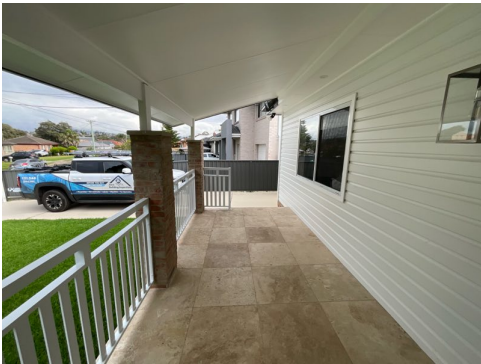
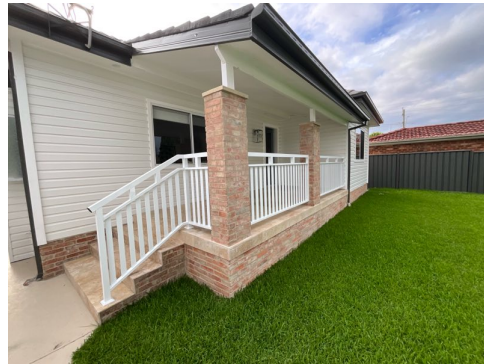
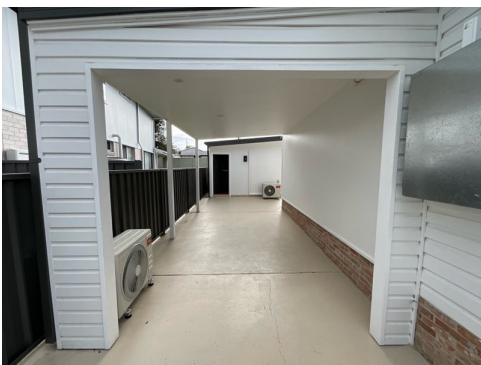
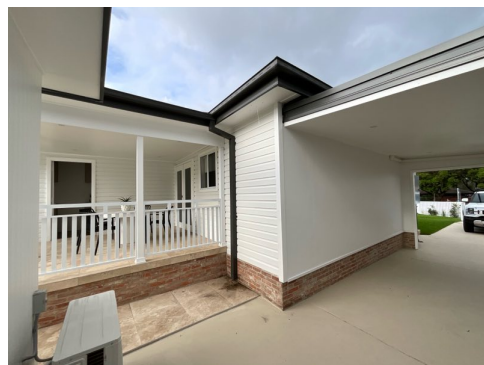
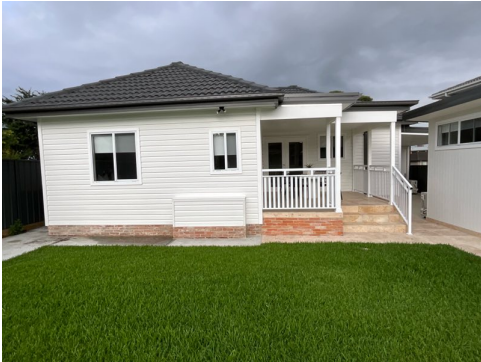
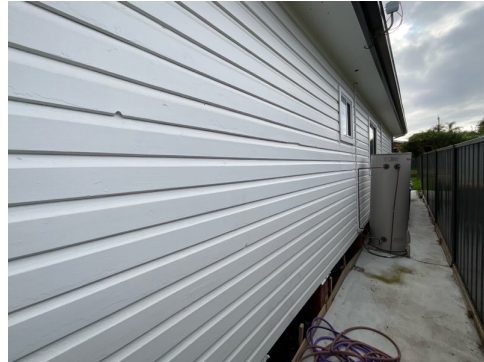
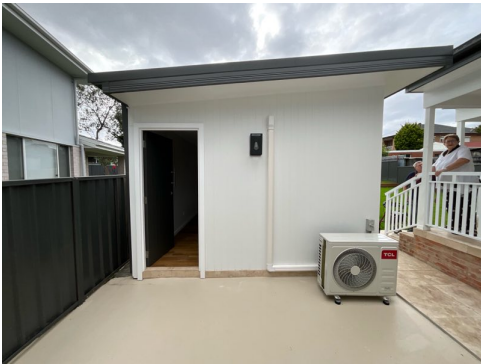
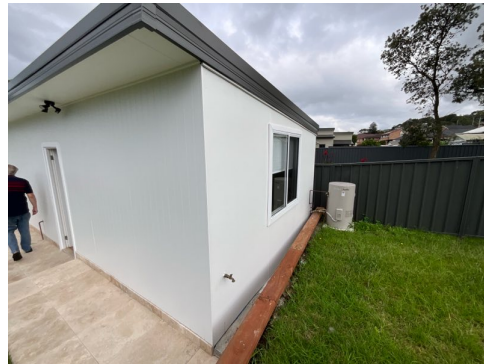
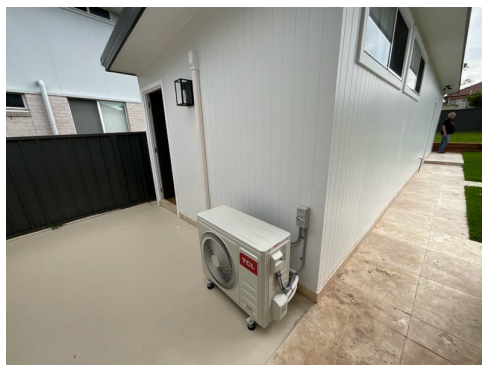
Finding: Additional Photos - Obstructions and Limitations

Information: These photographs are an indication of the obstructions and limitations which impeded full inspection of the property at the time of inspection, also for your reference.

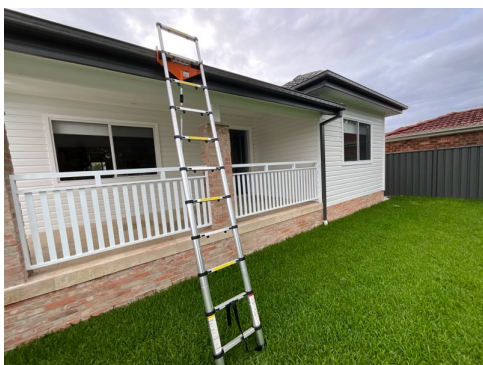
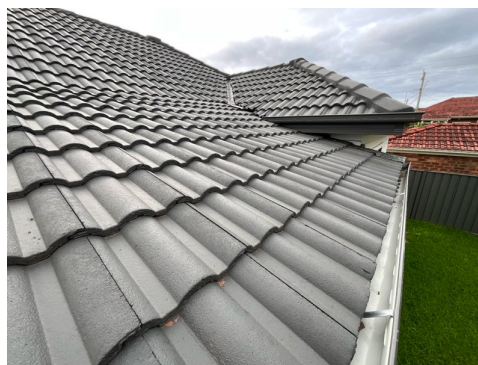
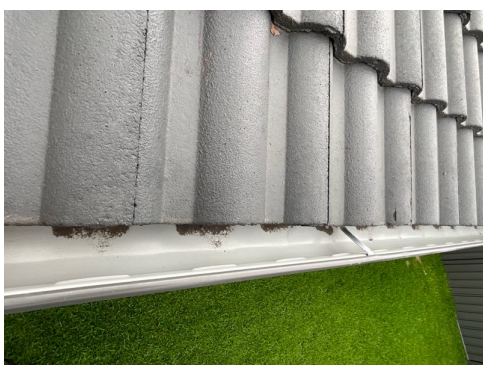
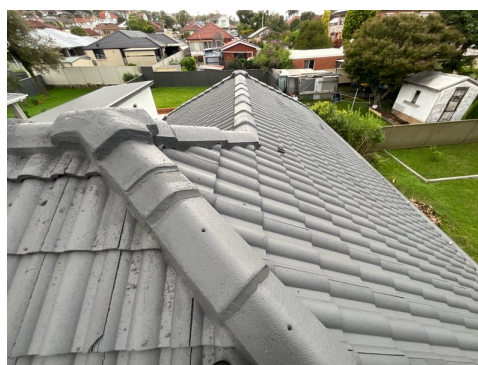
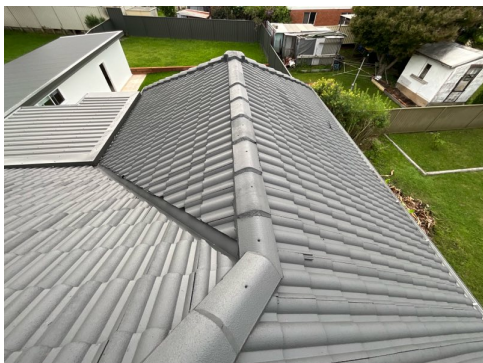
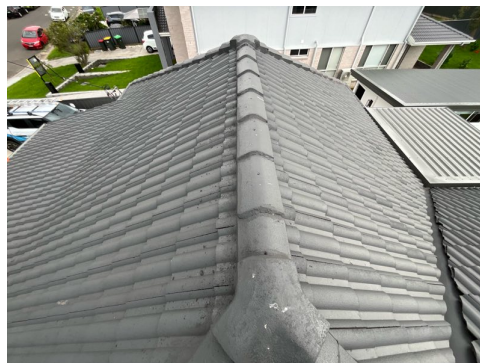
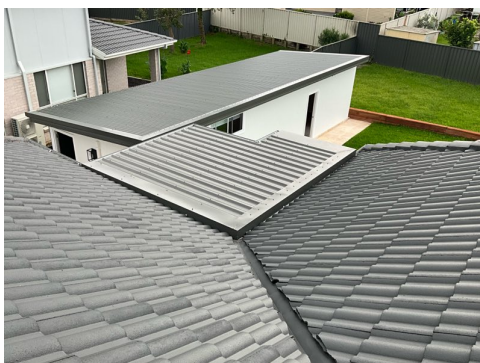
Finding: Additional Photos - Obstructions and Limitations

Information: These photographs are an indication of the obstructions and limitations which impeded full inspection of the property at the time of inspection, also for your reference.

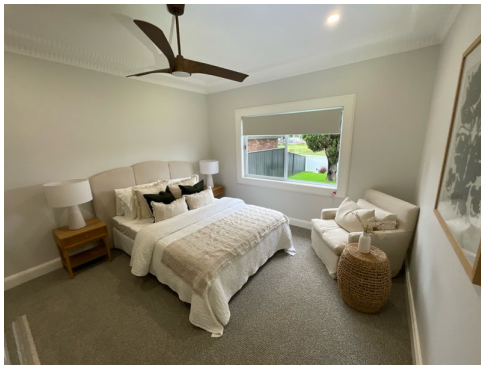
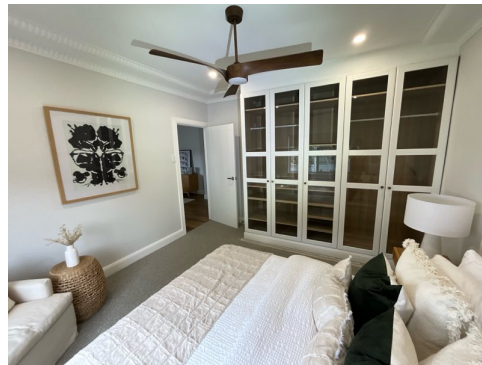
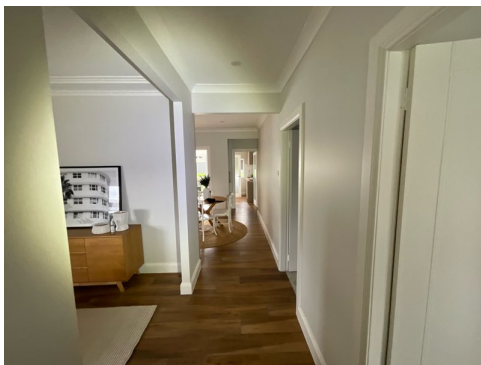
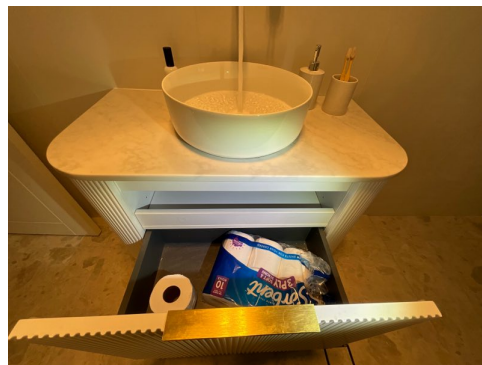
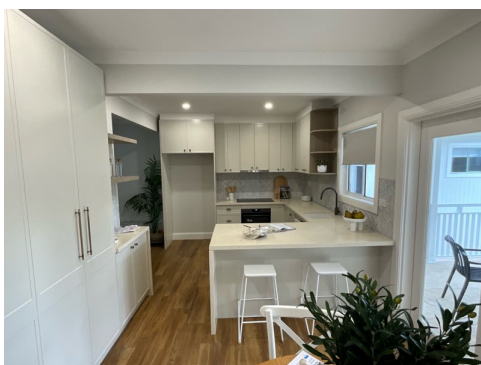
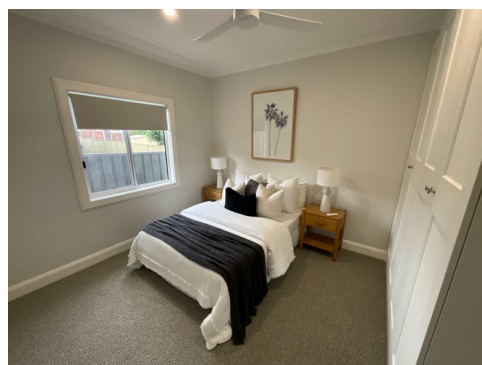
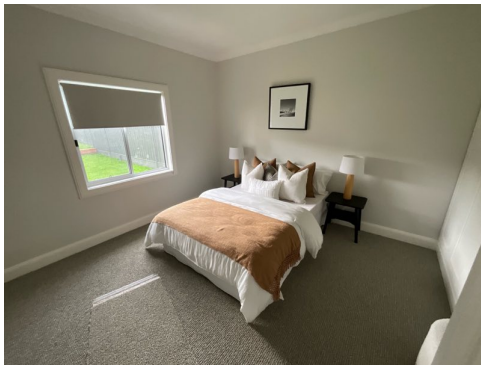
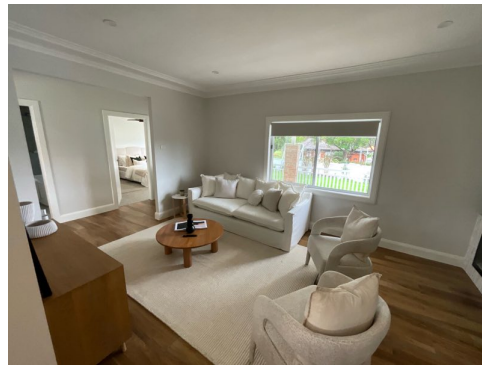
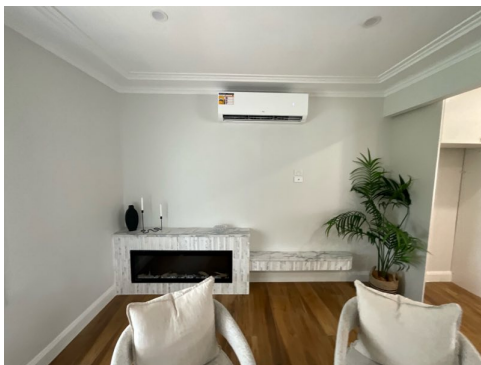
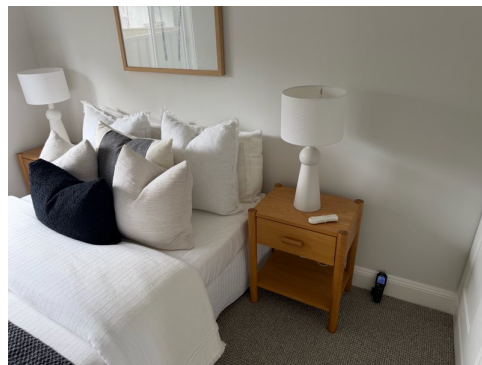
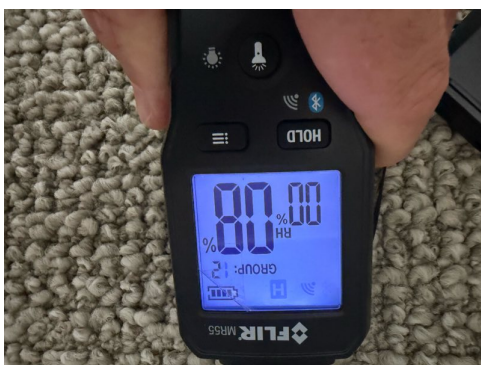
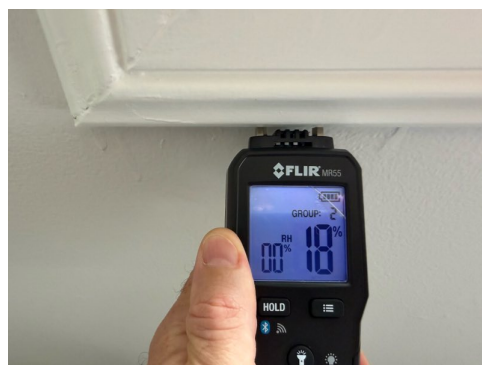
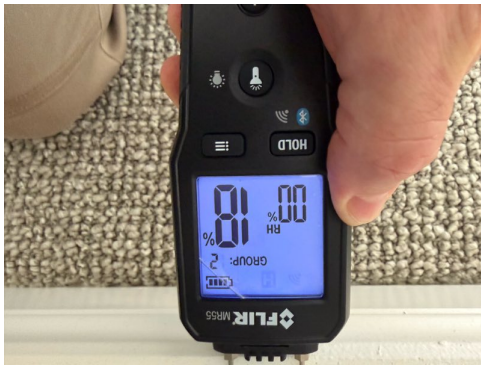
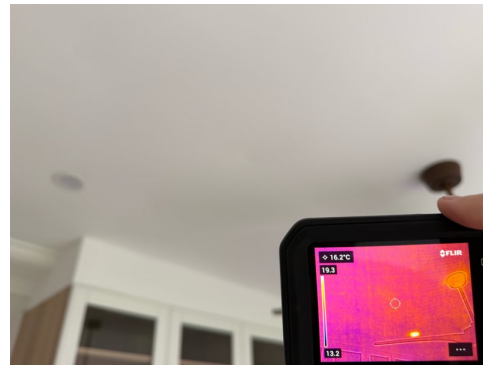
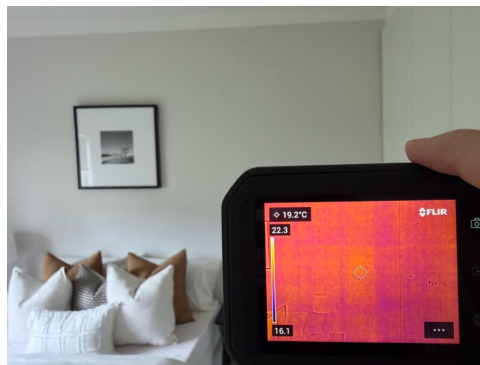
Finding: Additional Photos - Obstructions and Limitations

Information: These photographs are an indication of the obstructions and limitations which impeded full inspection of the property at the time of inspection, also for your reference.

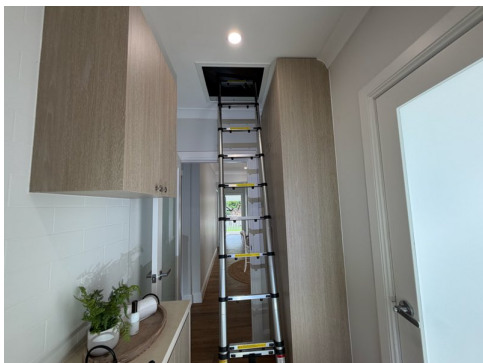
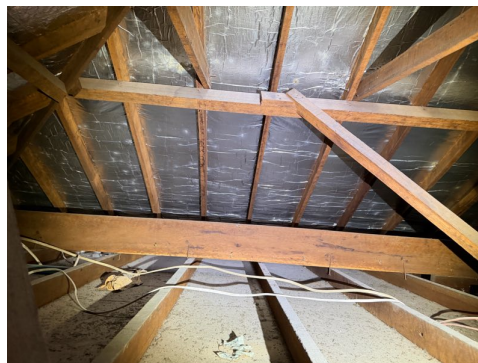
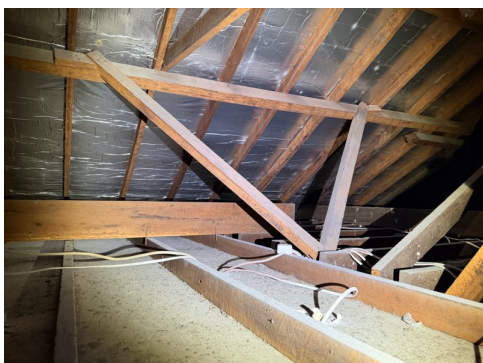
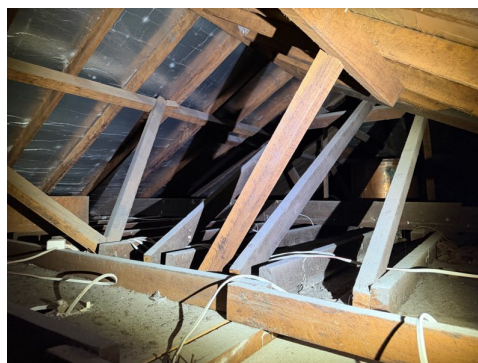
Finding: Additional Photos - Obstructions and Limitations

Information: These photographs are an indication of the obstructions and limitations which impeded full inspection of the property at the time of inspection, also for your reference.

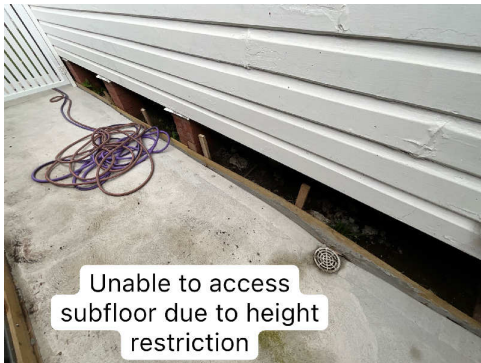
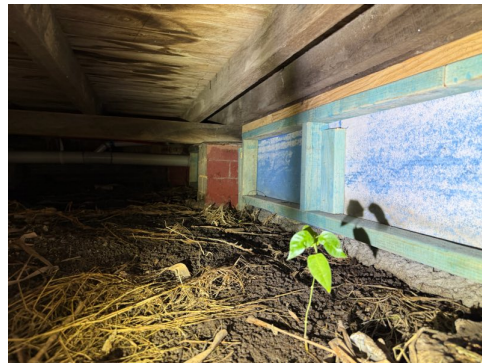
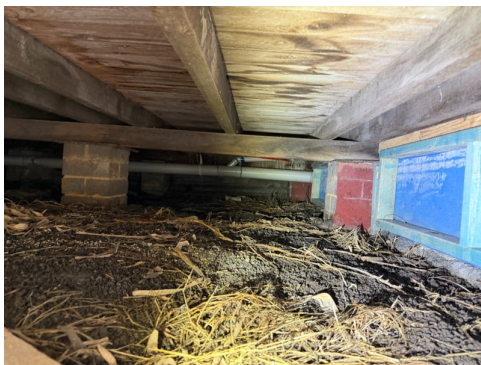
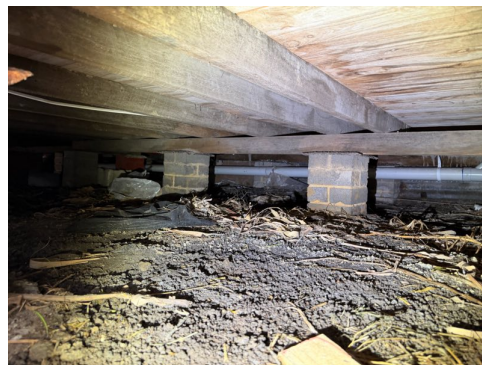
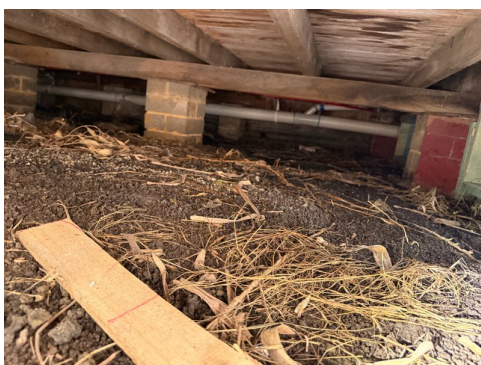
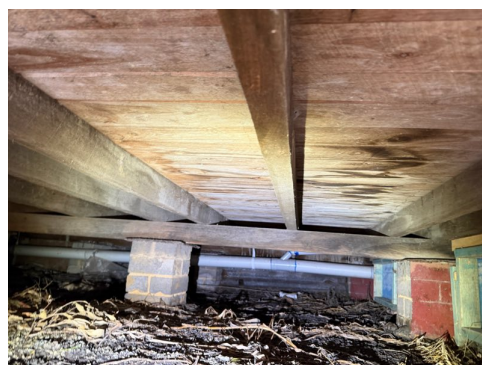
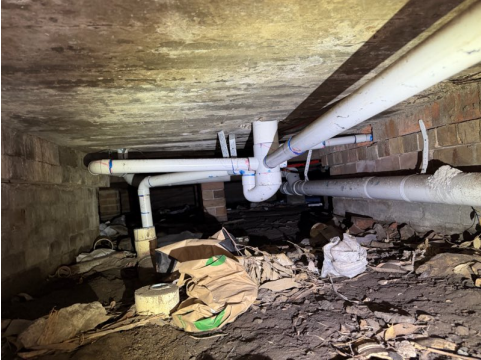
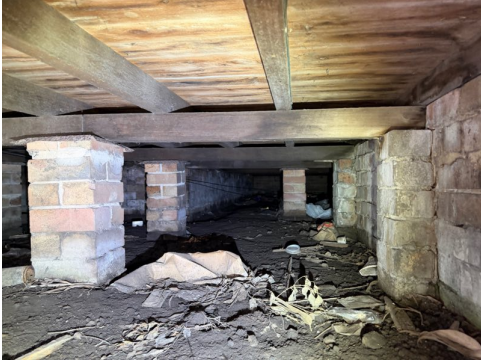
Finding: Additional Photos - Obstructions and Limitations

Information: These photographs are an indication of the obstructions and limitations which impeded full inspection of the property at the time of inspection, also for your reference.
