## Building Inspection Report

Inspection Date: Thu, 19 Feb 2026

Property Address: 385 Station St, Box Hill South VIC 3128,  
Australia

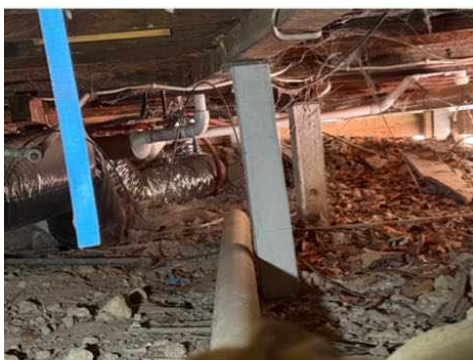
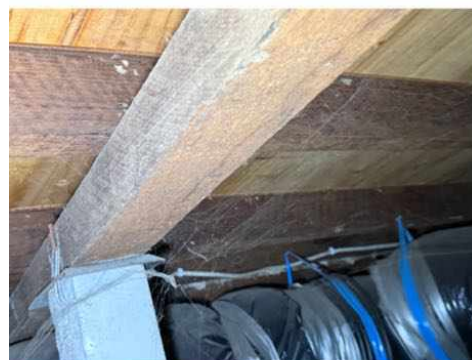
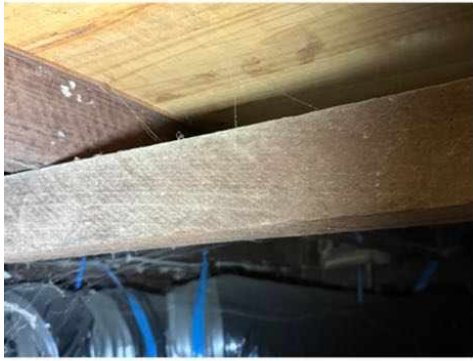
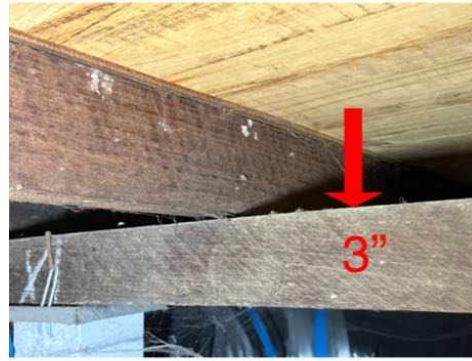
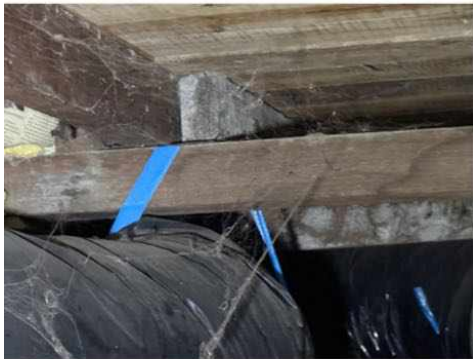
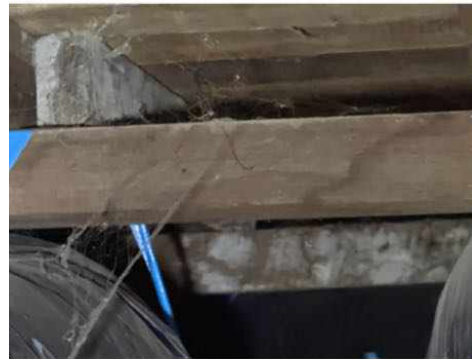
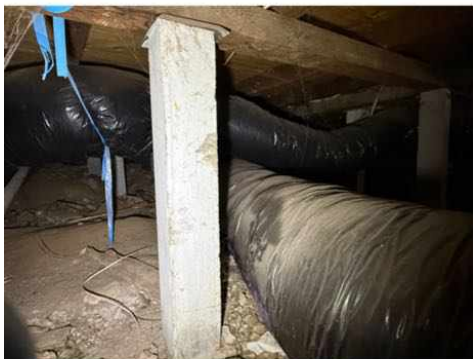
#### Defects 2.01

Building: Building 1  
Location: All Areas > All Areas  
Finding: Subfloor bearers  
Information: At the time of the inspection of the subfloor areas it was noted that the timber floor bearers had been installed on the flat, meaning instead of the traditional construction method of the timber bearer installed with the 4" up, these bearers were on the side. 3" vertical and 4" across. The bearers installed on their flat is considered to be a major defect due to structural weakness. The client can appoint a structural engineer to conduct a further inspection to check that these areas for structural integrity of the affected areas to assess the safety of the associated structures.

They did appear to have been installed like this during the time of the construction of the home and are suspected to have been this way for a long time. These timber bearers are supposed to be placed on edge to provide maximum resistance to bending and downward loads. Timber floor bearers are designed to support heavy floor loads, such as occupants, furniture and the floor system itself, and the orientation of the timber bearer maximises their vertical strength, prevents floor sagging and a level floor.

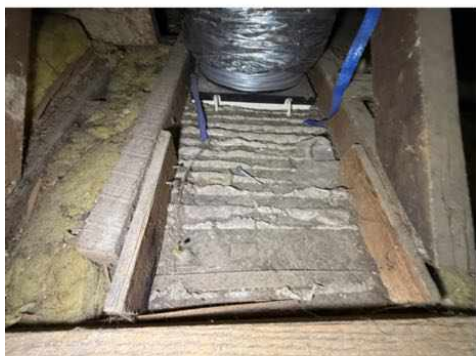
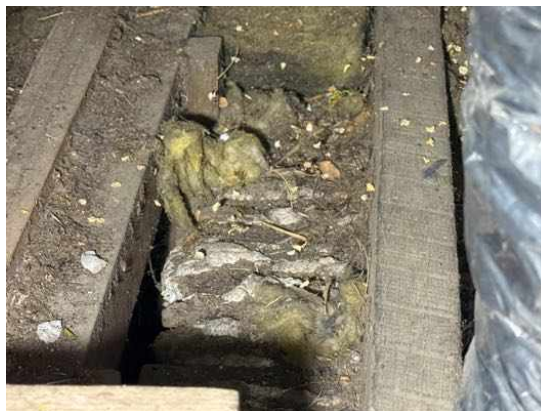
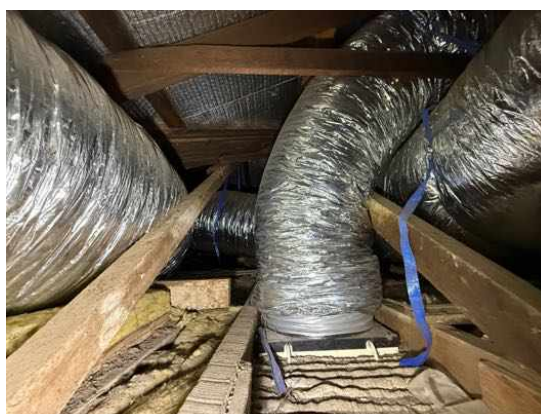
### Defects 3.01

Building:	Building 1
Location:	All Areas > All Areas
Finding:	Insulation - minor amount missing
Information:	Upon inspection of the roof void it was noted that some minor areas of the insulation was missing or removed. Insufficient insulation will result in a comparatively higher cost to heat and cool a property as there is a lack of Insulation (or uneven coverage of insulation) which works as a barrier to heat transfer. The roof insulation helps to keep

out unwanted heat in summer and preserves warmth inside your home in winter.

It can also help soundproof your home from unwanted airborne noise transfer. Installation of adequate insulation is required and should be conducted as soon as possible. Where insulation is absent, the area does not meet current Australian Standards.

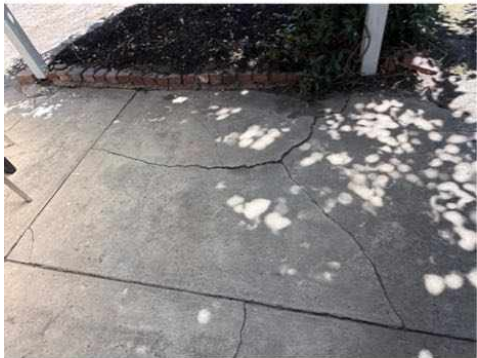
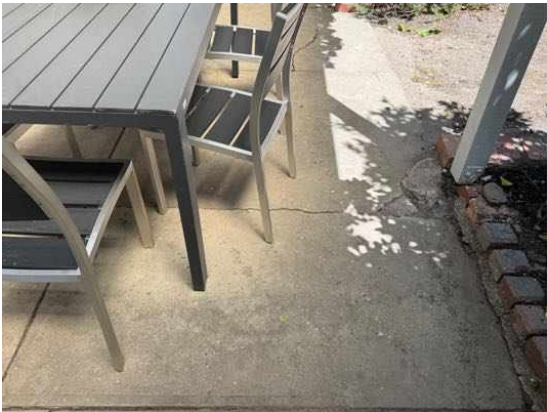
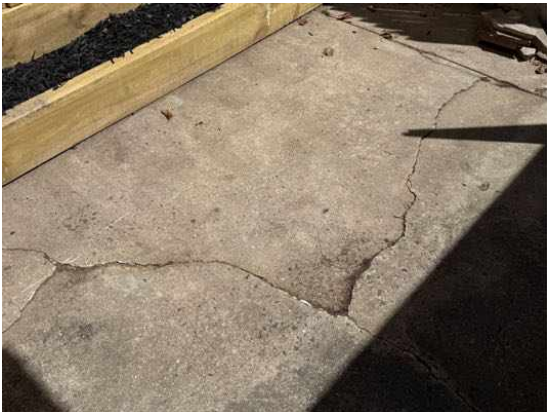
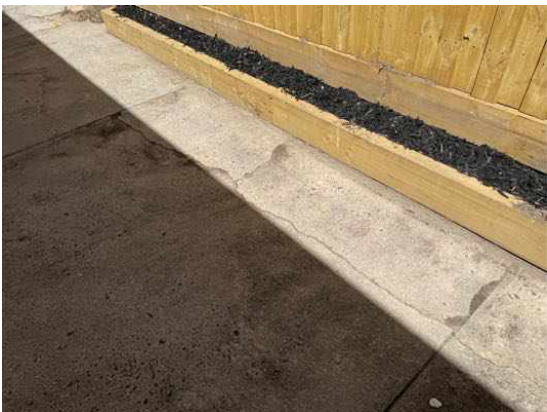
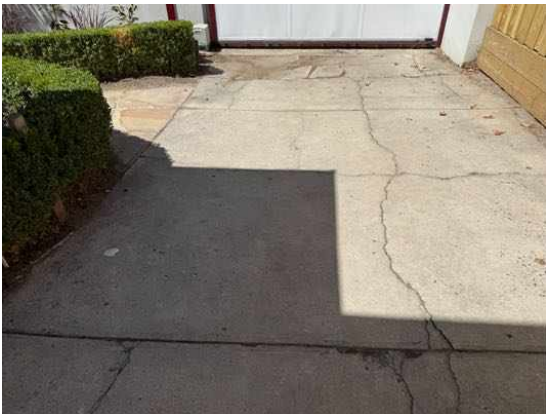
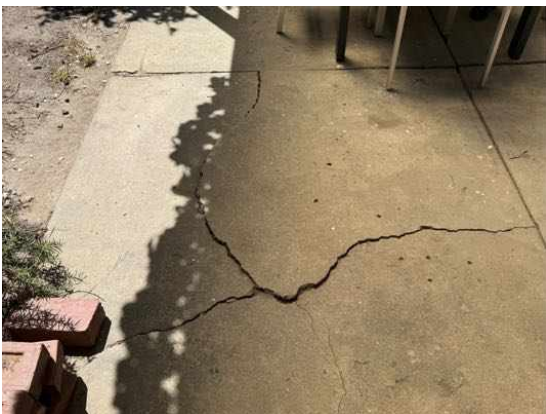
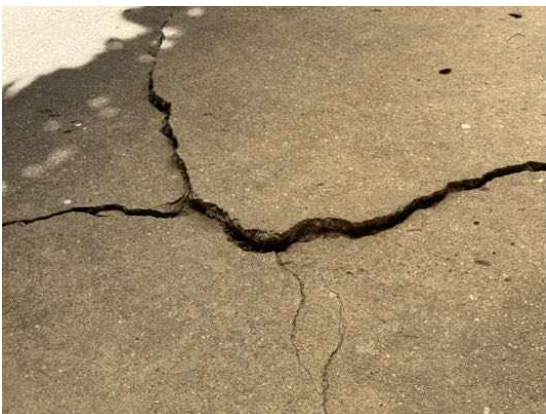
### Defects 3.02

Building:	Building 1
Location:	All Areas > All Areas
Finding:	Concrete driveway cracks
Information:	Numerous cracks on the driveway were observed at the time of the inspection. Also the rear pergola concrete showed concrete cracked and lifted, this area is considered to be a tripping hazard for occupants, especially young children and elderly. This area should be removed and re-instated to improve the overall appearance and aesthetics of the area.

Concrete cracks are a common occurrence as a result of many primary defects. Such causes may include age, general wear and tear, expected building movement, general expansion/contraction of building materials in different weather conditions, and/or minor failings in the installation or application of building materials. Monitoring of all cracking should be conducted periodically. Contact a relevant tradespersons,

especially where cracks have become trip hazards for occupants.

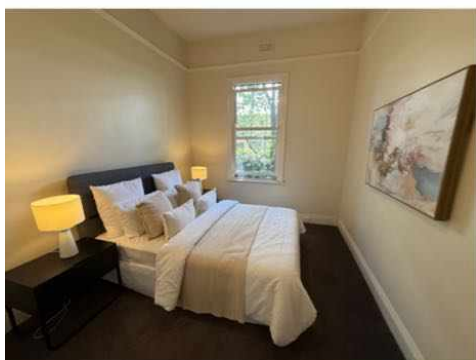
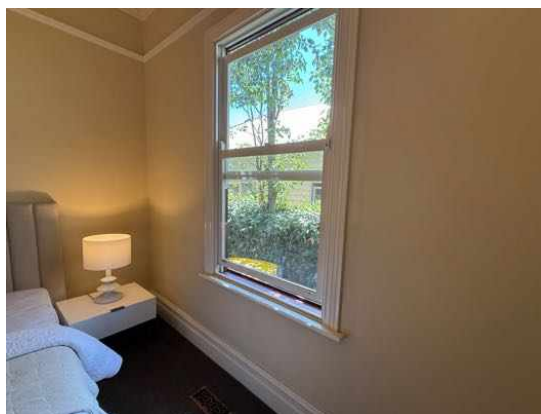
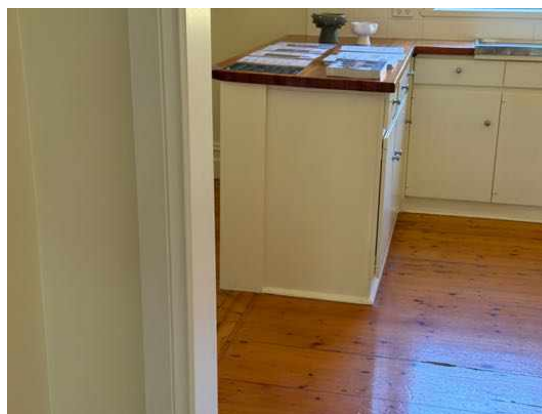
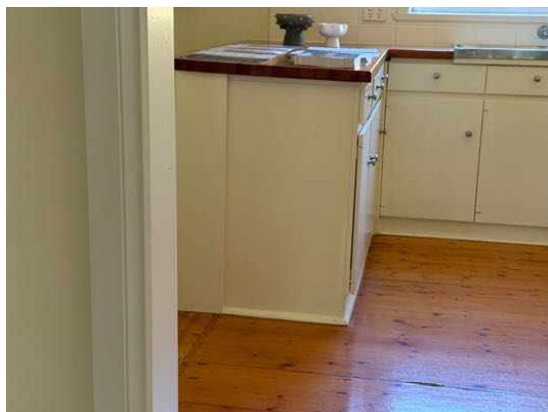
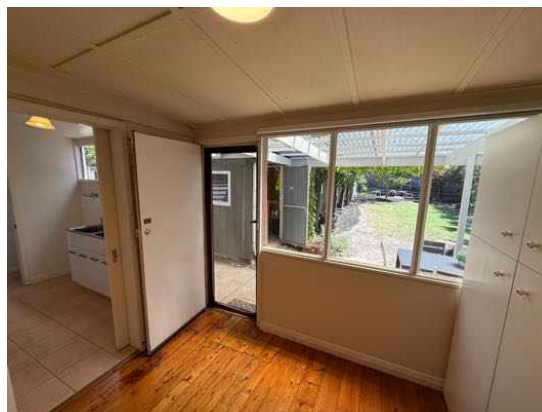
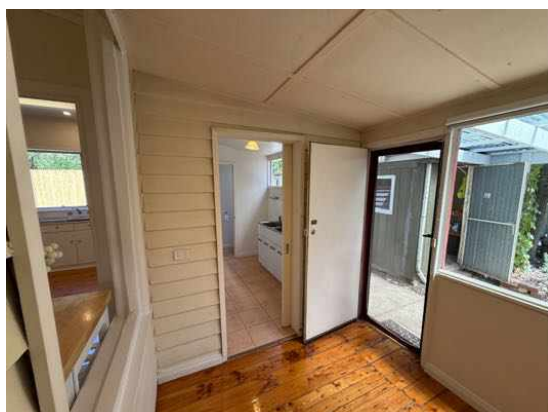
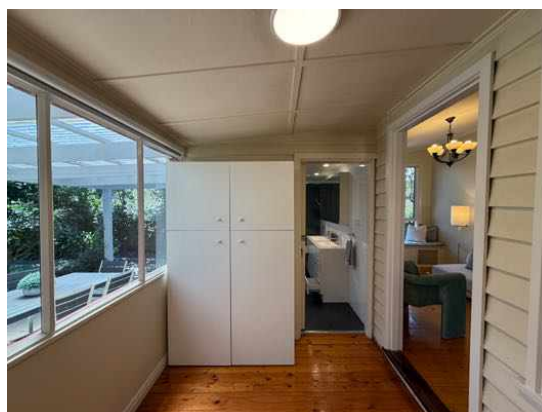
Defects 3.03

Building: Building 1  
Location: All Areas > All Areas  
Finding: Floor levels  
Information: The internal flooring throughout the home was observed to be showing signs of being out of level and uneven. At the time of the subfloor inspection it was observed that the home had been re-stumped with concrete stumps at some time. Uneven and out of level floors with a property of this age is considered in most cases to be normal however some areas were considered more than other areas. The uneven and out of level floors throughout the home is highly likely to indicate that at the time of the re-stumping of the home the stumps appeared to have been replaced at the original height and not has not been overly leveled. This could be due to the extensive plaster cracks that would have resulted in leveling the home.

Floor levels can have complex and varying causes, which will influence the required remedial works the client may wish to take. If client wishes to rectify these areas it is advised to begin by consulting a registered builder who has expertise in re-stumping to determine the required scope of works that may be deemed necessary. This may include some packing of stumps to some areas. Client may also consider consultation with a geotechnical engineer to understand what and how the surrounding soil is reacting to surrounding moisture.

A Registered Builder would generally carry out these types of works or can be guided and advised by an geotechnical or structural engineer where deemed to be required. The floors can be also monitored to identify any further movement even after floor have been rectified. Where flooring is uneven further, a potentially invasive inspection of the subfloor stumps and floor structures is required. If remedial work is carried out on the floors, it is likely that in some areas the floors would require the floors areas to be removed due to the close proximity to the ground.

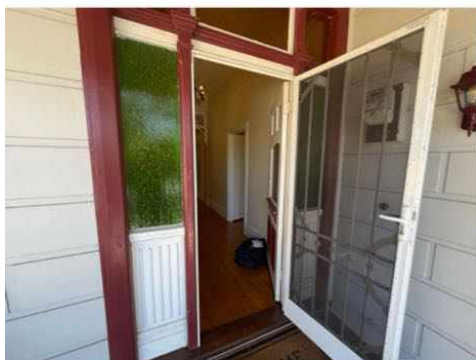
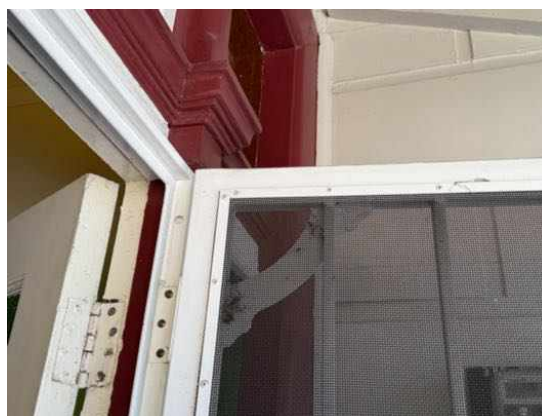
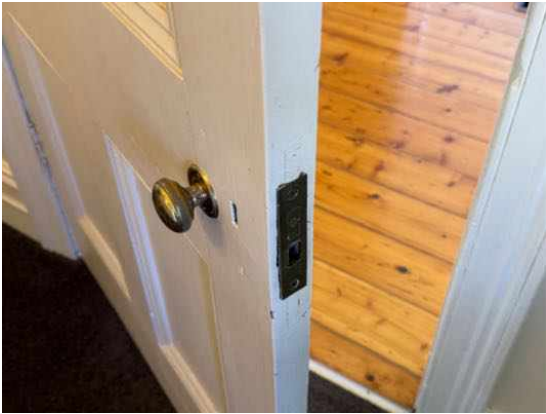
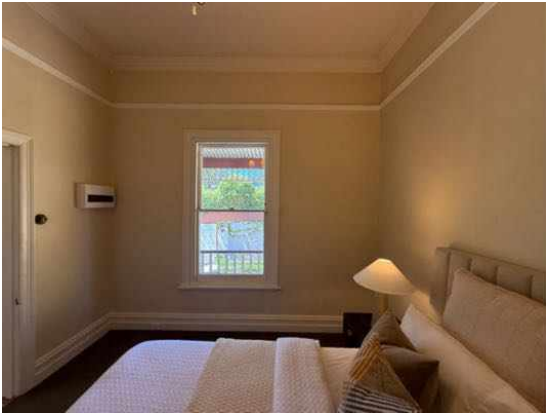
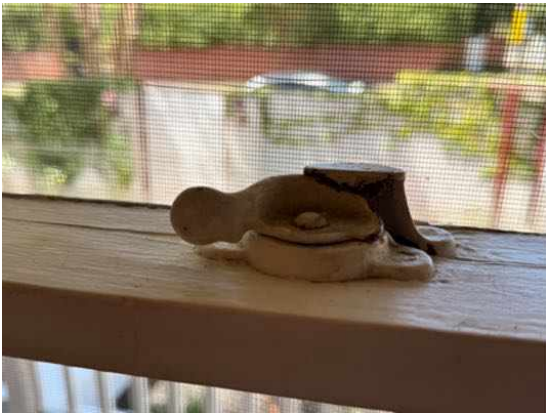
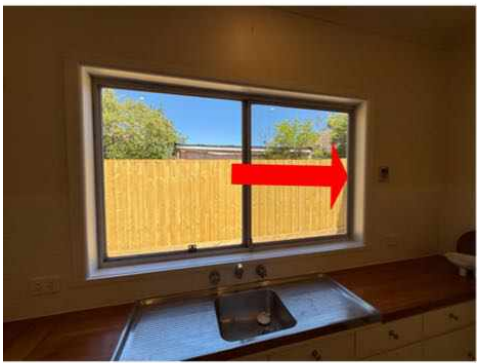
### Defects 3.04

Building:	Building 1
Location:	All Areas > All Areas
Finding:	Door handles and latches - door and window security
Information:	It was observed that doors still had the original door hardware, this door hardware has exceeded its useful life and is now considered to be a hazard for occupants. Numerous door handles and latches are not working as intended and in time occupants are highly likely to be stuck in a room unable to exit. The sliding doors throughout the home were also missing head pelmets and may also benefit by being renewed. Some handles and or door latches were observed to be sticking and handles spinning during normal operation.

Whilst detracting from the functionality of this building element, this minor defect may also be a safety hazard to all occupants, and may therefore have serious implications if occupants were not able to egress at the time of an emergency. It is suspected that this defect has occurred due to minor issues after painting, poor installation and or through general wear and tear, which is expected for building elements of this age. A qualified carpenter may be appointed to perform rectification works as necessary. If left unattended, further functional impairment is likely to occur.

Front exterior door and window security :- Numerous exterior doors and windows throughout the property were observed to require some maintenance. The exterior doors and windows may require new locks and other hardware to ensure the home has adequate security. Some door handles and keepers were observed to be poorly fitting. The exterior window locks were also considered to be an aged design and may not be providing adequate protection and security for occupants.

These remedial works will ensure that they offer adequate security and they operate correctly during standard operation. Doors and window hardware defects may inhibit the egress from the rooms and make it difficult for younger and other occupants to safely egress the interior areas if left unmanaged. The functionality of affected doors and windows may also be creating secondary defects to associated building elements, such as damage to the associated frames. Such defects may have several causes, ranging from, deteriorated door and window hardware or poor installation. A qualified carpenter should be appointed to perform remedial, rectification works to these doors and windows.

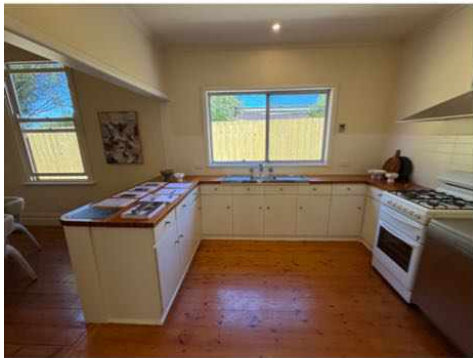
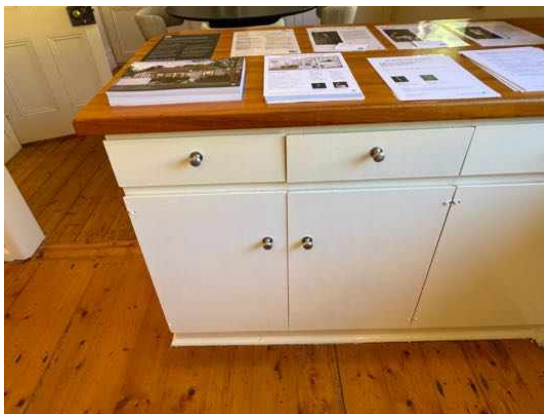
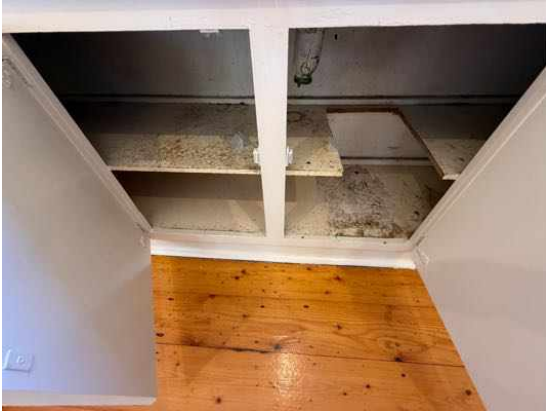
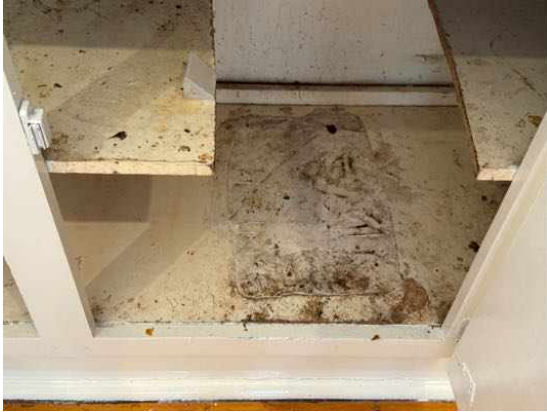
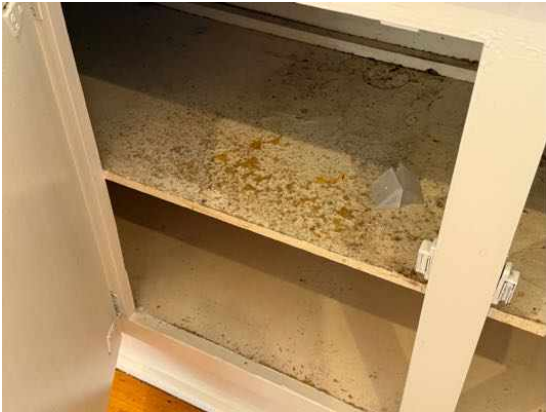
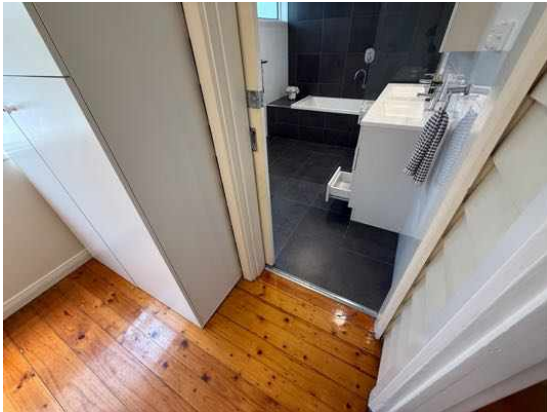
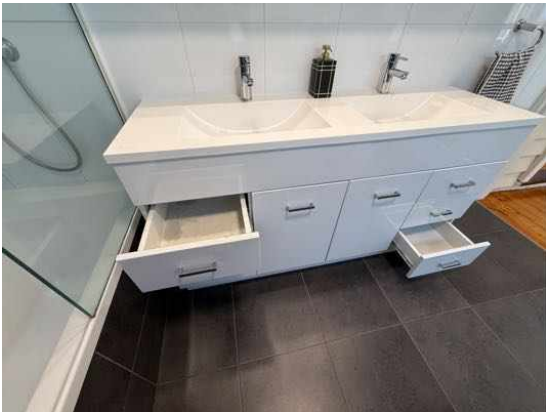
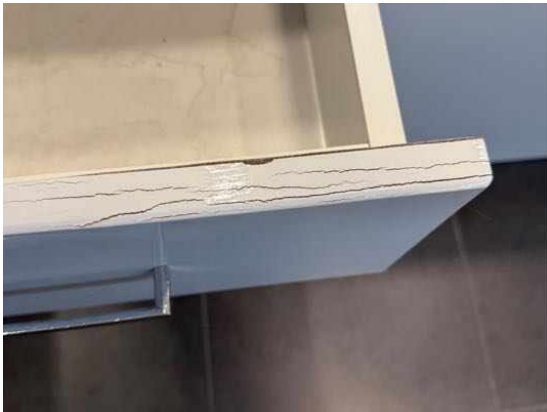
Defects 3.05

Building: Building 1  
Location: All Areas > All Areas  
Finding: Kitchen and bathroom cabinets  
Information: The kitchen and bathrooms cabinet doors showed that they were aged and deteriorated and signs of lack of maintenance over many years to the doors, drawers and cabinet carcasses. Many areas were observed to have some wear and may require some maintenance, remedial work or renewal to ensure further deterioration does not continue further. Although these defects may detract from the overall looks of the cabinetry, in most cases it does not necessarily affect the operational state of the cabinetry.

To improve the operation of these affected cabinets, cabinet doors or drawers, a qualified cabinet maker or carpenter may be appointed to renew, rejuvenate rectify or repair any cabinetry as deemed to be necessary. Such works should be completed at discretion of the client.

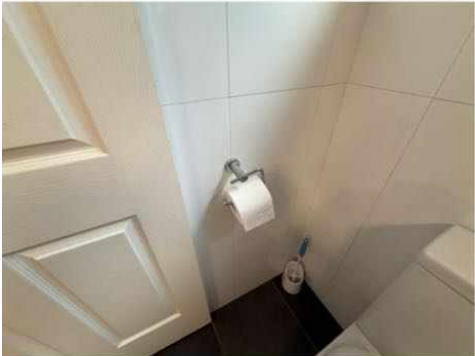
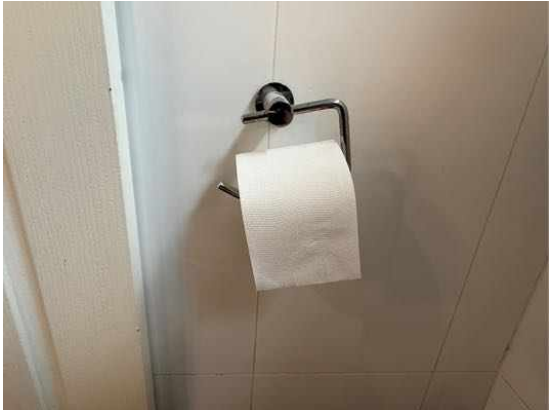
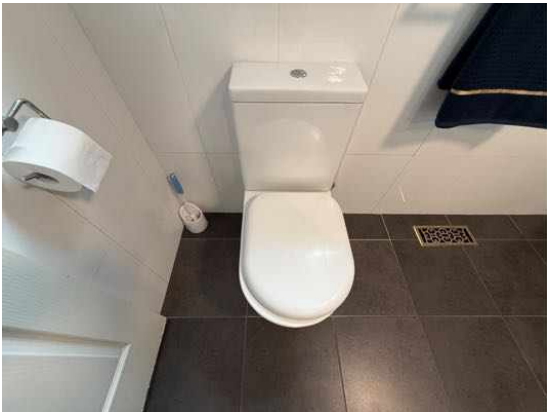
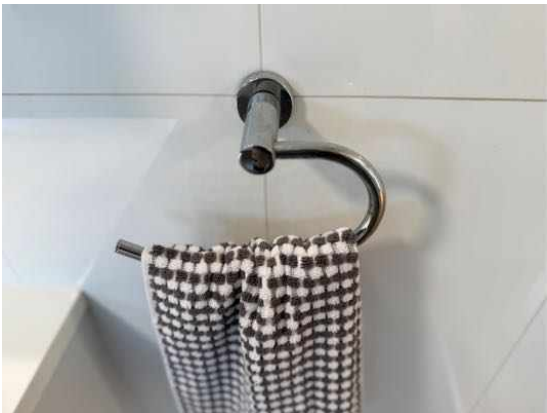
Defects 3.06

Building: Building 1  
Location: Bathroom > All Areas  
Finding: Toilet roll holders and towel rail - Loose  
Information: The toilet roll holders and towel rail were found to be loose at the time of inspection. While not a major operational defect, function can deteriorate if the problem is left unmanaged. It is recommended that some remedial works to rectify the loose toilet roll holders and towel rails to its original fixing. If these cannot be rectified to function as intended, client is recommended to renew. A qualified carpenter may be required to perform these works.

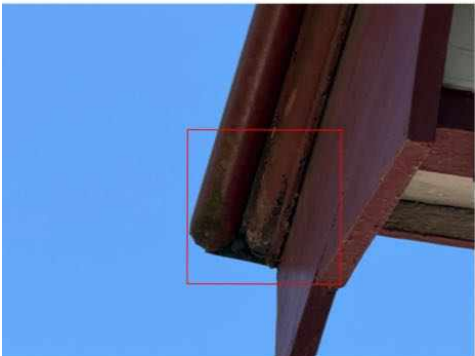
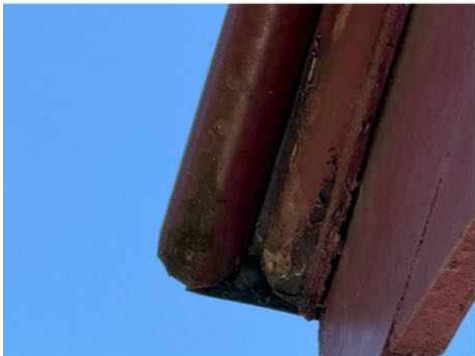
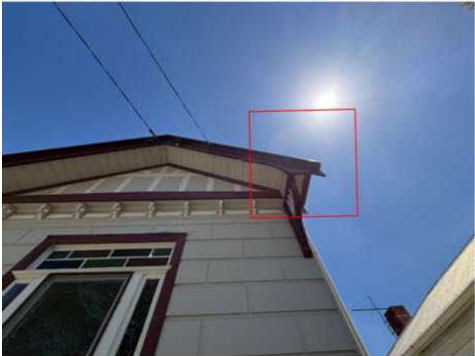
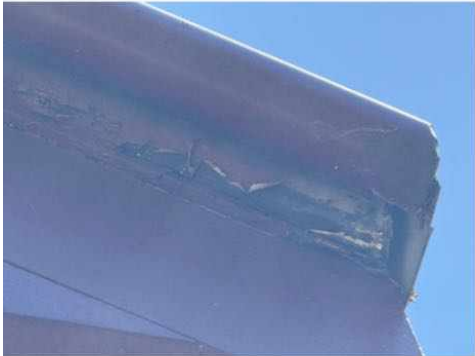
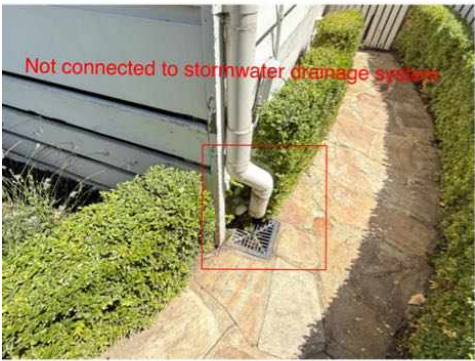
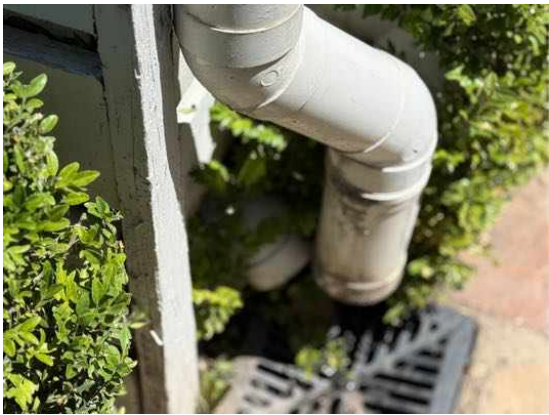
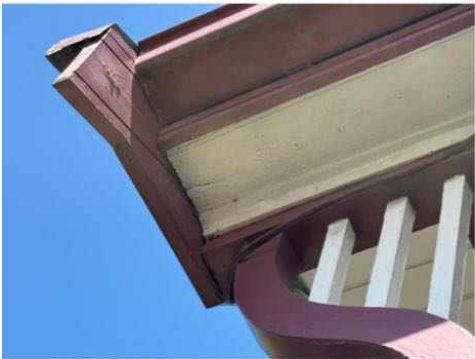
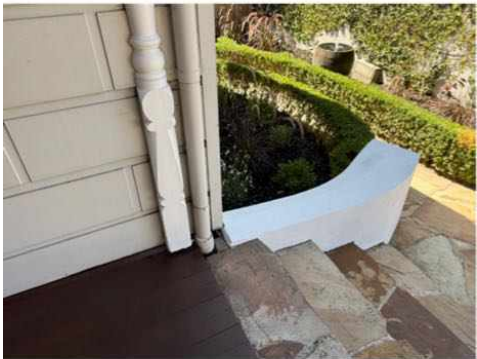
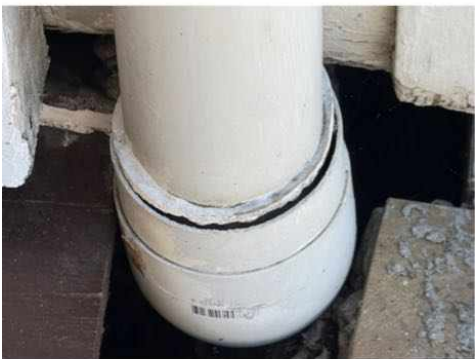
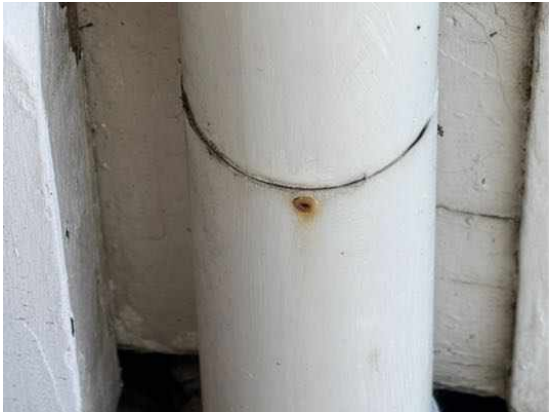
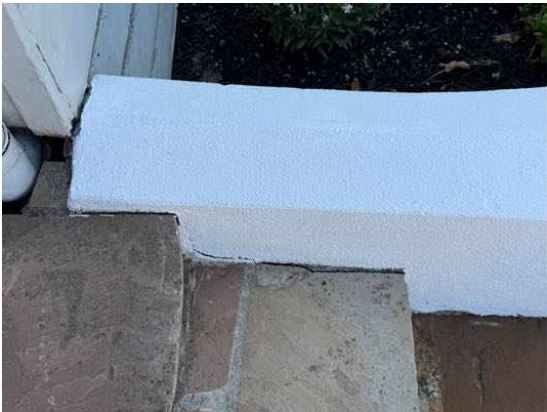
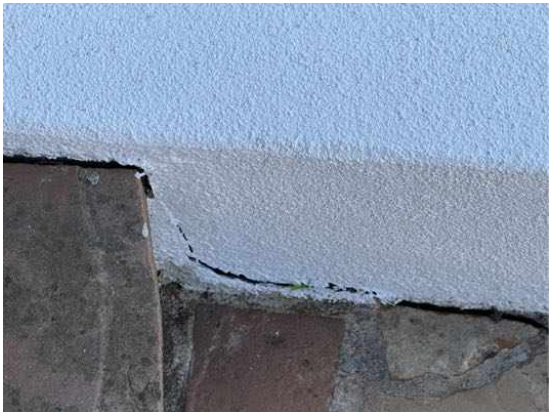
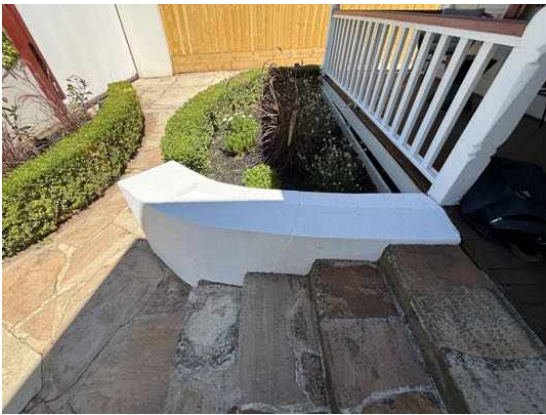
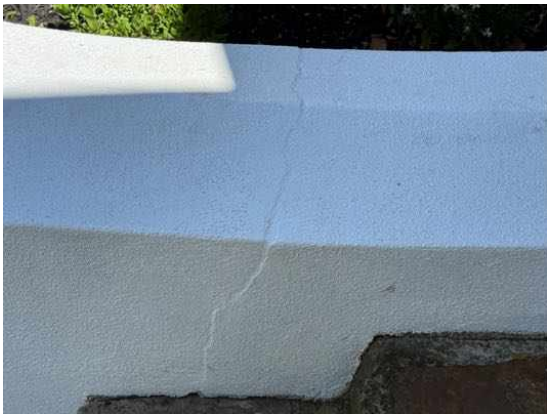
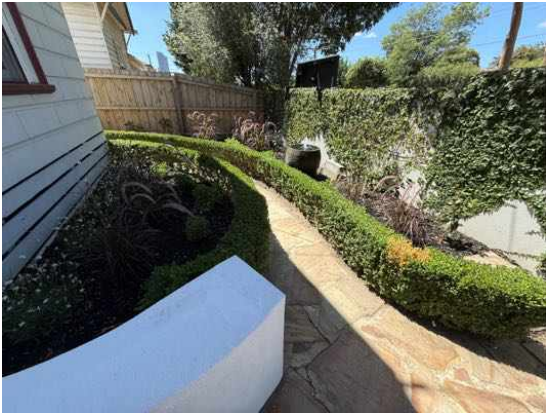
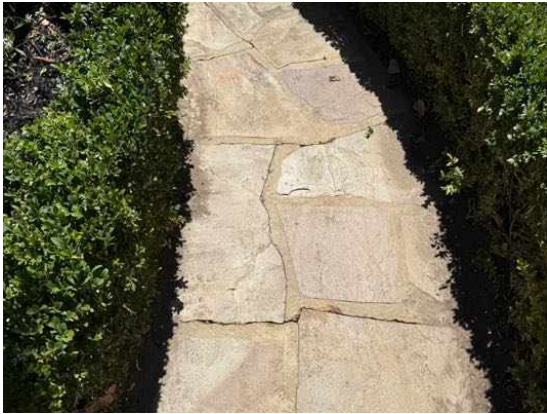
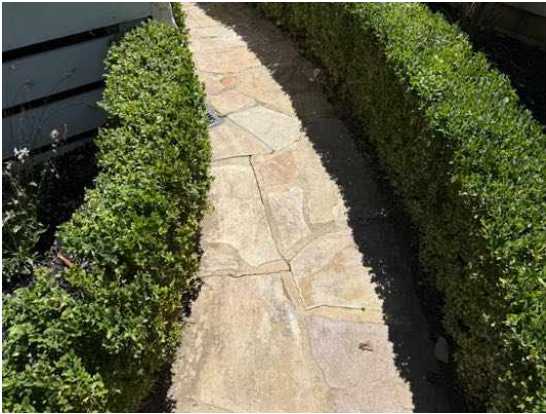
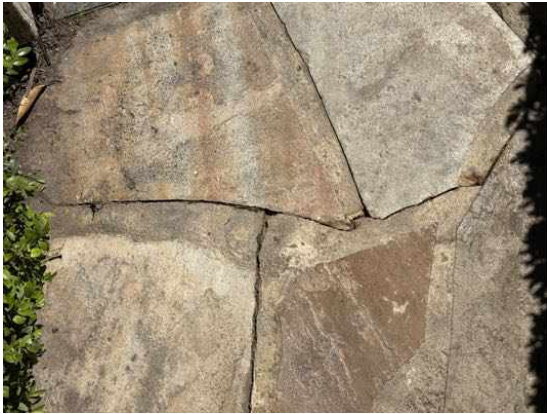
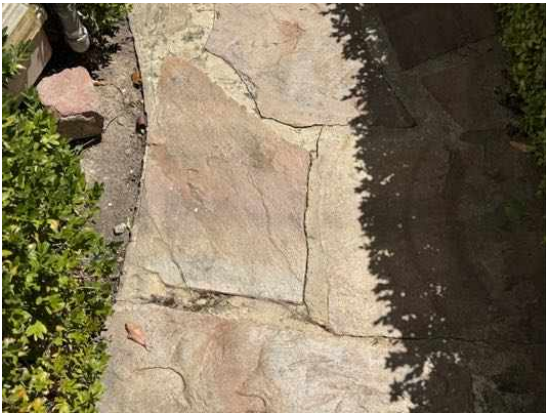
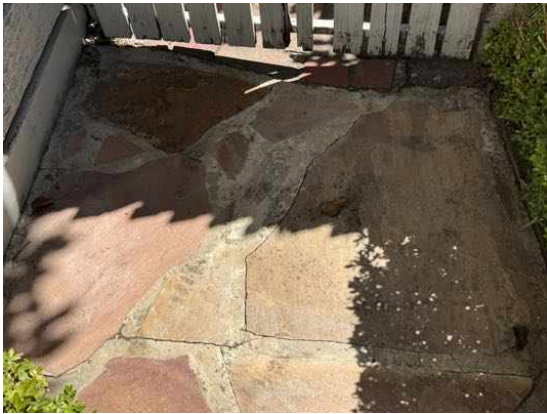
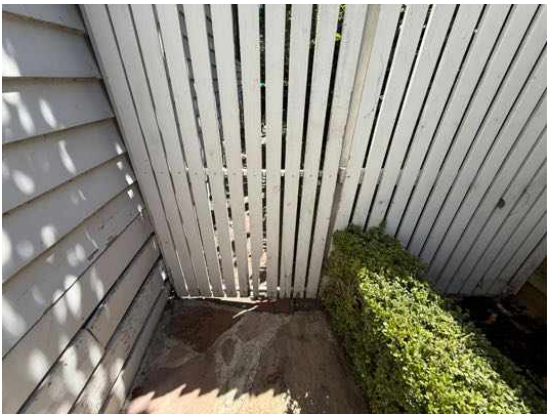
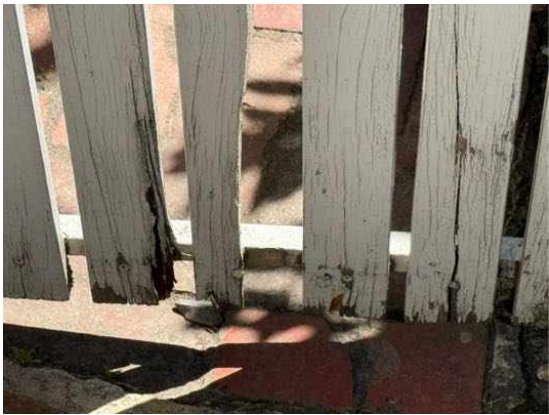
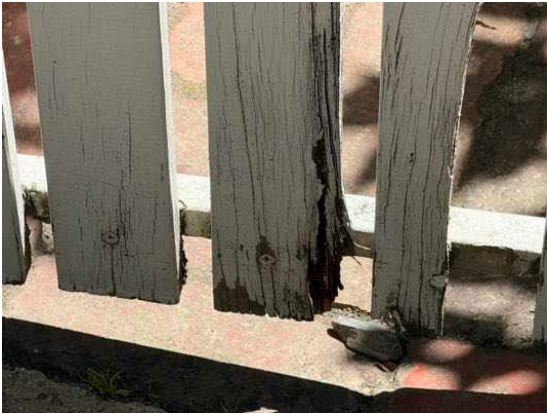
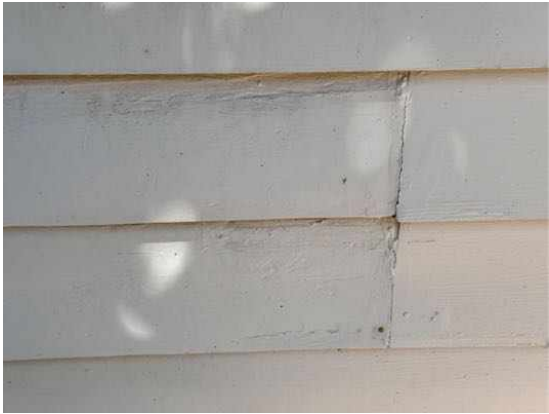
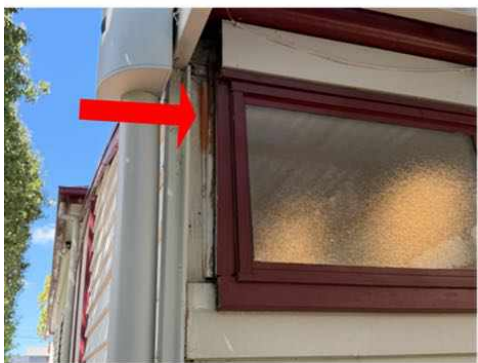
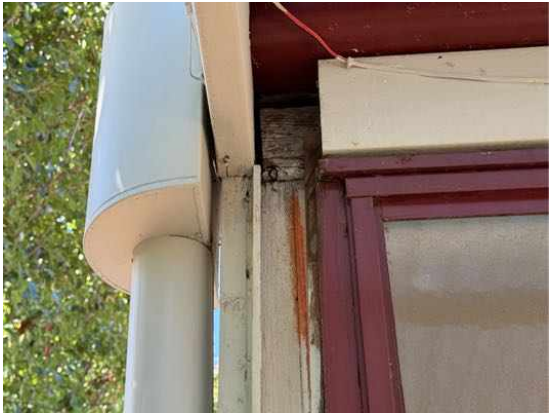
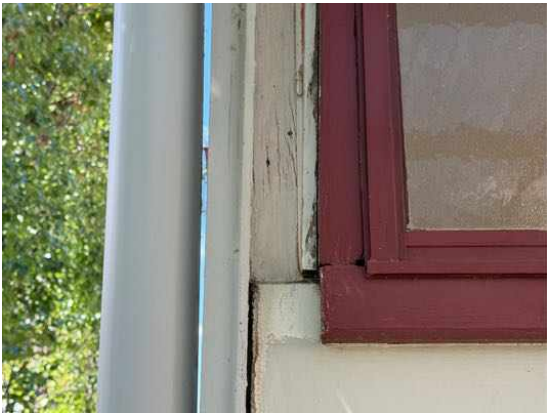
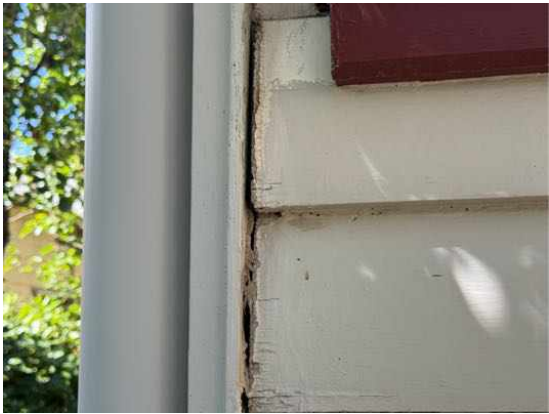
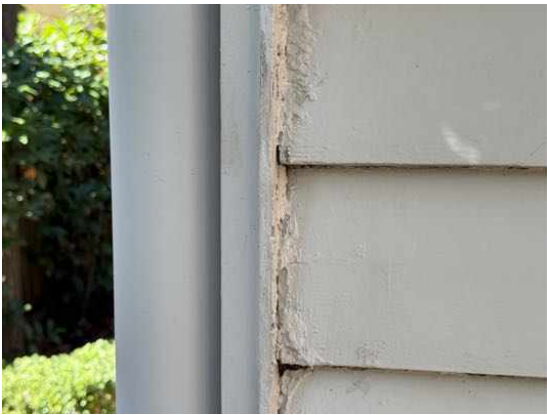
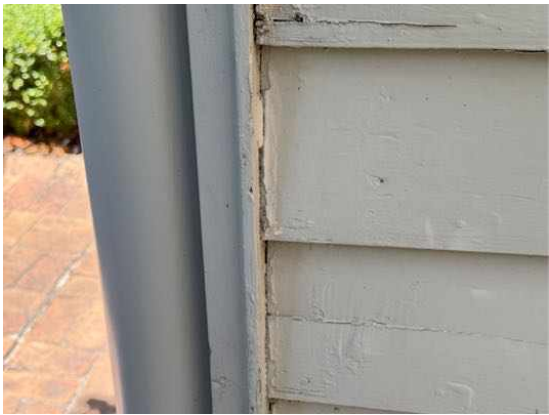
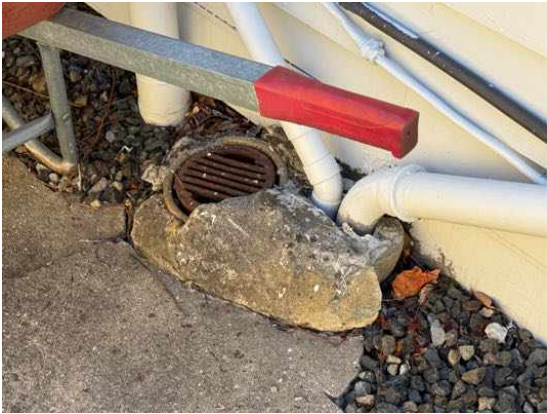
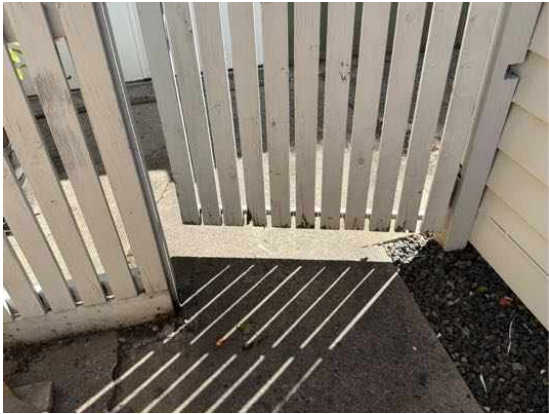
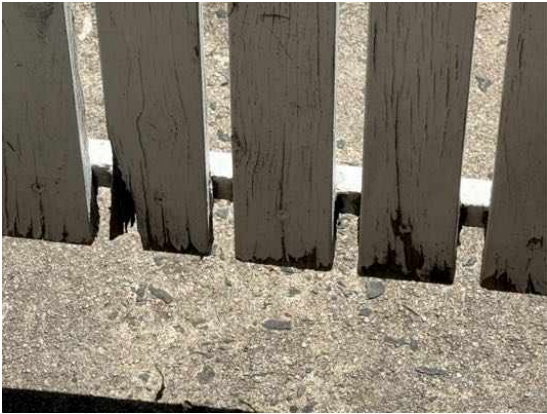
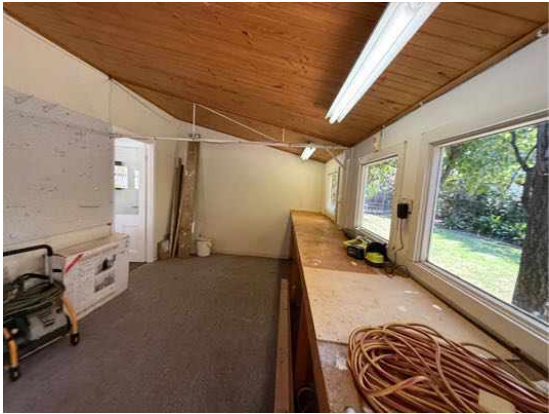
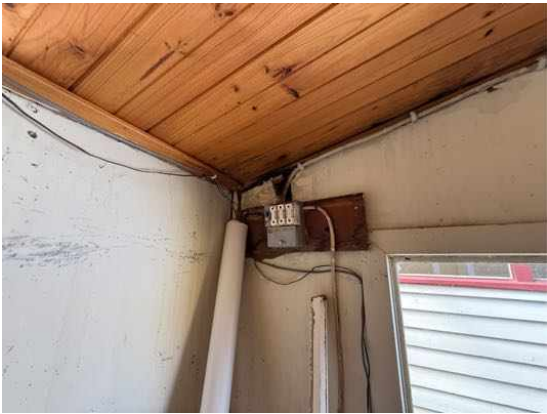
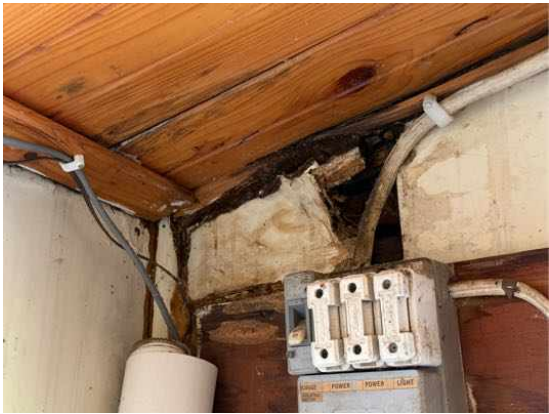
Building: Building 1  
Location: All Areas > All Areas  
Finding: Additional Photos  
Information: Additional photos are provided for either future maintenance items for clients attention and or general reference. Arrows may have been included to highlight areas of importance. Please discuss these photos with your building consultant for clarification.

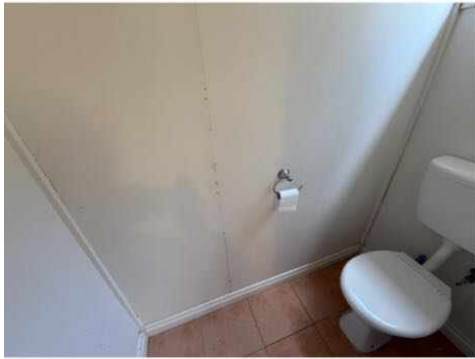
Building: Building 1  
Location: All Areas > All Areas  
Finding: Asbestos - Suspected ACM  
Information: Reporting on Asbestos is outside the Scope of this Report. This suspected defect is highlighted as a caution only. We suspect, based on our experience in the building industry, that there is a higher risk of the identified building element containing asbestos. As Asbestos Reporting is outside the scope of this report, we advise that you consider a separate Asbestos Inspection which can include the taking of samples for definitive confirmation of the presence of Asbestos when tested by a laboratory.

Asbestos sampling can only be taken upon ownership of the property only, due to being an invasive procedure. In the interim, the client is advised to act with caution, especially when considering any damage to building materials general wear and tear, renovations, extensions, demolition and general maintenance activities due to the suspected presence of Asbestos.

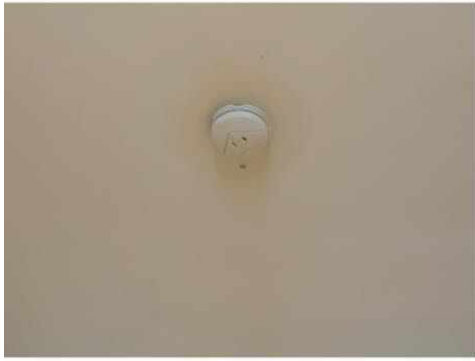
Building: Building 1  
 Location: All Areas > All Areas  
 Finding: Smoke detectors and alarms  
 Information: Reporting on Smoke Detectors or Alarms, including hard wired smoke detection systems and their legislative requirements, is outside the Scope of this Report. Please note that this defect is highlighted as a caution only. We suspect, based on our experience in the building industry, that smoke detectors are sometimes get overlooked, or they may be in a poor condition, so we recommend that they always should be addressed prior to occupation to improve occupant safety.

Always ensure sufficient working and suitable smoke detectors are installed prior and during to occupying any building. Additionally, it is advised that all smoke detectors be tested by the homeowner on a monthly basis.

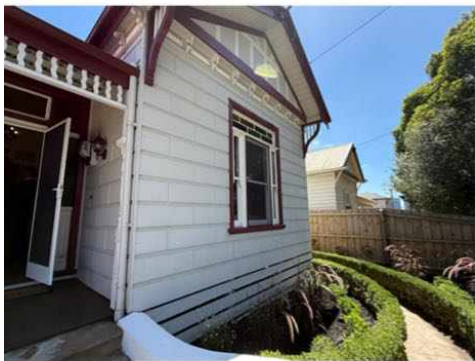
Building:	Building 1
Location:	All Areas > All Areas
Finding:	Timber in the ground and exposed to excessive weather conditions
Information:	External timbers in the ground and are frequently exposed to harsh and extreme weather conditions, will require adequate protection and maintenance in order to maintain their condition. Other timbers are exposed to moisture from ground contact which exposes these areas to accelerated wood rot and decay, damage and deterioration. Where timbers have not been painted properly or treated adequately, general deterioration is likely to occur at an accelerated rate.

If left unattended, replacement of these timbers is likely to be necessary in the future. Adequate treatment of these timbers is required to ensure excessive weathering does not occur, painting of these areas may be carried out by the client or by a painting contractor or general handyman.

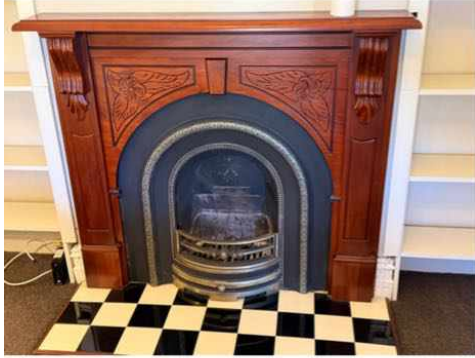
Building: Building 1  
 Location: All Areas > All Areas  
 Finding: Fireplace and chimney sweep  
 Information: Reporting on the fireplace and or the associated chimneys, including as to whether they are working or not and their legislative requirements, is outside the Scope of this Report. Please note that this is highlighted as a caution only. It is highly recommended the fireplaces and associated chimneys get checked periodically and even before use when they may not have been used in a while. If left unmaintained and not cleaned adequately a fireplace and chimneys may be or become a fire hazard.

We suspect, based on our experience in the building industry, that fireplaces and the

associated chimneys get over looked and do not get chimney swept or any maintenance for long periods of time. The chimney may therefore be in a poor condition, so we recommend that they always ensure that these areas be addressed prior to their use, this is to ensure home and occupant safety.

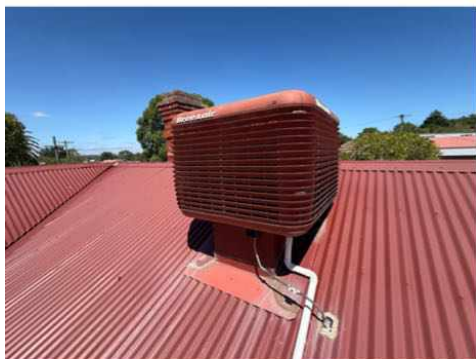
Building:	Building 1
Location:	All Areas > All Areas
Finding:	Evaporative air conditioner
Information:	Reporting on the Evaporative air conditioning unit, including as to whether they are working, is outside the Scope of this Report. Please note that this is highlighted as a recommendation only. It is recommended that the Evaporative air conditioning unit to receive maintenance and servicing. Servicing of this unit will improve occupants well being and ensure good functionality and prolonged serviceability. If left unmaintained, Evaporative air conditioning unit may be or become a health hazard.

We suspect, based on our experience in the building industry, that Evaporative air conditioning unit get over looked and do not get any maintenance for long periods of time. The Evaporative air conditioning unit may therefore be in a, less than perfect condition, so we recommend that they always ensure that these areas be addressed prior to their use, this is to ensure home and occupant health and safety.

A air-conditioner serviceman should be appointed to assess the condition of the unit and to service and clean as deemed necessary, this is at the discretion of the client.

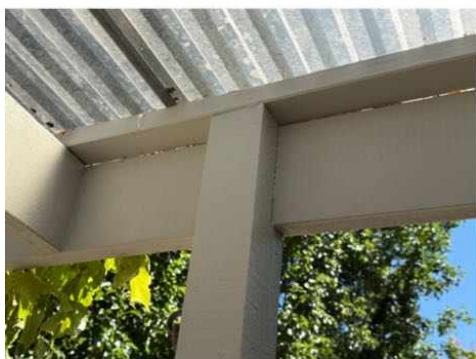
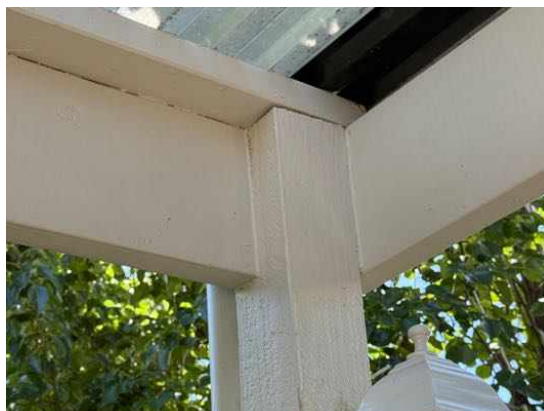
Building: Building 1  
 Location: All Areas > All Areas  
 Finding: Building elements missing  
 Information: Bolts and rafter brackets were observed to have been omitted or missing at the time of the inspection. The rear pergola areas have no bolts to the posts to perimeter beams and rafters brackets to beam missing, these types of building elements are an essential part of the building structure and will improve the longevity of the building structure as it becomes aged and deteriorated. Although some building elements may seem irrelevant or unnecessary, all building elements play a key role in the operation and function of the overall structure and its performance.

All cleaning, maintenance or replacement of any missing building elements should be conducted as soon as possible to ensure that no secondary damage or functional issues occur to associated building elements or materials not being installed. A qualified carpenter, builder or another appropriate tradesperson should be appointed to clean, maintain or replace the missing building elements or materials deemed necessary.
