Building and Timber Pest Inspection Report

Inspection Date: Tue, 13 Jan 2026

Property Address: 24 Don Mills Ave, Hebersham NSW 2770,
Australia

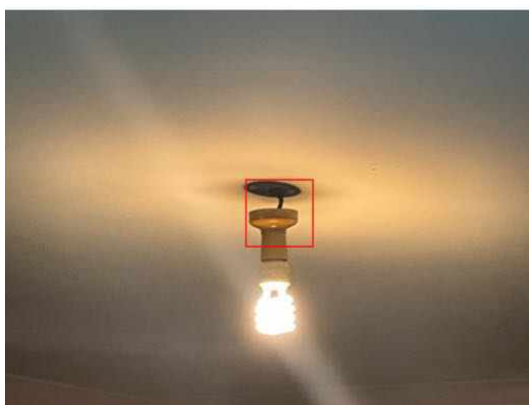
Building:	Main Building
Location:	Bedroom - Master
Finding:	Electrical fitting/light -- Broken/Loose
Information:	The electrical fitting or light in this area was found to be broken or loose at the time of inspection.

Breakage occurs generally when the building materials have aged and decayed, but may also be indicative of impact damage to the building element (accidental or deliberate).

Left unmanaged, the fitting is likely to further deteriorate, causing injuries or electrocution.

Repair and/or replacement of the broken fitting is advised urgently. A Licensed electrician should be appointed to repair/replace this element immediately.

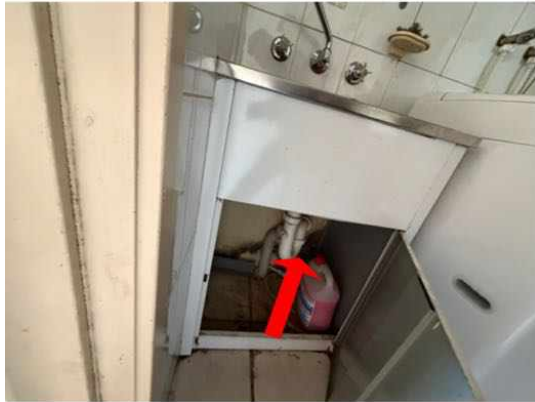
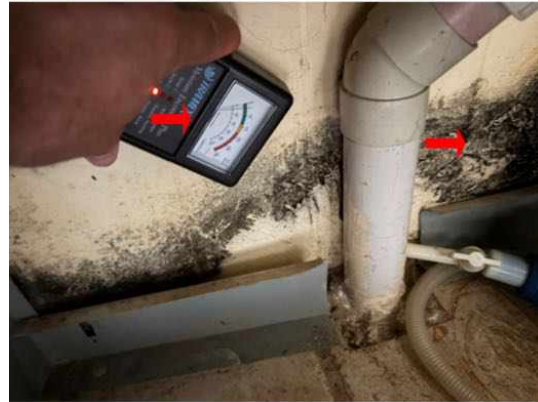
Finding 1.02

Building:	Main Building
Location:	Laundry
Finding:	Mould - Present
Information:	Where evidence of mould growth was noted, there may be environmental, biological or health issues associated with the report. A specialist inspection by a suitably qualified environmental health inspector is warranted, where mould is extensive or where any queries regarding air quality spores or other related issues apply.

At the time of inspection excess moisture was not identified. Any mould found during the inspection should be cleaned immediately by a cleaning contractor or the homeowner as applicable.

Generally, the client is advised to ensure that the general environment is free of moisture and humidity to aid in the prevention of mould formation and development.

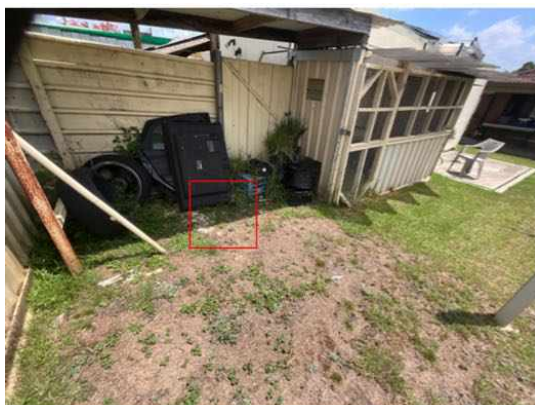
Finding 1.03

Building: Main Building

Information: Reporting on Asbestos is outside the Scope of this Report. This suspected defect is highlighted as a caution only. We suspect, based on our experience in the building industry, that there is a higher risk of the identified building element containing asbestos.

As Asbestos Reporting is outside the scope of this report, we advise that you consider a separate Asbestos Inspection and Condition Audit, which can include the taking of samples for definitive confirmation of the presence of Asbestos.

In the interim, the client is advised to act with caution, especially when considering any damage to building materials general wear and tear renovations extensions demolition and general maintenance activities due to the suspected presence of Asbestos.

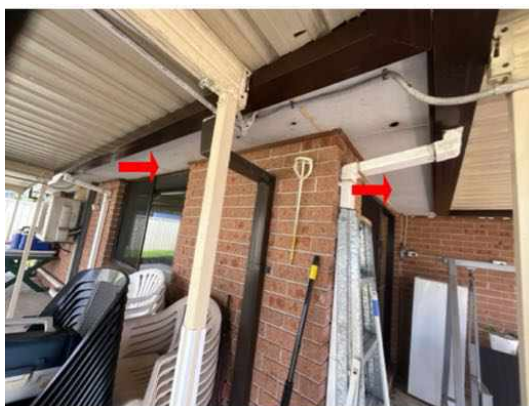
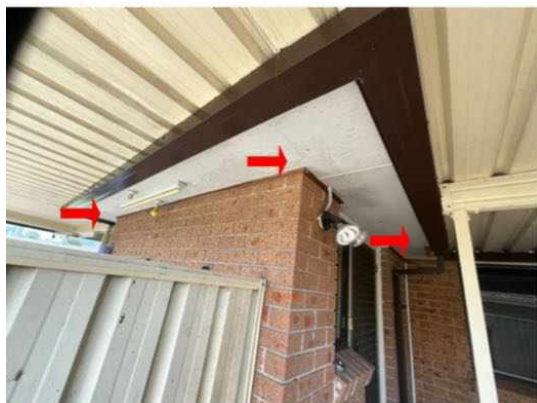
Finding 2.01

Common causes include faulty or missing flashing, cracked tiles, degraded pointing, lack of sealant and blocked weep holes. Rain penetration can also occur when water tracks horizontally under the lip of eaves and roof linings with insufficient angles, or by tracking across wall ties.

The cause of the water leak should be addressed immediately to prevent further damage. It is recommended that the water leak be resolved prior to any repairs of the damaged area, which may require localised replacement of building materials and refinishing.

A licensed builder must be appointed urgently for rectifications.

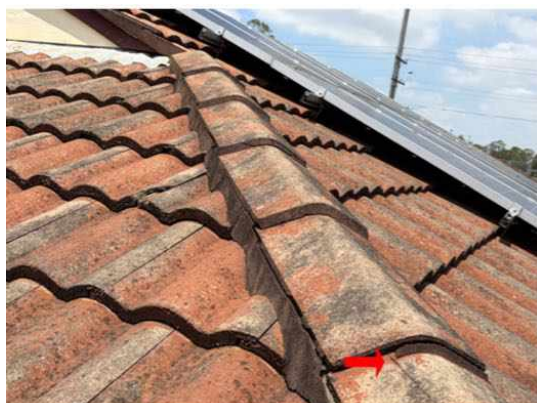
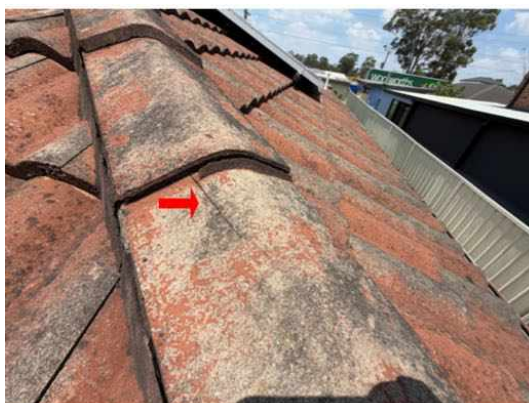
Finding 3.01

Location: Roof Exterior
 Finding: Roof tiles - Slippage
 Information: Upon inspection of the exterior roof covering, it was noted that numerous tiles have slipped from their original fixing. Tiles may slip over time due to a number of minor causes, including breakage of tiles, failings in the adjoining battens, or fixings that may have failed.

Roof tiles that have moved from their original position are very likely to allow water penetration into the roof void, exposing roofing structures to excessive moisture. This creates an environment that is conducive to water damage and accelerated deterioration of all associated building elements.

Replacement of loose or missing roofing tiles is recommended immediately to prevent the development of any secondary defects. A roofing restoration specialist should be appointed to complete such works as necessary.

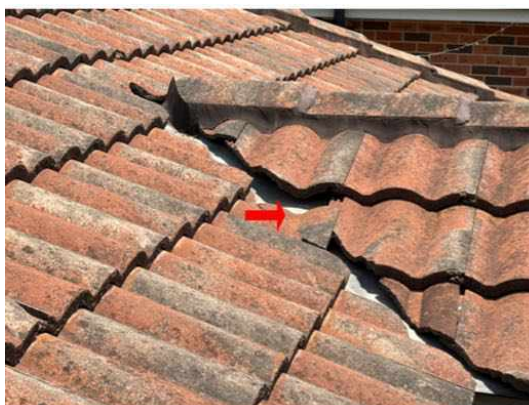
Finding 3.02

Building: Main Building
 Location: Roof Exterior
 Finding: Roof tiles - Weathered
 Information:

Upon inspection of the exterior roofing, the majority of roof tiles were considered to be in a fair condition. While weathering of the tiles is consistent with the age of the property, maintenance works are required.

Isolated areas of mortar have come loose and minor cracking is also present. Re-pointing and re-sealing the may be considered as an interim solution by the client to help preserve and extend the life span of the tiles.

Where left unmanaged, deteriorating roof tiles are likely to lead to a number of secondary defects, including minor water leaks and weather exposure to internal roofing structures.

Consultation with a licensed roofing contractor is highly advised to gain advice on cost

of remedial works that may be required in the short to medium term. Remedial works are likely to increase the longevity of the exterior roofing structure.

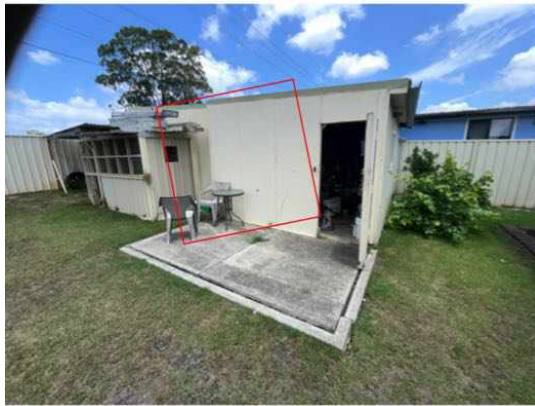
Finding 3.05

Building: Main Building
 Location: Shed
 Finding: Structure — Non Compliance Suspected
 Information:

While the structure does not currently appear to be unsafe, compliance with such standards ensures the structural integrity. As building standards have not been followed, this area provides a heightened risk of the development of building defects. The structural integrity of these areas may have been compromised, which creates potential for the development or presence of major safety issues.

It is highly recommended that any planned repair, remodelling or demolition works be carried out by licensed builders. A structural engineer should be appointed for consultation and any rectification required.

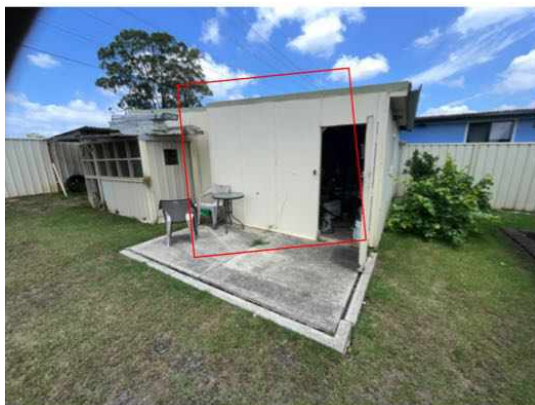
Finding 3.06

Building:	Main Building
Location:	Shed
Finding:	Water staining
Information:	Water staining was evident in this area at the time of inspection. Water staining indicates that surfaces have been exposed to excessive moisture over time. The minerals and other elements in the water lead to staining, which may graduate to corrosion and deterioration if left unmanaged.

While mostly an appearance defect, water staining can be indicative of more serious defects, which may be currently concealed by other building elements.

Where water staining is active, a licensed plumber must be consulted to identify the cause of the staining and to provide advice on any reparation works that may be required. Replacement of any broken or damaged structures is advised.

Conversely, where water staining is old and inactive, affected building materials may be repaired or replaced at client discretion. A qualified carpenter or registered builder may be appointed to perform these works.

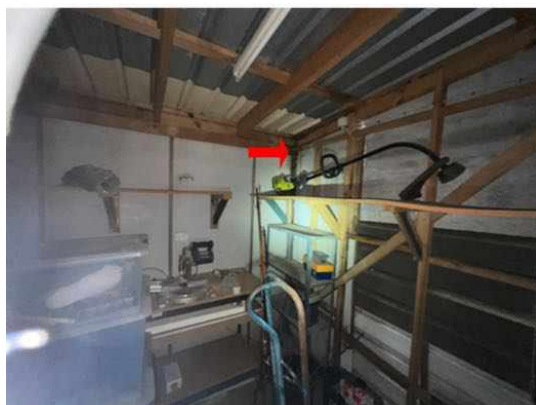
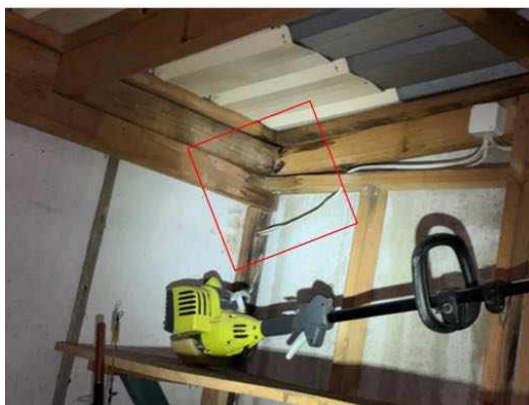
Finding 3.07

Building:	Main Building
Location:	Multiple areas of roof plumbing
Finding:	Water leak - External
Information:	Water leaks were found to be present to exterior plumbing work. Leaks are generally caused by deterioration of the plumbing elements over time, due to exposure to weather conditions, but may have also been caused by minor impact damage.

Such leaking creates damp conditions in the affected area, causing potential for water pooling and subsequent water damage if left unattended. These conditions may also attract termite attack, particularly if the area is subject to minimal levels of sun throughout daylight hours.

It is highly advised that a licensed plumber be appointed to rectify any water leaks that

may be present. Areas of repair and replacement of plumbing fittings and fixtures may be required and, as such, a quotation should be sought.

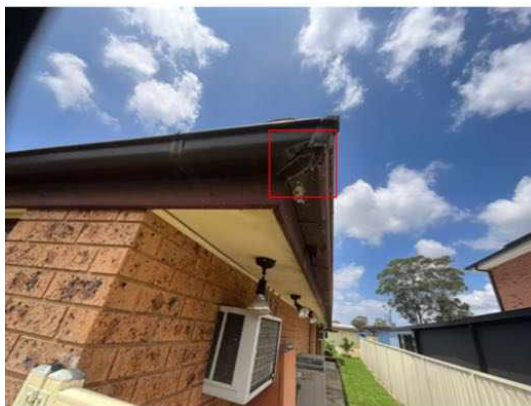
Finding 3.08

Building:	Main Building
Location:	Front left
Finding:	Stormwater drain - Not connected
Information:	The roof plumbing is not adequately connected to stormwater drainage on the site. This disconnection negatively impacts the functional capacity of the roof plumbing.

Where roof plumbing doesn't drain adequately, the area at the base perimeter can become excessively damp, potentially creating an environment that is susceptible to rust and corrosion of surrounding building elements, as well as attracting termites and other pests.

It is highly recommended that a plumber be appointed to further inspect the area and to install adequate drainage equipment where necessary.

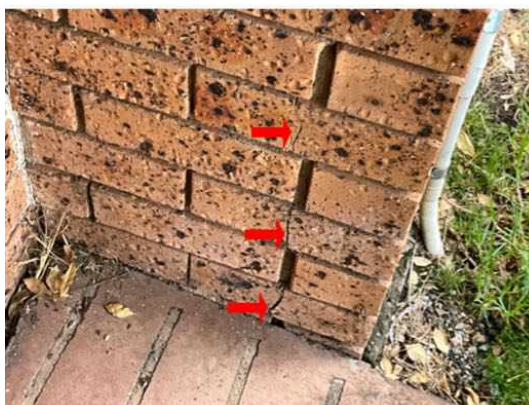
Finding 3.10

Building:	Main Building
Location:	Alfresco
Finding:	Damage to Masonry Walls (Cracks) - Category 0
Information:	It has been observed that damage to masonry walls caused by movement of slabs, footings, or other causes, has occurred. The degree of damage falls within Category 0, described as hairline cracks, which are less than 0.1mm in width limit.

Damage of this category is not considered a defect for rectification. Always contact

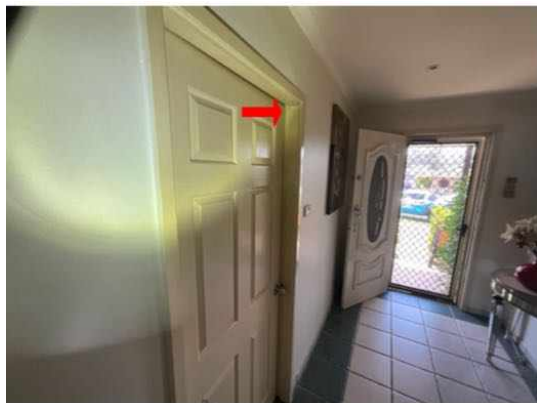
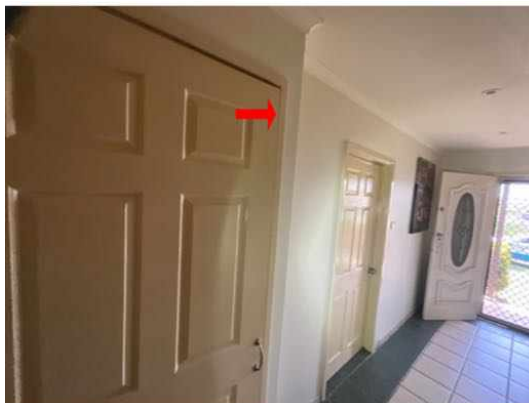
Finding 3.17

Building: Main Building
 Location: All Areas
 Finding: Door stop - Missing
 Information:

The door stop is missing or is inadequate to stop the door handle from damaging the wall. Although some building elements may seem irrelevant or unnecessary, all building elements play a key role in the operation and function of the overall structure and its performance.

Re-installation or replacement of the door stop is advised as soon as possible to prevent any subsequent damage to the door or associated structures. A registered builder may be appointed to perform these works at client discretion.

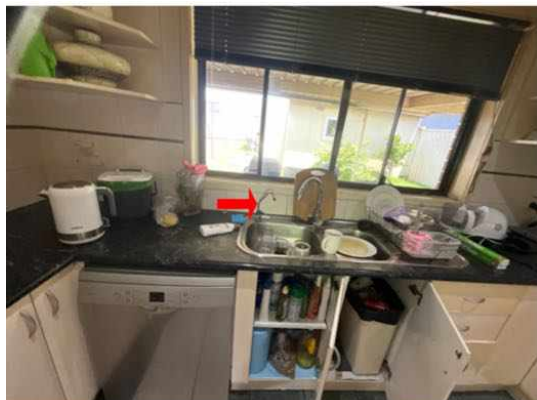
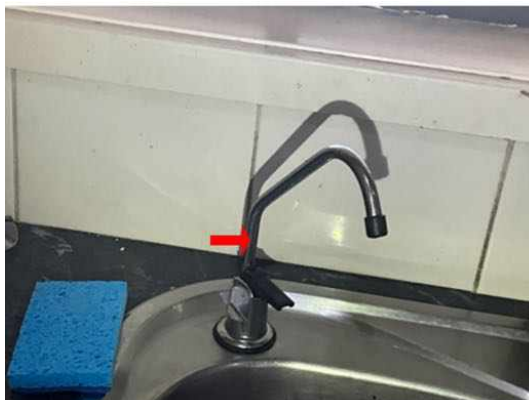
Finding 3.18

Building: Main Building
 Location: Kitchen
 Finding: Building element - Not operating
 Information:

Non-operational items should be addressed to ensure that the full function of the building structure is available. Where some building elements are not operating as intended, it is possible that secondary building defects could arise due to their non-

operation.

Repair and/or replacement of the faulty building element is recommended. It is highly recommended that the relevant tradesperson be engaged to perform any necessary works.

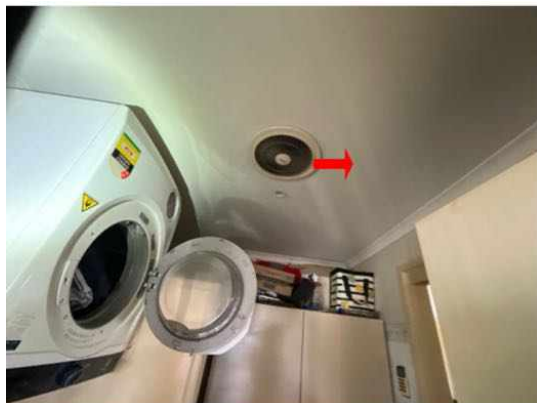
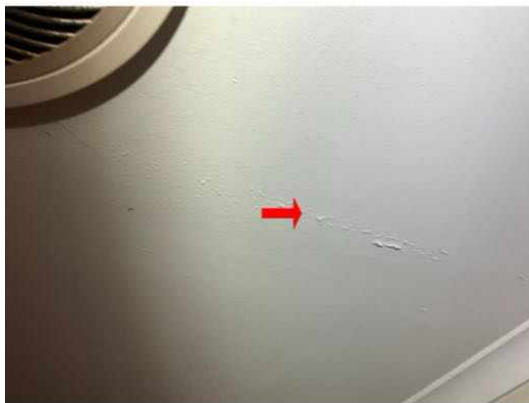
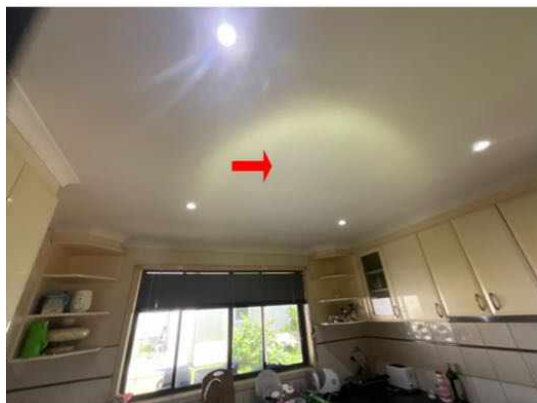
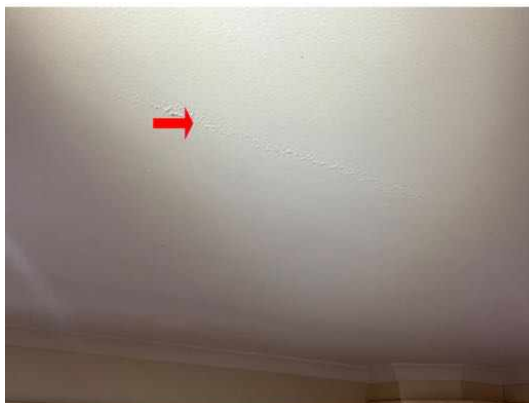
Finding 3.19

Building:	Main Building
Location:	Laundry, laundry
Finding:	Paint cracking and peeling
Information:	Cracking and ultimately flaking of paint can occur for a variety of reasons. Often these failures are due to the fact that the paint has inadequate adhesion and flexibility, both common problems with lower quality exterior flat paints.

When timber is involved, moisture intrusion results in swelling of the wood surface followed by contraction as the wood dries. The expansion and contraction cycles, can result in cracking and subsequent paint failure by flaking and peeling.

Cracking and flaking can also result when paint is applied too thinly due to overspreading (higher-than-recommended spread rate) or excessive thinning. These practices tend to diminish the paint's final film thickness, so that it is more vulnerable to cracking and flaking.

Inadequate surface preparation can also cause these failures, especially when paint is applied to bare wood or a very porous surface without first applying a primer.

A qualified painter should be appointed to rectify the problem.

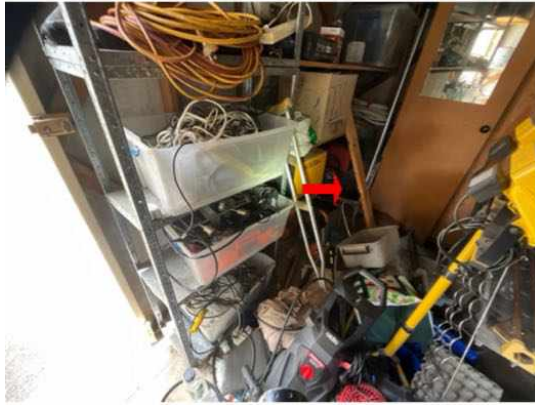
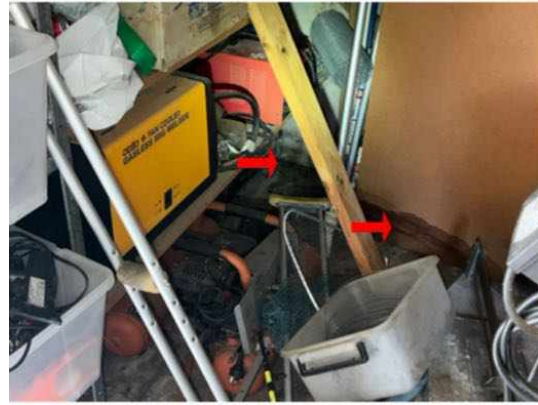
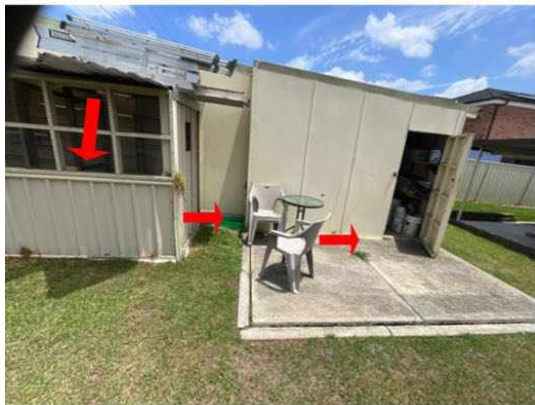
Common causes include faulty or missing flashing, cracked tiles, degraded pointing, lack of sealant and blocked weep holes. Rain penetration can also occur when water tracks horizontally under the lip of eaves and roof linings with insufficient angles, or by tracking across wall ties.

The cause of the water leak should be addressed immediately to prevent further damage. It is recommended that the water leak be resolved prior to any repairs of the damaged area, which may require localised replacement of building materials and refinishing.

A licensed builder must be appointed urgently for rectifications.

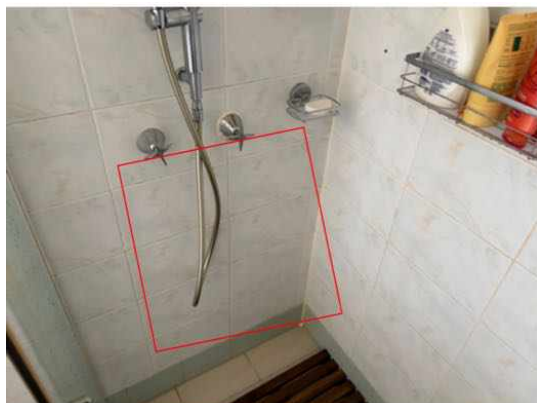
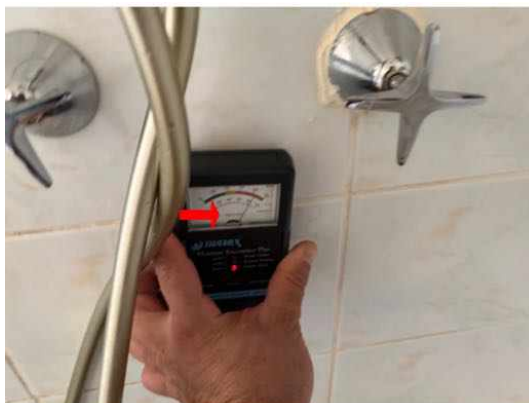
Finding 6.02

Building:	Main Building
Location:	Bathroom
Finding:	Water leak - Suspected
Information:	A water leak is suspected in this area as excessive moisture was detected at the time of inspection. Another potential cause maybe moisture ingress behind the tiles from around the wall fittings and penetrations.

Internal water leaks can be detrimental to surrounding building elements; their potential causes include damage to plumbing fittings and fixtures, through to water damage and deterioration of associated building elements.

Attracting termites, corrosion, mould, decay and water damage are potential outcomes where a minor water leak is left unattended. More serious defects may also result, such as electrical hazards, or water damage to structural building elements.

In extreme cases, structural damage may develop due to a prolonged water leak. It is highly advised that internal water leaks be addressed by a licensed plumber as a matter of relative urgency.

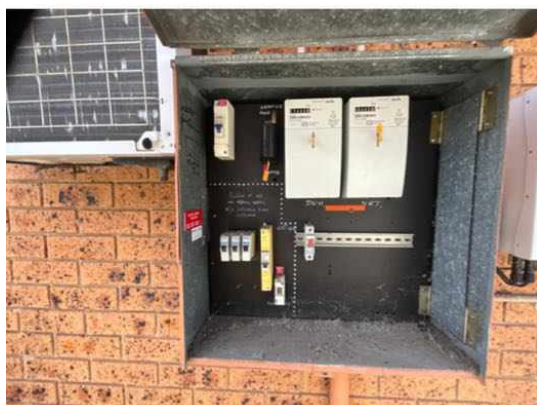
Finding 6.03

Information: The application of a post-construction chemical termite barrier is highly recommended for all properties, particularly if live termite activity has been found on the site previously. Such barriers are highly effective in preventing termite attack on any timber building elements throughout the property.

A durable notice should be placed in the switchboard unit to indicate current termite barriers. At the time of inspection, it appeared as though no termite management system has been installed, with no evidence to suggest preventative works taking place.

The client may consider gaining further advice from a pest controller as to the costs and procedures involved with this application. It is recommended that obtaining such advice be a short-term priority.

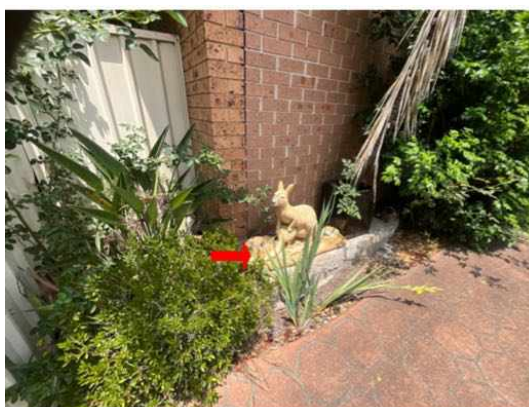
Finding 6.04

Building:	Main Building
Location:	Perimeter
Finding:	Slab Edge - Exposure
Information:	Slab Edge Exposure: Where external concrete slab edges are not exposed there is a high risk of concealed termite entry. In some buildings built since July 1995 the edge of the slab forms part of the termite shield system. In these buildings an inspection zone of at least 75mm should be maintained to permit detection of termite entry. The concrete edge should not be concealed by render, tiles, cladding, flashings, adjoining structures, paving, soil, turf or landscaping etc. Where this is the case you should arrange to have the slab edge exposed for inspection. Concealed termite entry may already be taking place but could not be detected at the time of the inspection. This may have resulted in concealed timber damage. Does the slab edge inspection zone fully comply?

Not able to comment. A very high proportion of termite attacks are over the edge of both Infill and other concrete slabs types. Covering the edge of a concrete slab makes concealed termite entry easy. Infill slab type construction has an even higher risk of concealed termite ingress as the slab edge is concealed due to the construction design and cannot be exposed. The type of slab may only be determined by assessment of the construction plans by a qualified person e.g. Builder, Architect. Construction Plans may be obtainable by your local Council or Builder. Termite activity and or damage may be present in concealed timbers of the building. We strongly recommend frequent regular inspections in accordance with AS 3660.2. Where the slab edge is not fully exposed or the slab is an infill slab or the slab type cannot be determined then we strongly recommend inspections every 3 to 6 months in accordance with AS 3660.2 or AS 4349.3.

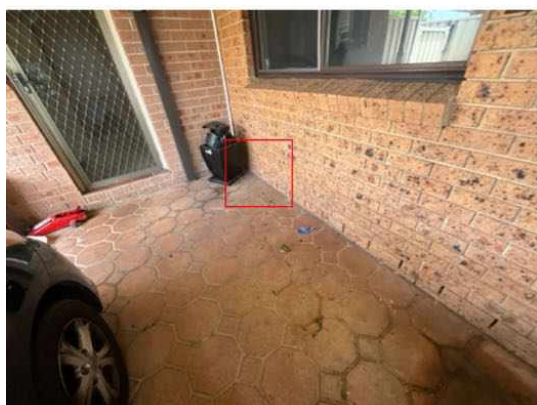
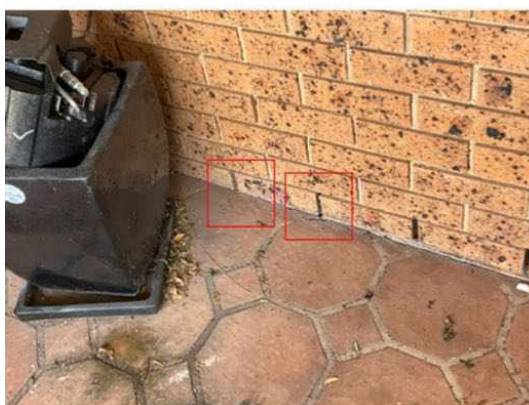
Weep holes in the exterior brickwork of the property are designed to allow condensation that may build up between the brickwork and subsequent timber framework to drain from within the wall hence preventing any deterioration of the timber building elements.

Additionally build-up of moisture is likely to occur if weep holes are covered further attracting termite activity to these areas.

It is highly recommended that weep holes are left exposed in all areas throughout the external property. Therefore if any termite activity leading into weep holes becomes easily detectable during frequent pest inspections.

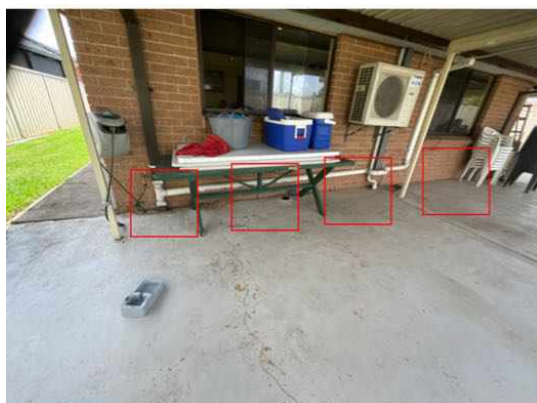
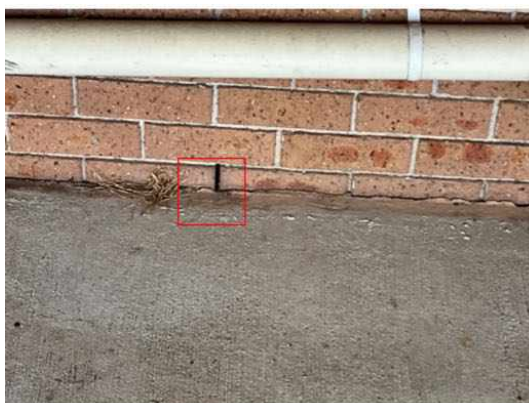
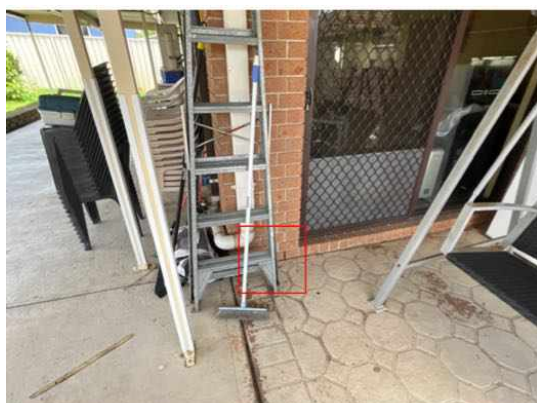
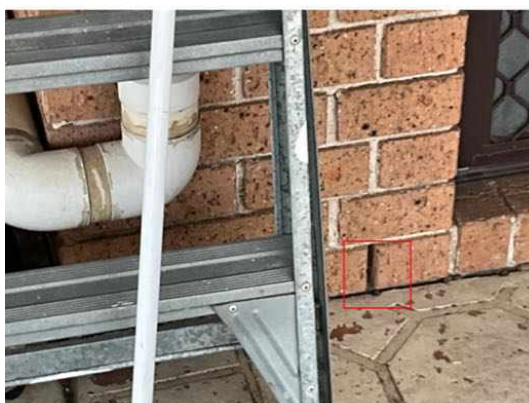
Finding 6.07

Building:	Main Building
Location:	Shed
Finding:	Bridging or breaching of termite barriers - damp course level
Information:	Bridging is the spanning of a termite barrier or inspection zone so that subterranean termites are provided with passage over or around that barrier.

Damp proof course (DPC) is a barrier of impervious material built into a wall or pier to prevent moisture from moving to any part of the building. Where external ground levels are built up over this barrier ingress is provided for moisture from the exterior grounds into the base brickwork or other building material and allowed to rise.

Such conditions attract termites into these damp areas which is likely to lead to infestation if left untreated.

While retrospective fitting of DPC is considered to be impractical works are required in order to prevent the extraction of moisture from the external environment into exterior brickwork or wall materials. Landscaping or re-paving of external grounds may be considered by the client. Regular annual inspections are strongly advised.

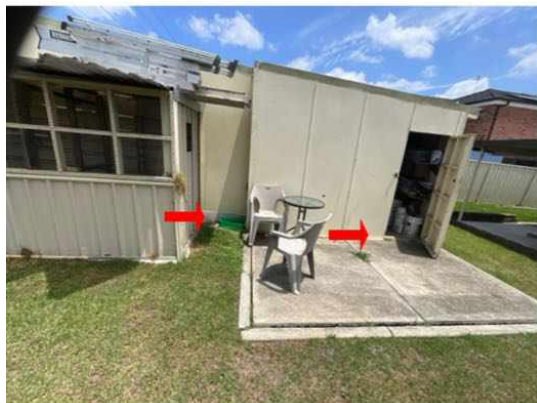
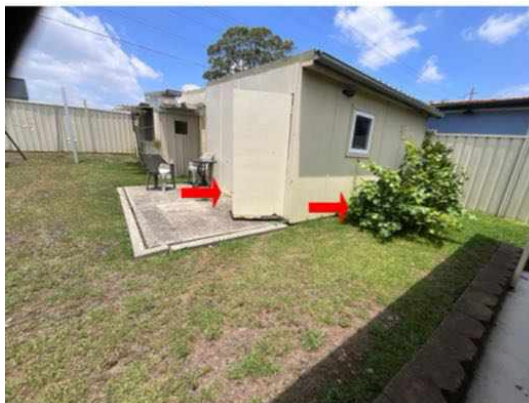
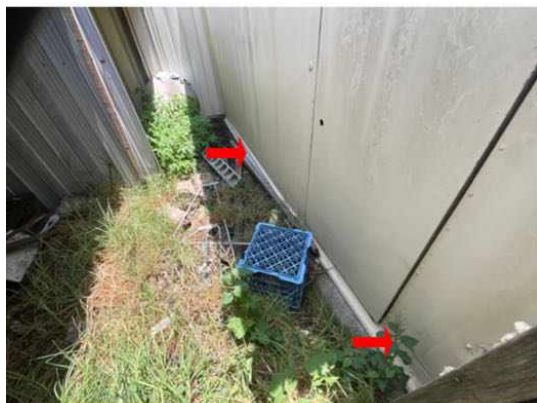
Finding 6.08

Building:	Main Building
Location:	Multiple areas of roof plumbing
Finding:	Water leak - External
Information:	Water leaks were found to be present to exterior plumbing work. Leaks are generally caused by deterioration of the plumbing elements over time, due to exposure to weather conditions, but may have also been caused by minor impact damage.

Such leaking creates damp conditions in the affected area, causing potential for water pooling and subsequent water damage if left unattended. These conditions may also attract termite attack, particularly if the area is subject to minimal levels of sun throughout daylight hours.

It is highly advised that a licensed plumber be appointed to rectify any water leaks that may be present. Areas of repair and replacement of plumbing fittings and fixtures may be required and, as such, a quotation should be sought.

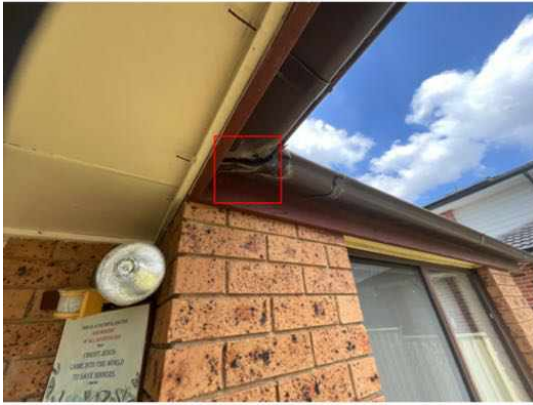
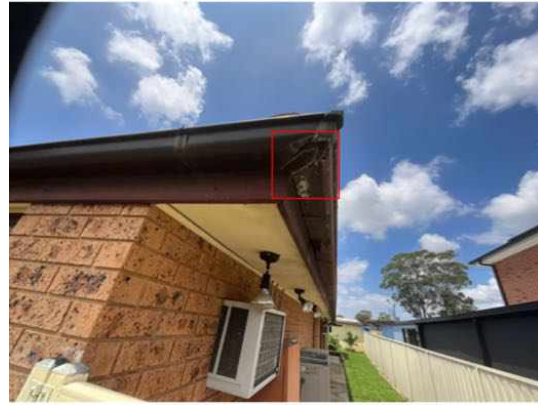
Finding 6.09

Building:	Main Building
Location:	Front left
Finding:	Stormwater drain - Not connected
Information:	The roof plumbing is not adequately connected to stormwater drainage on the site. This disconnection negatively impacts the functional capacity of the roof plumbing.

Where roof plumbing doesn't drain adequately, the area at the base perimeter can become excessively damp, potentially creating an environment that is susceptible to rust and corrosion of surrounding building elements, as well as attracting termites and other pests.

It is highly recommended that a plumber be appointed to further inspect the area and to install adequate drainage equipment where necessary.

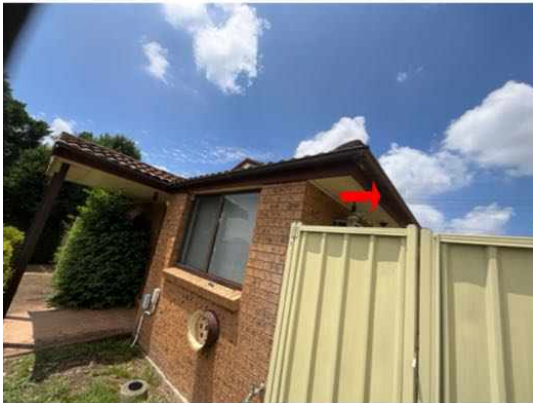
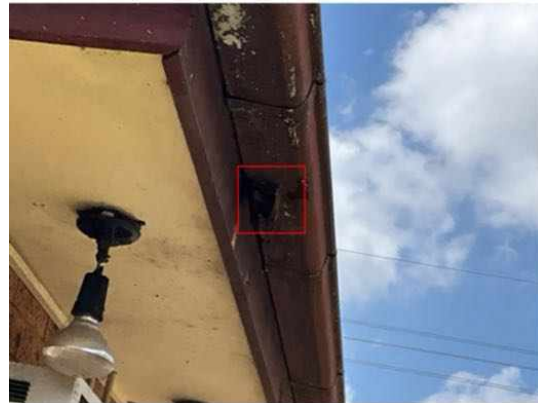
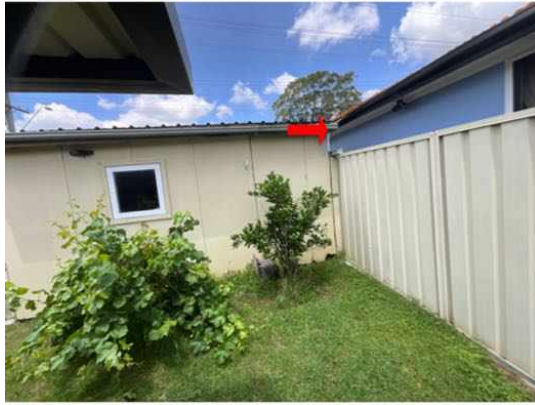
Finding 6.10

Building:	Main Building
Location:	Multiple areas
Finding:	Overflow - Not plumbed for drainage
Information:	The overflow is not plumbed or connected to suitable drainage, which can result in the surrounding area becoming excessively damp.

These damp conditions can lead to secondary defects such as rot, rust or corrosion of associated building elements, the formation of fungal decay, or even the creation of potential slip hazards. When coupled with poor site drainage, pooling of water may also attract termite activity to this area.

It is highly recommended that a licensed plumber be appointed to install adequate drainage to the overflow. These works will ensure that the area remains dry and free of any secondary defects.

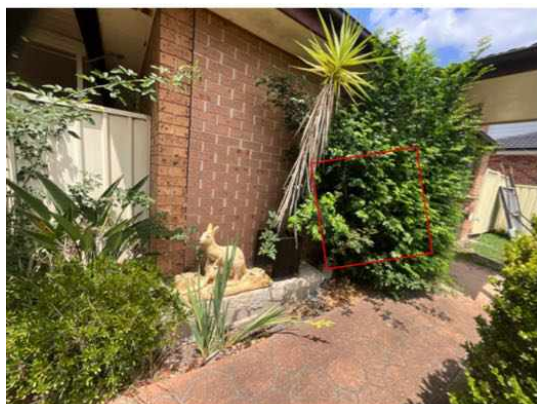
Finding 6.14

Building: Main Building
 Location: External tap
 Finding: Tap - No drain
 Information: The external tap in this area was noted to have no drain at the time of inspection.

This keeps the surrounding surfaces damp while using the tap, which becomes conducive to termite activity.

A licensed plumber must be appointed to ensure an appropriate drain is installed.

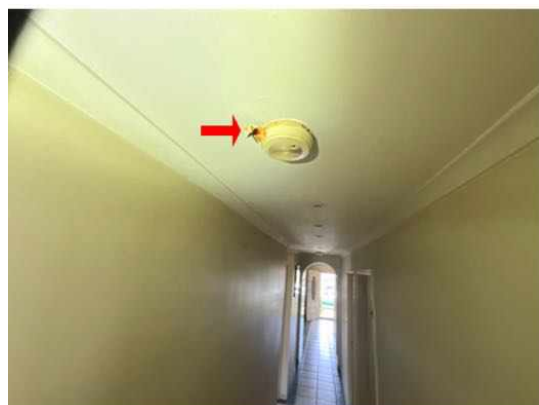
Please note that this defect is highlighted as a caution only. We suspect, based on our experience in the building industry, that the absence of smoke detectors, or their poor condition, should be addressed as a matter of urgency to improve occupant safety.

Always ensure sufficient working and suitable smoke detectors are installed prior to occupying any building. Additionally, it is advised that all smoke detectors be tested by the homeowner on a monthly basis.

Please refer to AS3786 and state based legislation, which may also apply.

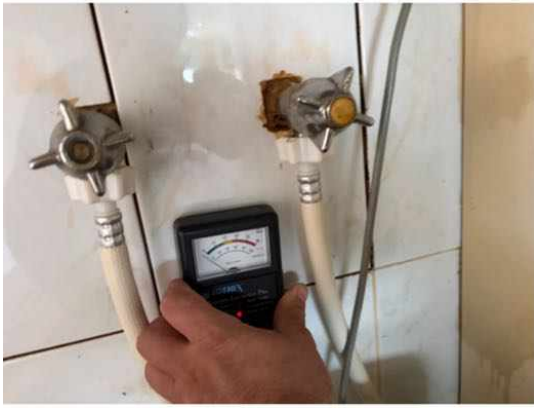
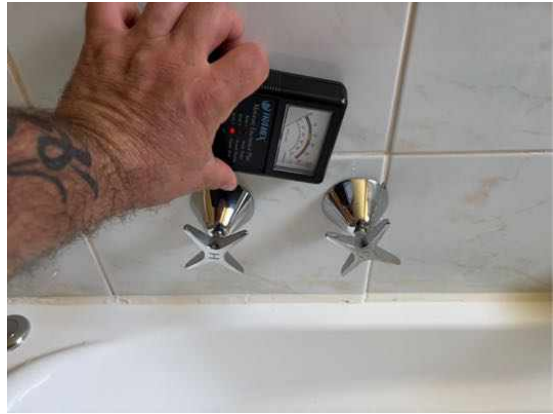
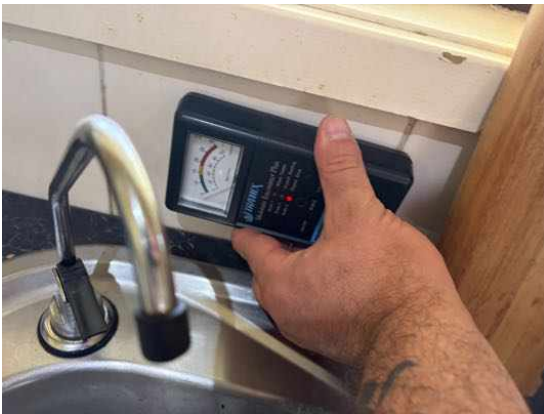
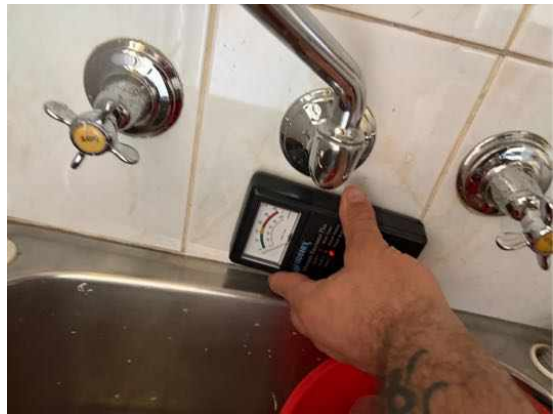
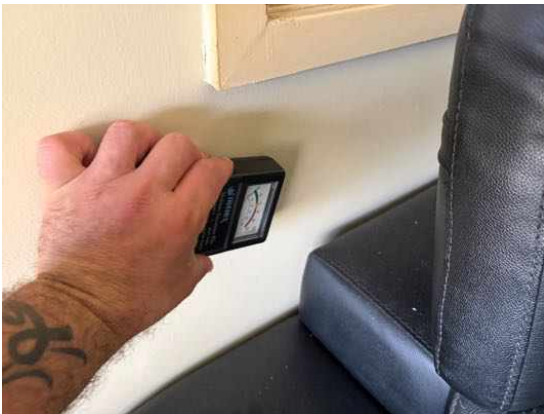
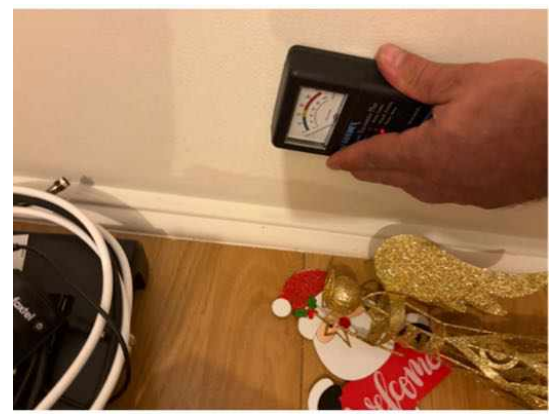
Building:	Main Building
Location:	All Areas
Finding:	Moisture metre
Information:	During the inspection the property was checked for moisture using a moisture metre.

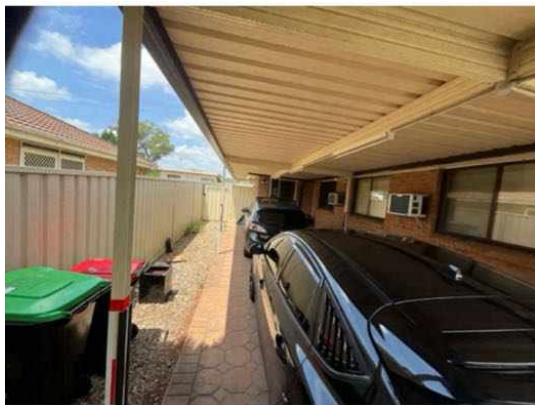
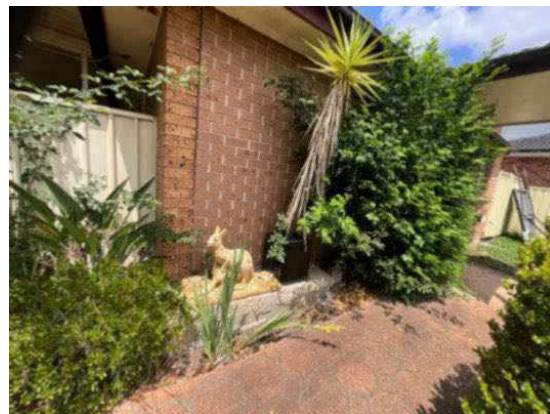
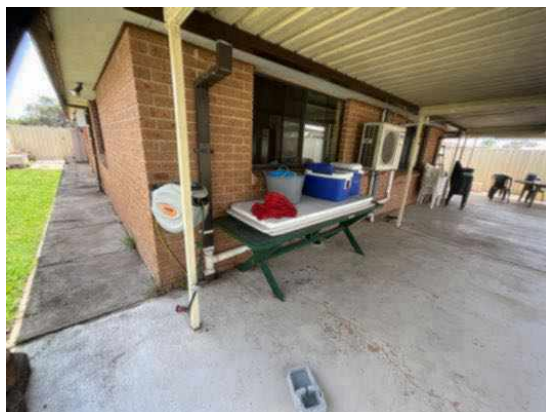
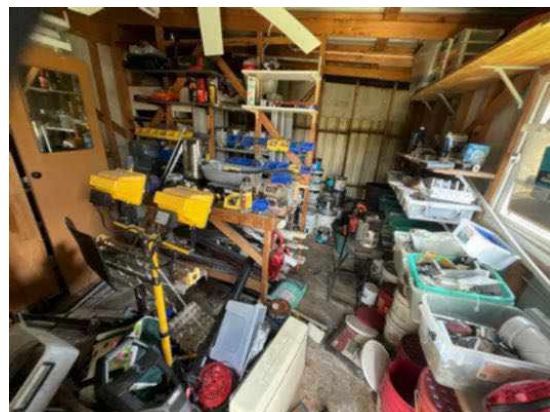
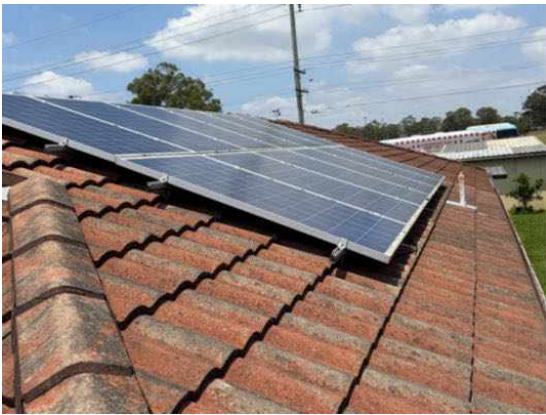
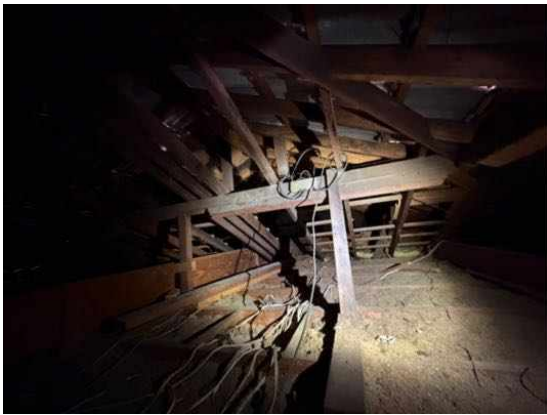
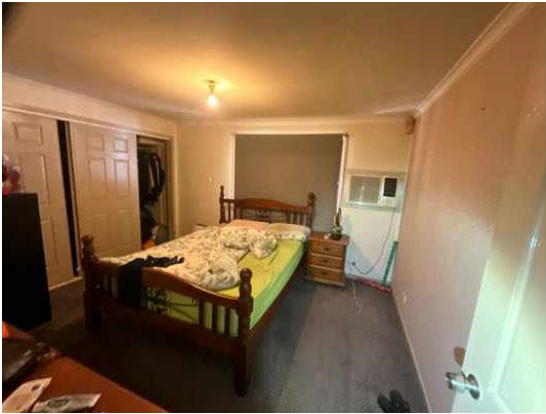
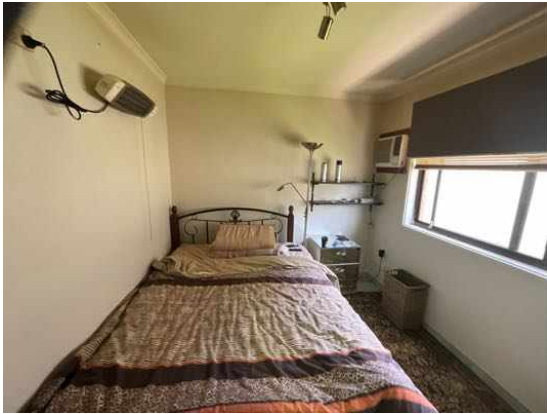
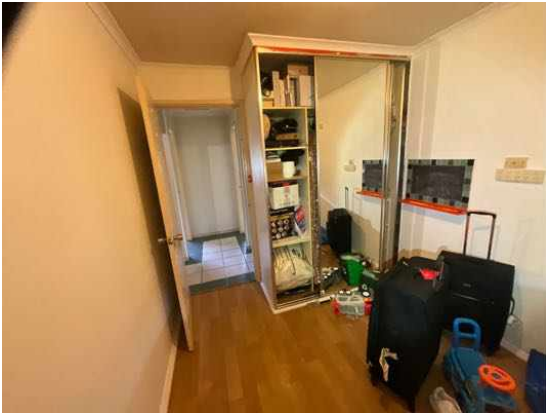
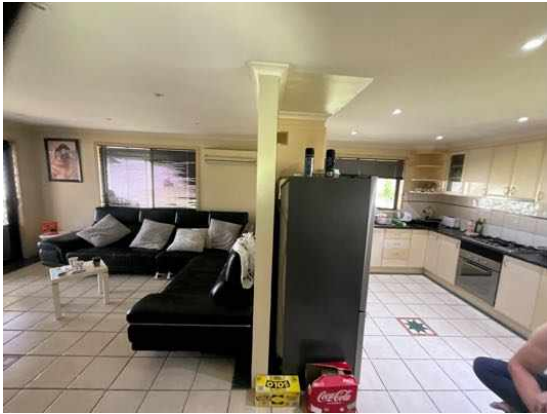
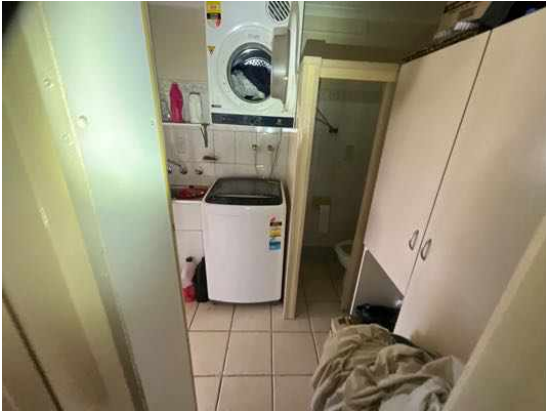
Building: Main Building
Location: All Areas
Finding: Additional Photos - Obstructions and Limitations
Information:

These photographs are an indication of the obstructions and limitations which impeded full inspection of the property at the time of inspection. These obstructions can hide an array of defects and should be removed to allow full inspection to be carried out. A re-inspection is recommended once the areas are made accessible.
