## Building and Timber Pest Inspection Report

Inspection Date: Tue, 13 Jan 2026

Property Address: The Avenue, 42/13-17 Brown St, Labrador  
QLD 4215, Australia

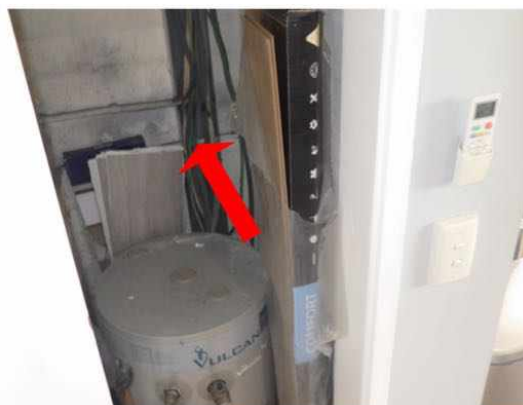
Exposed electrical cabling and/or connections represent a potential safety hazard including for fire and personal contact.

A licensed electrician should be engaged to undertake rectification work as a matter of priority.

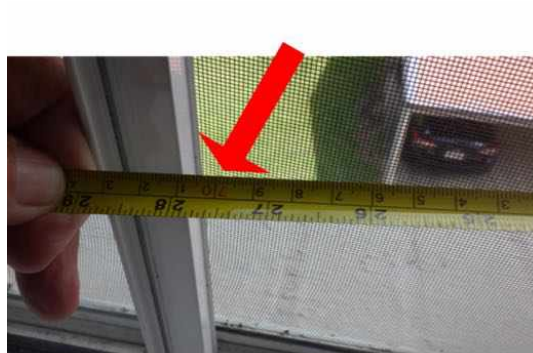
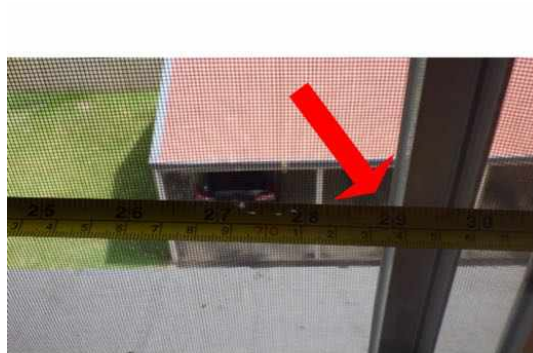
#### Finding 1.02

Building:	Main Building
Location:	Bedrooms > Existing
Finding:	Window safety
Information:	It was noted that the windows of the upper level bedrooms are less than 1.7m from the floor and have a fall greater than 2m on the exterior from the sill and as such are required to only open upto 125mm or have security grills fitted.

This is noted as a safety concern and this regulation may not have been in place at the time of construction.

Windows are defective if they do not comply with provision 3.9.2.5 of Volume 2 of the BCA that requires that a window opening must have protection if the floor below the window in a bedroom is 2 m or more above the ground surface beneath.

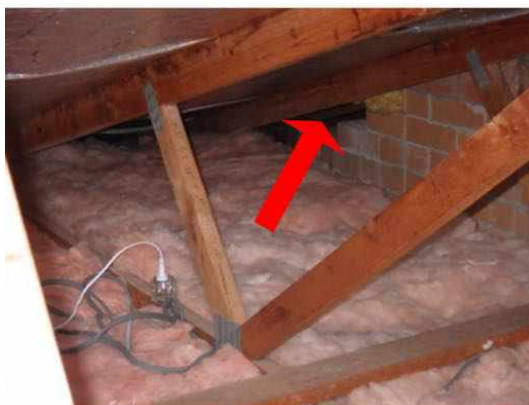
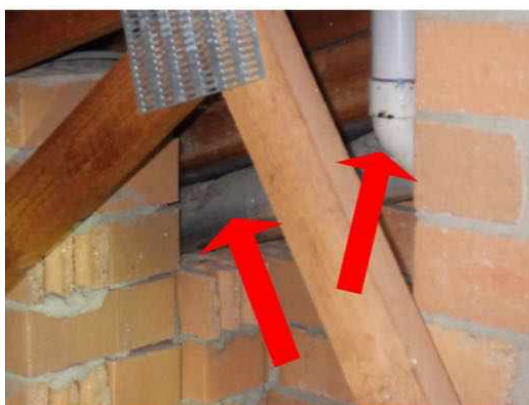
Information: At the time of inspection it was noted there were gaps in the brick, fire or party wall in the ceiling space area. The party wall has noticeable holes, gaps and unsealed penetrations which may compromise the fire rating integrity of the wall.

It is recommended a licensed builder registered for firewall construction is consulted regarding current party wall regulations and or rectification work and repairs.

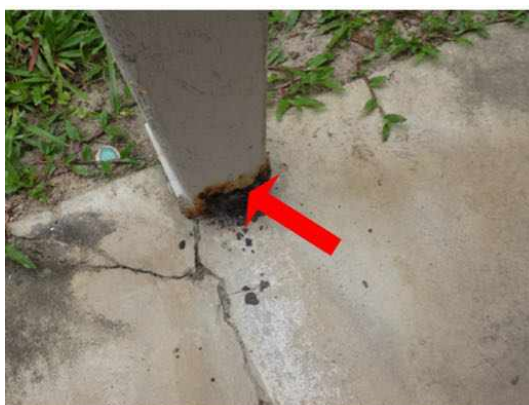
Building: Carport  
 Location: Carpark > Ground Level  
 Finding: Steel posts- Rusted or corroded  
 Information: The steel support posts to the carport area roof show evidence of rusting and corrosion, which is likely to have developed as a result of excessive exposure to moisture and or inadequate coatings.

As surface rust provides no protection to the underlying iron, the deteriorating condition is likely to worsen if not addressed in the short-term future.

Rusting and corrosion should be managed by ideally removing or limiting the affected surface from exposure to moisture. A licensed metal fabricator should be appointed to replace or repair any metal support posts that have been severely affected by rust.

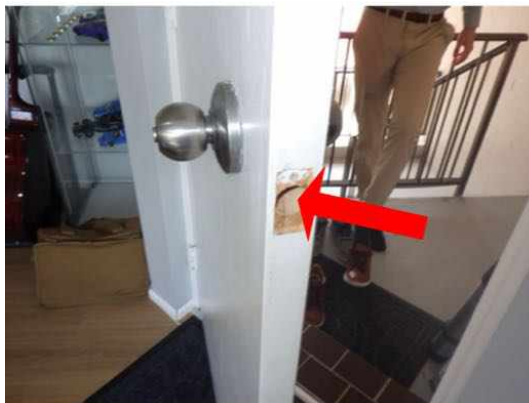
Information: It was noted that the door handle latch set to the entry door was missing at the time of inspection. Whilst detracting from the functionality of this building element, this minor defect may also compromise the required fire rating of the entry door.

A licensed fire door installer should be consulted for further advice and/ or to perform rectification works as necessary.

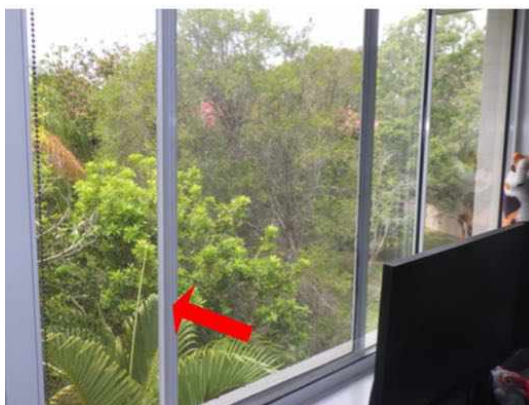
### Finding 3.04

Building: Main Building  
 Location: Dining Room > Centre Left  
 Finding: Window Catch - Latch missing  
 Information: It was noted that the window catch to the dining room area sliding window was missing at the time of inspection. Whilst detracting from the functionality of the window, this minor defect may also be a security risk.

It is suspected that this defect has occurred due general wear and tear, which is expected for building elements of this age.

An aluminium sliding window service agent or general handyperson may be appointed to perform rectification works as necessary, at client discretion.

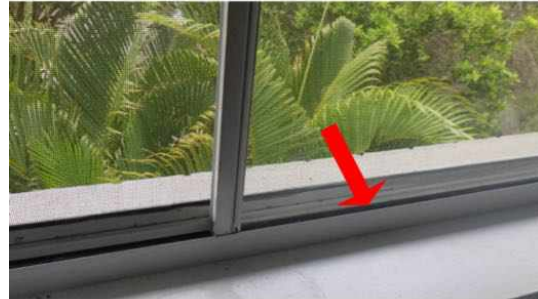
### Finding 3.05

Building: Main Building  
 Location: Dining Room > Centre Left  
 Finding: Window - Stiff to Slide  
 Information: The aluminium sliding window in the dining area was stiff to operate at the time of the inspection. Windows provide ventilation to the adjoining area and should be at a fully operational level to ensure user comfort.

Generally, factors such as general age of the building element and a lack of maintenance are the usual causes for this type of defect.

An aluminium window service agent will be required to repair the affected window.

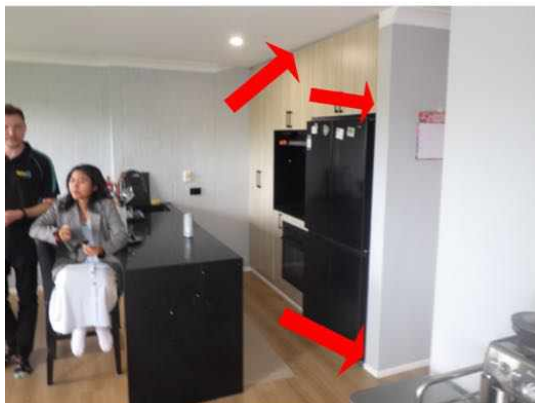
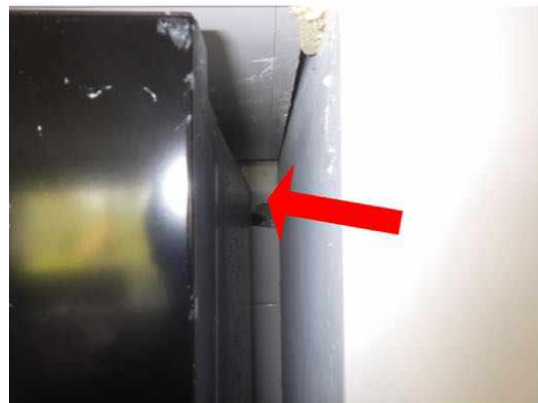
### Finding 3.06

Building: Main Building  
 Location: Kitchen > Centre Right  
 Finding: Incomplete works.  
 Information: At the time of inspection it appeared there were areas of incomplete renovation or alterations work to the floor and wall linings in the kitchen area fridge space and overhead cabinetry (as per example photos).

A qualified carpenter or general handyman could be engaged to complete the work, at the clients discretion.

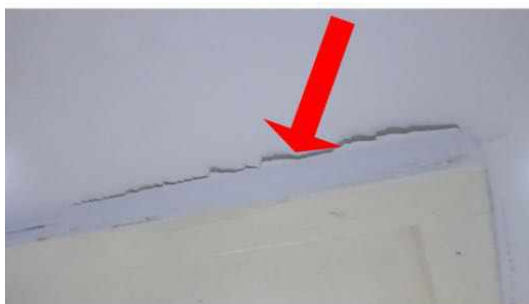
Building:	Main Building
Location:	Bathroom/Laundry > Centre
Finding:	Cracking - Ceiling
Information:	There is cracking or damage to an area of the bathroom/laundry area ceiling.

The cracking or damage appears minor in nature and is generally only ever an appearance defect. While such cracking may be noticeable in some cases, it is quite common and does not indicate any structural damage.

Cracking or damage of this nature can generally be repaired with minor sanding, filling and/or repainting. Such works should be performed by a qualified painter or a general handyman.

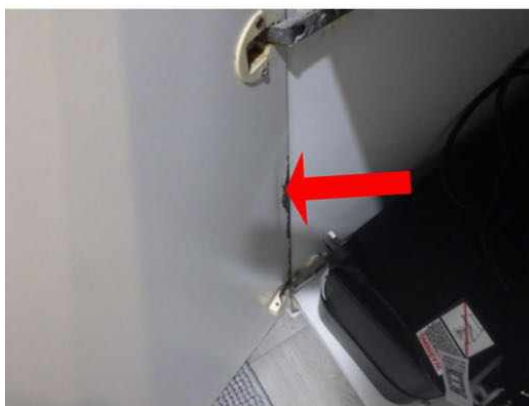
### Finding 3.10

Building:	Main Building
Location:	Bathroom/Laundry > Centre Right
Finding:	Cabinetry - Deterioration
Information:	At the time of inspection the bathroom cabinetry showed signs of minor deterioration. The level of damage appears consistent with exposure to moisture or general wear and tear.

A qualified cabinet maker or general handyman could be engaged to undertake repair works at the clients discretion.

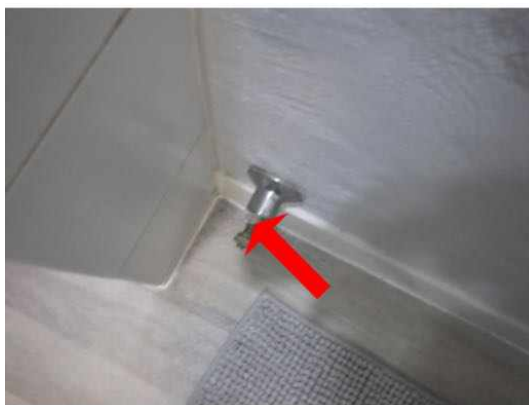
### Finding 3.11

Building: Main Building  
 Location: Bathroom/Laundry > Centre Left  
 Finding: Tap Missing  
 Information: At the time of inspection there was a tap handle fitting missing from the bathroom/laundry area wall.

A licensed plumber should be engaged to replace the missing tap.

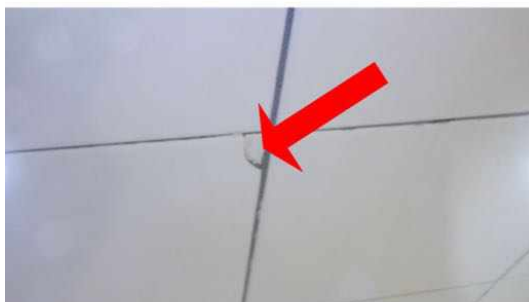
### Finding 3.12

Building: Main Building  
 Location: Bathroom/Laundry > Centre,Rear  
 Finding: Shower - Cracked tile  
 Information: Cracking was evident to a wall tile in the bathroom shower cubicle at the time of inspection. The cracking is more than likely due to impact damage, but may have also been caused by general ageing and deterioration of associated building elements. While the cracking appears to be minor, any additional impact may lead to further cracking.

As this area is frequently exposed to water, any cracking is likely to allow water penetration if left unmanaged.

Appointment of a tiling contractor is required to repair the cracked shower wall tile, so as to ensure no water damage occurs.

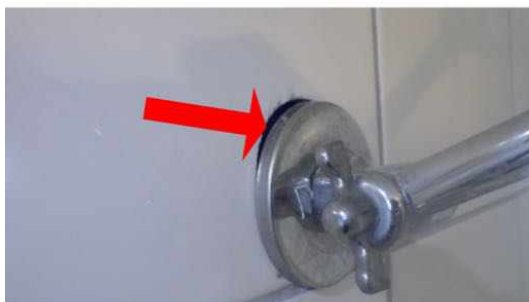
### Finding 3.13

Building: Main Building  
 Location: Bathroom/Laundry > Rear Left  
 Finding: Tiles - Gaps  
 Information: At the time of inspection there was a gap between the bathroom shower area shower rose back plate or shroud and the wall tiles. It is important this area is sealed to prevent moisture or liquids penetration and/or vermin from accessing and/or nesting in these areas.

A qualified tiler or general handyman could be engaged to undertake rectification work.

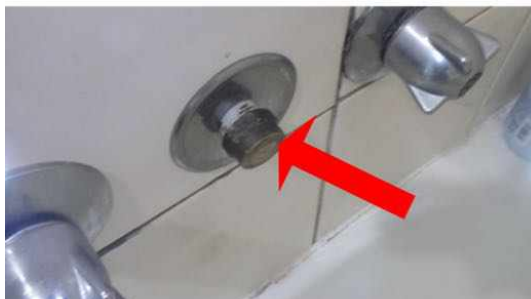
### Finding 3.14

Building: Main Building  
 Location: Bathroom/Laundry > Rear Left  
 Finding: Fitting Missing  
 Information: At the time of inspection there was a bath spout fitting missing from the bathroom area shower cubicle. It appears the bath spout has been purposely removed and the

pipework capped off (reason unknown).

A licensed plumber should be engaged to check the plumbing pipework and replace the missing bath spout.

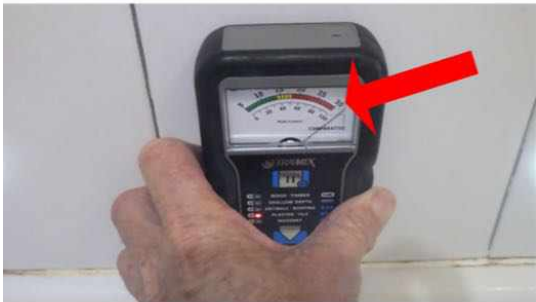
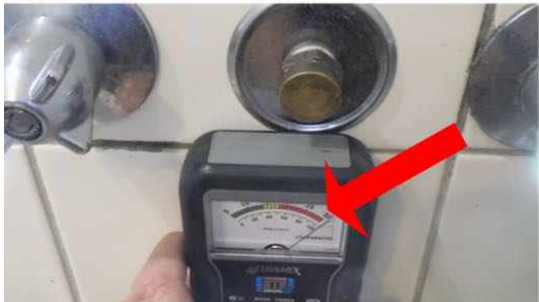
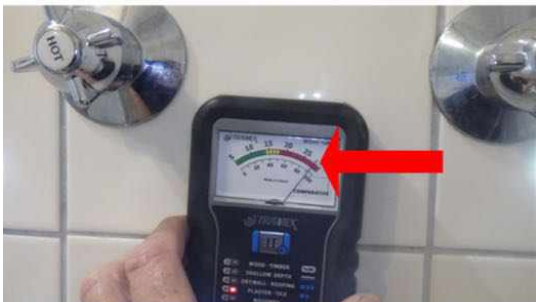
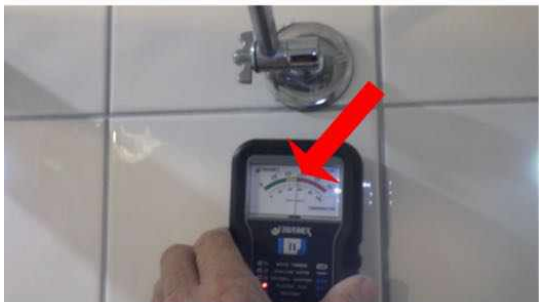
### Finding 3.15

Building: Main Building  
 Location: Bathroom/Laundry > Rear Left  
 Finding: Shower - Moisture  
 Information: Elevated moisture level readings were recorded on the south side wall to the bathroom shower alcove at the time of inspection. No moisture level readings were able to be obtained on the opposite side of the wall. Both sealant and grout appear in fair condition at present.

This defect is suspected to have been caused by a leaking water pipe or moisture permeating or leaching through the grouting and perhaps gaps in the sealant.

Consultation with a qualified plumber or bathroom specialist would be advised to identify the cause of damp and to perform remedial works as required.

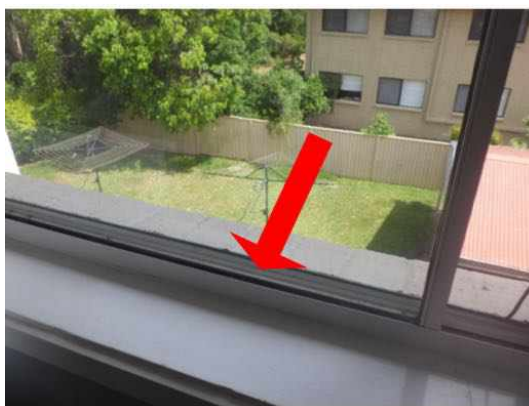
Generally, factors such as general age of the building element and a lack of maintenance are the usual causes for this type of defect.

An aluminium window service agent will be required to repair the affected windows.

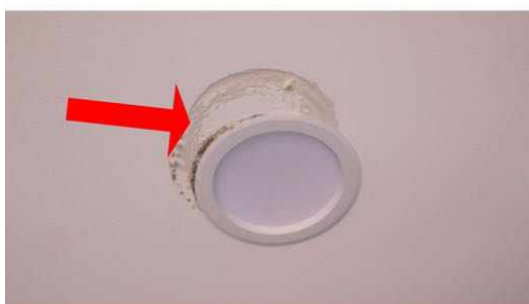
### Finding 3.19

Building:	Main Building
Location:	Bedroom 2 > Centre
Finding:	Ceiling - Scuffed
Information:	Superficial scuff marks were noted to the bedroom 2 ceiling at the time of inspection. Marked and scuffed surfaces, while detracting from the overall appearance of the affected building element, do not indicate any operational or structural damage. This degree of surface damage is consistent with previous alterations.

A qualified painter or general handyman may be appointed to rectify marked or scuffed surfaces at the client's discretion.

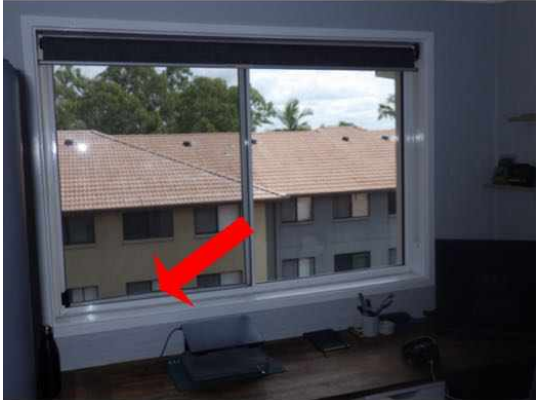
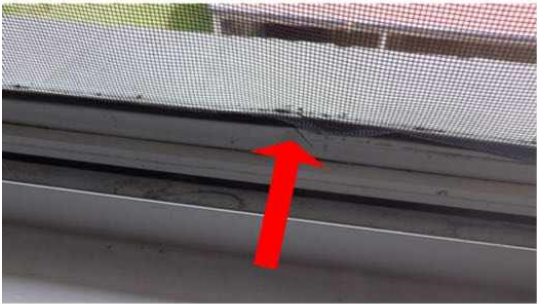
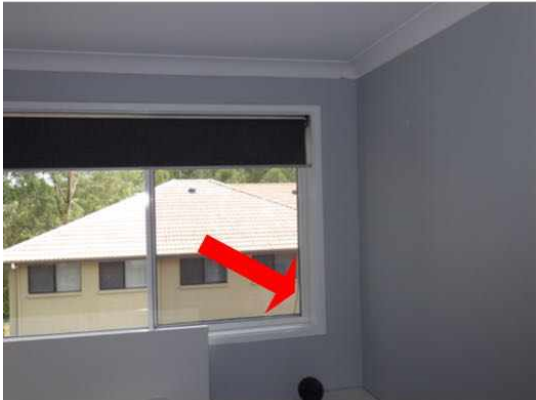
### Finding 3.20

Building:	Main Building
Location:	Bedrooms > Existing
Finding:	Insect Screens
Information:	At the time of inspection a number of insect screens showed signs of damage or general wear and tear (as per example photos).

A insect screen service agent or supplier could be consulted regarding repair or replacement of the damaged screens.

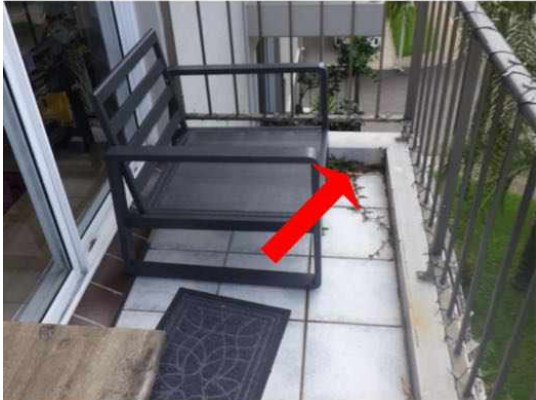
**Finding 3.21**

Building: Main Building  
Location: Balcony > Front Left  
Finding: Blocked Drain  
Information: At the time of inspection it was noted the external balcony area nib wall drain pipe was blocked with vegetation type debris.

A general handyman could be engaged to remove the debris and unblock the drain at the clients discretion.

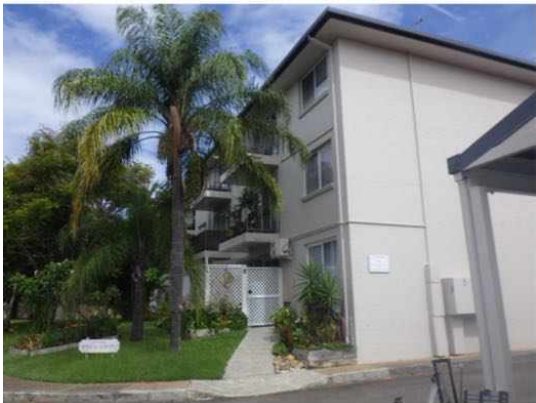
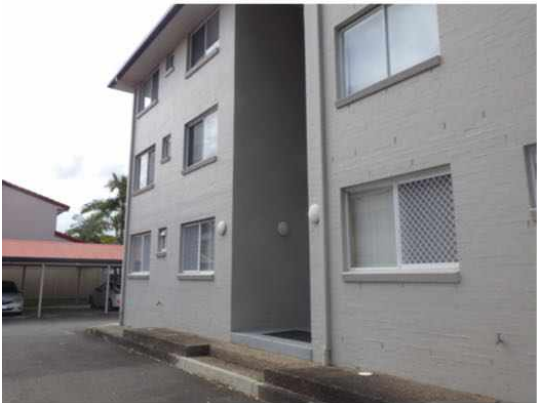
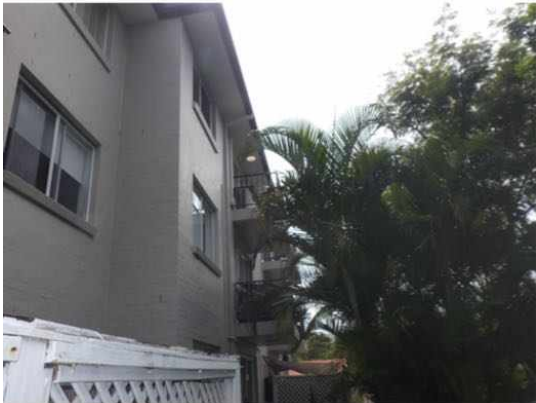
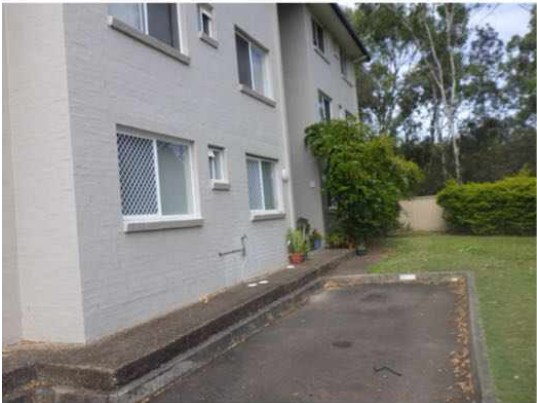
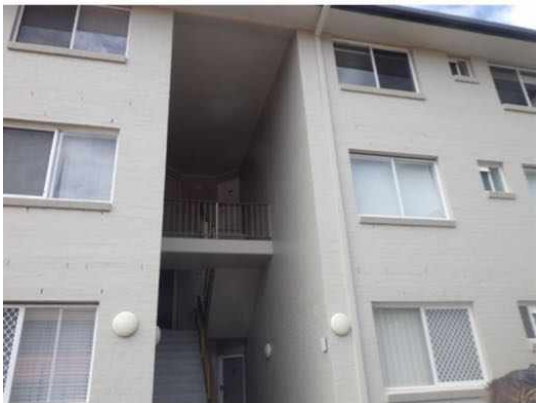
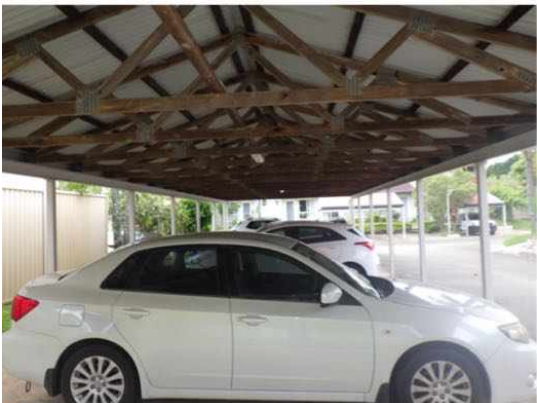
Building: Main Building  
Location: External Areas  
Finding: Additional Photos  
Information: Additional photos are provided for your general reference

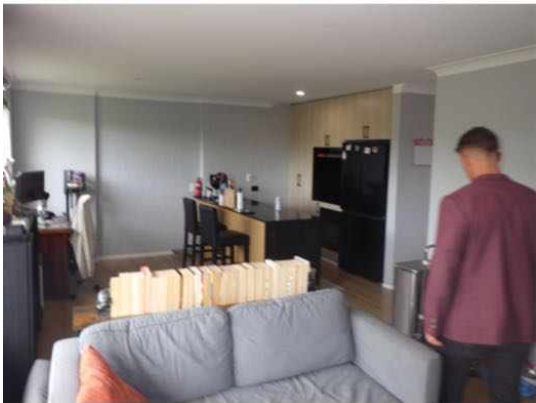
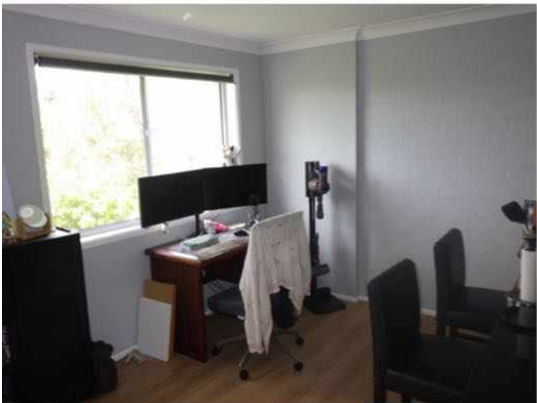
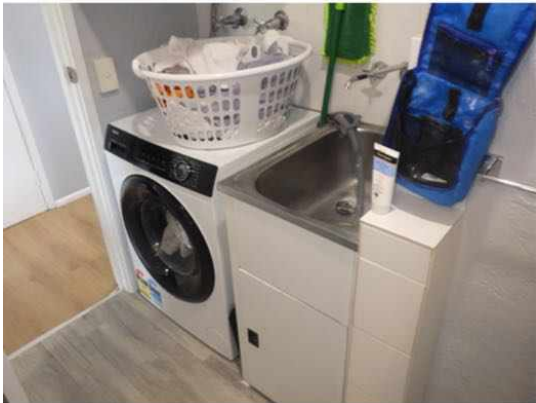
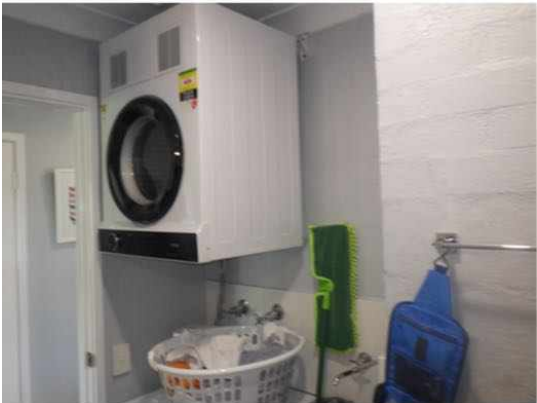
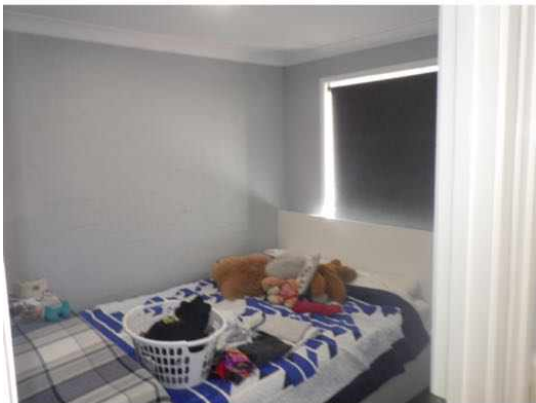
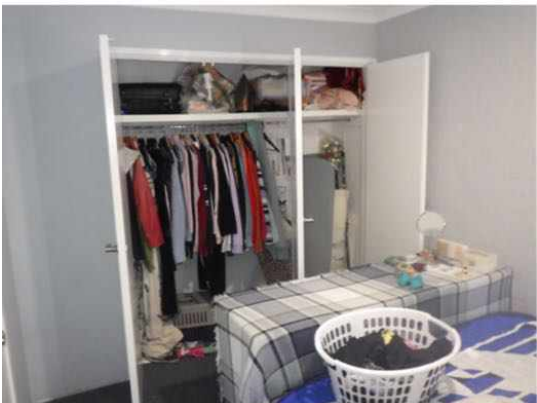
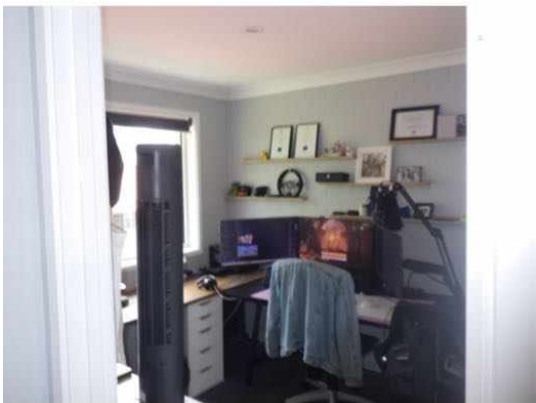
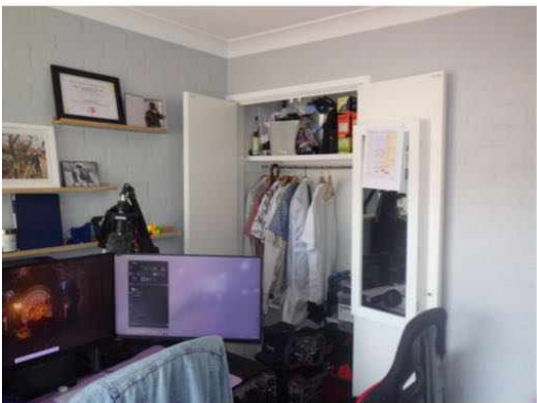
Building: Main Building  
Location: Internal Areas  
Finding: Additional Photos  
Information: Additional photos are provided for your general reference

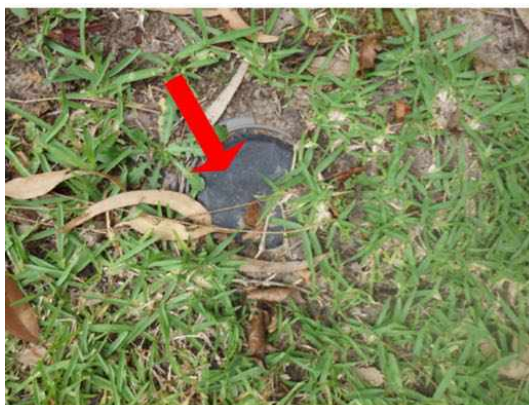
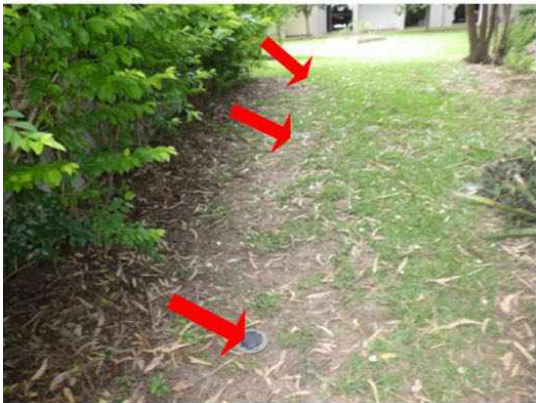
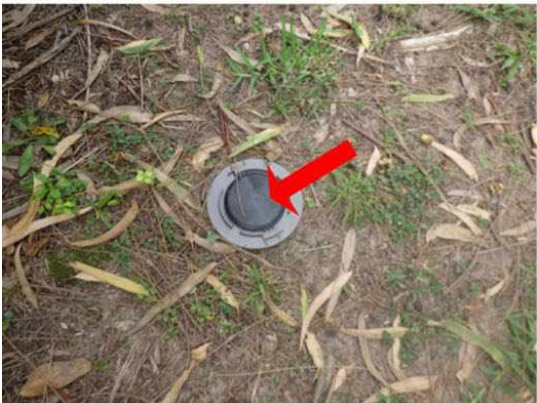
In this instance evidence of a previously installed baiting stations was observed. This system requires regular inspections and replenishment.

No evidence of regular or annual inspections was found.

Where a Termite Management System has been identified you should refer to the type of barrier date of installation warranty conditions and any documentation provided by a past owner or body corporate managers.

NOTE - The buildings body corporate managers may have information or documentation on any previously installed timber termite management system.
