## Building Inspection Report

Inspection Date: Thu, 26 Feb 2026

Property Address: unit 6/15 Beafield Rd, Para Hills West SA  
5096, Australia

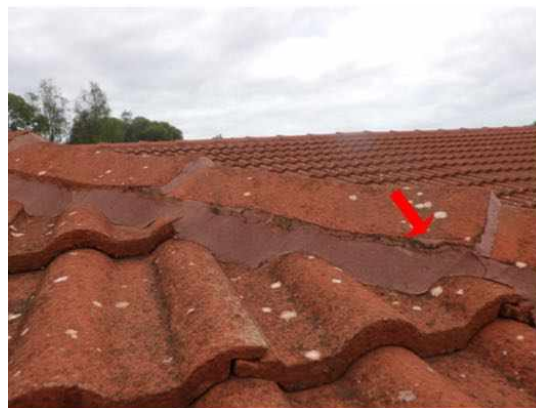
### Defects 3.01

Building:	Building 1
Location:	All External Areas
Finding:	Mortar - Deterioration
Information:	At the time of inspection it was noticed that evidence of mortar deterioration to few roof tiles around the property.

other building elements on the exterior roof covering, such as gable ends, hip capping and valleys. Upon inspection of the exterior roof, it was noted that sections of the mortar show varying levels of deterioration.

Mortar deterioration can be attended to by a handyperson where areas of deterioration are localised and easily accessible. Otherwise, consultation with a roofing contractor is advised where greater works are required.

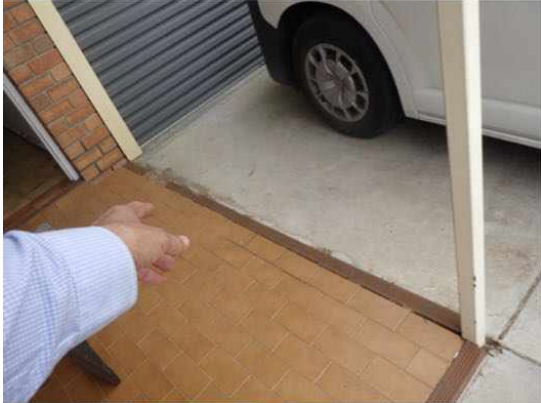
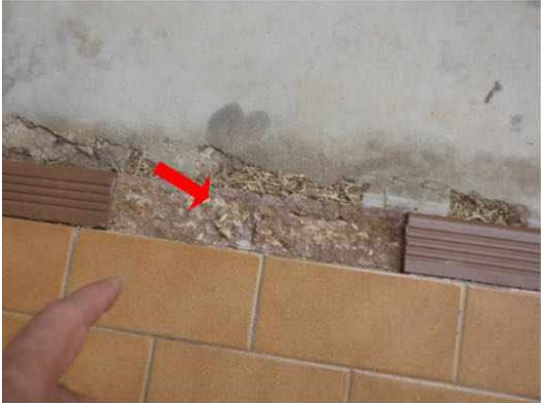
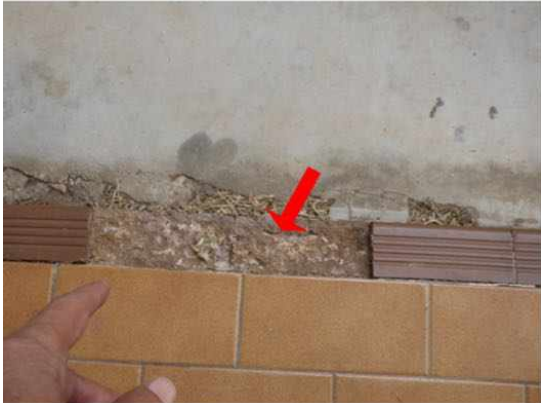
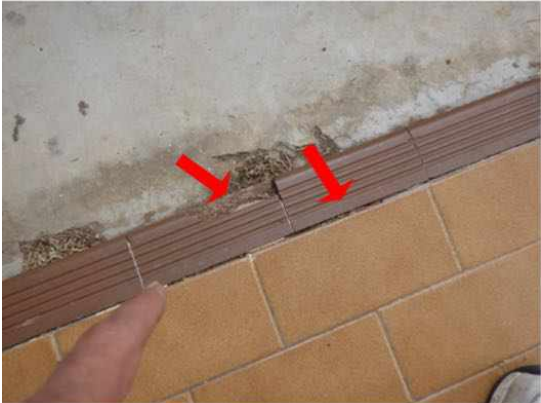
penetration over a prolonged period of time.

While not considered a matter of urgency, replacement of cracked floor tiles is advised as a solution. A tiling contractor or general handyperson may be appointed to perform these works at client discretion.
