Building and Timber Pest Inspection Report

Inspection Date: Fri, 23 Jan 2026

Property Address: 53 Air League Ave, Leppington NSW 2179,
Australia

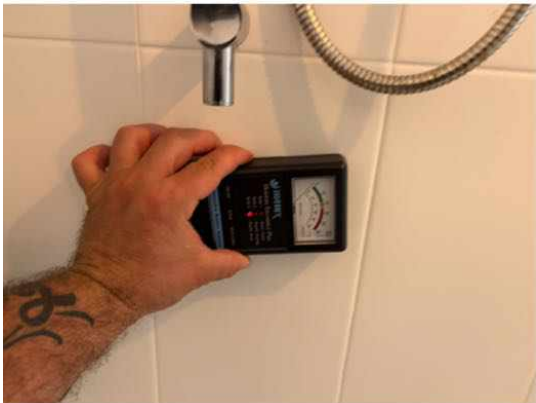
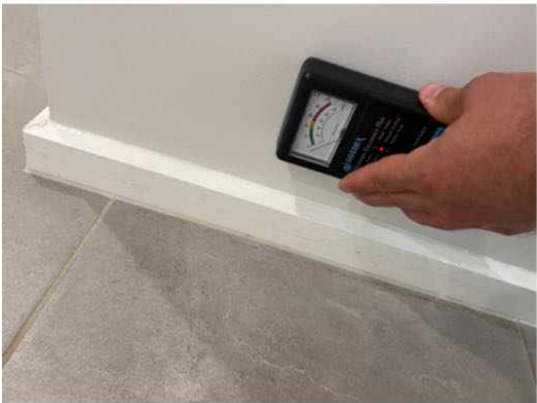
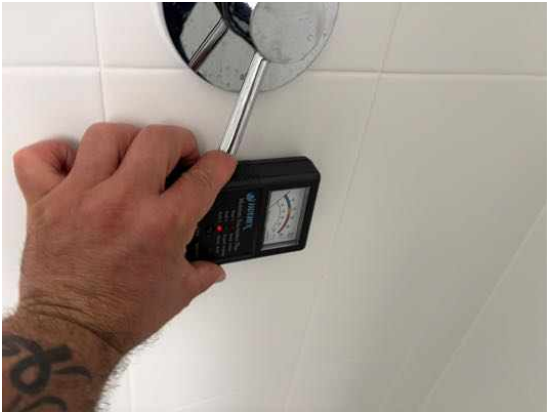
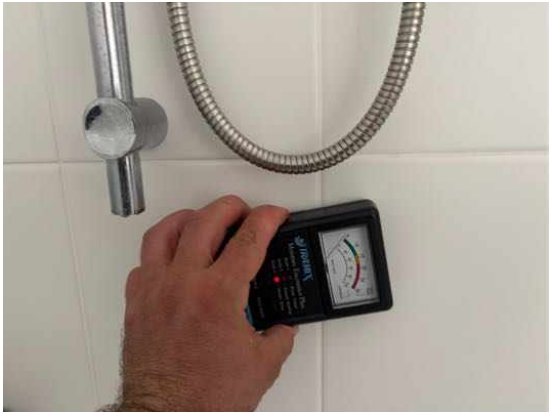
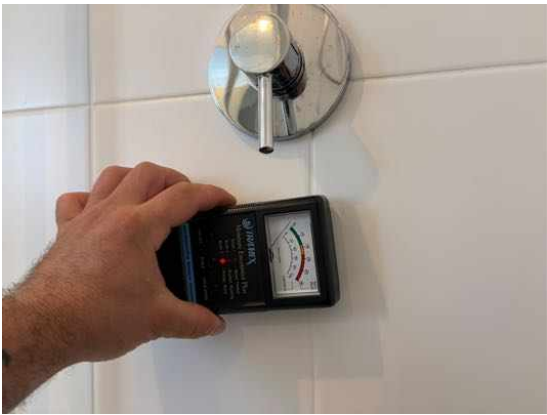
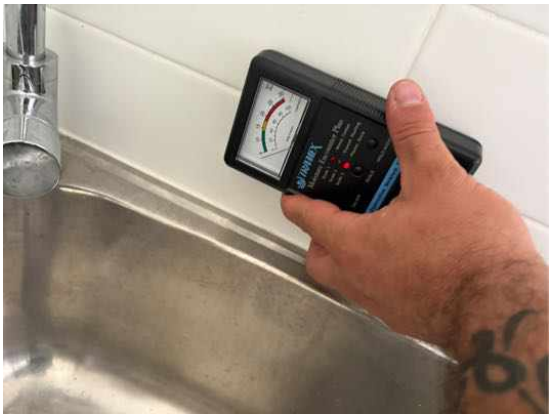
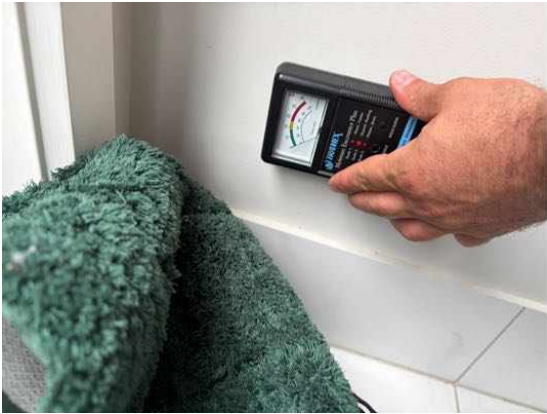
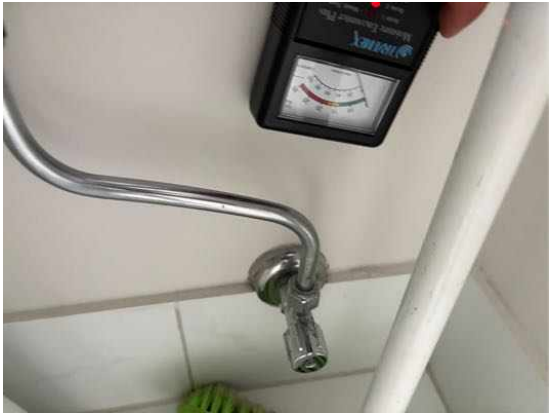
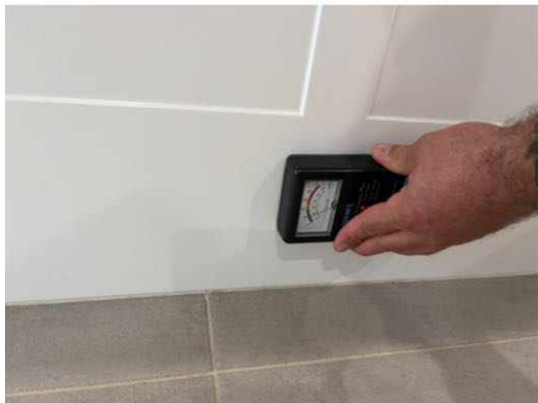
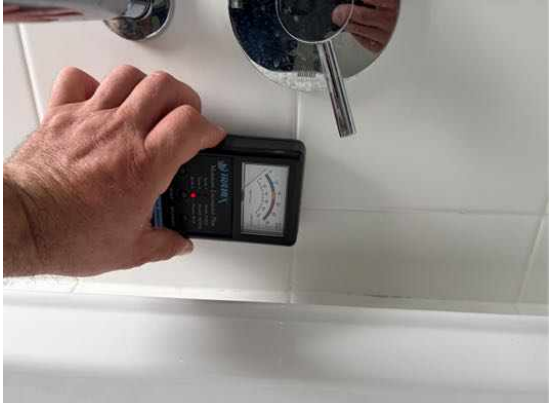
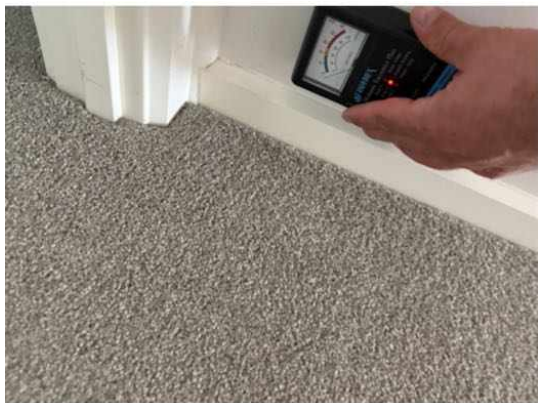
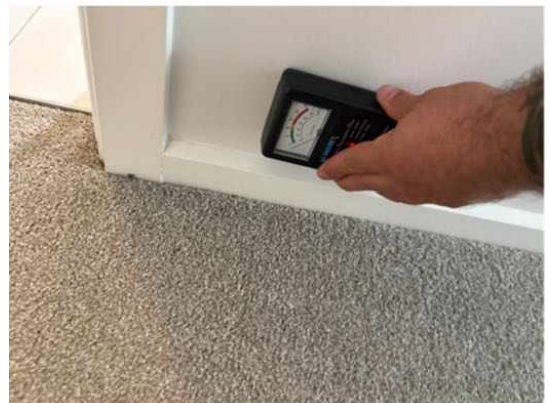
Building: Main Building
Location: All Areas
Finding: Moisture metre
Information: During the inspection the property was checked for moisture using a moisture metre.

This is for information only.

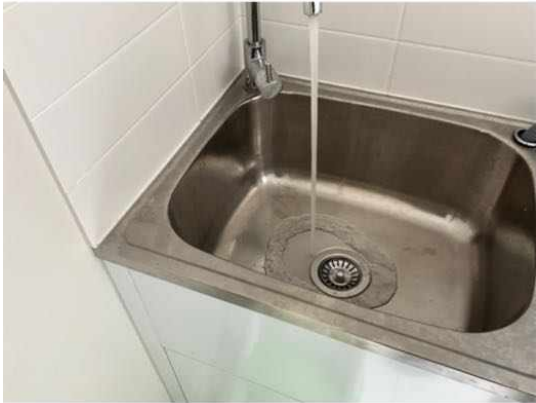
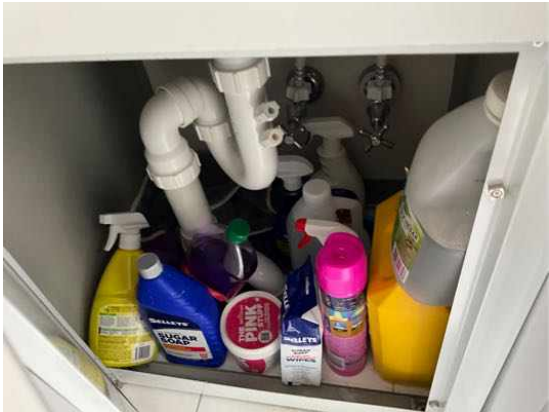
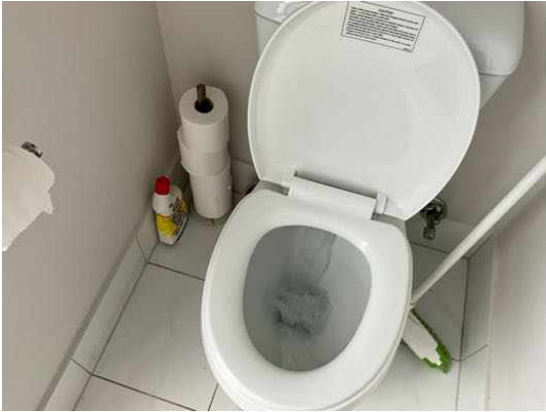
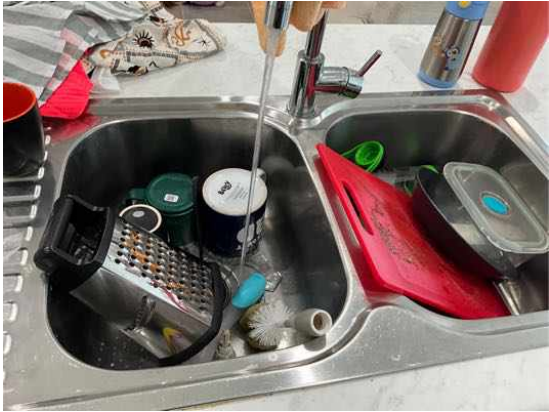
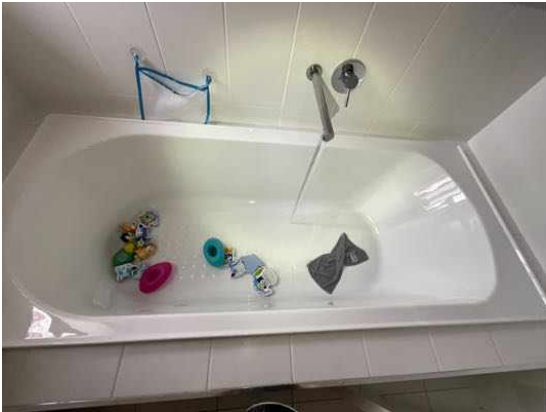
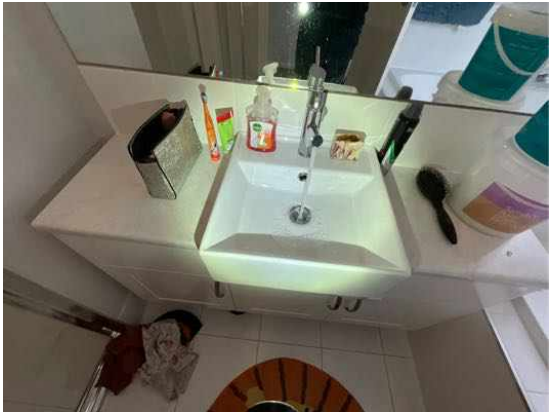
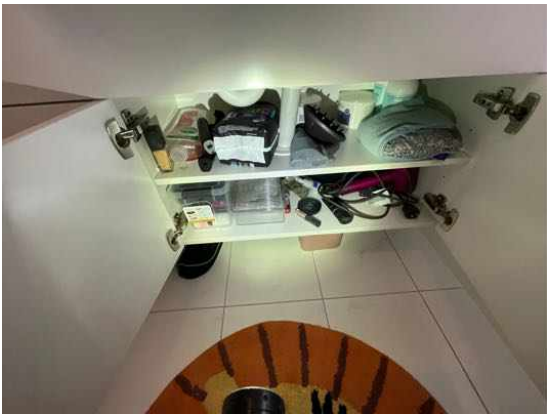
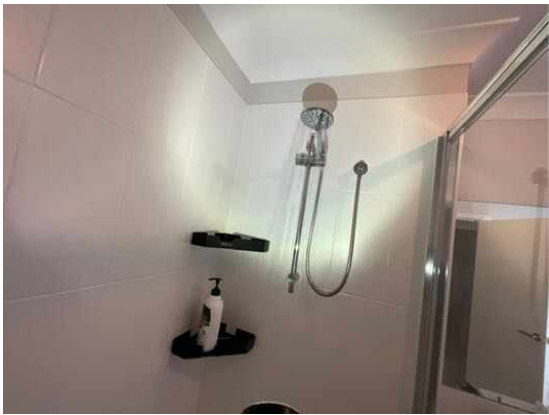
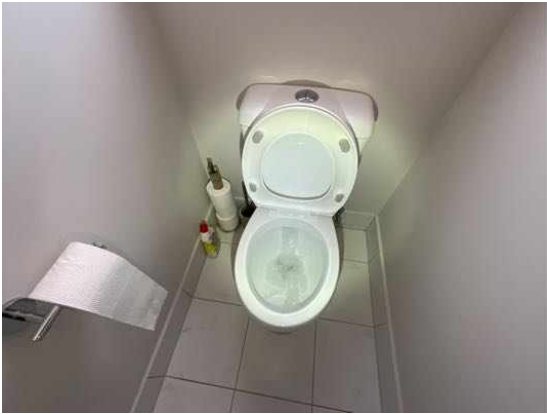
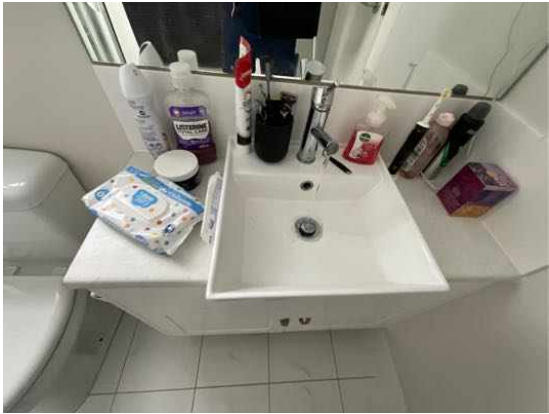
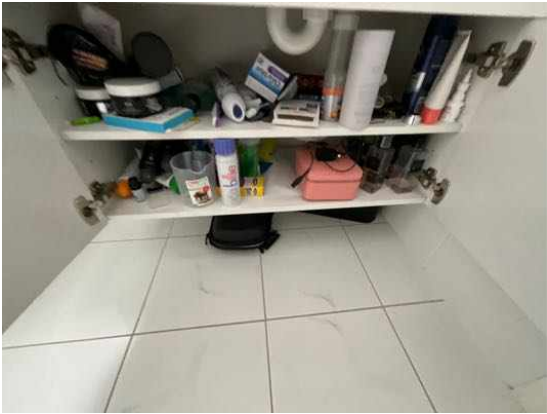
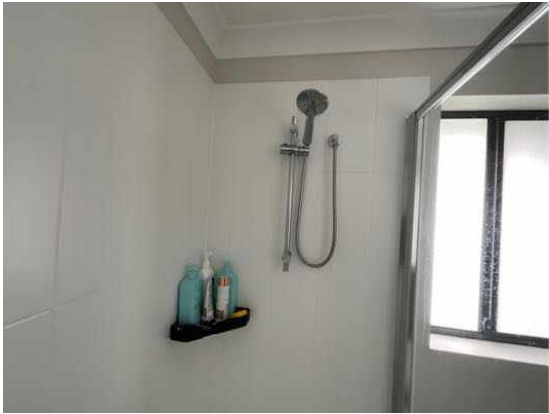
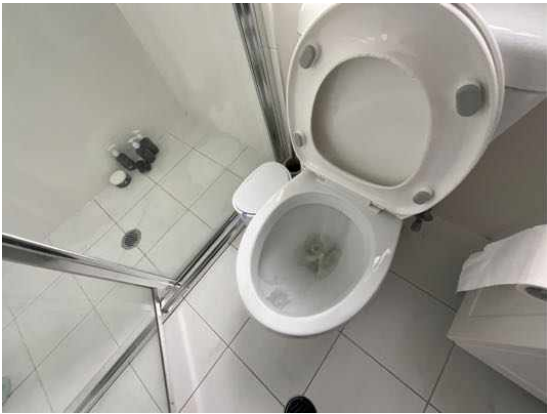
Building: Main Building
Location: All Wet Areas
Finding: Additional Photos
Information:

Additional photos are provided for your general reference.

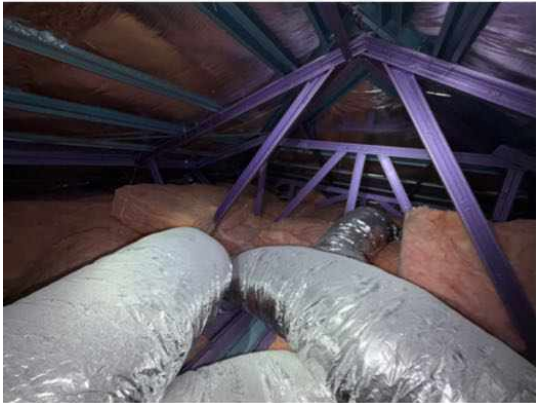
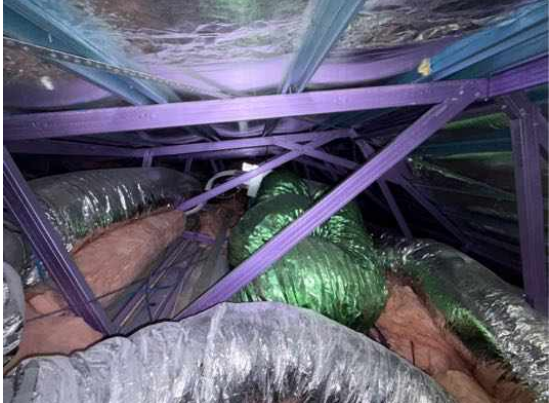
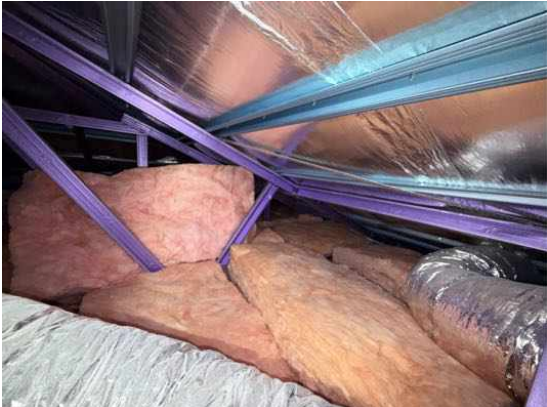
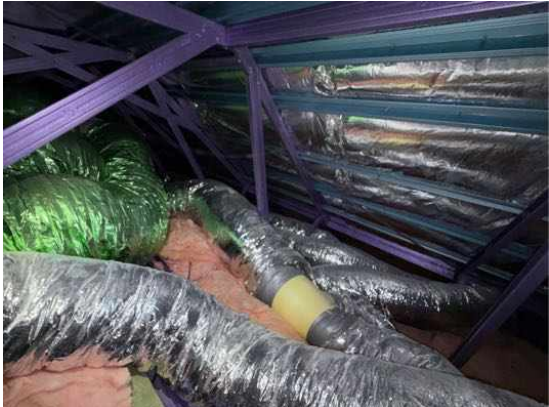
Building: Main Building
Location: Roof Void
Finding: Additional Photos
Information:

Additional photos are provided for your general reference.

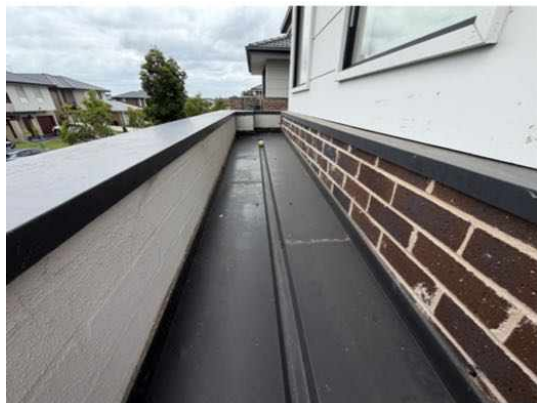
Building: Main Building
Location: Roof Exterior
Finding: Additional Photos
Information:

Additional photos are provided for your general reference.

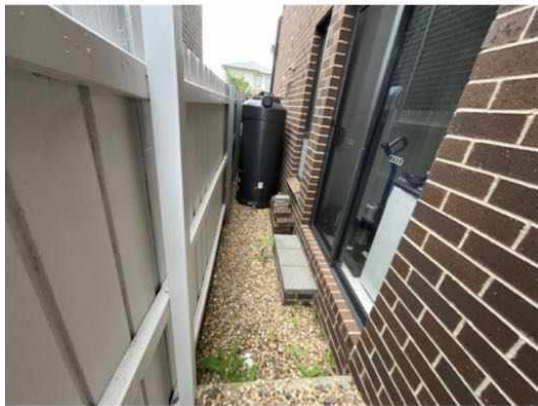
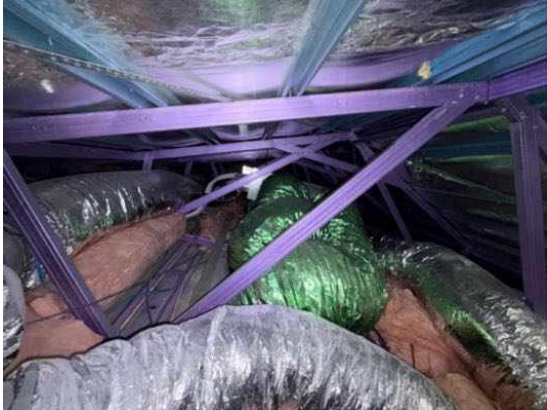
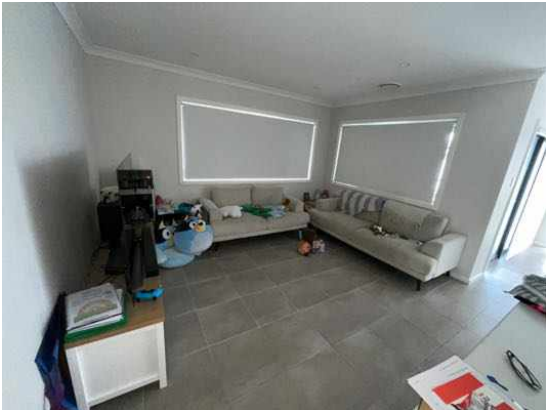
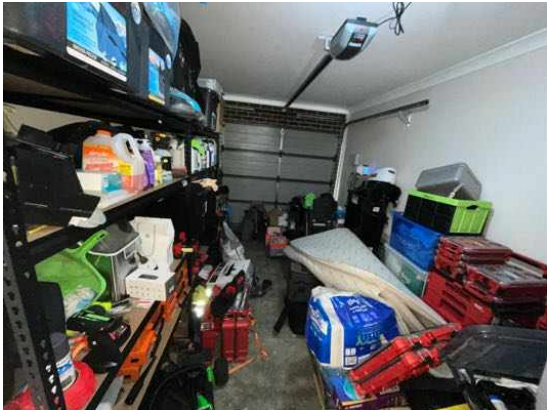
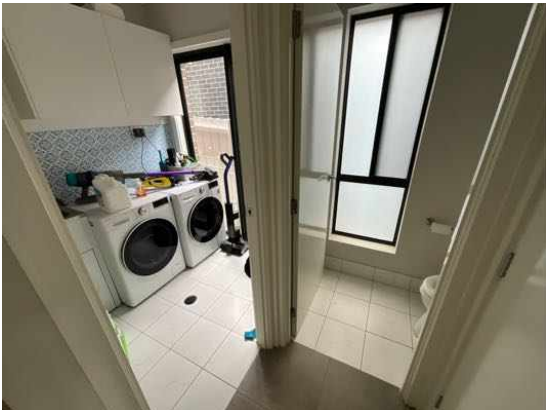
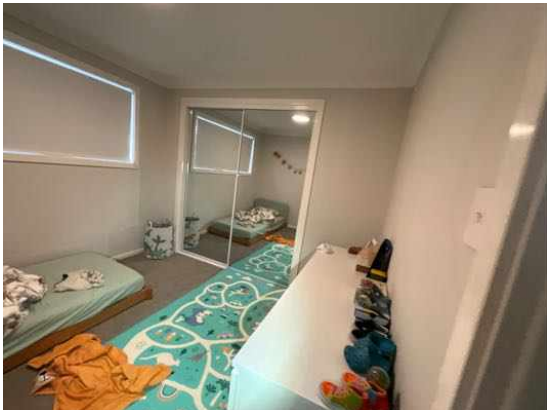
Building: Main Building
Location: All Areas
Finding: Additional Photos - Obstructions and Limitations
Information:

These photographs are an indication of the obstructions and limitations which impeded full inspection of the property at the time of inspection. These obstructions can hide an array of defects and should be removed to allow full inspection to be carried out. A re-inspection is recommended once the areas are made accessible.
