# Building Inspection Report

Inspection Date: Mon, 2 Mar 2026

Property Address: 1 Jelica Pl, Esk QLD 4312, Australia

This building inspection is of the colourbond roofing only. No other areas of this house form any part of this report.

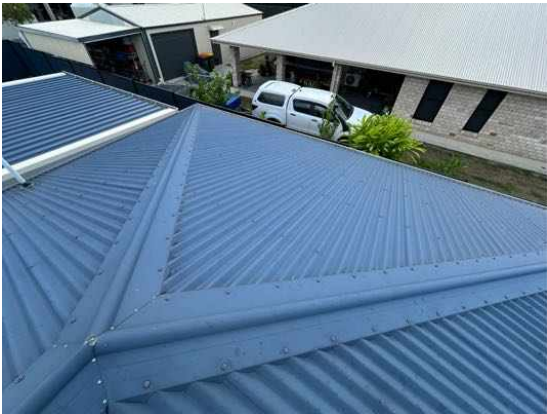
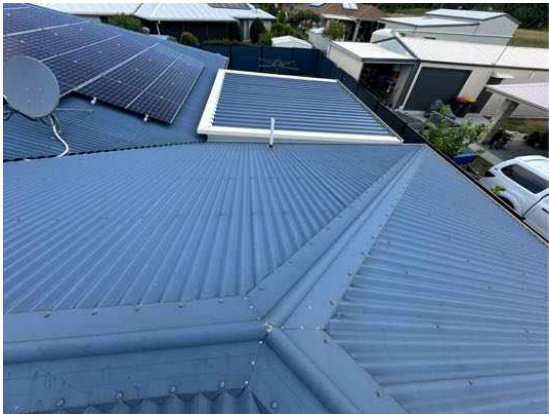
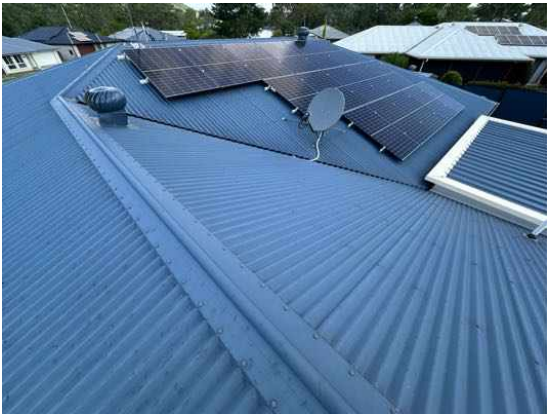
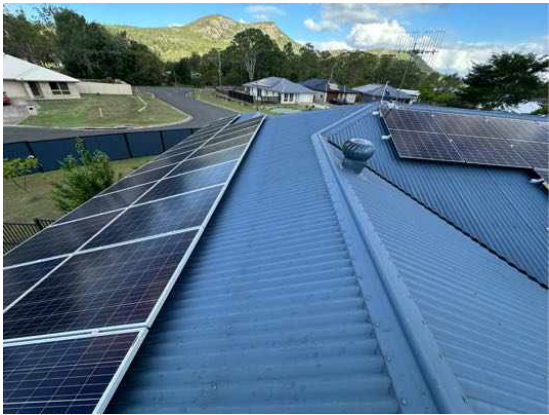
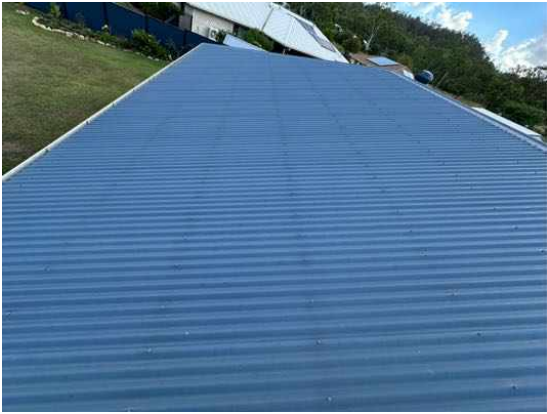
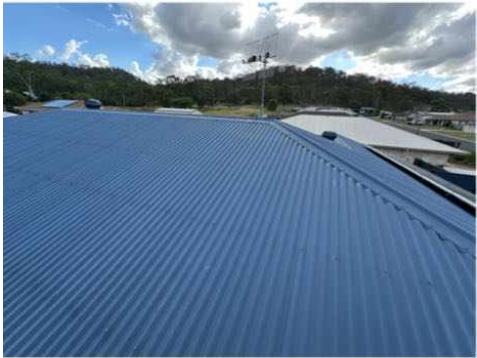
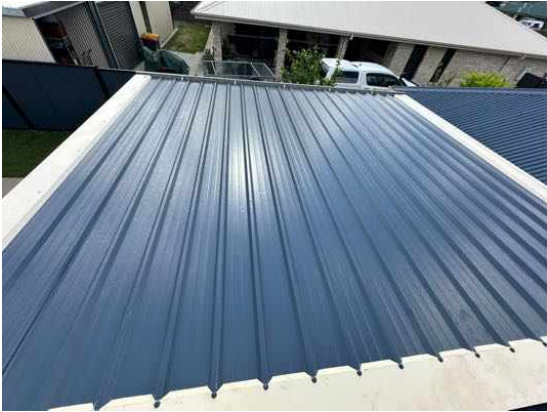
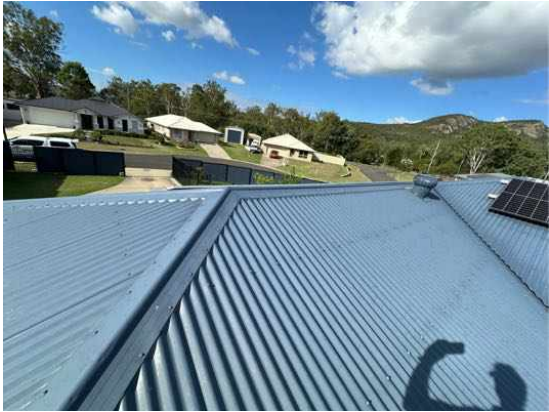
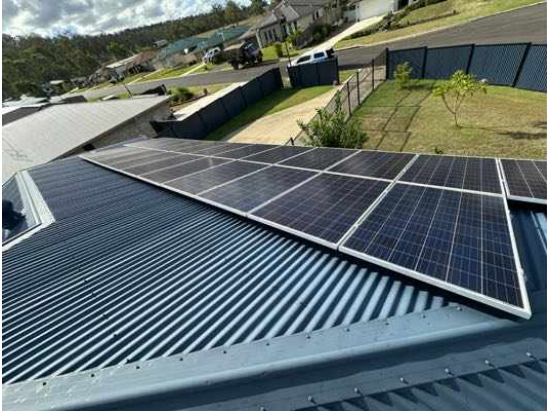
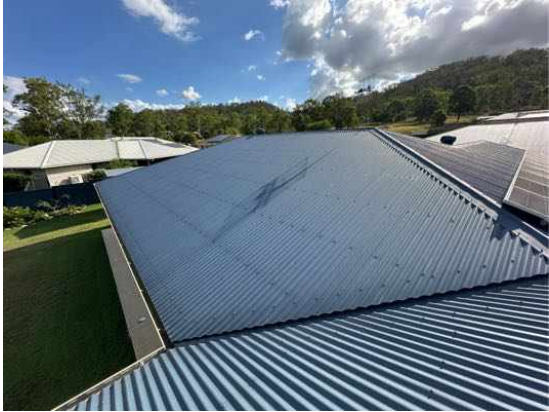
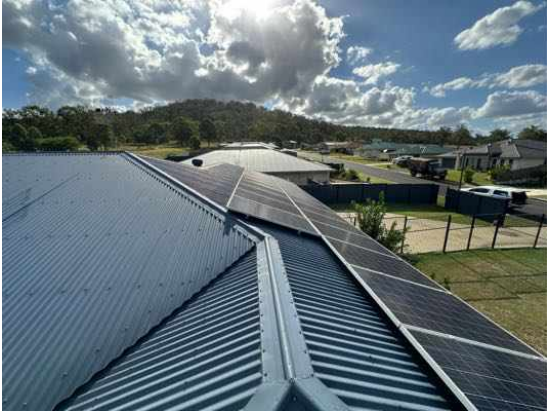
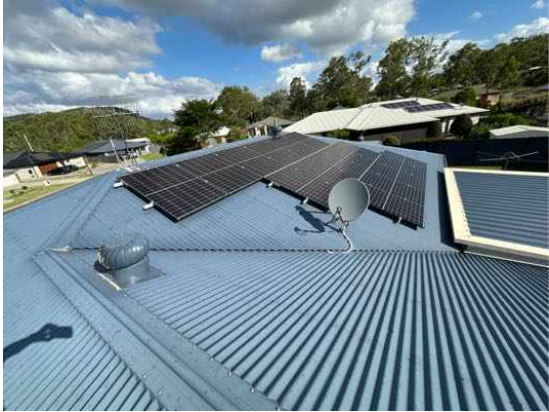
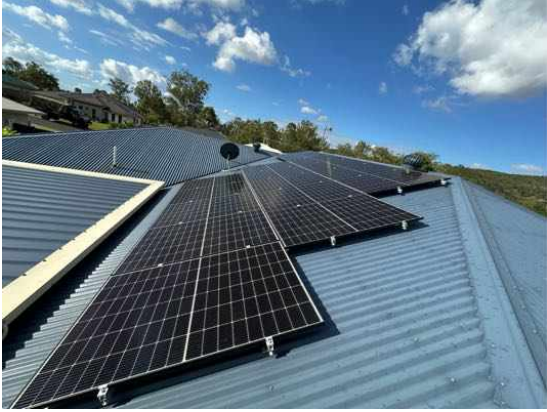
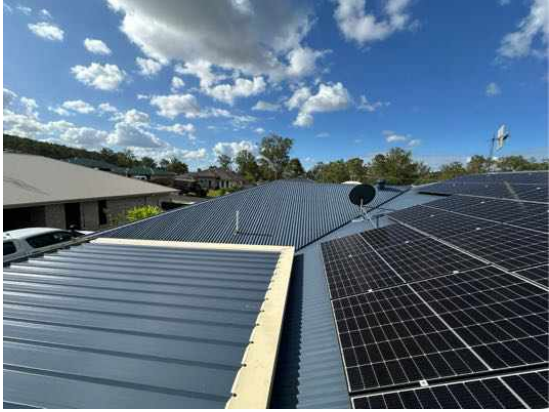
Building: Main Building  
Location:  
Finding: Additional Photos  
Information: Additional photos are provided for your general reference.
