# Building and Timber Pest Inspection Report

Inspection Date: Fri, 13 Mar 2026

Property Address: 2/59 Marsden St, Parramatta NSW 2150,  
Australia

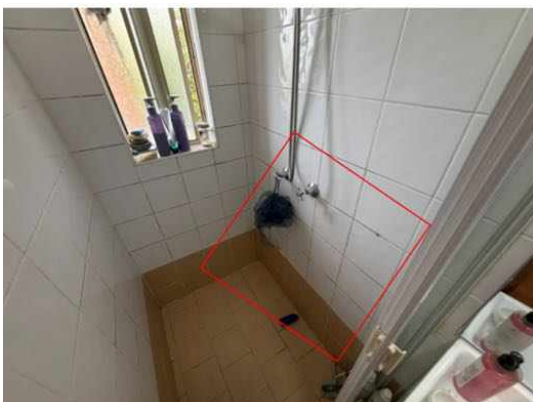
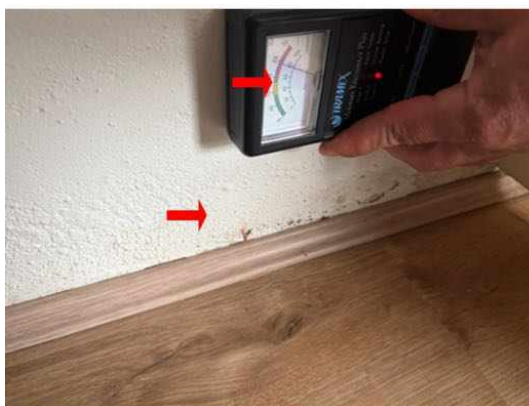
Finding: Water leak suspected - Internal

Information: A water leak is suspected in this area at the time of inspection. Internal water leaks can be detrimental to surrounding building elements; their potential causes include damage to plumbing fittings and fixtures, through to water damage and deterioration of associated building elements.

Rust, corrosion, decay and water damage are potential outcomes where a minor water leak is left unattended. More serious defects may also result, such as electrical hazards, or water damage to structural building elements.

In extreme cases, structural damage may develop due to a prolonged water leak. It is highly advised that internal water leaks be addressed by a licensed plumber as a matter of relative urgency.

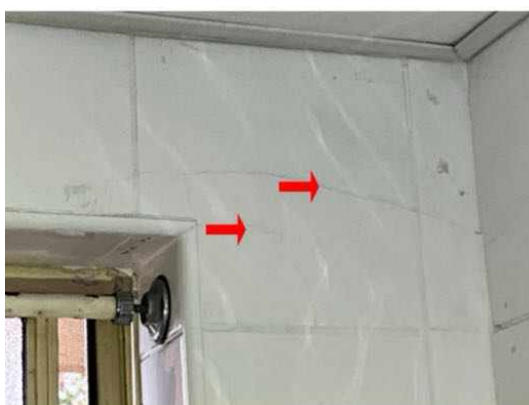
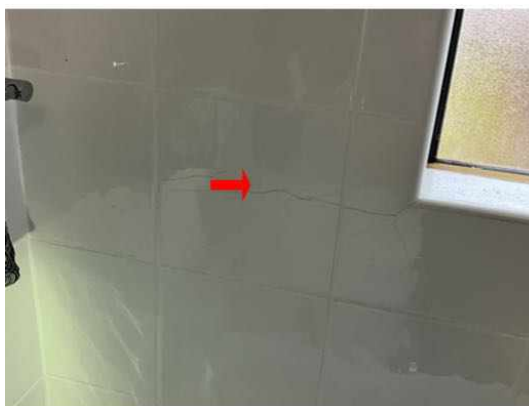
## Finding 2.02

Building:	Main Building
Location:	Bathroom
Finding:	Water leak - Suspected
Information:	A water leak is suspected in this area as excessive moisture was detected at the time of inspection. Another potential cause maybe moisture ingress behind the tiles from around the wall fittings and penetrations.

Internal water leaks can be detrimental to surrounding building elements; their potential causes include damage to plumbing fittings and fixtures, through to water damage and deterioration of associated building elements.

Attracting termites, corrosion, mould, decay and water damage are potential outcomes where a minor water leak is left unattended. More serious defects may also result, such as electrical hazards, or water damage to structural building elements.

In extreme cases, structural damage may develop due to a prolonged water leak. It is highly advised that internal water leaks be addressed by a licensed plumber as a matter of relative urgency.

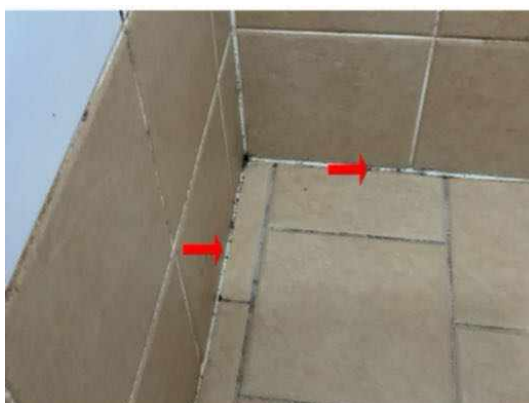
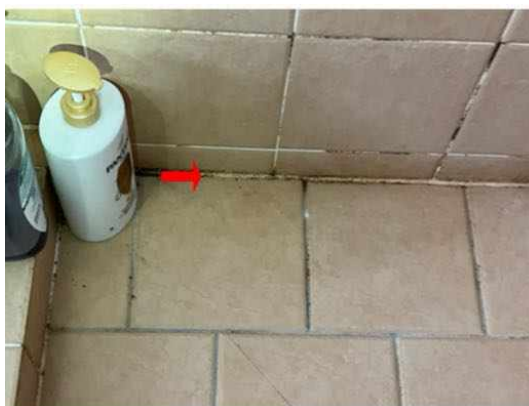
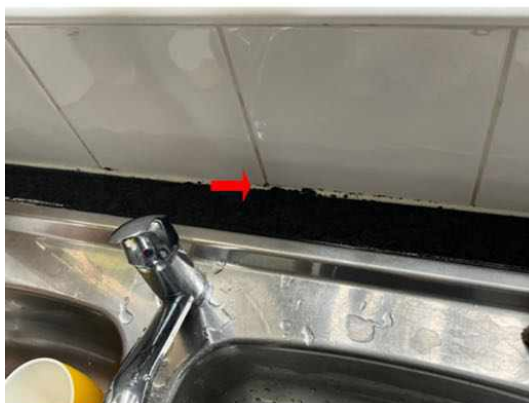
### Finding 3.02

Building: Main Building  
 Location: All Wet Areas  
 Finding: Sealant and grouting - Missing or damaged  
 Information:

It was noted on inspection that sealant or grout is degraded to this area.

Different materials and floor areas move at different rates, generally causing cracking to grout or sealant at this point. A flexible sealant is required to allow for expected expansion and contraction, while keeping the joint water tight and protective of all associated building materials.

Flexible and mould resistant materials should be applied to affected areas to prevent any subsequent water damage that is likely to occur. Regular maintenance and replacement of damage or missing or damaged sealant and grout is highly recommended to the wet areas, as this is a regular wear and tear defect. Sealant and grouting in areas that come into regular contact with water should be maintained for the long term care of your property.

A sealant specialist should be appointed to complete these works as soon as possible.

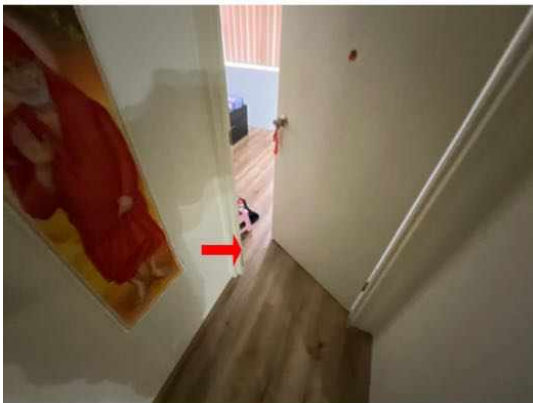
Binding and/or jamming of this door is evident during standard operation. This defect inhibits the functionality of the affected door as well as creating potential for secondary defects to associated building elements, such as damage to the floor covering or adjacent frame.

A door that binds to flooring or to the associated door frame may have several causes, ranging from minor defects, such as poor installation of the door or deteriorated hinges.

A licensed carpenter should be appointed to perform minor rectification works at client discretion.

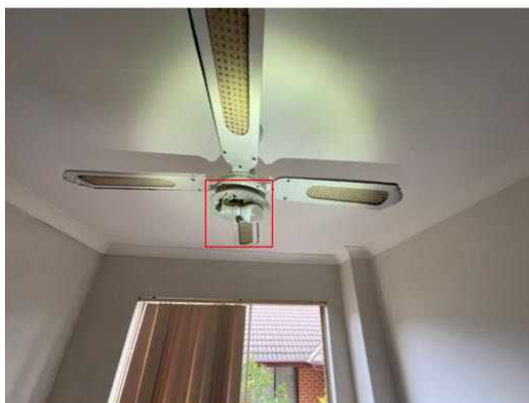
### Finding 3.07

Building:	Main Building
Location:	Both bedrooms
Finding:	Light cover - Missing (Cosmetic)
Information:	The light cover in this area was found to be missing at the time of inspection. Breakage occurs generally when the building materials have aged and decayed, but may also be indicative of impact damage to the building element (accidental or deliberate). This is mainly a cosmetic defect which can be replaced by the home owner.

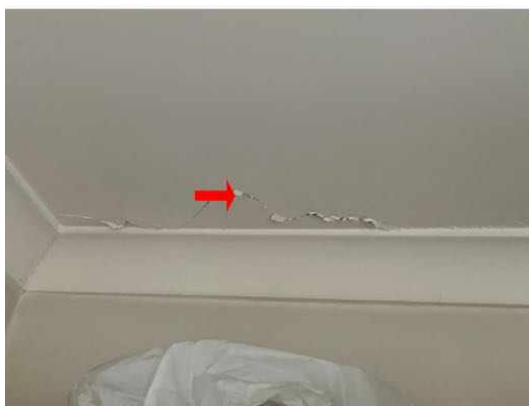
### Finding 3.08

Building:	Main Building
Location:	Multiple areas
Finding:	Cracks to internal render - Category 1
Information:	It has been observed that cracking to internal rendered surfaces has occurred. The degree of damage falls within Category 1, described as fine cracks that do not need repair and which are less than 1.0mm in width limit.

Damage of this category is not considered a defect for rectification. Always contact your building inspector should cracks widen, lengthen, or become more numerous.

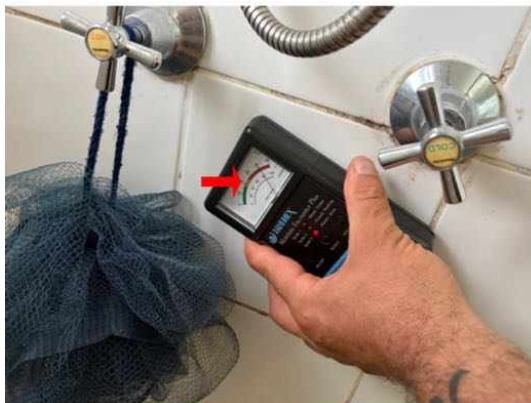
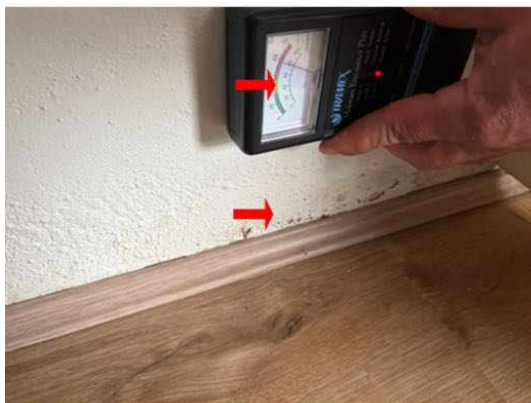
Building:	Main Building
Location:	Ensuite - Master
Finding:	Water leak suspected - Internal
Information:	A water leak is suspected in this area at the time of inspection. Internal water leaks can be detrimental to surrounding building elements; their potential causes include damage to plumbing fittings and fixtures, through to water damage and deterioration of associated building elements.

Rust, corrosion, decay and water damage are potential outcomes where a minor water leak is left unattended. More serious defects may also result, such as electrical hazards, or water damage to structural building elements.

In extreme cases, structural damage may develop due to a prolonged water leak. It is highly advised that internal water leaks be addressed by a licensed plumber as a matter of relative urgency.

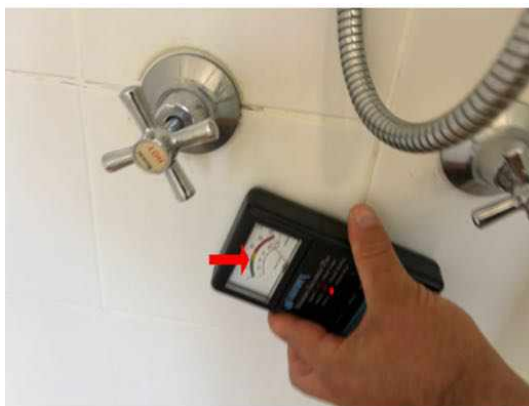
### Finding 6.02

Building: Main Building

Finding: Water leak - Suspected

Information: A water leak is suspected in this area as excessive moisture was detected at the time of inspection. Another potential cause maybe moisture ingress behind the tiles from around the wall fittings and penetrations.

Attracting termites, corrosion, mould, decay and water damage are potential outcomes where a minor water leak is left unattended. More serious defects may also result, such as electrical hazards, or water damage to structural building elements.

In extreme cases, structural damage may develop due to a prolonged water leak. It is highly advised that internal water leaks be addressed by a licensed plumber as a matter of relative urgency.

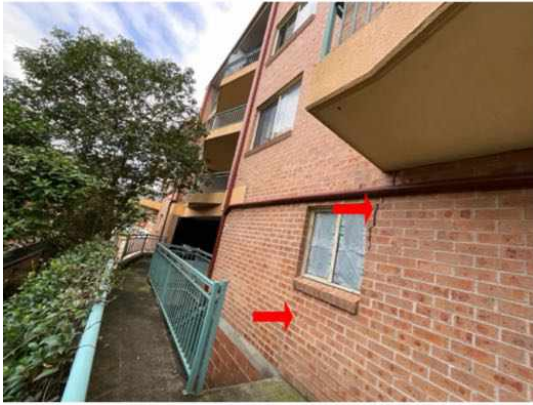
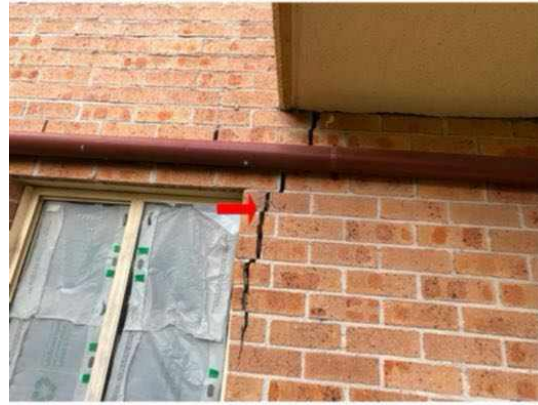
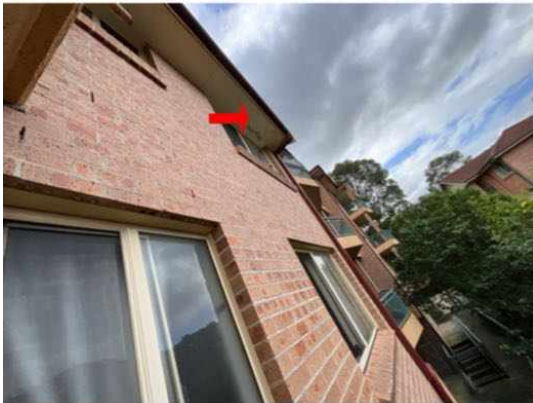
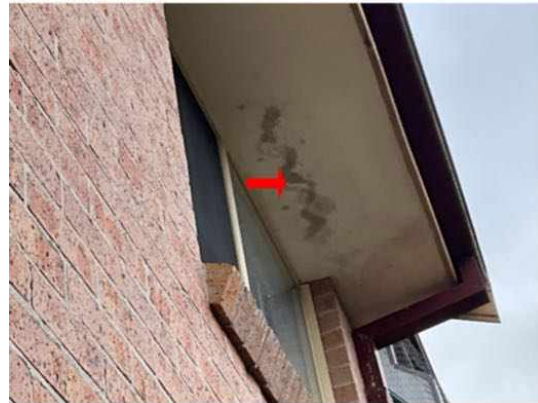
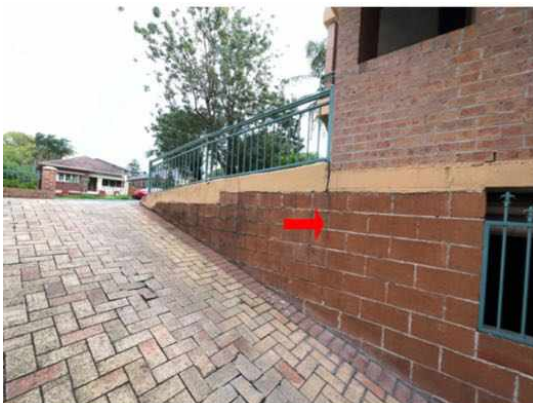
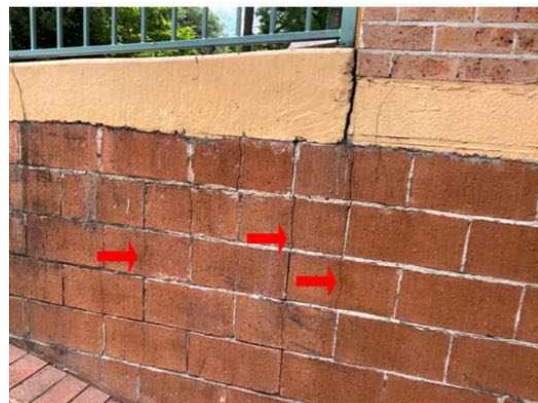
Building: Main Building  
Location: Other common areas  
Finding: Additional Photos  
Information: Additional photos are provided for your general reference.
