## Building Inspection Report

Inspection Date: Fri, 20 Feb 2026

Property Address: 401/85 Nicholson St, Brunswick East VIC  
3057, Australia

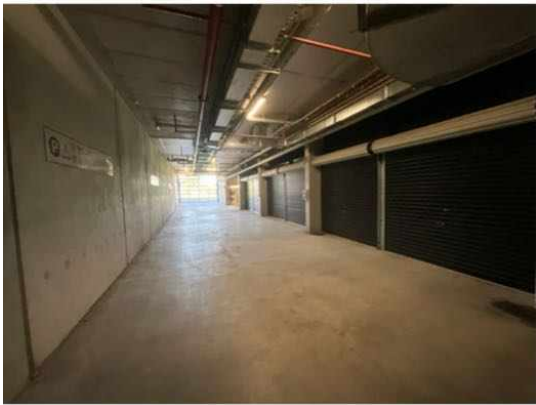
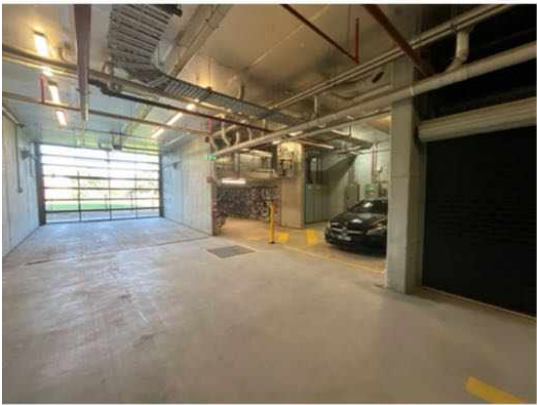
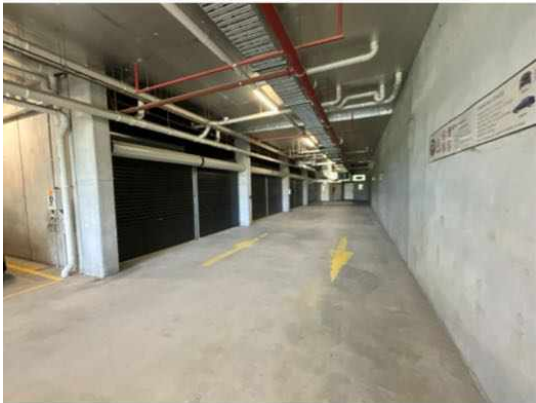
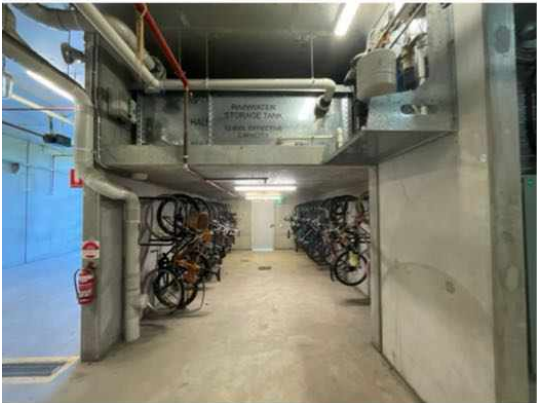
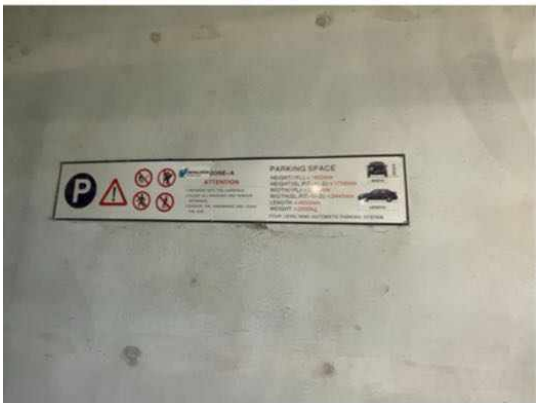
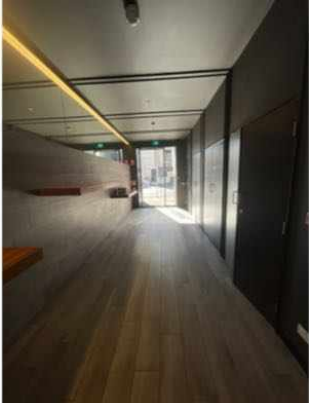
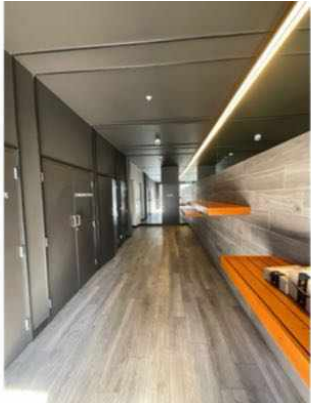
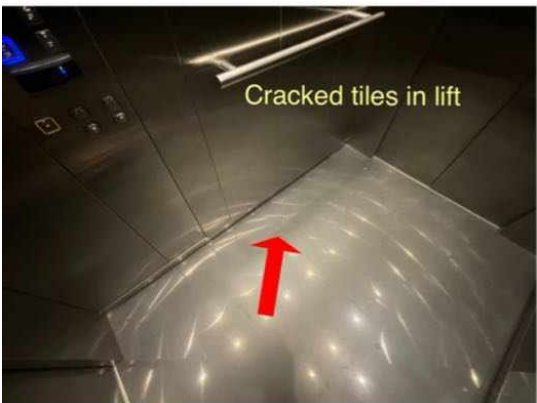
Building:  
Location: Common areas  
Finding: Additional Photos - for your information ( common areas)  
Information: Additional photos are provided for your general reference.

Cracked tiles in lift

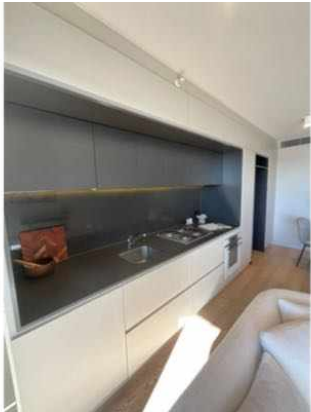
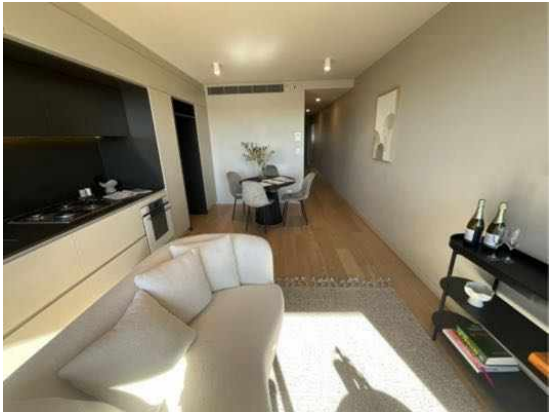
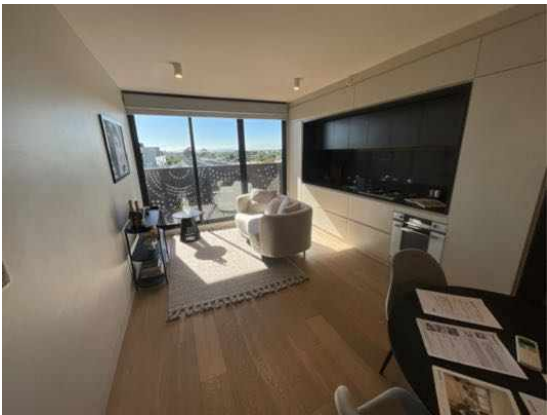
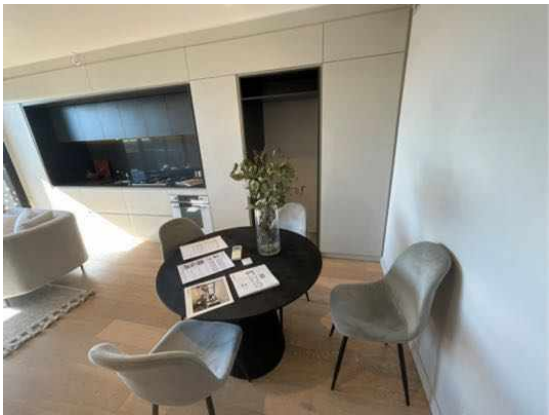
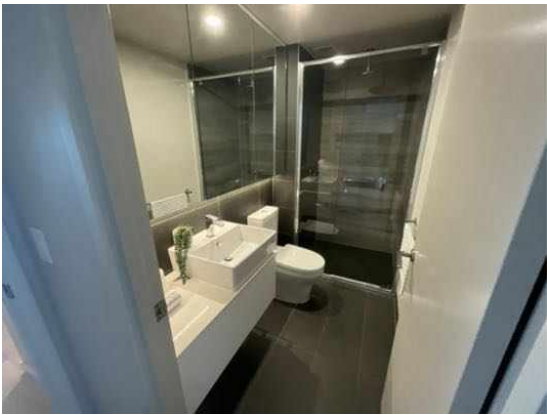
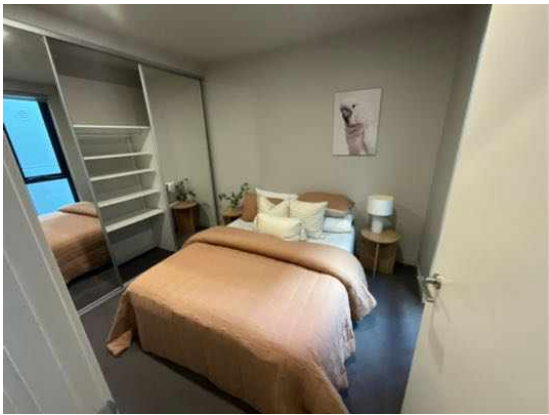
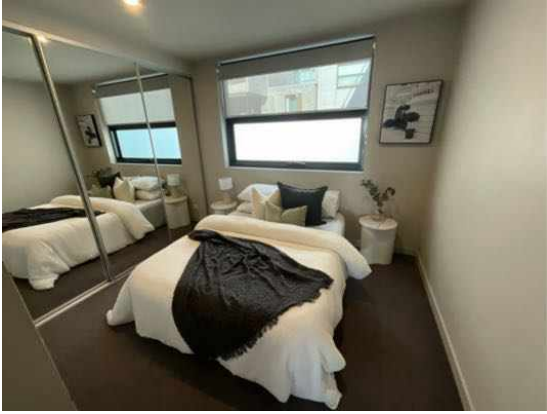
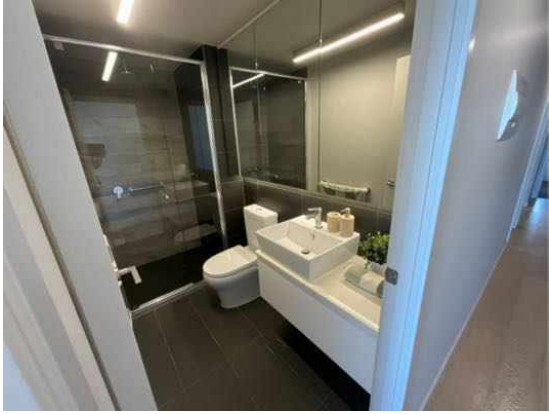
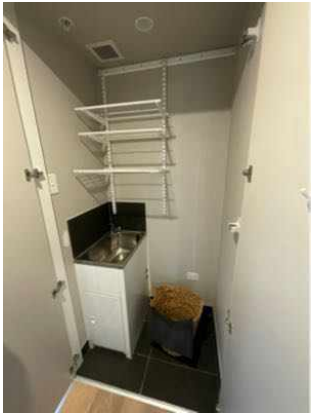
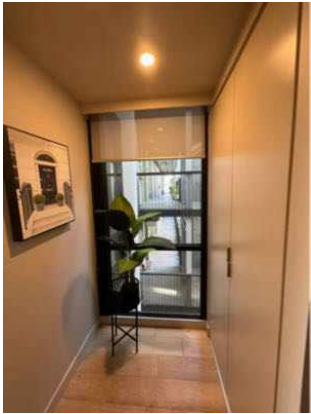
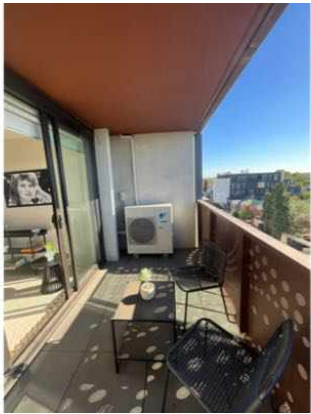
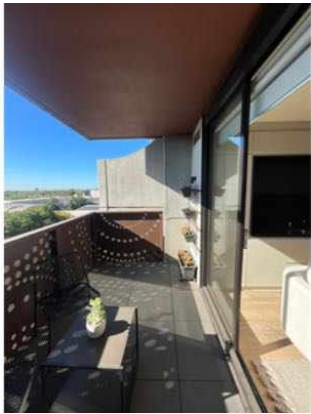
Building:  
Location: All Areas  
Finding: Additional Photos - Obstructions and Limitations  
Information: These photographs are an indication of the obstructions and limitations which impeded full inspection of the property at the time of inspection. These obstructions can hide an array of defects and should be removed to allow full inspection to be carried out. A re-inspection is recommended once the areas are made accessible.
