Building and Timber Pest Inspection Report

Inspection Date: Mon, 9 Mar 2026

Property Address: 27 Turnipwood Dr, Buderim QLD 4556,
Australia

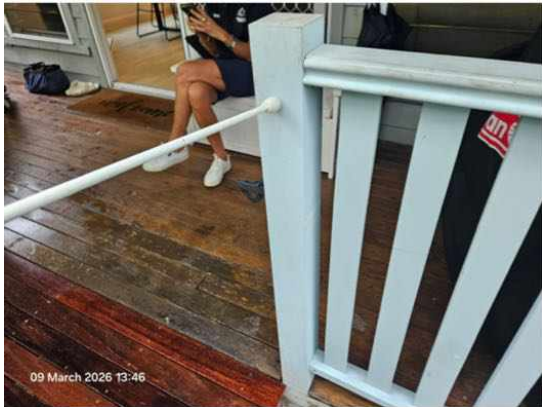
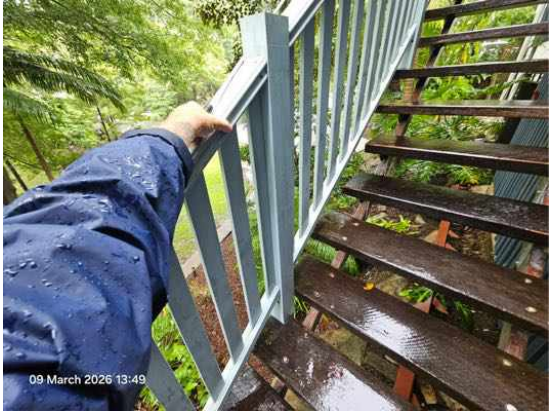
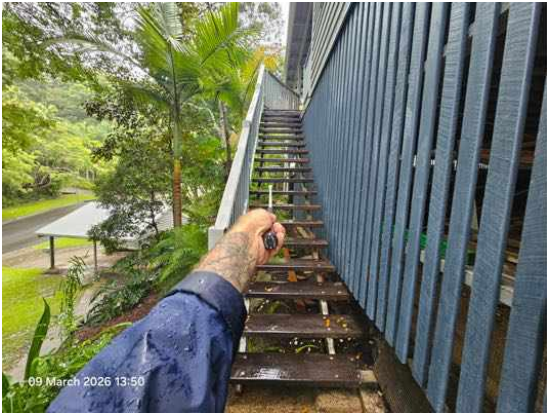
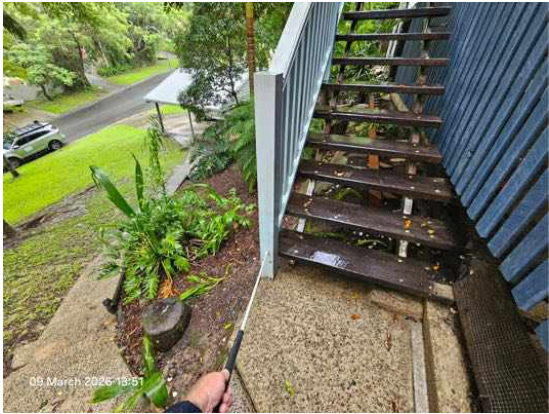
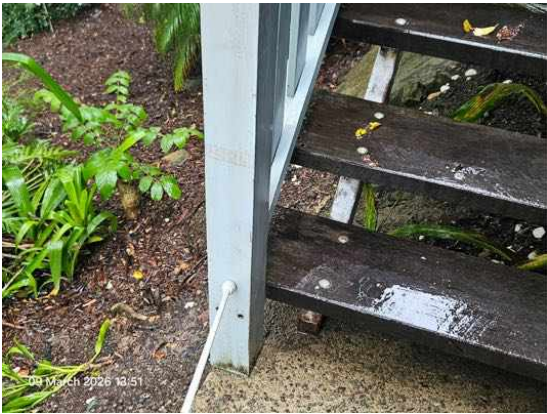
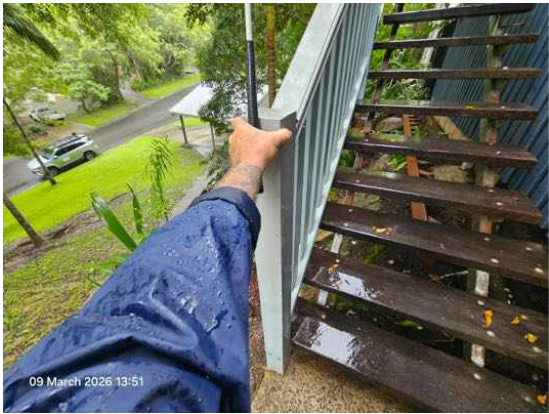
Building: Main Building
Location: Front stairs and deck
Finding: Deck / stairs - Balustrade / handrails
Information: The front stairway and deck handrails at the entry of the property are not adequately affixed in place. They can be readily moved and are loose in their current fixings. This could become a safety hazard if pressure is applied.

A licensed builder or licensed carpenter could be appointed to provide necessary works to the stair flight.

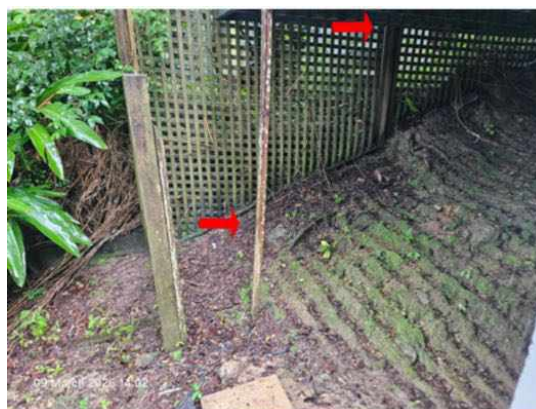
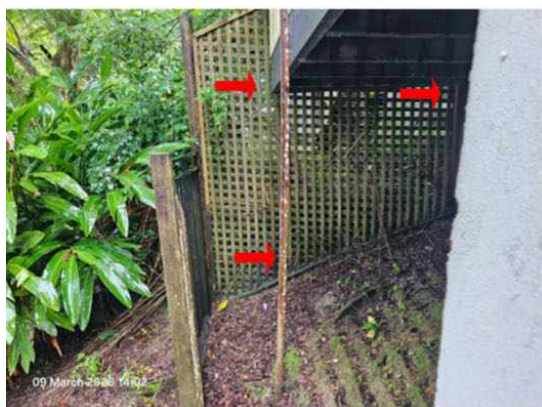
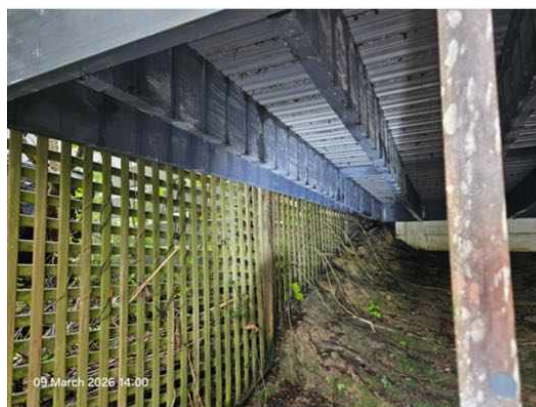
Finding 2.01

Building: Yard
 Location: Pool Area
 Finding: Decking support
 Information: On the day of inspection it was noted that the front left corner of the front pool decking is not supported adequately. It will require a post to the front corner to provide satisfactory stability. To a degree, the deck had a bounce when walked on. It appears that there is currently a 50 x 50mm pine batten fixed to the front of the deck to provide support to the deck and support to the barrier / privacy wall .

The front corner cantilevers by approximately 1.5m.

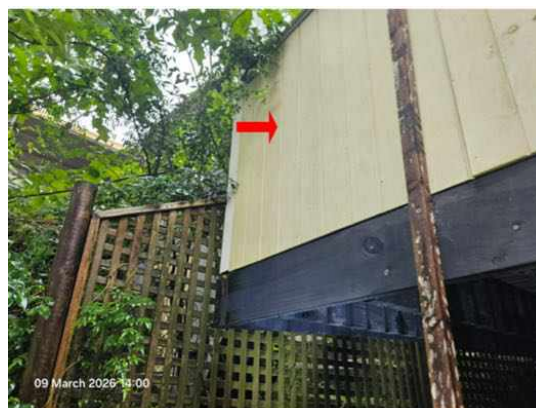
Finding 2.02

Building: Yard
 Location: Pool Area
 Finding: Pool deck - Balustrade / wall
 Information: The front privacy wall / balustrade of the pool deck at the front left of the property is loose and does not feel stable.

A licensed builder or licensed carpenter could be appointed to provide necessary works to the wall.

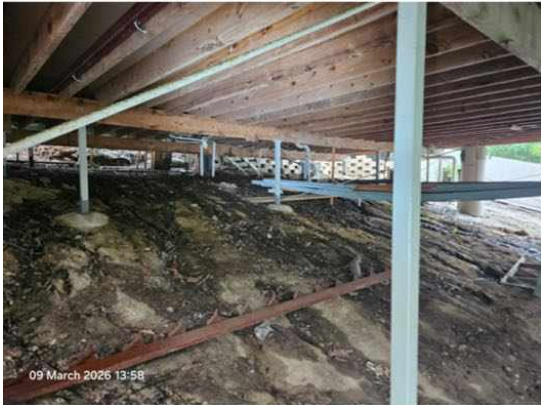
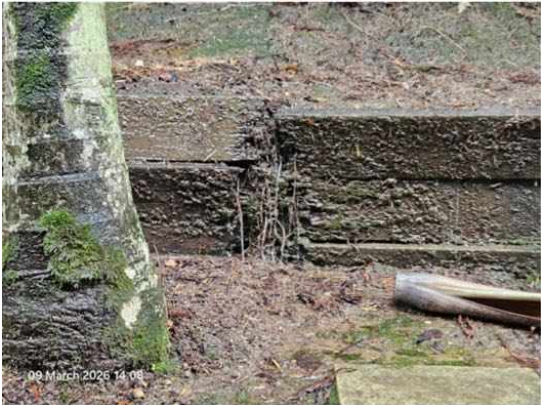
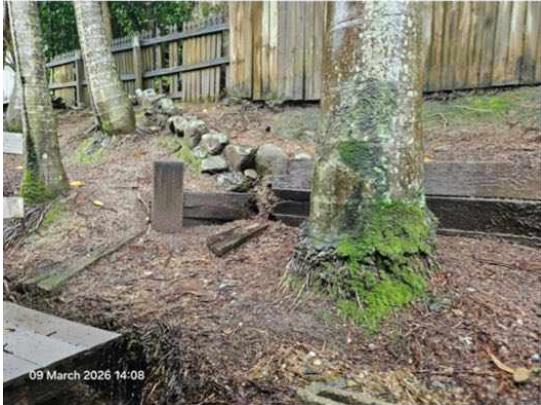
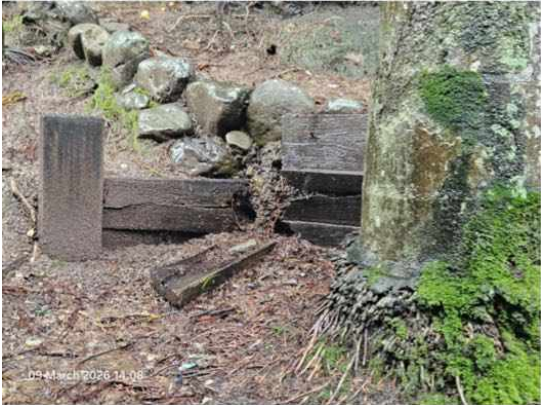
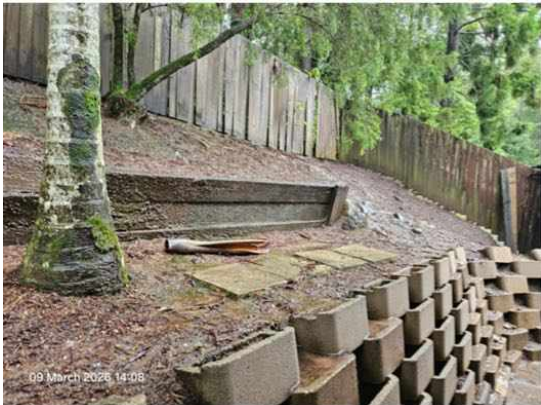
Finding 2.03

Building:	Yard
Location:	All External Areas
Finding:	Site drainage - Inadequate
Information:	The site drainage in this area was found to be inadequate at the time of inspection, creating potential for subsequent water damage to associated building elements.

It is important that surface water does not have continued flow through the site, around foundations or collect under or around the building. Stormwater should be carried away by regularly cleaned drains and downpipes should not discharge stormwater onto lower walls or plinths. Ground levels should be sloped to drain away from the building. Scouring was seen in the subfloor area around the post foundations.

Water damage and secondary defects are likely to occur if left unmanaged. Poor site drainage can lead to conducive conditions for timber pests and have an effect paths and hard stand areas such as paving. The paving around the pool area appeared to be affected by sub surface water.

Where site drainage is inadequate, a licensed landscaper should be consulted to further inspect the property and perform any remedial works as necessary.

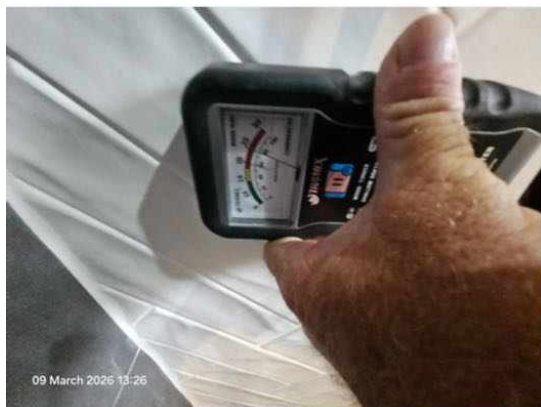
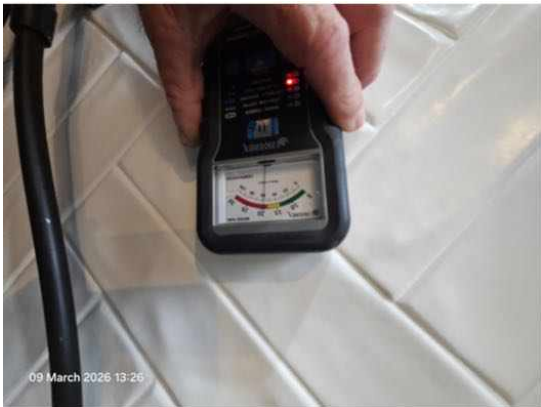
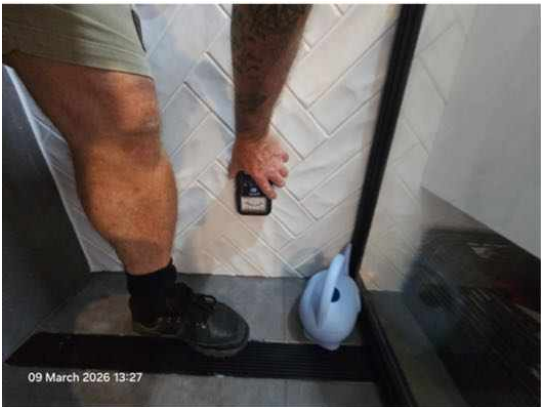
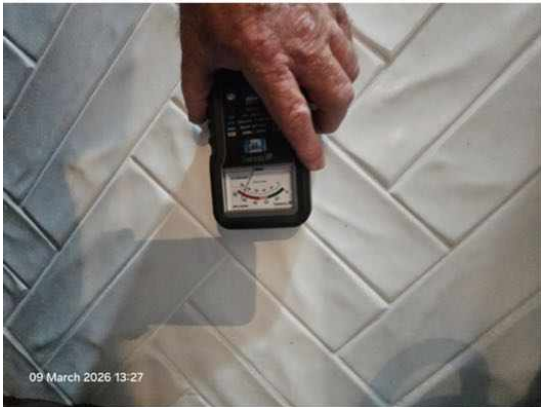
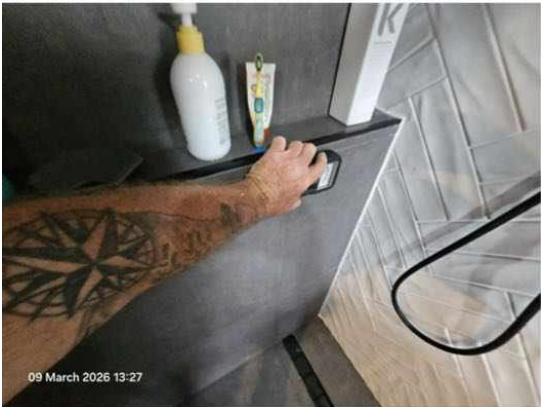
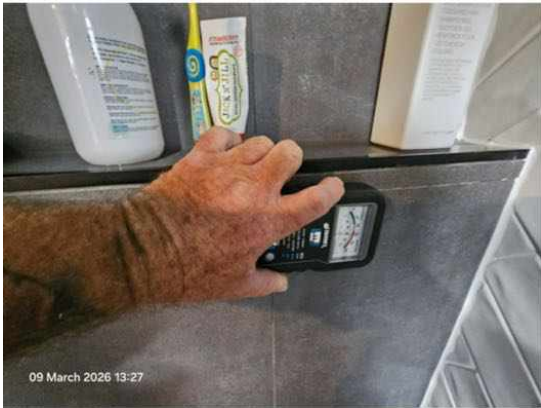
Finding 2.04

Building: Main Building
 Location: Ensuite - Master
 Finding: Elevated moisture present - ensuite shower
 Information: Elevated moisture was noted in the tiled wall surfaces of the ensuite shower.

The levels varied at differing points throughout the recess. This could possibly be due to deteriorated grout and silicone sealants and / or plumbing fittings and fixtures. The grouts and sealants can break down over time and become porous, allowing moisture to enter the wall sheet surface behind the tiles. It was reported on the day that this shower has recently been sealed by a shower restoration service; therefore, the moisture detected in the tile surface may be residual. The readings on the reverse side,

Moisture was also detected the in the walls on the reverse side of the shower in the bedroom. This wall surface is behind the tap combination.

Elevated moisture can attract timber pests and vermin, and produce conditions that promote timber pest attack, fungal growth and wood decay.

It is recommended that the moisture levels in these areas be monitored over time to confirm that the tiles surface restoration work was successful.

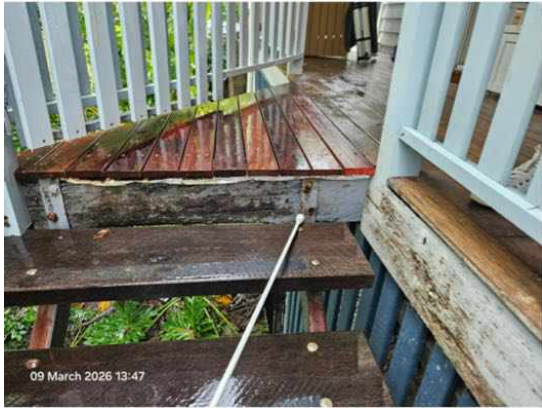
Finding 3.01

Building: Main Building
Location: Front entry
Finding: External stairs - disrepair
Information: On the day of inspection the front exterior stairs were assessed for soundness. Whilst being reasonably firm to traffic, there is rust visible in brackets and fixings missing. A noticeable bounce was evident and may require support if the client desires.

A licensed carpenter or licensed builder may be required to replace affected building materials.

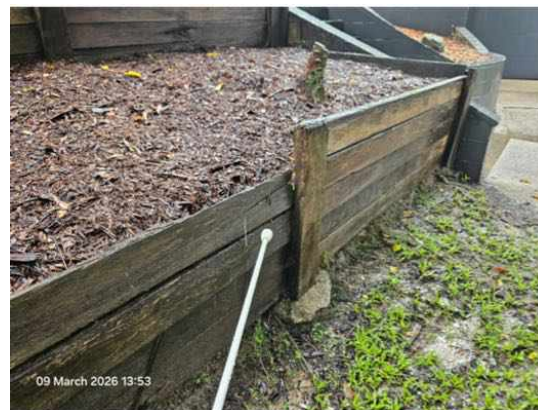
Finding 3.02

Building:	Yard
Location:	Front yard
Finding:	Retaining wall , timber - Defective
Information:	The retaining wall in this area was found to be defective at the time of inspection. Generally, defective retaining walls are caused by poor original design or material use. However, deteriorated retaining walls may also be a result of substandard construction, poor site drainage or unmanaged stormwater flows.

Repair and replacement should be expected. A landscaper may be appointed to repair or replace the wall, at the discretion of the client.

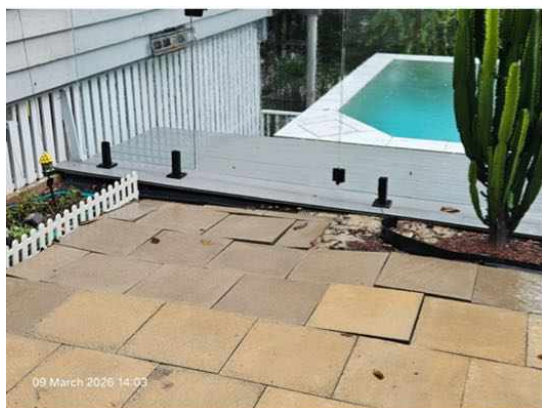
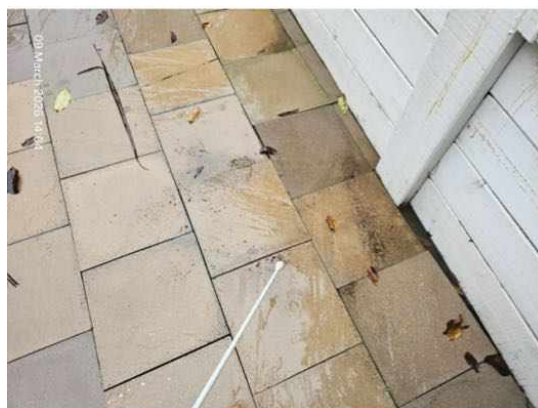
Finding 3.03

Building:	Yard
Location:	Pool Area
Finding:	Paving - subsided
Information:	The external paved area to the pool area is uneven and subsided in places. This is most likely due to moisture induced subsidence over an extended period of time. Given the observed overland flow of water and site drainage issues, it is likely that excessive moisture has affected the base materials. This can be common issue if the substrate is not prepared correctly during the initial installation / laying and with

exposure to the elements over time the base compacts. The initial base substrate may not be suitable for a pool area and excessive water exposure.

Re-paving of the area could be done at the clients discretion.

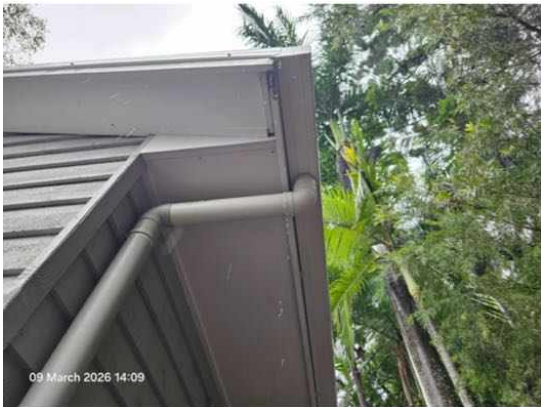
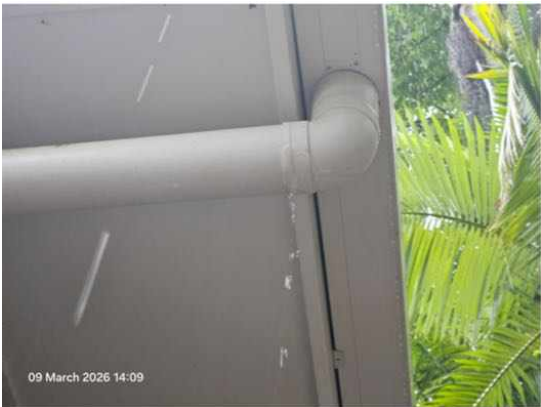
Finding 3.04

Building: Main Building
 Location: As shown
 Finding: Downpipe leaking
 Information: During the inspection of the perimeter of the building it was noted that there was a leaking downpipe. Leaking downpipes can create excess moisture at the building perimeter, leading to conditions conducive attractive to timber pests.

The client could engage a plumber to assess and resolve the leak.

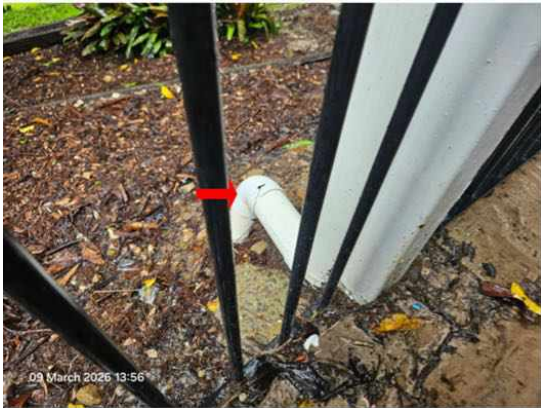
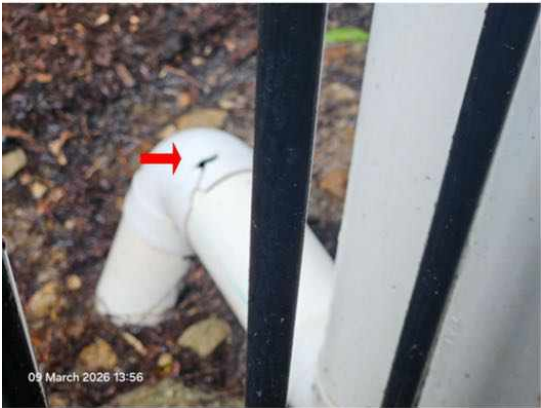
Finding 3.05

Building: Main Building
 Location: As shown
 Finding: Downpipe - Connection broken
 Information: The downpipes at the corners of the house show evidence of breakage and are not connected to the stormwater system adequately.

This leads to excessive moisture in the areas around the pipes and against the foundations of the house. This can lead to conducive conditions for timber pests and vermin infestation and have adverse effects on the foundations and external brickwork.

A licensed plumber may be appointed to repair the downpipe connections.

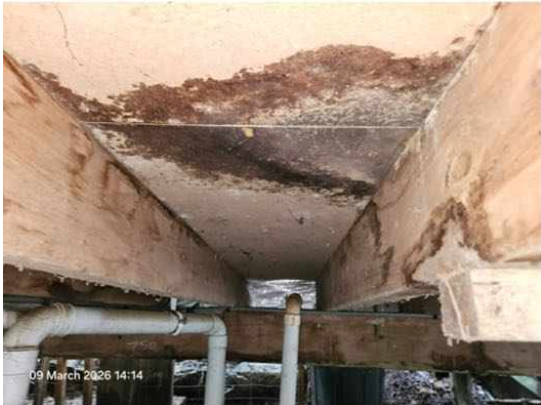
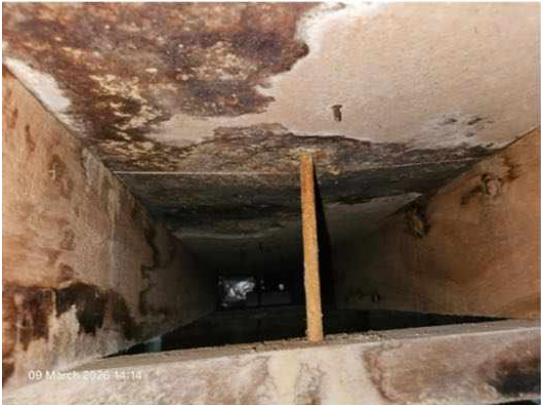
Building: Main Building
 Location: As shown
 Finding: Floor sheets - Water stained
 Information: Water staining to underside of the floor sheets in the areas beneath the bathroom, hallway and laundry were evident at the time of inspection. Water staining indicates that surfaces have been exposed to moisture over time. The stains did read as high in

moisture in some locations on the day of inspection; however they should be monitored over time and if they indicate an increase in moisture level, the floor surfaces and plumbing fixtures in these areas should be assessed. The conditions on the day were wet environmentally and it appears that some of the stains are remnants of a previous water leak. A current water leak has recently been repaired and it was reported that the elevated areas were from this bathroom shower rose leak. It is possible that many of these stains are remnants of a previous leak, occurring prior to the bathroom / ensuite renovations.

While mostly an appearance defect, water staining can be indicative of more serious defects, which may be currently concealed. Where water staining is active, a licensed plumber must be consulted to identify the cause of the staining and to provide advice on any reparation works that may be required.

Conversely, where water staining is old and inactive, affected building materials may be repaired or replaced at client discretion.

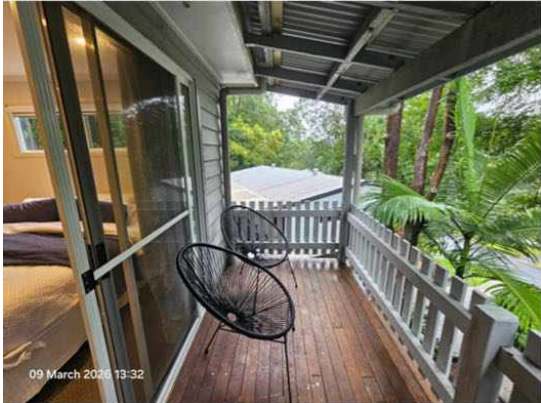
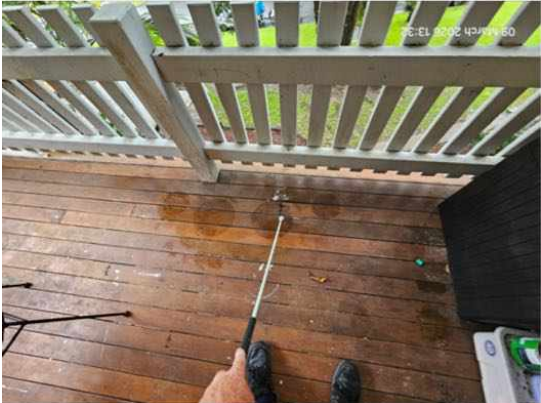
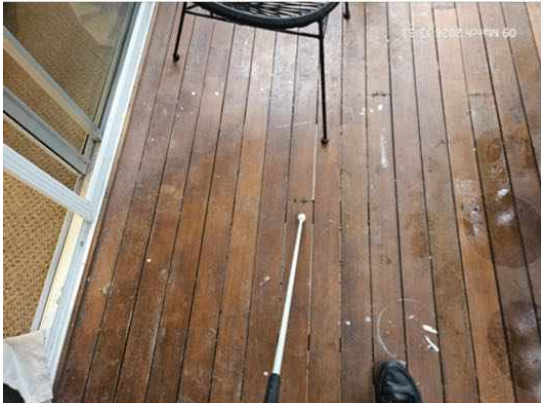
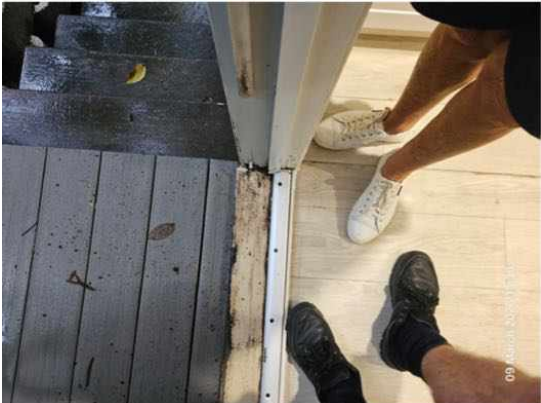
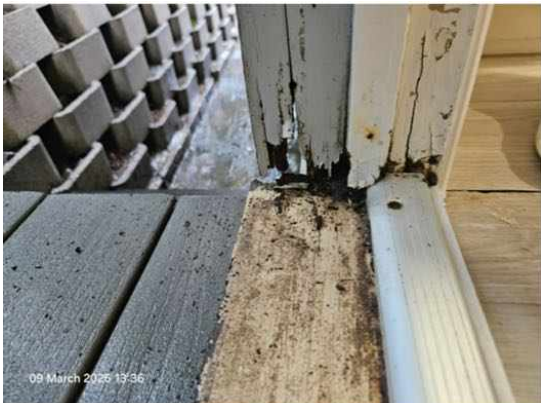
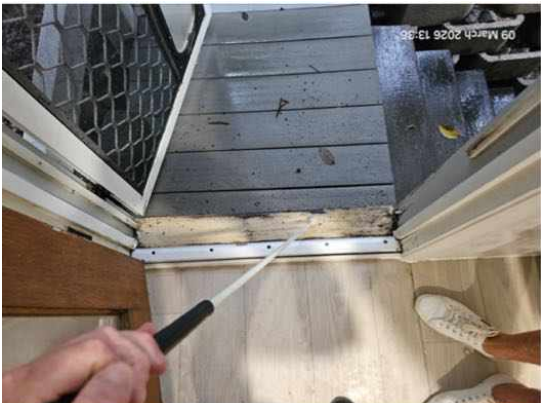
Building:	Main Building
Location:	As shown
Finding:	Wood rot / fungal decay
Information:	The timber components show evidence of wood rot in various sections of the timber.

Wood rot, also known as Fungal Decay, occurs when timbers and other cellulose building materials are exposed to damp conditions on an ongoing basis. This could be the result of exposure to weathering over a prolonged period of time, or the attraction of excessive moisture from other abutting building materials.

the useful life of these building elements. Prior to any works being performed, the cause of the moisture that has created the visible wood rot should be identified and addressed in a suitable manner. Replacement of affected timbers may then be a necessary step in protecting surrounding building elements from such deterioration.

A licensed carpenter or licensed builder should be consulted to advise on a solution for the affected building materials.

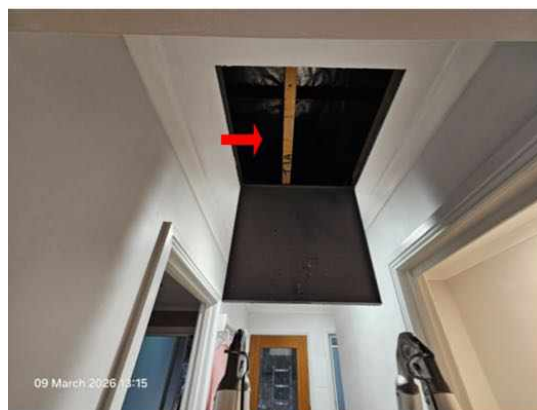
Building: Main Building
 Location: Laundry
 Finding: Ceiling access hatch - access obstructed
 Information: The ceiling space was not fully accessible due to the roof truss shown being positioned directly across the centre of the opening. The opening and the access are considered unsafe / difficult to attempt access.

Only a partial visual inspection from the ladder was possible.

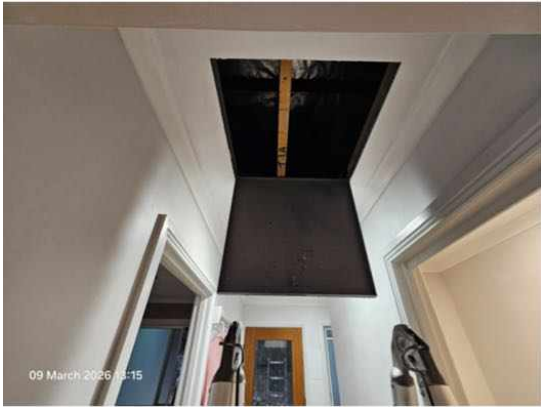
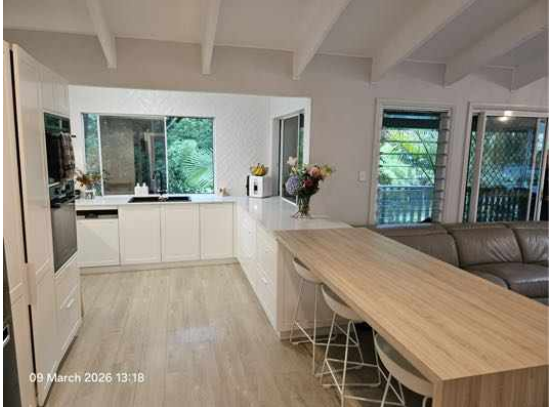
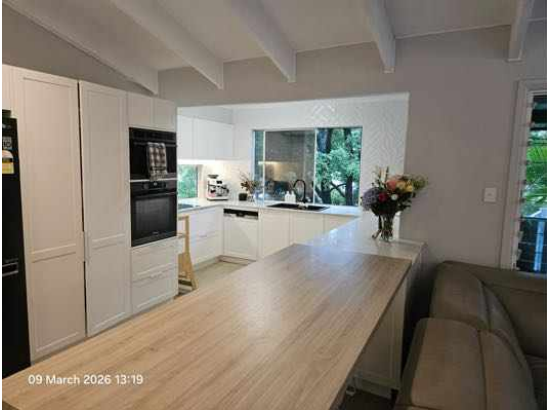
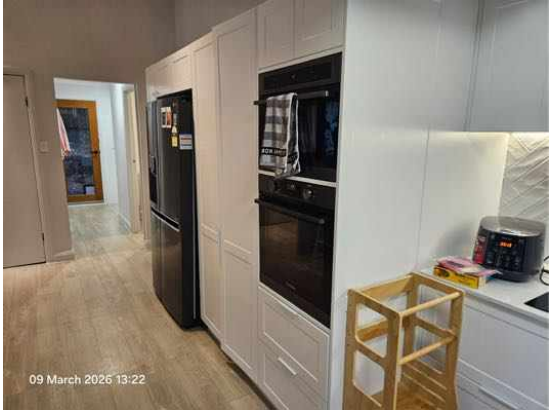
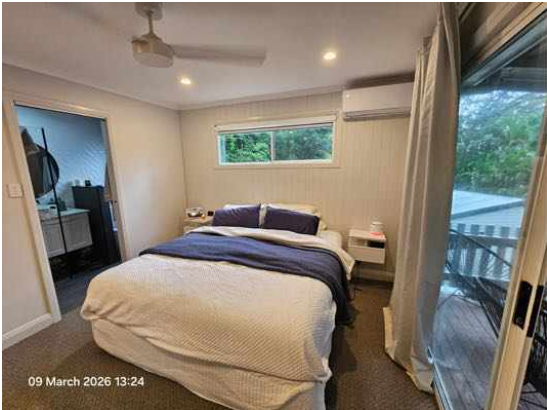
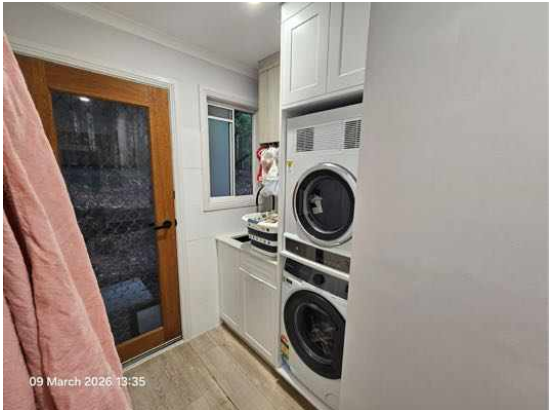
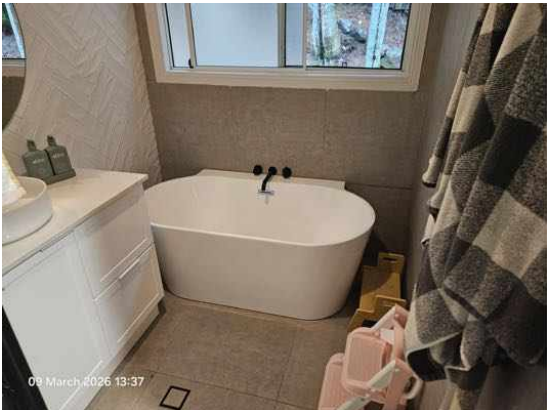
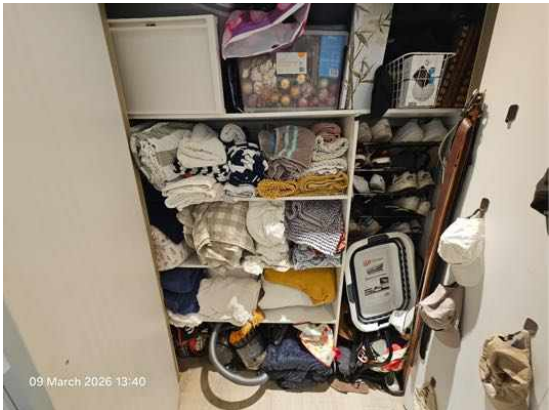
Building: Main Building
 Location: All Areas
 Finding: Additional Photos - Obstructions and Limitations
 Information: These photographs are an indication of the obstructions and limitations which impeded full inspection of the property at the time of inspection. These obstructions can prevent full inspections of the areas shown.

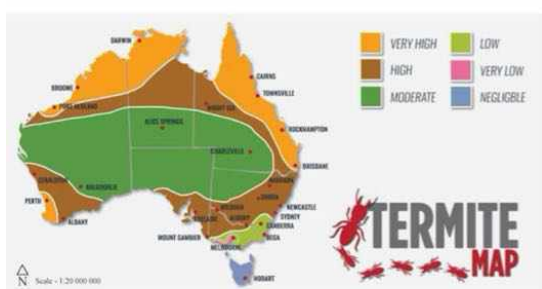
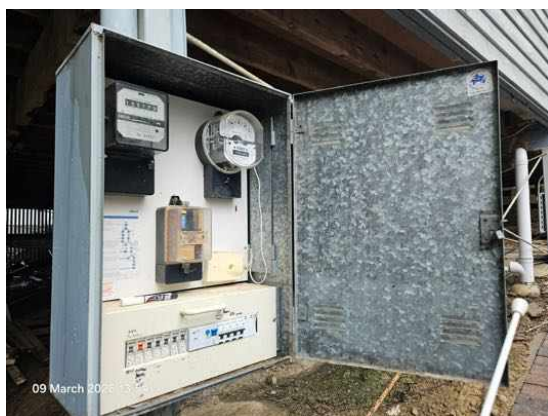
The building had a chemical barrier applied at construction. There is no evidence of a current barrier other than the visual inspection zone in the subfloor. In order for a barrier system to be effective, the property must have regular inspections at intervals of not greater than 12 months. Depending on the risk profile attributed to the property, these inspections may be recommended at lesser time periods.

Where a Termite Management System has been identified you should refer to the type of barrier, date of installation, warranty conditions and any documentation provided by a builder or past owner. Consult the company who installed the barrier to confirm whether the system is still under warranty.
