Building and Timber Pest Inspection Report

Inspection Date: Fri, 16 Jan 2026

Property Address: 15 Esplanade, Semaphore South SA 5019,
Australia

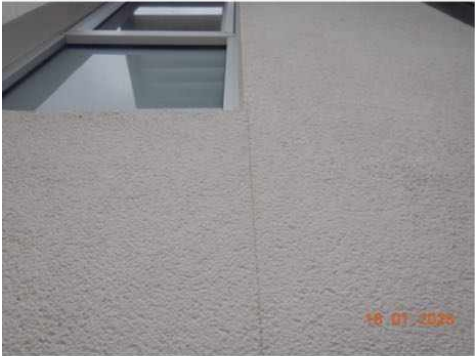
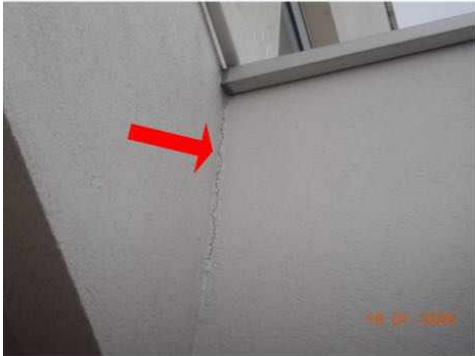
Building: Building 1
Location: Exterior walls
Finding: Render - Cracking [Fine] Hebel
Information: There are fine cracks evident to several small areas of rendered wall of the building which coincide with windows and or internal corners which is quite common in this type of hebel construction.

Although fine cracks are quite noticeable, they are often only considered to be an appearance defect and usually do not indicate any structural damage. Generally, the cause of a fine crack is indicative of general settlement or environmental/ seasonal factors.

Cracking of this nature can generally be repaired with minor filling and should be conducted by a qualified plasterer or painting contractor and could be carried out at the discretion of the client.

Always contact Jims Building Inspections for reinspection should further sustained movement become apparent.

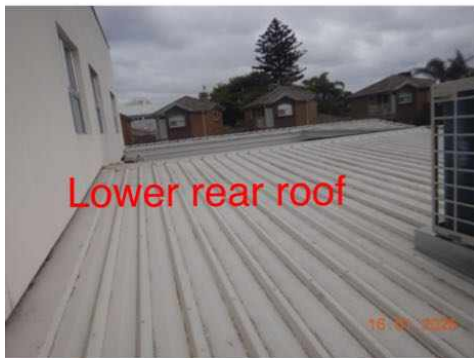
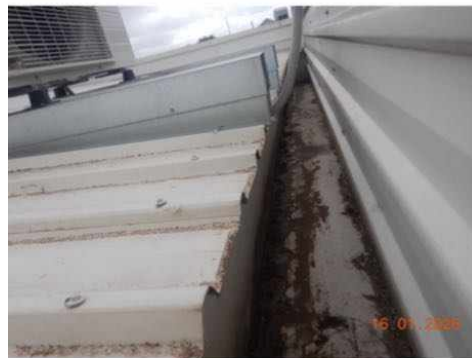
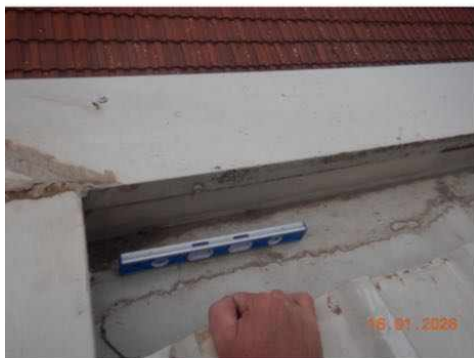
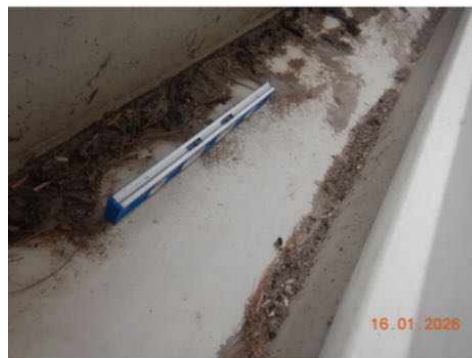
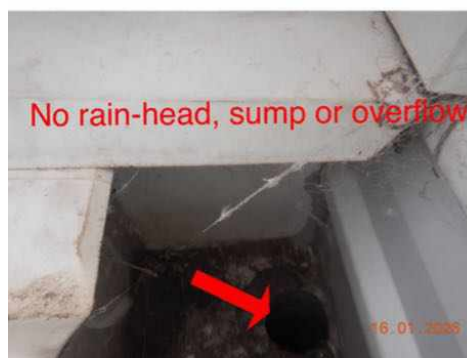
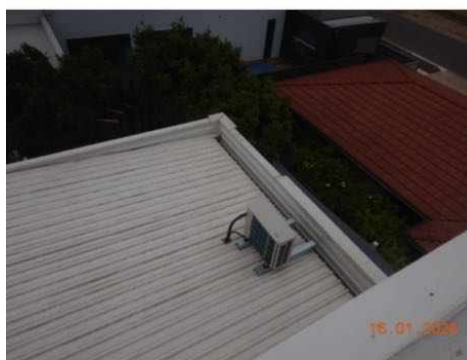
Finding 3.02

Building: Building 1
 Location: Roof Exterior
 Finding: Box gutters minor defects
 Information: It was noted that compliance issues exist with the box gutter system on the roof, main issues being

- Non compliant outlet and overflow size lower rear roof.
- Gutter changing direction upper roof.
- Some areas have inadequate fall.

(b) Gutters discharge, Box gutters to discharge at the downstream end without change of direction (i.e. not to the side).

Additional works would increase the functionality of the gutter system and could be a consideration in the short to mid term and should be carried out by a licensed, experienced roof plumber.

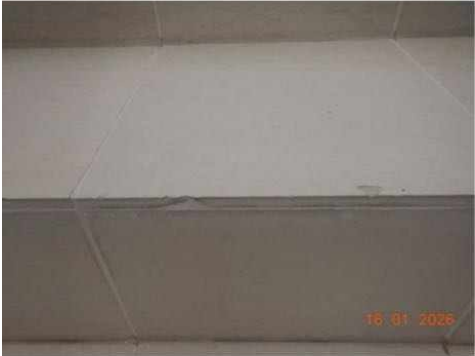
Finding 3.03

Building:	Building 1
Location:	Front Elevation
Finding:	Deteriorated Tiling, sealant and grout Balcony
Information:	It was noted on inspection that tiling, sealant or grout to the front porch and balcony is showing signs of deterioration with minor chips to stairway and deteriorated grout in some sections.

Flexible and mould resistant materials should be applied to any damaged areas to prevent any subsequent water damage that is likely to occur. Regular maintenance and replacement of damage or missing or damaged sealant and grout is highly recommended to the wet areas, as this is a regular wear and tear defect.

Deteriorated sealant and grouting in areas that come into regular contact with water should be maintained for the long term care of your property. A sealant specialist or tiling contractor should be appointed to complete these works as soon as possible

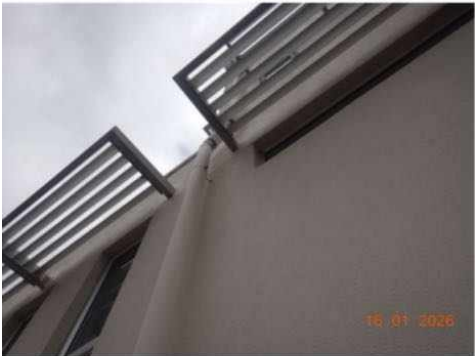
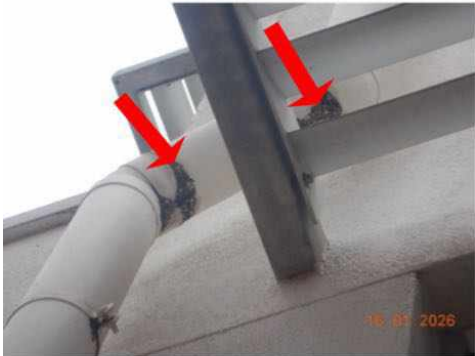
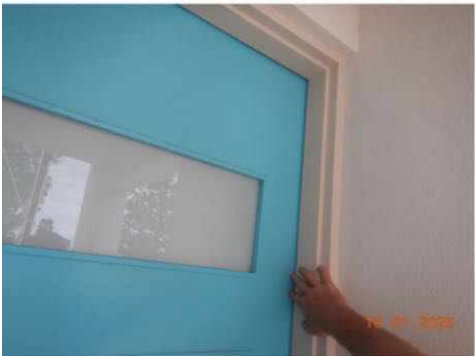
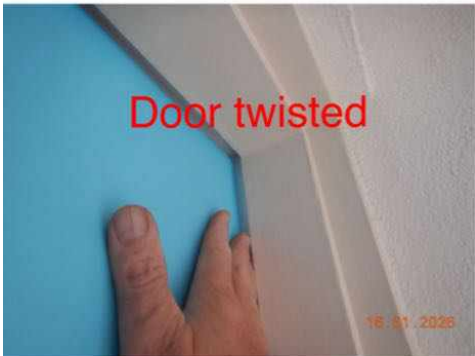
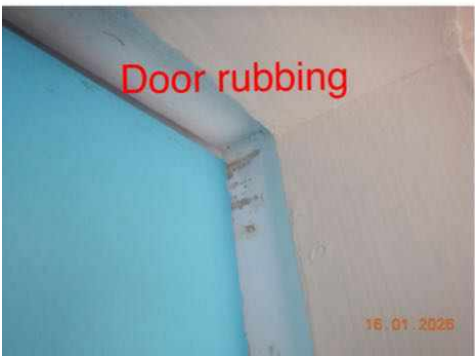
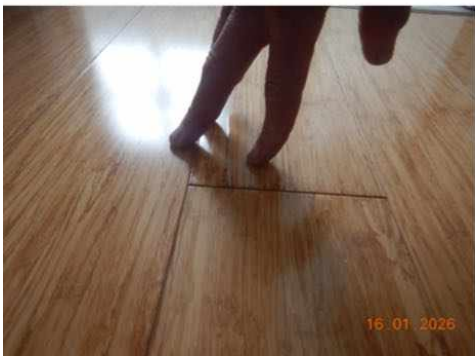
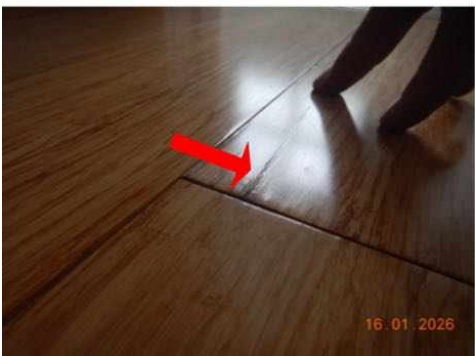
Finding 3.04

Building: Building 1
 Location: All Areas
 Finding: Minor defects present
 Information: There were several age and maintenance related defects evident to the dwelling at the time of inspection. These defects include but are not limited to

- Several dents to roofing
- Solar panels require cleaning
- Stormwater pipe appears to be leaking
- Front door twisted
- Minor mop/ moisture damage to floors

Appropriate licensed trades people could be appointed to make repairs at the discretion of the client.

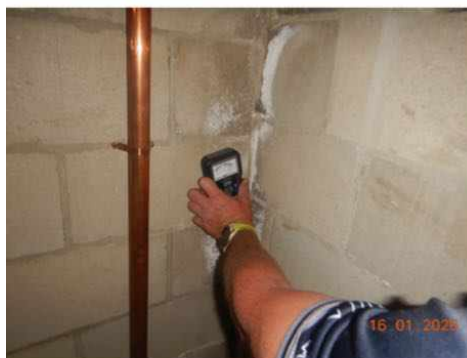
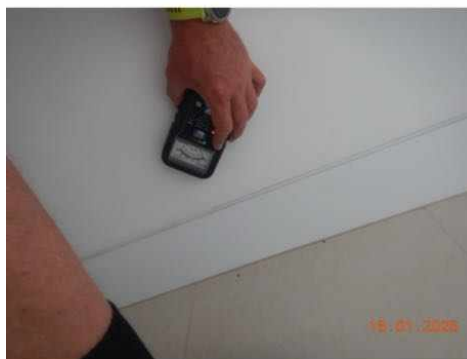
Building: Building 1
 Location: Stair well and lower wall
 Finding: Exterior walls - Lateral damp
 Information: There were high readings for moisture in the lower section of wall to the stair leading to the garage and the undercroft wall directly below this, at the time of inspection.

As moisture appears to be concentrated to one area, it is likely that a small issue is present, possibly linked to the stormwater pipe in the area.

Lateral penetrating damp refers to the sideways movement of moisture, predominantly from the earth retaining structures.

The implications of unmanaged damp range from mould fungi growth, wood rot and decaying building materials, to finishes including lifting, bubbling, peeling and staining of paint and plaster.

Additionally, the development of damp in proximity of timber building elements provides an environment that is conducive to termite / timber pest attack.

It is recommended to have a licensed plumber inspect the area in an attempt to ascertain where the issue is and provide remedial advice and works to prevent further deterioration

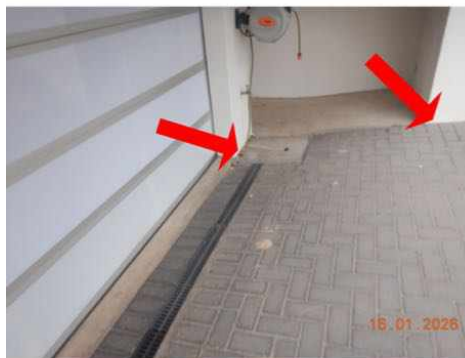
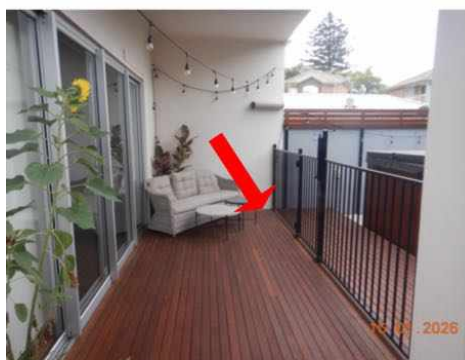
Finding 6.02

Building:	Building 1
Location:	All External Areas
Finding:	Slab Edge - Exposure
Information:	An inspection zone of at least 75mm in relation to the exposed slab edge, between the bottom brick and the perimeter pavement, is required. This inspection zone should be maintained in order to force termites into the open where they can be detected more readily during regular inspections. The slab edge should not be concealed by anything that may prevent inspection of the area, including render, landscaping, soil, turf, paving, concrete cladding or other structures.

If the slab edge is not properly exposed there is a high risk of concealed termite attack which your inspector will likely not be able to see. Sometimes, in order to determine the type of slab, a suitably qualified person such as an architect or builder may be required to consult construction plans.

Where the slab edge cannot be properly inspected, it is highly recommended that termite or timber pest inspections be carried out every 6-12 months to aid protection of the property against infestation and termite treatment advice is followed closely.

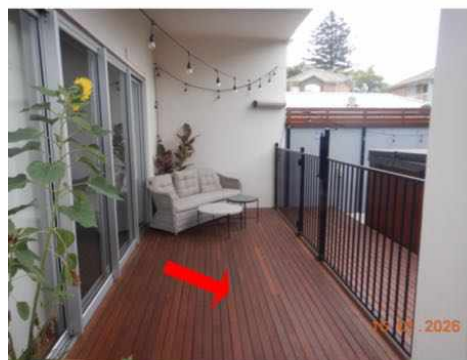
Finding 6.03

Building:	Building 1
Location:	Yard - Back
Finding:	Untreated or non-durable timbers in a hazardous environment
Information:	To reduce the risk of timber pest attack it is essential that timber used in a hazardous environment (e.g. in direct contact with the ground or frequently exposed to damp conditions) is of sufficient durability and/or is adequately preservative treated. Additionally any timber lying around or timber stumps should be removed.

Untreated timbers in direct contact with the ground are likely to develop severe wood rot and/or fungal decay if left unattended creating attraction for subterranean termites to infest the timbers from surrounding areas.

If untreated or non-durable timbers are found to be in a hazardous environment it is highly advised that replacement of these building elements be performed as soon as possible to aid the protection of the property against termite / timber pest attack. Failing this close monitoring is recommended in an attempt to identify termite infestation at an early stage.

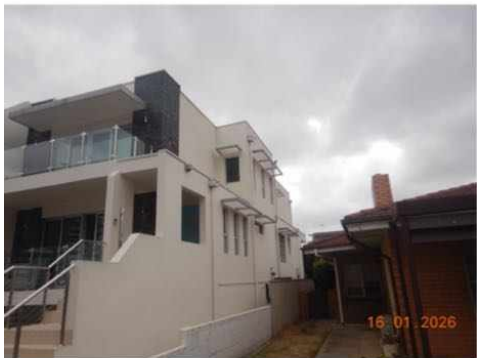
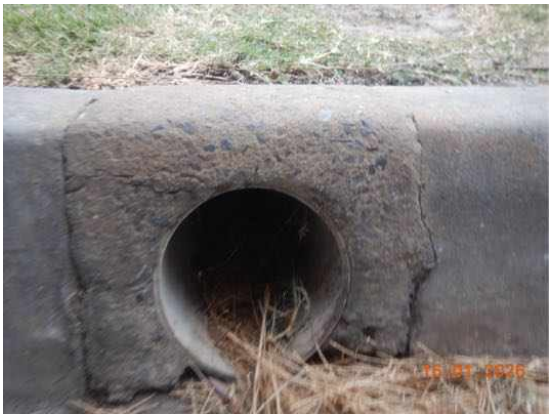
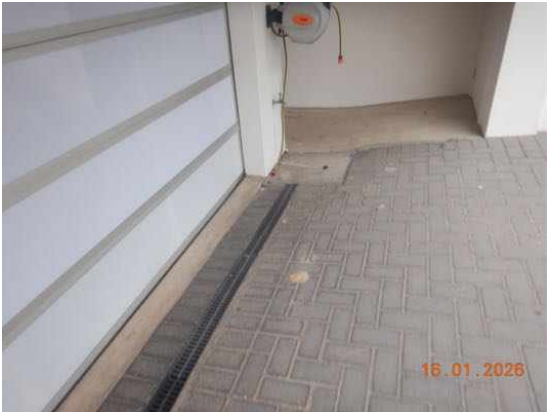
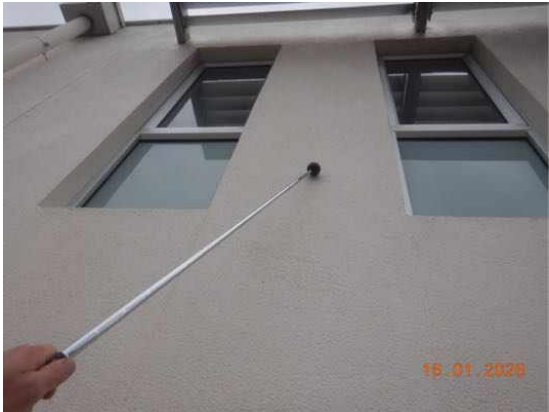
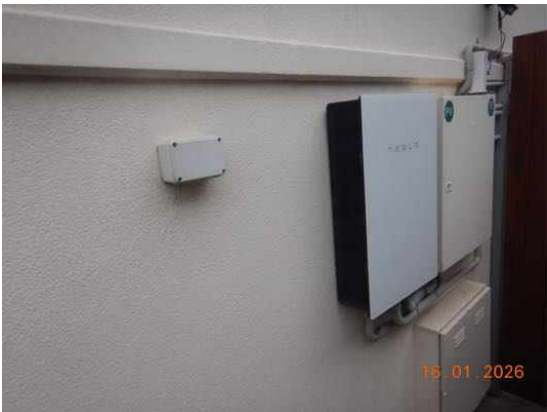
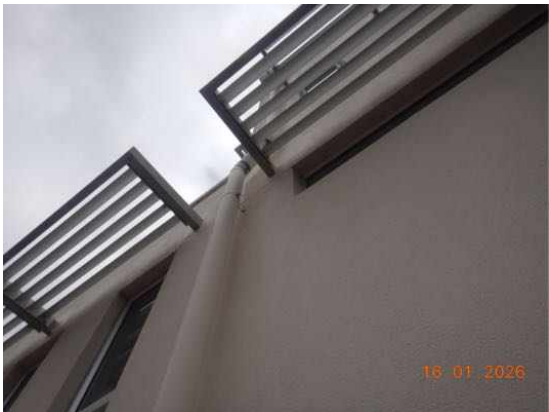
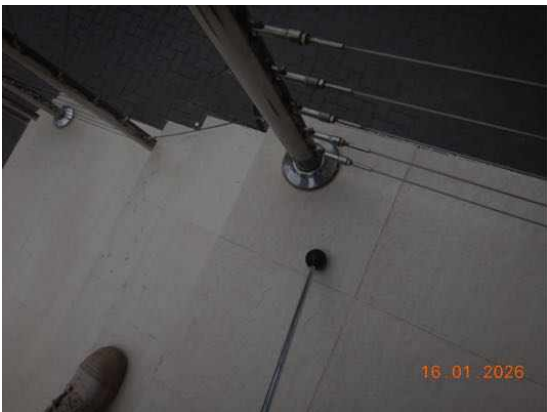
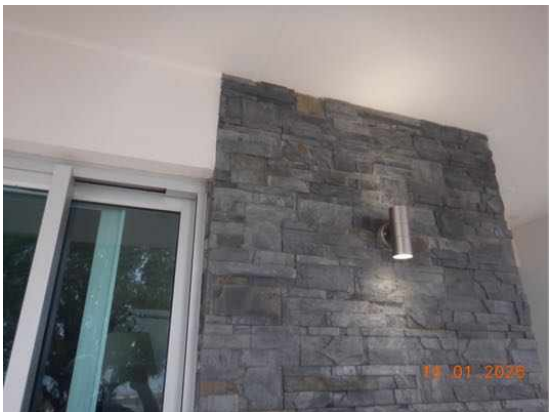
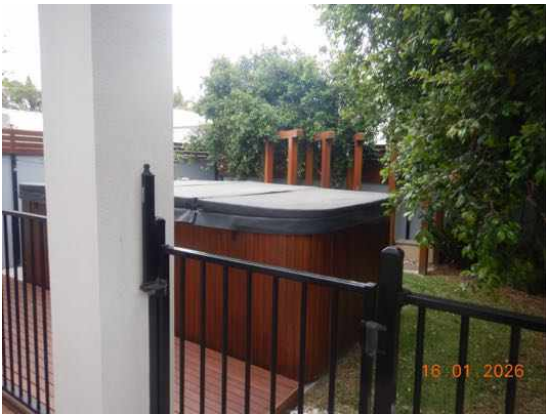
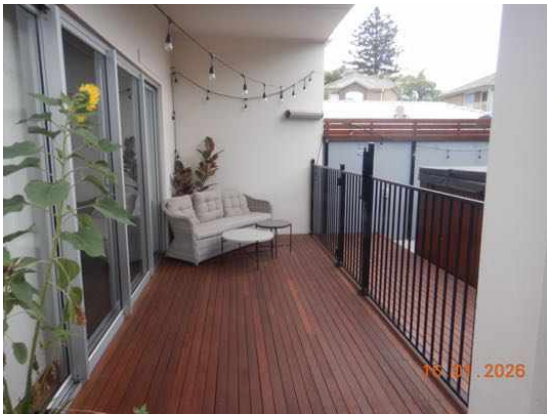
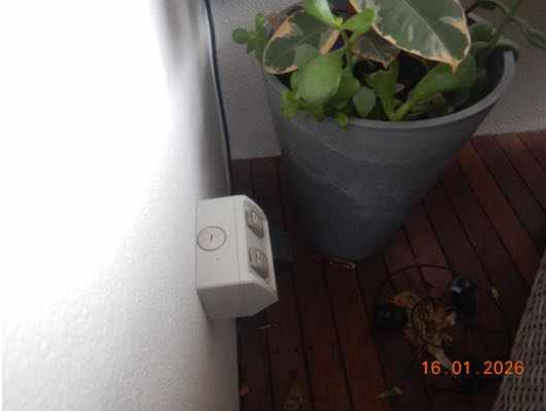
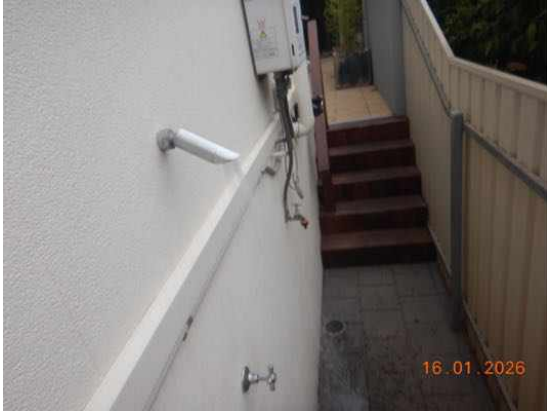
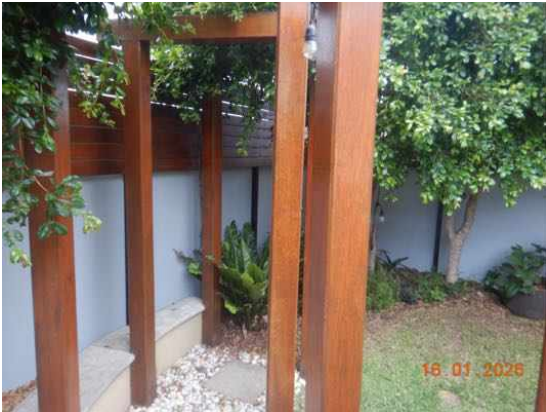
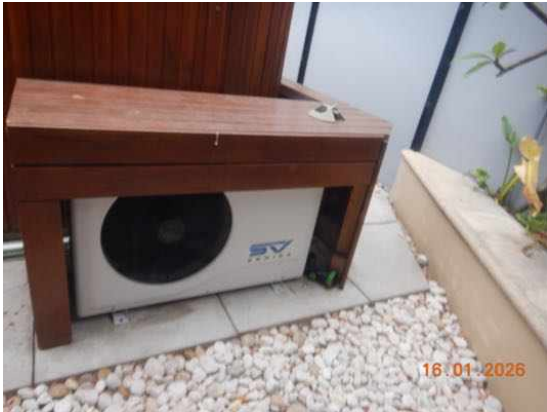
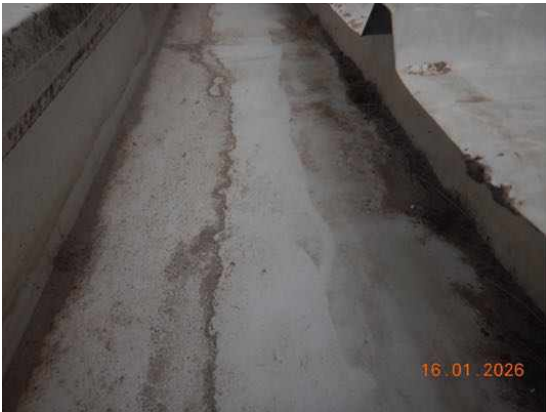
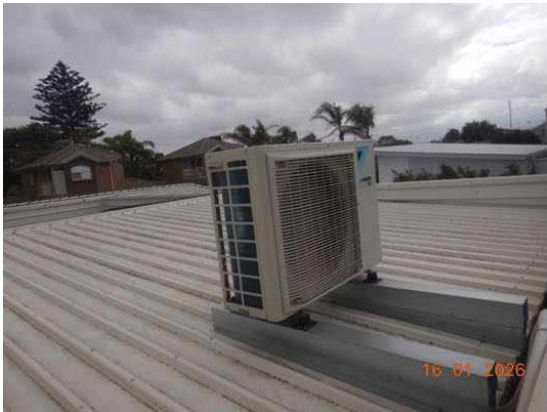
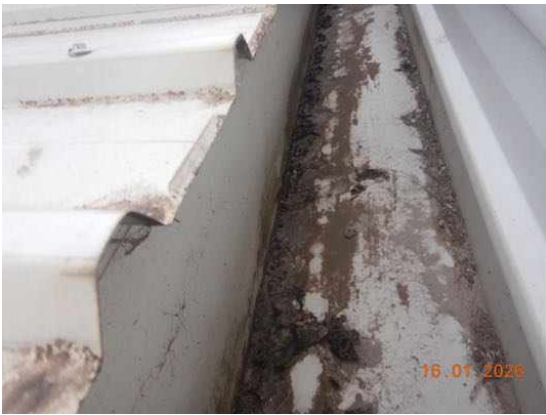
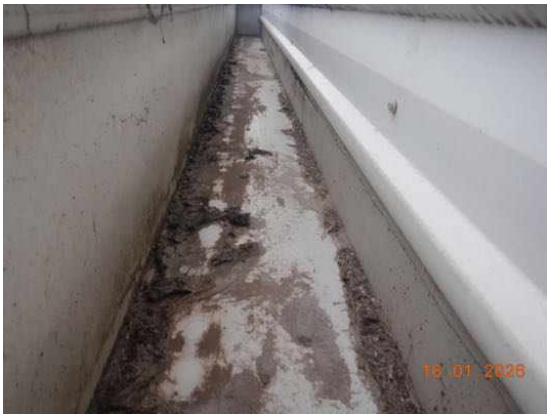
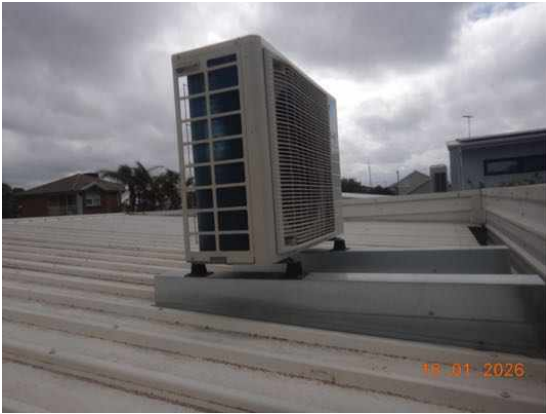
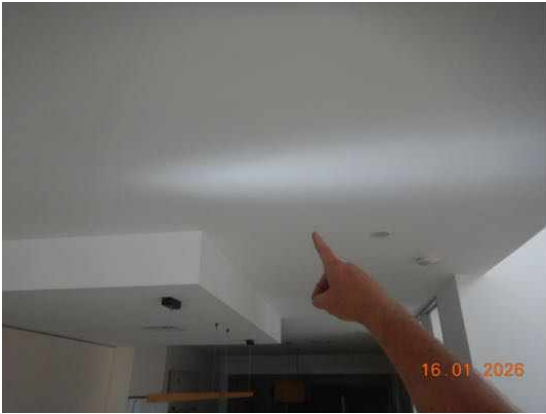
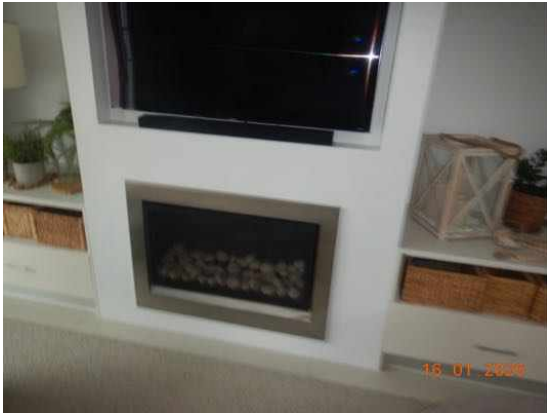
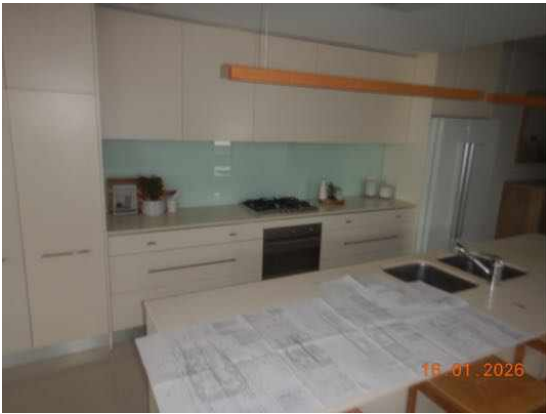
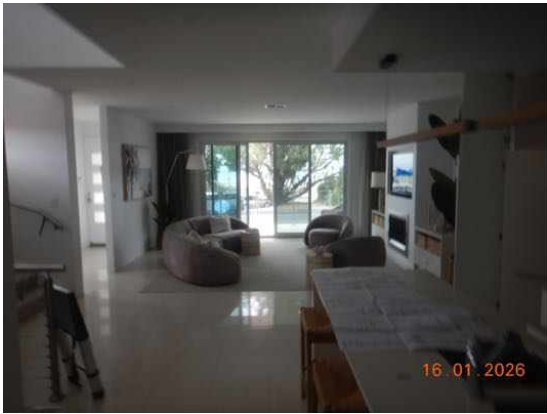
Building: Building 1
 Location: All Areas
 Finding: Additional Photos - Obstructions and Limitations
 Information:

These photographs are an indication of the obstructions and limitations which impeded full inspection of the property at the time of inspection. These obstructions can hide an array of defects and should be removed to allow full inspection to be carried out.
