Building and Timber Pest Inspection Report

Inspection Date: Mon, 9 Feb 2026

Property Address: 4/53 Horbury St, Sans Souci NSW 2219,
Australia

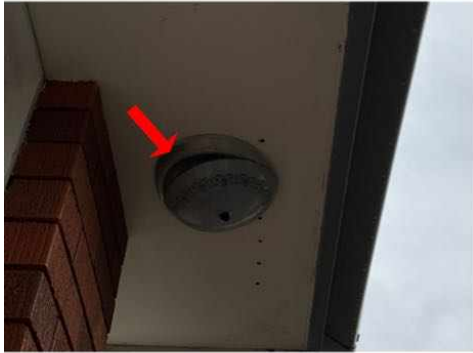
Finding 3.02

Building:	Main Building
Location:	Eaves
Finding:	Damaged Building Elements.
Information:	These type of defects generally occur when the building materials have either aged and decayed, or as a result of impact damage (accidental or deliberate).

Such works are necessary, as all building elements play a key role in the operation and function of the overall structure and its performance.

Relevant tradespersons should be appointed to repair or replace the affected building elements prior to any subsequent damage being caused.

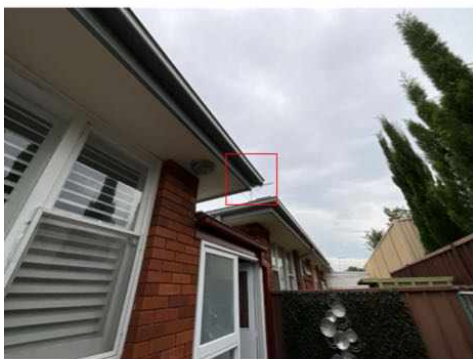
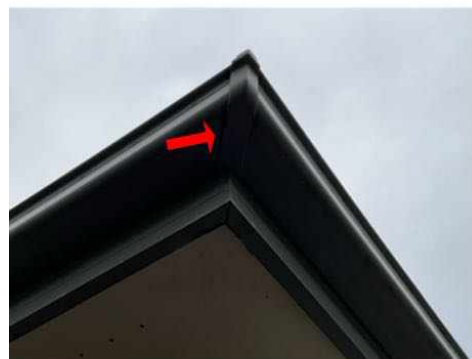
Finding 3.03

Building:	Main Building
Location:	Roof Exterior
Finding:	Suspected gutter leaking
Information:	Evidence observed during the inspection suggests that sections of the guttering may be leaking. Indicators include staining and dampness below the gutter line.

In addition, leaking gutters may increase moisture levels around the structure, which can create conducive conditions for timber decay and termite activity.

Further investigation during wet weather is recommended, and repairs or replacement should be carried out by a licensed roofing contractor if confirmed.

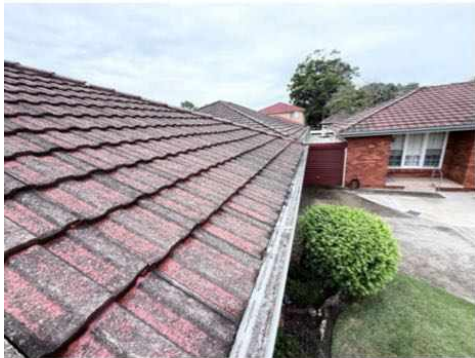
Finding 3.04

Building:	Main Building
Location:	Roof Exterior
Finding:	Roof tiles-overhang
Information:	Tiled roofing requires to overhang the inside face of a gutter by no less than

Leaving this unmanaged may lead to water ingress into the building, accelerating deterioration to associated building elements.

A roof plumber or roofing tiler may be engaged to rectify this defect.

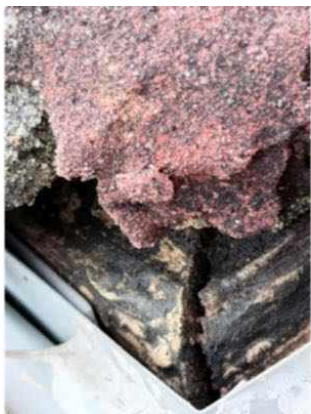
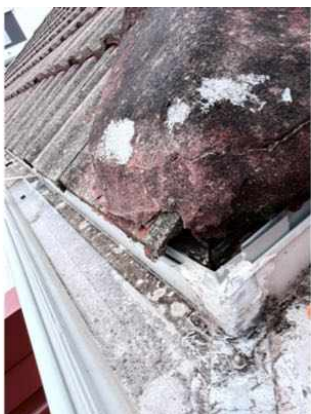
Finding 3.05

Building:	Main Building
Location:	Roof Exterior
Finding:	Roof tiles - Slippage
Information:	Upon inspection of the exterior roof covering, it was noted that numerous tiles have slipped from their original fixing. Tiles may slip over time due to a number of minor causes, including breakage of tiles, failings in the adjoining battens, or fixings that may have failed.

Mortar generally deteriorates as a result of frequent exposure to weather conditions over a prolonged period of time. Mortar that is deteriorating may allow water ingress into the roof void, putting associated building elements and roofing structures at risk of water damage. Deteriorated mortar also detracts from the functionality of roof tiles and other roofing elements, potentially decreasing weather tightness and roof drainage.

Mortar deterioration can be attended by a roofing contractor.

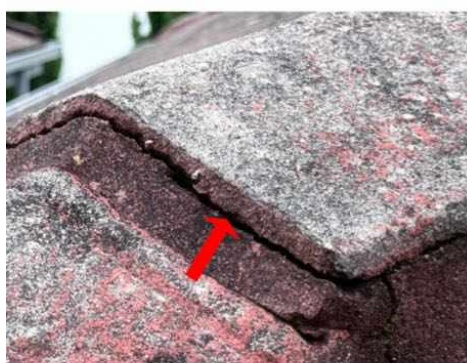
Finding 3.07

Building:	Main Building
Location:	Roof Exterior
Finding:	Roof tiles - Broken

If left to further deteriorate, broken and brittle roof tiles are likely to lead to water penetration via the roof into the ceiling space, causing secondary damage to ceiling linings, insulation and roof structures. Broken roof tiles are also likely to detract from the effectiveness of the roof drainage system, creating potential for secondary damage to the exterior roof covering and roof plumbing.

Replacement of broken tiles is required and should be performed by a roofing contractor as soon as possible.

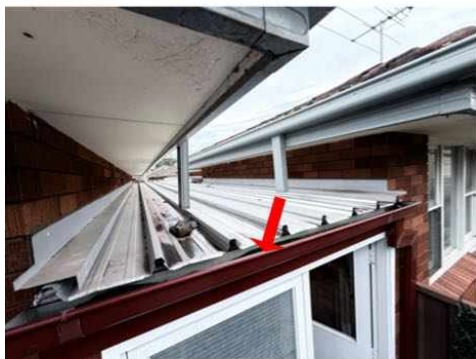
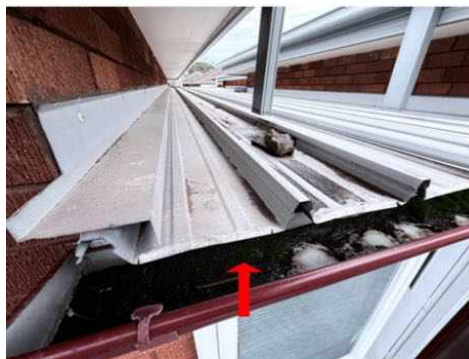
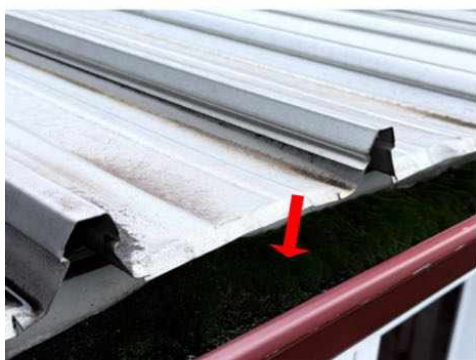
Finding 3.09

Building: Main Building

It is good building practice to install spreaders where upper-level downpipes discharge onto lower roof surfaces.

A roofing Plumber may be engaged rectify this defect

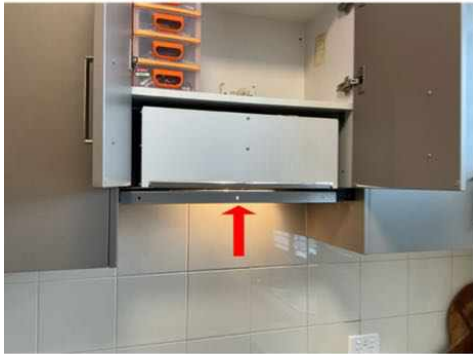
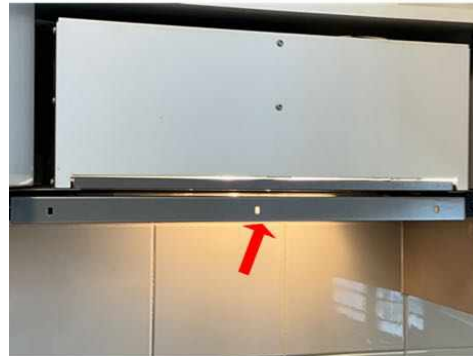
Finding 3.14

Building: Main Building

It is therefore preferable that the flue be re-directed to vent into the external environment.

A remedial builder should be appointed as soon as possible to provide further consultation on the scope of these works and to provide quotations for any necessary works.

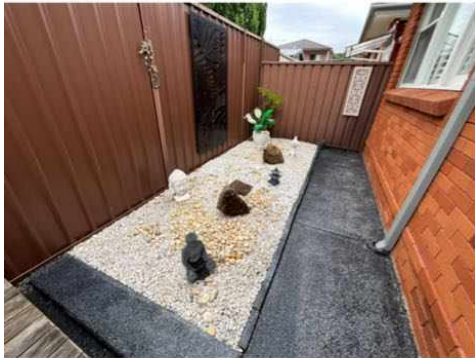
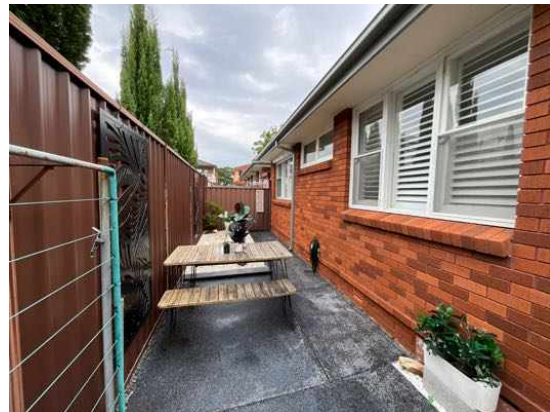
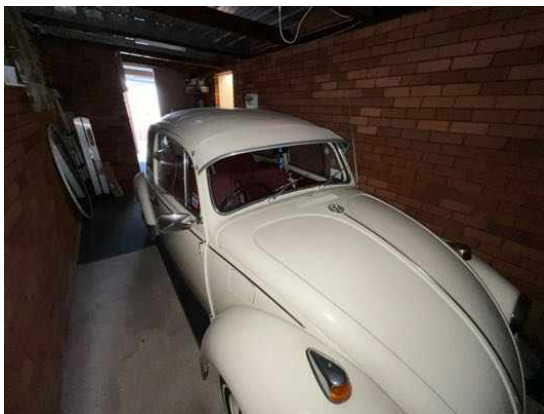
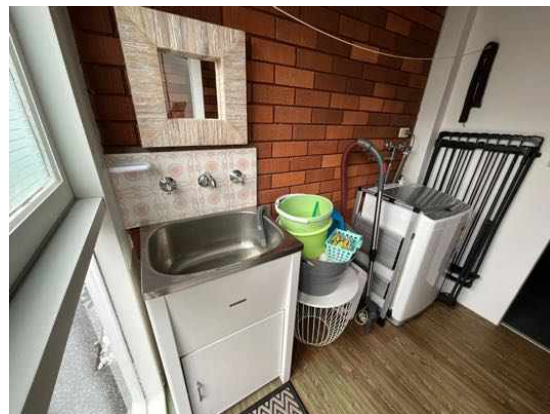
Noted Item

Building: Main Building
Location: All Areas
Finding: Additional Photos - Obstructions and Limitations
Information: These photographs are an indication of the obstructions and limitations which impeded full inspection of the property at the time of inspection. These obstructions can hide an array of defects and should be removed to allow full inspection to be carried out. A re-inspection is recommended once the areas are made accessible.

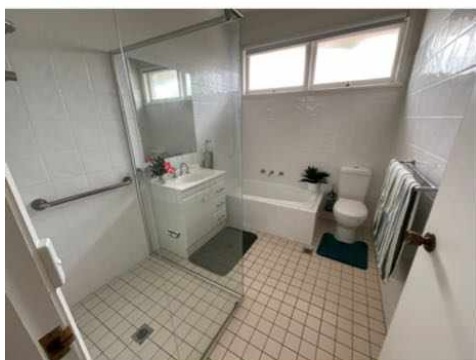
Building:	Main Building
Location:	All Areas
Finding:	Water Proofing Membranes
Information:	Internal Water Proofing Membranes, are crucial in preventing water ingress into the property.

With older property's where this information is unavailable all wet areas should be monitored. If any leaks, water staining, peeling or bubbling of the paint become evident to any adjacent walls or ceilings below a licensed builder or waterproofing specialist is recommended to investigate further.

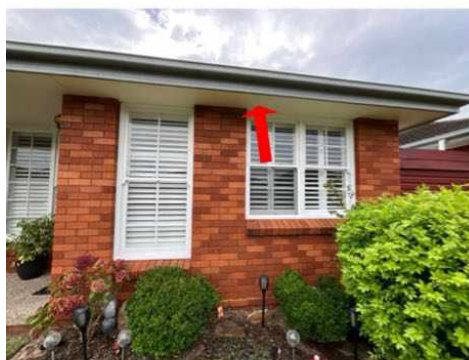
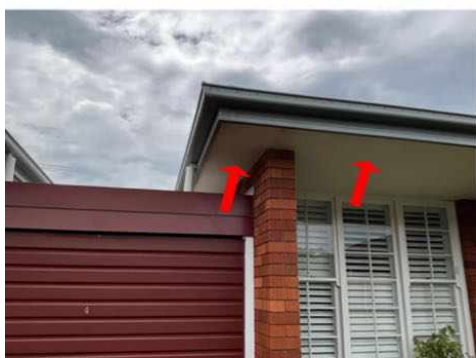
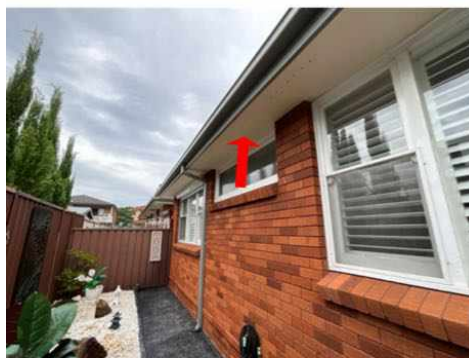
Building: Main Building
 Location: All Areas
 Finding: Asbestos - Suspected ACM Identified on Site
 Information: Reporting on Asbestos is outside the Scope of this Report. This suspected defect is highlighted as a caution only. We suspect, based on our experience in the building industry, that there is a higher risk of the identified building element containing asbestos.

As Asbestos Reporting is outside the scope of this report, we advise that you consider a separate Asbestos Inspection and Condition Audit, which can include the taking of samples for definitive confirmation of the presence of Asbestos.

In the interim, the client is advised to act with caution, especially when considering any damage to building materials general wear and tear renovations extensions demolition and general maintenance activities due to the suspected presence of Asbestos.

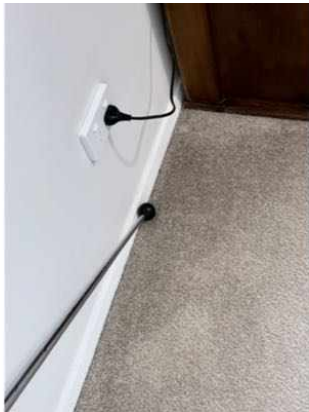
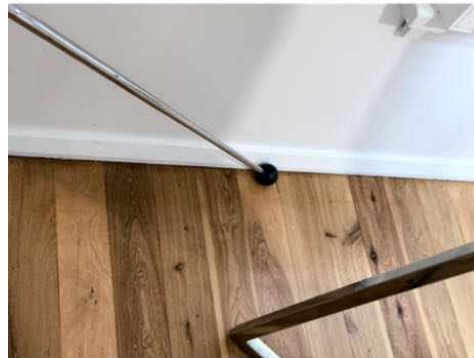
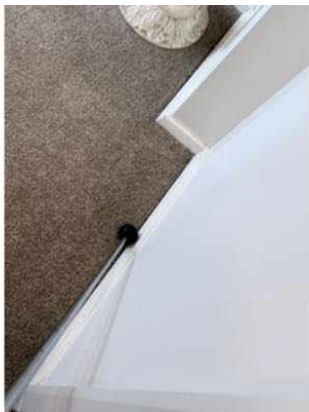
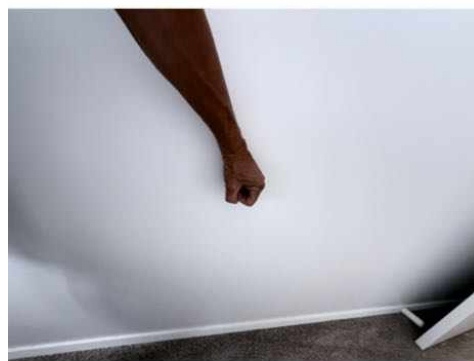
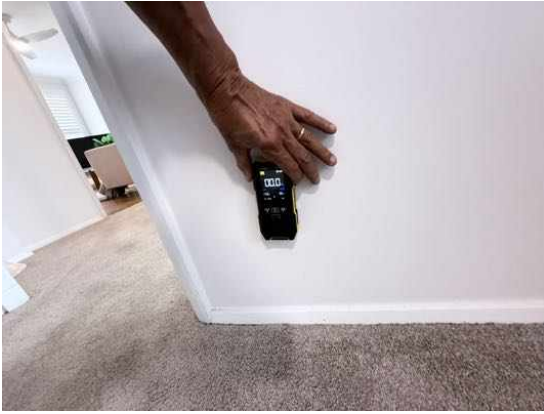
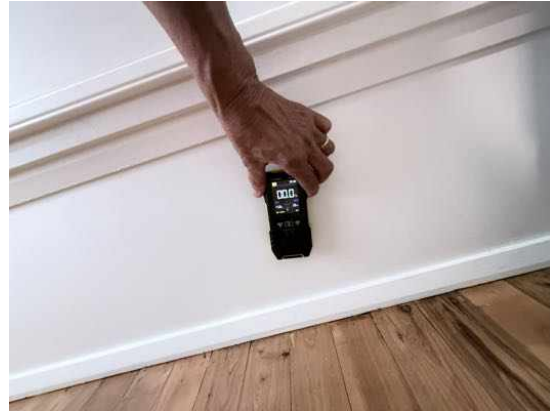
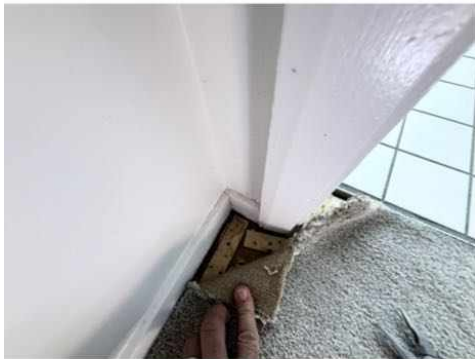
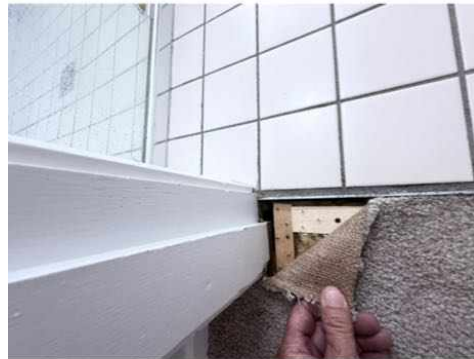
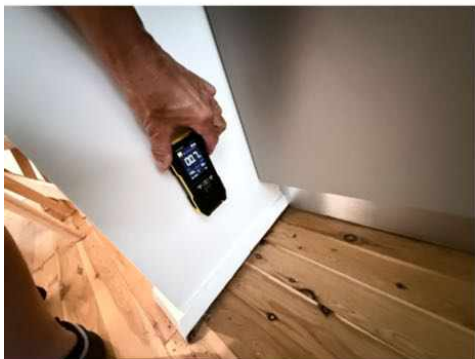
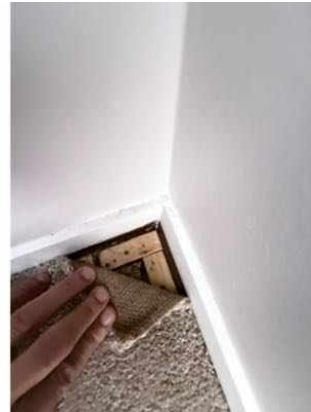
Building: Main Building
 Location: All Areas
 Finding: Termite Techniques
 Information: All areas of the dwelling are checked with particular attention paid to wet areas which were closely assessed to check for excessive levels of moisture and temperature

In an attempt to identify the presence of hidden timber pest activity, a variety of techniques are adopted to identify irregularities including, a moisture meter reading of susceptible areas, sounding of timber elements using a device called a "donga" visual assessment of materials affected by moisture or signs of deformity, trails and bridging constructed by termites, irregular and regular shaped holes in timber elements indicating pest destruction.

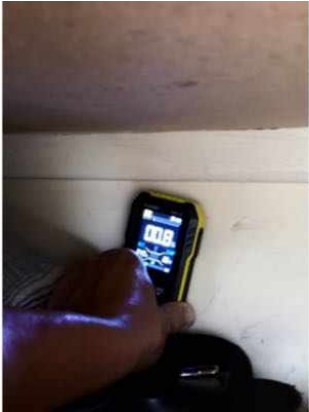
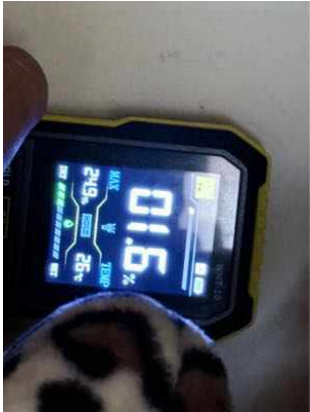
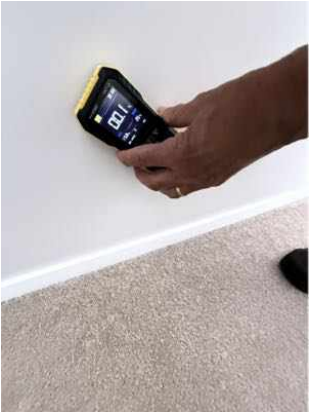
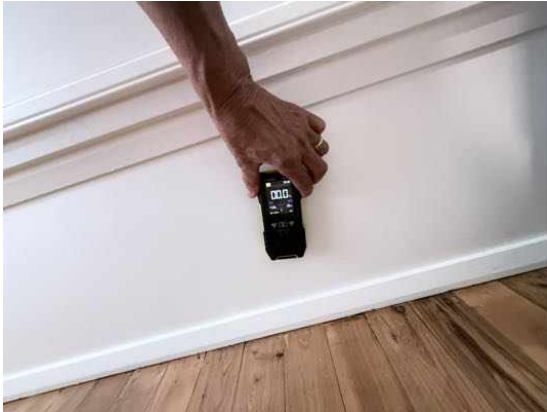
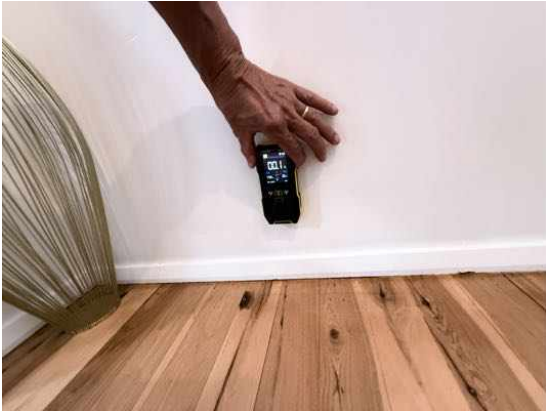
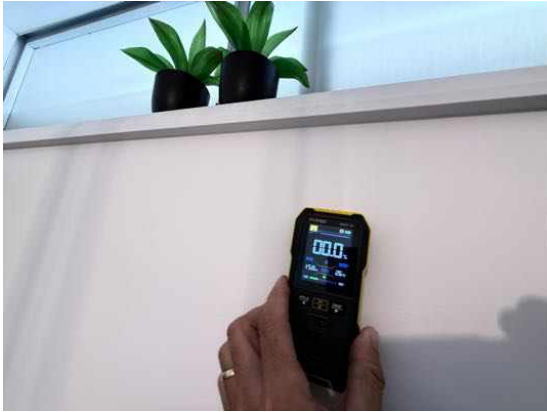
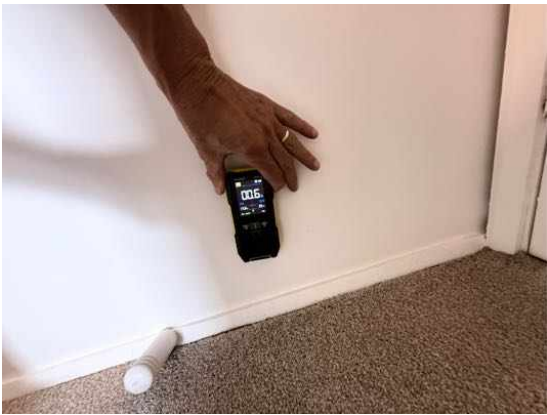
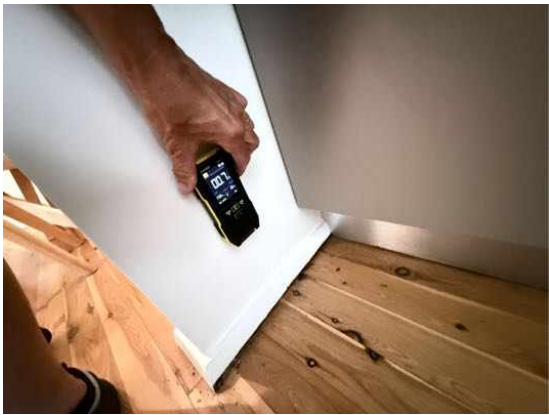
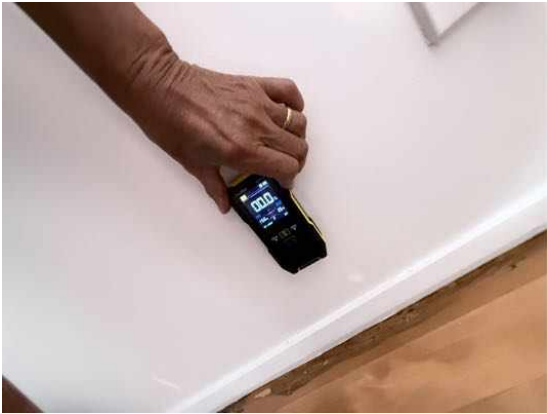
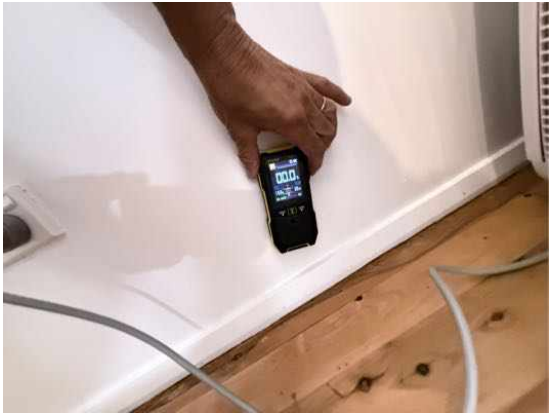
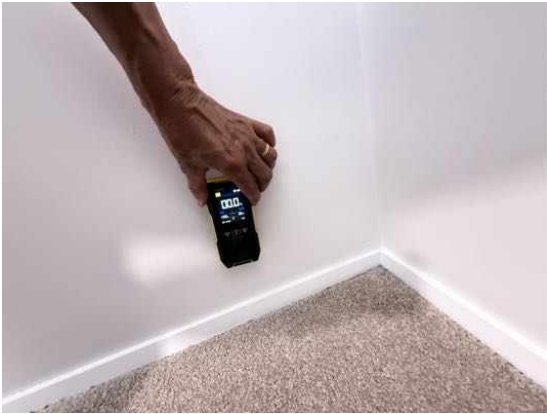
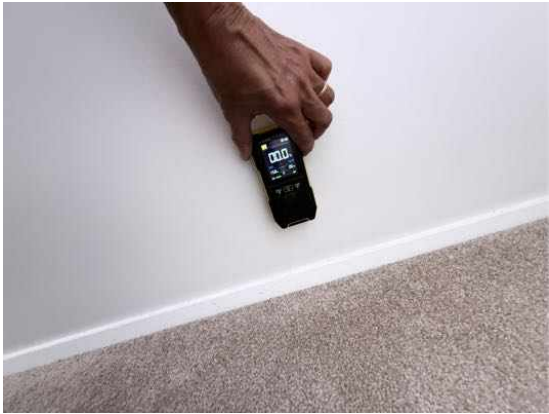
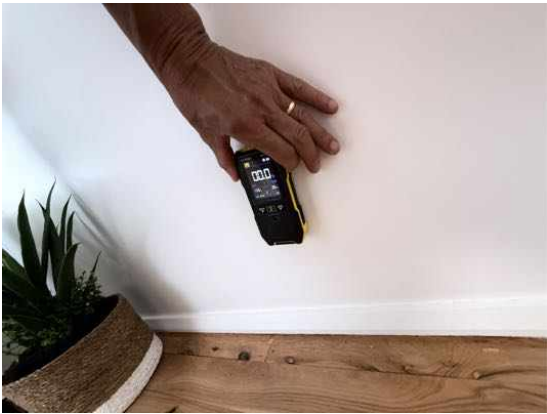
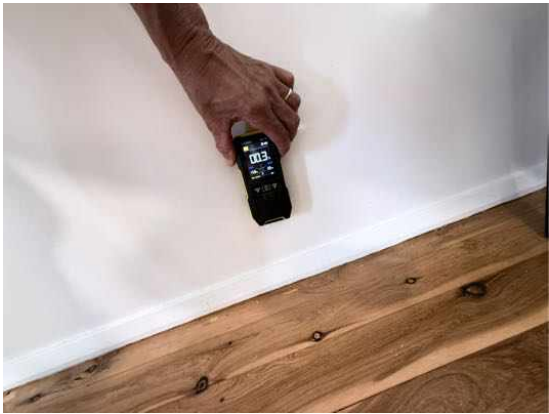
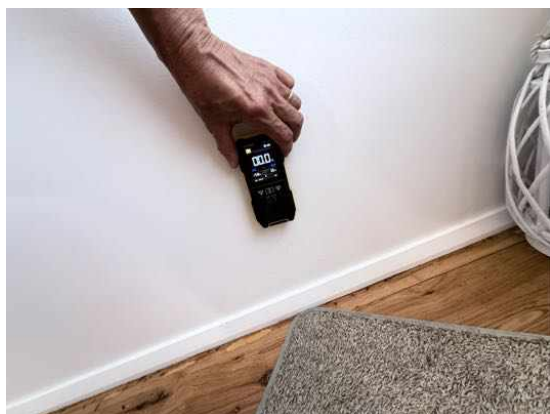
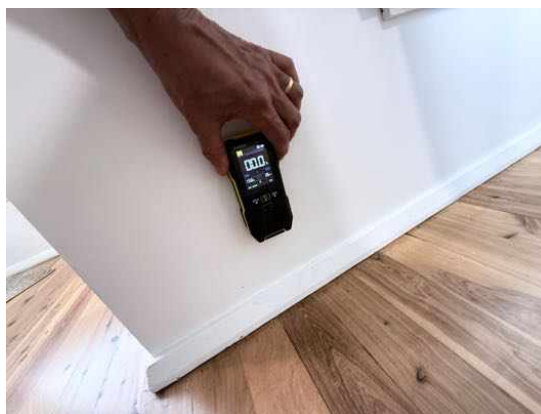
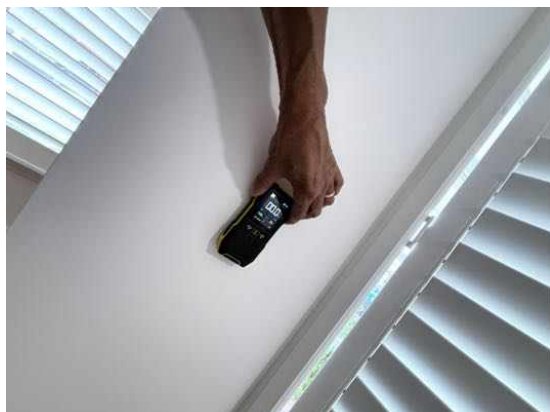
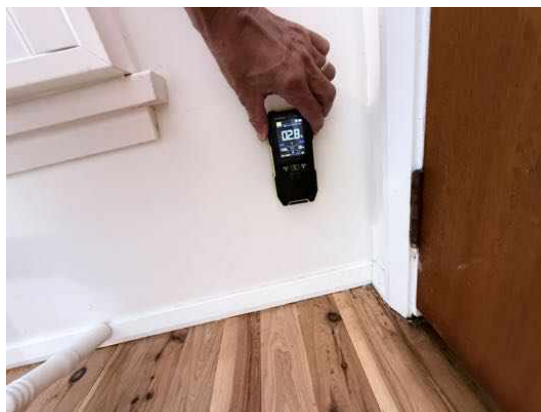
Finding: Moisture readings

Information: At the time of inspection, low moisture readings were noted in several accessible areas of the property, including, but not limited to, those shown in the accompanying photographs.

These areas were evaluated for elevated moisture levels and temperature irregularities,

which can indicate potential issues such as hidden leaks, failing waterproofing, timber pest activity or poor ventilation.

Any anomalies detected during the inspection have been documented in this report and may warrant further invasive investigation to determine their source and extent.

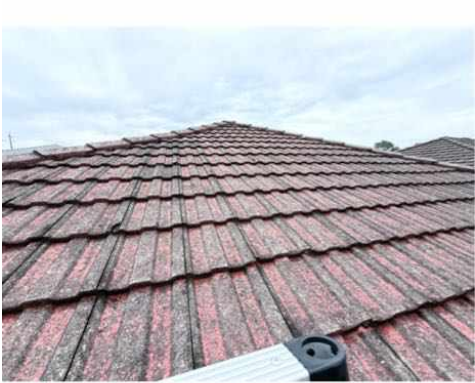
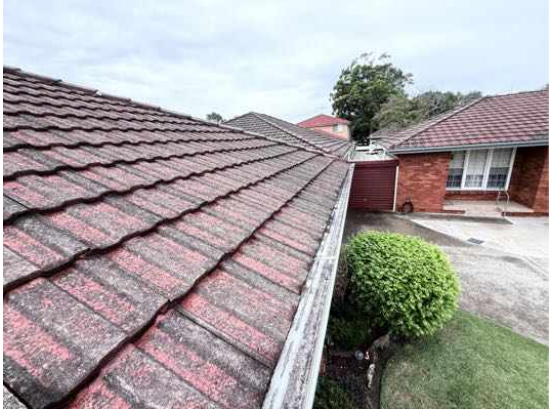
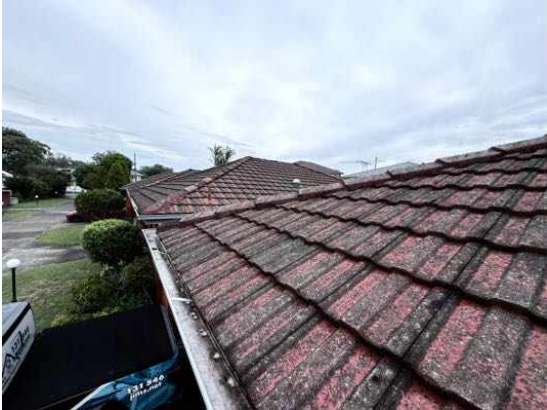
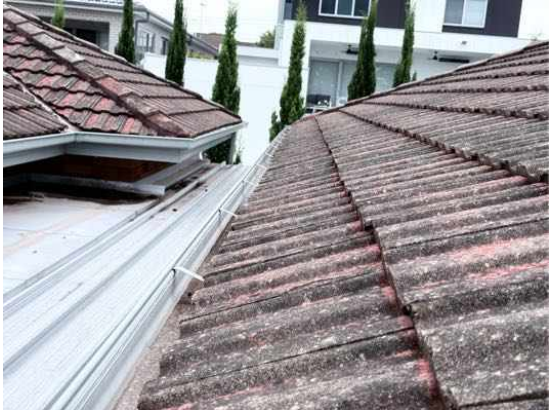
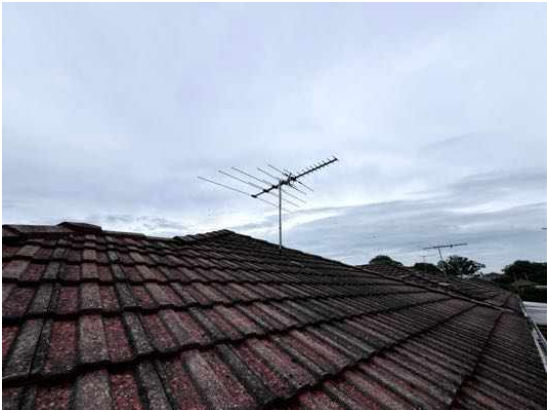
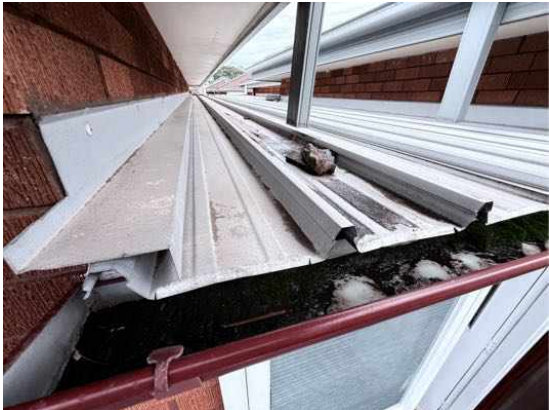
Building: Main Building
 Location: Roof Exterior
 Finding: Roof exterior condition
 Information: The roof exterior, including associated flashings and roof plumbing (gutters and downpipes), wherever safely accessible by a 3.6m ladder and located within a safe viewing position, was inspected and found to be in a serviceable condition unless noted otherwise elsewhere in the report

Please note: the roof inspection occurred on a dry day with no rain. Roof leaks may only become apparent when a rain event has occurred.

Where a full inspection was not possible, due to height, access and safety restrictions, it is recommended that a roofing contractor be engaged to conduct a further full inspection.

It is highly advised to have the roof inspected on a regular basis to determine the integrity of all roofing elements including tiles, roof sheets, skylights, roof vents, flashing, solar panel fixings, guttering, down pipes etc.

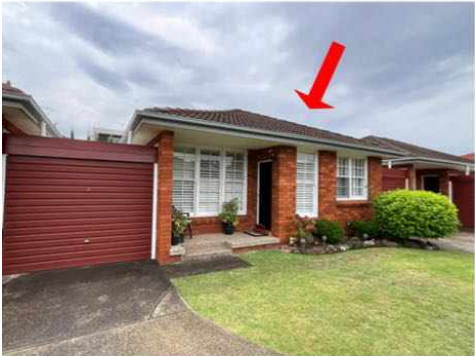
Building: Main Building
Location: Roof Exterior
Finding: Access limitations-roof exterior
Information: Several areas of the roof exterior could not be assessed safely

due to, but not limited to height restrictions, ladder limitations, steepness of roof, roof obstructions and poor visibility(line of sight)to some areas.
