Building and Timber Pest Inspection Report

Inspection Date: Mon, 23 Feb 2026

Property Address: 18 Stockade Pl, Woodcroft NSW 2767,
Australia

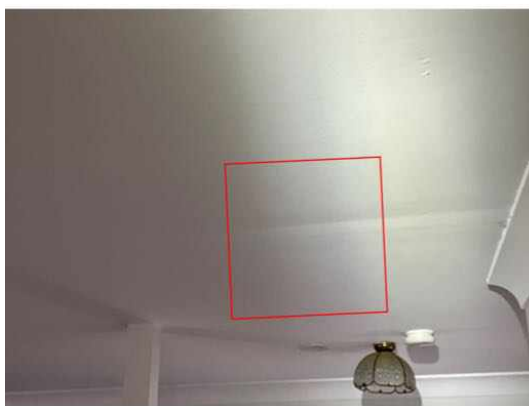
Finding 3.03

Building: Main Building

Finding: Skylight - Damaged cover

Information: The skylight covering appears to have been subject to minor damage and is cracked as a result. Although the surface was found to have been patch repaired, however it is likely to allow rain penetration and provides potential for water damage to the surrounding ceiling area.

Repair or replacement of the skylight covering is required to prevent any further damage to the surrounding area. Works should be completed as soon as possible by a qualified carpenter or general handyperson.

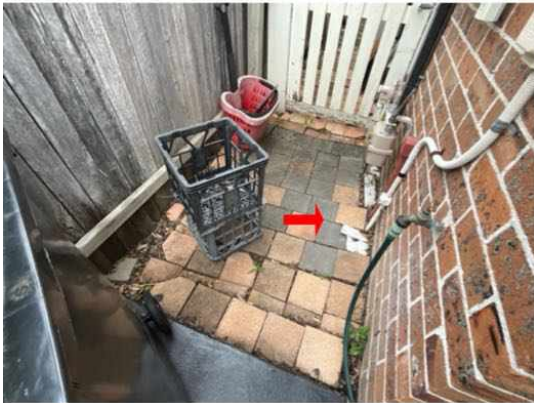
Sections of the external paved area are uneven, which may develop into a trip hazard. It appears as though the area has been subject to rough installation, or that paving sections have lifted due to movements in the foundation.

Left unmanaged, the May develop into a safety hazard due to trip and fall.

Re-paving of the area is required to remedy this situation. Further consultation with a specialist concreter is advised.

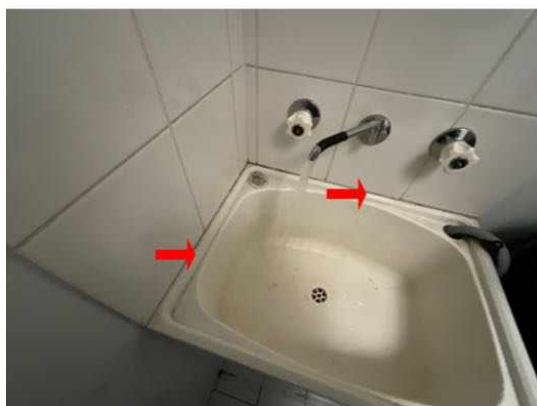
Building: Main Building
 Location: All Wet Areas
 Finding: Sealant and grouting - Missing or damaged
 Information:

It was noted on inspection that sealant or grout is degraded to this area.

Different materials and floor areas move at different rates, generally causing cracking to grout or sealant at this point. A flexible sealant is required to allow for expected expansion and contraction, while keeping the joint water tight and protective of all associated building materials.

Flexible and mould resistant materials should be applied to affected areas to prevent any subsequent water damage that is likely to occur. Regular maintenance and replacement of damage or missing or damaged sealant and grout is highly

recommended to the wet areas, as this is a regular wear and tear defect. Sealant and grouting in areas that come into regular contact with water should be maintained for the long term care of your property.

A sealant specialist should be appointed to complete these works as soon as possible.

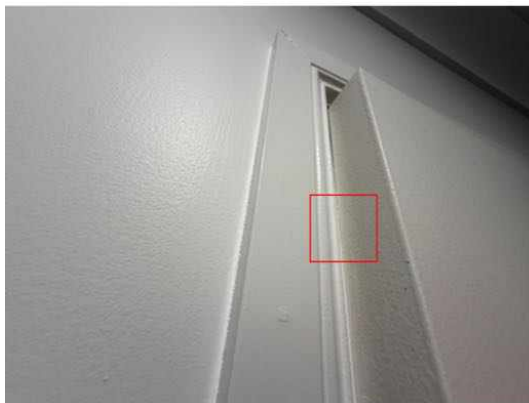
Binding and/or jamming of this door is evident during standard operation. This defect inhibits the functionality of the affected door as well as creating potential for secondary defects to associated building elements, such as damage to the floor covering or adjacent frame.

A door that binds to flooring or to the associated door frame may have several causes, ranging from minor defects, such as poor installation of the door or deteriorated hinges.

A licensed carpenter should be appointed to perform minor rectification works at client discretion.

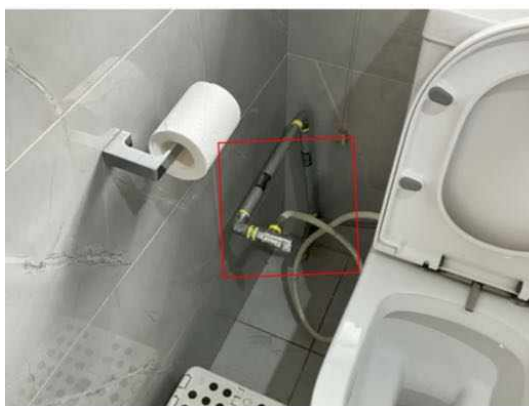
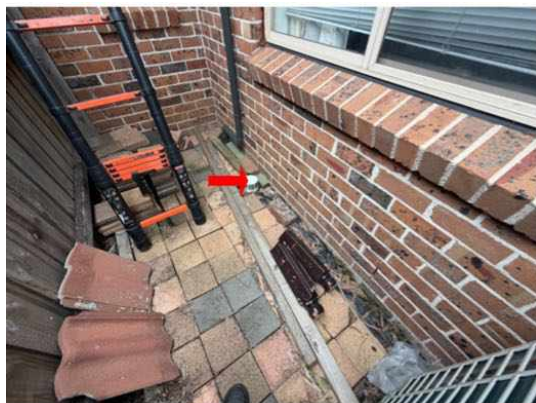
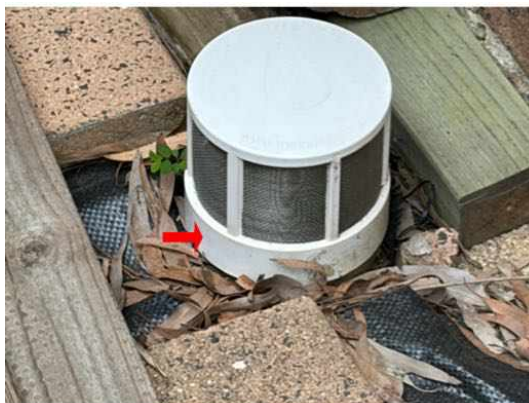
Finding 3.12

Building:	Main Building
Location:	Ensuite, yard
Finding:	Unconventional handyman work
Information:	This handyman work appears to have been completed to a substandard level and does not comply with regular building practices. Where handyman work is not completed satisfactorily, accelerated deterioration of the associated building elements is likely to occur and secondary defects to surrounding structures may develop.

It is highly recommended that the substandard work be rectified by professional services. Works to improve this area are likely to increase the safety and the operation of the associated building elements.

The client should exercise care when coming into the immediate vicinity of the substandard works. Rectification works are advised as soon as possible by the appropriate trades.

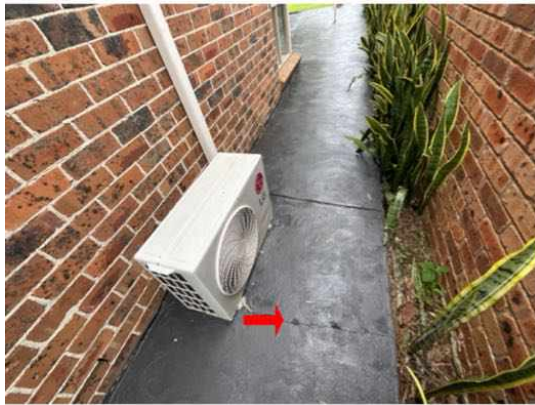
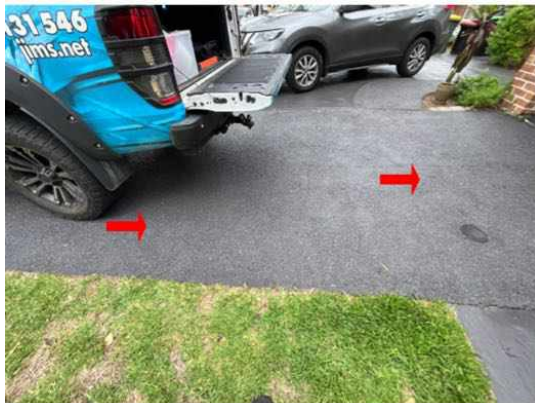
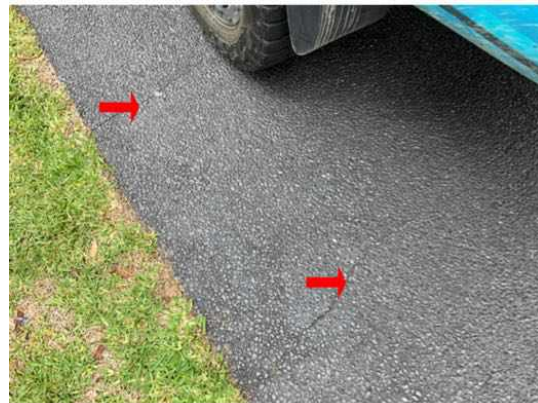
Finding 3.13

Building:	Main Building
Location:	Multiple areas
Finding:	Cracking - External Concrete Paving Damage Category 1 - Fine (less than 2mm)
Information:	Fine cracks were identified in external concrete paving. Although fine cracks are quite noticeable, they are often only considered to be an appearance defect, and usually do not indicate any structural damage. To be considered a Category 1 or fine crack, the crack is found to be less than 2mm in width.

Generally the cause of a hairline crack in existing concrete paving such as driveways and pathways is indicative of the expansion and contraction of the concrete. Such causes are generally due to environmental factors, such as moisture levels, weather conditions, root systems of nearby trees or the soil types on which they are laid.

Fine cracks may also be due to poor original installation of the concrete. Factors such as poor compaction of the sub surface and/or inadequate reinforcing of the slab may create cracking and other secondary defects.

Monitoring of all cracking should be conducted frequently. Always contact a building inspector should cracks widen, lengthen, or become more numerous.

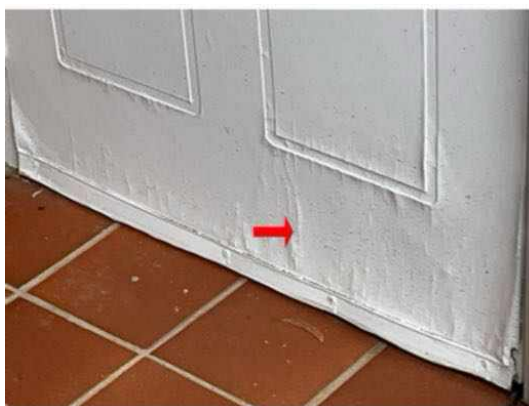
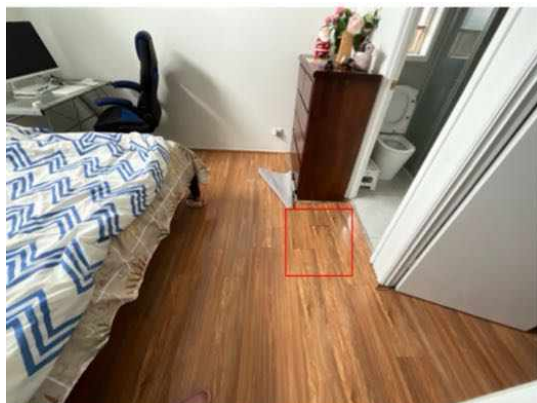
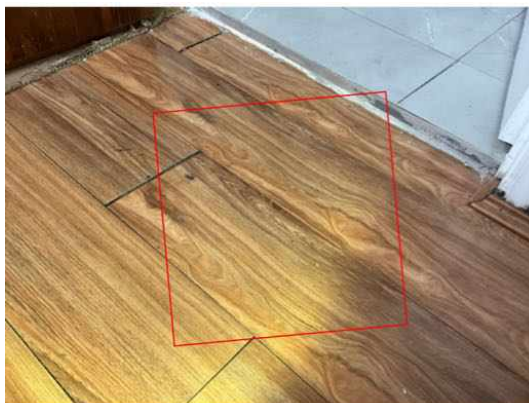
Finding 3.14

Building:	Main Building
Location:	Garage, master
Finding:	Building element - Swollen
Information:	Swollen building elements generally indicate that the building materials have been affected by excessive moisture over a prolonged period of time, and have swollen as a result. Further damage is likely to develop if left unmanaged. Excessive moisture is likely to lead to the development of secondary damage to any associated building elements, which may necessitate major reparation works if prolonged.

Repair and/or replacement of swollen building elements should be conducted by a general handyman or a licensed carpenter.

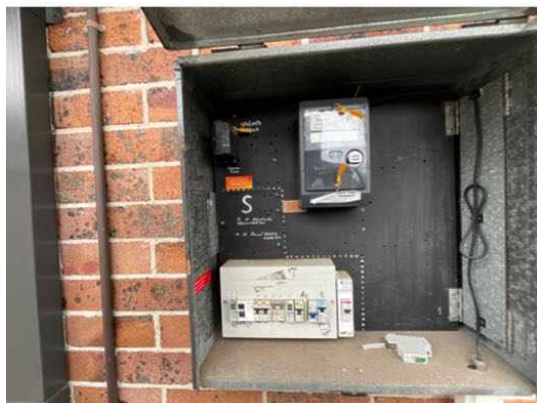
Building: Main Building
 Location: Meterbox
 Finding: Termite Management System - no evidence of installation
 Information: The application of a post-construction chemical termite barrier is highly recommended for all properties, particularly if live termite activity has been found on the site previously. Such barriers are highly effective in preventing termite attack on any timber building elements throughout the property.

system has been installed, with no evidence to suggest preventative works taking place.

The client may consider gaining further advice from a pest controller as to the costs and procedures involved with this application. It is recommended that obtaining such advice be a short-term priority.

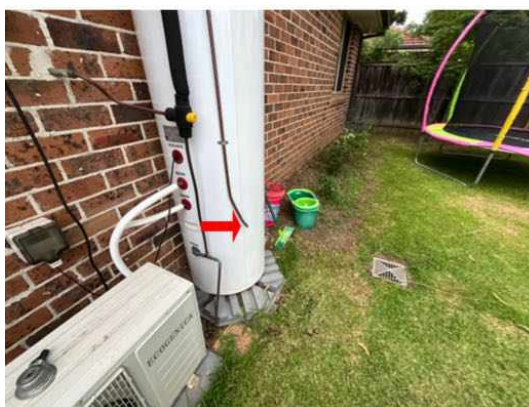
Finding 6.05

Building:	Main Building
Location:	Yard - Side
Finding:	Overflow - Not plumbed for drainage
Information:	The overflow is not plumbed or connected to suitable drainage, which can result in the surrounding area becoming excessively damp.

These damp conditions can lead to secondary defects such as rot, rust or corrosion of associated building elements, the formation of fungal decay, or even the creation of potential slip hazards. When coupled with poor site drainage, pooling of water may also attract termite activity to this area.

It is highly recommended that a licensed plumber be appointed to install adequate drainage to the overflow. These works will ensure that the area remains dry and free of any secondary defects.

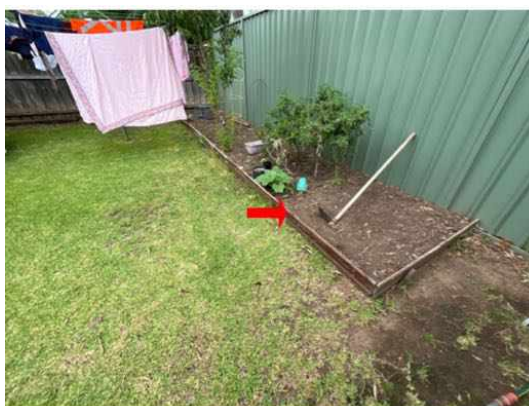
Finding 6.06

Building:	Main Building
Location:	Fencing & Landscaping
Finding:	Building materials in direct ground contact - conducive to termites
Information:	Where timber elements are in direct contact with the ground and consequently

moisture or dampness they become conducive to termite activity. Whether timber is used as a building element part of a fencing structure or stored as an unused item they can provide an environment that is attractive to termite infestation.

When met with excessive moisture timber begins to decay and develop wood rot. Any timbers that are in direct contact with external grounds especially if left untreated or non-durable also provide ingress for subterranean termites into that particular element.

The removal of any such materials that may be conducive to termite activity should be removed as soon as possible to minimise the risk of termite attack.

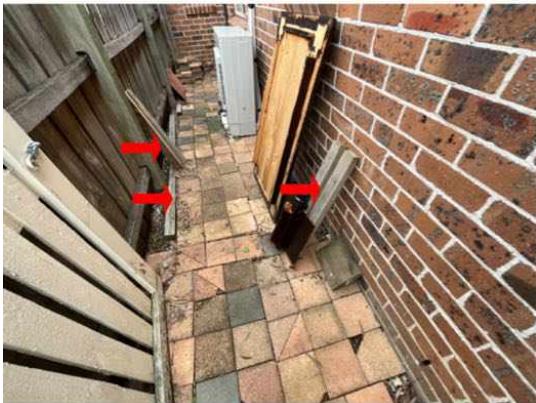
Finding 6.07

Building:	Main Building
Location:	Yard
Finding:	Stored timbers - subfloor space or external area
Information:	The storing of timbers in the subfloor space or around the external property increases the risk of termite activity being present. As they are likely to come into contact with weather conditions or excessive moisture wood rot is likely to develop on timbers that are not treated.

It is highly recommended that any stored timbers be immediately removed from areas in which they may attract any termite / timber pest attack. Minimisation of risk / prevention of termite attack is far more adequate than dealing with the presence of termite activity.

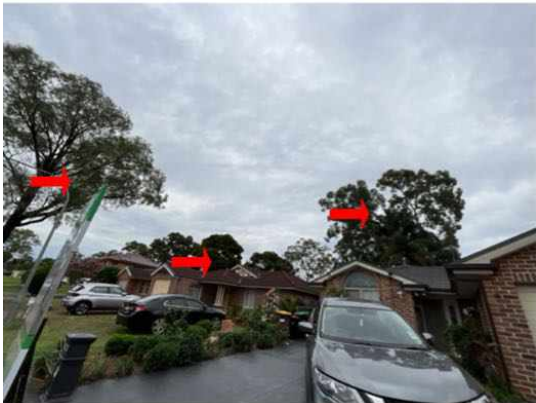
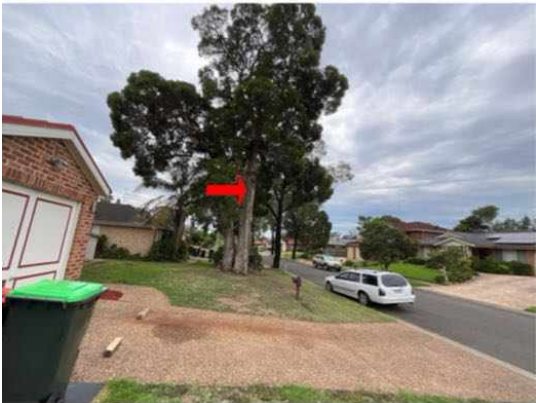
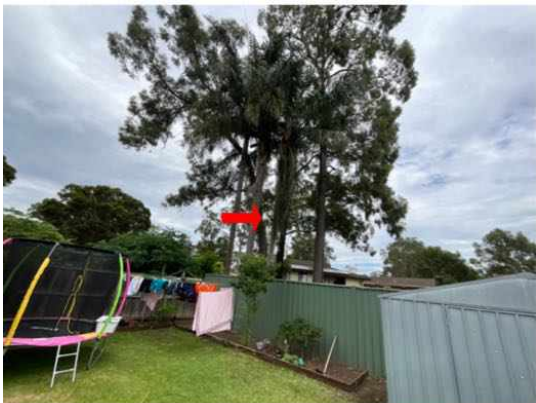
Finding 6.08

Building: Main Building
Location:
Finding: Surrounding bushland - Conductive
Information: Home and or building is situated in a high risk area for termite activity, due to close proximity to surrounding bushland.

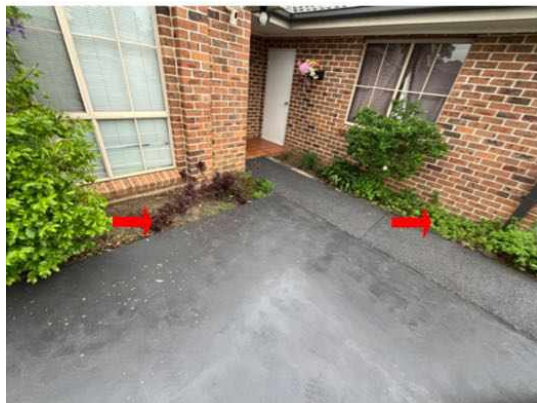
Finding 6.09

Building: Main Building
Location: Garden beds

Finding: Garden Beds
 Information: Garden beds were found to be evident in the garden area. These garden beds can include untreated timber, and with a combination of moisture from watering hosing can make conditions conducive to termite activity and termite ingress.

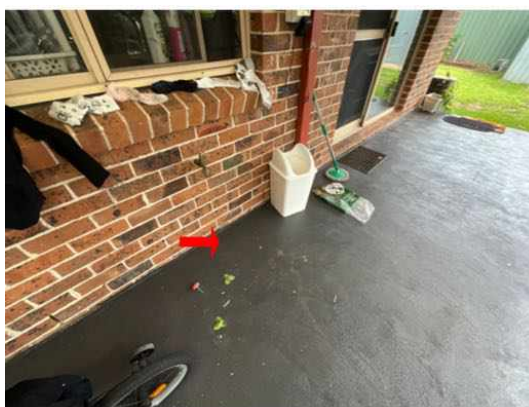
Finding 6.10

Building: Main Building
 Location: External tap
 Finding: Tap - No drain
 Information: The external tap in this area was noted to have no drain at the time of inspection.

This keeps the surrounding surfaces damp while using the tap, which becomes conducive to termite activity.

A licensed plumber must be appointed to ensure an appropriate drain is installed.

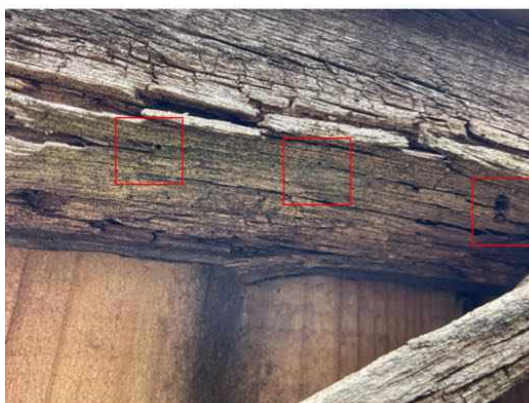
Building:	Main Building
Location:	Fencing
Finding:	Evidence of wood borer activity identified
Information:	Wood borers small beetles that colonise in exposed timber elements are a common timber pest that are regularly mistaken for termites. Although wood borer activity is generally not detrimental to the affected timber they may lead to serious damage and necessitate replacement of certain building elements if left unattended.

The other commonly known borer the Anobium borer is more likely to attack floorboards and may cause severe structural damage to flooring areas.

As no live wood borer activity was identified treatment is not required at this time. Replacement of affected timbers may be considered by the client for superficial reasons.

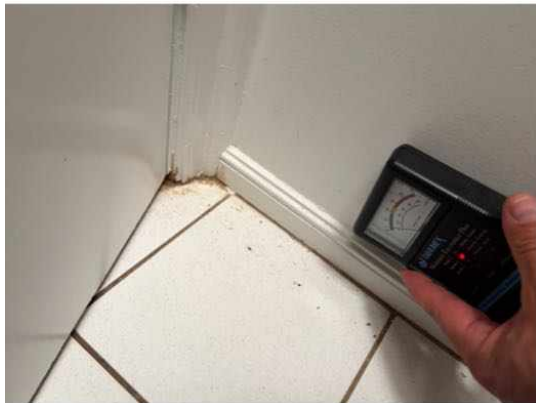
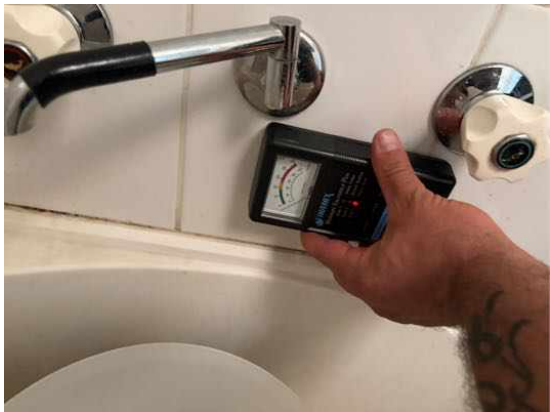
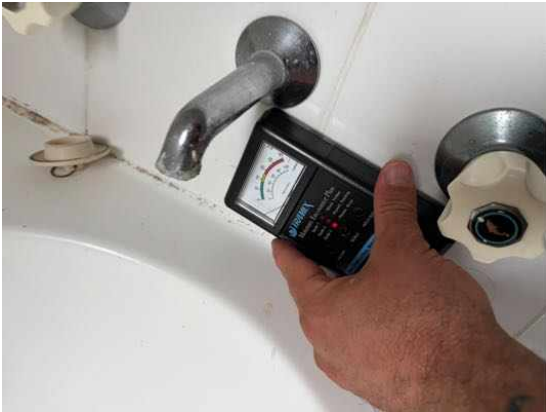
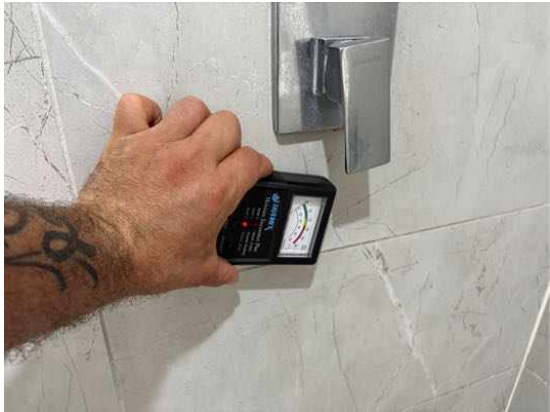
Building: Main Building
Location: All Areas
Finding: Moisture metre
Information: During the inspection the property was checked for moisture using a moisture metre.

This is for information only.

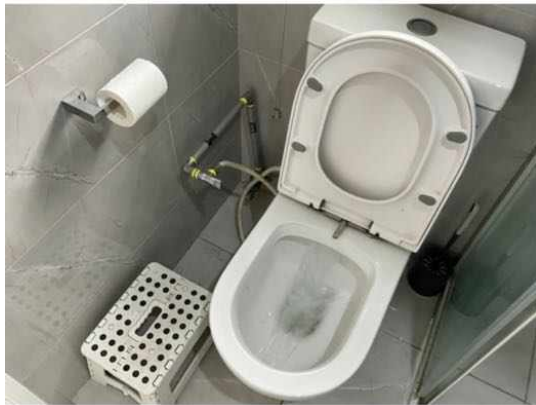
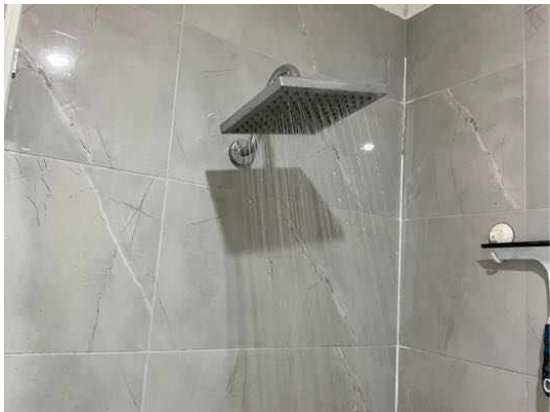
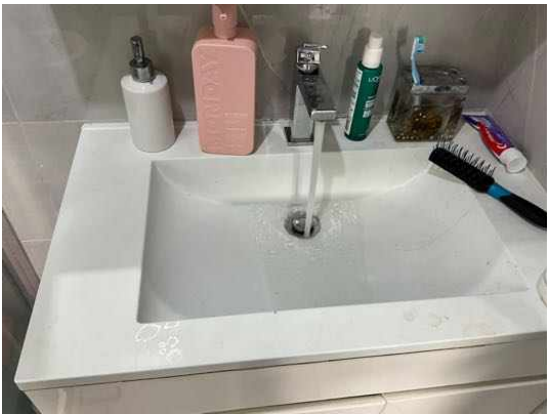
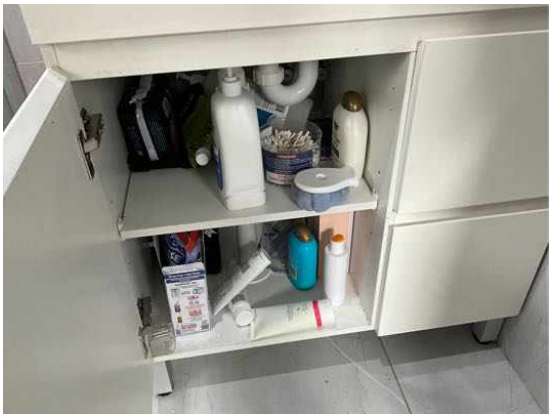
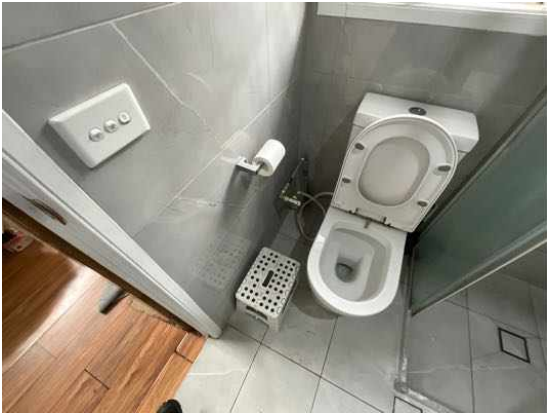
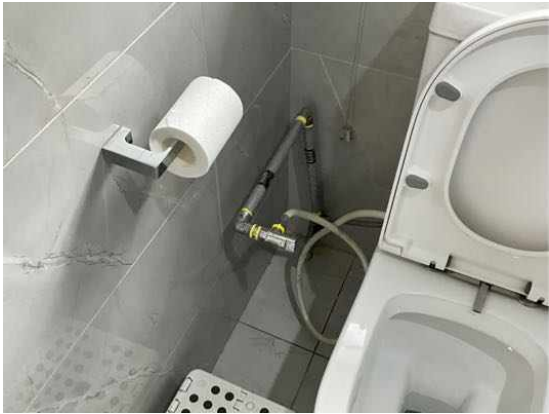
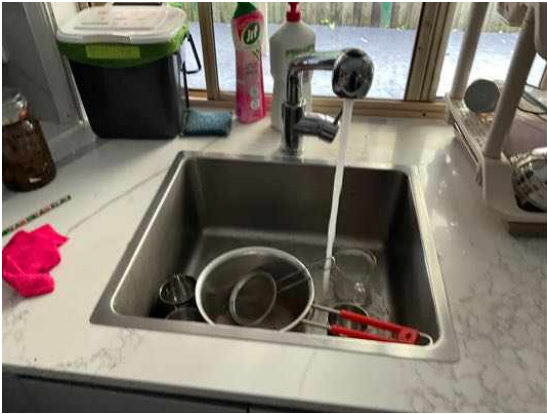
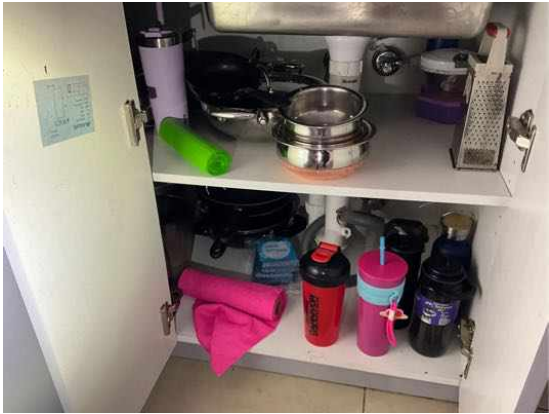
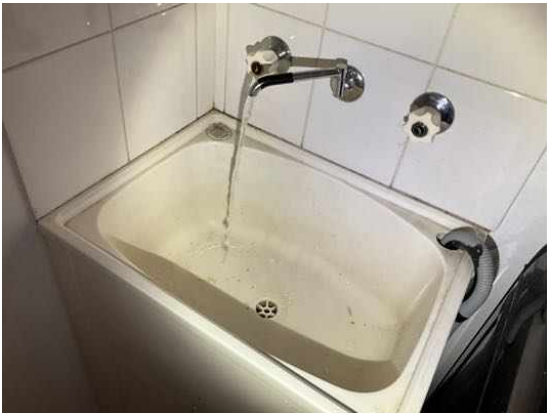
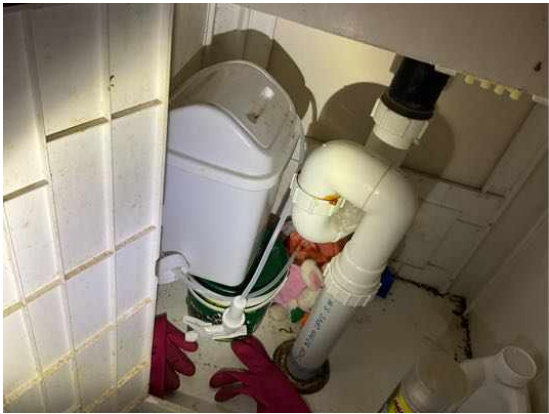
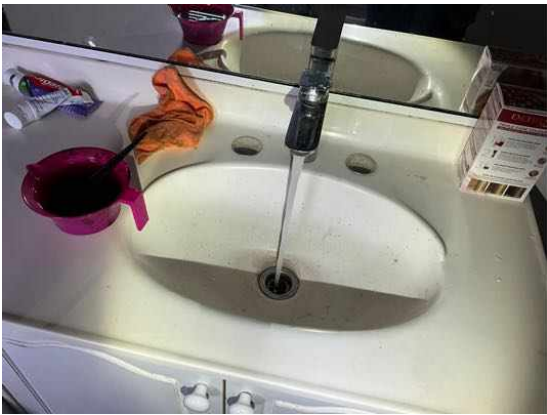
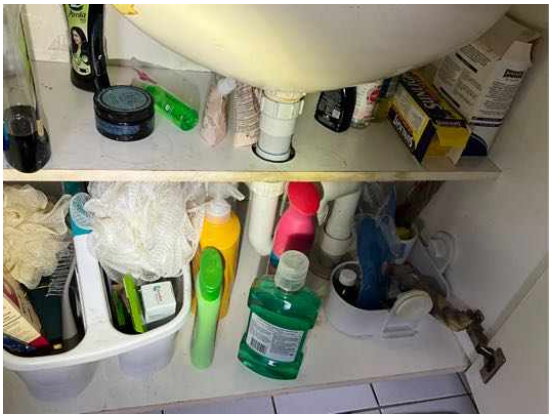
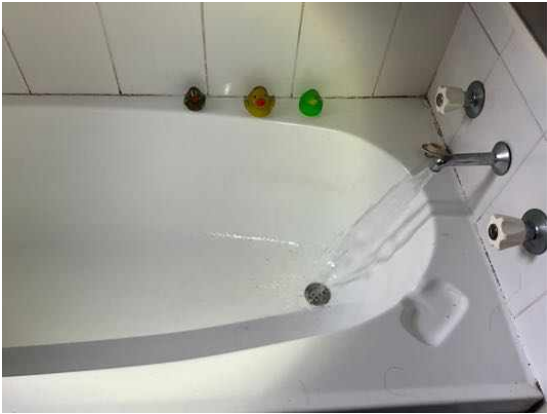
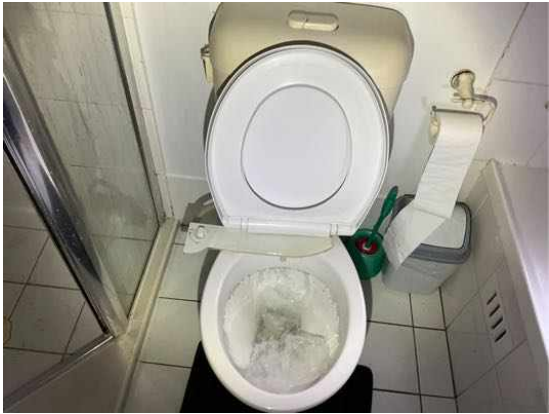
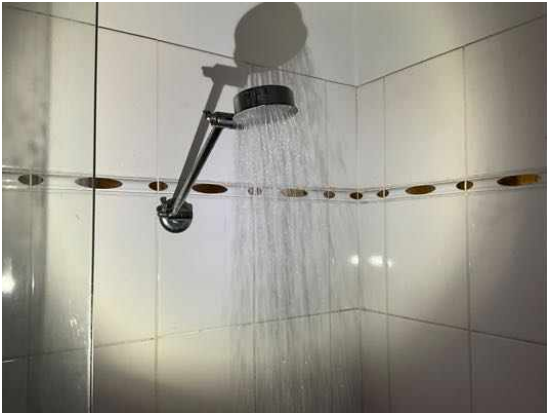
Building: Main Building
Location: All Wet Areas
Finding: Additional Photos
Information:

Additional photos are provided for your general reference.

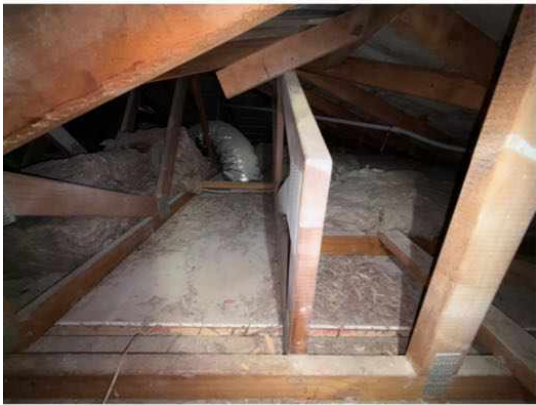
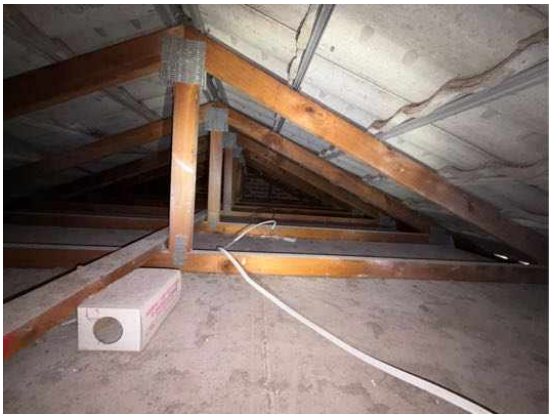
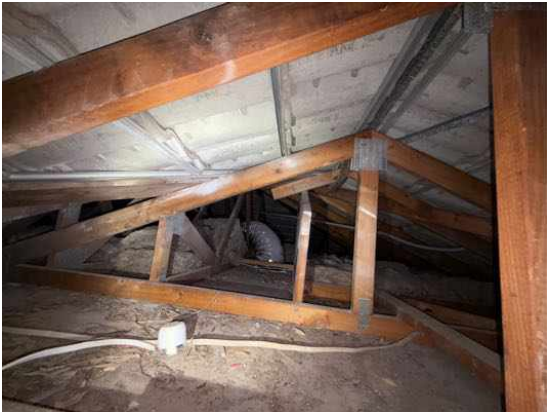
Building: Main Building
Location: Roof Void
Finding: Additional Photos
Information:

Additional photos are provided for your general reference.

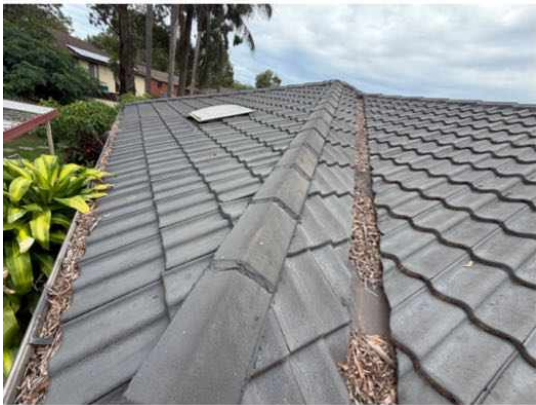
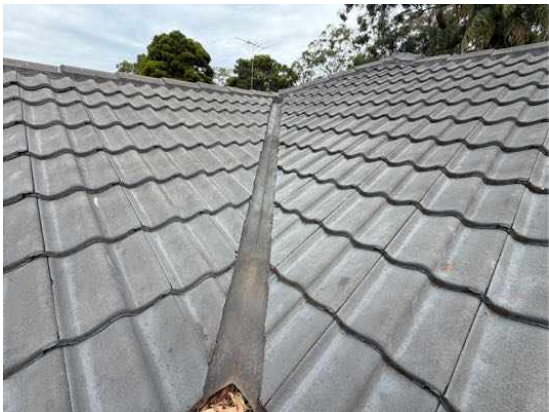
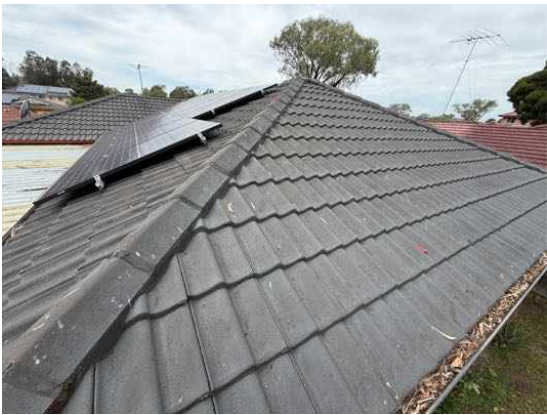
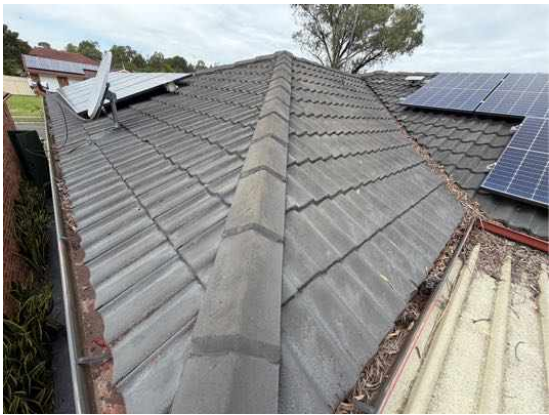
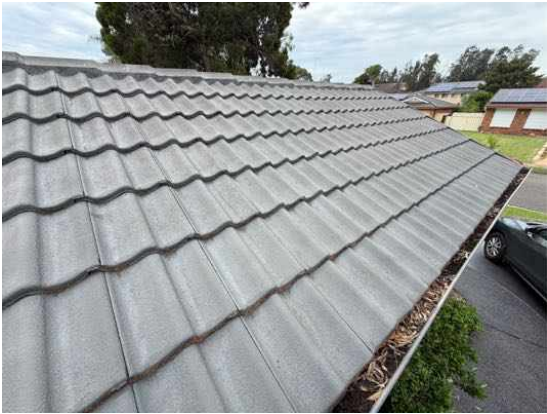
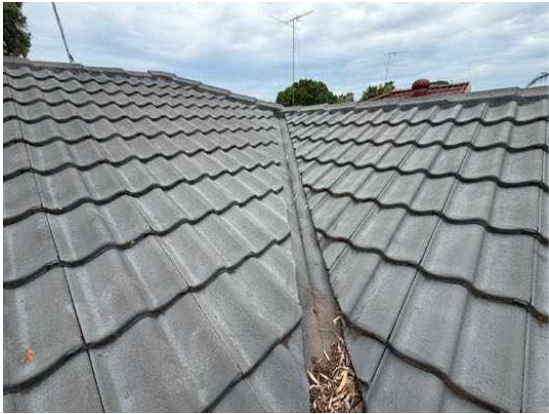
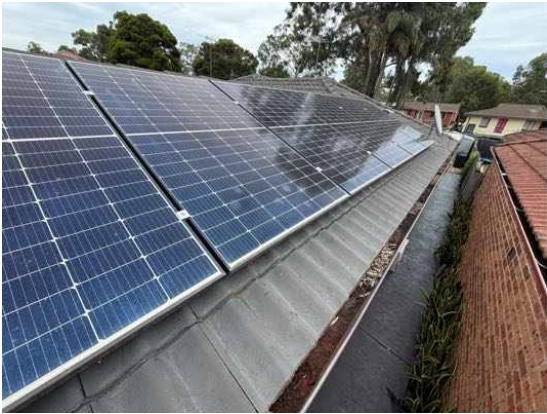
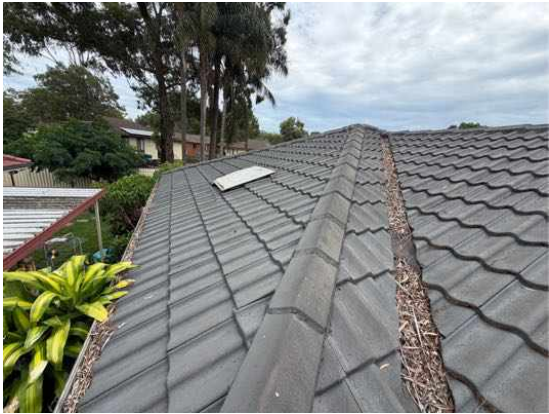
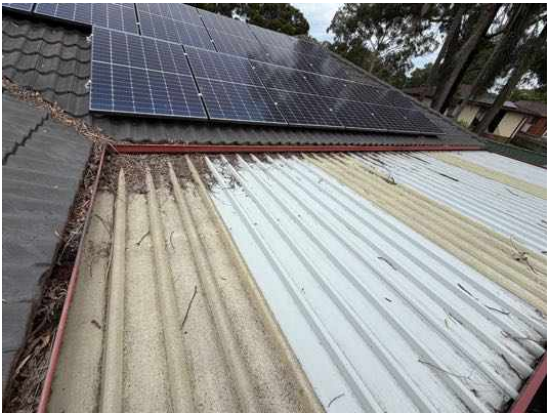
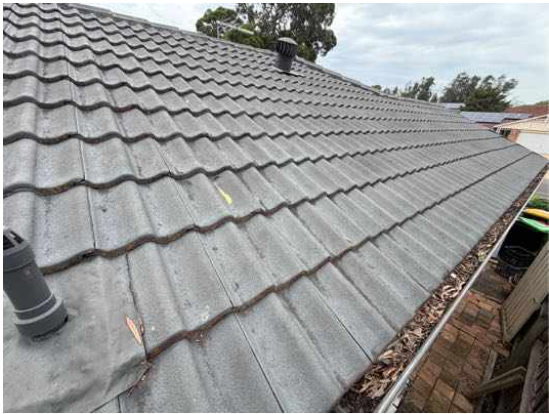
Building: Main Building
Location: Roof Exterior
Finding: Additional Photos
Information:

Additional photos are provided for your general reference.

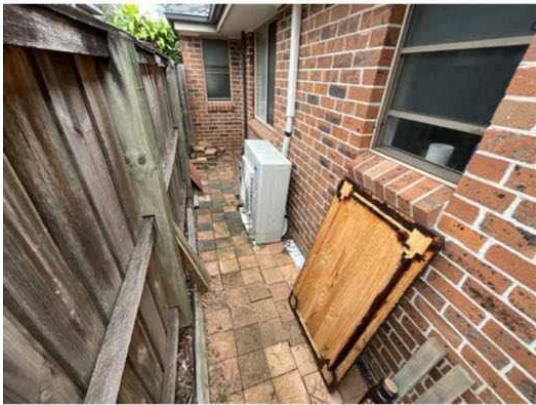
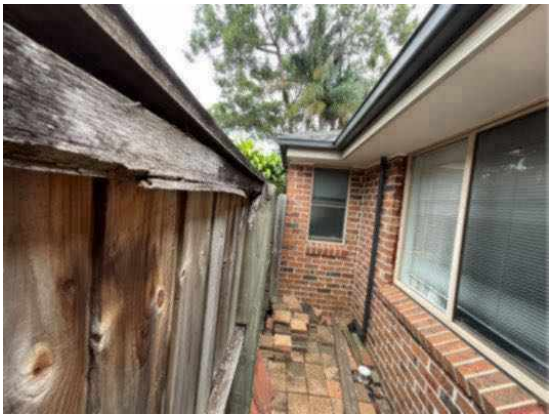
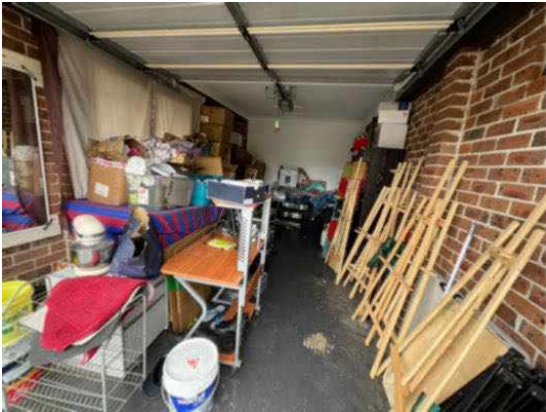
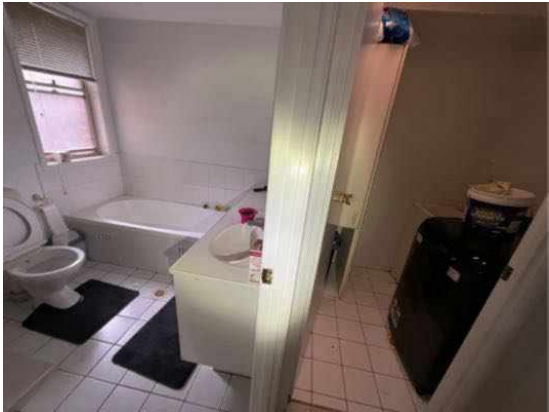
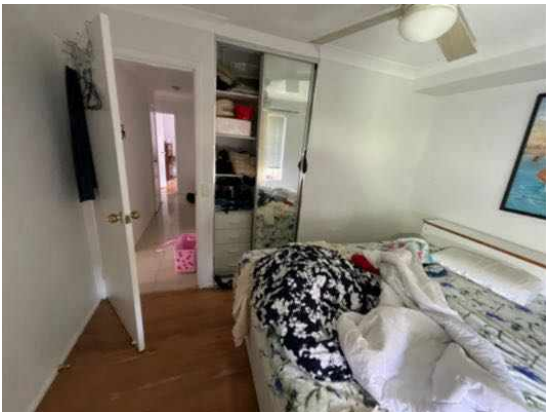
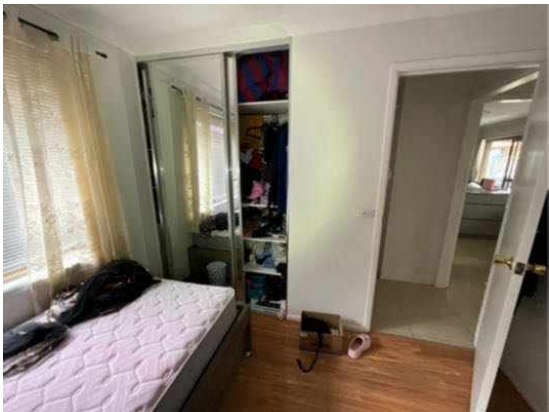
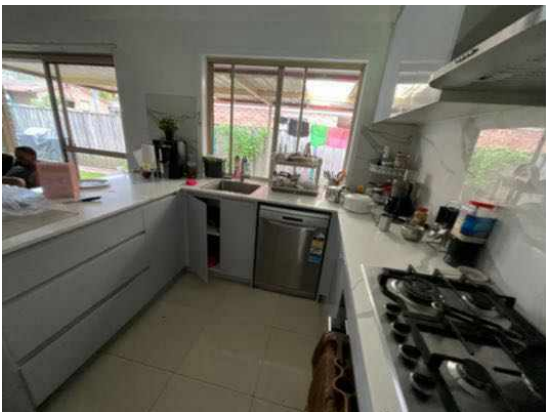
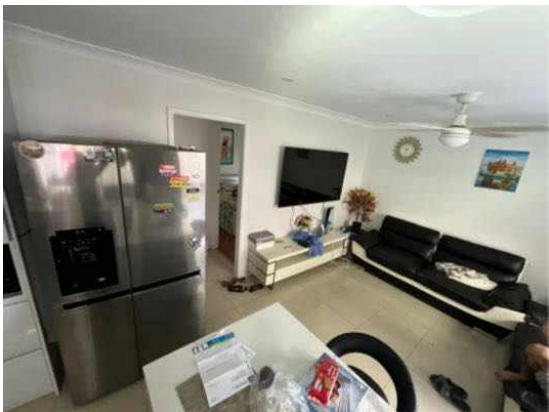
Building:	Main Building
Location:	All Areas
Finding:	Additional Photos - Obstructions and Limitations
Information:	These photographs are an indication of the obstructions and limitations which impeded full inspection of the property at the time of inspection. These obstructions can hide an array of defects and should be removed to allow full inspection to be carried out. A re-inspection is recommended once the areas are made accessible.
