Building Inspection Report

Inspection Date: Mon, 23 Feb 2026

Property Address: 18 Nisbett St, Reservoir VIC 3073, Australia

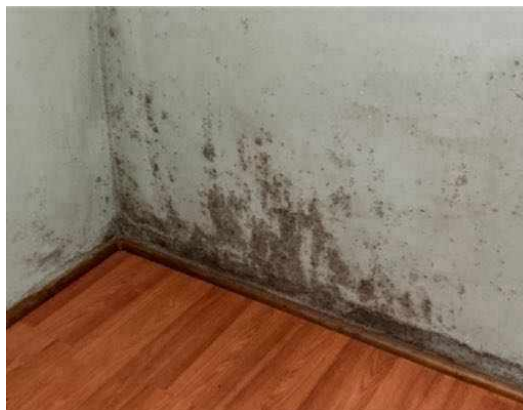
Defects 1.02

Building:	Main Building
Location:	All Areas
Finding:	Mould - Present
Information:	Where evidence of mould growth was noted, there may be environmental, biological or health issues associated with the report. A specialist inspection by a suitably qualified environmental health inspector is warranted, where mould is extensive or where any queries regarding air quality spores or other related issues apply.

Generally, the client is advised to ensure that the general environment is free of moisture and humidity to aid in the prevention of mould formation and development.

Any mould found during the inspection should be cleaned immediately by a cleaning contractor or the homeowner as applicable.

Please note that severely affected building elements may require replacement by a registered builder or qualified carpenter.

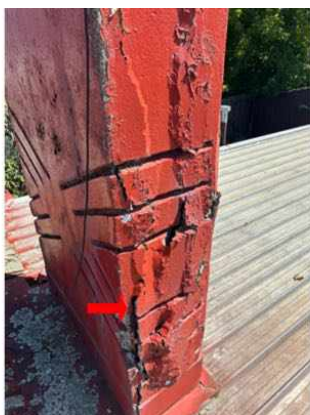
Ultimately, the cause of the concrete cancer (e.g. poor water proofing) must also be addressed, otherwise the problem is likely to recur. Treatment of concrete cancer can be expensive and, left unmanaged, the problem is likely to worsen over time, potentially leading to the development of major structural defects or safety hazards.

The client is advised to exercise caution and to prepare for the potential cost of remedial and / or replacement works. A structural engineer should be appointed to provide estimates on the required works.

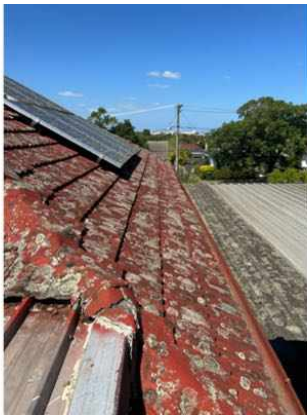
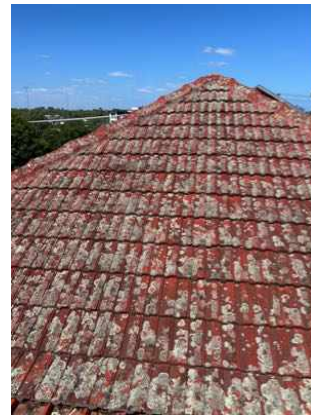
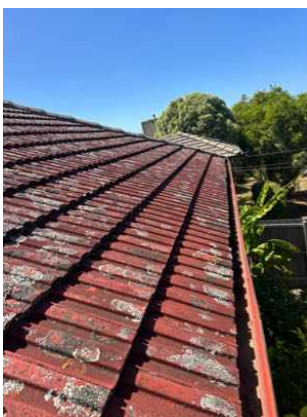
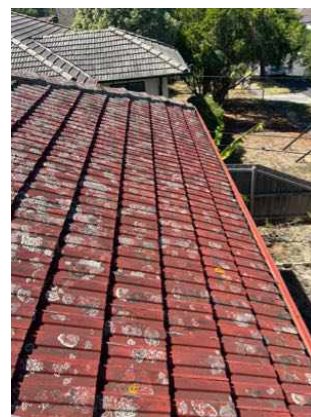
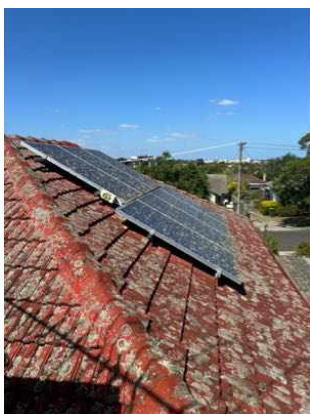
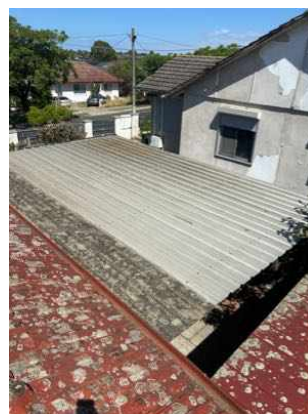
Where left unmanaged, deteriorating roof tiles are likely to lead to a number of secondary defects, including minor water leaks and weather exposure to internal roofing structures.

Consultation with a roofing contractor is highly advised to gain advice on cost of remedial works that may be required in the short to medium term. Remedial works are likely to increase the longevity of the exterior roofing structure.

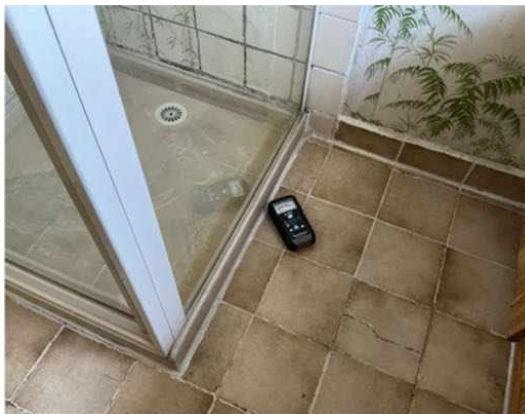
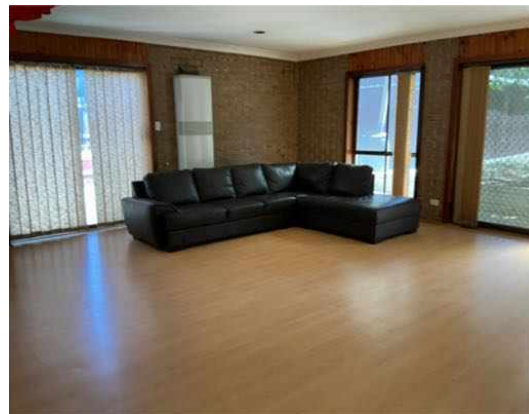
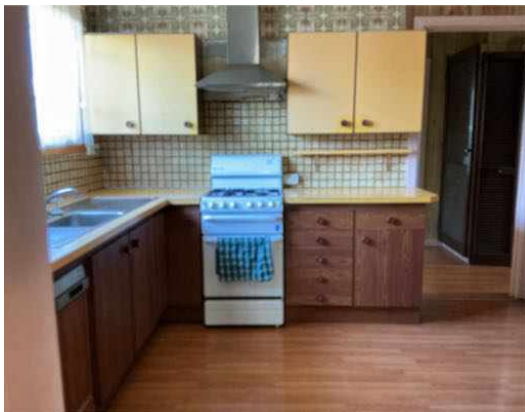
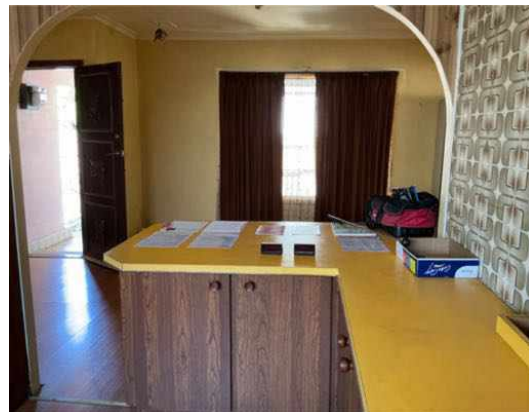
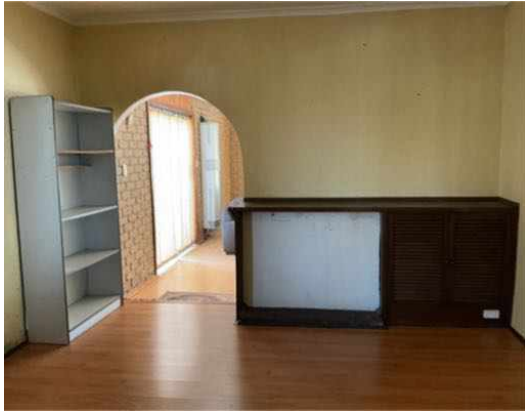
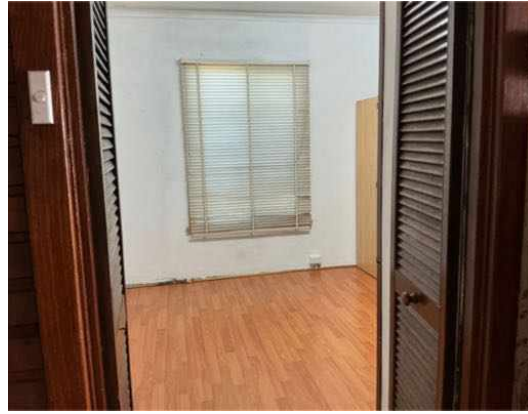
Finding: Additional Photos and Obstructions and Limitations

Information: These are additional photographs and photographs of the obstructions and limitations inside and outside (furniture, landscaping etc) which may impede full inspection of the property at the time of inspection. These obstructions can hide an array of defects and may be removed to allow full inspection to be carried out. A re-inspection may be made if clients require once the areas are made accessible.

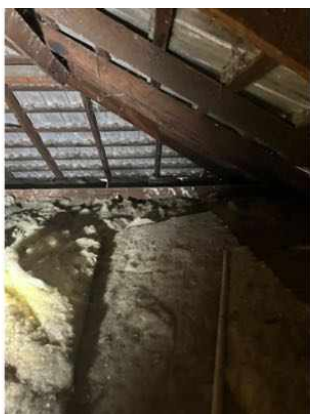
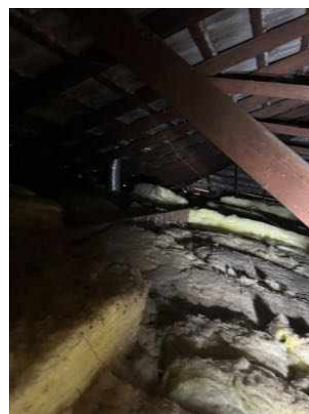
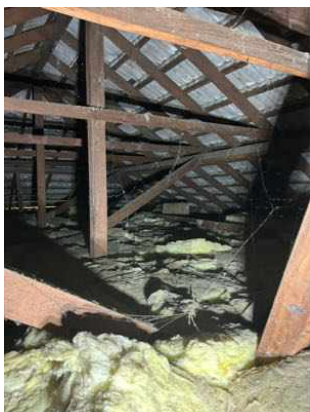
Noted Item

Building: Main Building
 Location: All Areas
 Finding: Additional Photos - Obstructions and Limitations
 Information: These photographs are an indication of the obstructions and limitations which impeded full inspection of the property at the time of inspection. These obstructions can hide an array of defects and should be removed to allow full inspection to be carried out. A re-inspection is recommended once the areas are made accessible.
