Building and Timber Pest Inspection Report

Inspection Date: Tue, 27 Jan 2026

Property Address: 29 Tarra Cres, Oak Flats NSW 2529,
Australia

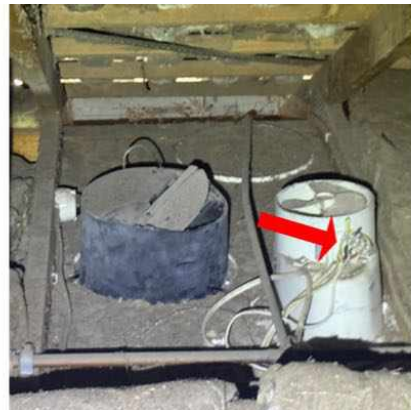
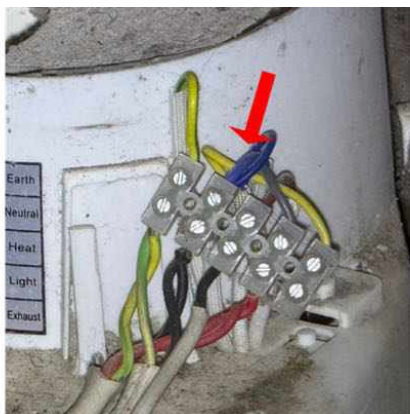
Building:	Building 1
Location:	Roof Cavity over rear bathroom
Finding:	Electrical cables missing a junction box
Information:	The electrical fitting in this roof area was found to be missing a junction box at the time of inspection.

This missing fitting and loose cables does expose electrical works, and may create a safety hazard if there is potential contact with persons in the area.

A Licensed electrician should be appointed to rectify these areas immediately.

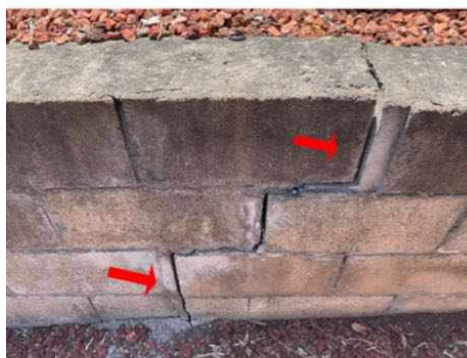
Finding 2.01

Location:	Exterior right front retaining wall
Finding:	Step cracking to wall - major (over 5mm)
Information:	Step cracking of up to 11mm was identified to the blockwork in the front right external wall area at the time of inspection.

The NSW Standards and Tolerances 2017 states cracks over 5mm in width are a major defect requiring rectification work. This applies to photo 2 and 3.

Step cracking, which is similar to other forms of cracking, has a variety of possible causes. However, the most common is the subsidence of adjacent footings.

Where step cracking is extensive or severe, the client is advised to consult a structural engineer. Minor step cracking can be used as a warning sign to address factors causing stress to the wall, which can include the effect of surrounding trees, water leaks, soil erosion, or even the presence of reactive soils in the surrounding area.

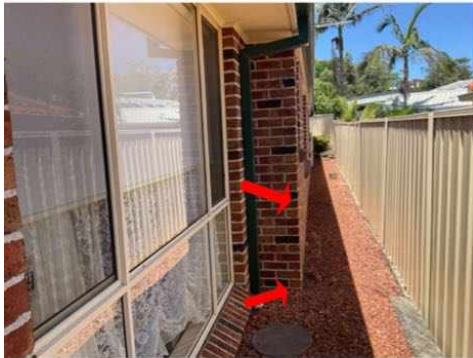
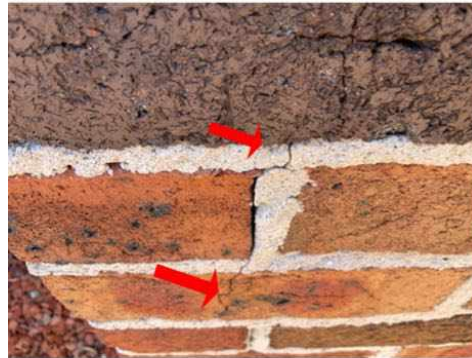
Finding 3.01

Building:	Building 1
Location:	Exterior right front wall
Finding:	Brickwork - Minor step cracking (continued) in right house wall
Information:	See also this very minor step cracking to the brickwork in this right middle wall area at the time of inspection.

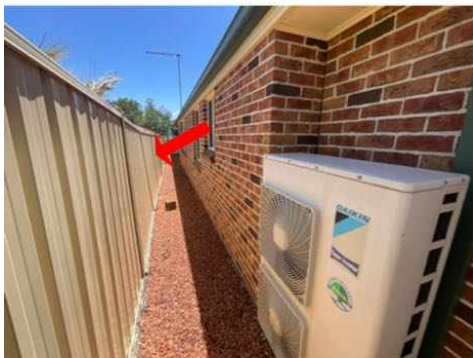
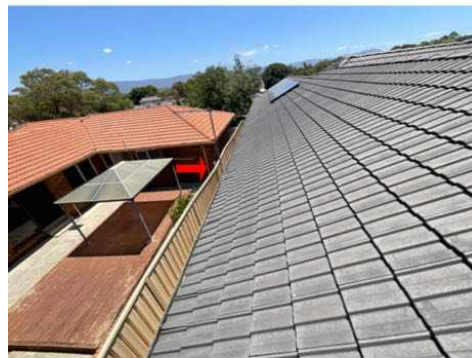
Finding 3.02

Building:	Building 1
Location:	Pictured fence
Finding:	Fence damaged - leaning
Information:	Evidence of damage to the pictured right fence was identified at the time of the inspection. The likely cause of this fence leaning is not enough concrete used in the post footings. If left unmanaged this fence may deteriorate further.

It is suggest a fencing contractor be engaged for rectification when convenient.

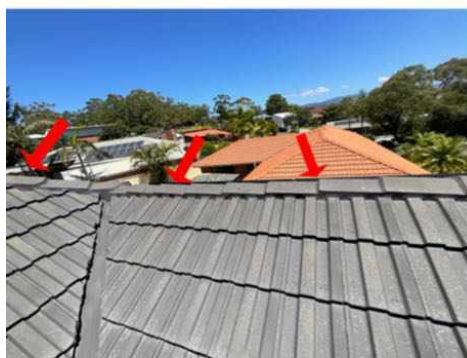
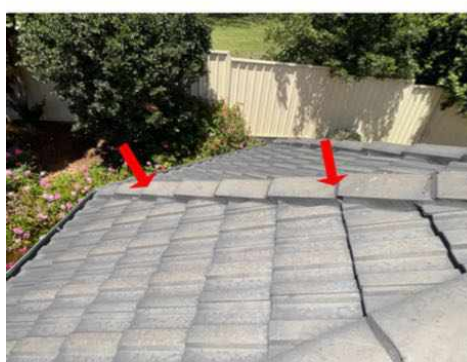
Finding 3.03

Building: Building 1
 Location: Roof Exterior
 Finding: Roof tiles - Weathered
 Information: Upon inspection of the exterior roofing, the majority of roof tiles were considered to be in a good condition. While weathering of the mortar is consistent with the age of the property, maintenance works are required.

Isolated areas of mortar have cracked and come loose. Re-pointing and re-sealing the may be considered as an interim solution by the client to help preserve and extend the life span of the tiles.

Where left unmanaged, deteriorating roof tiles are likely to lead to a number of secondary defects, including minor water leaks and weather exposure to internal roofing structures.

Consultation with a roofing contractor is highly advised to gain advice on cost of remedial works that may be required.

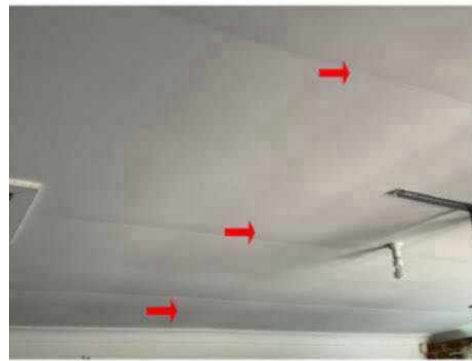
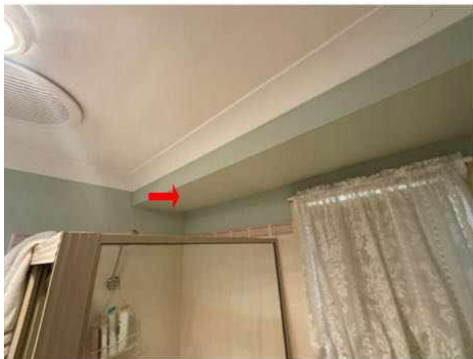
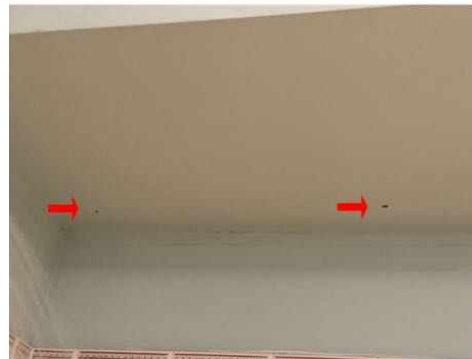
Finding 3.04

Building: Building 1
 Location: Garage, rear lounge room, ensuite shower
 Finding: Ceiling - Sagging

Information: Sections of some ceilings sagging and minor pulling of some ceiling nails (mainly in the garage) was found. Sagging to the fixed ceiling structure generally indicates that the building materials have swollen, due to contact with water, or that fixings (e.g. nails or glue) have become loose and require reattachment.

Where minor sagging is evident, comparatively minor works, such as re-gluing of ceiling sheets, may be required. Such works may be performed by relevant tradespeople, such as plasterers and painters. Where excessive moisture has caused the roofing structure to swell and sag, the source of the water leak should primarily be identified prior to any remedial works being performed.

The appropriate action should be taken by the client, mainly in the garage, to ensure that any potential further damage is limited. The other rear areas should be monitored annually for further movement. No moisture was found in any ceilings or wall areas.

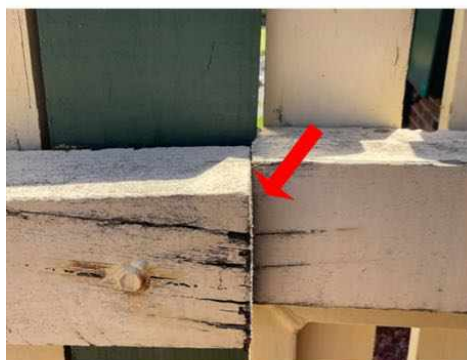
Building:	Building 1
Location:	Exterior right front wall
Finding:	Gate - Binding/ jamming/ damaged
Information:	Binding of this gate and minor fence splitting was found. The lock on this gate was also severely rusted. This gate binding inhibits the functionality of the affected gate

making it hard to operate. A gate that binds to the post or adjoining fence usually occurs as a result of minor movement of the post/fence or deteriorated hinges.

A qualified carpenter or general handyperson should be appointed to perform minor rectification works at client discretion.

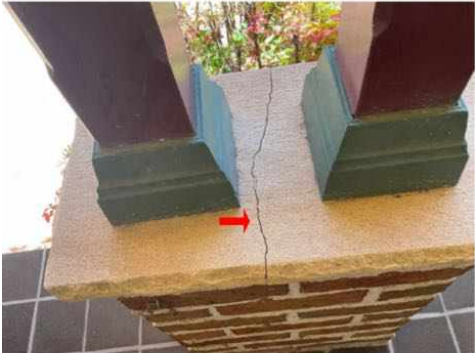
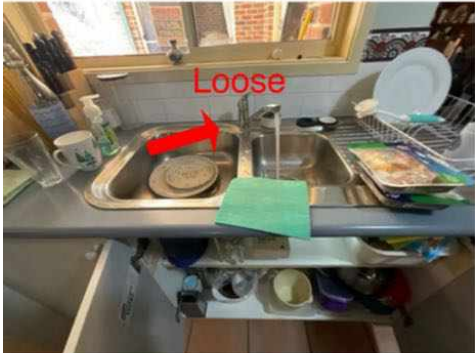
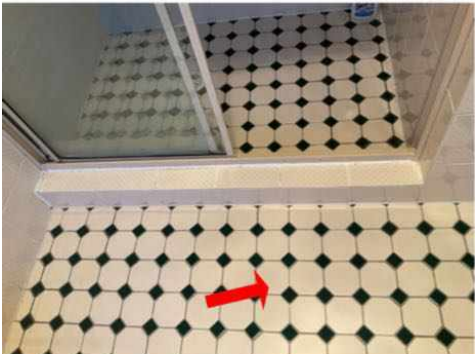
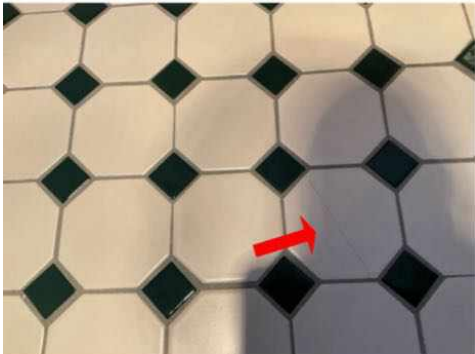
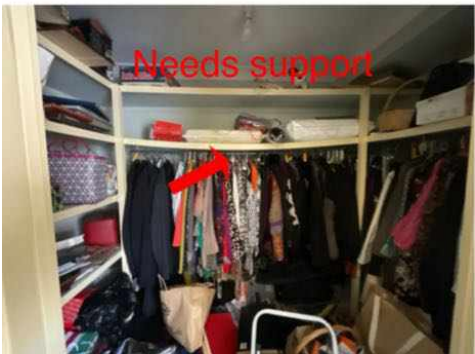
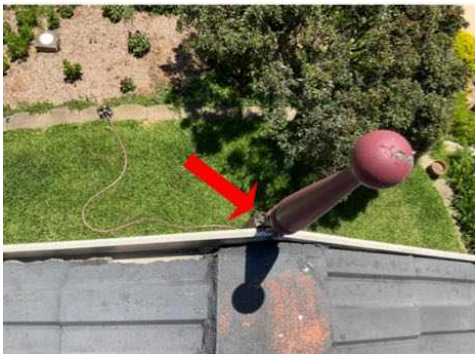
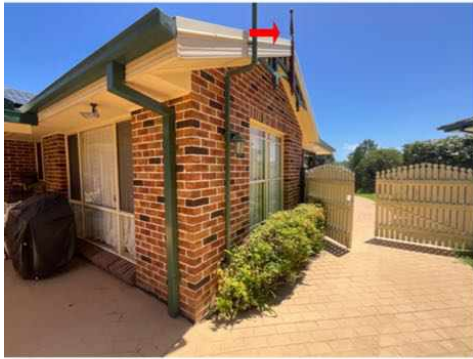
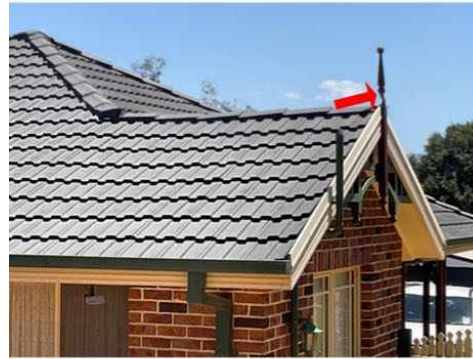
Finding 3.07

Building: Building 1
 Location: Pictured external areas
 Finding: Building elements - Damaged
 Information: Evidence of minor missing or damaged areas was identified at the time of the inspection. These include -

1. One piece of sandstone in a pillar close to the front door has cracked not affecting this pillar.
2. The kitchen sink tap is loose requiring refixing.
3. One cracked bathroom floor tile was found.
4. The bedroom 2 wardrobe needs additional support added.
5. Some areas of the roof (mostly finials) have been damaged by birds, the owner has

replacements onsite.

A carpenter and plumber would be the trades responsible for rectification of these areas when convenient.

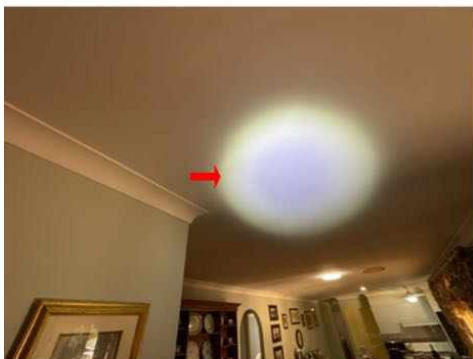
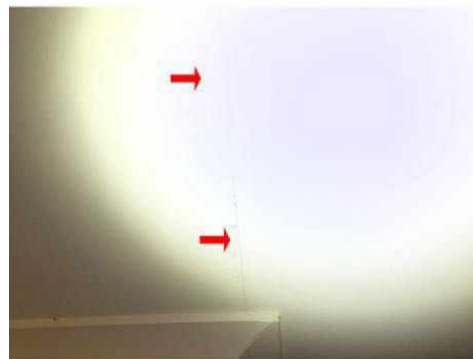
Finding 3.08

Building:	Building 1
Location:	Lounge Room, bathroom and other small areas
Finding:	Cracking - Damage Category 1 - Fine (up to 1mm)
Information:	Although fine cracks are quite noticeable, they are often only considered to be an appearance defect, and usually do not indicate any structural damage. Generally, the cause of a fine crack is indicative of a separation between building materials and finishes (e.g. paint, plaster, etc.) along joins.

Cracking of this nature can generally be repaired with minor sanding, filling and/or repainting. Such works should be performed by a qualified painter or a general handyman.

Monitoring of all cracking should be conducted frequently. Always contact a building inspector should cracks widen, lengthen, or become more numerous.

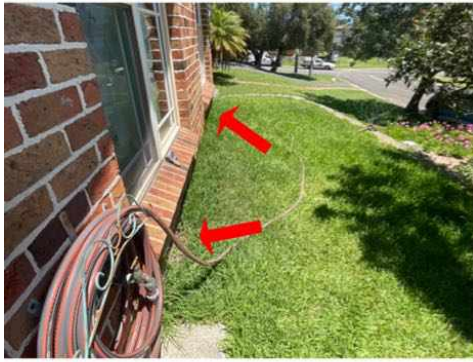
Building:	Building 1
Location:	Wall - front
Finding:	Bridging - Vegetation
Information:	Where vegetation obstructs inspection of building elements, also known as bridging as it provides a bridging point for the access of termites, full inspection can not be achieved. Consequently moisture or dampness may be present and the areas becomes conducive to termite activity. Plants against or very close to buildings provide cover, shade and can provide an environment that is attractive to termite infestation.

The removal and replanting of species that do not provide "cover" or cutting back of existing vegetation will assist greatly in preventing Bridging from occurring.

The removal of any such materials that may be conducive to termite activity should be carried out as soon as possible and arrange re inspection to minimize the risk of termite attack.

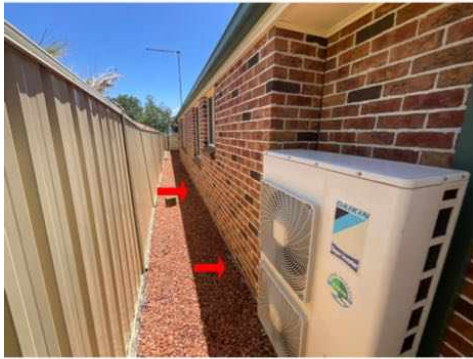
Finding 6.03

Building:	Building 1
Location:	Exterior walls
Finding:	Slab Edge - Exposure
Information:	An inspection zone of at least 75mm in relation to the exposed slab edge, between the bottom brick and the perimeter pavement, is required. This inspection zone should be maintained in order to force termites into the open where they can be detected more readily during regular inspections. The slab edge should not be concealed by anything that may prevent inspection of the area, including render, landscaping, soil, turf, paving, concrete cladding or other structures.

Where the slab edge cannot be properly inspected, it is highly recommended that termite or timber pest inspections be carried out every 6-12 months to aid protection of the property against infestation.

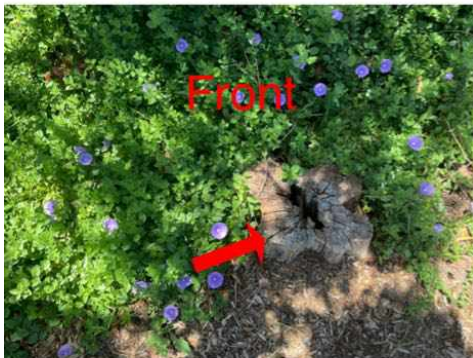
Finding 6.04

Building: Building 1
Location: Pictured front yard area
Finding: Tree stumps - left in ground
Information: Tree stumps left in ground provide opportunity for termite attack as they are likely to be subject to rot and decay providing an attractive food source. Treatment and/or Removal of the stump is highly recommended. A pest controller and tree removalist should be engaged to perform such works.

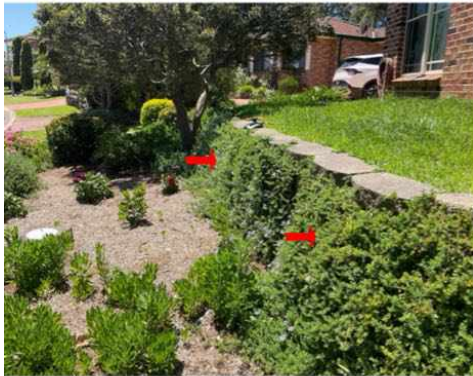
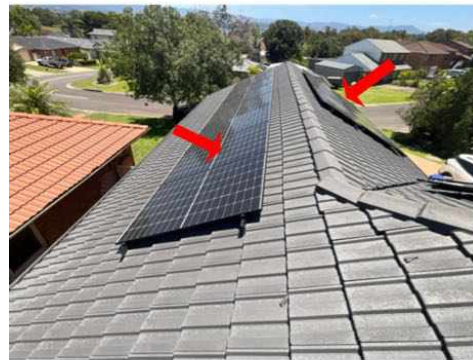
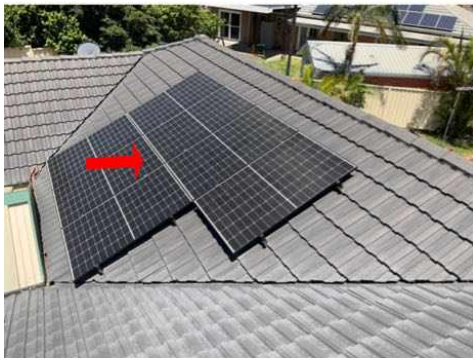
Building: Building 1
 Location: All External Areas
 Finding: Additional Photos - Obstructions and Limitations of EXTERNAL AREAS
 Information: These photographs are an indication of the obstructions and limitations which impeded full inspection of external areas at the time of inspection. These obstructions can hide an array of defects and should be removed to allow full inspection to be carried out. A re-inspection is recommended once the areas are made accessible.

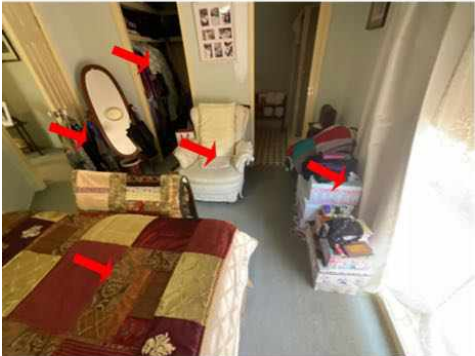
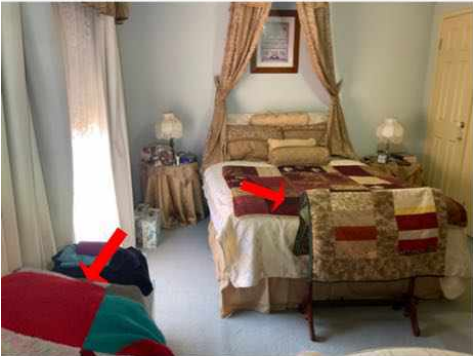
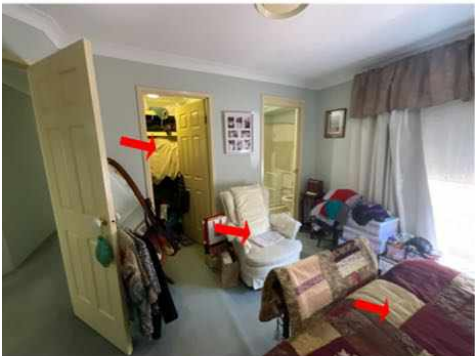
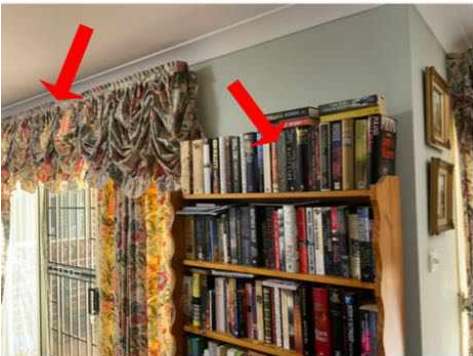
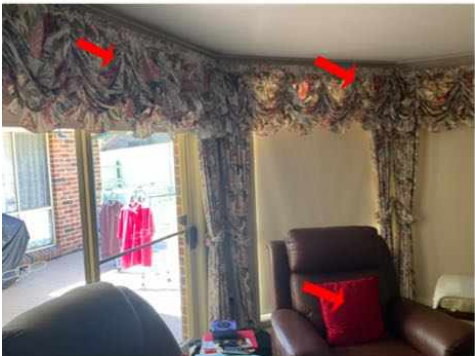
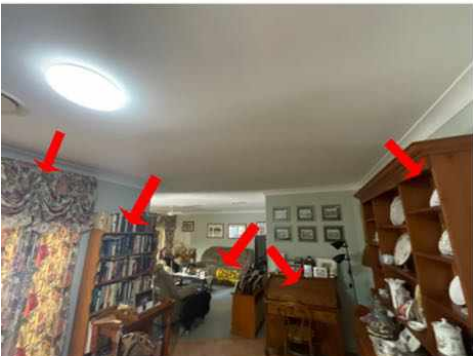
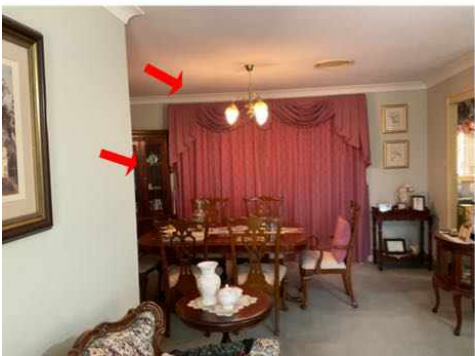
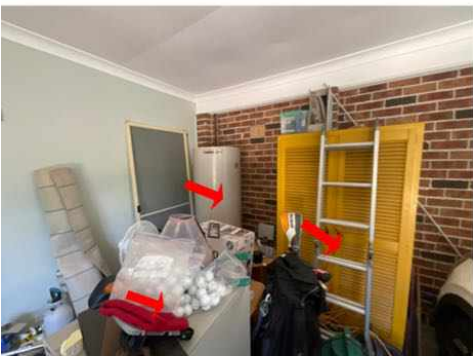
Building: Building 1
 Location: All Internal Areas
 Finding: Additional Photos - Obstructions and Limitations of INTERNAL AREAS
 Information: These photographs are an indication of the obstructions and limitations which impeded full inspection of Internal areas at the time of inspection. These obstructions can hide an array of defects and should be removed to allow full inspection to be

carried out. A re-inspection is recommended once the areas are made accessible.

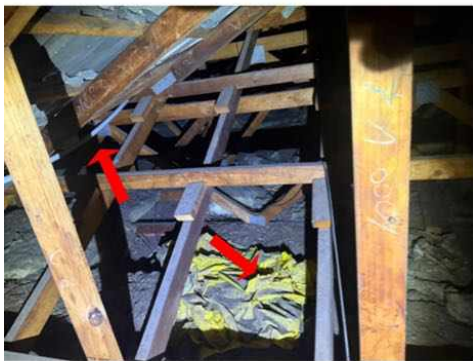
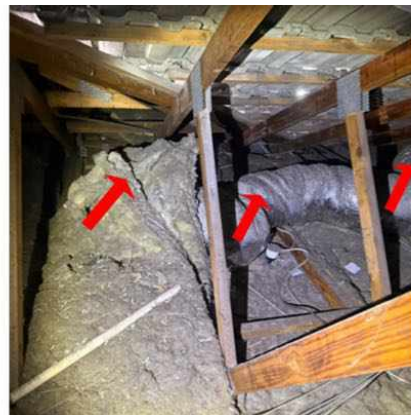
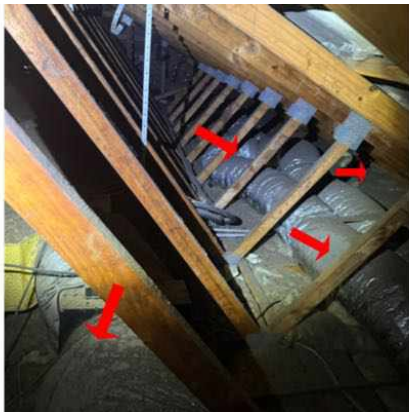
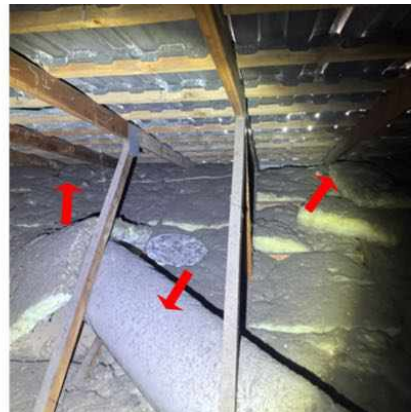
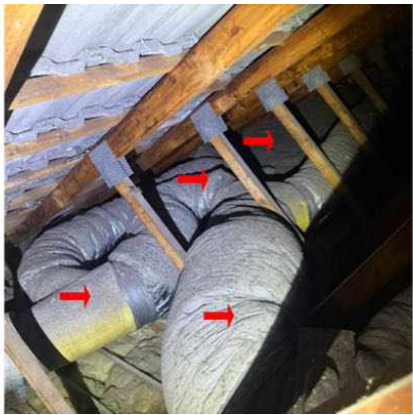
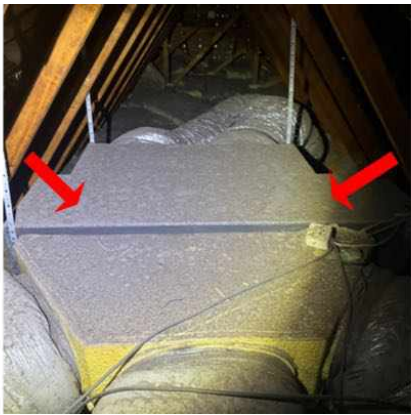
Building: Building 1
Location: All Roof cavity areas
Finding: Additional Photos - Obstructions and Limitations of the ROOF CAVITY
Information: These photographs are an indication of the obstructions and limitations which impeded full inspection of roof cavity areas at the time of inspection. These obstructions can hide an array of defects and should be removed to allow full inspection to be carried out if applicable. A re-inspection is recommended once the areas are made accessible.

The inspection was also limited to areas with an allowable crawl space of 600mm x 600mm, in particular towards the external walls where the roof line diminishes, these areas were not accessible.

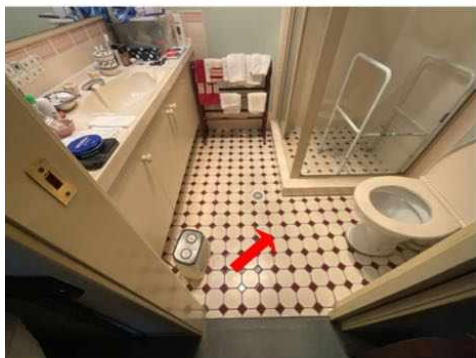
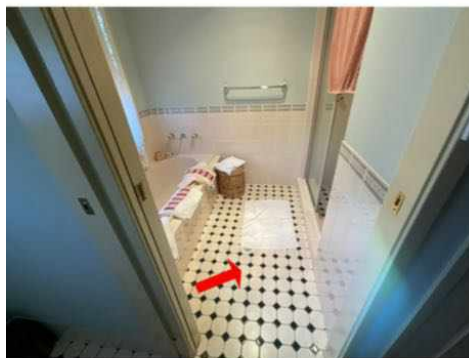
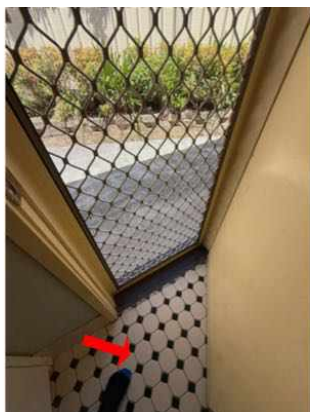
Building: Building 1
 Location: Bathrooms and laundry
 Finding: Waterproofing membranes - Information Only
 Information: Internal Water Proofing Membranes, are crucial in preventing water ingress into the property is important to know that the Membrane System used is to Australian Standards and has been installed correctly.

With older property's where this information is unavailable all wet areas should be monitored. If any leaks, water staining, peeling or bubbling of the paint become evident to any adjacent walls or ceilings below a licensed builder or waterproofing specialist is recommended to investigate further.
