Building and Timber Pest Inspection Report

Inspection Date: Tue, 17 Mar 2026

Property Address: 60 Moora Rd, Rushworth VIC 3612,
Australia

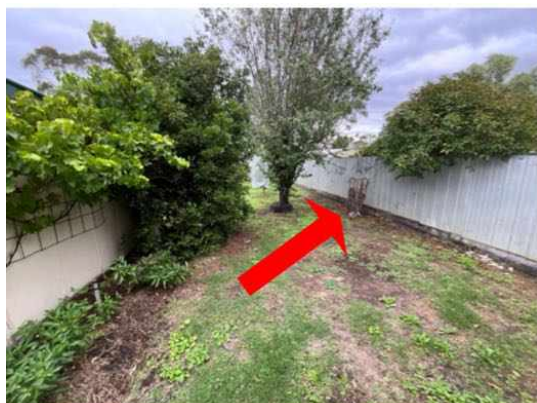
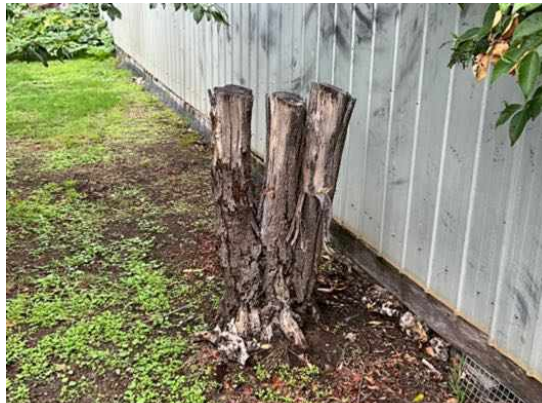
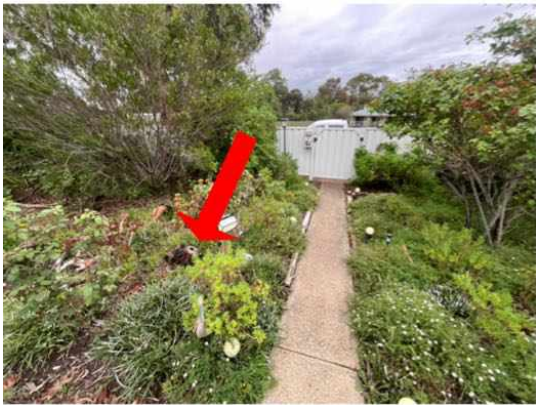
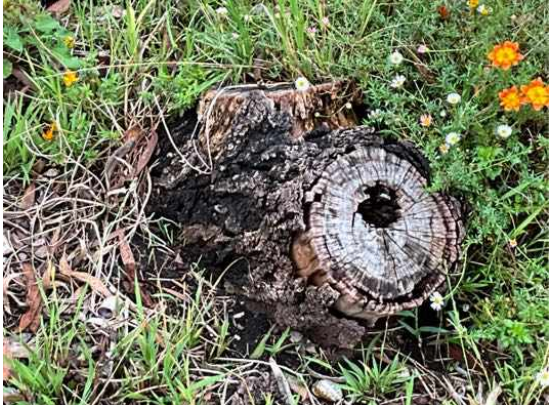
All tree stumps should be removed by professional tree removal services where possible. Meanwhile regular inspections are advised to identify any termite activity in the areas identified.

Services for tree stump removal should be contacted as soon as possible to reduce the risk of timber pest attack.

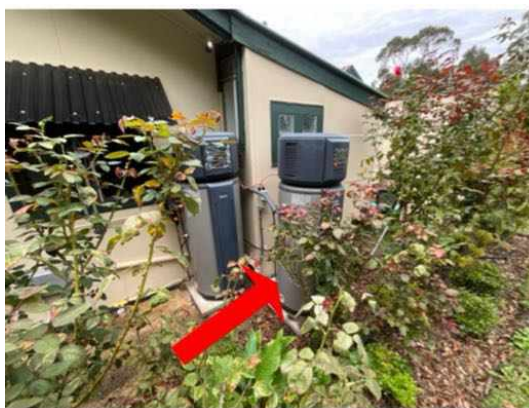
Finding 7.01

The development of fungal decay is accelerated by temperatures in the range of 5degreeC to 40degreeC as well as the presence of oxygen. Generally fungal decay develops on timber elements that are in use in an external environment which are exposed to rain penetration.

In this case although the affected timber element is in a decaying state the extent of any visible damage appears to be localised to a specific area and is yet to spread to other parts of the building element or affect adjoining structures. The fungal decay is therefore likely to be of a relatively superficial nature with minimal impact on the structural integrity or tensile strength of the timber element.

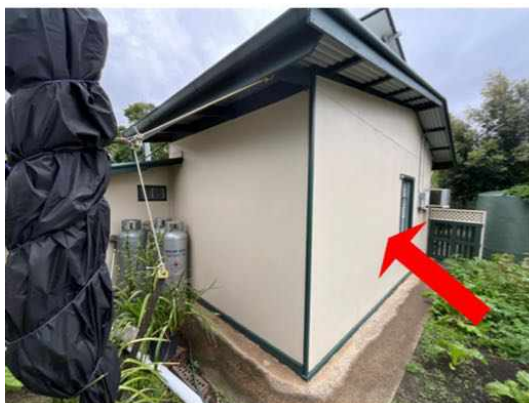
Noted Item

Building: Building 1
 Location: Front wall
 Finding: Cladding- deteriorated
 Information: The external cladding shows signs of damage in several areas. Although not serious at this point, monitoring should be undertaken at intervals to ensure no further damage occurs.
