Building and Timber Pest Inspection Report

Inspection Date: Fri, 20 Feb 2026

Property Address: 13/58-60 Falconer St, West Ryde NSW 2114,
Australia

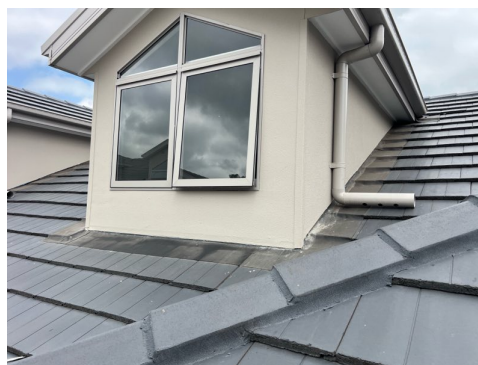
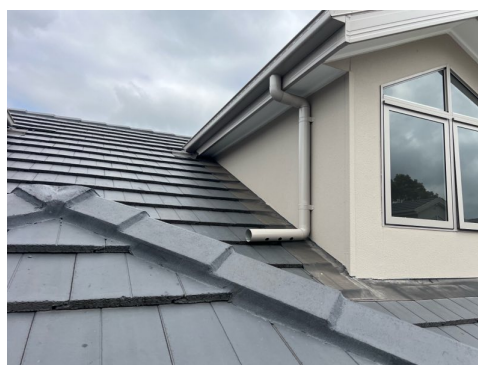
Building:	Main Building
Location:	Garage & Kitchen
Finding:	Water Staining and Possible Roof Flashing Defect – Garage and Kitchen Ceilings
Information:	<p>Water staining and associated ceiling damage were observed to the garage ceiling and kitchen ceiling internally, including discolouration, cracking and deterioration of the ceiling lining. These conditions are typically consistent with moisture intrusion from above.</p>

During the external roof inspection, the roof area and flashing junction directly below the upper-level windows was observed in the approximate location corresponding with the internal staining. Roof junctions and flashing details around walls and windows are common locations where moisture ingress may occur if flashings, sealants or roofing components are not performing effectively.

Although the precise source of the moisture could not be conclusively determined during the visual inspection, the proximity of the roof flashing and junctions in this area warrants further assessment. Moisture penetration through roof coverings or flashings can allow water to enter the roof space and affect ceiling linings internally.

It is recommended that a qualified roofing contractor inspect the roof coverings, flashings and junctions around the upper window area and carry out repairs as necessary. Following rectification of the moisture source, the affected ceiling areas should be repaired and repainted by a suitable tradesperson.

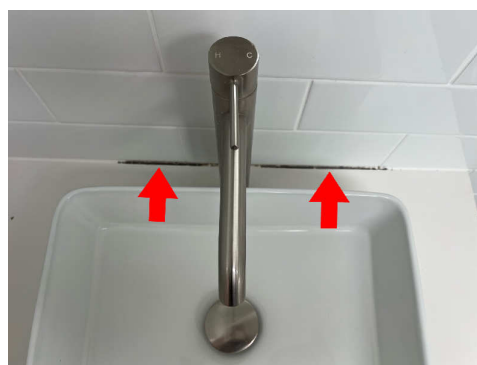
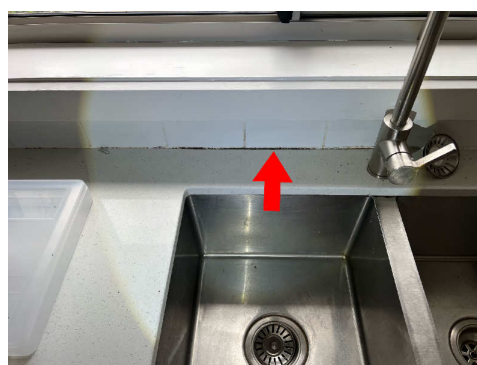
Finding 3.01

Mould and deterioration were observed to the silicone sealant at the junction between the benchtop/tiles and fixtures at the kitchen sink and the upstairs bathroom basin. The sealant along the rear edge of the kitchen sink splashback and around the bathroom basin shows visible mould growth and deterioration, indicating the sealant has likely aged and is no longer performing effectively as a hygienic waterproof barrier. Silicone in these wet areas is intended to prevent water from penetrating into gaps behind fixtures and benchtops; however, once mould develops or the sealant deteriorates, it can trap moisture and allow water to enter concealed areas, potentially leading to staining, ongoing mould growth, or deterioration of surrounding materials.

While this condition is common over time due to moisture exposure and normal wear, the affected silicone should be removed, the area thoroughly cleaned, and new mould-resistant sanitary-grade silicone applied to restore proper sealing and improve hygiene. This work would typically be carried out by a handyman, caulking contractor, or plumber and should be addressed as part of routine maintenance in the short term.

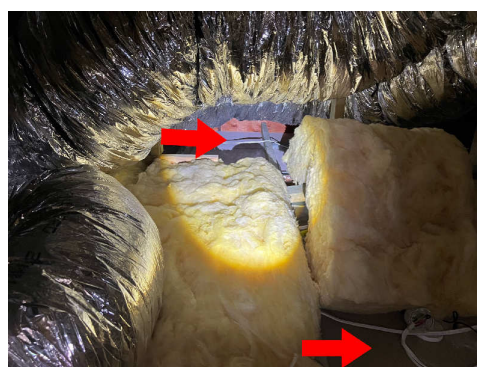
Finding 3.02

Building:	Main Building
Location:	Roof Void
Finding:	Incomplete Ceiling Insulation to Roof Space
Information:	Ceiling insulation within the roof space was observed to be incomplete and unevenly distributed, with some areas missing insulation coverage and other sections displaced. This condition was evident in the accessible areas at the time of inspection.

Incomplete or displaced insulation can reduce the thermal efficiency of the dwelling and may contribute to heat loss or gain, impacting occupant comfort and energy performance. It is recommended that the ceiling insulation be reviewed and made continuous by a suitably qualified insulation installer to achieve more consistent coverage. Rectification can be considered as part of routine maintenance in the medium term.

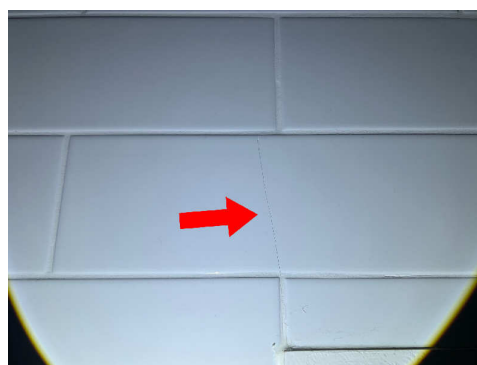
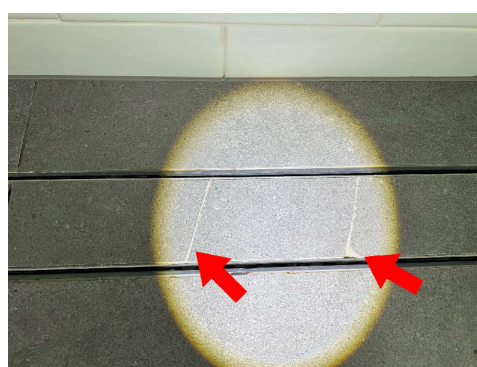
Finding 3.03

Building:	Main Building
Location:	Bathroom 1 & 2
Finding:	Cracked Tiles – Upstairs Shower Floor and Downstairs Bathroom Wall

Cracked tiles were observed to tiled surfaces within the bathrooms of the dwelling. A cracked floor tile was noted adjacent to the linear shower drain within the upstairs bathroom shower area, and a cracked wall tile was observed to the tiled wall surface in the downstairs bathroom near the doorway. Tile cracking can occur due to minor impact, installation stresses, or slight movement within the underlying substrate. While the affected tiles currently remain in place, cracks compromise the protective surface of the tiles and may allow moisture to penetrate through to the underlying bedding or wall materials, particularly in wet areas such as showers.

Although the cracking appears localised and does not presently indicate significant structural concerns, damaged tiles should be addressed to maintain the integrity, durability, and waterproof performance of the tiled surfaces. It is recommended that the affected tiles be assessed and replaced by a qualified tiler, with surrounding grout and joints appropriately reinstated as required. This work should be undertaken in the short to medium term as part of routine maintenance.

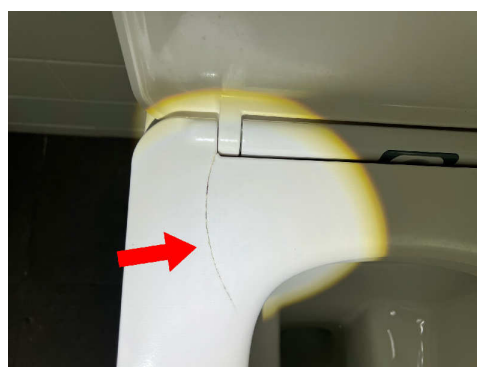
Finding 3.04

Finding: Cracked Toilet Seat

Information: A crack was observed to the toilet seat at the hinge area in the upstairs bathroom. The crack extends through the plastic seat material and appears to have developed due to wear, impact, or stress at the hinge fixing point. Damaged toilet seats may deteriorate further with normal use and could eventually fail or become uncomfortable or unsafe during use.

It is recommended that the toilet seat be replaced with a suitable compatible unit to restore normal function and hygiene. Replacement of the seat is a relatively straightforward maintenance task typically carried out by a handyman or plumber and should be addressed in the short term as part of routine maintenance.

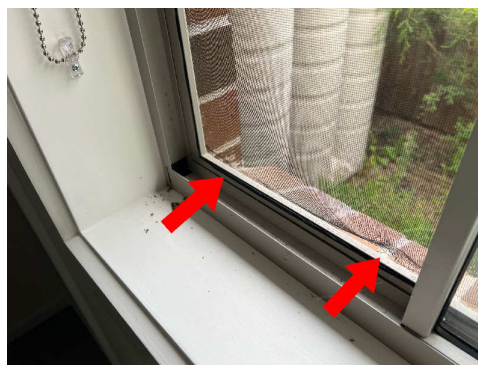
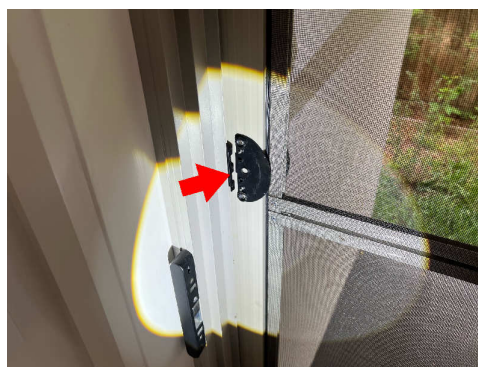
Finding 3.05

Finding: Damaged Flyscreen and Screen Door Lock

Damage was observed to the flyscreen of the downstairs bedroom window and to the locking mechanism of the external screen door. The flyscreen mesh to the bedroom window appears torn and partially detached along the lower edge, which reduces its effectiveness in preventing insects from entering the dwelling. Additionally, the lock mechanism to the external screen door appears damaged and may not operate as intended.

While these issues do not appear to affect the structural integrity of the dwelling, damaged flyscreens and faulty screen door locks reduce functionality and may impact security and usability. It is recommended that the flyscreen mesh be repaired or replaced and the screen door locking mechanism assessed and repaired or replaced by a suitable handyman or locksmith as required. These items should be addressed in the short term as part of routine maintenance to restore normal function.

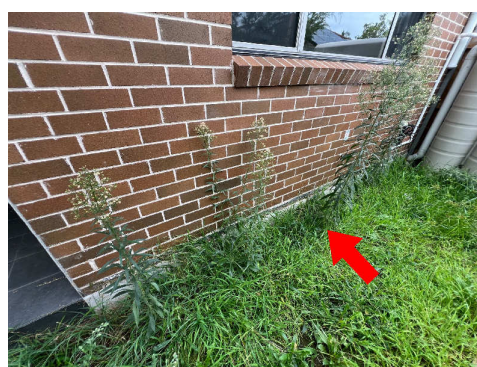
Information: Garden beds, vegetation and areas of grass were observed directly against the external walls of the dwelling in several locations around the property. Soil, mulch and vegetation positioned against external walls can create conditions that retain moisture against the building fabric and may obscure the lower wall areas from inspection. These conditions may also provide conducive environments for pest activity and moisture ingress, particularly where the finished ground level approaches the damp-proof course or weep holes within the brickwork.

Maintaining clear separation between garden beds, soil levels and the building structure is important to allow proper drainage, ventilation and visual inspection of the lower wall areas. Vegetation and soil build-up against walls can also contribute to moisture retention, which may affect building materials over time.

It is recommended that soil levels, garden beds and vegetation be trimmed back and maintained clear of the external walls, ensuring adequate clearance below the weep holes and damp-proof course. Ongoing maintenance of these areas should be undertaken as part of routine property maintenance to minimise the risk of moisture-related or pest issues.

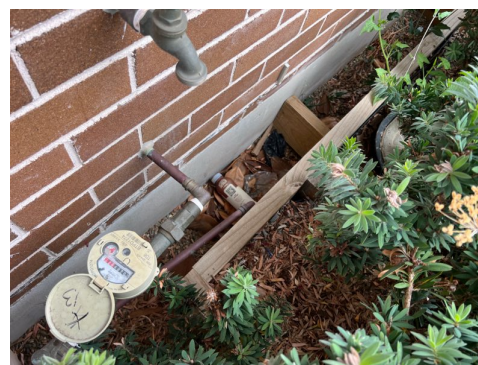
Finding 6.02

External hose taps were observed installed against the dwelling walls without any visible drainage provision beneath. No grated drain, spoon drain or adequate surface fall away from the structure was noted directly below the taps in the areas inspected. This condition allows water discharged from the taps, whether from use or minor leakage, to accumulate at the base of the wall and adjacent slab/footing areas.

The absence of drainage may contribute to ongoing moisture exposure to the wall base and surrounding materials. Prolonged wetting of these areas can increase the risk of moisture ingress, rising damp issues, or create conditions conducive to termite activity. Although no active moisture damage was noted at the time of inspection, the configuration presents a preventable moisture risk.

It is recommended that a licensed plumber assess the external taps and consider installation of an appropriate drainage solution (such as a grated drain connected to stormwater or improved surface grading) to direct water away from the structure. This should be addressed in the short term to reduce the risk of moisture-related deterioration.

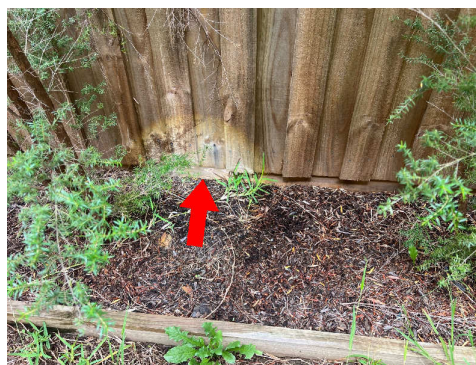
Finding 6.03

Building:	Main Building
Location:	Front & Rear
Finding:	Timber in Direct Contact with Soil – Conducive to Timber Pest Activity
Information:	<p>Timber elements were observed in direct contact with the soil and garden bed areas along sections of the property boundary and garden edging. Timber retaining pieces and garden bed edging materials were noted to be embedded in or directly touching the ground, which can create conditions conducive to timber pest activity and moisture-related deterioration.</p>

Timber placed directly in soil can retain moisture and may provide concealed pathways for termites or other timber pests to access nearby structures. These conditions can also lead to gradual timber decay over time. While the timber elements observed appear to be associated with garden edging and landscaping, their contact with soil is considered a conducive condition for termite activity and should be addressed to reduce potential risk.

It is recommended that timber elements in direct contact with soil be removed, replaced with suitable non-susceptible materials, or installed with adequate separation from the ground where possible. Ongoing monitoring and maintenance of landscaping materials around the dwelling should be undertaken to minimise conducive conditions for pest activity.

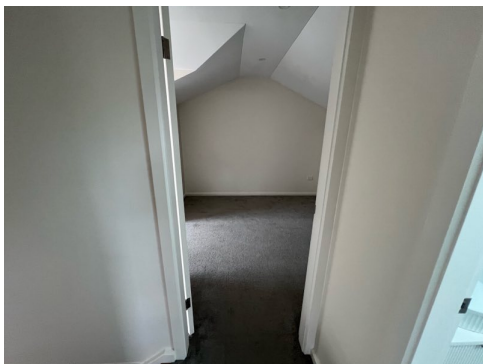
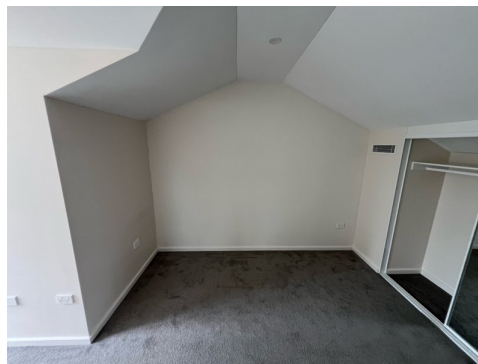
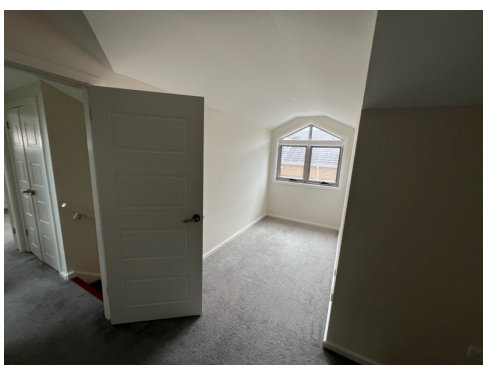
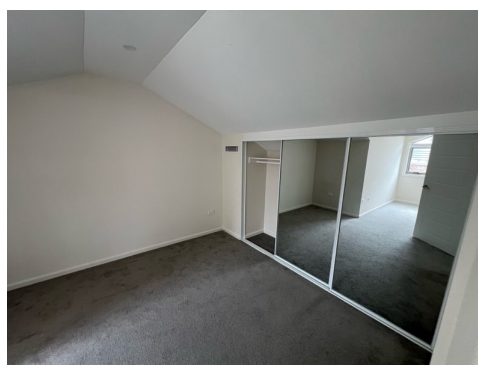
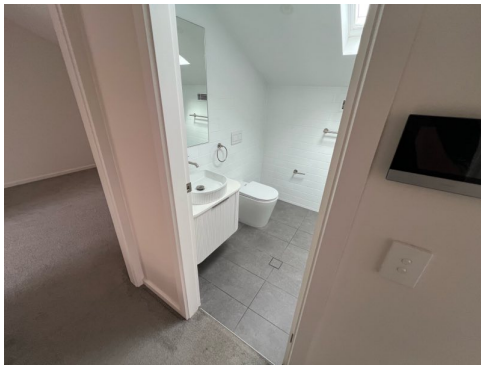
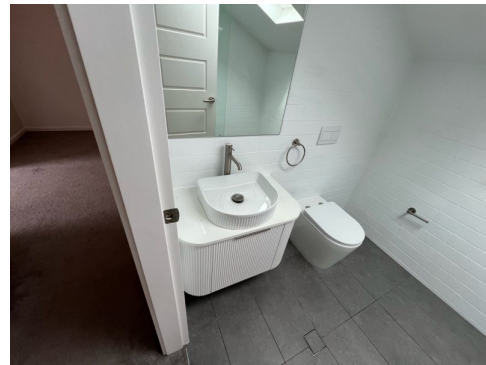
Finding: Additional Photos - Obstructions and Limitations

Information: These photographs are an indication of the obstructions and limitations which impeded full inspection of the property at the time of inspection. These obstructions can hide an array of defects and should be removed to allow full inspection to be carried out. A re-inspection is recommended once the areas are made accessible.

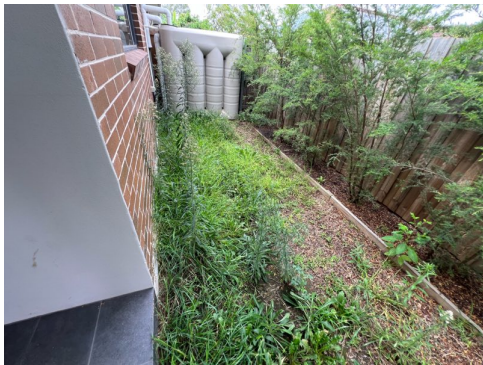
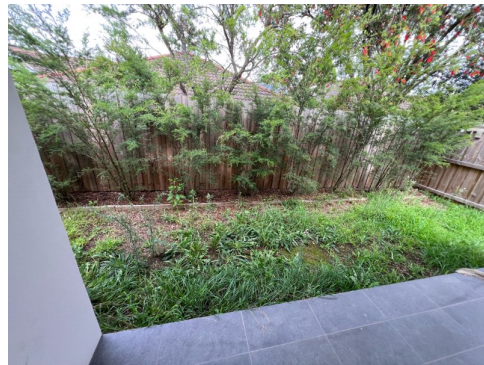
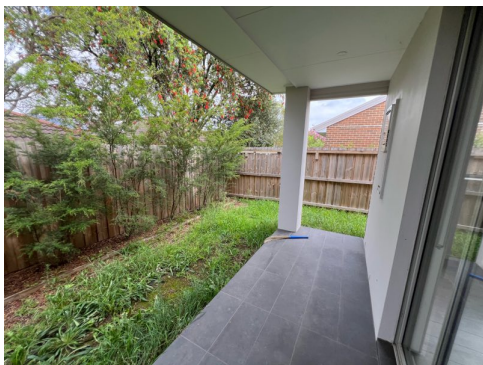
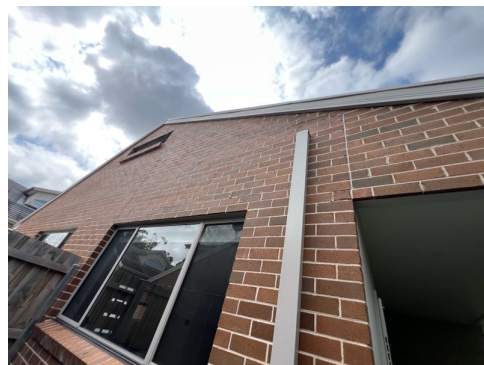
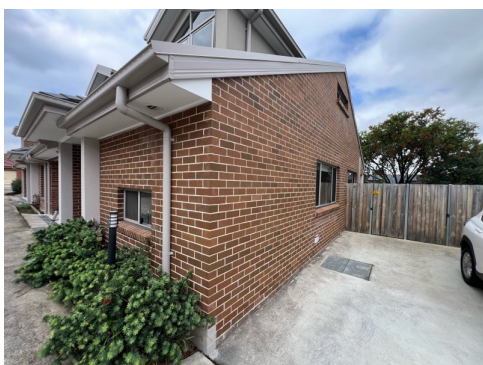
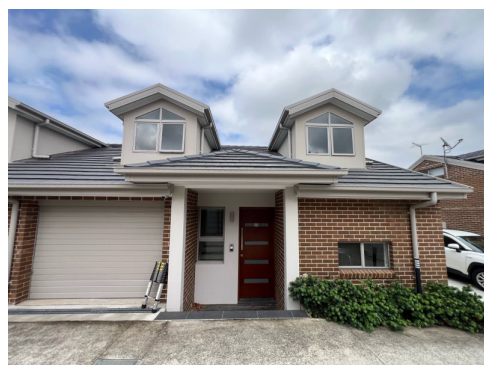
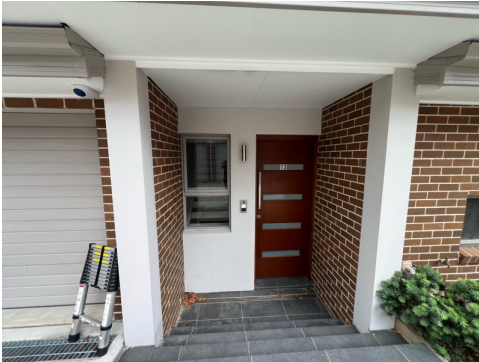
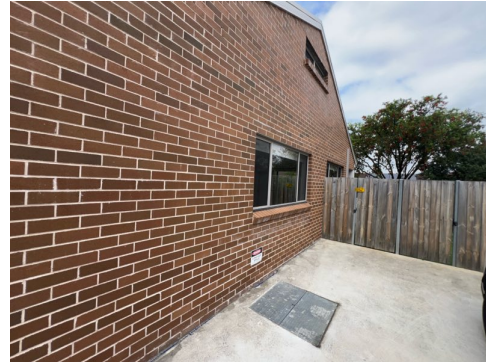
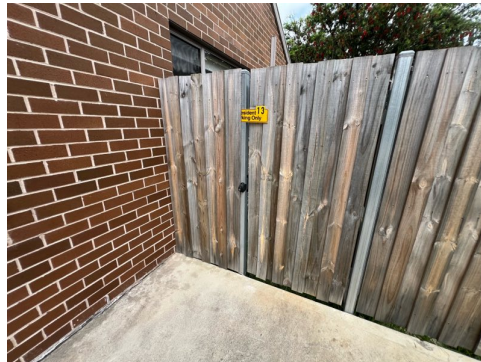
Finding: Additional Photos - Obstructions and Limitations

Information: These photographs are an indication of the obstructions and limitations which impeded full inspection of the property at the time of inspection. These obstructions can hide an array of defects and should be removed to allow full inspection to be carried out. A re-inspection is recommended once the areas are made accessible.

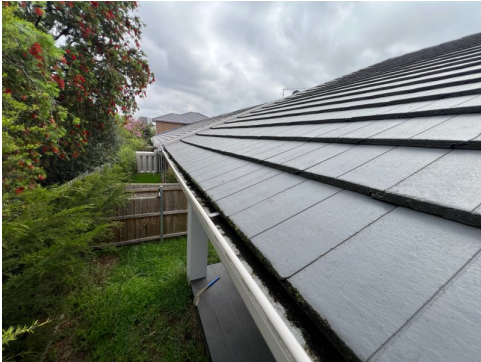
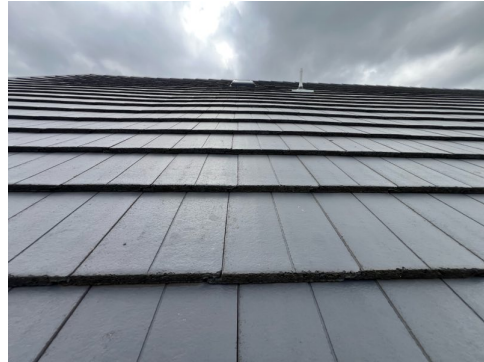
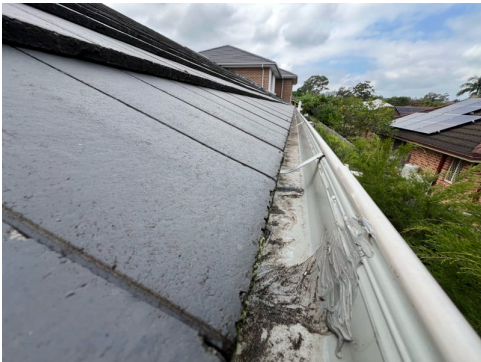
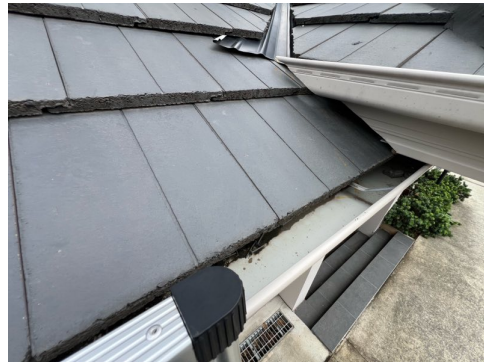
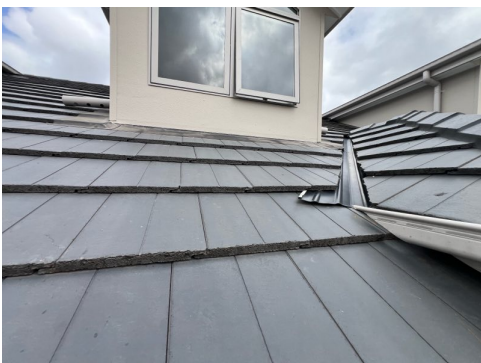
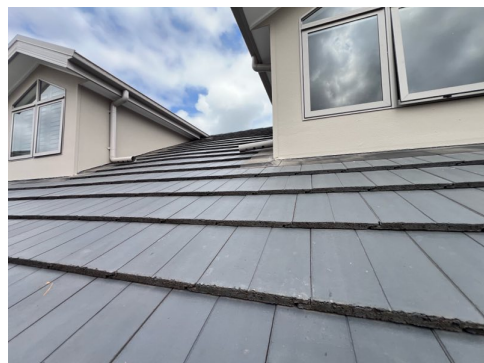
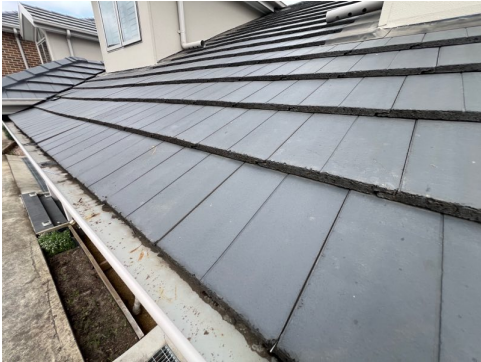
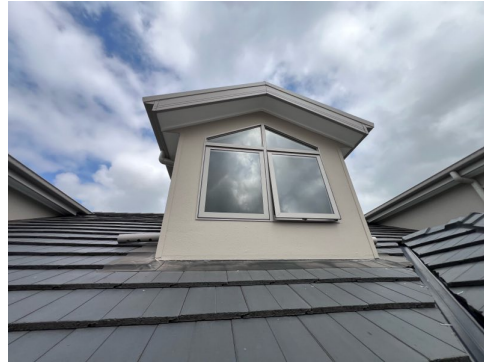
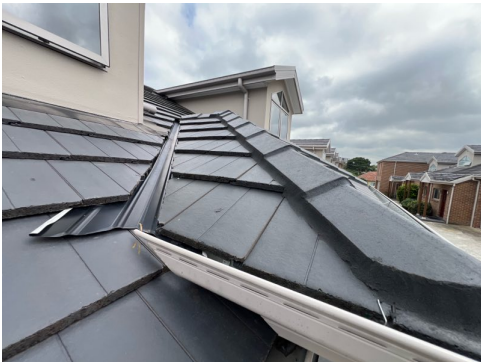
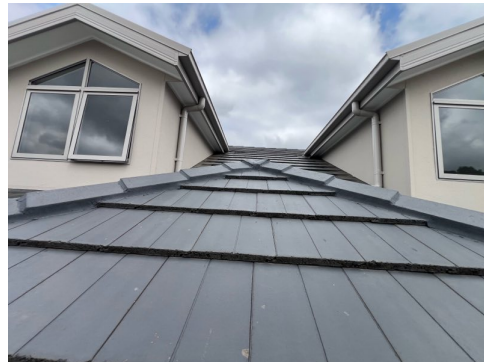
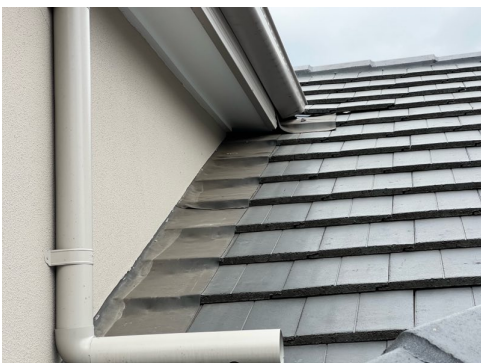
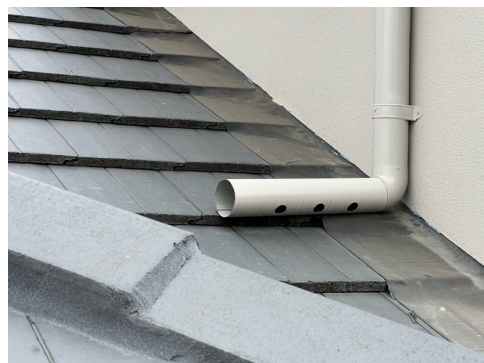
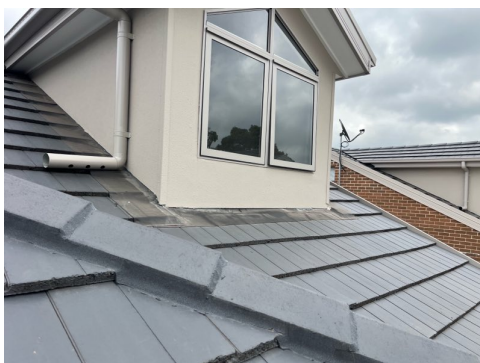
Building: Main Building
Location: Roof Exterior
Finding: Additional Photos
Information: Additional photos are provided for your general reference

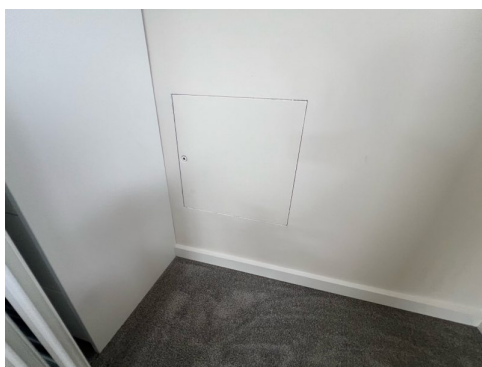
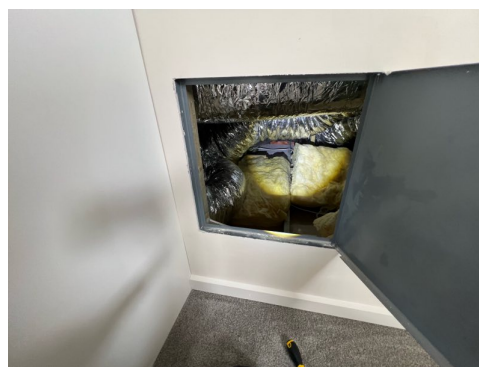
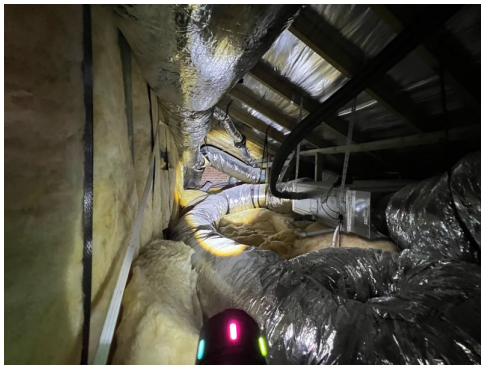
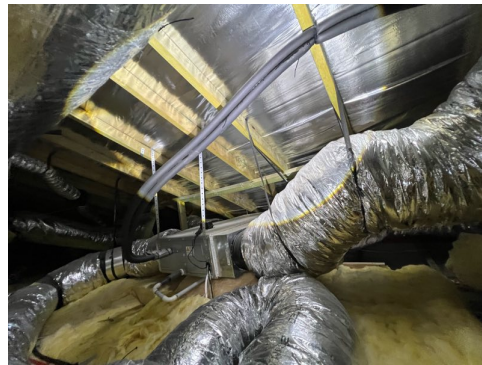
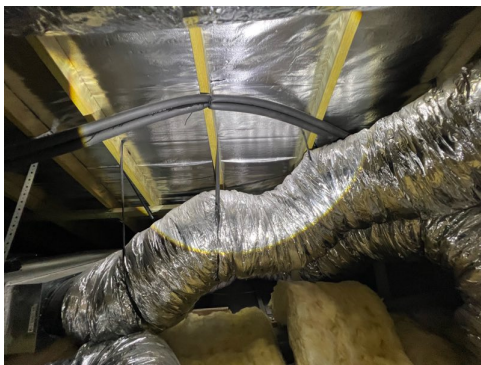
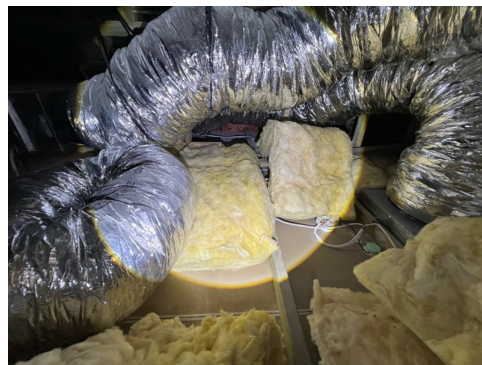
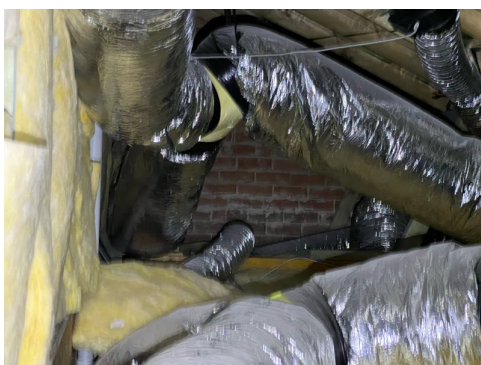
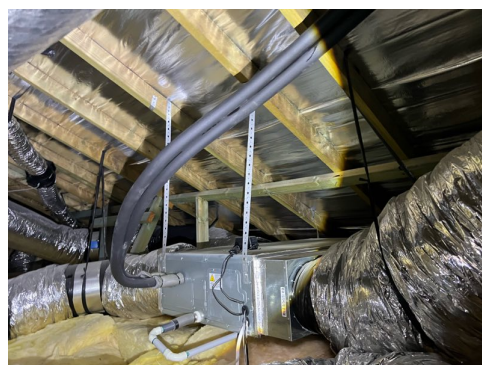
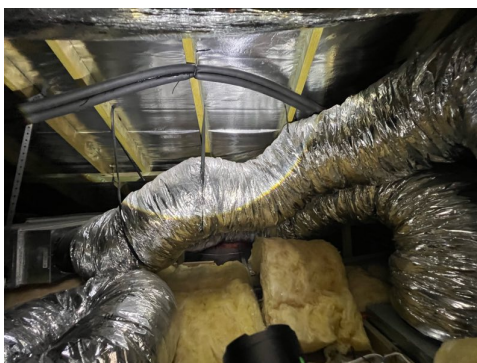
Building: Main Building
Location: Roof Void
Finding: Additional Photos
Information: Additional photos are provided for your general reference

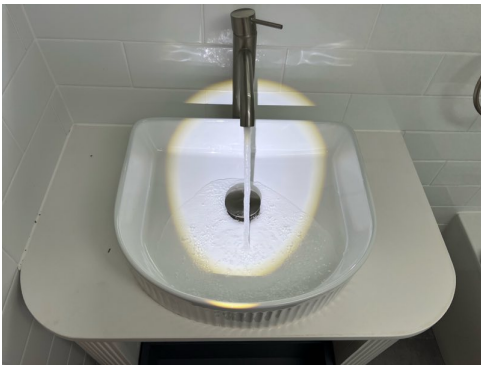
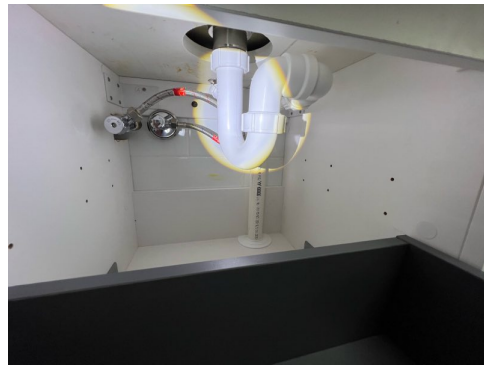
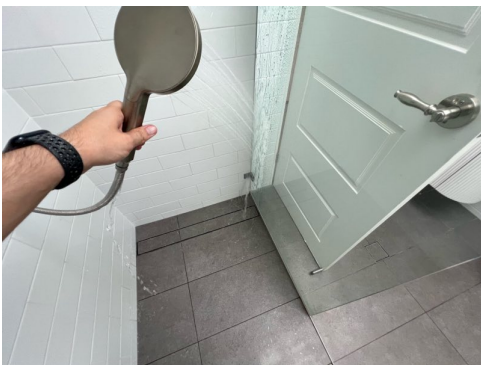
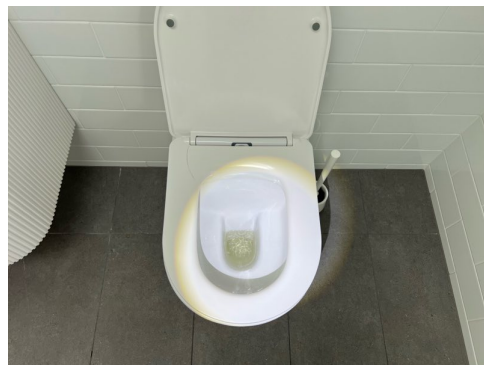
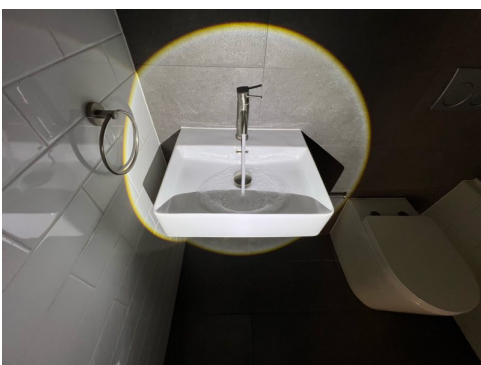
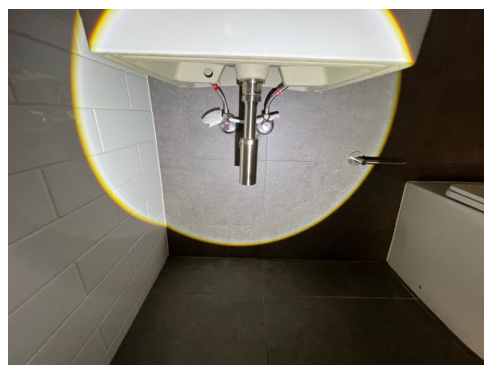
Information: All taps, mixers, and toilets were tested for correct operation, except where access was restricted. The shower recess waterproofing was assessed by conducting noninvasive moisture readings to the walls in and around the shower recess. No abnormal or significant moisture variations were detected within the areas tested. In addition, a visual inspection of the surrounding wall surfaces did not reveal any visible signs of recent or ongoing water damage where inspection was possible.

Based on the above observations, there is no conclusive evidence to suggest the presence of an active shower recess leak at the time of inspection, other than any issues already identified elsewhere in this report. It is therefore reasonable to assume that the shower waterproofing is currently performing as intended. However, it should be noted that if the shower has not been used for an extended period prior to the inspection, moisture readings may not accurately reflect underlying conditions and may result in misleading outcomes. As this inspection is limited to visual and noninvasive methods in accordance with pre-purchase inspection standards, it is not possible to definitively confirm the absence of leaks. If a higher level of certainty is required, a specialist invasive inspection is recommended.

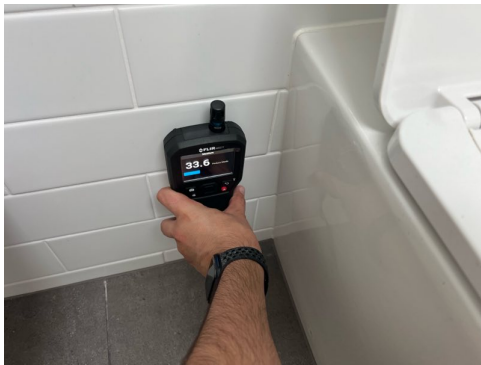
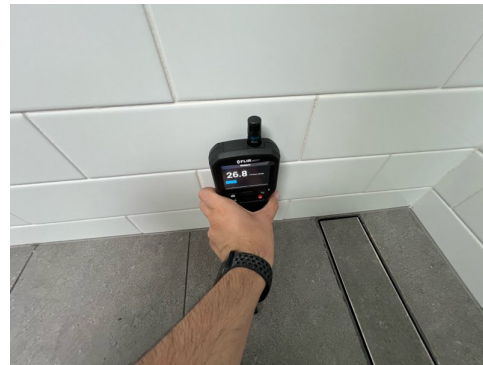
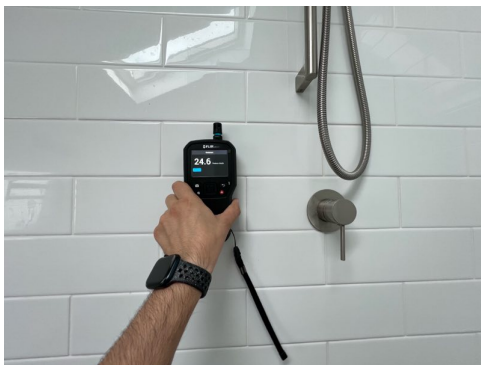
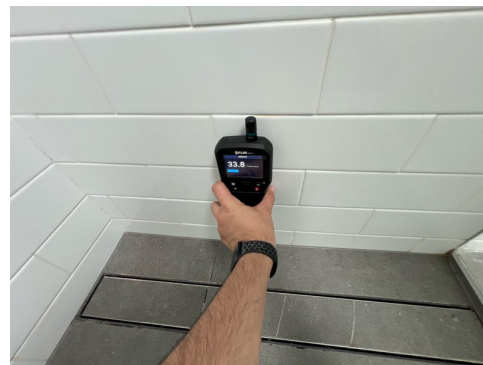
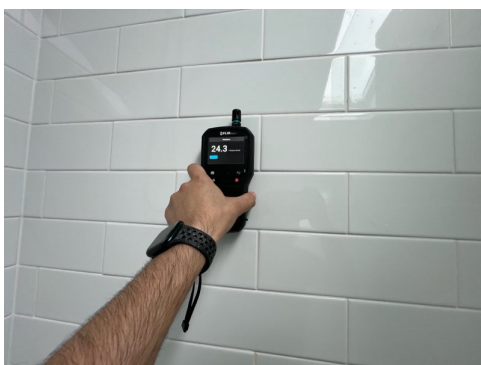
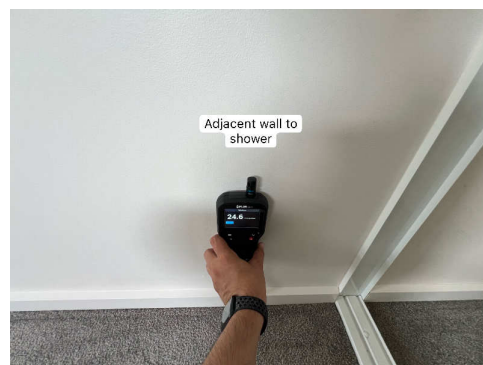
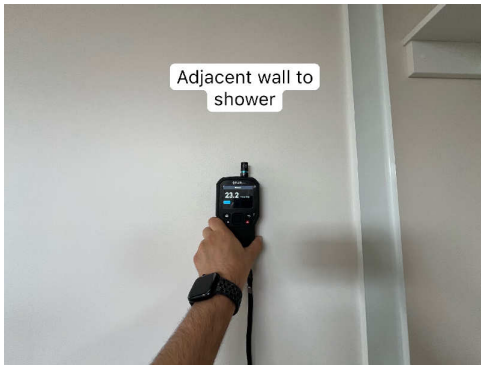
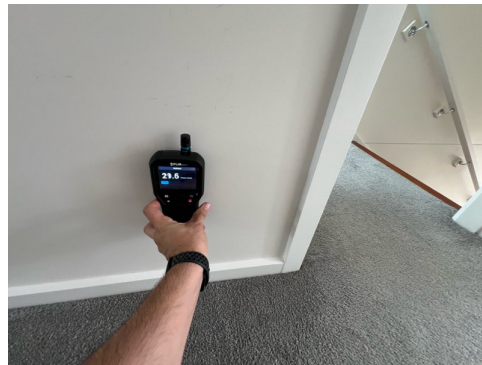
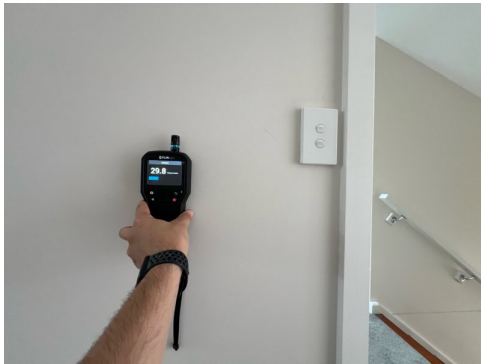
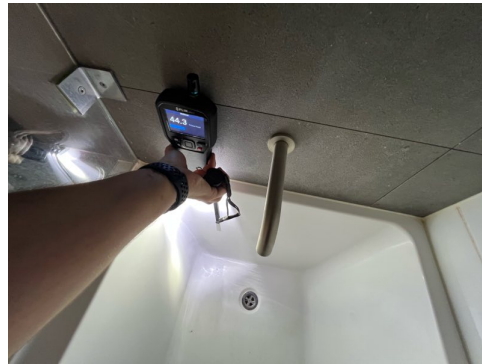
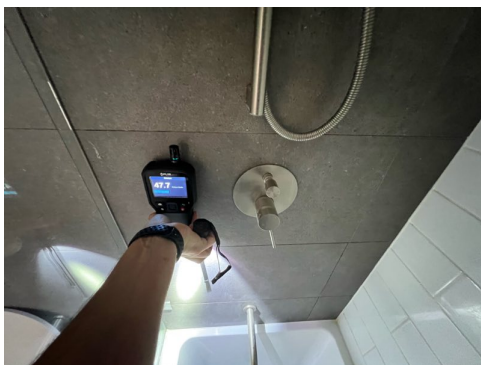
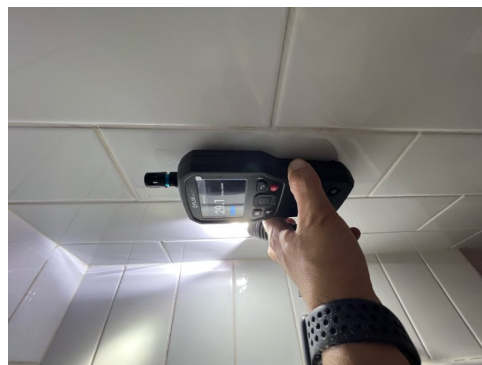
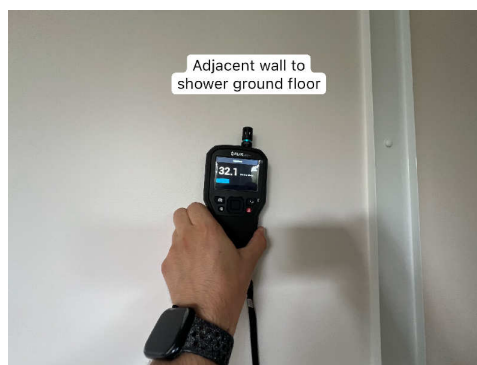
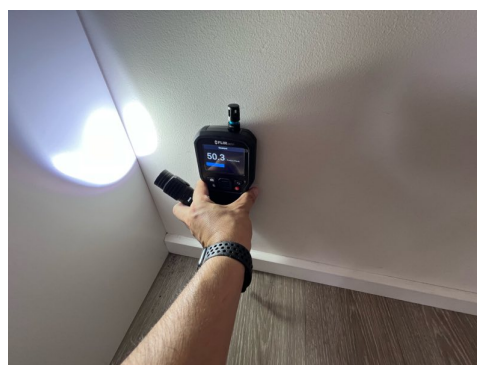
Finding: Moisture Meter Readings - For Information Only

Information: Moisture testing was undertaken to selected accessible internal surfaces using a noninvasive moisture meter at the time of inspection. Readings obtained provide an indicative assessment only and are intended as a guide to assist in identifying areas that may warrant further investigation.

No invasive testing was carried out, and moisture readings can be influenced by a range of factors including material type, surface finishes, environmental conditions, and recent use of wet areas. As such, the results are provided for information purposes only and do not constitute a definitive assessment of concealed moisture conditions. Concealed defects may exist that were not evident at the time of inspection.

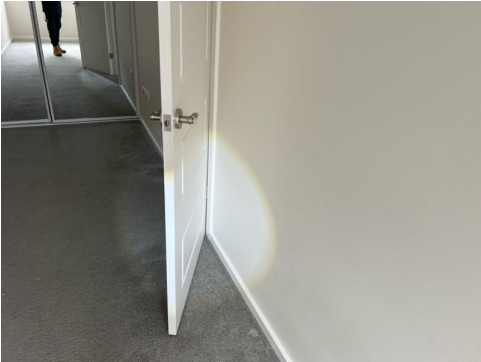
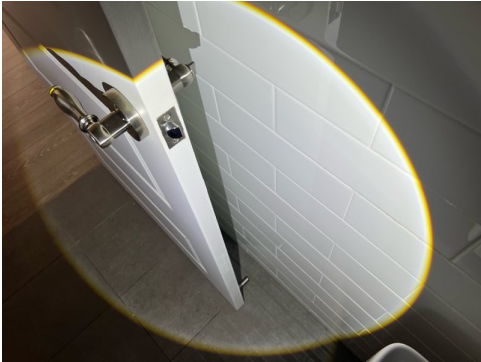
Finding: Door stop - Missing

Information: The door stop is missing or is inadequate to stop the door handle from damaging the wall. Although some building elements may seem irrelevant or unnecessary, all building elements play a key role in the operation and function of the overall structure and its performance.

Re-installation or replacement of the door stop is advised as soon as possible to prevent any subsequent damage to the door or associated structures. A general handyman may be appointed to perform these works at client discretion.
