Building and Timber Pest Inspection Report

Inspection Date: Mon, 16 Mar 2026

Property Address: 4 Darley Rd, Bardwell Park NSW 2207,
Australia

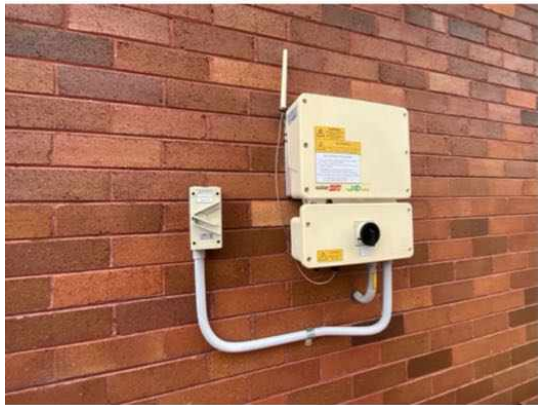
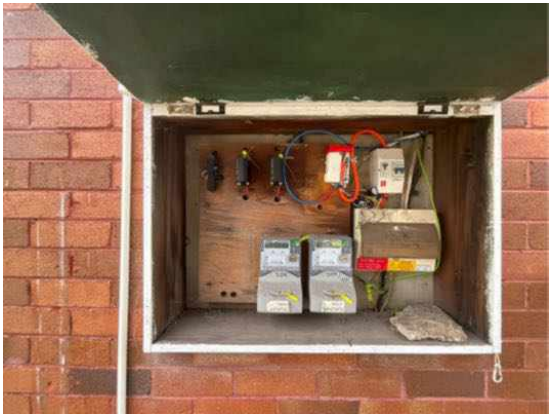
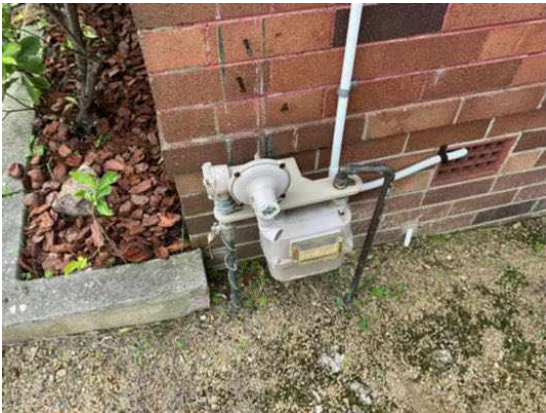
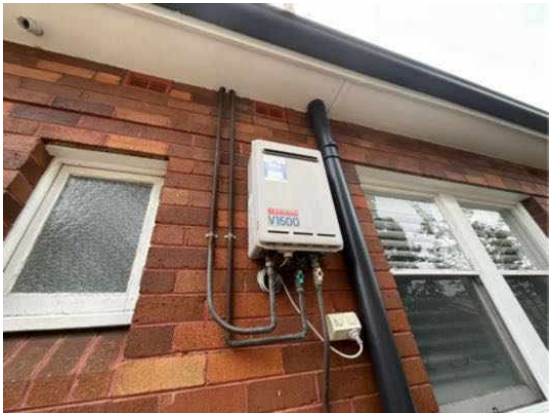
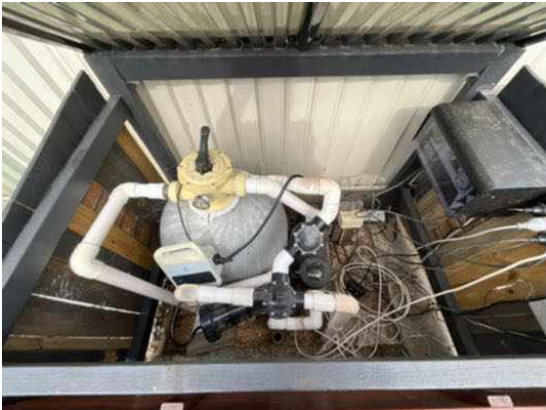
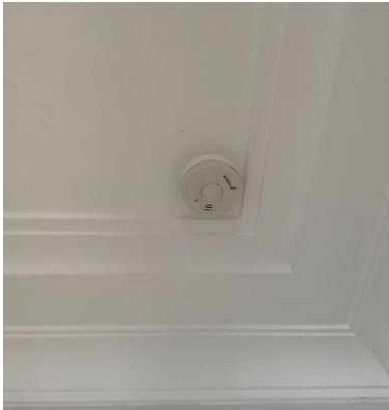
Building: Main Building
Location: All Areas
Finding: Photos Added
Information: Additional photos are provided for your general reference.

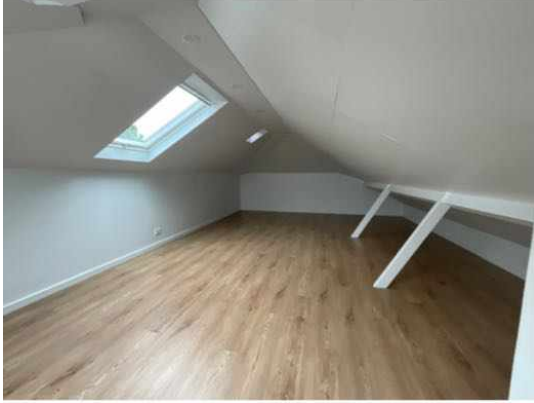
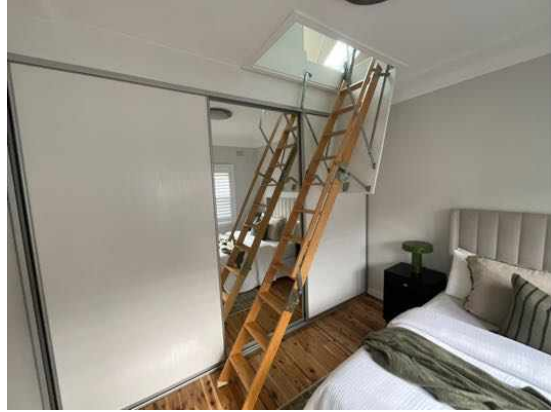
Building: Main Building
Location: Roof Void
Finding: Photos Added
Information: Additional photos are provided for your general reference.
