Building and Timber Pest Inspection Report

Inspection Date: Tue, 27 Jan 2026

Property Address: 625 Browns Plains Rd, Crestmead QLD
4132, Australia

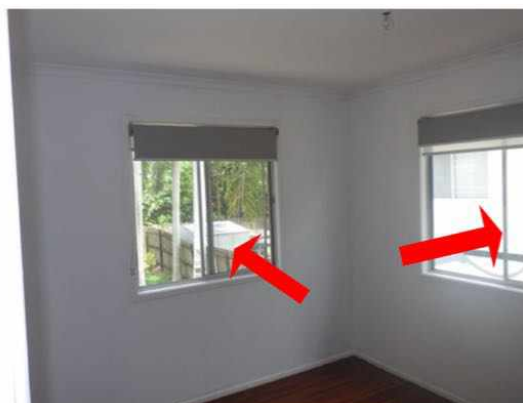
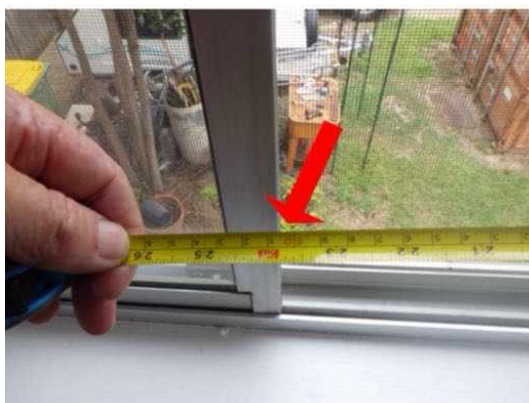
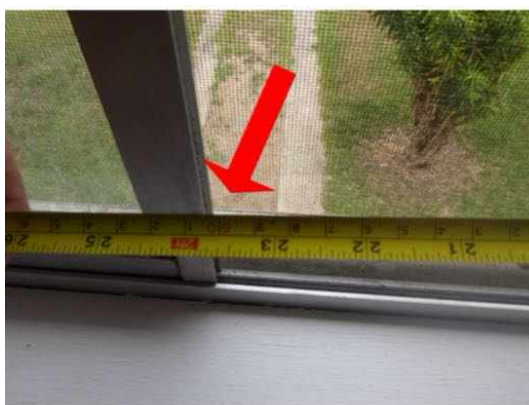
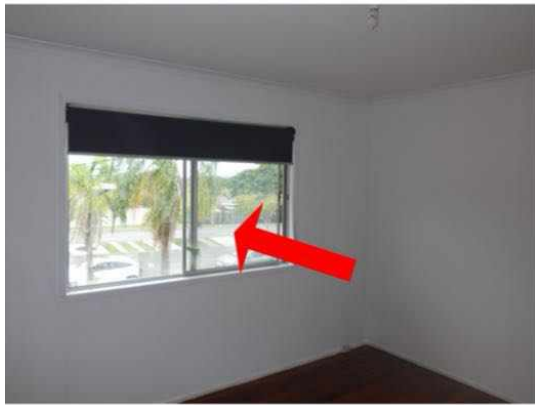
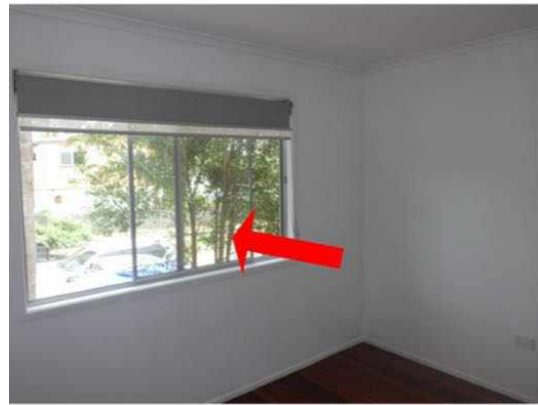
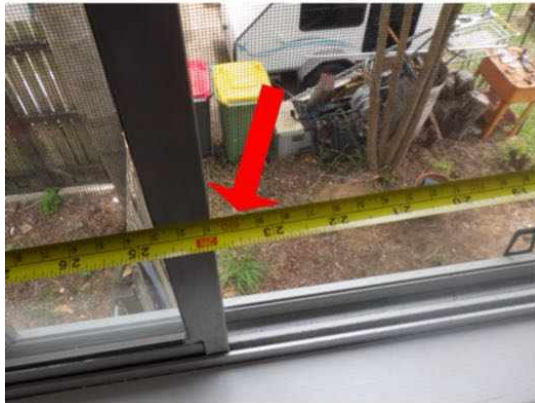
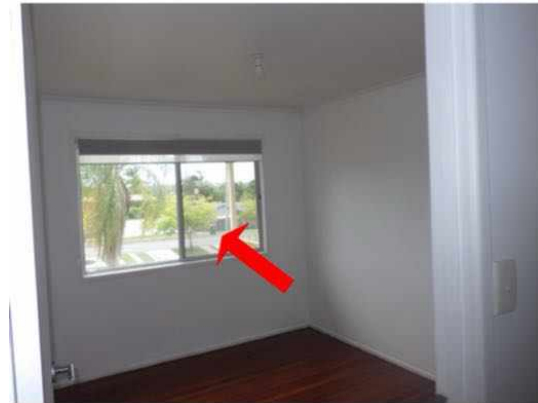
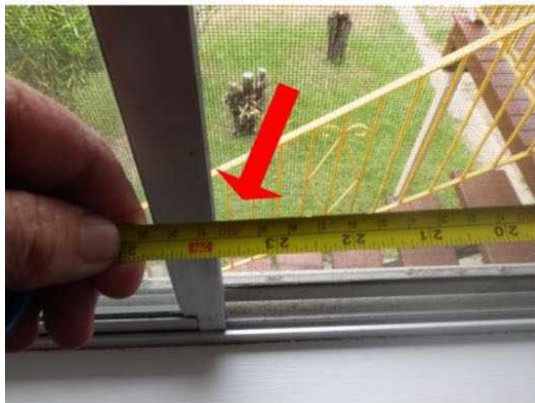
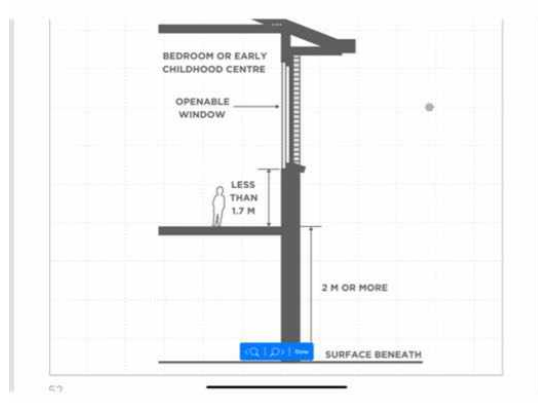
Building: Main Building
Location: Bedrooms > Existing
Finding: Window safety
Information: It was noted that the windows of the upper level bedrooms are less than 1.7m from the floor and have a fall greater than 2m on the exterior from the sill and as such are required to only open upto 125mm or have security grills fitted.

This is noted as a safety concern and this regulation may not have been in place at the time of construction.

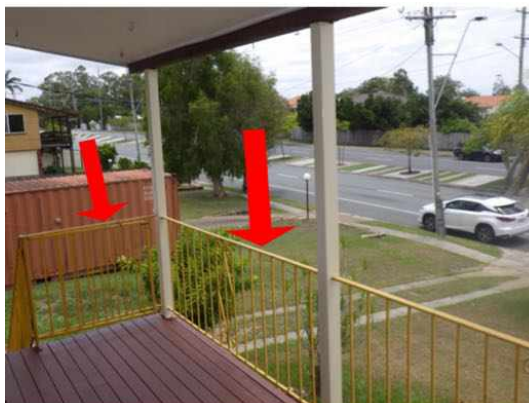
Finding 1.02

Building: Main Building
 Location: Balcony > Existing
 Finding: Balustrade - Suspected Non-Compliance
 Information: The balustrade to the front balcony was measured and found to be (.840mm high) less than the present building regulation requirement of 1000mm high.

This defect creates a potential safety hazard and should be rectified to ensure the safety of the area and to meet present building standards and regulations.

A registered builder should be contacted to discuss possible rectification solutions.

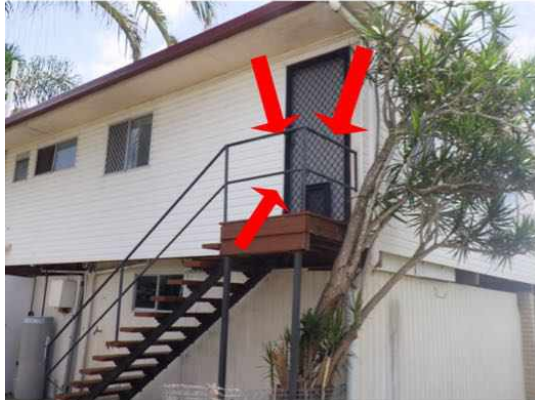
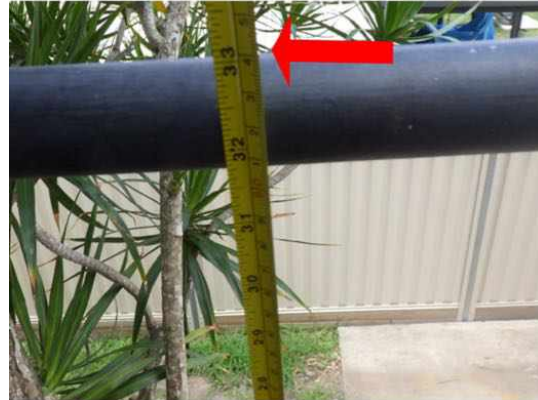
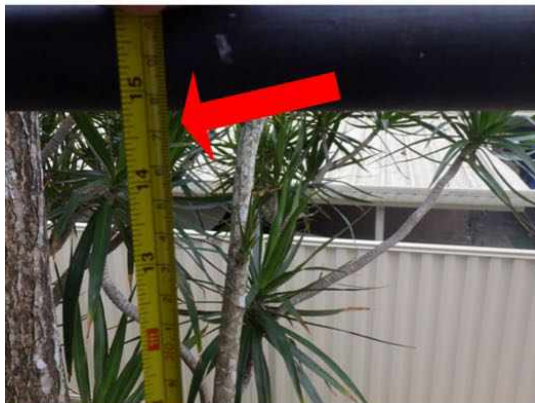
Finding 1.03

| Information: | The balustrade to the rear stair area landing was measured and found to be (.840mm high) less than the present building regulation requirement of 1000mm high. Additionally the gaps between the balustrade railing were found to be (.370mm wide) greater than the present building regulation requirement of 125mm. |

This defect creates a potential safety hazard and should be rectified as soon as possible to ensure the safety of the area and to meet present building standards and regulations.

A registered builder should be contacted to discuss possible rectification solutions.

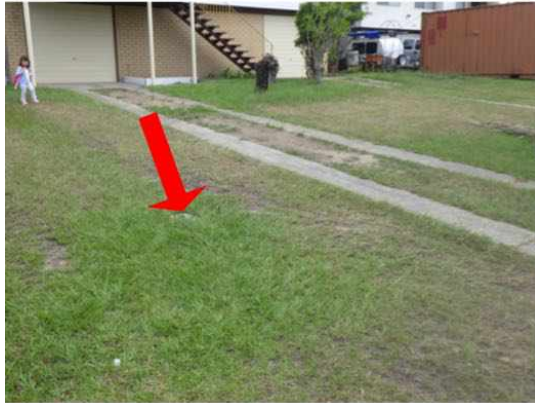
Building: Main Building
 Location: Yard - Front > Front Right
 Finding: Sewer line - Caps Missing
 Information: At the time of inspection it was noted the sewer line cap was missing on the front left side of the property.

It is assumed the caps have been previously removed.

A licensed plumber or general handyman could be engaged to replace the sewer line caps..

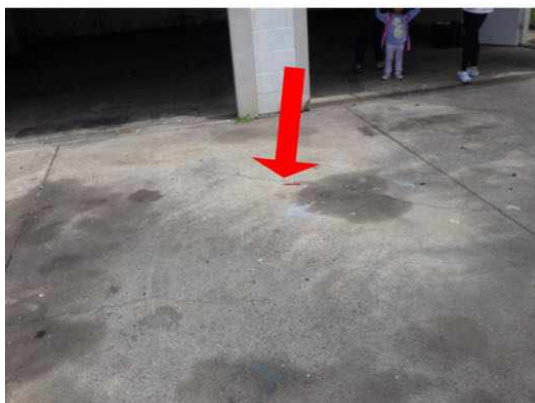
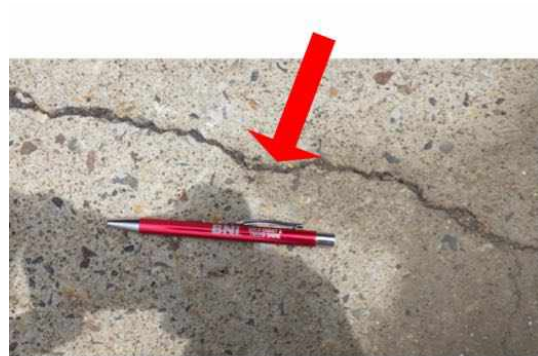
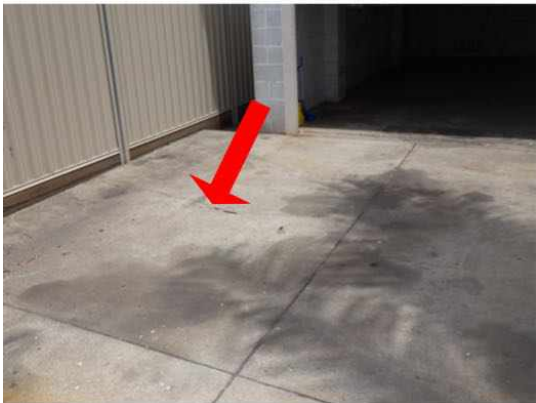
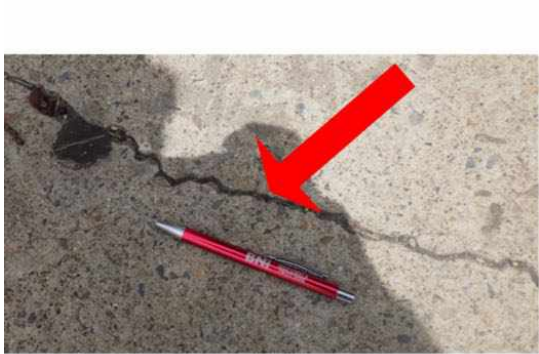
Finding 3.02

| Finding: | Cracking in concrete slab - Category 1 |
| Information: | Cracking coded as Category 1 was identified in the driveway and footpaths concrete slab. A Category 1 crack is described as a fine but noticeable crack, with the slab at an otherwise reasonable level. |

To be considered Category 1, the approximate width of the crack is less than 1.0mm, or a less than 10mm change in offset when a 3m straight edge is placed over the defect.

Category 1 cracks should be monitored for a period of 12 months. At the end of the monitoring period, identified cracks that are rated greater than Category 2 are considered defects, and require rectification.

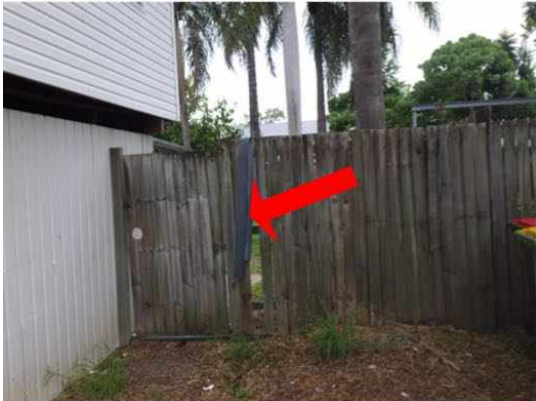
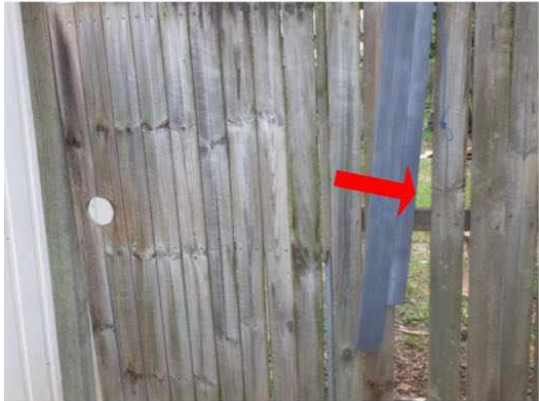
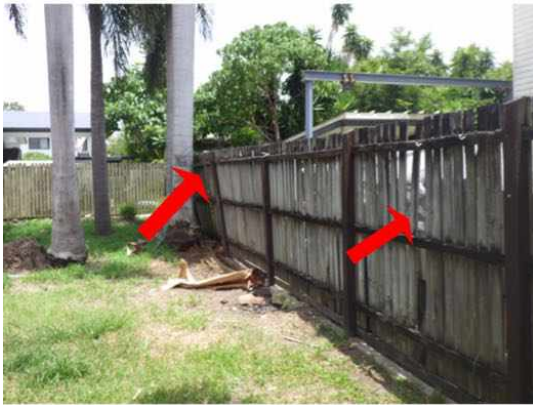
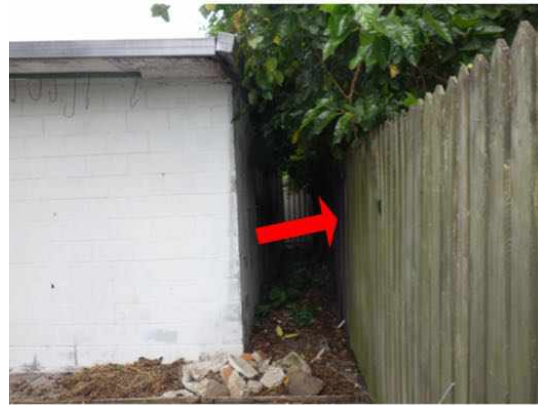
Finding 3.03

Building: Main Building
Location: Yard - Back > Existing
Finding: Fencing - Deteriorated
Information:

It was noted at the time of inspection that sections of the fencing to the right side and rear of the property have deteriorated. Typically fencing deteriorates due to age and or wear, rot and or rust which is generally expected for a structure of this age, due to prolonged exposure to weather conditions. Sometimes inadequate installation or maintenance can be to blame.

If left unattended, it is likely that further damage will occur. It is suspected that repair of several elements of the fencing may be required however replacement may be a consideration of the client also.

A licensed fencing contractor should be appointed to provide further advice and perform rectification works as necessary.

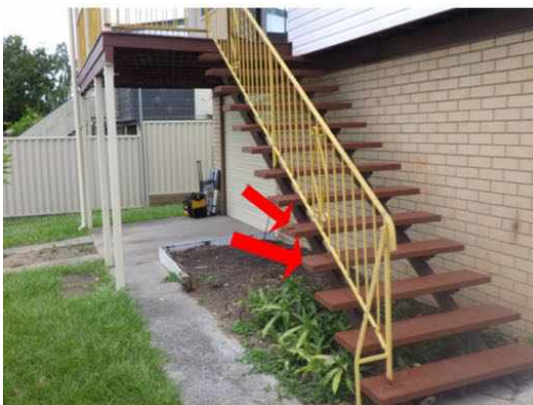
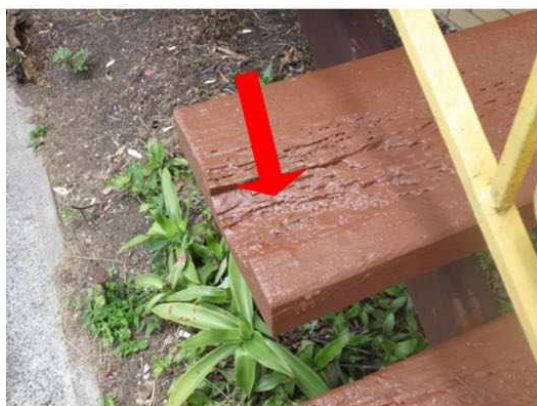
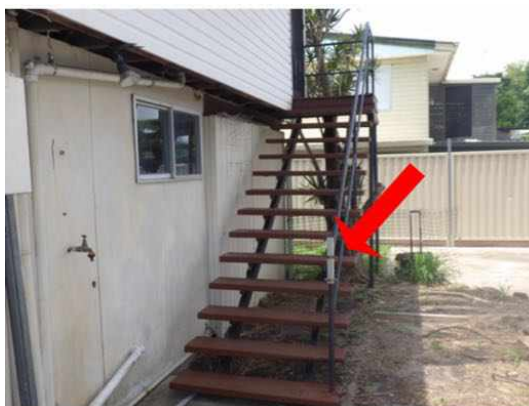
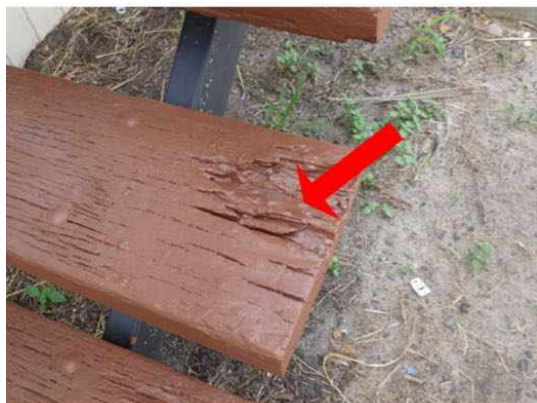
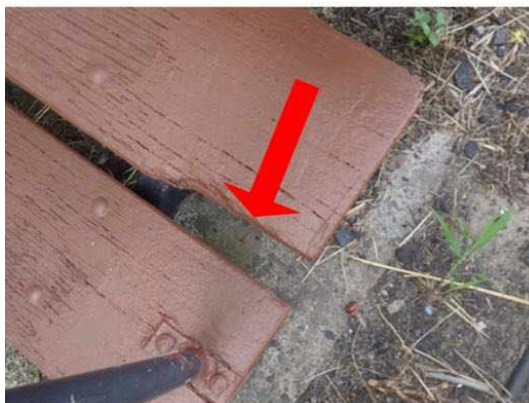
Finding 3.04

Finding: Stair treads - Deteriorated

Information: It was noted at the time of inspection that a number of the external timber stair treads to the front and rear of the property have deteriorated (as per example photos). Typically timber stair treads deteriorate due to age and or wear, rot and or rust which is generally expected for a structure of this age, due to prolonged exposure to weather conditions. Sometimes inadequate installation or maintenance can be to blame.

If left unattended, it is likely that further damage will occur. It is suspected that repair or replacement of several elements timber stair treads may be required.

A licensed carpenter could be appointed to provide further advice and perform rectification works as necessary.

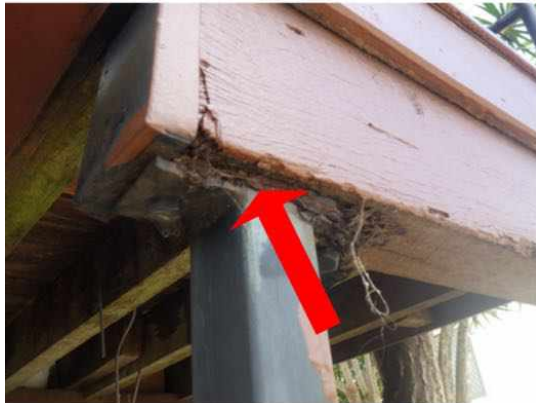
Finding 3.05

| Finding: | Steel posts- Rusted or corroded |
| Information: | The steel support posts to the rear stair landing area show evidence of rusting and corrosion, which is likely to have developed as a result of excessive exposure to moisture and or inadequate coatings. |

As surface rust provides no protection to the underlying iron, the deteriorating condition is likely to worsen if not addressed in the short-term future.

Where possible, the use of galvanized (treated) metals or aluminium coated metals aid in rust prevention, as does regular general maintenance. Rust formation can be controlled with coatings, such as paint, that isolate the iron from the environment.

Rusting and corrosion should be managed by ideally removing or limiting the affected surface from exposure to moisture. A registered builder should be appointed to replace the support posts that have been severely affected by rust or water damage.

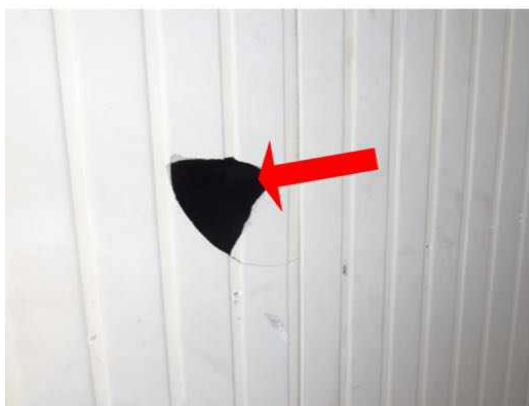
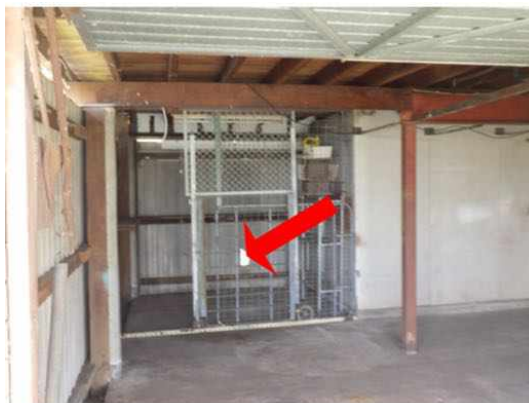
Finding 3.06

| Finding: | Walls - Damaged |
| Information: | At the time of inspection the wall cladding to the ground floor exterior of property were found to have suffered deterioration and damage in a number of areas (as per example photos). The damage may have been sustained as a result of a number of possible causes, including minor impact damage. |

The damage to the wall cladding in these areas detracts from the appearance of the structure.

NOTE - The lower area wall cladding maybe an asbestos containing materials.

A licensed carpenter or general handyman could be engaged to undertake repair work.

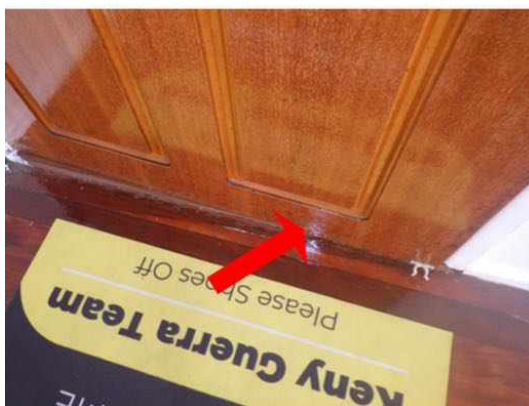
Finding 3.07

Building: Main Building
 Location: Entry > Front
 Finding: Door - Binding/Jamming
 Information: Binding and/or jamming of the entry door on the door sill was evident during standard operation. This defect inhibits the functionality of affected door as well as creating potential for secondary defects to associated building elements, such as damage to the door framing.

A door that binds to the associated door frame or sill may have several causes, such as poor installation of the door or deteriorated hinges.

A qualified carpenter or general handyperson could be appointed to perform minor rectification works at client discretion.

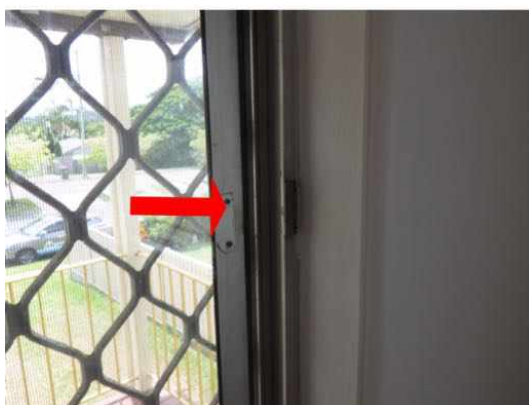
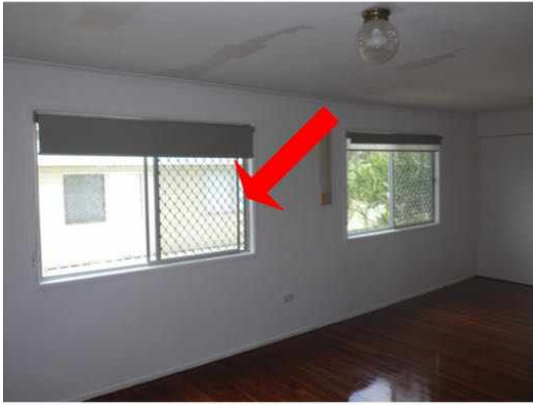
Finding 3.08

Building: Main Building
 Location: Living Room > Front Left, Centre Left
 Finding: Window - Broken latch
 Information: The window latches to the living room area sliding windows were found to be missing or broken at the time of inspection. Breakage occurs generally when the building materials have aged and decayed, but may be indicative of impact damage (accidental or deliberate).

Repair and/or replacement of the broken window catches is advised to improve the operational state of the associated windows.

An aluminium window service agent or general handyman should be appointed to repair/replace the window latch at the client's discretion.

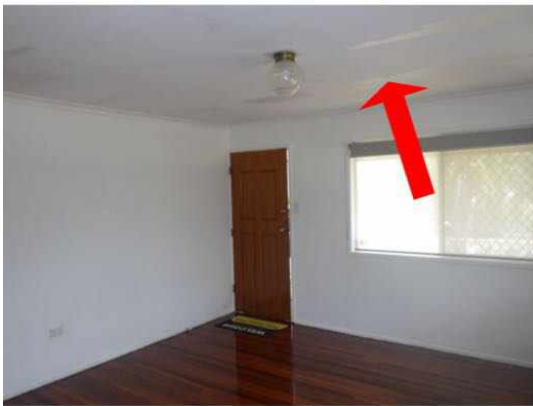
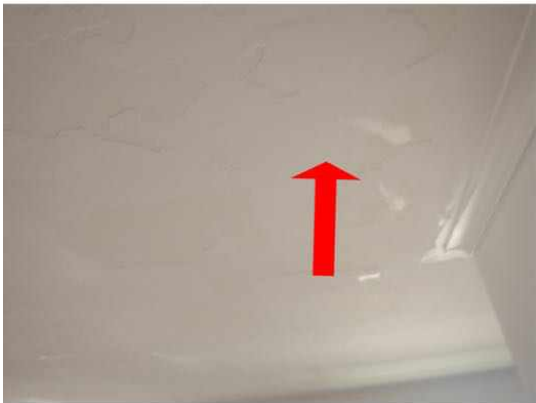
Finding 3.09

Building: Main Building
 Location: Living Room > Existing
 Finding: Ceiling Surface - Disfigurement
 Information: At the time of inspection the living room area ceiling surface showed evidence of significant surface disfigurement (cause unknown).

The level of damage may be the result of previous calcimine paint issues. In older homes original calcimine paint can become unstable, leading to severe peeling and flaking.

It is highly recommended a licensed painting contractor be engaged for further investigation and/or rectification options.

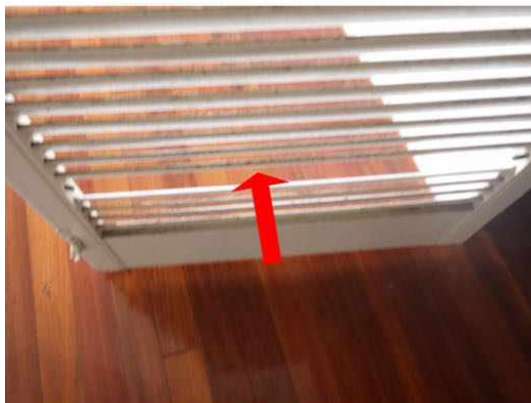
Finding 3.16

Building: Main Building
 Location: Hallway > Centre Left
 Finding: Door - Broken latch
 Information: The door latch to the linen cupboard door was found to be broken at the time of inspection. Breakage occurs generally when the building materials have aged and decayed, but may be indicative of impact damage (accidental or deliberate).

Replacement of the broken door catch is advised to improve the operational state of the associated door.

A general handyman could be appointed to replace the door latch at the client's discretion.

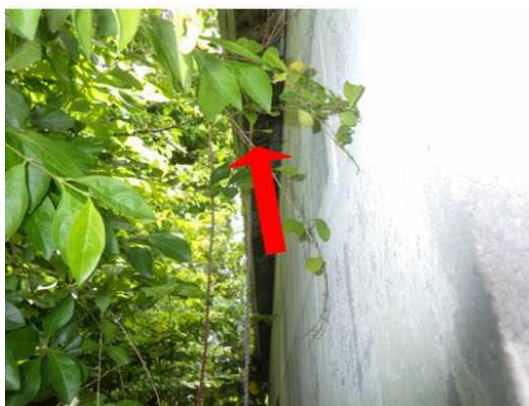
Finding 3.30

Building: Shed
 Location: Exterior walls - rear > Rear Right
 Finding: Window - missing
 Information: The window panel to the shed area rear right sliding window was found to be missing at the time of inspection. Breakage occurs generally when the building materials have aged and decayed.

Replacement of the missing window panel is advised to improve the operational state of the associated window.

An aluminium window service agent or general handyman should be appointed to replace the window panel at the client's discretion.

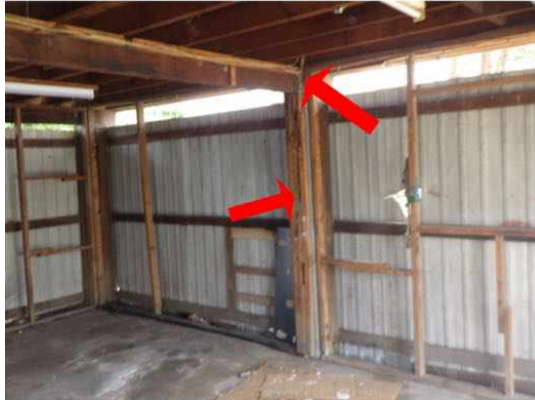
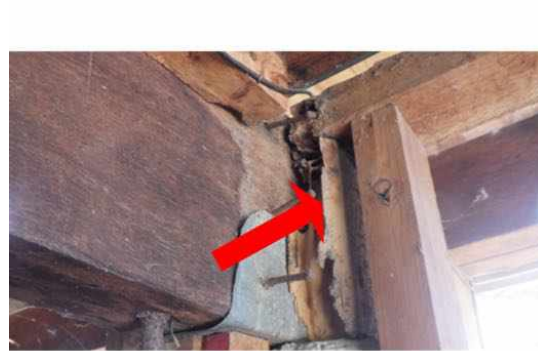
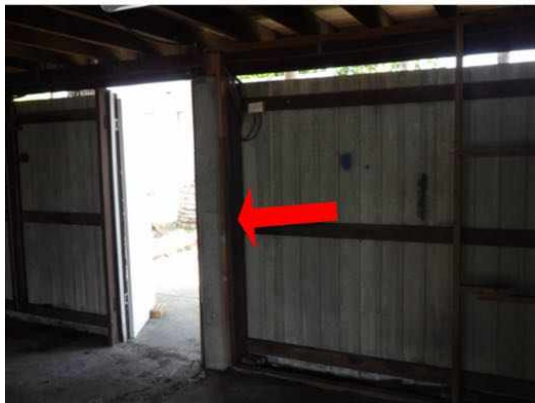
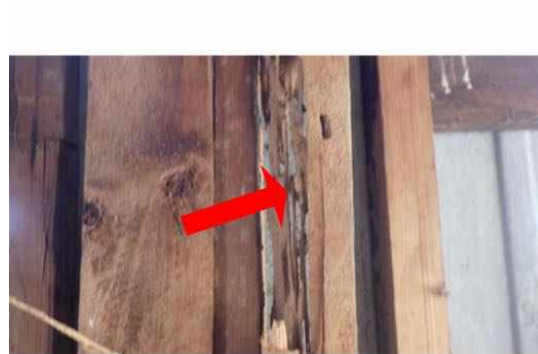
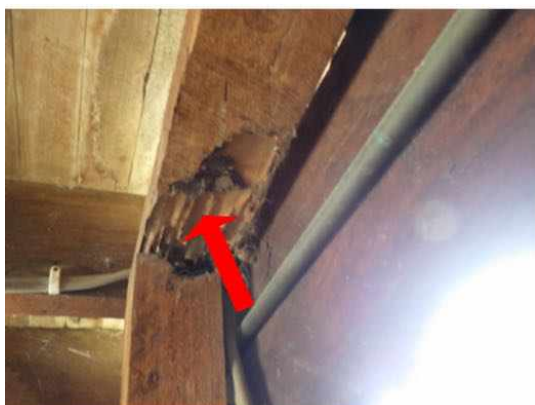
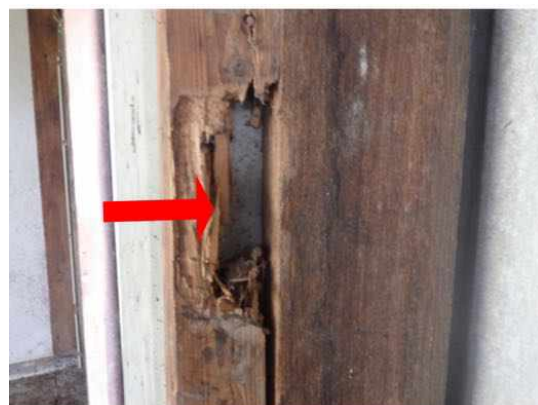
| Finding: | Evidence of termite damage - minor |
| Information: | Despite no live termite or timber pest activity being found, previous termite damage was found to have affected the timber wall framing in the ground floor garage area. This damage is considered to be inactive and is minor in nature. |

It is advised that the area be visually inspected frequently to ensure that the condition of affected building materials does not worsen. The level of damage appeared to be non- structural and is generally only considered to be superficial.

A licensed carpenter could be engaged to undertake repair work.

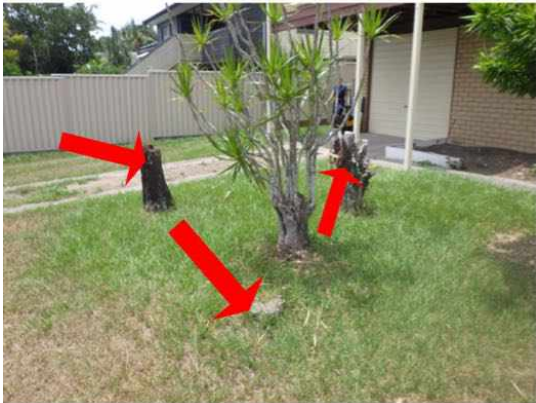
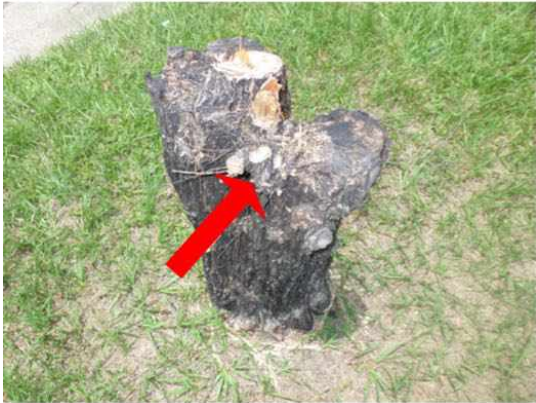
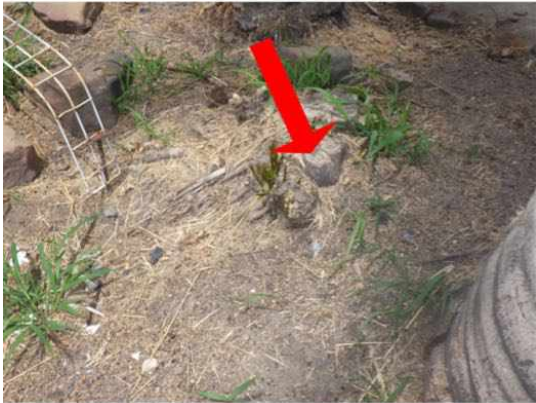
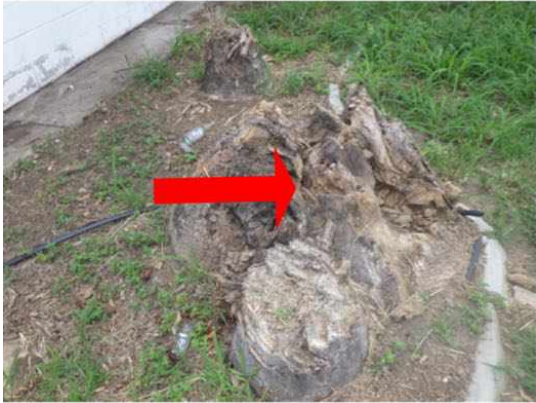
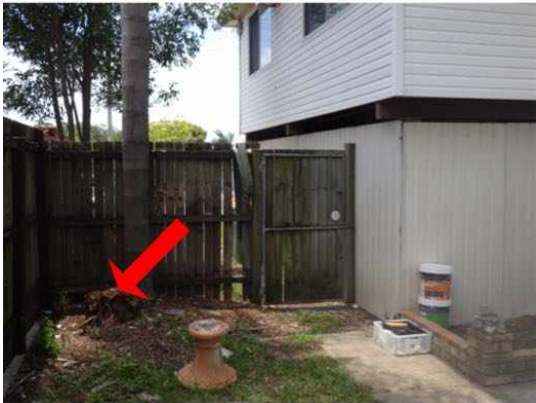
Finding 6.01

Any timbers in direct ground contact provide opportunity for concealed termite activity and are likely to be subject to premature rot and decay as the soil retains moisture or damp conditions against the timbers.

Removal or chemical treatment of any untreated timber or tree stumps which are in direct contact with external ground is highly recommended. Frequent pest inspections are advised to readily identify any termite activity in these areas.

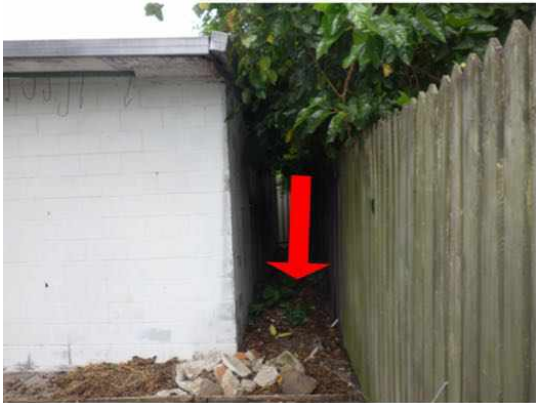
Finding 6.02

Building: Main Building
 Location: Yard - Back > Rear Left
 Finding: Garden Beds - Conditions Conducive to Termites
 Information: Garden beds and external landscape areas were found to contain tree stumps, debris and garden waste at the time of inspection (as per example photos). These garden beds can include untreated timber, and with a combination of moisture from watering hosing can make conditions conducive to termite activity and termite ingress. Removal of any garden debris or vegetation is advised. Frequent pest inspections are advised to readily identify any termite activity in these areas.

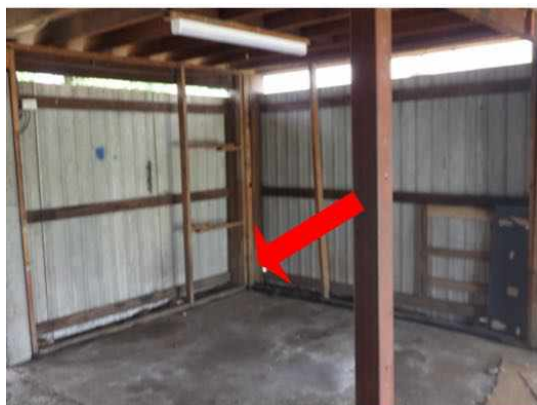
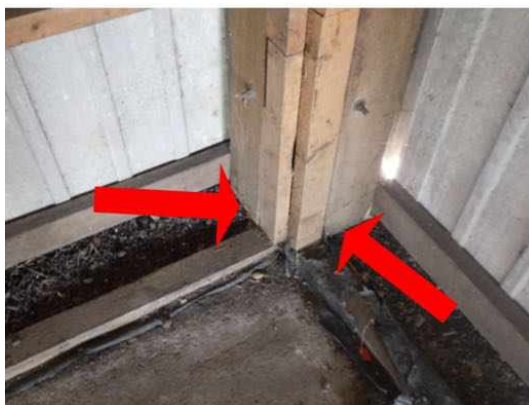
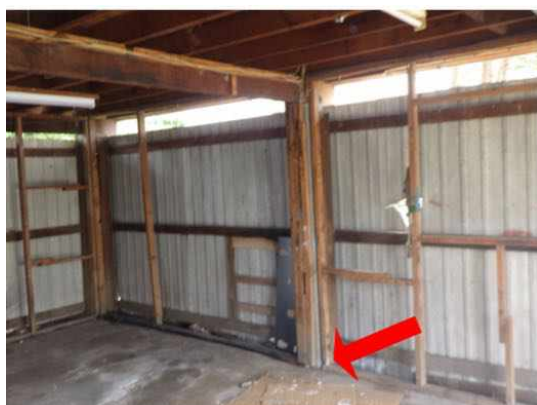
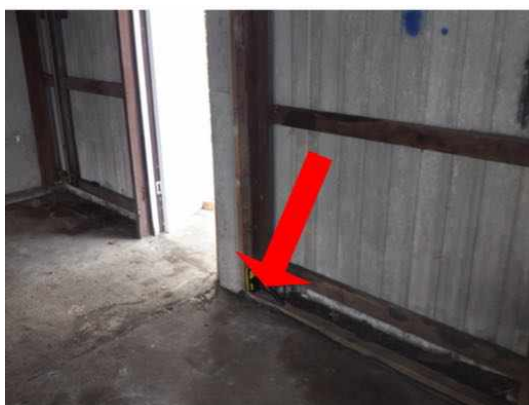
Finding 6.03

Any timbers in direct ground contact provide opportunity for concealed termite entry and are likely to be subject to premature rot and decay as the ground retains moisture or damp conditions against the timbers.

Ideally these types of timber members would be clear of the ground area by a minimum of 50mm to provide a clear inspection zone.

Frequent pest inspections are advised to readily identify any termite activity in these areas.

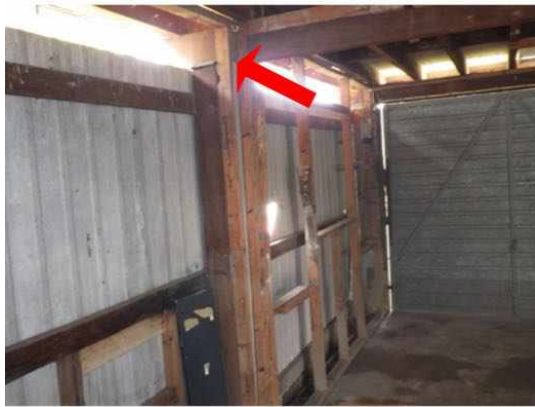
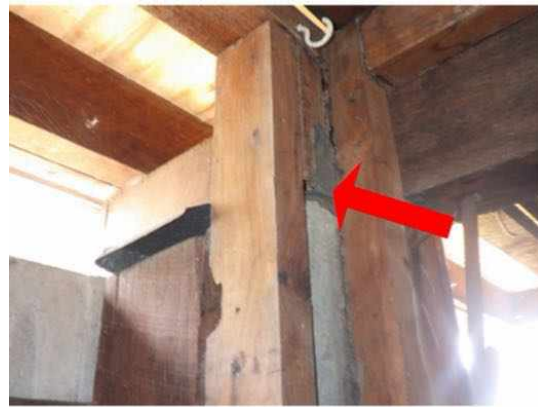
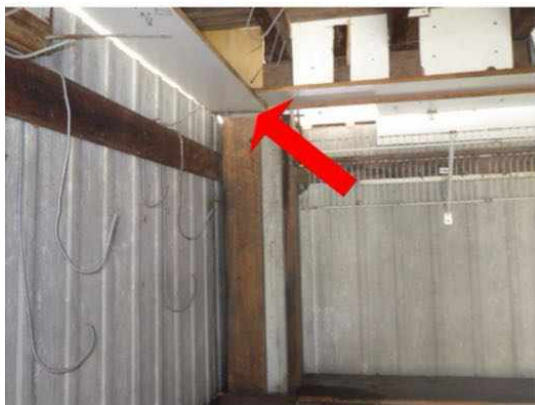
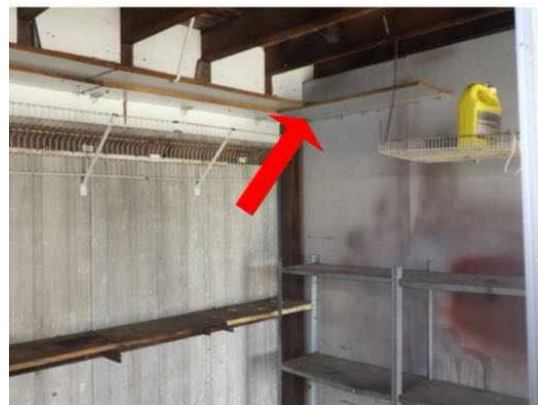
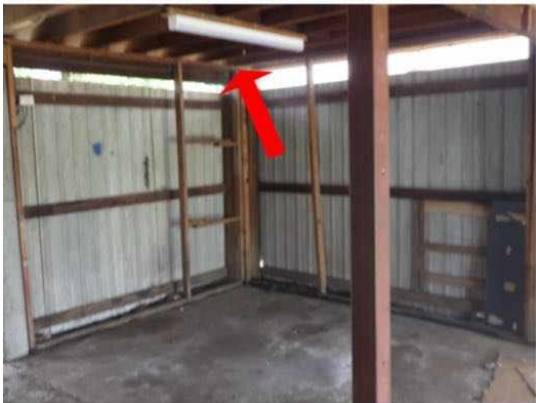
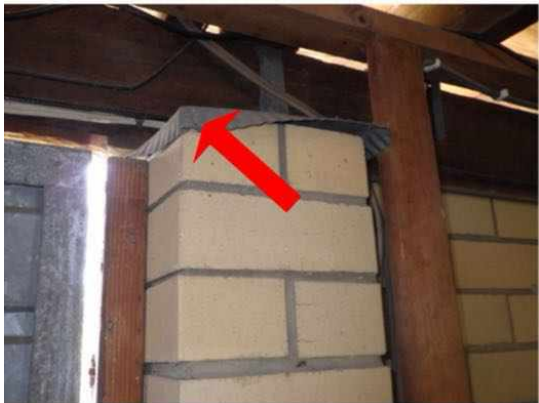
Finding 6.04

At the time of inspection it was noted a number of the metal ant caps have been altered or compromised, it is highly advised a qualified builder is engaged to re-install or replace the metal ant caps to restore the timber termite barrier system as required.

Where ant caps have been compromised, a licensed carpenter or builder should be engaged to replace or repair the metal ant caps as a matter of priority.

Frequent monitoring of these areas should be carried out in order to identify any signs of termite or timber pest workings.

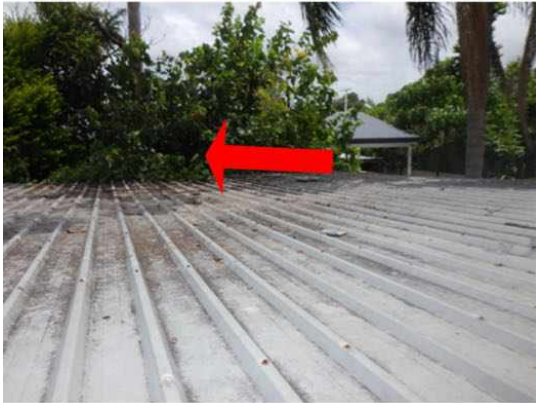
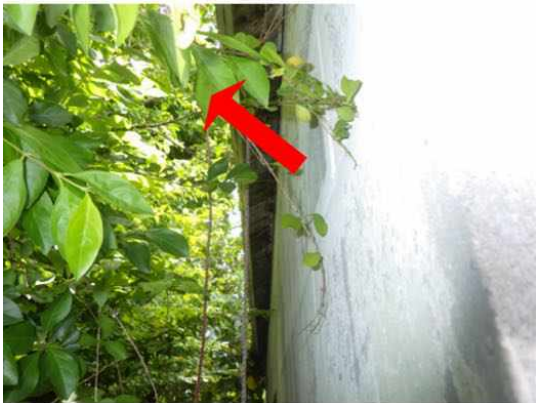
Finding 6.05

Building: Shed
Location: Roof Exterior > Rear
Finding: Vegetation
Information: At the time of inspection there was vegetation growing over external roof and wall areas to the shed on the left side of the property.

The vegetation over growing roof and wall areas should be trimmed back clear of the external surfaces. The grass and other vegetation heights should be maintained around the perimeter of the building to allow for an inspection zone around the building exterior.

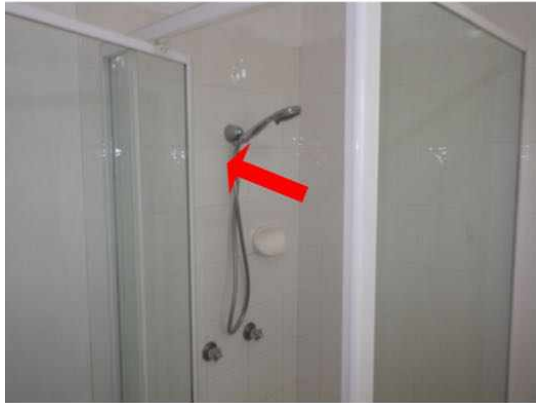
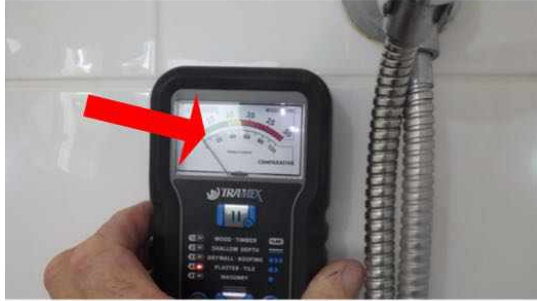
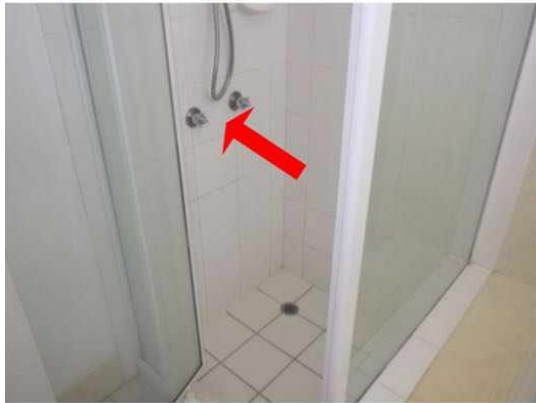
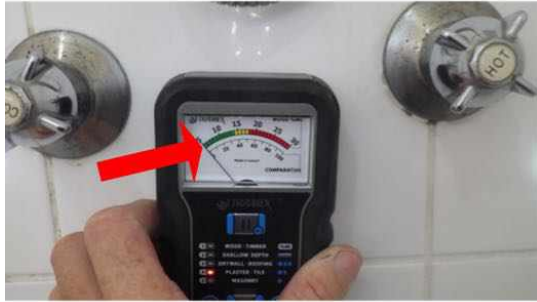
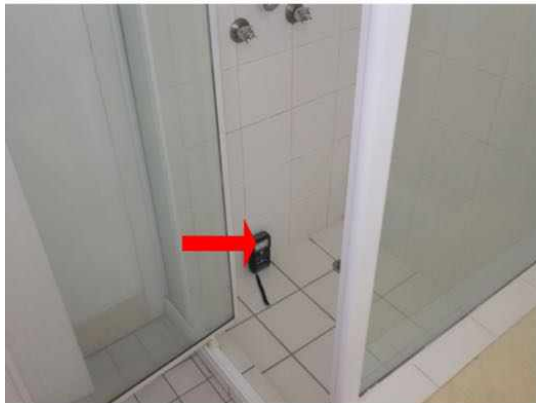
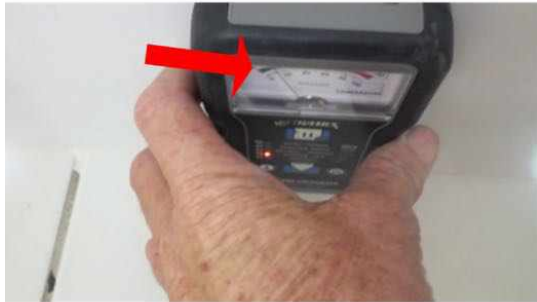
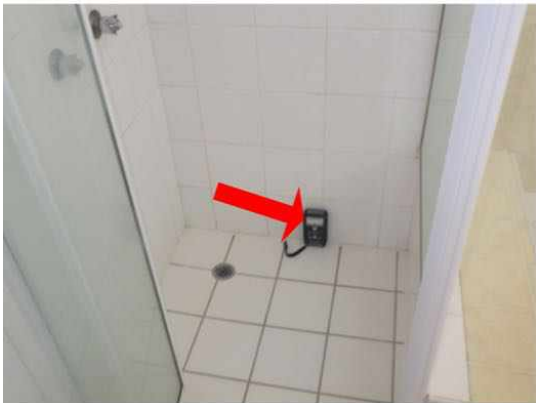
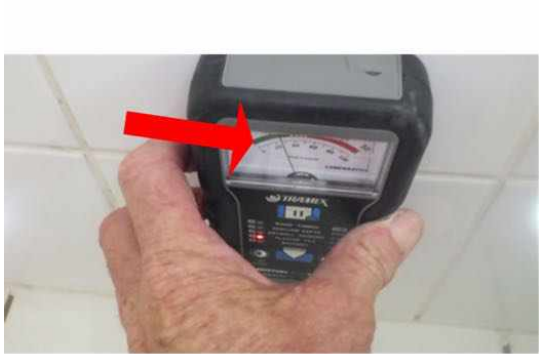
Finding: Moisture Level Readings

Information: At the time of inspection the bathroom shower cubicle areas checked with the Tramex Moisture Meter returned low - normal moisture level readings.

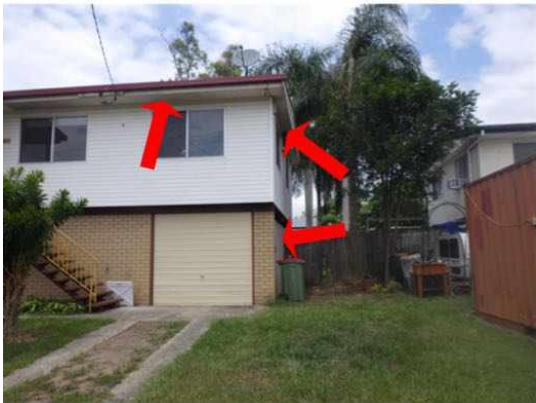
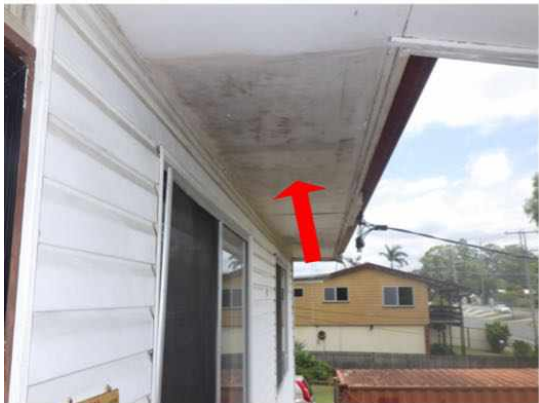
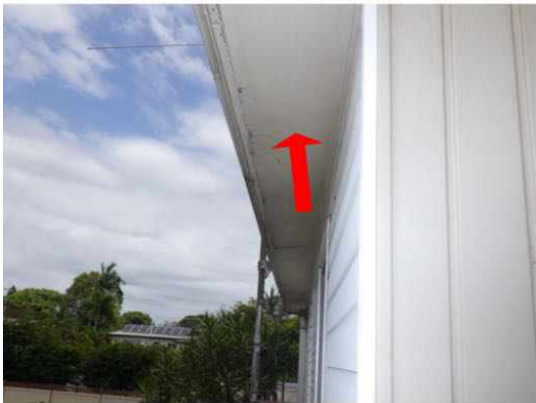
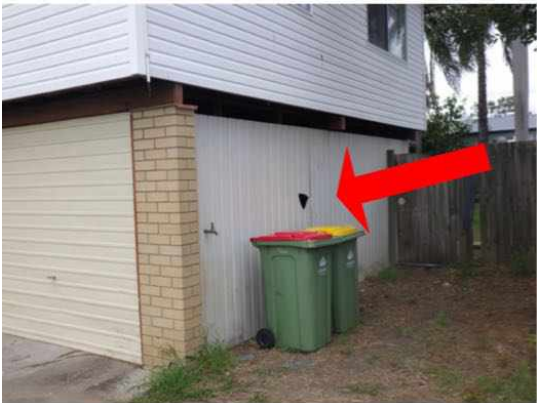
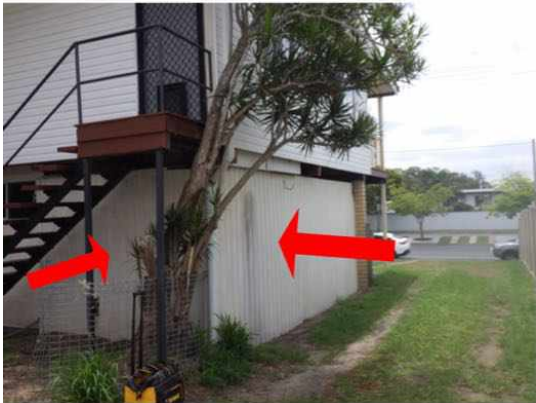
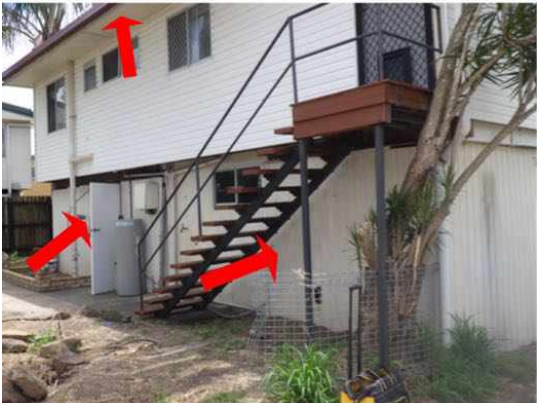
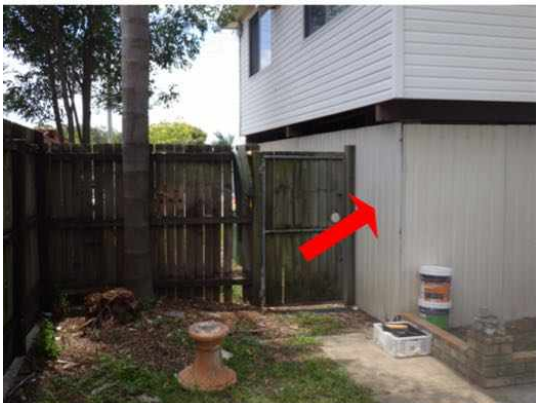
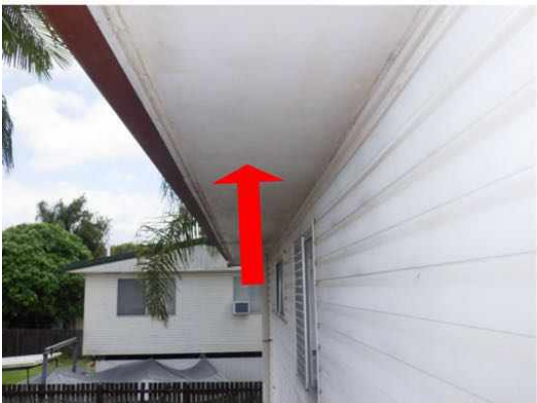
Building: Main Building
Location: External Areas > Existing
Finding: Asbestos - Suspected ACM Identified on Site
Information: At the time of inspection it was suspected exterior wall cladding and eaves linings may be of asbestos containing materials.

Reporting on Asbestos is outside the Scope of this Report. This suspected defect is highlighted as a caution only. We suspect, based on our experience in the building industry, that there is a higher risk of the identified building materials containing asbestos.

As Asbestos Reporting is outside the scope of this report, we advise that you consider a separate Asbestos Inspection and Condition Audit, which can include the taking of samples for definitive confirmation of the presence of Asbestos.

In the interim, the client is advised to act with caution, especially when considering any damage to building materials general wear and tear renovations extensions demolition and general maintenance activities due to the suspected presence of Asbestos.

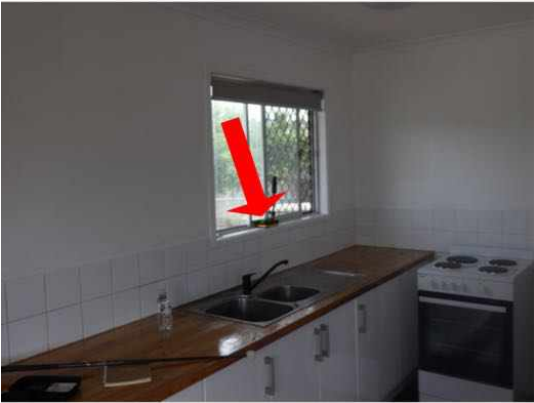
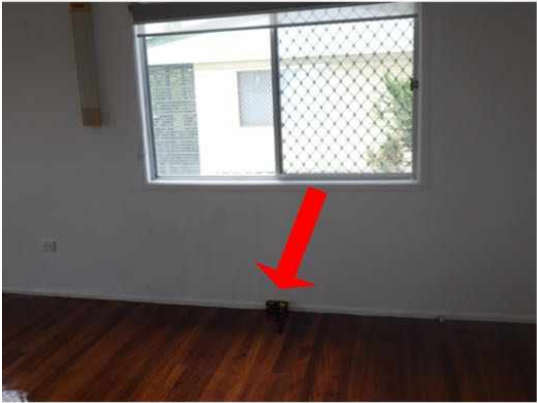
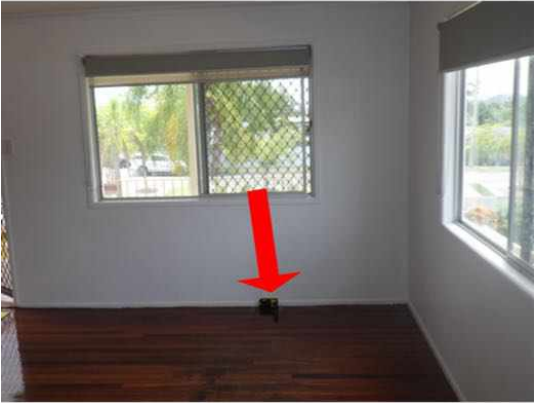
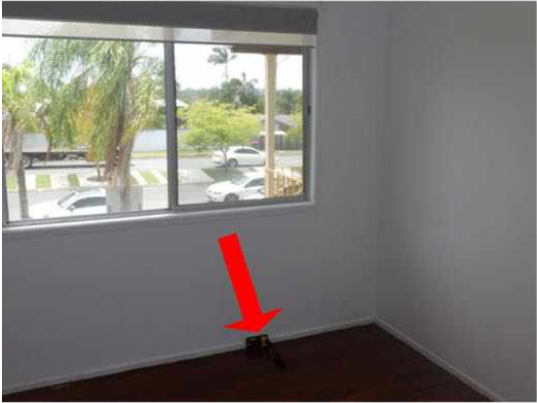
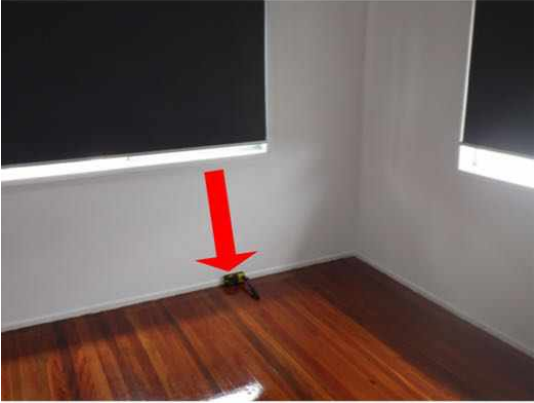
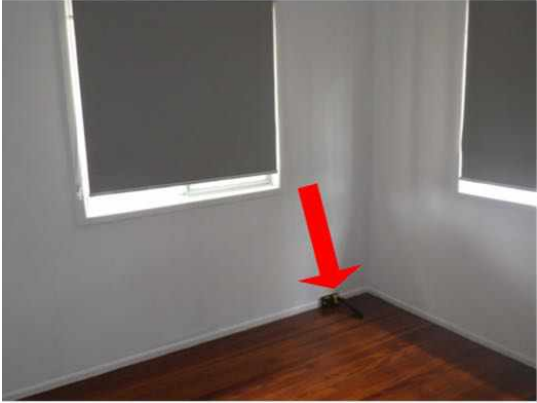
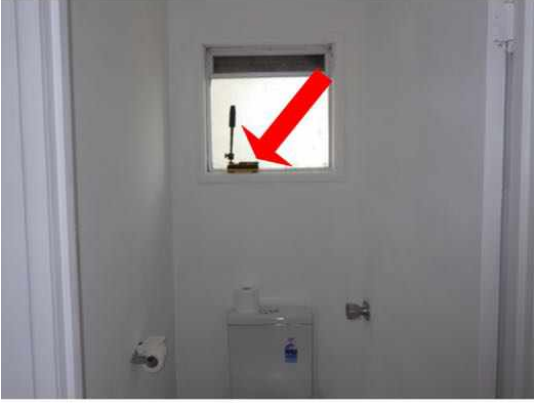
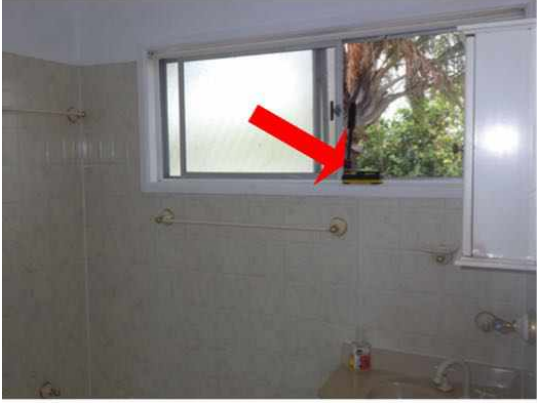
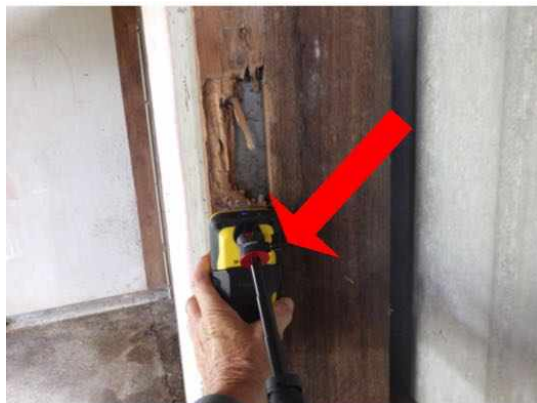
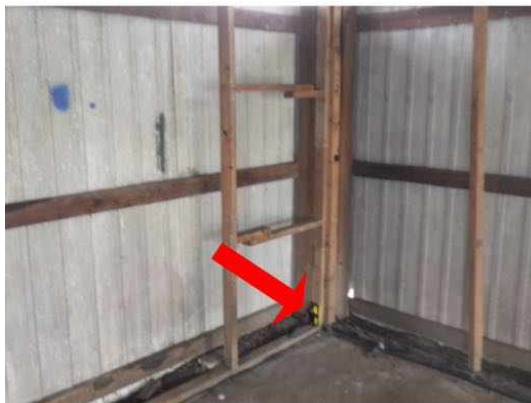
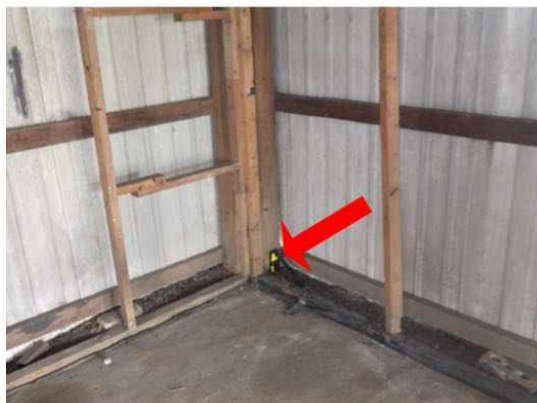
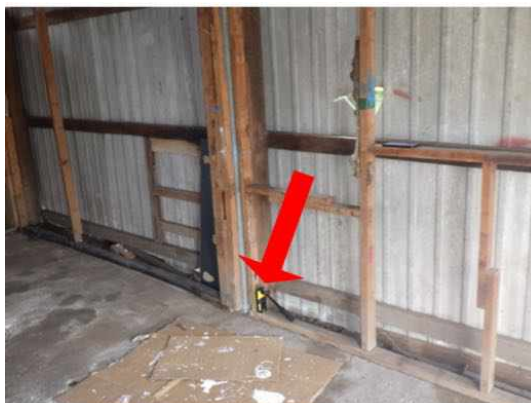
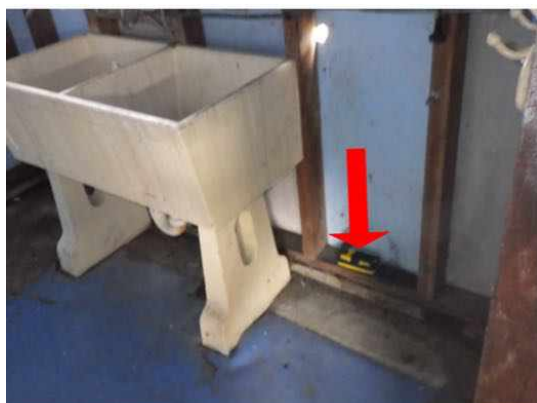
Building: Main Building
Location: Internal Areas > Existing
Finding: Termitracker
Information: The termitracker itracker was positioned randomly to internal wall, timber skirting and window frame areas checking for signs of termite activity.

No activity was recorded at the time of inspection.
