Building and Timber Pest Inspection Report

Inspection Date: Tue, 27 Jan 2026

Property Address: 625 Browns Plains Rd, Crestmead QLD
4132, Australia

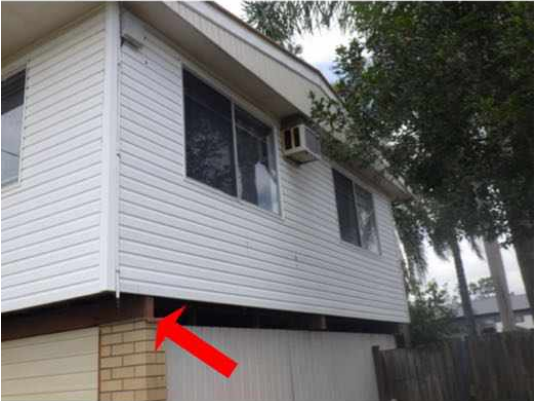
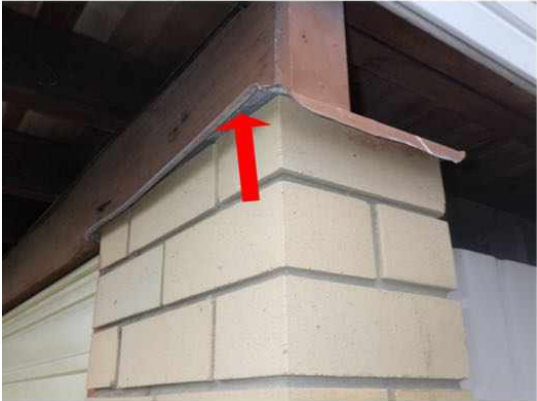
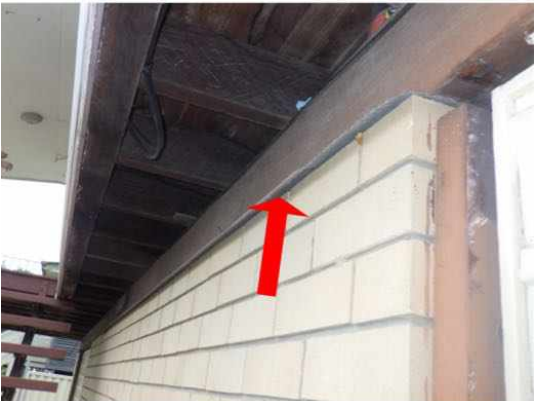
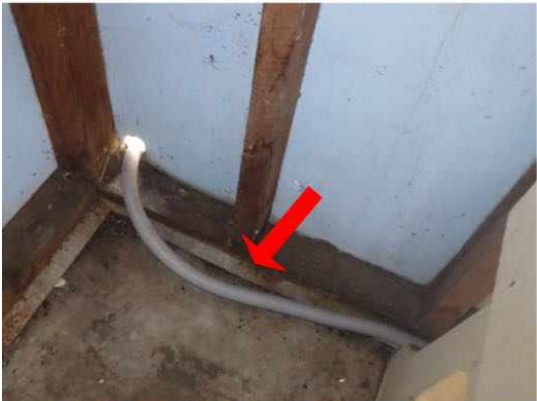
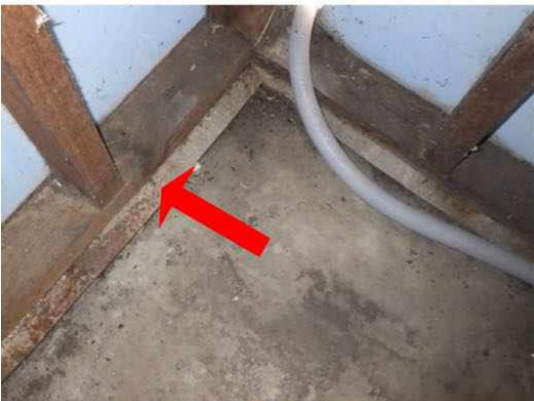
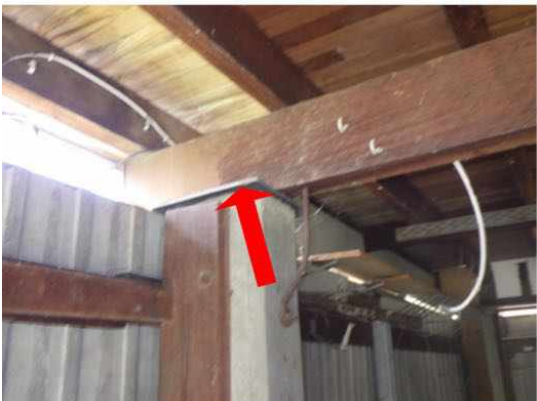
In this instance evidence of a previously installed physical barrier in the form of metal ant caps were observed in the subfloor garage area, although a number of the metal ant caps have been compromised, which will require replacement or repair.

This system requires regular annual inspections.

No evidence of regular or annual inspections was found.

At the time of inspection it was noted a number of the metal ant caps have been altered or compromised, it is highly advised a qualified builder is engaged to re-install or replace the metal ant caps to restore the timber termite barrier system as required.
