Building Inspection Report

Inspection Date: Fri, 6 Mar 2026

Property Address: 24 Webster Ave, CROYDON, VIC, 3136,
Australia

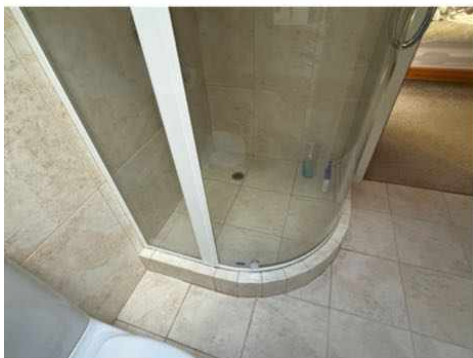
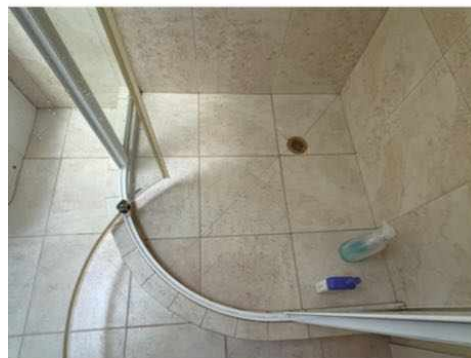
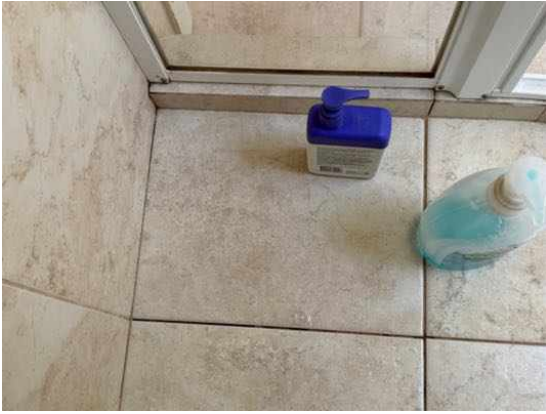
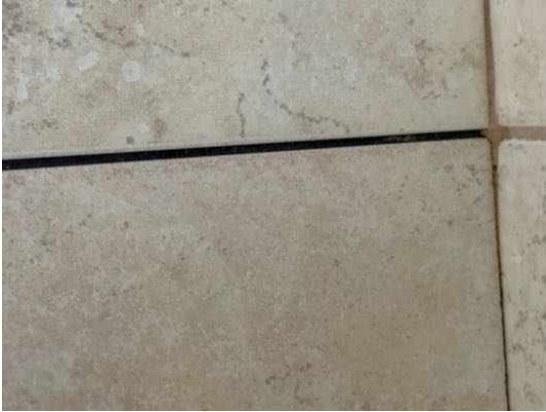
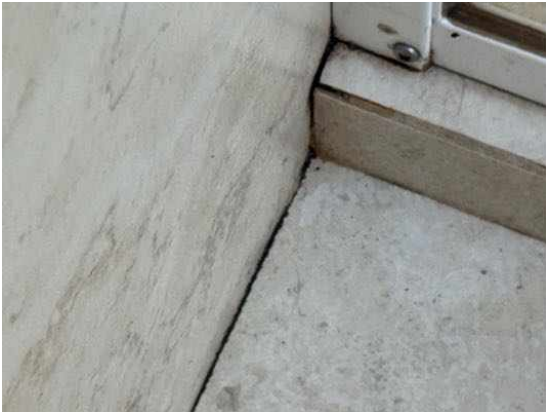
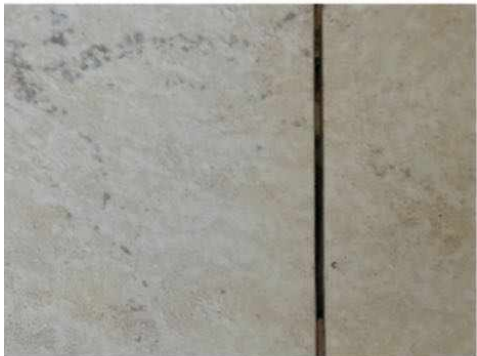
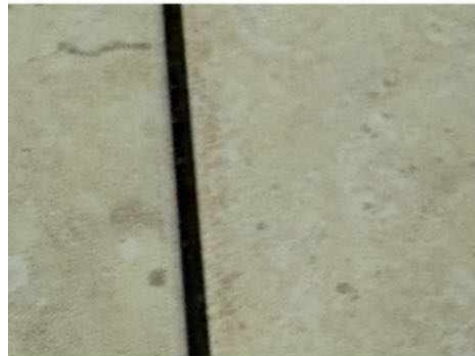
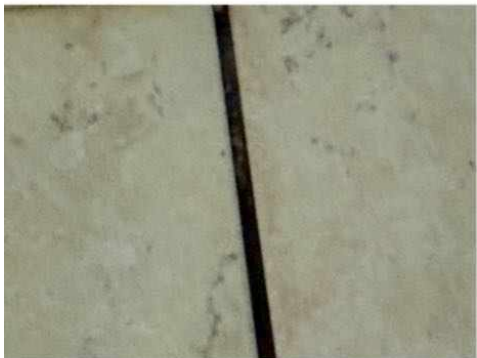
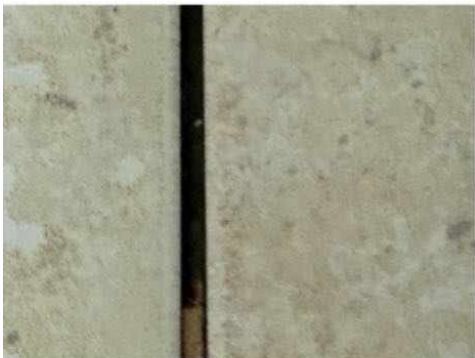
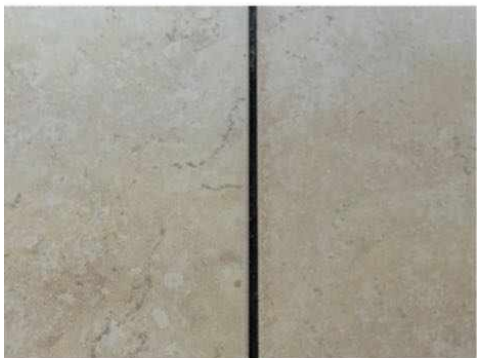
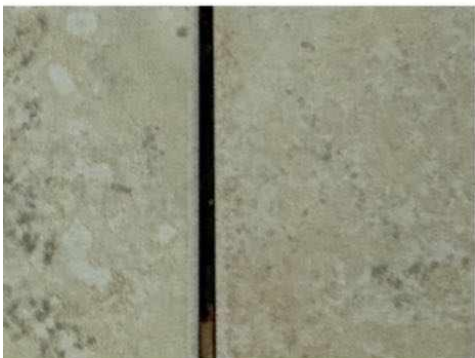
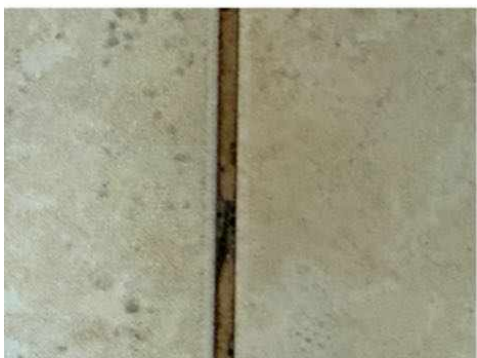
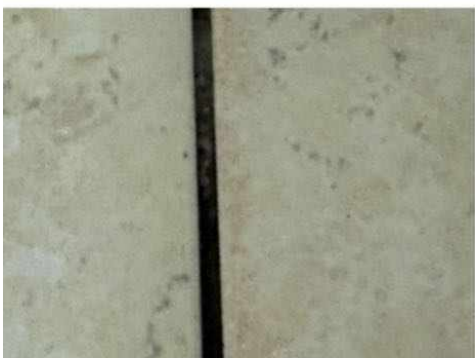
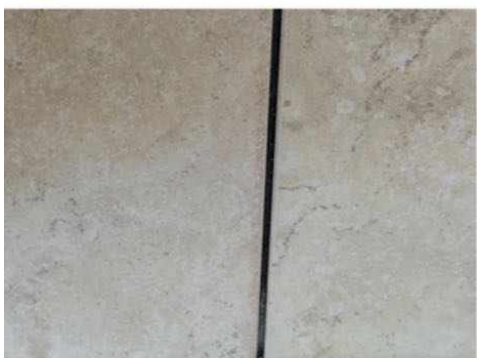
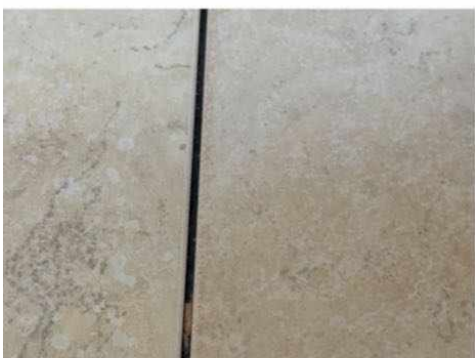
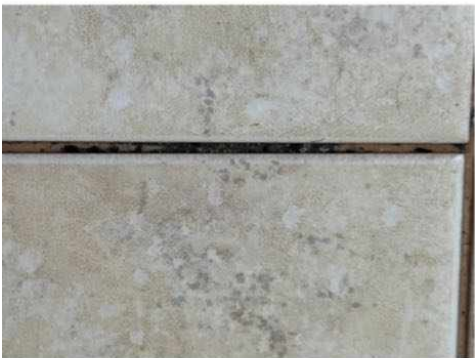
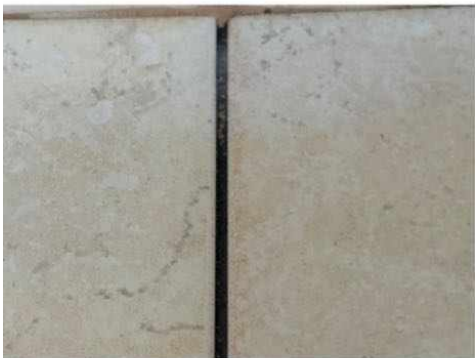
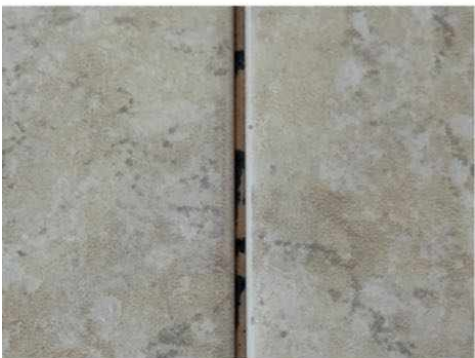
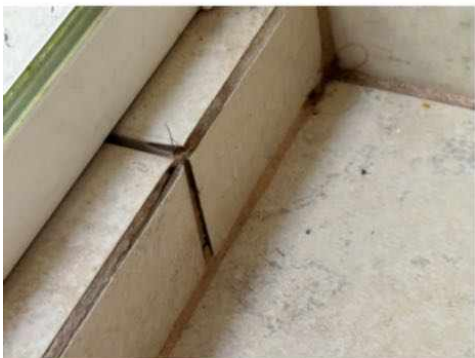
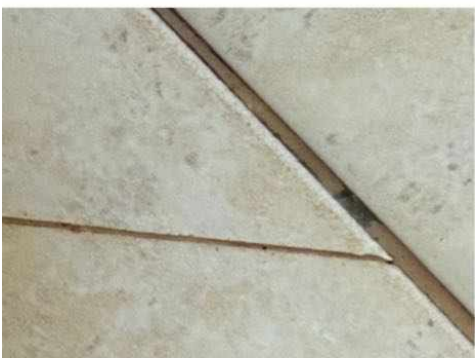
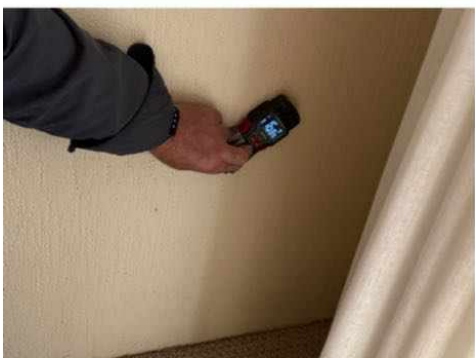
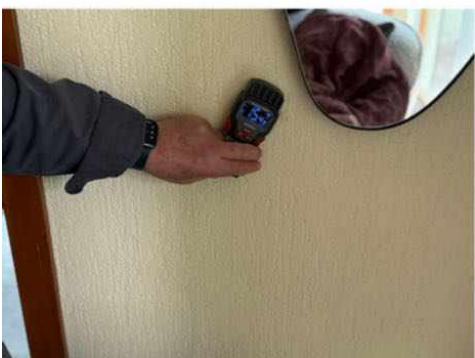
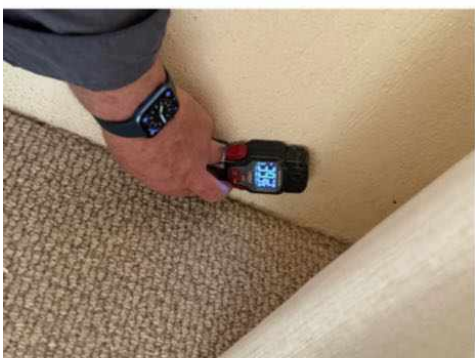
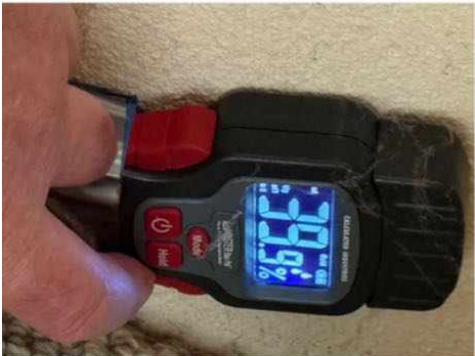
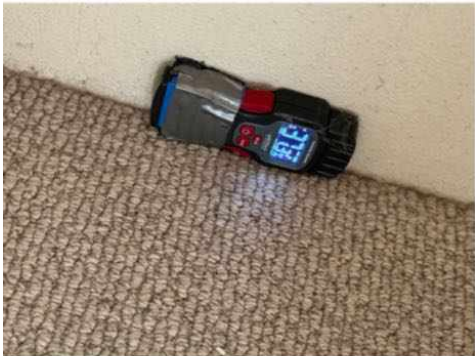
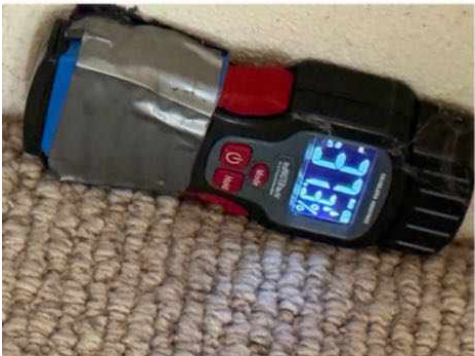
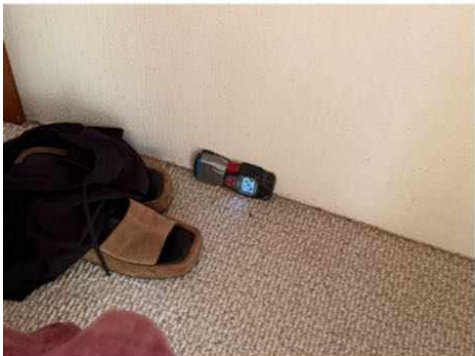
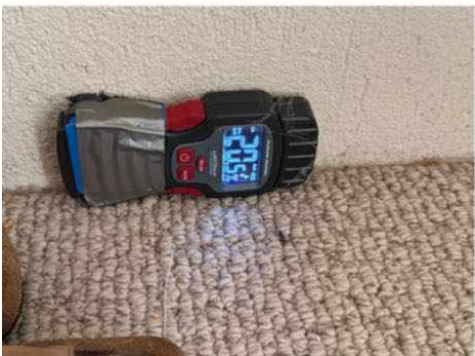
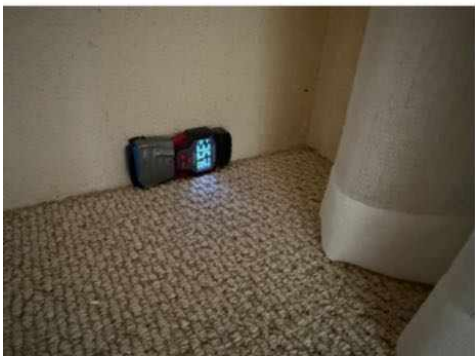
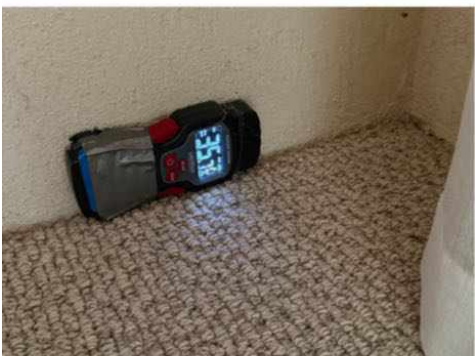
Defects 3.01

Building: Building 1
Location: All Areas > All Areas
Finding: Bathroom and en-suite shower cubical grout dislodged
Information: The bathroom and en-suite shower cubical grout was observed to have minor areas of grout that is missing or dislodged. Grout is used to protect gaps and crevices in building materials to ensure that they are water-tight and prevent water penetration to the associated floor and wall structures. The other side of the wall was test with a moisture meter at the time of the inspection showing a higher than normal moisture reading.

Where the grout is found to be missing or dislodge from these shower base joins, a tiling contractor should be appointed immediately or in the short term future to re-apply grout and any sealants where deemed to be necessary. Failure to do so is highly likely to lead to further water damage and deterioration over time to the surrounding adjoining floor, wall structures and other building elements in the adjoining areas.

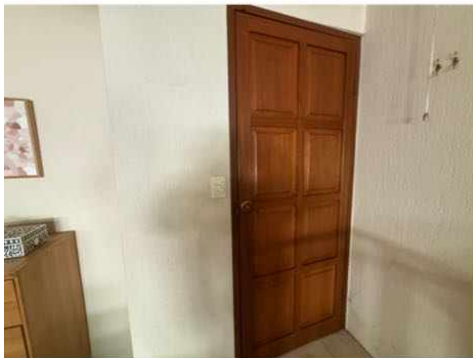
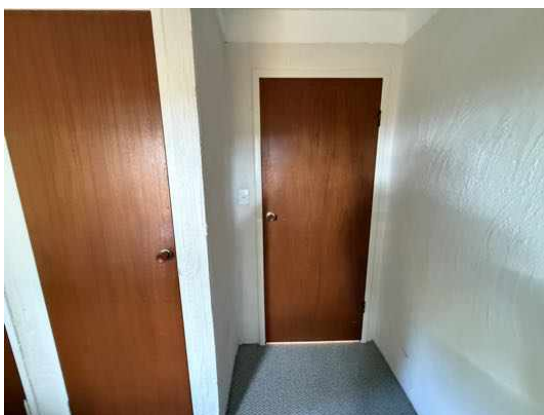
Defects 3.02

Building: Building 1
 Location: All Areas > All Areas
 Finding: Door adjustments
 Information: A couple of doors were observed to be binding and/or rubbing on the door frames during standard operation. This defect is suspected to inhibit the functionality of the affected door as well as creating potential for secondary defects to associated building elements, such as secondary damage and defects to the adjoining building elements. A door that binds to the associated door frame may have several causes, ranging from minor defects, such as poor installation of the door or deteriorated hinges.

Sliding door to top storey bathroom was observed to require some remedial work to replace or rectify the sliding door track or maintenance to make good. Generally, factors such as a lack of maintenance or general deterioration are the usual causes for this type of defect. Replacement of some door hardware may be required where deemed to be necessary, as well as minor repairs and cleaning. A qualified carpenter will be required to carry out remedial work on the affected doors.

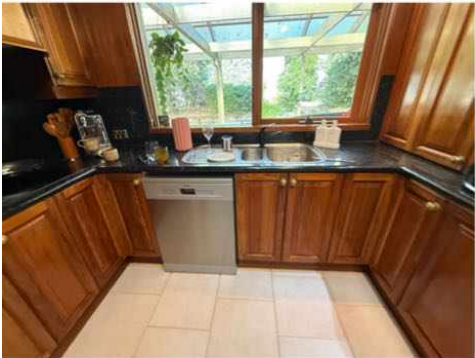
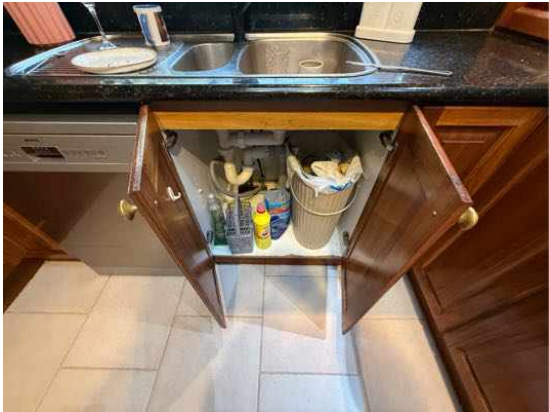
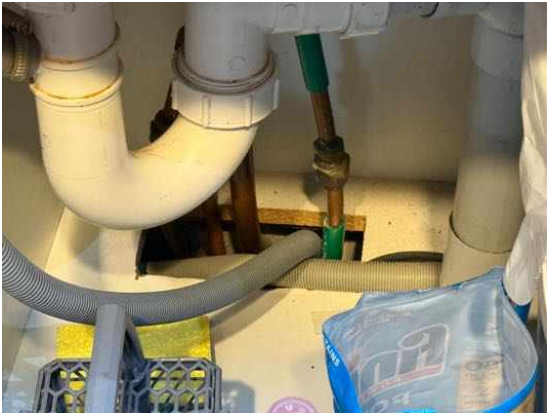
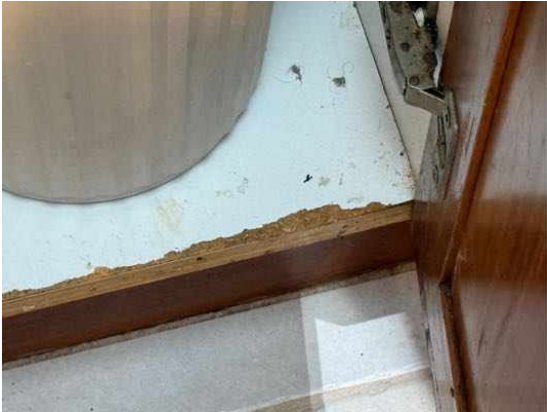
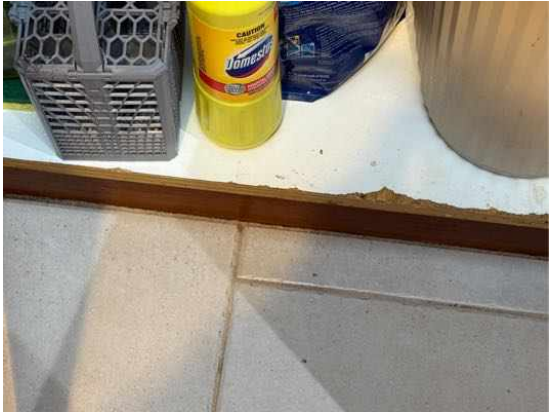
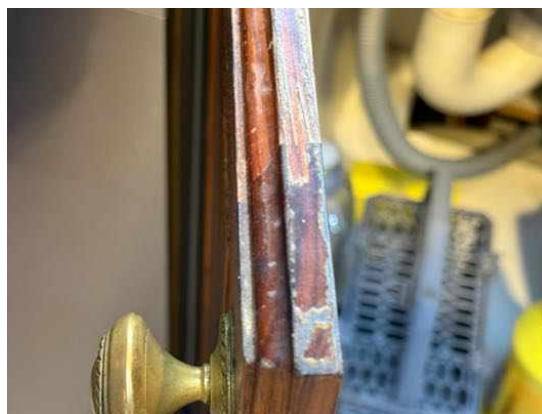
Defects 3.03

Building: Building 1
 Location: All Areas > All Areas
 Finding: Kitchen cabinetry

The kitchen cabinetry including cabinet doors and drawers showed signs of some moisture damage on the base of the sink cabinet carcasse and these two doors. Some maintenance, remedial work or repair is required to ensure further deterioration does not continue further. Although these defects may detract from the overall looks of the cabinetry, in most cases it does not necessarily affect the operational state of the cabinetry.

To improve the operation of these affected cabinets, cabinet doors or drawers, a qualified cabinet maker or carpenter may be appointed to rejuvenate rectify or repair any cabinetry as deemed to be necessary. Such works should be completed at discretion of the client.

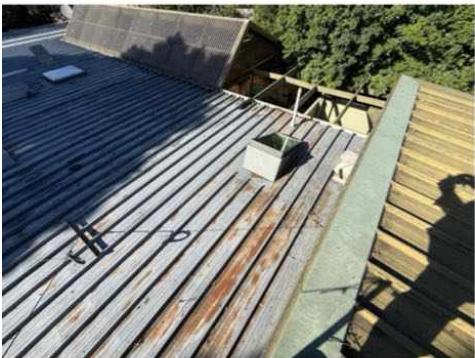
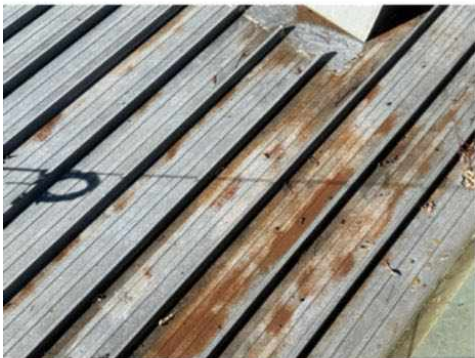
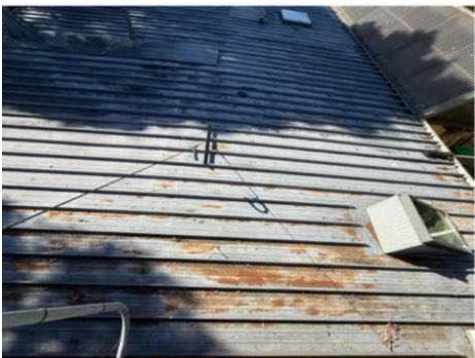
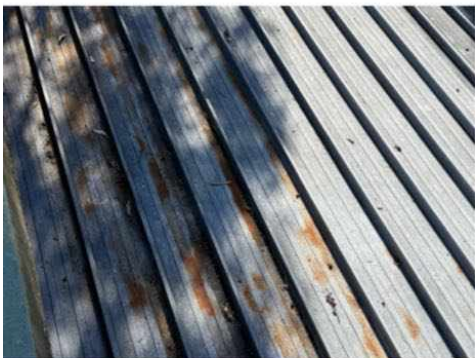
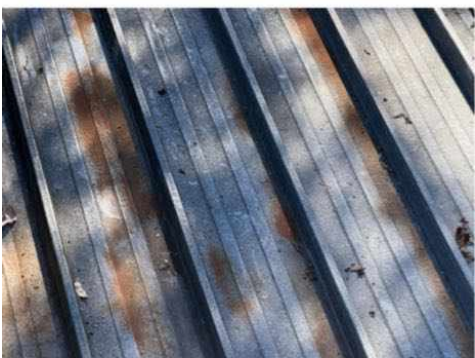
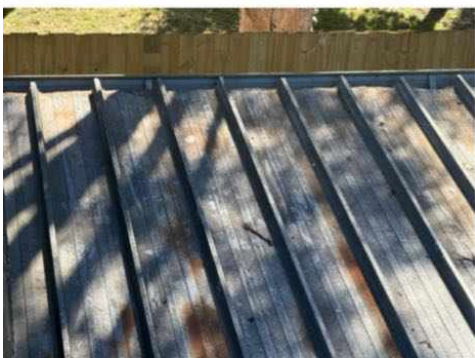
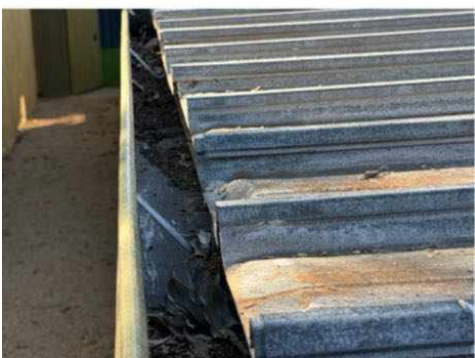
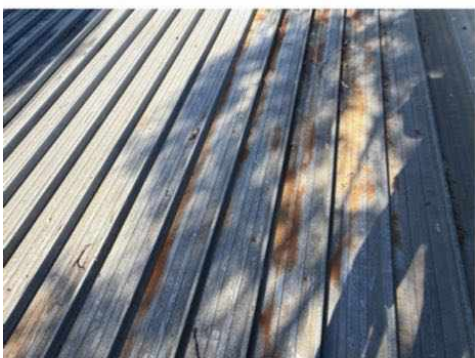
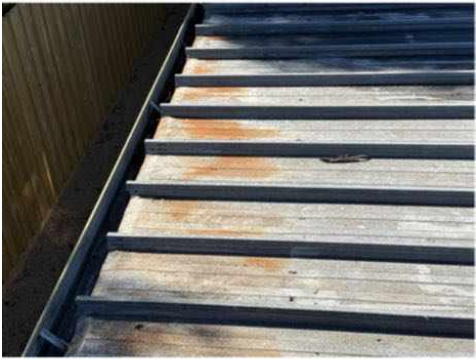
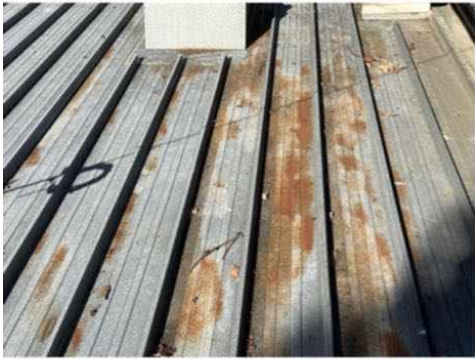
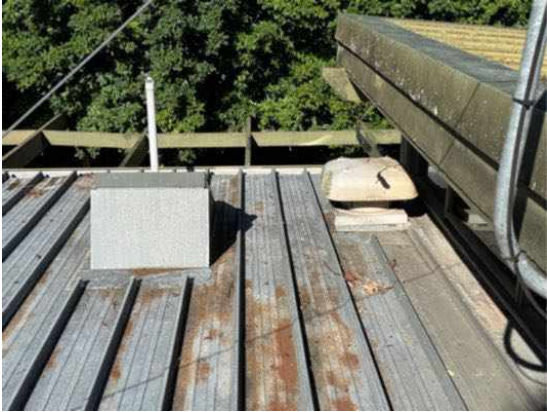
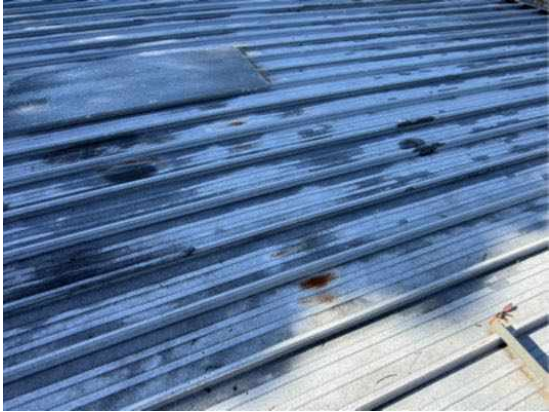
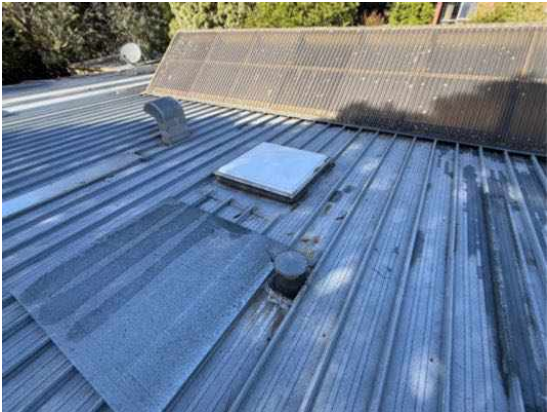
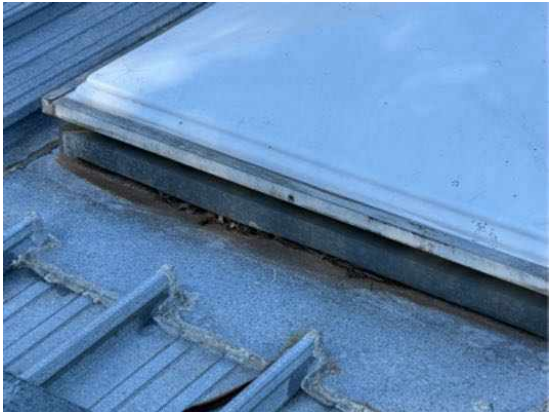
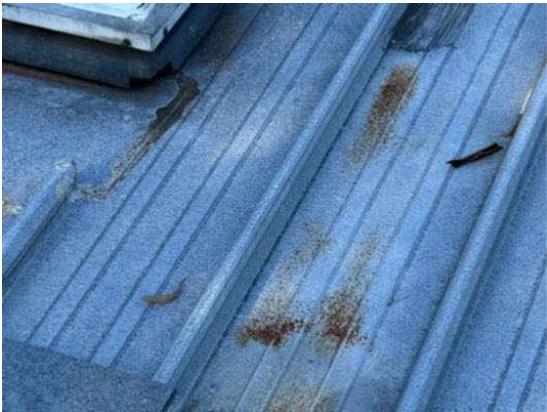
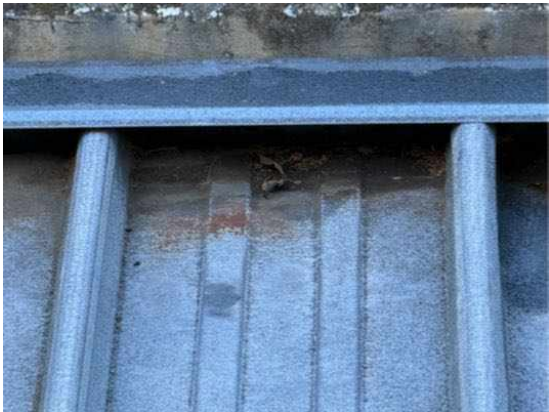
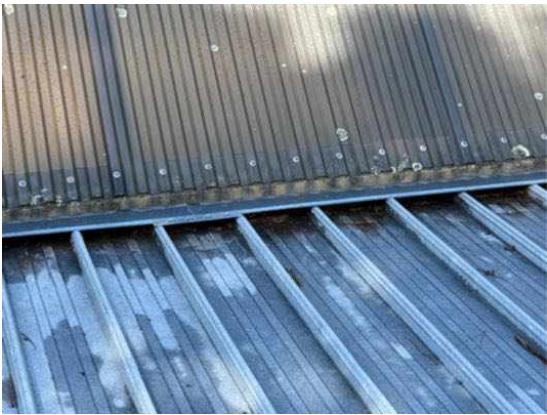
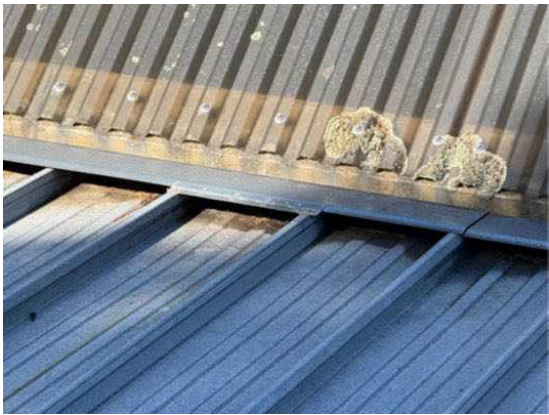
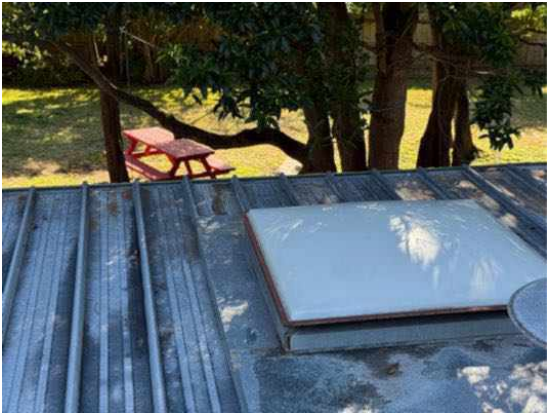
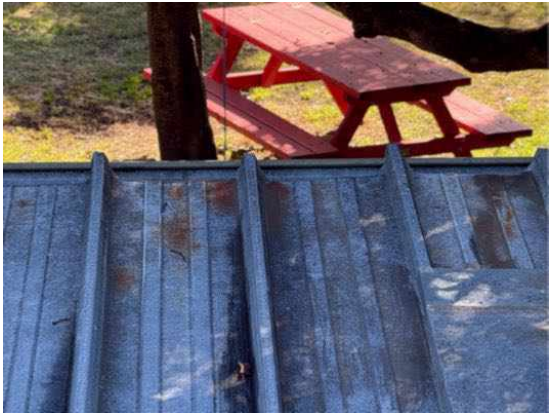
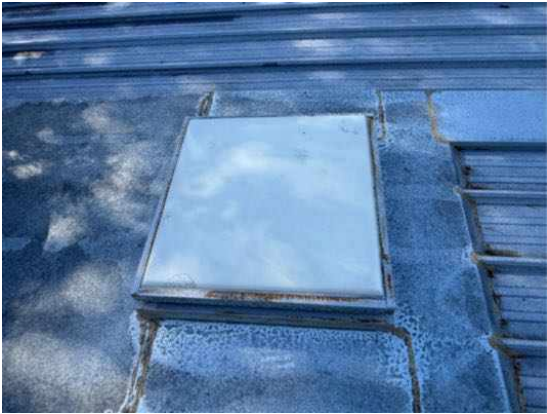
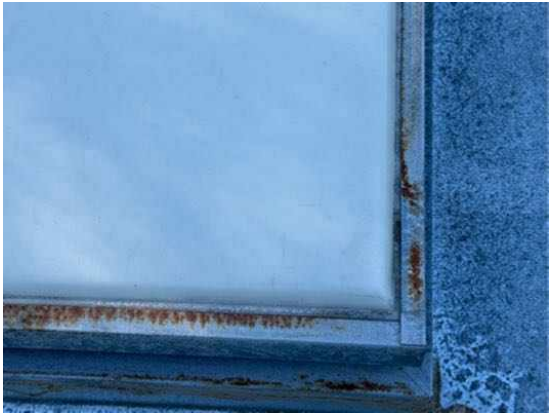
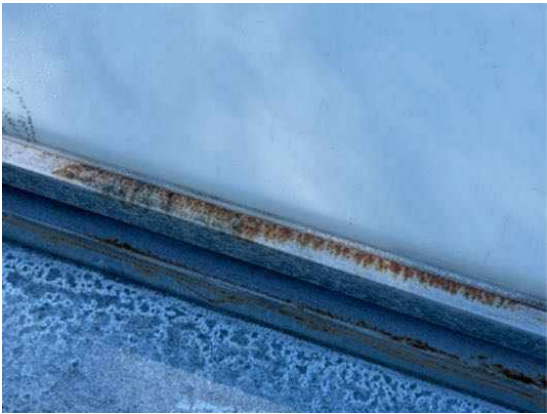
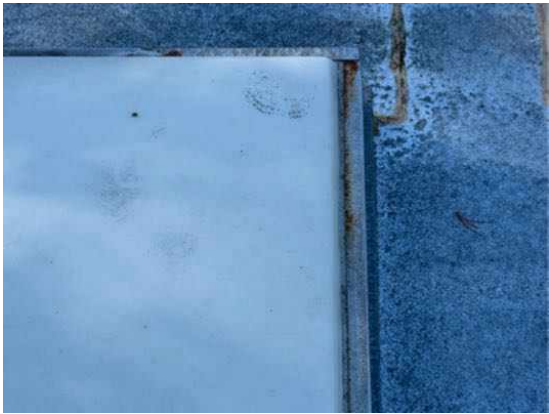
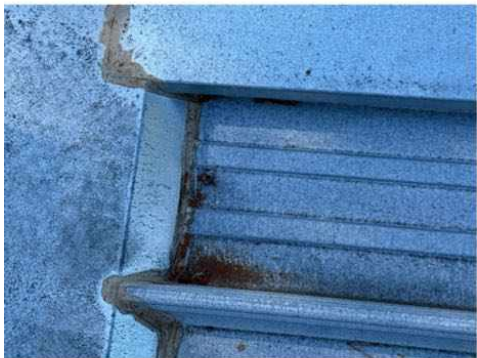
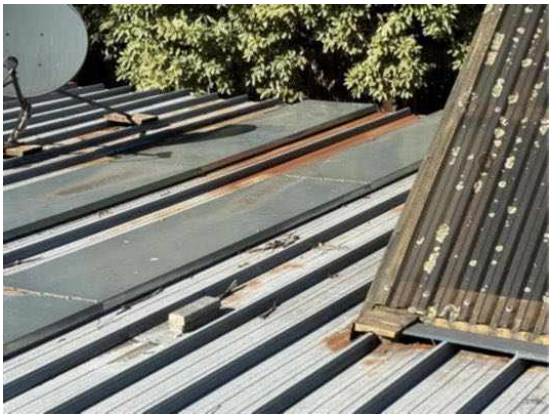
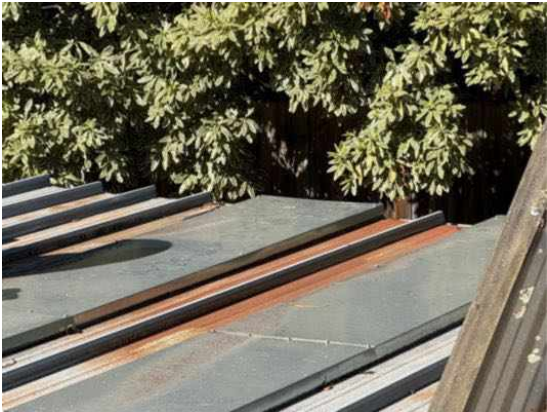
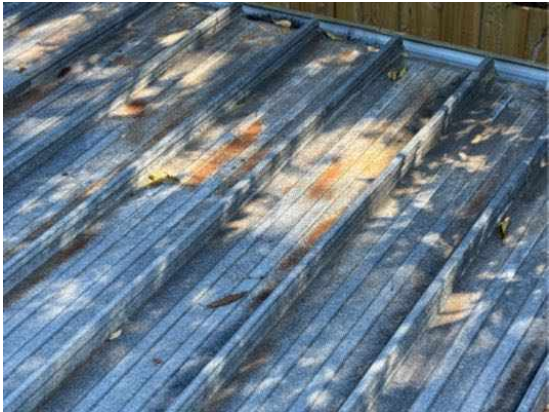
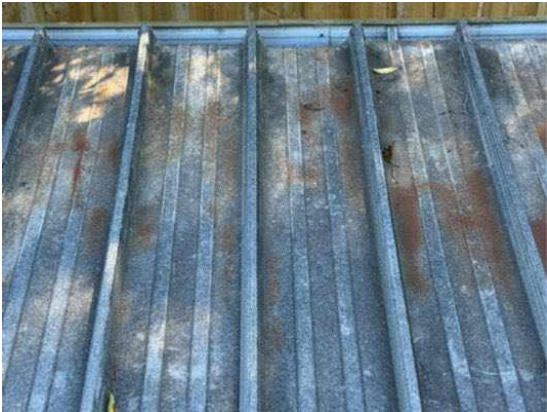
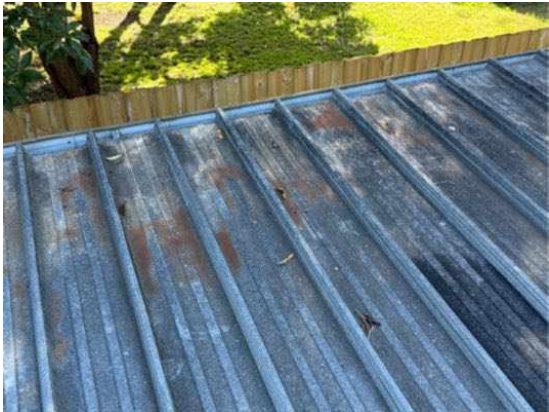
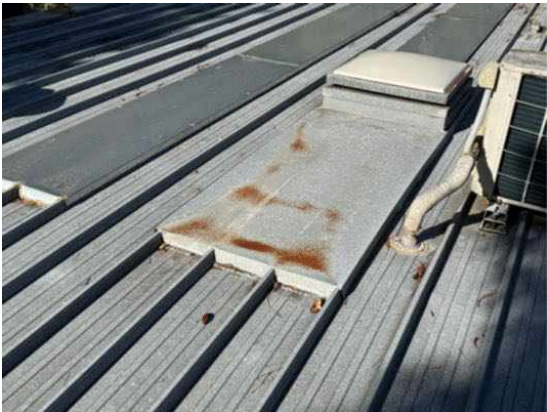
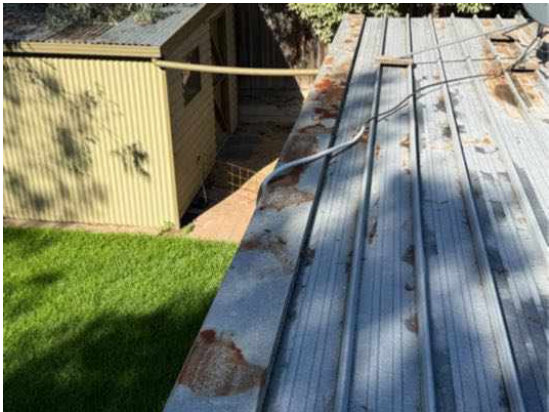
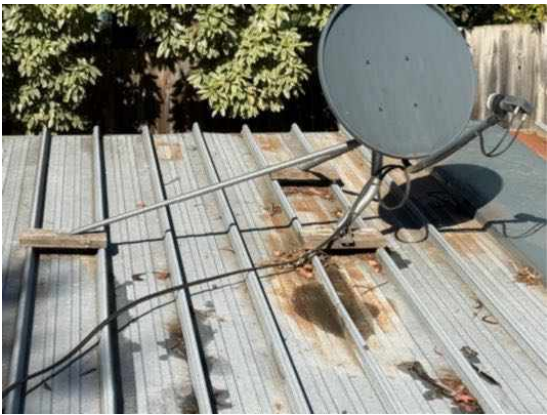
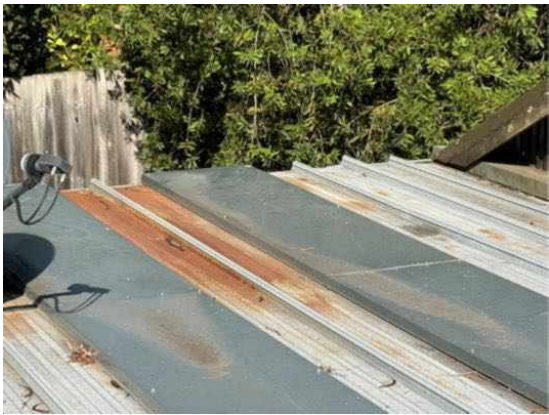
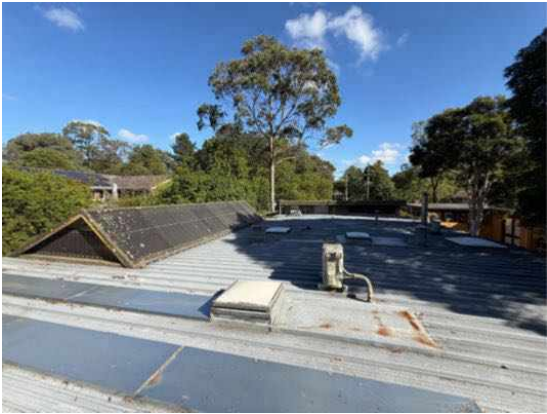
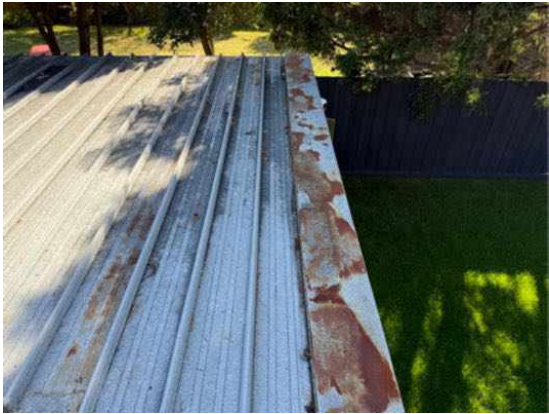
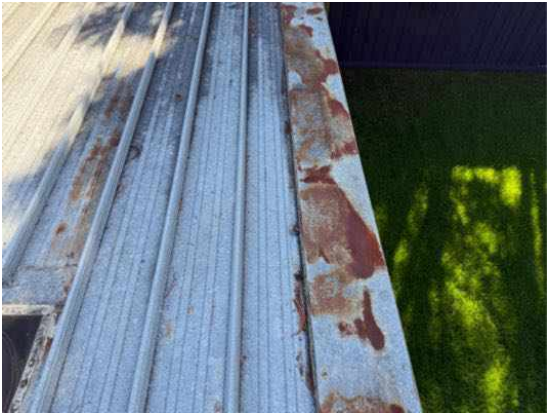
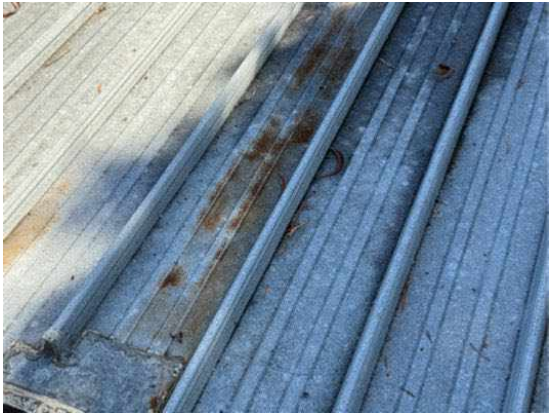
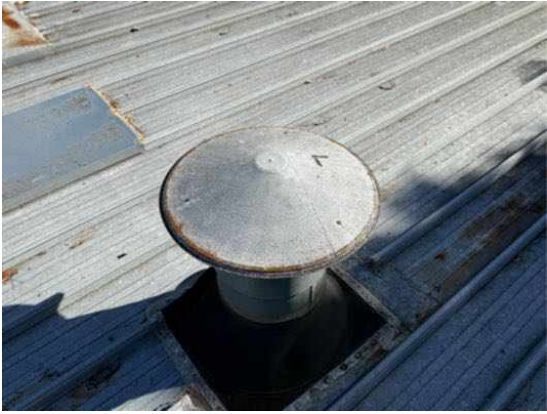
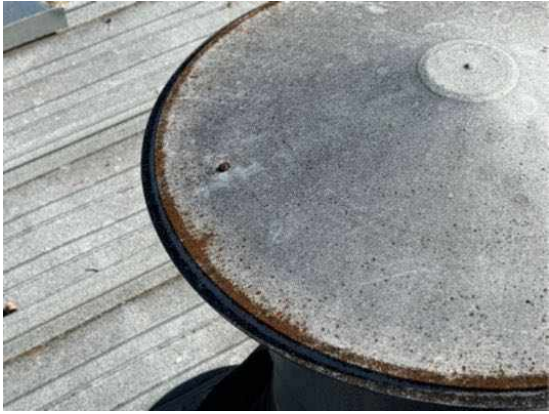
Defects 3.04

Building:	Building 1
Location:	All Areas > All Areas
Finding:	Roofing iron and roof flashings show rust and deterioration
Information:	At the time of the roof inspection it was observed that numerous areas of the rear exterior roofing iron was showing signs of rust and deterioration. It is highly recommended that the client appoint a registered roofing plumber to provide advice and the remedial work to either replace or the maintenance to neutralise rust to ensure the roofing iron and flashings remains weathertight and waterproof.

While the rust and weathering on the roofing iron is consistent with the age of the property, it is highly recommended that this remedial repair work and maintenance works are carried out in the short term future to maintain and prevent further rust, damage and deterioration. Where left unmanaged, deteriorating roofing is likely to lead to secondary defects over time, remedial works and maintenance of the roofing iron is suspected to increase in the future.

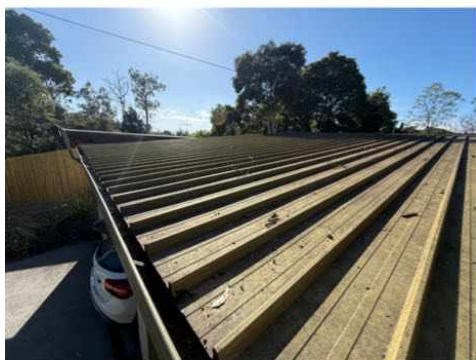
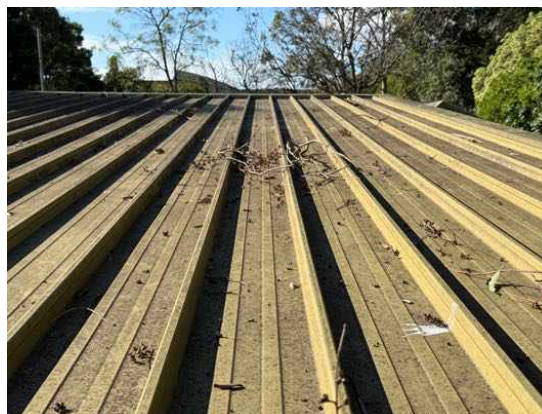
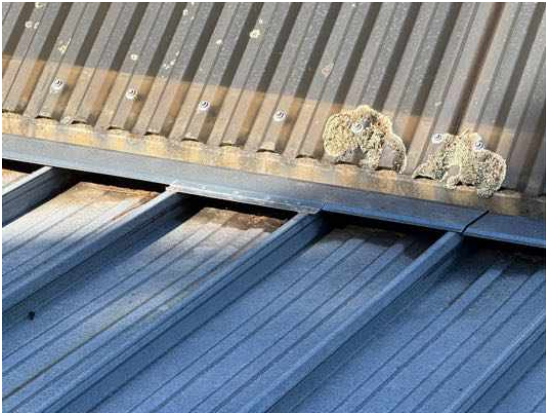
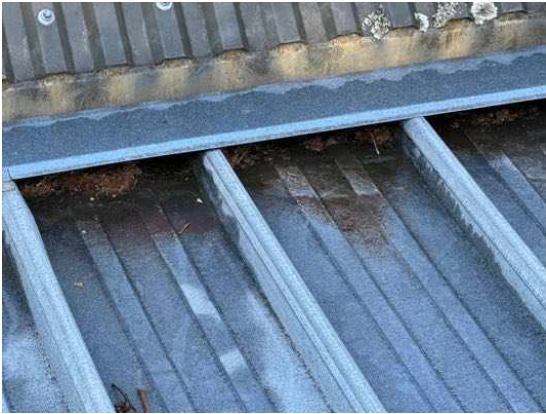
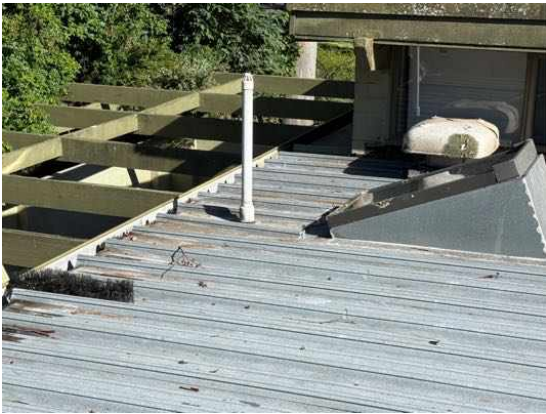
Defects 3.05

Building:	Building 1
Location:	All Areas > All Areas
Finding:	Gutters - minor blockages
Information:	Client should expect to clean out gutters regularly due to high standing trees around the perimeter of the property. This maintenance and the clearing out of the gutters is considered to be very important to prevent blockages of the guttering and downpipes which will lead to water pooling and accumulated water overflows, which is likely to subsequently flood exterior walls and enter internal areas and damage building structures and other building elements. Roof plumbing structures, such as guttering and downpipes, should be free of all debris to prevent blockages.

Blocked gutters are likely to lead to high levels of moisture in the affected areas. Such moisture will not only cause rust and decay of the associated building materials, but can also provide conditions that are conducive to termite and timber pest activity. Blockages in gutters should therefore be removed immediately to ensure dry conditions are maintained. It is recommended that blocked gutters be cleaned and leaf matter and debris be removed by a relevant tradespersons regularly, this may involve in the client appointing a gutter cleaning company regularly, periodically cleaning these gutters out.

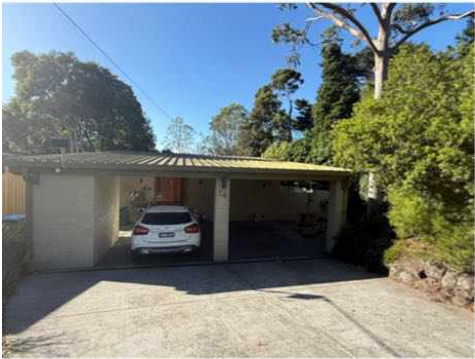
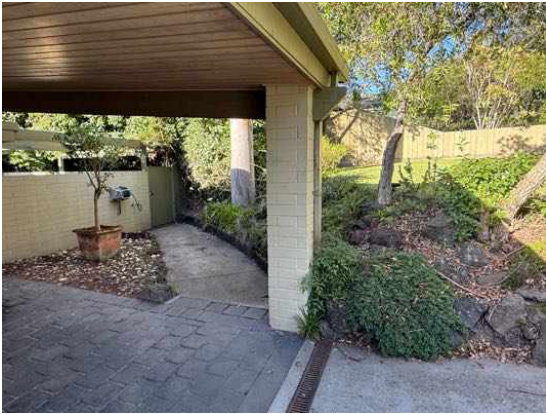
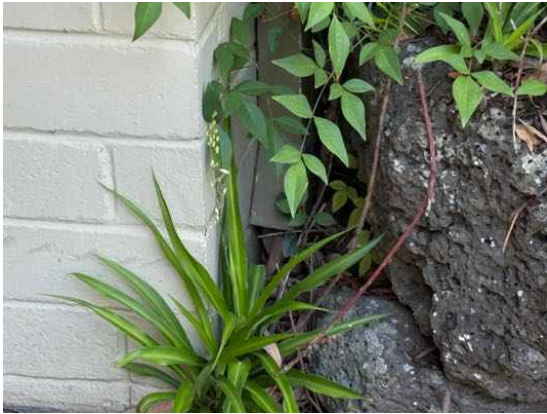
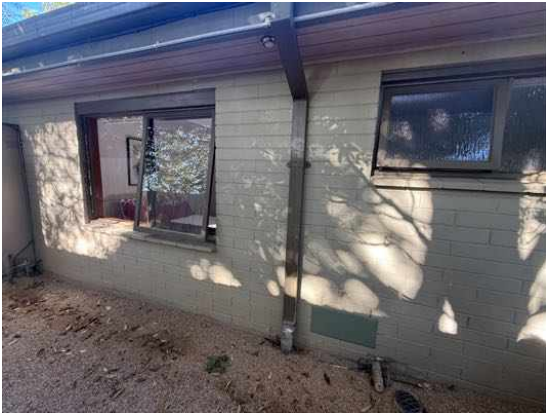
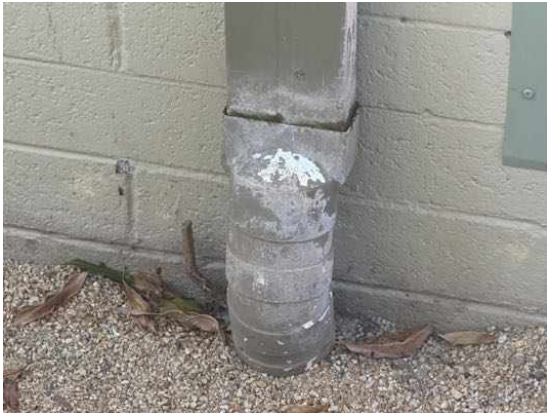
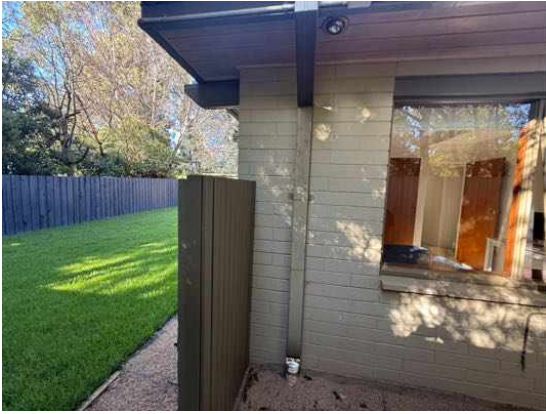
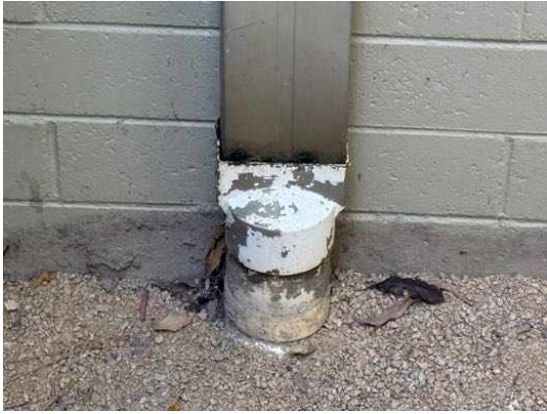
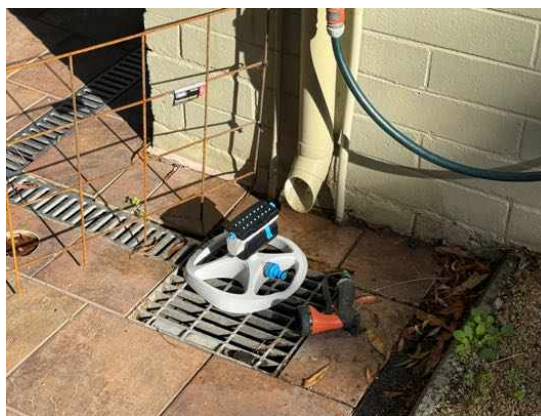
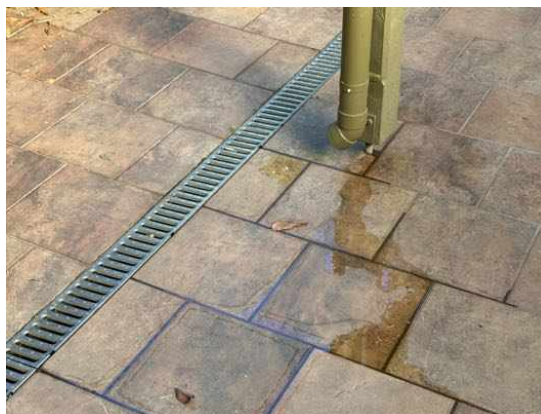
Defects 3.06

Building: Building 1
Location: All Areas > All Areas
Finding: Down-pipes not adequately connected to stormwater
Information: It was observed at the time of inspection that numerous of the down-pipes were not adequately connected or situated over stormwater point and not sealed adequately, these should be all connected properly into the stormwater drainage system and fully inserted into stormwater drainage point. Where these sit above the stormwater point, the surrounding areas are highly susceptible to excessive moisture from splashing out.

Where these are left unmanaged wood rot, rust, corrosion, termite and pest. If left unmanaged wood rot, rust and corrosion is likely to lead to secondary damage and defects to the surrounding building elements, adjoining these areas, this also makes these areas more susceptible to termite or timber pest activity. It is highly recommended that client appoint and seek advice and consultation with a licensed drainage plumber to gain advice and rectify affected down-pipes in the short term future.

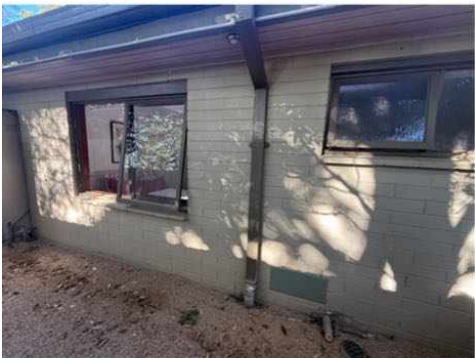
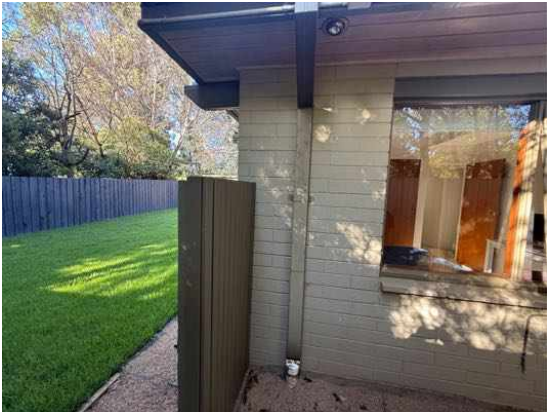
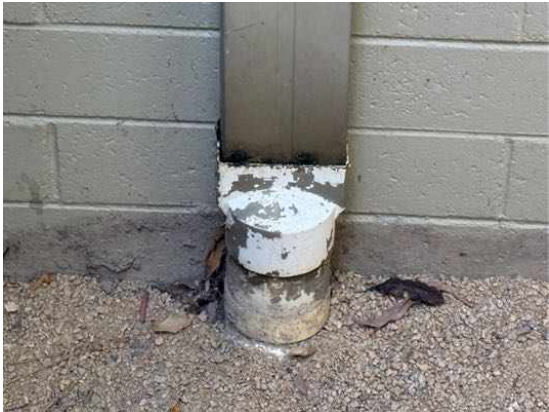
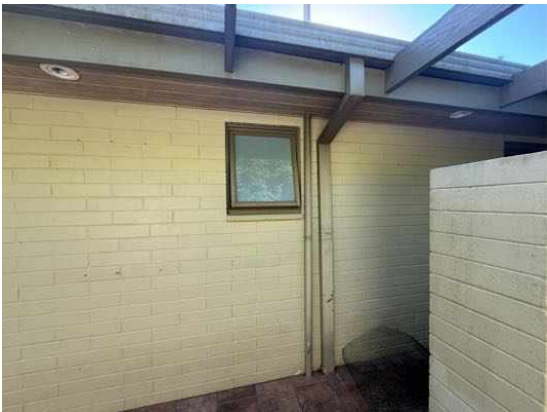
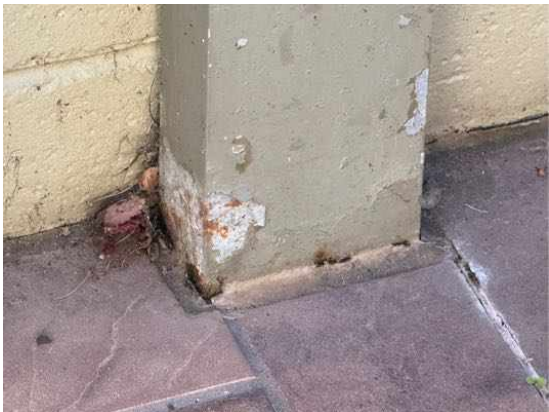
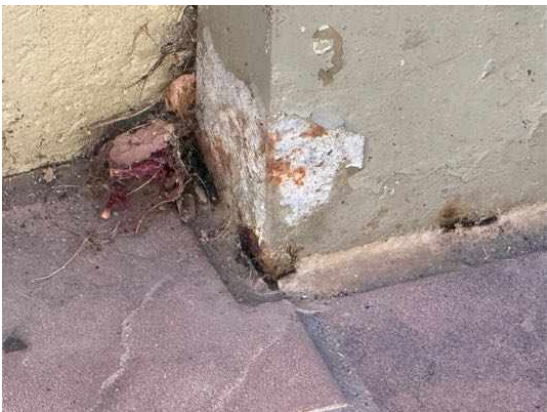
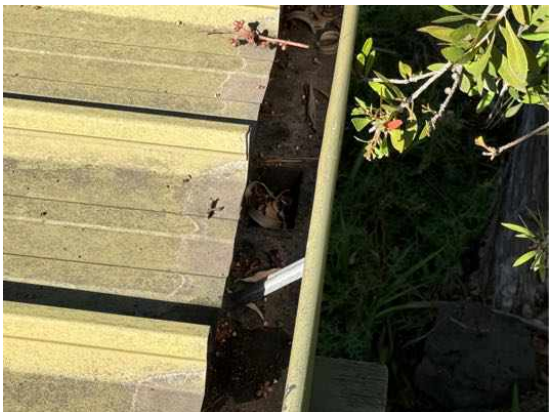
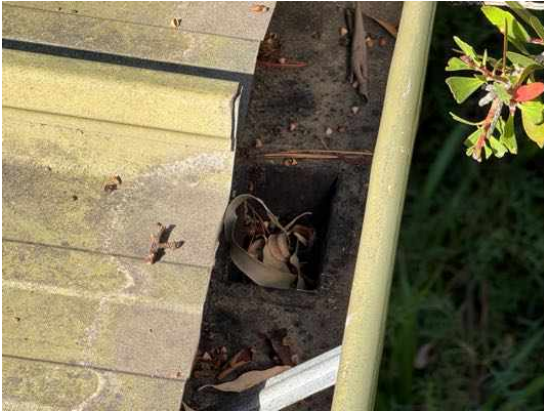
Defects 3.07

Building:	Building 1
Location:	All Areas > All Areas
Finding:	Downpipes rusted and deteriorated
Information:	It was observed at the time of inspection that some down-pipes were rusted and deteriorated beyond repair, making these areas susceptible to excessive water and moisture. This will therefore make these areas susceptible to excessive moisture, wood rot, rust, corrosion, termite and pest. If left unmanaged, moisture, wood rot, rust and corrosion is likely to lead to damage to adjoining areas and or other building elements, this also makes these areas more susceptible to termite or timber pest activity. It is recommended that client appoint, seek advice from a licensed roofing plumber to further investigate and where deemed to be necessary, rectify and repair all deteriorated downpipes and gutters that are deemed to be necessary.
