Building Inspection Report

Inspection Date: Fri, 6 Mar 2026

Property Address: 24 Webster Ave, CROYDON, VIC, 3136,
Australia

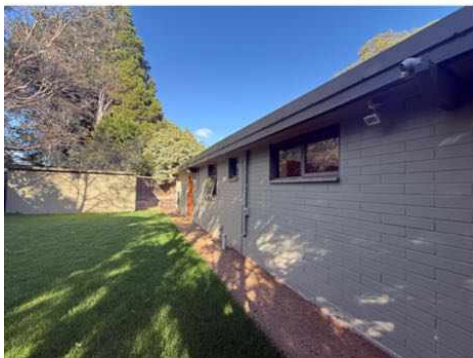
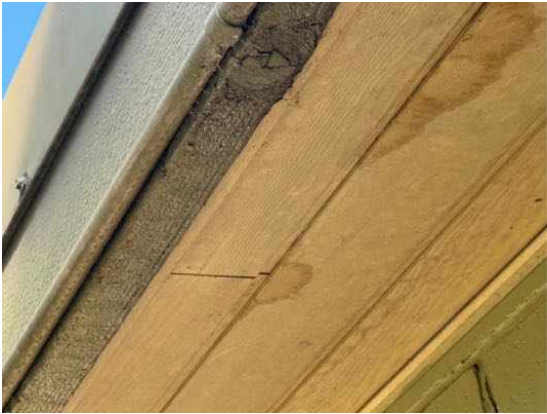
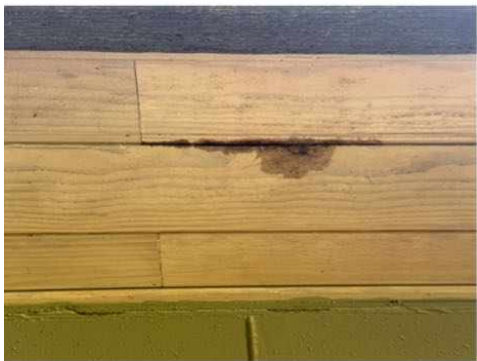
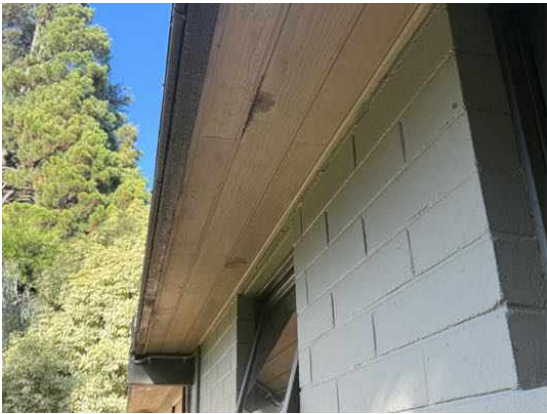
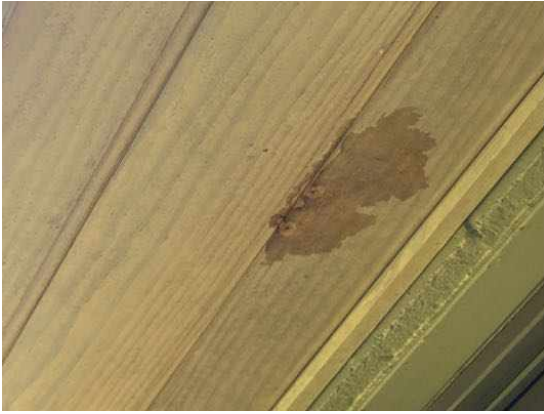
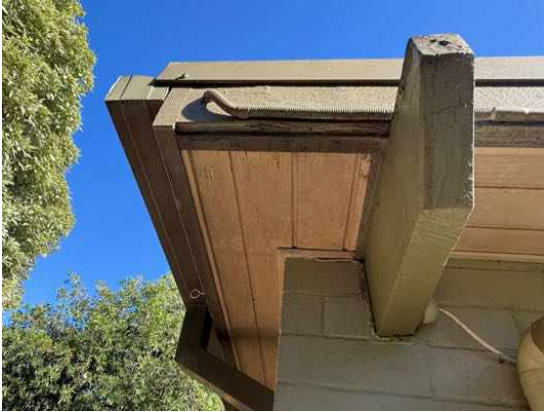
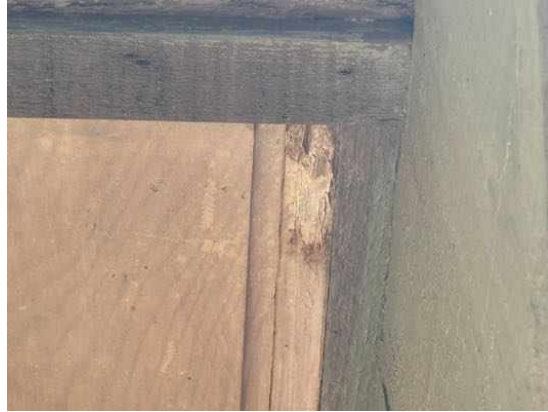
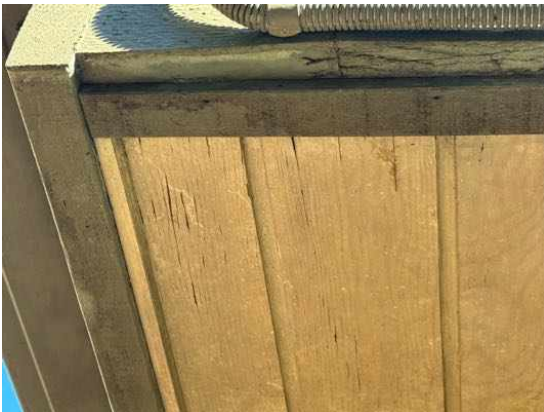
Defects 3.08

Building:	Building 1
Location:	Rear areas > All Areas
Finding:	Eaves - damage and deterioration from suspected water and moisture
Information:	The eaves to the rear areas of the home were observed to showing signs of suspected moisture. The damage is suspected to have been sustained as a result from overwhelmed roofing areas above. However this is not a conclusive answer, no definitive answer for the eaves suspected moisture was confirmed on the day of the inspection. Further investigation from a registered roofing plumber is recommended.

Where damage and deterioration from suspected moisture was observed, the primary requirement is to identify and rectify the source of the moisture and or roof leak. The damage to the eave in this area appeared to be minimal however it is unknown what it may have caused to the roof framing. It does detract from the appearance of the structure, as well as potentially compromising the structural integrity of the adjoining roofing area. Where eaves show suspected moisture damage and deterioration, remedial works are suspected to be required in the short term future. Where water damage is suspected as being the underlying cause, appointment of a licensed roofing plumber is recommended to identify any source of the water and moisture which is suspected to have affected the eaves.

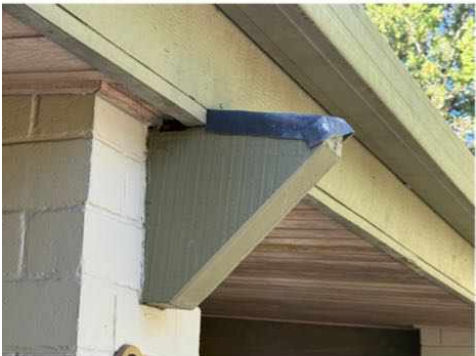
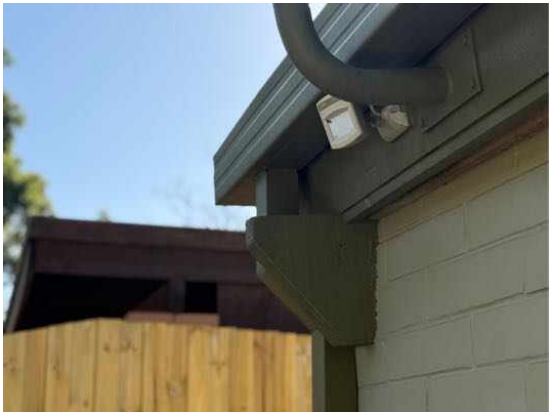
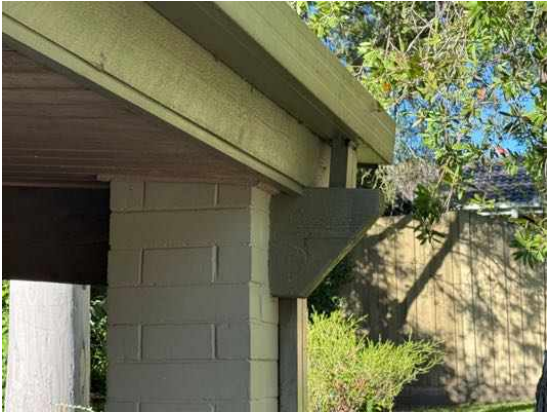
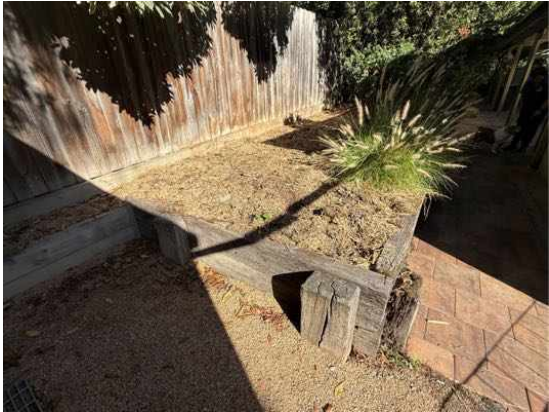
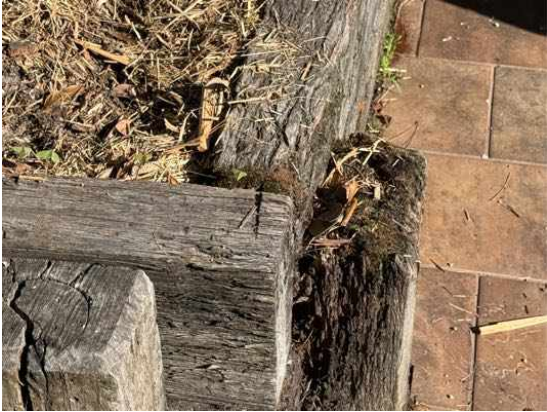
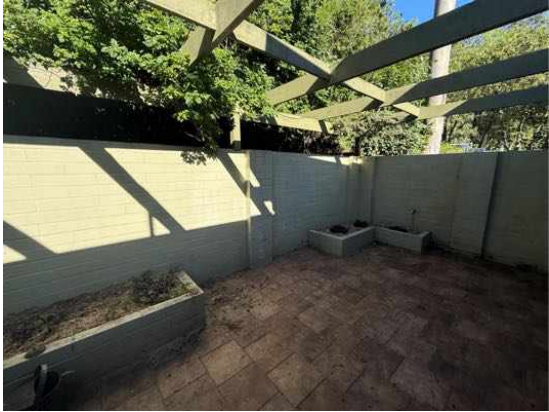
Defects 3.09

Building:	Building 1
Location:	All Areas > All Areas
Finding:	Wood rot
Information:	Wood rot was found to be affecting some pergola beams, protruding ends of beams, some retaining walls and other building elements and materials around the exterior and interior areas of the home. Wood rot, also known as Fungal Decay, occurs when timbers and other cellulose building materials are exposed to damp conditions on an ongoing basis.

Due to the pergolas not adequately protected against excessive water and moisture and frequent exposure to rain and other weather conditions it is highly likely making

these types of building elements susceptible to wood rot and accelerated deterioration. Early intervention and regular maintenance such as painting will prolong the useful life of these building elements. Prior to any works being performed, the cause of the moisture that has created the visible wood rot should be identified and addressed in a suitable manner.

It is advised that the relevant tradespersons be appointed to inspect and subsequently identify the cause of the numerous areas of wood rot. Replacement of affected building elements and materials may then be a necessary step in protecting surrounding areas from secondary damage and deterioration. A qualified carpenter should be appointed to assess the cause and to provide any remedial works as required to replace affected building materials.

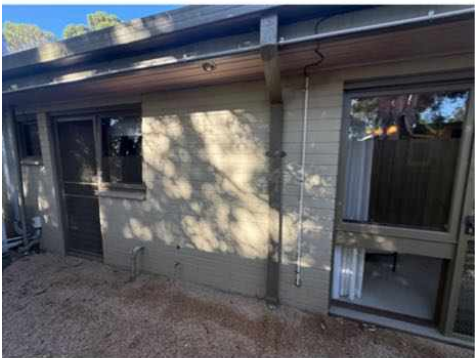
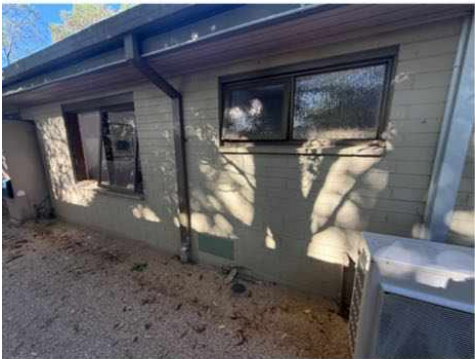
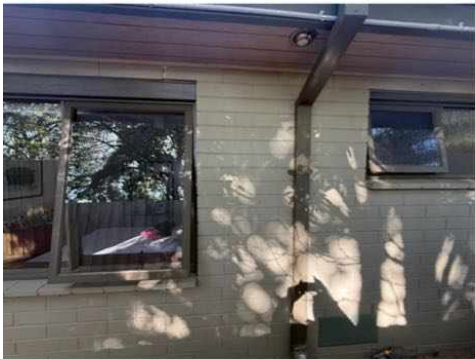
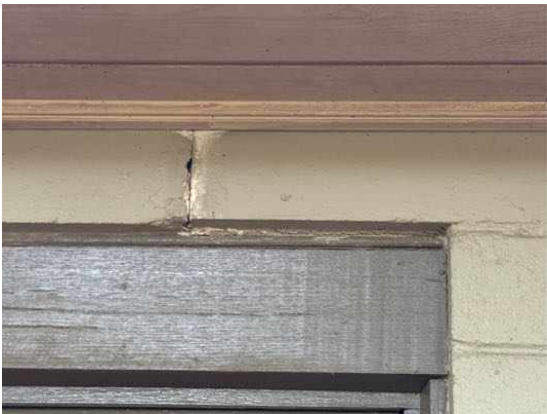
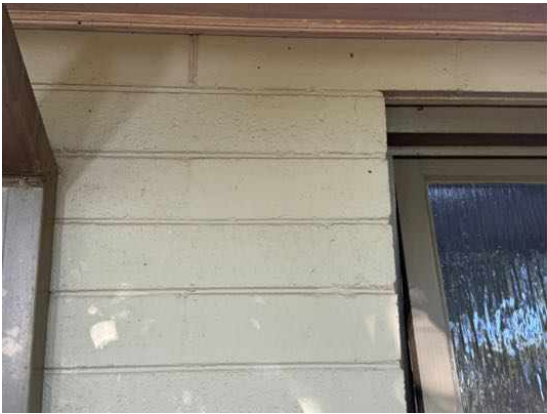
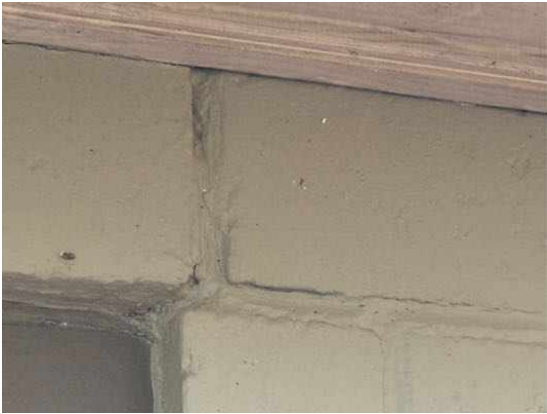
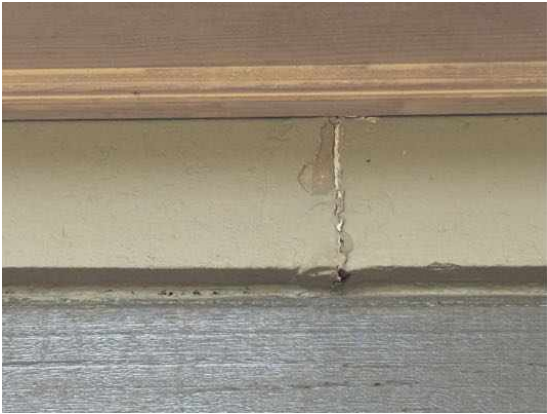
Defects 3.10

Building:	Building 1
Location:	All Areas > All Areas
Finding:	Brickwork - minor cracks
Information:	Although minor cracks are noticeable, they are often only considered to be an appearance defect and usually do not indicate any major structural damage. Generally, the cause of a minor cracks is indicative of some minor movement and expansion and contraction causing a minor separation between brickwork and mortar throughout the structure, single bricks may also show cracks of this nature.

All other areas of brickwork did not appear to show major damage or deterioration. These areas were considered to be structurally sound at the time of the inspection. Cracking of this nature can generally be repaired with minor filling and should be conducted by a qualified bricklayer. Always contact a builder or structural engineer should cracks widen lengthen or become more numerous.

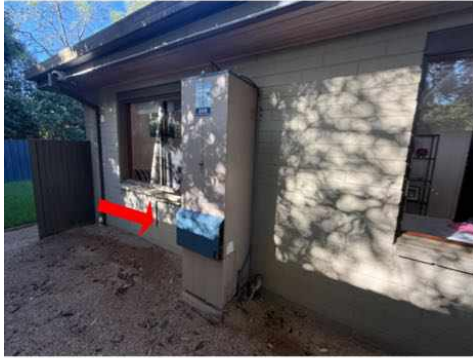
Defects 3.11

Building: Building 1
Location: All Areas > All Areas
Finding: HWS Overflow - Not Connected
Information: The Hot Water System (HWS) overflow was found to be disconnected from storm water drainage and may be or in the future create excessive moisture in the surrounding area.

These damp conditions can lead to secondary defects such as rot, rust or corrosion of associated building elements, the formation of fungal decay, or even the creation of potential slip hazards. When coupled with poor site drainage, pooling of water may also attract termite activity to this area.

It is highly recommended that a licensed plumber be appointed to connect the HWS overflow in order to prevent such an environment from being created. These minor works should be carried out as soon as possible.

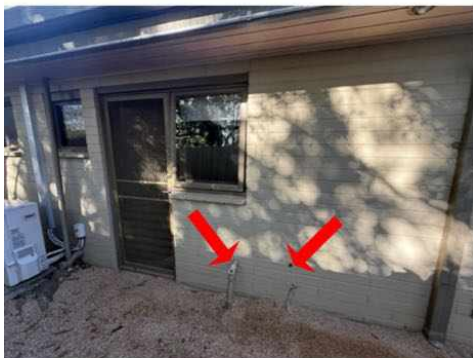
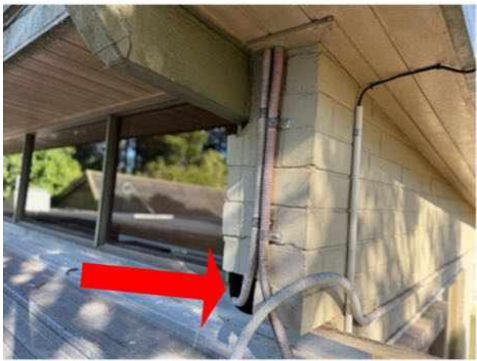
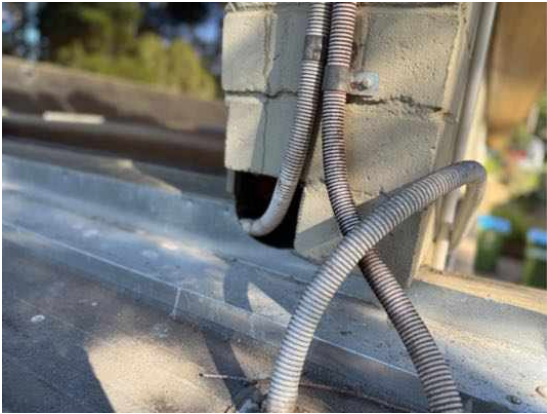
Defects 3.12

Building:	Building 1
Location:	All Areas > All Areas
Finding:	External roof and wall holes
Information:	Some holes were observed around the on the left hand side wall and roof. Gaps, cracks and holes around the home makes the area susceptible to pests, insect and vermin ingress, as well as allowing water penetration into these areas. As such, associated building elements are likely to deteriorate at an accelerated rate, due to weathering and other implications may be expected if these areas are not sealed off properly and left unmanaged. All excessive holes, gaps or cracks should be immediately and adequately filled by a suitable board, sealant or trimmings. Such works may be conducted by a qualified carpenter or licensed plumber.

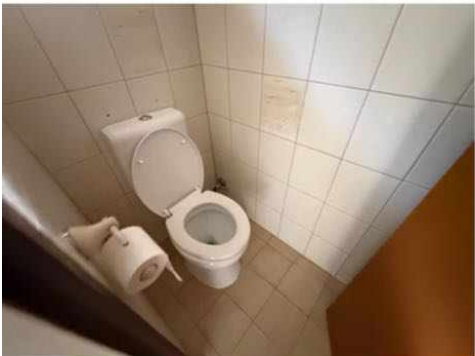
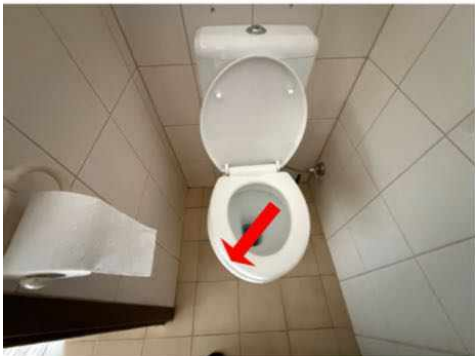
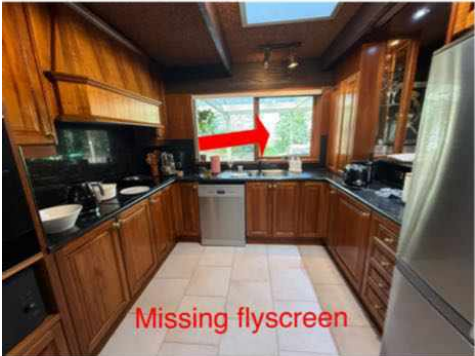
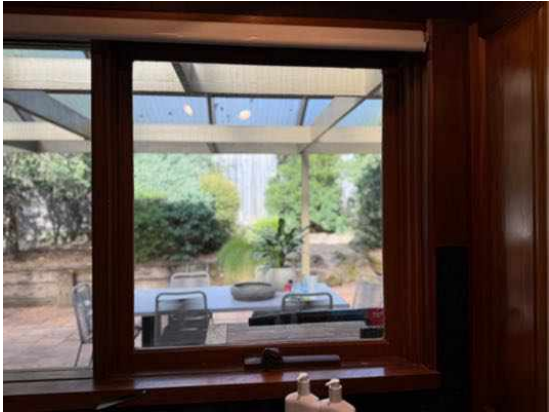
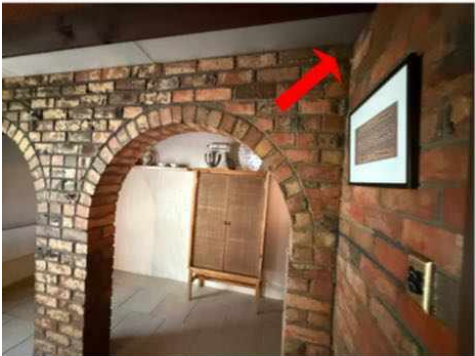
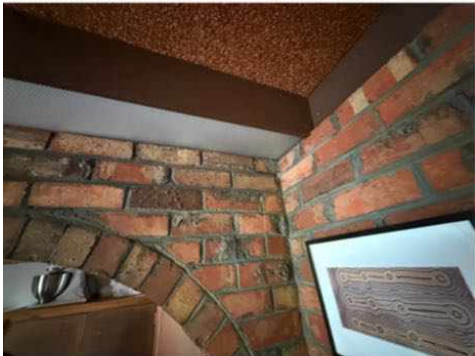
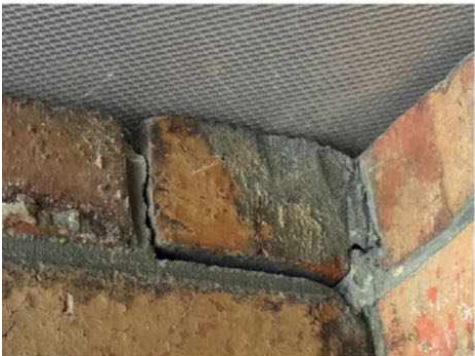
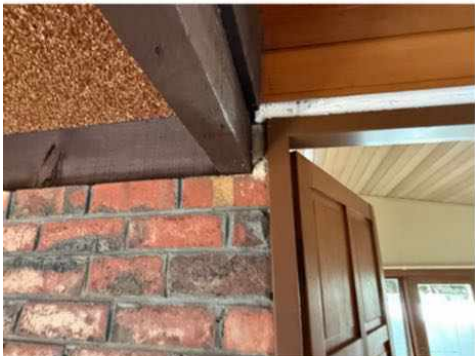
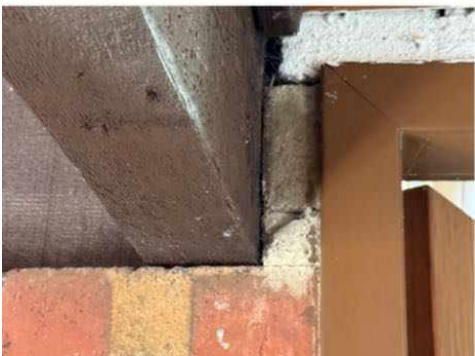
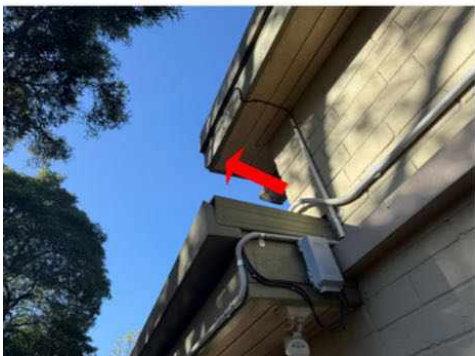
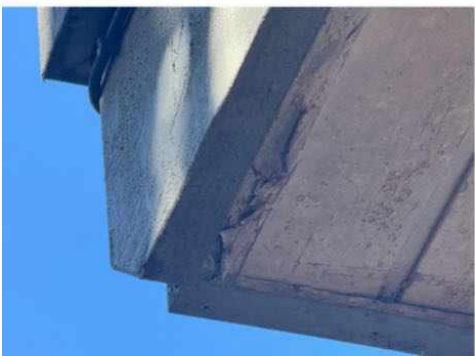
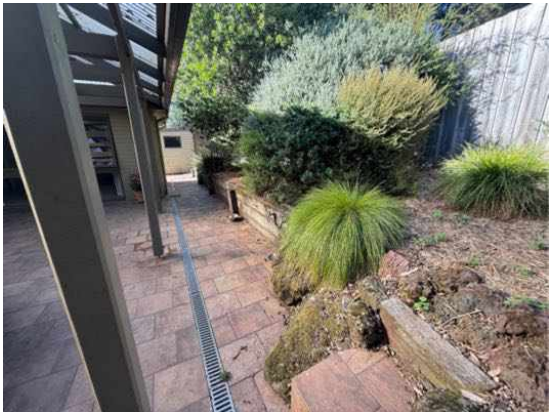
Noted Item

Building: Building 1
Location: All Areas > All Areas
Finding: Additional Photos
Information: Additional photos are provided for either future maintenance items for clients attention and or general reference. Arrows may have been included to highlight areas of importance. Please discuss these photos with your building consultant for clarification.

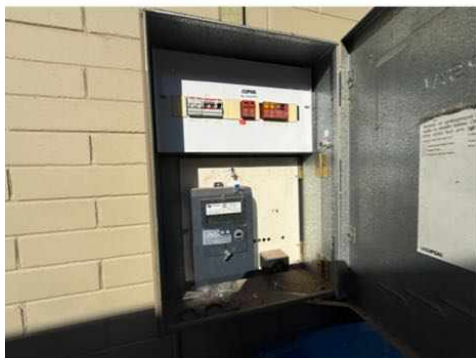
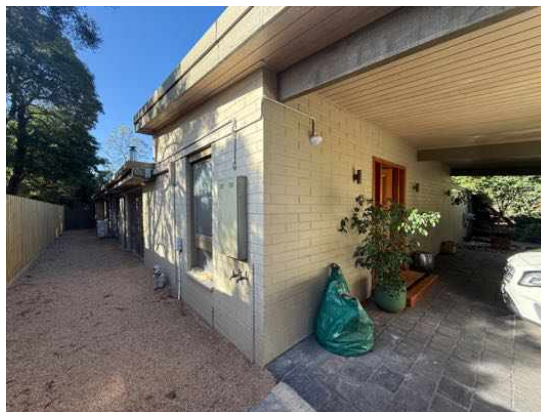
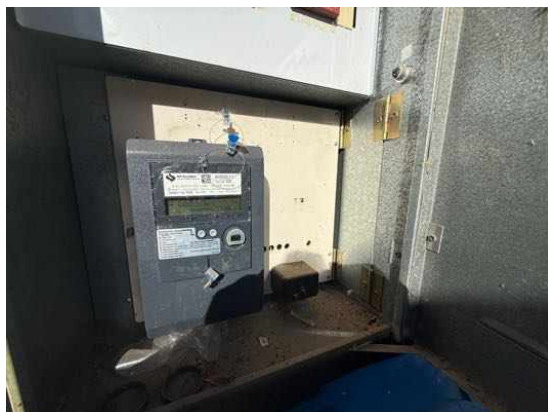
Noted Item

Building: Building 1
 Location: All Areas > All Areas
 Finding: Termite Management System - no evidence of a chemical installation or durable notice
 Information: At the time of the inspection no application of a chemical termite barrier or durable notice was observed. Such barriers are highly effective and highly recommended for all properties in preventing termite attack on any timber building elements throughout the property.

A durable notice should be placed in the switchboard unit or in the another accessible area to indicate current termite barriers. At the time of inspection, no evidence to suggest preventative works taking place. The client may consider gaining further advice from builders or a pest controller and as to the costs and procedures involved with this application.

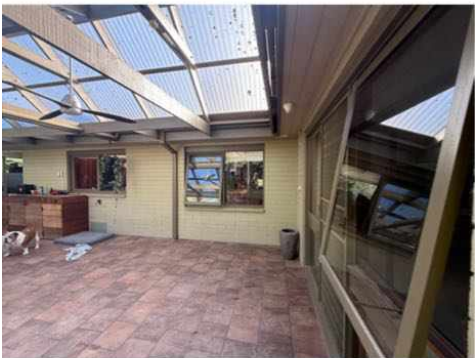
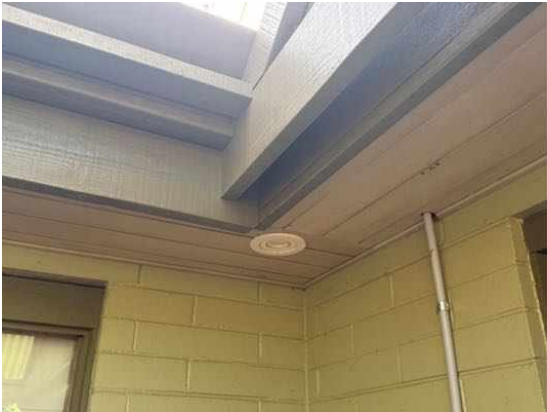
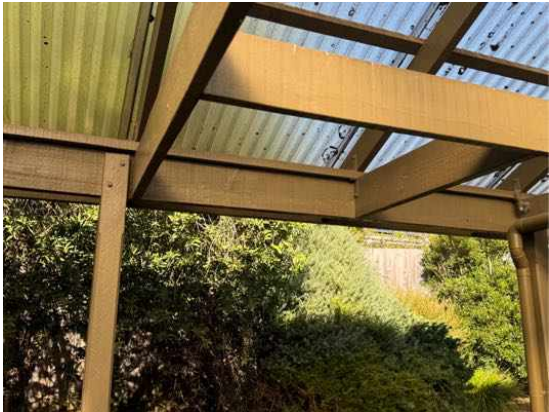
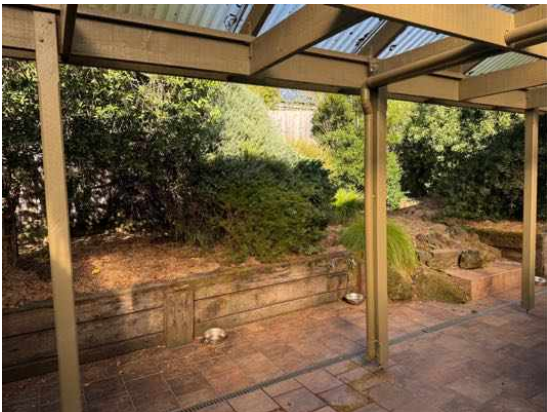
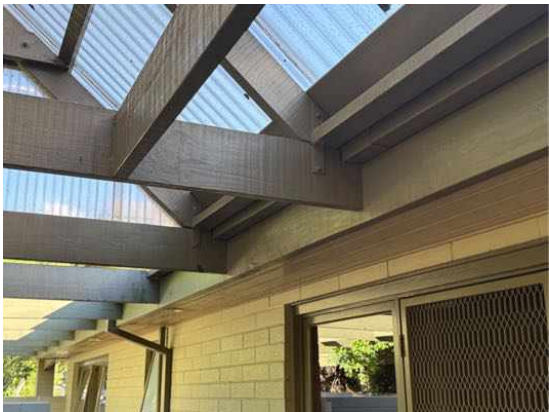
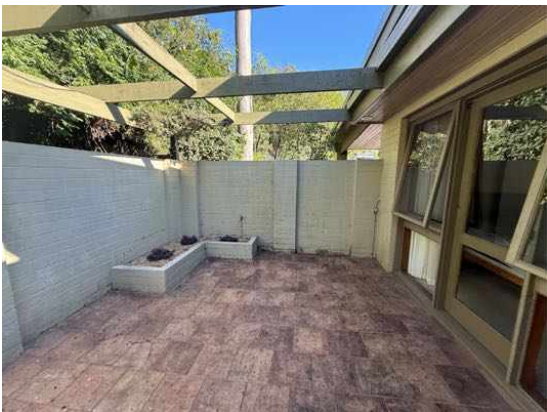
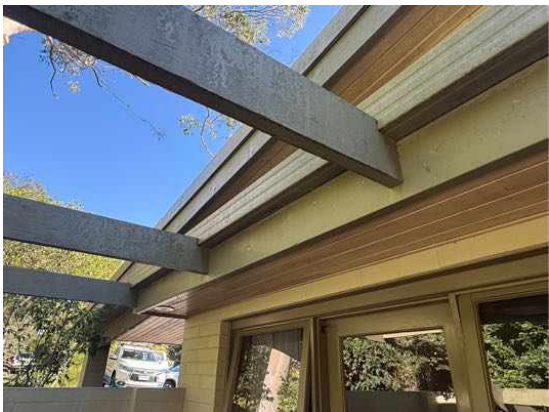
Noted Item

Building:	Building 1
Location:	All Areas > All Areas
Finding:	Back pergola roof brackets missing
Information:	Although some building elements may seem irrelevant or unnecessary at the time, all building elements play a key role in the operation and function of the overall structure and its performance. All the roof brackets that are missing to any of the roof structures should be installed to ensure that in the future as this structure ages and further deteriorates it will remain more stable over time. These types of structures are more susceptible to exposure from exterior weather conditions and are highly likely to become unstable if left unmanaged. The appropriate and relevant tradespersons should be appointed, to install, maintain or replace the missing building elements or materials deemed to be necessary.

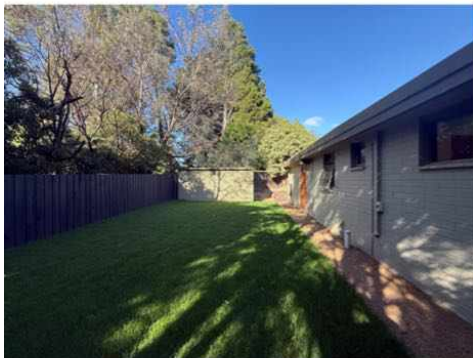
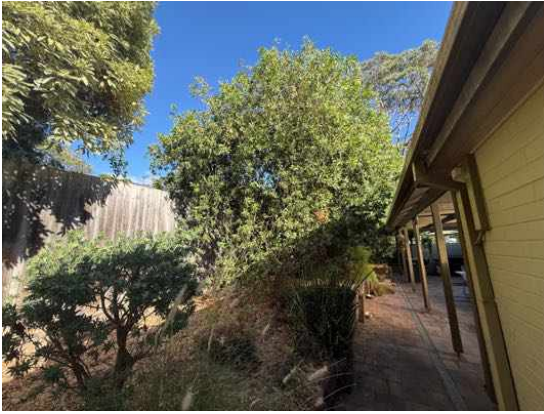
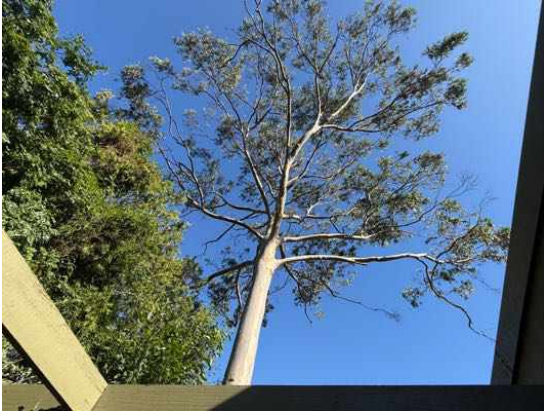
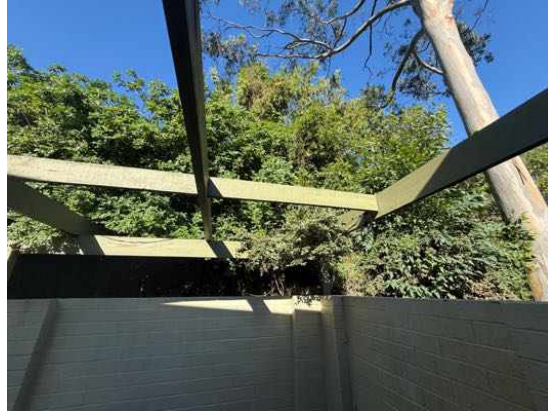
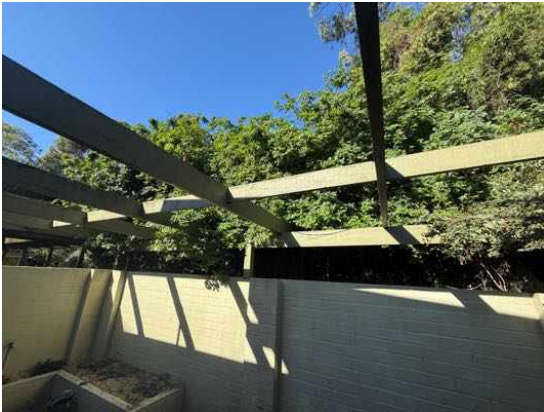
Noted Item

Building: Building 1
Location: All Areas > All Areas
Finding: Trees - Overhanging and filling gutters
Information: Overhanging trees often result in excessive amounts of leaf debris accumulating in gutters. Gutters are a critical part of the building's management of storm water and rain. It is therefore important that they be kept clear to prevent secondary damage to associated building elements, including exterior and interior walls, ceiling linings and any adjoining building elements. Where gutters get blocked from excessive leaf matter, water pooling is highly likely to occur more frequently, fast-tracking, rust and corrosion of the roof plumbing elements and making these areas even more susceptible to secondary defects

It is highly recommended that if at all possible, all overhanging tree branches be removed to prevent further damage. Such works can be performed by the homeowner; however, appointment of a landscape contractor or an arborist may be required. Consultation with a licensed roof plumber is required where guttering has been damaged.

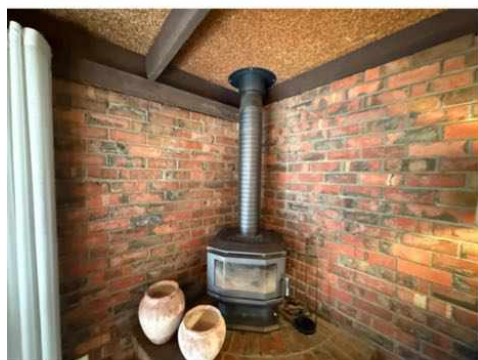
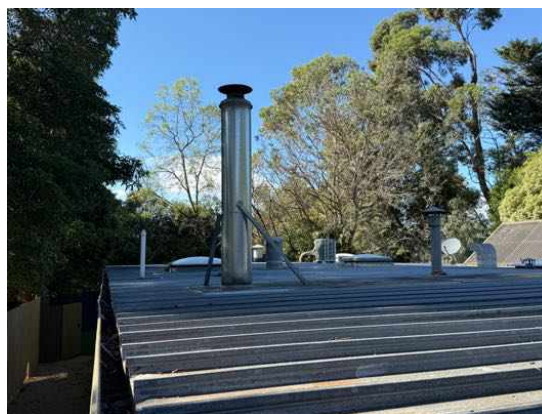
Noted Item

Building: Building 1
 Location: All Areas > All Areas
 Finding: Fireplace and chimney sweep
 Information: Reporting on the fireplace and or the associated chimneys, including as to whether they are working or not and their legislative requirements, is outside the Scope of this Report. Please note that this is highlighted as a caution only. It is highly recommended the fireplaces and associated chimneys get checked periodically and even before use when they may not have been used in a while. If left unmaintained and not cleaned adequately a fireplace and chimneys may be or become a fire hazard.

We suspect, based on our experience in the building industry, that fireplaces and the associated chimneys get over looked and do not get chimney swept or any maintenance for long periods of time. The chimney may therefore be in a poor condition, so we recommend that they always ensure that these areas be addressed prior to their use, this is to ensure home and occupant safety.

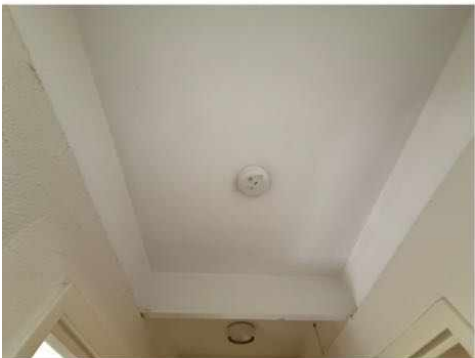
Noted Item

Building: Building 1
 Location: All Areas > All Areas
 Finding: Smoke detectors and alarms
 Information: Reporting on Smoke Detectors or Alarms, including hard wired smoke detection systems and their legislative requirements, is outside the Scope of this Report. Please note that this defect is highlighted as a caution only. We suspect, based on our experience in the building industry, that smoke detectors are sometimes get over looked, or they may be in a poor condition, so we recommend that they always should be addressed prior to occupation to improve occupant safety.

Always ensure sufficient working and suitable smoke detectors are installed prior and during to occupying any building. Additionally, it is advised that all smoke detectors be tested by the homeowner on a monthly basis.
