Building and Timber Pest Inspection Report

Inspection Date: Fri, 13 Feb 2026

Property Address: 63 Page Ave, North Nowra NSW 2541,
Australia

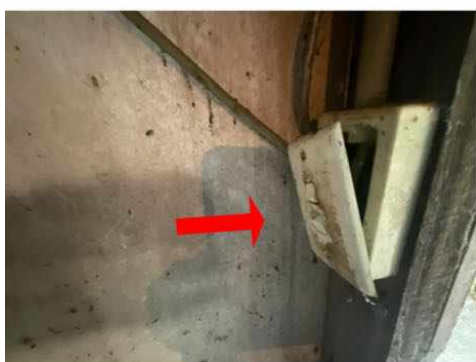
Building:	Building 2
Location:	Shed rear
Finding:	Switch loose
Information:	The electrical fitting in this shed area was found to be loose at the time of inspection.

A Licensed electrician should be appointed to rectify these area immediately.

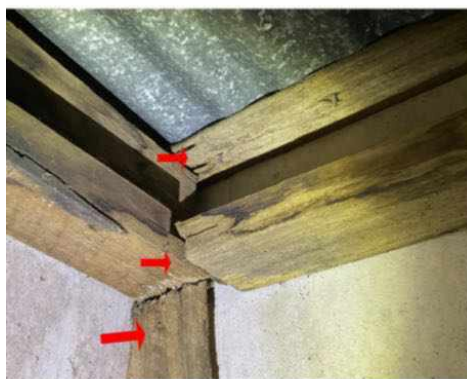
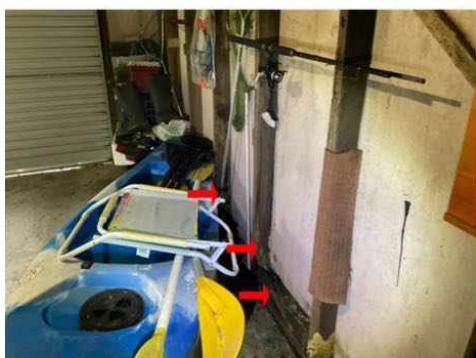
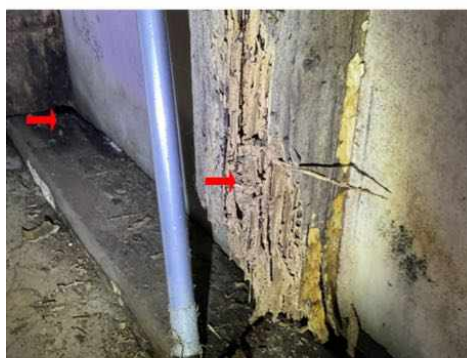
Finding 2.01

Building:	Building 2
Location:	Shed
Finding:	Wood rot to structural timbers.
Information:	The left front wall of the garage shows evidence of severe wood rot to wall studs and other nearby timbers and apparent termite damage. It appears the blocked or lack of working front drainage has lead to water damage to the lower areas. In high rain events front garage areas this appears to flood.

Replacement of the affected timbers is a necessary step in protecting surrounding building elements from such deterioration and supporting the roof.

A qualified plumber may be appointed to assess the cause of excessive moisture and to provide advice on any remedial works as required. A qualified carpenter or registered builder will be required to replace all the affected damaged building materials. Note - some garage areas particularly the rear cannot be accessed for inspection due to stored items and debris.

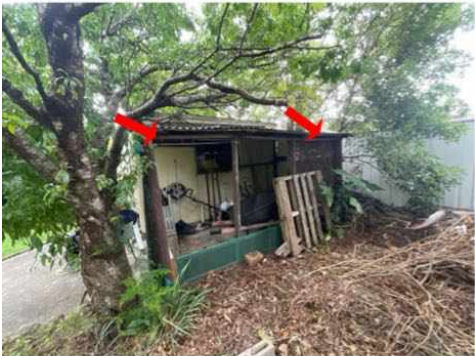
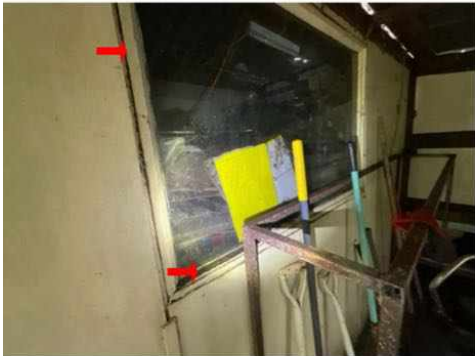
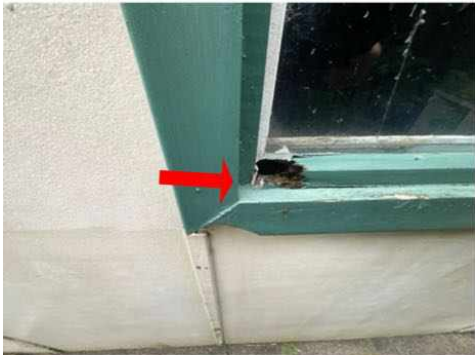
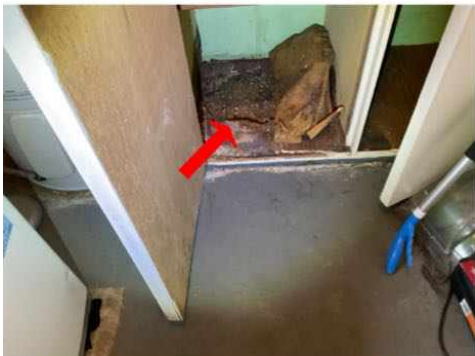
Finding 3.01

Building:	Building 1
Location:	Pictured exterior & interior areas
Finding:	Wood rot
Information:	These building areas on both buildings shows evidence of wood rot. Wood rot, also known as Fungal Decay, occurs when timbers and other cellulose building materials are exposed to damp conditions on an ongoing basis. This could be the result of exposure to weathering over a prolonged period of time, or the attraction of excessive moisture from other abutting building materials.

Early intervention and regular maintenance, particularly of exterior timbers, will prolong the useful life of these building elements. Prior to any works being performed, the cause of the moisture that has created the visible wood rot should be identified and addressed in a suitable manner. Replacement of affected timbers may then be a necessary step in protecting surrounding building elements from such deterioration.

A qualified carpenter or registered builder may also be required to replace affected building materials.

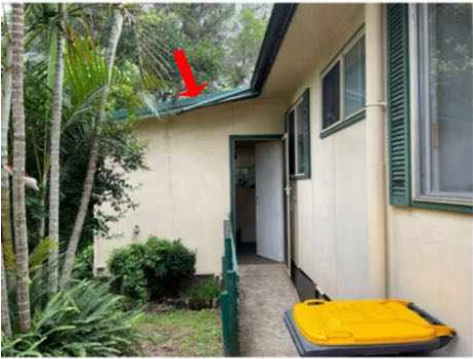
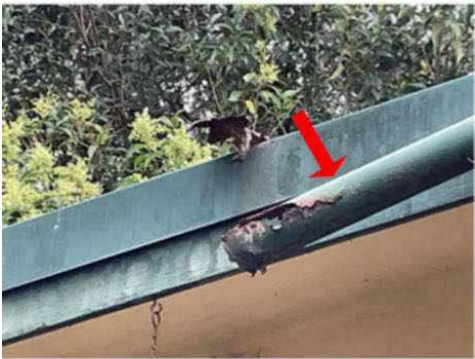
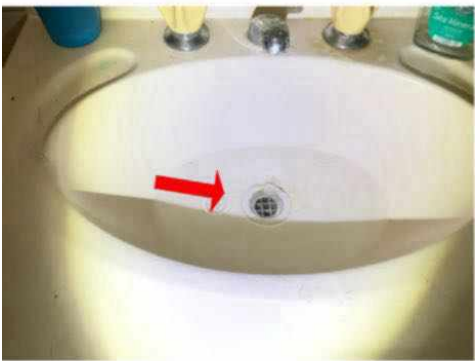
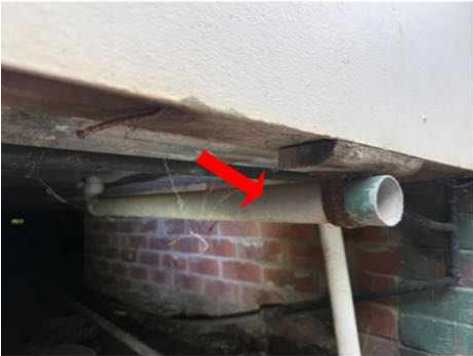
Finding 3.02

Building:	Building 1
Location:	Walls, verandah, garage
Finding:	Site drainage - Inadequate
Information:	The site drainage on both buildings was found to be inadequate at the time of inspection, creating potential for subsequent water damage to associated building elements.

The front downpipe run onto the wall causing further damage. The washing machine and bathroom floor waste overflows run against the rear house wall. The bathroom vanity is slow to drain and the tenant says blockages on the property occur and have been repaired a few times in approximately 15 months. The front garage drainage works appear to be substandard and blocked damaging many garage timbers. It appears water may also pool on the front steps.

Where site drainage is inadequate, installation of an Agricultural (Aggie) Drain may be required. A qualified plumber should be appointed to further inspect the property prior to purchase to quote and repair or replacement of damaged drainage areas. Secondary defects are likely to occur if left unmanaged.

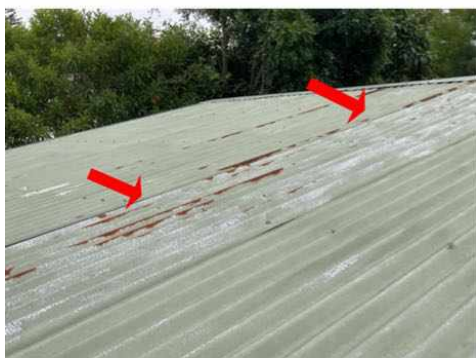
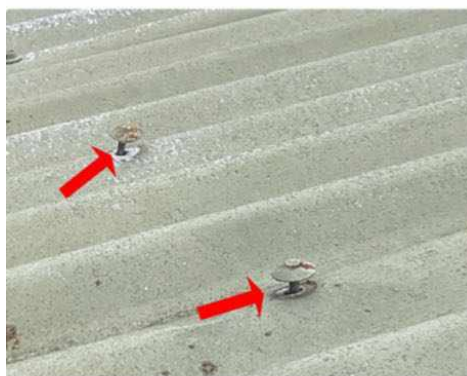
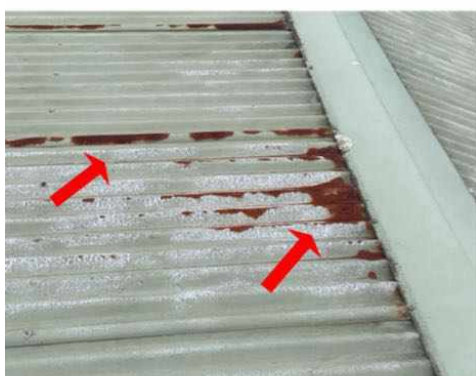
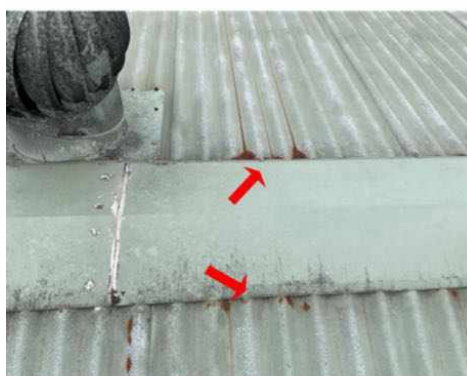
Finding 3.03

Building:	Building 1
Location:	Both External Roofs
Finding:	Roofing areas - Weathered
Information:	Upon inspection of the exterior roofing, the majority of the house roof areas were considered to be in fair condition and the garage roof in poor condition.

While weathering of these pictured areas is consistent with a the property where no maintenance has occurred. It appears some house roof areas need rust treatment or replacement and many garage areas need replacement due to severe rust. Numerous roof fixings are loose and also need repair/ replacement.

Re-sealing and replacing many areas of gaps, loose, rusted and damage sheets is required. Where left unmanaged, deteriorating roofing materials are likely to lead to a number of secondary defects, including minor water leaks and weather exposure to internal roofing structures.

Consultation with a roofing contractor is highly advised to gain advice on cost of remedial works that may be required in the short to medium term.

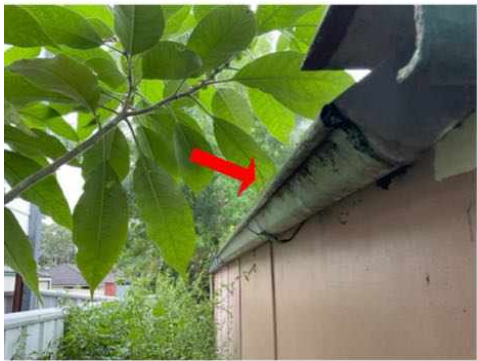
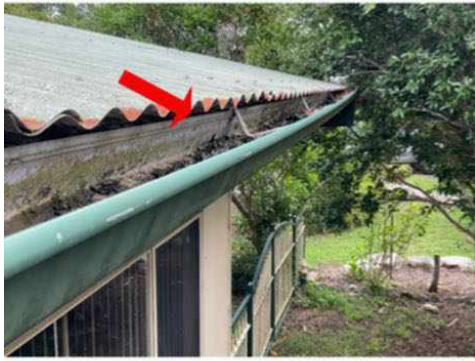
Finding 3.04

Building: Building 1
 Location: Most gutters on both buildings
 Finding: Gutters loose, damaged and insufficient fall
 Information: There is an insufficient fall and sagging in most of the garage and house gutters, which means that the angle of this gutter is inadequate for rainwater to drain away. This will result in pooling of water in these areas, creating the potential for water damage to nearby areas. This is likely to lead to further defects if not repaired. Adjustment by a roofing contractor is required as soon as possible to prevent any damage to this area.

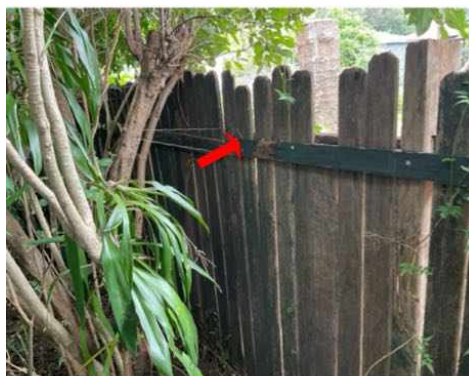
Finding: Fences damaged - leaning
 Information: Evidence of damage to the pictured front and other fences was identified at the time of the inspection. The likely cause of many of these fences leaning is not enough concrete used in the post footings, wood rot and bora damage. If left unmanaged these fences may deteriorate further. It is suggest a fencing contractor be engaged for rectification when convenient.

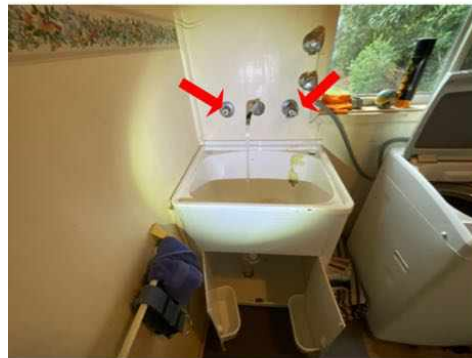
Finding 3.07

Building: Building 1
 Location: Pictured areas
 Finding: Building elements - Damaged
 Information: Evidence of minor missing or damaged areas was identified at the time of the inspection. These include -

1. The pictured front door and laundry cupboard doors are delaminating requiring replacement in the future.
2. The bathroom window latch is broken making the house not secure.
3. The laundry taps were missing and loose requiring repair.

A carpenter and plumber would be the trades responsible for rectification of these areas when convenient.

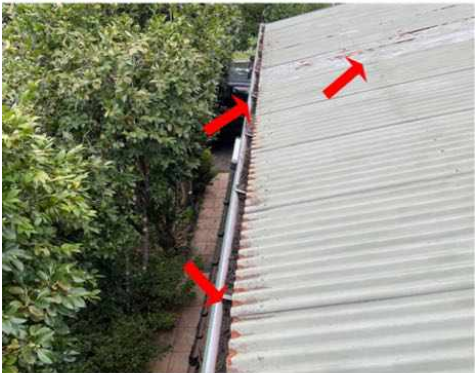
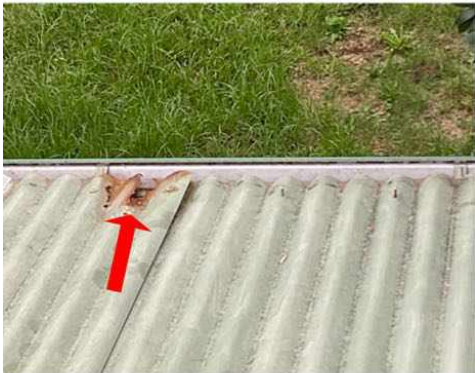
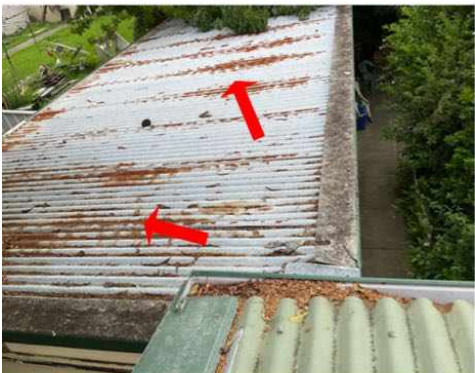
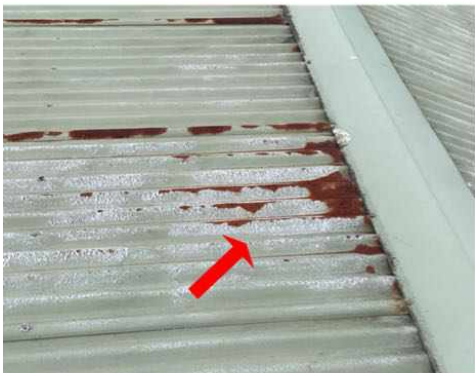
Finding 3.08

Building:	Main Building
Location:	Main building and shed
Finding:	Areas rusted or corroded
Information:	These roof areas shows evidence of rusting and corrosion, which is likely to have developed as a result of excessive exposure to moisture and or inadequate coatings.

As surface rust provides no protection to the underlying iron, the deteriorating condition is likely to worsen if not addressed in the short-term future.

Where possible, the use of galvanized (treated) metals or aluminium coated metals aid in rust prevention, as does regular general maintenance. Rust formation can be controlled with coatings, such as paint, that isolate the iron from the environment.

A roofing contractor should be consulted for quotes for repair/ replacement of these areas.

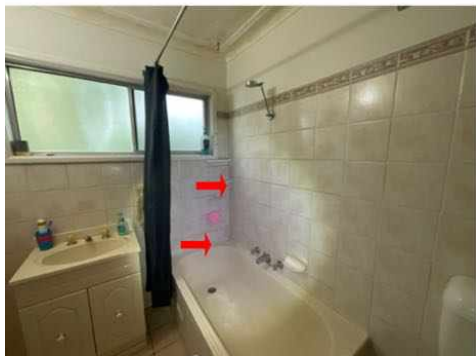
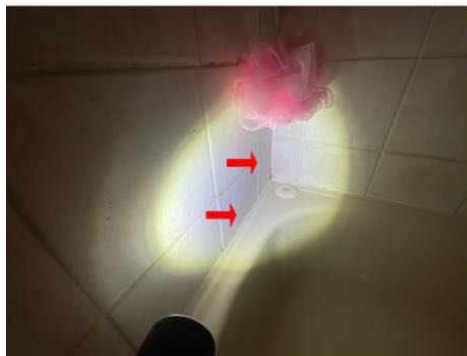
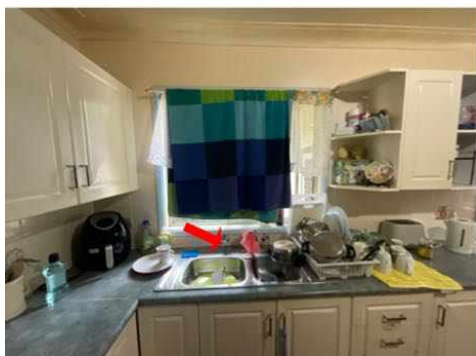
Finding 3.09

Building: Building 1
Location: Kitchen and bathroom
Finding: Sealant and grouting - Missing or damaged
Information: It was noted on inspection that sealant or grout is degraded to these pictured wet areas.

Different materials and floor areas move at different rates, generally causing cracking to grout or sealant at this point. A flexible sealant is required to allow for expected expansion and contraction, while keeping the joint water tight and protective of all associated building materials.

Flexible and mould resistant materials should be applied to affected areas to prevent any subsequent water damage that is likely to occur. Regular maintenance and replacement of damage or missing or damaged sealant and grout is highly recommended to the wet areas, as this is a regular wear and tear defect. Sealant and grouting in areas that come into regular contact with water should be maintained for the long term care of your property.

A sealant specialist or tiling contractor should be appointed to complete these works as soon as possible

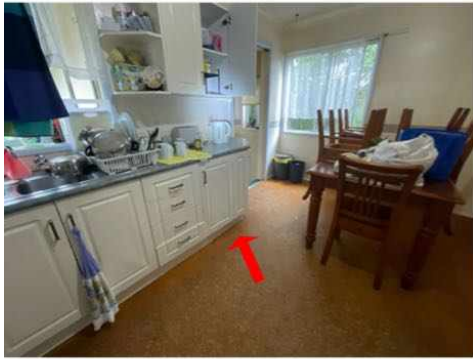
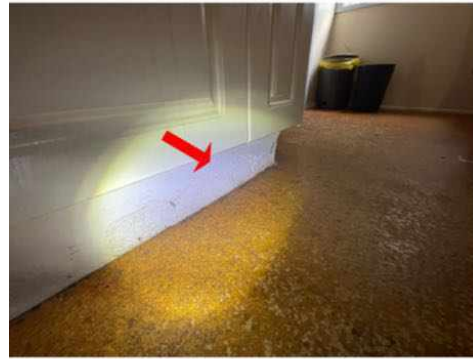
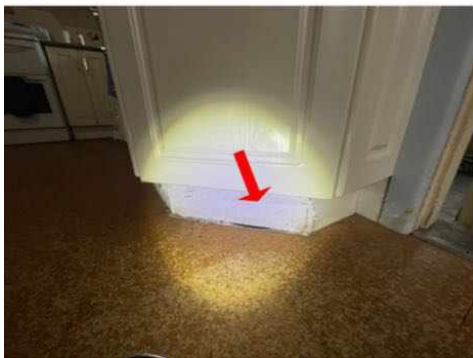
Finding 3.10

Building:	Building 1
Location:	Kitchen
Finding:	Swollen building elements
Information:	Swollen building elements generally indicate that the building materials have been affected by excessive moisture over a prolonged period of time, and have swollen as a result. The structural integrity of swollen building elements cannot be guaranteed, and further damage is possible if these areas are left unmanaged.

Repair or replacement of swollen building elements should be conducted by a qualified carpenter or cabinet maker.

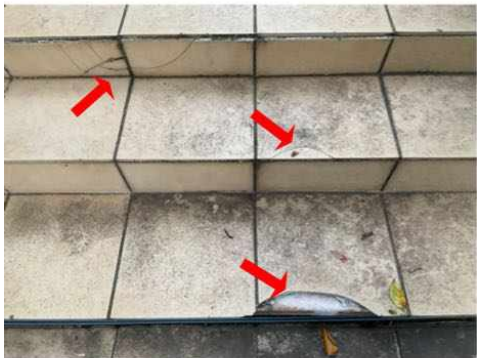
Finding 3.11

Building:	Building 1
Location:	Porch
Finding:	Tiles cracked
Information:	Cracked tiles were evident in these pictured front porch area at the time of inspection. It is suspected that this cracking has occurred as a result of impact damage.

Cracked tiles throughout the household detract from the overall appearance of the affected areas.

Replacement of cracked tiles is recommended as soon as possible. A tiling contractor may be appointed to perform these works. Where cracks become more numerous, contact a licensed building inspector for further investigation.

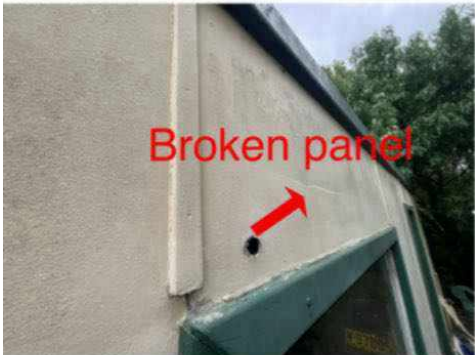
Finding 3.12

Building: Building 1
Location: Shed and house areas
Finding: Asbestos - Suspected ACM Identified on Site
Information: Reporting on Asbestos is outside the Scope of this Report. This suspected defect is highlighted as a caution only. We suspect, based on our experience in the building industry, that there is a higher risk of many building element containing asbestos. Many garage/ shed wall and roof areas are damaged.

As Asbestos Reporting is outside the scope of this report, we advise that you consider a separate Asbestos Inspection and Condition Audit, which can include the taking of samples for definitive confirmation of the presence of Asbestos.

In the interim, the client is advised to act with caution, especially when considering the damaged shed walls, general wear and tear and any renovations, extensions, demolition and general maintenance activities due to the suspected presence of Asbestos.

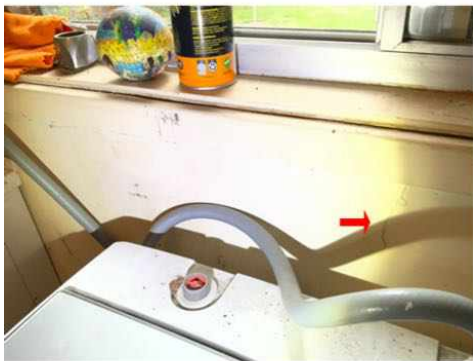
Finding 3.13

Information: Where evidence of mould growth was noted, there may be environmental, biological or health issues associated with the report. A specialist inspection by a suitably qualified environmental health inspector is warranted, where mould is extensive or where any queries regarding air quality spores or other related issues apply.

Generally, the client is advised to ensure that the general environment is free of moisture and humidity to aid in the prevention of mould formation and development.

Any mould found during the inspection should be cleaned immediately by a cleaning contractor or the homeowner as applicable.

Please - note that severely affected building elements may require replacement by a registered builder or qualified carpenter.

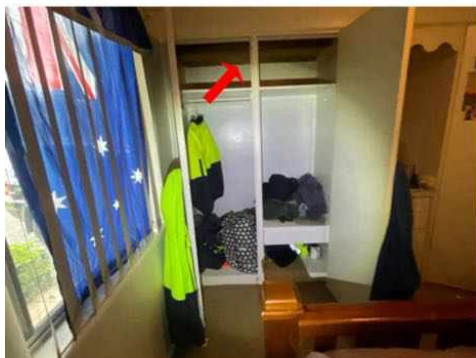
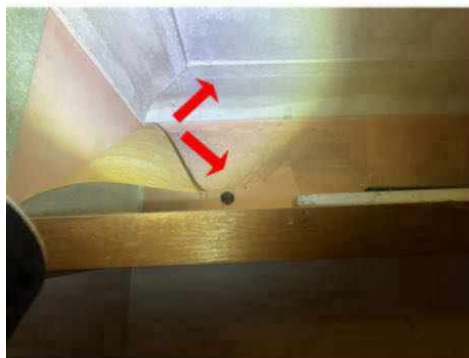
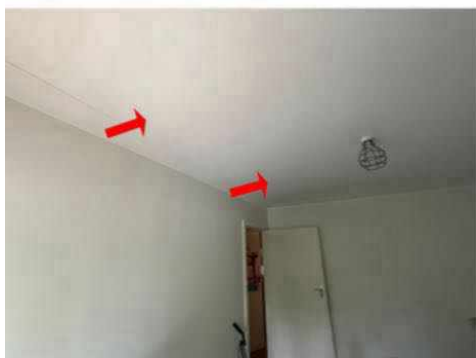
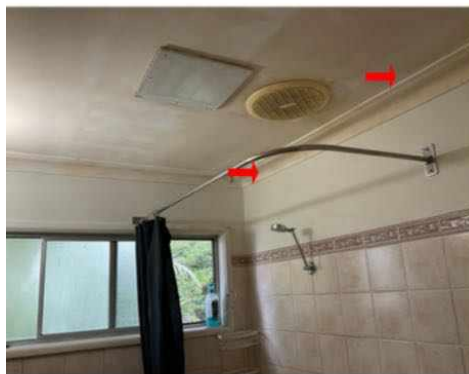
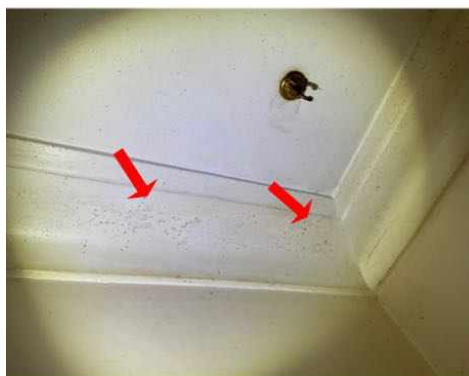
Finding 3.14

Building: Building 1
 Location: Pictured doors
 Finding: Doors - Binding/Jamming
 Information: Binding and/or jamming of several doors throughout the property were evident during

standard operation. This defect inhibits the functionality of affected doors as well as creating potential for secondary defects to associated building elements, such as damage to the floor covering.

A door that binds to flooring or to the associated door frame may have several causes, ranging from minor defects, such as poor installation of the door or deteriorated hinges, through to major structural issues, such as damage to subfloor structures.

For minor causes, a qualified carpenter or general handyperson should be appointed to perform minor rectification works at client discretion.

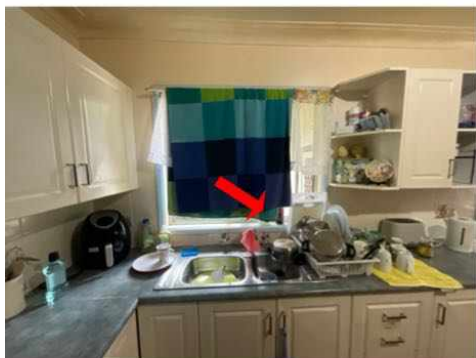
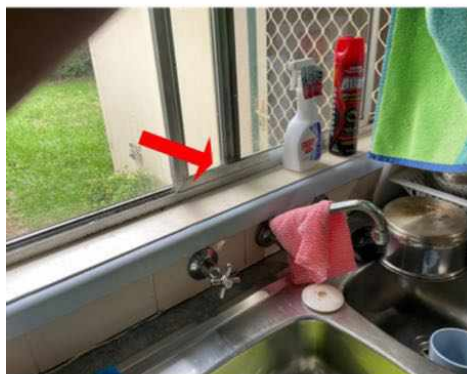
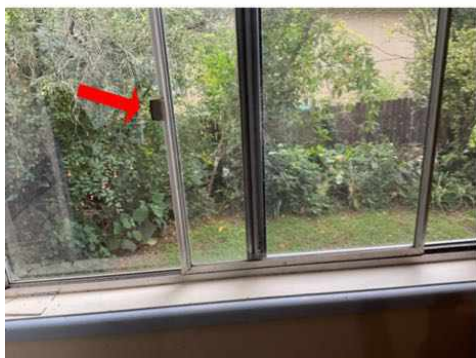
Finding 3.15

Building:	Building 1
Location:	Kitchen
Finding:	Window - Stiff to slide and now latching
Information:	The window in this sink area was jammed and difficult to operate at the time of the inspection. The dining room window latch will not lock. Windows provide ventilation to the adjoining area and should be at a fully operational level to ensure user comfort.

Restricted function of the window may also pose as a potential safety hazard if required for emergency egress from the building.

Generally, factors such as general age of the building element and a lack of maintenance are the usual causes for this type of defect.

Replacement of window hardware or frame may be required, as well as minor repairs and cleaning. A registered builder or general handy person will be required to repair the window.

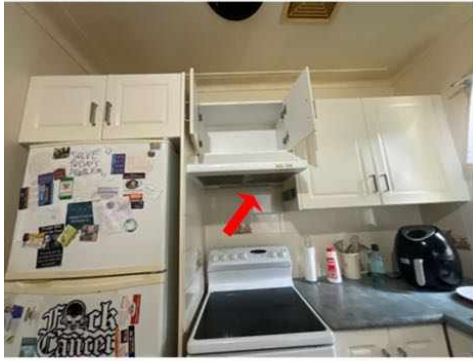
Finding 3.16

Building:	Building 1
Location:	Kitchen
Finding:	Rangehood cannot be plugged in
Information:	The ageing rangehood could not be plugged in at the time of inspection.

Without a functional fan, a build-up of grease and evaporative moisture is likely to accelerate deterioration of the range hood and associated flue. This potential build up may also create a minor fire hazard, particularly if left uncleaned.

A licensed electrician should be appointed to install PowerPoint to the fan on the range hood to restore it to a fully operational state.

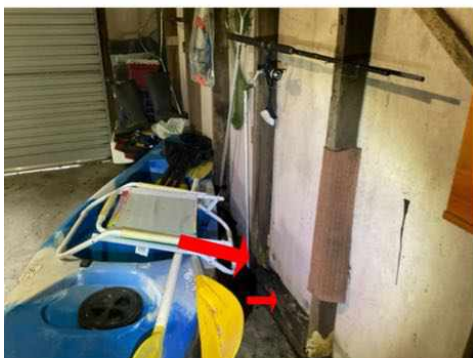
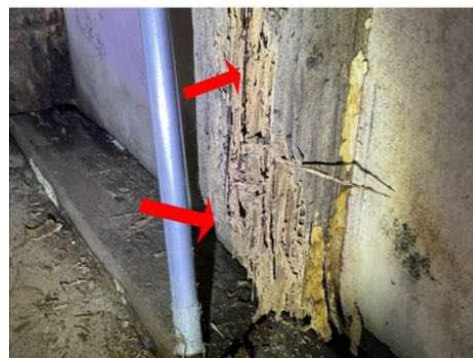
Finding 5.01

Building:	Building 2
Location:	Shed left wall
Finding:	Termite damage suspected
Information:	It is suspected that termite activity has occurred in this area. Many wall timbers are also severely wood rotted in this area. ALL stored items and debris needs to be removed from the entire property and all areas reinspected for termite activity and further defects due to the amount of areas that could not be inspected during this inspection.

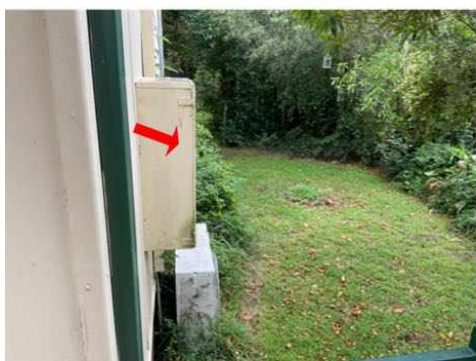
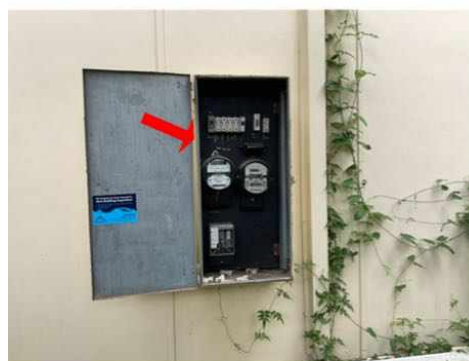
Finding 6.01

Building: Building 1
 Location: Meter Box
 Finding: Termite Management System - no evidence of a chemical installation
 Information: The application of a post-construction chemical termite barrier is highly recommended for all properties. Such barriers are highly effective in preventing termite attack on any timber building elements throughout the property. As it appears there is termite damage in the left garage wall, and many conducive conditions for termite activity were found,

A durable notice should be placed in the switchboard unit to indicate current termite barriers. At the time of inspection, no durable notice was evident and it appeared as though no chemical or other termite management system has been installed, with no evidence to suggest preventative works taking place since the property was built.

The client must consider gaining further advice from a pest controller as to the costs and procedures involved with a 'chemical' application. It is recommended that obtaining such advice be a short-term high priority.

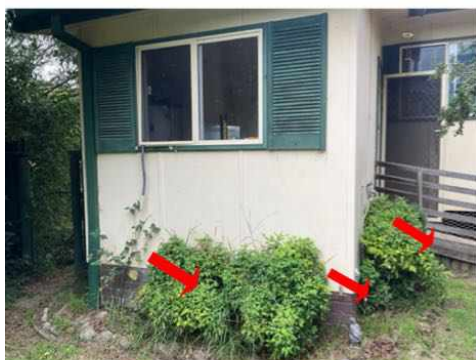
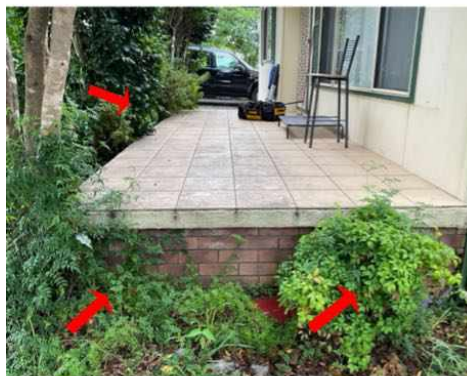
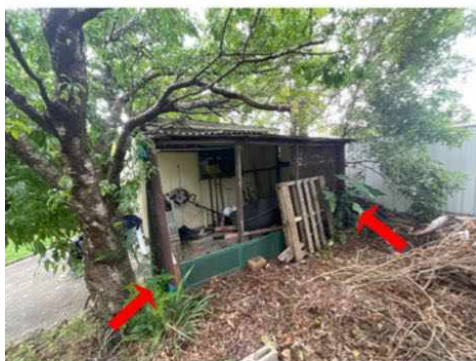
Finding 6.02

Building: Building 1
 Location: Many house and garage areas
 Finding: Bridging - Vegetation and decking
 Information: Where many areas of vegetation and decking obstructs inspection of building elements, also known as bridging as it provides a bridging point for the access of termites, full inspection can not be achieved. Consequently moisture or dampness may be present and the areas becomes conducive to termite activity. Plants and decks against or very close to buildings provide cover, shade and can provide an environment that is attractive to termite infestation.

walls will assist greatly in preventing Bridging from occurring.

The removal of any such stored building or plant materials that may be conducive to termite activity should be carried out as soon as possible and arrange re inspection to minimize the risk of termite attack.

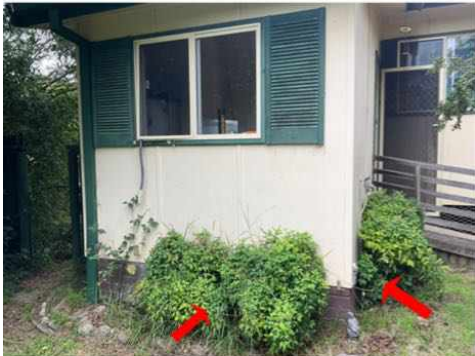
Finding 6.03

Building:	Building 1
Location:	Exterior walls
Finding:	Slab Edge - Exposure
Information:	An inspection zone of at least 75mm in relation to the exposed slab edge, between the bottom brick and the perimeter pavement, is required. This inspection zone should be maintained in order to force termites into the open where they can be detected more readily during regular inspections. The slab edge should not be concealed by anything that may prevent inspection of the area, including render, landscaping, soil, turf, paving, concrete cladding or other structures.

Where the slab edge cannot be properly inspected, it is highly recommended that termite or timber pest inspections be carried out every 6-12 months to aid protection

of the property against infestation.

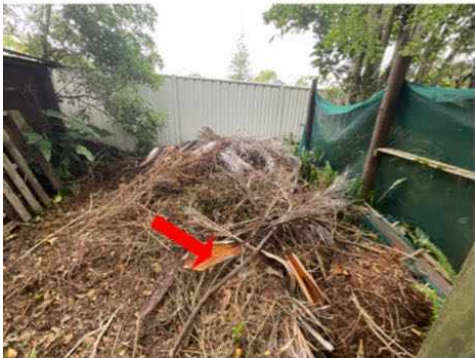
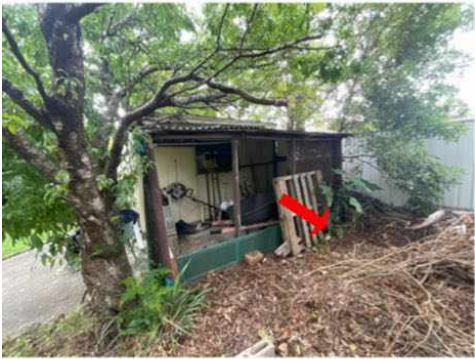
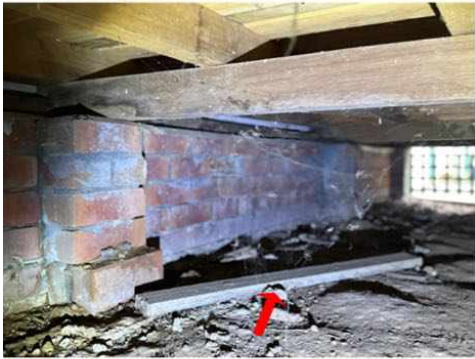
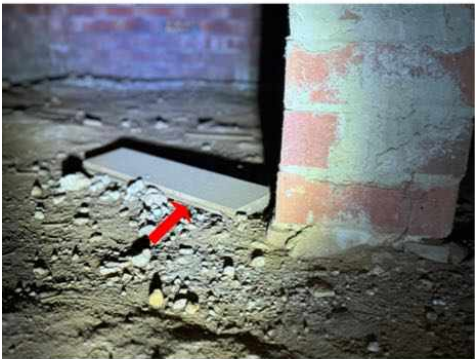
Finding 6.04

Building: Building 1
 Location: Yard and subfloor areas
 Finding: Timber in contact with the ground
 Information: Dozens of timbers/branches in direct ground contact provide opportunity for concealed termite entry and are likely to be subject to premature rot and decay as the soil retains moisture or damp conditions against the timbers.

Removal of all waste timber that is in direct contact with ground is highly advised. This timber is promoting mould and wood rot and is very attractive to termites.

Frequent pest inspections are advised to readily identify any termite activity in these areas.

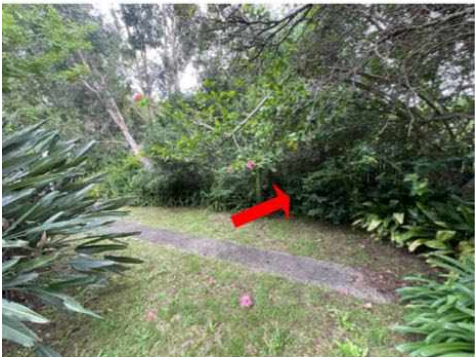
Finding 6.05

Building: Building 1
 Location: Yard areas
 Finding: Tree stumps - left in ground
 Information: Tree stumps left in ground provide opportunity for termite attack as they are likely to be subject to rot and decay providing an attractive food source. Treatment and/or Removal of the stump is highly recommended. A pest controller and tree removalist should be engaged to perform such works.

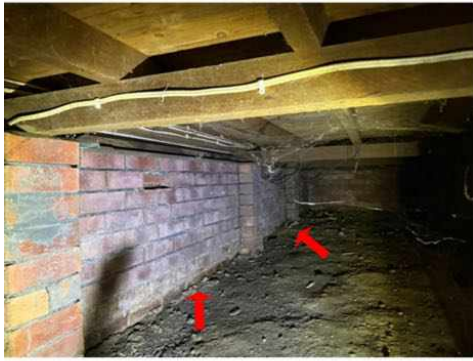
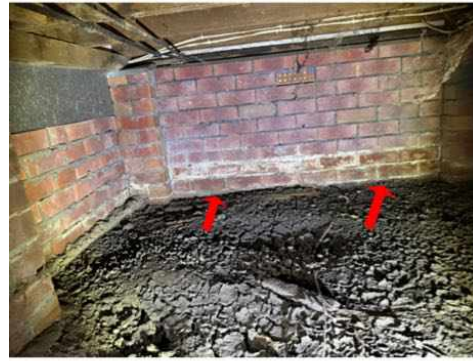
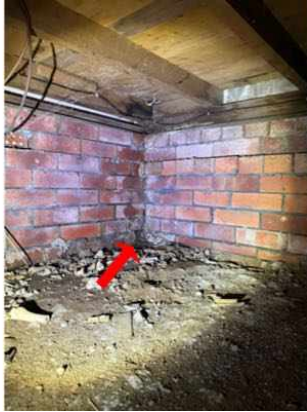
Finding 6.06

Rising damp is generally managed by the installation of a damp proof course during construction. A Damp Proof Course (DPC) is an impermeable barrier at the base of the wall above ground level. However, many 19th Century buildings have no damp course installed, or the materials have failed. The DPC may have been omitted as a consequence of poor workmanship, or it may have been bridged where materials built up against the side of the house allow moisture ingress above the DPC level.

The first step in addressing rising damp is to diagnose the cause. The identified cause should be addressed first before addressing the appearance and other defects which have resulted from the rising damp. If the original cause is not resolved, further cases of damp are likely to ensue, resulting in secondary defects.

Consultation with a qualified plumber is advised immediately to identify the cause of the damp and perform remedial works as required.

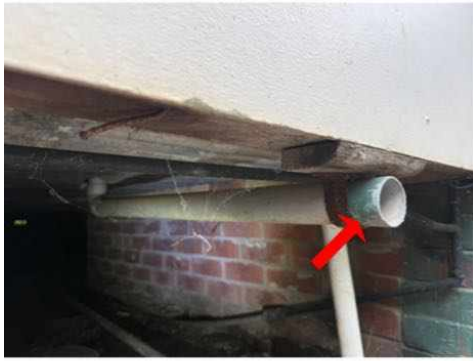
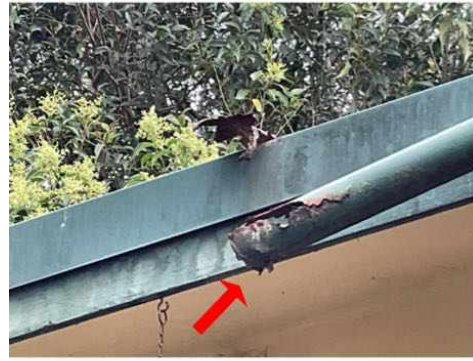
Finding 6.07

Building:	Building 1
Location:	Many external wall areas
Finding:	Overflows - Not plumbed for drainage
Information:	The pictured overflow pipes are not plumbed or connected to suitable drainage, which has resulted in the surrounding area becoming excessively damp.

These damp conditions can lead to secondary defects such as rot, rust or corrosion of associated building elements, the formation of fungal decay, or even the creation of potential slip hazards. When coupled with poor site drainage, pooling of water may also attract termite activity to this area. It is highly recommended that a qualified plumber be appointed to install adequate drainage to these areas. These works will ensure that the area remains dry and free of any secondary defects.

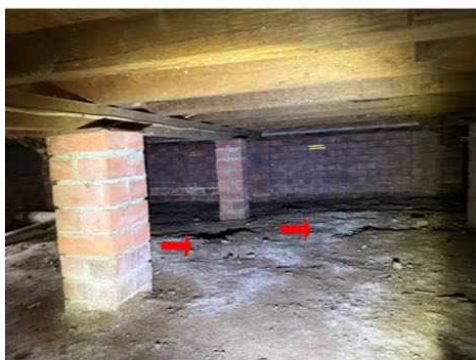
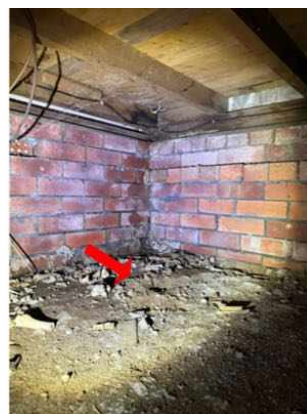
Finding 6.08

Information: Where evidence of mould growth was noted, there may be environmental, biological or health issues associated with the report. A specialist inspection by a suitably qualified environmental health inspector is warranted, where mould is extensive or where any queries regarding air quality spores or other related issues apply.

Subfloor mould is generally caused by moisture ingress, lack of external drainage, lack of adequate ventilation and subfloor debris present. These issues need rectification

to stop mould development. Any mould found during the inspection should be cleaned immediately by a cleaning contractor or the homeowner as applicable.

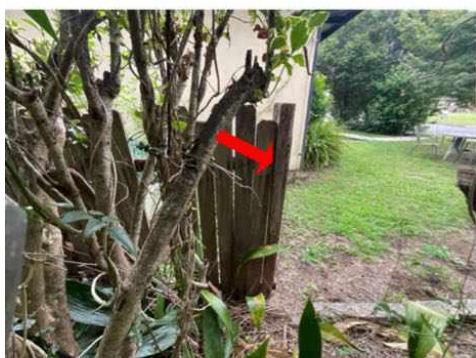
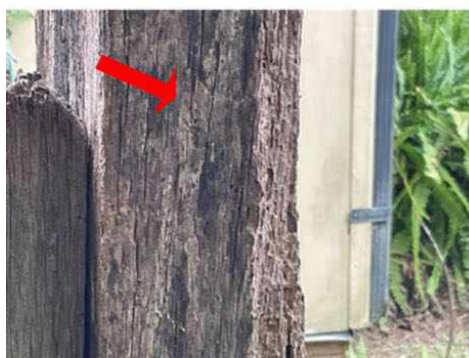
Building: Building 1
Location: Some house and many other areas
Finding: Fungal decay - present (localised)
Information: Fungal decay also known as wood decay or wood rot generally refers to the deterioration of timber elements when in contact with excessive levels of moisture for a prolonged period of time.

The development of fungal decay is accelerated by temperatures from 5degreeC to 40degreeC as well as the presence of oxygen. Generally fungal decay develops on timber elements that are in use in an external environment which are exposed to rain penetration.

Note - See ALL wood rot photos, all these show fungal decay.

In this case, many of the affected timber elements are in a decaying state and will need replacement by a carpenter or licensed builder.

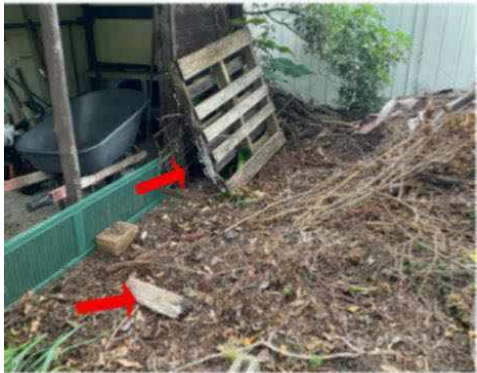
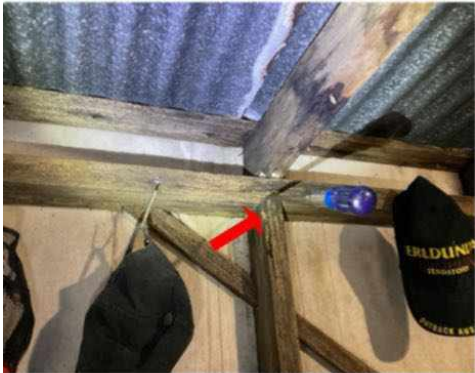
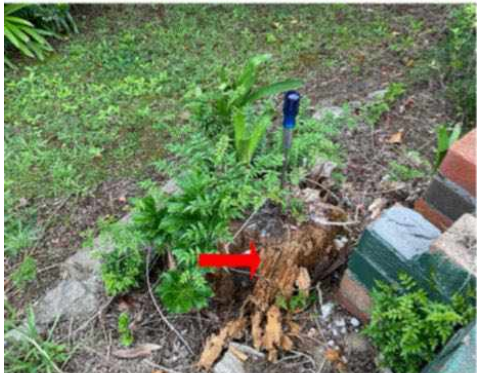
Finding 8.01

Building:	Building 1
Location:	Yard, fence and shed areas
Finding:	Evidence of wood borer activity identified
Information:	Wood borers small beetles that colonise in exposed timber elements are a common timber pest that are regularly mistaken for termites. Although wood borer activity is generally not detrimental to the affected timber they may lead to serious damage and necessitate replacement of certain building elements if left unattended.

The other commonly known borer the Anobium borer is more likely to attack floorboards and may cause severe structural damage to flooring areas.

As no live wood borer activity was identified treatment is not required at this time.

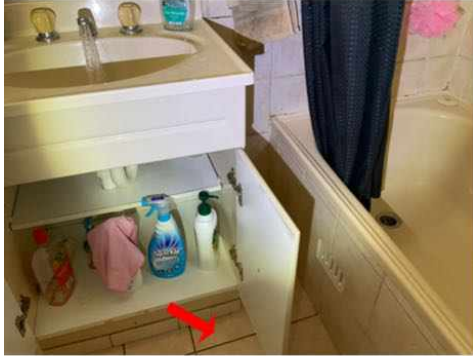
With older property's where this information is unavailable all wet areas should be monitored. If any leaks, water staining, peeling or bubbling of the paint become evident to any adjacent walls or ceilings below a licensed builder or waterproofing specialist is recommended to investigate further.

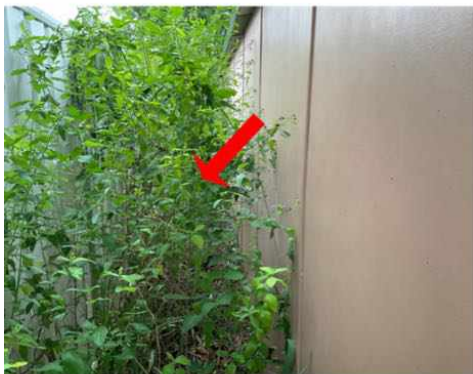
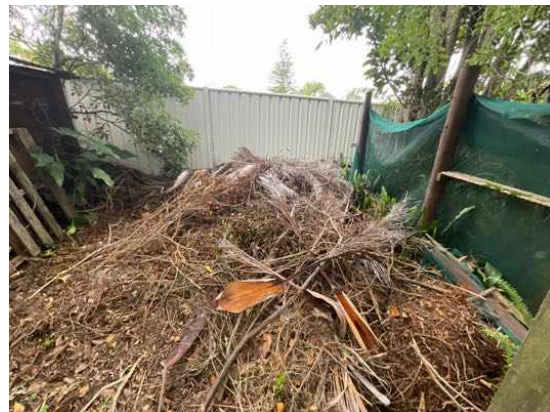
Noted Item

Finding: Additional Photos - Obstructions and Limitations of EXTERNAL AREAS

Information: These photographs are an indication of the obstructions and limitations which impeded full inspection of external areas at the time of inspection. These obstructions can hide an array of defects and should be removed to allow full inspection to be carried out. A re-inspection is recommended once the areas are made accessible.

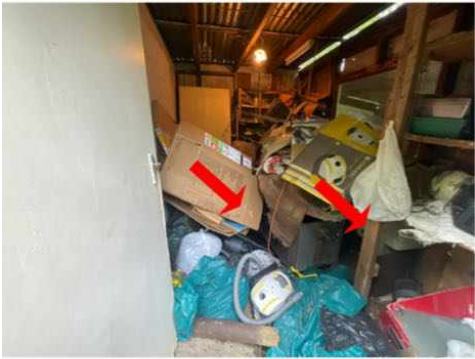
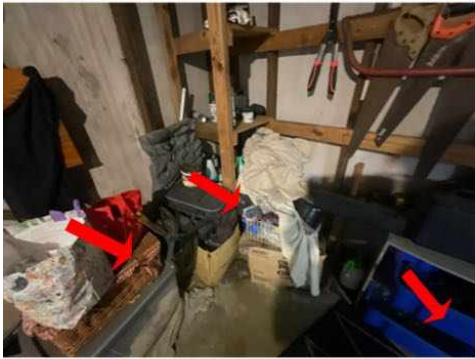
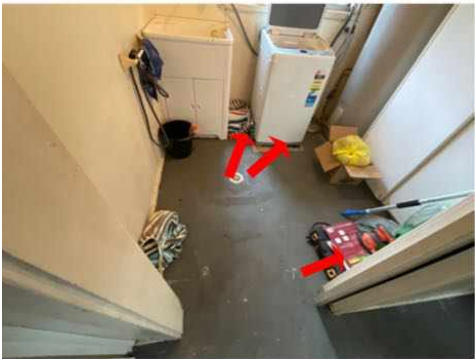
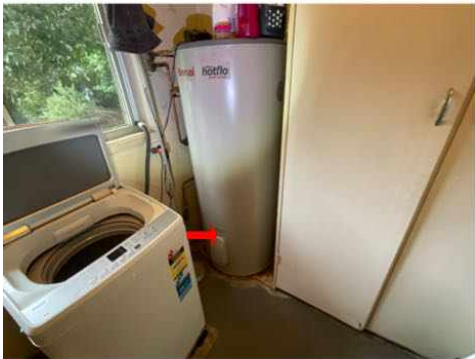
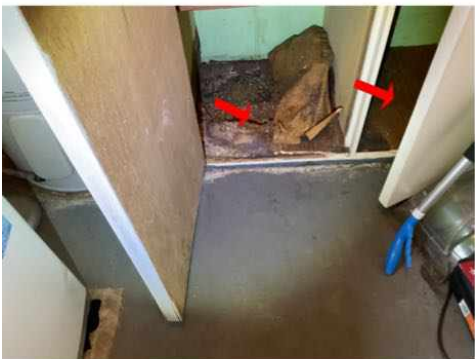
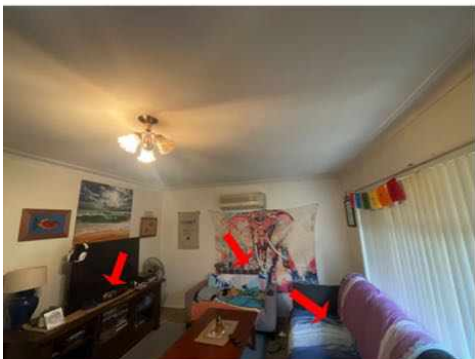
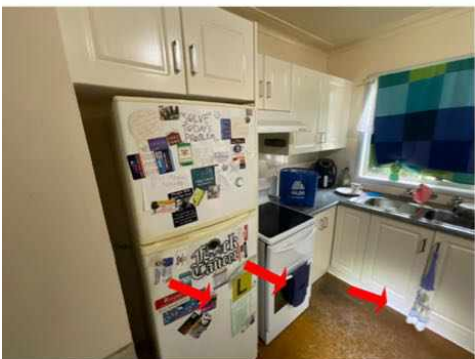
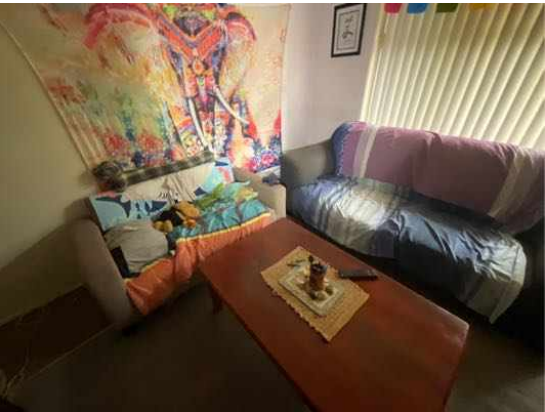
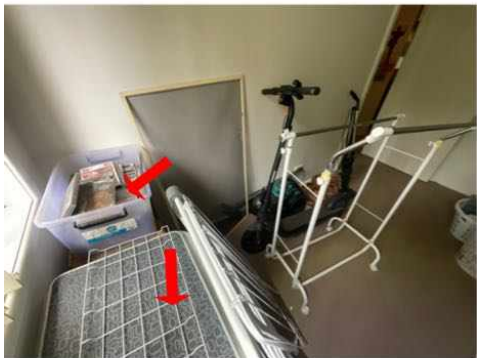
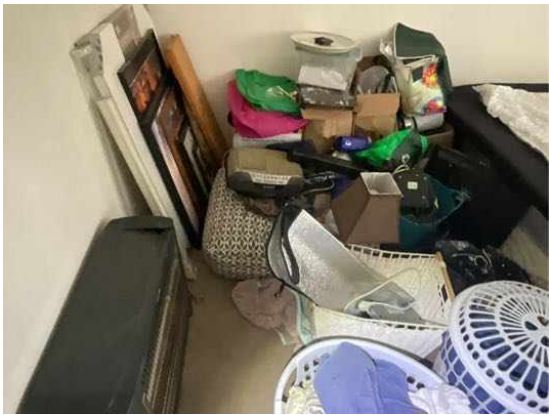
Building: Building 1
Location: All Internal Areas
Finding: Additional Photos - Obstructions and Limitations of INTERNAL AREAS
Information: These photographs are an indication of the obstructions and limitations which impeded full inspection of Internal areas at the time of inspection. These obstructions can hide an array of defects and should be removed to allow full inspection to be carried out. A re-inspection is recommended once the areas are made accessible.

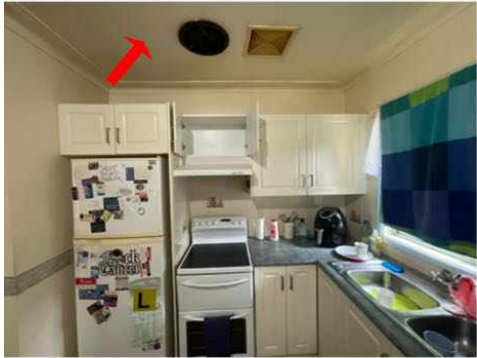
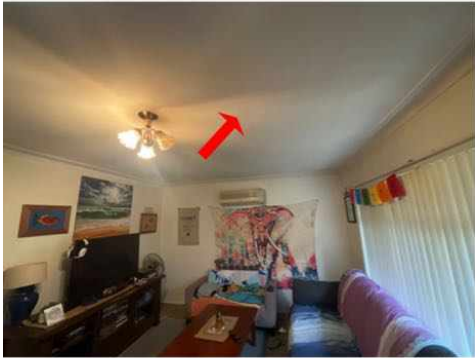
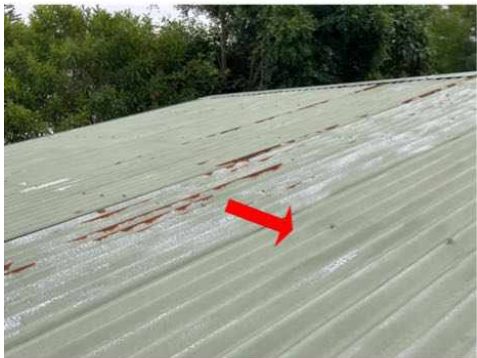
Building: Building 1
Location: All Roof cavity areas - No Access
Finding: Additional Photos - Obstructions and Limitations of the ROOF CAVITY
Information: These photographs are an indication of the obstructions and limitations which impeded full inspection of roof cavity areas at the time of inspection. These obstructions can hide an array of defects and should be removed to allow full inspection to be carried out if applicable. A re-inspection is recommended once the areas are made accessible.

The inspection was also limited to areas with an allowable crawl space of 600mm x 600mm, in particular towards the external walls where the roof line diminishes, these areas were not accessible.

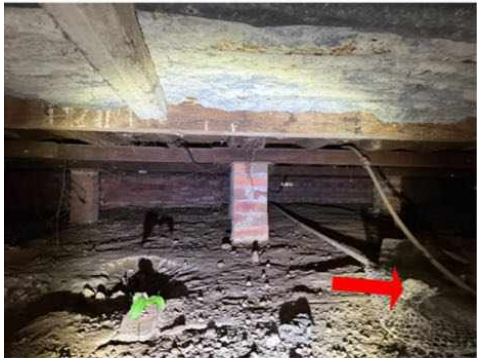
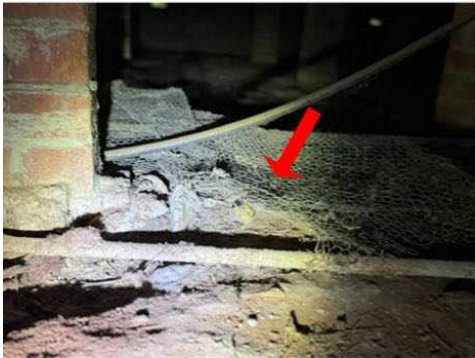
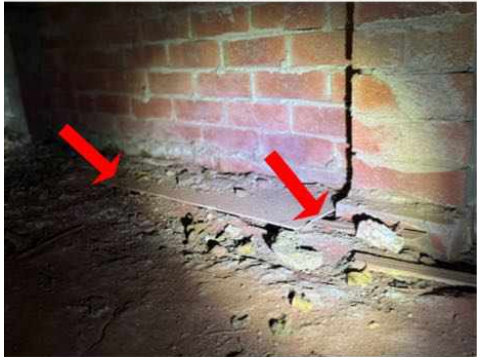
Building: Building 1
Location: All Subfloor Areas
Finding: Additional Photos - Obstructions and Limitations of SUBFLOOR AREAS
Information: These photographs are an indication of the obstructions and limitations which impeded full inspection of subfloor areas at the time of inspection. These obstructions can hide an array of defects and should be removed to allow full inspection to be carried out. A re-inspection is recommended once the areas are made accessible.
