# Building and Timber Pest Inspection Report

Inspection Date: Mon, 2 Mar 2026

Property Address: 68 Olive Hill Dr, Cobbitty NSW 2570,  
Australia

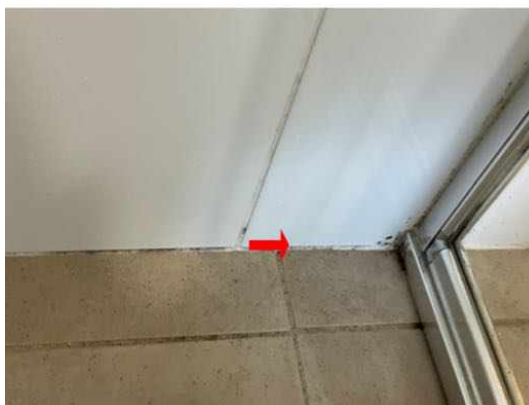
Building:	Main Building
Location:	Bathroom
Finding:	Sealant and grouting - Missing or damaged
Information:

It was noted on inspection that sealant or grout is degraded to this area.

Different materials and floor areas move at different rates, generally causing cracking to grout or sealant at this point. A flexible sealant is required to allow for expected expansion and contraction, while keeping the joint water tight and protective of all associated building materials.

Flexible and mould resistant materials should be applied to affected areas to prevent any subsequent water damage that is likely to occur. Regular maintenance and replacement of damage or missing or damaged sealant and grout is highly recommended to the wet areas, as this is a regular wear and tear defect. Sealant and grouting in areas that come into regular contact with water should be maintained for the long term care of your property.

A sealant specialist should be appointed to complete these works as soon as possible.

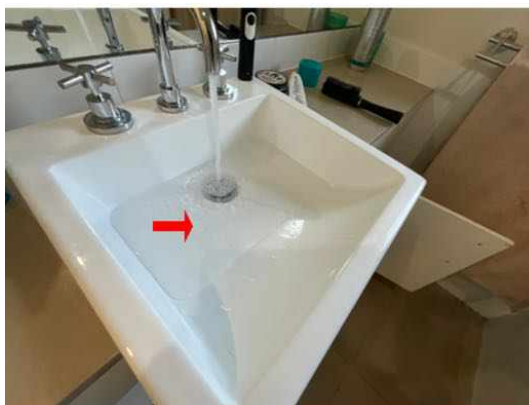
### Finding 3.04

Building: Main Building  
 Location: Ensuite, bathroom  
 Finding: Sink/basin - slow draining  
 Information:

The sink/basin drain appeared to be partially blocked at the time of inspection. Blockages here are usually caused by hair and other debris. If left unmanaged, a lack of general maintenance may lead to the development of more significant defects, such as water damage to surrounding building materials.

A licensed plumber should be appointed to remove the blockage at the client discretion.

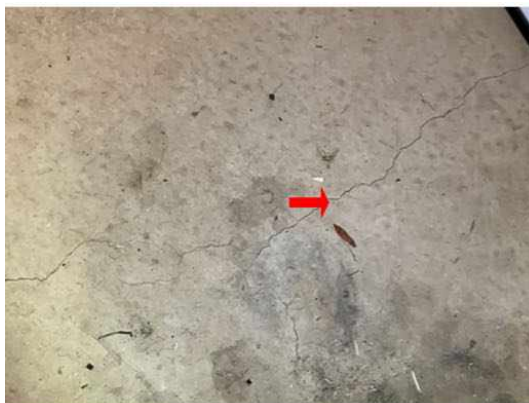
Building:	Main Building
Location:	Garage
Finding:	Crack in concrete slab - Category 1
Information:	A crack coded as Category 1 was identified in the slab. A Category 1 crack is described as a fine but noticeable crack, with the slab at an otherwise reasonable level.

To be considered Category 1, the approximate width of the crack is less than 1.0mm, or a less than 10mm change in offset when a 3m straight edge is placed over the defect.

Category 1 cracks should be monitored for a period of 12 months. At the end of the monitoring period, identified cracks that are rated greater than Category 2 are considered defects, and require rectification.

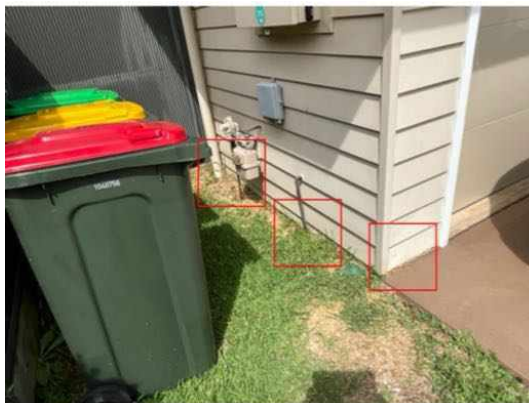
Generally this takes the form of finished ground levels external paving or concrete being retrospectively installed above the damp course level the adjacent internal floor level or weep and ventilation holes.

Where bridging has occurred full inspection is prevented and termites may enter a property in a concealed or undetectable manner.

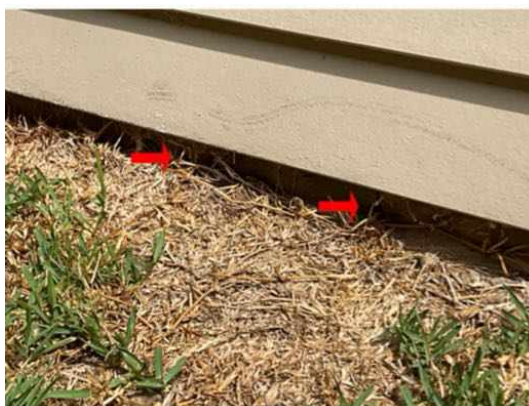
### Finding 6.03

Building: Main Building  
 Location: Exterior walls - right side  
 Finding: Bridging - Vegetation  
 Information: Where vegetation obstructs inspection of building elements, also known as bridging as it provides a bridging point for the access of termites, full inspection can not be achieved. Consequently moisture or dampness may be present and the areas becomes conducive to termite activity. Plants against or very close to buildings provide cover, shade and can provide an environment that is attractive to termite infestation.

The removal and replanting of species that do not provide "cover" or cutting back of existing vegetation will assist greatly in preventing Bridging from occurring.

The removal of any such materials that may be conducive to termite activity should be carried out as soon as possible and arrange re inspection to minimize the risk of termite attack.

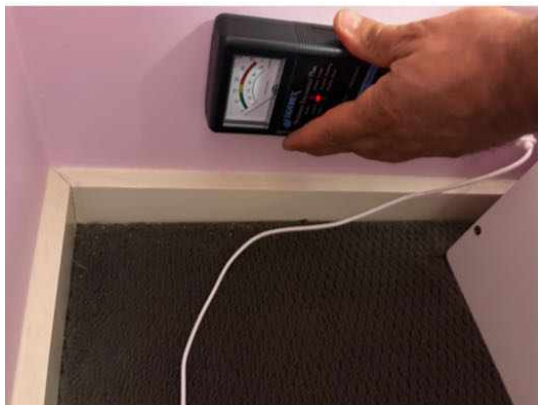
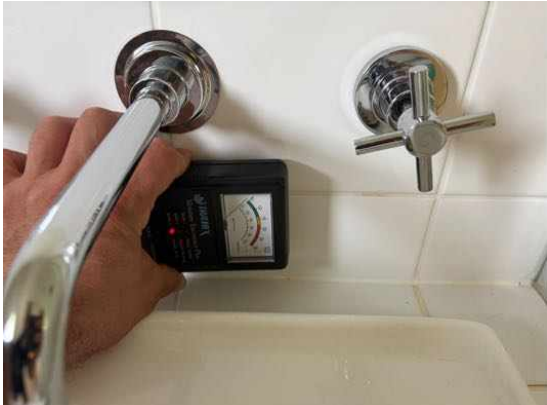
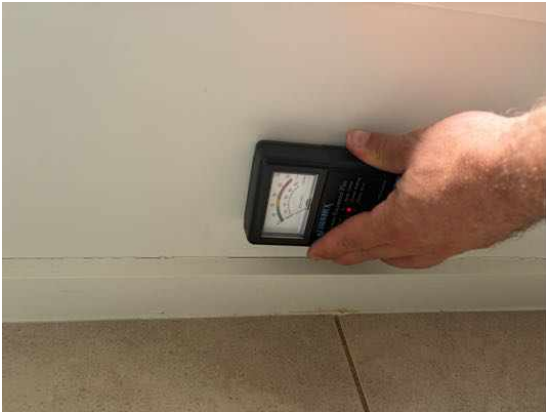
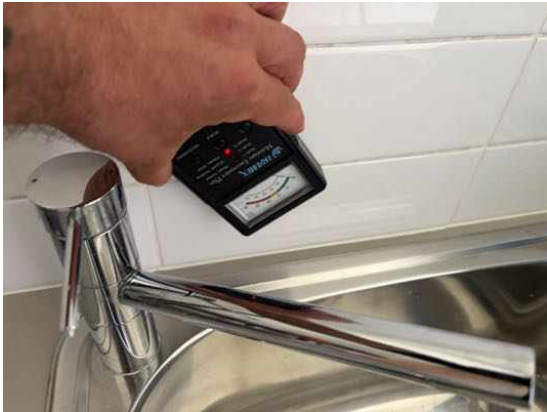
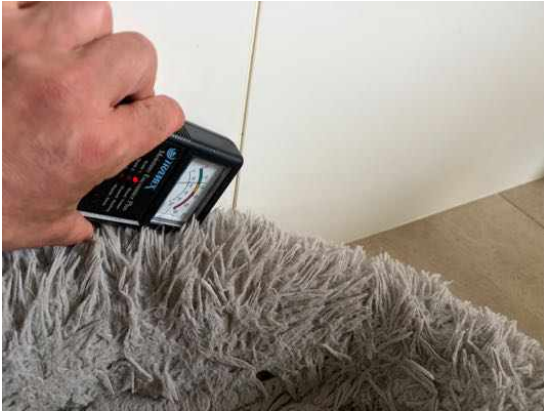
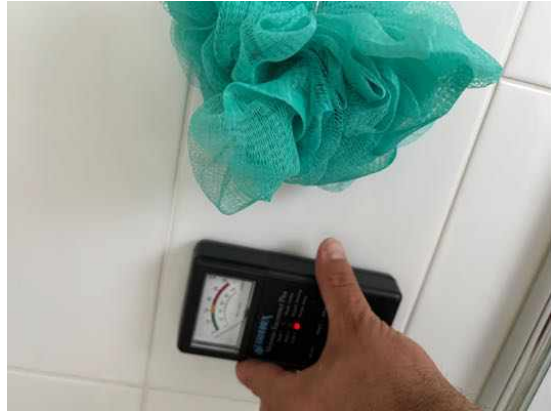
Building: Main Building  
Location: All Areas  
Finding: Moisture metre  
Information: During the inspection the property was checked for moisture using a moisture metre.

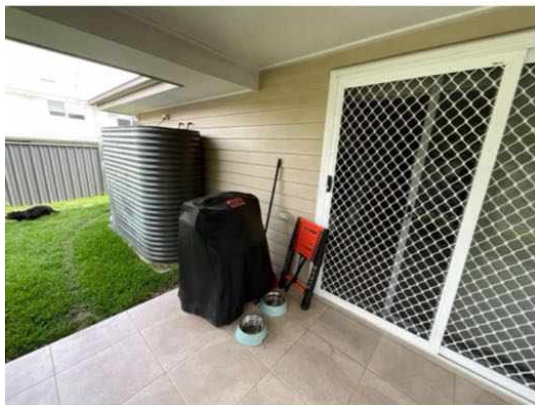
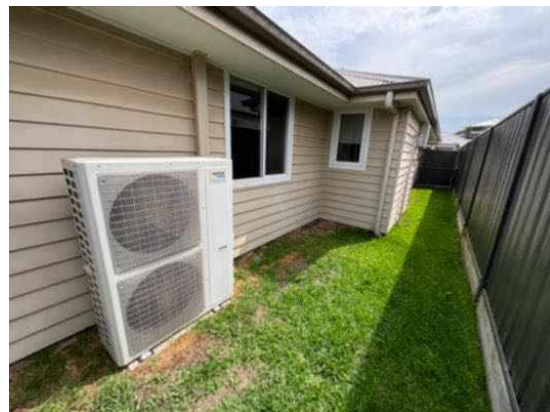
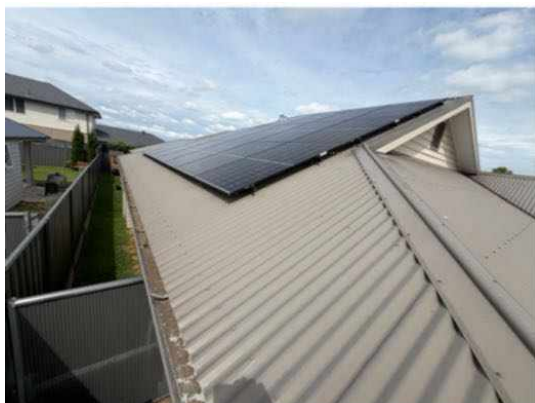
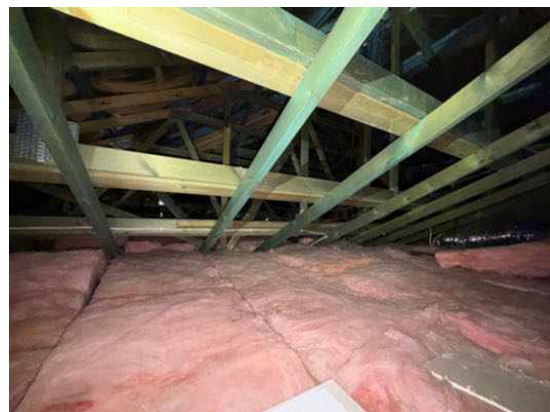
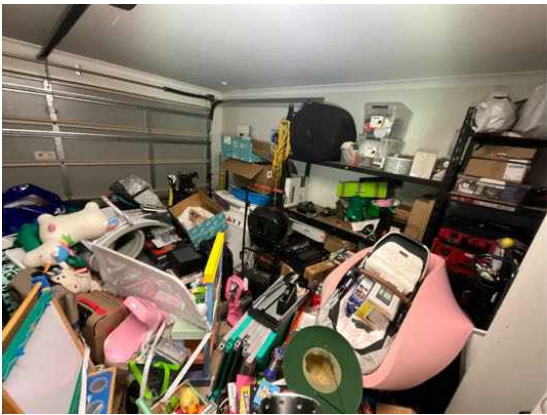
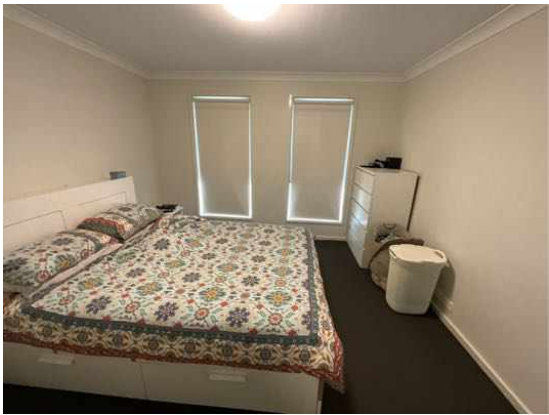
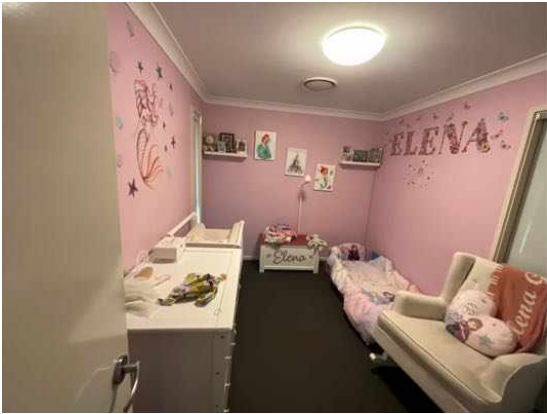
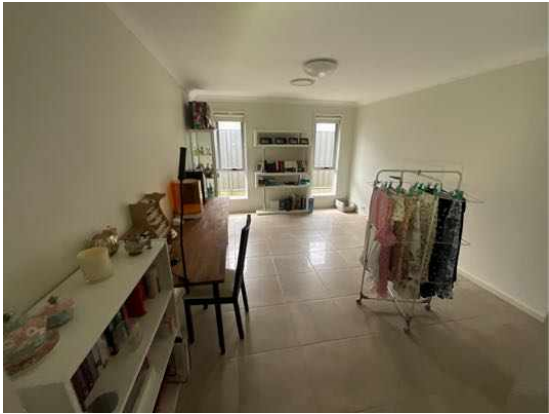
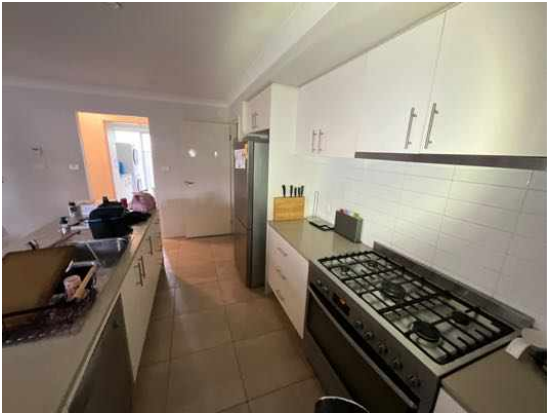
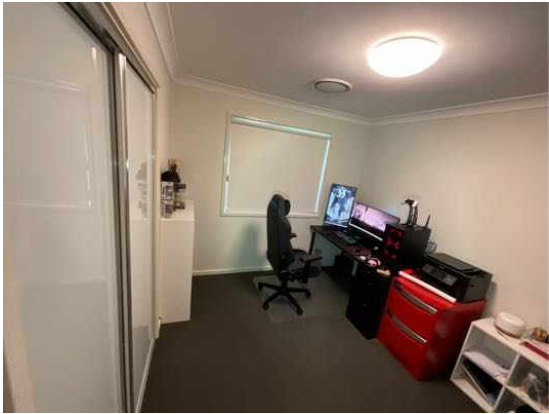
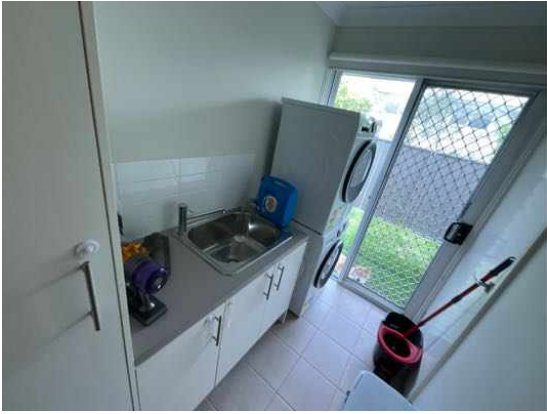
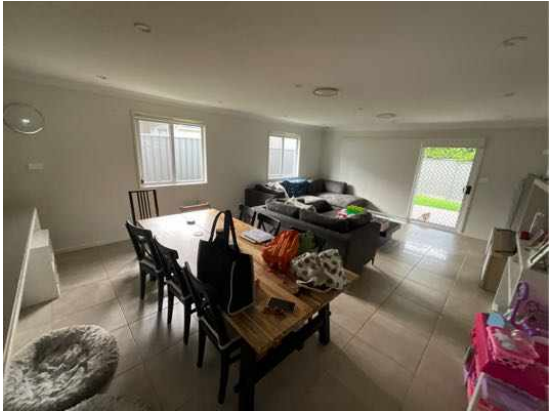
Building: Main Building  
Location: All Areas  
Finding: Additional Photos - Obstructions and Limitations  
Information:

These photographs are an indication of the obstructions and limitations which impeded full inspection of the property at the time of inspection. These obstructions can hide an array of defects and should be removed to allow full inspection to be carried out. A re-inspection is recommended once the areas are made accessible.

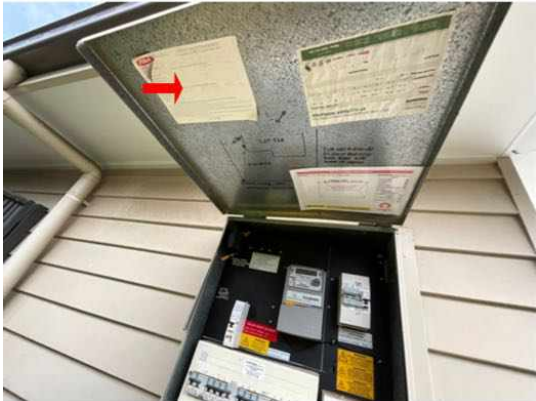
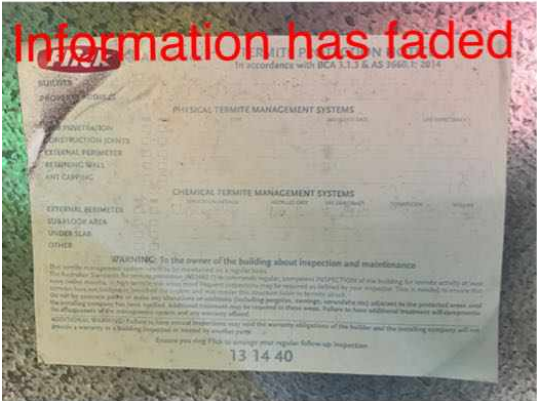
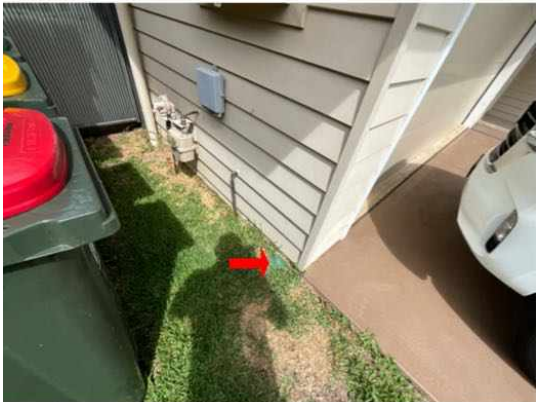
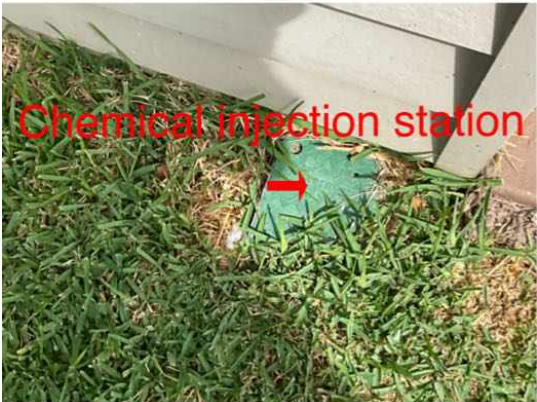
# The following items were noted as - Evidence of a previous termite management program

Where a Termite Management System has been identified you should refer to the type of barrier date of installation warranty conditions and any documentation provided by a builder or past owner. Consult the company who installed the barrier to confirm whether the system is still under warranty.

Most chemical termite management systems expire and require replenishment and all physical systems are primarily designed to prevent concealed entry.
