# Building and Timber Pest Inspection Report

Inspection Date: Fri, 20 Mar 2026

Property Address: 17 Black Knight Street Mordialloc, Vic

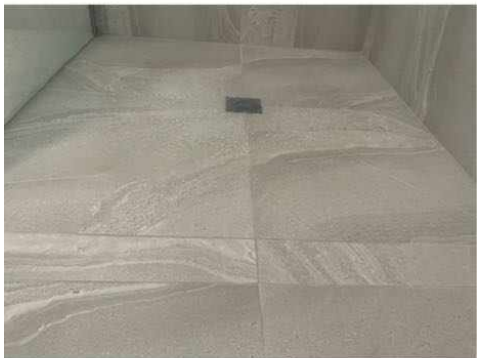
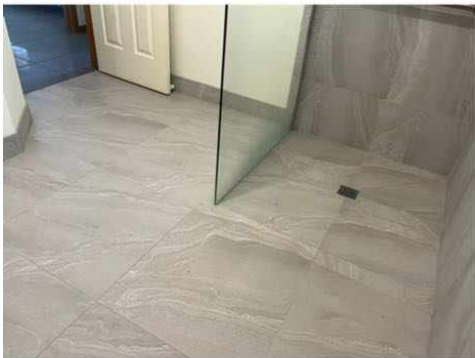
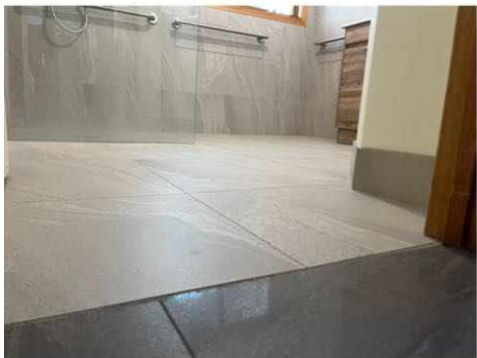
#### Noted Item

Building: Garage  
 Location: Bathroom  
 Finding: Additional Photos  
 Information: Additional photos are provided for your general reference
