Building and Timber Pest Inspection Report

Inspection Date: Wed, 25 Feb 2026

Property Address: 127 O'connell Street, Caddens NSW 2747

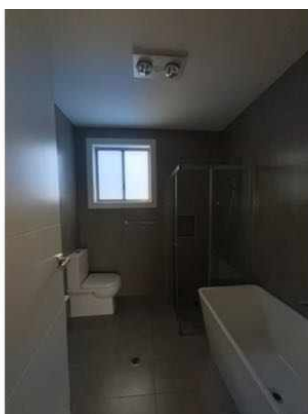
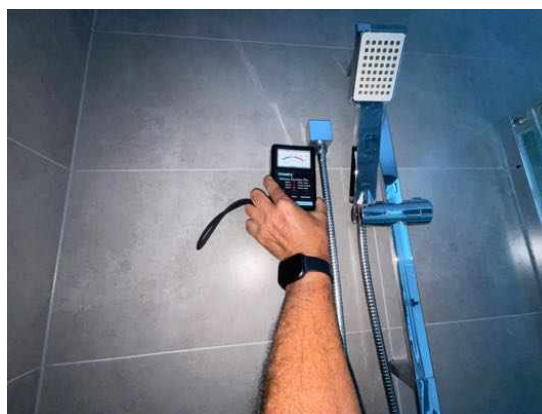
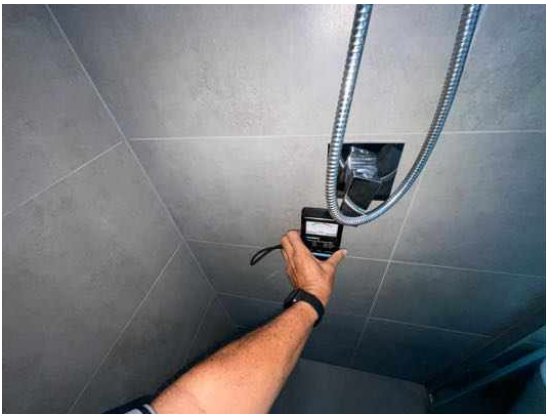
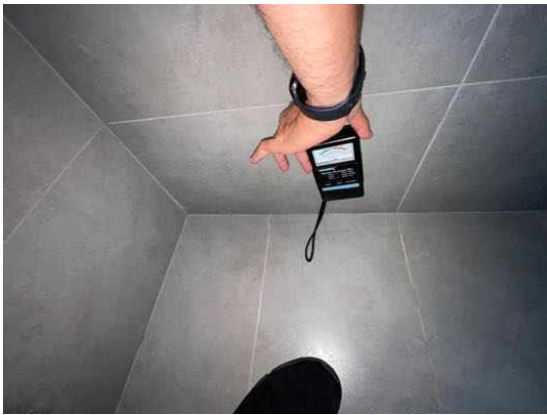
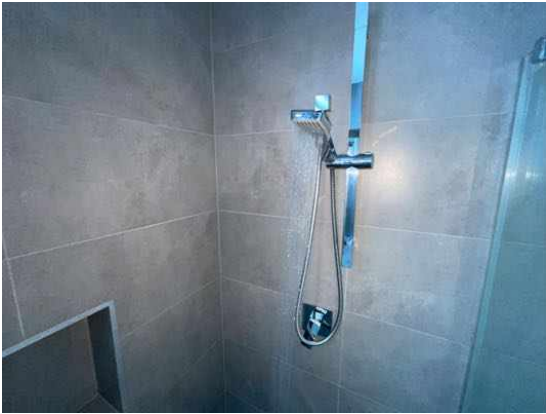
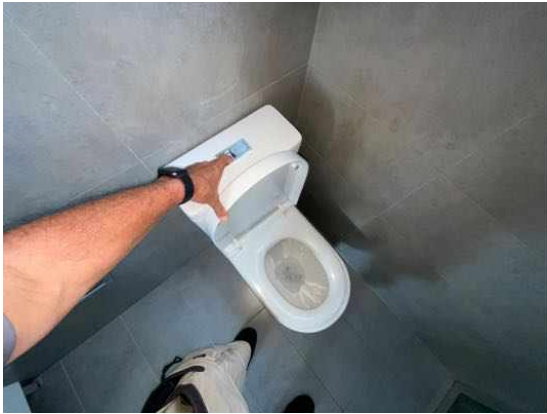
Building: Main Building
 Location: Bathroom
 Finding: Wet Areas - Bathroom(s) - Overall Condition & Recommendations.
 Information: Overall Condition & Recommendations

It is not possible under the visual inspection criteria of a standard pre-purchase report to categorically determine if leaks are present. If a more detailed or accurate assessment is required, a special-purpose inspection should be undertaken.

Alternatively, the assumption should be made that leakage may occur, particularly where historical or environmental conditions are conducive. The visual nature of this inspection cannot detect issues concealed behind wall/floor linings or cabinetry, and invasive investigation may be necessary to confirm the true condition of adjacent or hidden structures.

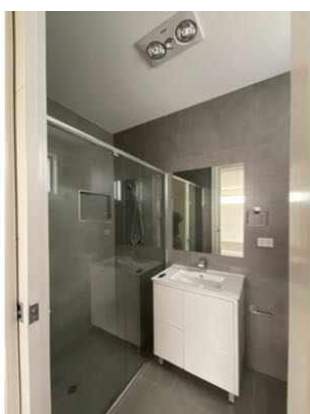
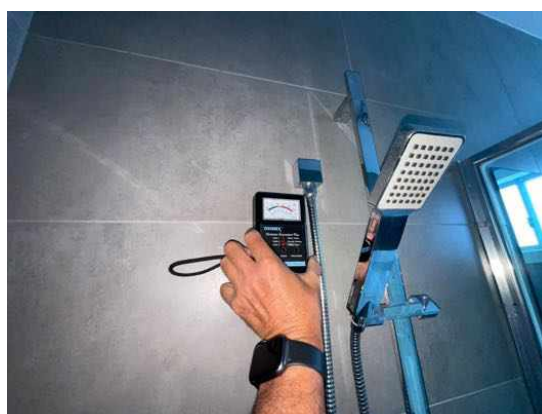
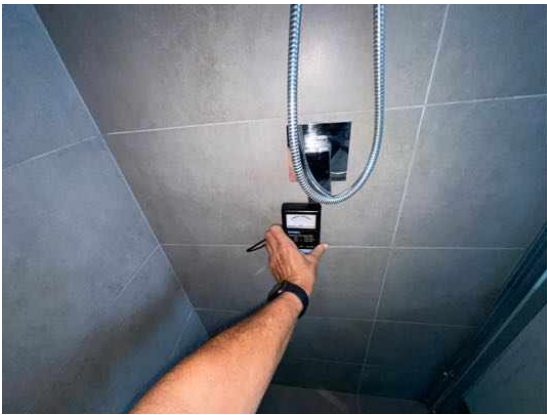
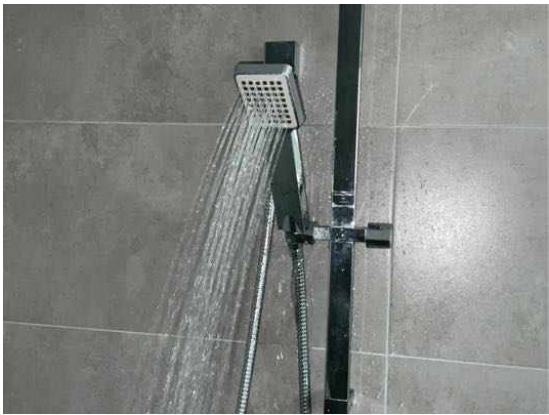
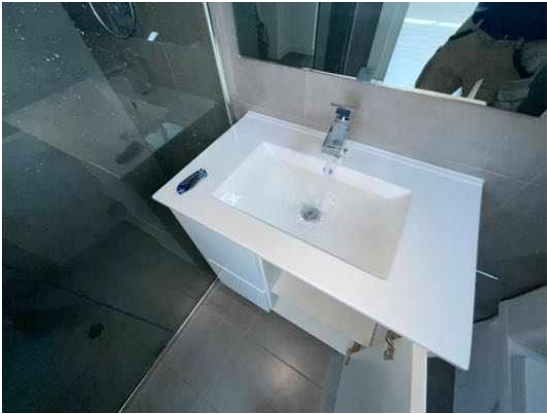
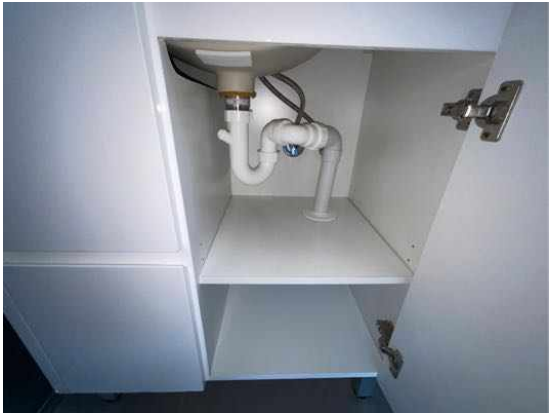
Building: Main Building
 Location: Ensuite
 Finding: Wet Areas - Bathroom(s) - Overall Condition & Recommendations.
 Information: Overall Condition & Recommendations

It is not possible under the visual inspection criteria of a standard pre-purchase report to categorically determine if leaks are present. If a more detailed or accurate assessment is required, a special-purpose inspection should be undertaken.

Alternatively, the assumption should be made that leakage may occur, particularly where historical or environmental conditions are conducive. The visual nature of this inspection cannot detect issues concealed behind wall/floor linings or cabinetry, and invasive investigation may be necessary to confirm the true condition of adjacent or hidden structures.

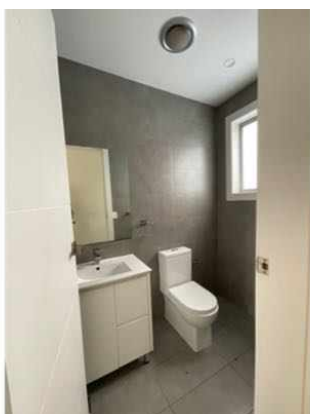
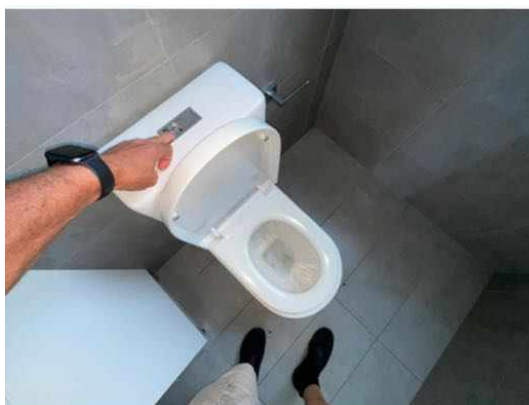
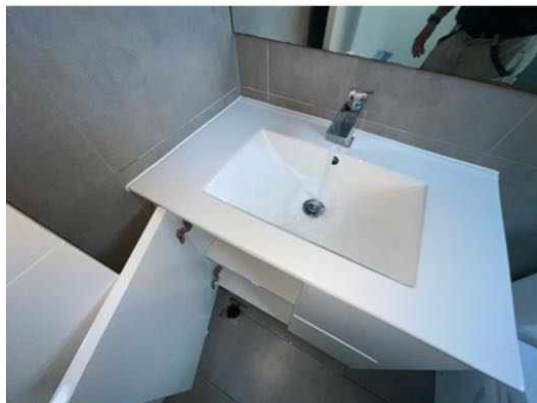
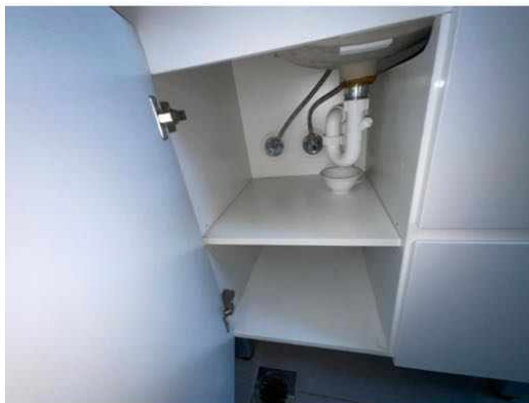
Building: Main Building
Location: Toilet (WC)
Finding: Overall Condition: Toilet & Basin.
Information: TOILET & BASIN ASSESSMENT

- Sealant around the basin and wall junctions appeared to be in serviceable condition
- Regular maintenance of sealant and grouting in wet areas is essential to prolong the life of surrounding materials and reduce the risk of water damage.

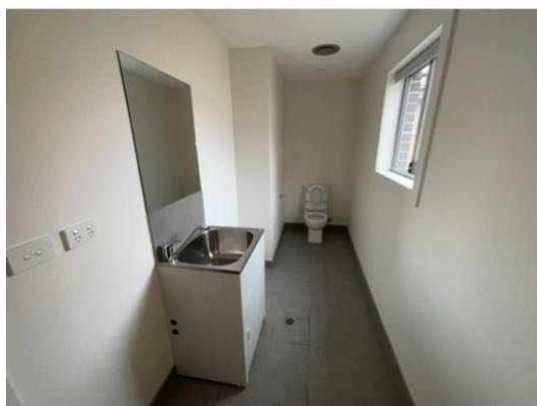
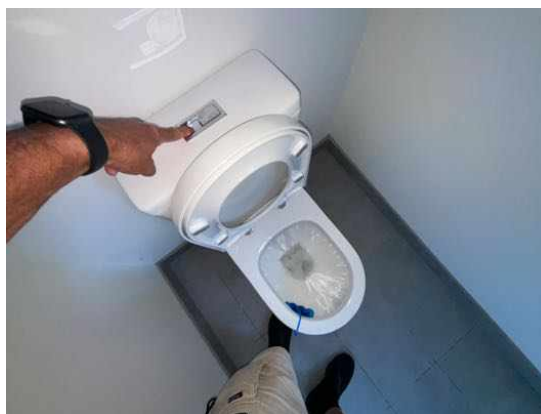
Building: Garage
 Location: Laundry
 Finding: Overall Condition: Toilet.
 Information: TOILET ASSESSMENT

Toilet:

- No leaks were observed during the flushing process.
- The toilet operated normally with no signs of malfunction or abnormal water flow.
- The toilet pan was securely fixed to the floor at the time of inspection.
