Building and Timber Pest Inspection Report

Inspection Date: Wed, 28 Jan 2026

Property Address: 2/22 Stevens St, Sunshine Beach QLD 4567,
Australia

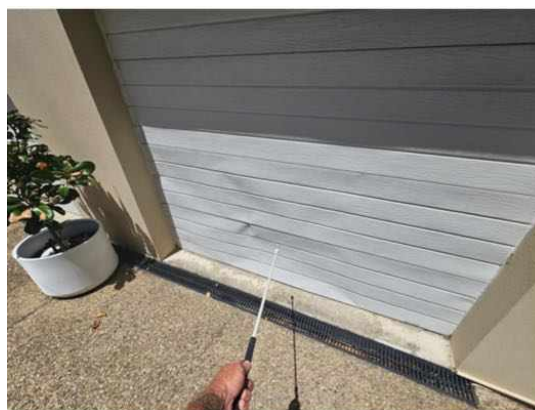
Finding 3.01

Building:	Main Building
Location:	Garage
Finding:	Garage door - dent
Information:	On the day of inspection the garage door panel at the lower left of the door was noted as being dented. The door could not operated on the day of inspection.

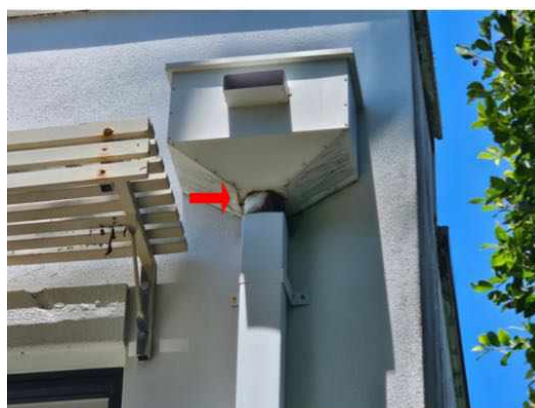
Finding 3.02

Building:	Main Building
Location:	Front elevation
Finding:	Downpipe dropper - rusting
Information:	On the day of inspection it was noted that the downpipe dropper / outlet of the front rain head was rusting.

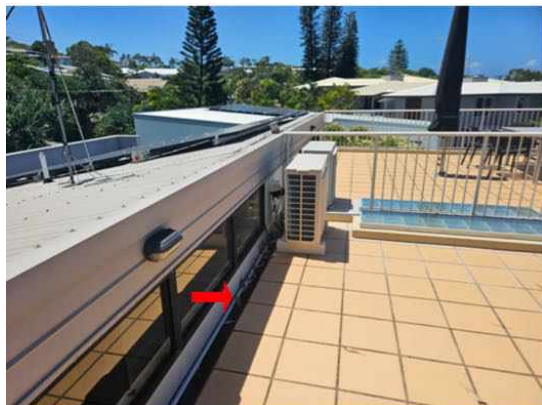
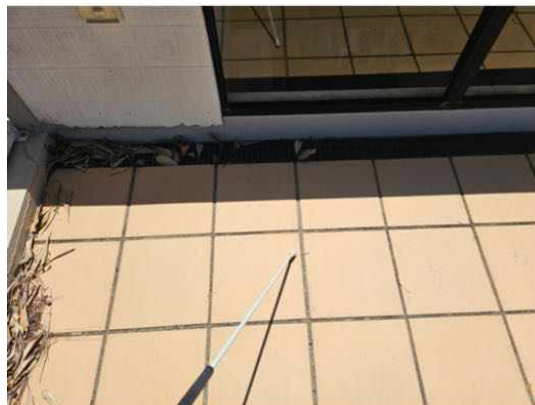
Finding 3.03

Building:	Main Building
Location:	Roof top terrace
Finding:	Tiles drummy - Category 1
Information:	Drummy tiles were identified in the roof top terrace at the time of inspection. These would be categorised as a category 1 type, meaning the tile is hollow underneath showing the adhesive has delaminated ; however the tile is not moving and the grout is intact. Please see the attached photos for locations.

The term 'drummy' refers to tiles that have become detached from their fixing, despite otherwise being in relatively good condition. Such defects are generally caused by physical or moisture damage to the area. Drummy tiled areas may also be a direct result of poor workmanship during the construction process.

Tiled areas may swell and shrink with changes in air humidity if the area has sustained moisture damage. Any exposure to moisture is capable of causing tiled areas to become drummy and/or cracked over a prolonged period of time. Drummy tiled areas generally require removal and replacement of affected tiles.

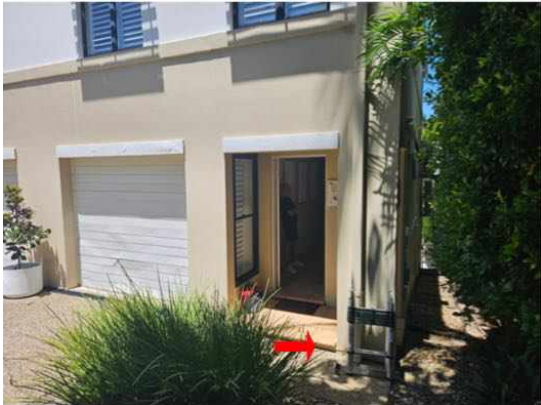
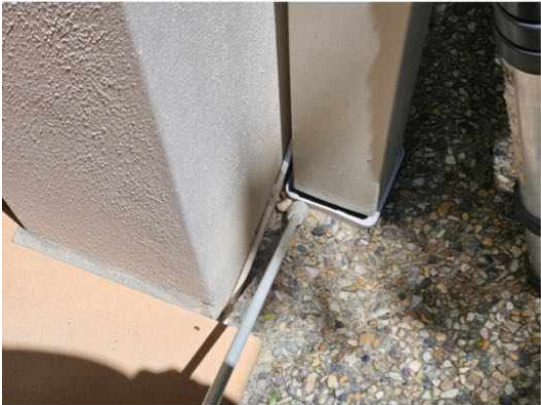
Finding 3.04

Building:	Main Building
Location:	Front elevation
Finding:	Downpipe - Connection broken
Information:	The downpipe at the front corner of the townhouse shows evidence of breakage and is not connected to the stormwater system adequately.

This leads to excessive moisture in the areas around the pipes and against the foundations of the house. This can lead to conducive conditions for timber pests and vermin infestation and have adverse effects on the foundations and external brickwork.

A licensed plumber may be appointed to repair the downpipe connections.

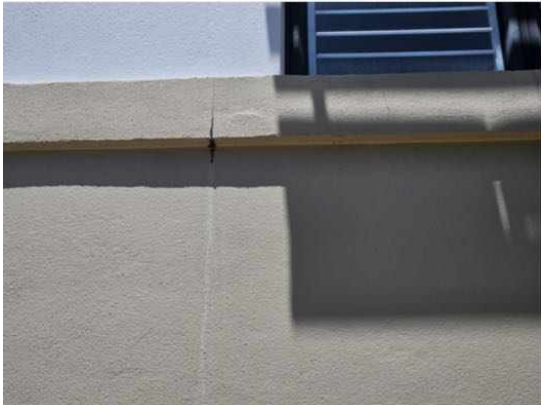
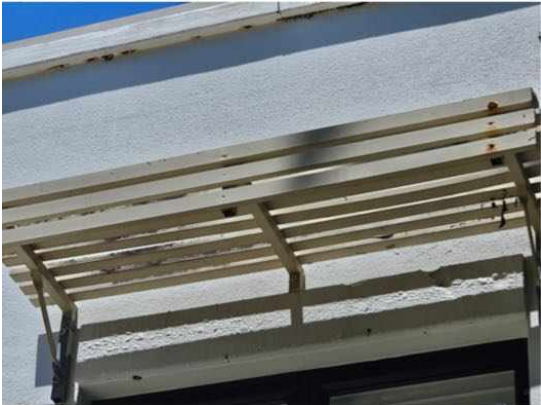
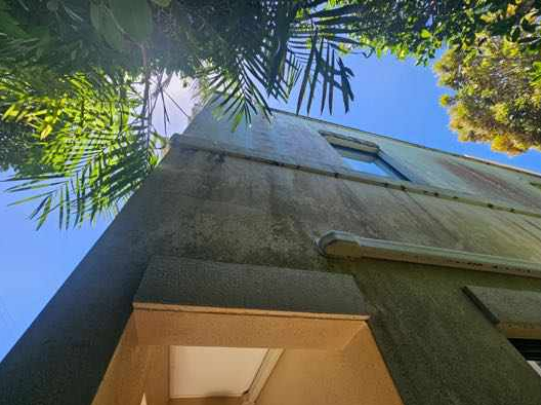
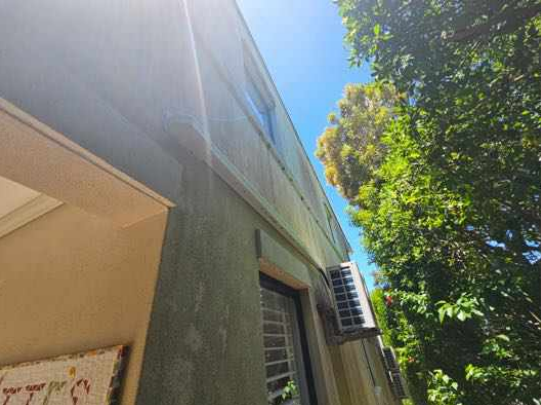
Finding 3.05

Building: Main Building
Location: All External Areas
Finding: External painting deteriorated
Information: The external paintwork in the areas shown requires attention to prepare and re-paint.

A painting contractor could be appointed to perform necessary works to aid the appearance of the affected area and to ensure the area is protected against further deterioration.

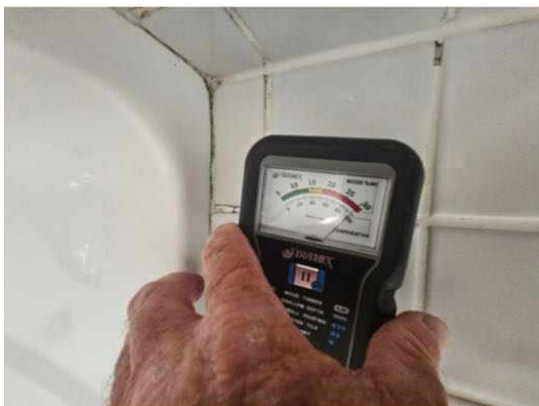
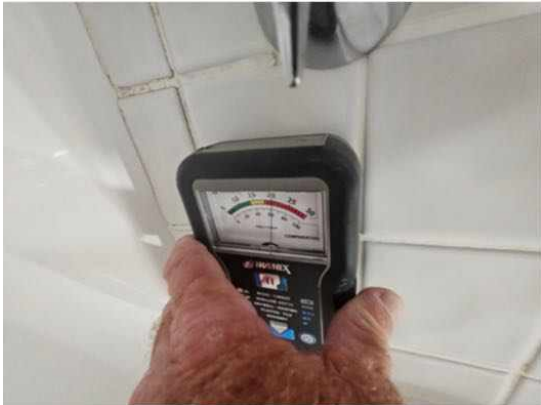
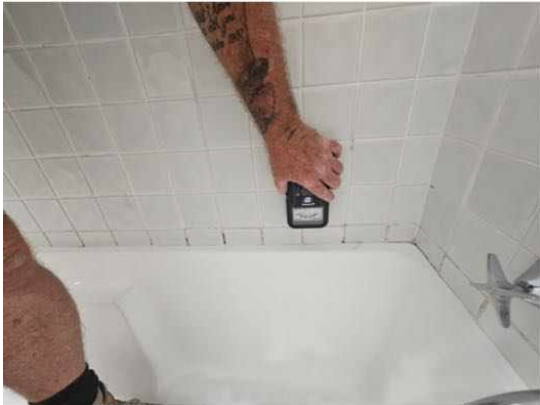
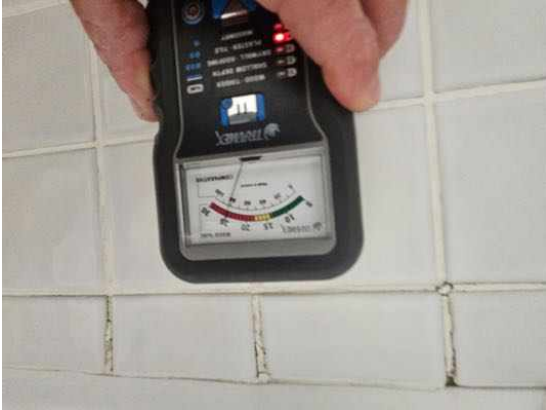
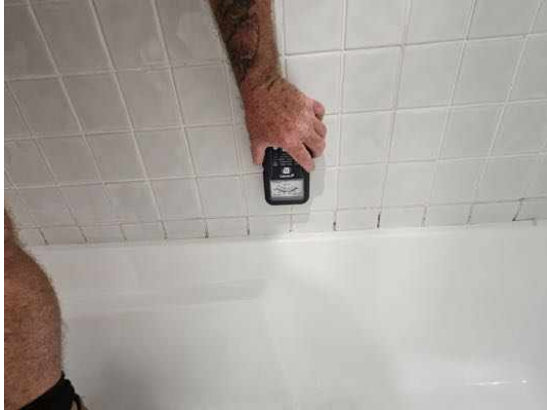
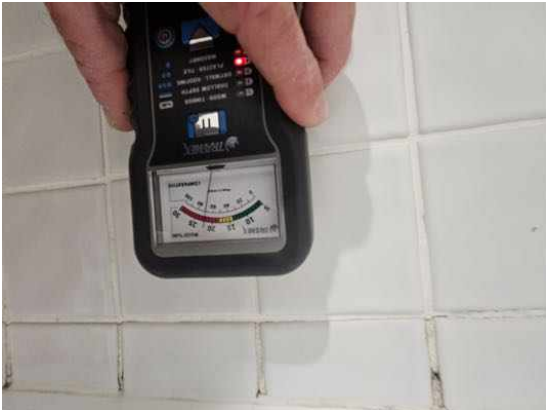
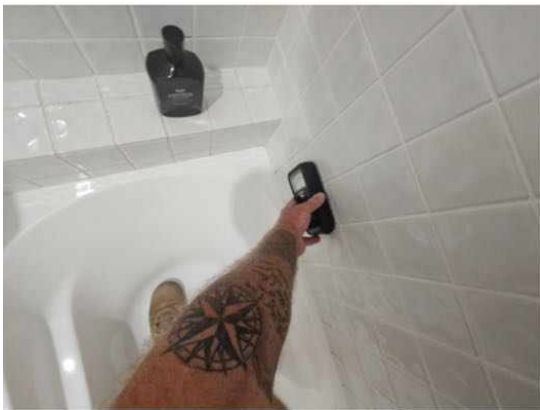
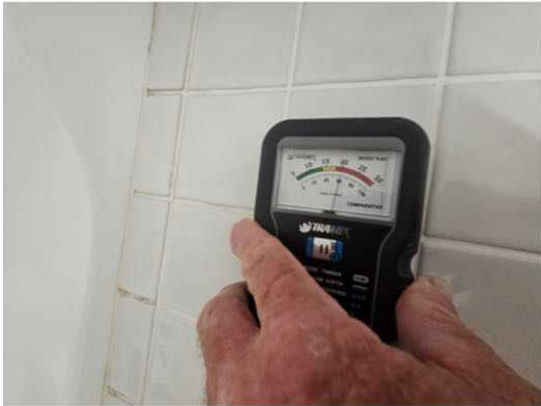
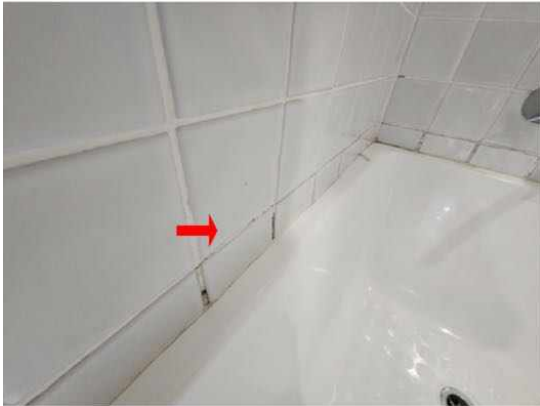
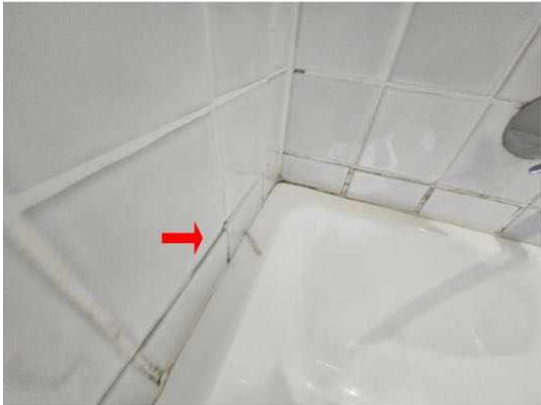
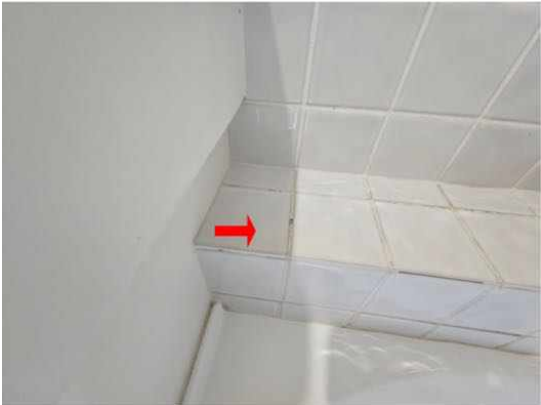
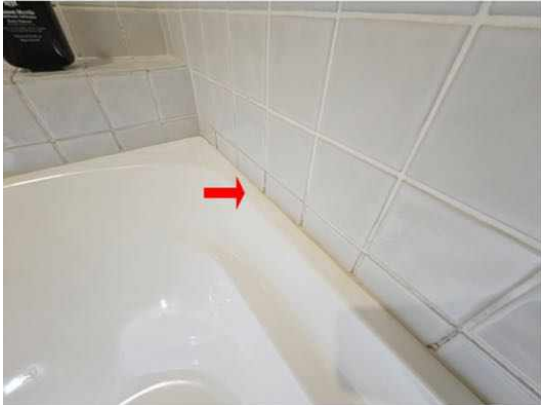
Finding 3.06

Building: Main Building
Location: Bathroom 2
Finding: Elevated moisture present at the time of inspection - bathroom 2
Information: Elevated moisture was noted in the lower tiled wall surfaces of the second bathroom shower.

This appears to be due to deteriorated grout and silicone sealants in the bottom two rows of tiles. These can break down over time and become porous, allowing moisture to enter the wall sheet surface behind the tiles.

Elevated moisture can attract timber pests and vermin, and produce conditions that promote timber pest attack, fungal growth and wood decay.

It is recommended that the grout and silicone could be renewed to possibly eliminate any further moisture penetration.

A licensed tiler and / or sealant specialist could be engaged to renew these elements.

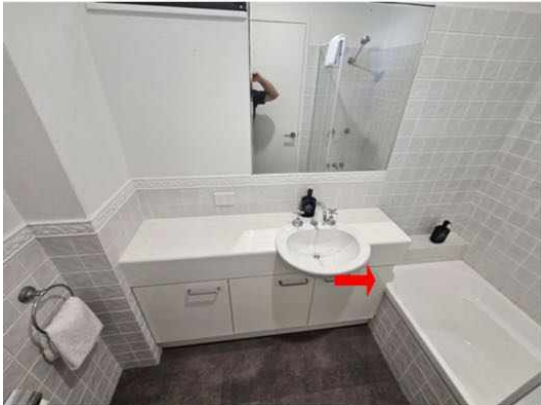
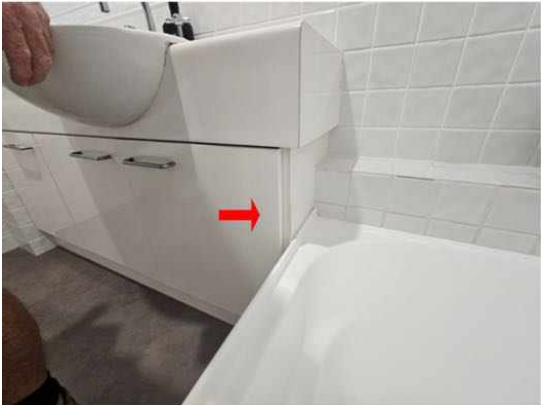
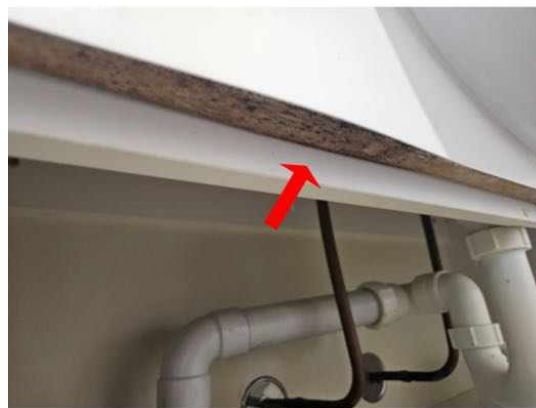
Finding 3.07

Building: Main Building
Location: Bathrooms
Finding: Bathroom cabinetry
Information: Whilst inspecting the bathrooms, minor moisture damage was noted in the vanities.

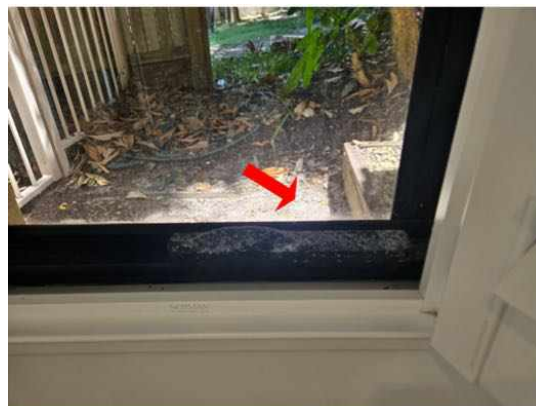
Finding 3.08

Building:	Main Building
Location:	Bedroom, ground floor
Finding:	Window lock - degraded
Information:	On the day of inspection the bedroom awning window latch mechanism was noted as corroded. This may require replacement by a suitably qualified technician in the short term.

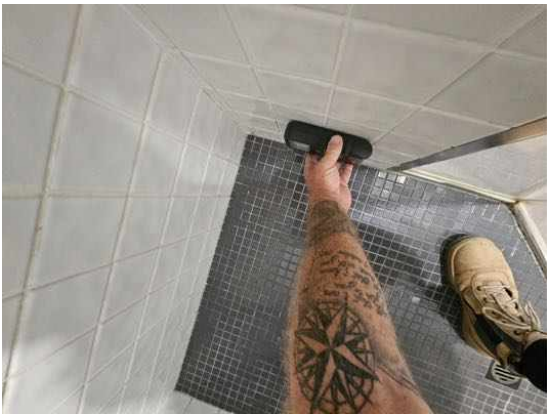
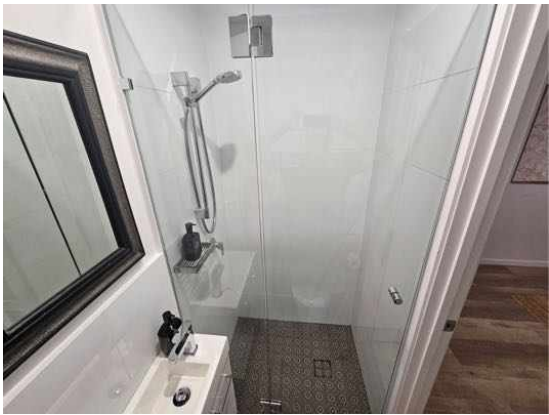
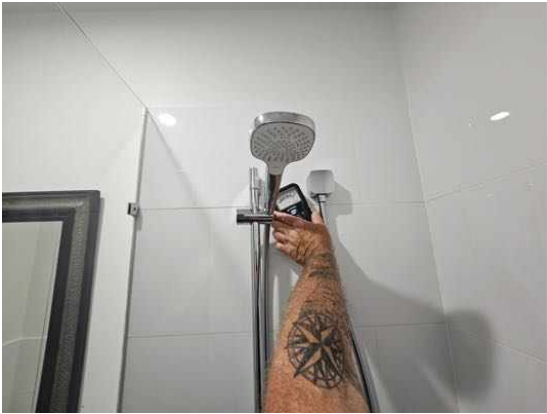
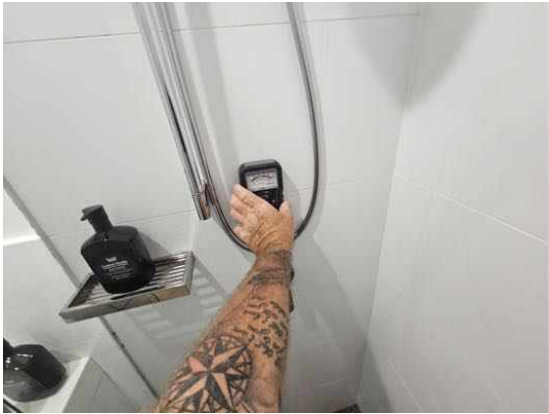
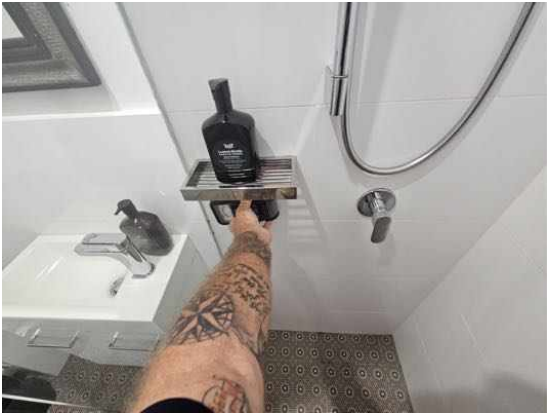
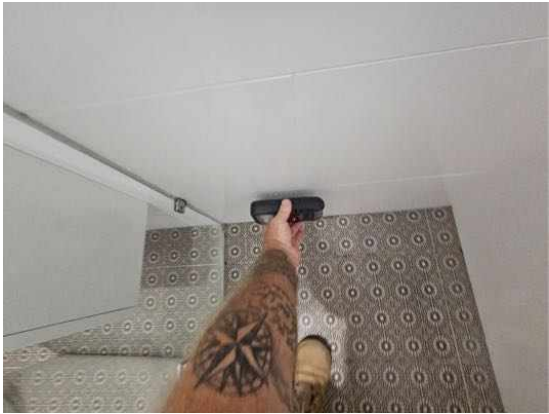
Building: Main Building
Location: Bathroom1, ensuite
Finding: No moisture detected in bathroom 1 / ensuite
Information: On the day of inspection the showers in the bathroom and ensuite are measure for moisture using a "Tramex" moisture meter. During this inspection no moisture was detected in these areas and the tiled / sheeted surfaces appear to be in good order.

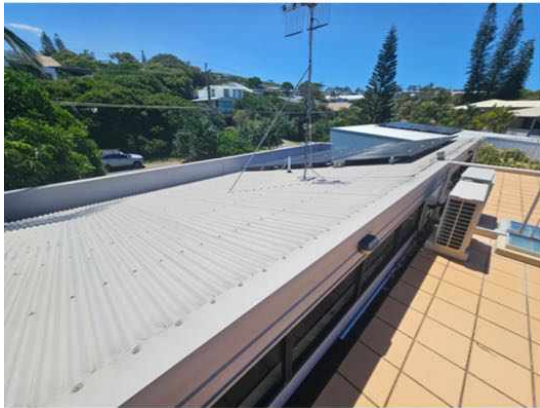
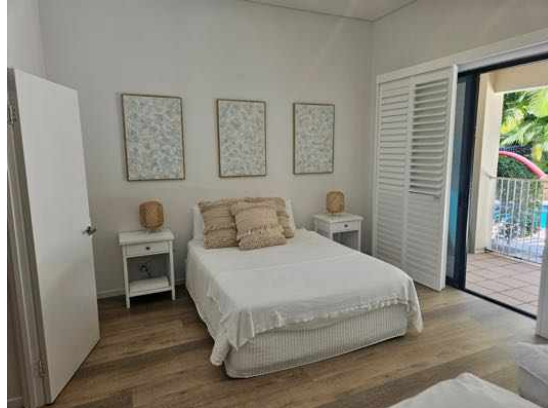
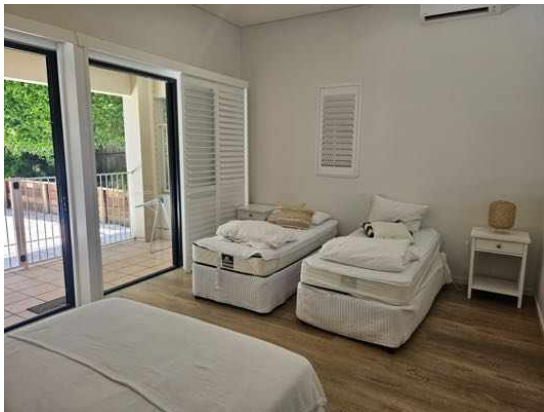
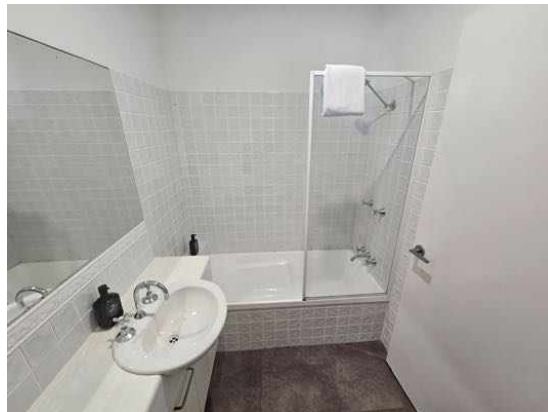
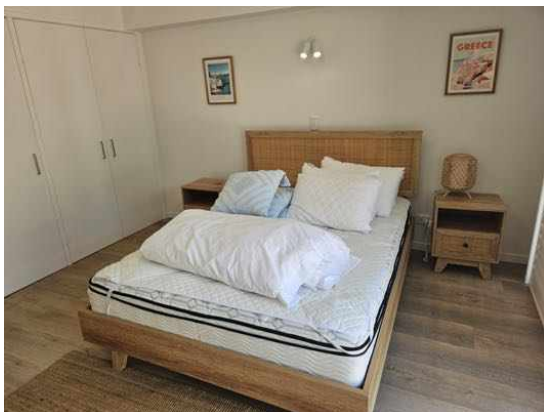
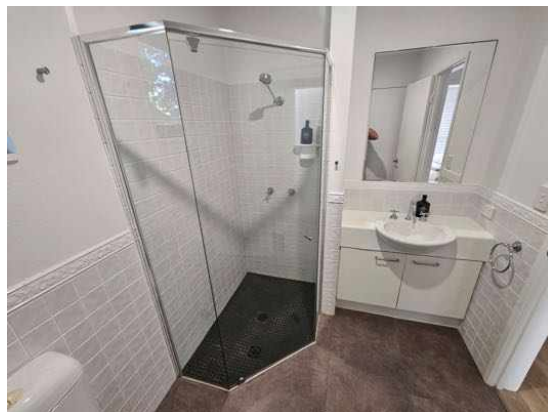
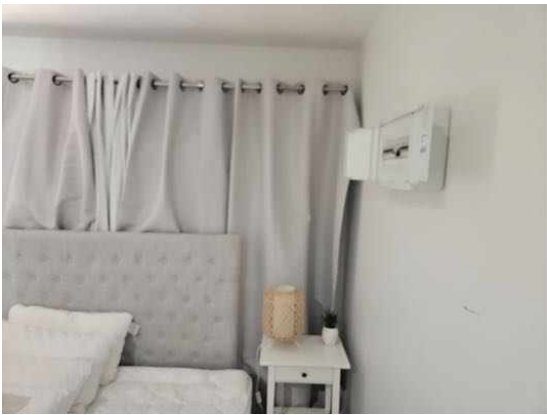
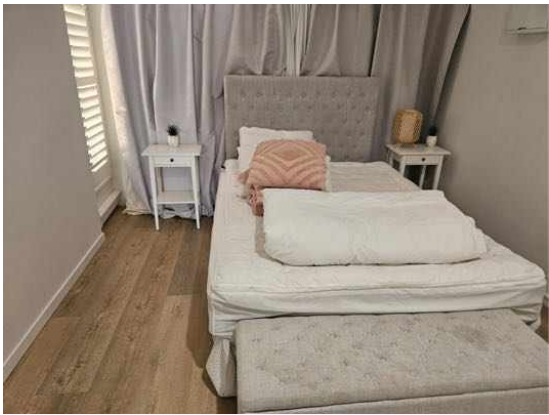
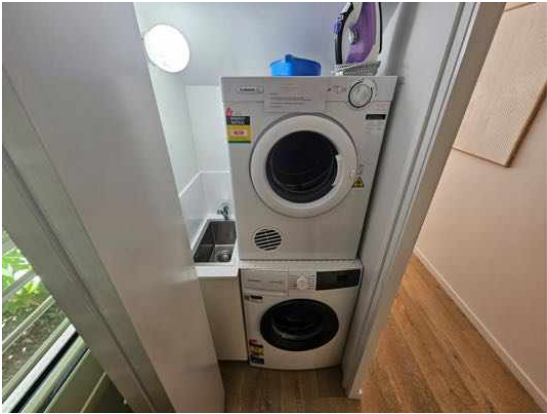
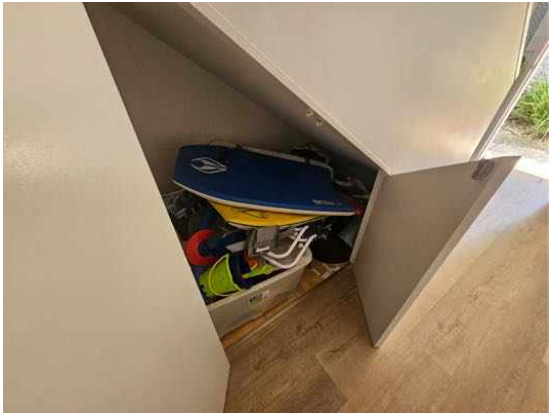
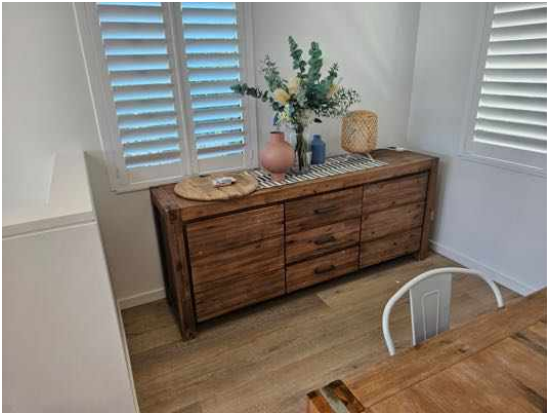
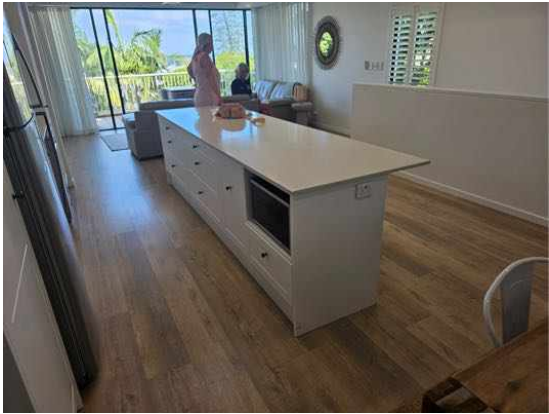
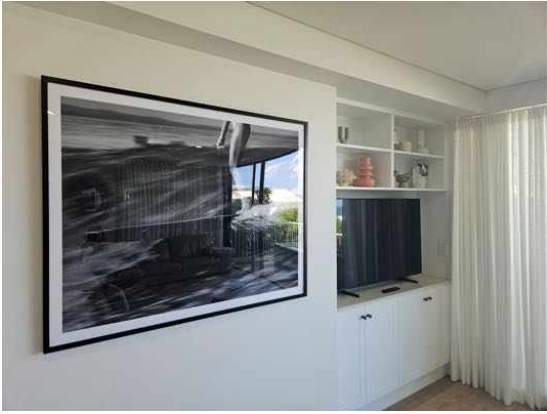
Building: Main Building
Location: All Areas
Finding: Additional Photos - Obstructions and Limitations
Information: These photographs are an indication of the obstructions and limitations which impeded full inspection of the property at the time of inspection. These obstructions can hide an array of defects and should be removed to allow full inspection to be carried out. A re-inspection is recommended once the areas are made accessible.

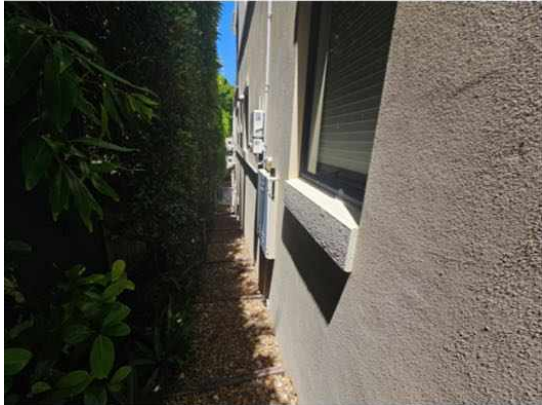
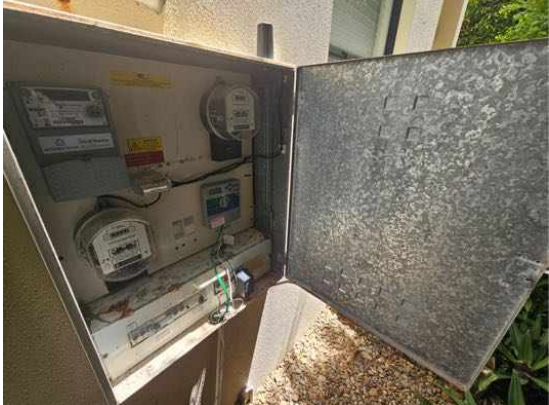
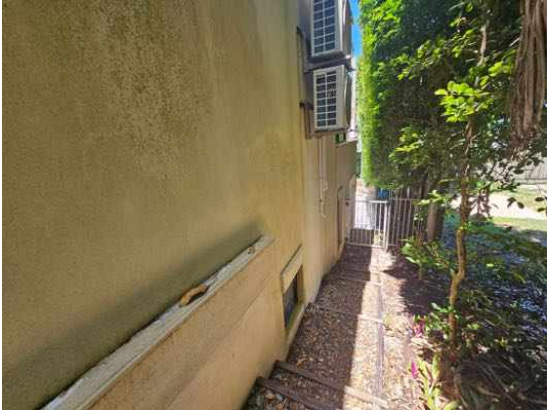
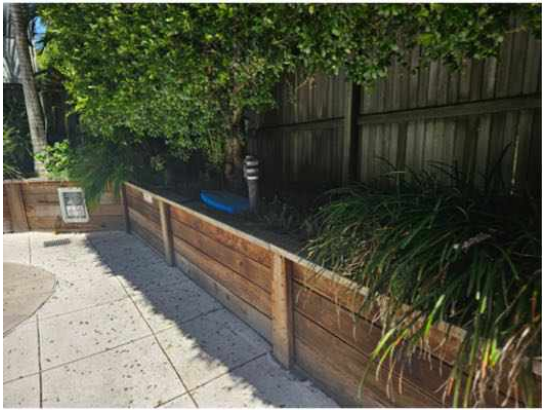
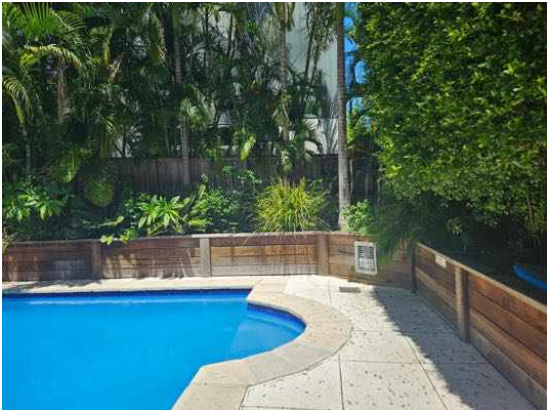
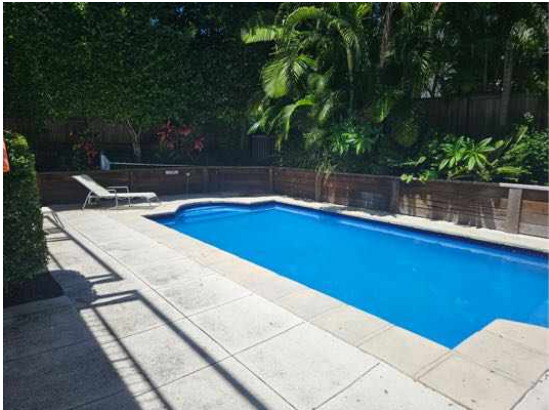
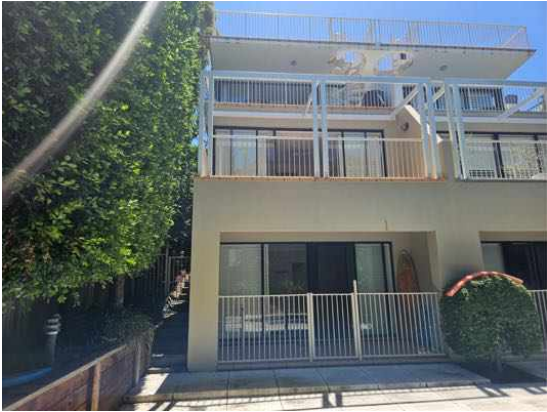
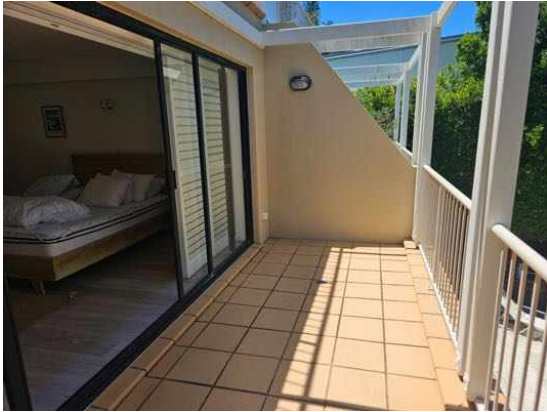
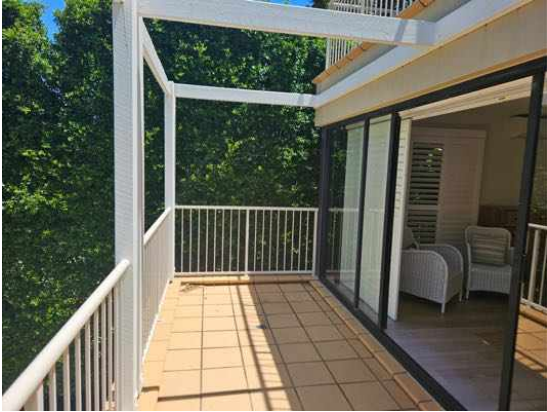
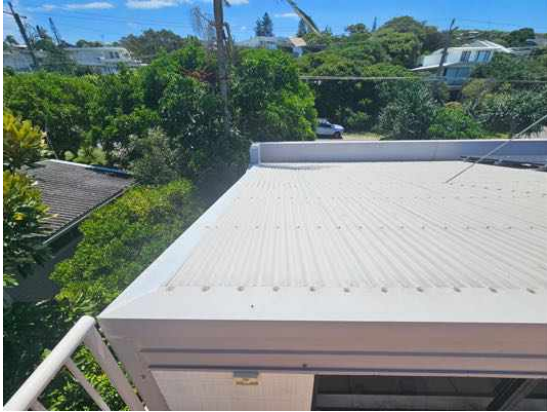
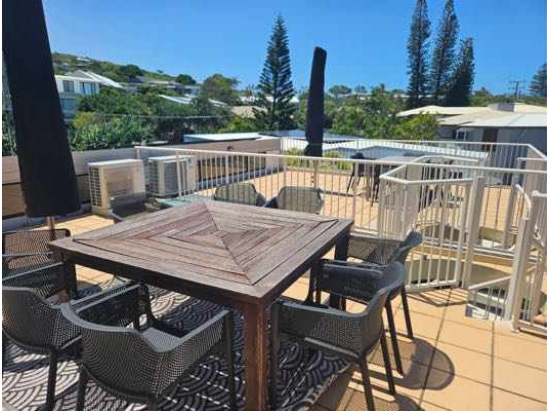
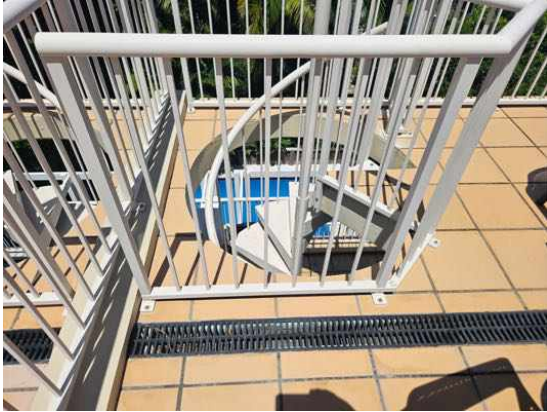
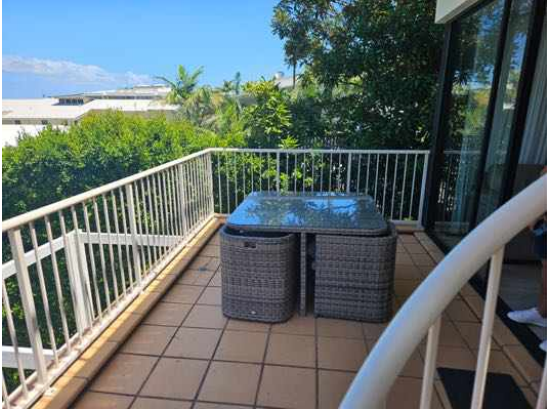
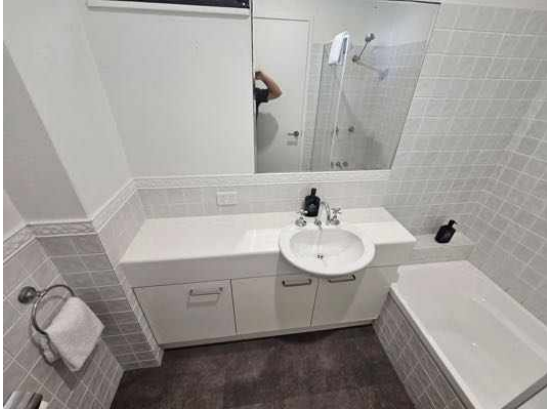
Building: Main Building
Location: All Areas
Finding: Additional Photos for client reference
Information: Additional photos are provided for your general reference.
