Building and Timber Pest Inspection Report

Inspection Date: Thu, 2 Apr 2026

Property Address: 13-10 Mickleham Dr, Cranbourne North VIC
3977, Australia

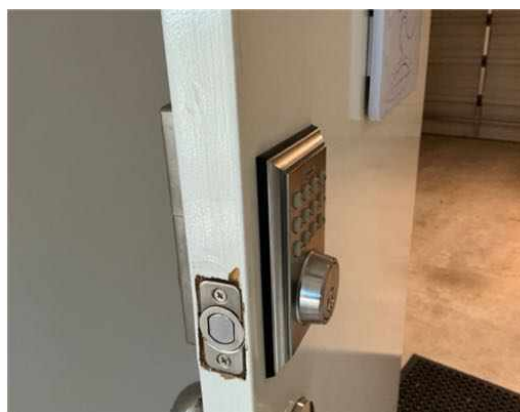
Finding 3.06

Building:	Main Building
Location:	Garage
Finding:	Door lock requires adjustment
Information:	The garage door lock is stiff to operate and requires adjustment to make it operate properly. This can happen overtime with deterioration or lack of maintenance. Recommend engaging a carpenter to repair/maintain at the owners discretion.
