Building Inspection Report

Inspection Date: Thu, 19 Mar 2026

Property Address: Unit 1/16 Starling St, MONTMORENCY,
VIC, 3094, Australia

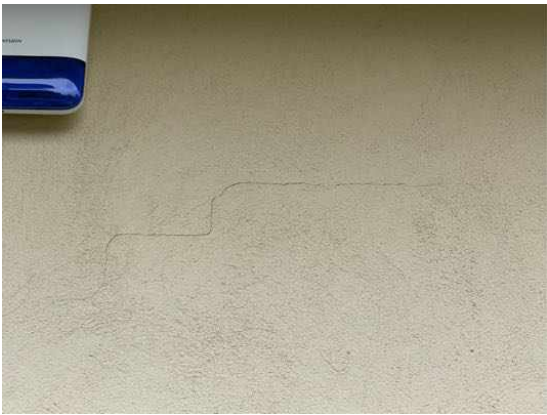
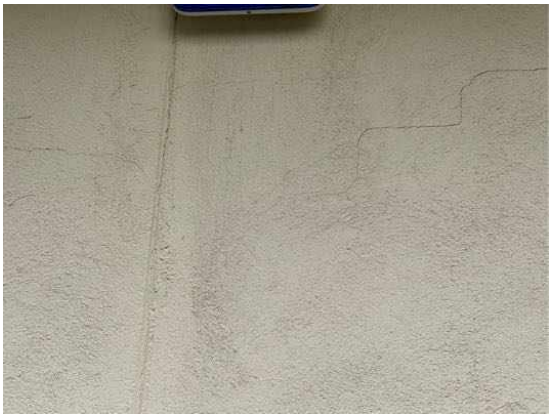
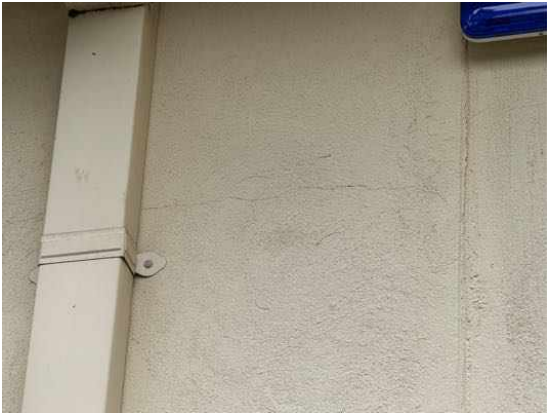
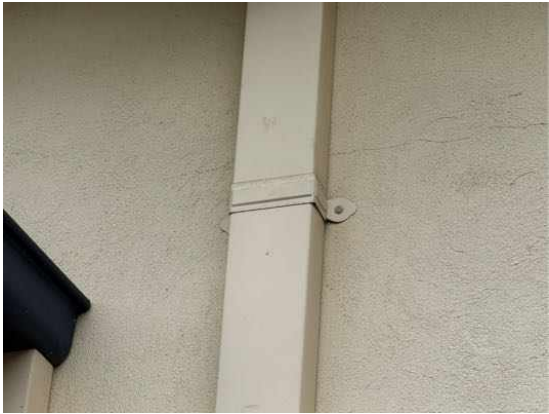
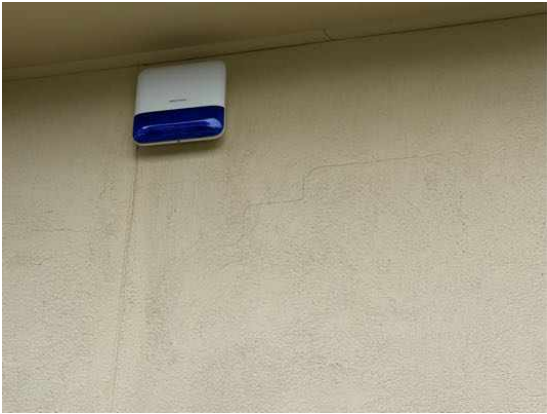
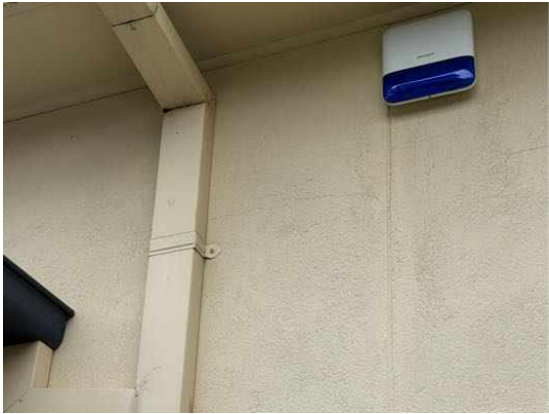
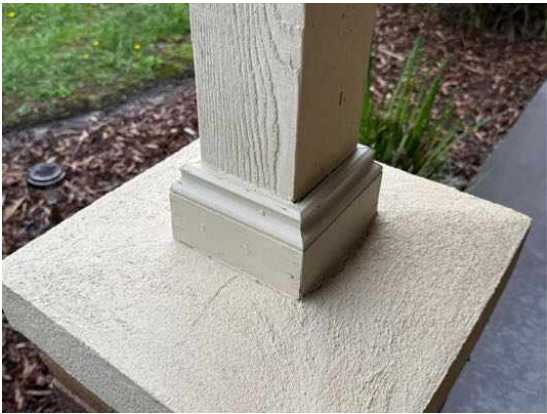
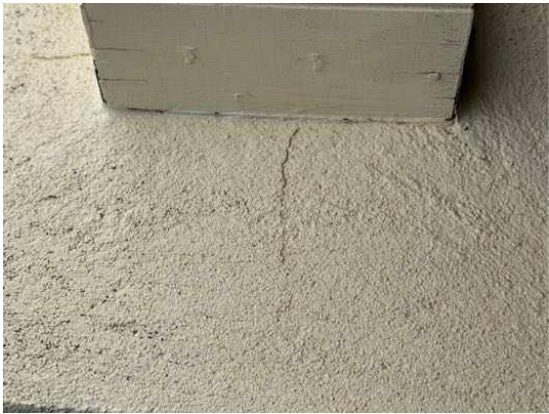
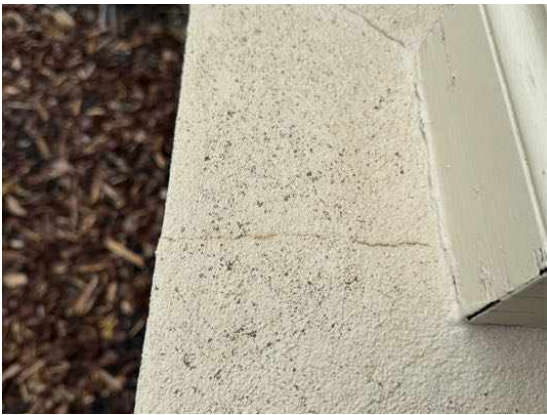
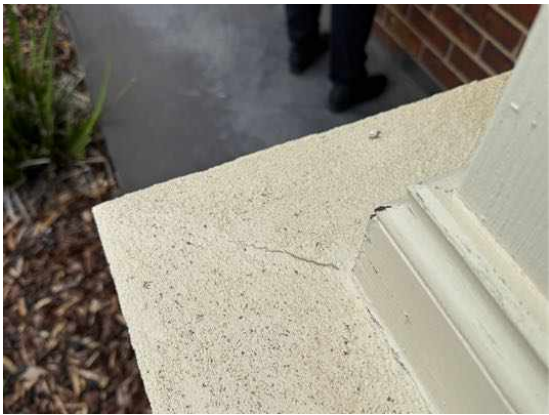
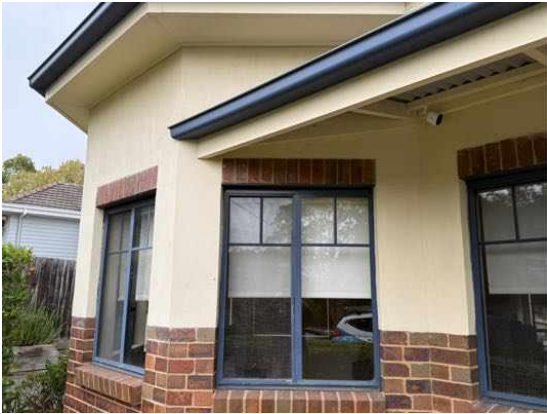
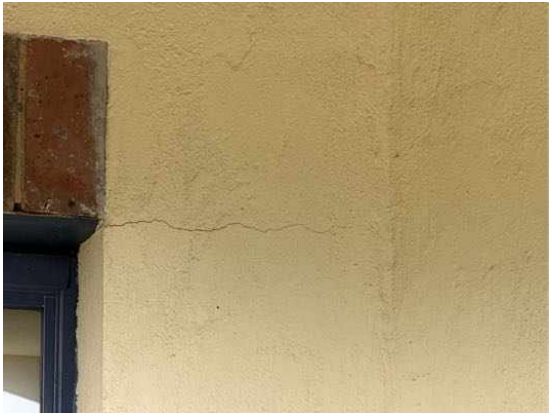
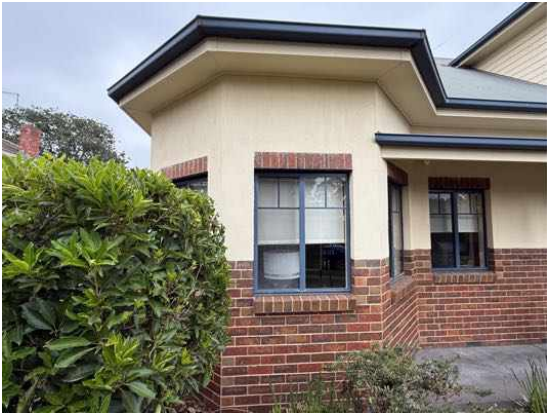
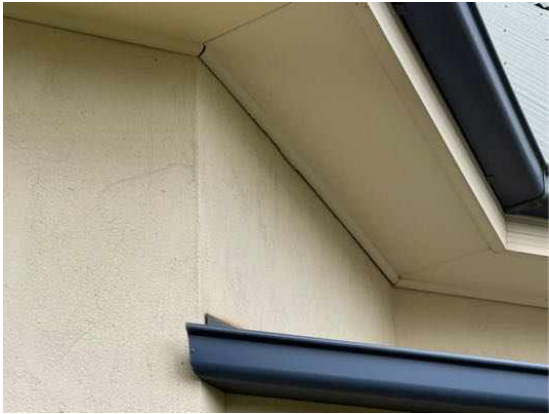
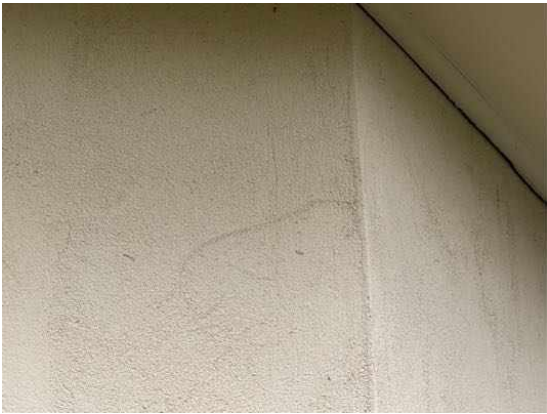
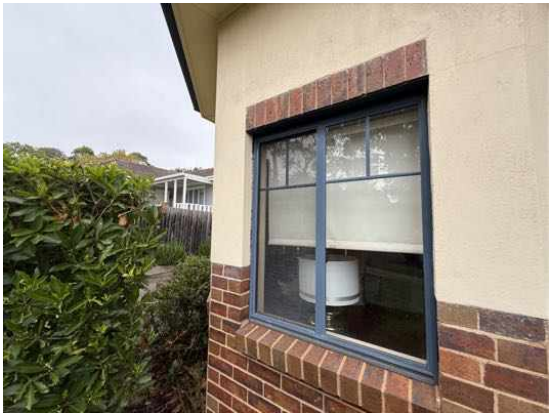
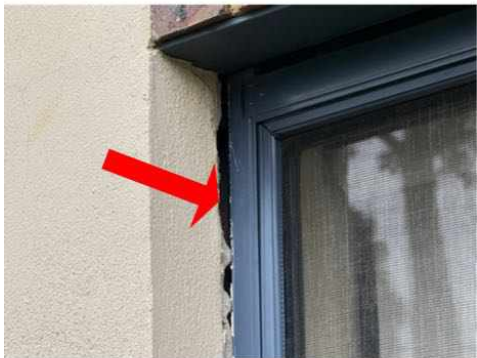
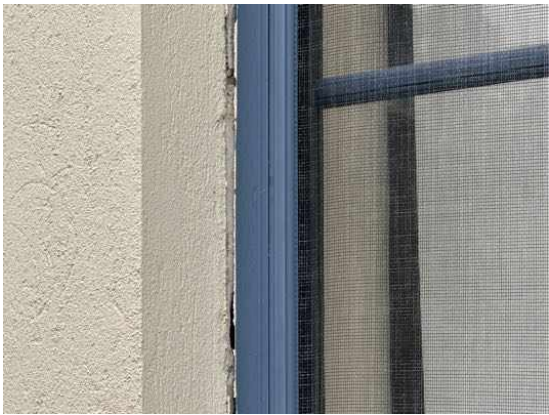
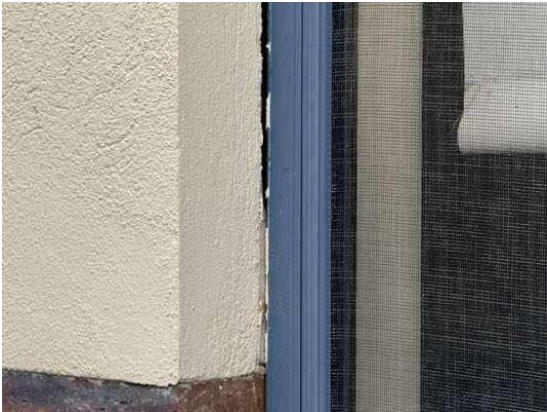
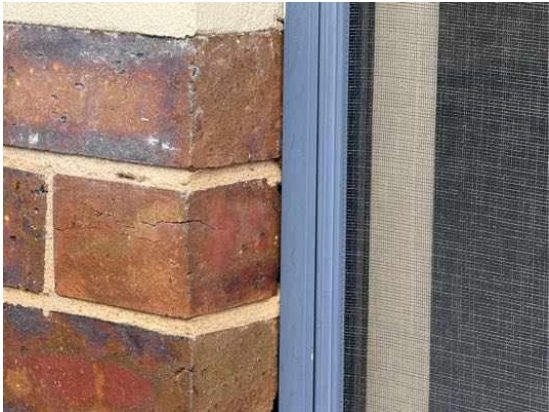
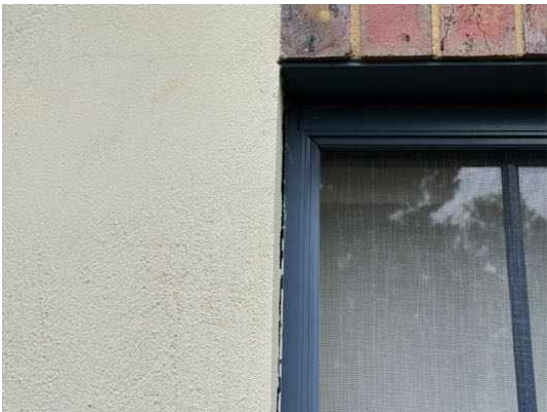
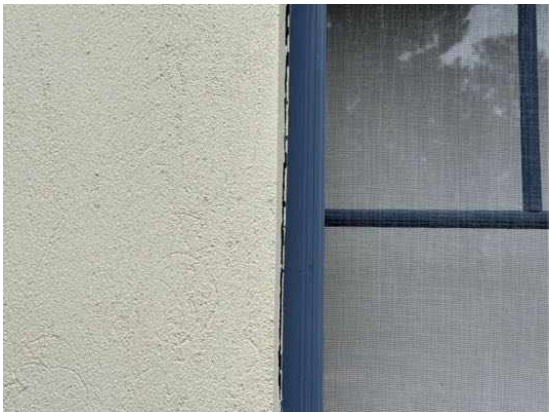
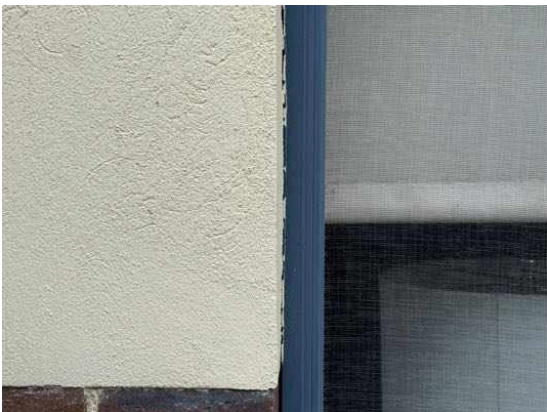
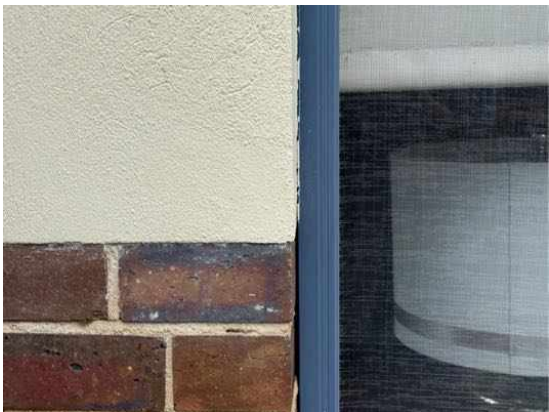
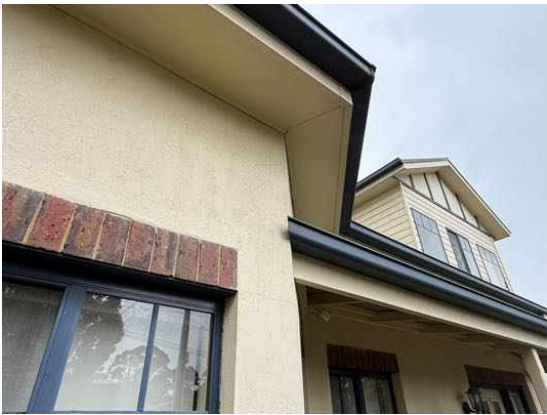
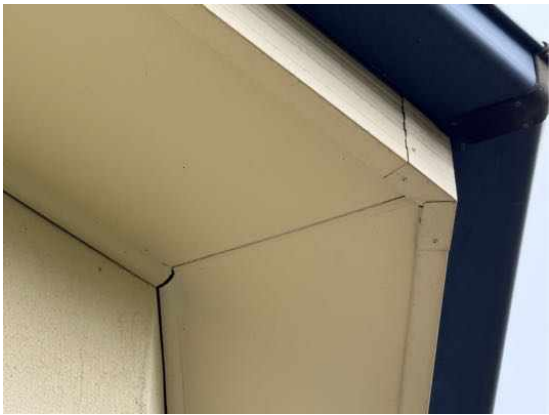
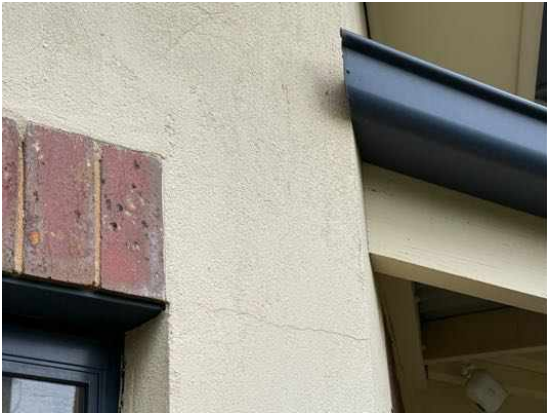
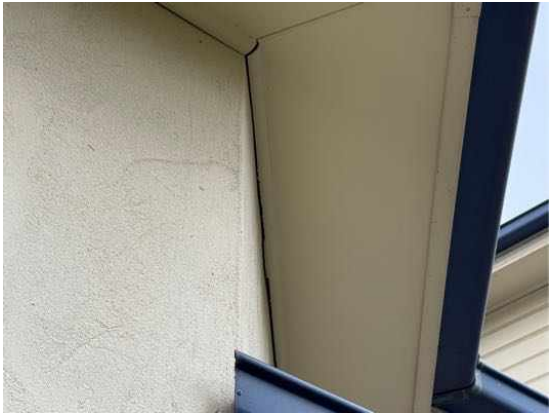
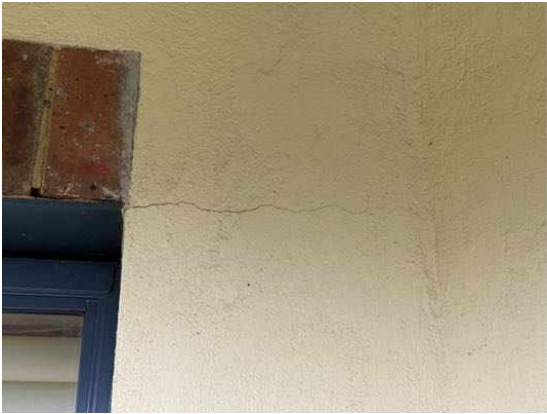
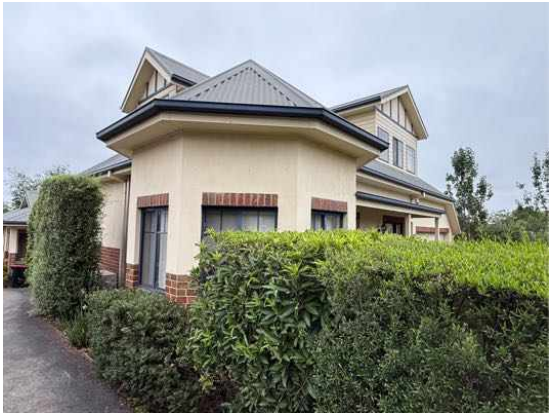
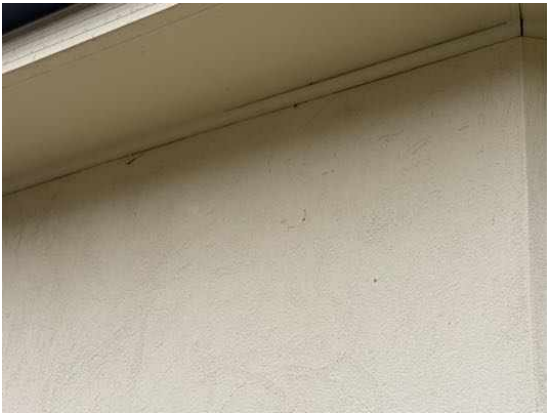
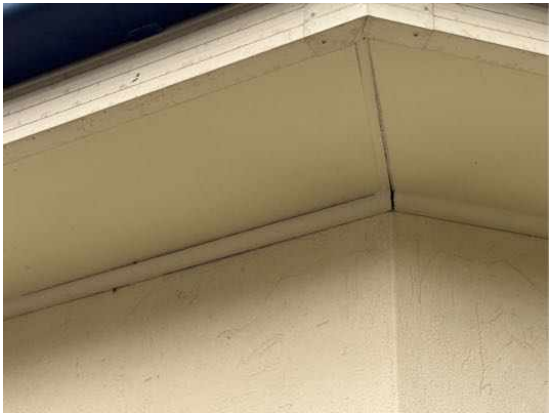
Defects 2.01

Building:	Building 1
Location:	All Areas > All Areas
Finding:	Brickwork rendered wall cracks and excessive movement
Information:	At the time of the inspection of the home, numerous cracks were observed to the exterior brickwork rendered walls. The front left hand side showed excessive movement where it is highly recommended to appoint a Structural Engineer to check these areas.

Structural issues are generally the underlying cause of these types of brickwork cracking and movement. The rendered brickwork wall cracks are suspected as a result of excessive movement within these foundations, or subsidence, and expansion and contraction of building materials in different weather conditions. These types of cracks may develop further if left unattended with potential for necessitating in some major remedial works.

The client should elect to appoint a structural engineer and a builder to inspect the structural integrity of these areas of affected brickwork, to assess the safety of the associated structures. The engineer can also nominate a scope of works required for the rectification. Always contact a Registered builder or engineer should cracks widen lengthen or become more numerous, even after repair works have been completed.

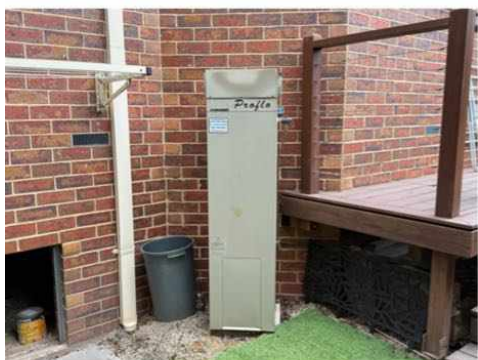
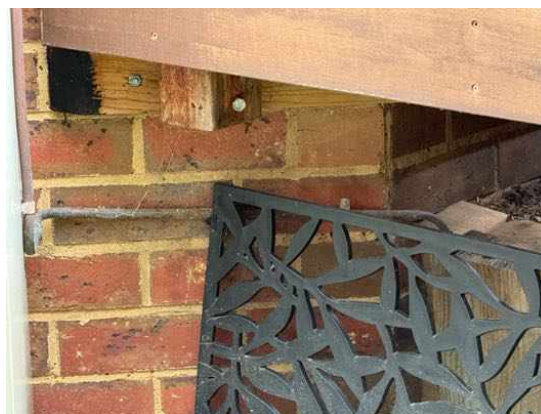
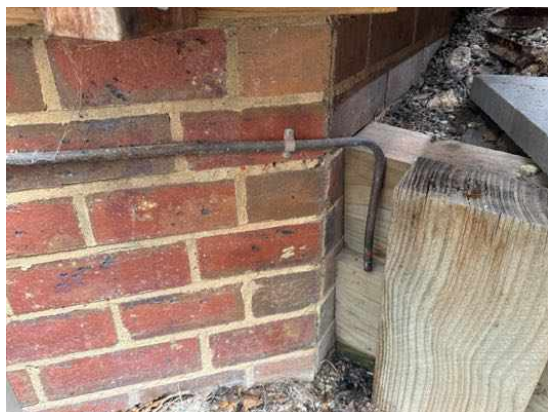
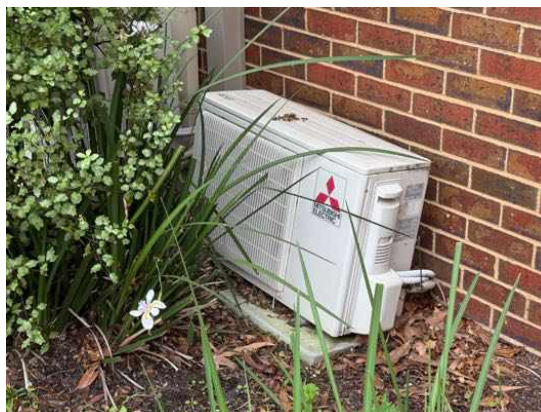
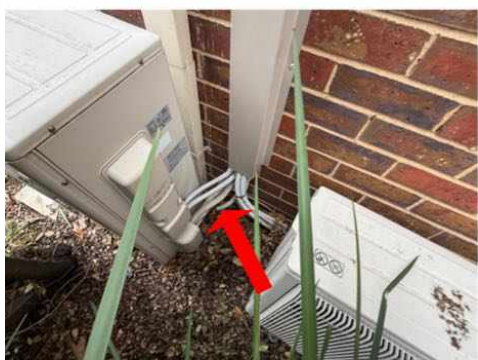
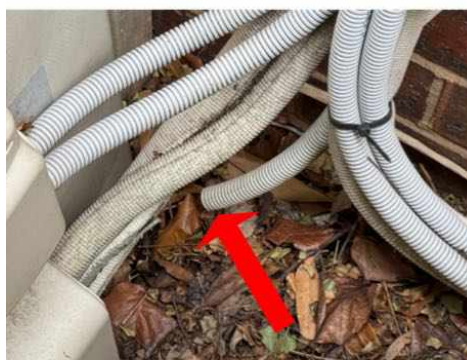
Defects 3.01

Building:	Building 1
Location:	All Areas > All Areas
Finding:	HWS and air-conditioning overflows not connected
Information:	The Hot Water System (HWS) and air-conditioning overflows were found not to be connected to any form of storm water drainage system and may in the future create excessive moisture in the surrounding area, as these units as they get aged, deteriorated and particularly during their use. These types HWS appeared to show some age and developing some rust and corrosion up around the top of the unit. These types HWS air-conditioning unit was observed to be on an excessive lean, it will require some remedial work to re-establish the unit to a straight and level position.

As these units age and deteriorate they will continue to create damp conditions around the base perimeter, which can lead to secondary defects such as mould and mildew, rust or corrosion of associated and adjoining building elements, as well as the formation of fungal decay and even the creation of potential slip hazards for occupants. When coupled with poor site drainage, pooling of water may also attract termite activity to these areas. It is highly recommended that a licensed plumber be appointed to connect the HWS and air-conditioning overflows in order to prevent such an environment from being created. These minor works should be carried out immediately or as soon as possible.

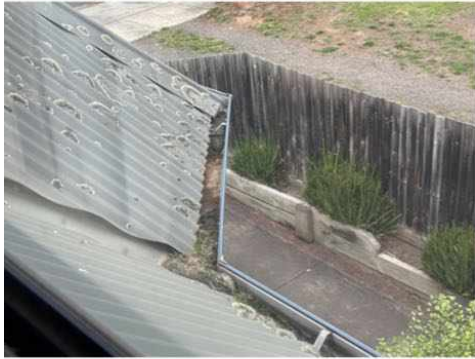
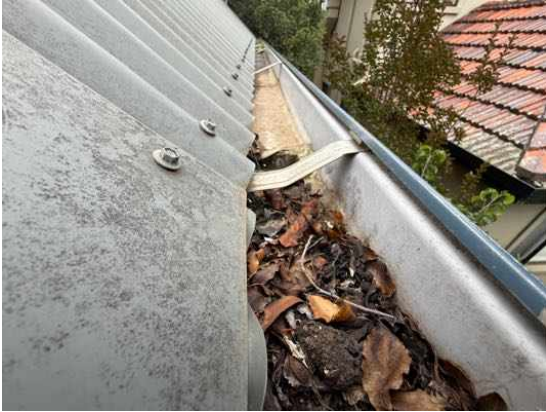
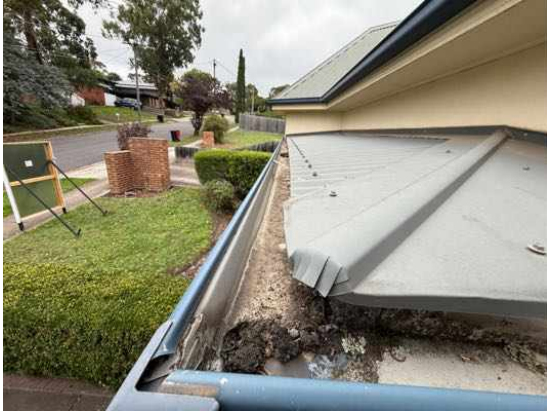
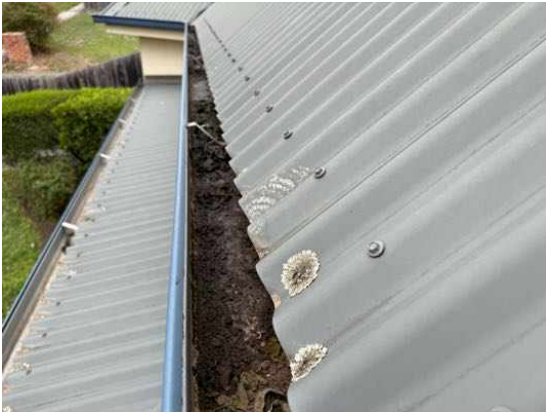
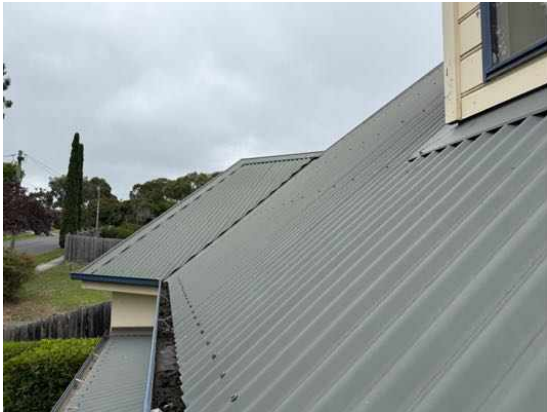
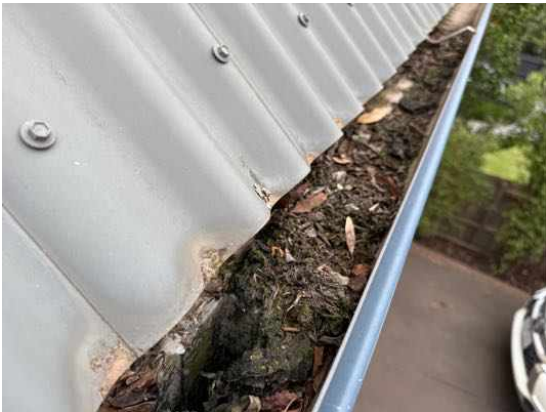
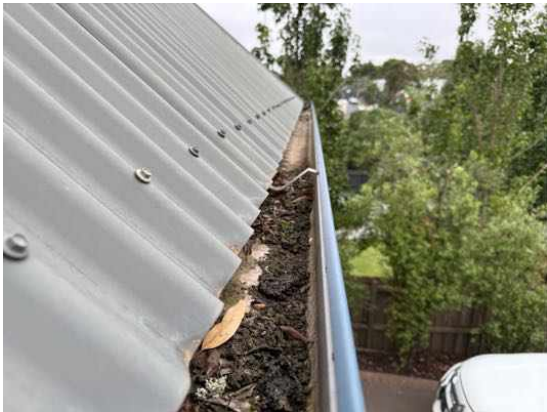
Defects 3.02

Building:	Building 1
Location:	All Areas > All Areas
Finding:	Gutters - Partially blocked
Information:	Roof plumbing structures, such as guttering and downpipes, should be free of all leaf matter and debris to prevent blockages. Blockages of the guttering and downpipes will lead to pooling and accumulated water overflows, which is likely to subsequently flood eaves and exterior walls. Blocked gutters are likely to lead to high levels of moisture in the affected areas. Such moisture will not only cause rust and decay of the associated building materials, but can also provide conditions that are conducive to termite and timber pest activity.

Blockages in gutters should therefore be removed immediately to ensure dry conditions are maintained. Client should consider the appointment of a gutter cleaning company to carry out these works or with a Licensed Plumber for further specific advice on remedial works that may be deemed to be required. In the interim, it is highly advised that blocked gutters be removed by the homeowner, gutter cleaning company or a general handy-person in the short term future.

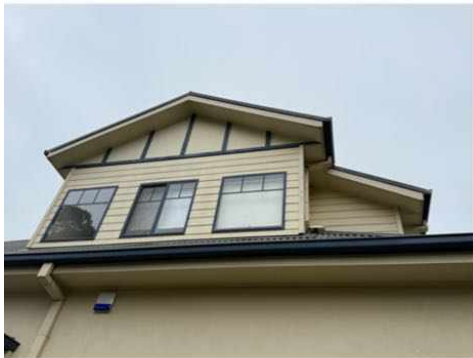
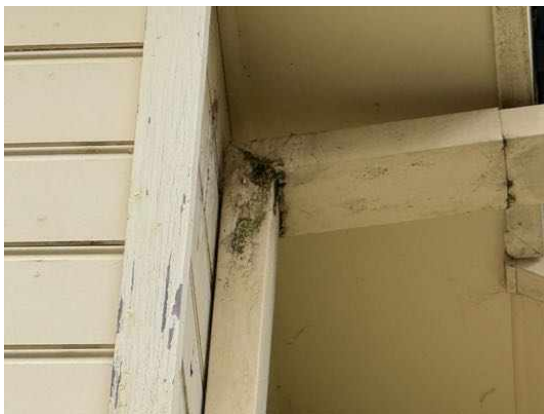
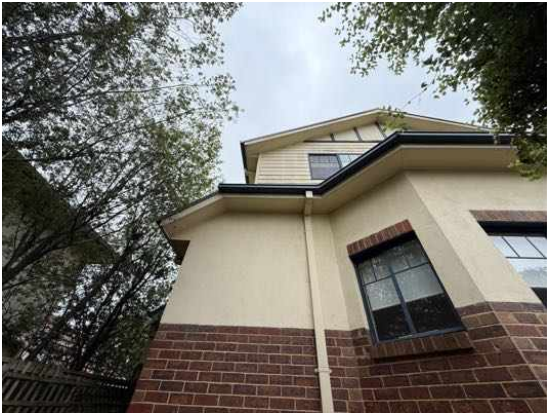
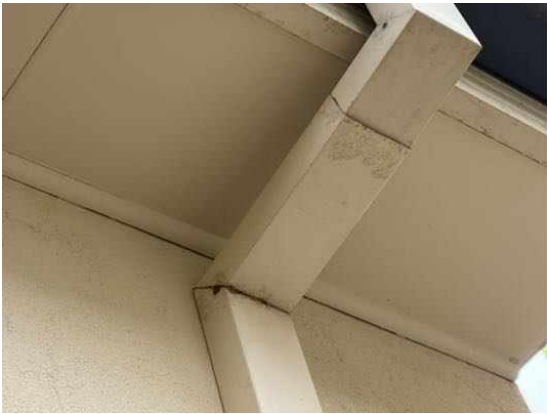
Defects 3.03

Building: Building 1
Location: All Areas > All Areas
Finding: Down-pipes weeping from joints
Information: It was observed at the time of inspection that some of the down-pipes were weeping from the joints and not sealed adequately, these should be all properly sealed to prevent down-pipes weeping from the joints. Where these down-pipes are not sealed or joined properly, the surrounding areas are highly susceptible to excessive moisture from splashing out and weeping joints.

If left unmanaged makes these areas highly susceptible to excessive water and moisture, wood rot, rust and corrosion is likely to lead to damage to adjoining areas, building structures and building elements, this also makes these areas more susceptible to termite or timber pest activity. It is recommended that the client appoint and seek advice from a licensed roof plumber to rectify any areas deemed to be necessary.

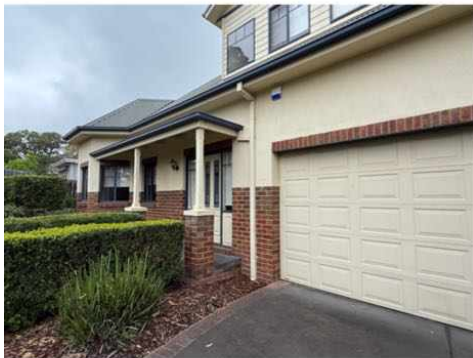
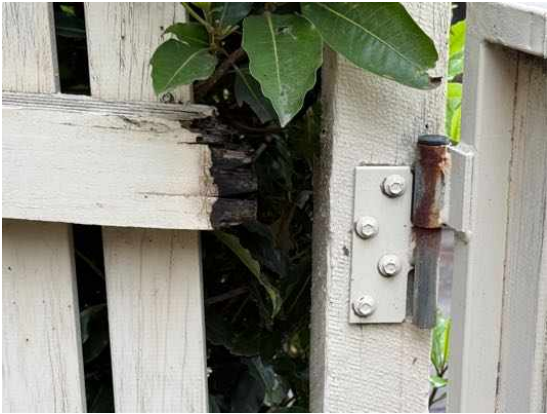
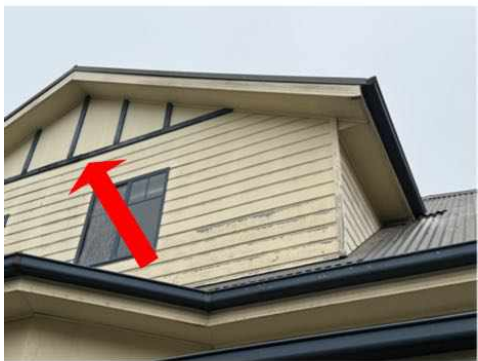
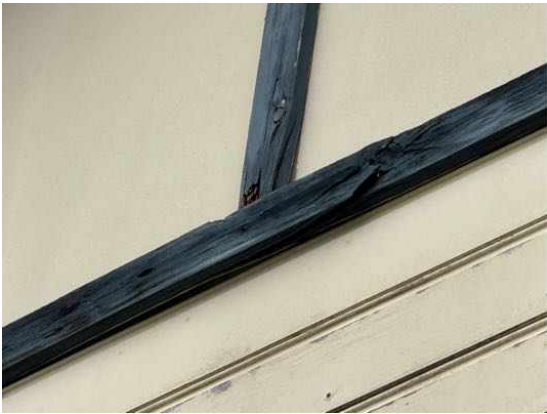
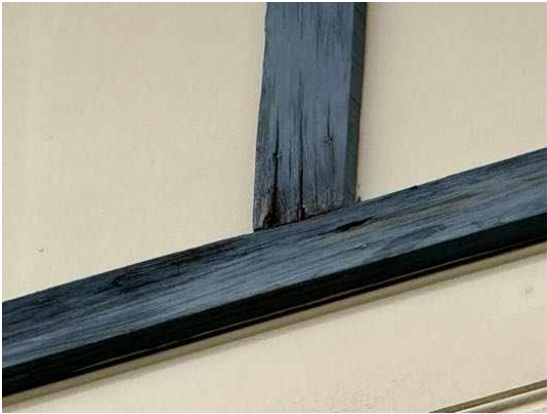
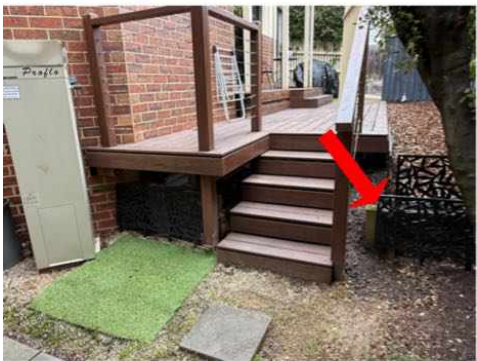
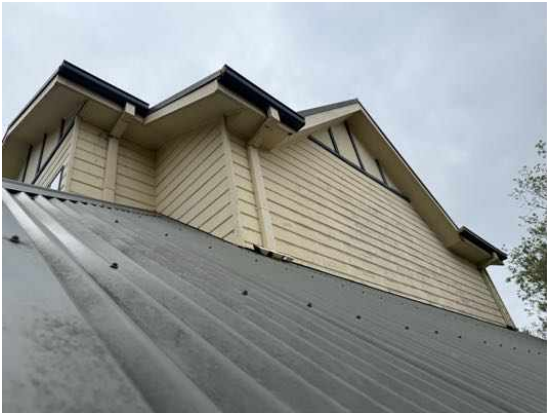
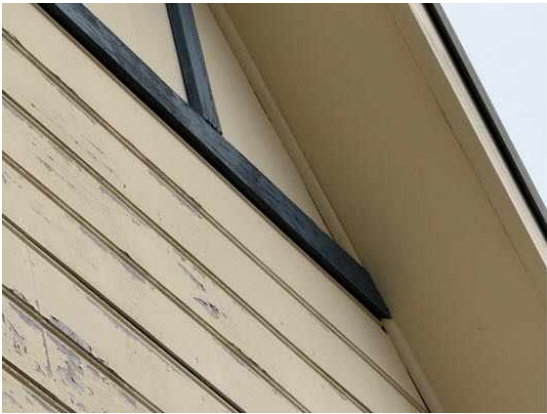
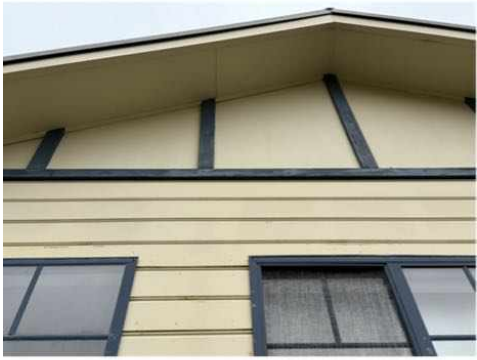
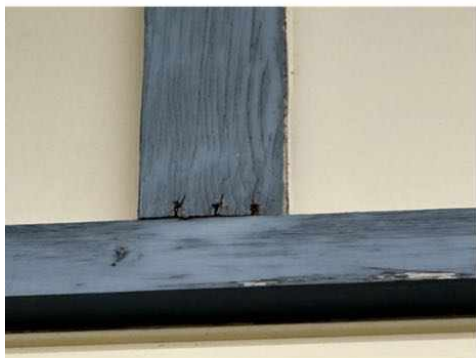
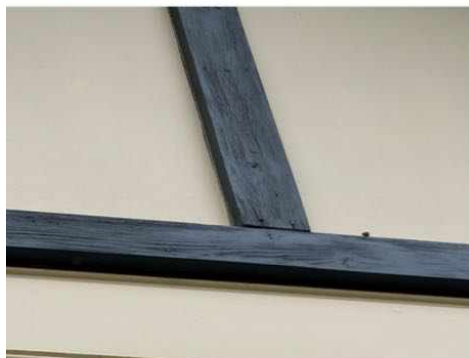
Defects 3.04

Building: Building 1
Location: All Areas > All Areas
Finding: Wood rot
Information: Some wood rot is suspected to be affecting some gable end roof slats. Wood rot, also known as Fungal Decay, occurs when timbers and other cellulose building materials are exposed to damp conditions on an ongoing basis. It is suspected to be due to frequent exposure to rain and other weather conditions also make building elements susceptible to accelerated deterioration.

Early intervention and regular maintenance such as painting will prolong the useful life of these building elements. Prior to any works being performed, the cause of the moisture that has created the visible wood rot should be identified and addressed in a suitable manner. Replacement of affected building elements may then be a necessary step in protecting surrounding areas from such deterioration. A qualified carpenter should be appointed to assess the cause of the moisture and to provide advice on any remedial works as required. A qualified carpenter or registered builder may also be required to replace affected building materials.

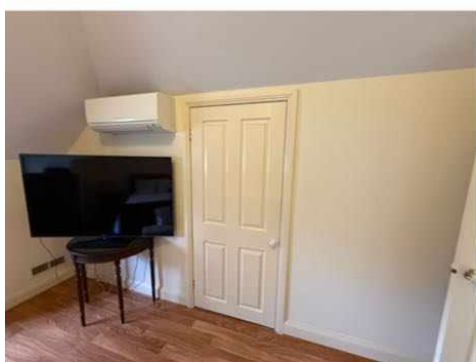
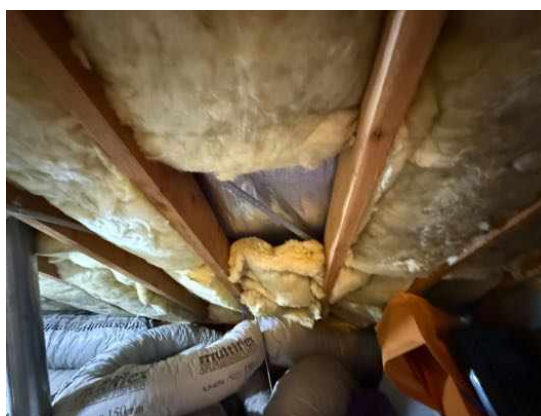
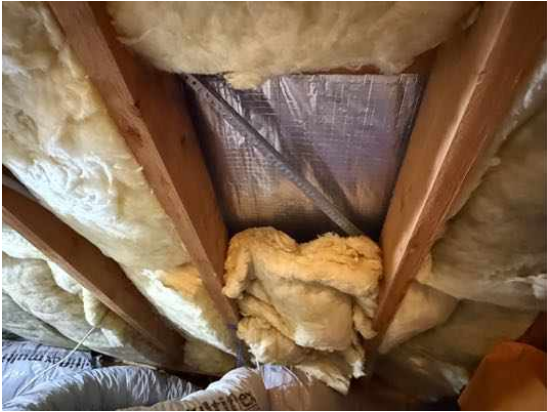
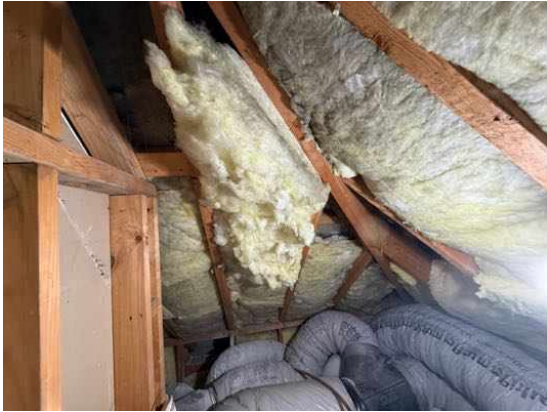
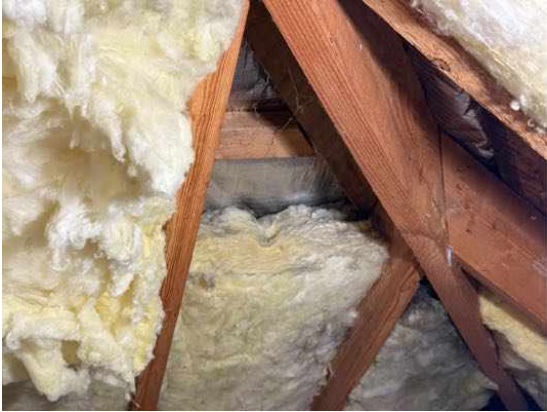
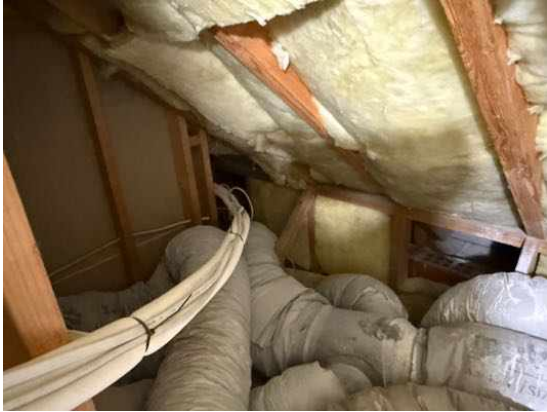
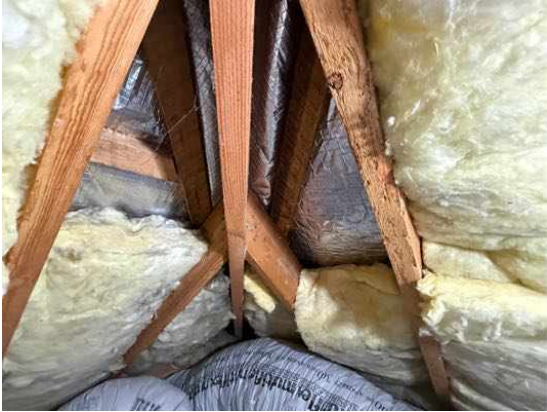
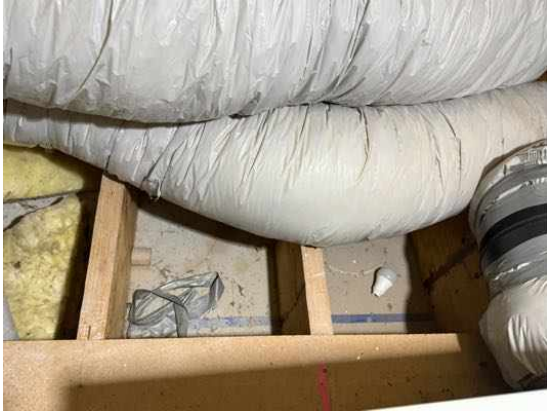
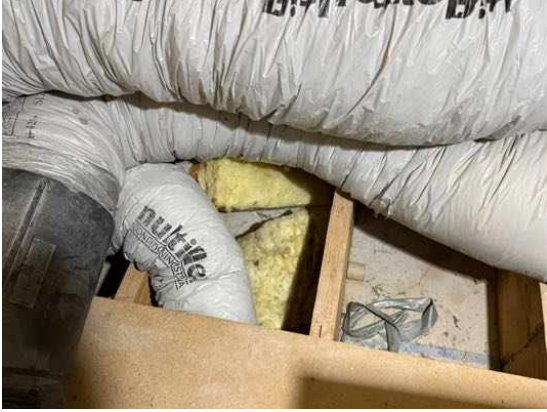
Defects 3.05

Building:	Building 1
Location:	All Areas > All Areas
Finding:	Insulation - poorly installed - missing or moved
Information:	Some areas of the roof insulation in the roof space is suspected to have been poorly installed, missing or have been moved from their original position. Insufficient insulation will result in a comparatively higher cost to heat and cool a property as there is a lack of Insulation (or uneven coverage of insulation) which works as a barrier to heat transfer. This helps to keep out unwanted heat in summer and preserves warmth inside your home in winter. It can also help soundproof your home from unwanted airborne noise transfer.

Example - Where there is a gap in coverage totaling 5% there is a potential for up to 50% of the energy efficiency to escape. Caution should always be exercised when accessing the roof void. Do not attempt to stand on the framework and especially be aware that there is a potential for electric shock if contact is made with exposed or faulty electrical wiring.

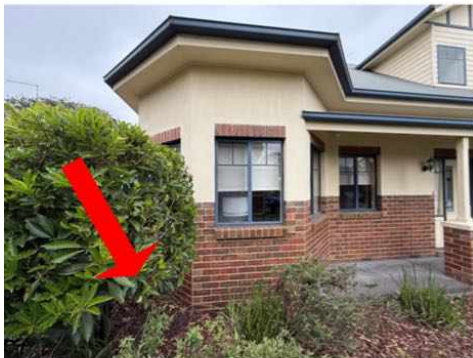
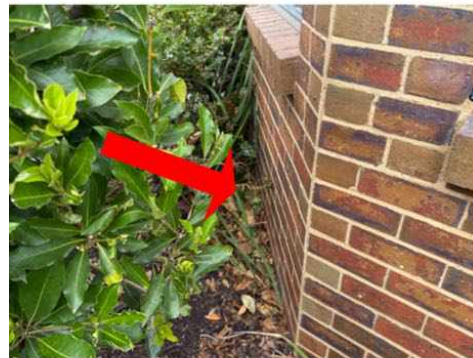
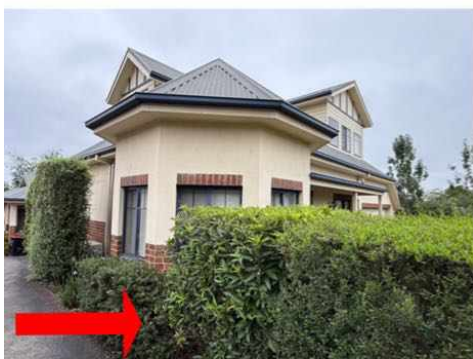
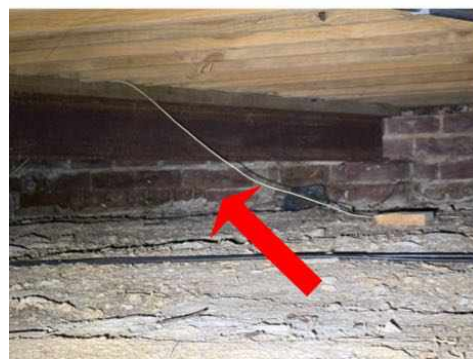
Defects 3.06

Building: Building 1
 Location: All Areas > All Areas
 Finding: A subfloor vent was partially buried on the top left hand side of the home
 Information: It was observed at the time of inspection that a vent on the top left hand side had been covered with garden mulch and was buried below the garden level. During the inspection it was observed that this area shows some concerning movement in the rendered brickwork walls and windows. Also during the subfloor inspection moisture was observed within this area of concern and it is recommended to keep clear.

It is important that these subfloor vents are kept open and free of obstructions to ensure that the subfloor ventilation is not restricted around the exterior of the home. The subfloor when well ventilated will aid in maintaining dry conditions, preventing secondary damage such as wood rot and pest activity, as well as preventing the development of mould and mildew. But in wet and damp areas within subfloor areas, these can lead to respiratory safety hazards for occupants. Therefore it is important to ensure that the subfloor area is free of any build up around all perimeters of the home and air can move freely throughout the subfloor areas.

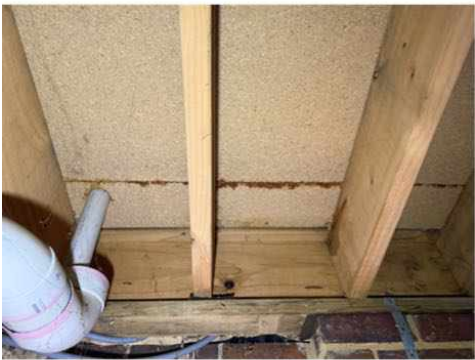
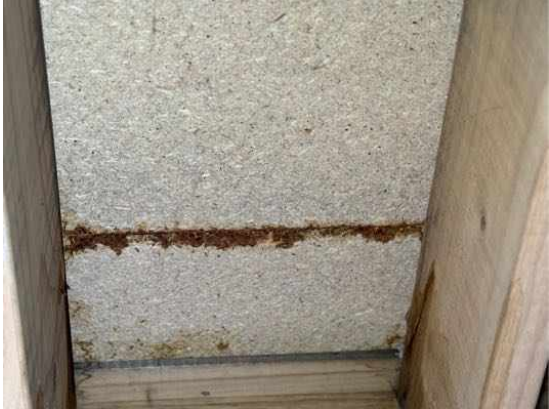
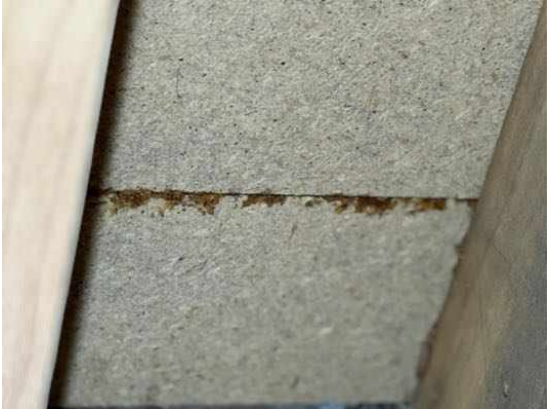
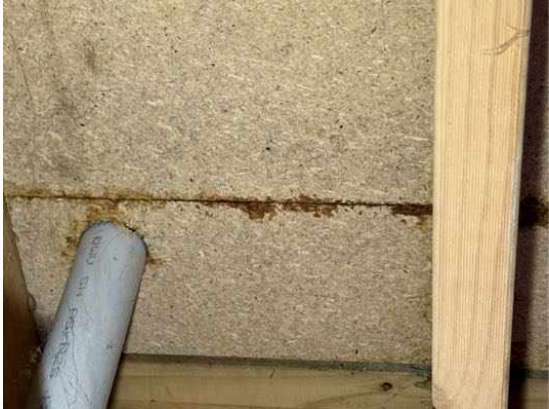
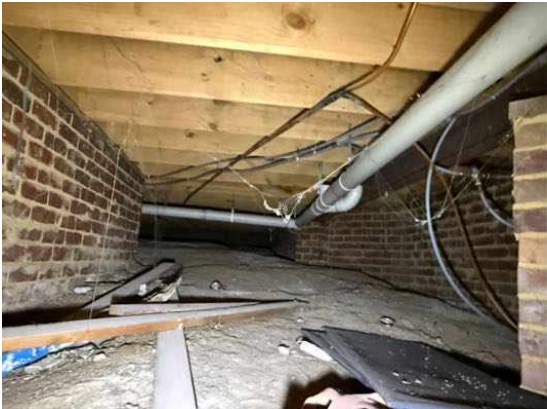
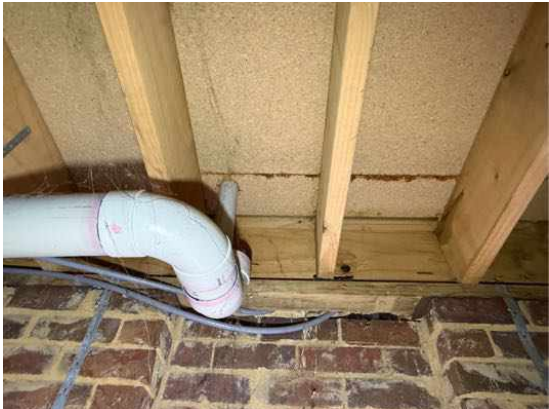
Defects 3.07

Building: Building 1
 Location: All Areas > All Areas
 Finding: Subfloor previous moisture stains observed under the Laundry and Kitchen areas

Some previous moisture stains were observed under the Laundry and Kitchen areas at the time of the subfloor inspection. The moisture stains did not appear to be active moisture and did not appear to have sustained moisture damage to the surrounding timber framing structures in this area. The client may appoint a relevant contractor carry out a further inspection of this area to check for further hidden damage. It is not suspected that any remedial work or repairs are expected to be required in these areas.

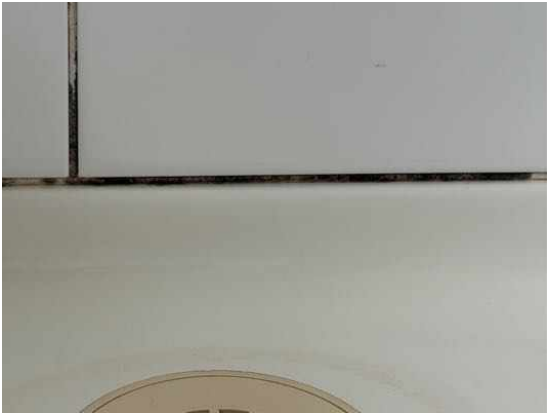
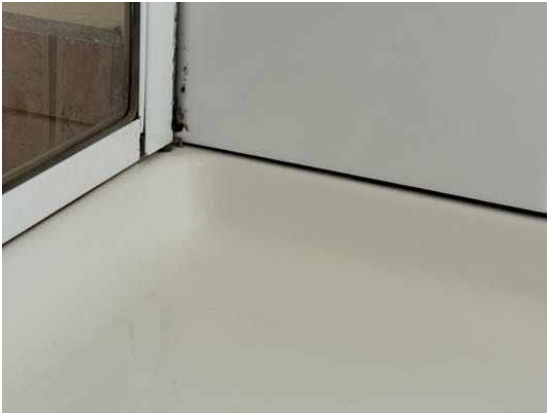
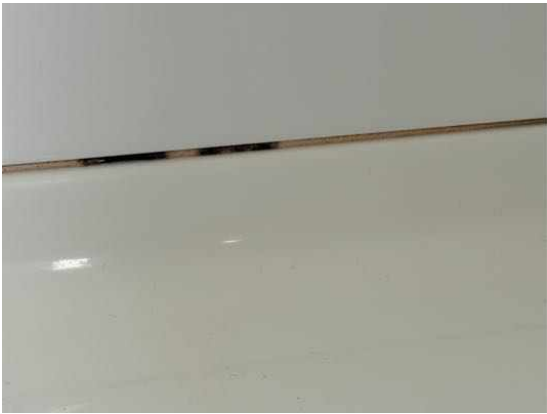
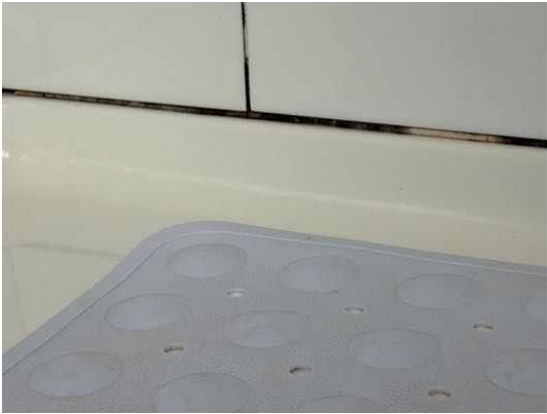
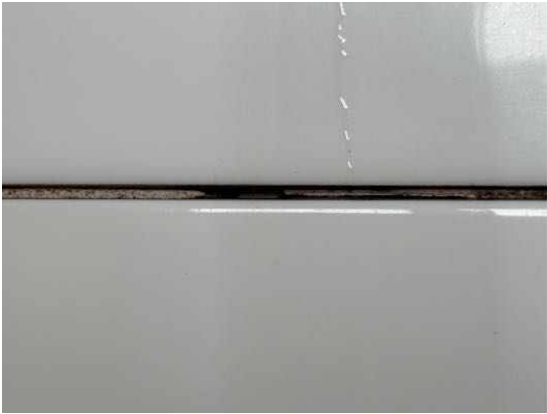
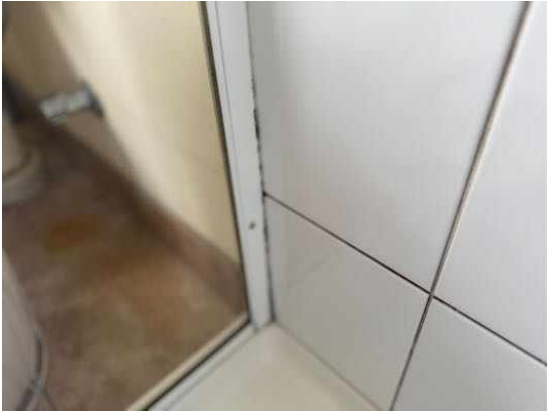
Defects 3.09

Building:	Building 1
Location:	All Areas > All Areas
Finding:	Grout and sealant in bathroom shower cubicle
Information:	<p>It was observed that grout and sealant in the shower alcove wall tiling had been dislodged in minor areas. It also shows excessive mould which should be removed immediately or in the short term future. Where grout or sealant is missing and or show excessive mould, accelerated damage and deterioration as well as more secondary defects to the adjoining structures is highly likely to occur.</p> <p>Regular maintenance and replacement of grout and sealants is highly recommended to all the wet areas. Grout and sealant is considered to be a regular wear and tear defect. Sealant and grouting in these types of wet areas will come into regular contact with water and moisture and should be maintained for the long term care of your property.</p>

Different materials on the walls and floor areas move at different rates, generally causing cracking to grout or sealant at these points. A flexible sealant is required to allow for expected expansion and contraction, while keeping the joint water tight and protective of all associated building structures and materials. Flexible and mould resistant materials should be applied to affected areas to prevent any subsequent water damage that is likely to occur if left unmanaged. Client should appoint a floor and wall tiler to complete these works as soon as possible.

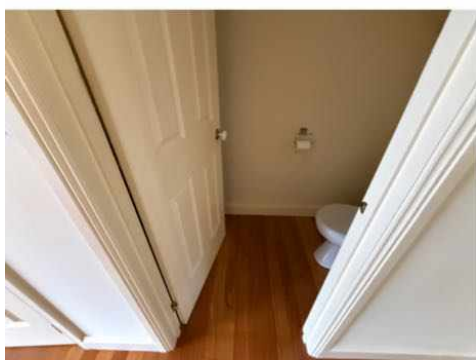
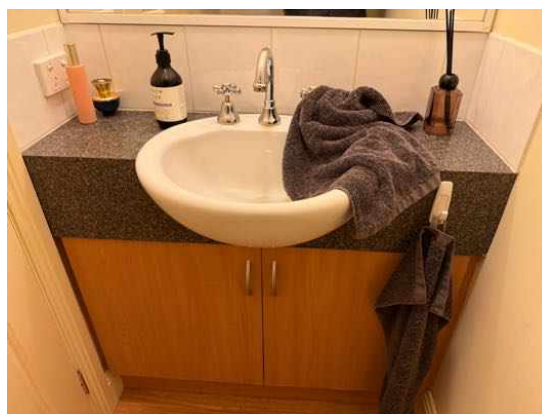
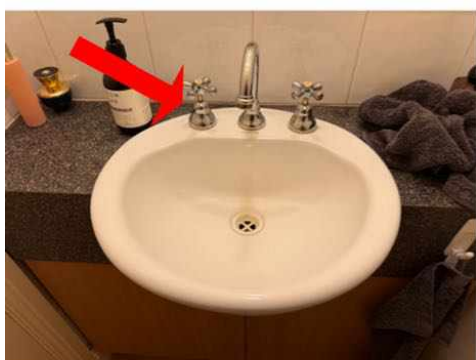
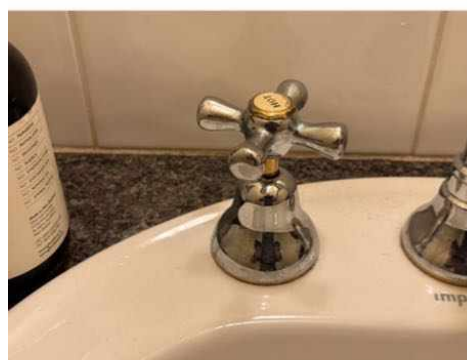
Defects 3.10

Building:	Building 1
Location:	Bottom storey toilet > All Areas
Finding:	Hot water tap suspected to be non-operational
Information:	The Hot water tap in the bottom toilet was observed to be either broken, very stiff and not operating correctly as intended. Non operating or breakage to building elements occurs generally when the building elements have either aged and deteriorated or not installed properly. Repair and/or replacement of the broken water tap is therefore recommended so as to ensure that the basin tap is fully operational. A licensed plumber or relevant tradespersons should be appointed to correct these areas and to perform necessary works to appropriately rectify, repair or replace the affected building element. This is at the client's discretion.
