Building Inspection Report

Inspection Date: Thu, 19 Mar 2026

Property Address: Unit 1/16 Starling St, MONTMORENCY,
VIC, 3094, Australia

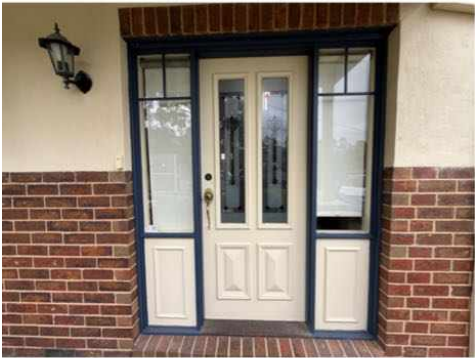
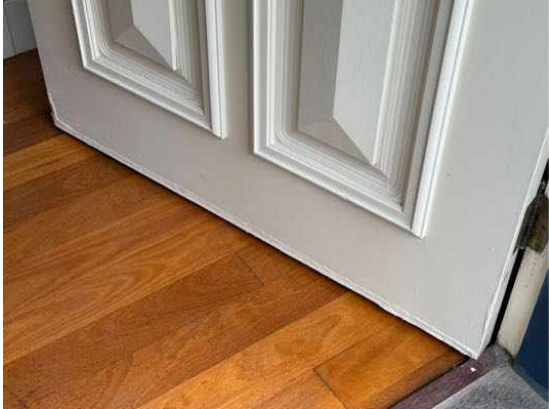
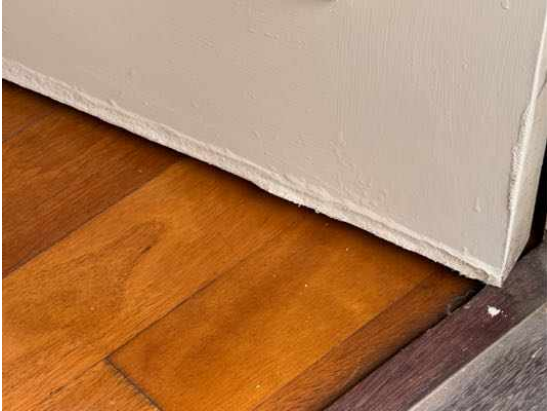
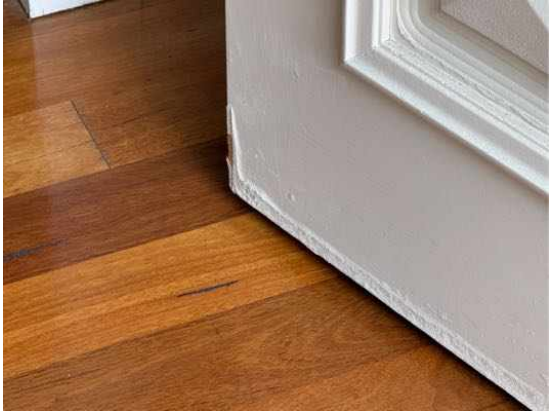
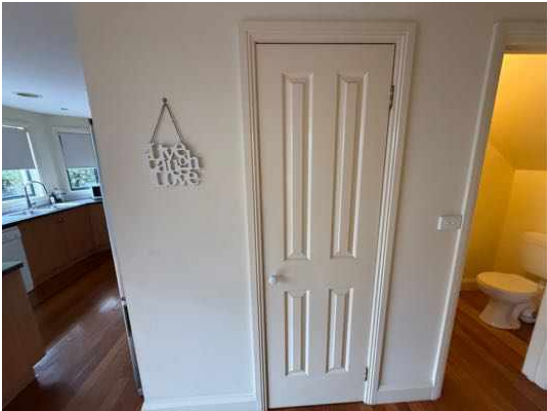
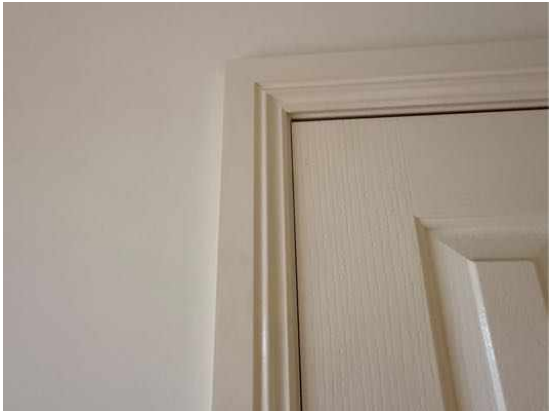
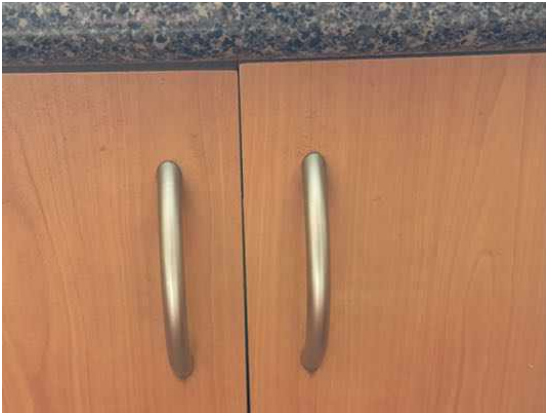
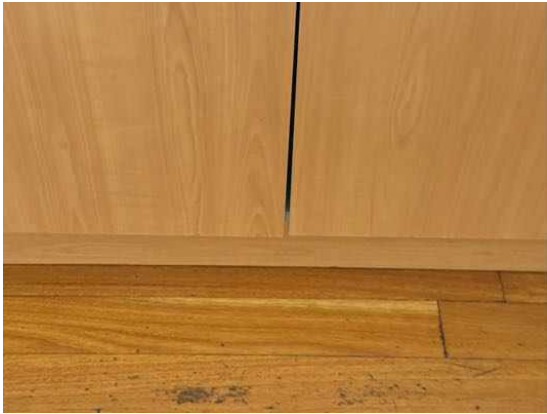
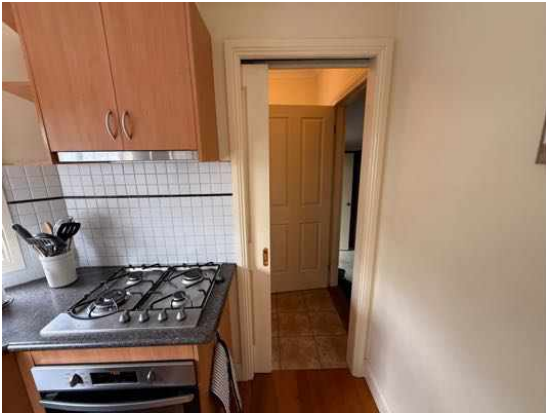
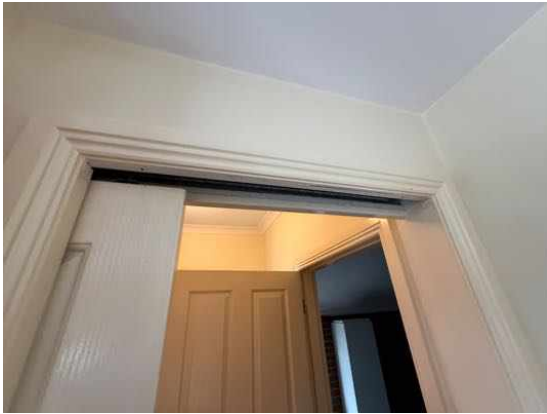
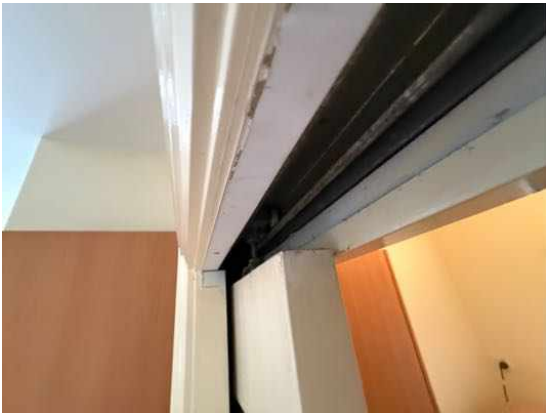
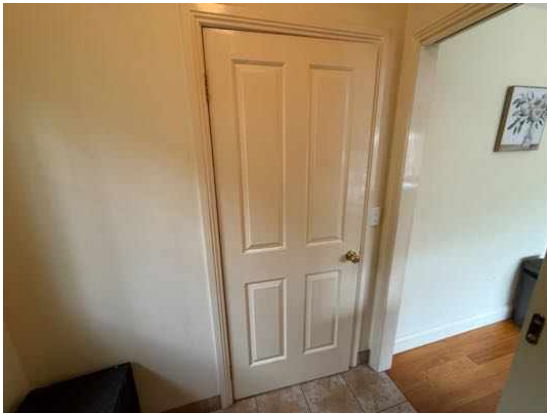
Defects 3.11

Building:	Building 1
Location:	All Areas > All Areas
Finding:	Doors - minor maintenance
Information:	Some doors or door hardware were observed to require some minor maintenance or repair. For example door latches and handles or rubbing on adjacent door jambs or not latching correctly. Where doors are hard to operate, these types of defects will make it difficult for younger and other occupants to safely egress the interior areas. All doors should be rectified to ensure they operate easily during standard operation. These doors and door hardware defects may inhibit a safe and timely egress in the

case of an emergency.

Some of these doors require some minor adjustment to ensure their functionality is not affected and not creating secondary defects to associated building elements, such as damage to the associated door frames and or floor coverings in left unmanaged. For most minor causes, a qualified carpenter should be appointed to perform minor rectification works at the clients discretion.

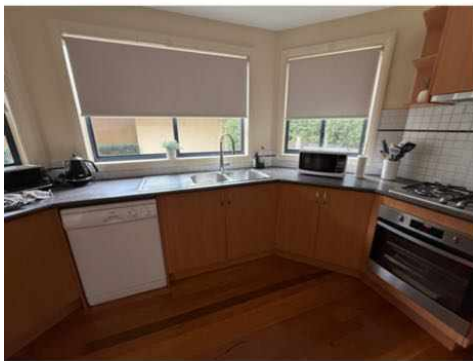
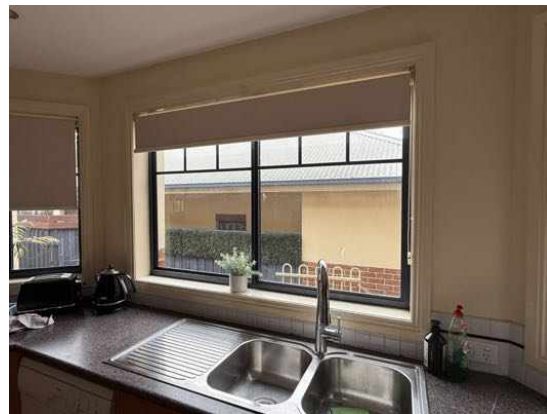
Defects 3.12

Building:	Building 1
Location:	All Areas > All Areas
Finding:	Flyscreens
Information:	Some flyscreens were found to be missing from the windows throughout the home at the time of inspection. Whether the flyscreens have not been installed or have been removed for maintenance and or painting purposes, this missing building element detracts from the operational state of the window. Where not replaced, missing flyscreens allow pest and insect ingress into the adjoining room/s. It is advised that all missing building elements be installed or replaced in order to ensure the full function of all building structures. A qualified carpenter may be appointed to replace flyscreens at the discretion of the client.

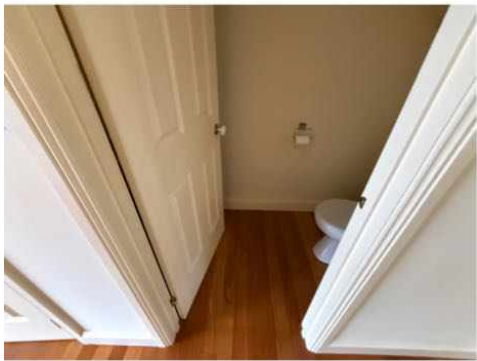
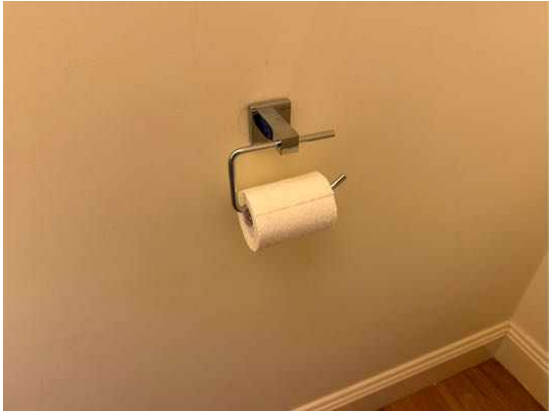
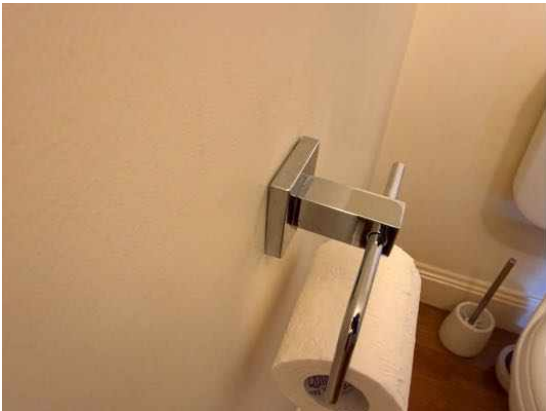
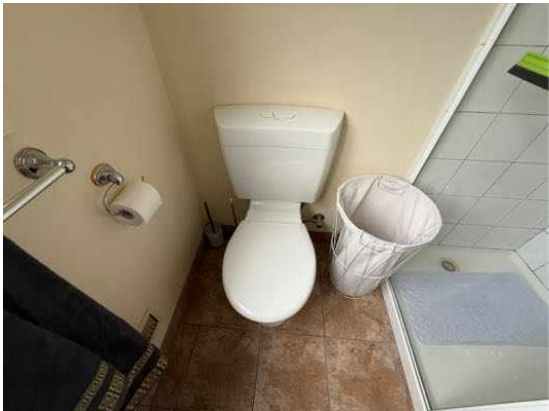
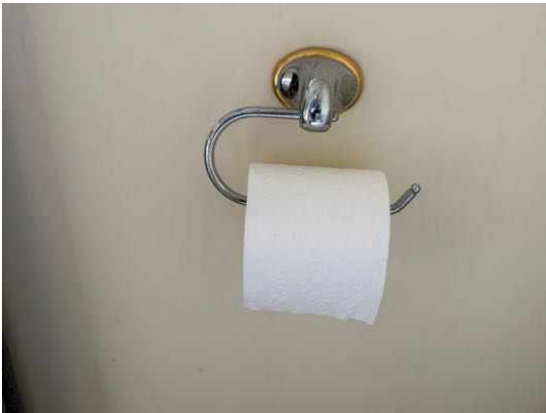
Defects 3.13

Building:	Building 1
Location:	Bottom storey toilet > All Areas
Finding:	Toilet roll holders - Loose
Information:	The toilet roll holders and towel rail were found to be loose at the time of inspection. While not a major operational defect, function can deteriorate if the problem is left unmanaged. It is recommended that some remedial works to rectify the loose toilet roll holders and towel rails to its original fixing. If these cannot be be rectified to function as intended, client is recommended to renew. A qualified carpenter may be required to perform these works.

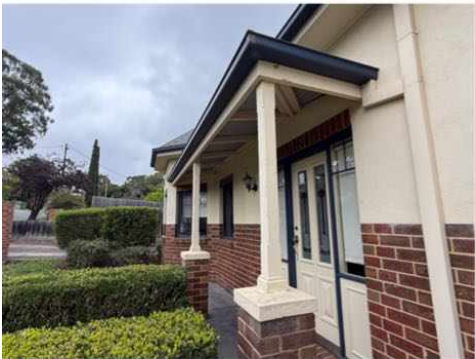
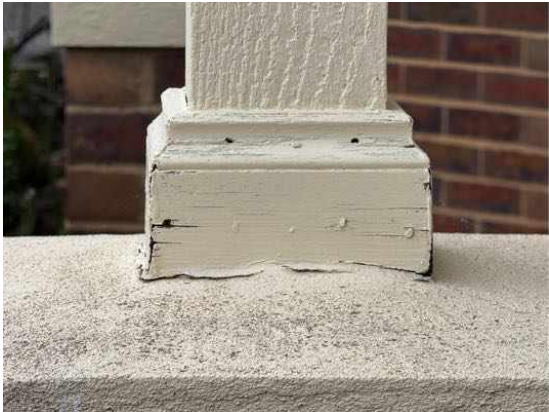
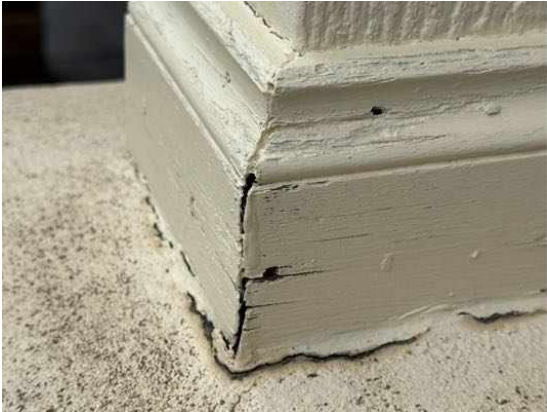
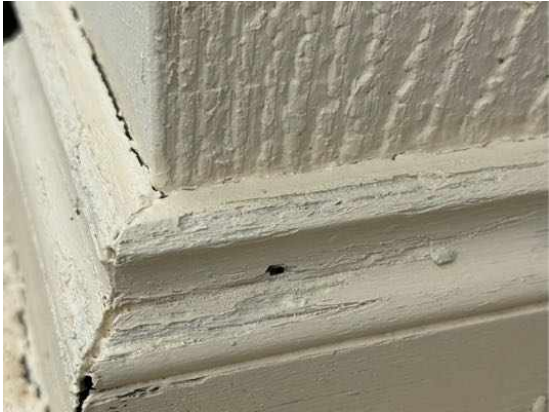
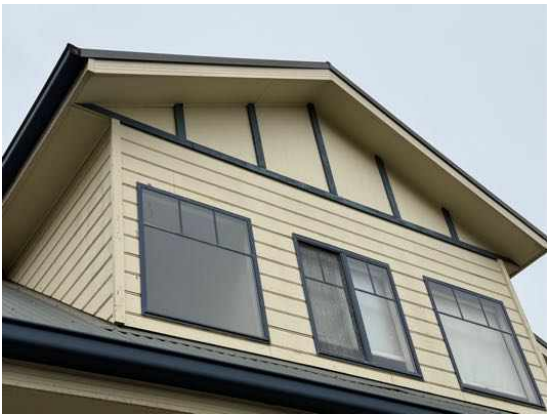
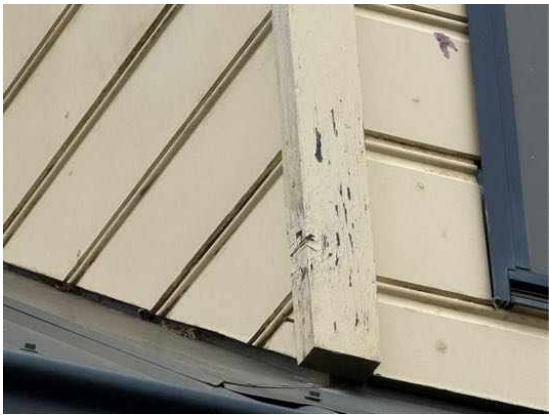
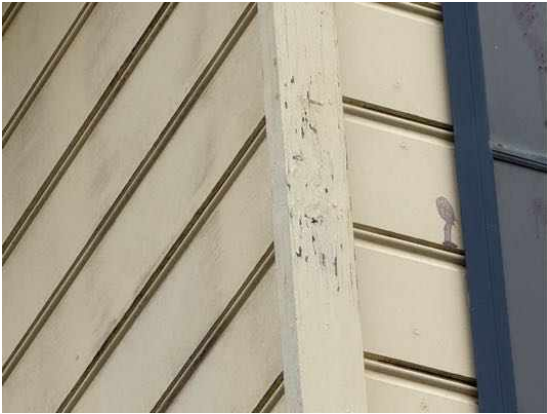
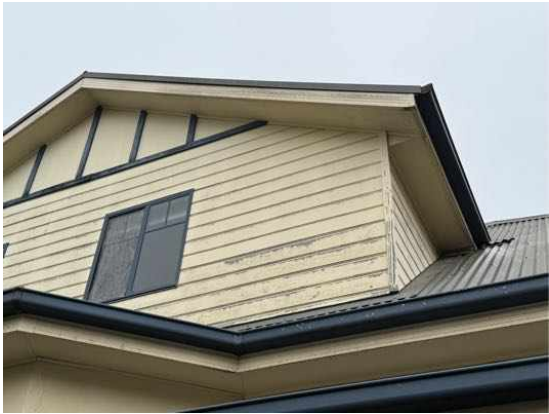
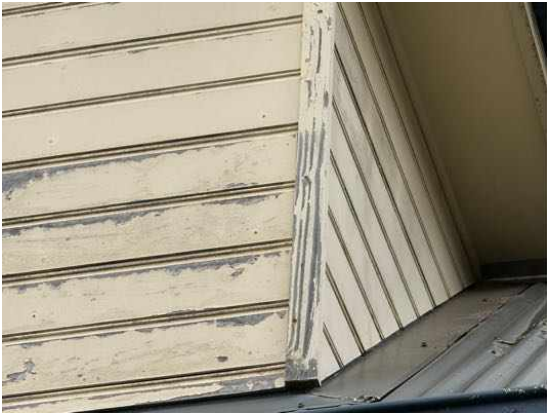
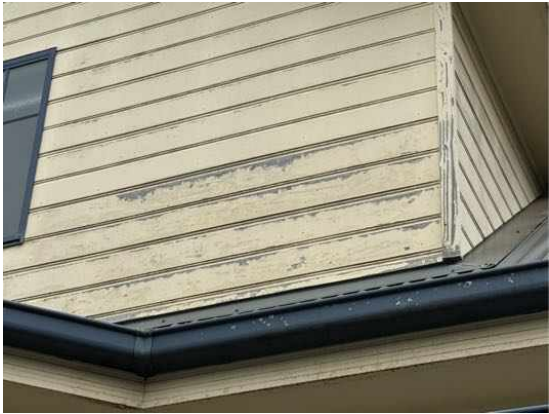
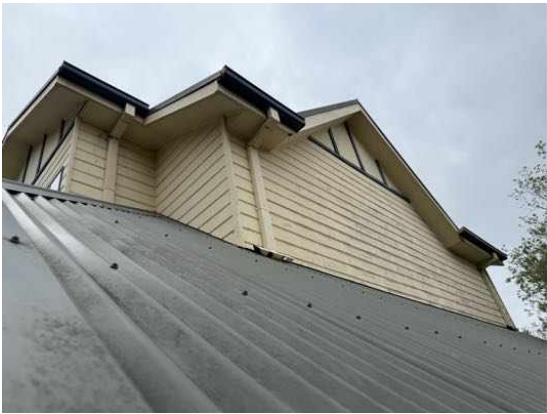
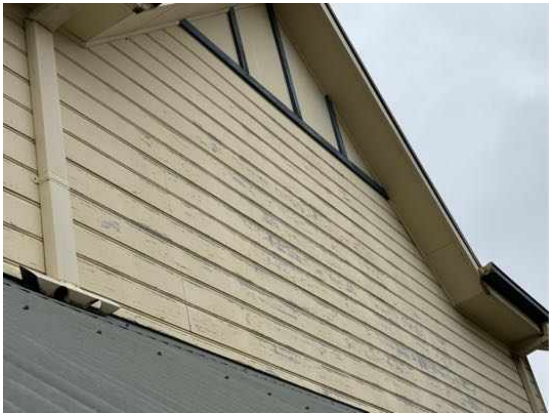
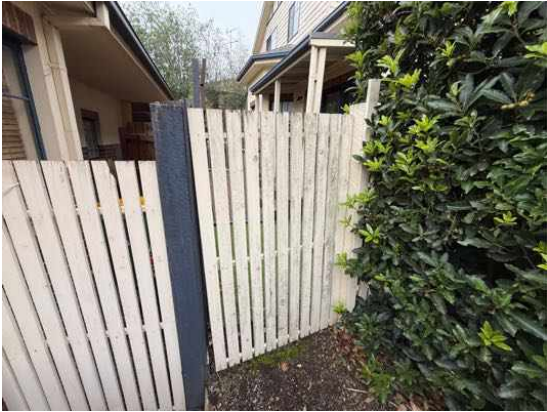
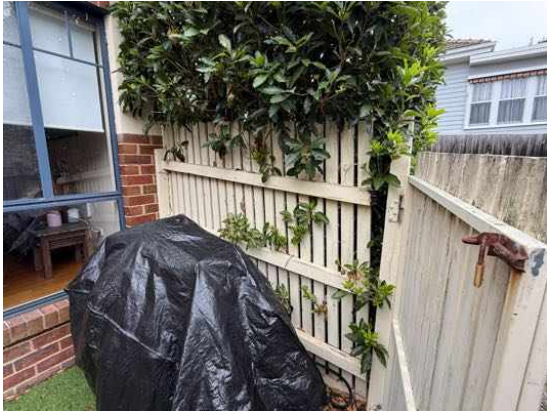
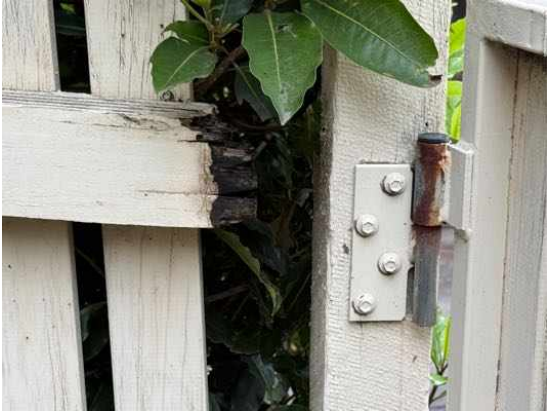
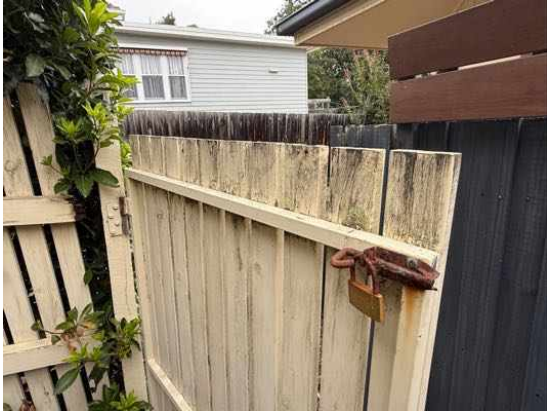
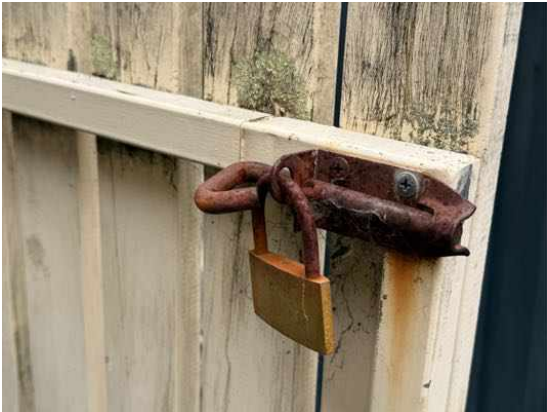
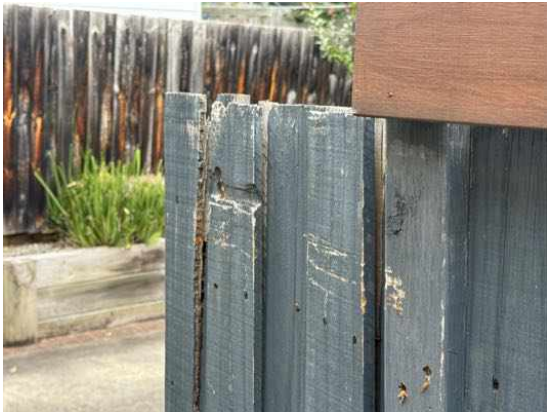
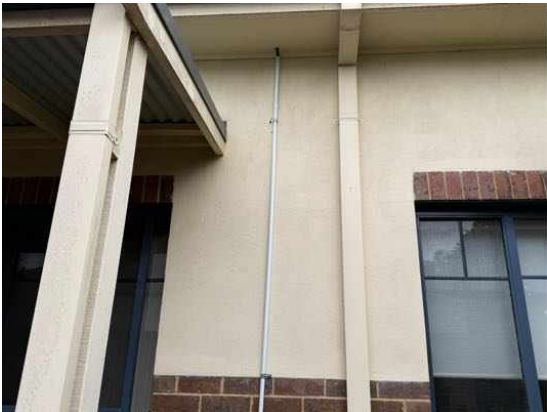
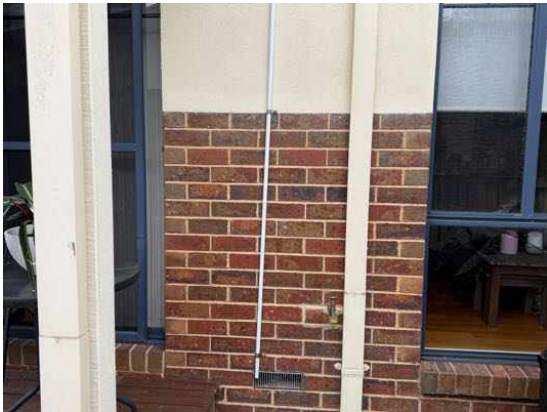
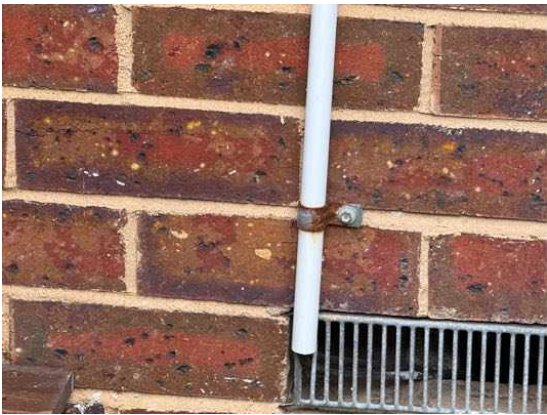
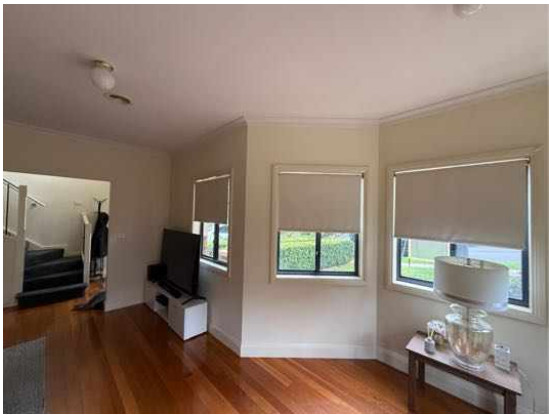
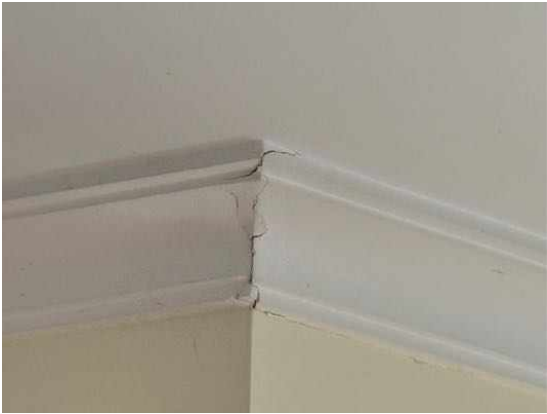
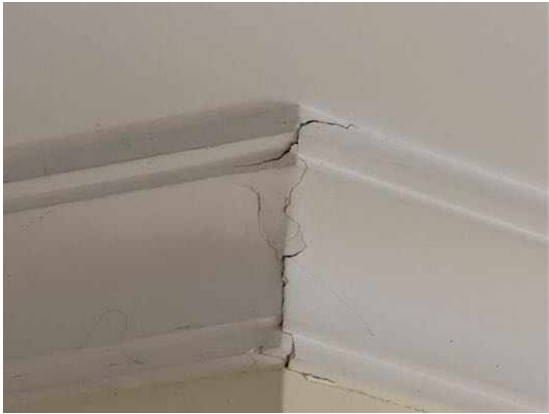
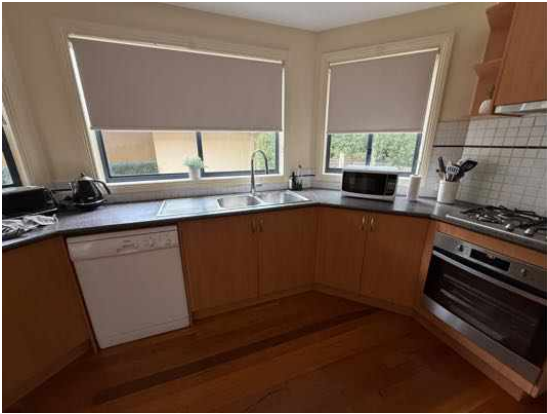
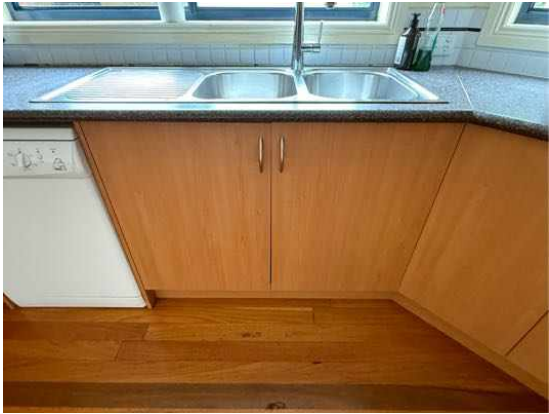
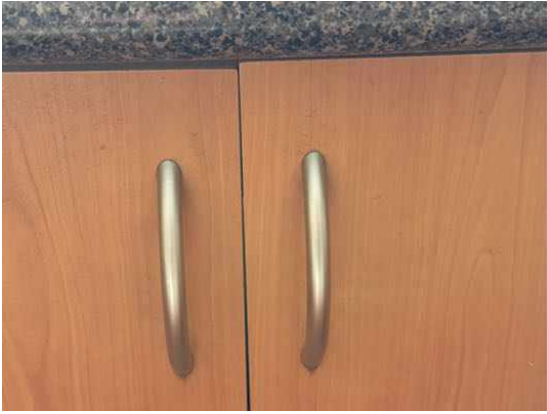
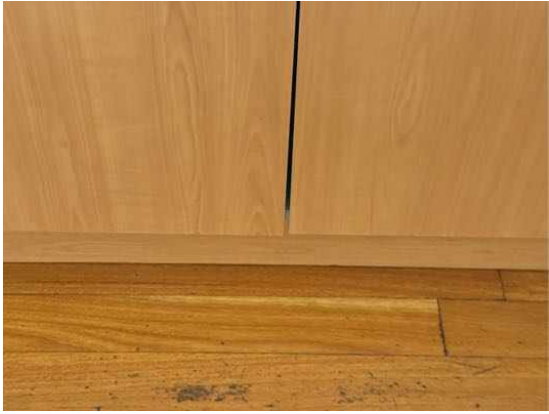
Noted Item

Building: Building 1
Location: All Areas > All Areas
Finding: Additional Photos
Information: Additional photos are provided for either future maintenance items for clients attention and or general reference. Arrows may have been included to highlight areas of importance. Please discuss these photos with your building consultant for clarification.
