Building and Timber Pest Inspection Report

Inspection Date: Wed, 7 Jan 2026

Property Address: 29/171-177 Moorefields Rd, Roselands
NSW 2196, Australia

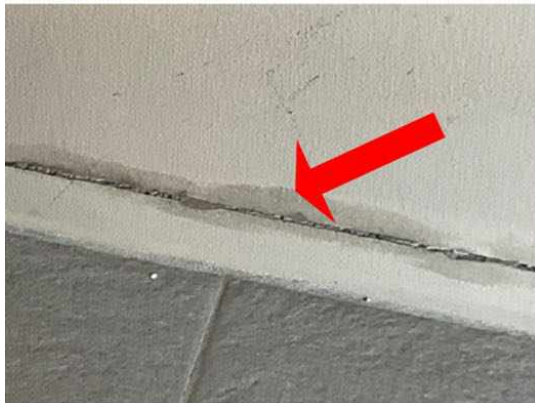
Building: Main Building
Location: Porch
Finding: Porch - Water Ingress and Staining
Information: Evidence of moisture staining and deterioration was observed to the porch area, consistent with suspected water ingress. This is likely associated with inadequate waterproofing, defective flashing, or moisture penetration from adjacent external elements.

Further investigation by a qualified building professional is recommended to identify the source of moisture and undertake rectification works to prevent ongoing damage.

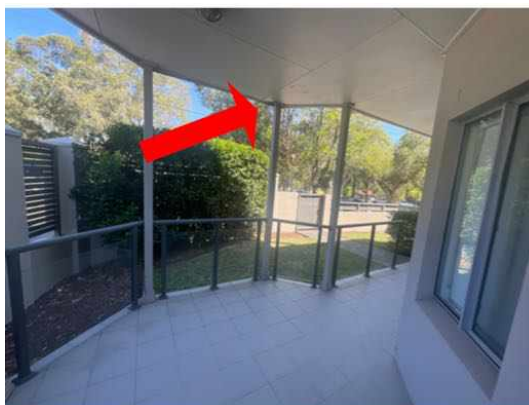
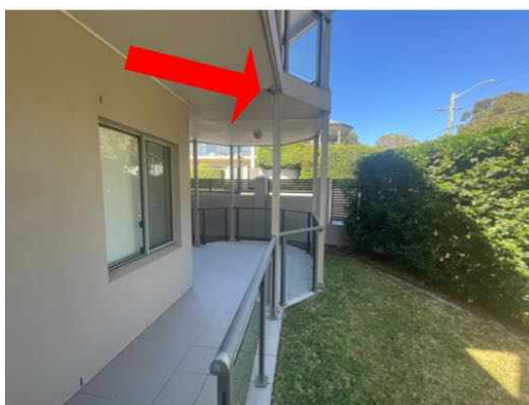
Finding 2.02

Finding: Eaves - Damaged

Information: The eaves around the external property were found to be in a visibly poor condition. The damage may have been sustained as a result of a number of possible causes, including poor roof drainage, leaking roof plumbing or minor impact damage.

The damage to the eave sheeting in this area detracts from the appearance of the structure, as well as potentially compromising the structural integrity of the roofing area.

Where eaves show moderate to severe damage, remedial works may be required. Where water damage is suspected as being the underlying cause, appointment of a licensed plumber is advised as a matter of urgency to identify the source of the water leak.

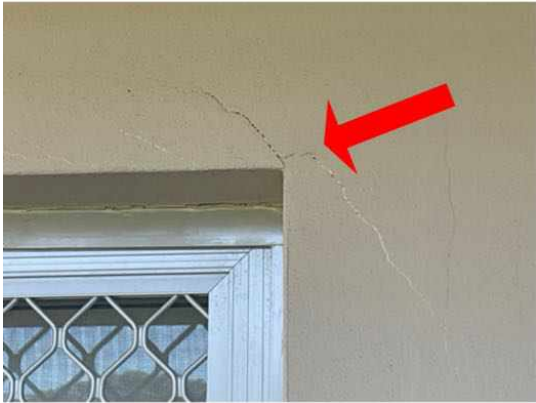
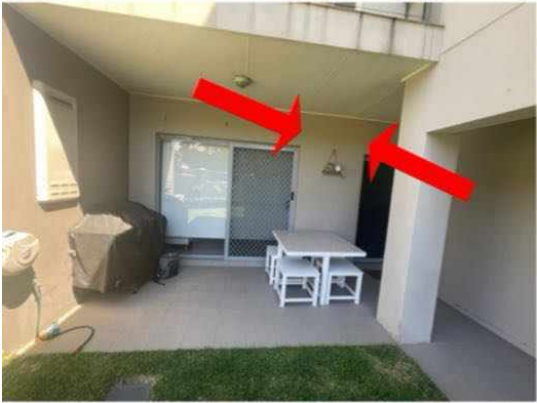
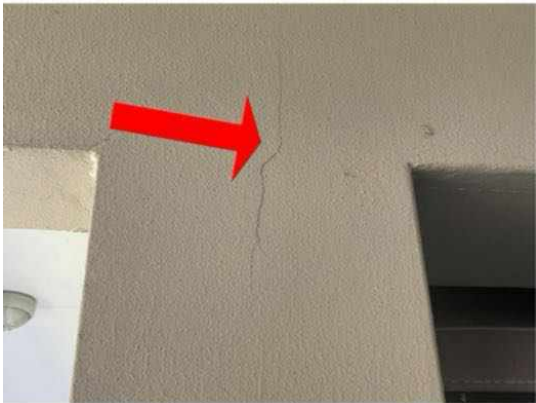
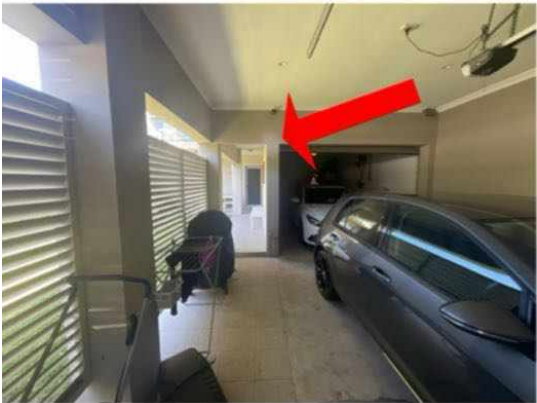
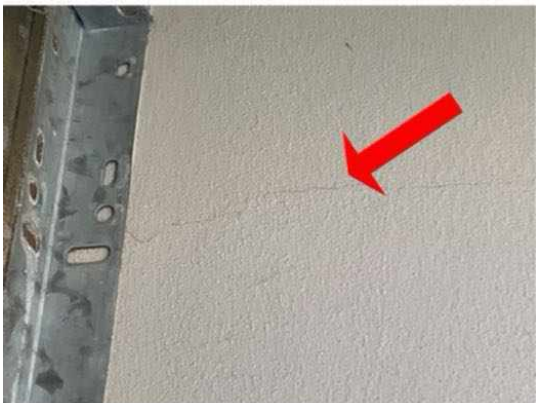
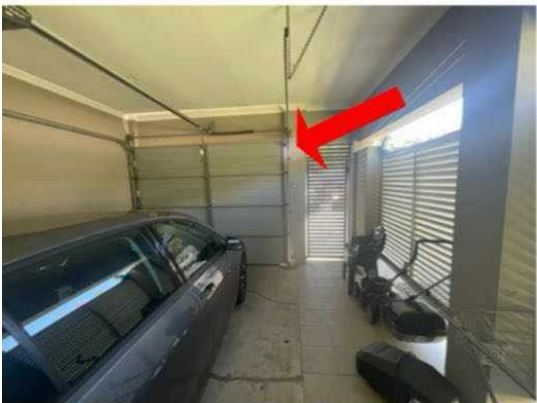
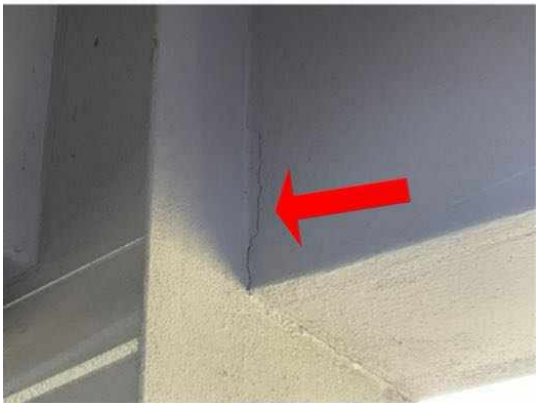
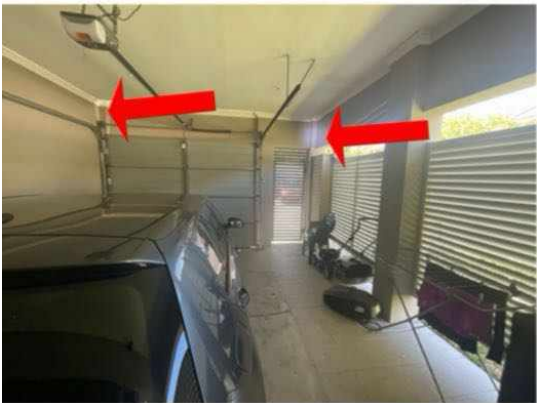
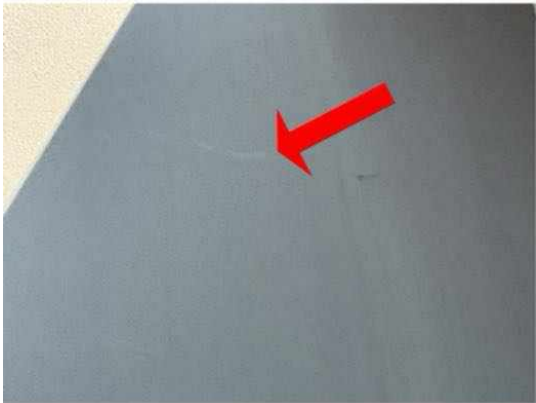
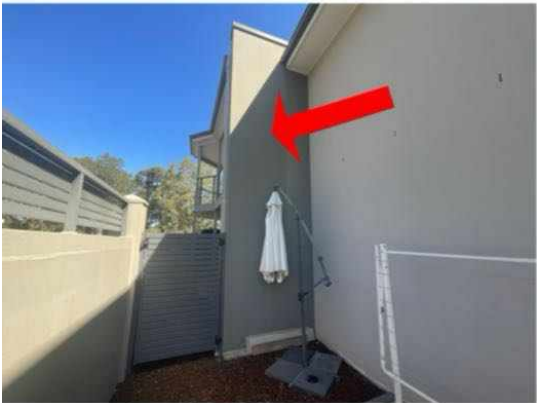
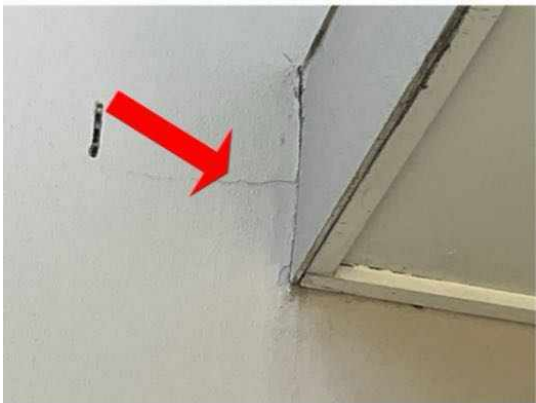
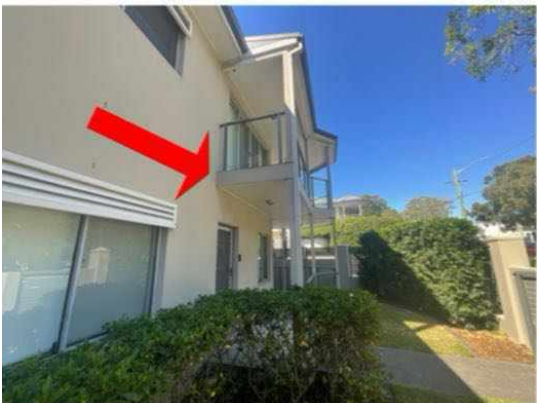
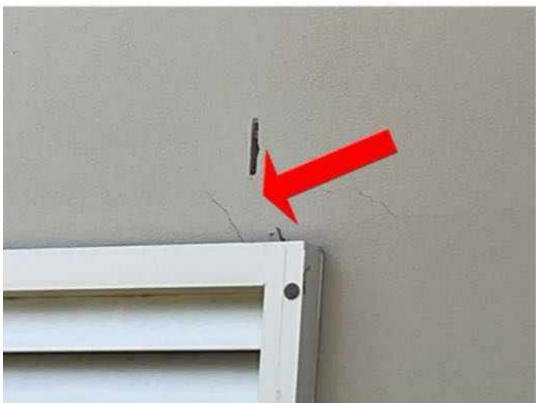
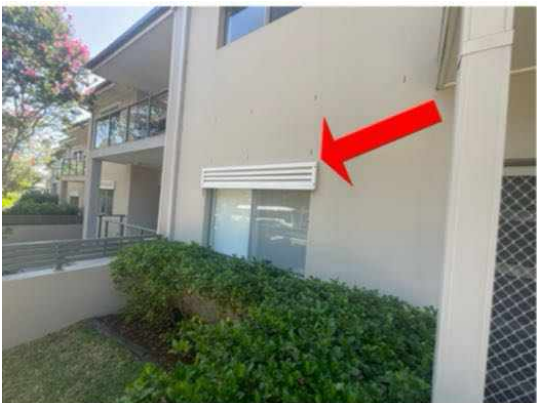
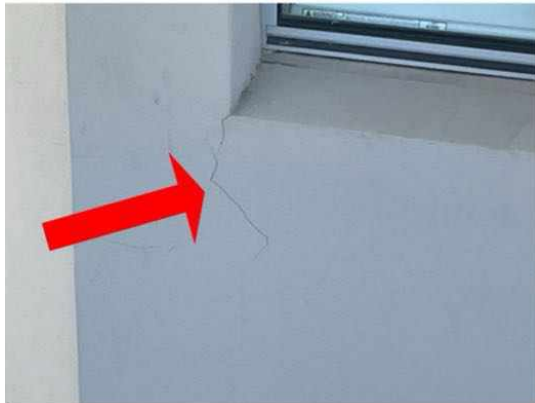
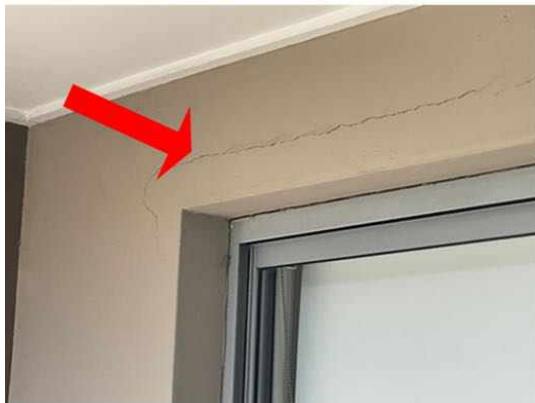
Finding 3.01

Finding: Cracks to external render - Category 1
Information: It has been observed that cracking to internal rendered surfaces has occurred. The degree of damage falls within Category 1, described as fine cracks that do not need repair and which are less than 1.0mm in width limit.

Damage of this category is not considered a defect for rectification. Always contact your building inspector should cracks widen, lengthen, or become more numerous.

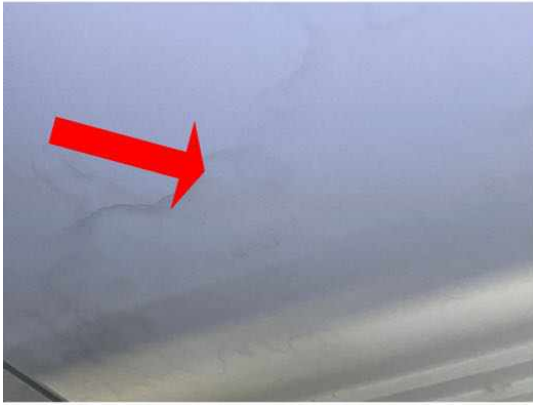
Finding: Ceiling - Water stained

Information: Water staining to ceiling linings in this area was evident at the time of inspection. Water staining indicates that surfaces have been exposed to excessive moisture over time. The minerals and other elements in the water lead to staining, which may graduate to corrosion and deterioration if left unmanaged.

While mostly an appearance defect, water staining can be indicative of more serious defects, which may be currently concealed by interior ceilings.

Where water staining is active, a licensed plumber must be consulted to identify the cause of the staining and to provide advice on any reparation works that may be required. Replacement of any damaged structures is advised.

Conversely, where water staining is old and inactive, affected building materials may be repaired or replaced at client discretion.

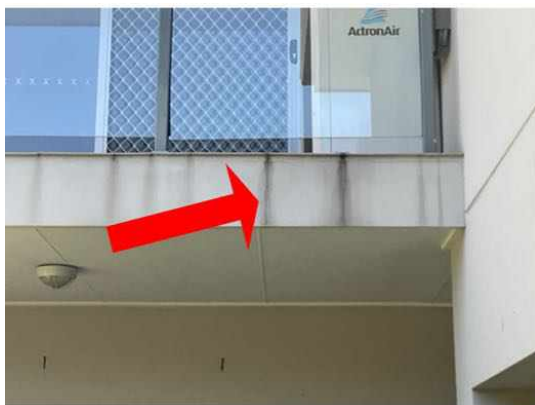
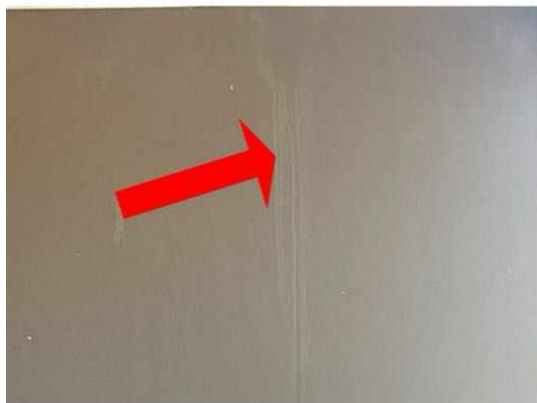
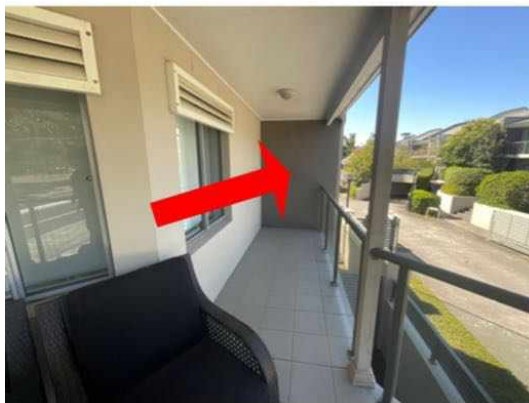
Finding 3.04

Finding: Walls - Water stained

Information: Water staining to sections of the walls in this area was evident at the time of inspection. Water staining indicates that surfaces have been exposed to excessive moisture over time. The minerals and other elements in the water lead to staining, which may graduate to corrosion and deterioration if left unmanaged.

While mostly an appearance defect, water staining can be indicative of more serious defects, which may be currently concealed by wall linings.

Where water staining is active, a licensed plumber must be consulted to identify the cause of the staining and to provide advice on any reparation works that may be required. Replacement of any broken or damaged structures is advised.

Conversely, where water staining is old and inactive, affected building materials may be repaired or replaced at client discretion.

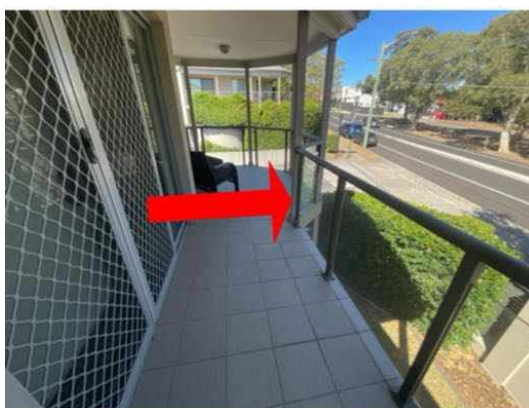
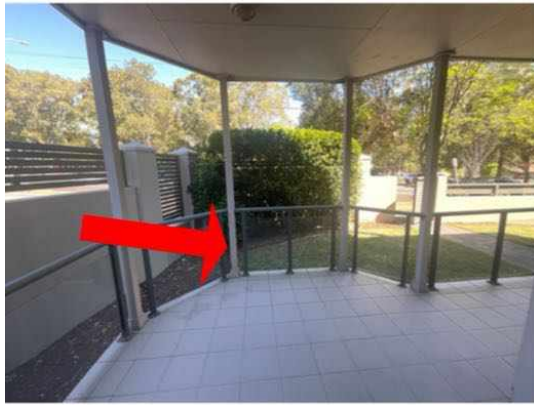
Finding 3.05

Building:	Main Building
Location:	All External Areas
Finding:	External painting deteriorated
Information:	Much of the external paintwork including but not limited to windows, fascias, guttering, veranda and other external fitments have been neglected and require attention to prepare and re-paint.

Whilst incomplete or missing paint finish is generally an appearance defect, it can also lead to the development of secondary building defects over time. Incomplete areas of paint finish expose the area to moisture, potentially accelerating the deterioration of underlying building materials.

Degraded paint finishes should be sanded back, filled, leveled and painted, as applicable. Where inadequate or missing paint protection has led to the deterioration of the associated building element, repair and/or replacement of this building element may be required.

A painting contractor should be appointed as soon as possible to perform necessary works to aid the appearance of the affected area and to ensure the area is protected against further deterioration. Alternatively, the homeowner following manufacturer instructions may perform these works.

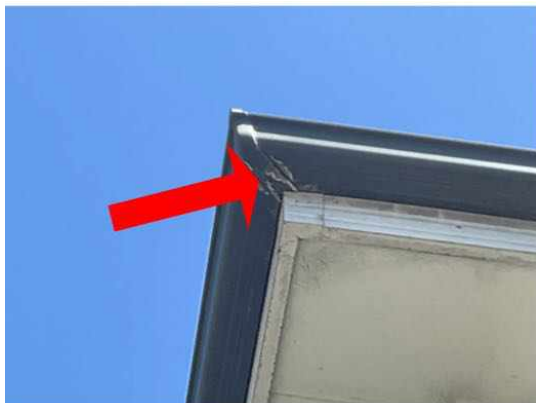
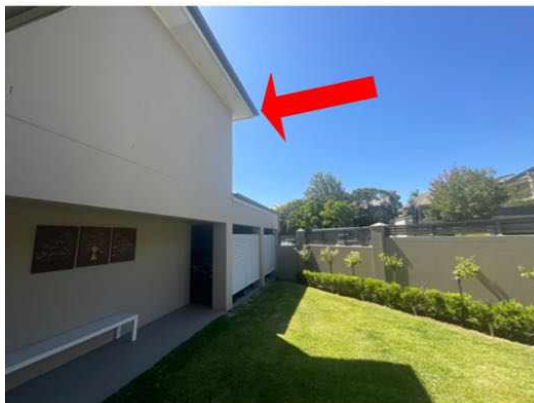
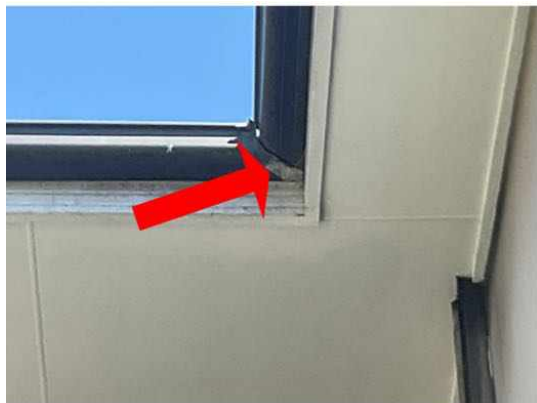
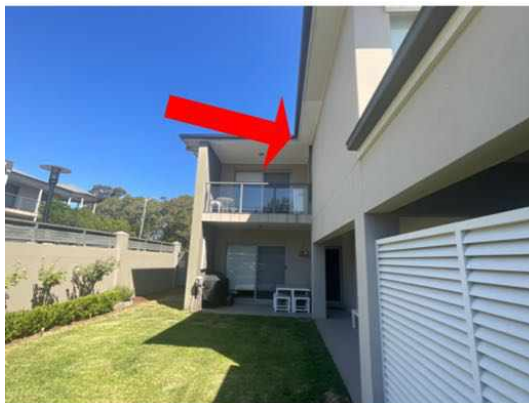
Finding 3.06

Building:	Main Building
Location:	Roof Exterior
Finding:	Water Leak - Gutters
Information:	Water leaks were found to be present to exterior plumbing work. Leaks are generally caused by deterioration of the plumbing elements over time, due to exposure to weather conditions, but may have also been caused by minor impact damage.

Such leaking creates damp conditions in the affected area, causing potential for water pooling and subsequent water damage if left unattended. These conditions may also attract termite attack, particularly if the area is subject to minimal levels of sun throughout daylight hours.

It is highly advised that a licensed plumber be appointed to rectify any water leaks that may be present. Areas of repair and replacement of plumbing fittings and fixtures may be required and, as such, a quotation should be sought.

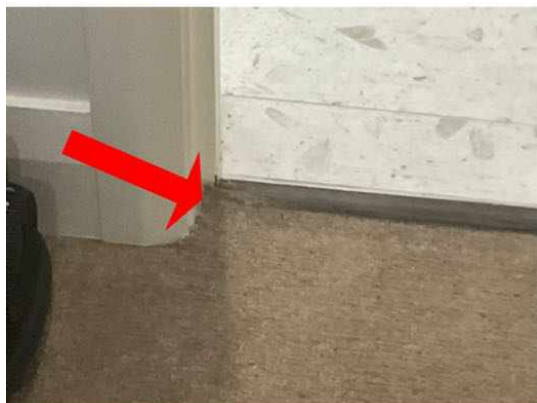
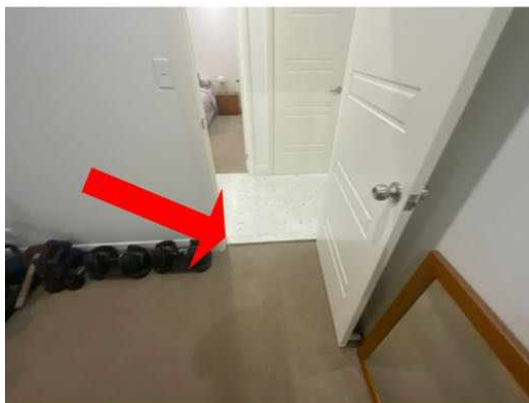
Finding 3.07

Building:	Main Building
Location:	All Internal Areas
Finding:	Carpet - damaged / deteriorated
Information:	Static Damage

Static is created through friction and as a result, the carpet snaps, crackles and pop as you walk across. Due to the dry weather and low humidity, static charges are formed within the carpet thus resulting to static damage. Although new types of carpets have anti-static agents like conductive agents and fine metal wires that protects the carpet.

Replacement of the affected carpet is required as a matter of urgency to ensure the safety of the area. Where required, remedial works should be undertaken to any associated walls and flooring showing evidence of mould.

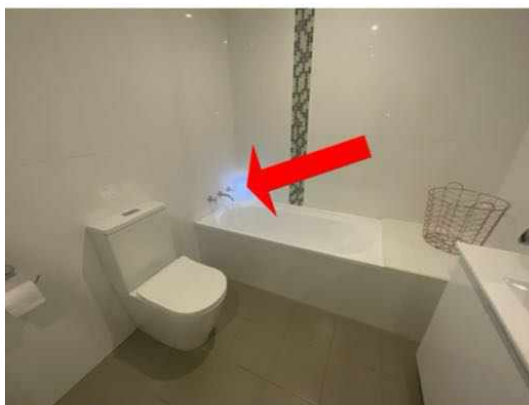
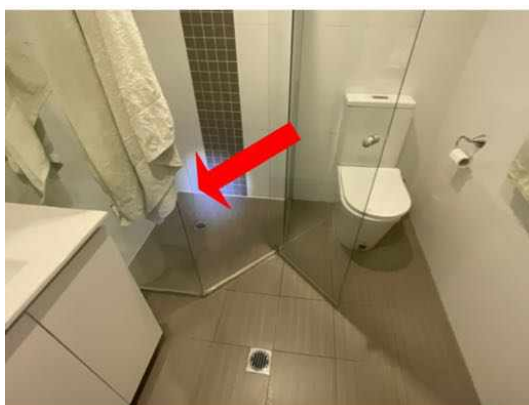
Finding 3.08

Building:	Main Building
Location:	Bathroom
Finding:	Sealant and grouting - Missing or damaged
Information:	It was noted on inspection that sealant or grout is degraded to the tiled shower alcove and or other areas of the bathroom.

There appears to be excessive mould to the sealant and grout which will likely require scraping out and replacement.

A sealant specialist or tiling contractor should be appointed to complete these works

as soon as possible

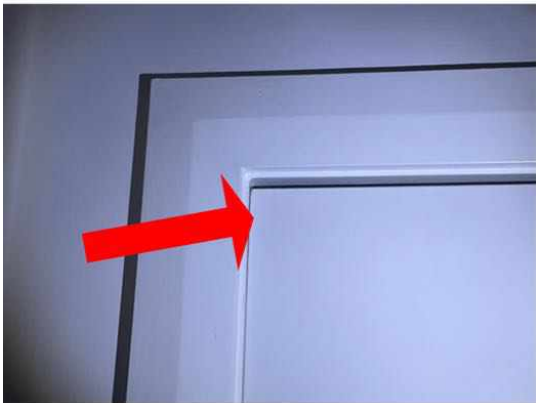
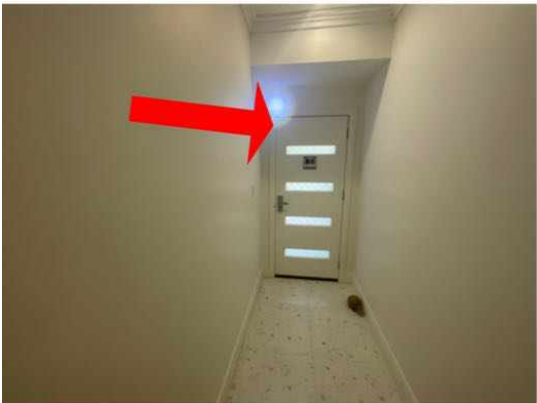
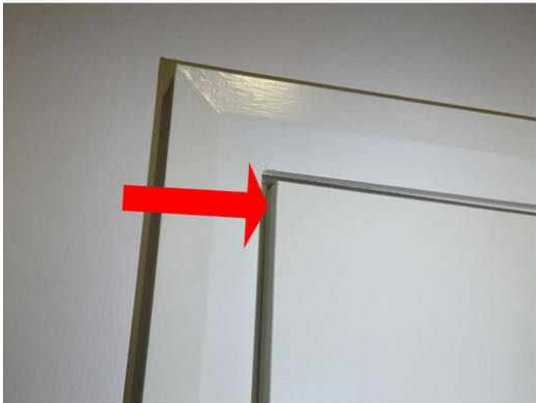
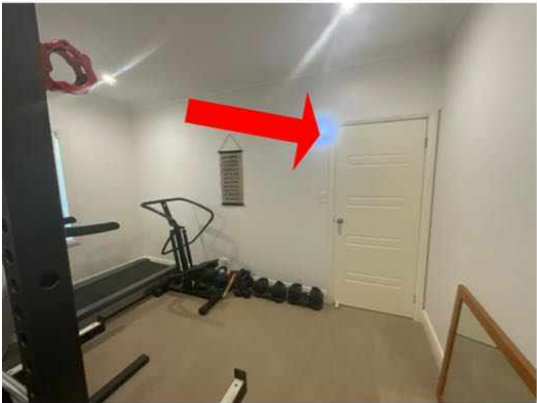
Finding 3.09

Building:	Main Building
Location:	All Internal Areas
Finding:	Door - Binding/jamming
Information:	Binding and/or jamming of this door is evident during standard operation. This defect inhibits the functionality of the affected door as well as creating potential for secondary defects to associated building elements, such as damage to the floor covering.

Where door binding/jamming appears to indicate major structural issues, a registered builder specialising in re-stumping should be appointed to provide an estimate on the cost of rectification.

For minor causes, a qualified carpenter or general handyperson should be appointed to perform minor rectification works at client discretion.

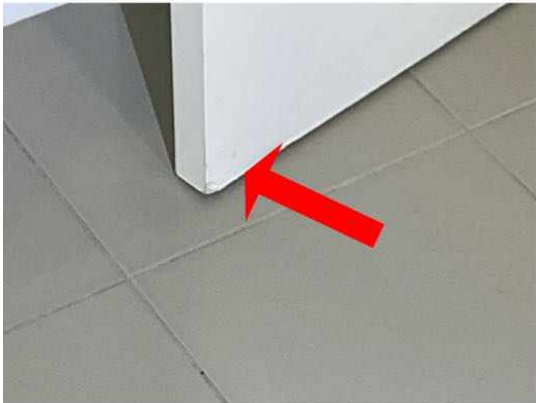
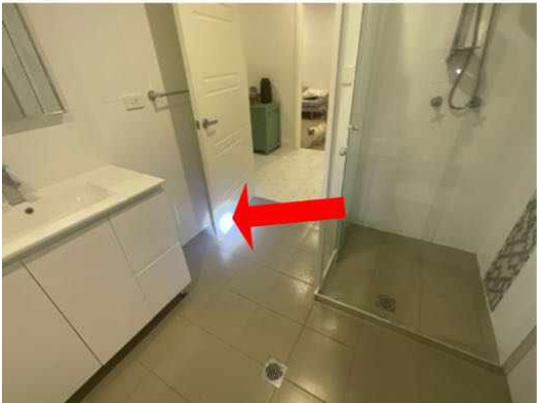
Building: Main Building
 Location: Bathroom
 Finding: Door - swelling and damage at the bottom edge
 Information: Swollen and damaged door base in bathroom due to moisture exposure. Edges show fraying and surface degradation.

Replace or seal the affected door. Ensure door edges are properly sealed to prevent future water damage.

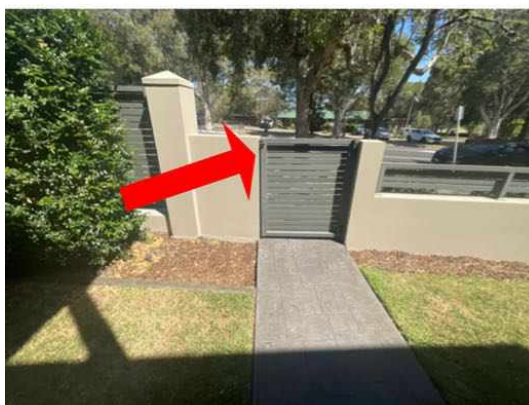
Finding 3.11

Building:	Main Building
Location:	All External Areas
Finding:	Gate - Binding / Jamming
Information:	Binding and/or jamming of this gate is evident during standard operation. This defect inhibits the functionality of the affected gate as well as creating potential for secondary defects to associated building elements, such as damage to the walls. A gate that binds to gate frame may have several causes, ranging from minor defects, such as poor installation of the gate or deteriorated hinges, through to major structural issues, such as damage to post or wall structures. For minor causes, a qualified carpenter or general handyman should be appointed to perform minor rectification works at client discretion.

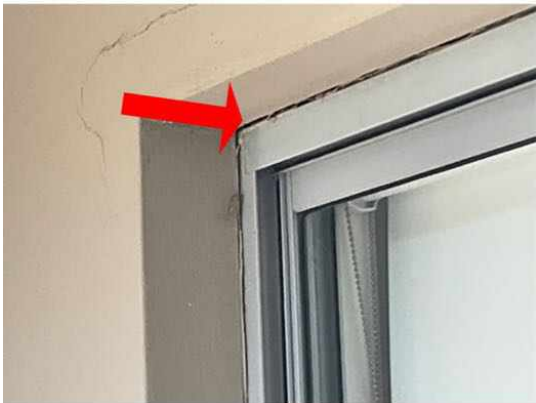
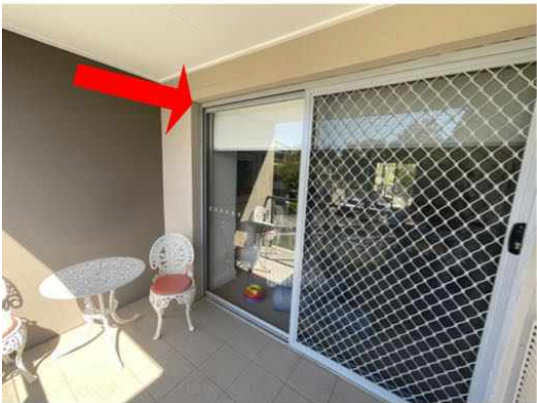
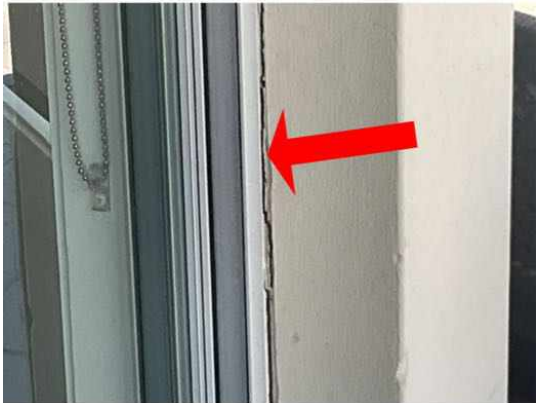
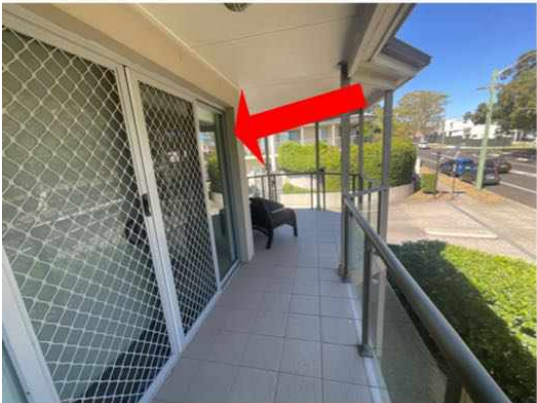
Finding 3.12

Building:	Main Building
Location:	Exterior walls
Finding:	External Door Seals - Missing
Information:	Sealing external doors is a requirement of the Building Code of Australia which may not be applicable to this particular property however missing seals adversely affect the energy efficiency of the structure.

Where external door seals are missing the area is no longer weather-tight. Insulation of the area against external weather conditions will also be compromised.

It is recommended that all missing weather seals be installed by a general handyman or a licensed carpenter to prevent any damage and to restore the external door seals to a fully functional level.

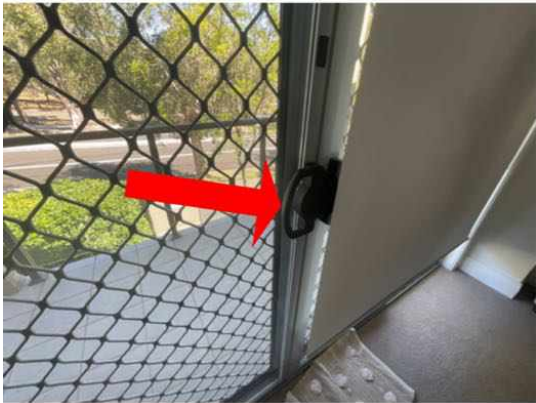
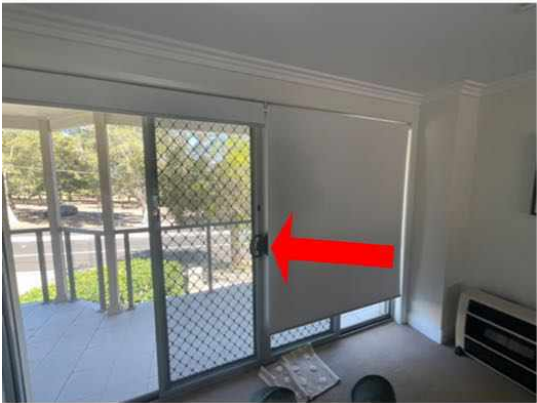
Finding 3.13

Building: Main Building
Location: Balcony - front
Finding: Fitting (door handle) - Loose
Information: The fitting in this area is loose and requires adjustment to tighten.

If left unmanaged, the fitting may further deteriorate, causing potential for the development of other minor secondary defects.

A relevant tradesperson should be appointed to perform these rectification works at discretion of the client.

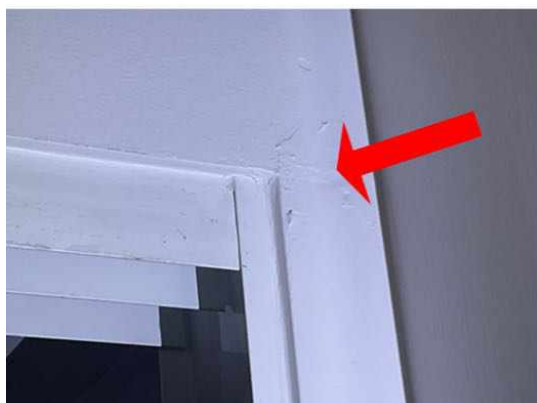
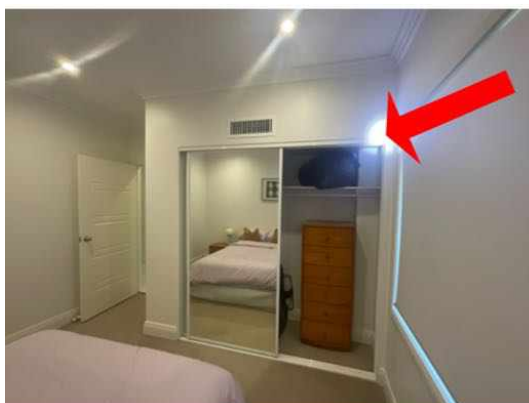
Finding 3.14

Building:	Main Building
Location:	All Internal Areas
Finding:	Cracking - Damage Category 1 - Fine (up to 1mm)
Information:	Although fine cracks are quite noticeable, they are often only considered to be an appearance defect, and usually do not indicate any structural damage. Generally, the cause of a fine crack is indicative of a separation between building materials and finishes (e.g. paint, plaster, etc.) along joins.

Cracking of this nature can generally be repaired with minor sanding, filling and/or repainting. Such works should be performed by a qualified painter or a general handyman.

Monitoring of all cracking should be conducted frequently. Always contact a building inspector should cracks widen, lengthen, or become more numerous.

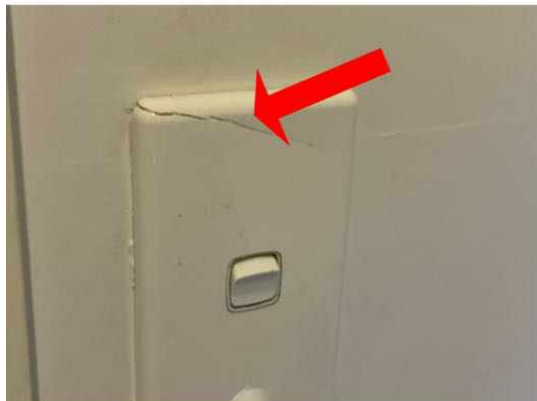
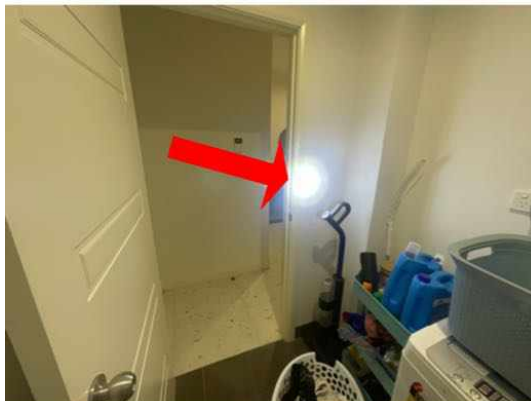
Finding 3.15

Building:	Main Building
Location:	Laundry
Finding:	Switches - Damaged/Faulty
Information:	The switches in this area was found to be damaged or faulty at the time of inspection. This occurs generally when the building materials have either aged and decayed or as a result of impact damage (accidental or deliberate). This damage may also have occurred during installation.

Repair and/or replacement of the switches is advised to ensure the fixture and it's associated structures are safe and fully operational. A licensed electrician should be appointed to repair/replace the light switch as soon as possible.

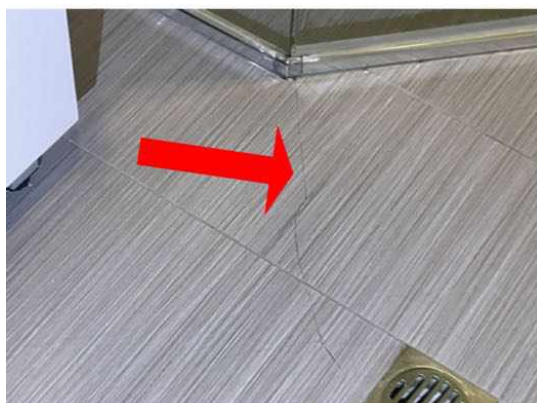
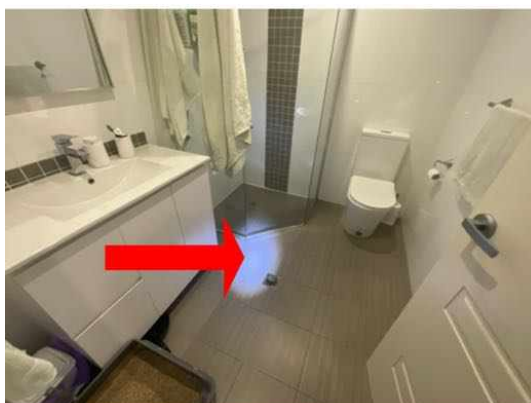
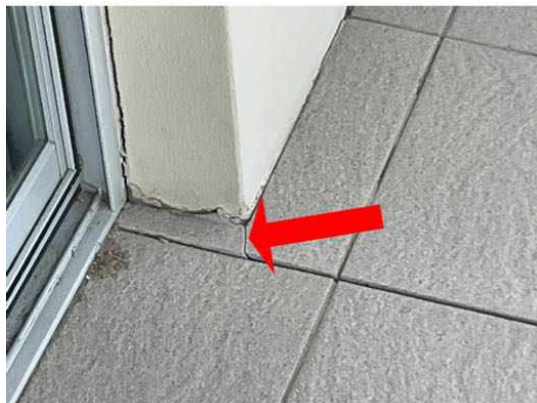
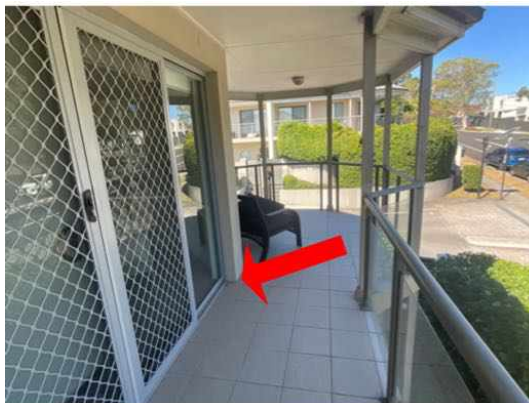
Finding 3.16

Building: Main Building
 Location: Bathroom > Level 1, Upstairs
 Finding: Tiles - Cracked or damaged
 Information:

Cracking was evident to the tiling in this area at the time of inspection. While the cracking appears to be minor, this area is frequently exposed to water, allowing potential for water penetration into adjoining sections of walls or flooring.

If left unmanaged, water penetration to these areas may lead to subsequent water damage, which is likely necessitate repair work to affected building elements.

A tiling contractor should be appointed to ensure that no further water damage occurs. The re-application of silicone and grouting throughout remaining tile work is also advised, to further protect the area against water penetration.

Where water penetration has led to water damage, appointment of a relevant tradesperson may be required to repair damaged building elements.

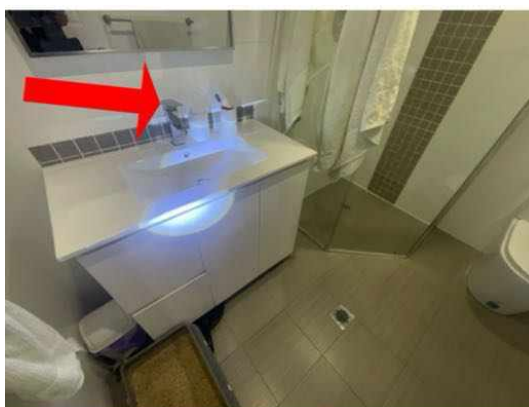
Finding 3.17

Building:	Main Building
Location:	Ensuite
Finding:	Fitting (tap ware) - Loose
Information:	The fitting in this area is loose and requires adjustment to tighten.

If left unmanaged, the fitting may further deteriorate, causing potential for the development of other minor secondary defects.

A relevant tradesperson should be appointed to perform these rectification works at discretion of the client.

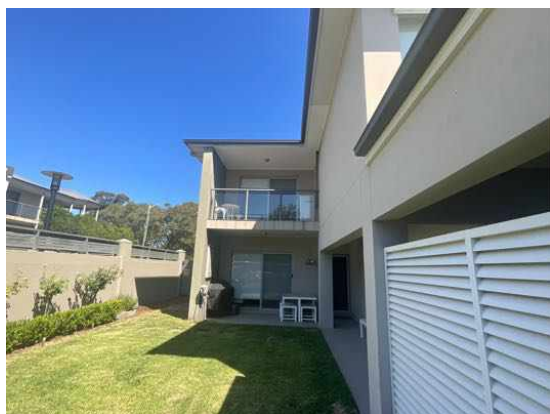
Building: Main Building
Location: All Areas
Finding: Garden Beds - Conditions Conducive to Termites
Information: Garden beds were found to be evident in the garden area. These garden beds can include untreated timber, and with a combination of moisture from watering hosing can make conditions conducive to termite activity and termite ingress.

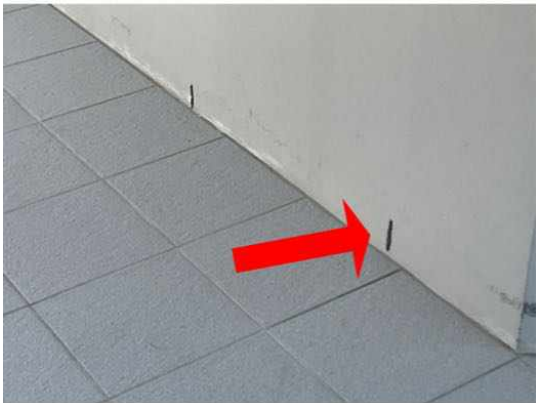
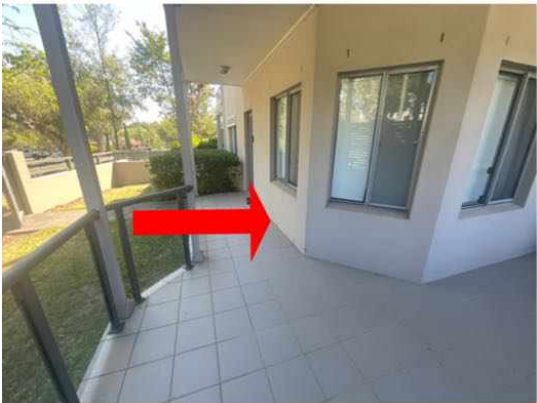
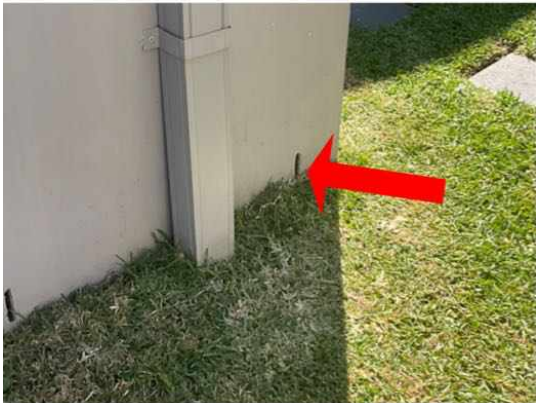
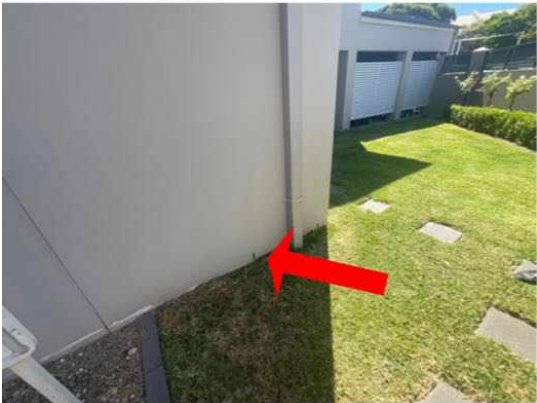
Finding 6.02

Building:	Main Building
Location:	All Areas
Finding:	Bridging or breaching of termite barriers - weep holes
Information:	Bridging is the spanning of a termite barrier or inspection zone so that subterranean termites are provided with passage over or around that barrier.

Weep holes in the exterior brickwork of the property are designed to allow condensation that may build up between the brickwork and subsequent timber framework to drain from within the wall hence preventing any deterioration of the timber building elements.

Additionally build-up of moisture is likely to occur if weep holes are covered further attracting termite activity to these areas.

It is highly recommended that weep holes are left exposed in all areas throughout the external property. Therefore if any termite activity leading into weep holes becomes easily detectable during frequent pest inspections.

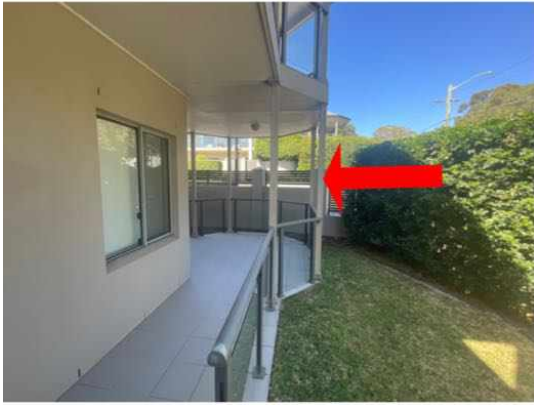
Finding 6.03

Building: Main Building
Location: All Areas
Finding: Timber - exposed to weather
Information: External timbers that are frequently exposed to harsh weather conditions require adequate protection in order to maintain their condition. Where timbers have not been painted or treated adequately, general deterioration is likely to occur at an accelerated rate.

If left unattended, replacement of these timbers is likely to be necessary in the short-term future. Adequate treatment of these timbers is required as soon as possible by a painting contractor or general handyman.

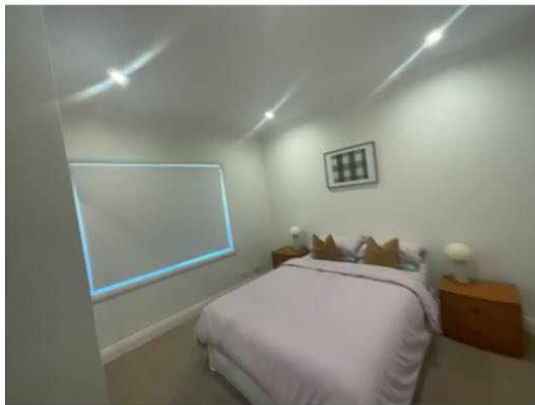
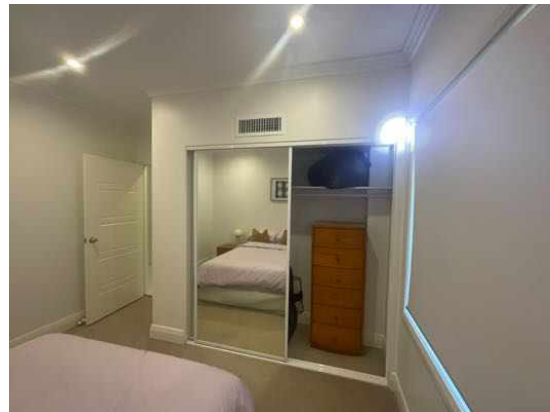
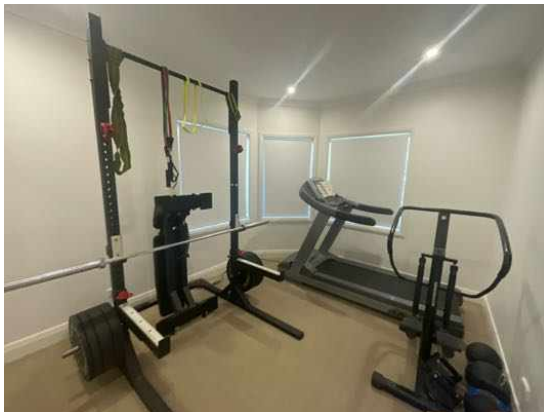
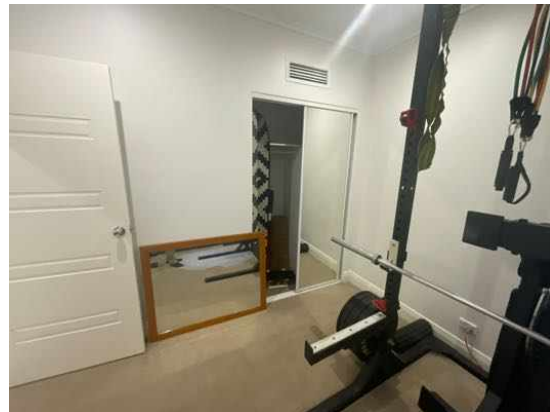
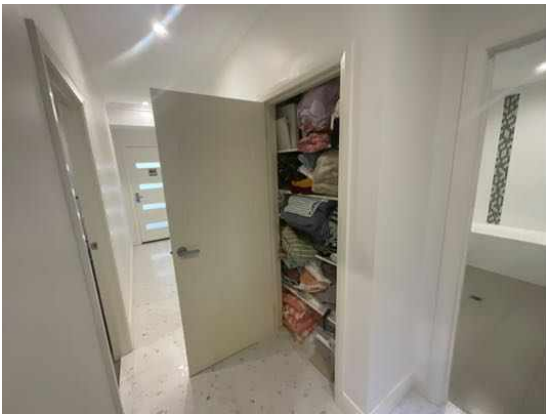
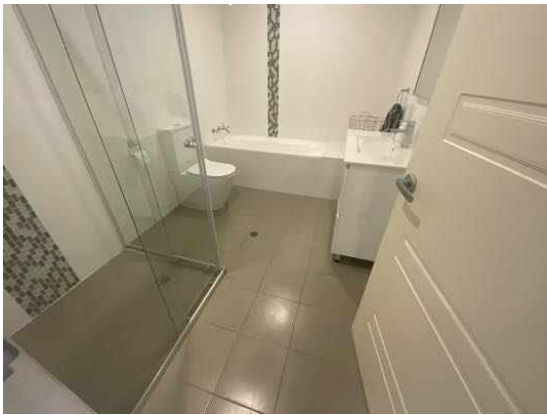
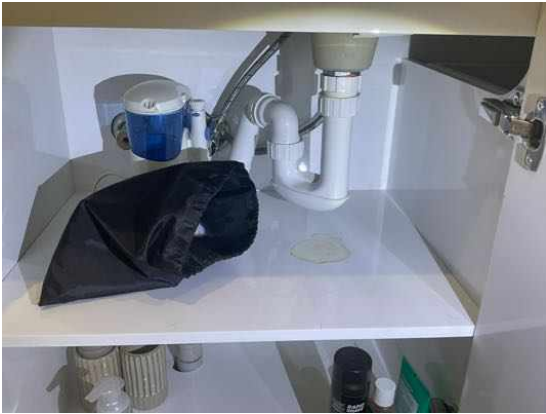
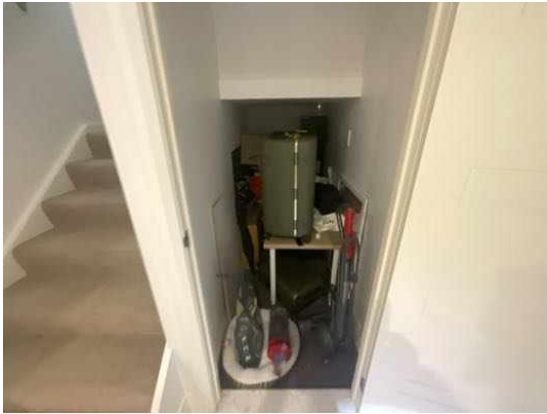
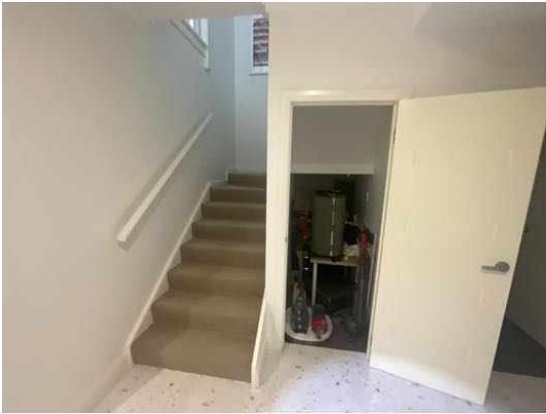
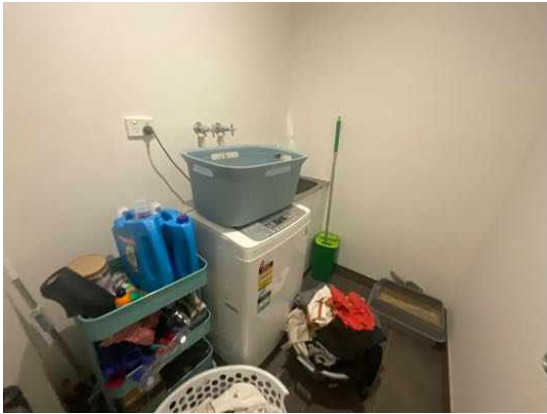
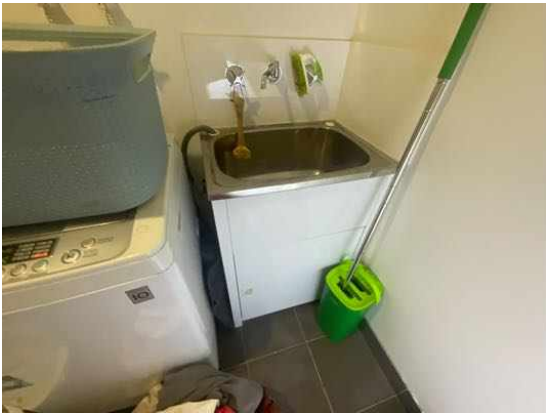
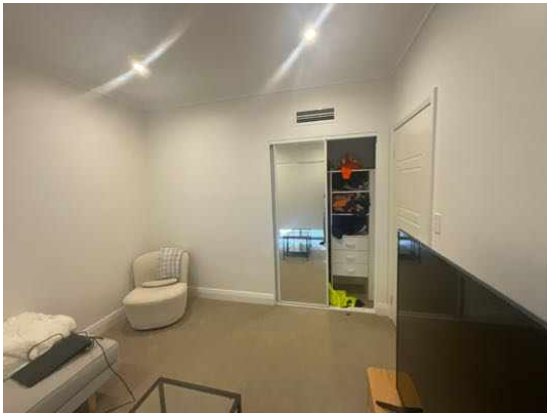
Building: Main Building
Location: All Areas
Finding: Additional Photos - Obstructions and Limitations
Information: These photographs are an indication of the obstructions and limitations which impeded full inspection of the property at the time of inspection. These obstructions can hide an array of defects and should be removed to allow full inspection to be carried out. A re-inspection is recommended once the areas are made accessible.
