Building and Timber Pest Inspection Report

Inspection Date: Wed, 7 Jan 2026

Property Address: 29/171-177 Moorefields Rd, Roselands
NSW 2196, Australia

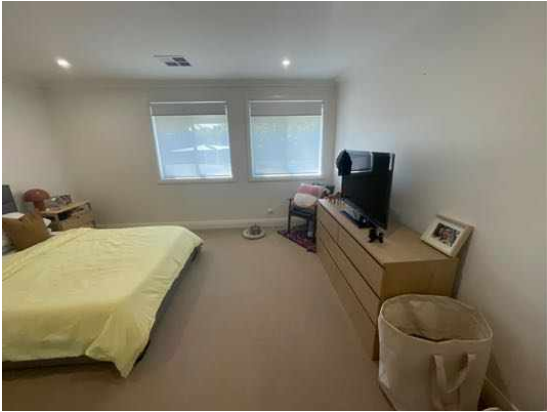
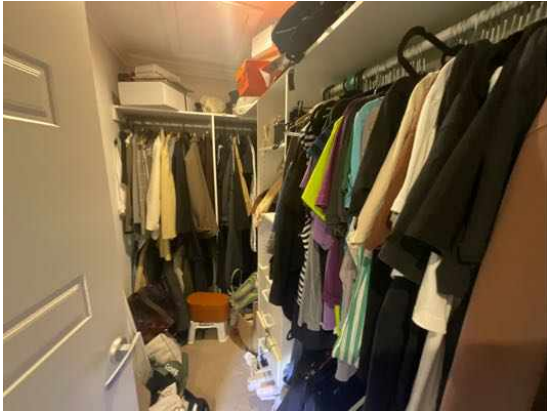
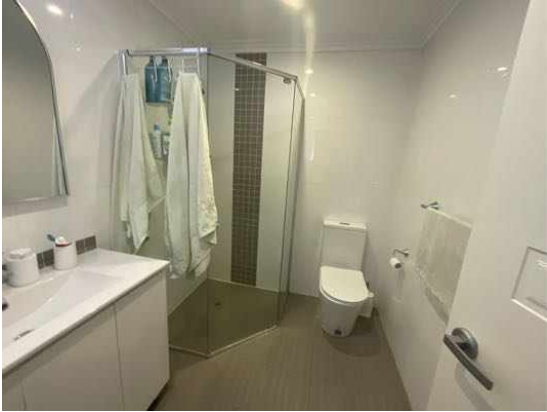
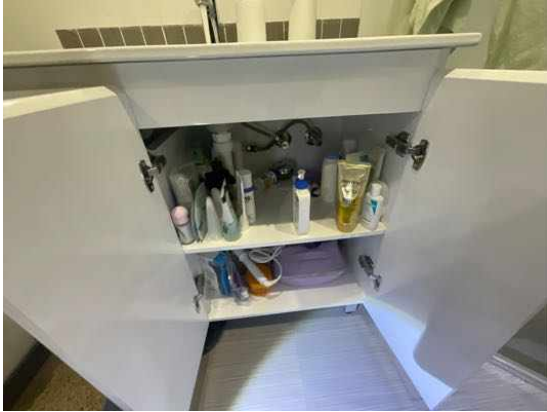
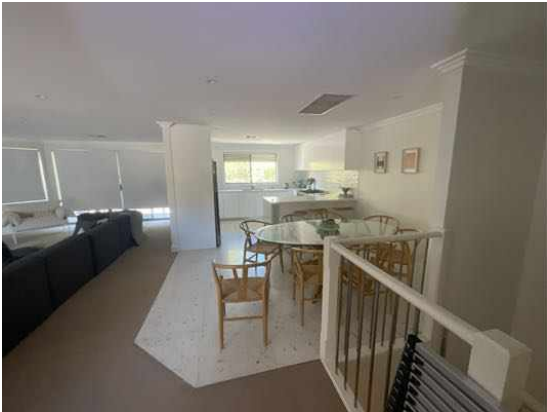
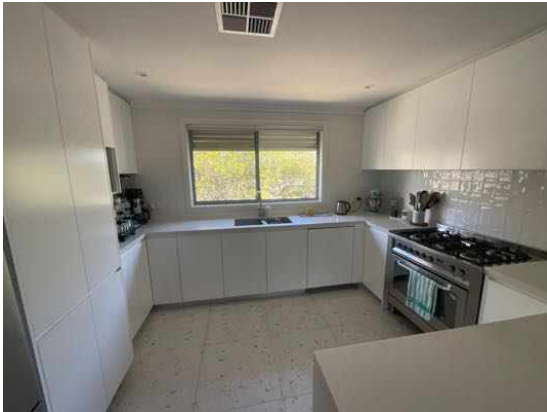
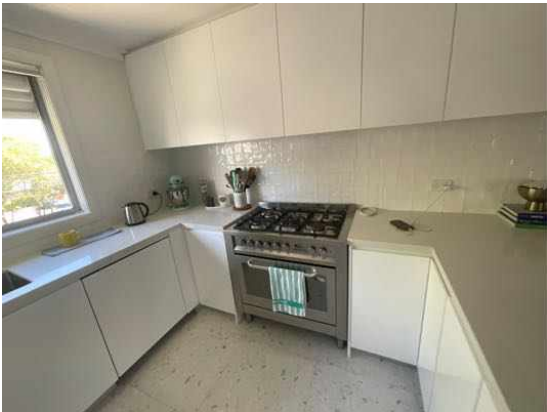
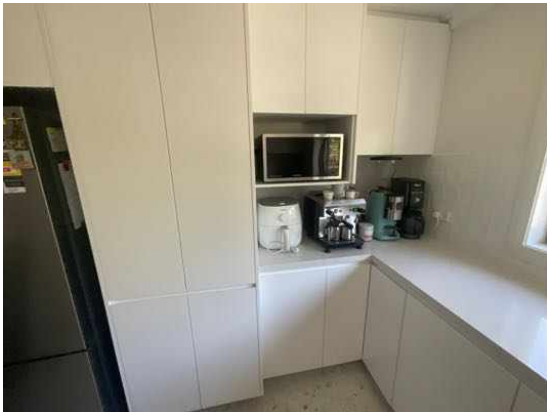
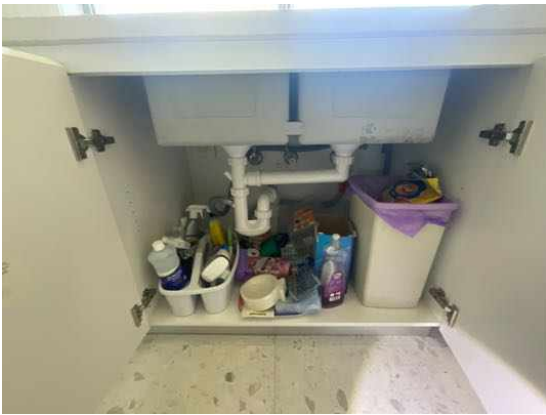
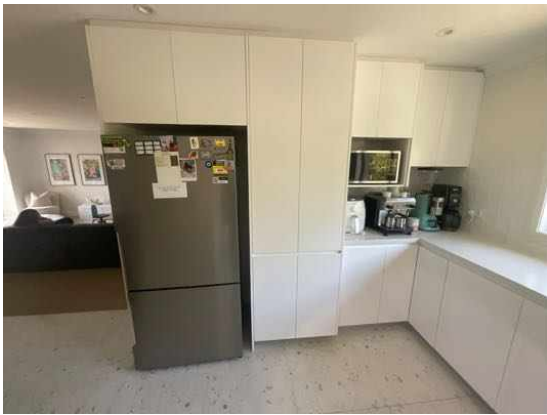
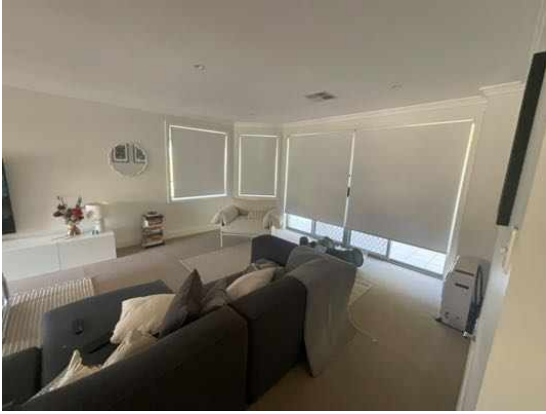
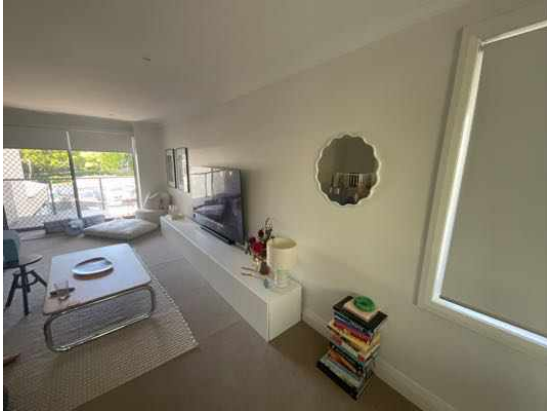
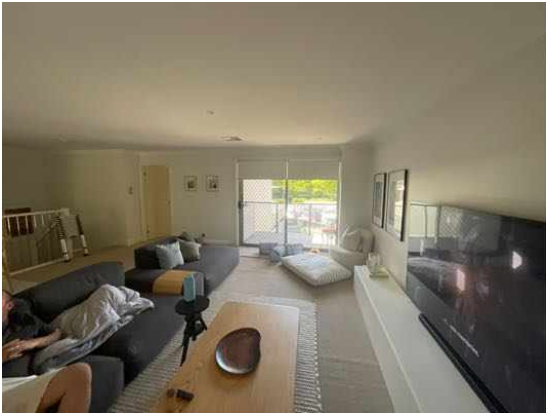
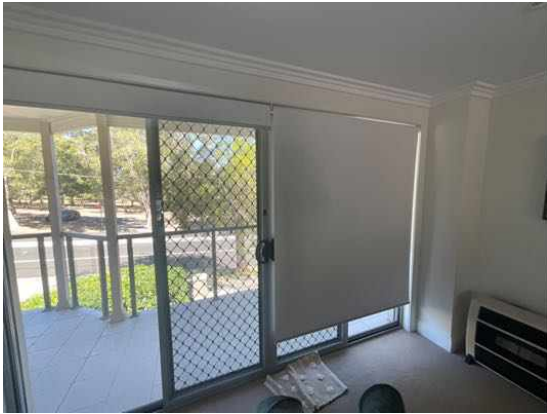
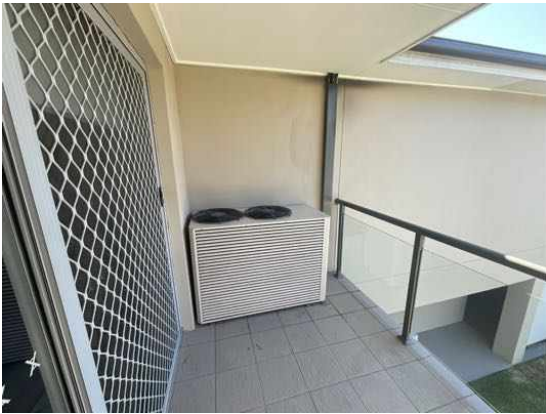
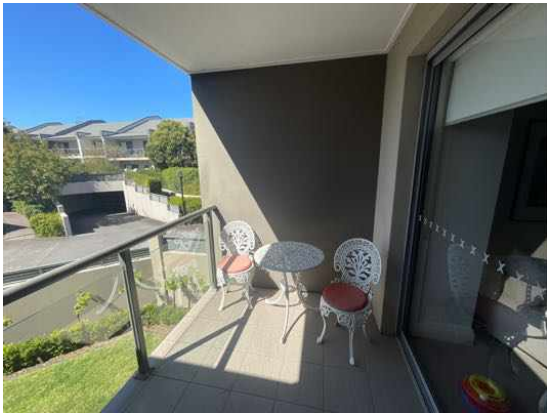
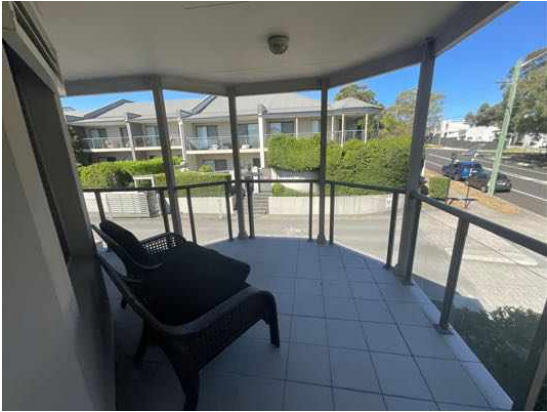
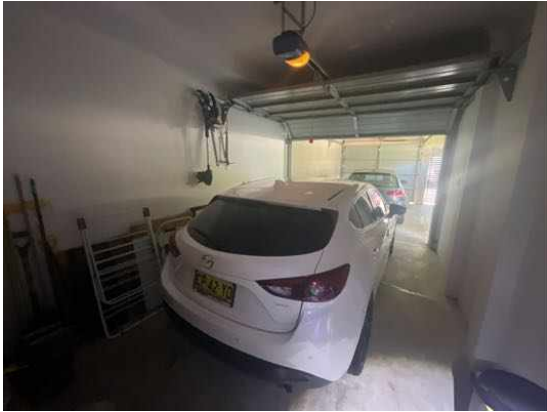
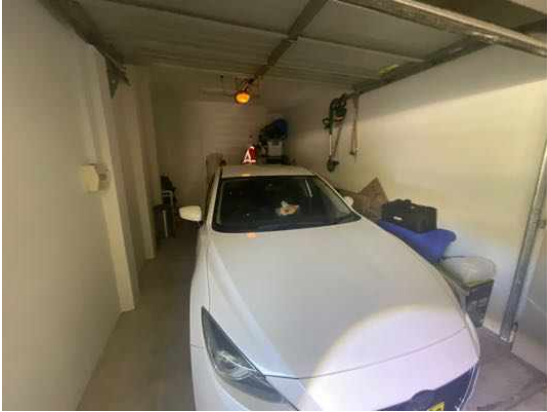
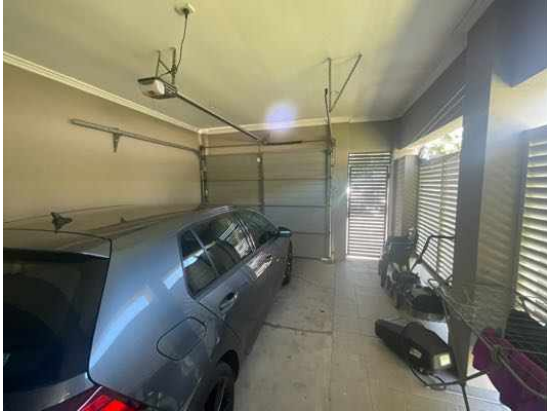
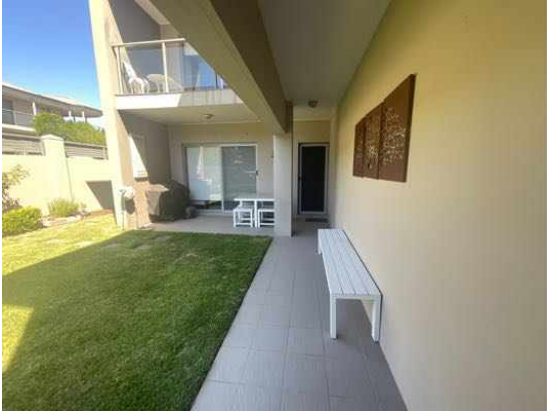
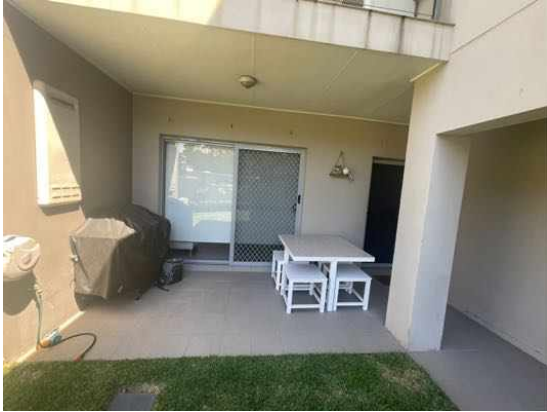
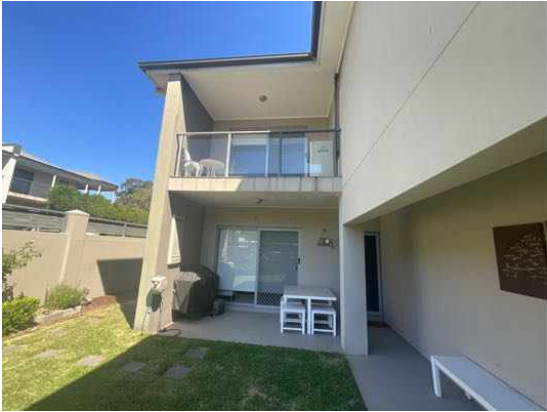
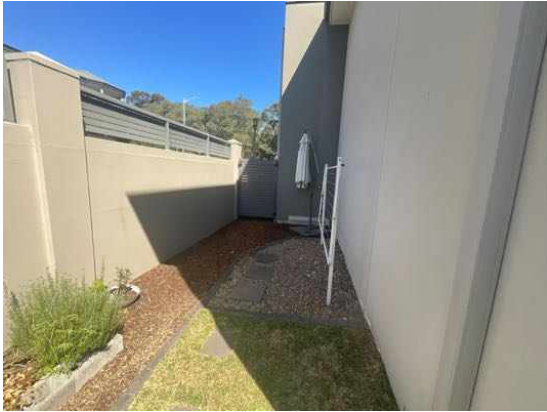
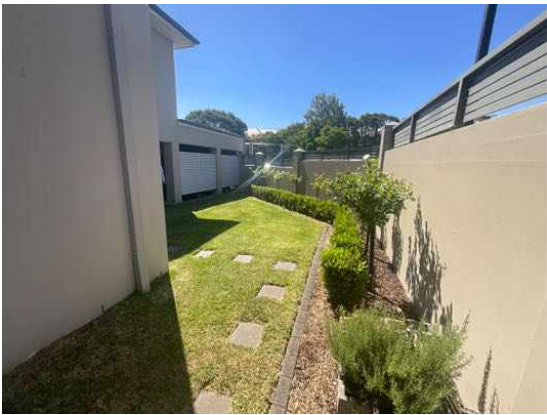
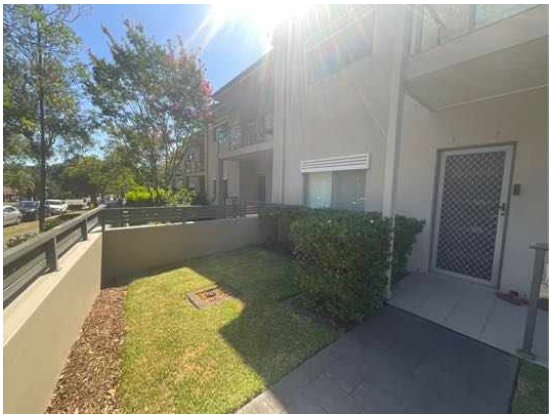
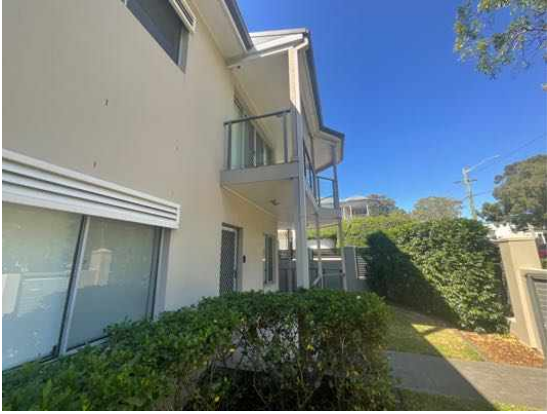
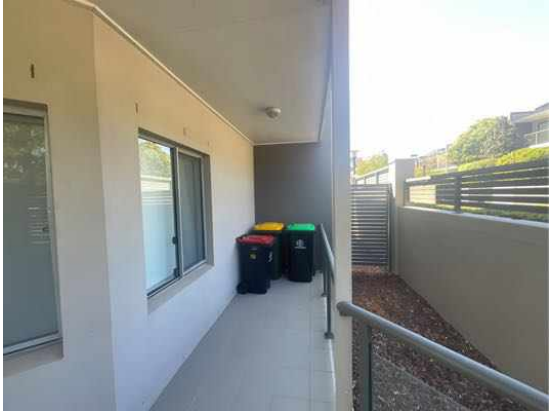
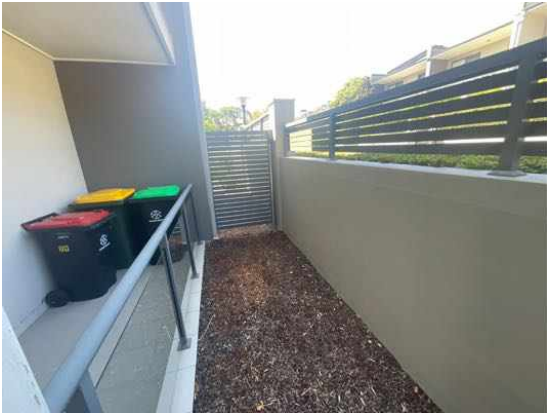
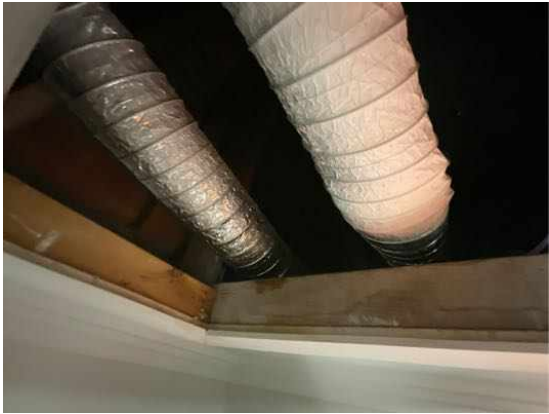
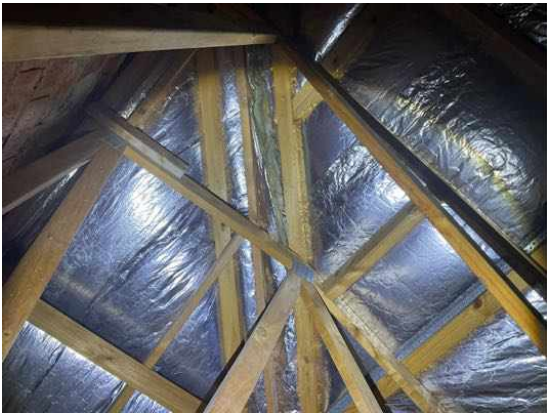
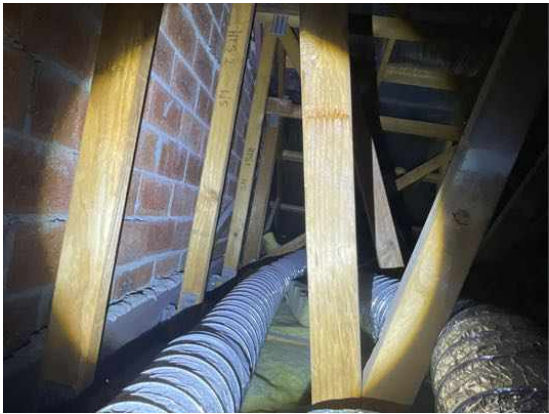
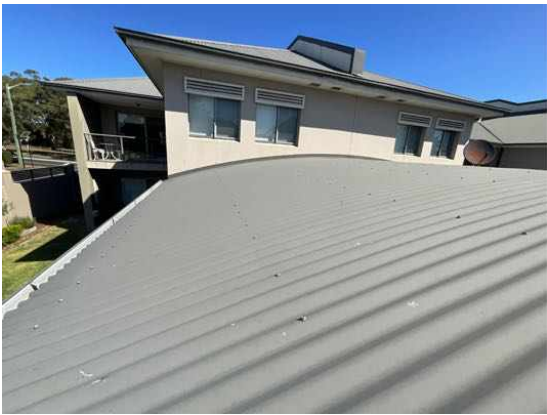
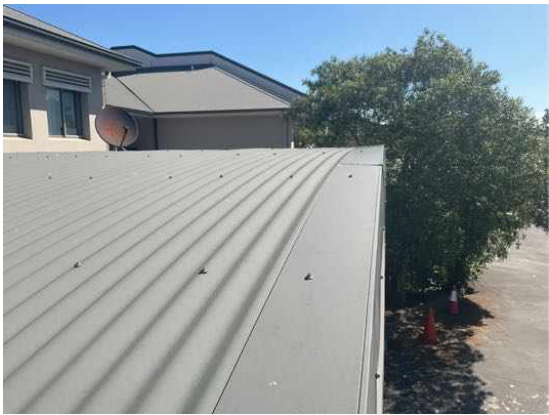
Building: Main Building
Location: All Areas
Finding: Additional Photos - Obstructions and Limitations
Information: These photographs are an indication of the obstructions and limitations which impeded full inspection of the property at the time of inspection. These obstructions can hide an array of defects and should be removed to allow full inspection to be carried out. A re-inspection is recommended once the areas are made accessible.

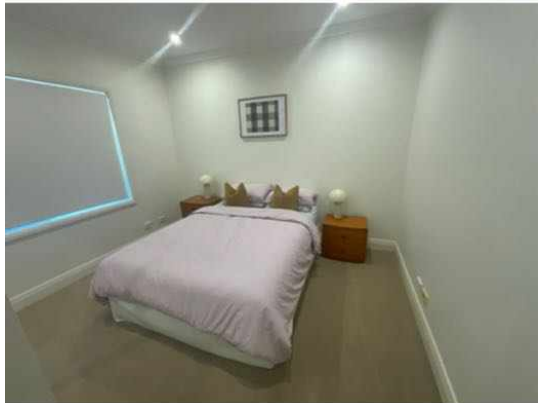
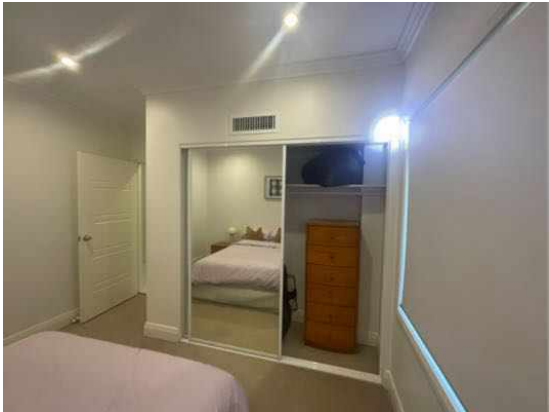
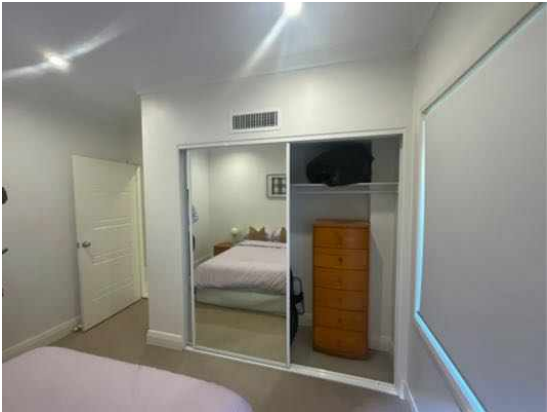
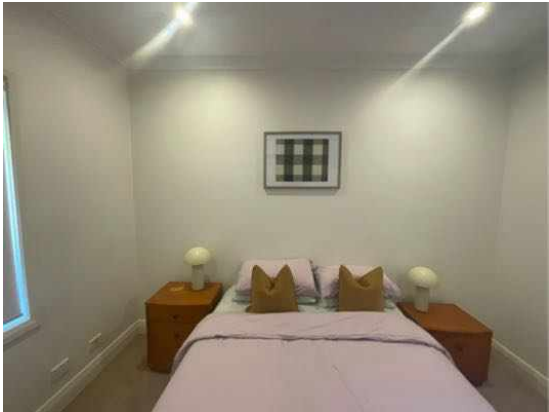
Building: Main Building
Location: All Areas
Finding: Additional Photos
Information: Additional photos are provided for your general reference

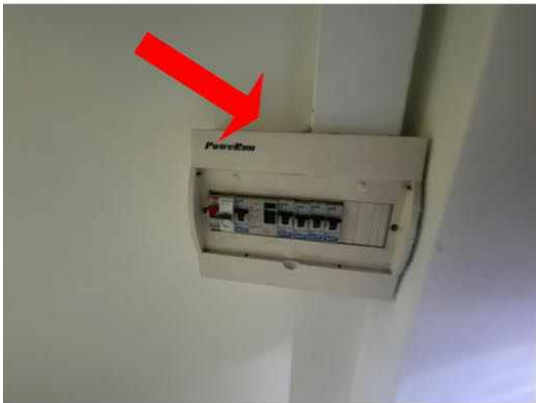
Noted Item

Building:	Main Building
Location:	All Areas
Finding:	Termite Management System - no evidence of a chemical installation
Information:	The application of a post-construction chemical termite barrier is highly recommended for all properties, particularly if live termite activity has been found on the site previously. Such barriers are highly effective in preventing termite attack on any timber building elements throughout the property.

A durable notice should be placed in the switchboard unit to indicate current termite barriers. At the time of inspection, it appeared as though no termite management system has been installed, with no evidence to suggest preventative works taking place.

The client may consider gaining further advice from a pest controller as to the costs and procedures involved with this application. It is recommended that obtaining such advice be a short-term priority.
