Building and Timber Pest Inspection Report

Inspection Date: Sat, 7 Feb 2026

Property Address: 15/49 Maranda St, Shailer Park QLD 4128,
Australia

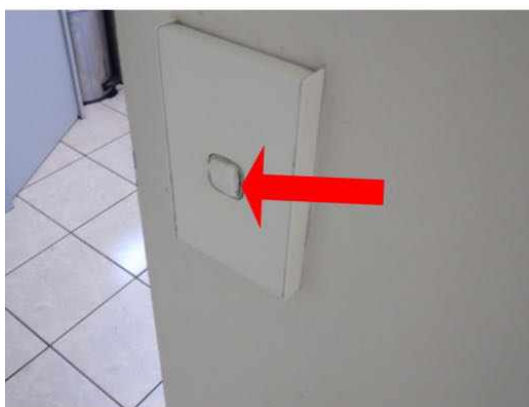
Building:	Main Building
Location:	Hallway > Front Right
Finding:	Light Switch
Information:	At the time of inspection the light switch activator in the hallway area was loose in the cover panel.

A licensed electrician should be engaged to repair or replace the light switch fitting.

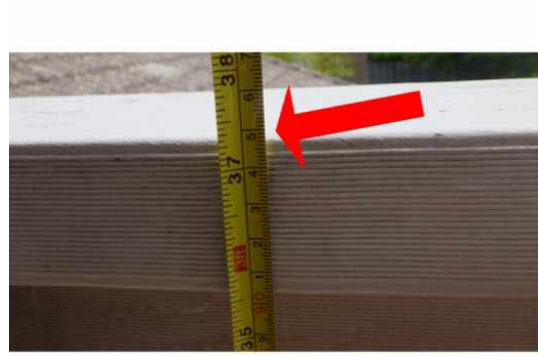
Finding 1.02

Building:	Main Building
Location:	Balcony > Existing
Finding:	Balustrade - Suspected Non-Compliance
Information:	The upper level balcony area balustrade was measured and found to be (.950mm high) less than the present building regulation requirement of 1000mm high.

Some changes to the building regulations are made to ensure the safety of all inhabitants and balustrades are definitely one of those crucial regulations.

A registered builder should be contacted to discuss possible rectification solutions.

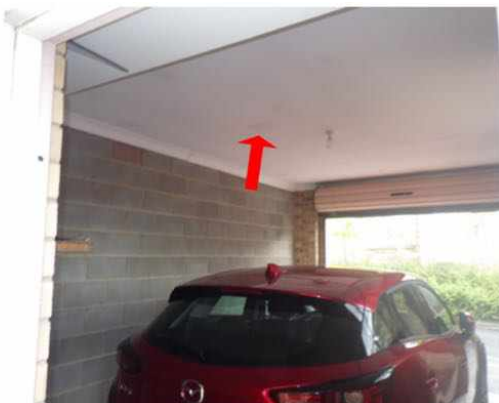
Building: Garage
 Location: Garage > Centre
 Finding: Ceiling - Water stained
 Information: Water staining to ceiling linings in the garage area was evident at the time of inspection. Water staining indicates that surfaces have been exposed to excessive moisture over time. The minerals and other elements in the water lead to staining, which may graduate to corrosion and deterioration if left unmanaged.

While mostly an appearance defect, water staining can be indicative of more serious defects, which may be currently concealed by interior ceilings.

Where water staining is old and inactive, affected building materials may be repaired or replaced at client discretion.

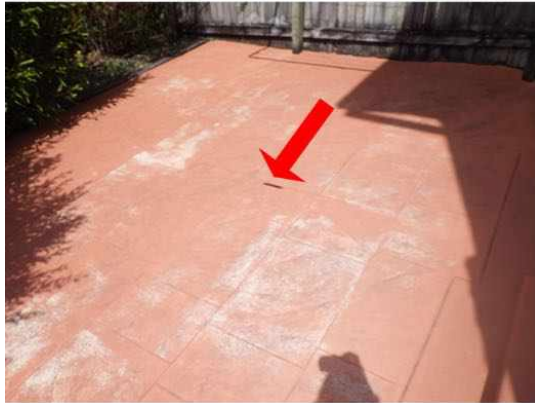
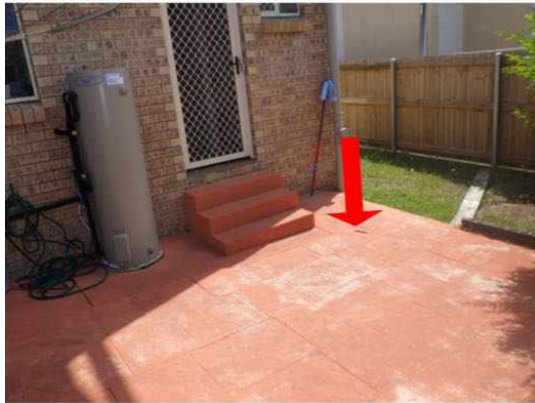
Finding 3.06

Building:	Main Building
Location:	Yard - Back > Existing
Finding:	Concrete Slab - Movement
Information:	The concrete slab/ steps to the rear of the property appears to have moved significantly away from the building exterior wall. The concrete slab or steps movement is assumed to be the result of ground subsidence or ground movement in the area.

It is advised the area is regularly monitored for any further change.

Always contact a building inspector should gaps or cracks widen, lengthen or become more numerous.

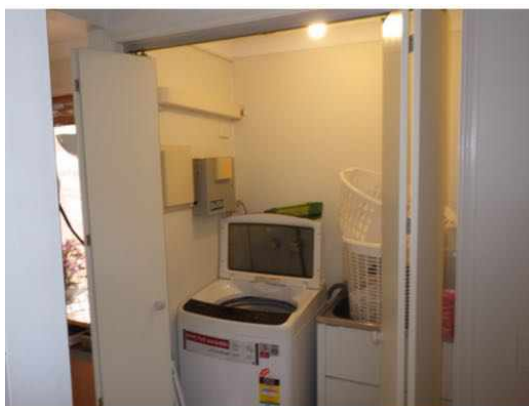
Finding 3.13

Building:	Main Building
Location:	Laundry > Centre
Finding:	Ceiling - Water stained
Information:	Water staining and/or damage to ceiling linings in the laundry area was evident at the time of inspection. Water staining indicates that surfaces have been exposed to excessive moisture at some time. The minerals and other elements in the water lead to staining, which may graduate to corrosion and deterioration if left unmanaged. The damaged or water stained ceiling linings returned low - normal moisture level readings at the time of inspection.

While mostly an appearance defect, water staining can be indicative of more serious defects, which may be currently concealed by interior ceilings.

Where water staining is old and inactive, affected building materials may be repaired or replaced at client discretion.

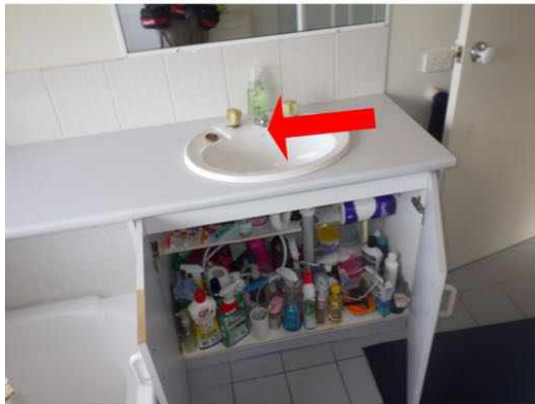
Finding 3.24

Building: Main Building
 Location: Bathroom > Centre Right
 Finding: Cabinetry - Deterioration
 Information: At the time of inspection the bathroom cabinetry showed signs of minor deterioration. The level of damage appears consistent with exposure to moisture or general wear and tear.

A qualified cabinet maker or general handyman could be engaged to undertake repair works at the clients discretion.

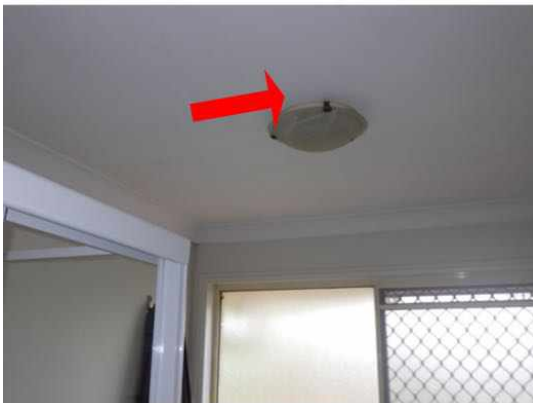
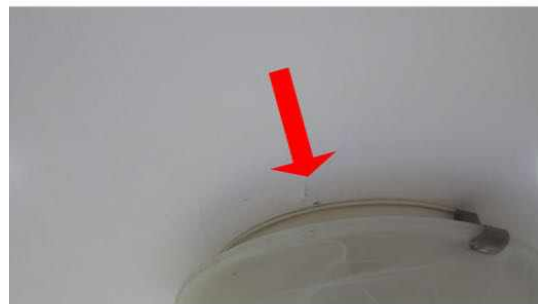
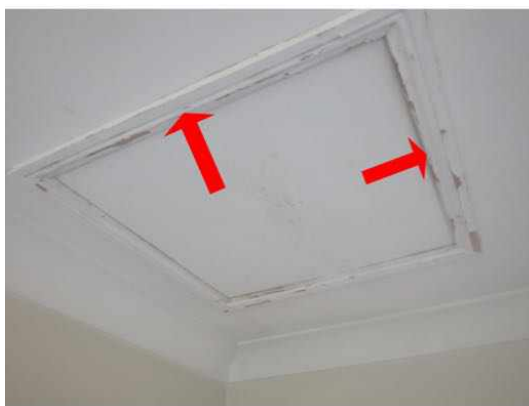
Finding 3.26

Building: Main Building
 Location: Bathroom > Centre
 Finding: Painted surface - Ceiling
 Information: Sections of paint in the upper level bathroom ceiling area were found to have bubbled and deteriorated. Paint bubbling or deterioration is generally an indication of excessive moisture in the area generally caused by a lack of natural or mechanical ventilation.

The presence of excessive moisture can have major implications on associated building elements if left unattended. While only seemingly minor at this stage, the damage cannot be fully determined.

It is advised that the affected ceiling area be further Inspected and/or repaired by a licensed painter.

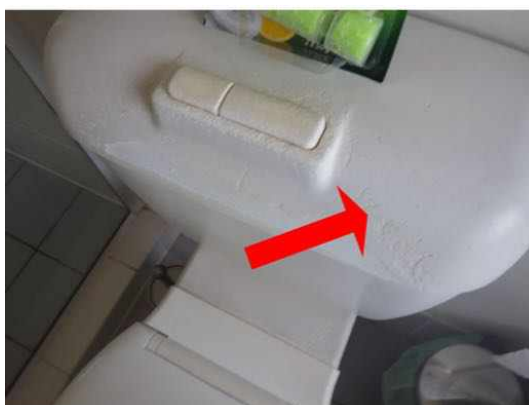
Finding 3.27

Building: Main Building
 Location: Bathroom > Centre Left
 Finding: Toilet Cistern
 Information: At the time of inspection the bathroom toilet cistern showed evidence of deterioration.

While generally considered a visual defect only, a qualified plumber could be engaged to replace the toilet cistern at the clients discretion.

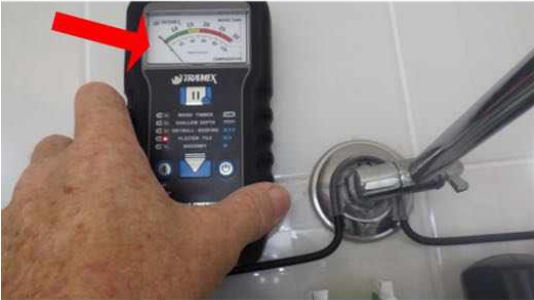
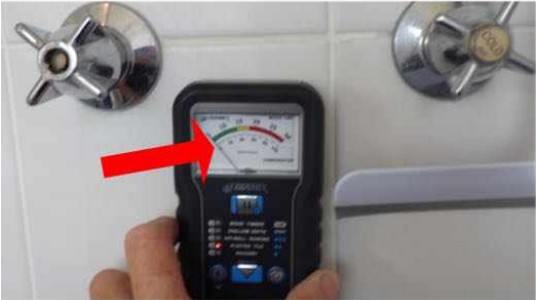
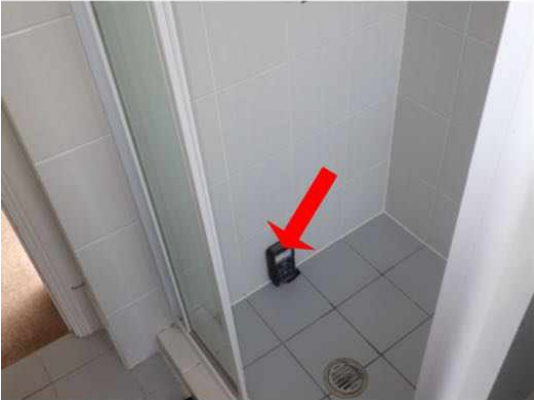
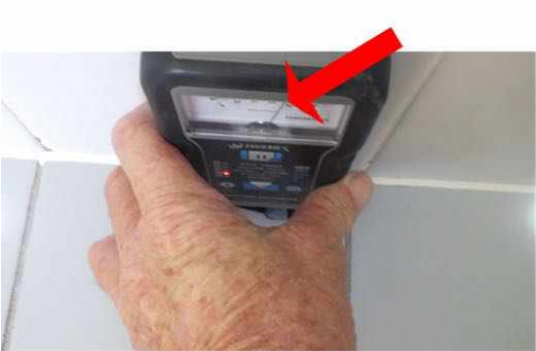
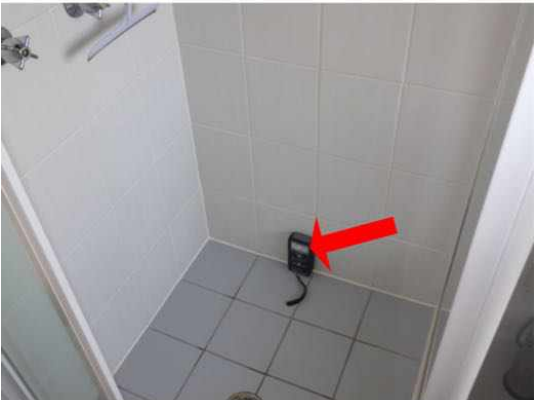
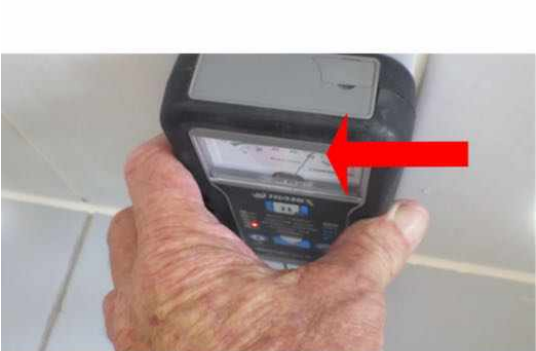
Finding 3.28

Building: Main Building
 Location: Bathroom > Front Left
 Finding: Shower - Monitor
 Information: Elevated moisture level readings were recorded to the lower 200mm of wall to the bathroom shower alcove at the time of inspection. There was no elevated moisture level readings around the tap area, and no elevated readings transferring outside the shower cubicle or to the other side of the wall in the areas where moisture readings were able to be obtained. Both sealant and grout appear in good condition at present.

This defect is quite common, and is suspected to have been caused by moisture permeating or leaching through the grouting and perhaps gaps in the sealant.

Monitoring the area is advised and if any visual signs of excessive moisture appear (peeling paint, mould) then consultation with a qualified plumber or bathroom specialist would be advised to identify the cause of damp and to perform remedial works as required.

Always ensure that sealant and grout is in good condition to prevent any moisture issues occurring in the future.

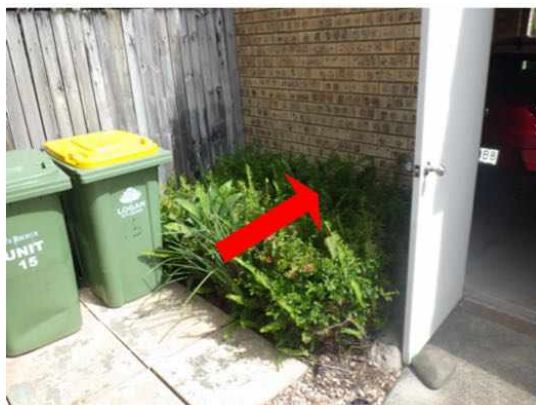
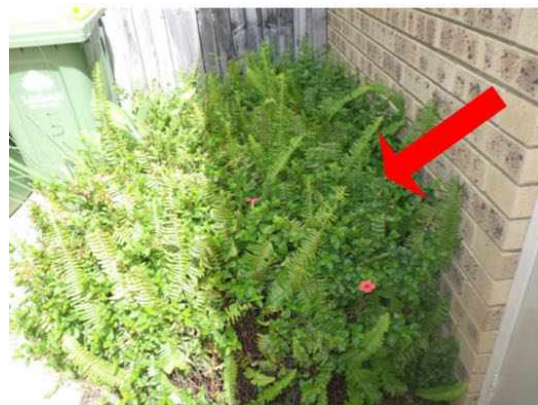
Building: Garage
Location: Exterior walls - rear > Existing
Finding: Vegetation
Information: At the time of inspection there was vegetation growing over external wall areas at the rear of the garage.

The vegetation over growing wall areas should be trimmed back clear of the external surfaces. The grass and other vegetation heights should be maintained around the perimeter of the building to allow for an inspection zone around the building exterior.

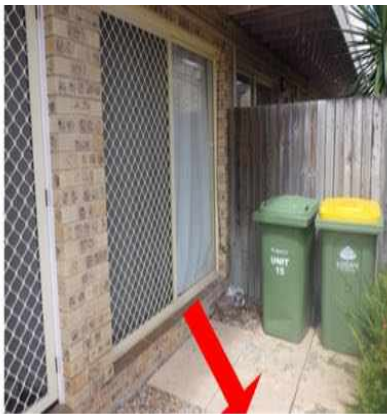
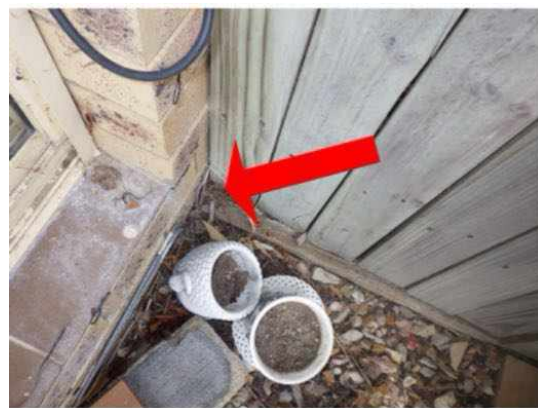
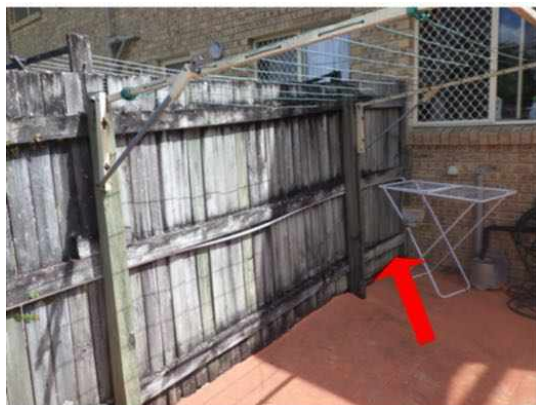
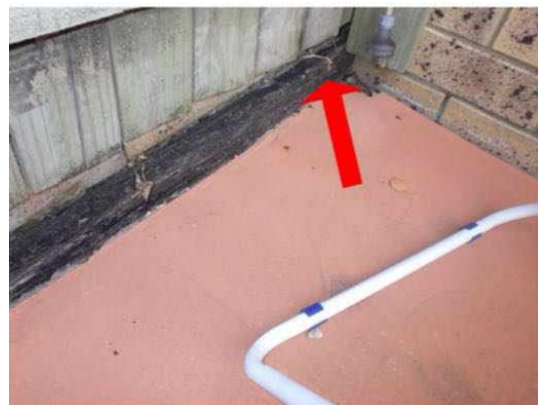
Finding 6.02

Building:	Main Building
Location:	Exterior walls - front > Front Right,Rear Right
Finding:	In ground contact
Information:	The timber fence posts or rails fixed to the exterior wall brickwork are in direct contact with the footpaths concrete slab.

Any timbers in direct ground contact provide opportunity for concealed termite entry and are likely to be subject to premature rot and decay as the ground retains moisture or damp conditions against the timbers.

Ideally these types of timber members would be clear of the ground area by a minimum of 50mm to provide a clear inspection zone.

Frequent pest inspections are advised to readily identify any termite activity in these areas.

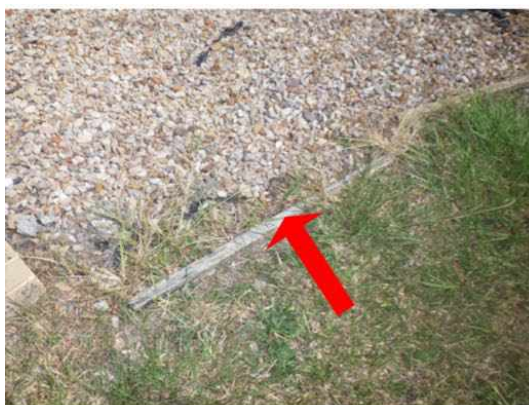
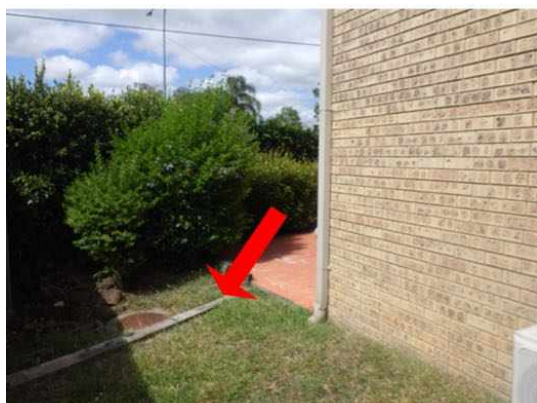
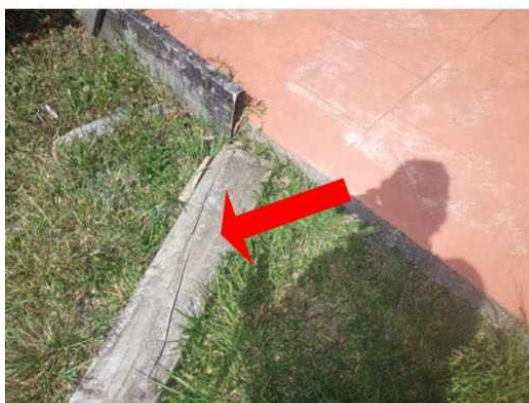
Finding 6.03

Building:	Main Building
Location:	Yard - Side > Ground Level
Finding:	In ground - Timber

Any timbers in direct ground contact provide opportunity for concealed termite activity and are likely to be subject to premature rot and decay as the soil retains moisture or damp conditions against the timbers.

Removal of any untreated timber or tree stumps which are in direct contact with external ground is recommended. Frequent pest inspections are advised to readily identify any termite activity in these areas.

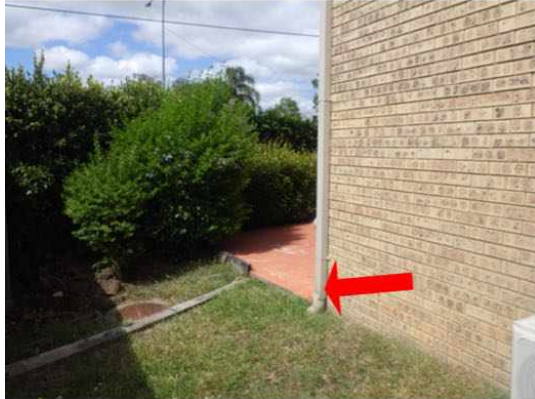
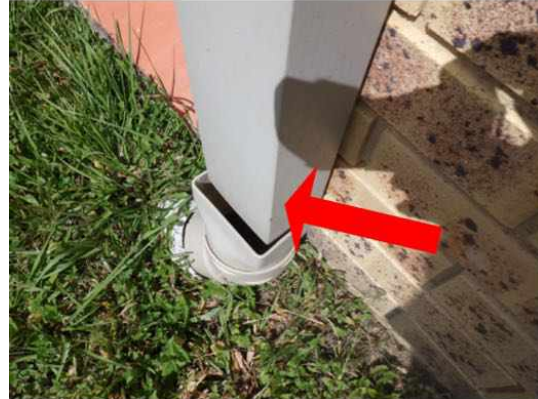
Building: Main Building
 Location: Exterior walls - left side > Rear Left
 Finding: Stormwater pipe - Damaged
 Information: The down pipe to the left side exterior wall of the building has disconnected from the top of the stormwater line adaptor.

rust and corrosion of surrounding building elements, as well as attracting termites and other pests.

It is recommended that a plumber or handyman be appointed to repair the down pipe as necessary.

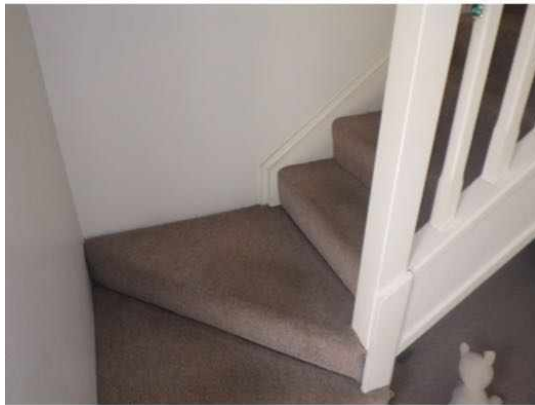
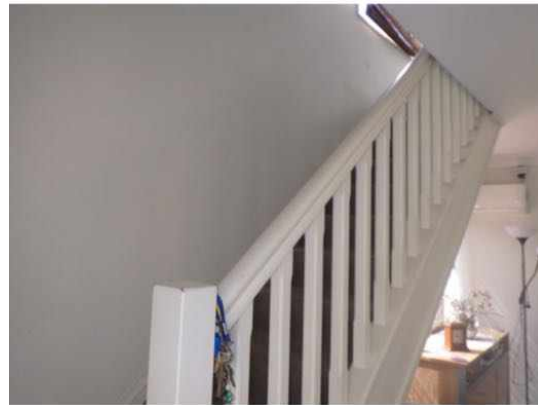
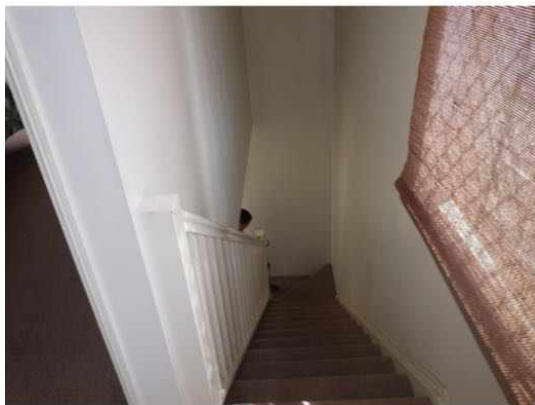
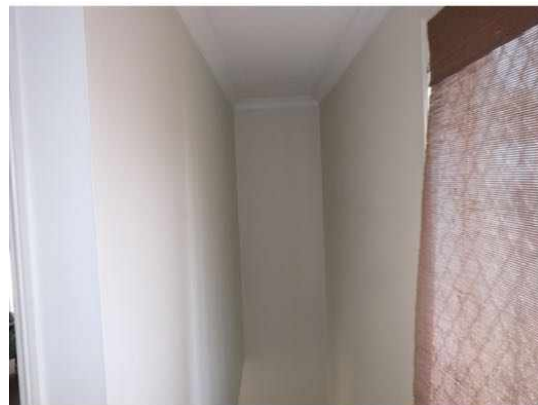
Building: Main Building
Location: Stairs - Internal > Existing
Finding: No obvious defect
Information: No obvious defects found at the time of inspection.

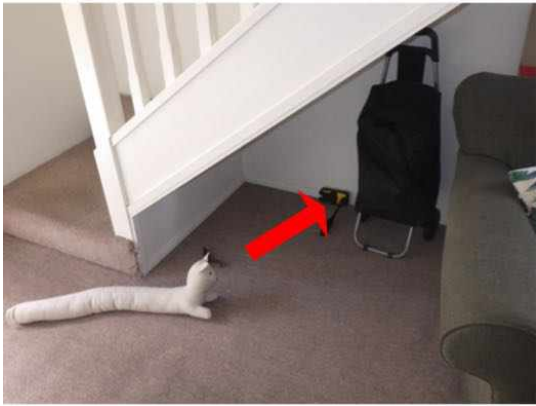
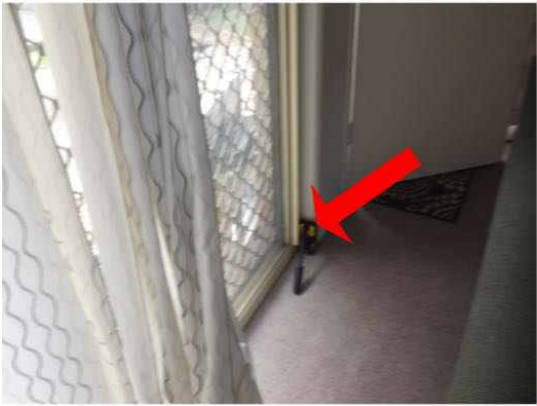
Building: Main Building
Location: Internal Areas > Existing
Finding: Termitracker
Information: The termitracker itracker was positioned randomly to internal wall, timber skirting and window frame areas checking for signs of termite activity.

No activity was recorded at the time of inspection.

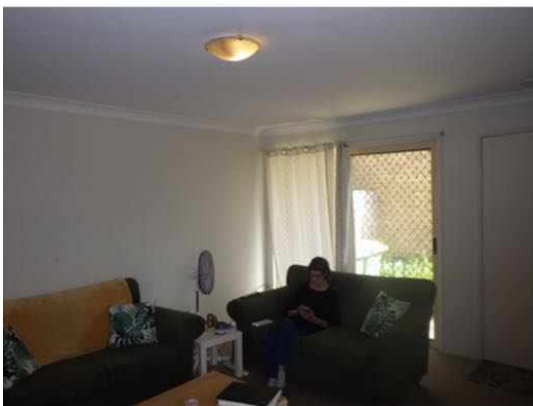
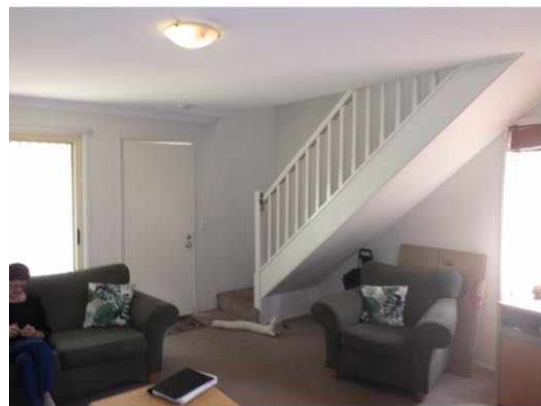
Building: Main Building
 Location: Internal Areas > Existing
 Finding: Additional Photos - Obstructions and Limitations
 Information: These photographs are an indication of the obstructions and limitations which impeded full inspection of the property at the time of inspection. These obstructions can hide an array of defects and should be removed to allow full inspection to be carried out. A re-inspection is recommended once the areas are made accessible.

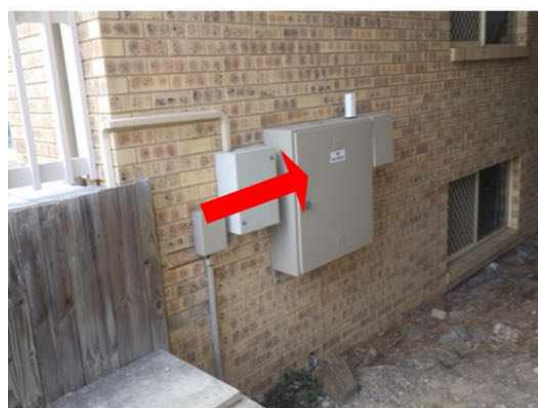
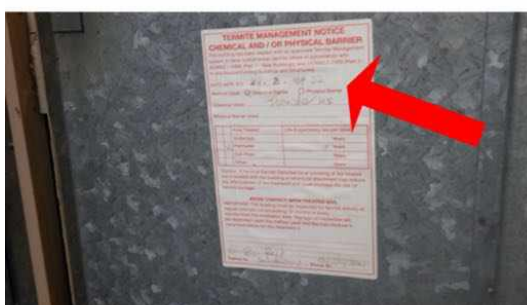
In this instance evidence of a previously installed part physical and chemical barrier was observed, along with a durable notice inside the electrical meter box (dated 24.08 2022 ?) on the northern end of the building. These systems require regular annual inspections.

No evidence of regular or annual inspections was found.

Where a Termite Management System has been identified you should refer to the type of barrier date of installation warranty conditions and any documentation provided by the seller or past owner.

NOTE - The buildings body corporate managers may have further information or documentation on any previously installed timber termite barriers or management system installed on the property.
