Building Inspection Report

Inspection Date: Thu, 12 Feb 2026

Property Address: 1 Taylor St, Brighton East VIC 3187,
Australia

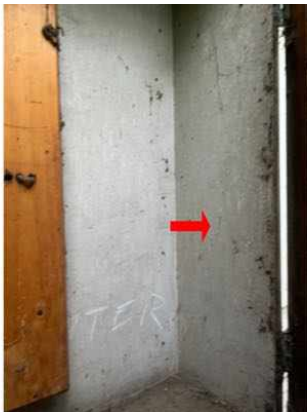
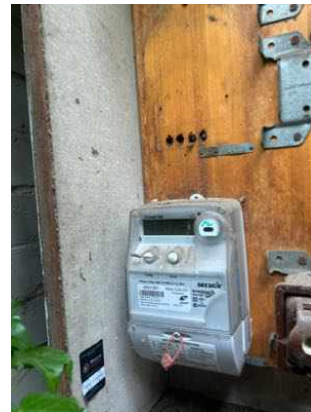
Defects 1.02

| Information: | Reporting on Asbestos is outside the Scope of this Report. This suspected defect is highlighted as a caution only. We suspect, based on our experience in the building industry, that there is a higher risk of the identified building element containing asbestos. |

As Asbestos Reporting is outside the scope of this report, we advise that you consider a separate Asbestos Inspection and Condition Audit, which can include the taking of samples for definitive confirmation of the presence of Asbestos.

In the interim, the client is advised to act with caution, especially when considering any

damage to building materials general wear and tear renovations extensions demolition and general maintenance activities due to the suspected presence of Asbestos.

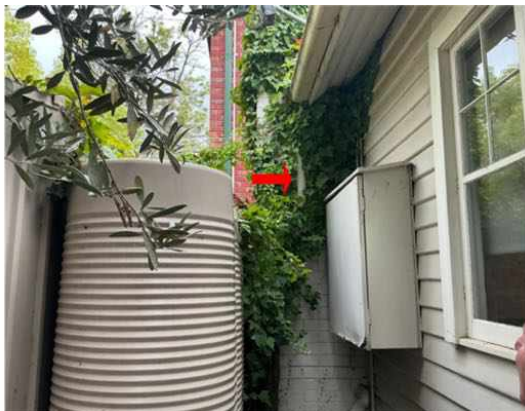
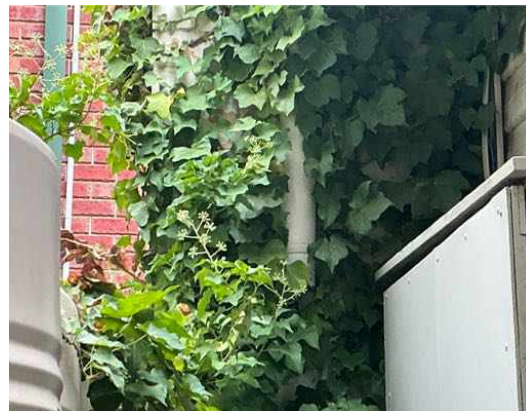
Defects 2.01

Where roof plumbing doesn't drain adequately, the area at the base perimeter can become excessively damp, potentially creating an environment that is susceptible to rust and corrosion of surrounding building elements, as well as attracting termites and other pests.

It is highly recommended that a plumber be appointed to further inspect the area and to install adequate drainage equipment where necessary.

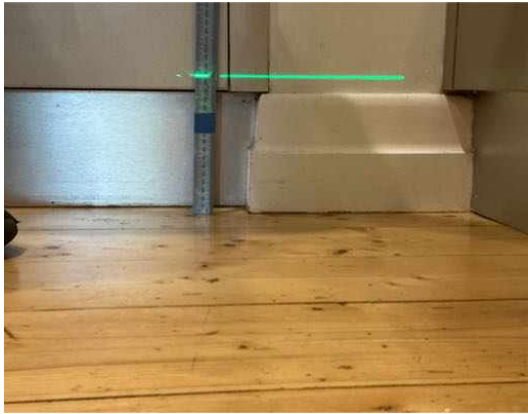
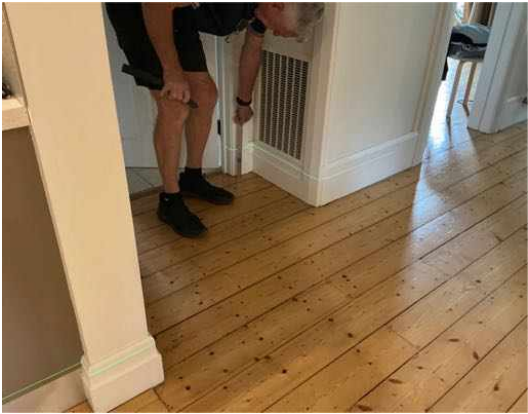
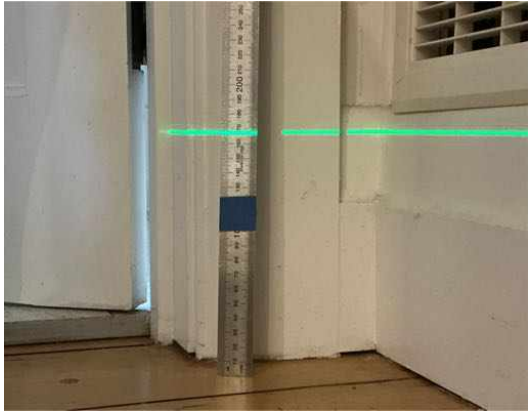
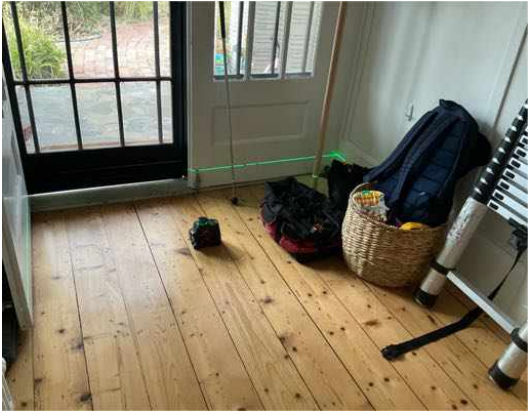
Defects 2.02

| Information: | The internal flooring in this area is out of level and uneven. Uneven flooring is likely to indicate minor defects such as expected movement of the foundations of the property, but may also indicate subsidence of the associated subfloor stumps. |

It is advised that the flooring be closely monitored to identify any further movement. Where flooring remains relatively unchanged for an extended period of time (i.e. several months), it is likely that this defect has been caused by expected movement of the foundations of the property.

However, where flooring is uneven further, potentially invasive inspection of the subfloor structures and stumps in this area is required. In this case, works to repair are likely to be required, and would be carried out by a registered builder specialising in re-stumping.

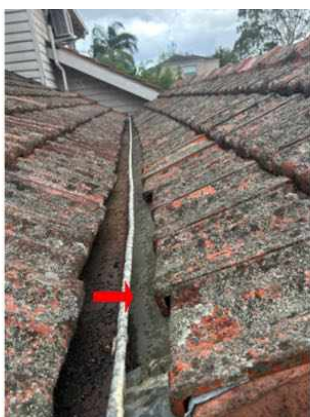
Defects 2.04

Building: Carport
 Location: Side elevation
 Finding: Roof plumbing - Flashing inadequate
 Information: Some sections of the roof are missing or have inadequate roof flashings. Flashings are metal and other materials which are applied to seals and intersections between roof coverings and building elements. They are designed to aid in weatherproofing of roof joins.

Flashings that are not installed adequately or are missing are likely to result in water penetration to the interior of the property, as well as creating excessively damp conditions against the exterior surfaces and around the base perimeter of the building.

Premature ageing and secondary building defects are imminent where roof plumbing is missing or inadequately installed. Additionally, water pooling also creates an environment that is susceptible to termite and pest infestation.

A roofing plumber should be appointed as soon as possible to install relevant roof

plumbing materials, ensuring that no further damage is sustained.

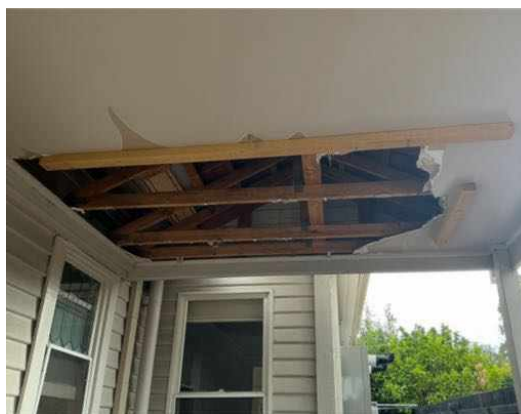
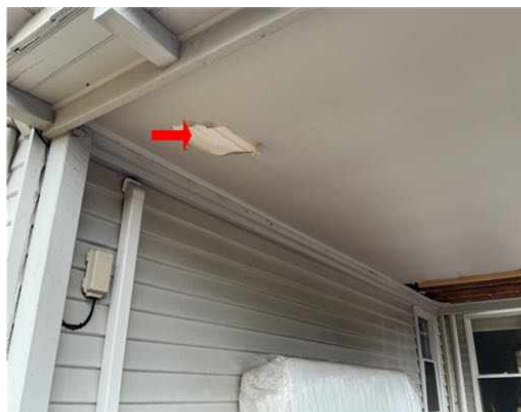
Defects 3.01

| Finding: | Ceiling - Water damaged |
| Information: | Water damage to the ceiling lining is generally an indication of excessive moisture being present in the roof void, usually via a leak to the roof covering. |

Where water damage is evident to the ceiling, the primary requirement is to identify and rectify the source of the leak. A roofing plumber should be appointed as soon as possible to identify the leak and perform rectification works as necessary, ensuring the water damage is restricted.

Once the leak is repaired, consultation with relevant tradespeople, including plasterers and painters, is advised. Rectification works may include replacement of ceiling lining or minor repainting, depending on the extent of the damage.

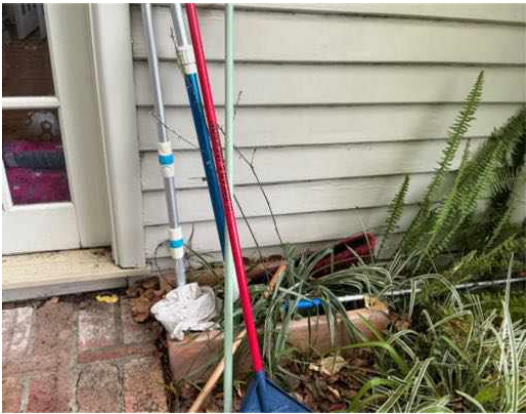
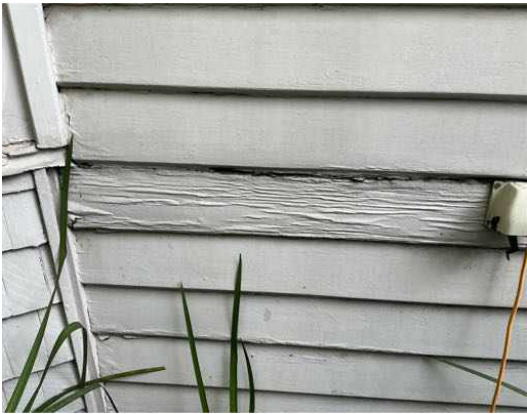
Defects 3.02

| Information: | The external weatherboards show signs of fungal decay (wood rot) in several sections. This wood rot is suspected to have developed over a prolonged period of time due to frequent weather exposure, which is expected in a property of this age and condition |

Weatherboards are sealed and protected by paint and other sealants. When these sealants deteriorate over time, they allow water penetration to the weatherboards, causing wood rot. If left unmanaged, the wood rot is likely to develop further, possibly necessitating major repair or replacement works in the long-term future.

To maintain the condition of the external wall cladding, any severely affected weatherboards should be substituted as soon as possible with pre-treated replacements. Where weatherboards have rotted due to excessive moisture other than rain penetration, the cause of the moisture should be identified immediately by a licensed plumber. A qualified carpenter should be appointed to repair and replace rotting weatherboards.

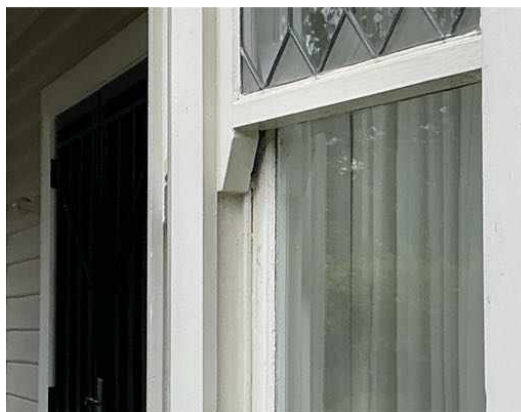
Defects 3.03

Windows provide ventilation to the adjoining area and should be at a fully operational level to ensure user comfort. Restricted function of the window may also pose as a potential safety hazard if required for emergency egress from the building.

Where windows have been painted shut the seal of the paint needs to be broken. This is generally done by breaking the seal of the paint and then maintaining the sash tracks clearing and lubricating them with silicone. Remedial paint work will likely be required and can be completed along with the rest of the remedial works necessary by a general handyman.

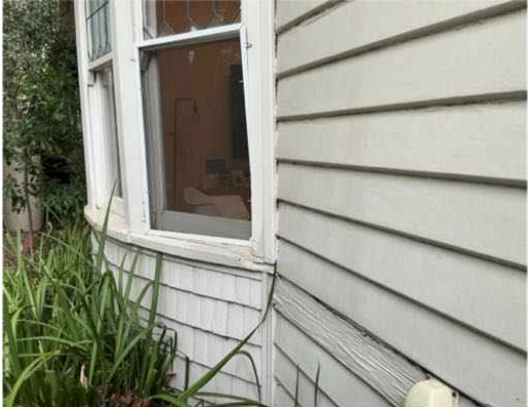
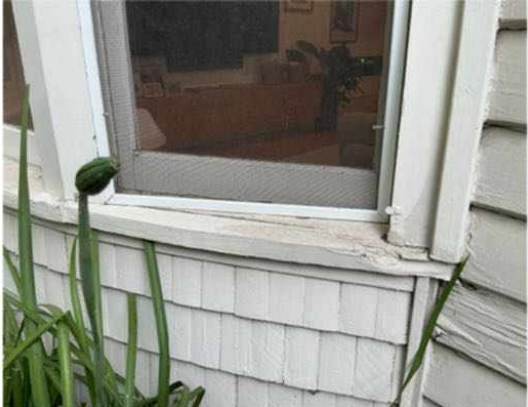
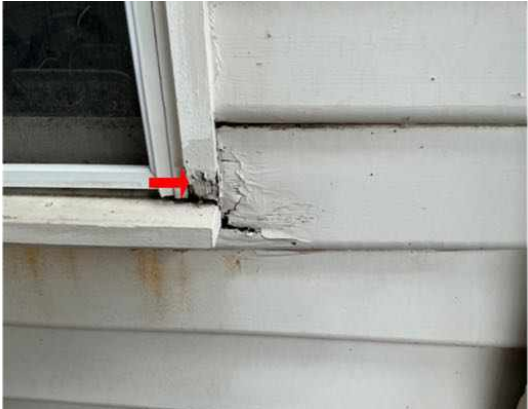
Defects 3.04

| Finding: | Windows - Wood rot |
| Information: | Wood rot was found to be affecting external windows. Wood rot, also known as Fungal Decay, occurs when timbers and other cellulose building materials are exposed to damp conditions on an ongoing basis. |

It is likely that this wood rot has developed as a result of frequent exposure to rain and other weather conditions. It is suspected that failure to maintain the window frames over a prolonged period has resulted in them deteriorating at an accelerated rate, increasing their susceptibility to the development of wood rot. Leaks in roof plumbing or associated pipework may have also contributed to the formation of the wood rot in this area.

elements. Prior to any works being performed, any associated pipework or roof plumbing should be inspected by a licensed plumber for faults or leaks.

Repair and/or replacement of affected window frames may be a necessary step in protecting surrounding building elements from such deterioration. Remedial works should be performed by a qualified carpenter or registered builder as soon as possible to prevent any further damage.

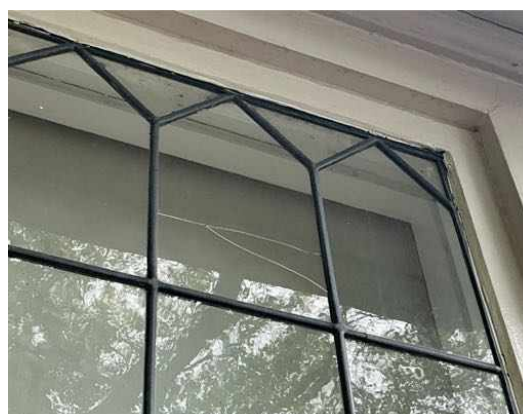
Defects 3.05

Finding: Window - Cracked
 Information: Cracks were identified in the window in this area. Cracking in windows is generally the result of impact damage, and is likely to develop further when left unmanaged.

The likelihood of this windowpane further cracking and shattering is increased exponentially, providing a safety hazard in the area. The cracked window also impairs the weather tightness of the building, creating potential for minor water leaks.

A qualified glazier is required to repair the window as soon as possible. Depending on the extent of the cracking, replacement of the window may be required. Please be advised that any persons coming into contact with the cracked window should do so with due caution to avoid any personal injury that may ensue.

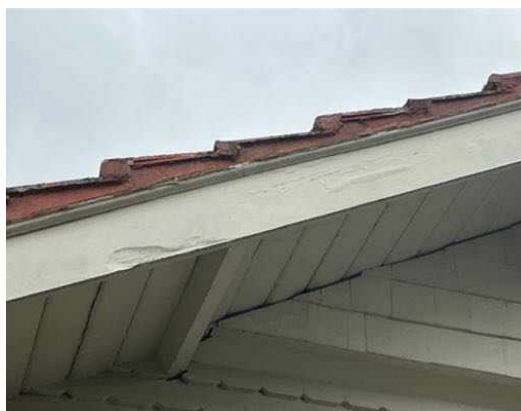
Defects 3.06

Building: Main Building
 Location: Fascias
 Finding: Fascias - Wood rot
 Information: Wood rot was found to be affecting fascias and barges in this area, evidenced by the presence of mould on the surface in some areas. Wood rot, also known as Fungal Decay, occurs when timbers and other cellulose building materials are exposed to damp conditions on an ongoing basis.

It is likely that this wood rot has developed as a result of faults in the roof plumbing, creating excessive moisture in this areas. Frequent exposure to rain and other weather conditions also make fascias and barges susceptible to accelerated deterioration.

Early intervention and regular maintenance will prolong the useful life of these building elements. Prior to any works being performed, the cause of the moisture that has created the visible wood rot should be identified and addressed in a suitable manner.

It is advised that a roof plumber be appointed to inspect all roof plumbing and subsequently identify the cause of the wood rot. Replacement of affected fascias and barges may then be a necessary step in protecting surrounding building elements from such deterioration.

A qualified plumber may be appointed to assess the cause of excessive moisture and to provide advice on any remedial works as required. A qualified carpenter or registered builder may also be required to replace affected building materials.

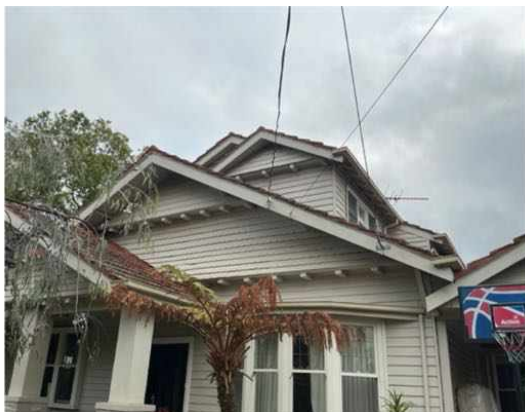
Defects 3.08

| Information: | Upon inspection of the exterior roofing, the majority of roof tiles were considered to be in a fair condition. While weathering of the tiles is consistent with the age of the property, maintenance works are required. |

Isolated areas of mortar have come loose in the valleys and minor cracking is also present. Re-pointing and re-sealing the may be considered as an interim solution by the client to help preserve and extend the life span of the tiles.

Where left unmanaged, deteriorating roof tiles are likely to lead to a number of secondary defects, including minor water leaks and weather exposure to internal roofing structures.

Consultation with a roofing contractor is highly advised to gain advice on cost of remedial works that may be required in the short to medium term. Remedial works are likely to increase the longevity of the exterior roofing structure.

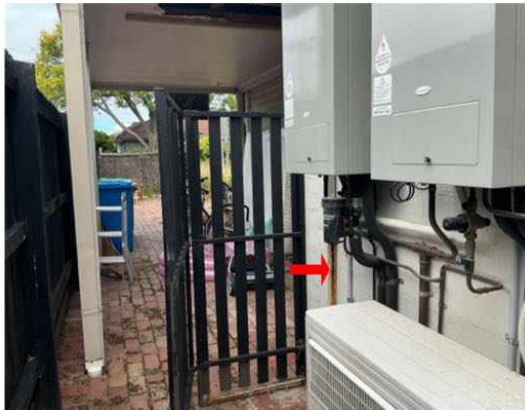
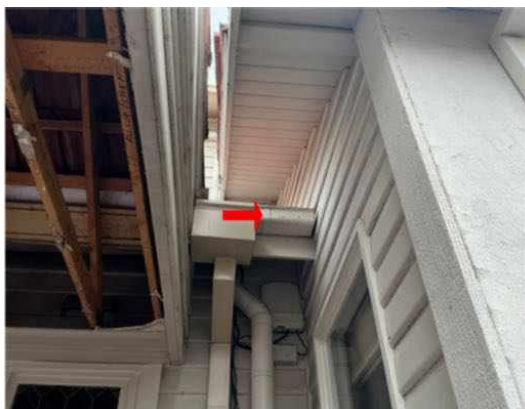
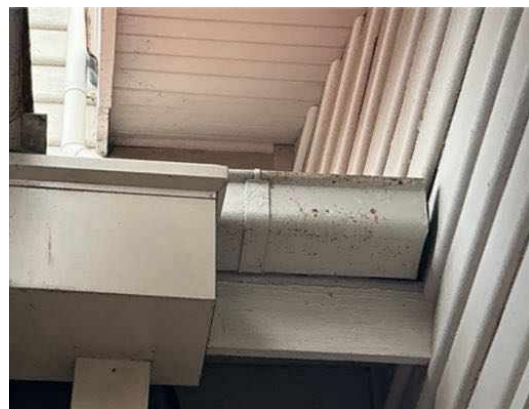
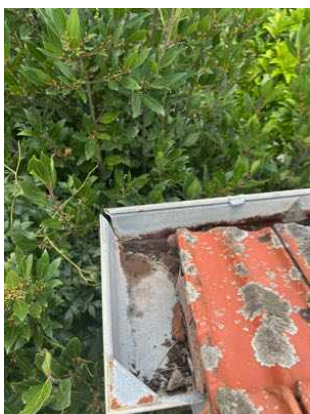
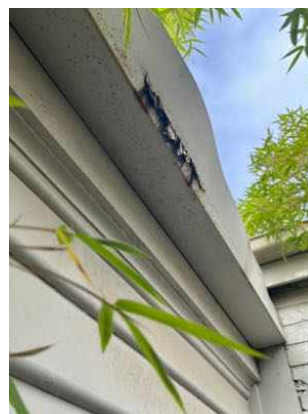
Defects 3.09

| Finding: | Roof plumbing - Rusted or corroded |
| Information: | The roof plumbing has areas of rust and corrosion. It is suspected that this has been caused by blockages, resulting in pooling or standing water, that have prematurely rusted elements of the roof plumbing. |

Rusted roof plumbing will generally develop holes and leaks that can affect other building elements with poor drainage of storm water. Poorly drained roof areas will also lead to damp conditions surrounding the base perimeter of the building which, if left unmanaged, can lead to a range of secondary building defects.

Repair and/or replacement of rusted roof plumbing is highly required in order to reinstate the roof drainage system to a fully operational level. To further maintain these areas, gutters should be cleaned frequently, allowing the avoidance of any partial blockages.

A licensed plumber or specialist roof restoration company should be appointed to undertake these works. It is advised that such works be completed as soon as possible to prevent any further damage and deterioration.

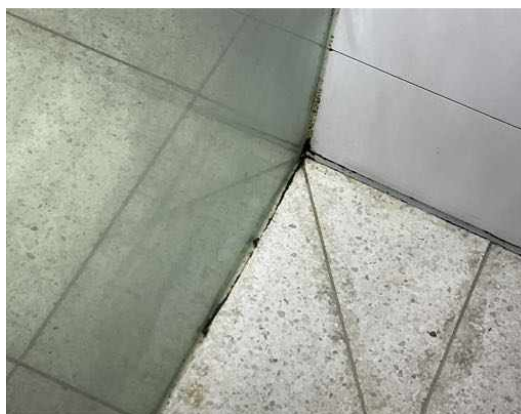
Defects 3.13

| Finding: | Sealant and grouting - Missing or damaged |

Flexible and mould resistant materials should be applied to affected areas to prevent any subsequent water damage that is likely to occur. Regular maintenance and replacement of damage or missing or damaged sealant and grout is highly recommended to the wet areas, as this is a regular wear and tear defect. Sealant and grouting in areas that come into regular contact with water should be maintained for the long term care of your property.

A sealant specialist or tiling contractor should be appointed to complete these works as soon as possible

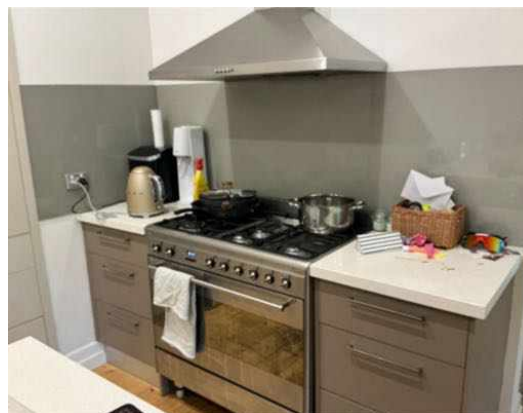
Defects 3.14

| Finding: | Warranty - Expired |

Information: Where appliances are beyond their warranty period, the owner should be prepared to meet the cost of replacement or repair of the item at any time. The operation of the appliance can not be guaranteed and further inspection by an appropriately qualified tradesperson may be required.

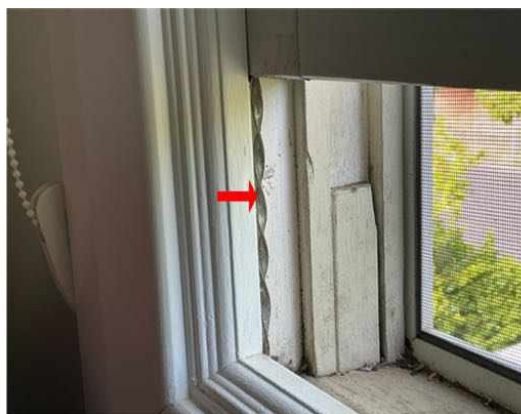
Defects 3.16

Information: Sashes are the moveable panes of windows that primarily slide vertically over each other to expose one half of the window area. Each sash is provided with springs balances and/or compression weather-stripping, which act to hold the window in place in one position.

The sash balance mechanism will need replacement to allow the window to function as intended. Such works may be completed by a qualified carpenter or registered builder.

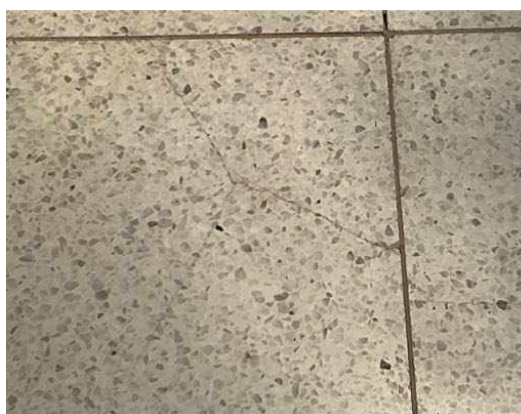
Defects 3.17

Cracked tiles throughout the household detract from the overall appearance of the affected areas, as well as creating potential for water penetration to adjoining building elements. If left unmanaged, water damage may occur as a result of constant water penetration over a prolonged period of time.

While not considered a matter of urgency, replacement of cracked floor tiles is advised as a solution. A tiling contractor or general handyperson may be appointed to perform these works at client discretion. Where cracks become more numerous, consultation with a registered builder specialising in re-stumping may be required.

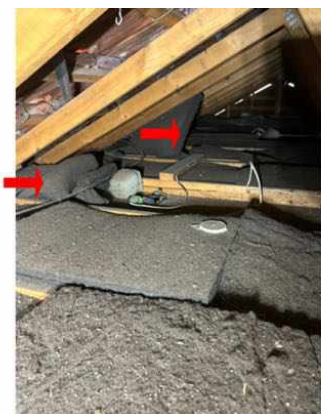
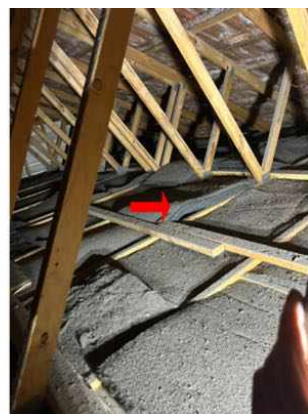
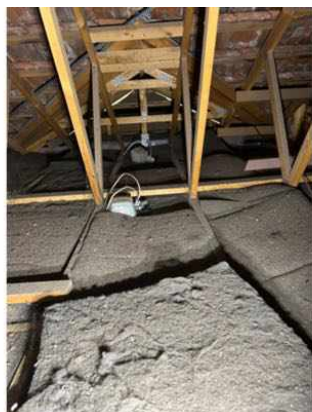
Defects 3.18

The level of insulation in the property does not meet current Australian Standards. Installation of adequate insulation is required and should be conducted as soon as possible.

Caution should be exercised when accessing the roof void. Do not attempt to stand on the framework to the underside of the trusses and be aware there is a potential for electric shock if contact is made with exposed or faulty electrical wiring.

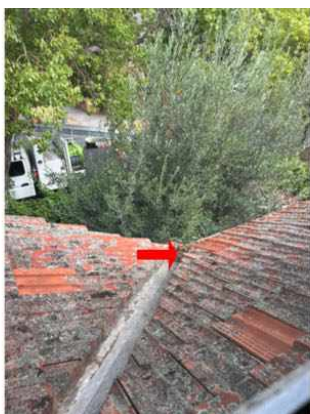
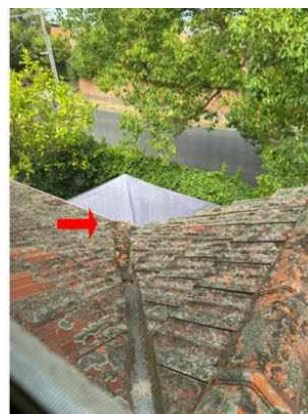
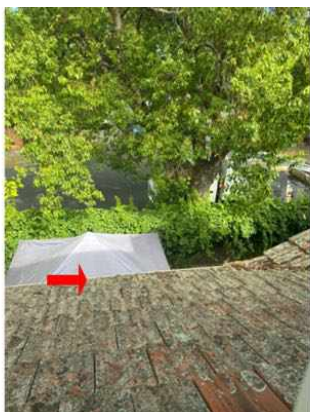
Defects 3.20

Blocked gutters are likely to lead to high levels of moisture in the affected areas. Such moisture will not only cause rust and decay of the associated building materials, but can also provide conditions that are conducive to termite and timber pest activity. Blockages in gutters should therefore be removed immediately to ensure dry conditions are maintained.

Consult a Licensed Plumber for further specific advice on remedial works that may be required. In the interim, it is highly advised that blocked gutters be removed by the homeowner or a general handyperson as a matter of urgency.

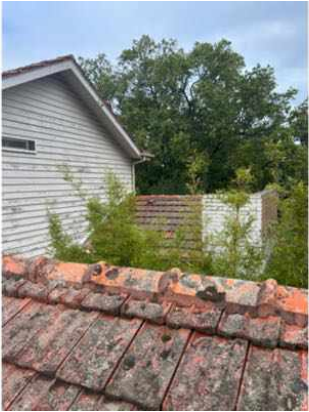
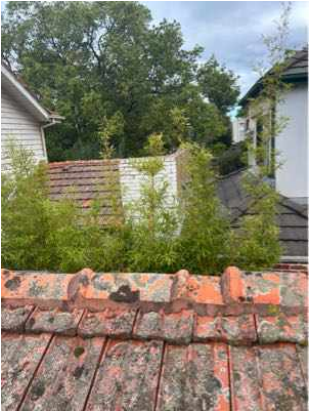
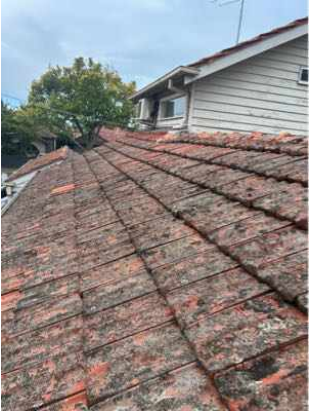
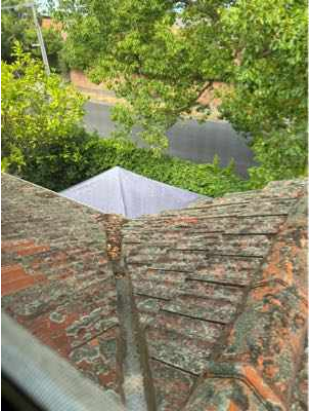
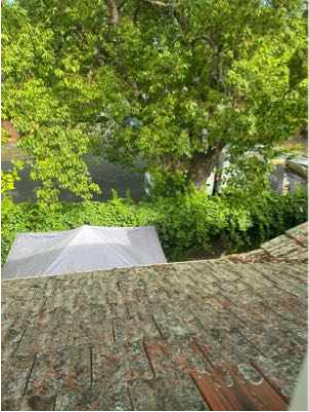
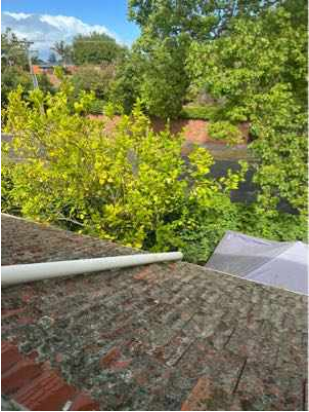
Defects 3.21

| Information: | Upon inspection of the exterior roofing, the majority of roof tiles were considered to be in a fair condition. While weathering of the tiles is consistent with the age of the property, maintenance works are required. |

Isolated areas of mortar have come loose in the valleys and minor cracking is also present. Re-pointing and re-sealing the may be considered as an interim solution by the client to help preserve and extend the life span of the tiles.

Where left unmanaged, deteriorating roof tiles are likely to lead to a number of secondary defects, including minor water leaks and weather exposure to internal roofing structures.

Consultation with a roofing contractor is highly advised to gain advice on cost of remedial works that may be required in the short to medium term. Remedial works are likely to increase the longevity of the exterior roofing structure.

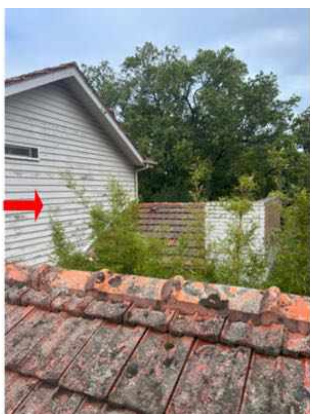
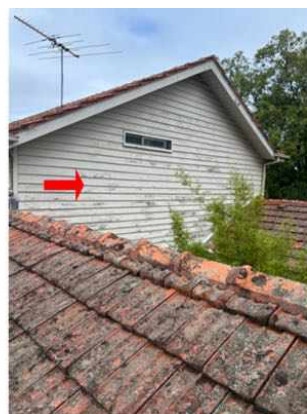
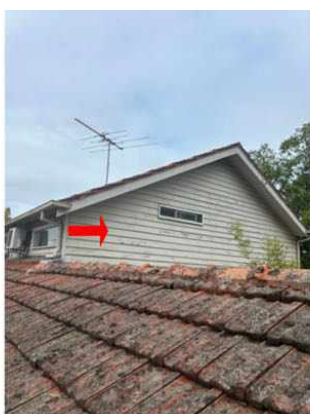
Defects 3.22

Building: Main Building
Location: All Areas
Finding: External painting deteriorated
Information: Much of the external paintwork including but not limited to windows, fascias, guttering, veranda and other external fitments have been neglected and require attention to prepare and re-paint.

Whilst incomplete or missing paint finish is generally an appearance defect, it can also lead to the development of secondary building defects over time. Incomplete areas of paint finish expose the area to moisture, potentially accelerating the deterioration of underlying building materials.

Degraded paint finishes should be sanded back, filled, leveled and painted, as applicable. Where inadequate or missing paint protection has led to the deterioration of the associated building element, repair and/or replacement of this building element may be required.

A painting contractor should be appointed as soon as possible to perform necessary works to aid the appearance of the affected area and to ensure the area is protected against further deterioration. Alternatively, the homeowner following manufacturer instructions may perform these works.

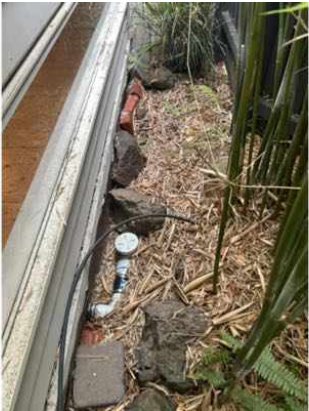
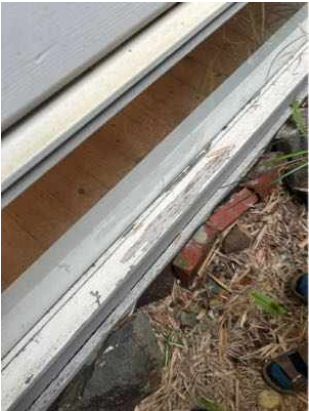
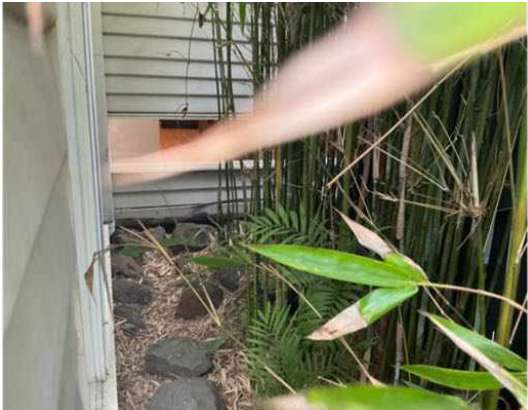
Defects 3.23

| Information: | The perimeter paving or ground levels were found to have an inadequate slope away from the adjoining building structure, creating potential for water pooling in this area. |

Perimeter paving is required to fall from the building by a minimum of 25mm in the first metre and bare ground should fall away from the house by 50mm in the first meter. This standard ensures that excessive moisture does not pool around the base of building structures, which creates potential for water and structural damage, as well

as making the area susceptible to termite and timber pest activity.

Where paving or ground levels do not have adequate fall, a licensed paving contractor should be appointed to install or remove and re-level pavement.

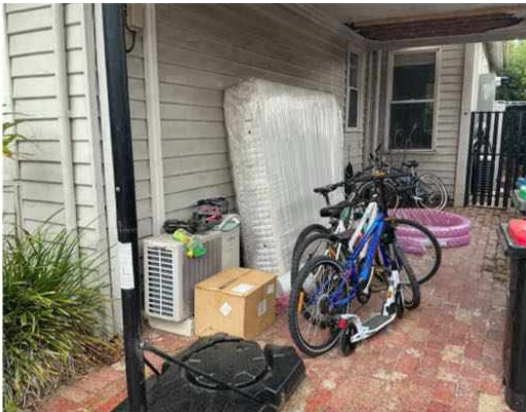
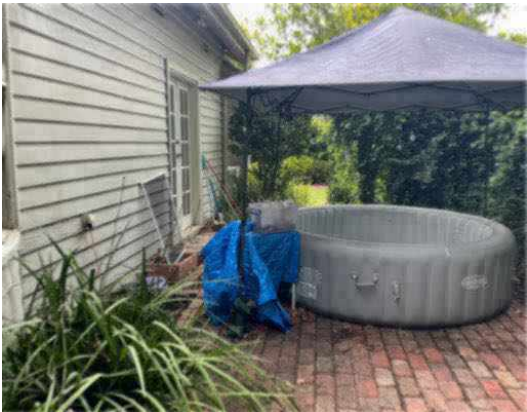
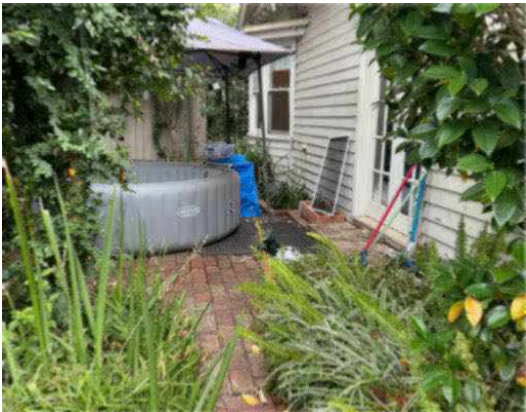
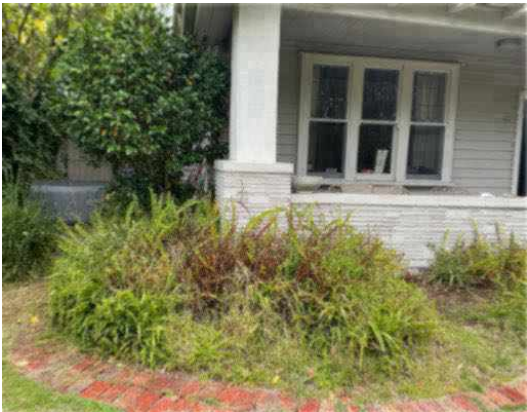
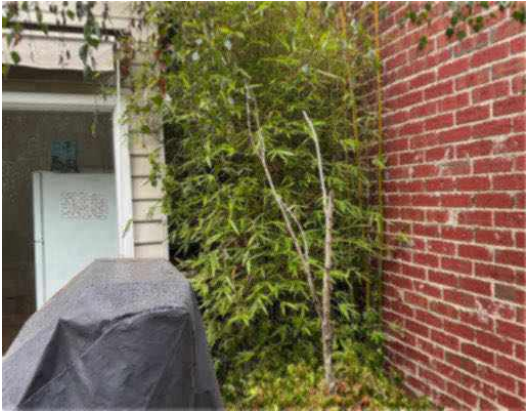
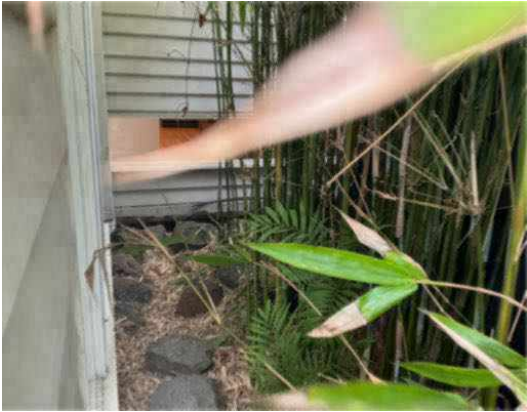
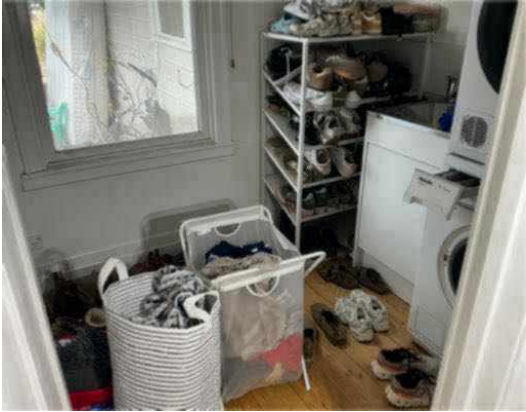
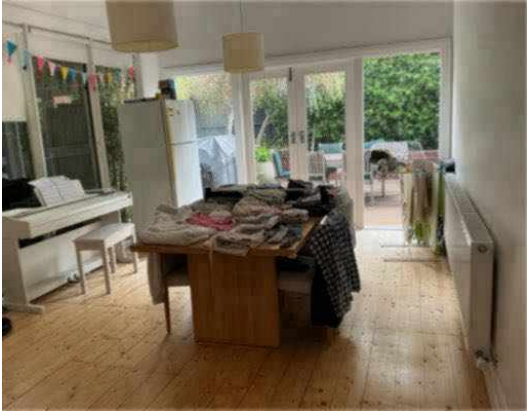
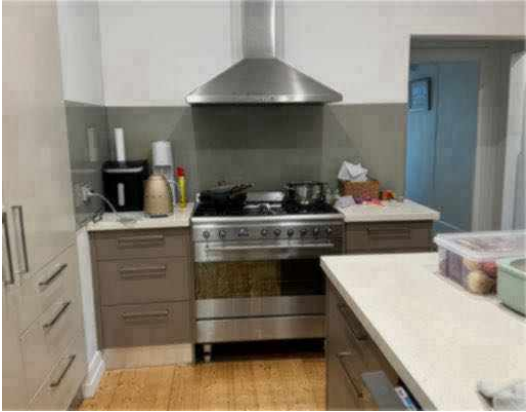
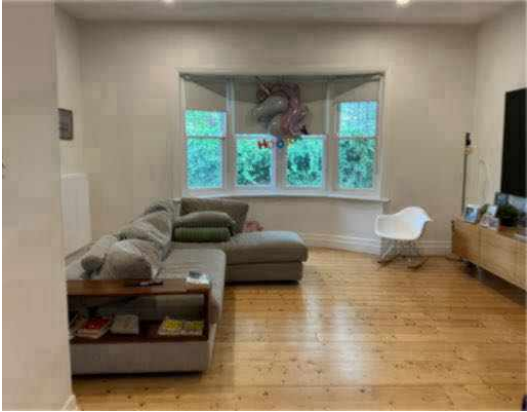
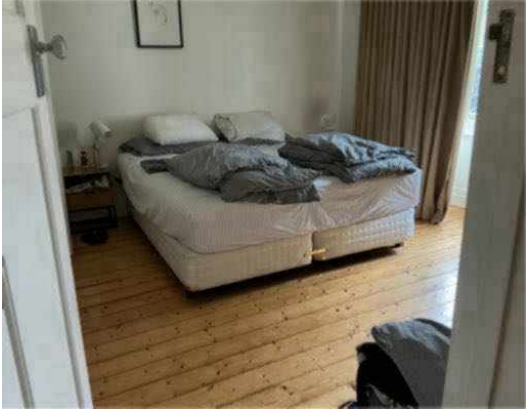
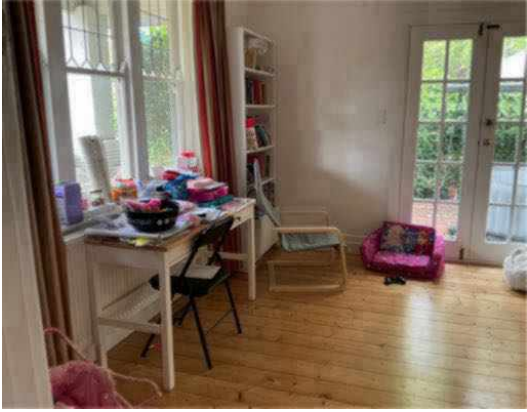
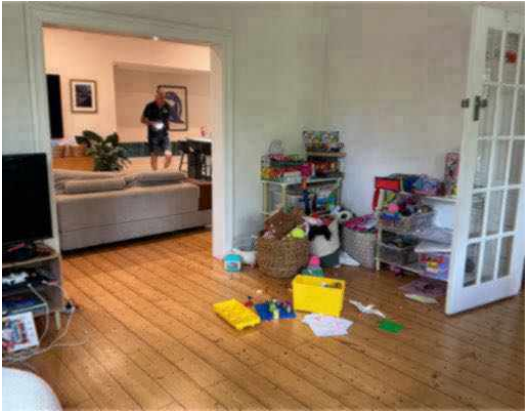
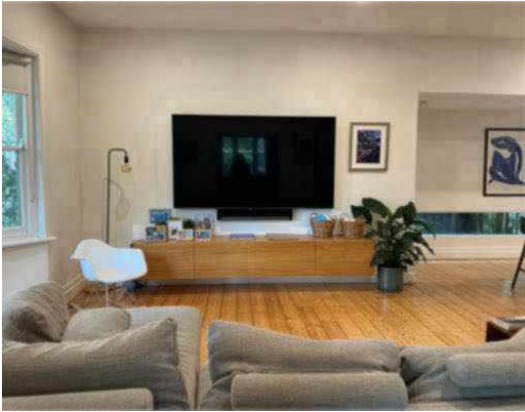
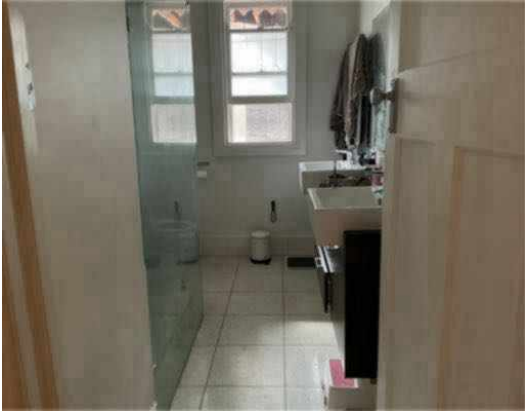
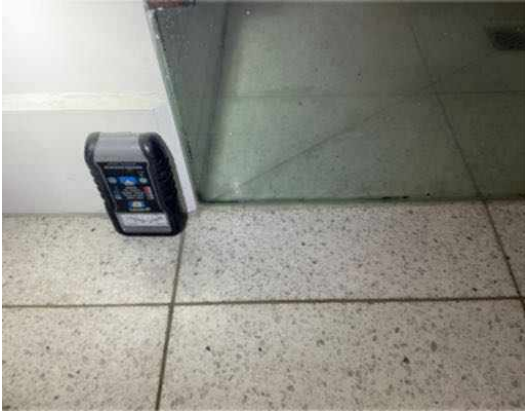
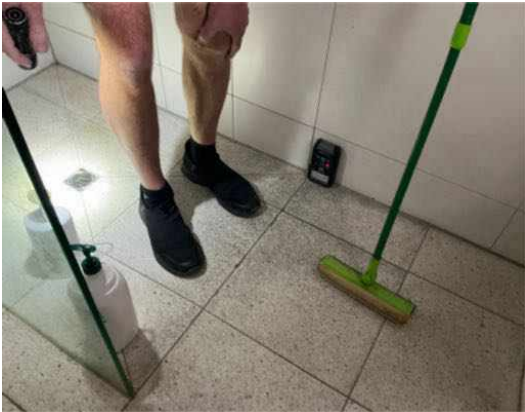
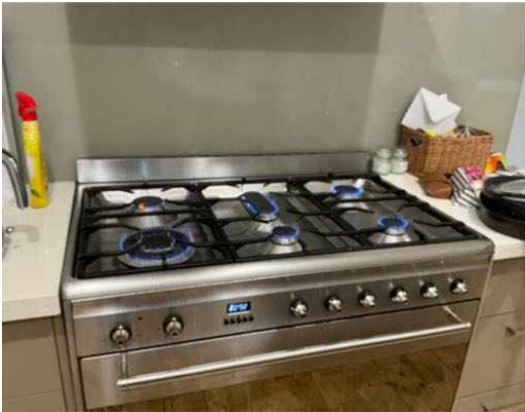
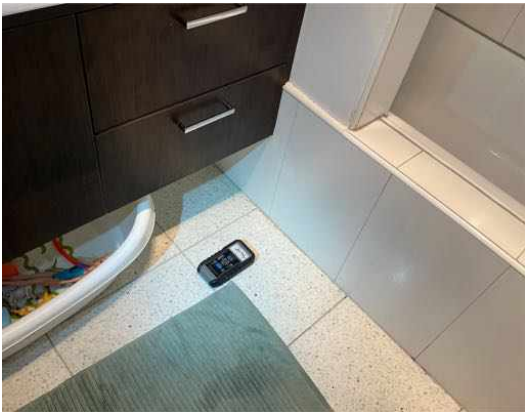
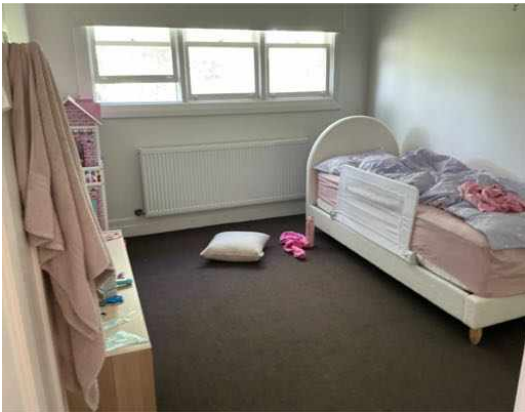
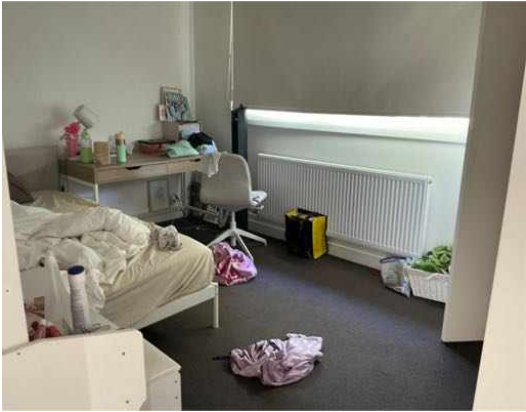
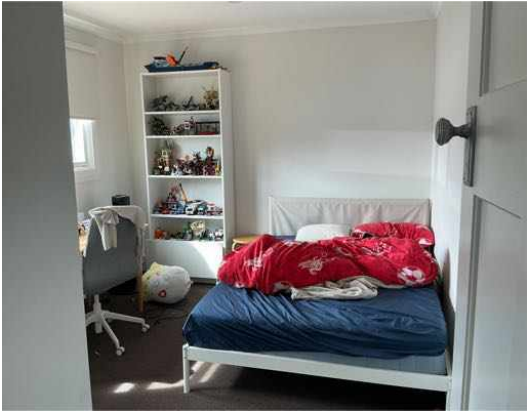
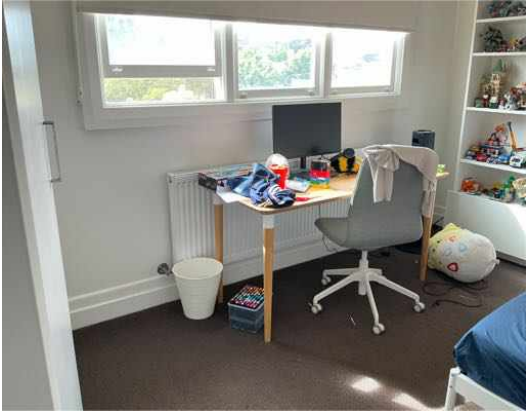
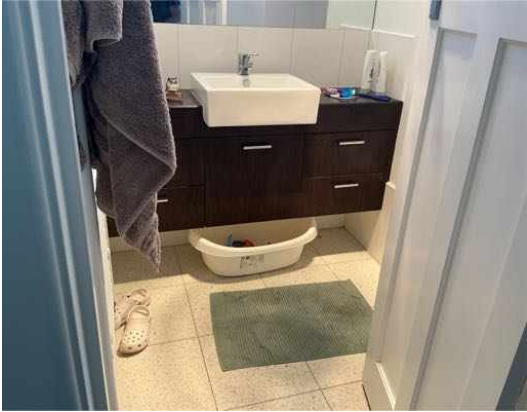
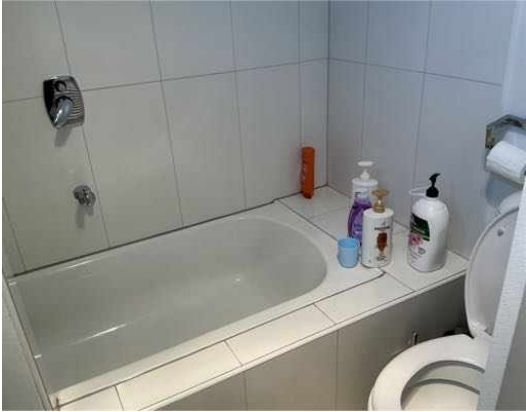
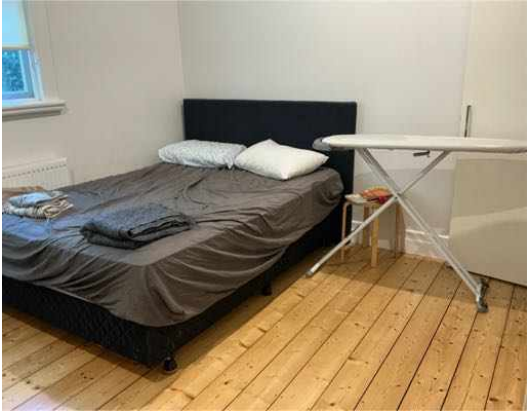
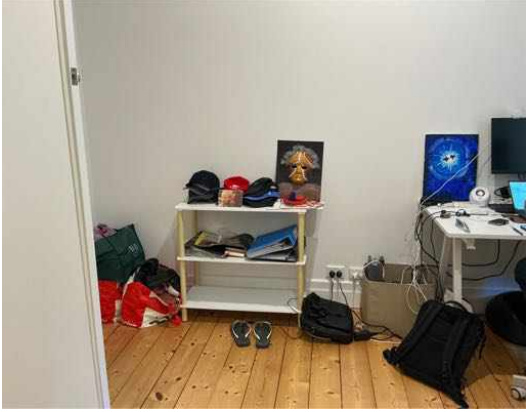
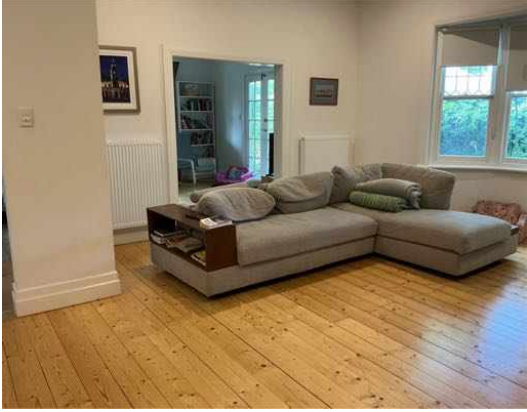
Noted Item

Building: Main Building
Location: Inside and outside
Finding: Additional Photos and Obstructions and Limitations
Information: These are additional photographs and photographs of the obstructions and limitations inside and outside (furniture, landscaping etc) which may impede full inspection of the property at the time of inspection. These obstructions can hide an array of defects and may be removed to allow full inspection to be carried out. A re-inspection may be made if clients require once the areas are made accessible.

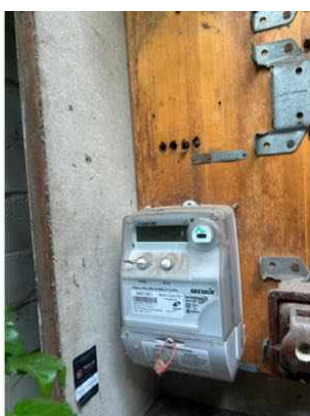
Building: Main Building
 Location: Electrical Switchboard
 Finding: Termite Management System - no evidence of a chemical installation
 Information: The application of a post-construction chemical termite barrier is highly recommended for all properties, particularly if live termite activity has been found on the site previously. Such barriers are highly effective in preventing termite attack on any timber building elements throughout the property.

A durable notice should be placed in the switchboard unit to indicate current termite barriers. At the time of inspection, it appeared as though no termite management system has been installed, with no evidence to suggest preventative works taking place.

The client may consider gaining further advice from a pest controller as to the costs and procedures involved with this application. It is recommended that obtaining such advice be a short-term priority.

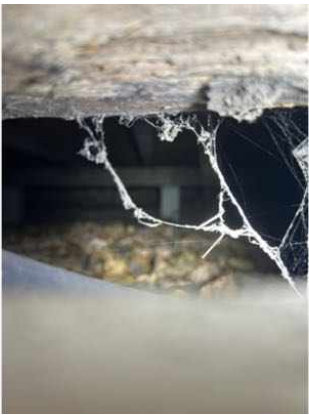
Building: Main Building
 Location: Subfloor
 Finding: Additional Photos - Obstructions and Limitations
 Information: These photographs are an indication of the obstructions and limitations which impeded full inspection of the property at the time of inspection. These obstructions can hide an array of defects and should be removed to allow full inspection to be carried out. A re-inspection is recommended once the areas are made accessible.
