Building and Timber Pest Inspection Report

Inspection Date: Tue, 10 Mar 2026

Property Address: 64 Heidelberg St, Mambourin VIC 3024,
Australia

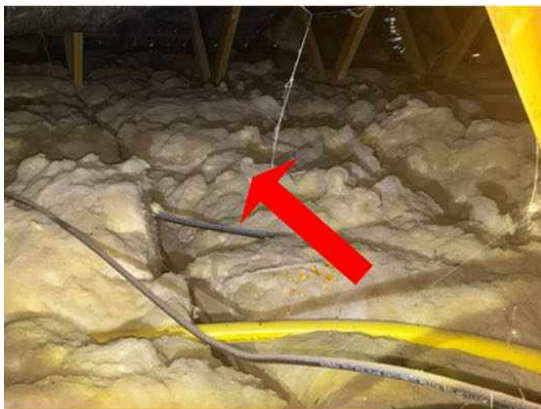
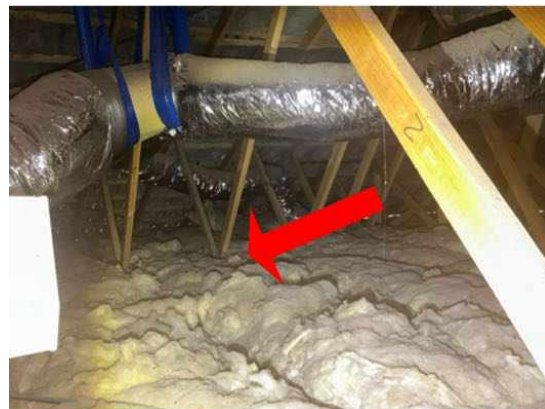
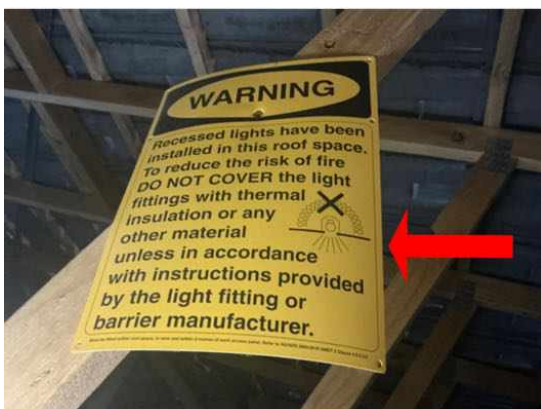
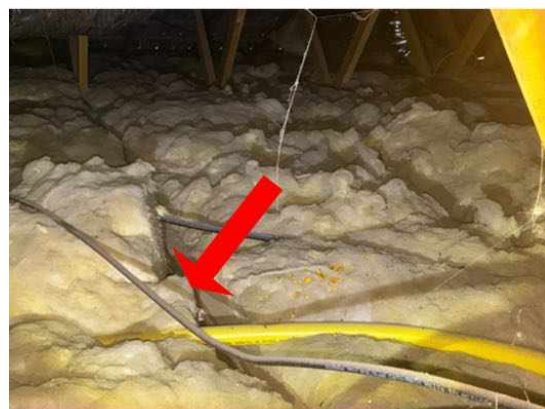
Building: Main Building
 Location: Roof Void
 Finding: Insulation - Covering downlights
 Information: Sections of insulation in the roof void have been poorly installed or moved from their original position and are covering down light fittings. While the down lights have been fitted with appropriate protective covers, the presence of this insulation creates a potential fire hazard.

Any insulation within the vicinity of down light fixtures should be moved and re-applied to more appropriate sections of the roof void, thus ensuring the area is fire-safe. An insulation contractor should be appointed as soon as possible to perform any necessary works as required.

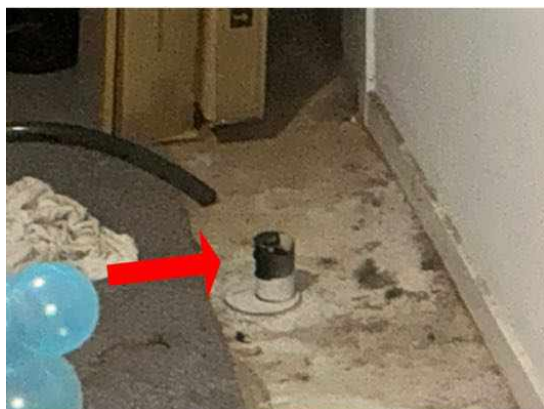
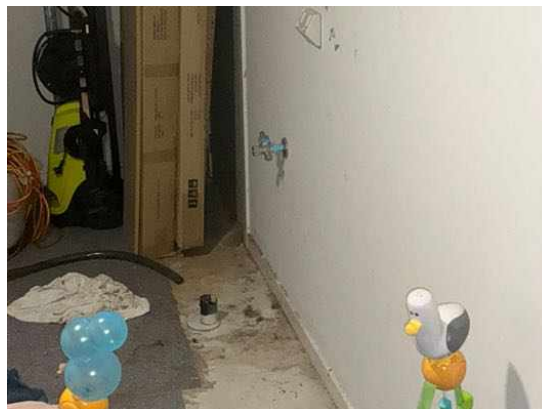
Finding 1.02

Building: Main Building
 Location: Garage

Finding: Garage sewer waste not sealed adequately
 Information: It was observed at the time of the inspection the sewer waste provision in the garage floor was not sealed adequately. Sewer wastes should be sealed to prevent smells and odours coming from the main sewer and discharging into the building causing an unhealthy atmosphere.

A licensed plumber should review immediately

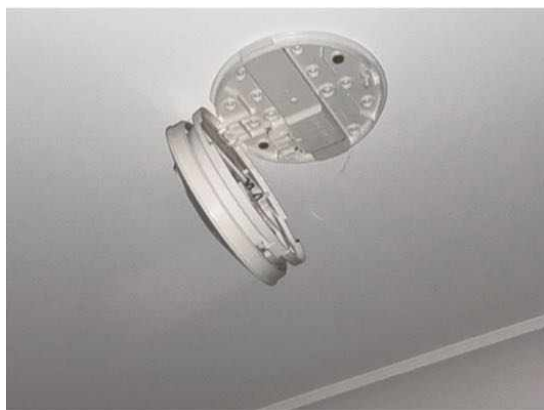
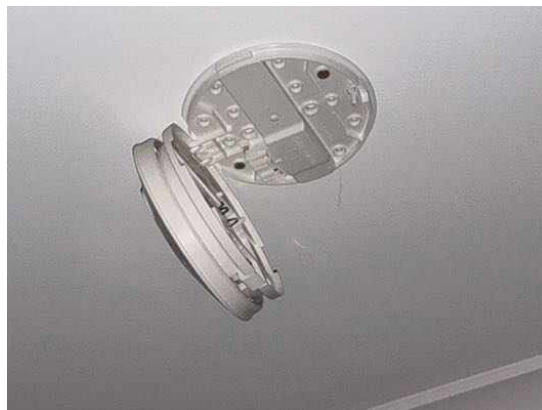
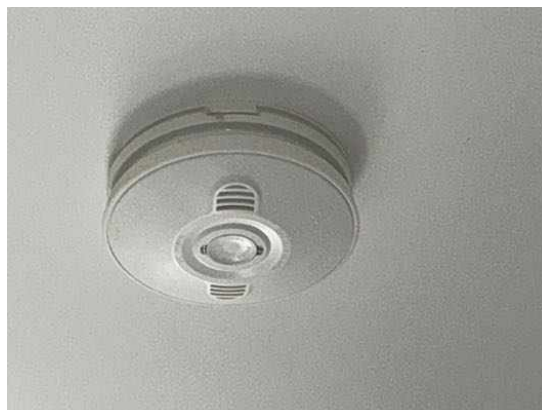
Finding 1.03

Building: Main Building
 Location: All Internal Areas
 Finding: Smoke Detectors and Alarms
 Information: Reporting on Smoke Detectors or Alarms, including hard wired smoke detection systems and their legislative requirements, is outside the Scope of this Report.

Please note that this defect is highlighted as a caution only. We suspect, based on our experience in the building industry, that the absence of smoke detectors, or their poor condition, should be addressed as a matter of urgency to improve occupant safety.

Further Inspection and/or advisory services is necessary to provide advice on the sufficiency, type and location of smoke detectors, and to test the functionality of all devices including battery replacement. Greater requirements for fire safety and detection exist for commercial buildings.

Always ensure sufficient working and suitable smoke detectors are installed prior to occupying any building. Additionally, it is advised that all smoke detectors be tested by the homeowner on a monthly basis.

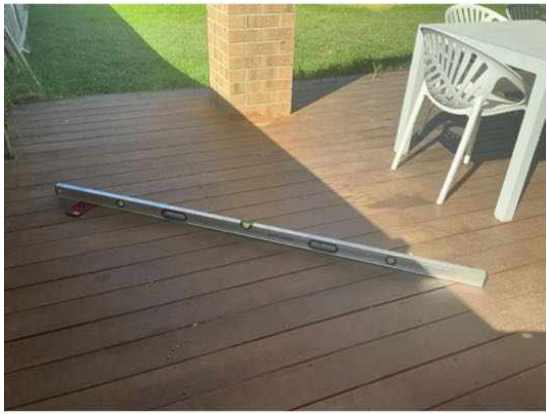
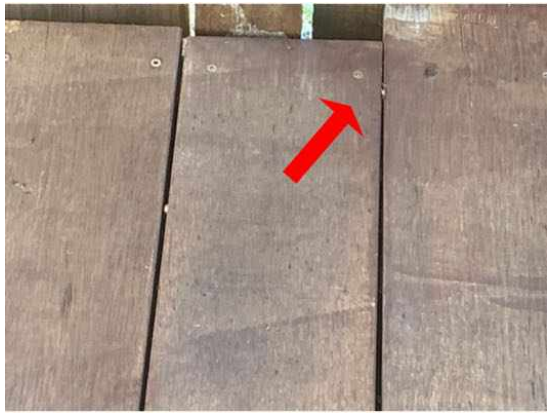
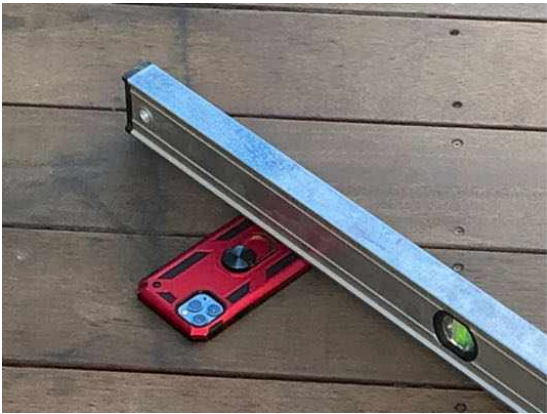
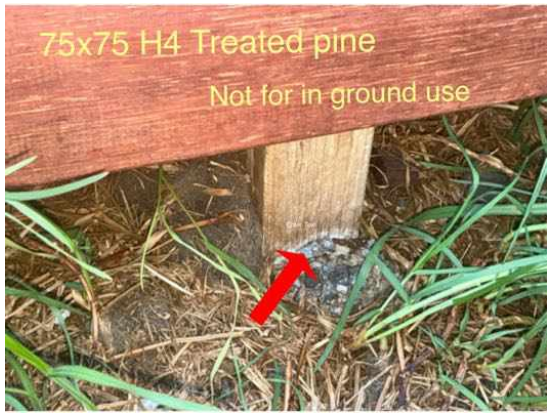
It is highly advised to request that the current owner provide a Defect report (Owner Builder/Section 137b) for this structure. This would involve a structural engineer or a licenced building surveyor conducting an inspection of the structure and advising of any defects and/or areas of non-compliance in accordance with the current building codes. The current owner should then attend to any issues on this report prior to settlement.

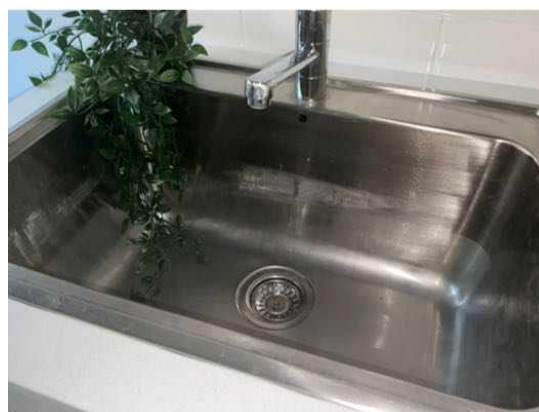
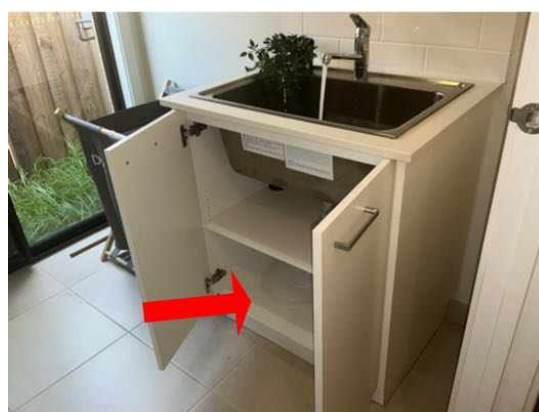
Finding 2.02

Building: Main Building
 Location: Laundry
 Finding: Plumbing to laundry tub leak
 Information: It was observed at the time of the inspection that there was a significant water leak in the plumbing to the laundry tub and cabinet. The leak was causing flooding to the laundry floor.

A licensed plumber should be engaged to review immediately.

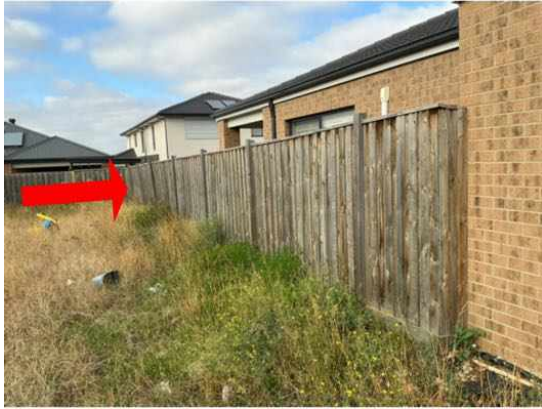
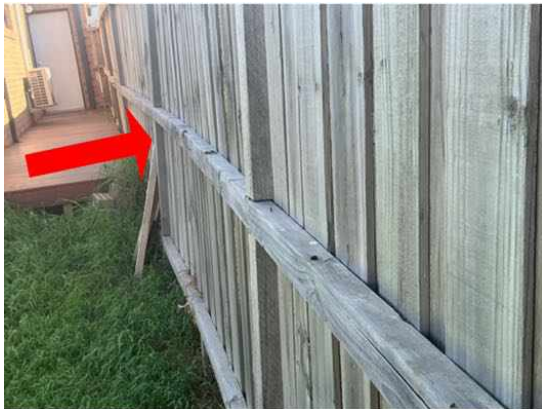
Finding 3.01

Building: Main Building
 Location: All External Areas
 Finding: Fencing - Deteriorated
 Information: It was noted at the time of inspection that sections of the fencing throughout the property have deteriorated. Typically fencing deteriorates due to age and or wear, rot and or rust which is generally expected for a structure of this age, due to prolonged exposure to weather conditions. Sometimes inadequate installation or maintenance can be to blame.

If left unattended, it is likely that further damage will occur. It is suspected that repair of several elements of the fencing may be required however replacement may be a consideration of the client also.

A licensed fencing contractor should be appointed to provide further advice and perform rectification works as necessary.

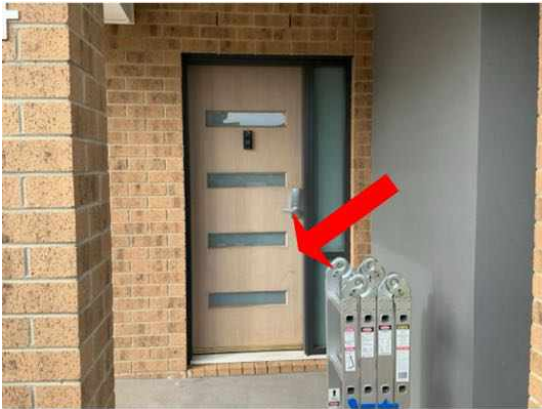
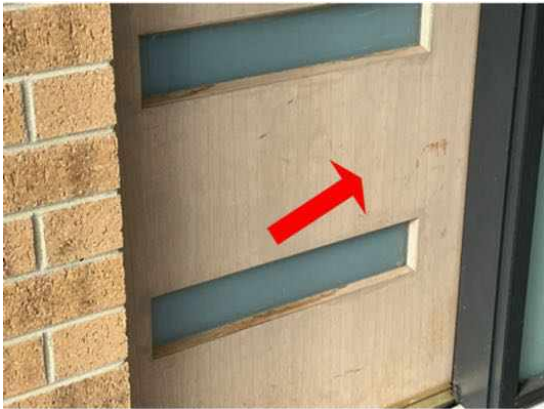
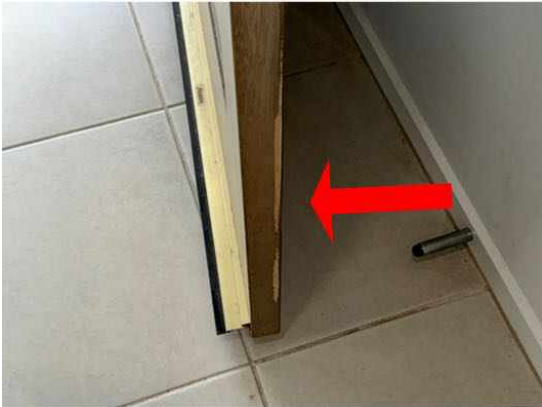
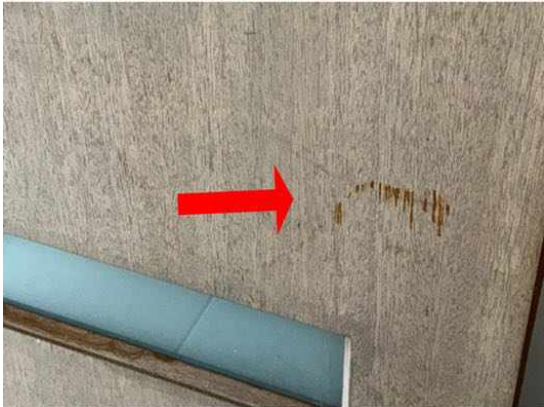
Finding 3.02

Building:	Main Building
Location:	Front Elevation
Finding:	Front door, poor condition
Information:	It was observed at the time of the inspection that the paintwork and the veneer to the front door was scuffed, chipped and was displaying minor damage.

Unattended to the damage could prematurely deteriorate the door which could eventually require replacement.

A general handyman should be engaged to review at their owners discretion

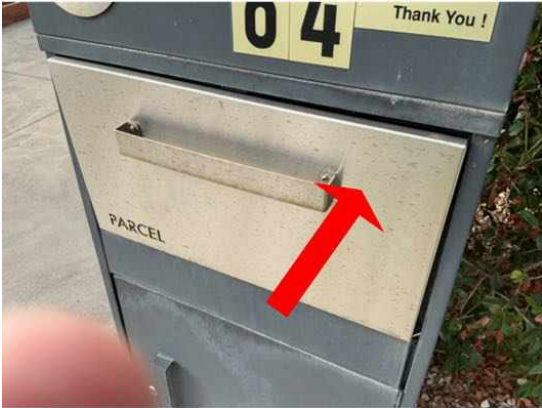
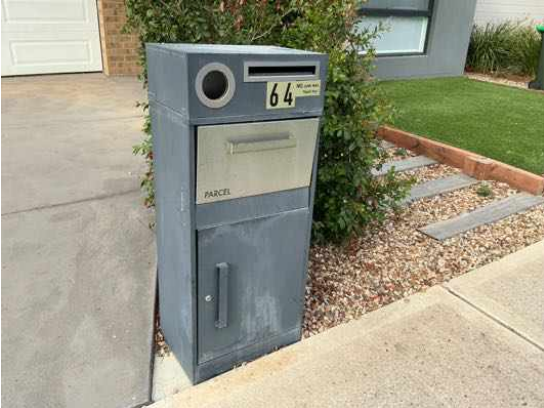
Finding 3.03

Building: Main Building
 Location: Yard - Front
 Finding: Letterbox damage
 Information: It was noted that the time of the inspection that the door to the letterbox was damaged.

Unattended to deliveries could become difficult and inconvenient.

A general handyman should be engaged to review at the owners discretion

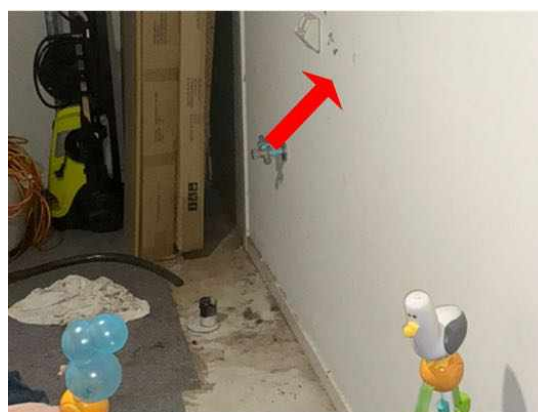
Finding 3.04

Building:	Main Building
Location:	Garage
Finding:	Garage wall damaged
Information:	It was noted at the time of the inspection that the garage wall was damaged and marked to the rear of the garage

Although this is anaesthetic detracts from the overall appearance of the building.

A general handyman should be engaged to review at the owners discretion

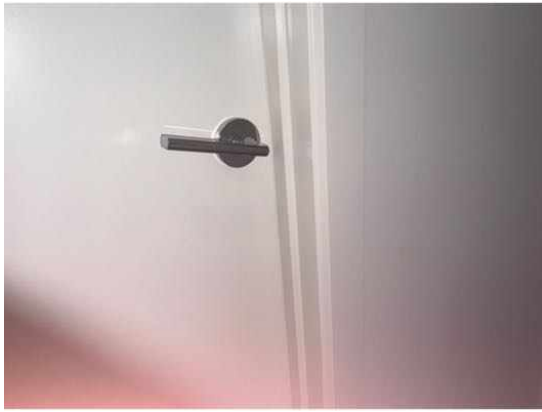
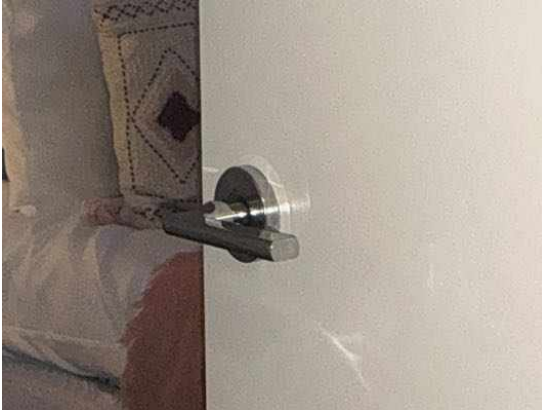
Finding 3.05

Building:	Main Building
Location:	All Internal Areas
Finding:	Door handle required adjustment
Information:	It was observed that many internal door handles required adjustment the levers were pointing in an upward direction. Correctly fitted door levers are horizontal. The door leaves may have been incorrectly fitted at the time of construction.

Although one aesthetic defect general handyman should be engaged to reviewer at the owners discretion

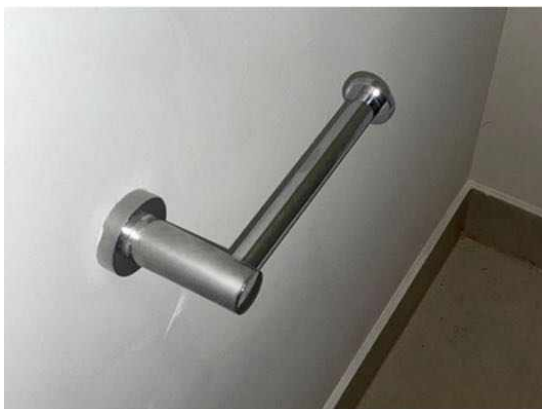
Finding 3.06

Building:	Main Building
Location:	WC and ensuite bathroom
Finding:	Toilet roll holder - Loose
Information:	The toilet roll holder was found to be loose at the time of inspection. While not a major operational defect, function can deteriorate if the problem is left unmanaged.

It is advised that the homeowner performs remedial works to re-attach the toilet roll holder to its original fixing. A general handyperson may be required to perform these works.

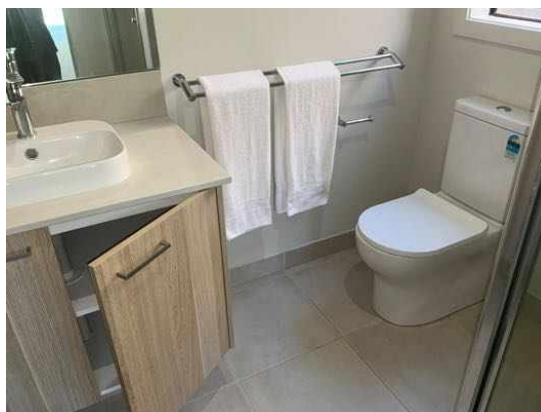
Finding 3.07

Building:	Main Building
Location:	Ensuite
Finding:	Towel rail - Loose
Information:	The towel rails were found to be loose at the time of inspection. While not a major operational defect, function can deteriorate if the problem is left unmanaged.

It is advised that the homeowner performs remedial works to re-attach the towel rail to its original fixing. A general handyperson may be required to perform these works.

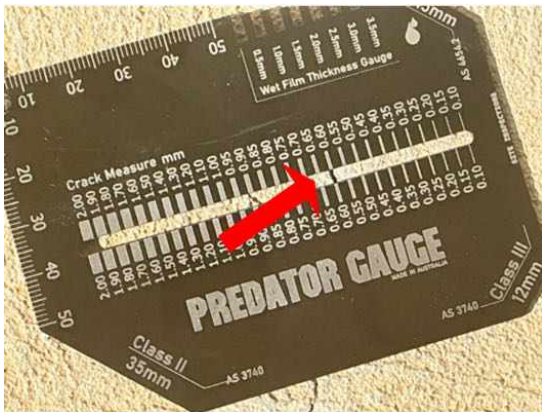
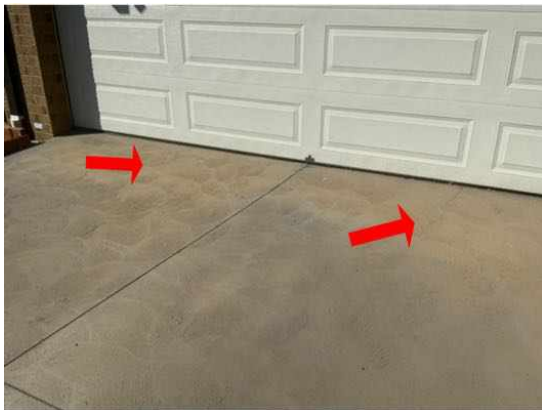
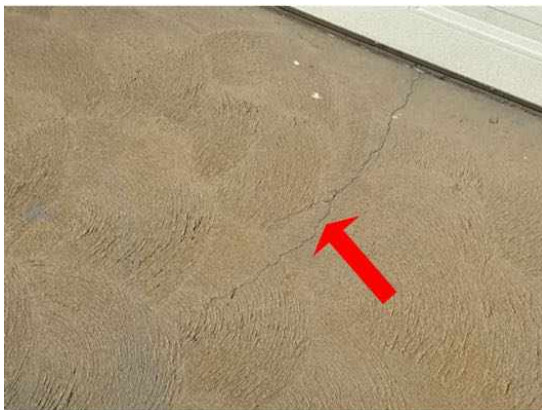
Finding 3.08

Building:	Main Building
Location:	Driveway
Finding:	Crack in concrete slab - Category 1
Information:	A crack coded as Category 1 was identified in the slab. A Category 1 crack is described as a fine but noticeable crack, with the slab at an otherwise reasonable level.

To be considered Category 1, the approximate width of the crack is less than 1.0mm, or a less than 10mm change in offset when a 3m straight edge is placed over the defect.

Category 1 cracks should be monitored for a period of 12 months. At the end of the monitoring period, identified cracks that are rated greater than Category 2 are considered defects, and require rectification.

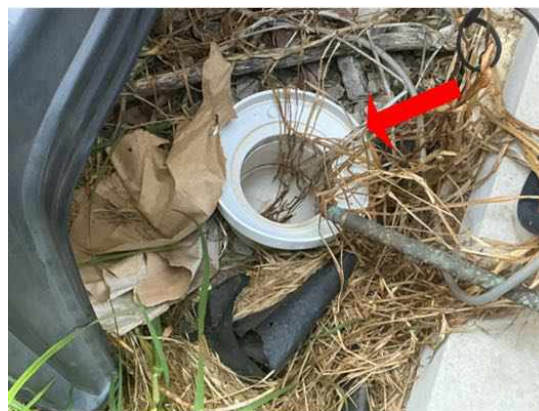
Finding 3.09

Building: Main Building
 Location: Exterior walls - right side
 Finding: Drainage grate cap missing
 Information: It was noted at the time of the inspection that the stormwater grate cap adjacent to the hot water service was missing

These cups are provided to prevent debris falling into the stormwater drain system and causing blockages.

A general handyman or licensed plumber should review as soon as possible

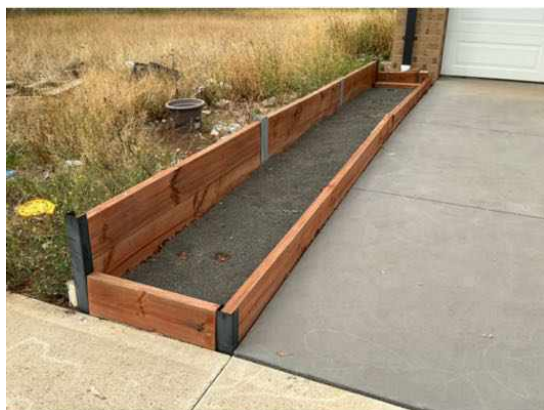
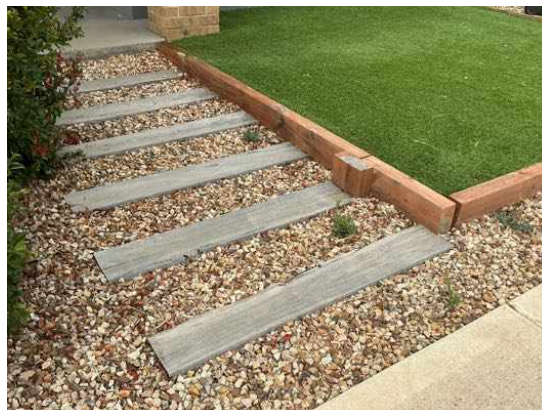
Building:	Main Building
Location:	All External Areas
Finding:	Untreated or non-durable timbers in a hazardous environment
Information:	To reduce the risk of timber pest attack it is essential that timber used in a hazardous environment (e.g. in direct contact with the ground or frequently exposed to damp conditions) is of sufficient durability and/or is adequately preservative treated.

Untreated timbers in direct contact with the ground are likely to develop severe wood rot and/or fungal decay if left unattended creating attraction for subterranean termites to infest the timbers from surrounding areas.

If untreated or non-durable timbers are found to be in a hazardous environment it is highly advised that replacement of these building elements be performed as soon as possible to aid the protection of the property against termite / timber pest attack.

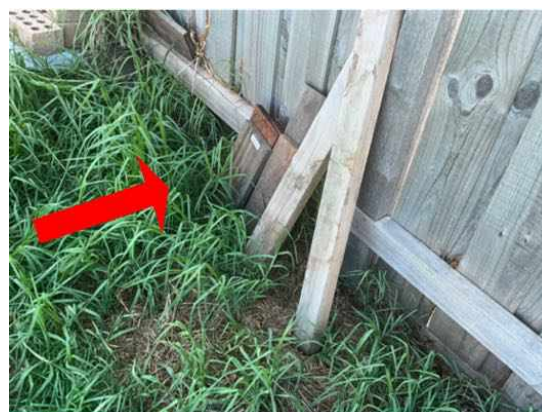
Finding 6.02

Building:	Main Building
Location:	Yard - Back
Finding:	Stored timbers - subfloor space or external area
Information:	The storing of timbers in the subfloor space or around the external property increases the risk of termite activity being present. As they are likely to come into contact with weather conditions or excessive moisture wood rot is likely to develop on timbers that are not treated.

It is highly recommended that any stored timbers be immediately removed from areas in which they may attract any termite / timber pest attack. Minimisation of risk / prevention of termite attack is far more adequate than dealing with the presence of termite activity.

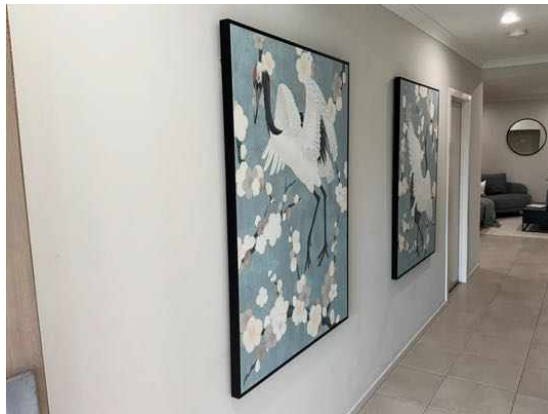
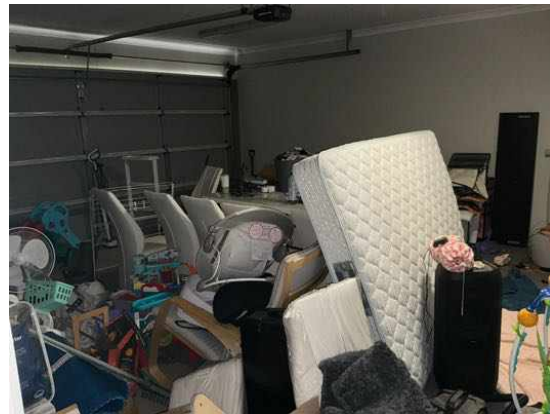
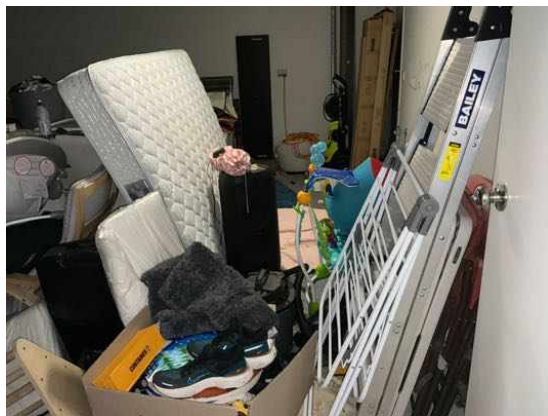
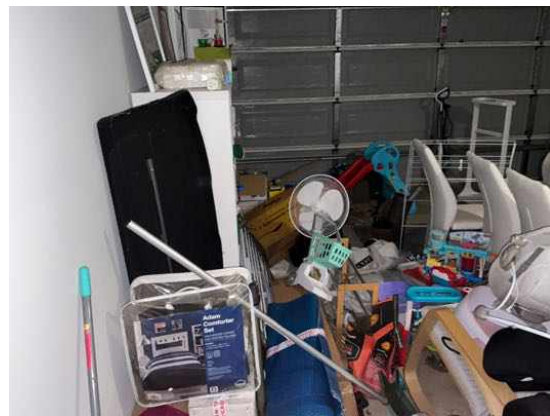
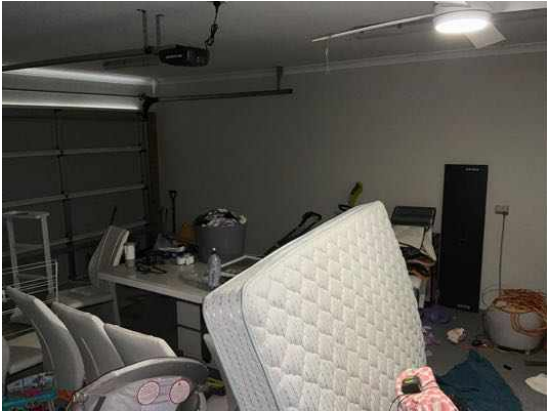
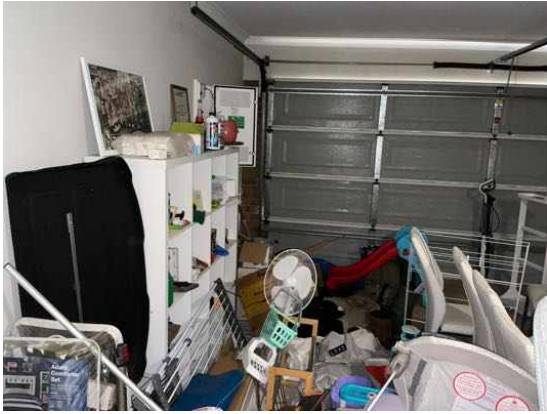
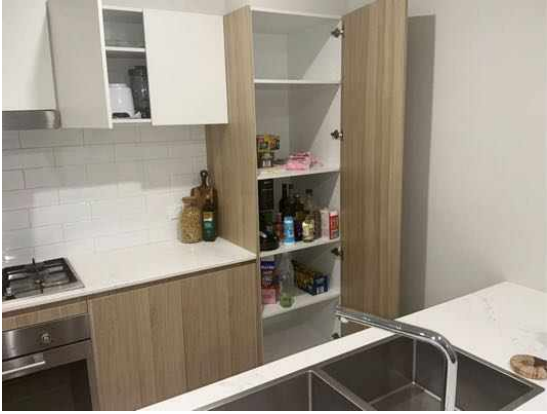
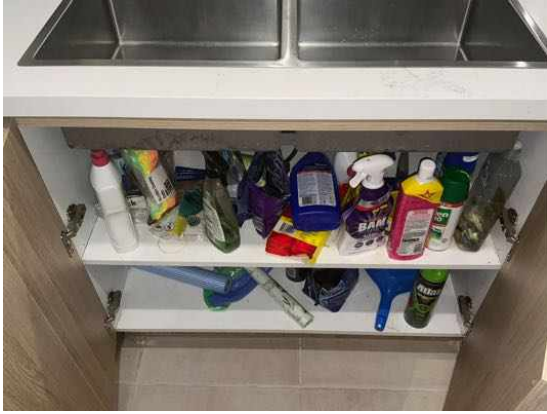
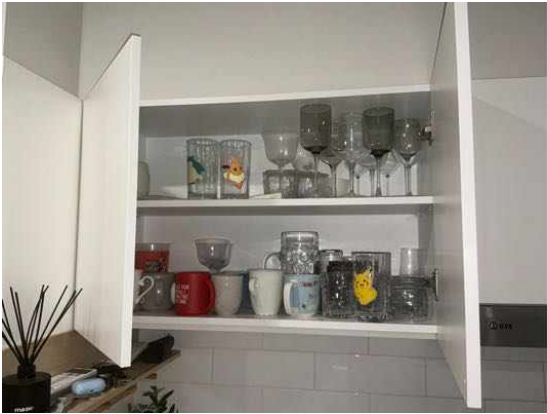
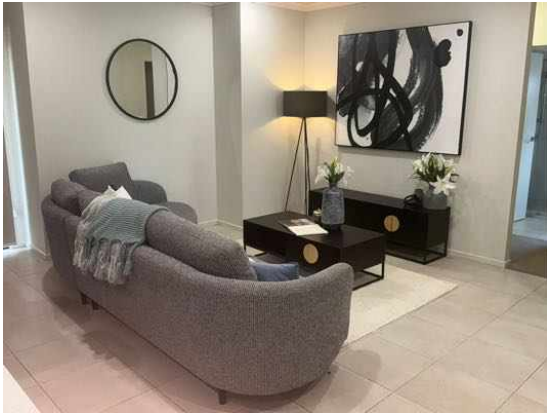
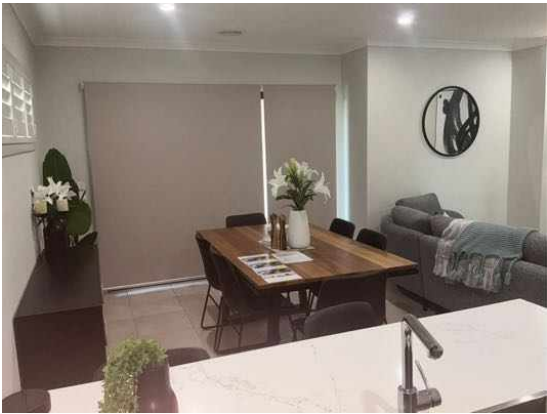
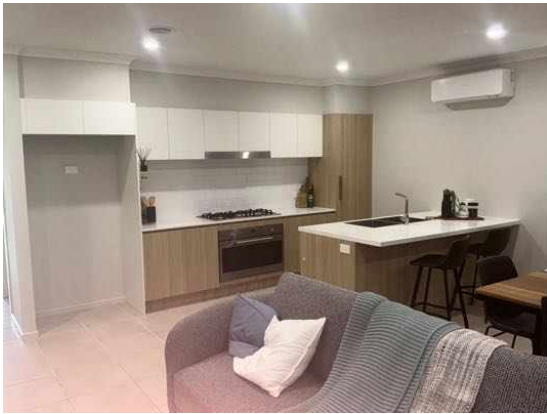
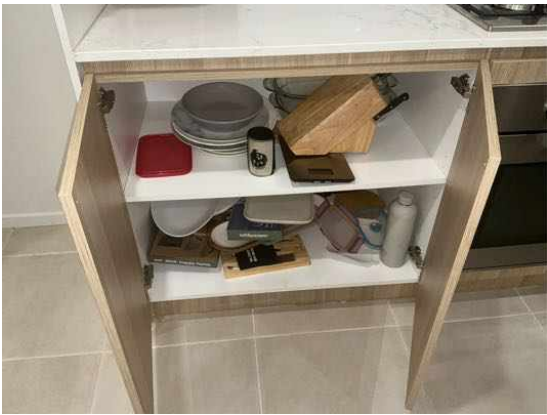
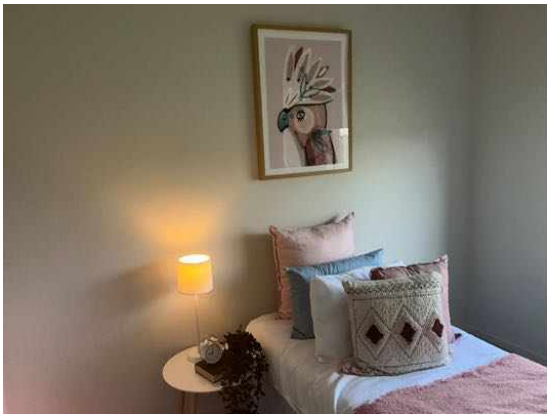
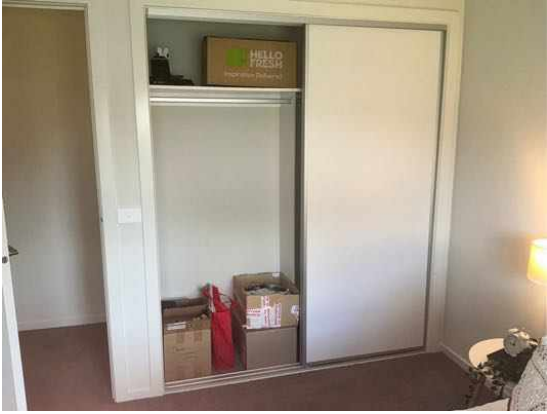
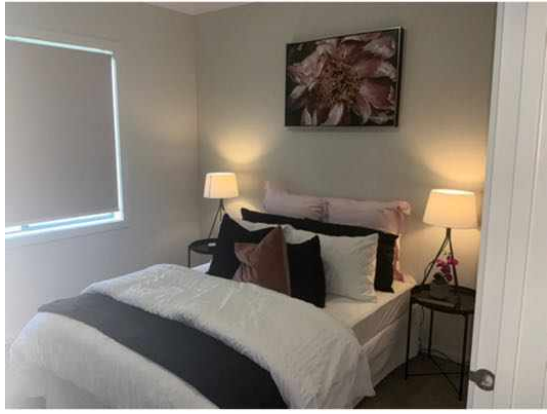
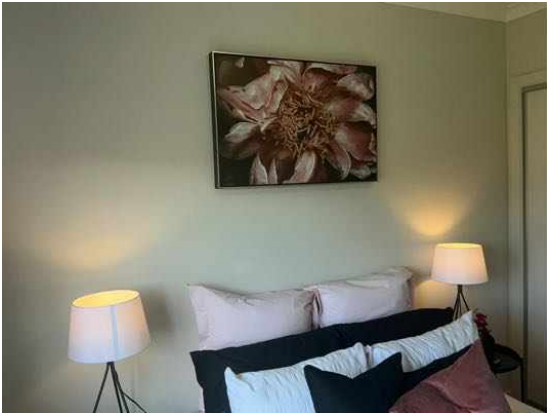
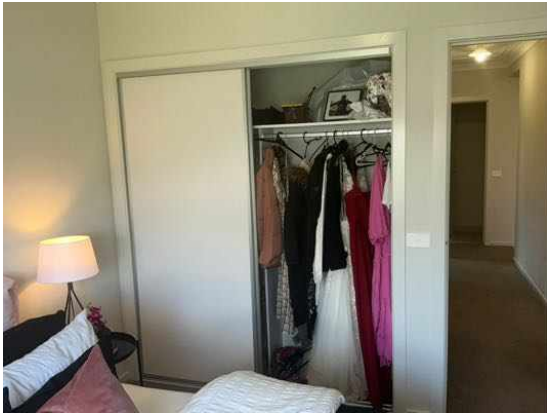
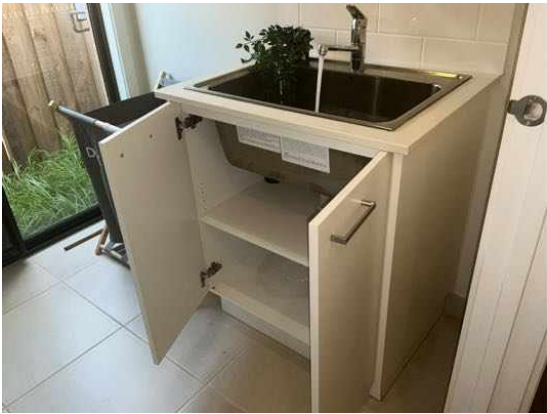
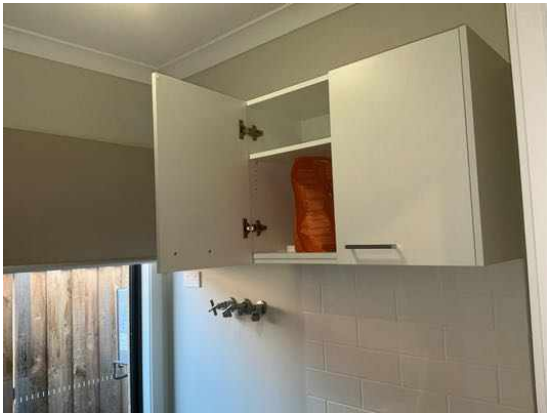
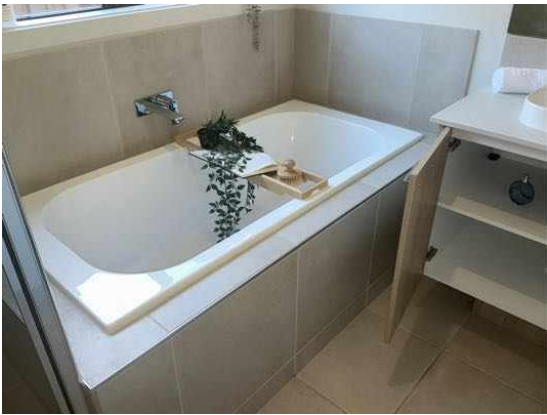
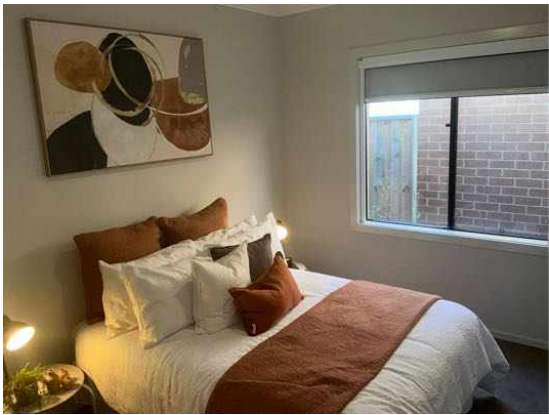
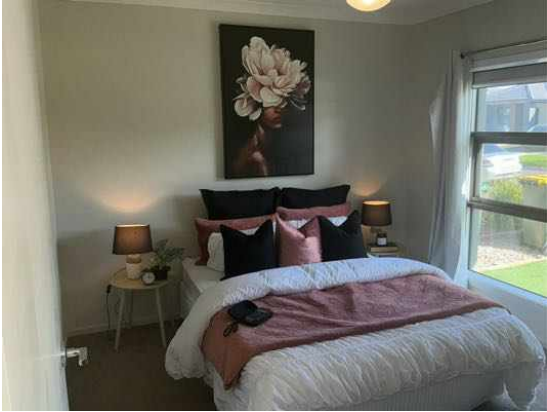
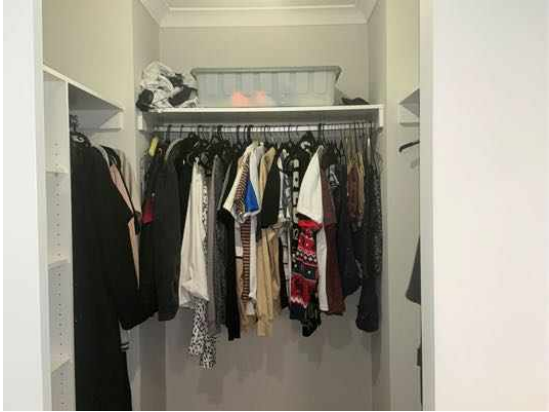
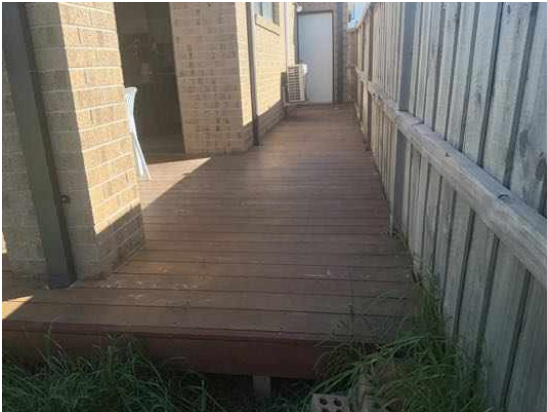
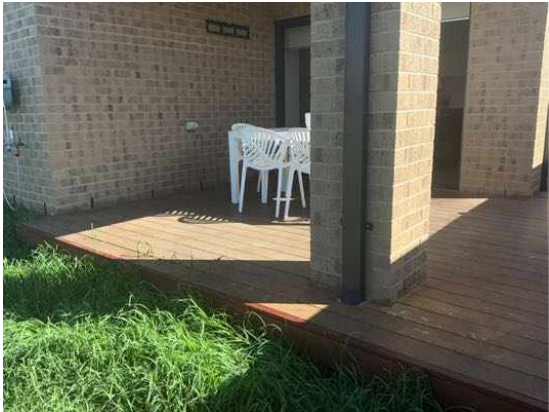
Finding: Additional Photos - Obstructions and Limitations

Information: These photographs are an indication of the obstructions and limitations which impeded full inspection of the property at the time of inspection. These obstructions can hide an array of defects and should be removed to allow full inspection to be carried out. A re-inspection is recommended once the areas are made accessible.

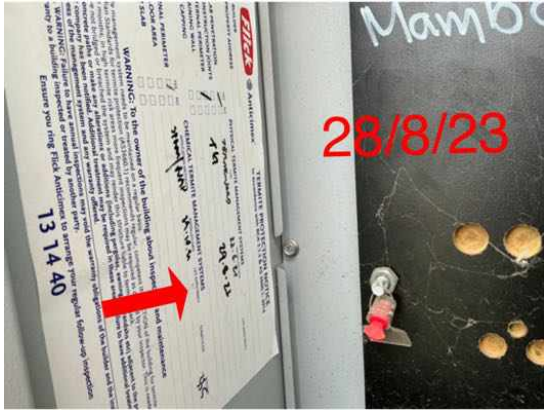
Building:	Main Building
Location:	All External Areas
Finding:	Evidence of a chemical treated zone barrier was identified
Information:	During inspection of the property, it was noted that works to install a chemical treated zone barrier had previously been completed. A chemical treated zone barrier is likely to ensure effective protection against termites.

However, we strongly recommend annual inspections of the barrier and surrounding areas as there are several factors that can lead to deterioration of the barrier and decrease its effectiveness.

Where a Termite Management System has been identified, the client should identify to the type of barrier, date of installation, warranty conditions and any documentation provided by a builder or past owner. Consult the company who installed the barrier to confirm whether the system is still under warranty.
