# Building and Timber Pest Inspection Report

Inspection Date: Wed, 18 Mar 2026

Property Address: 4/50 Eleanor St, Footscray VIC 3011,  
Australia

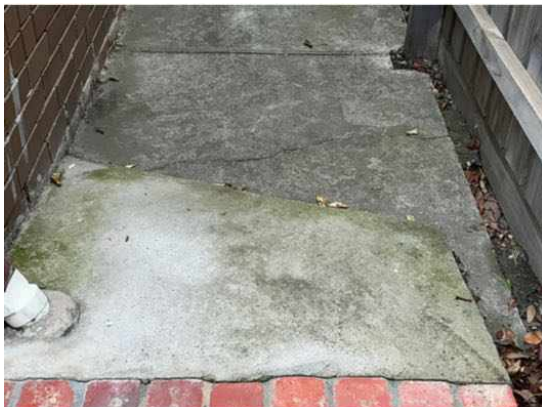
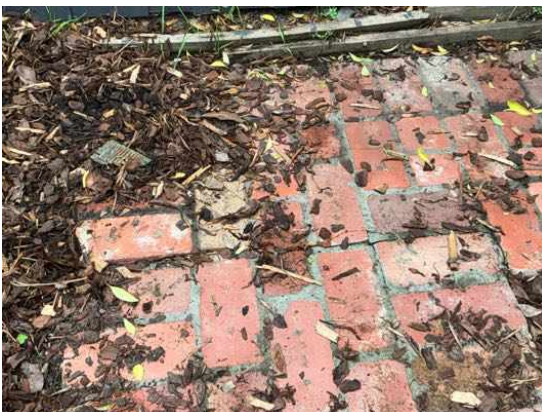
Building: Main Building  
Location: All Internal Areas  
Finding: Paving - Uneven  
Information: Sections of the external paved area are uneven, creating a potential trip hazard. It appears as though the area has been subject to rough installation, or that paving sections have lifted due to movements in the foundation of the property.

Where paving creates a trip hazard, personal injury may ensue if due caution is not taken by all persons within this area.

Re-paving of the area is required as soon as possible to remedy this situation. Further consultation with a specialist concreter is advised.

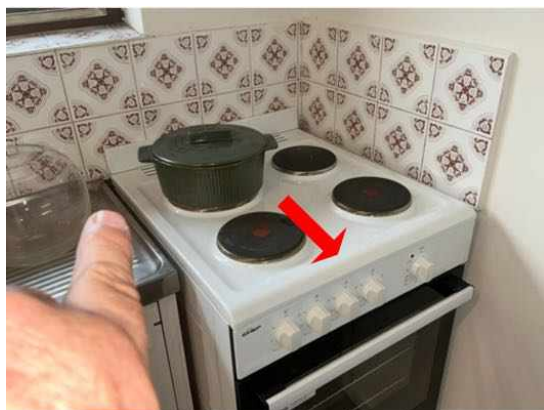
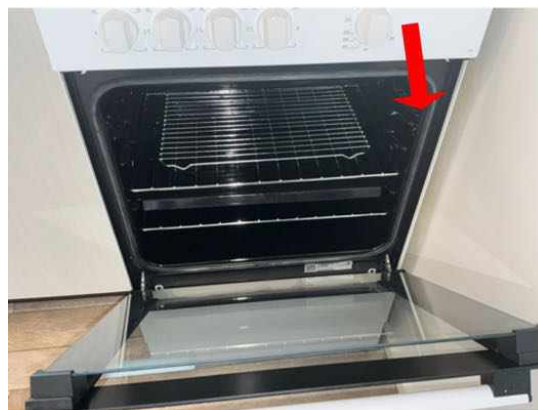
#### Finding 1.02

Building: Main Building  
Location: Kitchen

Finding: Kitchen stove not secured to wall  
 Information: It was observed at the time of the inspection that the kitchen stove was not secured to the wall and appeared to be unstable. Without being secured to the wall, the oven could tip forward causing injury and property damage.

The oven should be secured to the wall immediately by a licensed plumber.

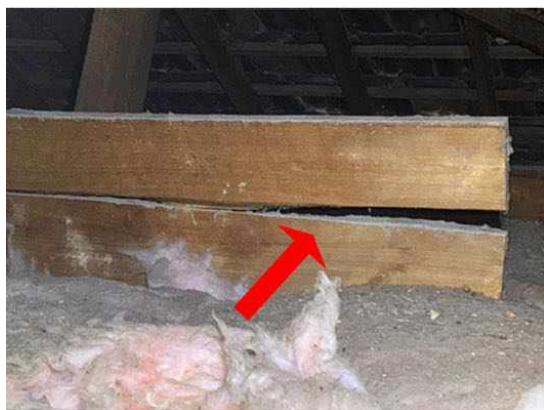
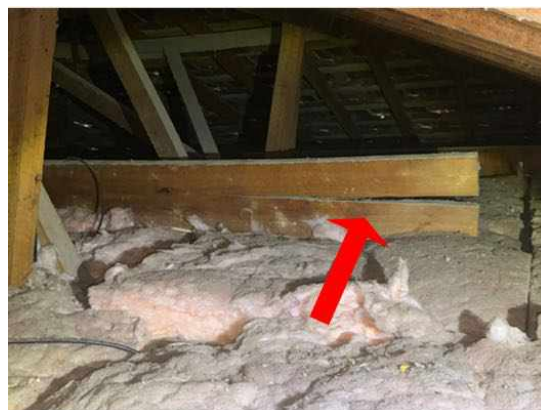
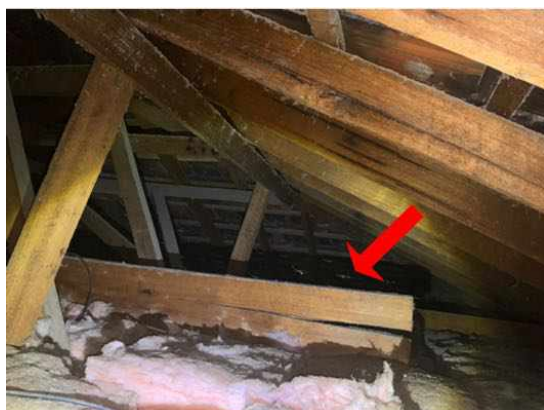
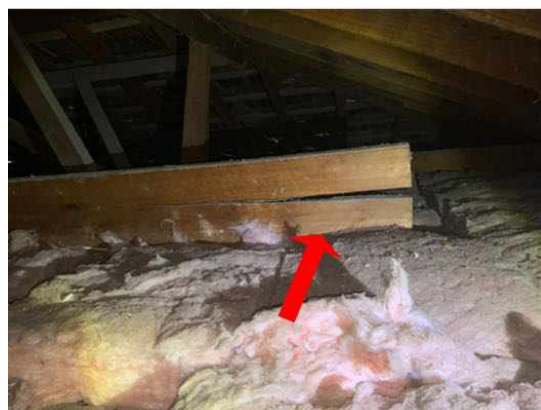
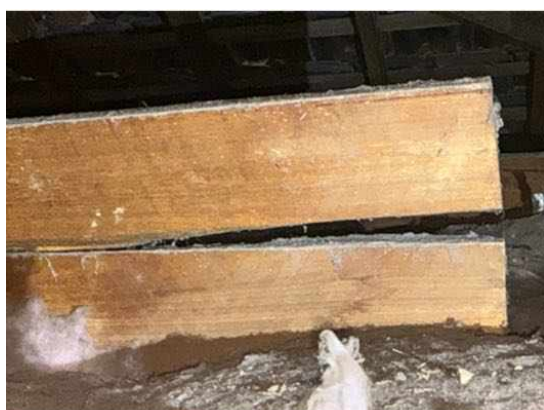
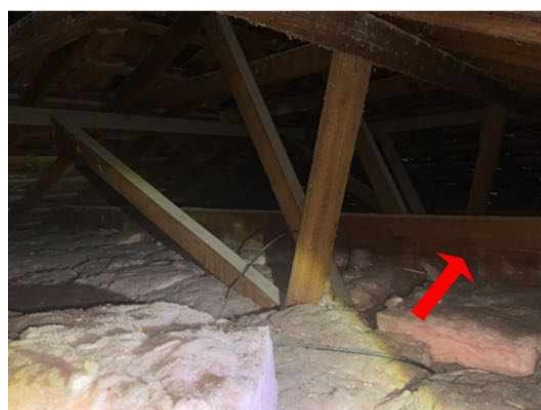
### Finding 2.01

Building: Main Building  
 Location: Roof Void  
 Finding: Timber hanging beam deteriorated  
 Information: It was observed at the time of the inspection that the timber hanging beam supporting the floor joists over the lounge room has overtime dried and split opened. Movement in unseasoned hardwood is not unexpected however this would be considered excessive. This was a normal acceptable style of construction at the time.

The split hanging beam can reduce the structural integrity of the beam and could affect the stability of the lounge room ceiling and cause cracking to the plaster.

The beam should be repaired by a qualified carpenter as soon as possible

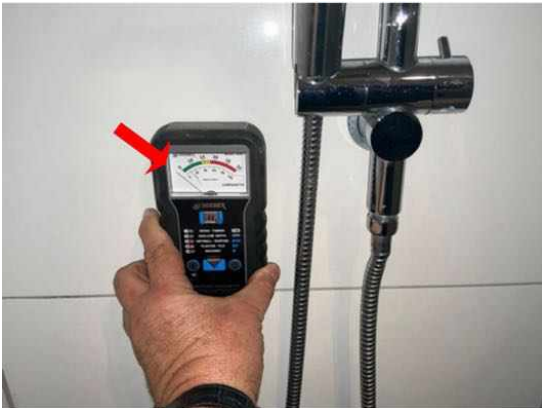
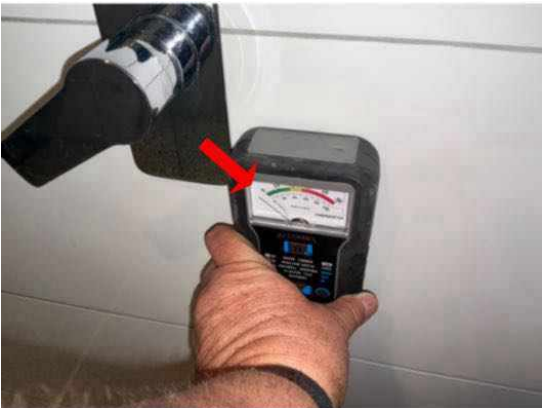
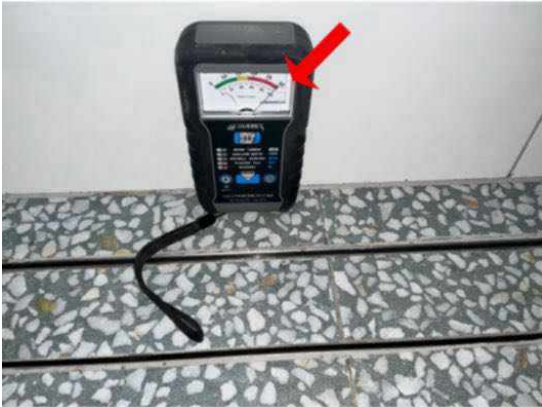
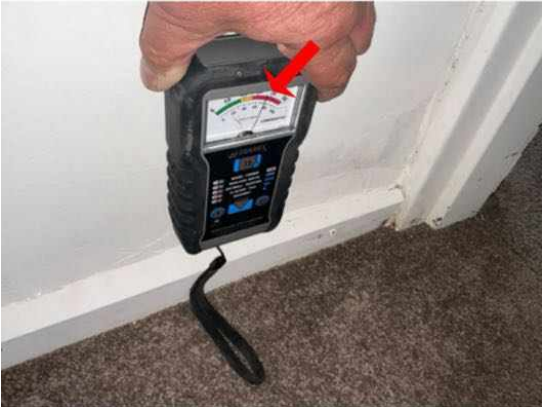
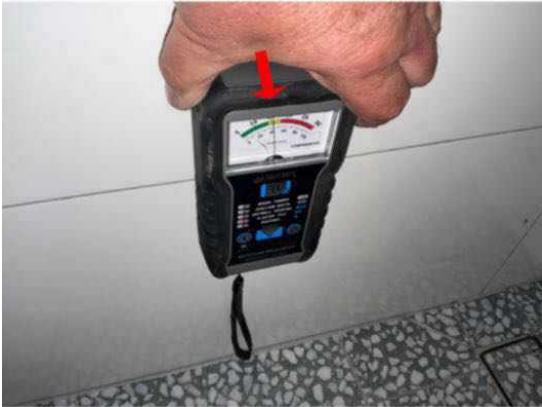
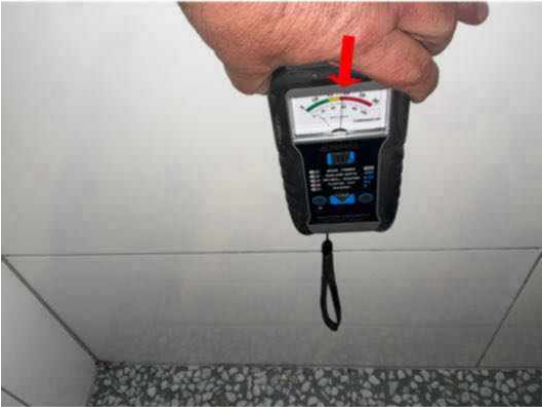
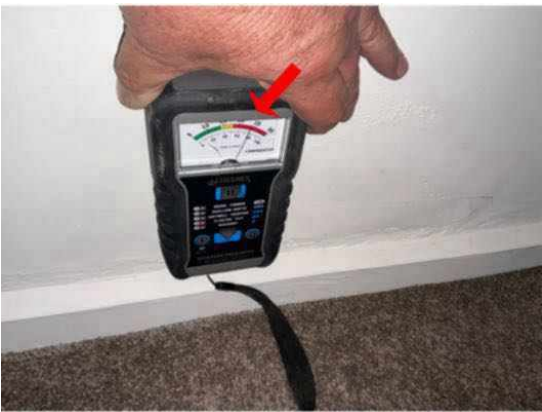
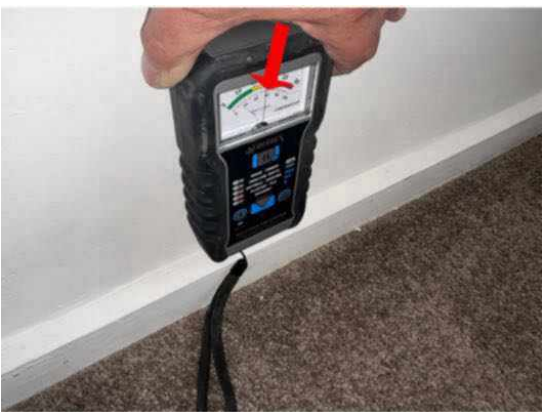
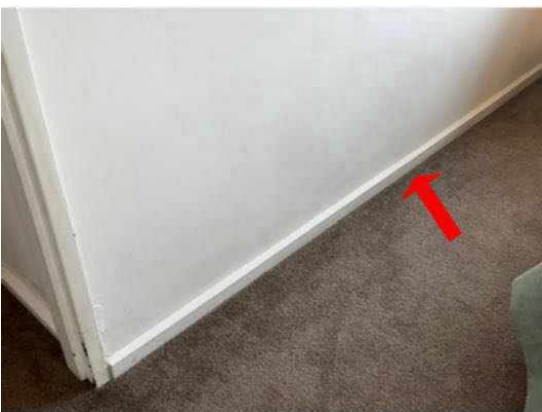
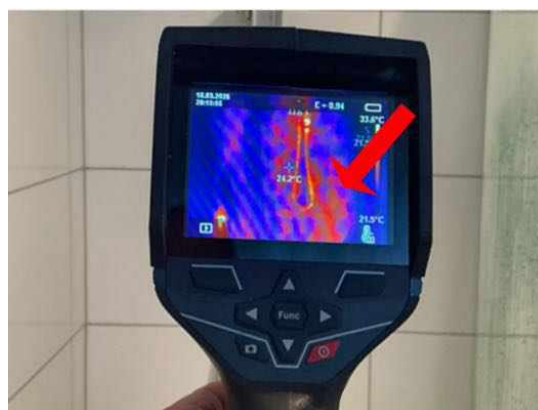
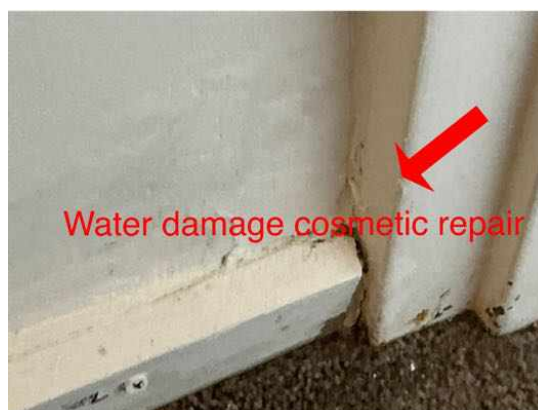
## Finding 2.02

Building:	Main Building
Location:	Bathroom
Finding:	Shower base - suspected Leaking
Information:	Leaking was evident to the shower base at the time of inspection. It is suspected that the leaking has occurred as a result of minor impact damage to the shower base or general ageing of the building elements.

Leaking from the shower base, where left unattended, is likely to lead to water damage to adjoining flooring and walls. Such damage can lead to water damage and necessitate extensive remedial works being required. Active water leaks may also create an environment that is susceptible to the formation and development of mould.

A moisture meter and thermal camera were used and high readings were obtained from the bottom 400 mm of the shower base both inside the shower closet and the adjacent internal walls. The shower closet appears to have been a recent renovation and the tiles appear to be adhesive spot fixed without a full coverage of adhesive endearing the title to the substrate. Shower leaks can be caused by numerous reasons for example plumbing leaks, poor waterproofing techniques and poor tile installation. Spot fixing can allow the transfer of moisture between the tile and the substrate.

Appointment of a tiling and waterproofing contractor is required to review as soon as possible and prior to further use of the shower.

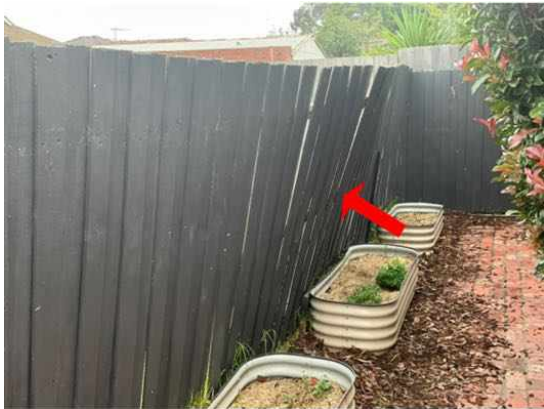
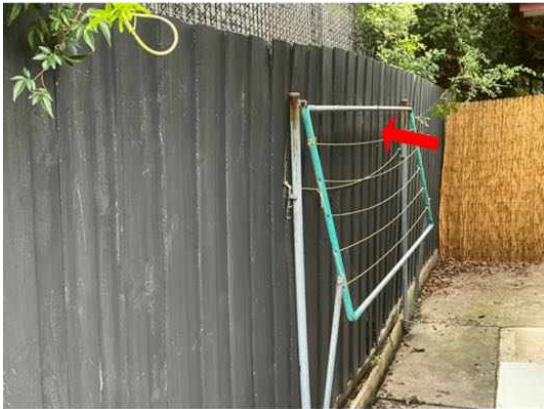
### Finding 3.01

Building:	Main Building
Location:	All External Areas
Finding:	Fencing - Deteriorated
Information:	It was noted at the time of inspection that sections of the fencing throughout the property have deteriorated. Typically fencing deteriorates due to age and or wear, rot and or rust which is generally expected for a structure of this age, due to prolonged exposure to weather conditions. Sometimes inadequate installation or maintenance can be to blame.

If left unattended, it is likely that further damage will occur. It is suspected that repair of several elements of the fencing may be required however replacement may be a consideration of the client also.

A licensed fencing contractor should be appointed to provide further advice and perform rectification works as necessary.

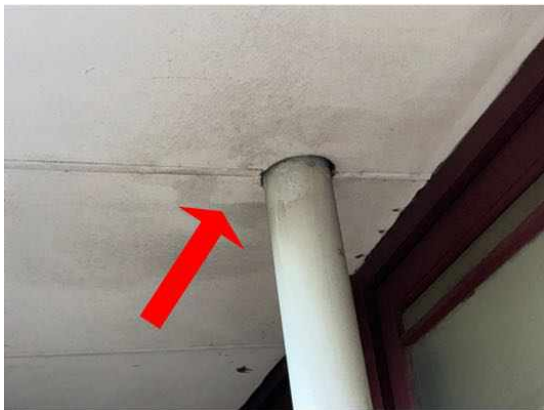
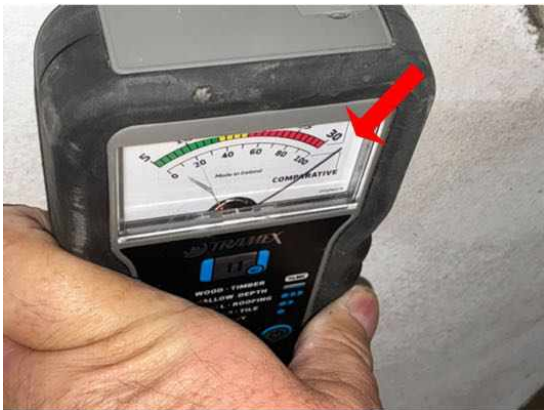
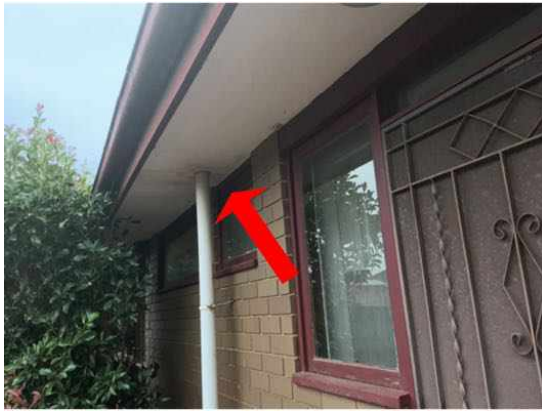
**Finding 3.02**

Building: Main Building  
 Location: Roof Exterior  
 Finding: Exterior roof - Leaking- minor  
 Information: Active roof leaks were evident at the time of inspection. Roof leaks can have a number of causes, including damage to roof coverings, deterioration of roof fixtures and fittings, or loosely associated materials (fascias etc.).

Where water leaks are active, rain penetration is likely to cause water damage to associated structures and building elements in this area, which can have a range of implications. If left unmanaged, the development of major structural damage to the roofing and associated structures may occur.

A roof plumber should be appointed as soon as possible to primarily identify the cause of the leak, and to provide subsequent repair works as necessary. Depending on the extent of the damage, replacement of sections of the roof covering and/or roofing structures may be required, and may be performed by a registered builder or qualified carpenter.

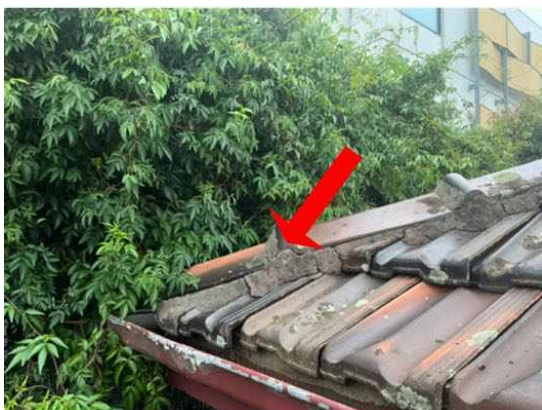
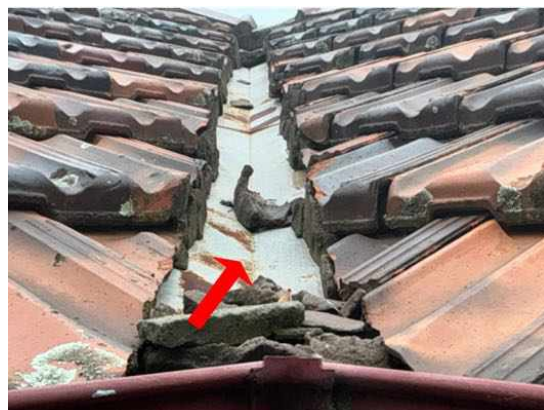
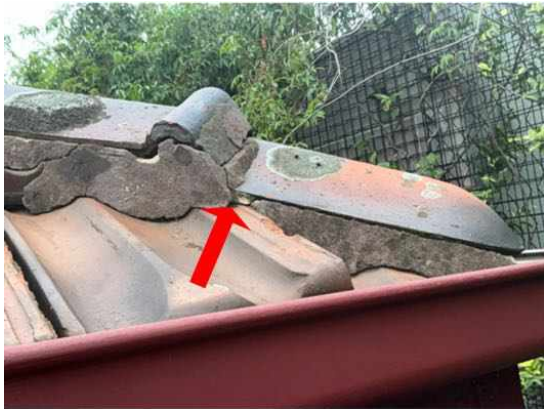
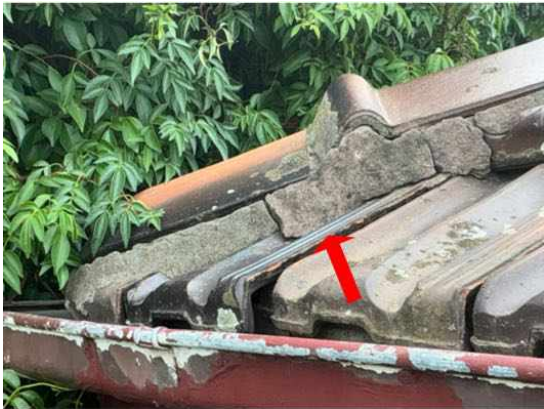
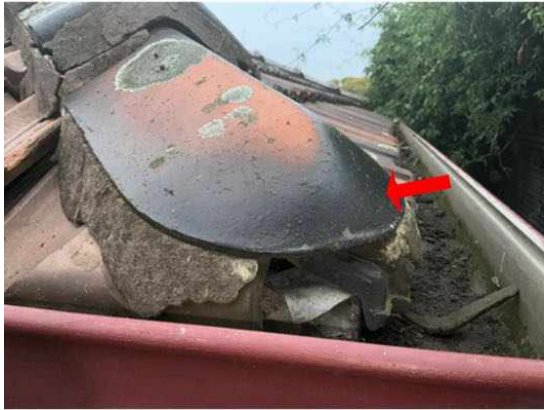
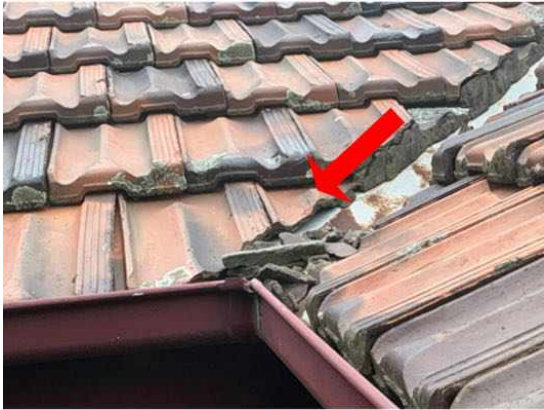
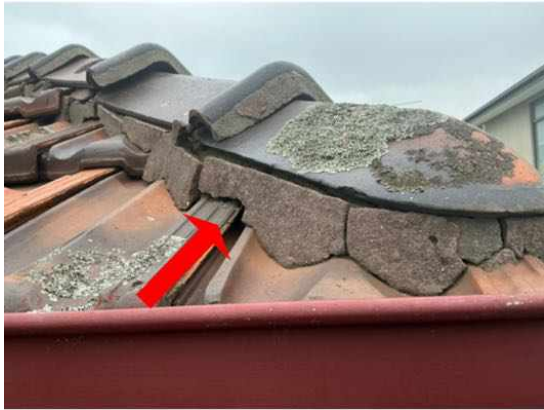
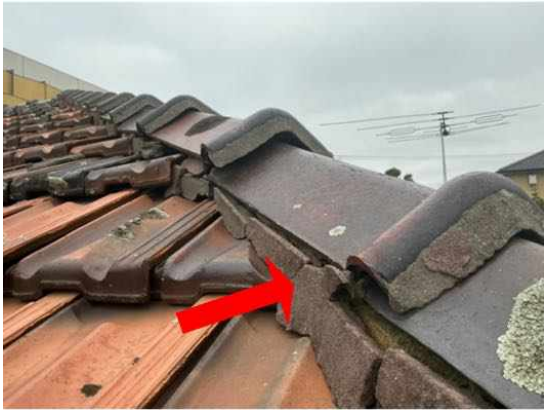
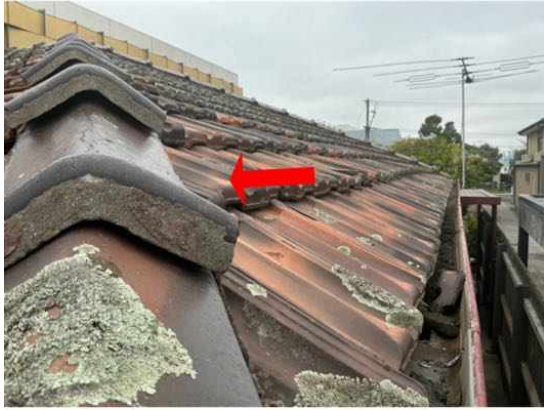
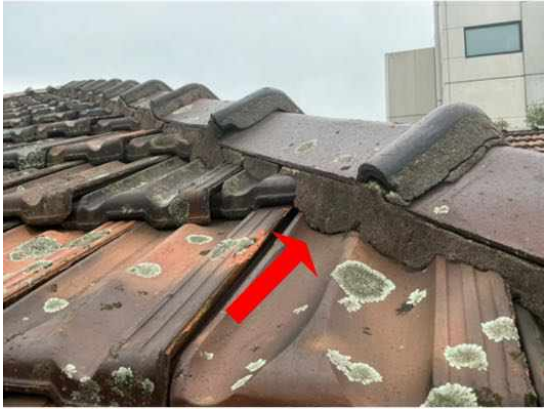
### Finding 3.03

Building:	Main Building
Location:	Roof Exterior
Finding:	Roof and hip tiles broken painting and weathered
Information:	Upon inspection of the exterior roofing, the majority of roof tiles were considered to be in a fair condition. While weathering of the tiles is consistent with the age of the property, maintenance works are required.

Isolated areas of mortar have come loose in the valleys and minor cracking is also present. Re-pointing and re-sealing the may be considered as an interim solution by the client to help preserve and extend the life span of the tiles.

Where left unmanaged, deteriorating roof tiles are likely to lead to a number of secondary defects, including minor water leaks and weather exposure to internal roofing structures.

Consultation with a roofing contractor is highly advised to gain advice on cost of remedial works that may be required in the short to medium term. Remedial works are likely to increase the longevity of the exterior roofing structure.

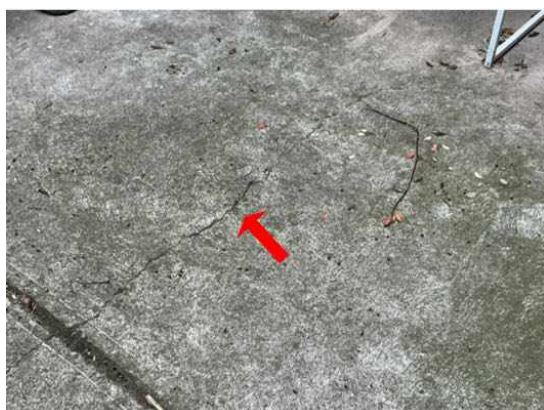
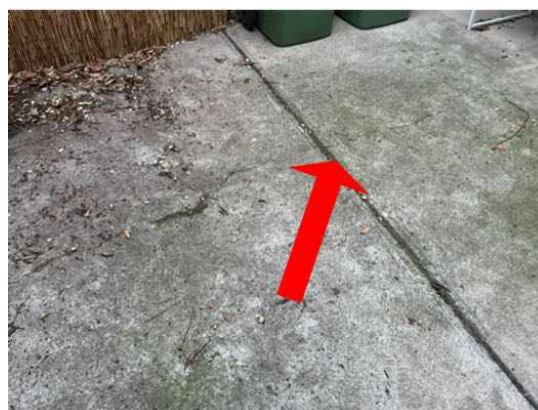
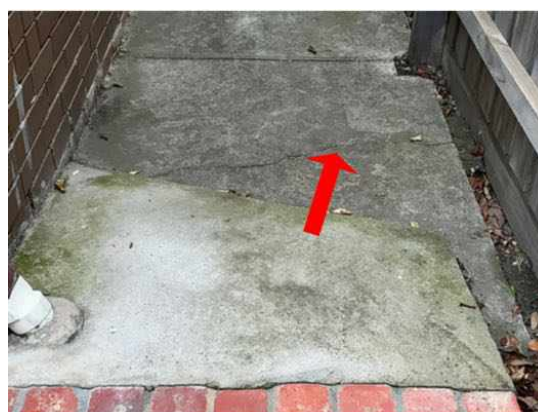
Building: Main Building  
 Location: All External Areas  
 Finding: Crack in concrete slab - Category 1  
 Information: A crack coded as Category 1 was identified in the slab. A Category 1 crack is described as a fine but noticeable crack, with the slab at an otherwise reasonable level.

To be considered Category 1, the approximate width of the crack is less than 1.0mm, or a less than 10mm change in offset when a 3m straight edge is placed over the defect.

Category 1 cracks should be monitored for a period of 12 months. At the end of the monitoring period, identified cracks that are rated greater than Category 2 are considered defects, and require rectification.

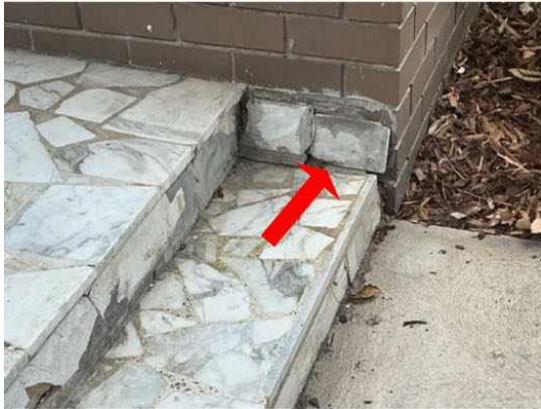
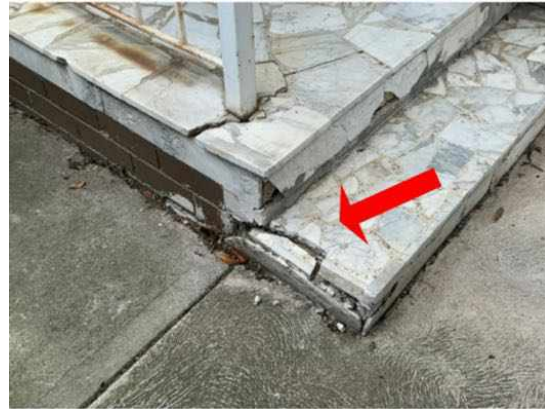
### Finding 3.05

Building: Main Building  
 Location: Porch  
 Finding: Damaged tiles  
 Information: It's was observed at the time of the inspections that the floor tiles to the front porch were broken and damaged. Although an anaesthetic defect it however detracts from the overall appearance of the building

An experienced floor and wall tiles should review at the owners discretion

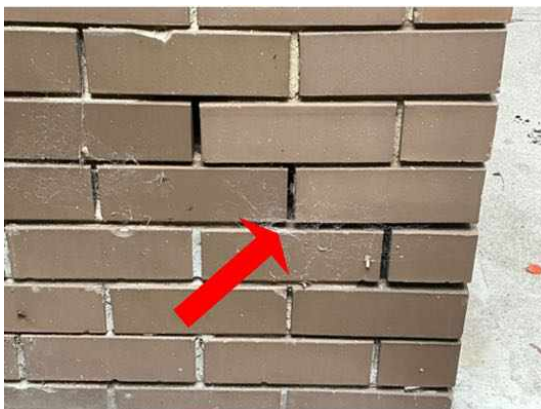
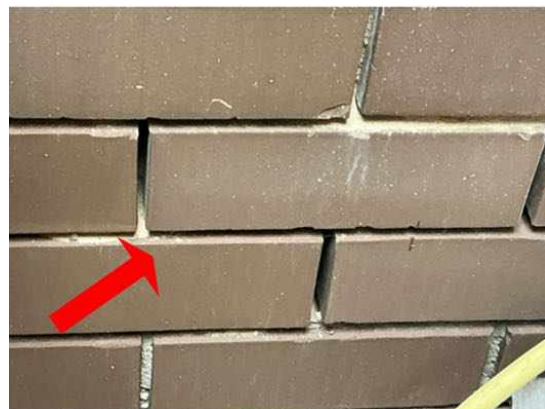
### Finding 3.06

Building:	Main Building
Location:	All External Areas
Finding:	Brickwork - Deteriorated mortar
Information:	Mortar, or 'bedding', is the material which fills joins and intersections between bricks in masonry walls and structures. Sections of mortar in this brickwork were identified as having deteriorated, which is generally expected for a property of this age and condition.

Mortar may deteriorate as a result of age of building materials, minor movement of bricks, or frequent exposure to weathering. Mortar should be replaced to ensure that bricks remain in their intended location and to prevent gaps, which would allow water or moisture ingress and secondary damage as a result.

Mortar deterioration can be addressed by a bricklayer where areas of deterioration are localised and easily accessible. Alternatively, appointment of a registered builder is advised, to repoint large areas of decaying mortar. Where secondary structural defects have become evident, consultation with a structural engineer may be required.

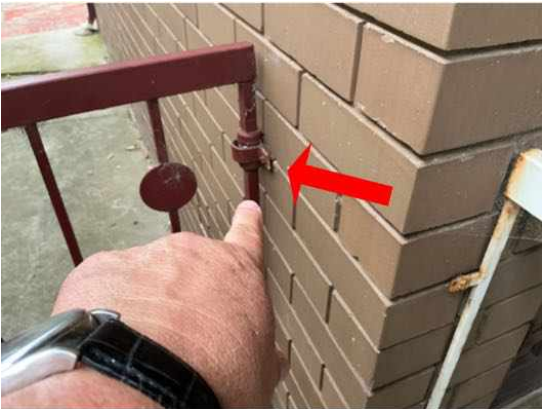
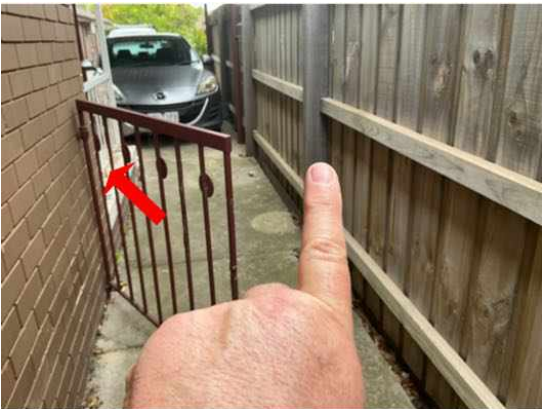
Information: It's was observed at the time of the inspection that the gate was in need of adjustment. The hinges appeared to be deteriorated and there was no catch holding the gate closed. There were also signs of corrosion to the metal.

A general handyman should be engaged to review at the owners discretion.

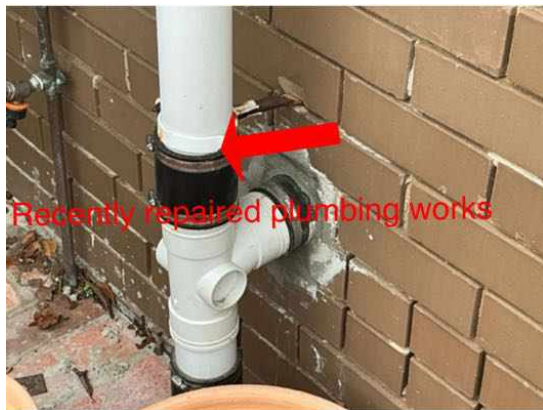
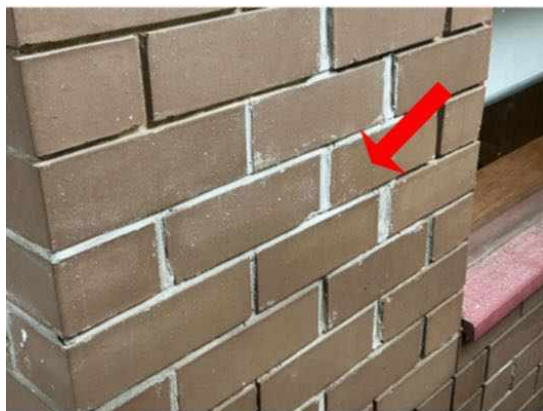
**Finding 3.08**

Building:	Main Building
Location:	All Areas
Finding:	Poor quality repair work
Information:	It was observed at the time of the inspection that repairs has been undertaken to the external brickwork. The repairs are demonstrating poor workmanship and appears to be incomplete. Recent plumbing repairs were also observed.

Although anaesthetic defect it detracts from the overall appearance of the building.

The owners should engage a general handyman or experienced an bricklayer to review at their discretion

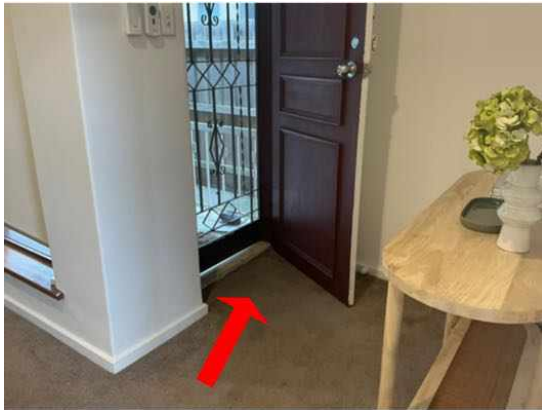
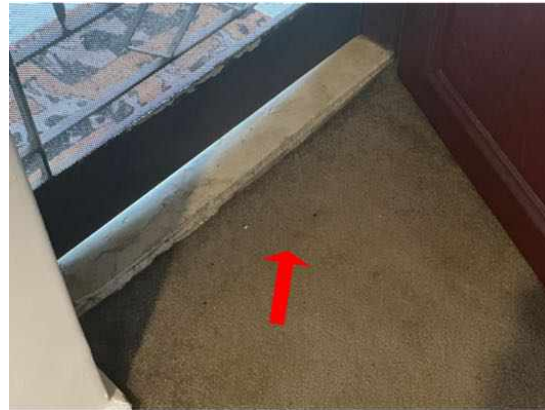
### Finding 3.09

Building:	Main Building
Location:	Entry
Finding:	Floor uneven
Information:	It was noted at the time of the inspection that the floor to the front door area was uneven. The timber floor appears to have settled and dropped slightly lower than the concrete door threshold. This may be due to timber shrinkage overtime. The floor in this area may need re-levelling or adjustment.

A licensed flooring contractor or general handyman should be engaged to review at

their owners discretion.

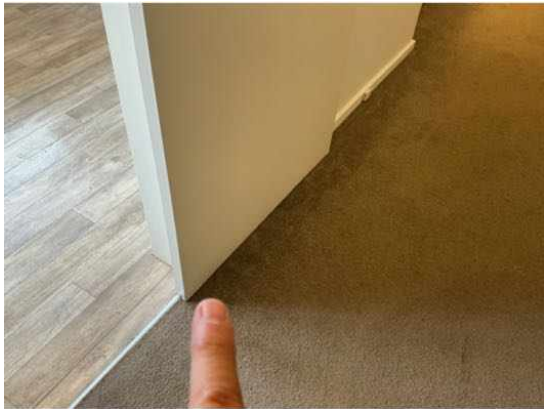
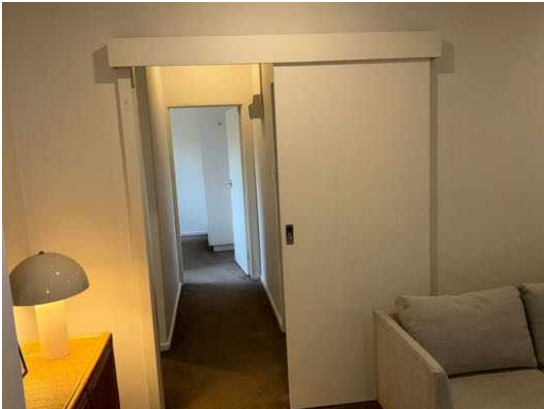
Building:	Main Building
Location:	All Internal Areas
Finding:	Sliding door guides missing/not working
Information:	The door guides for the sliding doors throughout the building are missing.

Doors without the correct guides will cause damage to the paint finishes to the door.

A general handyman or carpenter should be engaged to review at the owners discretion

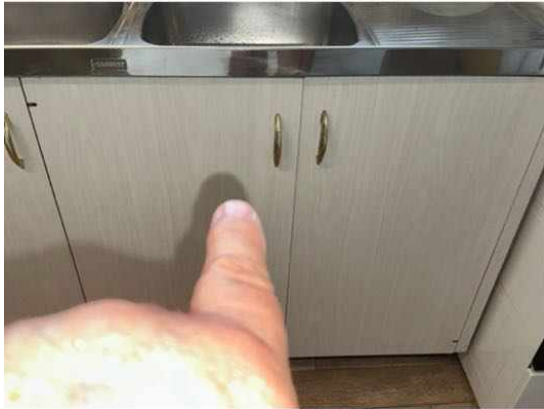
**Finding 3.12**

Building: Main Building  
 Location: Kitchen  
 Finding: Kitchen cabinets deteriorated  
 Information: It was observed at the time of the inspection that several cabinet doors require required adjustment. Some cabinet doors had damaged melamine laminate surfaces. Which unattended to will deteriorate further overtime.

An experienced cabinet maker should be engaged to review as their owners disc

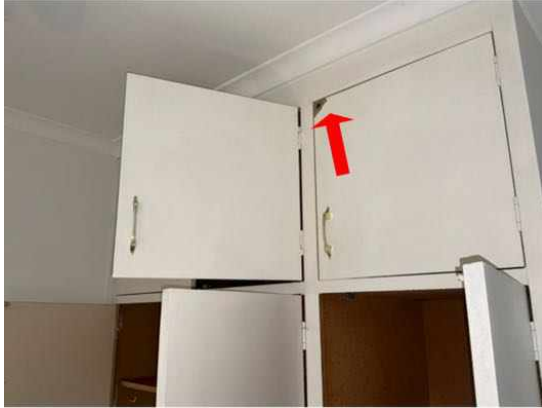
Building:	Main Building
Location:	Bedroom - Master
Finding:	Damaged wardrobe door
Information:	It was observed at the time of the inspection that the small wardrobe door two bedroom two has been chipped and damaged. Although an anaesthetic defect it detracts from the overall appearance of the building.

A general handyman should be engaged to review at their owners discretion.

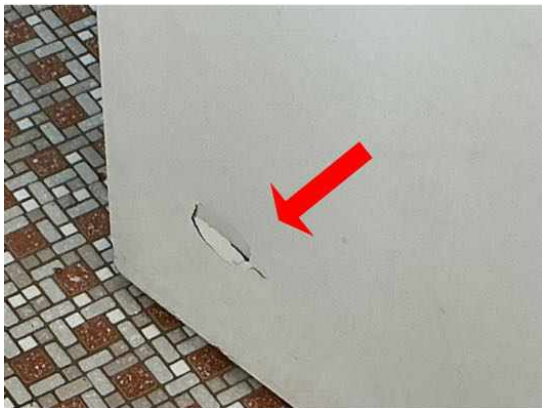
### Finding 3.17

Finding: Laundry door damaged

Information: It was observed at the time of the inspection that the laundry door appears to have suffered some impact damage which is evident in the face of the door

A qualified carpenter or general handyman should be engaged to review at their owners discretion

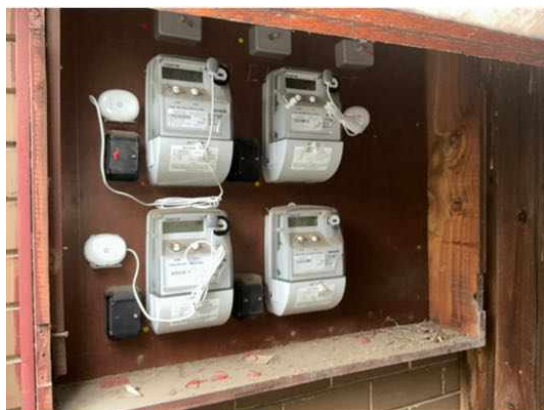
Building:	Main Building
Location:	Meter Box
Finding:	Termite Management System - no evidence of a chemical installation
Information:	The application of a post-construction chemical termite barrier is highly recommended for all properties, particularly if live termite activity has been found on the site previously. Such barriers are highly effective in preventing termite attack on any timber building elements throughout the property.

A durable notice should be placed in the switchboard unit to indicate current termite barriers. At the time of inspection, it appeared as though no termite management system has been installed, with no evidence to suggest preventative works taking place.

The client may consider gaining further advice from a pest controller as to the costs and procedures involved with this application. It is recommended that obtaining such advice be a short-term priority.

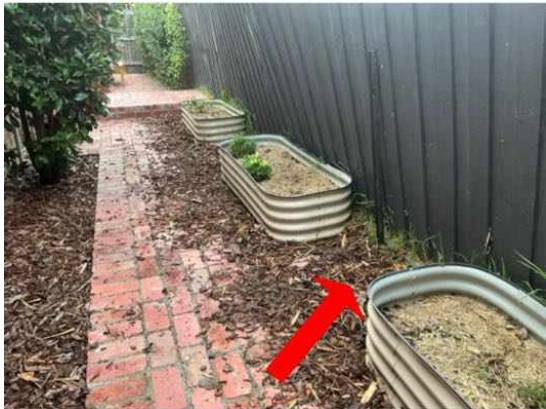
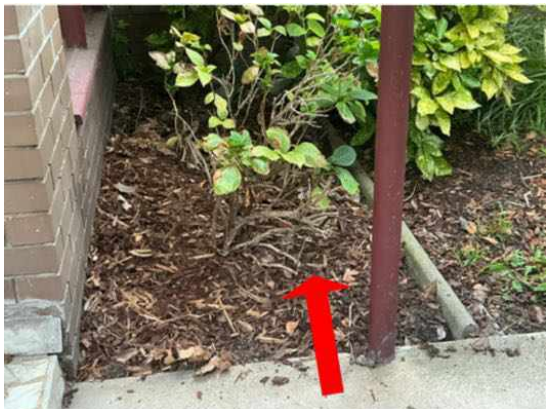
**Finding 6.03**

Building: Main Building  
 Location: All External Areas  
 Finding: Garden Beds - Conditions Conducive to Termites  
 Information: Garden beds were found to be evident in the garden area. These garden beds can include untreated timber, and with a combination of moisture from watering hosing can make conditions conducive to termite activity and termite ingress.

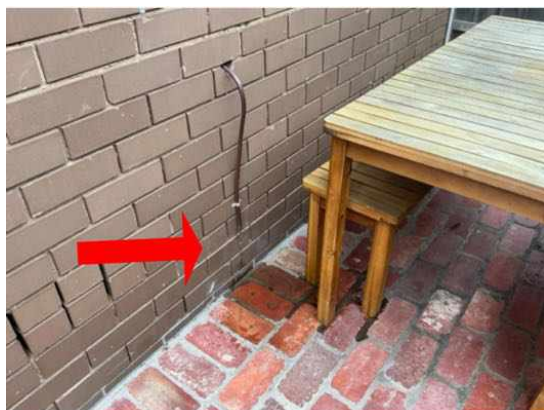
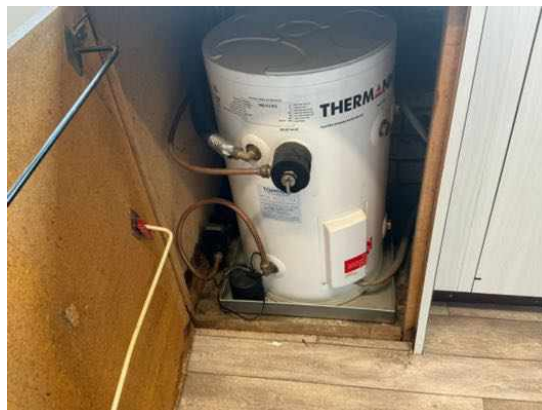
**Finding 6.04**

Location: Exterior walls - rear  
 Finding: Hot water heater overflow pipe not connected  
 Information: The water heater overflow was found to be disconnected from the stormwater system and is creating excessive moisture to the surrounding area.

Such leaking creates an environment which is conducive to an array of defects including water damage to associated building materials and the attraction of termites or timber pest infestation.

A Licensed plumber should be engaged to review as soon as possible

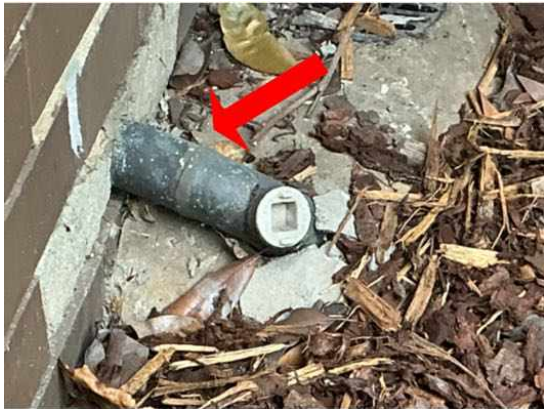
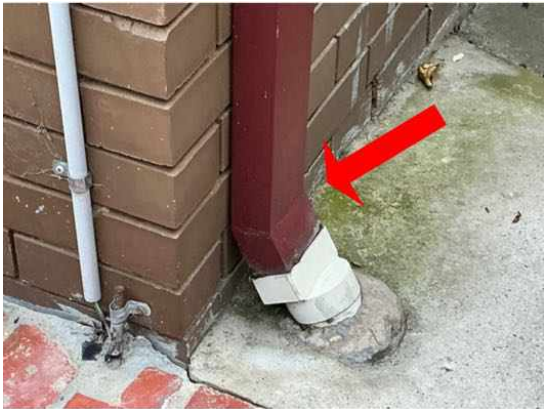
### Finding 6.05

Building: Main Building  
 Location: All External Areas  
 Finding: Bridging of termite barrier  
 Information: Bridging of termite barriers occurs when termites bridge (usually by building a mud tunnel) a termite barrier or inspection zone or where termites have a passage allowing them to bridge the barrier.

Generally this takes the form of finished ground levels external paving or concrete being retrospectively installed above the damp course level the adjacent internal floor level or weep and ventilation holes.

Where bridging has occurred full inspection is prevented and termites may enter a property in a concealed or undetectable manner.

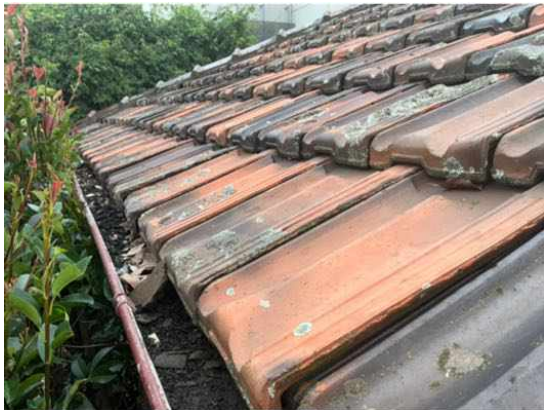
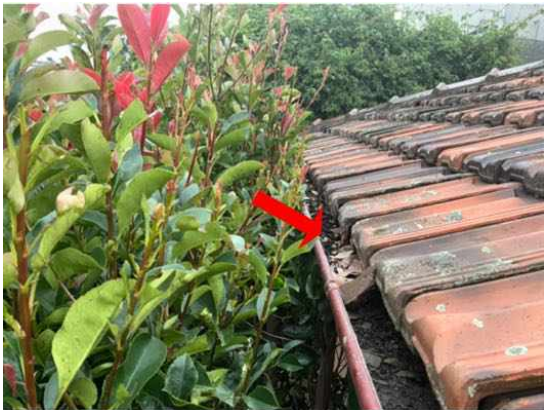
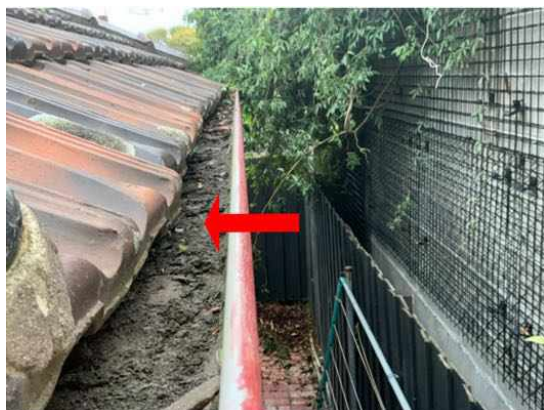
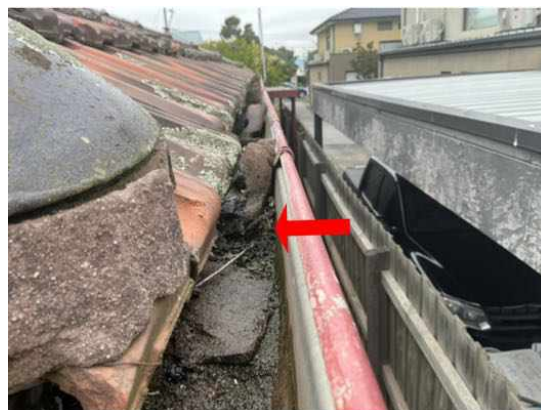
**Finding 6.06**

Blocked gutters are likely to lead to high levels of moisture in the affected areas. Such moisture will not only cause rust and decay of the associated building materials, but can also provide conditions that are conducive to termite and timber pest activity. Blockages in gutters should therefore be removed immediately to ensure dry conditions are maintained.

Consult a Licensed Plumber for further specific advice on remedial works that may be required. In the interim, it is highly advised that blocked gutters be removed by the homeowner or a general handyperson as a matter of urgency.

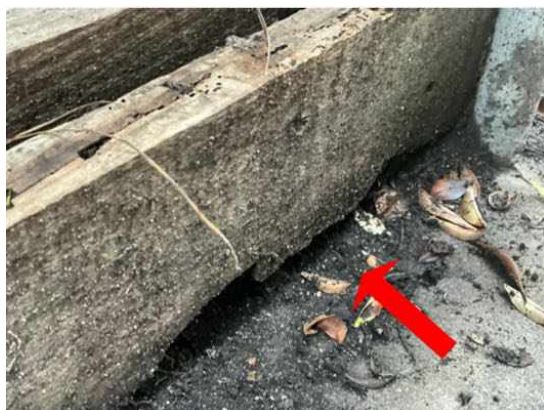
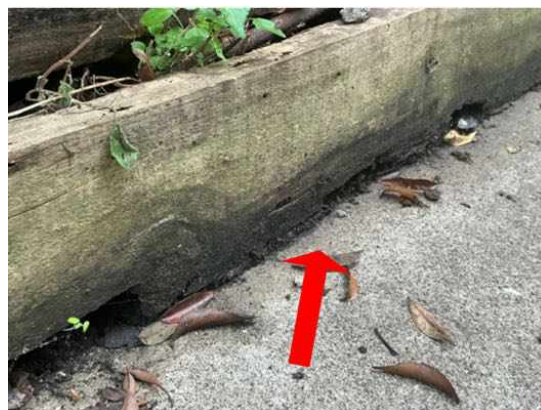
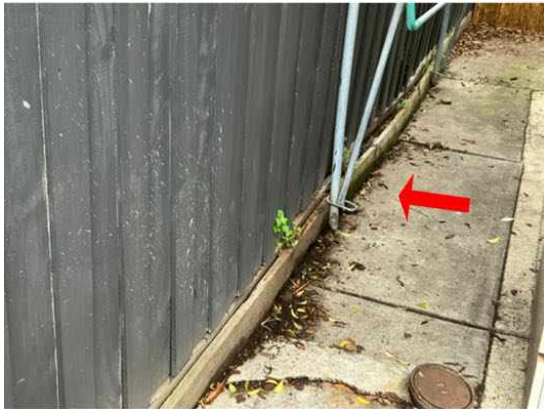
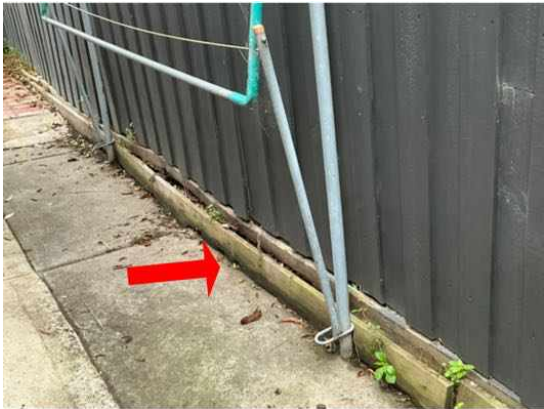
### Finding 7.01

Building:	Main Building
Location:	All External Areas
Finding:	Fungal decay - present (localised)
Information:	Fungal decay also known as wood decay or wood rot generally refers to the deterioration of timber elements when in contact with excessive levels of moisture for a prolonged period of time.

The development of fungal decay is accelerated by temperatures in the range of 5degreeC to 40degreeC as well as the presence of oxygen. Generally fungal decay develops on timber elements that are in use in an external environment which are exposed to rain penetration.

In this case although the affected timber element is in a decaying state the extent of any visible damage appears to be localised to a specific area and is yet to spread to other parts of the building element or affect adjoining structures. The fungal decay is therefore likely to be of a relatively superficial nature with minimal impact on the structural integrity or tensile strength of the timber element.

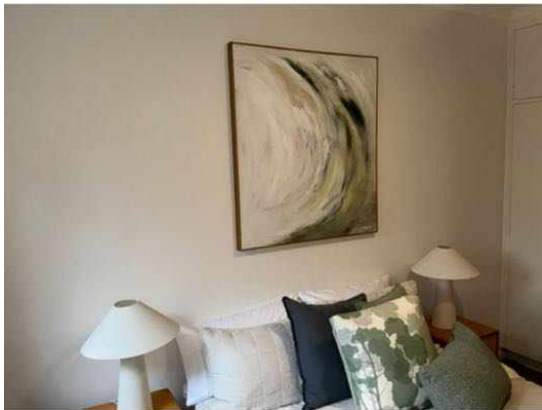
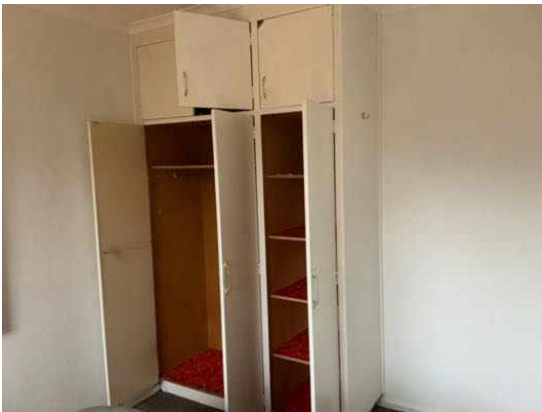
Building: Main Building  
Location: All Areas  
Finding: Additional Photos - Obstructions and Limitations  
Information: These photographs are an indication of the obstructions and limitations which impeded full inspection of the property at the time of inspection. These obstructions can hide an array of defects and should be removed to allow full inspection to be carried out. A re-inspection is recommended once the areas are made accessible.

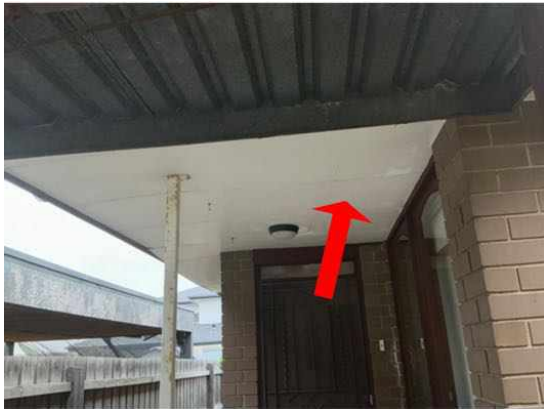
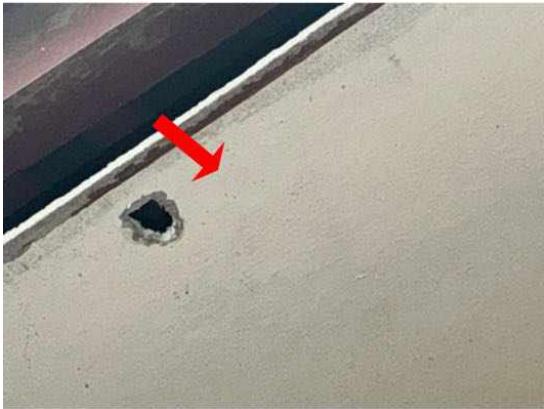
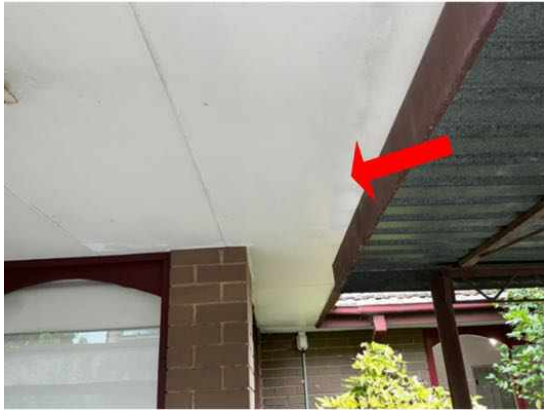
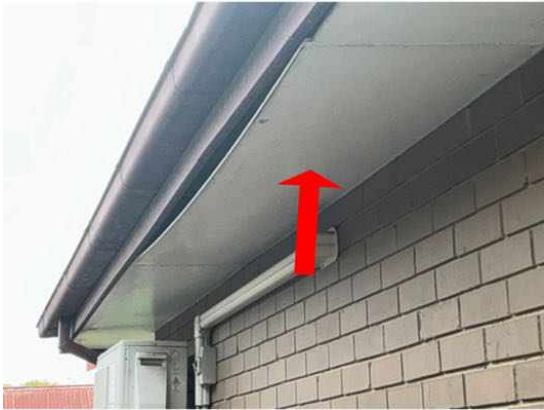
Building: Main Building  
 Location: Eaves  
 Finding: Asbestos - Suspected ACM Identified on Site  
 Information: Reporting on Asbestos is outside the Scope of this Report. This suspected defect is highlighted as a caution only. We suspect, based on our experience in the building industry, that there is a higher risk of the identified building element containing asbestos.

As Asbestos Reporting is outside the scope of this report, we advise that you consider a separate Asbestos Inspection and Condition Audit, which can include the taking of samples for definitive confirmation of the presence of Asbestos.

In the interim, the client is advised to act with caution, especially when considering any damage to building materials general wear and tear renovations extensions demolition and general maintenance activities due to the suspected presence of Asbestos.
