Building and Timber Pest Inspection Report

Inspection Date: Thu, 12 Feb 2026

Property Address: 37 Doe St, Rye VIC 3941, Australia

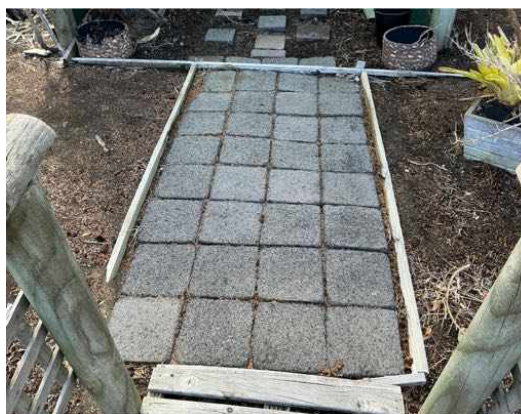
Finding 3.02

Building:	Main Building
Location:	Driveway
Finding:	Driveway Cracking
Information:	Cracks were identified in the driveway external concrete paving. Although cracks are quite noticeable, they are often only considered to be an appearance defect, and usually do not indicate any structural damage.

Generally the cause of the cracks in existing concrete paving such as driveways and pathways is indicative of the expansion and contraction of the concrete. Such causes are generally due to environmental factors, such as moisture levels, weather conditions, root systems of nearby trees or the soil types on which they are laid.

Cracks may also be due to poor original installation of the concrete. Factors such as poor compaction of the sub surface and/or inadequate reinforcing of the slab may create cracking and other secondary defects.

Monitoring of all cracking should be conducted frequently. Always contact a building inspector should cracks widen, lengthen, or become more numerous.

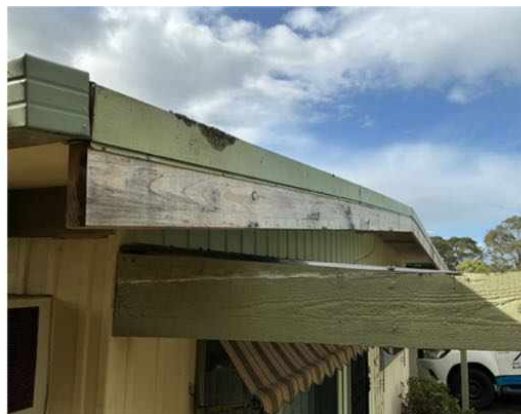
Building:	Main Building
Location:	Exterior
Finding:	External painting deteriorated
Information:	Much of the external paintwork has been neglected and requires attention to prepare and re-paint.

Whilst incomplete or missing paint finish is generally an appearance defect, it can also lead to the development of secondary building defects over time. Incomplete areas of paint finish expose the area to moisture, potentially accelerating the deterioration of underlying building materials.

Degraded paint finishes should be sanded back, filled, leveled and painted, as applicable. Where inadequate or missing paint protection has led to the deterioration of the associated building element, repair and/or replacement of this building element may be required.

A painting contractor should be appointed as soon as possible to perform necessary works to aid the appearance of the affected area and to ensure the area is protected against further deterioration. Alternatively, the homeowner following manufacturer instructions may perform these works.

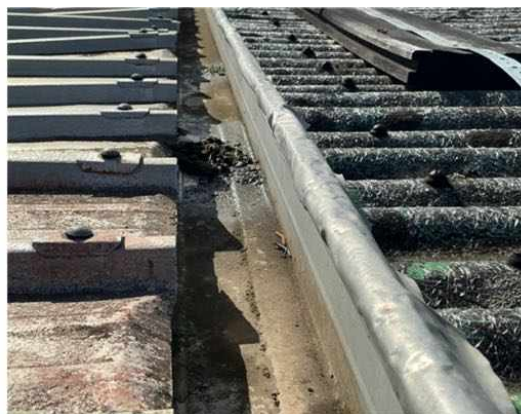
Finding 3.05

Building:	Main Building
Location:	Carport
Finding:	Roof sheets deteriorated and fixings loose and rusted
Information:	Upon inspection of the exterior carport roof covering, it was noted that the fibreglass roof sheets have deteriorated and numerous roof fixings have become loose from their original fixings or are rusted. It is suspected that this defect has developed as a result of a lack of adequate maintenance, but may also have been caused by inappropriate fixings being used in the construction process.

Loose roof sheeting detracts from the weather tightness of the roof covering, making the internal roofing structure susceptible to water penetration and subsequent damage. If left unaddressed, it is likely that secondary damage to associated building elements will develop, potentially necessitating remedial works to these structures.

A roofing restoration contractor should be appointed to advise on rectification options and on the cost of repair. It is advised that remedial works be performed as soon as possible to prevent any further damage.

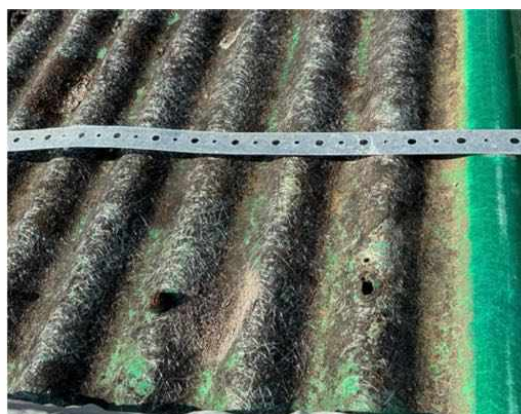
Finding 3.06

Location: Carport
 Finding: Flashings - Rusted or corroded
 Information: The carport flashing to the roof shows evidence of rusting and corrosion, which is likely to have developed as a result of excessive exposure to moisture and or inadequate coatings.

As surface rust provides no protection to the underlying iron, the deteriorating condition is likely to worsen if not addressed in the short-term future.

Rusting and corrosion should be managed by ideally removing or limiting the affected surface from exposure to moisture. A registered builder may be appointed to replace any building elements that have been severely affected by rust or water damage.

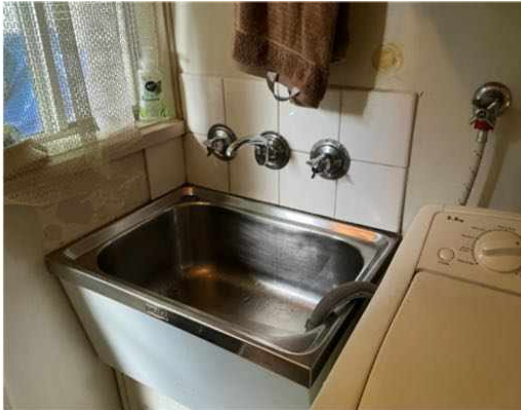
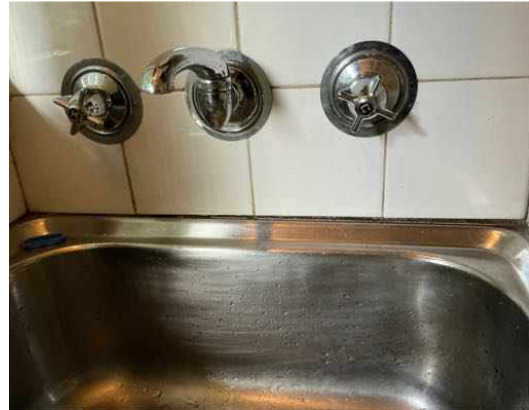
Building:	Main Building
Location:	Laundry
Finding:	Laundry- Sealant and grouting - Missing or damaged
Information:	It was noted on inspection that sealant or grout is degraded to the laundry splash back and or other areas of the laundry.

There appears to be excessive mould to the sealant and grout which will likely require scraping out and replacement.

Flexible and mould resistant materials should be applied to affected areas to prevent any subsequent water damage that is likely to occur. Regular maintenance and replacement of damage or missing or damaged sealant and grout is highly recommended to the wet areas, as this is a regular wear and tear defect. Sealant and grouting in areas that come into regular contact with water should be maintained for the long term care of your property.

A sealant specialist or tiling contractor should be appointed to complete these works as soon as possible

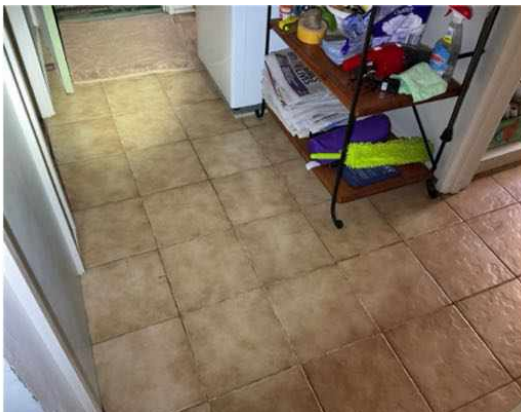
Finding 3.11

Building: Main Building
 Location: Laundry and kitchen
 Finding: Cracked tiles-laundry
 Information: Cracking/damage to the tiles was evident to the laundry and kitchen areas at the time of inspection. It is suspected that this cracking has occurred as a result of minor settlement/shrinkage or impact damage.

Cracked tiles to the household detract from the overall appearance of the affected areas however it is unlikely to create or lead to any secondary defects.

While not considered a matter of urgency, replacement of cracked tiles is recommended at the clients discretion. A tiling contractor may be appointed to perform these works. Where cracks become more numerous, contact a licensed building inspector for further investigation.

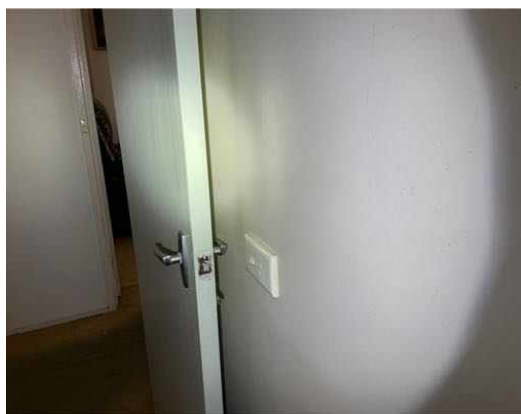
Finding 3.12

Building:	Main Building
Location:	Bathroom
Finding:	Door stop missing
Information:	The door stop to the bathroom is missing and is unable to stop the door furniture from damaging the wall. Although some building elements may seem irrelevant or unnecessary, all building elements play a key role in the operation and function of the overall structure and its performance.

Re-installation or replacement of the door stop is advised as soon as possible to prevent any subsequent damage to the door or associated structures. A general handyman may be appointed to perform these works at client discretion.

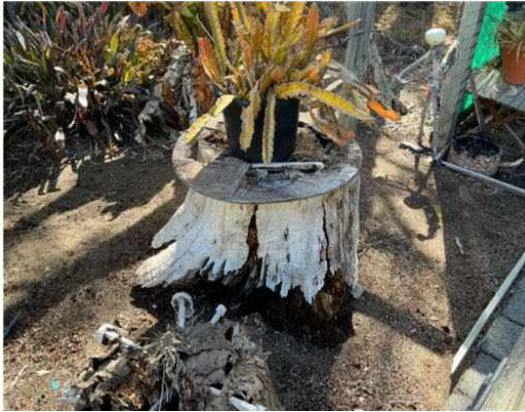
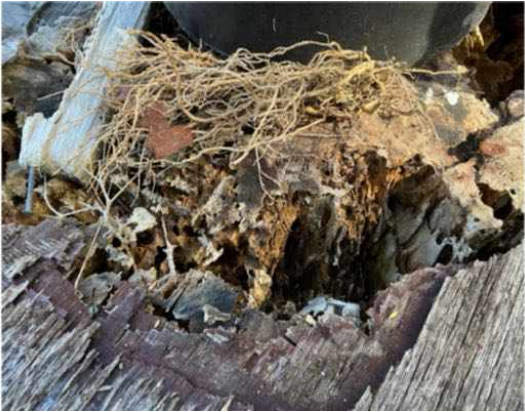
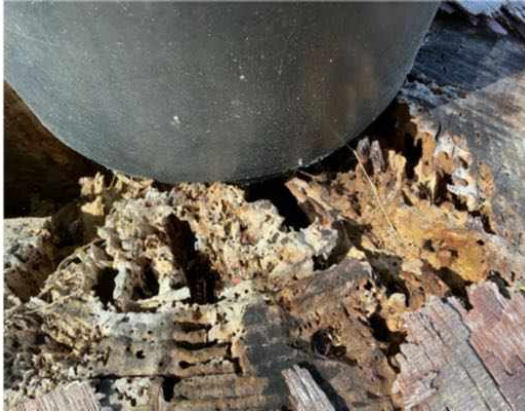
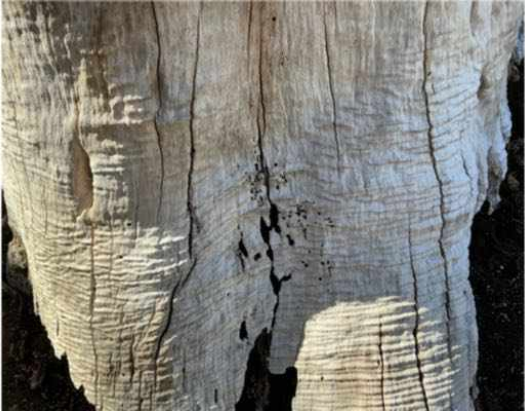
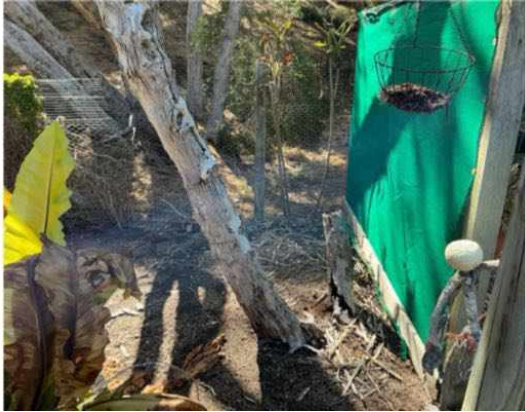
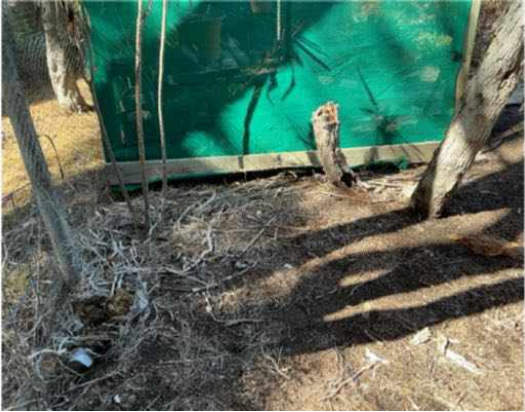
Building:	Main Building
Location:	Yard - Back
Finding:	Evidence of termite activity to trees and stumps
Information:	During the inspection of the rear yard area evidence consistent with termite damage was observed to several trees and tree stumps within the backyard. The damage included timber deterioration and characteristics typically associated with termite activity.

No intrusive inspection of the affected trees or surrounding soil was undertaken at the time of inspection. The presence of termite damage to trees and stumps within close proximity to the dwelling increases the risk of termite activity impacting the main structure, as these materials can serve as a food source and potential nesting site.

Install an appropriate termite management system.

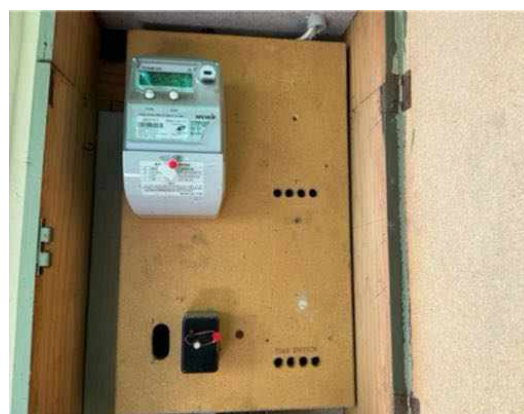
Finding 6.01

Building:	Main Building
Location:	All External Areas
Finding:	No Termite Management System - no evidence of a chemical installation
Information:	The application of a post-construction chemical termite barrier is highly recommended for all properties, particularly if live termite activity has been found on the site previously. Such barriers are highly effective in preventing termite attack on any timber building elements throughout the property.

A durable notice should be placed in the switchboard unit to indicate current termite barriers. At the time of inspection, it appeared as though no termite management system has been installed, with no evidence to suggest preventative works taking place.

The client may consider gaining further advice from a pest controller as to the costs and procedures involved with this application. It is recommended that obtaining such advice be a short-term priority.

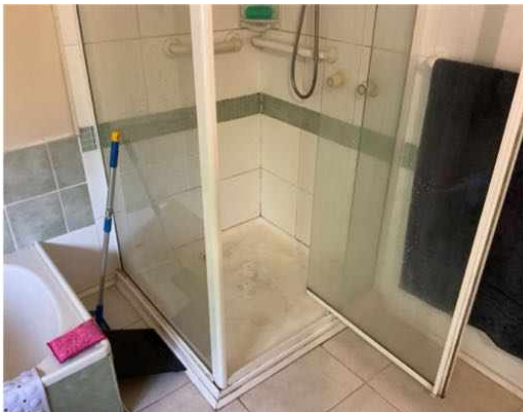
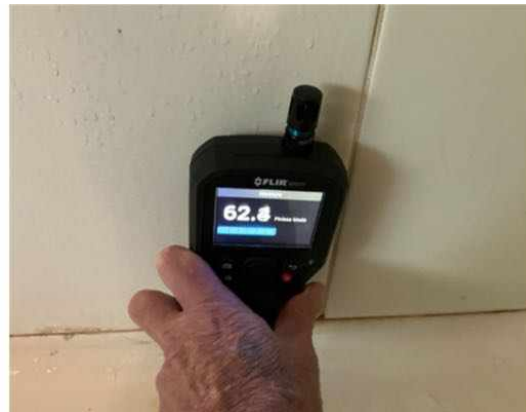
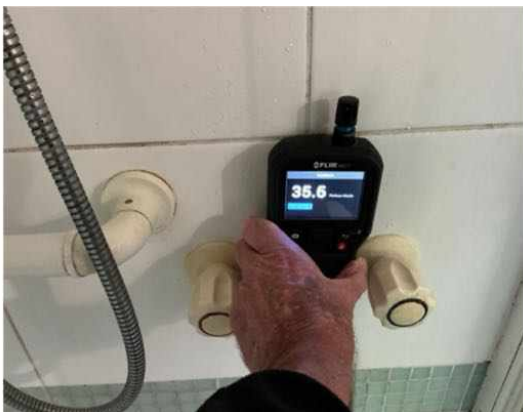
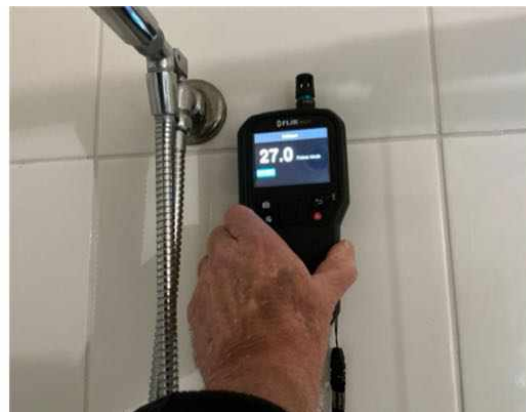
Finding 6.02

Building:	Main Building
Location:	Bathroom
Finding:	Shower - Damp
Information:	Damp is evident to parts of the bathroom shower alcove found using using a moisture meter. This defect is quite common, and is suspected to have been caused by moisture permeating through the grouting in this area, which shows evidence of deterioration creating moist conditions. Leaking pipes within the adjoining wall is also a possible cause. Excessive moisture can attract termites.

Damp (or structural damp) refers to the presence of unwanted moisture in the structure of a building, either as the result of intrusion from outside, or condensation

from within the structure. In the shower area, internal water leaks or other sources of excessive moisture are generally the cause of damp.

Consultation with a qualified plumber or bathroom specialist is advised immediately to identify the cause of damp and to perform remedial works as required. Where excessive mould growth is present, further inspection by a specialist environmental health inspector should also be considered.

Always ensure that sealant and grout is in good condition to prevent any moisture issues occurring in the future.

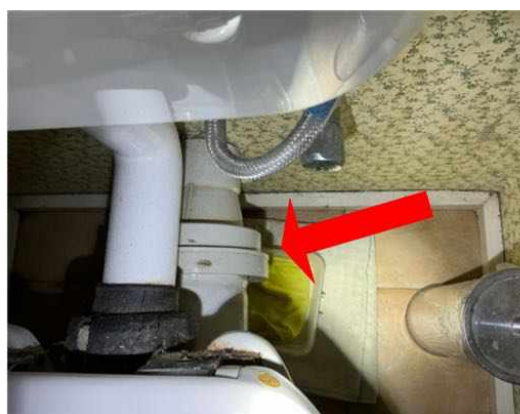
Finding 6.03

Building:	Main Building
Location:	Toilet (WC)
Finding:	Toilet - Leaking
Information:	At the time of inspection, the toilet showed evidence of leaking during operation.

Although common, internal water leaks can be detrimental to surrounding building elements. This leak will create excessive moisture which could attract termites. Rust, corrosion, mould, decay and water damage are all potential outcomes of a water leak that is left unattended, which are then likely to develop into more serious defects and may necessitate major repair works. Additionally, internal water leaks may significantly increase the water usage within the property.

It is highly advised that internal water leak be addressed by a licensed plumber as soon as possible. Use of the leaking toilet should be minimised until such time.

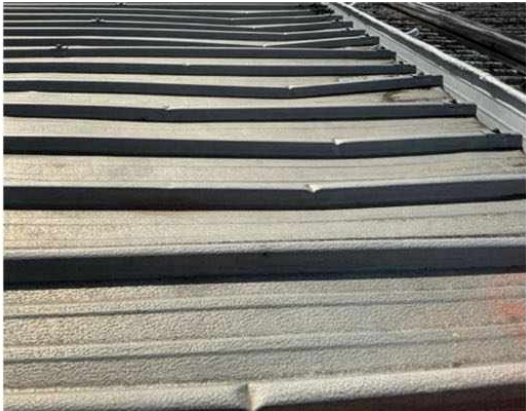
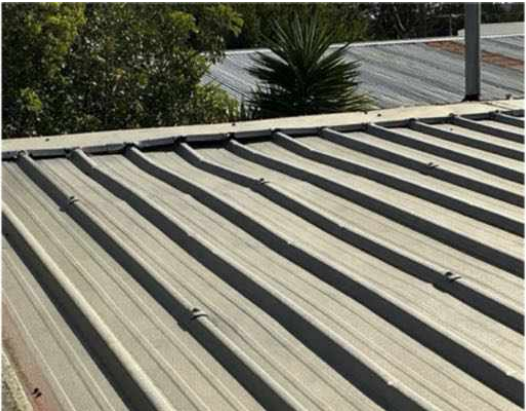
water following heavy rain events. This has happened with impact damage or someone not walking/standing on the roof correctly.

Prolonged water retention can accelerate corrosion in metal roofing materials and has the potential for water ingress or moisture into the roof void and ceiling linings.

Persistent moisture increases the risk of timber rot in roof framing members, fungal growth, corrosion of metal components and the attraction of termites.

Rectification by a qualified roofing contractor is recommended as soon as possible to prevent potential structural damage, internal water ingress, and conditions conducive to timber pest activity.

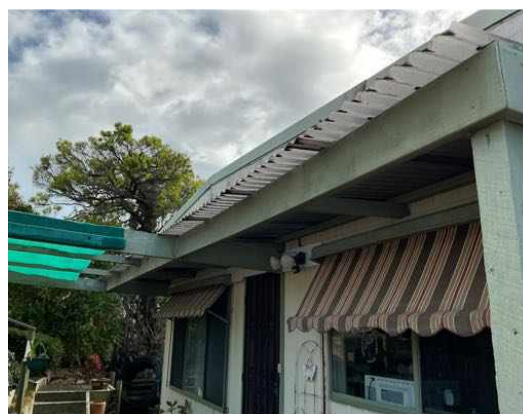
Finding 6.05

Building:	Main Building
Location:	Carport and front patio
Finding:	No gutters or down pipes installed
Information:	No gutters or down pipes installed to the carport and front patio roof. Where plumbing doesn't drain adequately, the area at the apse perimeter can become excessively damp, potentially creating an environment that is susceptible to rust and corrosion of surrounding building elements as well as attracting termites and other pests. Recommend engaging a plumber to install gutters and down pipes to reduce the risk of footing movement and other moisture related issues as soon as possible.

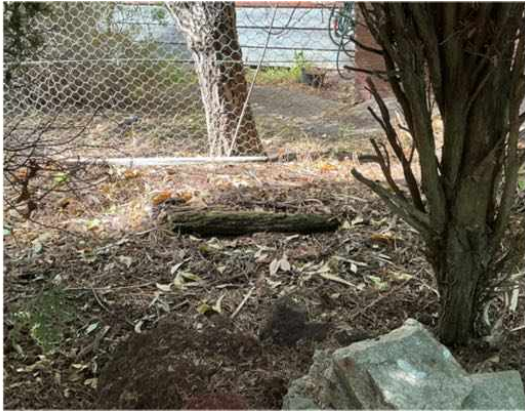
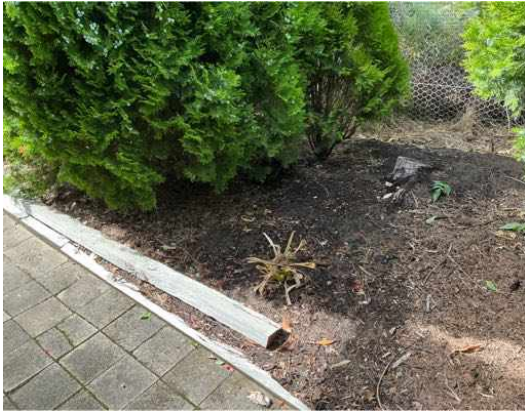
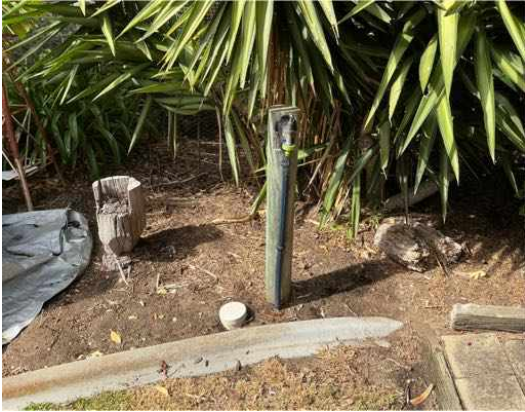
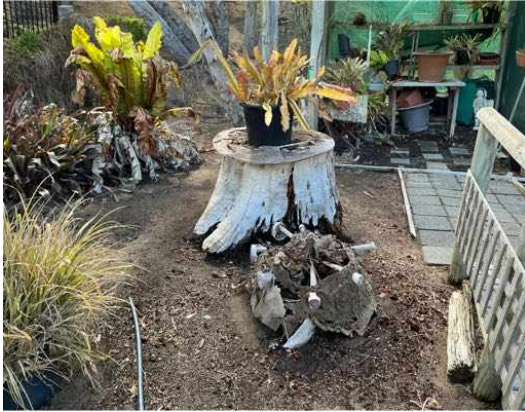
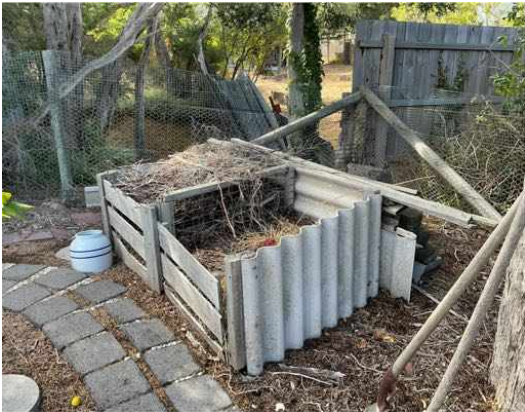
Finding 6.06

Building:	Main Building
Location:	Yards
Finding:	Stored timbers/stumps - external area
Information:	The storing of timbers or tree stumps to the external property increases the risk of termite activity being present. As they are likely to come into contact with weather conditions or excessive moisture wood rot is likely to develop on timbers that are not treated. It is highly recommended that any stored timbers or stumps be immediately removed from areas in which they may attract any termite / timber pest attack. Minimisation of risk / prevention of termite attack is far more adequate than dealing with the presence of termite activity.

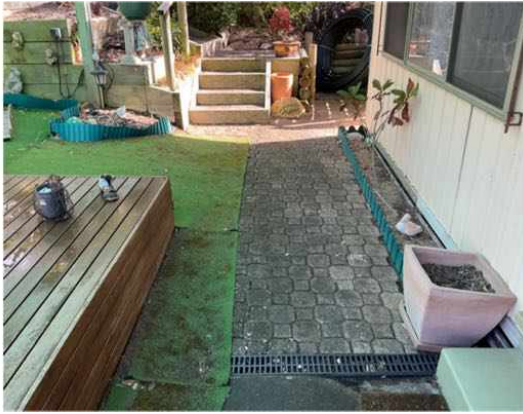
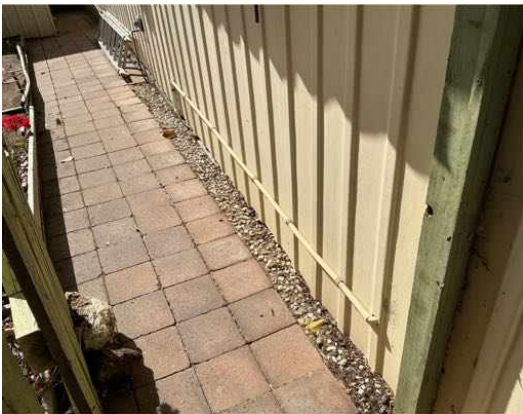
Finding 6.07

Building: Main Building
 Location: Yards
 Finding: Site drainage - poor/inadequate
 Information: The site drainage to parts of the yards was found to be inadequate at the time of inspection, creating potential for subsequent water damage to associated building elements. Excessive moisture will attract termites.

buried DPC.

Where site drainage is inadequate, installation of an Agricultural (Aggie) Drain may be required. A qualified plumber should be appointed to further inspect the property and perform any remedial works as necessary. Water damage and secondary defects are likely to occur if left unmanaged.

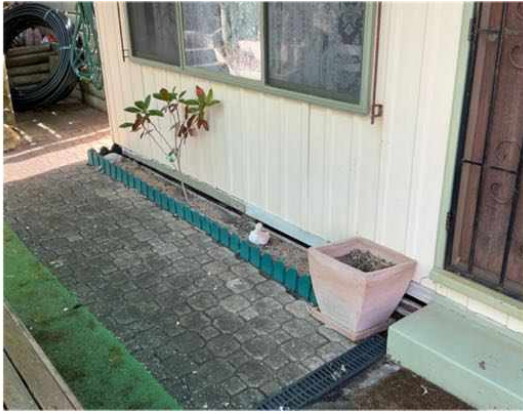
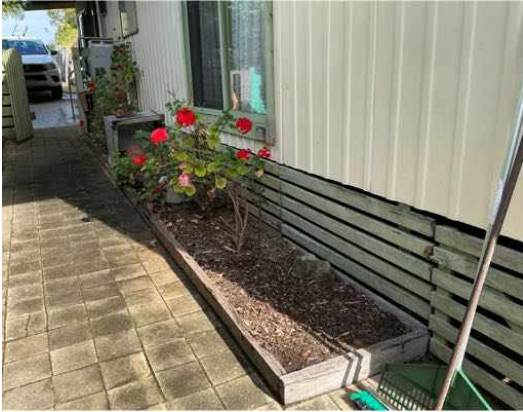
Finding 6.08

Building:	Main Building
Location:	Yards
Finding:	Garden Beds Conditions Conducive to Termites
Information:	Garden beds were found to be evident in close proximity to the building. Garden beds immediately adjacent to the perimeter of the building block the visual inspection of these areas, providing a concealed termite entry point.

These garden beds can include untreated timber, and with a combination of moisture from watering hosing can make conditions conducive to termite activity and termite ingress.

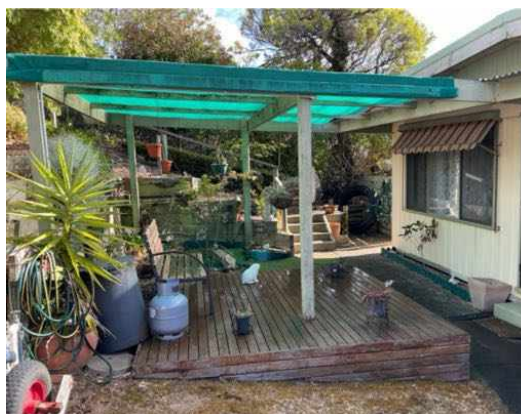
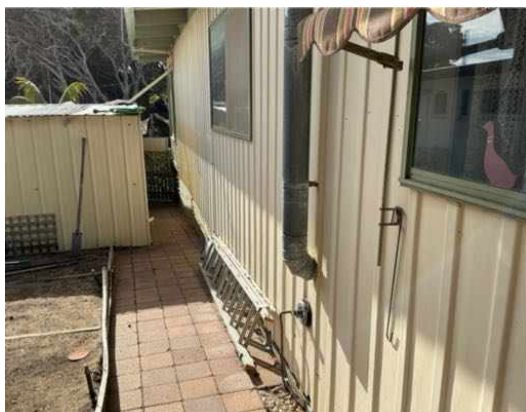
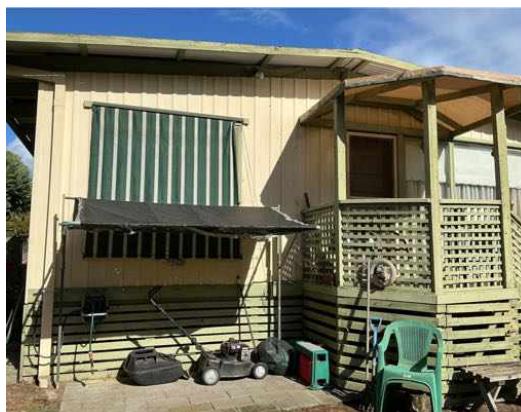
Finding 6.09

Building:	Main Building
Location:	Various parts of the building
Finding:	Bridging attachments to buildings
Information:	Bridging occurs when items against a building provide a concealed entry point for termites into the building or by passing around a termite management system.

Where any part of an attachment to a building is not isolated and is not provided with a clear gap of not less than 25mm from building, bridging occurs. Attachments to buildings such as hot water services, downpipes, verandahs, decks, steps, fences, service conduits and the like provide the opportunity for concealed entry.

Building attachments of this nature need to be frequently inspected for termite activity by a qualified inspector.

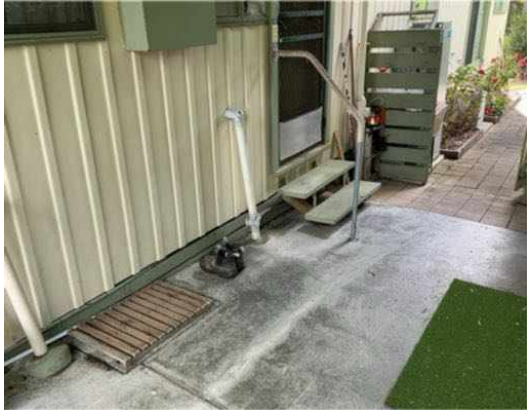
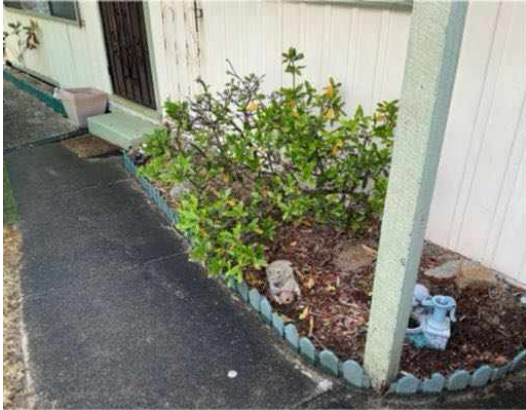
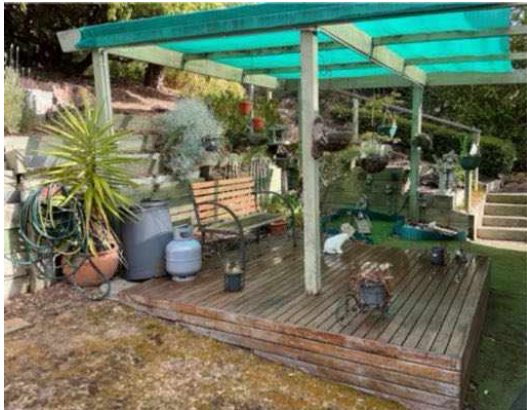
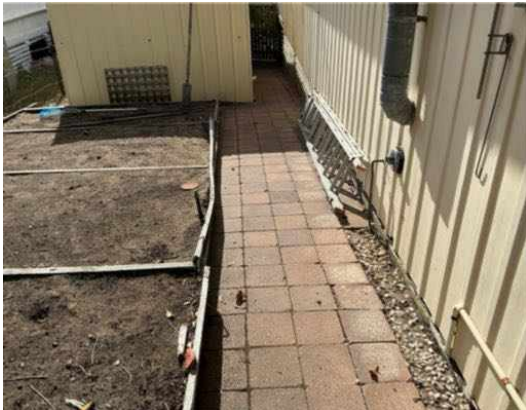
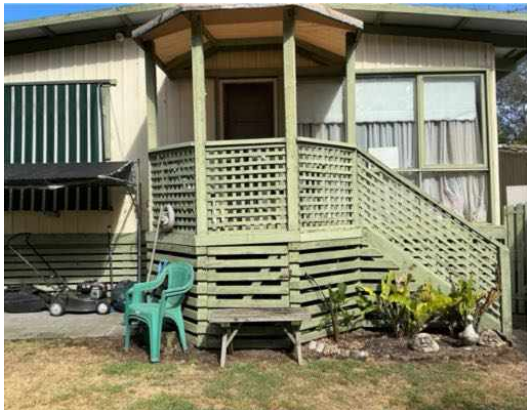
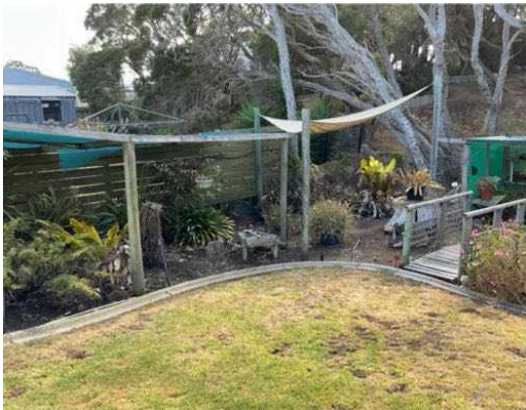
Finding 6.10

Building:	Main Building
Location:	Various parts of the building
Finding:	In ground contact
Information:	Any timbers in direct ground contact provide opportunity for concealed termite entry and are likely to be subject to premature rot and decay as the soil retains moisture or damp conditions against the timbers.

Remove untreated timber that is in direct contact with external grounds. Consider replacement with more durable materials i.e. treated timber or non timber elements. Frequent pest inspections are advised to readily identify any termite activity in these areas.

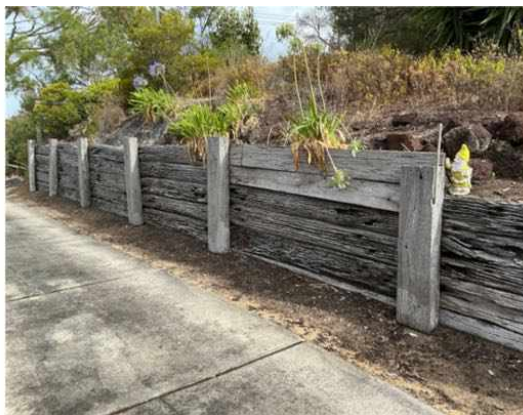
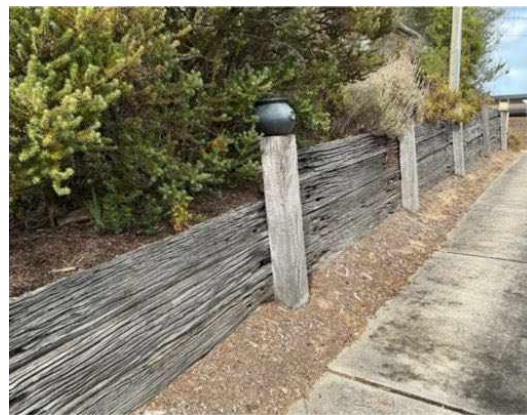
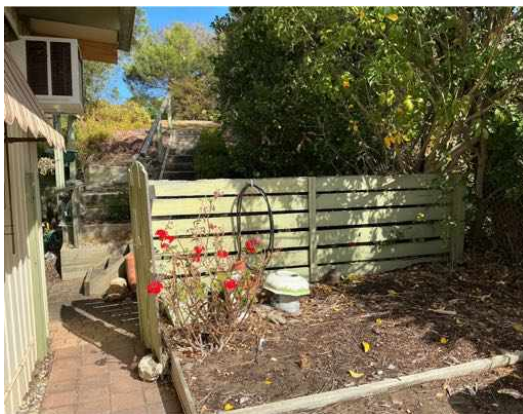
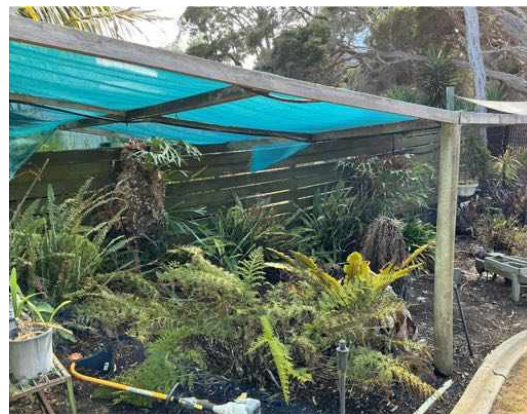
Finding: Fencing and retaining walls - wood rot-fungal decay

Information: It was noted at the time of inspection that sections of the fencing and retaining walls to the property have deteriorated and have fungal decay/wood rot present. Typically fencing deteriorates due to age and or wear, rot and or rust which is generally expected for a structure of this age, due to prolonged exposure to weather conditions. Sometimes inadequate installation or maintenance can be to blame.

If left unattended, it is likely that further damage will occur. It is suspected that repair of several elements of the fencing may be required however replacement may be a consideration of the client also.

A licensed fencing contractor should be appointed to provide further advice and perform rectification works as necessary.

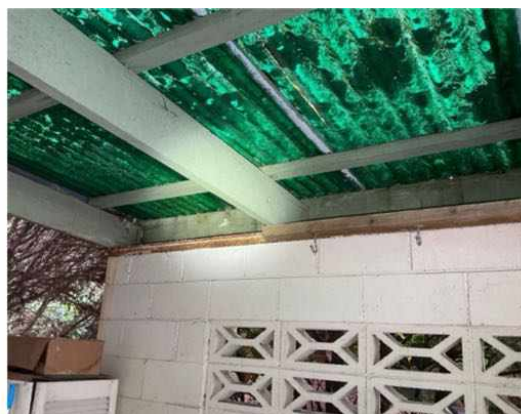
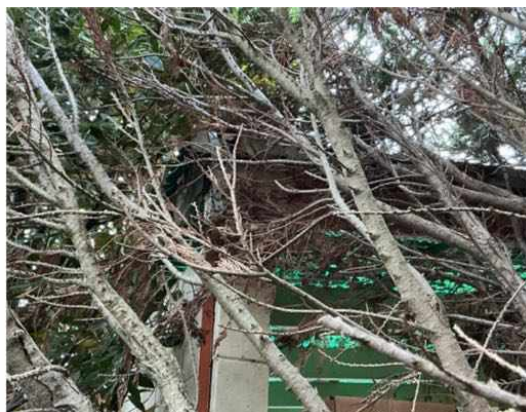
Finding 7.02

Finding: Wood rot to carport

Information: Parts of the carport framing shows evidence of wood rot. Wood rot, also known as Fungal Decay, occurs when timbers and other cellulose building materials are exposed to damp conditions on an ongoing basis. This could be the result of exposure to weathering over a prolonged period of time, or the attraction of excessive moisture

Wood rot is often associated with general damp problems and is evidenced by a 'musty' smell or mould and mildew occurring on surfaces. If left unmanaged, damp conditions can lead to further health problems and the decay of timbers will continue.

Early intervention and regular maintenance, particularly of exterior timbers, will prolong the useful life of these building elements. Prior to any works being performed, the cause of the moisture that has created the visible wood rot should be identified and addressed in a suitable manner. Replacement of affected timbers may then be a necessary step in protecting surrounding building elements from such deterioration.

A qualified plumber may be appointed to assess the cause of excessive moisture and to provide advice on any remedial works as required. A qualified carpenter or registered builder may also be required to replace affected building materials.

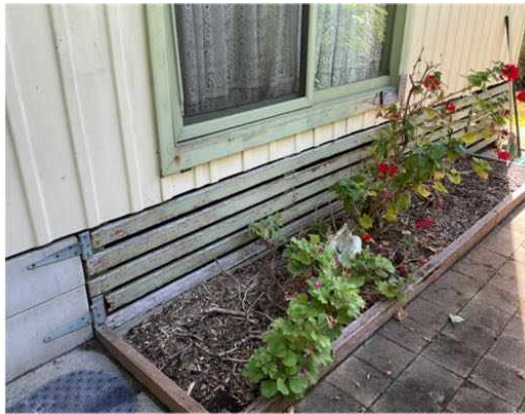
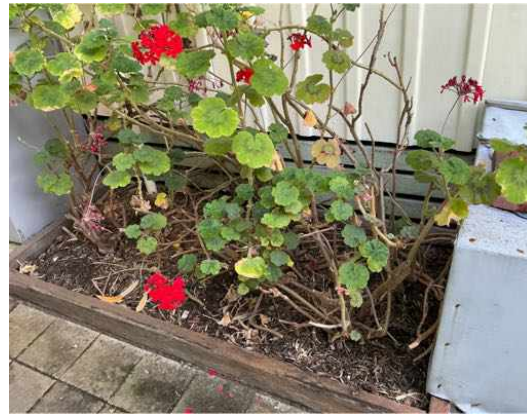
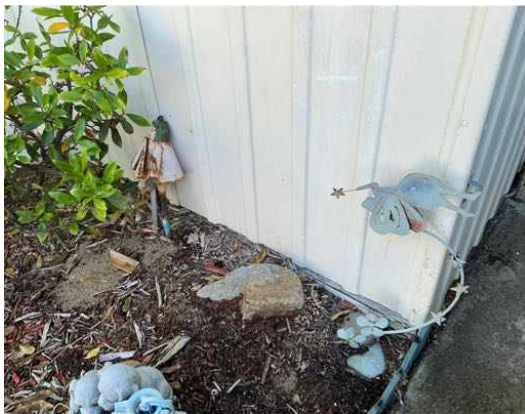
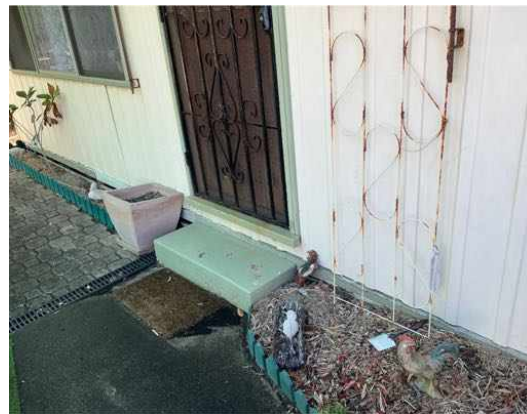
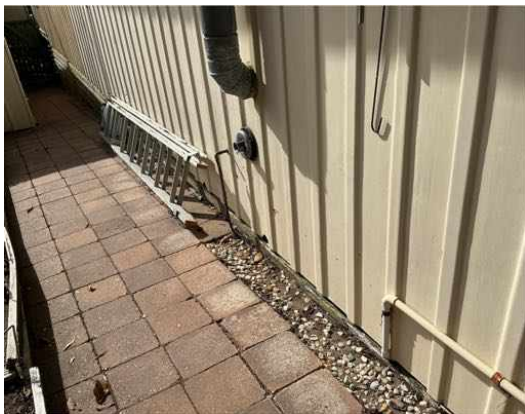
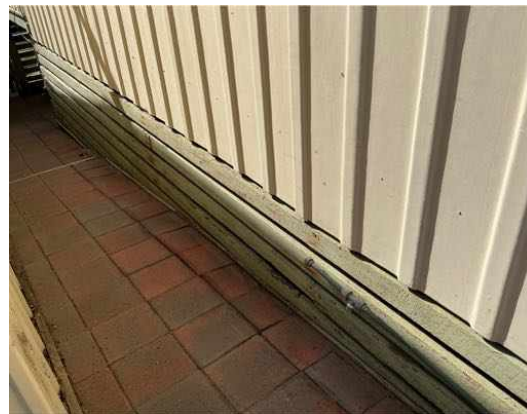
Finding 7.03

Finding: Wood rot cladding

Information: Parts of the cladding to the building shows evidence of deterioration and wood rot. Wood rot, also known as Fungal Decay, occurs when timbers and other cellulose building materials are exposed to damp conditions on an ongoing basis. This could be the result of exposure to weathering over a prolonged period of time, or the attraction of excessive moisture from other abutting building materials. Contributing factors also include poor air ventilation in the area.

Wood rot is often associated with general damp problems and is evidenced by a 'musty' smell or mould and mildew occurring on surfaces. If left unmanaged, damp conditions can lead to further health problems and the decay of timbers will continue.

Early intervention and regular maintenance, particularly of exterior timbers, will prolong the useful life of these building elements. Prior to any works being performed, the cause of the moisture that has created the visible wood rot should be identified and addressed in a suitable manner. Replacement of affected timbers may then be a necessary step in protecting surrounding building elements from such deterioration.

A qualified plumber may be appointed to assess the cause of excessive moisture and to provide advice on any remedial works as required. A qualified carpenter or

registered builder may also be required to replace affected building materials.

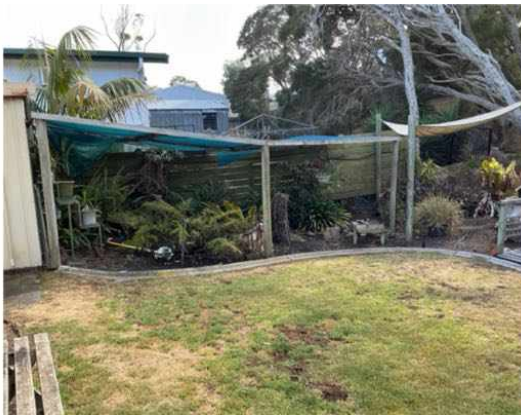
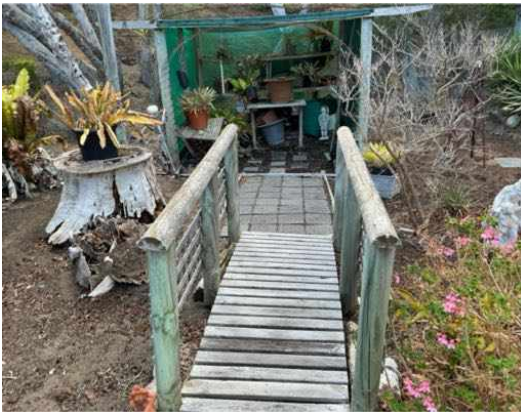
Finding 7.04

Finding: Wood rot

Information: Parts of the timber structures in the rear yard shows evidence of wood rot. Wood rot, also known as Fungal Decay, occurs when timbers and other cellulose building materials are exposed to damp conditions on an ongoing basis. This could be the result of exposure to weathering over a prolonged period of time, or the attraction of excessive moisture from other abutting building materials. Contributing factors also

Wood rot is often associated with general damp problems and is evidenced by a 'musty' smell or mould and mildew occurring on surfaces. If left unmanaged, damp conditions can lead to further health problems and the decay of timbers will continue.

Early intervention and regular maintenance, particularly of exterior timbers, will prolong the useful life of these building elements. Prior to any works being performed, the cause of the moisture that has created the visible wood rot should be identified and addressed in a suitable manner. Replacement of affected timbers may then be a necessary step in protecting surrounding building elements from such deterioration.

A qualified plumber may be appointed to assess the cause of excessive moisture and to provide advice on any remedial works as required. A qualified carpenter or registered builder may also be required to replace affected building materials.

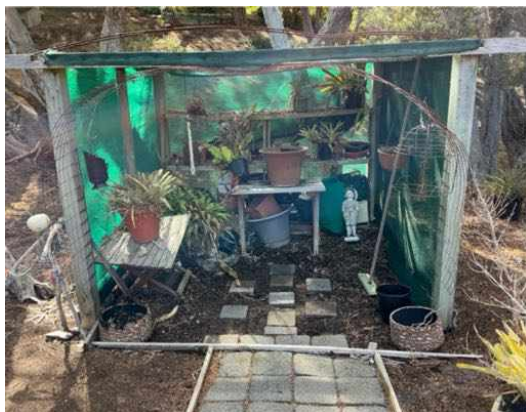
Finding 7.05

Building:	Main Building
Location:	Front and rear patio
Finding:	Wood rot to patio framing
Information:	Parts of the front and rear patio framing shows evidence of wood rot. Wood rot, also known as Fungal Decay, occurs when timbers and other cellulose building materials are exposed to damp conditions on an ongoing basis. This could be the result of exposure to weathering over a prolonged period of time, or the attraction of excessive moisture from other abutting building materials. Contributing factors also include poor air ventilation in the area.

Wood rot is often associated with general damp problems and is evidenced by a 'musty' smell or mould and mildew occurring on surfaces. If left unmanaged, damp conditions can lead to further health problems and the decay of timbers will continue.

Early intervention and regular maintenance, particularly of exterior timbers, will prolong the useful life of these building elements. Prior to any works being performed, the cause of the moisture that has created the visible wood rot should be identified and addressed in a suitable manner. Replacement of affected timbers may then be a necessary step in protecting surrounding building elements from such deterioration.

A qualified plumber may be appointed to assess the cause of excessive moisture and to provide advice on any remedial works as required. A qualified carpenter or registered builder may also be required to replace affected building materials.

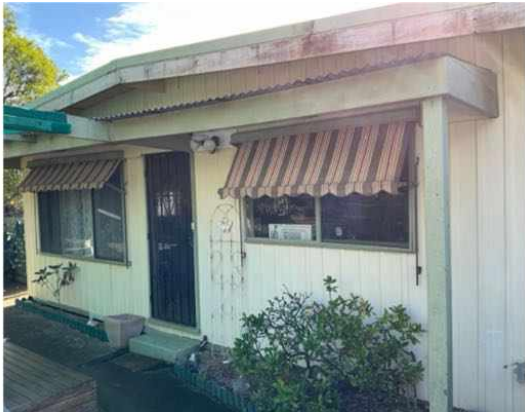
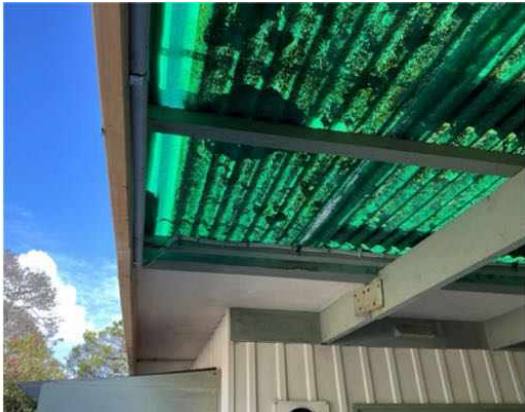
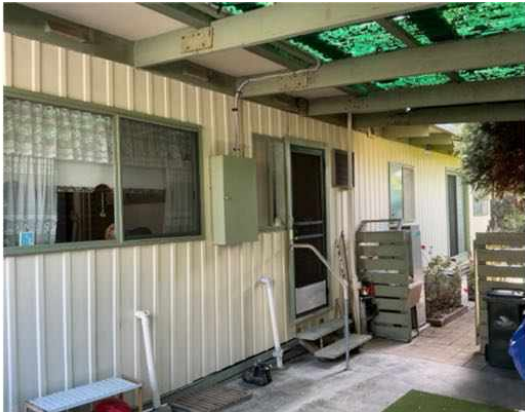
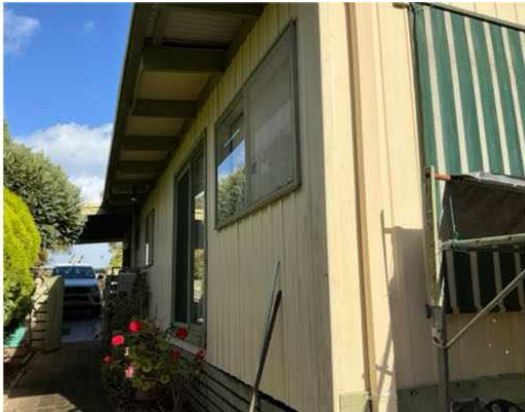
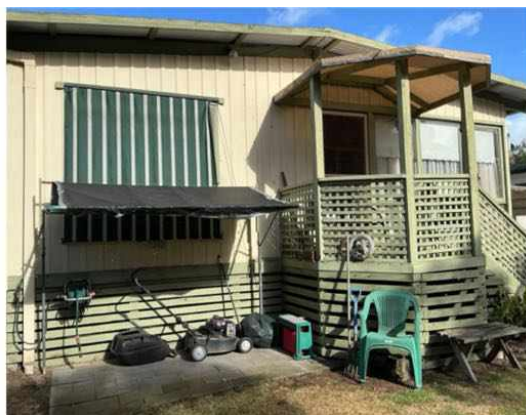
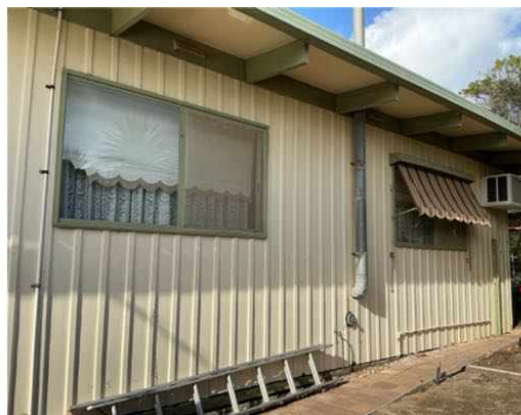
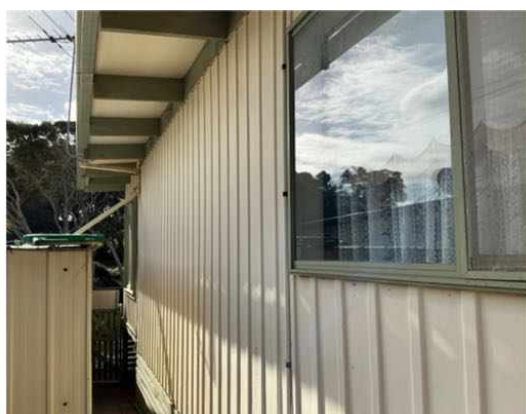
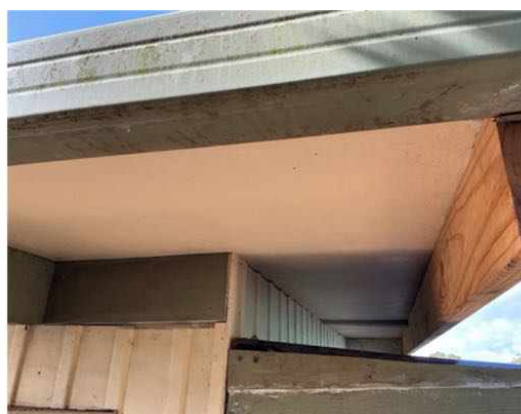
Building: Main Building
Location: Various parts of the building
Finding: Asbestos - Suspected ACM Identified on Site
Information: It is suspected that the eaves and wall cladding to the building contains asbestos. Reporting on Asbestos is outside the Scope of this Report. This suspected defect is highlighted as a caution only. We suspect, based on our experience in the building industry, that there is a higher risk of the identified building element containing asbestos.

As Asbestos Reporting is outside the scope of this report, we advise that you consider a separate Asbestos Inspection and Condition Audit, which can include the taking of samples for definitive confirmation of the presence of Asbestos.

In the interim, the client is advised to act with caution, especially when considering any damage to building materials, general wear and tear, renovations, extensions, demolition and general maintenance activities due to the suspected presence of Asbestos.

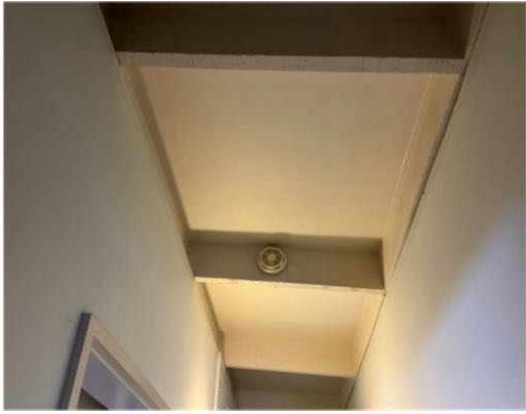
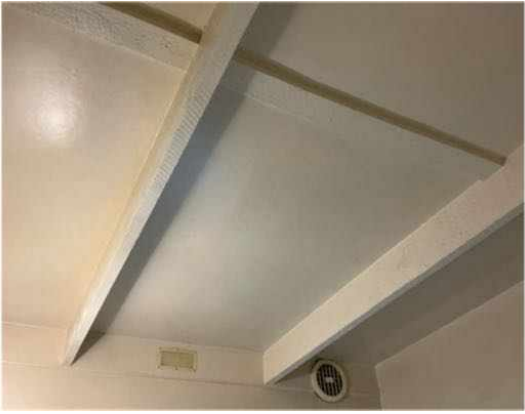
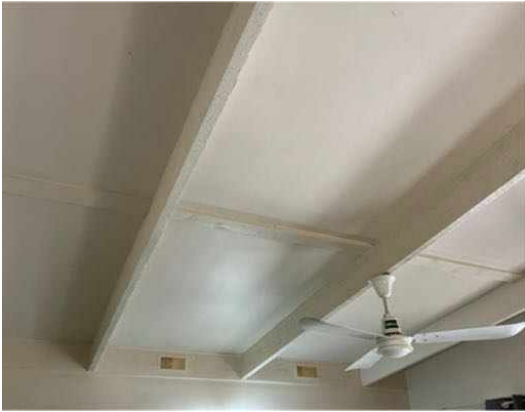
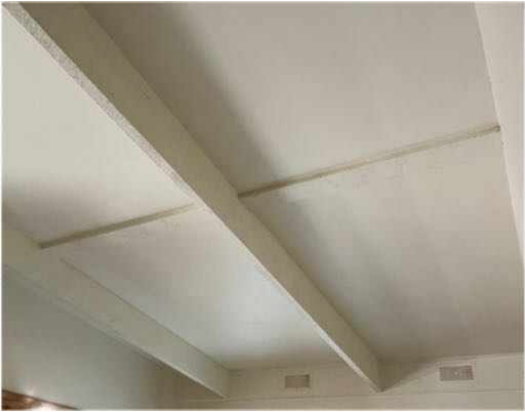
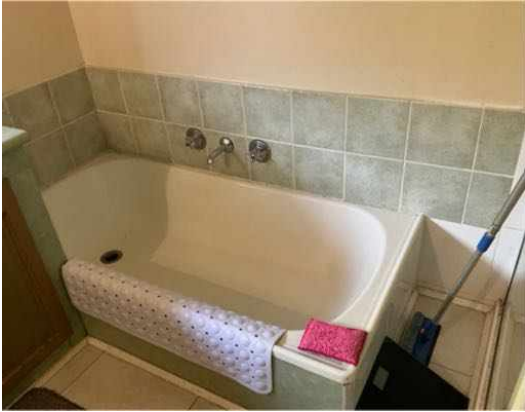
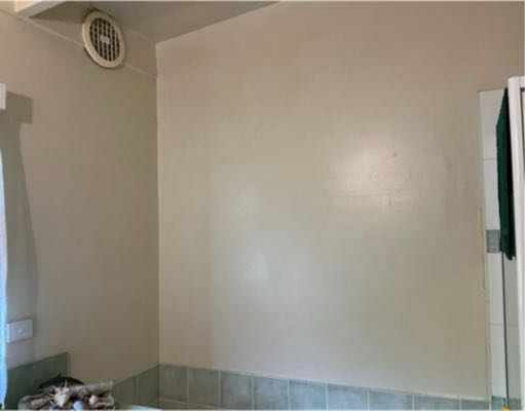
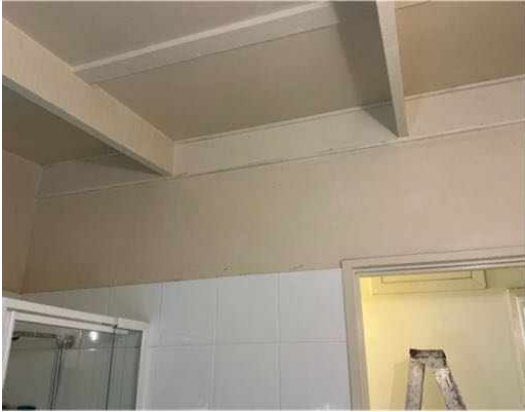
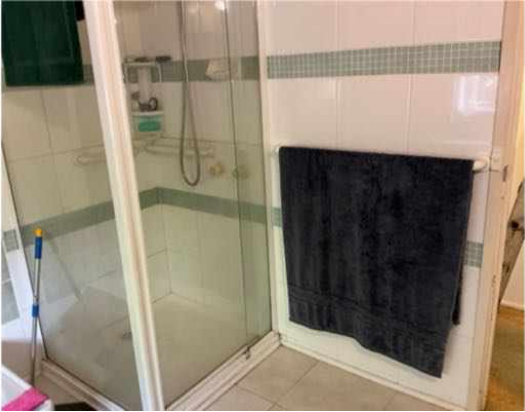
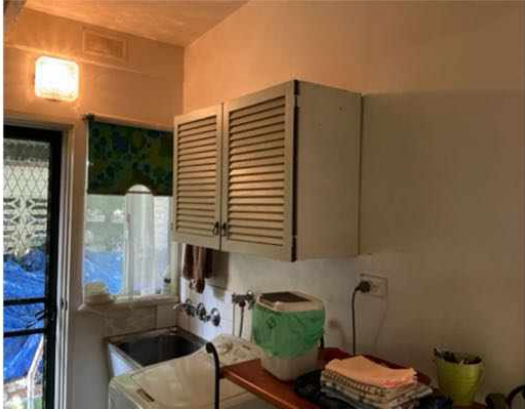
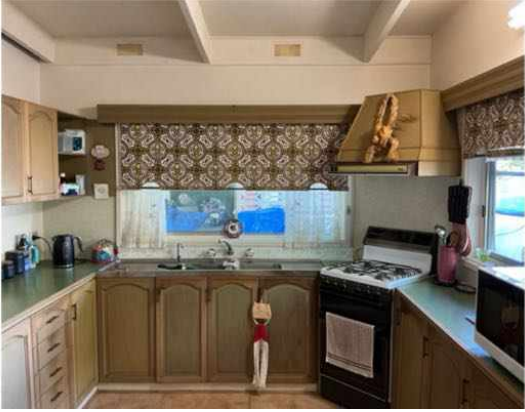
Building:	Main Building
Location:	Various parts of the building
Finding:	Asbestos - Suspected ACM Identified on Site
Information:	It is suspected that the ceiling linings to the building and cement sheet cladding to parts of the bathroom, laundry, kitchen and ceiling space contain asbestos. Reporting on Asbestos is outside the Scope of this Report. This suspected defect is highlighted as a caution only. We suspect, based on our experience in the building industry, that there is a higher risk of the identified building element containing asbestos.

As Asbestos Reporting is outside the scope of this report, we advise that you consider a separate Asbestos Inspection and Condition Audit, which can include the taking of samples for definitive confirmation of the presence of Asbestos.

In the interim, the client is advised to act with caution, especially when considering any damage to building materials, general wear and tear, renovations, extensions, demolition and general maintenance activities due to the suspected presence of Asbestos.
