Building and Timber Pest Inspection Report

Inspection Date: Thu, 12 Feb 2026

Property Address: 37 Doe St, Rye VIC 3941, Australia

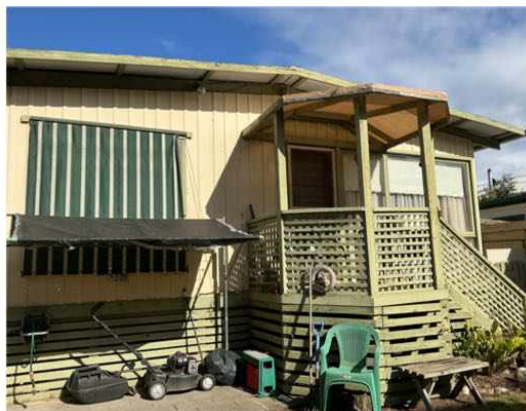
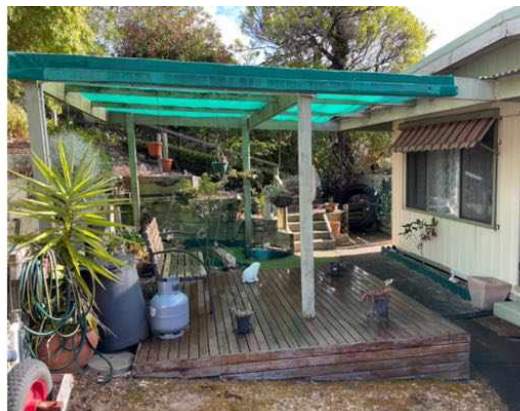
Building: Main Building
 Location: All External Areas
 Finding: Additional Photos - Obstructions and Limitations
 Information: These photographs are an indication of the obstructions and limitations which impeded full inspection of the property at the time of inspection. These obstructions can hide an array of defects and should be removed to allow full inspection to be carried out. A re-inspection is recommended once the areas are made accessible.

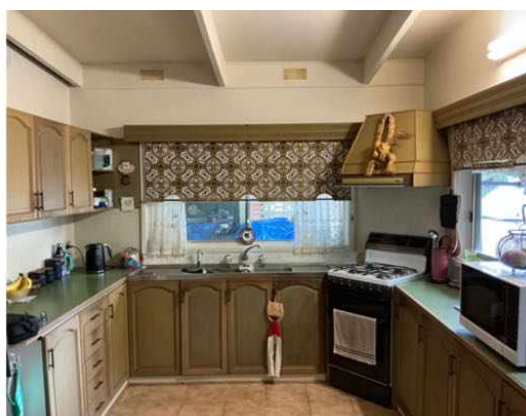
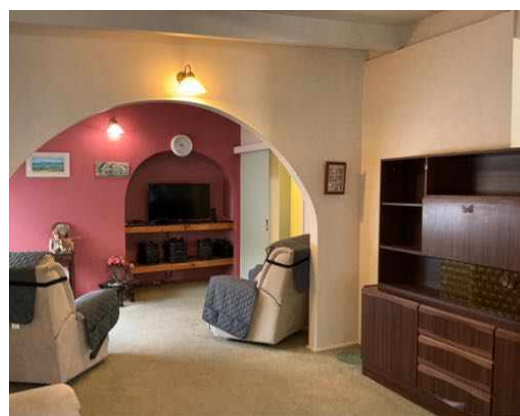
Building: Main Building
 Location: All Internal Areas
 Finding: Additional Photos - Obstructions and Limitations
 Information: These photographs are an indication of the obstructions and limitations which impeded full inspection of the property at the time of inspection. These obstructions can hide an array of defects and should be removed to allow full inspection to be carried out. A re-inspection is recommended once the areas are made accessible.

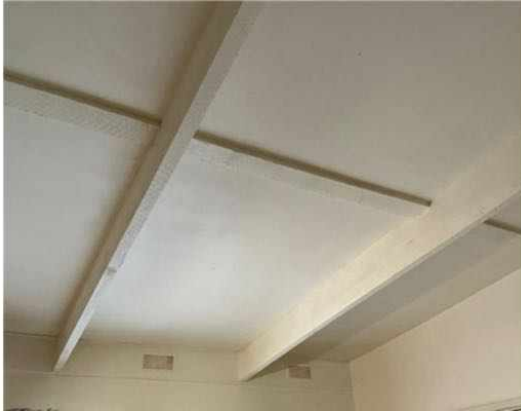
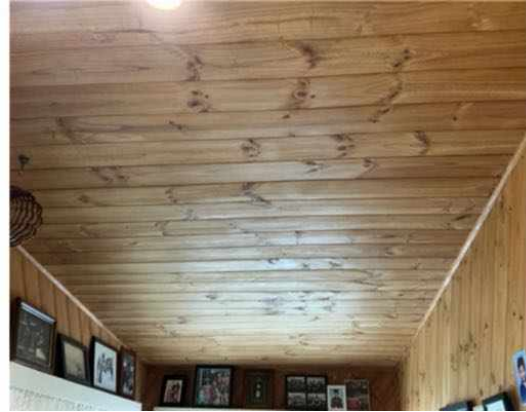
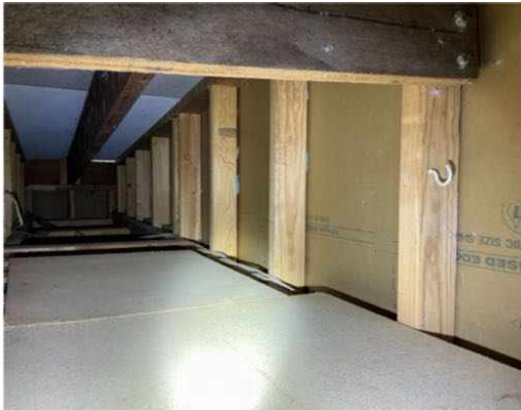
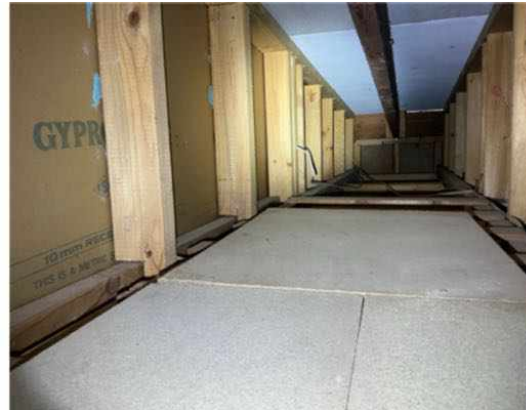
Building: Main Building
 Location: Roof Void

Finding: Obstructions and Limitations -roof cavity
 Information: These photographs are an indication of the obstructions and limitations which impeded full inspection of the roof cavity at the time of inspection. These obstructions can hide an array of defects and should be removed to allow full inspection to be carried out. A re-inspection is recommended once the areas are made accessible.

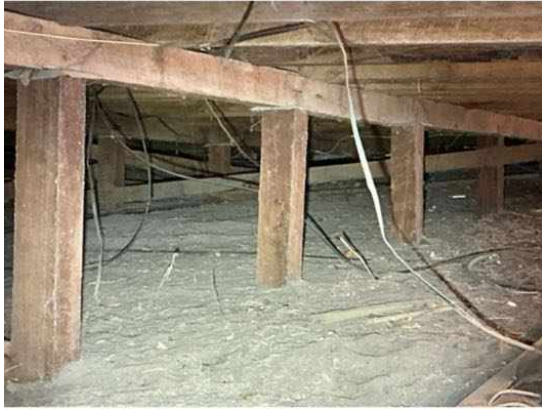
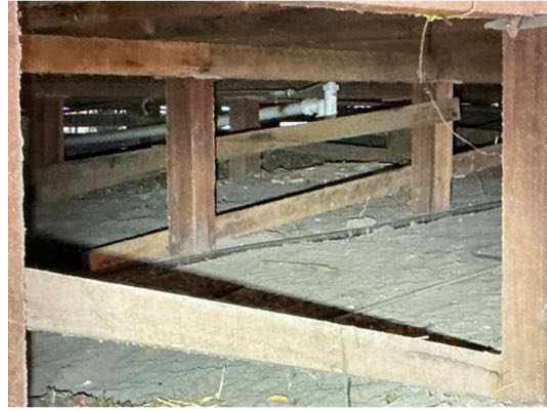
Building: Main Building
 Location: Subfloor
 Finding: Obstructions and Limitations -subfloor
 Information: These photographs are an indication of the obstructions and limitations which impeded full inspection of the subfloor at the time of inspection. These obstructions can hide an array of defects and should be removed to allow full inspection to be carried out. A re-inspection is recommended once the areas are made accessible.

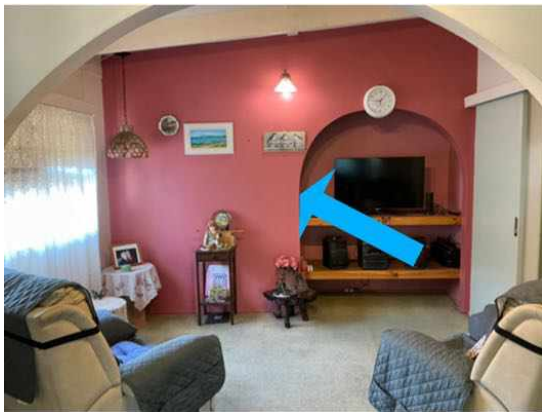
Building: Main Building
Location: Living room/bedroom
Finding: The living room/bedroom wall is not loadbearing
Information: The living room/bedroom wall is not loadbearing and could be removed without effect on the roof structure.
