Building and Timber Pest Inspection Report

Inspection Date: Mon, 2 Feb 2026

Property Address: 1/63 Carr St, Coogee NSW 2034, Australia

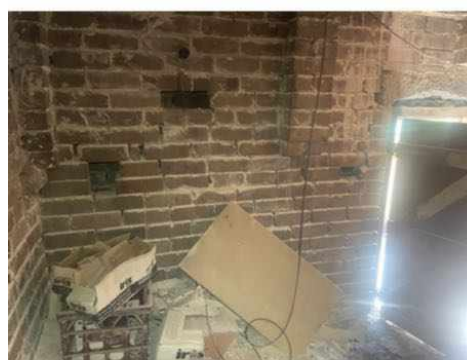
Finding 1.01

Building:	Main Building
Location:	Subfloor
Finding:	Electrical wires exposed
Information:	Exposed electrical wiring was identified. Exposed electrical wiring represents a potential safety hazard including for fire and personal contact. Contact a licensed electrician urgently for further inspection investigation and rectification.

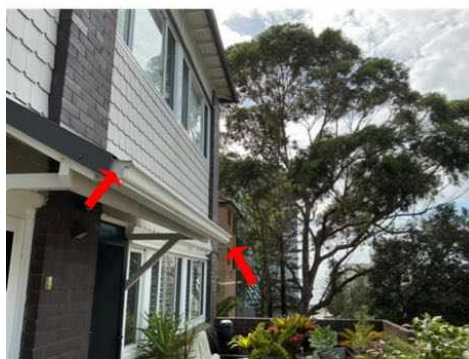
Finding 1.02

Building:	Main Building
Location:	Front porch- main entrance
Finding:	Guttering and/or Downpipes - Not plumbed for drainage
Information:	The guttering or downpipes are not plumbed or connected to suitable drainage, which can result in the surrounding area becoming excessively damp. These damp conditions can lead to secondary defects such as rot, rust or corrosion of associated building elements, the formation of fungal decay, or even the creation of potential slip

hazards.

When coupled with poor site drainage, pooling of water may also attract termite activity to this area.

It is highly recommended that a qualified plumber be appointed to install adequate drainage to the overflow. These works will ensure that the area remains dry and free of any secondary defects.

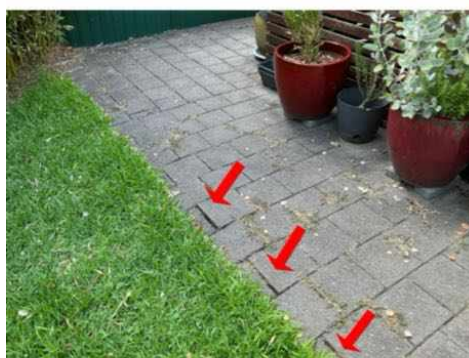
Finding 1.03

Building: Main Building
Location: Back yard, side passage
Finding: Paving uneven
Information: Sections of the external paved area are uneven, creating a potential trip hazard. It appears as though the area has been subject to rough installation, or that paving sections have lifted due to movements in the foundation of the property.

Where paving creates a trip hazard, personal injury may ensue if due caution is not taken by all persons within this area.

Re-paving of the area is required as soon as possible to remedy this situation. Further consultation with a specialist concreter is advised.

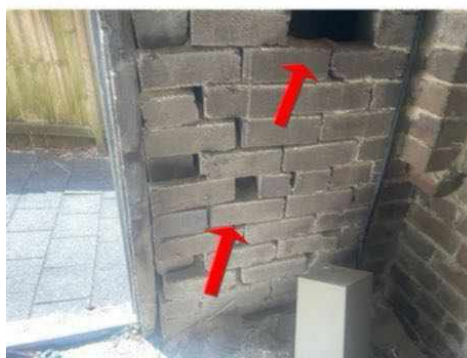
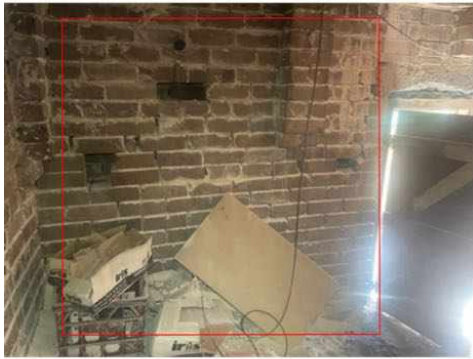
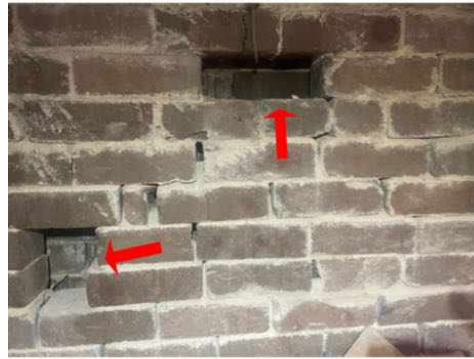
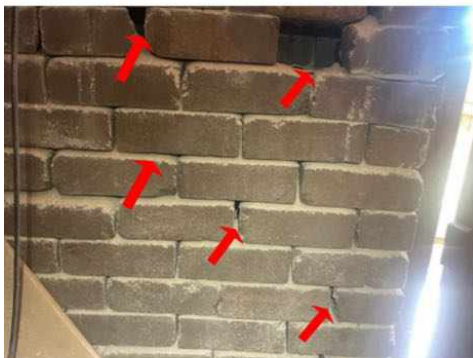
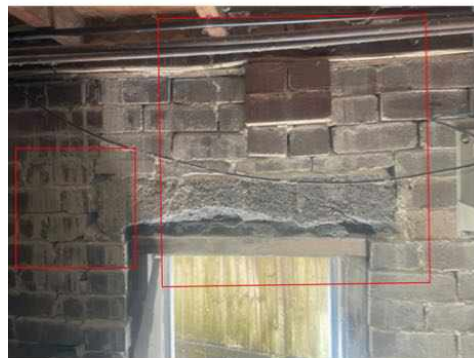
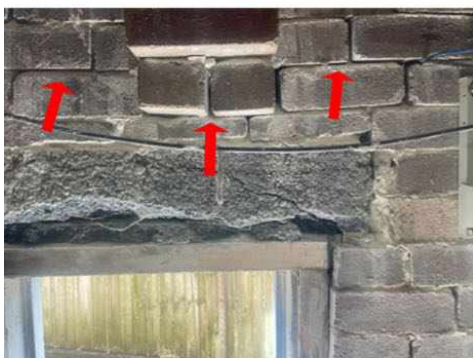
Finding 2.01

Building:	Main Building
Location:	Subfloor
Finding:	Brickwork - Deteriorated mortar throughout subfloor
Information:	Mortar, or 'bedding', is the material which fills joints and intersections between bricks in masonry walls and structures. Sections of mortar in this brickwork were identified as having deteriorated, which is generally expected for a property of this age and condition.

Mortar may deteriorate as a result of age of building materials, minor movement of bricks, or frequent exposure to weathering. Mortar should be replaced to ensure that bricks remain in their intended location and to prevent gaps, which would allow water or moisture ingress and secondary damage as a result.

Mortar deterioration can be addressed by a bricklayer where areas of deterioration are localised and easily accessible. Alternatively, appointment of a registered builder is advised, to repoint large areas of decaying mortar. Where secondary structural defects have become evident, consultation with a structural engineer may be required.

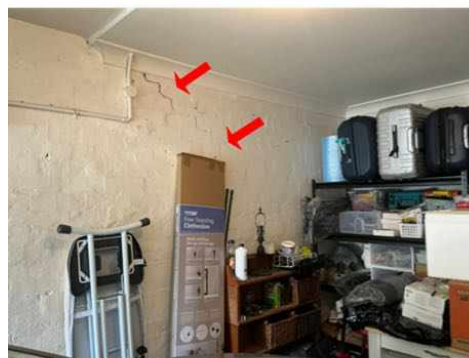
Finding 3.01

Building:	Main Building
Location:	Garage wall
Finding:	Brickwork - Step cracking
Information:	Step cracking was identified to the brickwork in this area at the time of inspection. Step cracking, which is similar to other forms of cracking, has a variety of possible causes. However, the most common is the subsidence of adjacent footings.

Step cracking is a relatively common defect, and is most likely to occur adjacent to windows, doors and other openings. Mortar failure in the gaps between affected bricks indicates the stresses and tensions affecting the wall.

Where step cracking is extensive or severe, the client is advised to consult a structural engineer. Minor step cracking can be used as a warning sign to address factors causing stress to the wall, which can include the effect of surrounding trees, water leaks, soil erosion, or even the presence of reactive soils in the surrounding area.

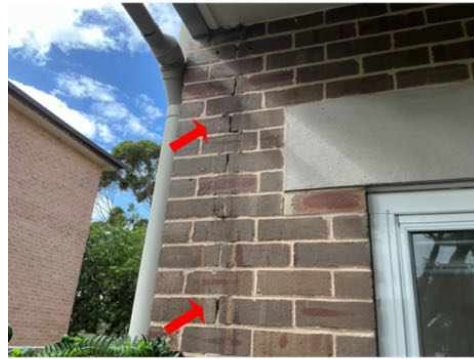
Finding 3.02

Building:	Main Building
Location:	Rear balcony wall
Finding:	Brickwork - Deteriorated mortar
Information:	Mortar, or 'bedding', is the material which fills joins and intersections between bricks in masonry walls and structures. Sections of mortar in this brickwork were identified as having deteriorated, which is generally expected for a property of this age and condition.

Mortar may deteriorate as a result of age of building materials, minor movement of bricks, or frequent exposure to weathering. Mortar should be replaced to ensure that bricks remain in their intended location and to prevent gaps, which would allow water or moisture ingress and secondary damage as a result.

Mortar deterioration can be addressed by a bricklayer where areas of deterioration are localised and easily accessible. Alternatively, appointment of a registered builder is advised, to repoint large areas of decaying mortar. Where secondary structural defects have become evident, consultation with a structural engineer may be required.

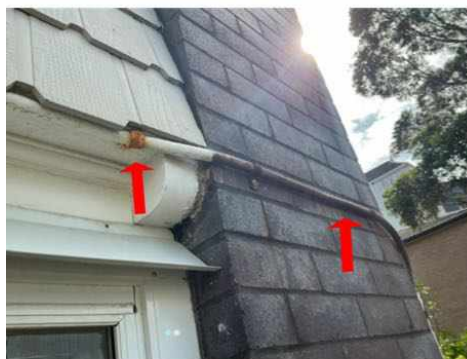
Building:	Main Building
Location:	Front balcony
Finding:	Building element - Rusted or corroded. Brackets and steel tubing
Information:	This building element shows evidence of rusting and corrosion, which is likely to have developed as a result of excessive exposure to moisture and or inadequate coatings.

As surface rust provides no protection to the underlying iron, the deteriorating condition is likely to worsen if not addressed in the short-term future.

Where possible, the use of galvanized (treated) metals or aluminium coated metals aid in rust prevention, as does regular general maintenance. Rust formation can be controlled with coatings, such as paint, that isolate the iron from the environment.

Rusting and corrosion should be managed by ideally removing or limiting the affected surface from exposure to moisture. A registered builder may be appointed to replace any building elements that have been severely affected by rust or water damage.

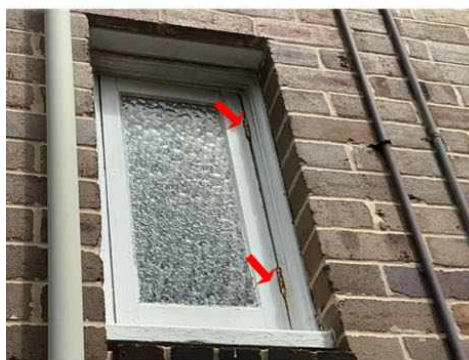
Finding 3.05

Building:	Main Building
Location:	Side passage
Finding:	Building element - Rusted or corroded- window hinges
Information:	This building element shows evidence of rusting and corrosion, which is likely to have developed as a result of excessive exposure to moisture and or inadequate coatings.

As surface rust provides no protection to the underlying iron, the deteriorating condition is likely to worsen if not addressed in the short-term future.

Where possible, the use of galvanized (treated) metals or aluminium coated metals aid in rust prevention, as does regular general maintenance. Rust formation can be controlled with coatings, such as paint, that isolate the iron from the environment.

Rusting and corrosion should be managed by ideally removing or limiting the affected surface from exposure to moisture. A registered builder may be appointed to replace any building elements that have been severely affected by rust or water damage.

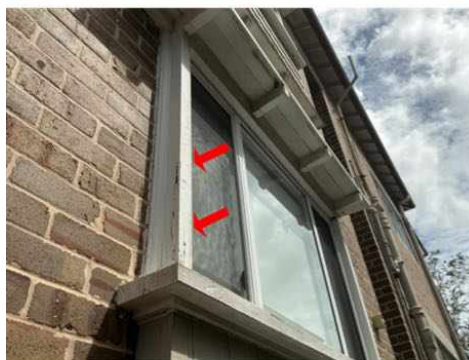
Finding 3.06

Building:	Main Building
Location:	Side passage- window frames
Finding:	External painting deteriorated
Information:	Much of the external paintwork including but not limited to windows, fascias, guttering, veranda and other external fitments have been neglected and require attention to prepare and re-paint.

Whilst incomplete or missing paint finish is generally an appearance defect, it can also lead to the development of secondary building defects over time. Incomplete areas of paint finish expose the area to moisture, potentially accelerating the deterioration of underlying building materials.

Degraded paint finishes should be sanded back, filled, leveled and painted, as applicable. Where inadequate or missing paint protection has led to the deterioration of the associated building element, repair and/or replacement of this building element may be required.

A painting contractor should be appointed as soon as possible to perform necessary works to aid the appearance of the affected area and to ensure the area is protected against further deterioration. Alternatively, the homeowner following manufacturer instructions may perform these works.

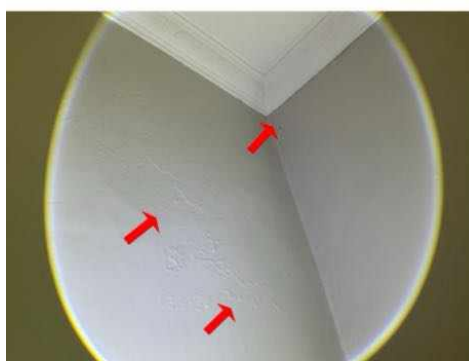
Finding 3.07

Building: Main Building
 Location: Third bedroom - nearest kitchen
 Finding: Painted surface - Bubbling
 Information: Sections of paint in this area were found to have bubbled and deteriorated. Paint bubbling is generally an indication of excessive moisture in the area, that is currently hidden by the painted surface.

The presence of excessive moisture can have major implications on associated building elements if left unattended. While only seemingly minor at this stage, the damage cannot be determined due to the paint obstructing any further inspection of the damage.

It is highly advised that the affected paint be cleaned to allow a further, more invasive inspection by a licensed plumber. Failure to act on this defect may necessitate major works in the future.

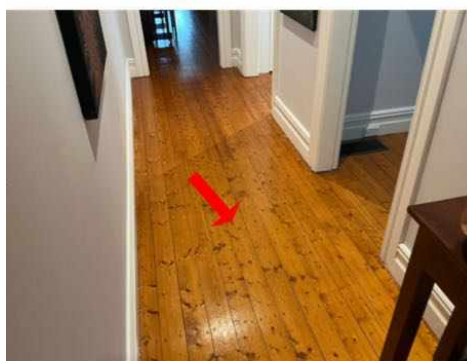
Finding 3.08

Building: Main Building
 Location: Hallway
 Finding: Floors - bouncy

Bouncy floors generally indicate that the floorboards or the subfloor structures are coming loose from the joists that they are installed on. Bouncy flooring may also be the result of gaps between flooring and stumps or joist structures, which require packing.

The client is advised to seek quotations for required repairs from a Registered Builder specialising in re-stumping. The potential resolution may range from packing gaps in subfloor structures through to replacement of subfloors stumps and refixing of flooring.

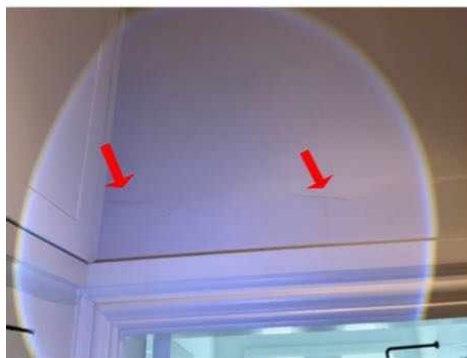
Finding 3.09

Building: Main Building
Location: Entrance to main bathroom
Finding: Cracks to internal render - Category 1
Information: It has been observed that cracking to internal rendered surfaces has occurred. The degree of damage falls within Category 1, described as fine cracks that do not need repair and which are less than 1.0mm in width limit.

Damage of this category is not considered a defect for rectification. Always contact your building inspector should cracks widen, lengthen, or become more numerous.

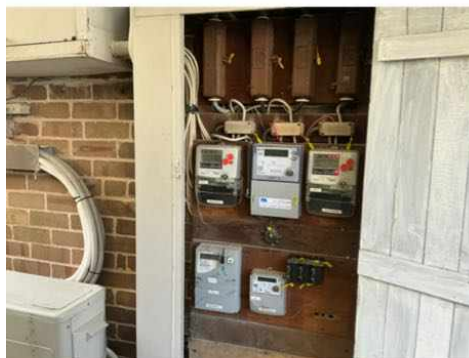
Building:	Main Building
Location:	Meter box and kitchen sink
Finding:	Termite Management System - no evidence of a chemical installation
Information:	The application of a post-construction chemical termite barrier is highly recommended for all properties, particularly if live termite activity has been found on the site previously. Such barriers are highly effective in preventing termite attack on any timber building elements throughout the property.

A durable notice should be placed in the switchboard unit to indicate current termite barriers. At the time of inspection, it appeared as though no termite management system has been installed, with no evidence to suggest preventative works taking place.

The client may consider gaining further advice from a pest controller as to the costs and procedures involved with this application. It is recommended that obtaining such advice be a short-term priority.

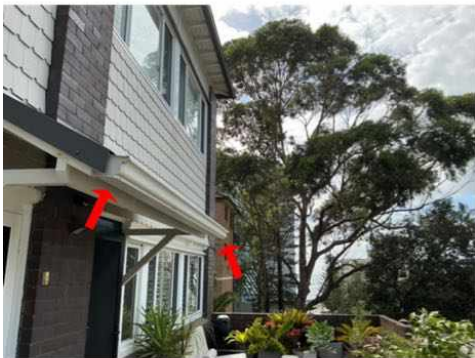
Finding 6.02

Building:	Main Building
Location:	Front balcony- main entrance
Finding:	Overflow - Not plumbed for drainage (Excessive Moisture)
Information:	The overflow is not plumbed or connected to suitable drainage, which has resulted in the surrounding area becoming excessively damp. These damp conditions can lead to secondary defects such as rot, rust or corrosion of associated building elements, the formation of fungal decay, or even the creation of potential slip hazards.

When coupled with poor site drainage, pooling of water may also attract termite activity to this area. It is highly recommended that a qualified plumber be appointed to install adequate drainage to the overflow. These works will ensure that the area remains dry and free of any secondary defects.

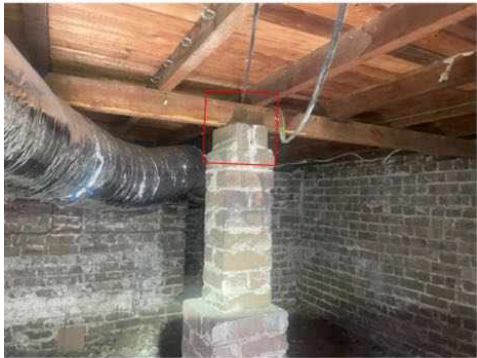
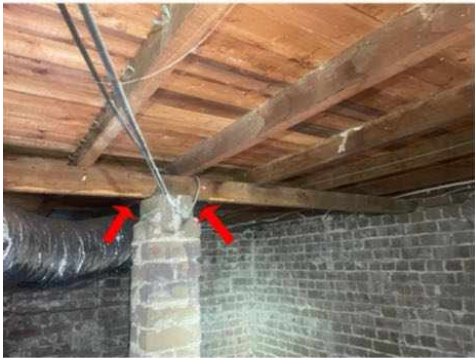
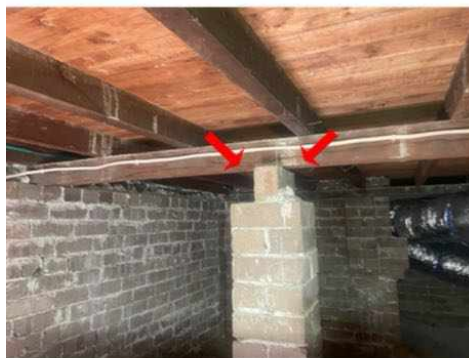
Finding 6.03

Building: Main Building
Location: Back yard, side passage
Finding: Ant caps - Not installed, subfloor
Information: Ant caps have not been installed to the subfloor structure at the time of inspection. Generally, ant caps are installed to the intersection between the top of the stumps (or piers) and the subfloor structures.

Installed during the construction process, ant caps are designed to easily identify termite or pest ingress from stumps to the adjoining bearers.

Where ant caps have not been installed, frequent monitoring of these areas should be carried out in order to identify any signs of termite or timber pest workings.

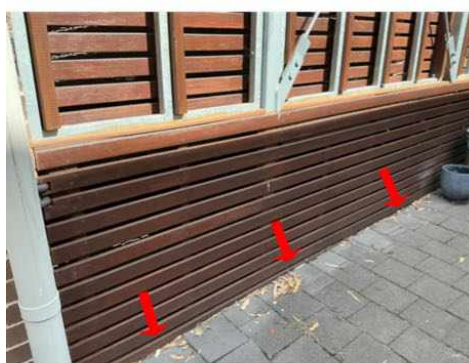
Finding 6.04

Building: Main Building
 Location: Side and rear balcony perimeter
 Finding: Untreated or non-durable timbers in a hazardous environment (Timbers in ground contact)
 Information: To reduce the risk of timber pest attack it is essential that timber used in a hazardous environment (e.g. in direct contact with the ground or frequently exposed to damp conditions) is of sufficient durability and/or is adequately preservative treated.

Untreated timbers in direct contact with the ground are likely to develop severe wood rot and/or fungal decay if left unattended creating attraction for subterranean termites to infest the timbers from surrounding areas.

If untreated or non-durable timbers are found to be in a hazardous environment it is highly advised that replacement of these building elements be performed as soon as possible to aid the protection of the property against termite / timber pest attack.

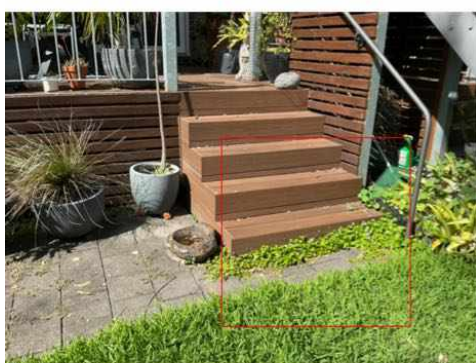
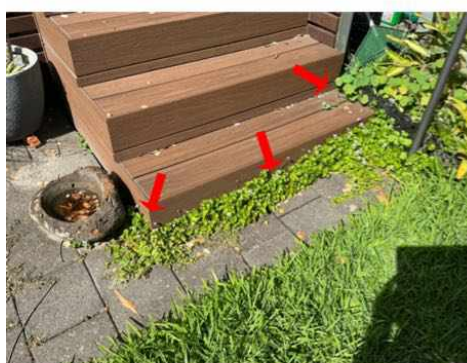
Finding 6.05

Building: Main Building
 Location: Rear staircase
 Finding: Bridging - Vegetation

Information: Where vegetation obstructs inspection of building elements, also known as bridging as it provides a bridging point for the access of termites, full inspection can not be achieved. Consequently moisture or dampness may be present and the areas becomes conducive to termite activity. Plants against or very close to buildings provide cover, shade and can provide an environment that is attractive to termite infestation.

The removal and replanting of species that do not provide "cover" or cutting back of existing vegetation will assist greatly in preventing Bridging from occurring.

The removal of any such materials that may be conducive to termite activity should be carried out as soon as possible and arrange re inspection to minimize the risk of termite attack.

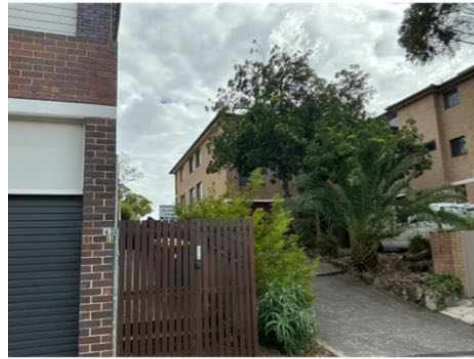
Finding 6.06

Building: Main Building
 Location: All Areas
 Finding: Trees to be inspected within the property.
 Information: Trees can be conducive to termite activity and nesting. Trees over 100mm on the property, should be drilled and tested for termite activity.

Regular inspections every 6-12 months- or advised by the termite management system installer.

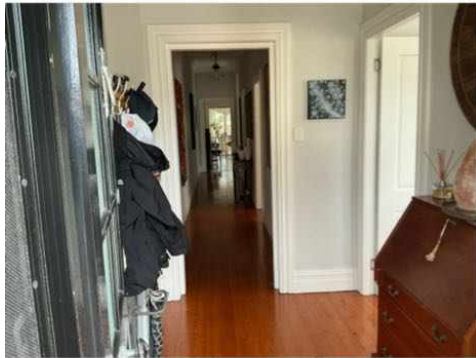
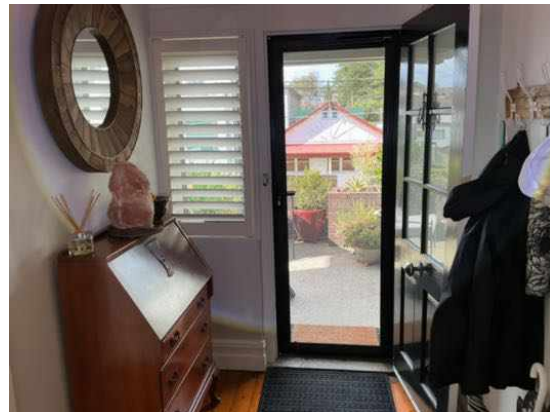
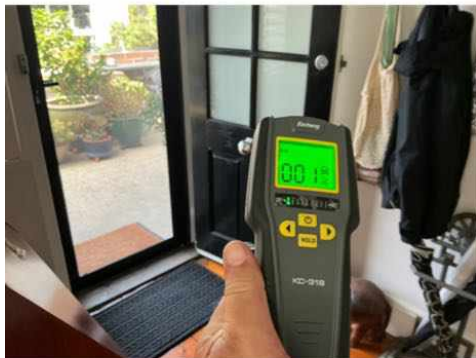
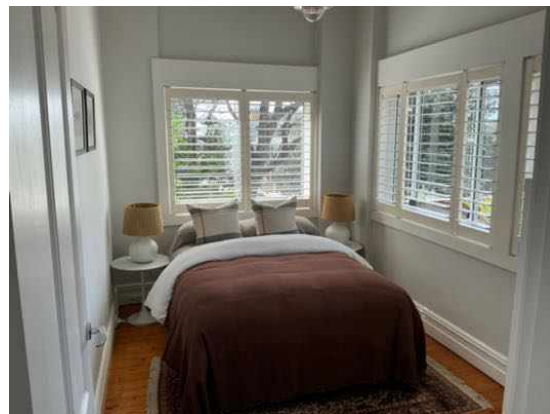
Noted Item

Building: Main Building
Location: All interior
Finding: Additional Photos - Obstructions and Limitations
Information: These photographs are an indication of the obstructions and limitations which impeded full inspection of the property at the time of inspection. These obstructions can hide an array of defects and should be removed to allow full inspection to be carried out. A re-inspection is recommended once the areas are made accessible.

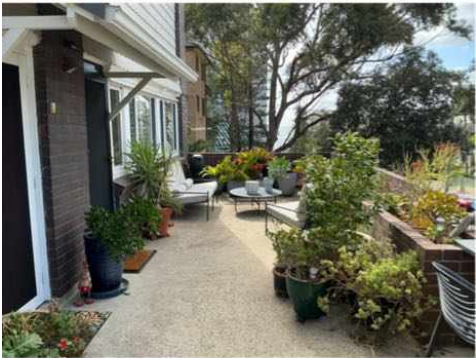
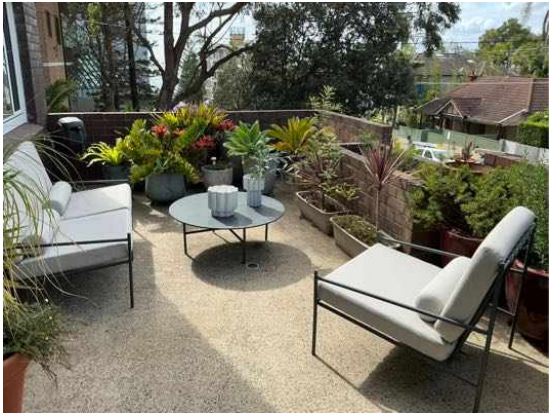
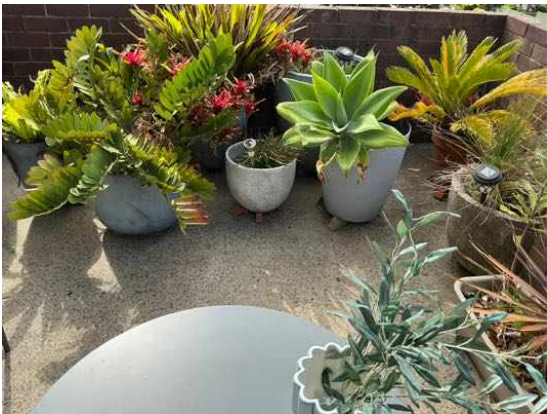
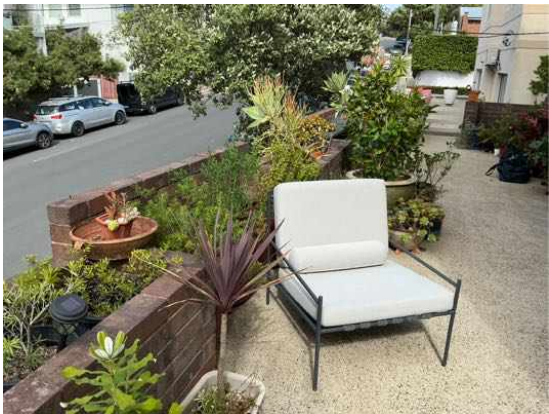
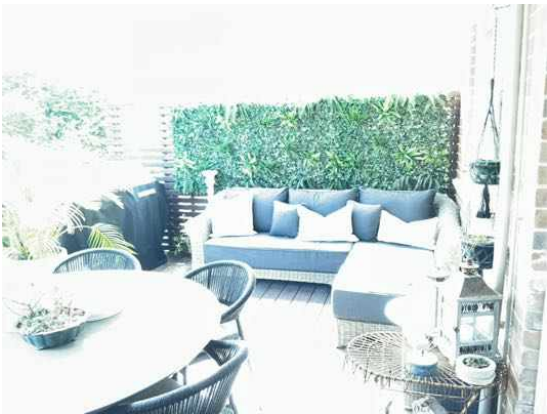
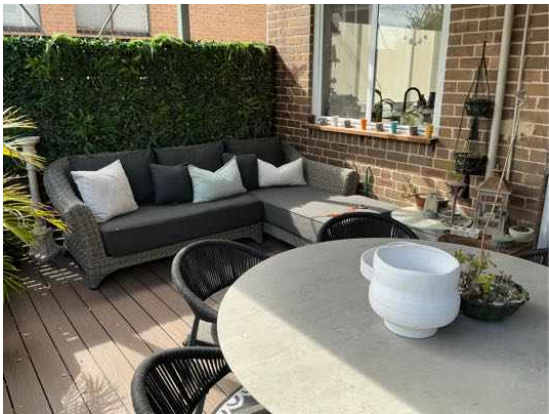
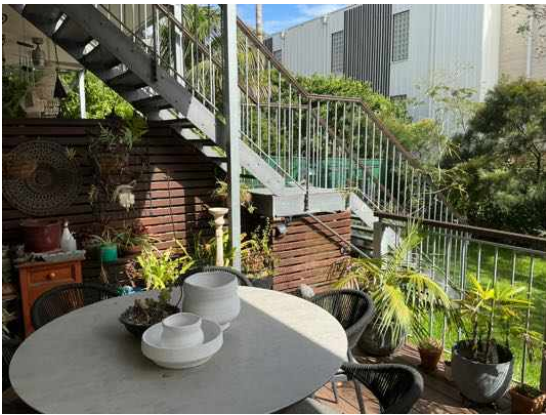
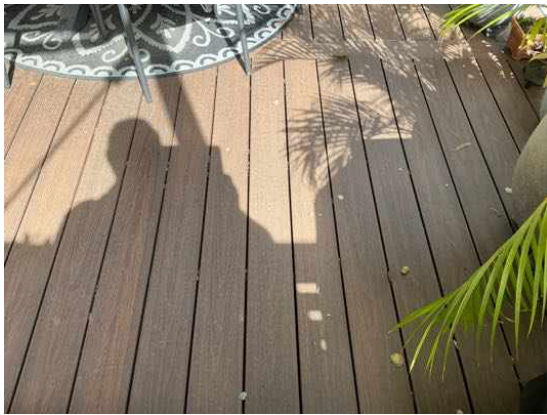
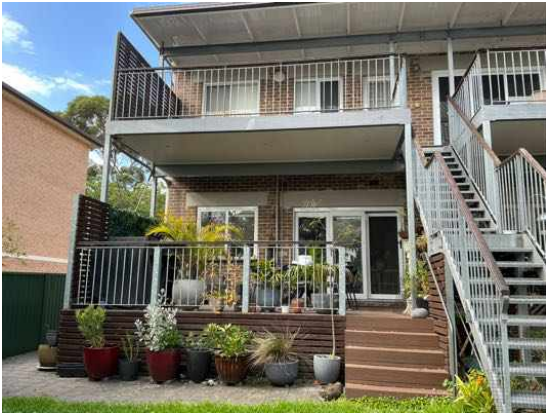
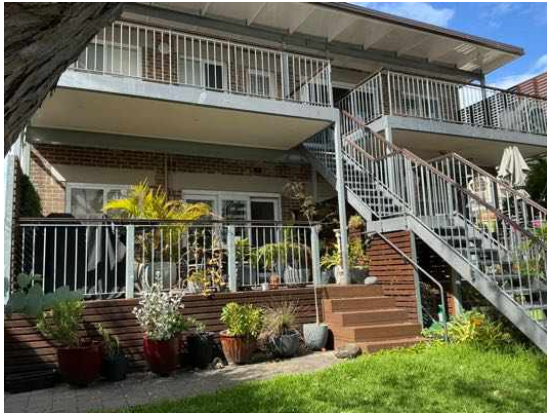
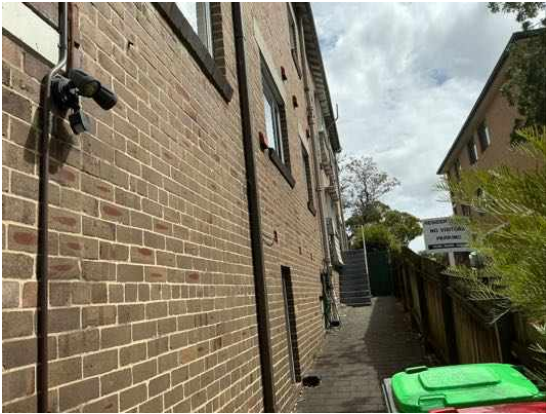
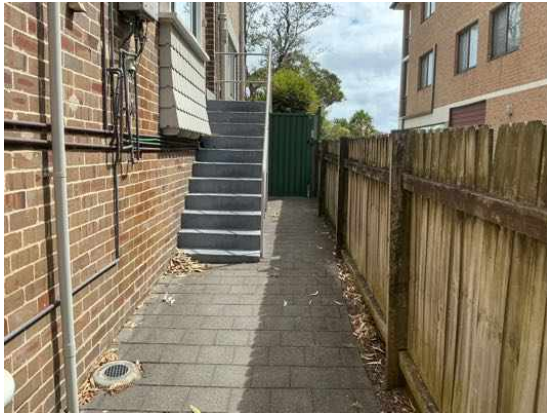
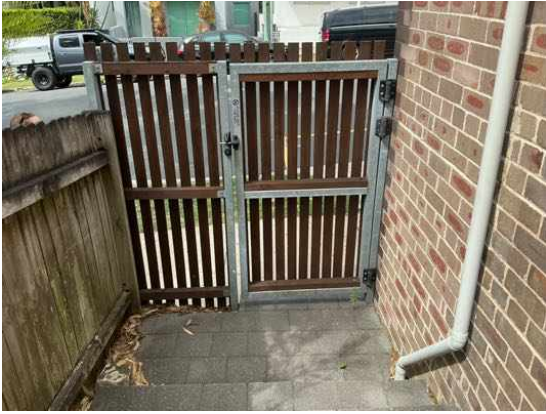
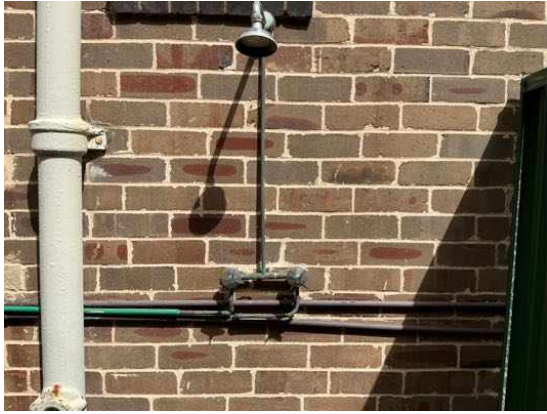
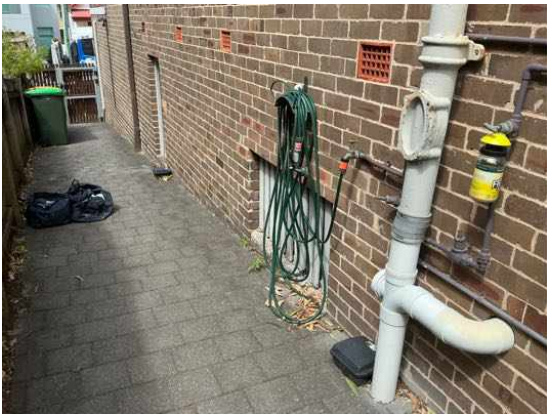
Building: Main Building
Location: Exterior
Finding: Additional Photos - Obstructions and Limitations
Information: These photographs are an indication of the obstructions and limitations which impeded full inspection of the property at the time of inspection. These obstructions can hide an array of defects and should be removed to allow full inspection to be carried out. A re-inspection is recommended once the areas are made accessible.

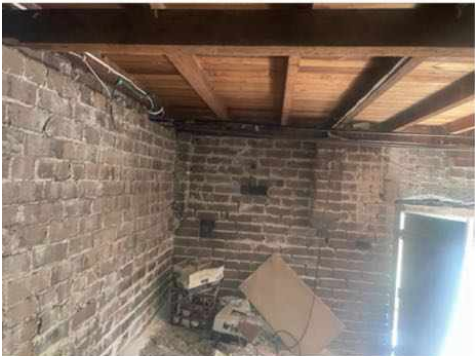
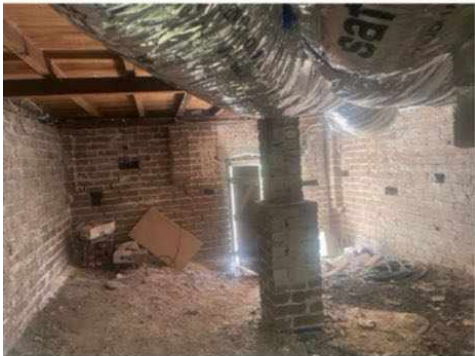
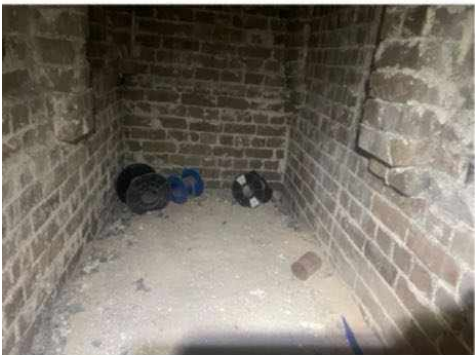
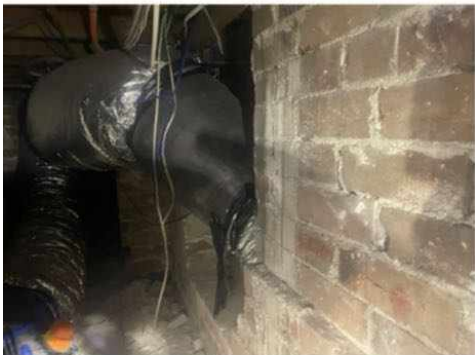
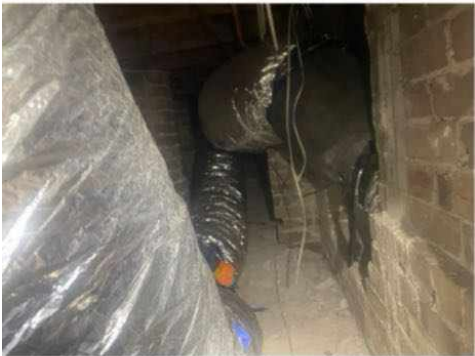
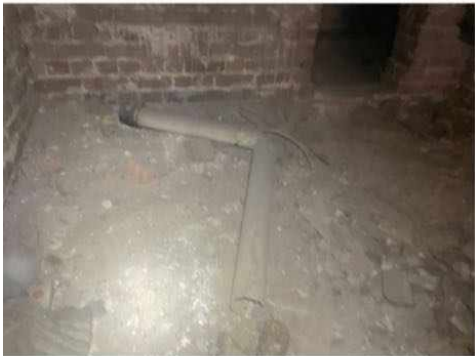
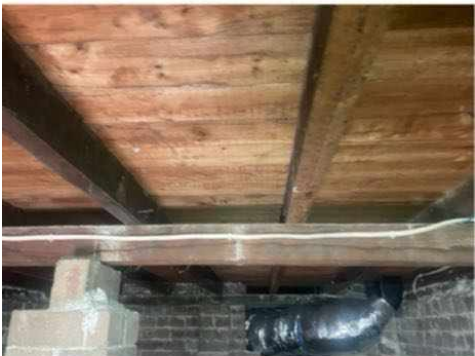
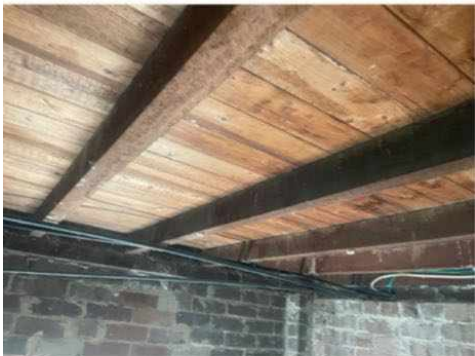
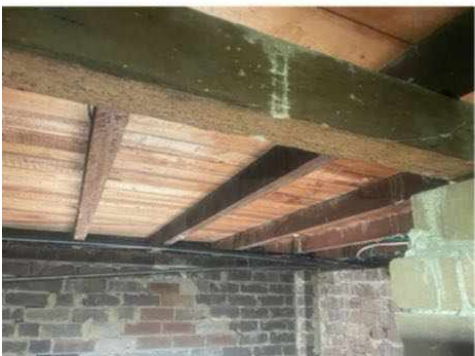
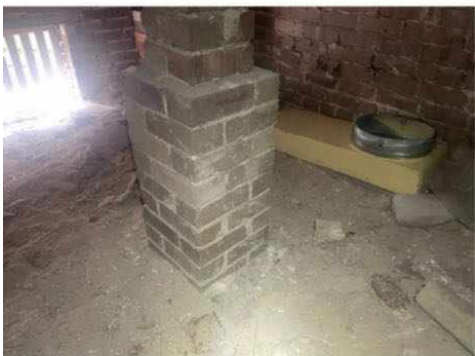
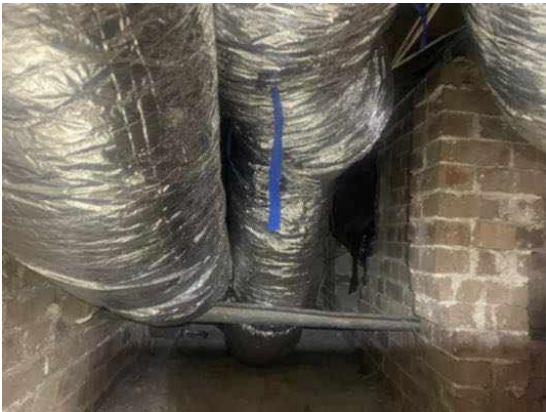
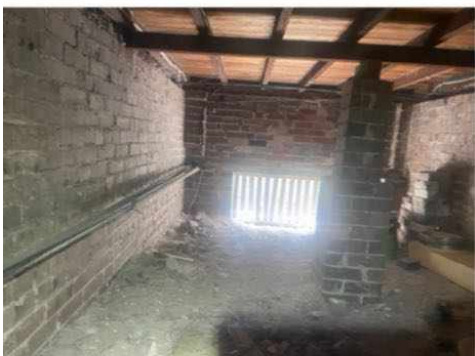
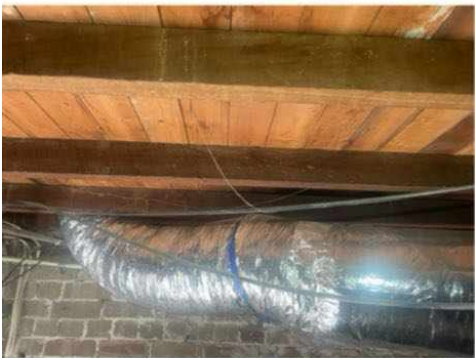
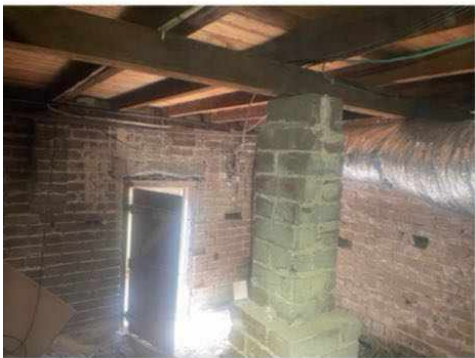
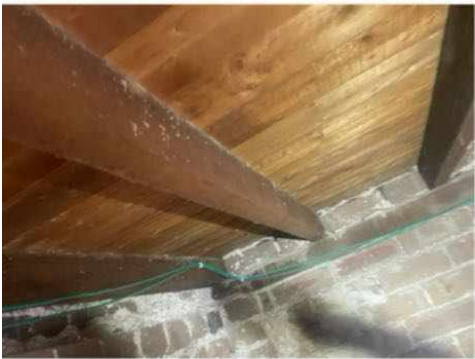
Building: Garage
Location: Subfloor
Finding: Additional Photos - Obstructions and Limitations
Information: These photographs are an indication of the obstructions and limitations which impeded full inspection of the property at the time of inspection. These obstructions can hide an array of defects and should be removed to allow full inspection to be carried out. A re-inspection is recommended once the areas are made accessible.
