Building and Timber Pest Inspection Report

Inspection Date: Thu, 22 Jan 2026

Property Address: 11/37 Shedworth St, Marayong NSW 2148,
Australia

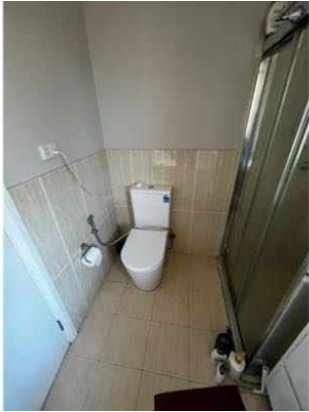
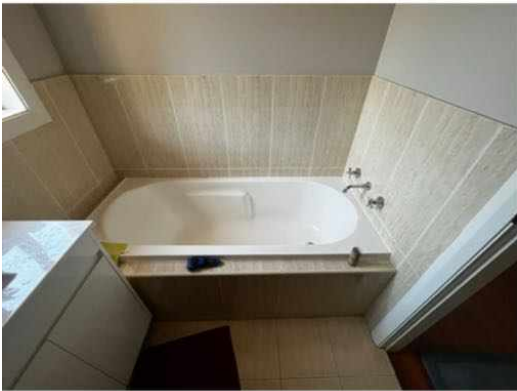
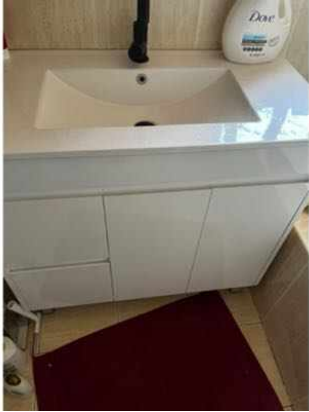
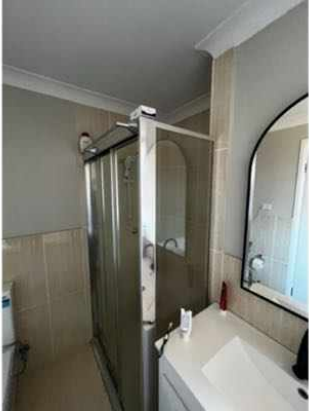
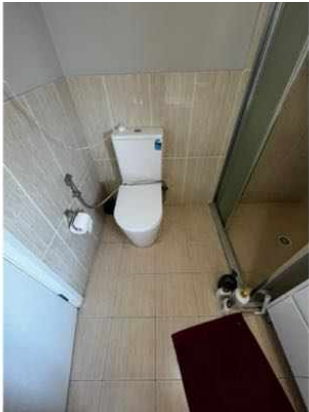
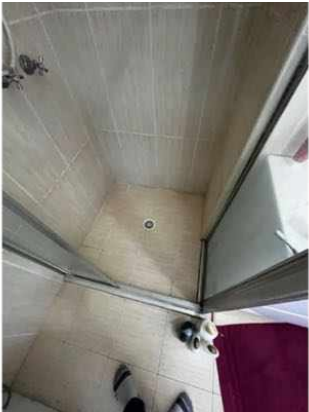
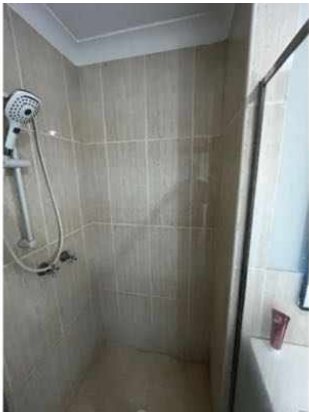
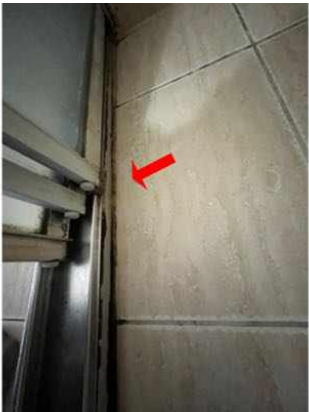
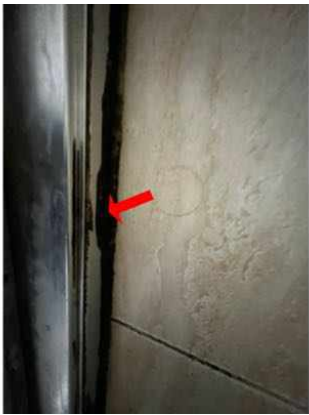
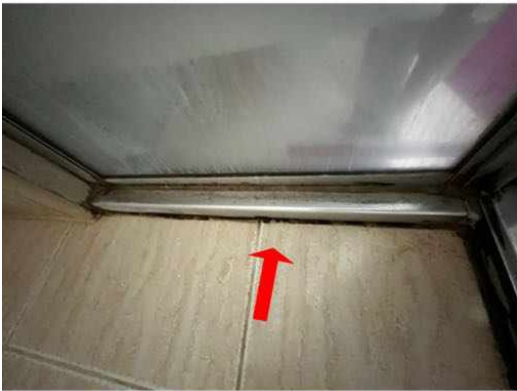
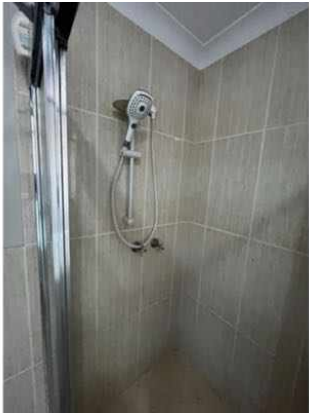
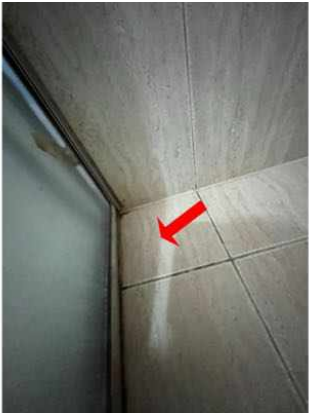
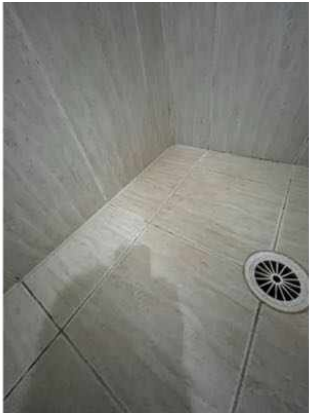
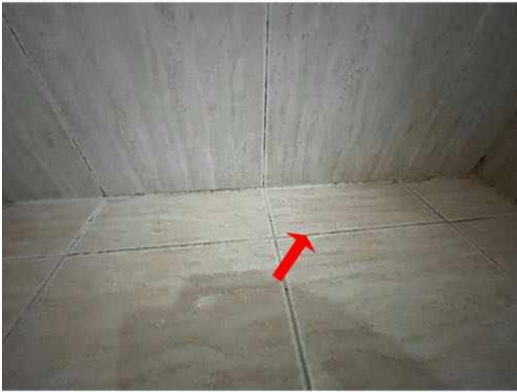
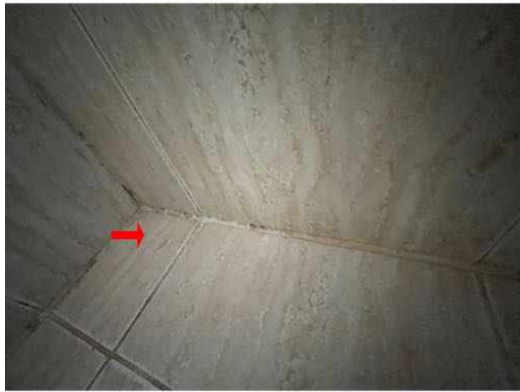
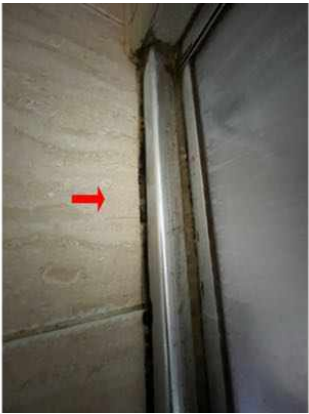
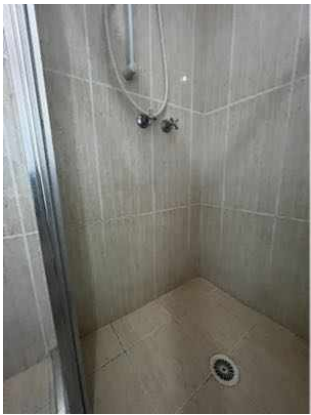
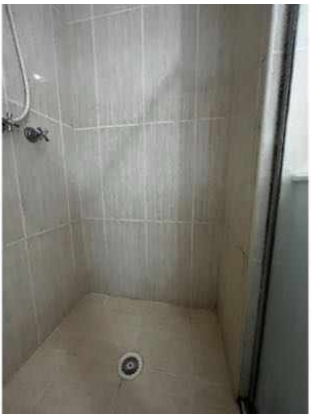
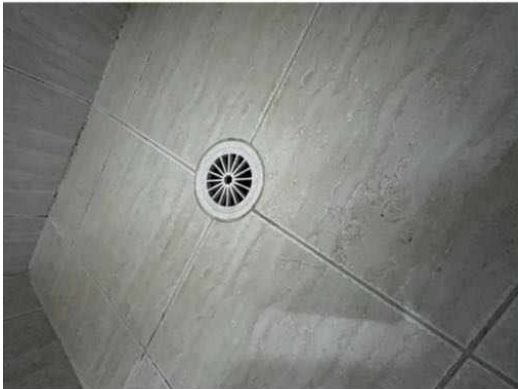
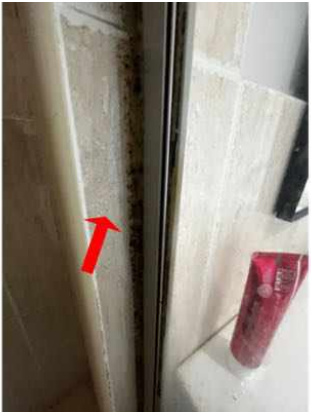
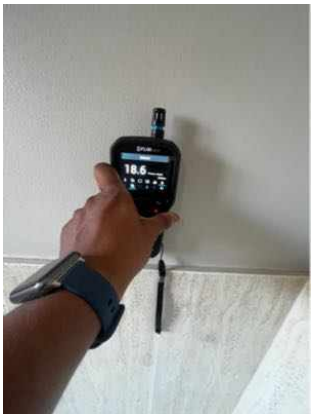
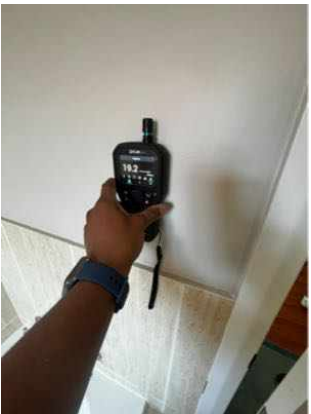
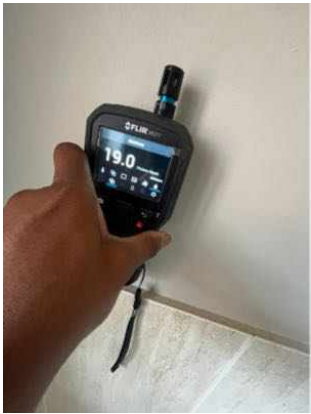
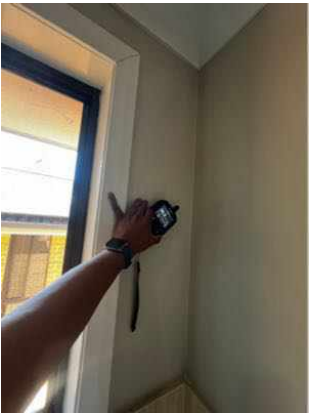
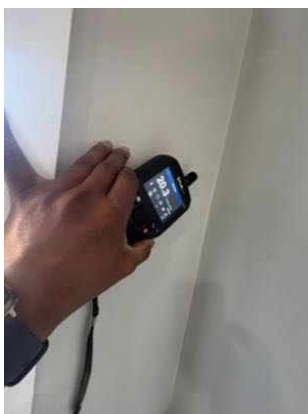
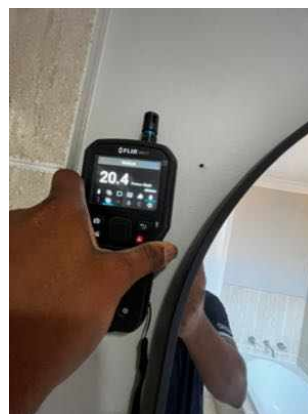
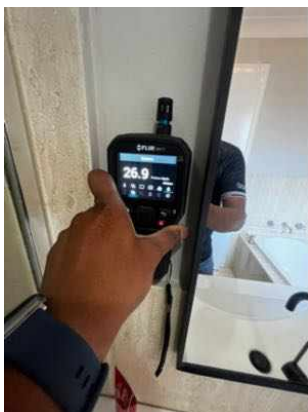
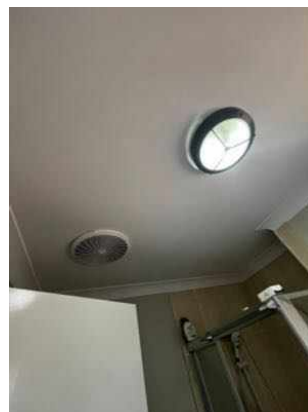
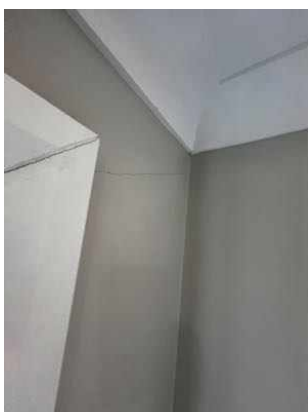
There appears to be excessive mould to the sealant and grout which will likely require scraping out and replacement.

A sealant specialist or tiling contractor should be appointed to complete these works as soon as possible

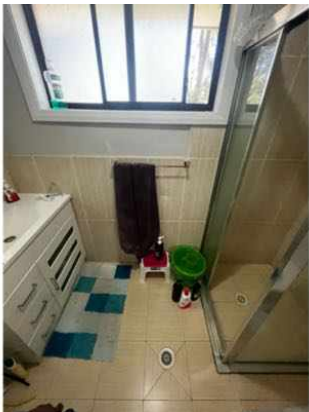
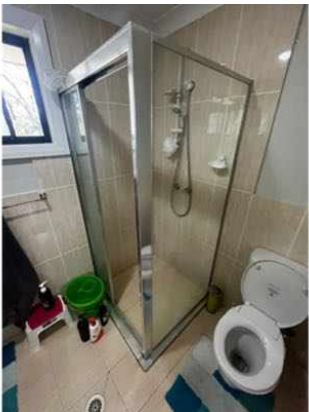
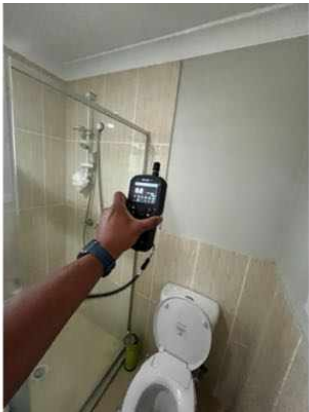
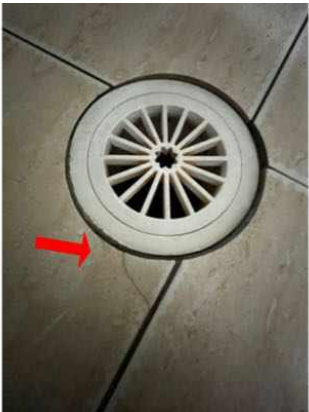
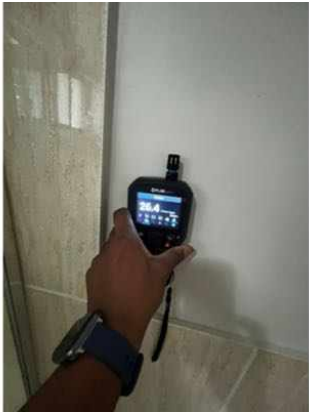
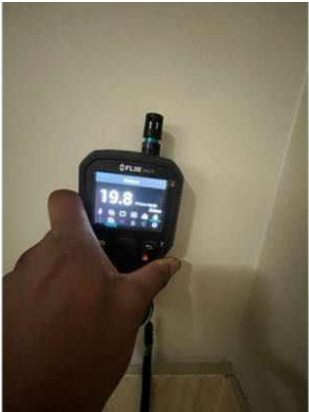
Finding 2.02

Building:	Main Building
Location:	Ensuite
Finding:	Sealant and grouting - Missing or damaged
Information:	It was noted on inspection that sealant or grout is degraded to the tiled shower alcove and or other areas of the bathroom.

Flexible and mould resistant materials should be applied to affected areas to prevent any subsequent water damage that is likely to occur. Regular maintenance and replacement of damage or missing or damaged sealant and grout is highly recommended to the wet areas, as this is a regular wear and tear defect. Sealant and grouting in areas that come into regular contact with water should be maintained for the long term care of your property.

A sealant specialist or tiling contractor should be appointed to complete these works as soon as possible to prevent any further damage.

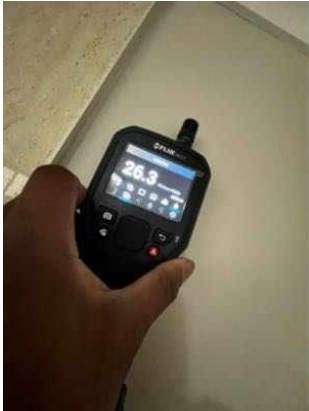
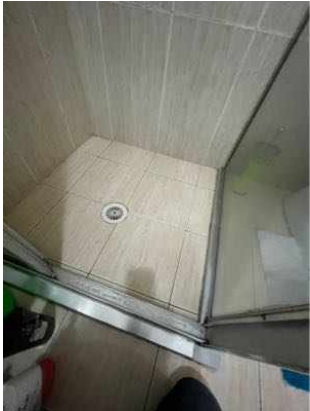
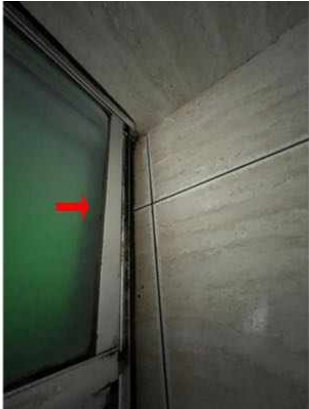
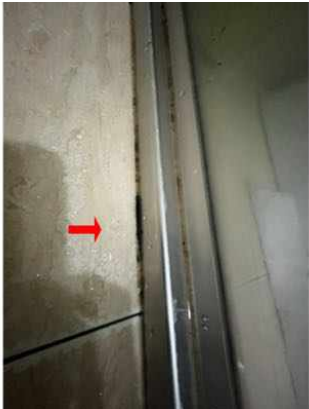
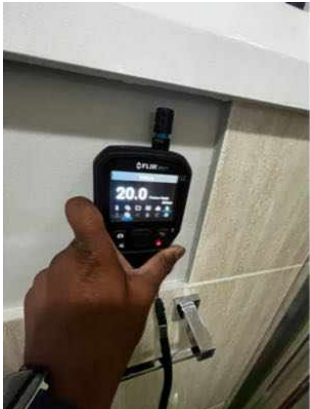
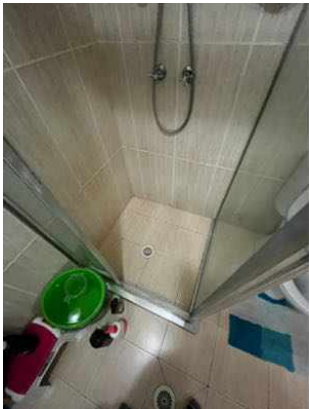
Different materials and floor areas move at different rates, generally causing cracking to grout or sealant at this point. A flexible sealant is required to allow for expected expansion and contraction, while keeping the joint water tight and protective of all associated building materials.

There appears to be excessive mould to the sealant and grout which will likely require scraping out and replacement.

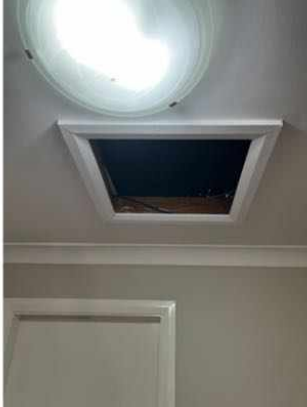
Finding 3.01

Roof Space/Void at the time of inspection such as Electrical wires and cross beams, rafters, low clearance as of the pitch in the roof. These obstructions can hide an array of defects and should be removed to allow full inspection to be carried out.

A re-inspection is recommended once the areas are made accessible.

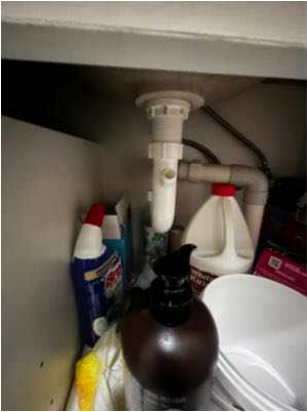
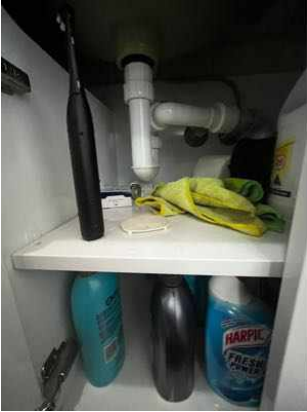
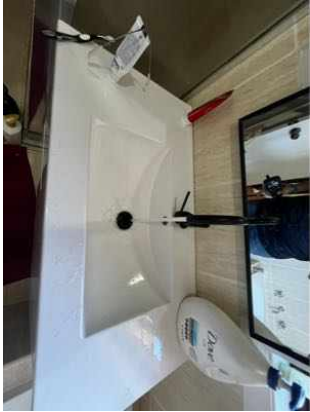
Finding 3.02

Building: Main Building
 Location: Kitchen/ Laundry/ Ensuite/ Bathroom
 Finding: Cabinetry Plumbing - Kitchen/ Laundry/Powder
 Information: All cupboards where sinks and basins with drainage plumbing were inspected and no evidence of leaks were present at the time of inspection.

Upon Inspection in the Laundry the sink was not to be found, only the Hot and cold water taps were installed in the wall. This is non compliant .

If damp or wet conditions do occur there are many consequences including the development of fungal decay and/or wood rot, swelling or water damage to building materials.

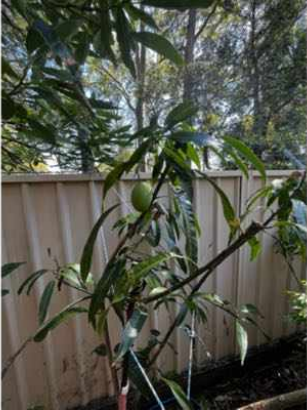
Finding 3.03

Building: Main Building
Location: Yard
Finding: Perimeter Fencing -
Information: For your information photos taken at the time of inspection.

Some parts of the fence needs attention and looks deteriorated.

It is best to consult a fencing professional to take advise and fix the fence in good condition.

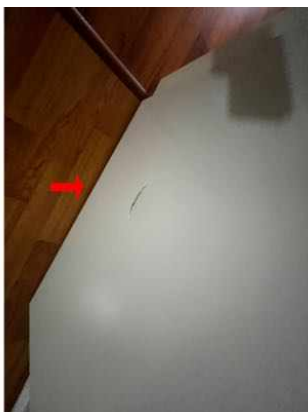
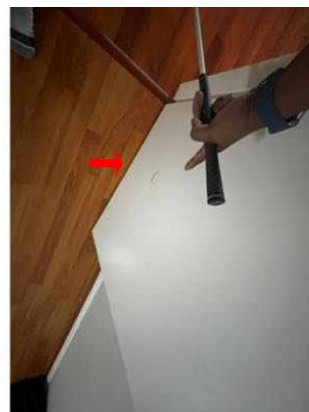
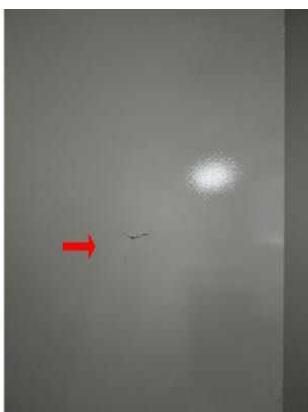
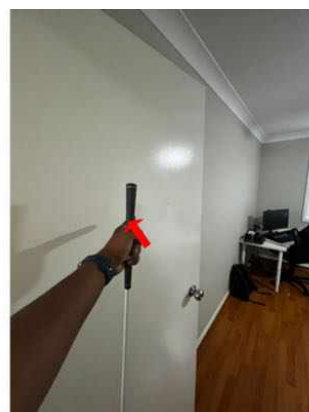
Building:	Main Building
Location:	Bedroom Door
Finding:	Door - Damaged.
Information:	At the time of inspection, it was noted that the Bedroom door had damages in few spots and broken.

Restricted function of the affected door may pose as a potential hazard if required to operate for daily needs.

Generally, factors such as general age of the building element and a lack of maintenance are the usual causes for this type of defect.

Replacement of door hardware or tracks may be required, as well as minor repairs and cleaning. A general handy Man will be required to repair the affected doors.

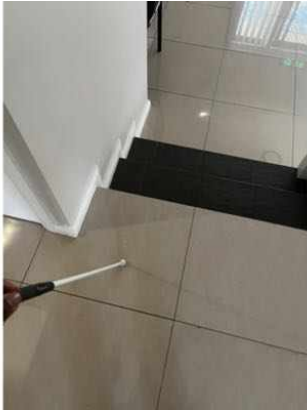
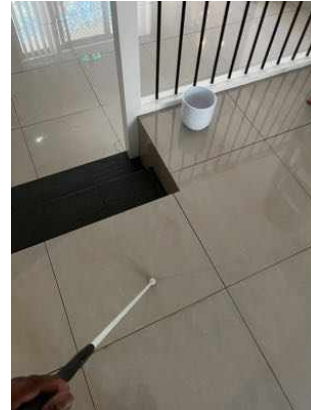
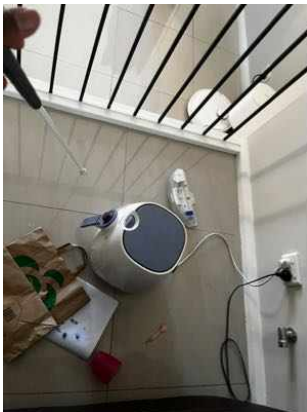
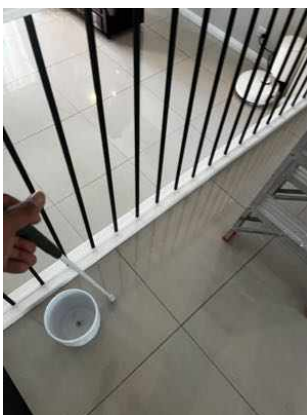
Finding 3.05

Building: Main Building
 Location: Lounge
 Finding: Tiles - Drummy
 Information:

Drummy tiled areas were identified at the time of inspection. The term 'drummy' refers to tiles that have become detached from their fixing, despite otherwise being in relatively good condition. Such defects are generally caused by physical or moisture damage to the area. Drummy tiled areas may also be a direct result of poor workmanship during the construction process.

Tiled areas may swell and shrink with changes in air humidity if the area has sustained moisture damage. Any exposure to moisture is capable of causing tiled areas to

become drummy and/or cracked over a prolonged period of time. Drummy tiled areas generally require removal and replacement of affected tiles, with adequate sealant and grouting.

Specialist trades are available for these types of services. A registered builder may be required to undertake works if damage is extensive or if secondary building defects have resulted. Otherwise, it is advised that a tiling contractor be appointed to perform works as necessary. Immediate action is recommended to ensure that no further damage is sustained in the affected area.

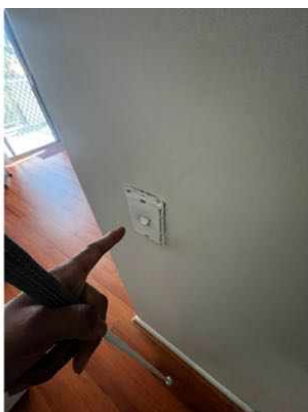
Finding 3.06

Building: Main Building
Location: Bed room
Finding: Electrical switch- cover missing
Information: The electrical switch cover in this area was found to be missing at the time of inspection. Breakage occurs generally when the building materials have aged.

Left unmanaged, the fitting is unlikely to cause further damage to surrounding building elements. However, the broken fitting does expose electrical works, and may create a safety hazard if there is potential contact with persons in the area.

Repair and/or replacement of the broken fitting is advised. A Licensed electrician should be appointed to repair/replace the fitting immediately.

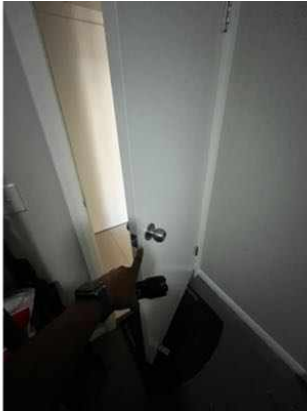
Finding 3.07

Building: Main Building
Location: Garage
Finding: Door - not Latching.
Information: At the time of inspection, it was noted that the Garage Door not latching during operation.

Binding and/or jamming of this door is evident during standard operation. This defect inhibits the functionality of the affected door as well as creating potential for secondary defects to associated building elements, such as damage to the floor covering.

For minor causes, a qualified carpenter or general handyperson should be appointed to perform minor rectification works at client discretion.

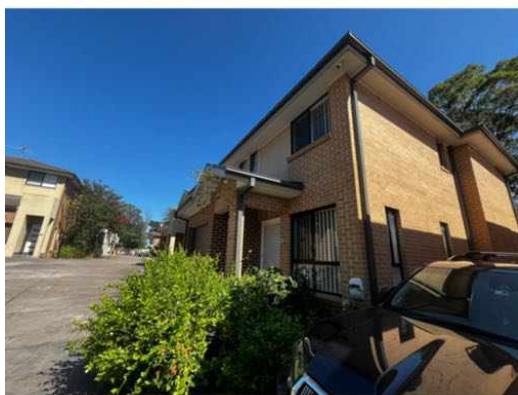
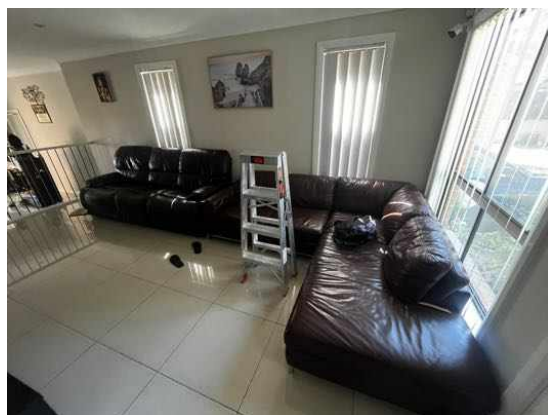
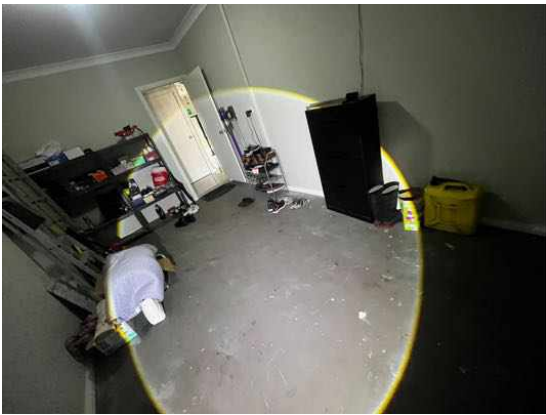
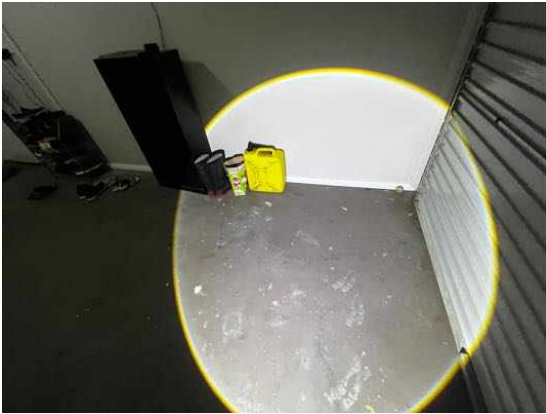
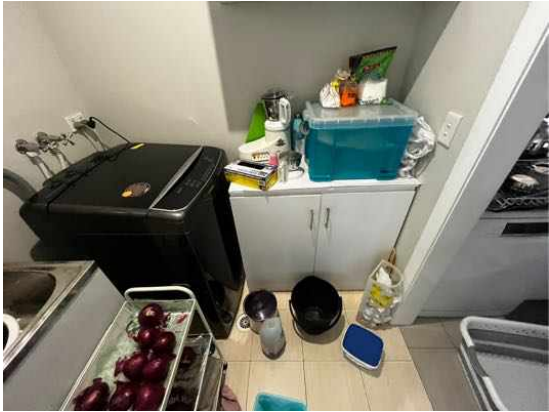
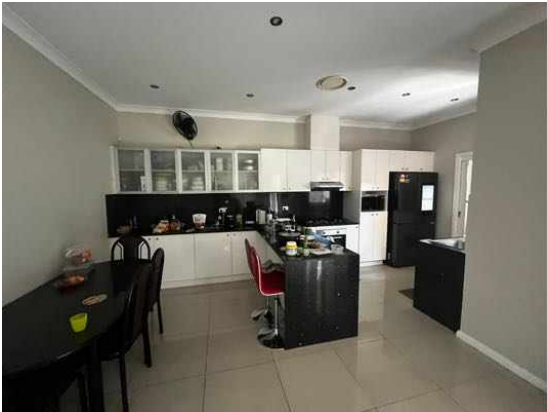
Finding: Additional Photos - Obstructions and Limitations

Information: These photographs are an indication of the obstructions and limitations which impeded full inspection of the property at the time of inspection. These obstructions can hide an array of defects and should be removed to allow full inspection to be carried out. A re-inspection is recommended once the areas are made accessible.

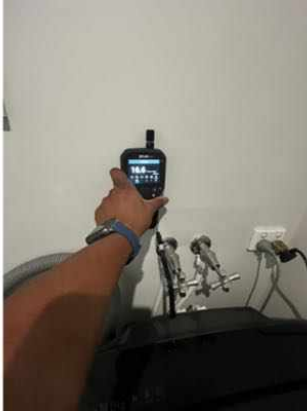
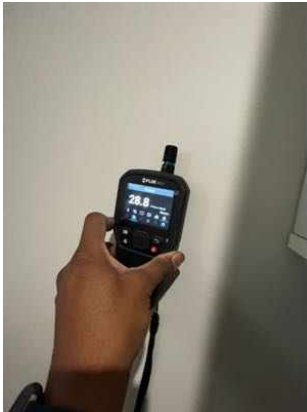
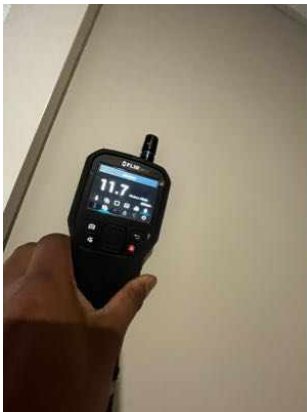
Building: Main Building
Location: Laundry
Finding: High Moisture Readings
Information: All areas of dwellings are checked with particular attention paid to wet areas which were closely assessed to check for moisture levels of moisture and temperature anomalies.

Some readings for moisture were found in the walls adjacent the showers at the time of inspection.

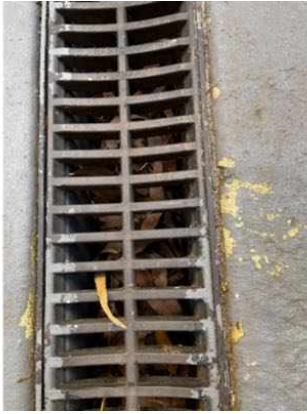
Finding 6.05

Building:	Main Building
Location:	Side Yard
Finding:	Gutters - Blocked/ Fungal Development
Information:	Upon Inspection of the plumbing structures, such as guttering and downpipes, should be free of all debris to prevent blockages. Blockages of the guttering and downpipes will lead to pooling and accumulated water overflows, which is likely to subsequently flood eaves and exterior walls.

Blocked gutters are likely to lead to high levels of moisture in the affected areas. Such moisture will not only cause rust and decay of the associated building materials, but can also provide conditions that are conducive to termite and timber pest activity. Blockages in gutters should therefore be removed immediately to ensure dry conditions are maintained.

Consult a Licensed Plumber for further specific advice on remedial works that may be required. In the interim, it is highly advised that blocked gutters be removed by the homeowner or a general handyperson as a matter of urgency.

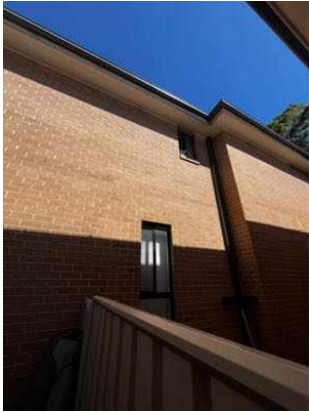
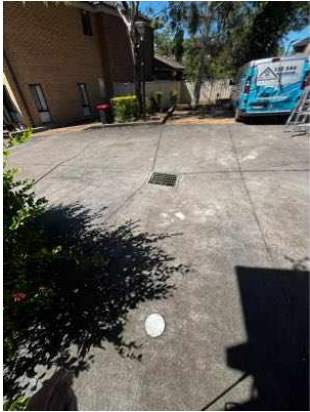
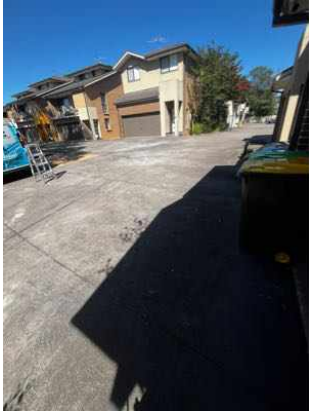
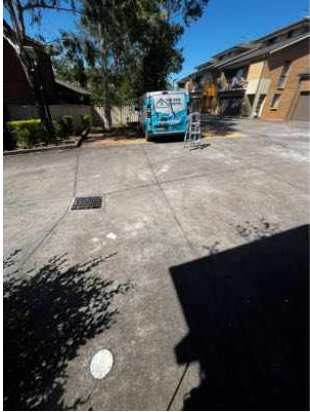
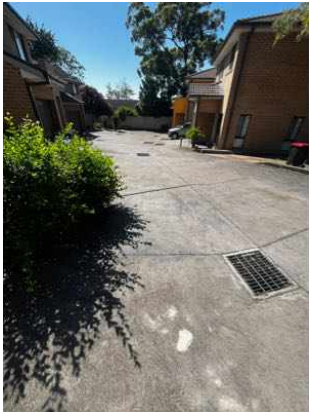
Building: Main Building
Location: Common Areas
Finding: Additional Photos
Information: Additional photos are provided for your general reference

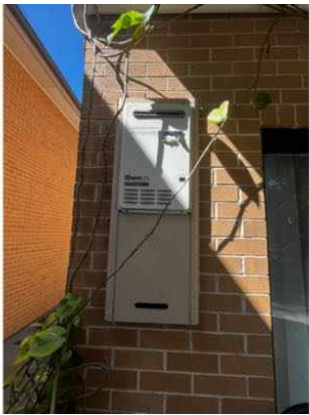
Building: Main Building
Location: Yard
Finding: Hot Water Unit
Information: The HWS appeared to be working at the time of inspection.

Water pressure appears to be normal, however, this is not an opinion of a licensed plumber.

Kindly get the HWS system checked by a Licensed Plumber for recomendation.
