# Building and Timber Pest Inspection Report

Inspection Date: Fri, 30 Jan 2026

Property Address: 67 Clare St, Blacktown NSW 2148, Australia

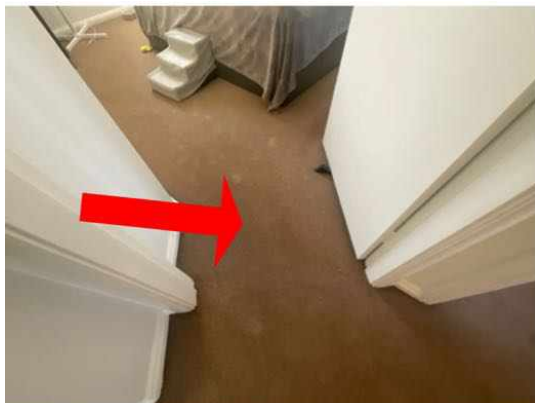
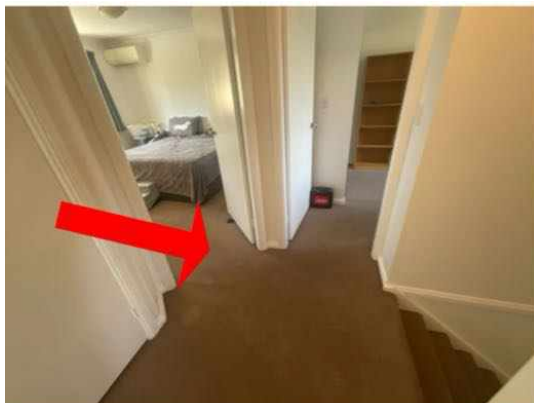
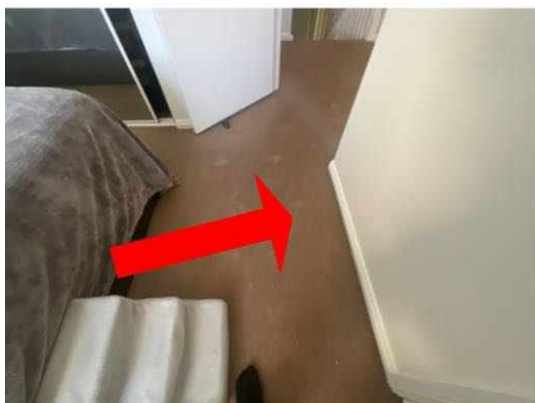
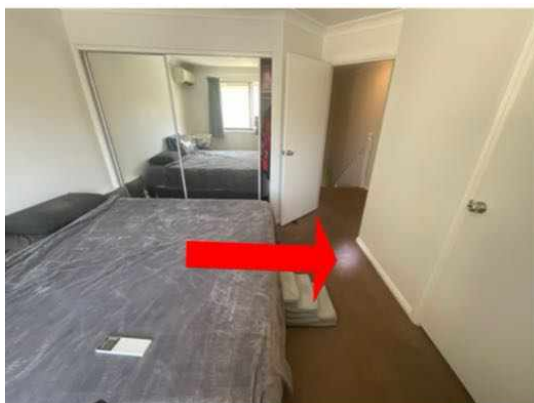
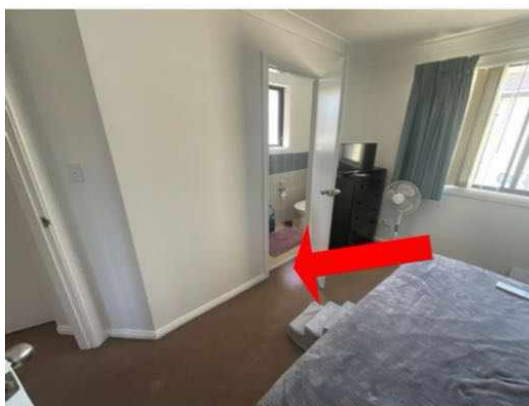
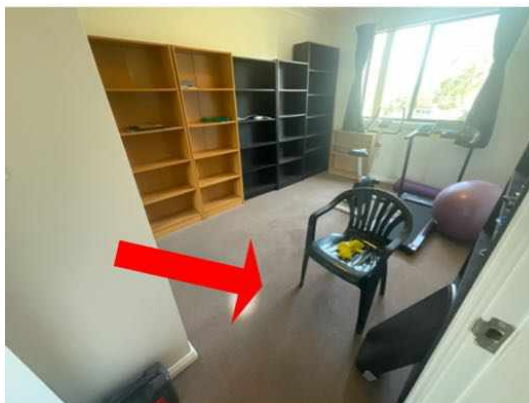
#### Finding 2.01

Building: Main Building  
Location: All Internal Areas  
Finding: Floor Vibration / Excessive Bounce  
Information: Excessive floor bounce was observed in multiple areas of the first floor. This may indicate inadequate floor stiffness, such as insufficient joist sizing, spacing, span, or fixing. Further assessment by a suitably qualified structural engineer or builder is recommended to determine the cause and confirm compliance with relevant Australian Standards and the NCC.

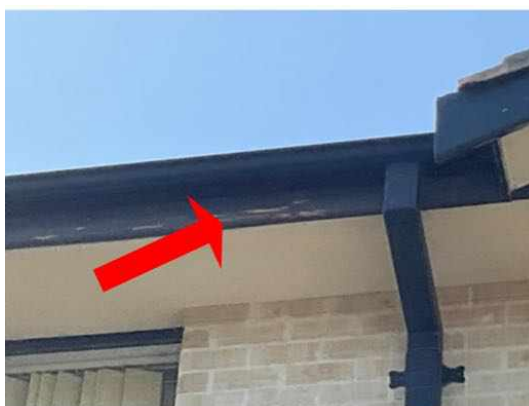
Finding: External painting deteriorated  
Information: Much of the external paintwork including but not limited to windows, fascias, guttering, veranda and other external fitments have been neglected and require attention to prepare and re-paint.

Whilst incomplete or missing paint finish is generally an appearance defect, it can also lead to the development of secondary building defects over time. Incomplete areas of paint finish expose the area to moisture, potentially accelerating the deterioration of underlying building materials.

Degraded paint finishes should be sanded back, filled, leveled and painted, as applicable. Where inadequate or missing paint protection has led to the deterioration of the associated building element, repair and/or replacement of this building element may be required.

A painting contractor should be appointed as soon as possible to perform necessary works to aid the appearance of the affected area and to ensure the area is protected against further deterioration. Alternatively, the homeowner following manufacturer instructions may perform these works.

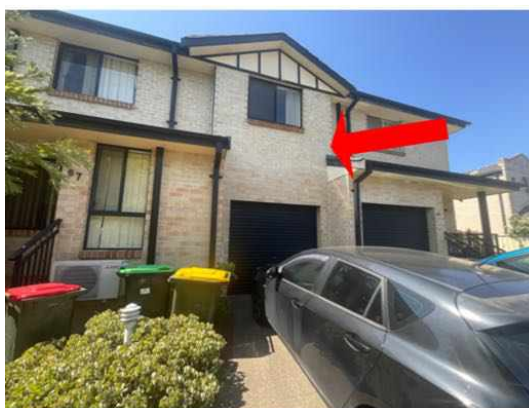
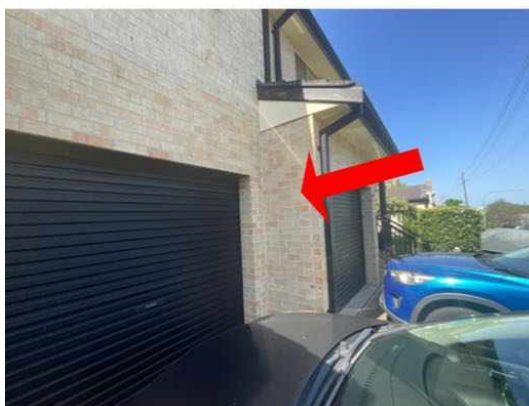
### Finding 3.04

Location:	Exterior walls - front
Finding:	Cracking - Articulation joints absent
Information:	The articulation or control joints throughout the exterior cladding were absent at the time of inspection.

When render cracking occurs due to the absence of expansion joints between external claddings at the junction, it's primarily a consequence of inadequate allowance for the natural movement of materials. Here's a detailed look at this defect:

**Material Expansion and Contraction:** External claddings, such as bricks, concrete, hebel, blue boards, undergo dimensional changes in response to environmental factors like temperature and moisture variations. Different materials expand and contract at different rates. Without expansion joints, this movement can exert stress on the adjacent render, leading to cracking.

**Absence of Buffer Zone:** Expansion joints act as buffer zones, allowing for controlled movement and relieving stress on the render. Without these joints, the forces generated by material expansion and contraction have nowhere to dissipate, causing the render to crack as it tries to accommodate the movement.

**Structural Integrity Compromised:** The absence of expansion joints may indicate a lack of consideration for structural dynamics during the design or construction phase. This oversight can compromise the structural integrity of the building, as unchecked material movement can lead to more significant issues beyond surface render cracki

To rectify this defect, it's essential to retroactively introduce expansion joints between the external claddings at the junction. This may involve carefully cutting and retrofitting expansion joint materials or implementing alternative solutions, depending on the specific requirements of the building. Additionally, addressing any underlying structural issues and ensuring proper surface preparation before repairing the render can help prevent recurrence of cracking. Regular maintenance and monitoring are also necessary to identify and address any emerging issues promptly.

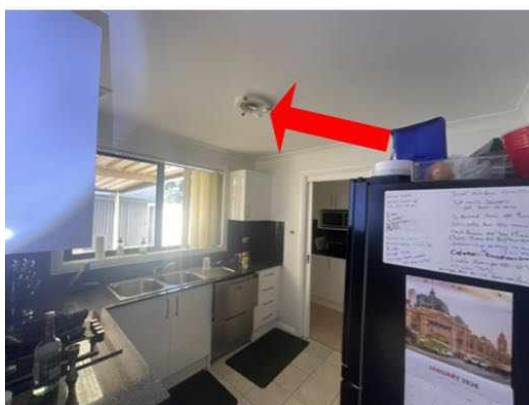
### Finding 3.05

Building:	Main Building
Location:	Kitchen
Finding:	Light fitting - Missing
Information:	The light cover in the area has been missing. An electrician should be appointed as soon as possible to replace the light and to provide any remedial works as required.

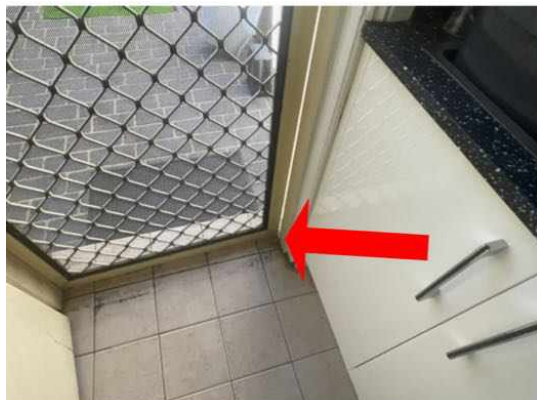
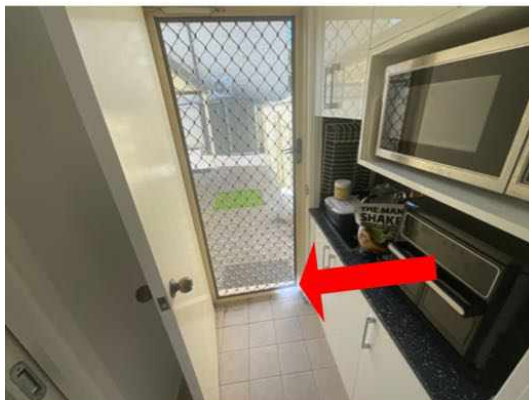
### Finding 3.06

Building:	Main Building
Location:	Laundry
Finding:	Door - Binding/jamming
Information:	Binding and/or jamming of this door is evident during standard operation. This defect inhibits the functionality of the affected door as well as creating potential for secondary defects to associated building elements, such as damage to the floor covering.

A door that binds to flooring or to the associated door frame may have several causes, ranging from minor defects, such as poor installation of the door or deteriorated hinges, through to major structural issues, such as damage to subfloor structures.

builder specialising in re-stumping should be appointed to provide an estimate on the cost of rectification.

For minor causes, a qualified carpenter or general handyperson should be appointed to perform minor rectification works at client discretion.

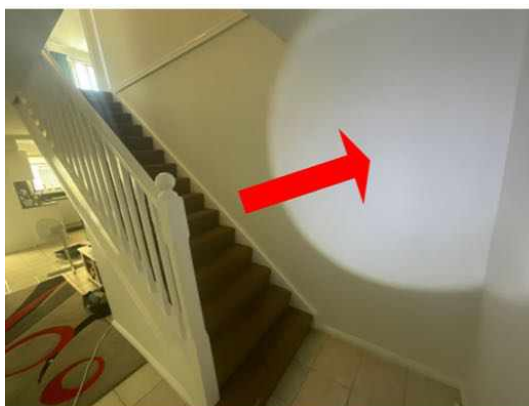
### Finding 3.07

Building:	Main Building
Location:	All Internal Areas
Finding:	Paint finish - Substandard, Wear and Tear
Information:	The paint finish in this area was found to have been completed to a substandard level or wear and tear as the normal deterioration of a property from ordinary, everyday use. Exposure to the elements, time, as well as day to day living can cause fair wear and tear.

If this applies, further areas of poor and incomplete finishes could develop over time. Furthermore, substandard, wear and tear paint finishes in areas exposed to moisture, e.g. external areas or wet areas, could lead to deterioration of underlying building materials.

Substandard, wear and tear paint finishes should be sanded back, filled, leveled and repainted, as applicable. Where inadequate paint protection has led to the deterioration of the associated building element, repair and/or replacement of this building element may be required.

A painting contractor should be appointed as soon as possible to perform necessary works to aid the appearance of the affected area and to ensure that the area is protected against further deterioration. Alternatively, the homeowner following manufacturer instructions may be able to provide this service.

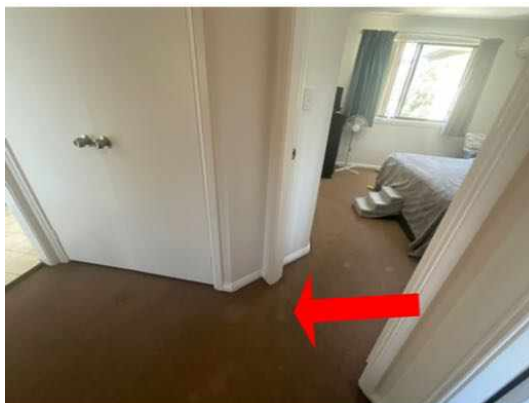
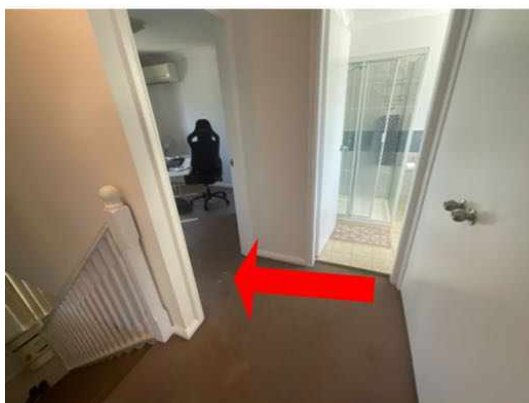
### Finding 3.08

Building:	Main Building
Location:	All Internal Areas
Finding:	Carpet - damaged / deteriorated
Information:	Static Damage

Static is created through friction and as a result, the carpet snaps, crackles and pop as you walk across. Due to the dry weather and low humidity, static charges are formed within the carpet thus resulting to static damage. Although new types of carpets have anti-static agents like conductive agents and fine metal wires that protects the carpet.

The color differences between carpet areas caused by every day deterioration through physical contact and resulting random differences in pile lay direction; usually referred as shading.

Shading is a characteristic especially for all cut-pile carpets and others refer to this as a manufacturing defect but it's not. It is caused by the physical difference between cut end lustre and side lustre of the fiber. The side of the fibers reflects more light and will appear brighter and lighter in color while the end will absorb more light and darker in color.

If two adjacent areas have different identical tension during the manufacturing, unevenness and rippling will develop. Ripples can also be caused by dragging heavy furniture across the carpet which creates friction between the two objects.

Given the situation, lighter colored carpet fades faster than darker colored carpets because of it contains smaller amounts of dye used in the carpet. The best way to prevent sunlight damage is keeping the windows covered with draperies and protective coating, filtering UV rays that damages the carpet.

Replacement of the affected carpet is required as a matter of urgency to ensure the safety of the area. Where required, remedial works should be undertaken to any associated walls and flooring showing evidence of mould.

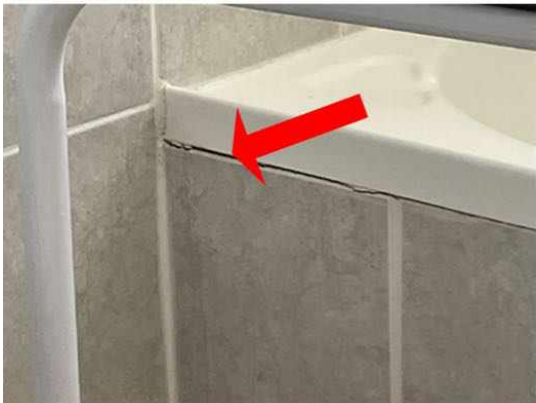
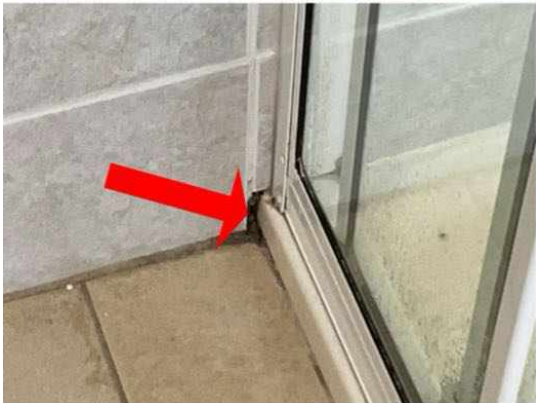
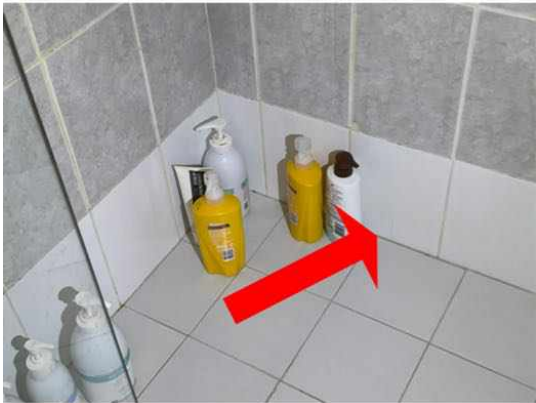
### Finding 3.09

Building:	Main Building
Location:	Bathroom
Finding:	Sealant and grouting - Missing or damaged
Information:	It was noted on inspection that sealant or grout is degraded to the tiled shower alcove and or other areas of the bathroom.

Flexible and mould resistant materials should be applied to affected areas to prevent any subsequent water damage that is likely to occur. Regular maintenance and replacement of damage or missing or damaged sealant and grout is highly recommended to the wet areas, as this is a regular wear and tear defect. Sealant and grouting in areas that come into regular contact with water should be maintained for the long term care of your property.

A sealant specialist or tiling contractor should be appointed to complete these works as soon as possible

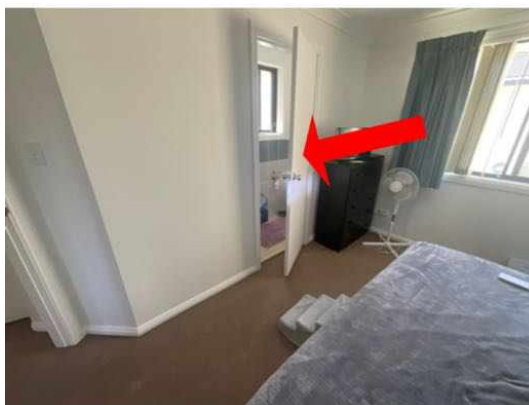
### Finding 3.10

Building:	Main Building
Location:	Ensuite
Finding:	Door frames - not square
Information:	It appears that one and / or more doors have been installed in a manner which is not consistent with acceptable standards of workmanship. The door frames are not square and or plumb and require rectification.

Deviation from the manufacturer's installation instructions is considered a defect with reference to Standards and Tolerances.

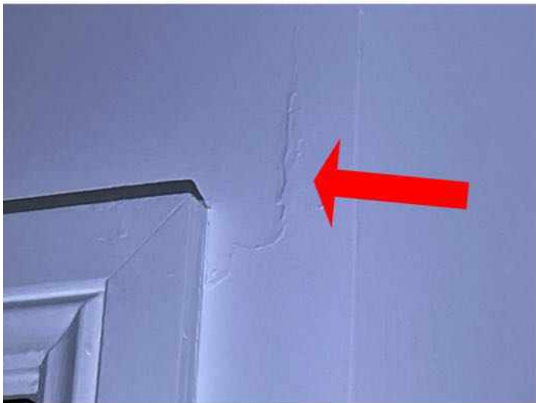
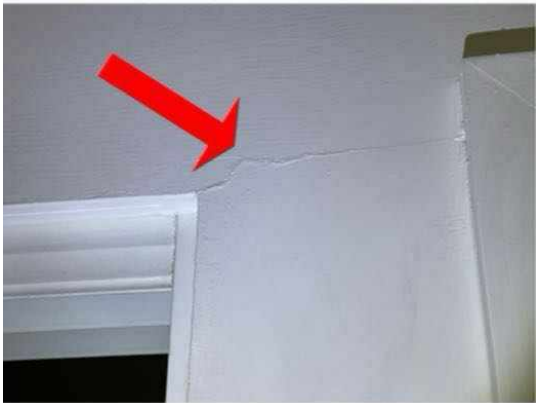
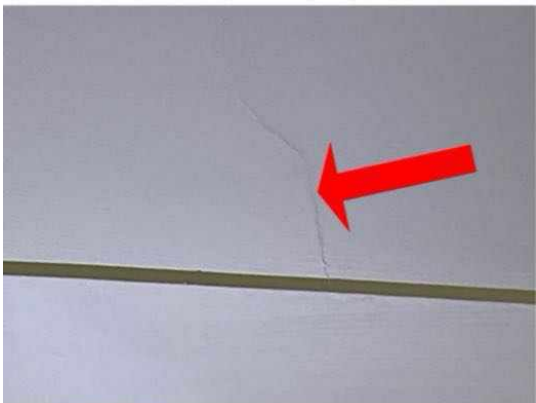
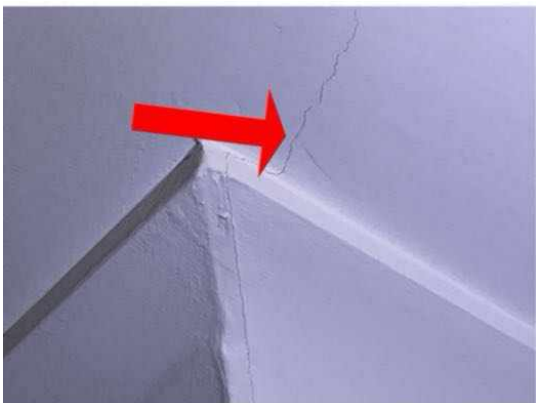
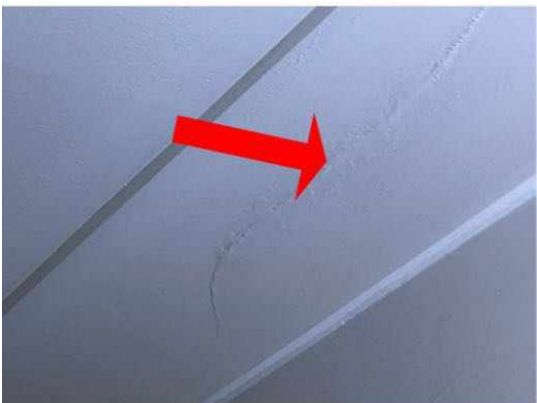
### Finding 3.11

Building:	Main Building
Location:	All Internal Areas
Finding:	Cracking - Damage Category 1 - Fine (up to 1mm)
Information:	Although fine cracks are quite noticeable, they are often only considered to be an appearance defect, and usually do not indicate any structural damage. Generally, the cause of a fine crack is indicative of a separation between building materials and finishes (e.g. paint, plaster, etc.) along joins.

Cracking of this nature can generally be repaired with minor sanding, filling and/or repainting. Such works should be performed by a qualified painter or a general handyman.

Monitoring of all cracking should be conducted frequently. Always contact a building inspector should cracks widen, lengthen, or become more numerous.

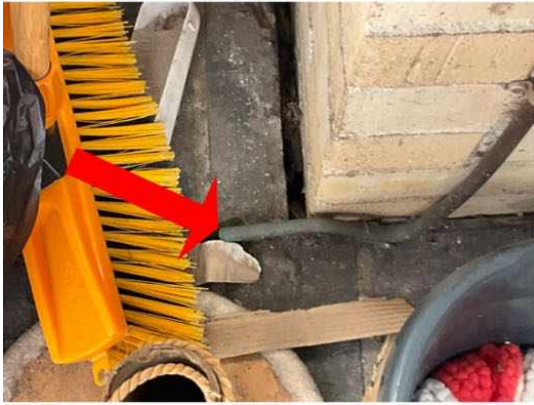
These damp conditions can lead to secondary defects such as rot, rust or corrosion of associated building elements, the formation of fungal decay, or even the creation of potential slip hazards. When coupled with poor site drainage, pooling of water may also attract termite activity to this area.

It is highly recommended that a licensed plumber be appointed to connect the HWS overflow in order to prevent such an environment from being created. These minor works should be carried out as soon as possible.

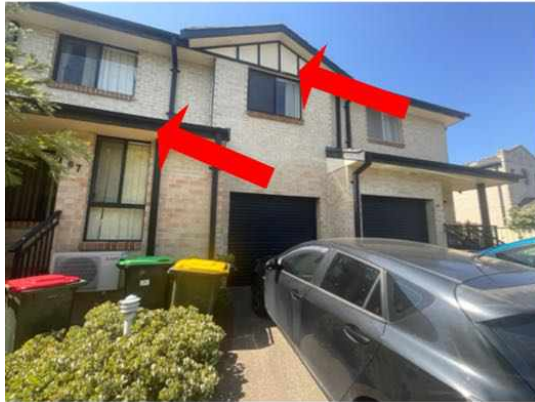
### Finding 6.04

Building:	Main Building
Location:	All Areas
Finding:	Timber - exposed to weather
Information:	External timbers that are frequently exposed to harsh weather conditions require adequate protection in order to maintain their condition. Where timbers have not been

painted or treated adequately, general deterioration is likely to occur at an accelerated rate.

If left unattended, replacement of these timbers is likely to be necessary in the short-term future. Adequate treatment of these timbers is required as soon as possible by a painting contractor or general handyman.

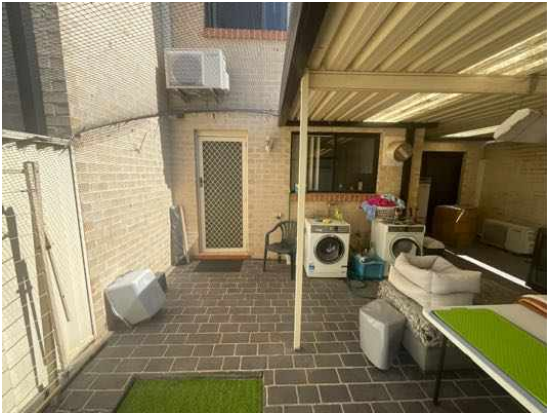
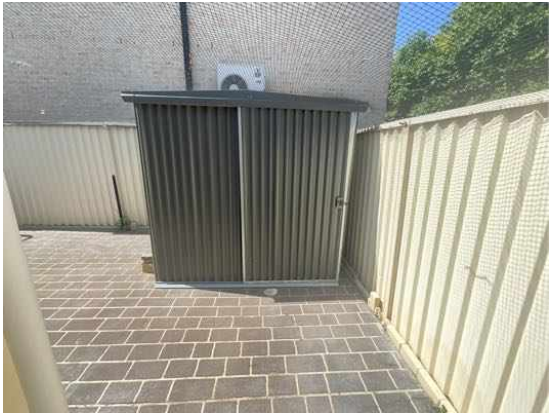
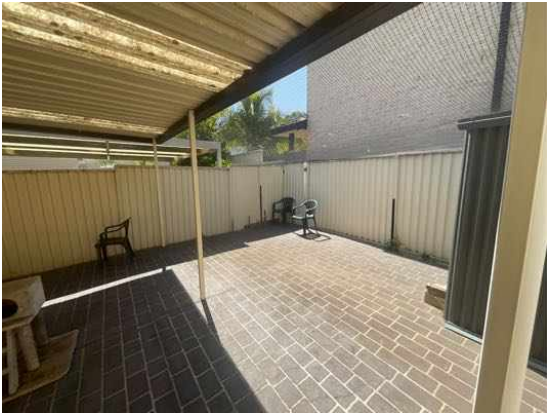
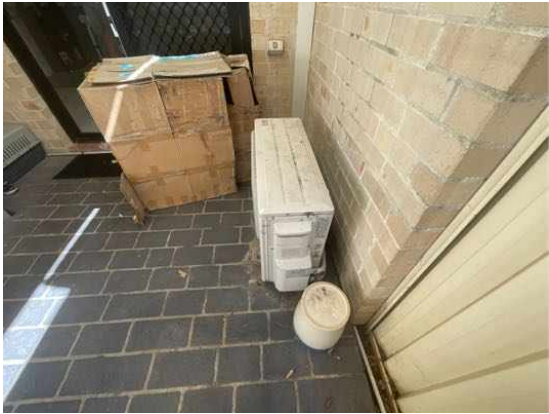
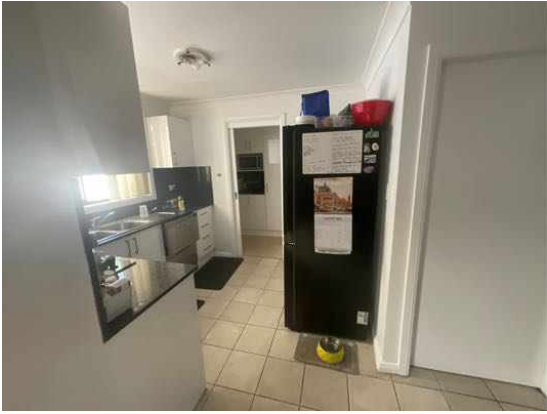
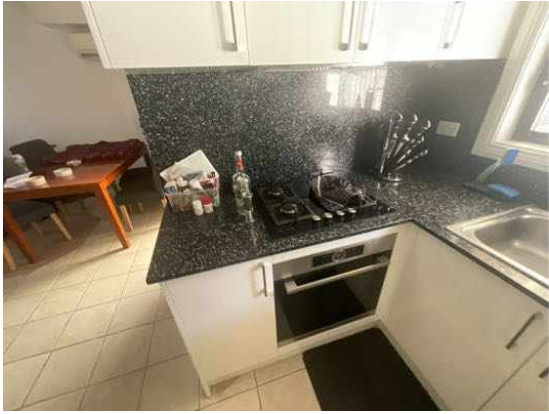
Building: Main Building  
Location: All Areas  
Finding: Additional Photos - Obstructions and Limitations  
Information: These photographs are an indication of the obstructions and limitations which impeded full inspection of the property at the time of inspection. These obstructions can hide an array of defects and should be removed to allow full inspection to be carried out. A re-inspection is recommended once the areas are made accessible.

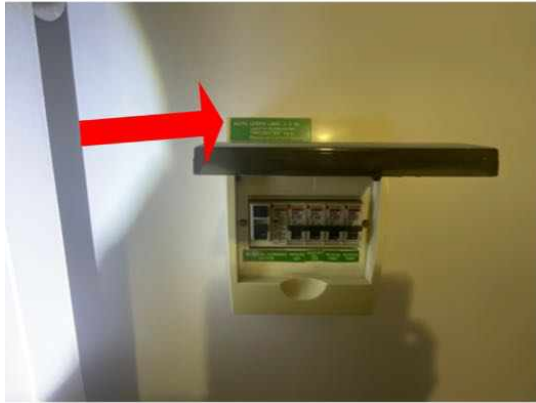
Building: Main Building  
 Location: All Areas  
 Finding: Termite Management System - no evidence of a chemical installation  
 Information: The application of a post-construction chemical termite barrier is highly recommended for all properties, particularly if live termite activity has been found on the site previously. Such barriers are highly effective in preventing termite attack on any timber building elements throughout the property.

A durable notice should be placed in the switchboard unit to indicate current termite barriers. At the time of inspection, it appeared as though no termite management system has been installed, with no evidence to suggest preventative works taking place.

The client may consider gaining further advice from a pest controller as to the costs and procedures involved with this application. It is recommended that obtaining such advice be a short-term priority.
