# Building and Timber Pest Inspection Report

Inspection Date: Thu, 26 Feb 2026

Property Address: 82 Jacaranda Cres, Casula NSW 2170,  
Australia

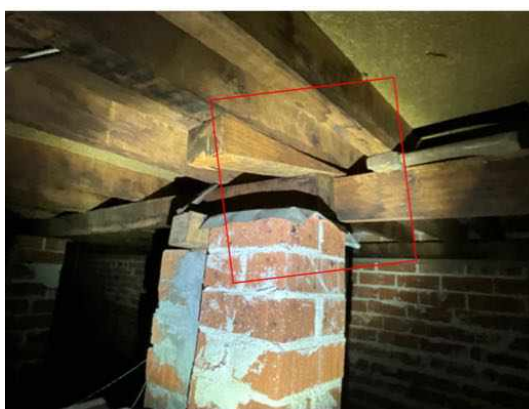
### Finding 2.01

**Information:** This handyman work appears to have been completed to a substandard level and does not comply with regular building practices. Where handyman work is not completed satisfactorily, accelerated deterioration of the associated building elements is likely to occur and secondary defects to surrounding structures may develop.

It is highly recommended that the substandard work be rectified by professional services. Works to improve this area are likely to increase the safety and the operation of the associated building elements.

The client should exercise care when coming into the immediate vicinity of the substandard works. Rectification works are advised as soon as possible by the appropriate trades.

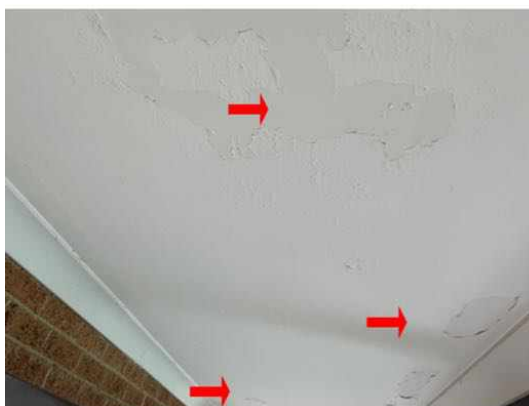
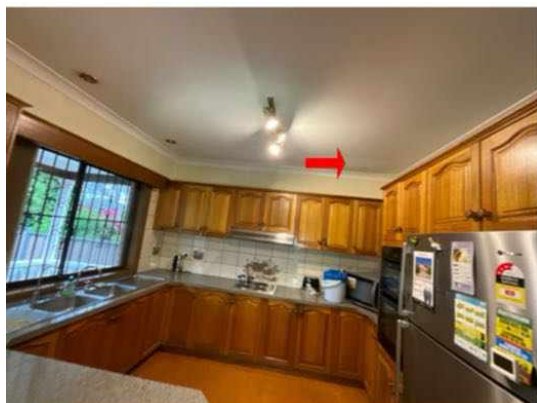
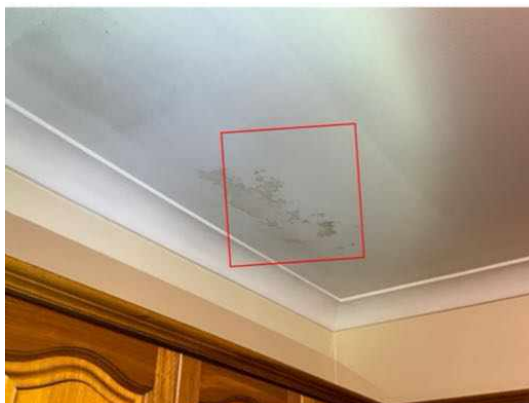
### Finding 3.01

**Finding:** Ceiling - Water damaged

**Information:** Water damage to the ceiling lining is generally an indication of excessive moisture being present in the roof void, usually via a leak to the roof covering.

Where water damage is evident to the ceiling, the primary requirement is to identify and rectify the source of the leak. A roofing plumber should be appointed as soon as possible to identify the leak and perform rectification works as necessary, ensuring the water damage is restricted.

Once the leak is repaired, consultation with relevant tradespeople, including plasterers and painters, is advised. Rectification works may include replacement of ceiling lining or minor repainting, depending on the extent of the damage.

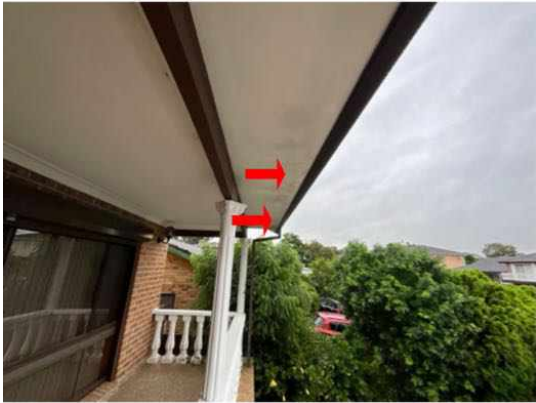
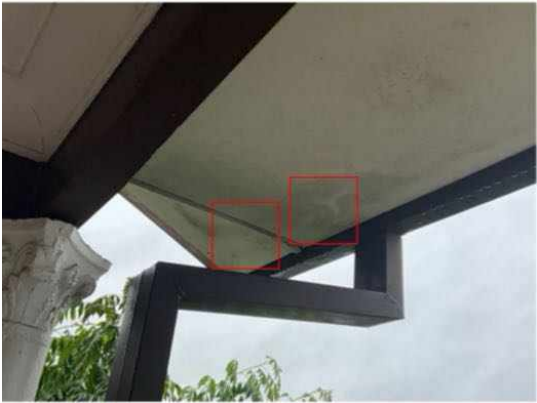
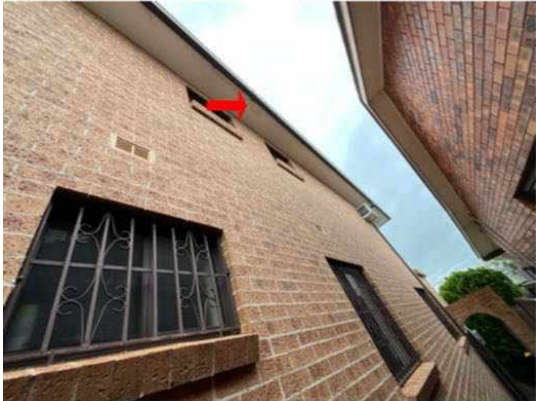
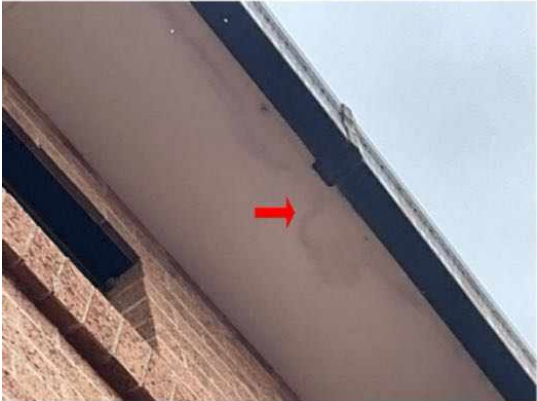
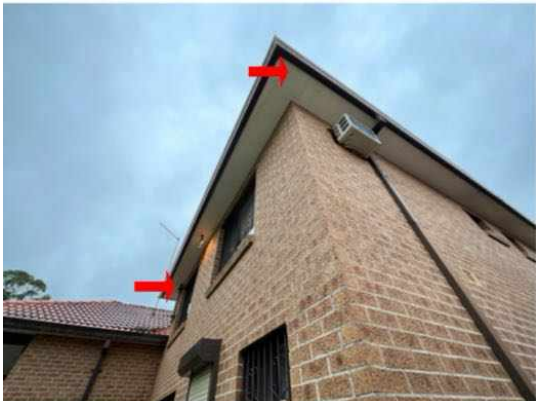
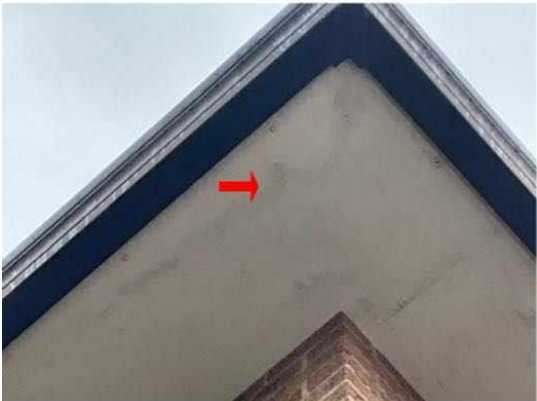
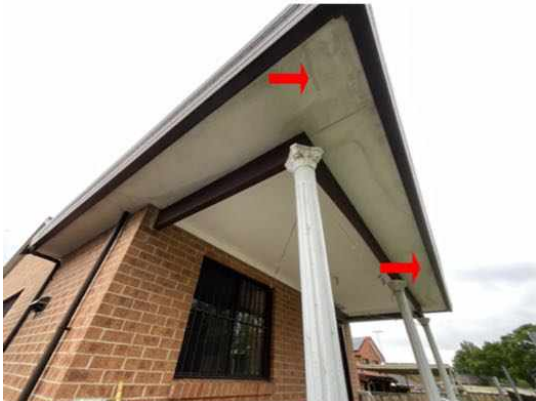
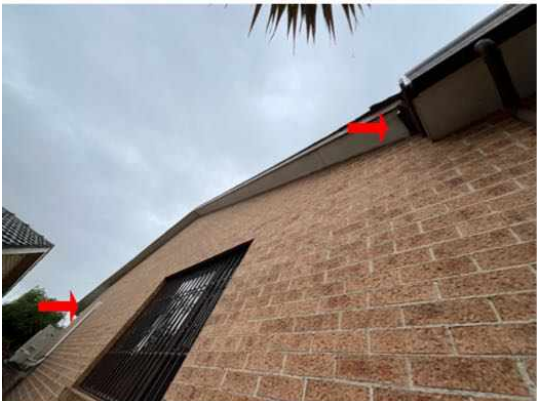
### Finding 3.02

| Finding: | Eaves/Roof plumbing -- water damages |
| Information: | Water damage is generally an indication of excessive moisture being present, usually via a leak. It is suspected that gutter blockages causing stormwater to backflow into the eaves causing water damages. This is additionally conducive to termite activity due to the damp conditions. |

Where water damage is evident, the primary requirement is to identify and rectify the source of the leak. Gutters must be kept clear of any blockages moving forward. A roofing plumber should be appointed for further assessment if the problem persists.

Once the leak is repaired, consultation with relevant tradespeople, including carpenters, plasterers and painters, is advised.

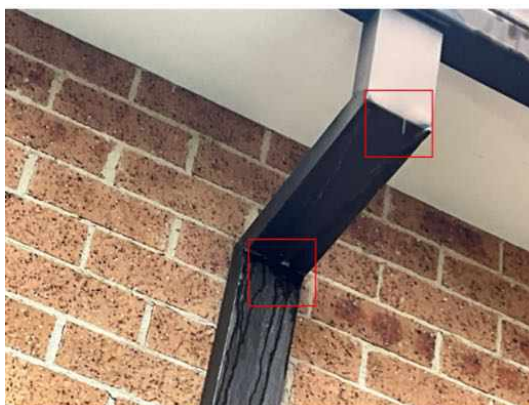
Finding 3.03

| Finding: | Water leak - External |
| Information: | Water leaks were found to be present to exterior plumbing work. Leaks are generally caused by deterioration of the plumbing elements over time, due to exposure to weather conditions, but may have also been caused by minor impact damage. |

Such leaking creates damp conditions in the affected area, causing potential for water pooling and subsequent water damage if left unattended. These conditions may also attract termite attack, particularly if the area is subject to minimal levels of sun throughout daylight hours.

It is highly advised that a licensed plumber be appointed to rectify any water leaks that may be present. Areas of repair and replacement of plumbing fittings and fixtures may be required and, as such, a quotation should be sought.

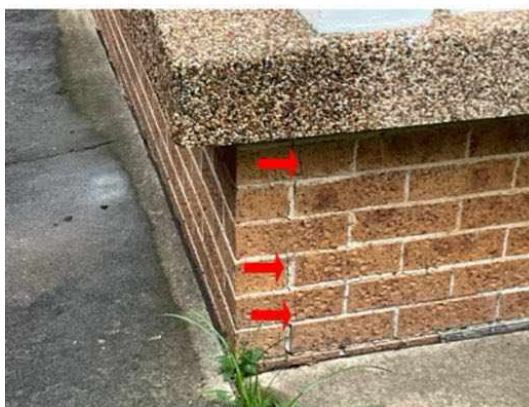
| Finding: | Damage to Masonry Walls (Cracks) - Category 1 |
| Information: | It has been observed that damage to masonry walls caused by movement of slabs, footings, or other causes, has occurred. The degree of damage falls within Category 1, described as fine cracks, which are less than 1.0mm in width limit, and that do not need repair. |

Damage of this category is not considered a defect for rectification. Always contact your building inspector should cracks widen, lengthen, or become more numerous.

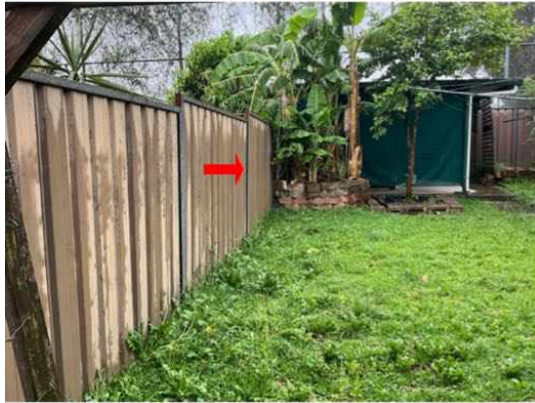
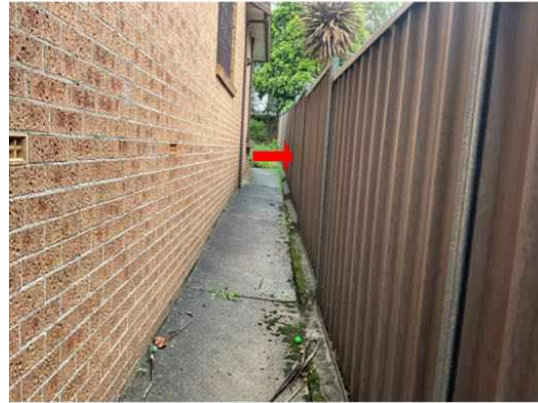
### Finding 3.06

| Finding: | Fencing - Deteriorated |
| Information: | It was noted at the time of inspection that sections of the fencing in this area has deteriorated. Typically fencing deteriorates due to age and or wear, rot and or rust which is generally expected for a structure of this age, due to prolonged exposure to weather conditions. Sometimes inadequate installation or maintenance can be to blame. |

If left unattended, it is likely that further damage will occur. It is suspected that repair of several elements of the fencing may be required however replacement may be a consideration of the client also.

A licensed fencing contractor should be appointed to provide further advice and perform rectification works as necessary.

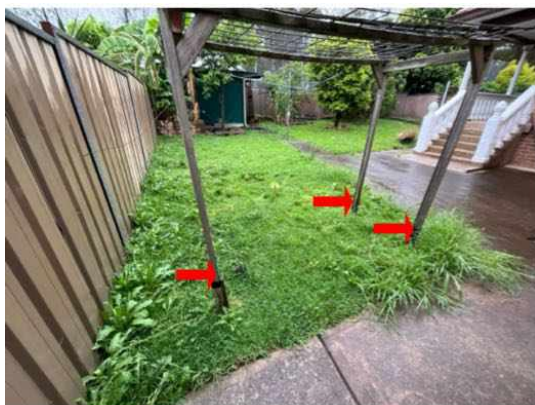
### Finding 3.07

| Finding: | Untreated or non-durable timbers in a hazardous environment |
| Information: | To reduce the risk of timber pest attack it is essential that timber used in a hazardous environment (e.g. in direct contact with the ground or frequently exposed to damp conditions) is of sufficient durability and/or is adequately preservative treated. |

Untreated timbers in direct contact with the ground are likely to develop severe wood rot and/or fungal decay if left unattended creating attraction for subterranean termites to infest the timbers from surrounding areas.

If untreated or non-durable timbers are found to be in a hazardous environment it is highly advised that replacement of these building elements be performed as soon as possible to aid the protection of the property against termite / timber pest attack.

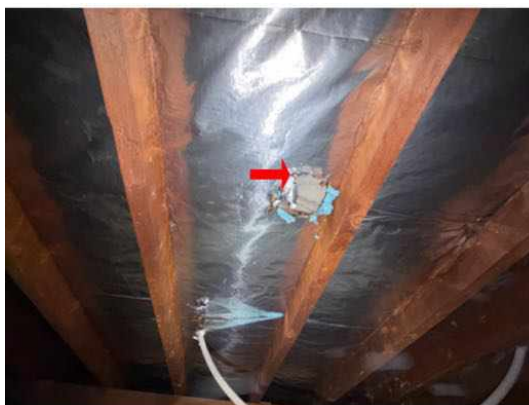
### Finding 3.08

| Finding: | Sarking - Damaged |

Where sarking is damaged, both insulation and moisture protection of the property are inhibited. This creates a loss of energy and thus negatively impacts the energy efficiency of the property, allowing potential for moisture ingress from condensation or leaking roof tiles.

It is important to repair any holes or damaged sections of sarking to ensure that the building material is fully functional. A registered builder or qualified carpenter should be consulted to provide further advice on this defect and to perform rectification works at client discretion.

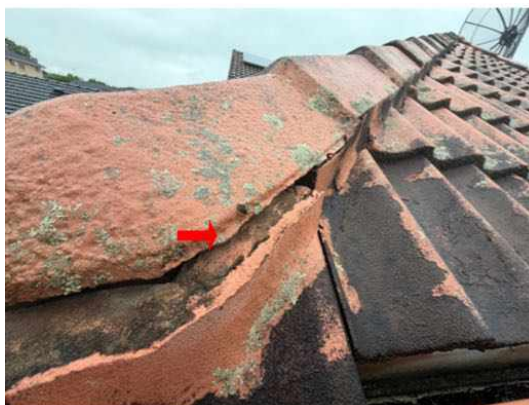
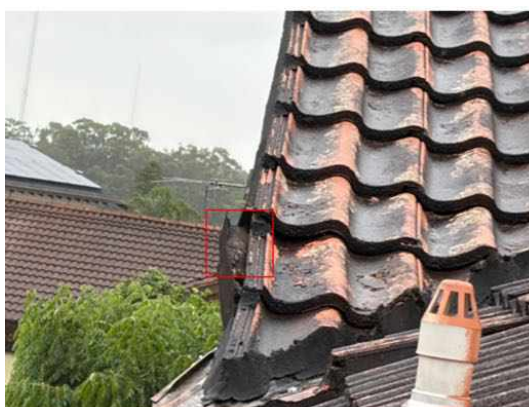
### Finding 3.09

Upon inspection of the exterior roofing, the majority of roof tiles were considered to be in a fair condition. While weathering of the tiles is consistent with the age of the property, maintenance works are required.

Isolated areas of mortar have come loose and minor cracking is also present. Re-pointing and re-sealing the may be considered as an interim solution by the client to help preserve and extend the life span of the tiles.

Where left unmanaged, deteriorating roof tiles are likely to lead to a number of secondary defects, including minor water leaks and weather exposure to internal roofing structures.

Consultation with a licensed roofing contractor is highly advised to gain advice on cost of remedial works that may be required in the short to medium term. Remedial works are likely to increase the longevity of the exterior roofing structure.

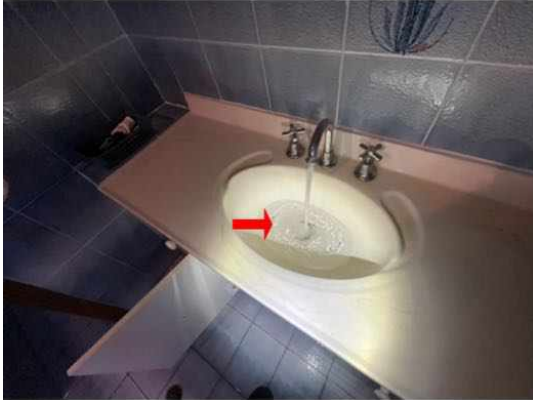
### Finding 3.10

The sink/basin drain appeared to be partially blocked at the time of inspection. Blockages here are usually caused by hair and other debris. If left unmanaged, a lack of general maintenance may lead to the development of more significant defects, such as water damage to surrounding building materials.

A licensed plumber should be appointed to remove the blockage at the client discretion.

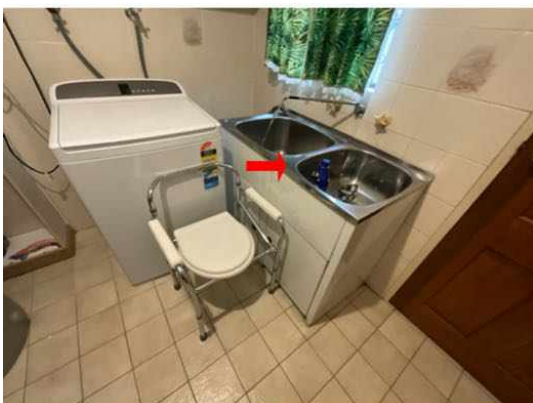
### Finding 3.11

Building: Main Building  
 Location: Laundry  
 Finding: Fitting or fixture - Loose sink  
 Information:

The laundry sink in this area is loose and can be moved with minimal force applied by hand. The sink should be fixed firmly to the wall and/or floor.

If left unmanaged, the sink may move and cause damage to pipes, fitting and finishes.

A licensed plumber should be appointed to perform these rectification works.

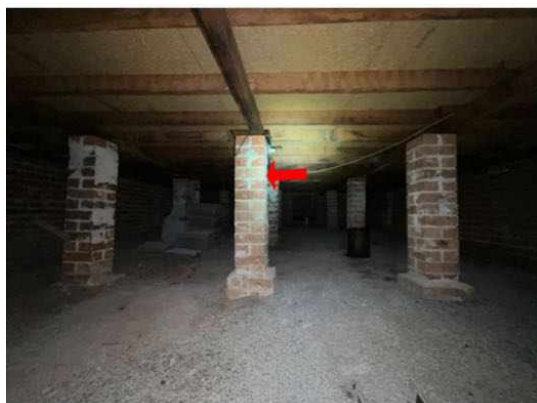
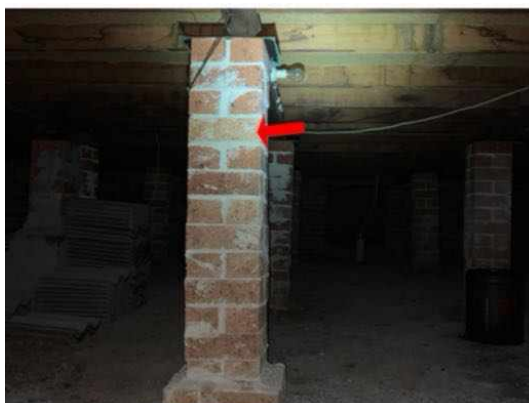
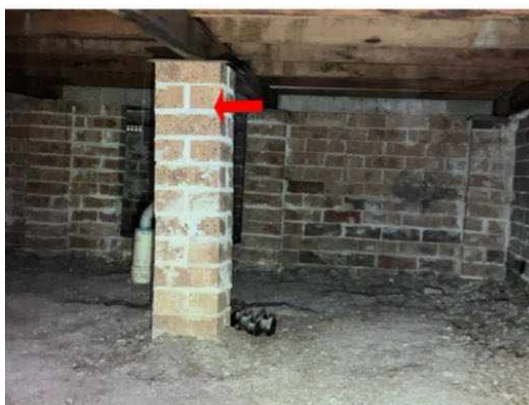
### Finding 3.12

Location: Subfloor  
 Finding: Piers - Leaning  
 Information: Pier to the subfloor structure is leaning, indicating that its structural integrity may have been affected. The cause of this instability is likely to be caused by movement / minor subsidence of the pier due to moisture.

Although only minor the pier should be monitored to avoid potential structural damage, which is likely to lead to a range of major and minor defects. Improving site drainage is recommended to avoid further movement / subsidence of the affected pier.

If further movement is evident appointment of a structural engineer is advised to assess the condition of the piers and provide advice on remedial works that may be required.

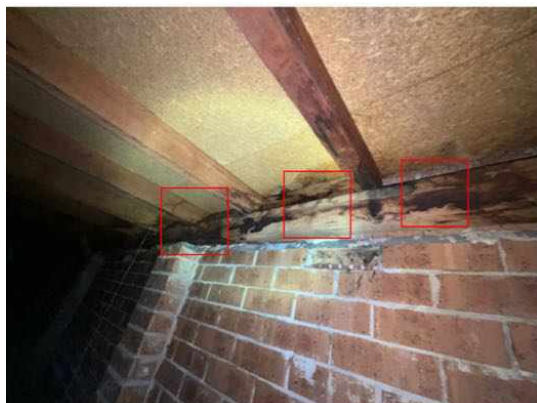
### Finding 3.13

Building: Main Building  
 Location: Subfloor  
 Finding: Subfloor members — Water staining  
 Information: There is evidence of water staining to the subfloor members under the bathroom.

This water staining indicates that surfaces have been exposed to excessive moisture

over time, potentially due to water leak. The minerals and other elements in the water lead to staining, which may graduate to corrosion and deterioration if left unmanaged.

A licensed plumber must be appointed immediately for further assessment and to confirm whether any active leaks are affecting the area or not and also that the waterproofing membrane is in serviceable condition.

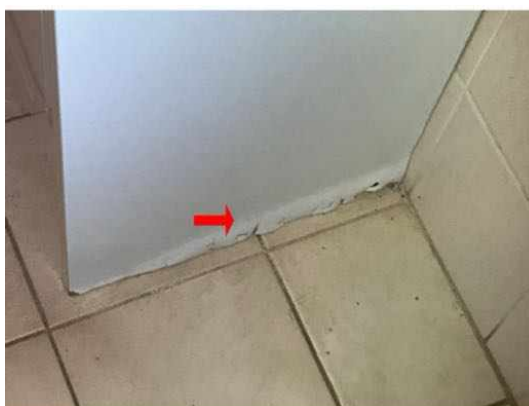
### Finding 3.14

| Finding: | Cupboard/vanity - Swollen/Water Damaged |
| Information: | Water damage was identified inside the vanity/cupboards in this area and it was also found to be swollen. Water damaged/swollen building elements generally indicate that the building materials have been affected by excessive moisture over a prolonged period of time, and have swollen as a result. A licensed plumber should be engaged to assess where the moisture is coming from and carry out any rectification as soon as possible. Replacement of the vanity/cupboards is also advised by a licensed cabinetmaker. |

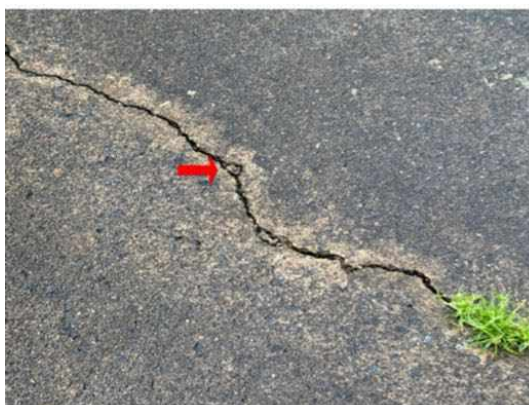
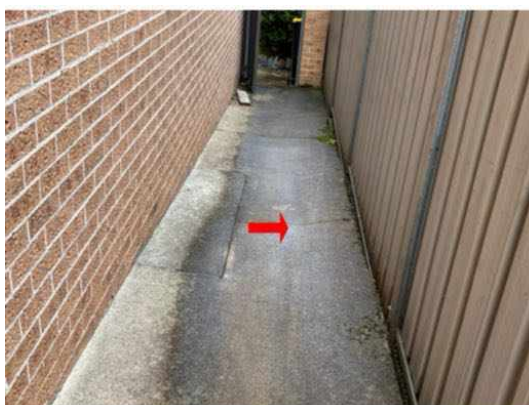
### Finding 3.15

| Finding: | Cracking - External Concrete Paving Damage Category 2 - Distinct (less than 3mm) |
| Information: | Distinct cracks were identified in external concrete paving. Distinct cracks are generally found in older concrete paving, and may also present as a trip hazard as consequence of an uneven or curved surface. |

General age and expected deterioration of the paved areas is a common cause of this type of cracking. However, expansion and contraction of the slab may also have occurred due to environmental factors. Such factors include variable moisture and weather conditions, the presence of trees and their roots having a settling or lifting affect on the soil, or the effect of load bearing, e.g. heavy vehicles over a sustained period of time.

Cracking to this degree may also be due to poor original installation of the concrete. Factors such as poor compaction of the sub surface and/or inadequate reinforcing of the slab may create cracking and other secondary defects.

Repairs are likely to be required to prevent further cracking and to reduce hazards associated with cracking, such as tripping. Monitoring of all cracking should be conducted frequently. Always contact a building inspector should cracks widen, lengthen, or become more numerous.

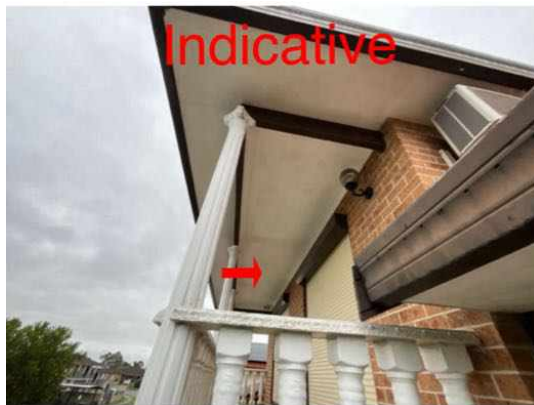
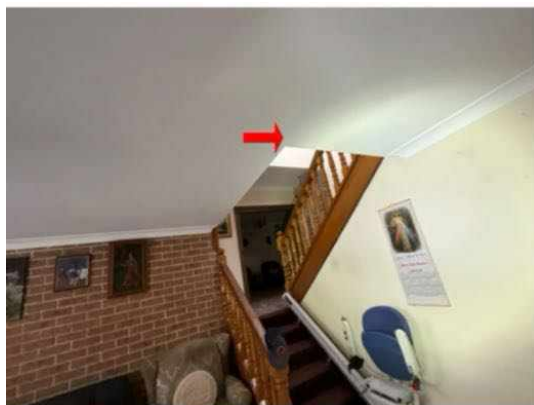
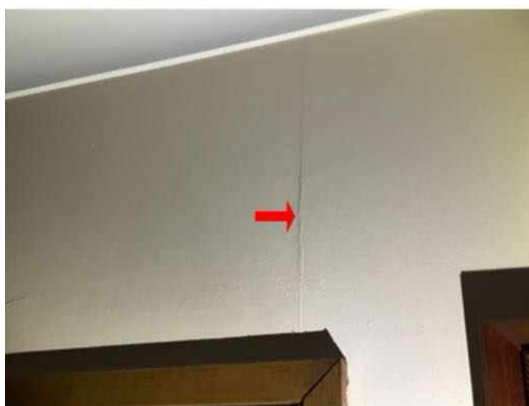
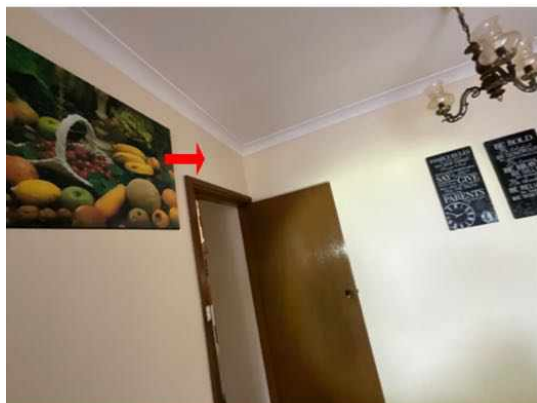
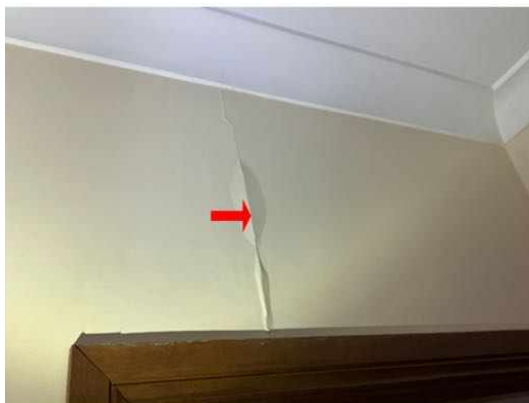
**Finding 3.16**

| Finding: | Cracking - Damage Category 1 - Fine (up to 1mm) |
| Information: | Although fine cracks are quite noticeable, they are often only considered to be an appearance defect, and usually do not indicate any structural damage. Generally, the cause of a fine crack is indicative of a separation between building materials and finishes (e.g. paint, plaster, etc.) along joins. |

Cracking of this nature can generally be repaired with minor sanding, filling and/or repainting. Such works should be performed by a qualified painter or a general handyman.

Monitoring of all cracking should be conducted frequently. Always contact a building inspector should cracks widen, lengthen, or become more numerous.

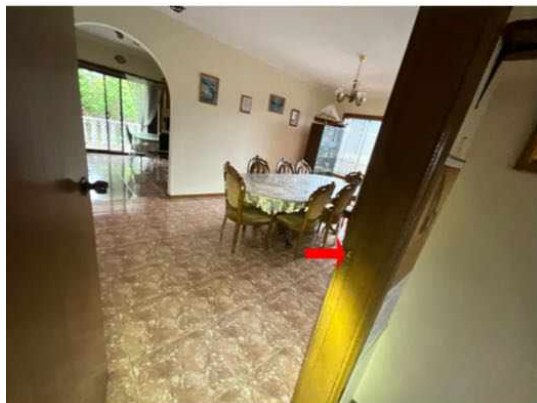
### Finding 3.17

This is a common defect and is expected in a property of this age, whether being due to substandard installation or general deterioration of the door hardware.

Readjustment of the striker plate is recommended at client discretion. Works such as these can be completed by a general handyman or qualified carpenter.

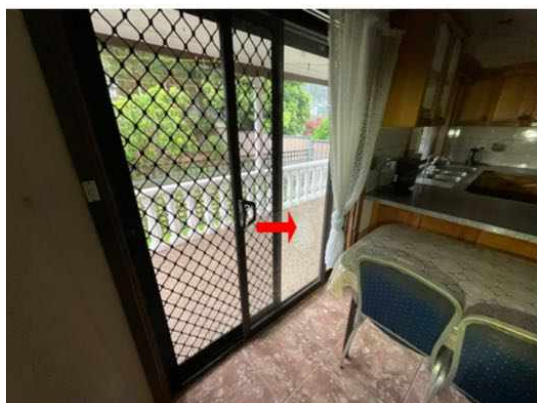
The door in this area was jammed and difficult to slide along the associated tracks at the time of the inspection. Restricted function of the affected door may pose as a potential safety hazard if required for emergency egress from the building.

Generally, factors such as general age of the building element and a lack of maintenance are the usual causes for this type of defect.

Replacement of door hardware or tracks may be required, as well as minor repairs and cleaning. A registered builder will be required to repair the affected doors.

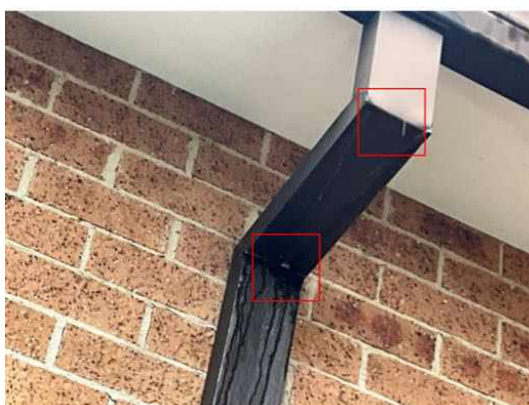
| Finding: | Water leak - External |
| Information: | Water leaks were found to be present to exterior plumbing work. Leaks are generally caused by deterioration of the plumbing elements over time, due to exposure to weather conditions, but may have also been caused by minor impact damage. |

Such leaking creates damp conditions in the affected area, causing potential for water pooling and subsequent water damage if left unattended. These conditions may also attract termite attack, particularly if the area is subject to minimal levels of sun throughout daylight hours.

It is highly advised that a licensed plumber be appointed to rectify any water leaks that may be present. Areas of repair and replacement of plumbing fittings and fixtures may be required and, as such, a quotation should be sought.

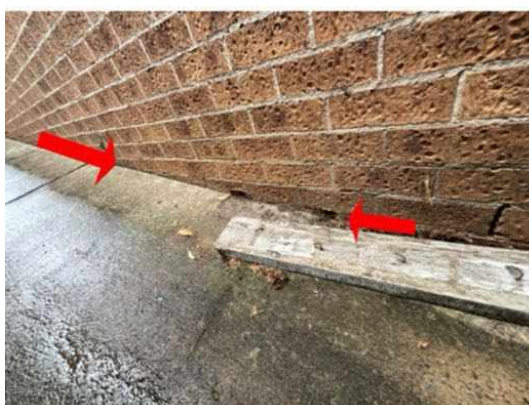
Weep holes in the exterior brickwork of the property are designed to allow condensation that may build up between the brickwork and subsequent timber framework to drain from within the wall hence preventing any deterioration of the timber building elements.

Additionally build-up of moisture is likely to occur if weep holes are covered further attracting termite activity to these areas.

It is highly recommended that weep holes are left exposed in all areas throughout the external property. Therefore if any termite activity leading into weep holes becomes easily detectable during frequent pest inspections.

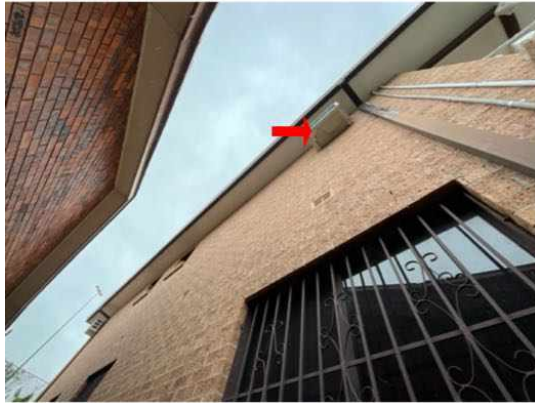
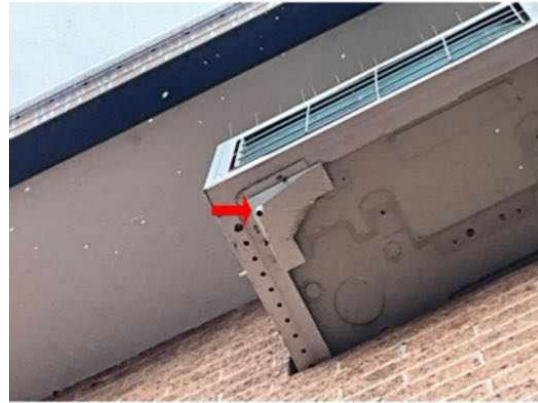
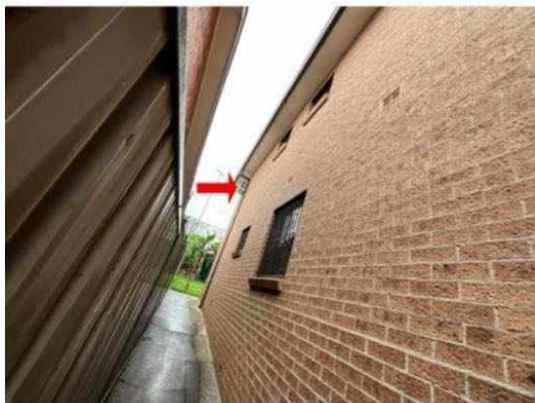
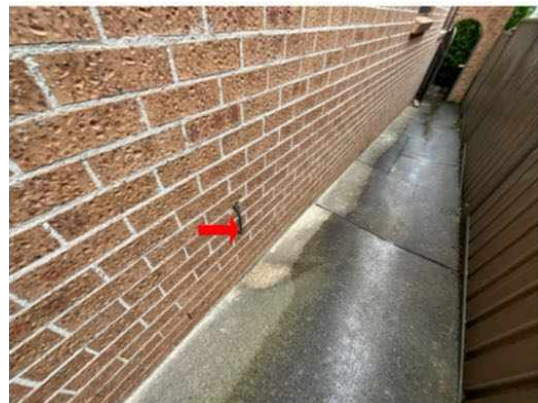
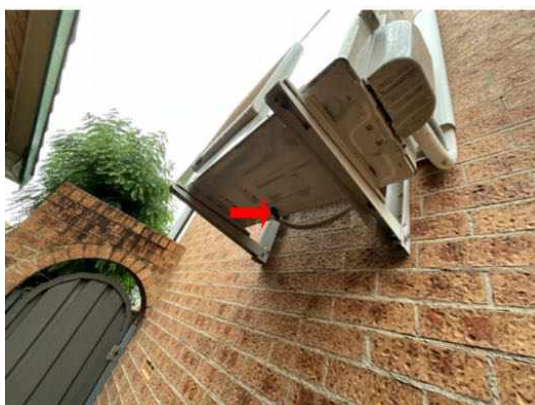
## Finding 6.07

These damp conditions can lead to secondary defects such as rot, rust or corrosion of associated building elements, the formation of fungal decay, or even the creation of potential slip hazards. When coupled with poor site drainage, pooling of water may also attract termite activity to this area.

It is highly recommended that a licensed plumber be appointed to install adequate drainage to the overflow. These works will ensure that the area remains dry and free of any secondary defects.

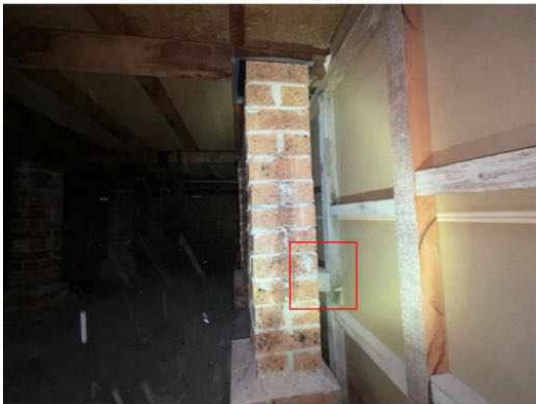
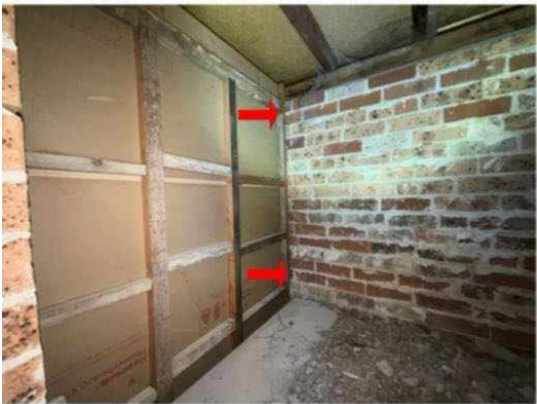
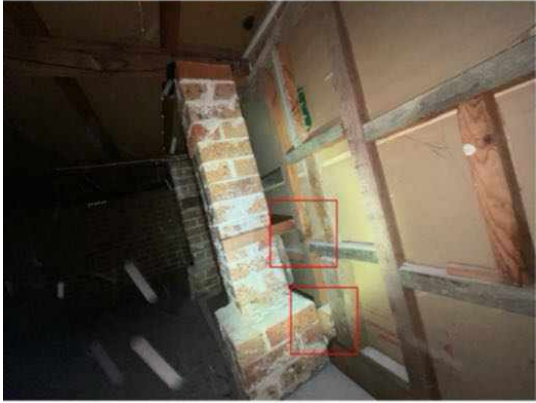
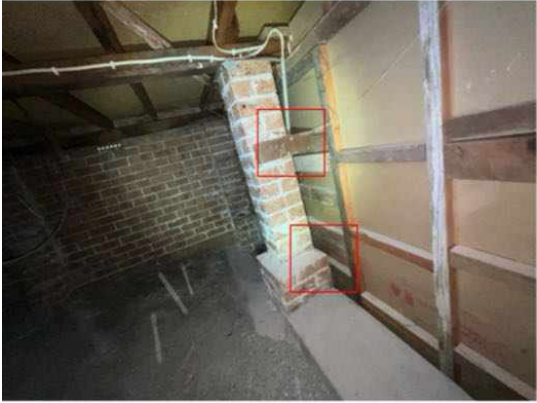
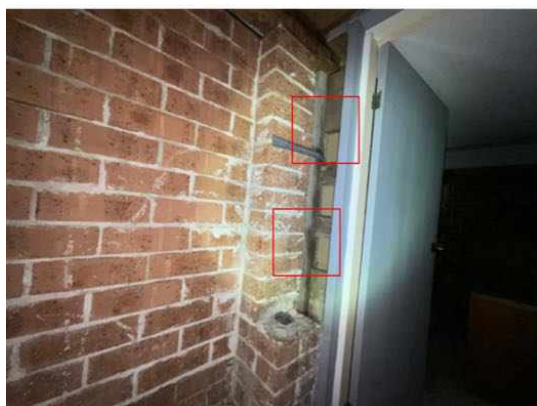
### Finding 6.08

Building: Main Building  
Location: Subfloor  
Finding: Bridging of termite barrier  
Information: Bridging of termite barriers occurs when termites bridge (usually by building a mud tunnel) a termite barrier or inspection zone or where termites have a passage allowing them to bridge the barrier.

Generally this takes the form of finished ground levels external paving or concrete being retrospectively installed above the damp course level the adjacent internal floor level or weep and ventilation holes.

Where bridging has occurred full inspection is prevented and termites may enter a property in a concealed or undetectable manner.

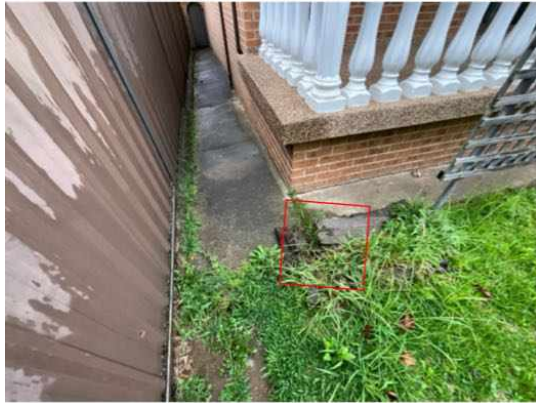
### Finding 6.09

| Information: | Where timber elements are in direct contact with the ground and consequently moisture or dampness they become conducive to termite activity. Whether timber is used as a building element part of a fencing structure or stored as an unused item they can provide an environment that is attractive to termite infestation. |

When met with excessive moisture timber begins to decay and develop wood rot. Any timbers that are in direct contact with external grounds especially if left untreated or non-durable also provide ingress for subterranean termites into that particular element.

the risk of termite activity being present. As they are likely to come into contact with weather conditions or excessive moisture wood rot is likely to develop on timbers that are not treated.

It is highly recommended that any stored timbers be immediately removed from areas in which they may attract any termite / timber pest attack. Minimisation of risk / prevention of termite attack is far more adequate than dealing with the presence of termite activity.

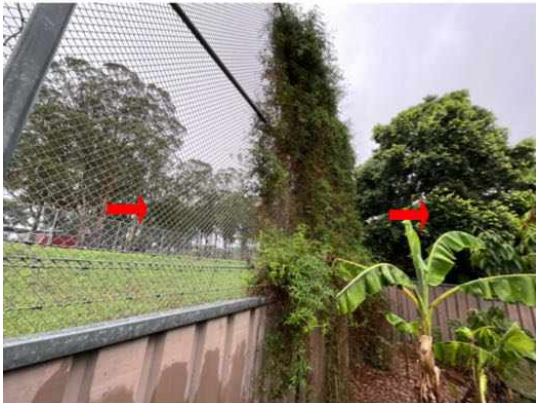
**Finding 6.12**

Building: Main Building  
 Location: Vegetation  
 Finding: Vegetation - Abutting property  
 Information: Vegetation against external wall may have an invasive root system. If there are weak points in the brick work or concrete slab, it is possible for the roots to gain entry into these areas. Once the roots have gained entry, it is possible for termites to gain concealed entry via these roots. It is recommended to remove the vegetation and root system where possible.

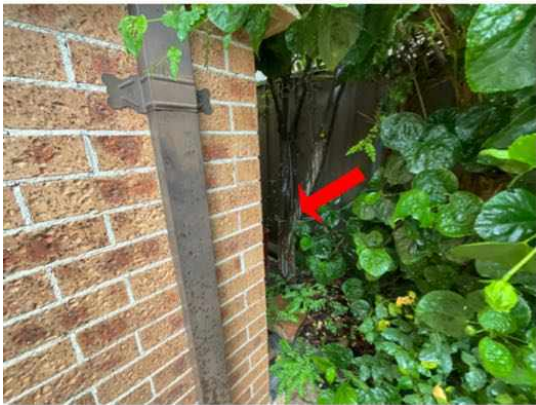
**Finding 6.13**

| Finding: | Garden Beds |
| Information: | Garden beds were found to be evident in the garden area. These garden beds can include untreated timber, and with a combination of moisture from watering hosing can make conditions conducive to termite activity and termite ingress. |

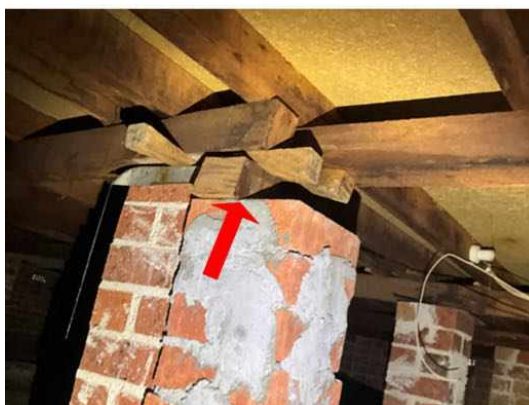
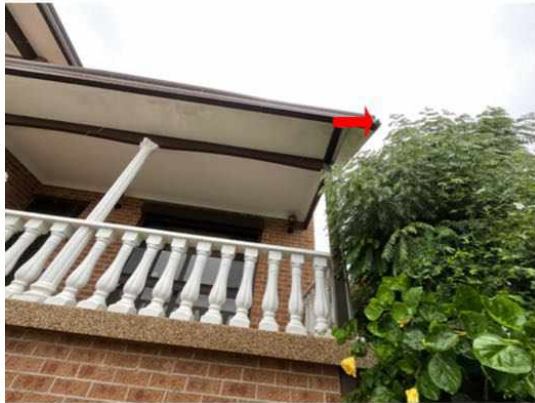
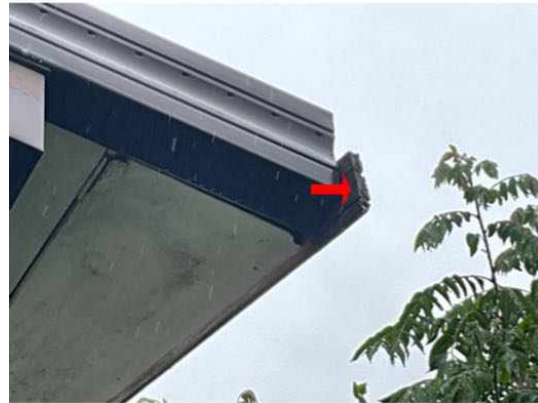
### Finding 7.01

**Building:** Main Building  
**Location:** Fascias  
**Finding:** Fascias - Wood rot/decay  
**Information:** Wood rot was found to be affecting fascias and barges in this area, evidenced by the presence of mould on the surface in some areas. Wood rot, also known as Fungal Decay, occurs when timbers and other cellulose building materials are exposed to damp conditions on an ongoing basis.

It is likely that this wood rot has developed as a result of faults in the roof plumbing, creating excessive moisture in this areas. Otherwise frequent exposure to rain and other weather conditions also make fascias and barges susceptible to accelerated deterioration.

Early intervention and regular maintenance will prolong the useful life of these building elements. Prior to any works being performed, the cause of the moisture that has created the visible wood rot should be identified and addressed in a suitable manner.

It is advised that a roof plumber be appointed to inspect all roof plumbing and subsequently identify the cause of the wood rot. Replacement of affected fascias and barges may then be a necessary step in protecting surrounding building elements from such deterioration.

A licensed plumber may be appointed to assess the cause of excessive moisture and to provide advice on any remedial works as required. A licensed carpenter may also be required to replace affected building materials.

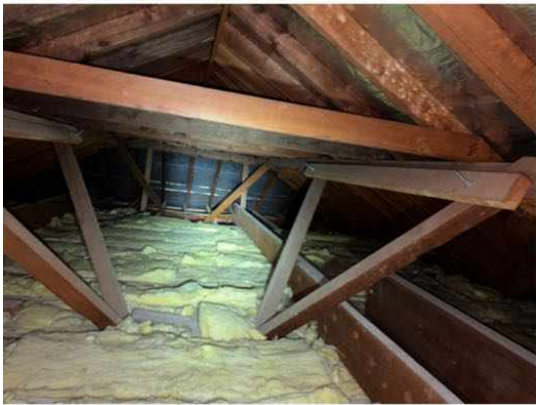
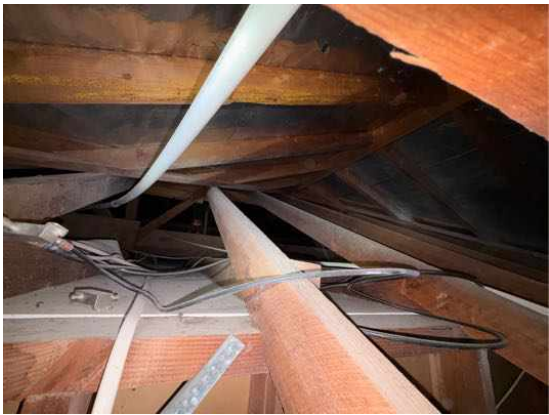
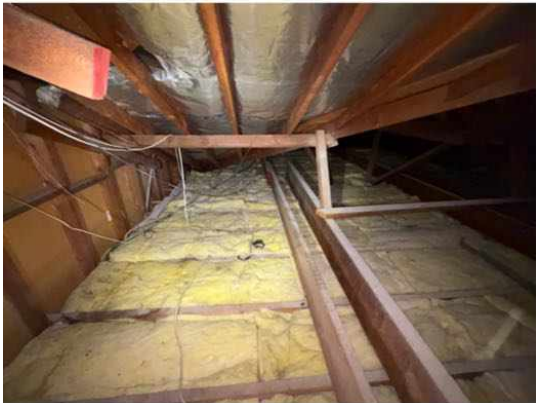
Building: Main Building  
Location: Roof Void  
Finding: Additional Photos  
Information:

Additional photos are provided for your general reference.

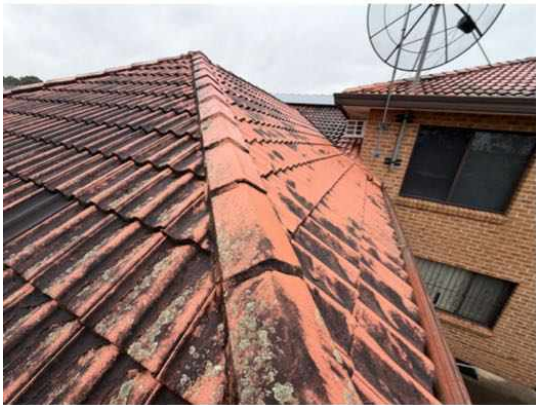
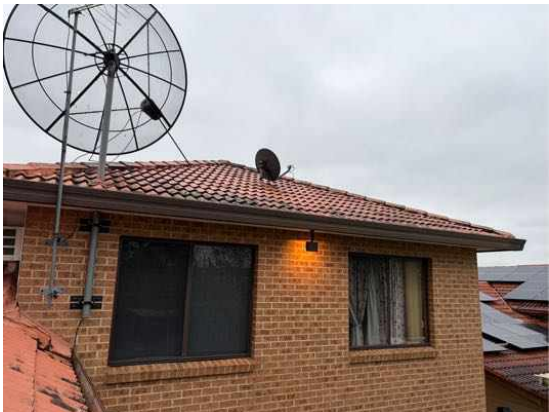
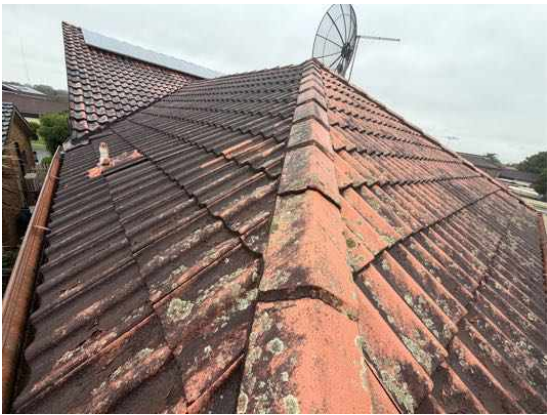
Building: Main Building  
Location: Roof Exterior  
Finding: Additional Photos  
Information:

Additional photos are provided for your general reference.

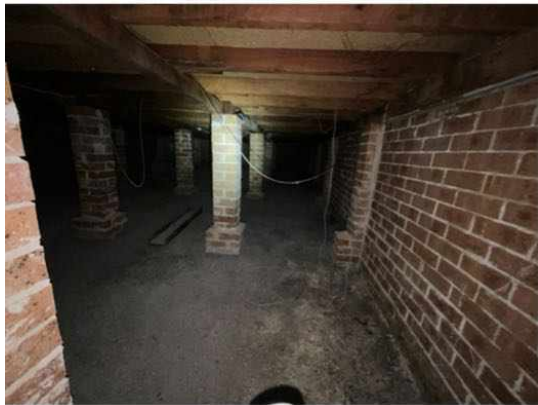
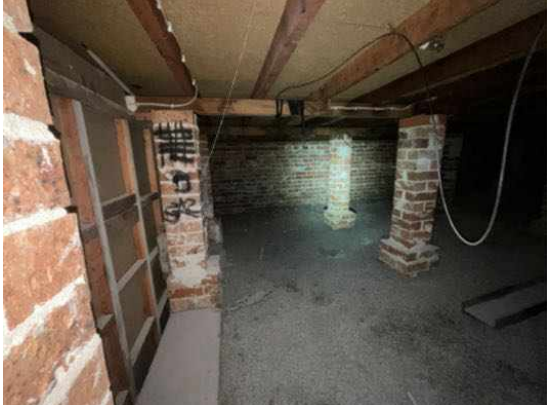
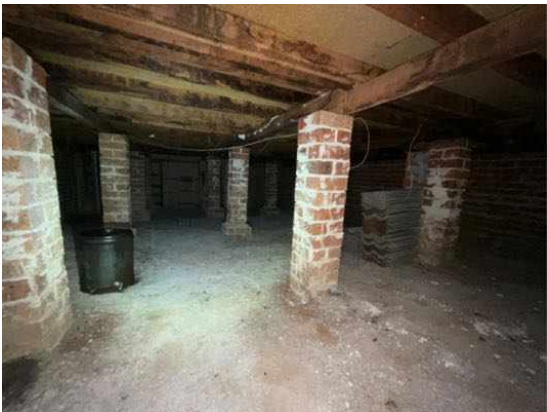
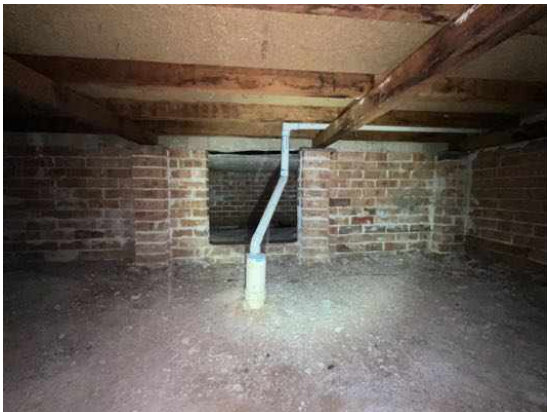
Finding: Additional Photos

Information: Additional photos are provided for your general reference.

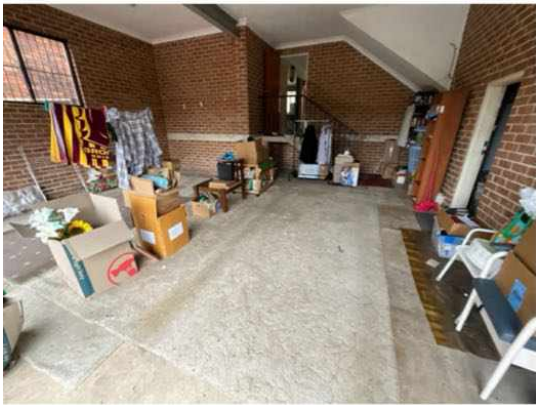
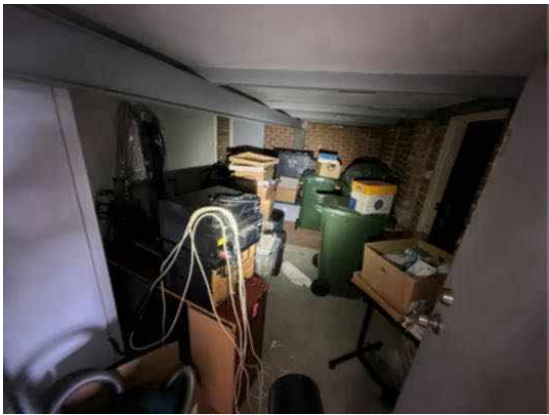
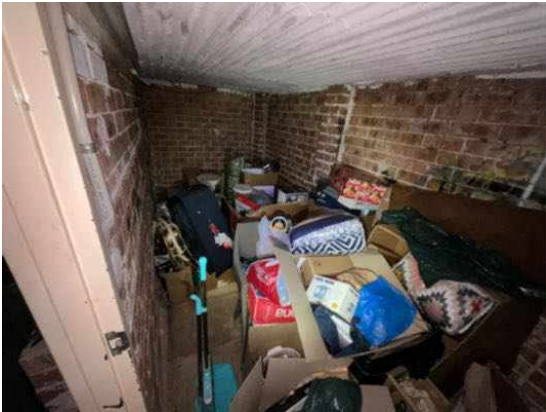
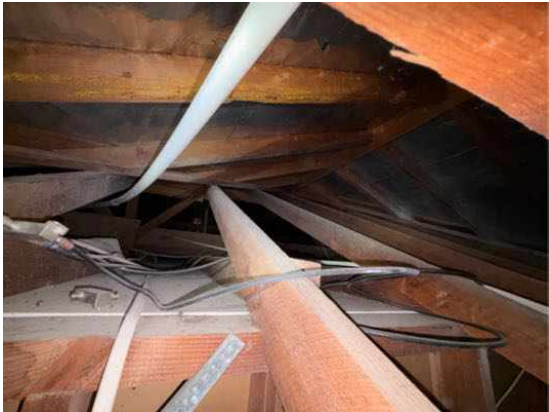
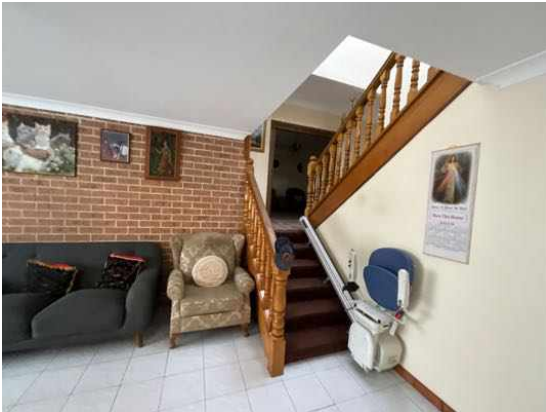
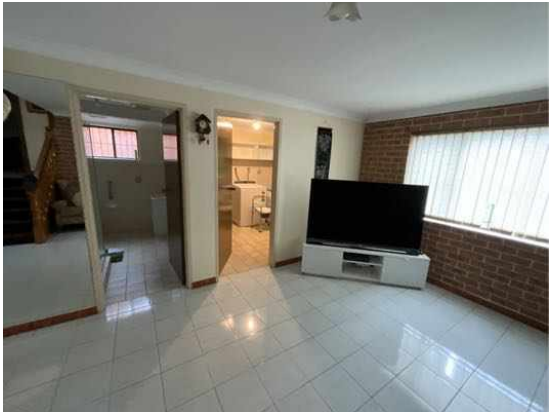
Building: Main Building  
Location: All Areas  
Finding: Additional Photos - Obstructions and Limitations  
Information: These photographs are an indication of the obstructions and limitations which impeded full inspection of the property at the time of inspection. These obstructions can hide an array of defects and should be removed to allow full inspection to be carried out. A re-inspection is recommended once the areas are made accessible.
