Building and Timber Pest Inspection Report VR

Inspection Date: Fri, 9 Jan 2026

Property Address: 32 Warradale Road Silverdale NSW 2752

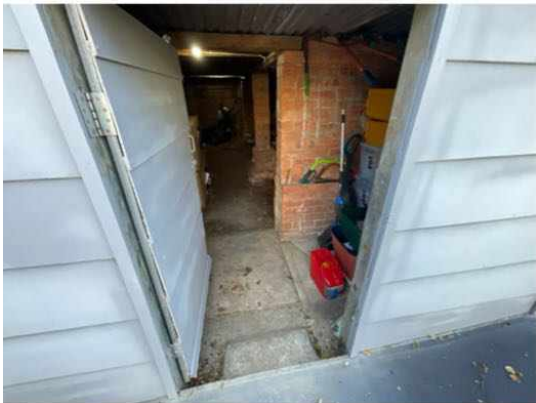
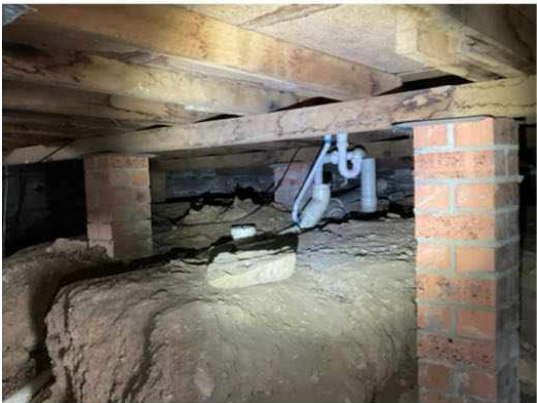
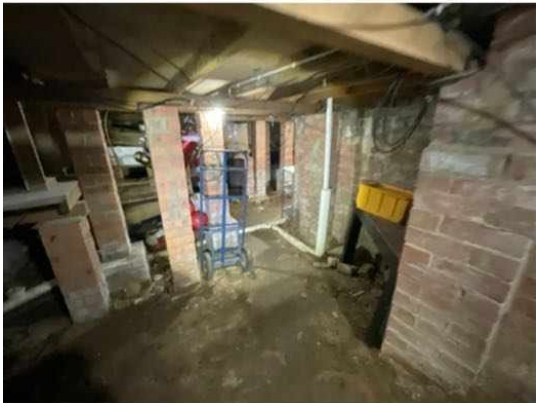
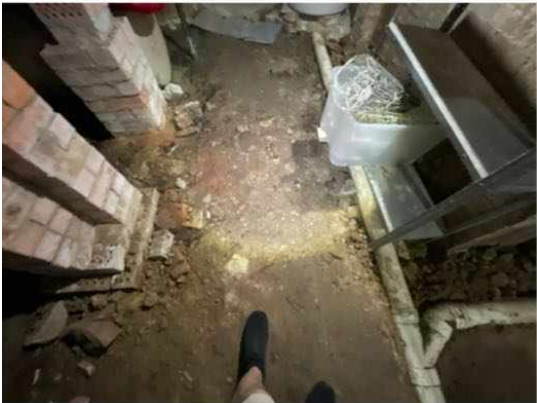
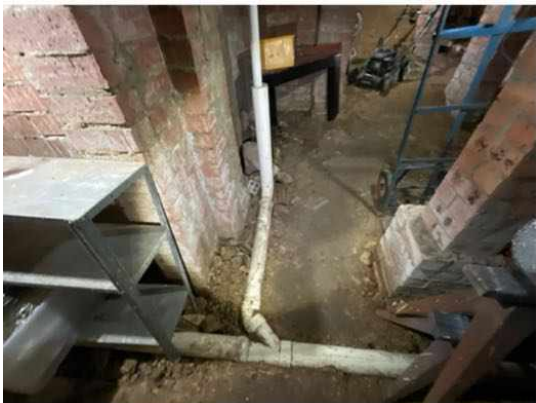
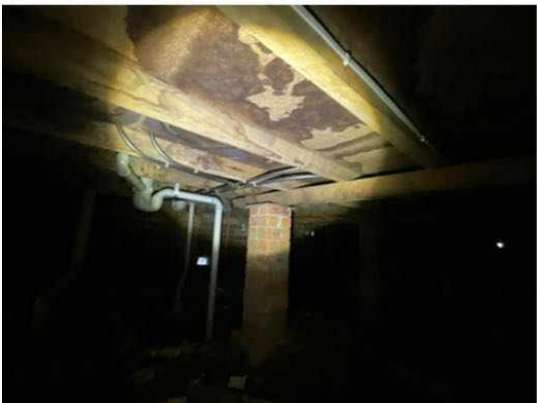
Building: Main Building
 Location: Subfloor
 Finding: Subfloor Inspection Summary
 Information: 1. Access & Limitations

- Improve subfloor ventilation to enhance air movement and assist in moisture dissipation.
- Improve subfloor drainage and surface water management to reduce damp soil conditions and the potential for ongoing moisture exposure.

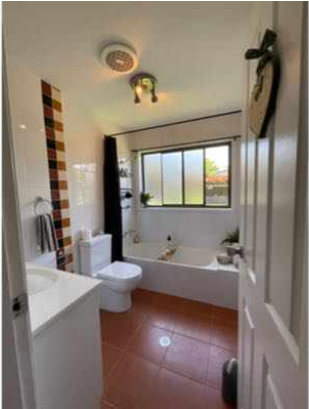
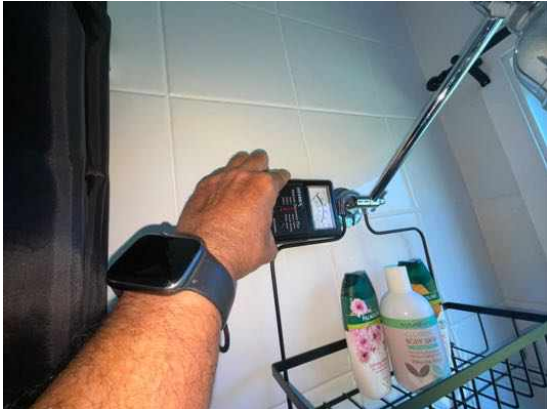
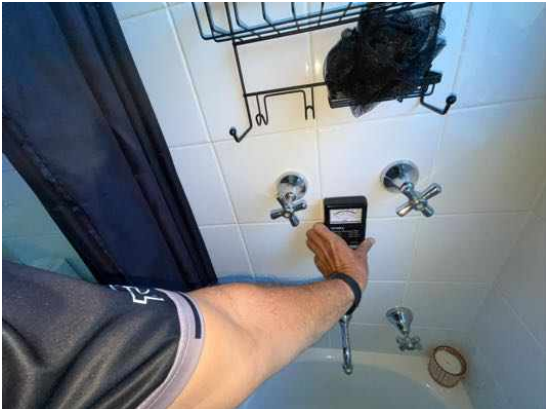
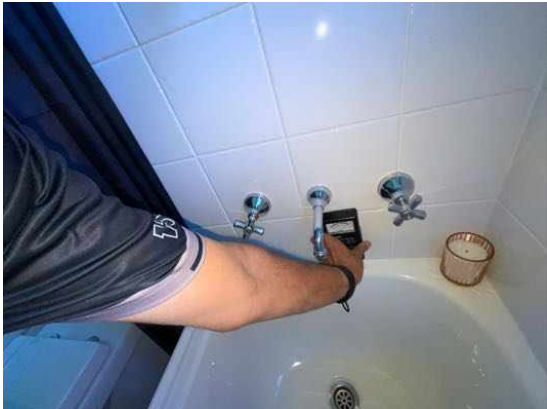
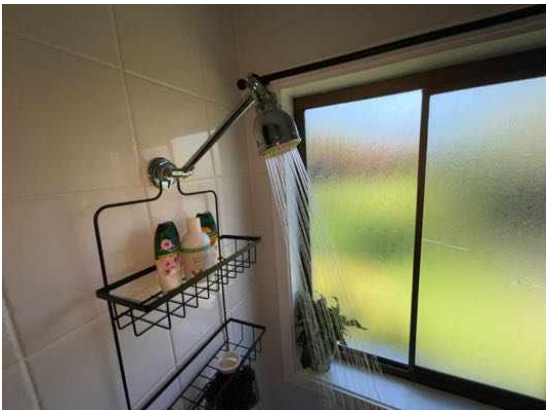
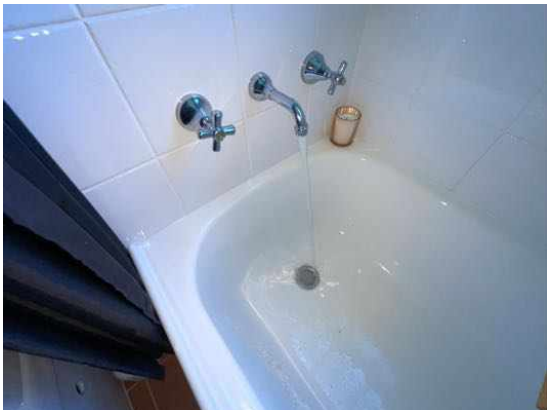
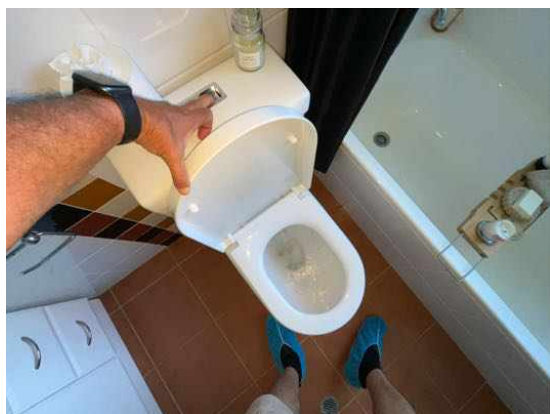
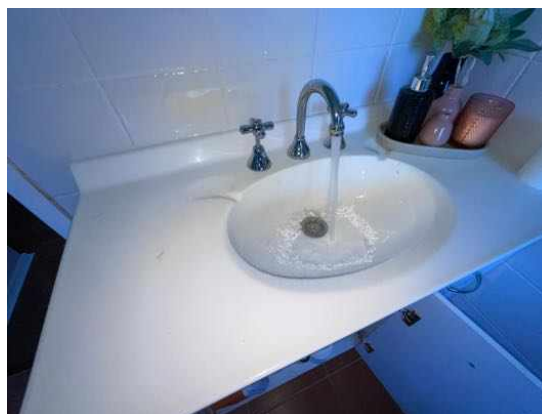
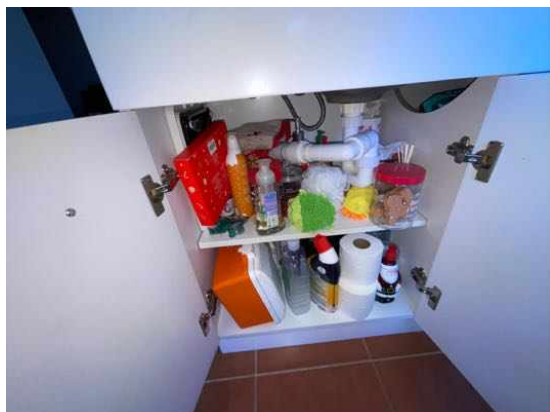
Building: Main Building
Location: Bathroom
Finding: Wet Areas - Bathroom(s) - Overall Condition & Recommendations.
Information: Overall Condition & Recommendations

It is not possible under the visual inspection criteria of a standard pre-purchase report to categorically determine if leaks are present. If a more detailed or accurate assessment is required, a special-purpose inspection should be undertaken.

Alternatively, the assumption should be made that leakage may occur, particularly where historical or environmental conditions are conducive. The visual nature of this inspection cannot detect issues concealed behind wall/floor linings or cabinetry, and invasive investigation may be necessary to confirm the true condition of adjacent or hidden structures.

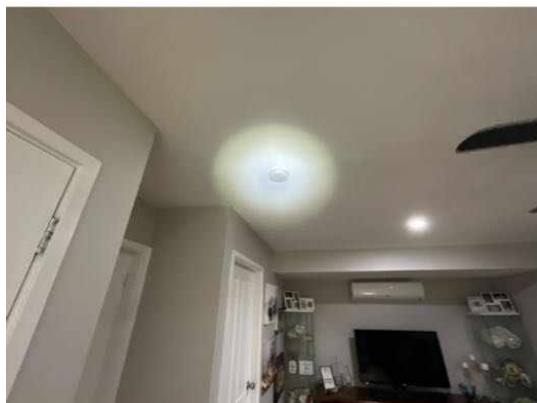
Building:	Main Building
Location:	All Areas
Finding:	Smoke Detectors / Alarms.
Information:	Reporting on the presence, type, location, or compliance of smoke detectors or alarms, including hard-wired smoke detection systems and their legislative requirements, is outside the scope of this inspection report.

- All smoke detectors be tested monthly by the homeowner.
- All systems comply with the requirements of AS 3786 and any applicable state-based legislation.

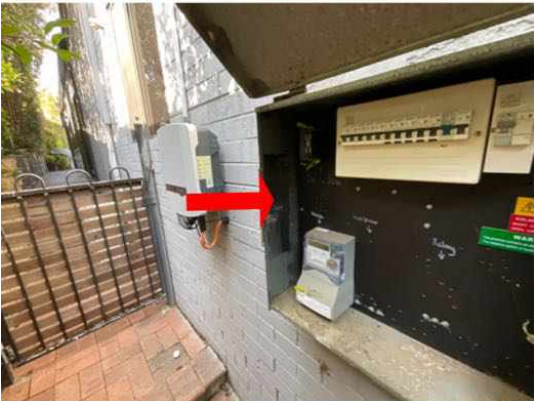
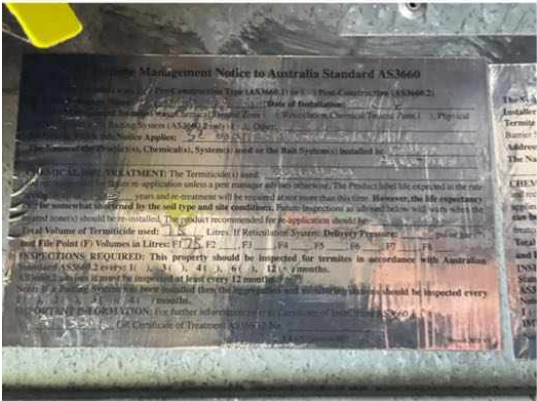
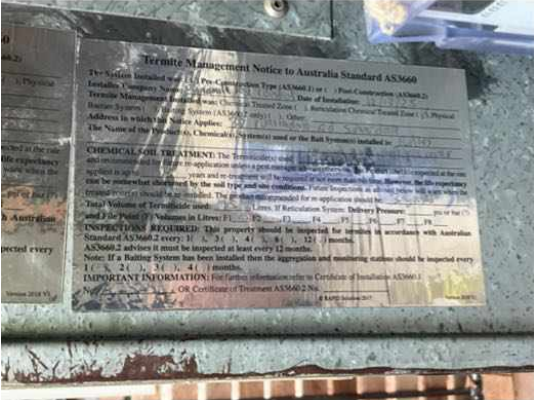
The following items were noted as - Evidence of a previous termite management program

- Physical barriers
- Chemical treatments
- Baiting systems
- Regular inspections and monitoring

These measures work together to reduce the likelihood of undetected termite access and long-term structural damage to the building.
