## Building Inspection Report VR

Inspection Date: Wed, 14 Jan 2026

Property Address: 14 Base St, Victoria Point QLD 4165,  
Australia

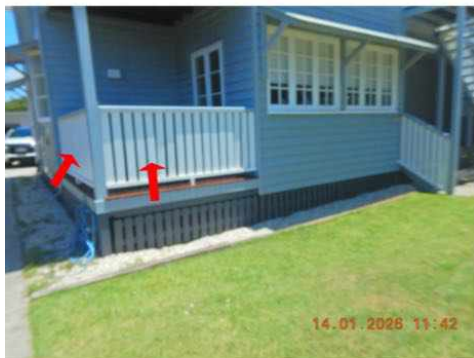
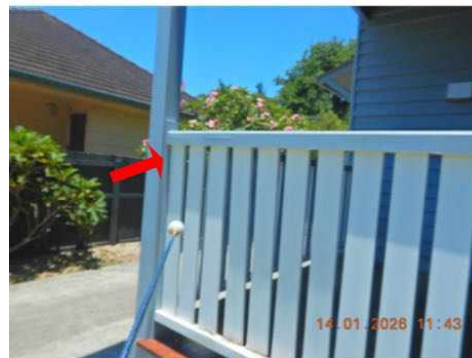
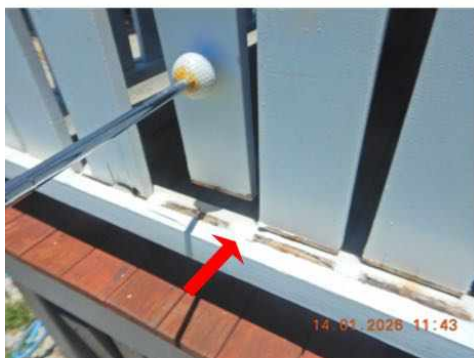
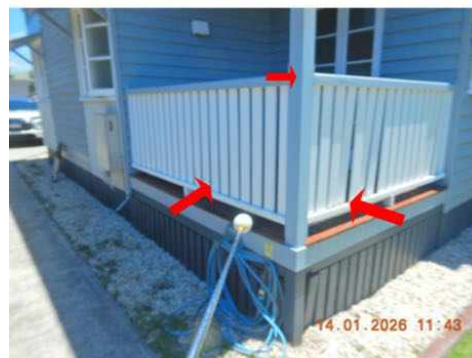
#### Defects 1.01

Building: Main Building  
Location: Patio/ Deck/Stairs > All Areas  
Finding: External Handrail's/ Balustrade  
Information: The external Front patio/stairs/deck areas and rear deck and stairs handrail / Balustrades on this building are showing signs of deterioration due to environmental and moisture damage. Commonly known as wood rot , the bottom edges of the timber slats have come loose from the bottom rail, and some handrails were found to be not adequately secured to the posts in areas. Repair work or replacement is recommended as a priority to assure the personnel safety of anyone using these areas to access the building. The service of a carpenter or registered builder could be engaged to carry out this task.

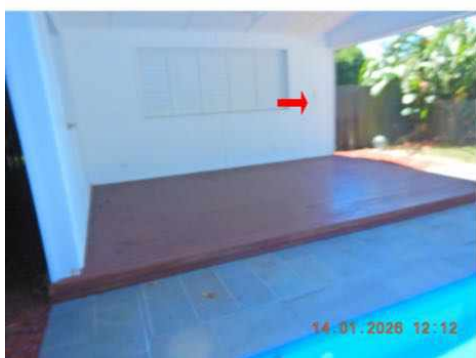
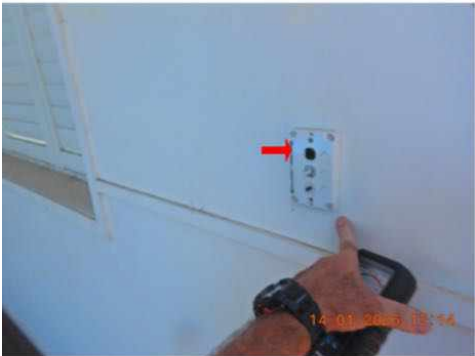
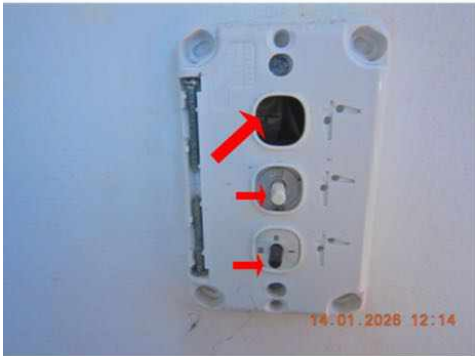
### Defects 1.03

Building: Main Building  
 Location: Pool Area > Rear Right  
 Finding: Electrical fitting - Broken  
 Information: The pool house electrical ceiling light and fan switch fitting in this area was found to be broken at the time of inspection. Breakage occurs generally when the building materials have aged and decayed, but may also be indicative of impact damage to the building element (accidental or deliberate).

Left unmanaged, the fitting is unlikely to cause further damage to surrounding building elements. However, the broken fitting does expose electrical works, and may create a safety hazard if there is potential contact with persons in the area.

Repair and/or replacement of the broken fitting is advised. A Licensed electrician should be appointed to repair/replace the fitting immediately.

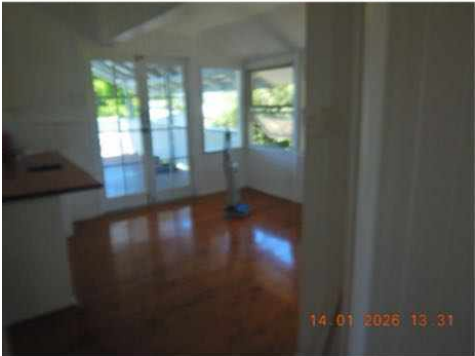
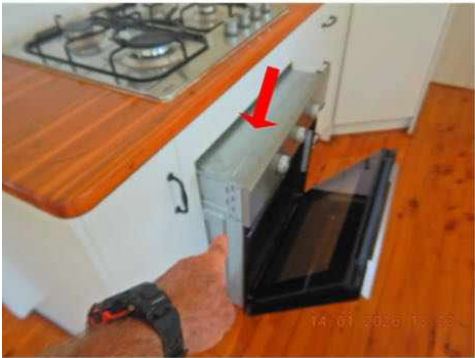
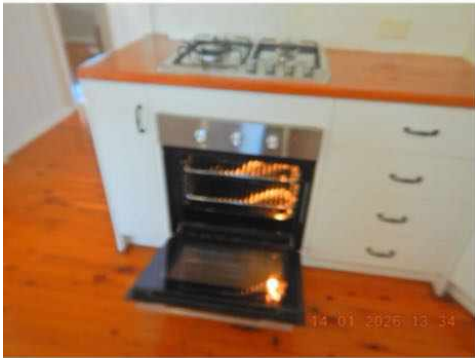
**Defects 1.04**

Building: Main Building  
Location: Kitchen/ Dining > Rear  
Finding: Oven Not secured correctly  
Information: The under bench oven was found to be loose in the opening and requires a couple of fixtures to secure it correctly.

At present this unit can be removed and may pose a safety hazard to anyone using this area.

The electrical contractor can complete the job.

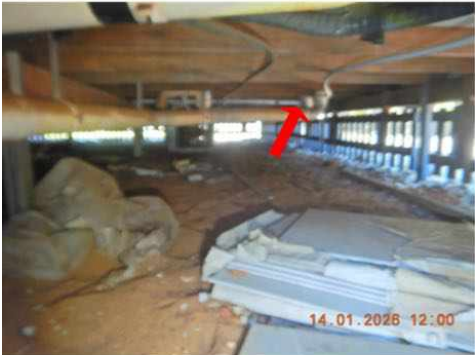
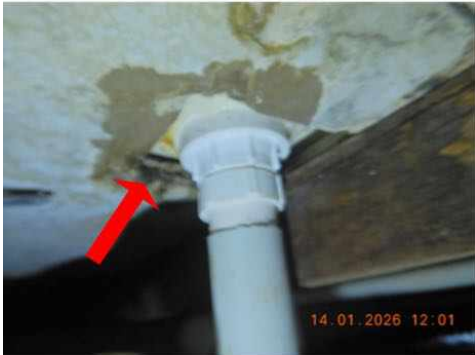
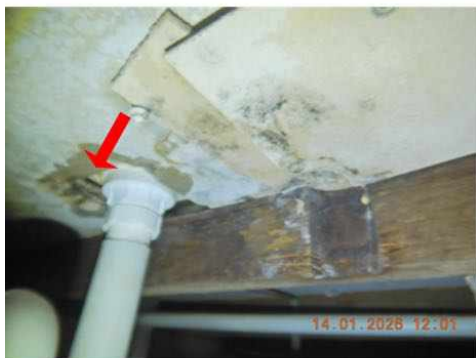
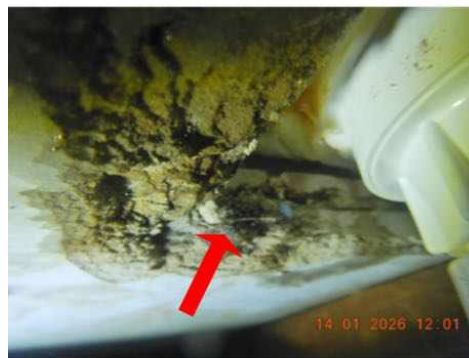
#### Defects 2.01

Building: Main Building  
Location: Bedroom 2 > Rear Left  
Finding: Shower base - Leaking  
Information: Leaking was evident to the lower level bedroom-2 ensuite shower base at the time of inspection. It is suspected that the leaking has occurred as a result of minor impact damage to the shower base or general ageing of the building elements.

Leaking from the shower base, where left unattended, is likely to lead to water damage to adjoining flooring and walls. Such damage can lead to water damage and necessitate extensive remedial works being required. Active water leaks may also create an environment that is susceptible to the formation and development of mould.

Appointment of a plumbing contractor is required to repair or replace the shower base. Such works should be performed as soon as possible to ensure that no further damage occurs.

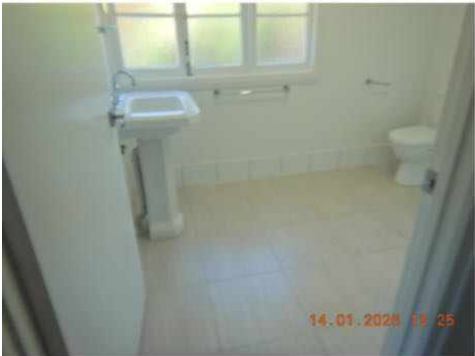
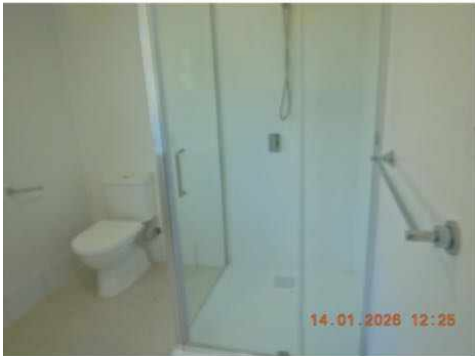
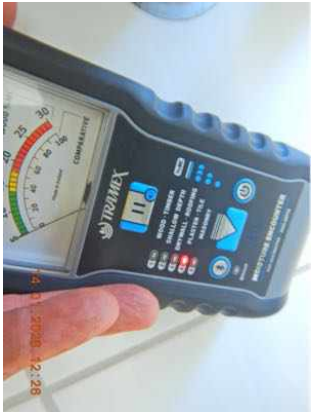
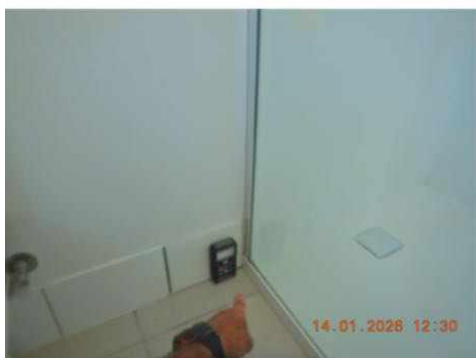
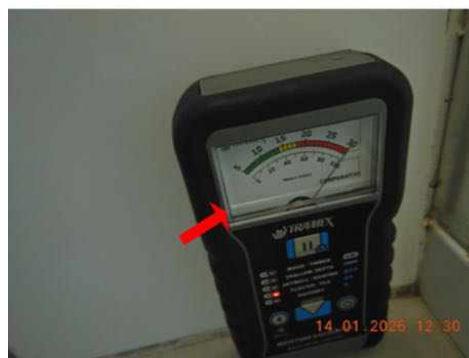
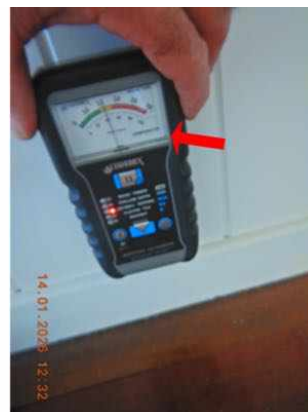
## Defects 2.02

Building:	Main Building
Location:	Bedroom - Master/ Ensuite > Rear
Finding:	moisture meter readings
Information:	There was a high moisture meter reading of 30 % in the master bedroom shower wall area at the time of this inspection. This can be caused by water ingress into the wall cavity from external sources or a possible plumbing leak . Wet areas can also have a potential failure to the water proofing membrane causing potential water issues. A licensed plumbing contractor or waterproofing contractor should inspect this area and report .

As the bedroom -2 shower that backs onto this wall was found to be leaking in the subfloor area, this MAY be the cause of the high moisture in this area.

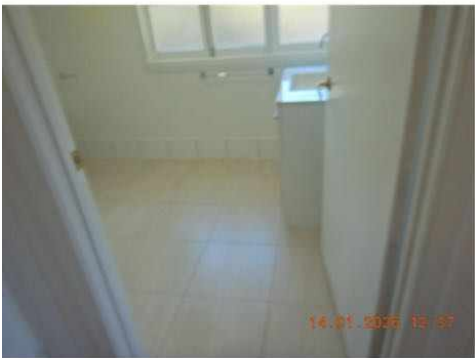
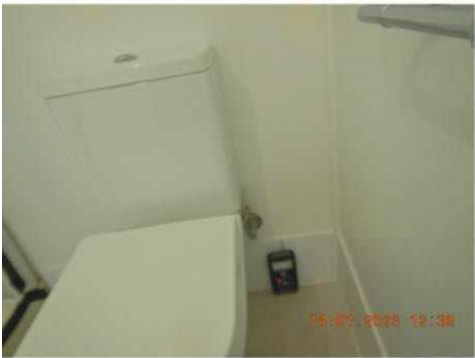
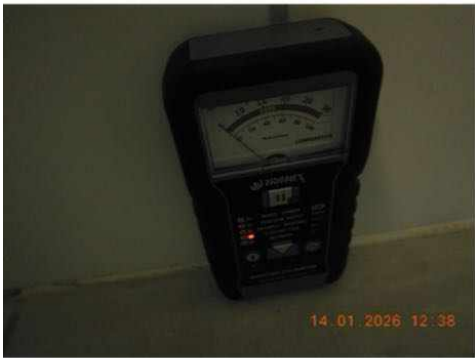
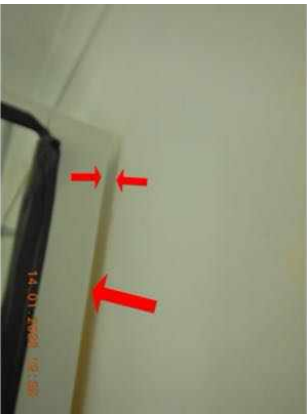
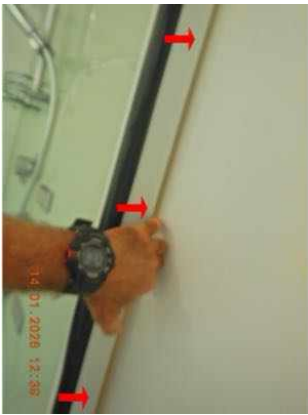
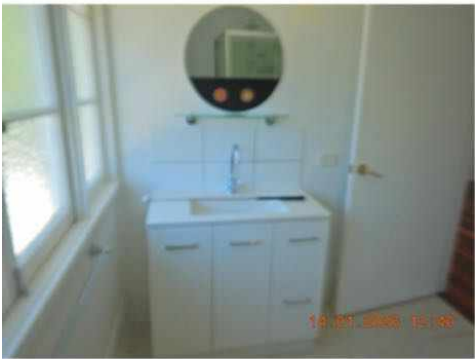
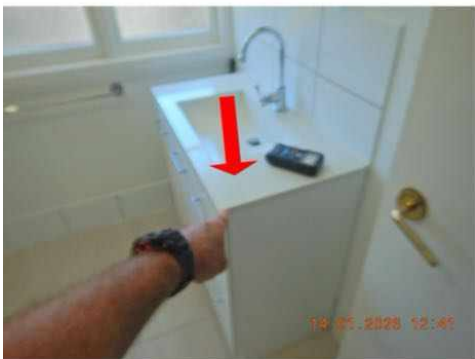
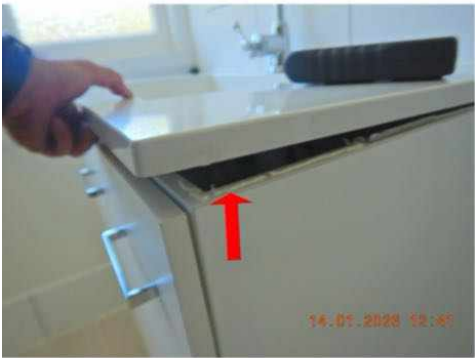
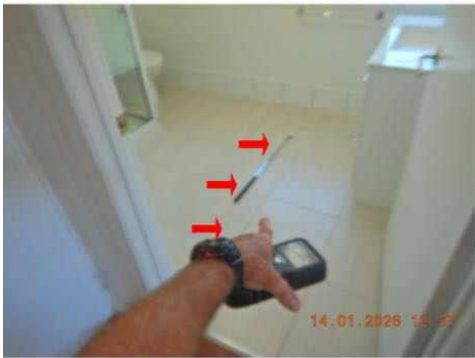
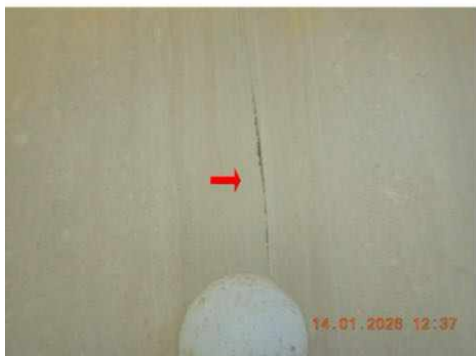
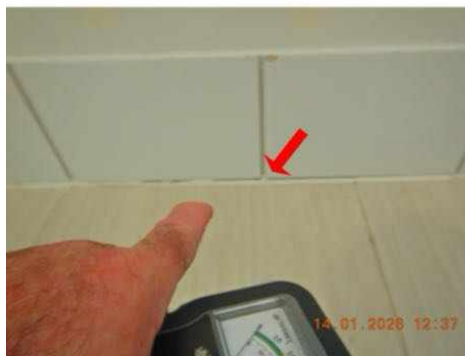
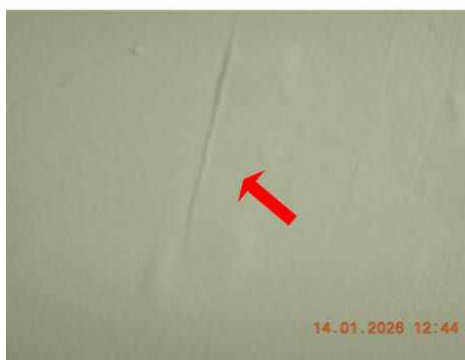
## Defects 2.03

Building: Main Building  
 Location: Bedroom 2/ Ensuite > Front Left  
 Finding: Bathroom in a deteriorated condition  
 Information: The bedroom -2 bathroom was found to be in a minor state of deterioration, with a glass panel missing in the shower screen and the shower unit detached of the rear wall.

This unit was found to be leaking into the subfloor area at the time of this inspection, and will require repairs.

The vanity unit top is not secured adequately to the unit and can be lifted up, this will require repairs secured.

There is minor movement cracking to the floor tiles in the centre of this room ,and repairs may be required if the movement cracking continues.

There appears to have been repairs to the ceiling area, and have been completed to a poor standard, and repairs will be required.

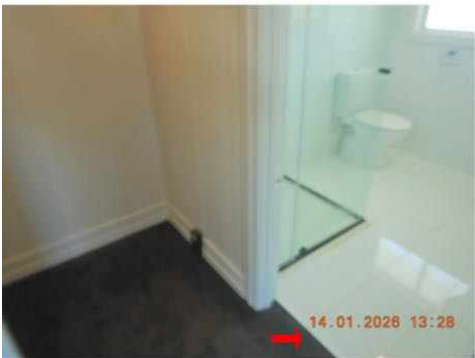
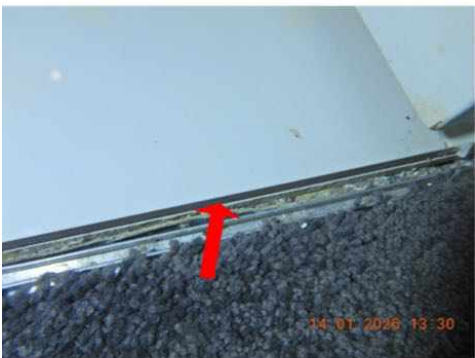
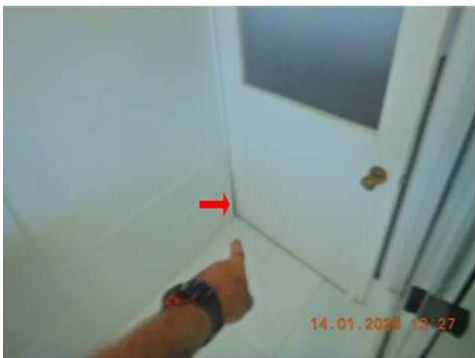
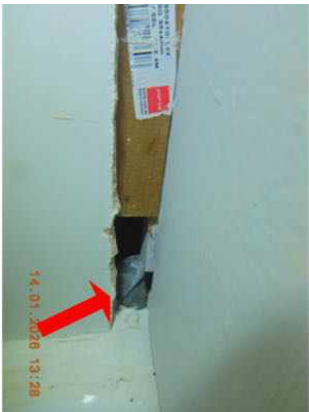
## Defects 2.04

Building: Main Building  
 Location: Bedroom 3/ Ensuite > All Areas  
 Finding: Waterproofing not installed  
 Information: The bedroom-3 ensuite floor area is suspected to not have a waterproof membrane installed as per Australian building code standards at the time of this inspection , no water stop angle or waterproofing was sighted at the door front to this room or other wet area.

There is a noticeable gap behind this ensuite doorway , and NO waterproof membrane was sighted, and may allow water into the floor cavity or ceilings below.

Monitoring of this area for any moisture deterioration occurring is recommended.

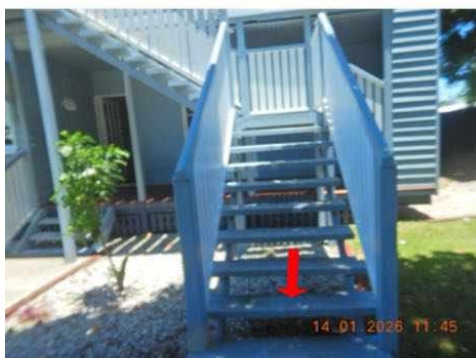
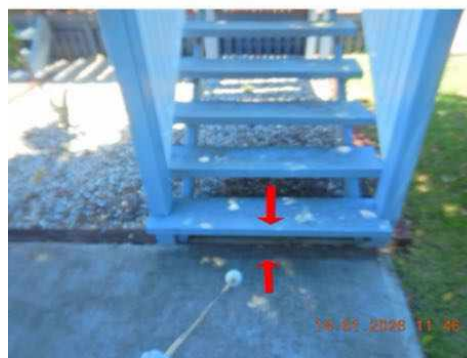
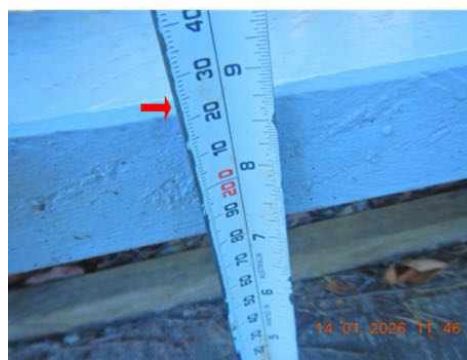
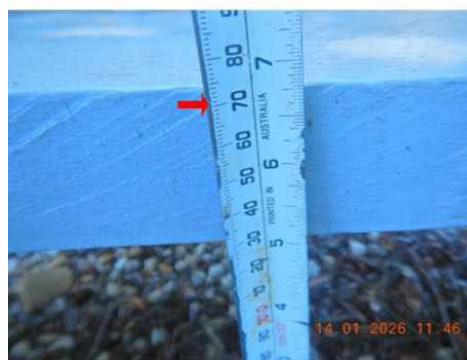
## Defects 3.02

Building:	Main Building
Location:	Stairs - External > Centre
Finding:	External stairs
Information:	main front stairs were found to have a bottom riser of 220 mm from the concrete to the first step and should not be greater than 190 mm.

The difference of 50 mm at the bottom step can cause some people to be unbalanced and there is a potential for a fall.

The installation of a 50 mm paver secured to the concrete should be considered.

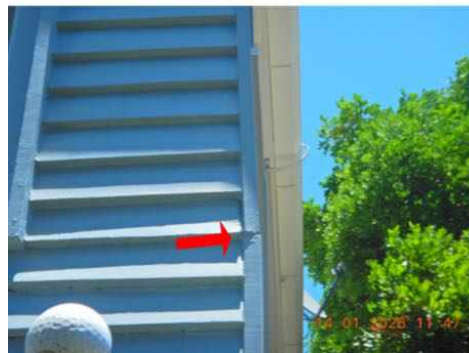
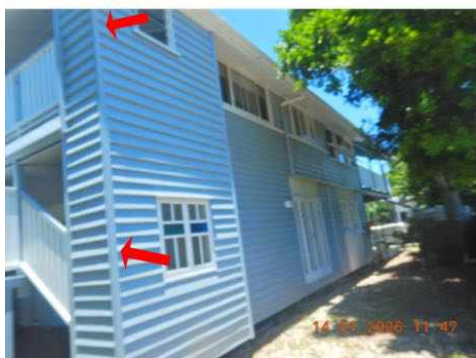
### Defects 3.03

Building:	Main Building
Location:	Exterior walls - front > Front Right
Finding:	Timber wall Framing ( As- 1684.2 )
Information:	The front right side external balcony wall and timber stop were noticeably leaning out off plumb.

As the original house is suspected to be 80 years old and has been lifted and built in underneath, this defect is considered a cosmetic defect only at this time.

New construction Timber wall framing is considered defective if it deviates from plane ( horizontal or vertical bow ) by more than 4 mm in any 2 meter length of wall framing.

Areas of wall framing in this area were found to be bowed / bent or out of horizontal or vertical tolerances by up to \_ mm over a 2 meter level.

This will require correction at the client's discretion.

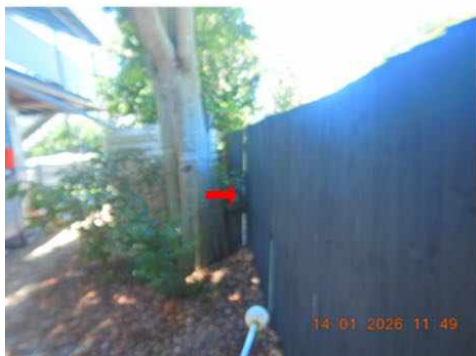
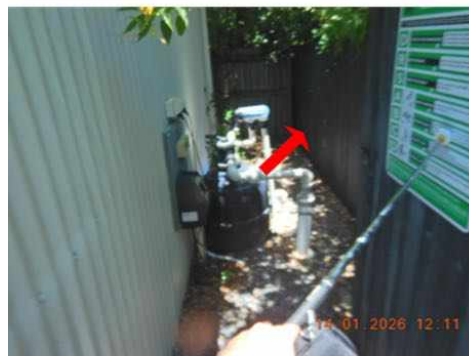
### Defects 3.04

Building:	Main Building
Location:	Yard > All Areas
Finding:	Fencing - Deteriorated
Information:	It was noted at the time of inspection that sections of the boundary timber fencing throughout the property have deteriorated. Typically fencing deteriorates due to age and or wear, rot and or rust which is generally expected for a structure of this age, due to prolonged exposure to weather conditions. Sometimes inadequate installation or maintenance can be to blame.

If left unattended, it is likely that further damage will occur. It is suspected that repair of several elements of the fencing may be required however replacement may be a consideration of the client also.

A licensed fencing contractor should be appointed to provide further advice and perform rectification works as necessary.

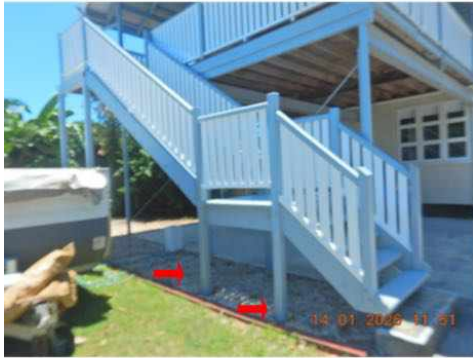
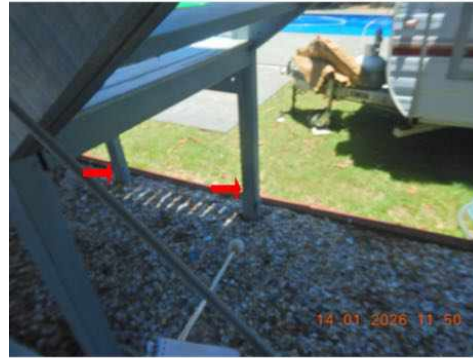
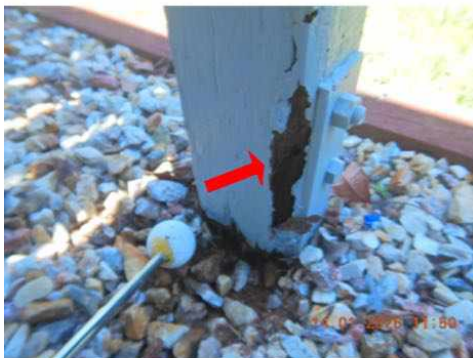
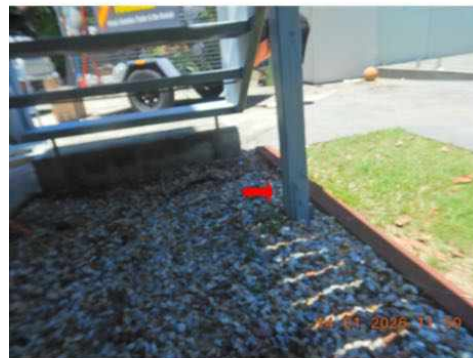
### Defects 3.05

Finding: Wood rot

Information: The rear deck stairs landing timber posts shows evidence of minor wood rot at the base of the posts. Wood rot, also known as Fungal Decay, occurs when timbers and other cellulose building materials are exposed to damp conditions on an ongoing basis. This could be the result of exposure to weathering over a prolonged period of time, or the attraction of excessive moisture from other abutting building materials. Contributing factors also include poor air ventilation in the area.

Wood rot is often associated with general damp problems and is evidenced by a 'musty' smell or mould and mildew occurring on surfaces. If left unmanaged, damp conditions can lead to further health problems and the decay of timbers will continue.

Early intervention and regular maintenance, particularly of exterior timbers, will prolong the useful life of these building elements. Prior to any works being performed, the cause of the moisture that has created the visible wood rot should be identified and addressed in a suitable manner. Replacement of affected timbers may then be a necessary step in protecting surrounding building elements from such deterioration.

A qualified plumber may be appointed to assess the cause of excessive moisture and to provide advice on any remedial works as required. A qualified carpenter or

registered builder may also be required to replace affected building materials.

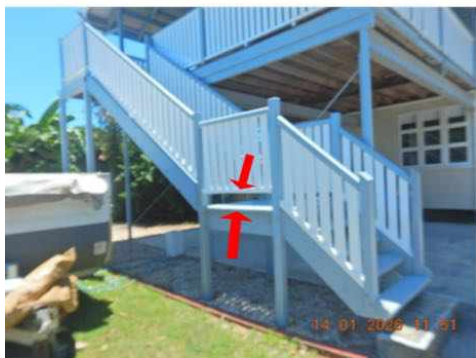
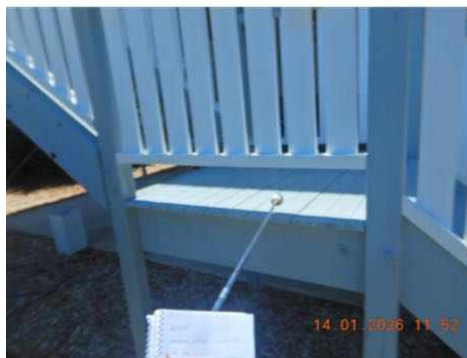
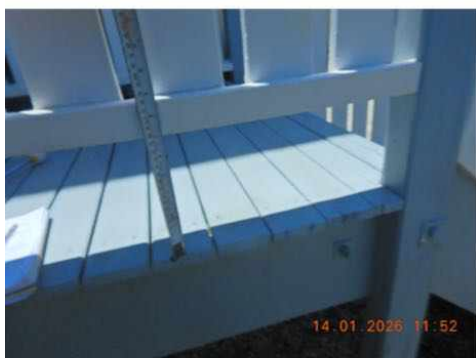
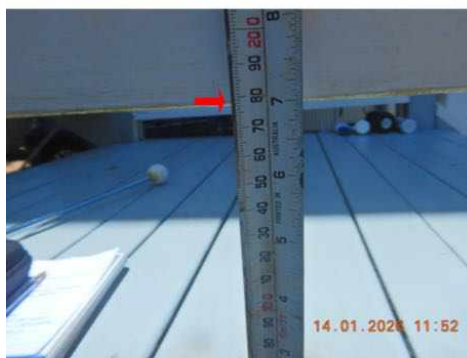
### Defects 3.06

Building:	Main Building
Location:	Deck > Rear
Finding:	External stairs handrails
Information:	The rear deck external timber stairs handrails were noted to have gaps of 180 mm between the timber bottom rails and decking, and do not meet current Australian standards.

This has created a safety hazard, for potential falls through the current handrail in place.

Due to the age of the building this standard possibly does not apply to this handrail, but as the building has had recent renovation works completed, it is believed the external timber handrail's should comply with current standards .

A carpenter contractor or stair manufacturer could be in gaged to alter the handrails to meet current standards.

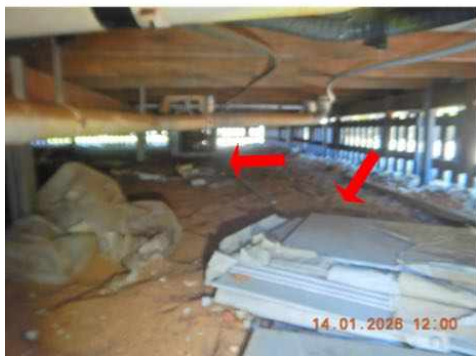
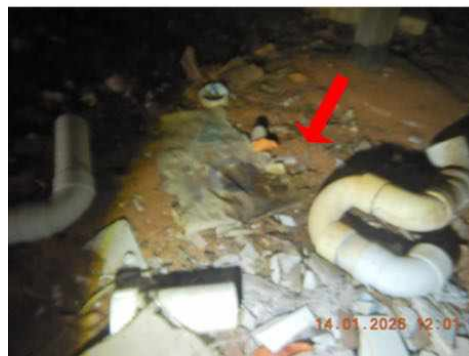
### Defects 3.07

Building:	Main Building
Location:	Bedroom 2 > All Areas
Finding:	Subfloor - Debris
Information:	An array of debris was found in the subfloor area at the time of inspection. Debris in this area restricts subfloor ventilation and creates potential for concealed pest entry. Stored timbers and other materials may also make the area susceptible to termite activity and wood rot.

A clear and empty subfloor will be better ventilated and easier to maintain in a dry condition. The removal of any timber debris is vital in minimising the risk of termite or wood borer activity.

Debris in the subfloor should be removed as soon as possible. Depending on the location and amount of debris and stored items, the homeowner may elect to undertake this task. Alternatively there are a large number of rubbish removal subcontractors that could undertake these works.

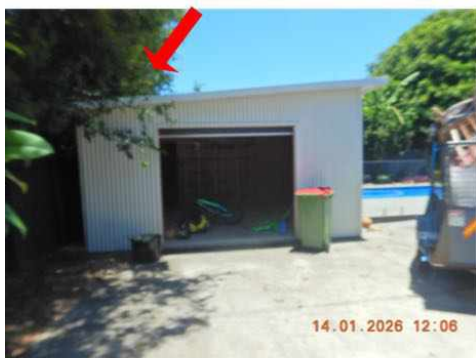
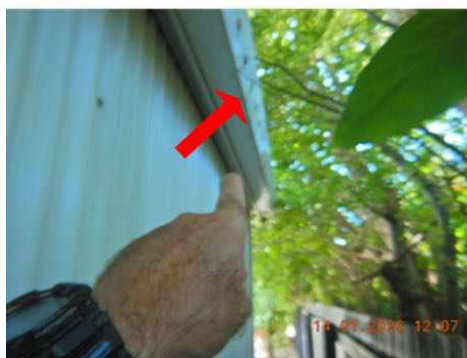
## Defects 3.08

Building:	Main Building
Location:	Shed > Centre Left
Finding:	Trees - Overhanging and filling gutters
Information:	The rear left side detached metal shed was found to have a large tree in direct contact with the roof and guttering on this building.

Gutters are a critical part of the building's management of storm water and rain. It is therefore important that they be kept clear to prevent secondary damage to associated building elements, including exterior and interior walls, ceiling linings and any adjoining building elements. Where gutters are blocked, pooling of rainwater is likely to occur, fast-tracking rust and corrosion of the roof plumbing elements.

It is highly advised that all overhanging tree branches be removed as soon as possible to prevent any further damage. Repair and/or replacement of sections of damaged guttering may also be required where the extent of the damage necessitates.

Such works should be performed by the homeowner; however, appointment of a landscape contractor or an arborist may be required. Consultation with a licensed roof plumber is required where guttering has been damaged.

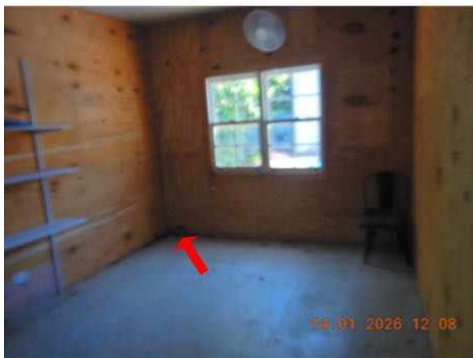
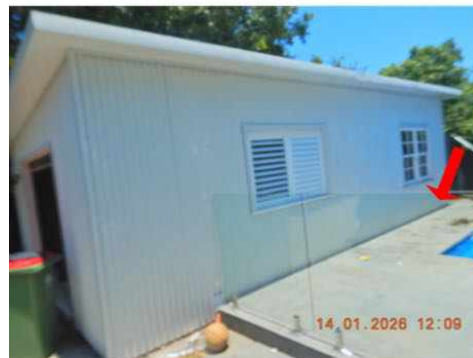
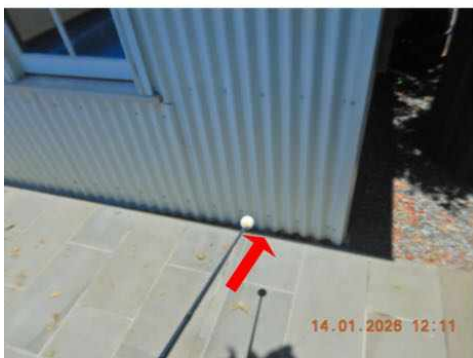
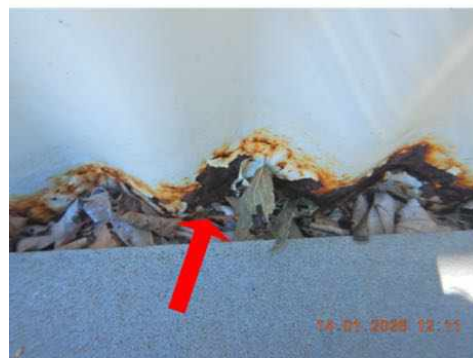
### Defects 3.09

Building:	Main Building
Location:	Shed > Rear Right
Finding:	Building element - Rusted or corroded
Information:	The rear left detached metal shed structure shows evidence of rusting and corrosion to the rear right side metal wall material , which is likely to have developed as a result of excessive exposure to moisture and or inadequate coatings.

As surface rust provides no protection to the underlying iron, the deteriorating condition is likely to worsen if not addressed in the short-term future.

Where possible, the use of galvanized (treated) metals or aluminium coated metals aid in rust prevention, as does regular general maintenance. Rust formation can be controlled with coatings, such as paint, that isolate the iron from the environment.

Rusting and corrosion should be managed by ideally removing or limiting the affected surface from exposure to moisture. A registered builder may be appointed to replace any building elements that have been severely affected by rust or water damage.

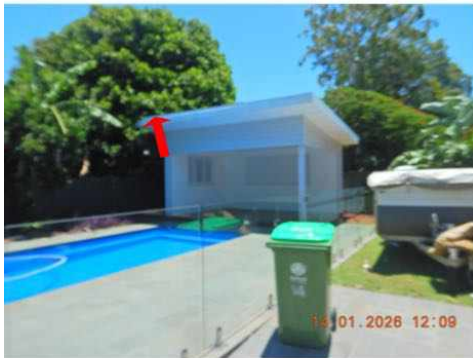
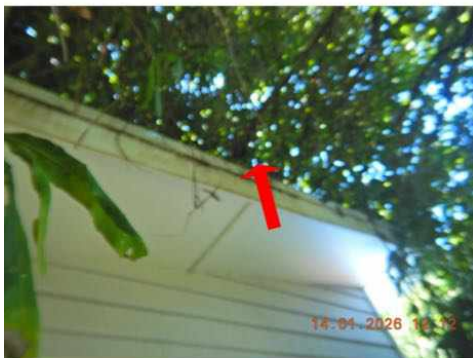
### Defects 3.10

Building: Main Building  
 Location: Pool Area > Rear Right  
 Finding: Trees - Overhanging and filling gutters  
 Information: The rear right side pool hours structure was found to have a large tree in direct contact with the roof areas, and the gutters were blocked with vegetation debris.

Gutters are a critical part of the building's management of storm water and rain. It is therefore important that they be kept clear to prevent secondary damage to

associated building elements, including exterior and interior walls, ceiling linings and any adjoining building elements. Where gutters are blocked, pooling of rainwater is likely to occur, fast-tracking rust and corrosion of the roof plumbing elements.

It is highly advised that all overhanging tree branches be removed as soon as possible to prevent any further damage. Repair and/or replacement of sections of damaged guttering may also be required where the extent of the damage necessitates.

Such works should be performed by the homeowner; however, appointment of a landscape contractor or an arborist may be required. Consultation with a licensed roof plumber is required where guttering has been damaged.

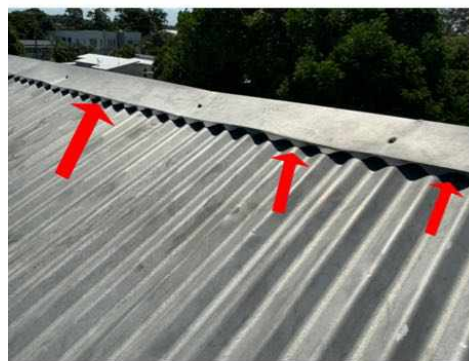
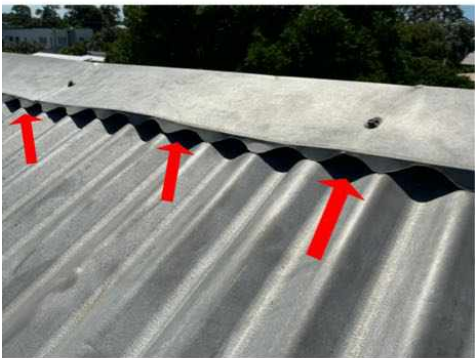
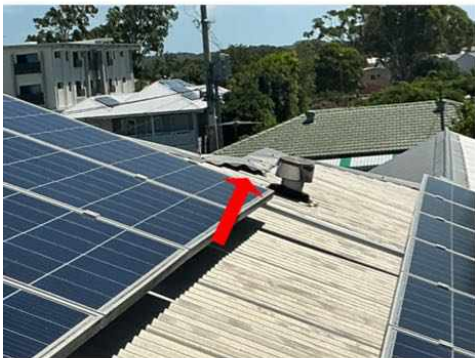
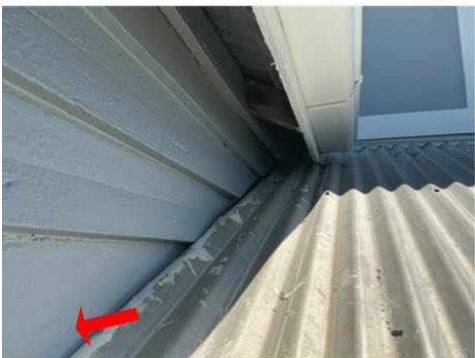
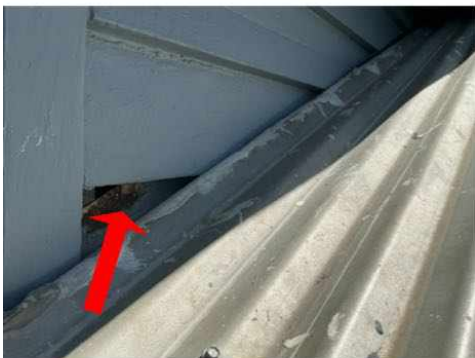
### Defects 3.12

Building:	Main Building
Location:	Roof Exterior > All Areas
Finding:	Roof plumbing - Loose flashing
Information:	Metal and other material flashings are applied to seals and intersections between roof coverings and building elements. They are designed to aid in weatherproofing of roof joins, and require regular inspection and maintenance as they are more subject to rust-related deterioration.

The flashing in this section of the exterior roofing appears to have come loose from its original fixing. It is suspected that this minor defect has occurred as a result of general deterioration over time.

Re-fixing and potential replacement of certain areas of flashing is advised to promote adequate roof drainage and protection from water penetration. Failure to perform these works may result in water damage and accelerated deterioration of associated building elements.

A roofing contractor or roofing plumber should be appointed as soon as possible to restore the flashing to a fully operational state.

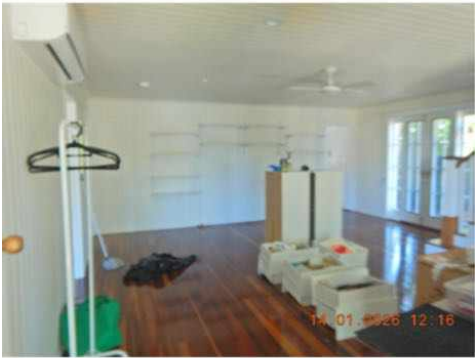
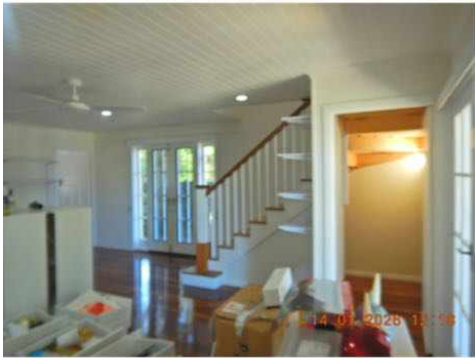
**Defects 3.13**

Building: Main Building  
Location: Living Room > Front Right  
Finding: Hopper Window springs broken  
Information: The downstairs front living room wall window was found to have the operating side spring damaged.

This will restrict the operational capacity of this window and will need to be replaced.

A windows service technician could complete the job.

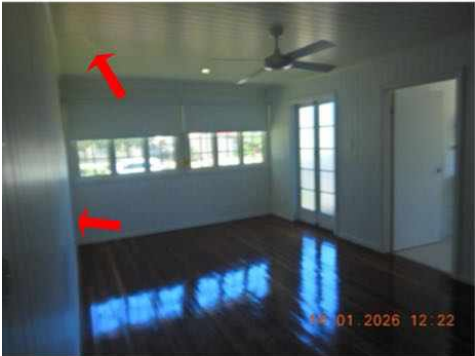
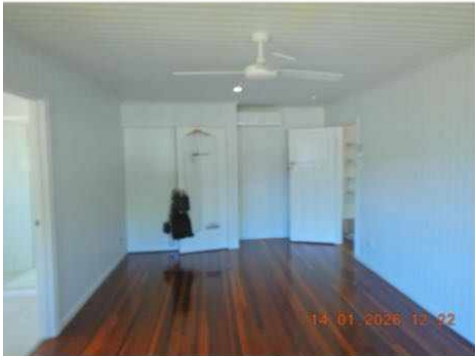
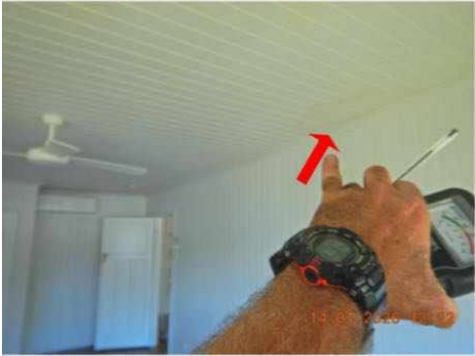
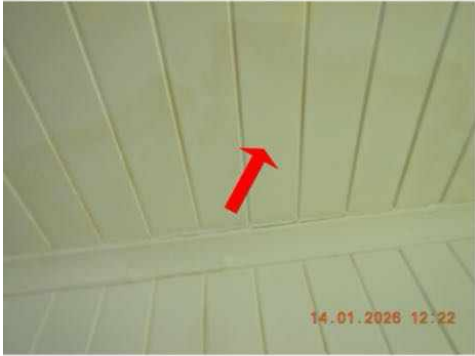
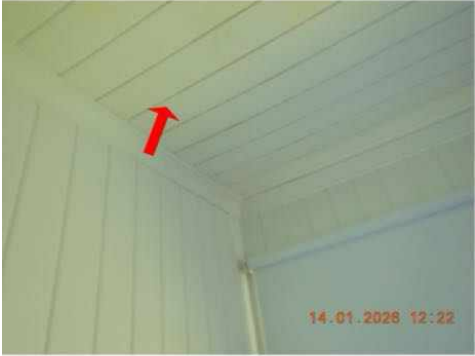
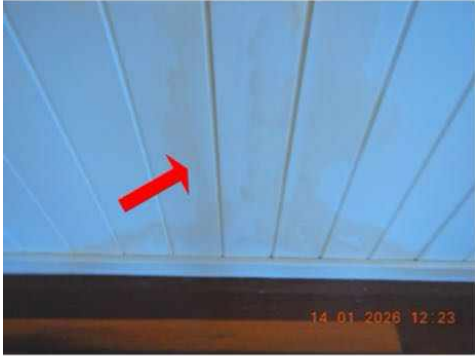
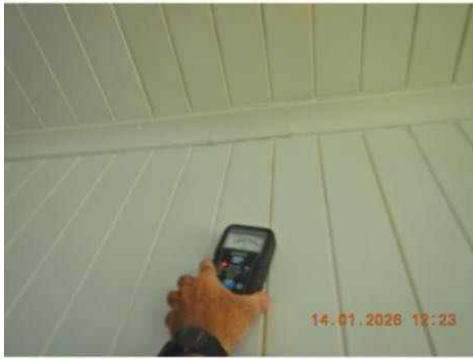
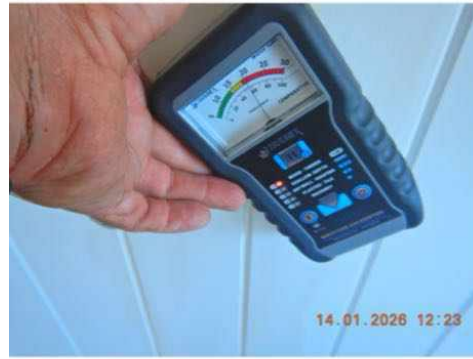
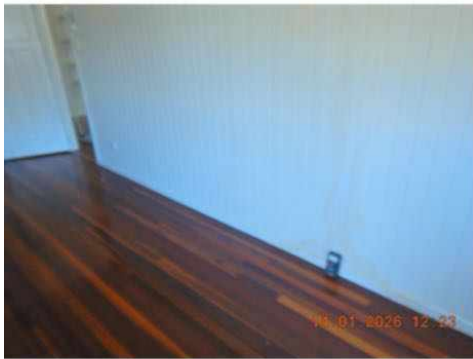
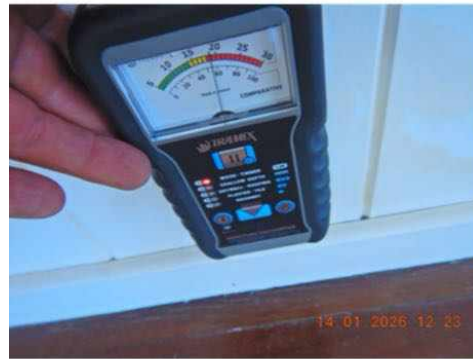
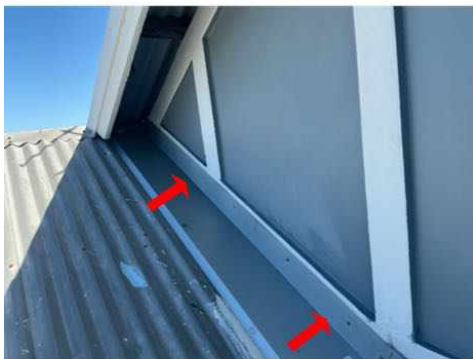
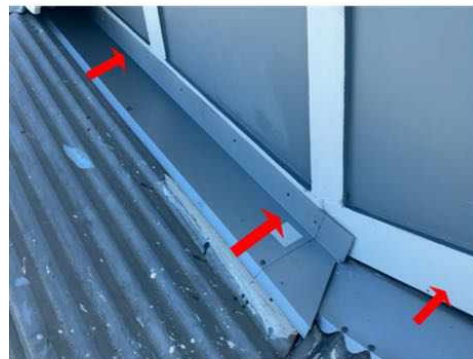
### Defects 3.14

Building: Main Building  
 Location: Bedroom - Master > Front Left  
 Finding: Ceiling - Water stained  
 Information: Water staining was noted to the master bedroom wall and ceiling, with slightly high moisture meter readings of 18 % identified.

There has been repairs to areas of the upper level roof flashings that were the cause of this damage, and minor repair works to the wall and ceiling paint work will be required.

Water staining to ceiling linings in this area was evident at the time of inspection. Water staining indicates that surfaces have been exposed to excessive moisture over time. The minerals and other elements in the water lead to staining, which may graduate to corrosion and deterioration if left unmanaged.

While mostly an appearance defect, water staining can be indicative of more serious defects, which may be currently concealed by interior ceilings.

Where water staining is active, a licensed plumber must be consulted to identify the cause of the staining and to provide advice on any reparation works that may be required. Replacement of any damaged structures is advised.

Conversely, where water staining is old and inactive, affected building materials may be repaired or replaced at client discretion.

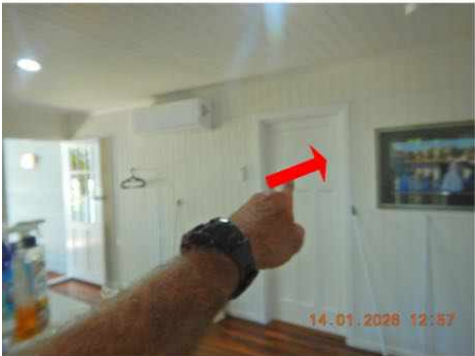
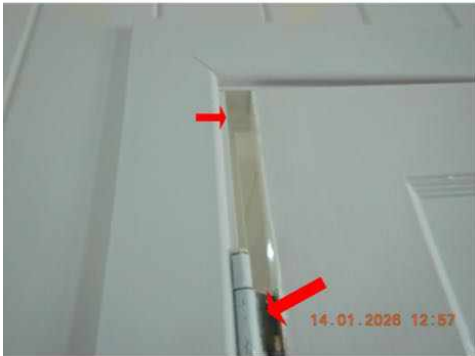
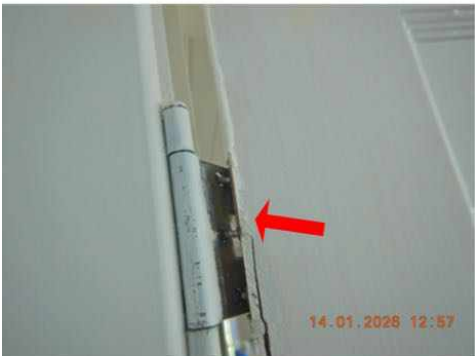
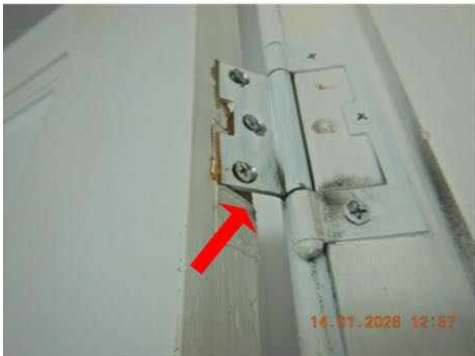
### Defects 3.15

Building:	Main Building
Location:	Bedroom - Master > Front
Finding:	Door hinge loose
Information:	The top hinge on the master bedroom door was found to be loose and in need of re fixing. The door rubs at the top and wont close as a result of the hinge being loose . A handyman could complete this task.

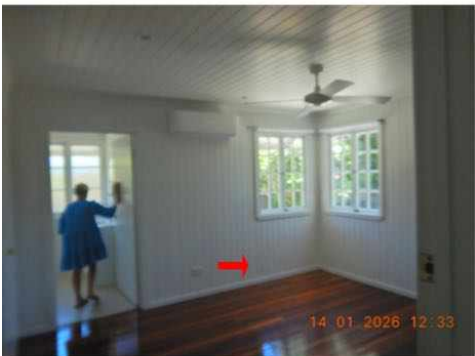
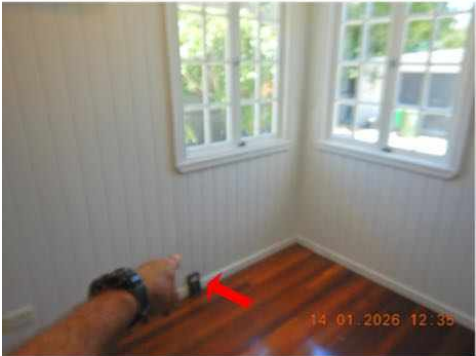
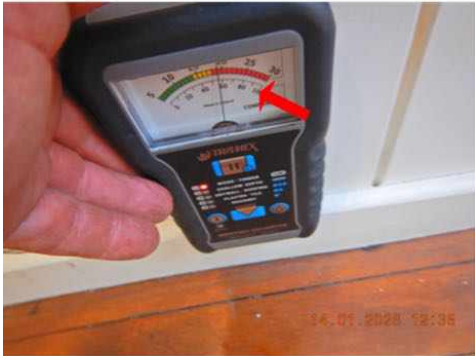
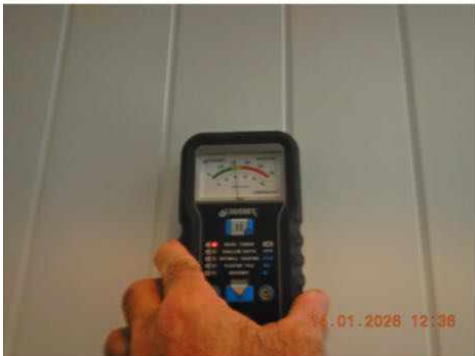
**Defects 3.16**

Building: Main Building  
Location: Bedroom 2 > Rear Right  
Finding: moisture meter readings  
Information: There was a slightly high moisture meter reading of 18 % in the bedroom -2 rear wall window area at the time of this inspection. This can be caused by water ingress into the wall cavity from external sources or a possible plumbing leak . Wet areas can also have a potential failure to the water proofing membrane causing potential water issues. A licensed plumbing contractor or waterproofing contractor should inspect this area and report .

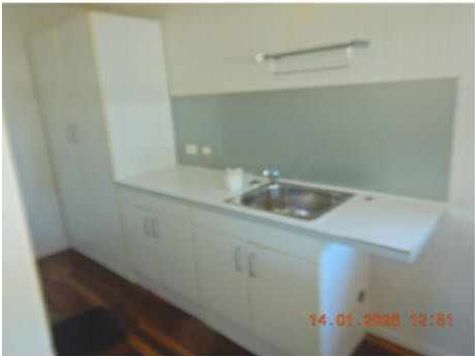
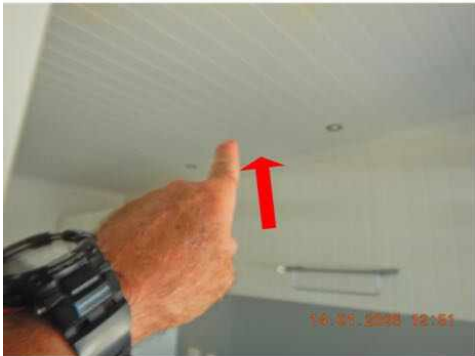
**Defects 3.17**

Building: Main Building  
Location: Laundry > All Areas  
Finding: Ceiling light not working  
Information: The laundry ceiling down lights were not working at the time of this inspection. The light fitting should be inspected by a licensed electrical contractor and, if required the fitting may need to be replaced.

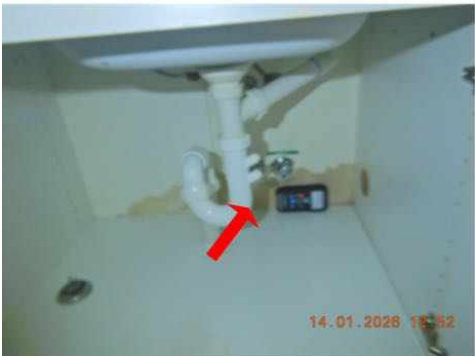
**Defects 3.18**

Building: Main Building  
 Location: Laundry > Rear  
 Finding: Suspected old Water damage.  
 Information: There appears to be old water damage to the rear laundry sink area joinery identified.

Moisture meter readings in this area were in the low range at the time of this inspection, but this area should be monitored for any further moisture deterioration occurring.

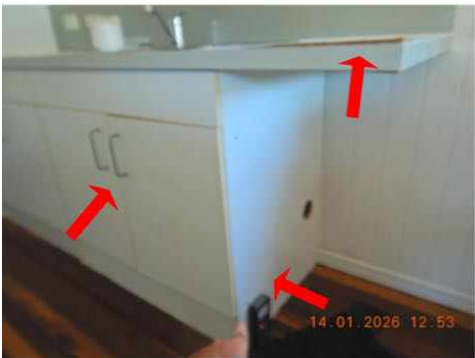
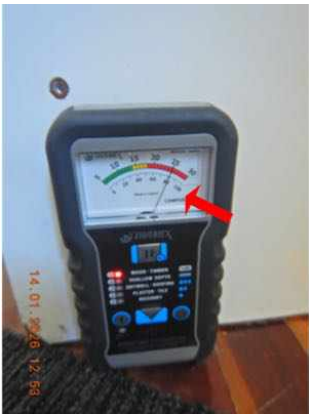
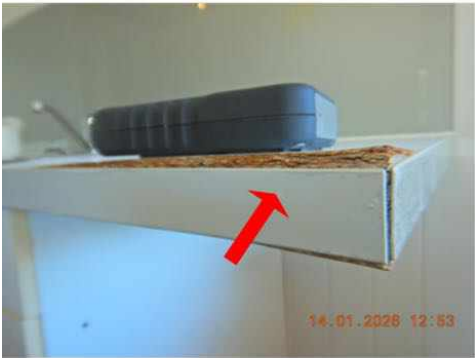
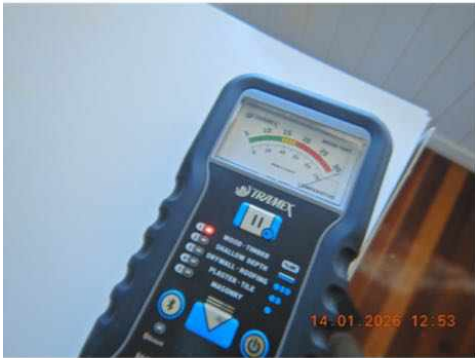
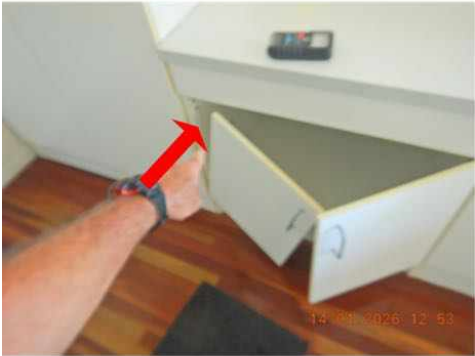
### Defects 3.19

Building: Main Building  
 Location: Laundry > Rear Right  
 Finding: Laundry bench top swollen/ Deterioration  
 Information: The laundry bench top was found to be in a deteriorated condition and is swollen at the right side of the sink.

The under bench door was found to have a damaged hinge and the door was detached, and will require minor repairs.

The laundry bench top will require replacement.

A handyman could complete this task.

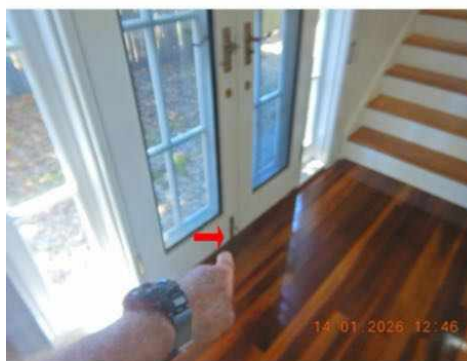
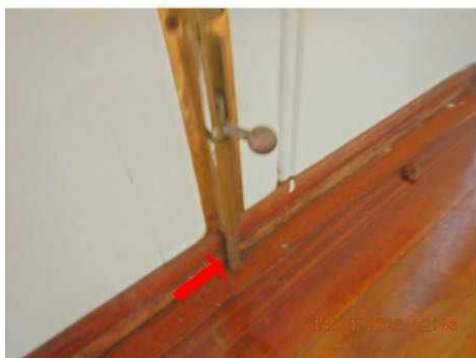
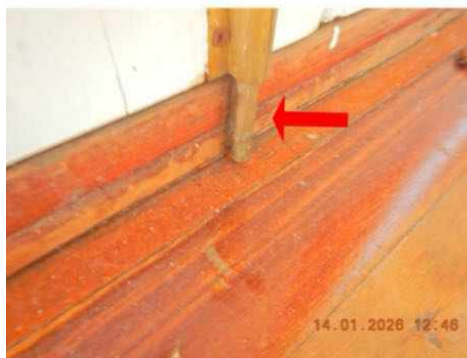
Defects 3.20

Building: Main Building  
 Location: Stairs - Internal > Front Left  
 Finding: Door catch damaged  
 Information: The french door bolt at the top of the door is not secured by a latch plate or hole in the flooring, and will require repair.

The door can be opened without the latch being engaged.
